PEF Responses to E.I.W. Data Request

A. Studies completed by utility on assessment of nature and causes of storm related damages resulting the 2004 and 2005 hurricane seasons:

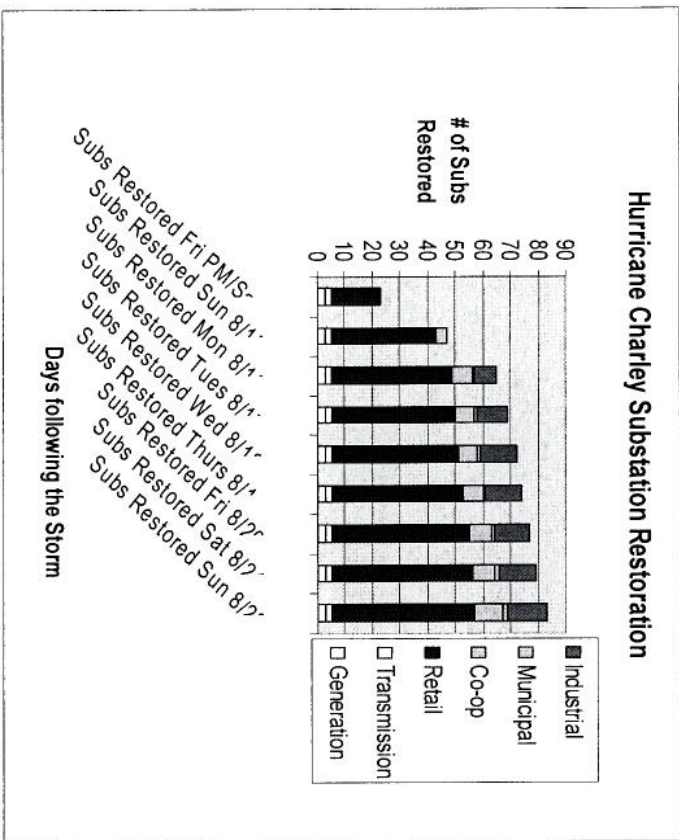
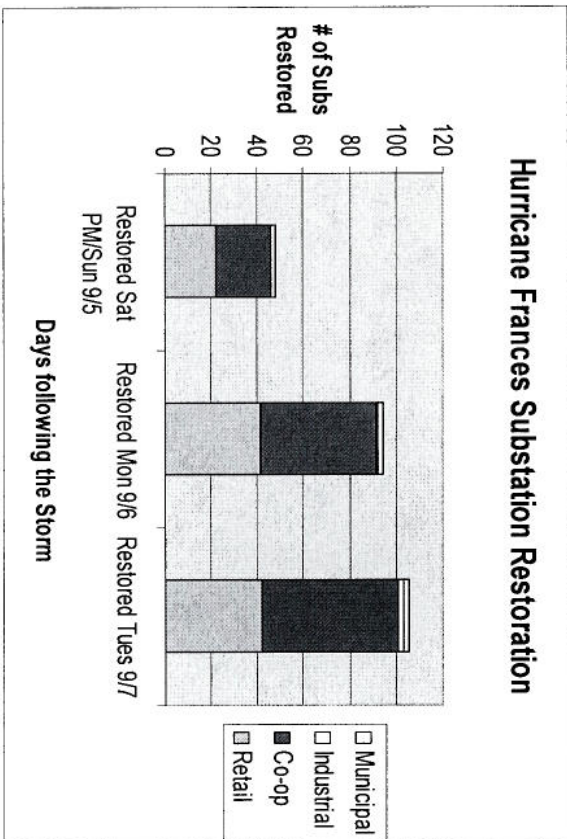
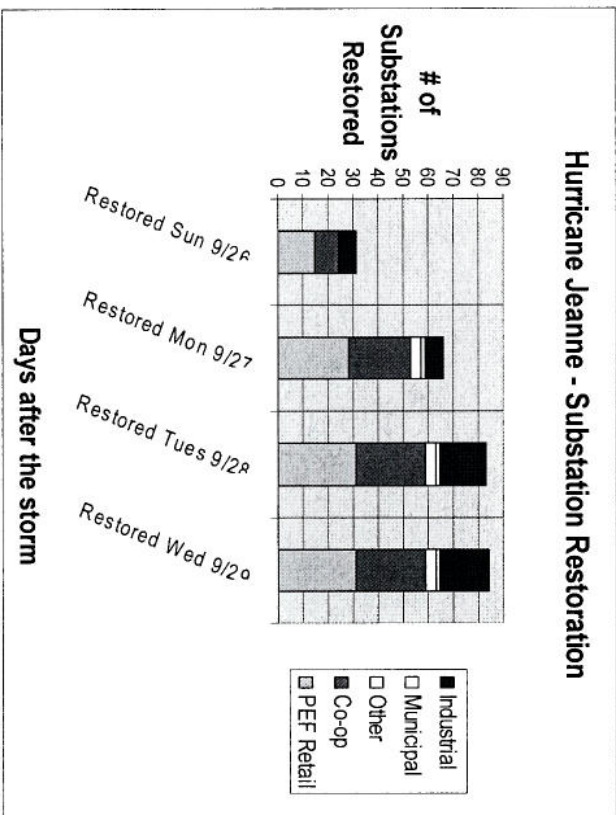
As a general matter, PEF was able to bring its substations back on line quickly by restoring the source lines to the substations. Attachment F shows the time taken to restore PEF substations after each of the three 2004 hurricanes.
