BEFORE THE  
FLORIDA PUBLIC SERVICE COMMISSION

DOCKET NO. 20240001-EI

In re: Fuel and purchased power  
cost recovery clause with generating  
performance incentive factor.

PROCEEDINGS: HEARING

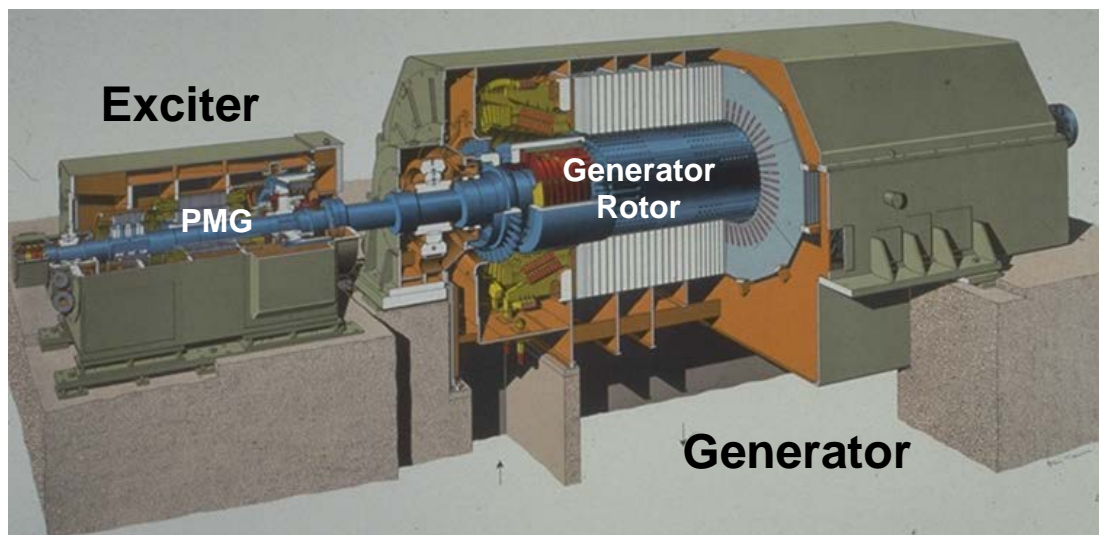
**Figure 4 - Generator Exciter Configuration**

20 A. The generator exciter creates a DC current by rotating the PMG inside of exciter  
21 windings (wire coil). This DC current is fed to the rotor of the synchronous  
22 generator to create a magnetic field which is rotated inside the generaor to create  
23 electricity. The exciter is connected to the generator shaft as shown in Figure 4.

1 The exciter PMG is what initiates the process of energizing the generator for  
2 production of electricity. Without the exciter, the generator is simply a rotating  
3 mass and cannot produce power because there is no magnetic field.
