SECO Energy Report to the Florida Public Service Commission Pursuant to Rule 25-6.0343, F.A.C. Calendar Year 2016

# 2. Number of meters served in calendar year 2016

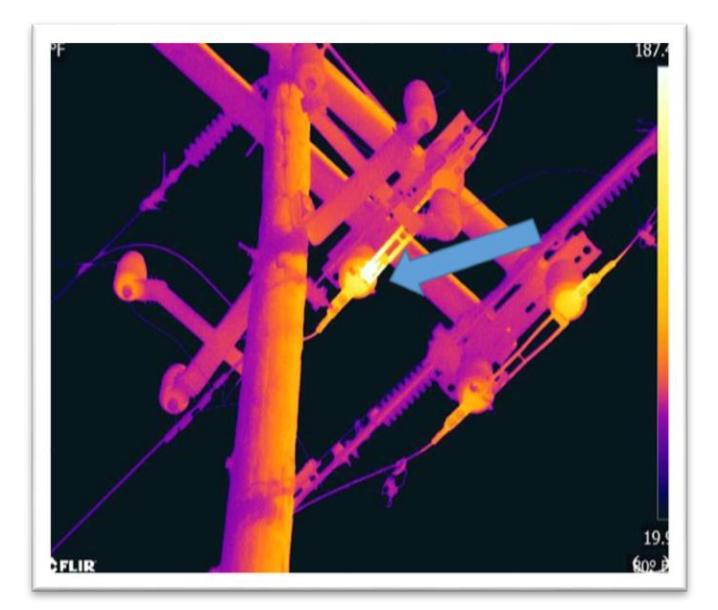
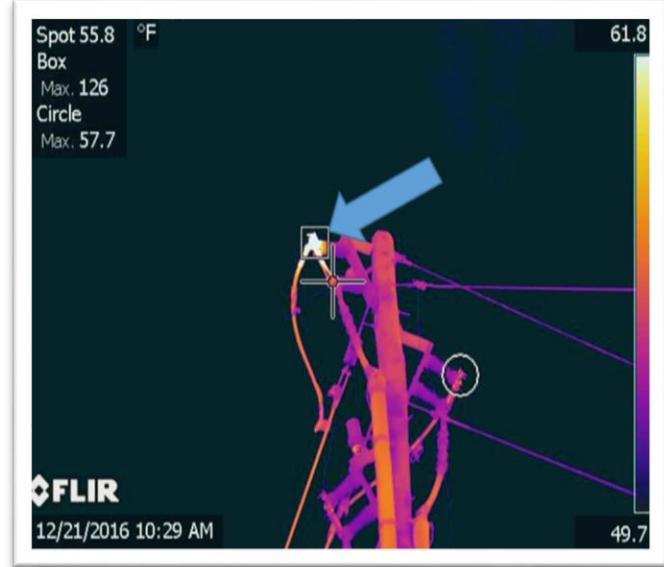
As illustrated by the following infrared photos of a distribution pole, this proactive approach allows SECO to detect hotspots and identify devices before they fail in order to minimize service interruptions to its members.
