# Appendix B

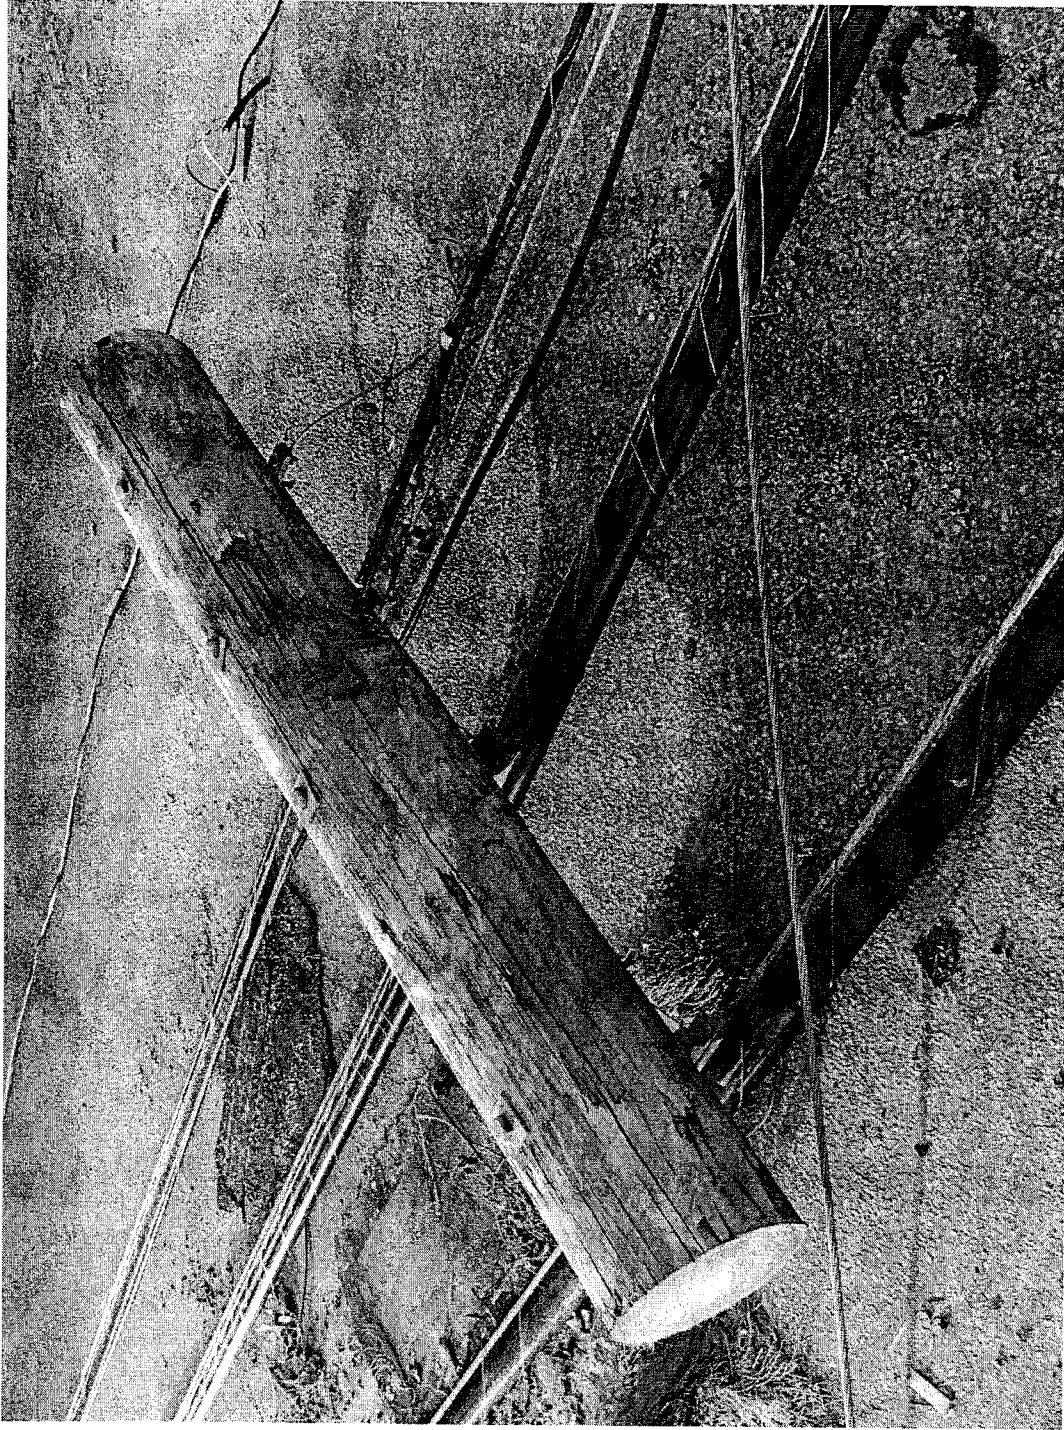
This healthy pole fell during the storm. It is burdened with a 2" telephone bundle, a 3" CATV bundle and a three cable telecommunication carrier bundle.

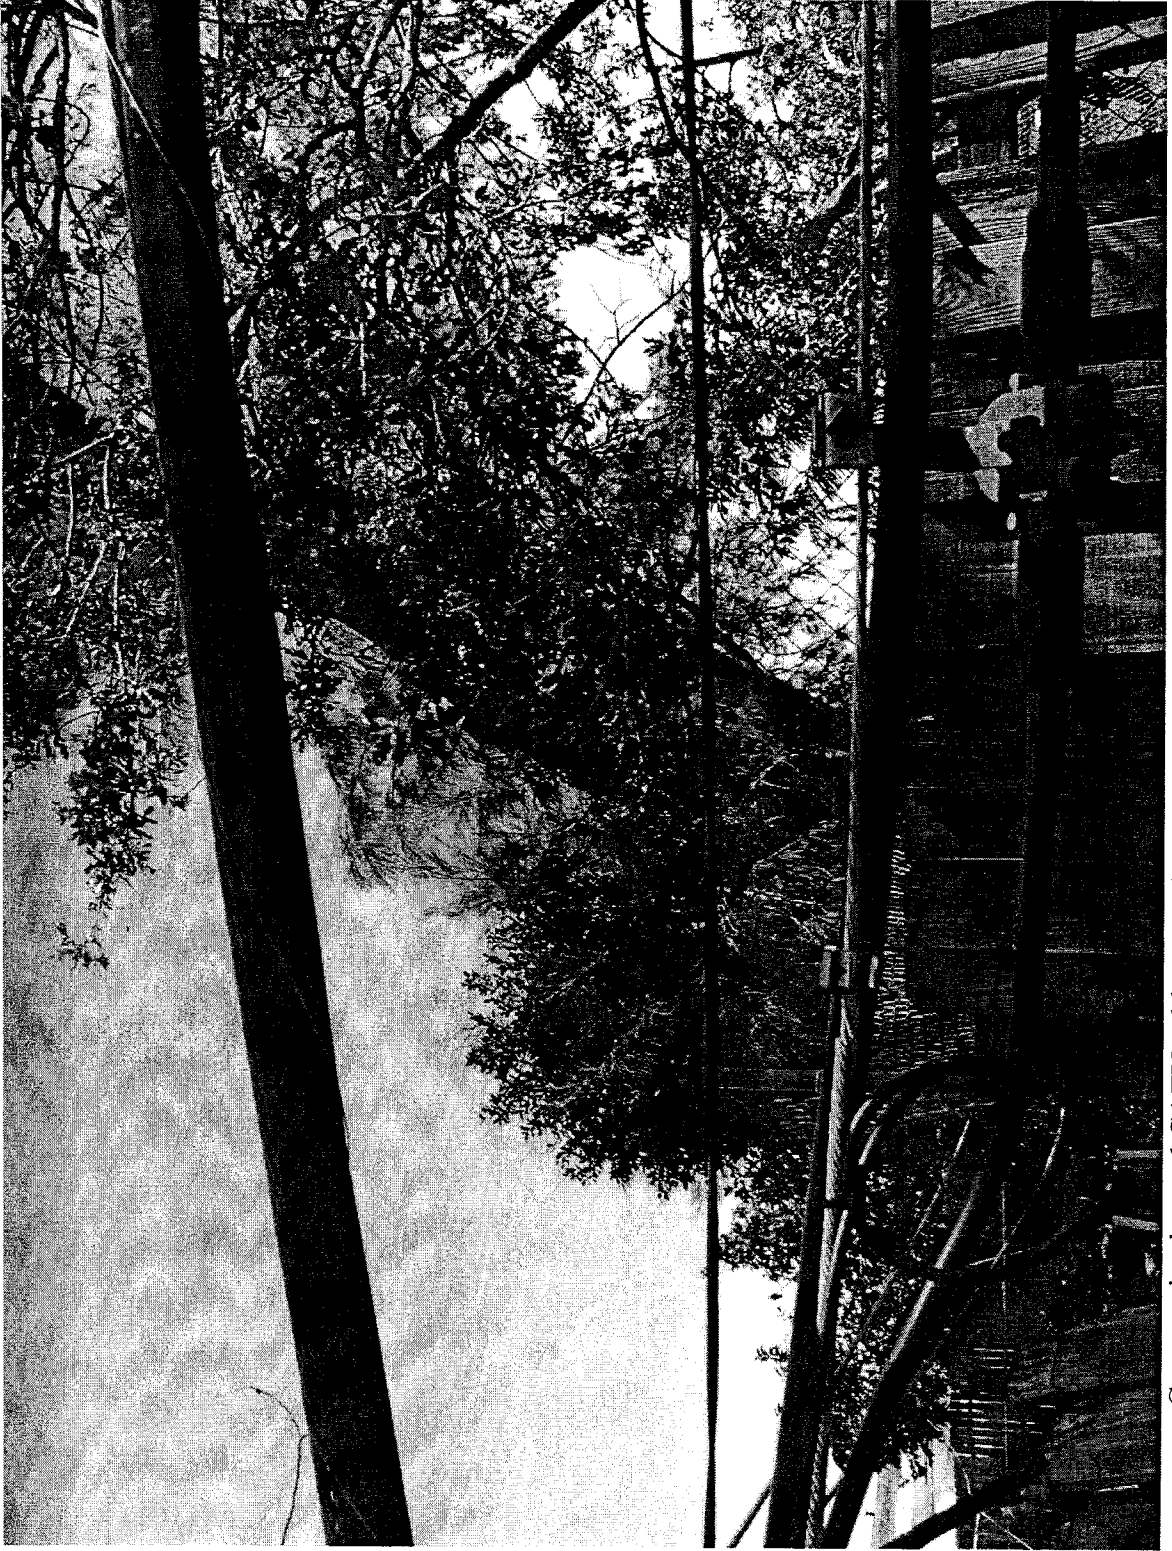
Communication and CATV cable at eye level after a storm passed through and blew the pole over.

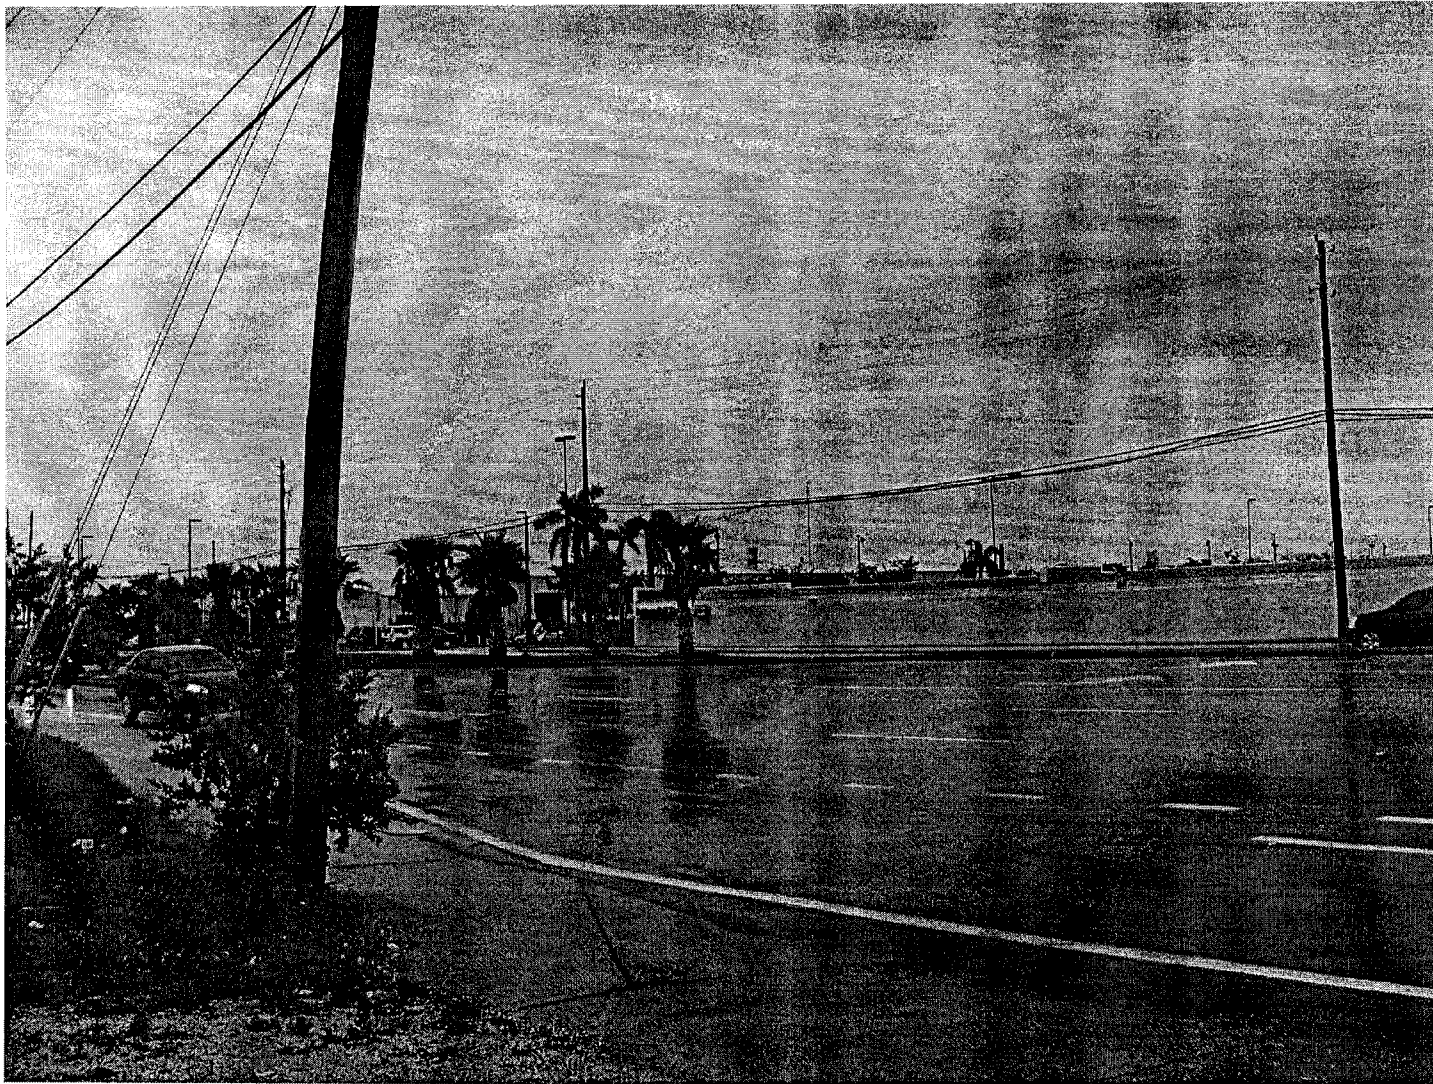
Three bundled cables attached within one foot of space on the pole (against FPL standards). Additionally there are multiple cables coming off the pole at the Sam's club sign (almost mid picture) and tossed together about thirty feet to the right of the pole. All the cables inter-twine at midspan, causing a very large cross-section sail for the wind to catch.

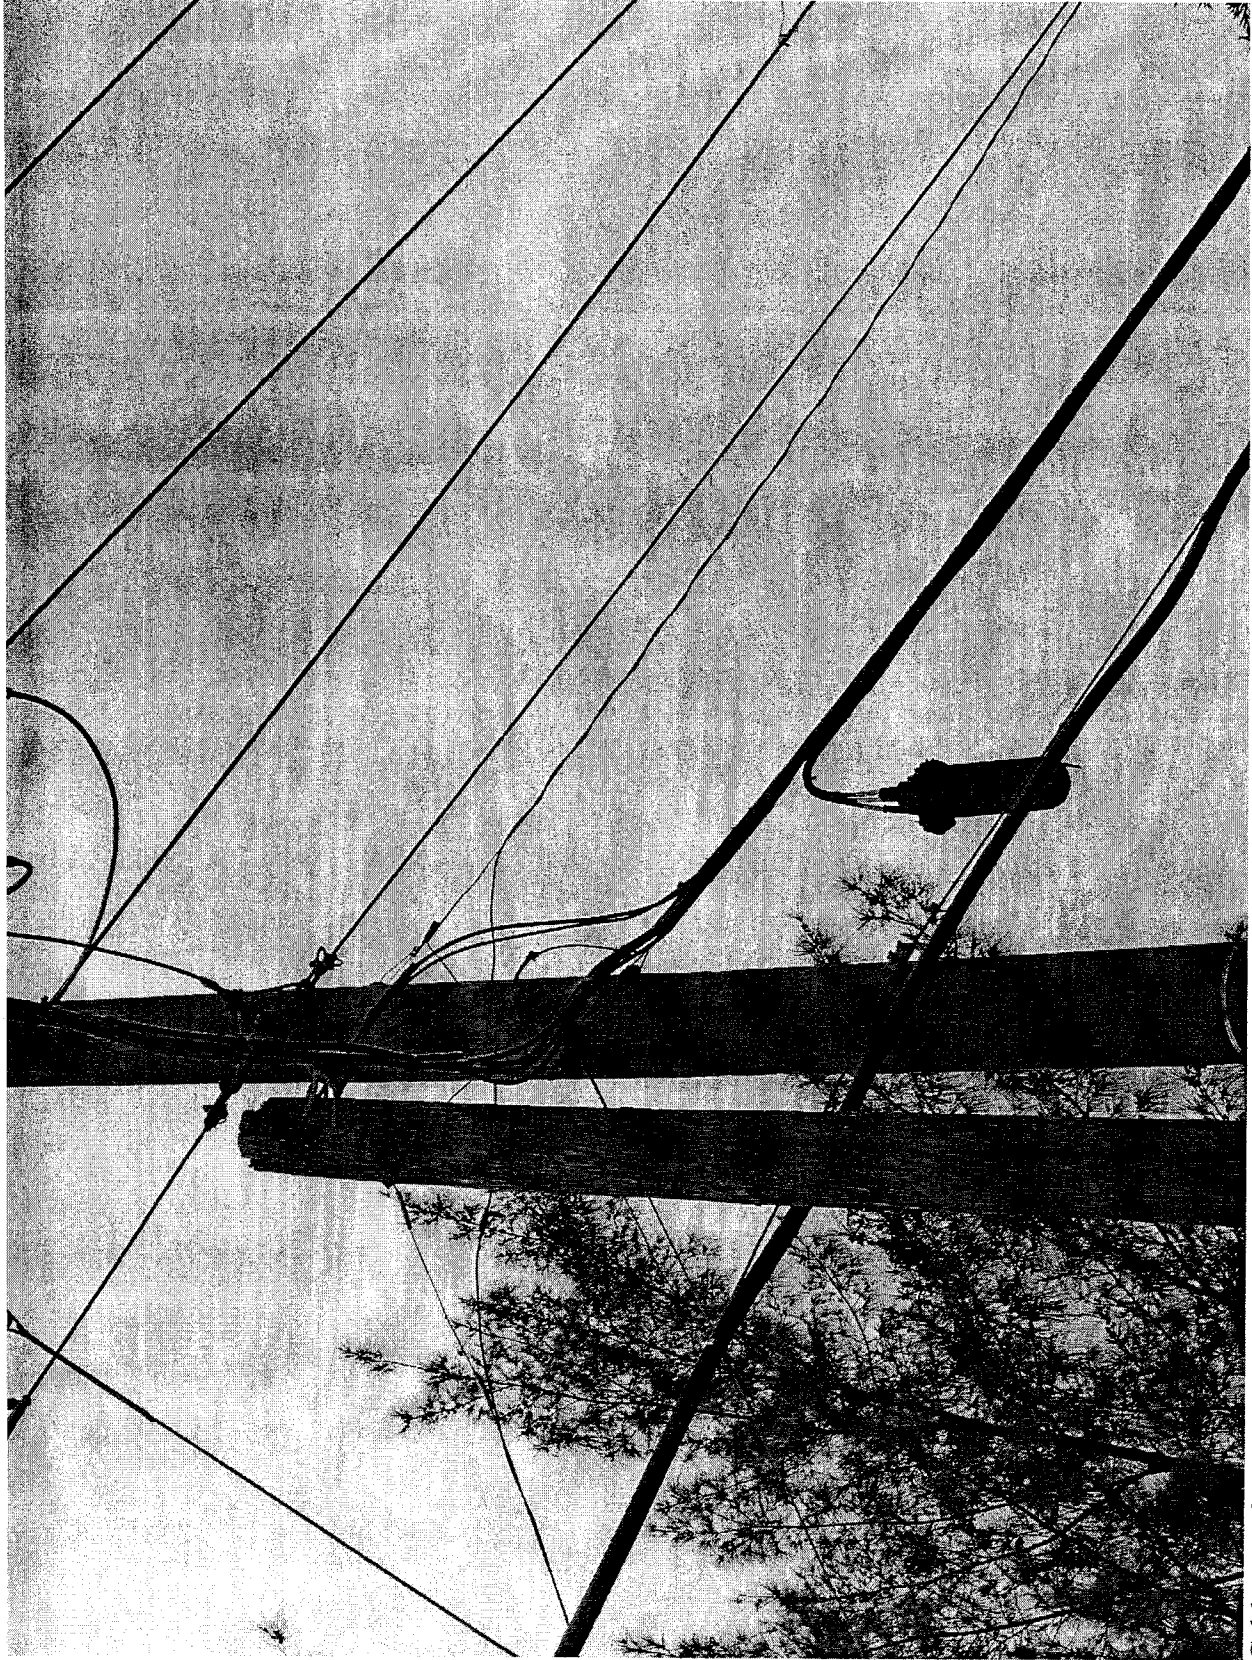
Cable transfer of large cable and multiple attachments not completely transferred and hanging in the wind, preventing the old pole from being removed.

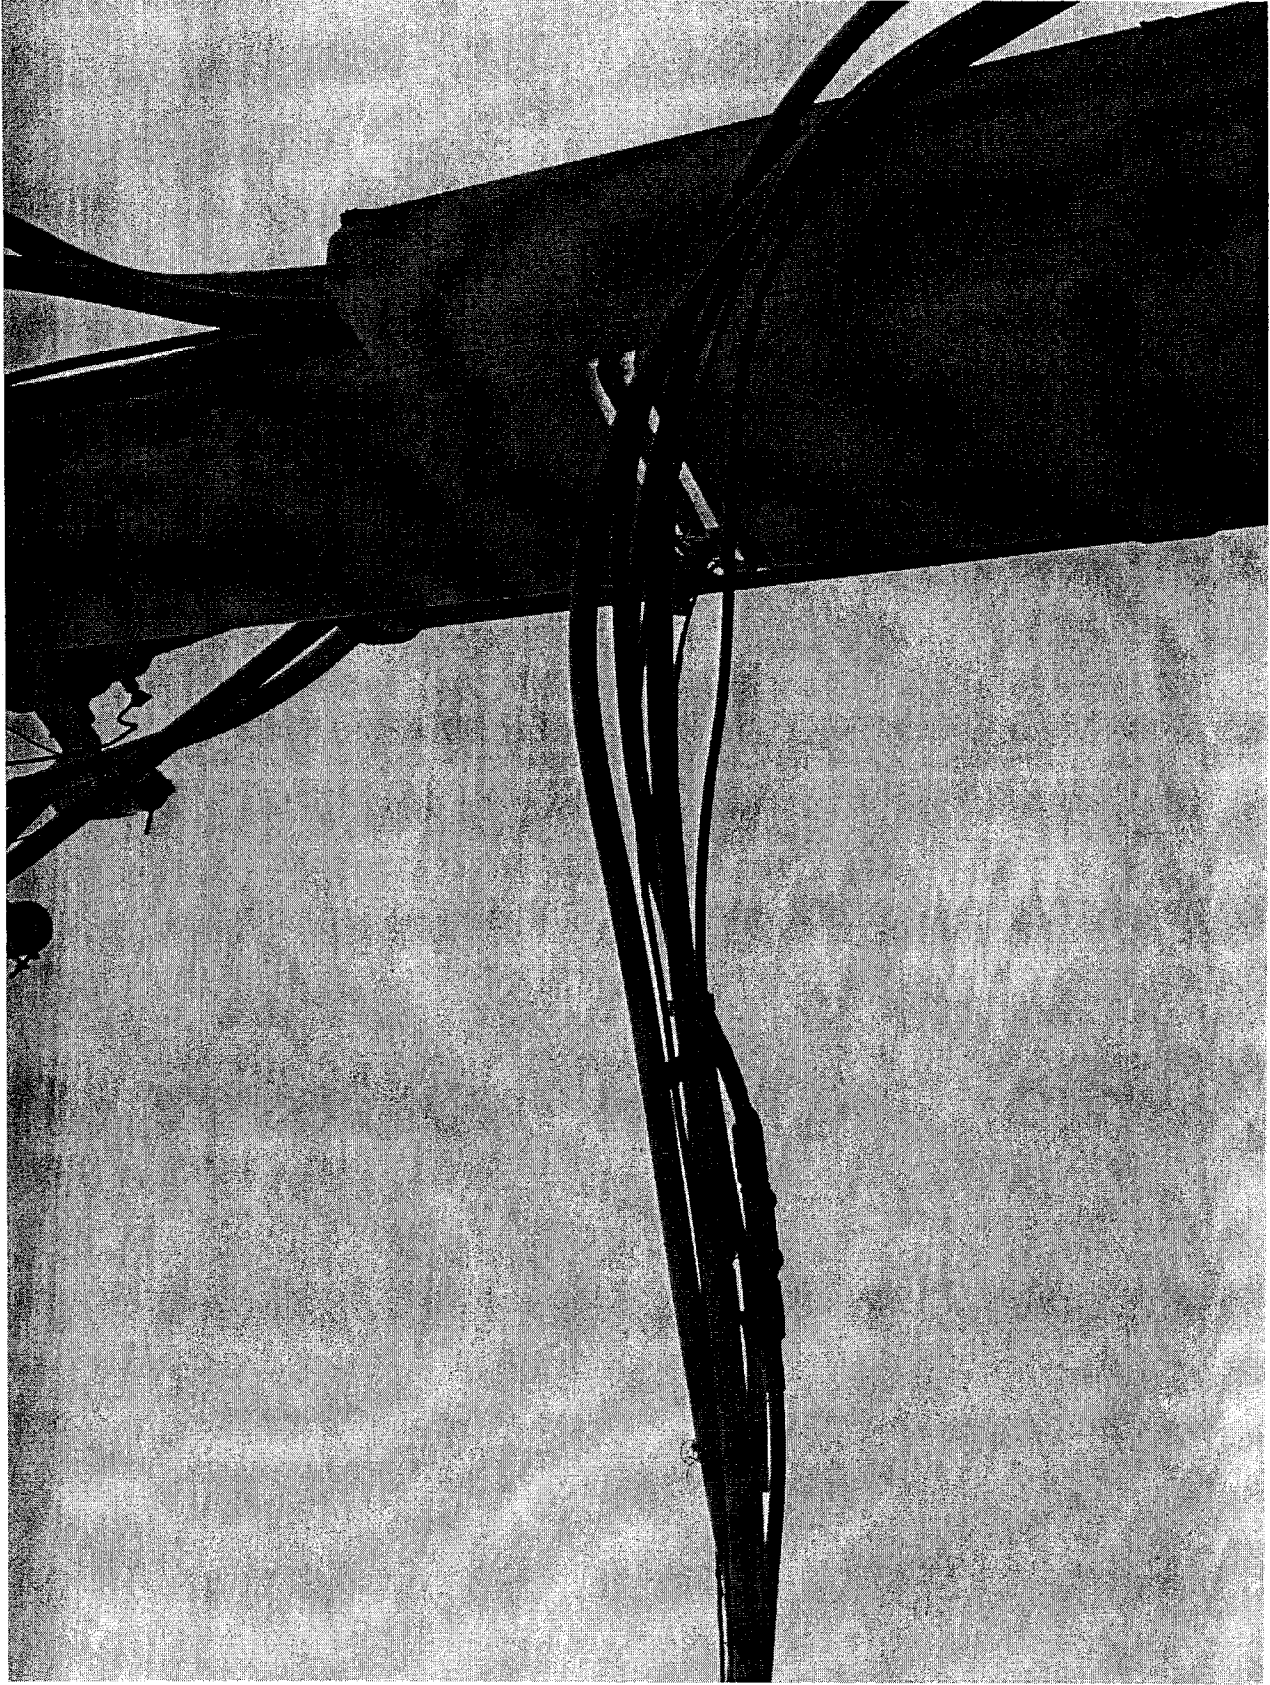
This bundle contains six cables and a messenger cable. Two of the cables are more than one inch in diameter. The bundle reaches a diameter of five inches and more where splices exist.

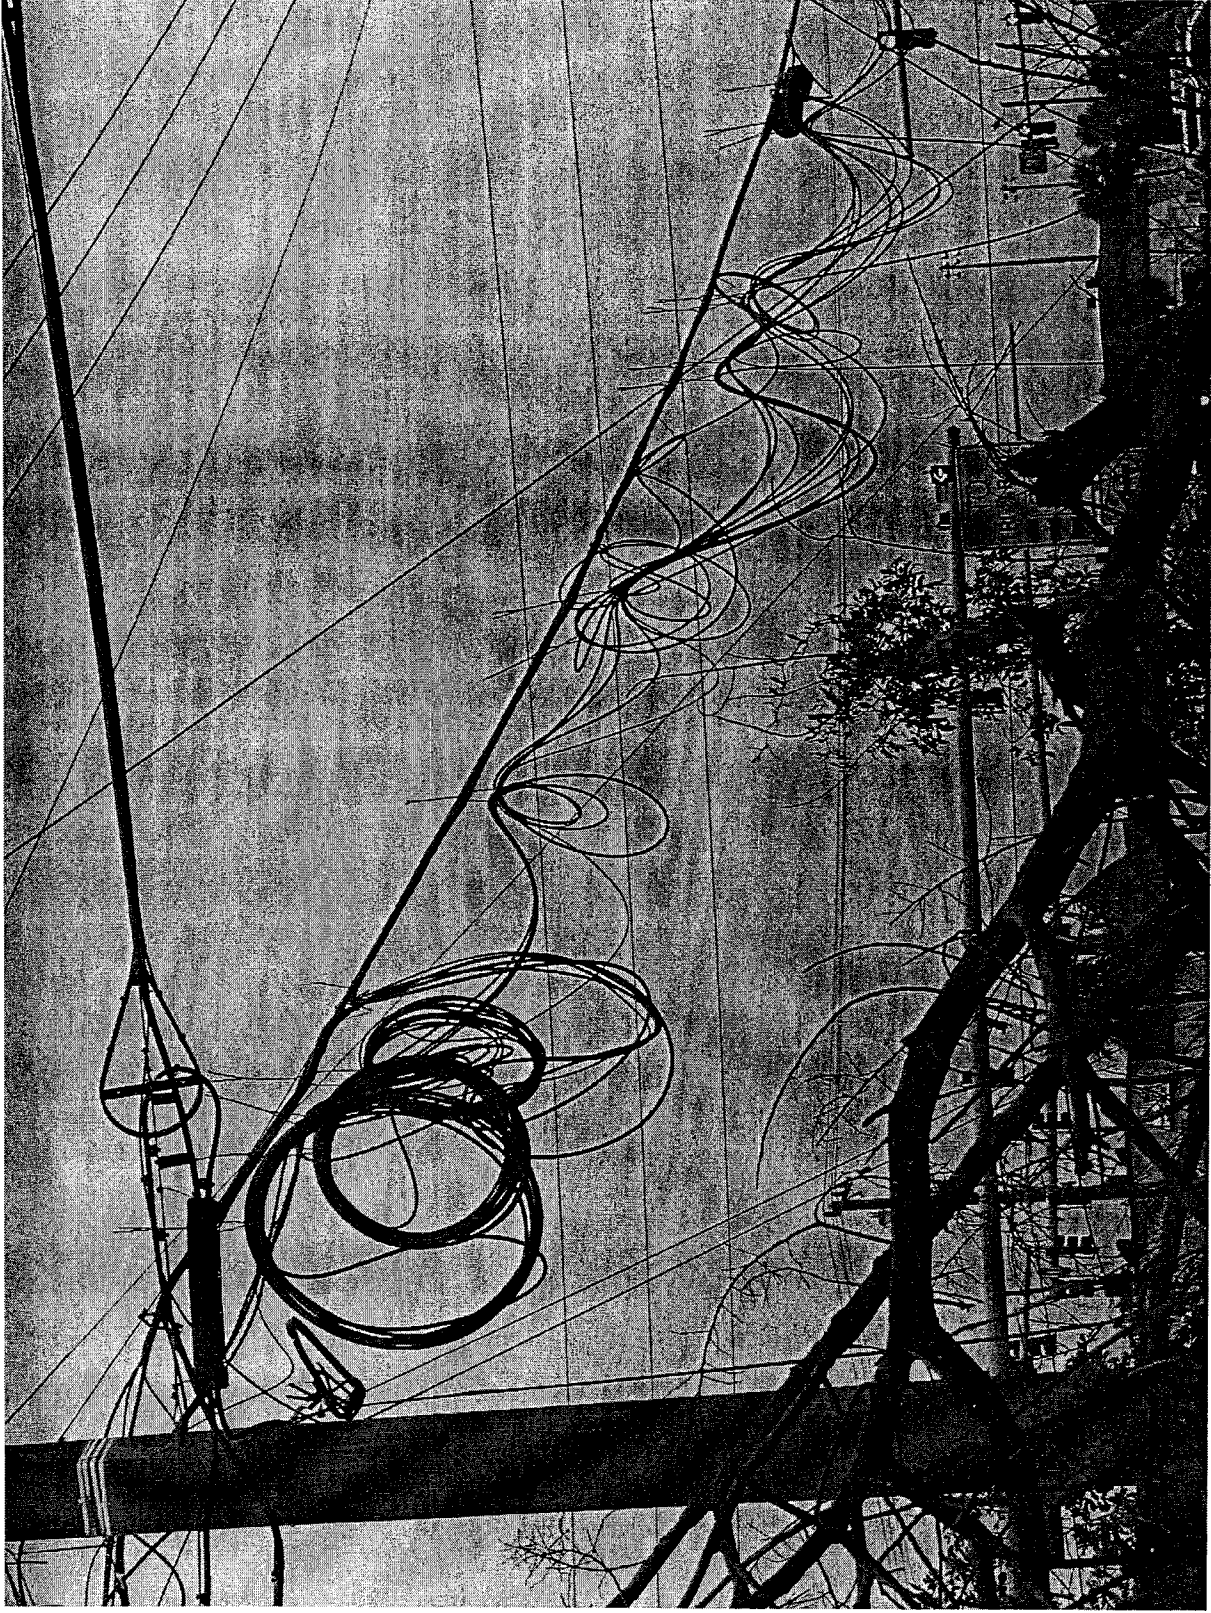
Very sloppily constructed CATV bundle with many cables attached along with a telephone bundle
