COMMENTS
TAMPA ELECTRIC COMPANY
ON RULE 25-6.0342, FLORIDA ADMINISTRATIVE CODE

Illustrations of Various Overlashings

DOCKET NO. 060173-EU
EXHIBIT NO. ____ (TEC-1)

EXHIBIT OF
TAMPA ELECTRIC COMPANY

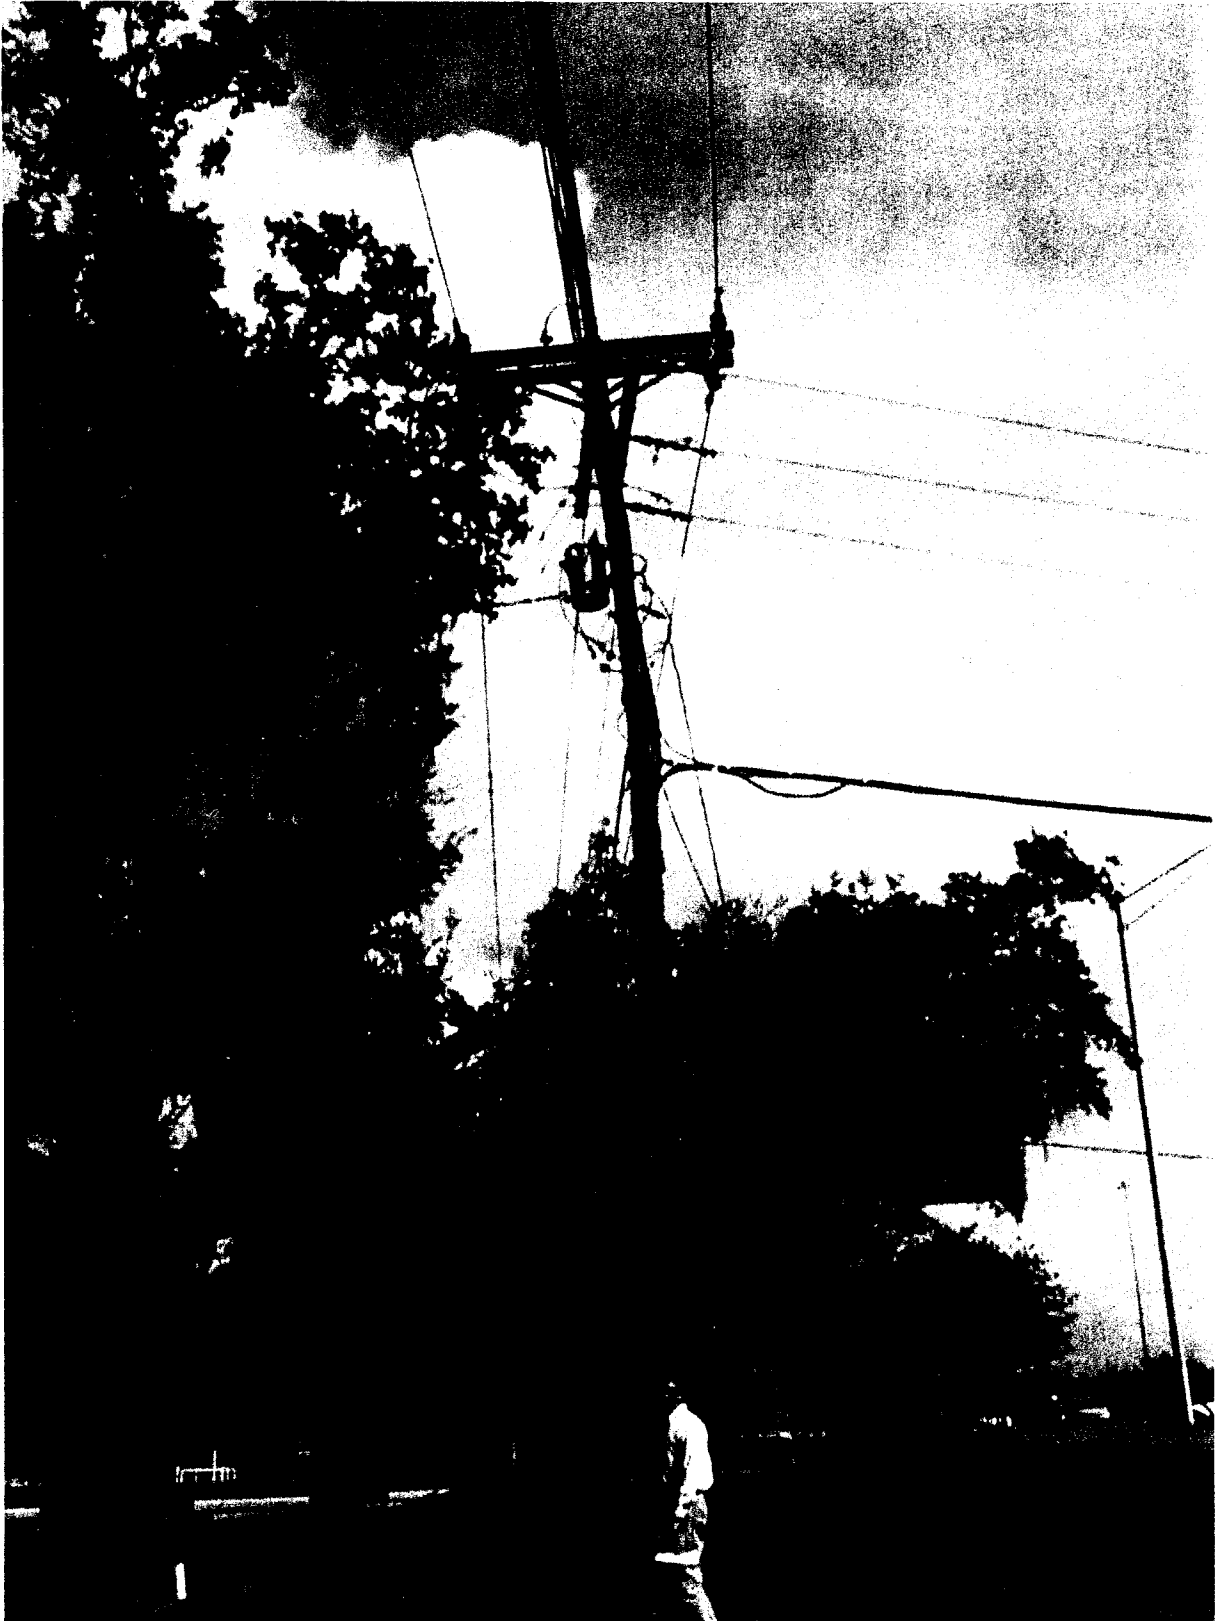
DOCUMENT 1

Document 1 shows the condition of a pole found in the field while working on another project. It is obvious that the third party attachment at the center of the pole is overloading the pole. This was caused by a cable television (CATV) company installing an unnoticed 300 foot span of cable over eight lanes of vehicle traffic with two additional overlashings of fiber. The cable had inadequate guying to hold up the additional weight of the cable and caused the pole to split. The pole was replaced with a special order spun concrete pole as shown in Documents 2 and 3.

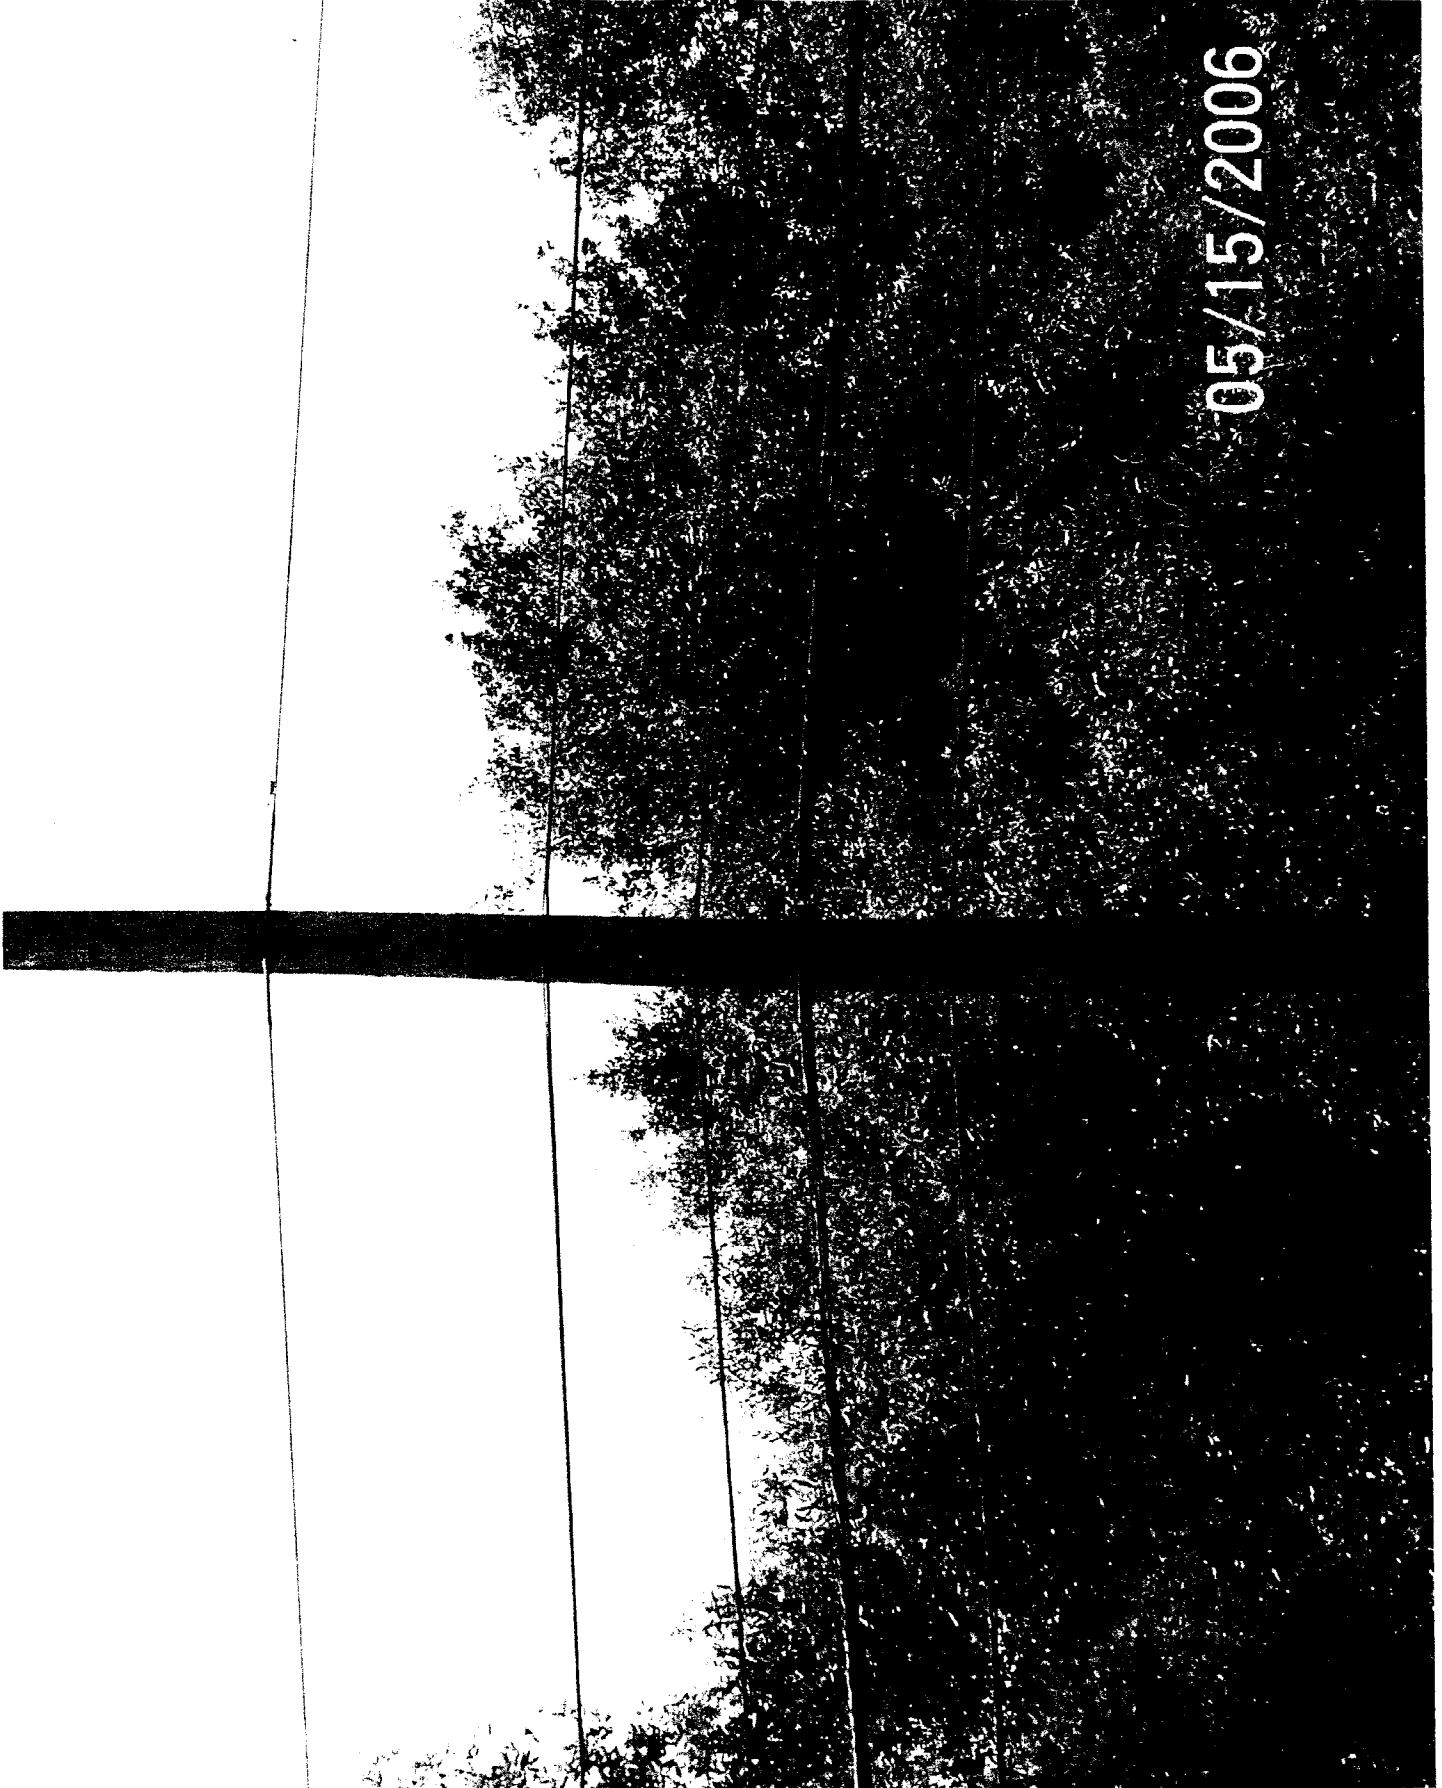
DOCUMENT 4

Document 4 is a close up of an array of cable and communications attachments on a pole located on 30th Street, just south of Fletcher Avenue in Tampa. Notice the size of the overlashed cable relative to other attachments.

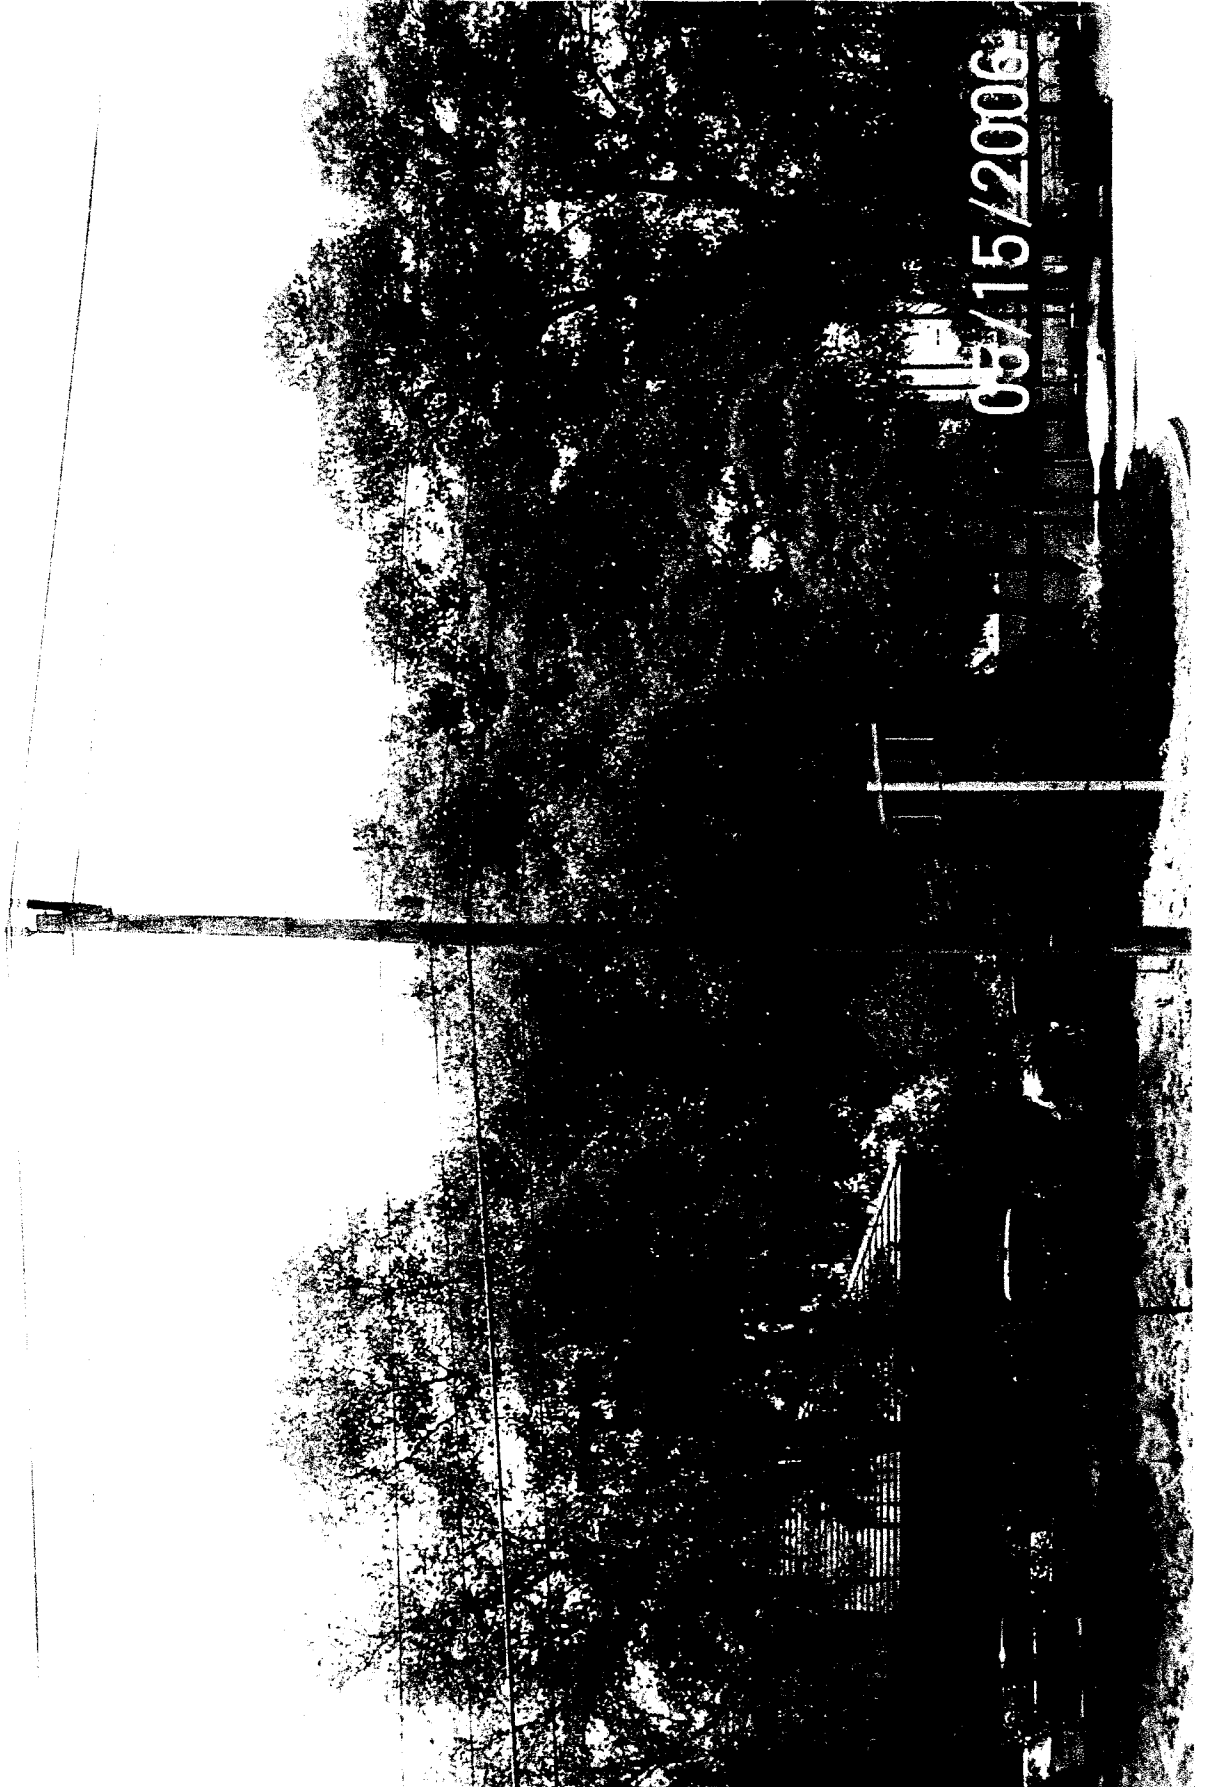
DOCUMENT 5

Document 5 is a full view of the 30th Street pole showing all of the wires and cables attached to the pole.

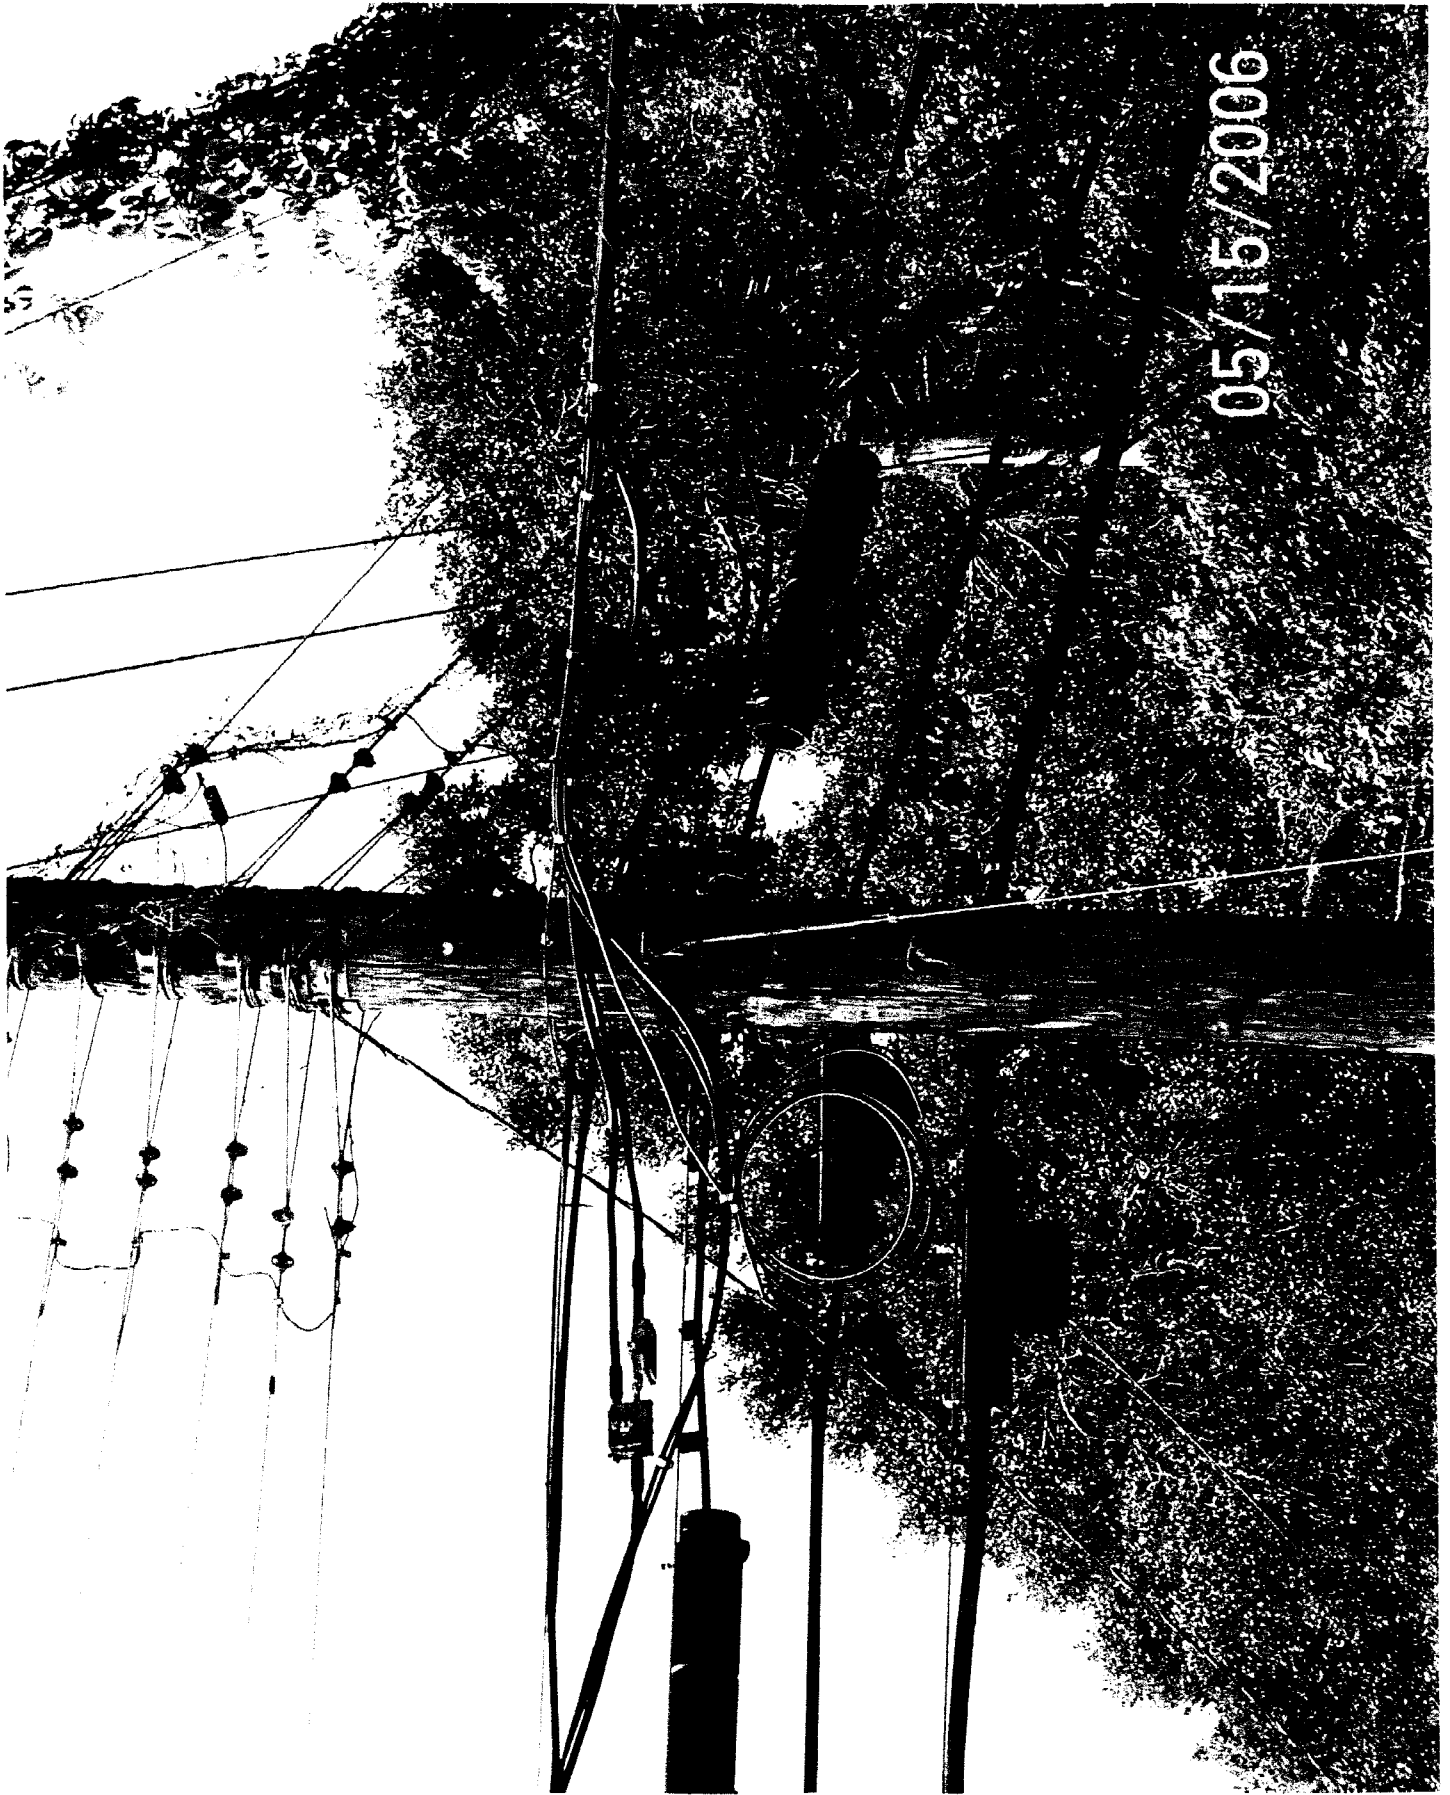
DOCUMENT 6

Document 6 taken at the intersection of Harney Road and Fowler Avenue/Main Street illustrates a number of cables in a bundle together with various items of equipment. This array of cable and equipment significantly affects wind stress and pole loading. Document 7 shows these same attachments at the Harney Road intersection looking to the east and Document 8 shows the western view of the entire pole at the Harney Road intersection.

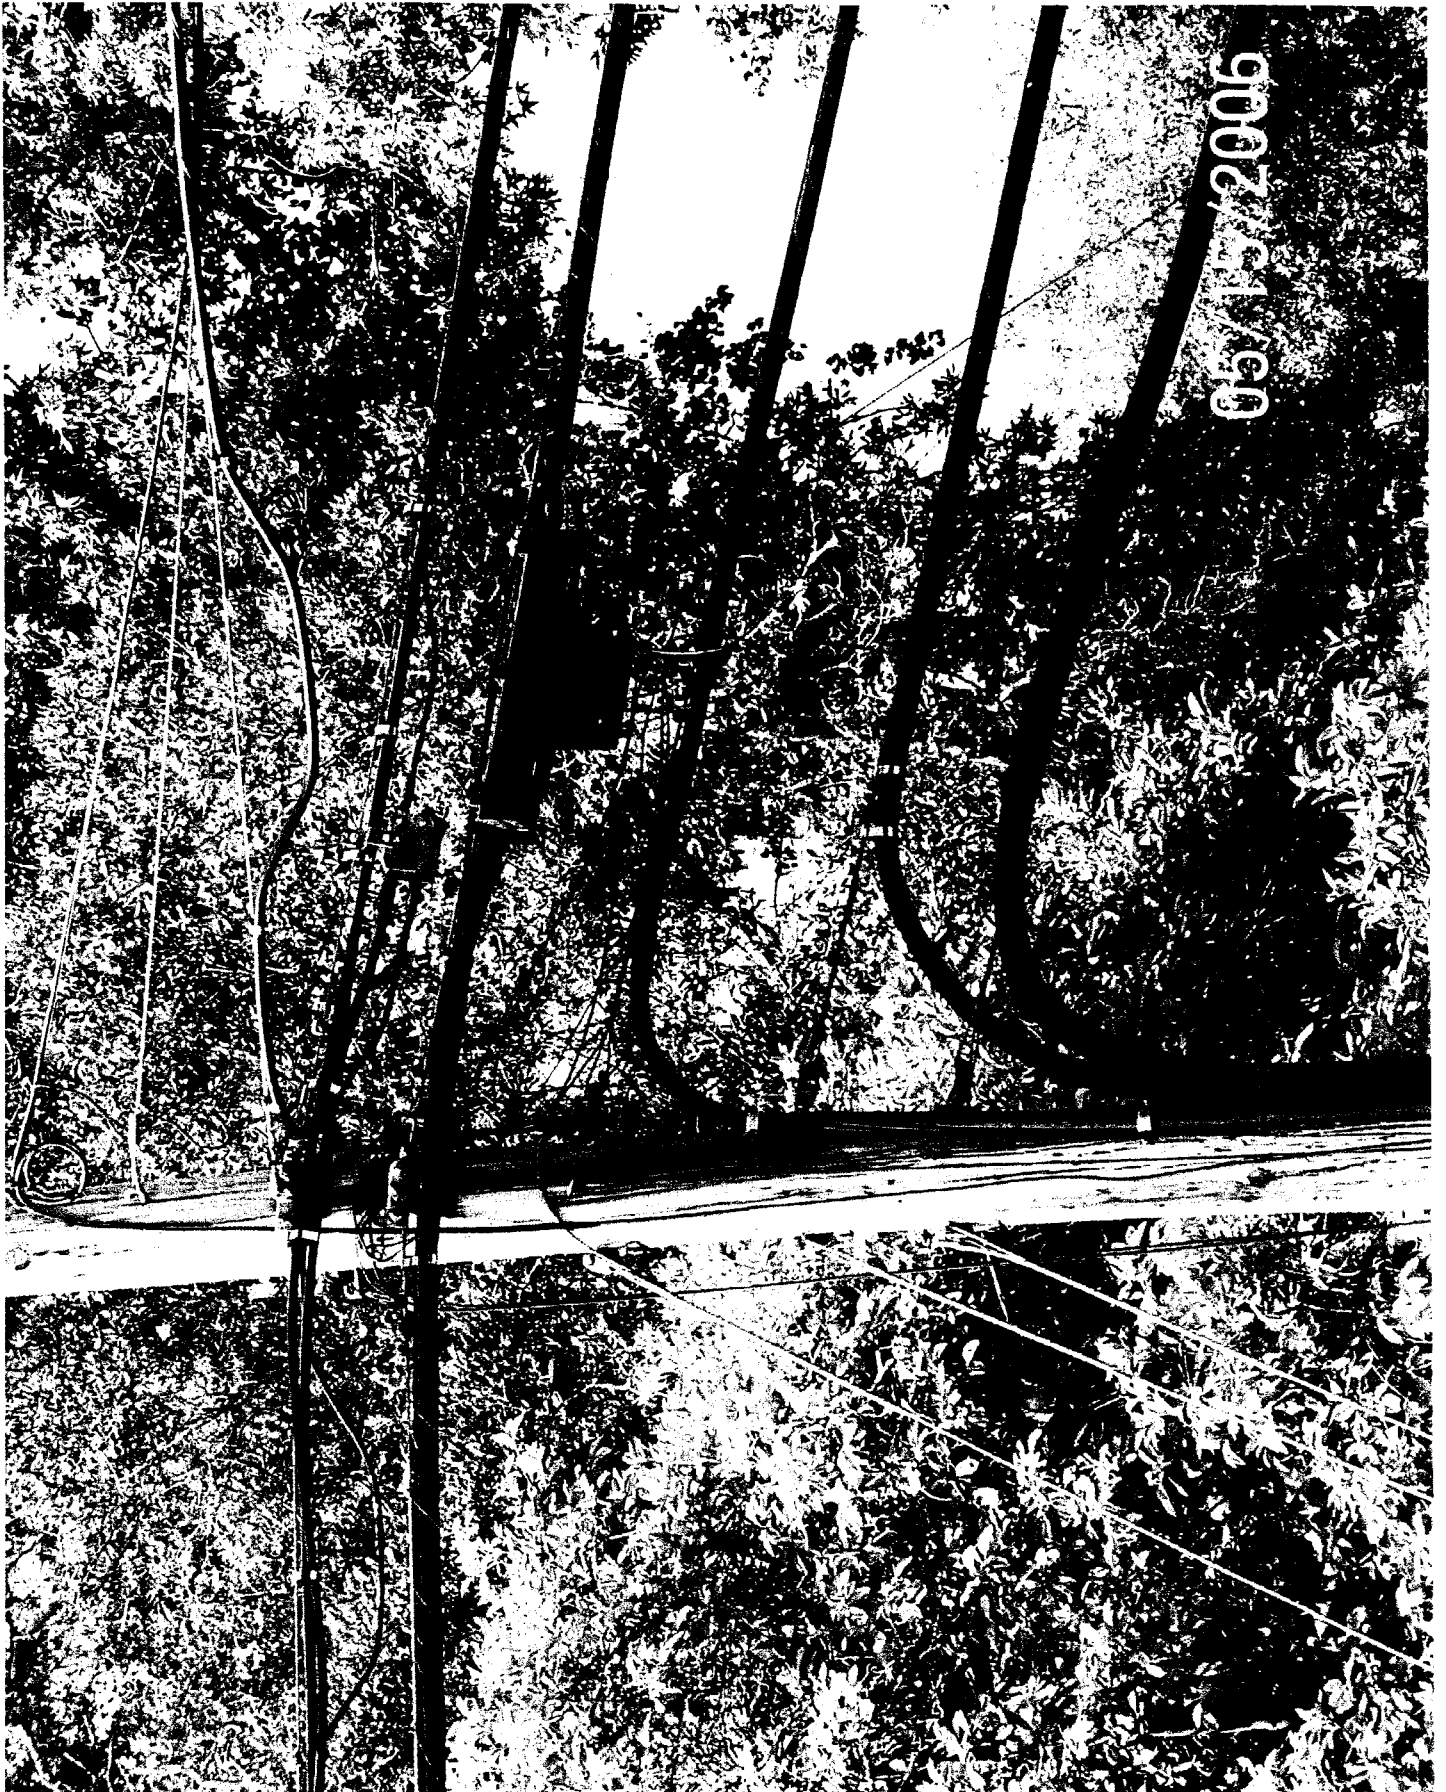
DOCUMENT 9

Document 9 taken on Knights Griffin Road at the Knight's Creek Bridge illustrates the size of various overlashed cables which can be 3" – 4" in diameter. Documents 10 and 11 show the significant sag these cables have over a span.

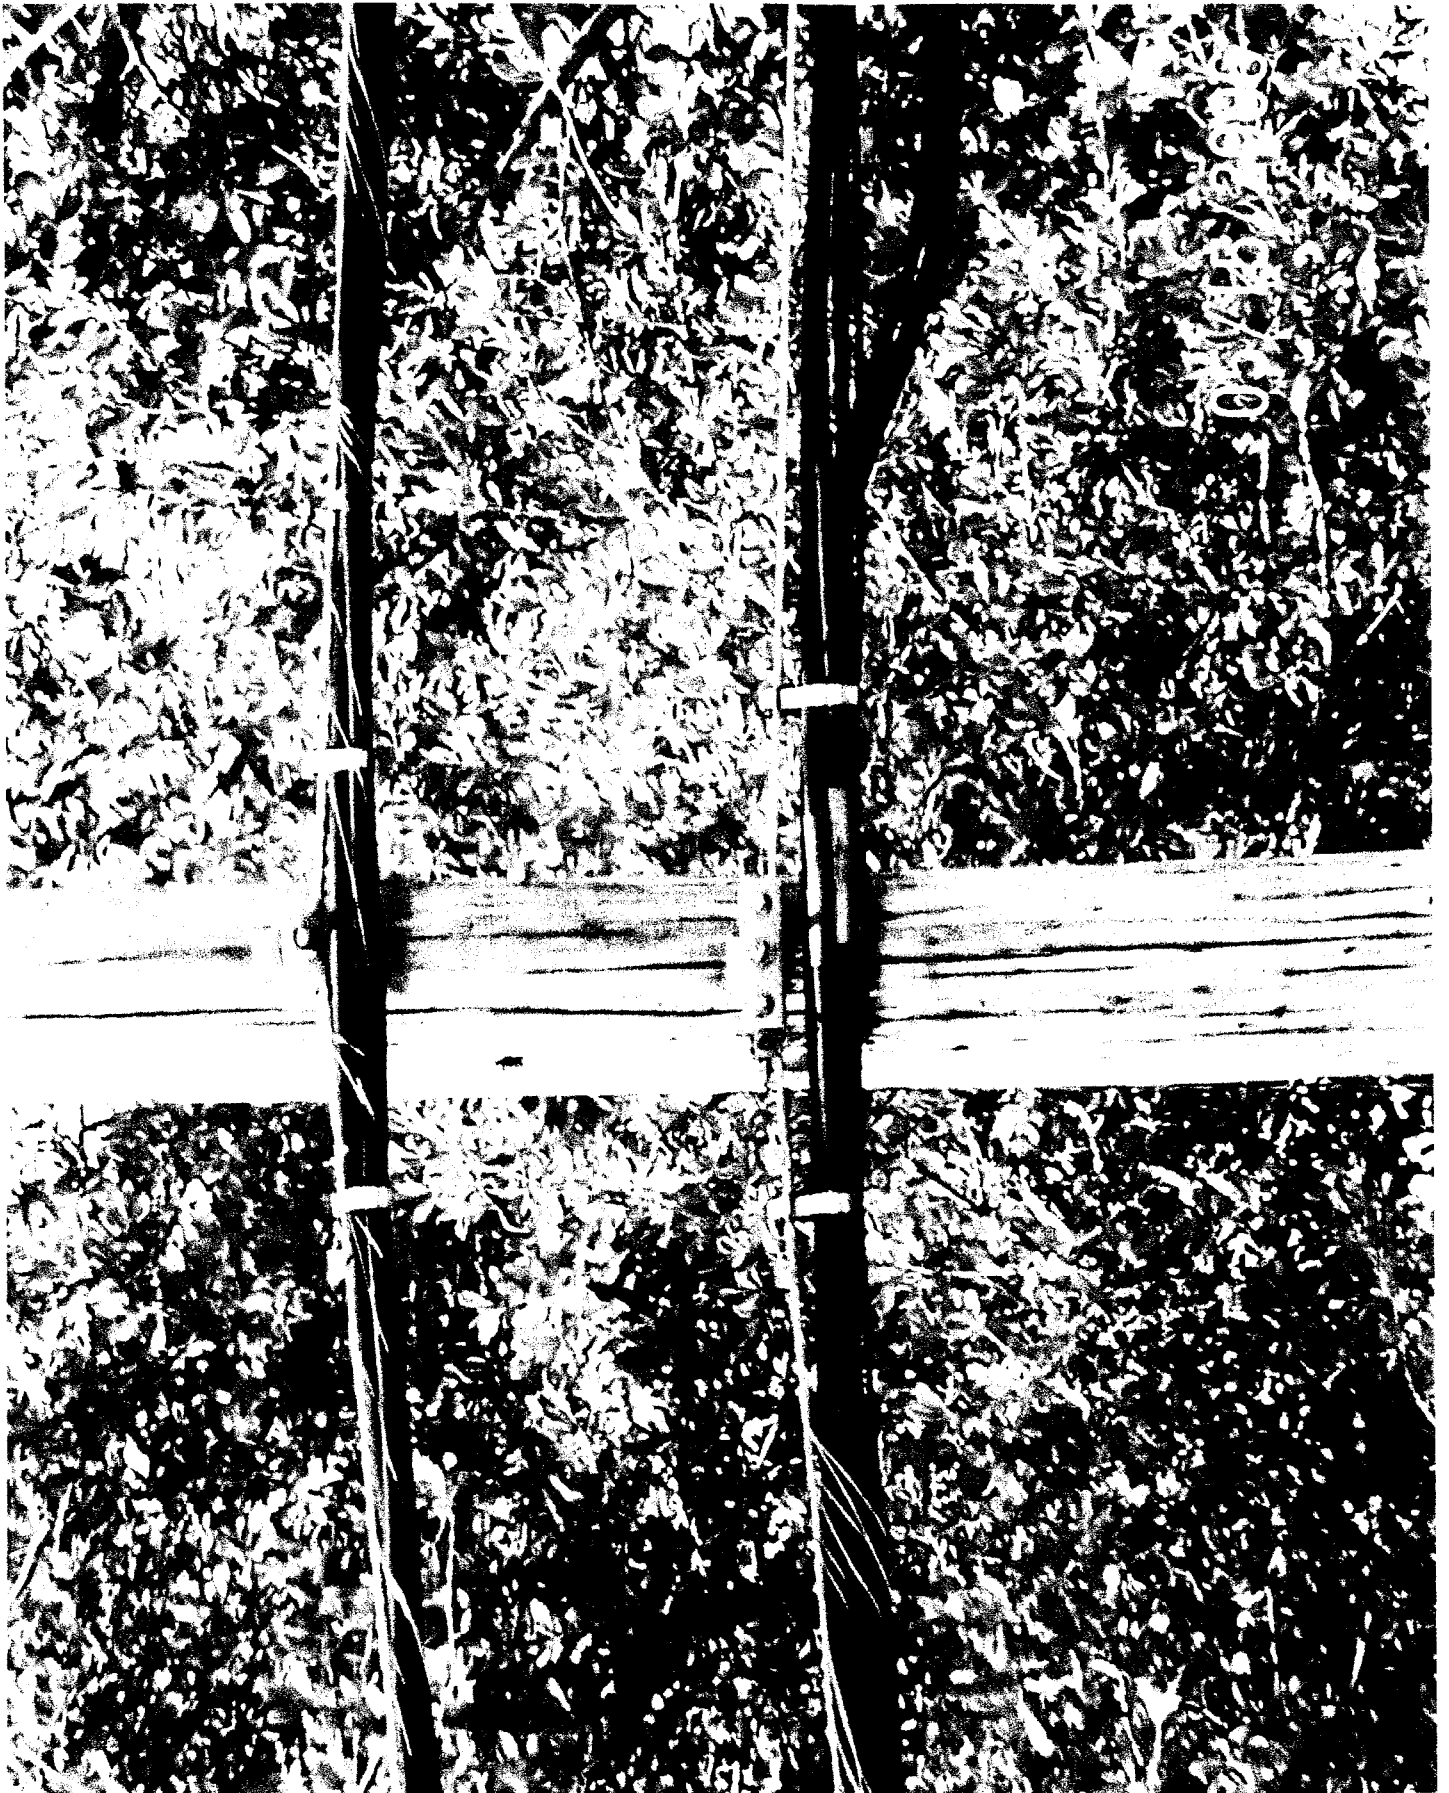
DOCUMENT 12

Document 12 details a bundle of cables overlashed three or four times and attached to a wooden pole located on Fletcher Avenue near 42nd Street. Documents 13 and 14 show a concrete pole that replaced a wooden pole, because of an overloaded condition caused by an attacher.

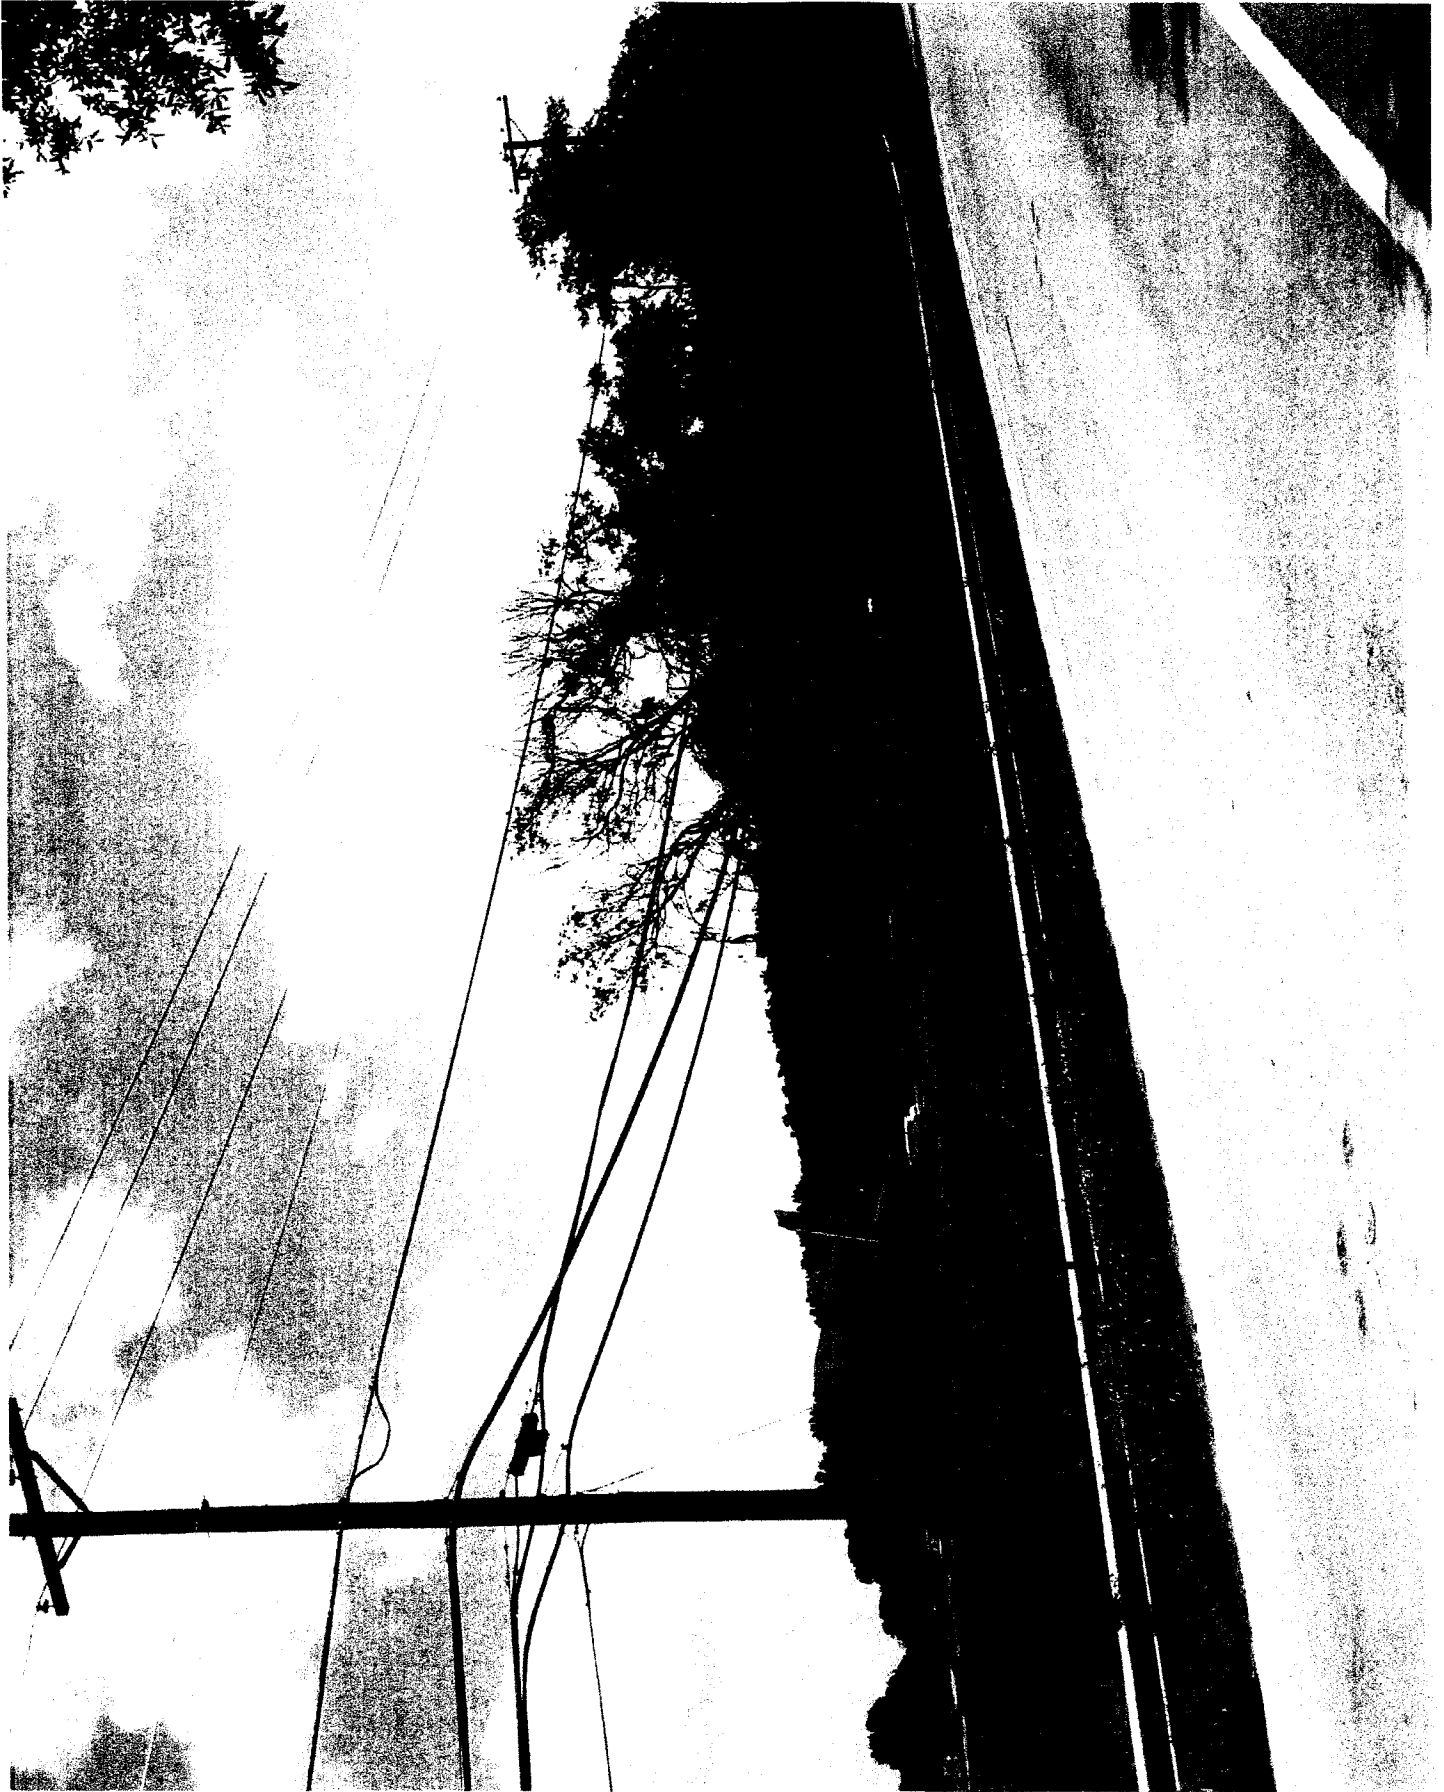
DOCUMENT 18

Documents 17 is a photograph of facilities on Thonotosassa Road west of McIntosh Road that shows the sag and stress placed on poles with both a short span crossing the road and a long span along the road. Documents 18 and 19 are photographs of facilities on Thonotosassa Road just west of Stone Lake Ranch which show how larger cable trunks that are attached to Tampa Electric poles adds weight that sags significantly at mid-span.

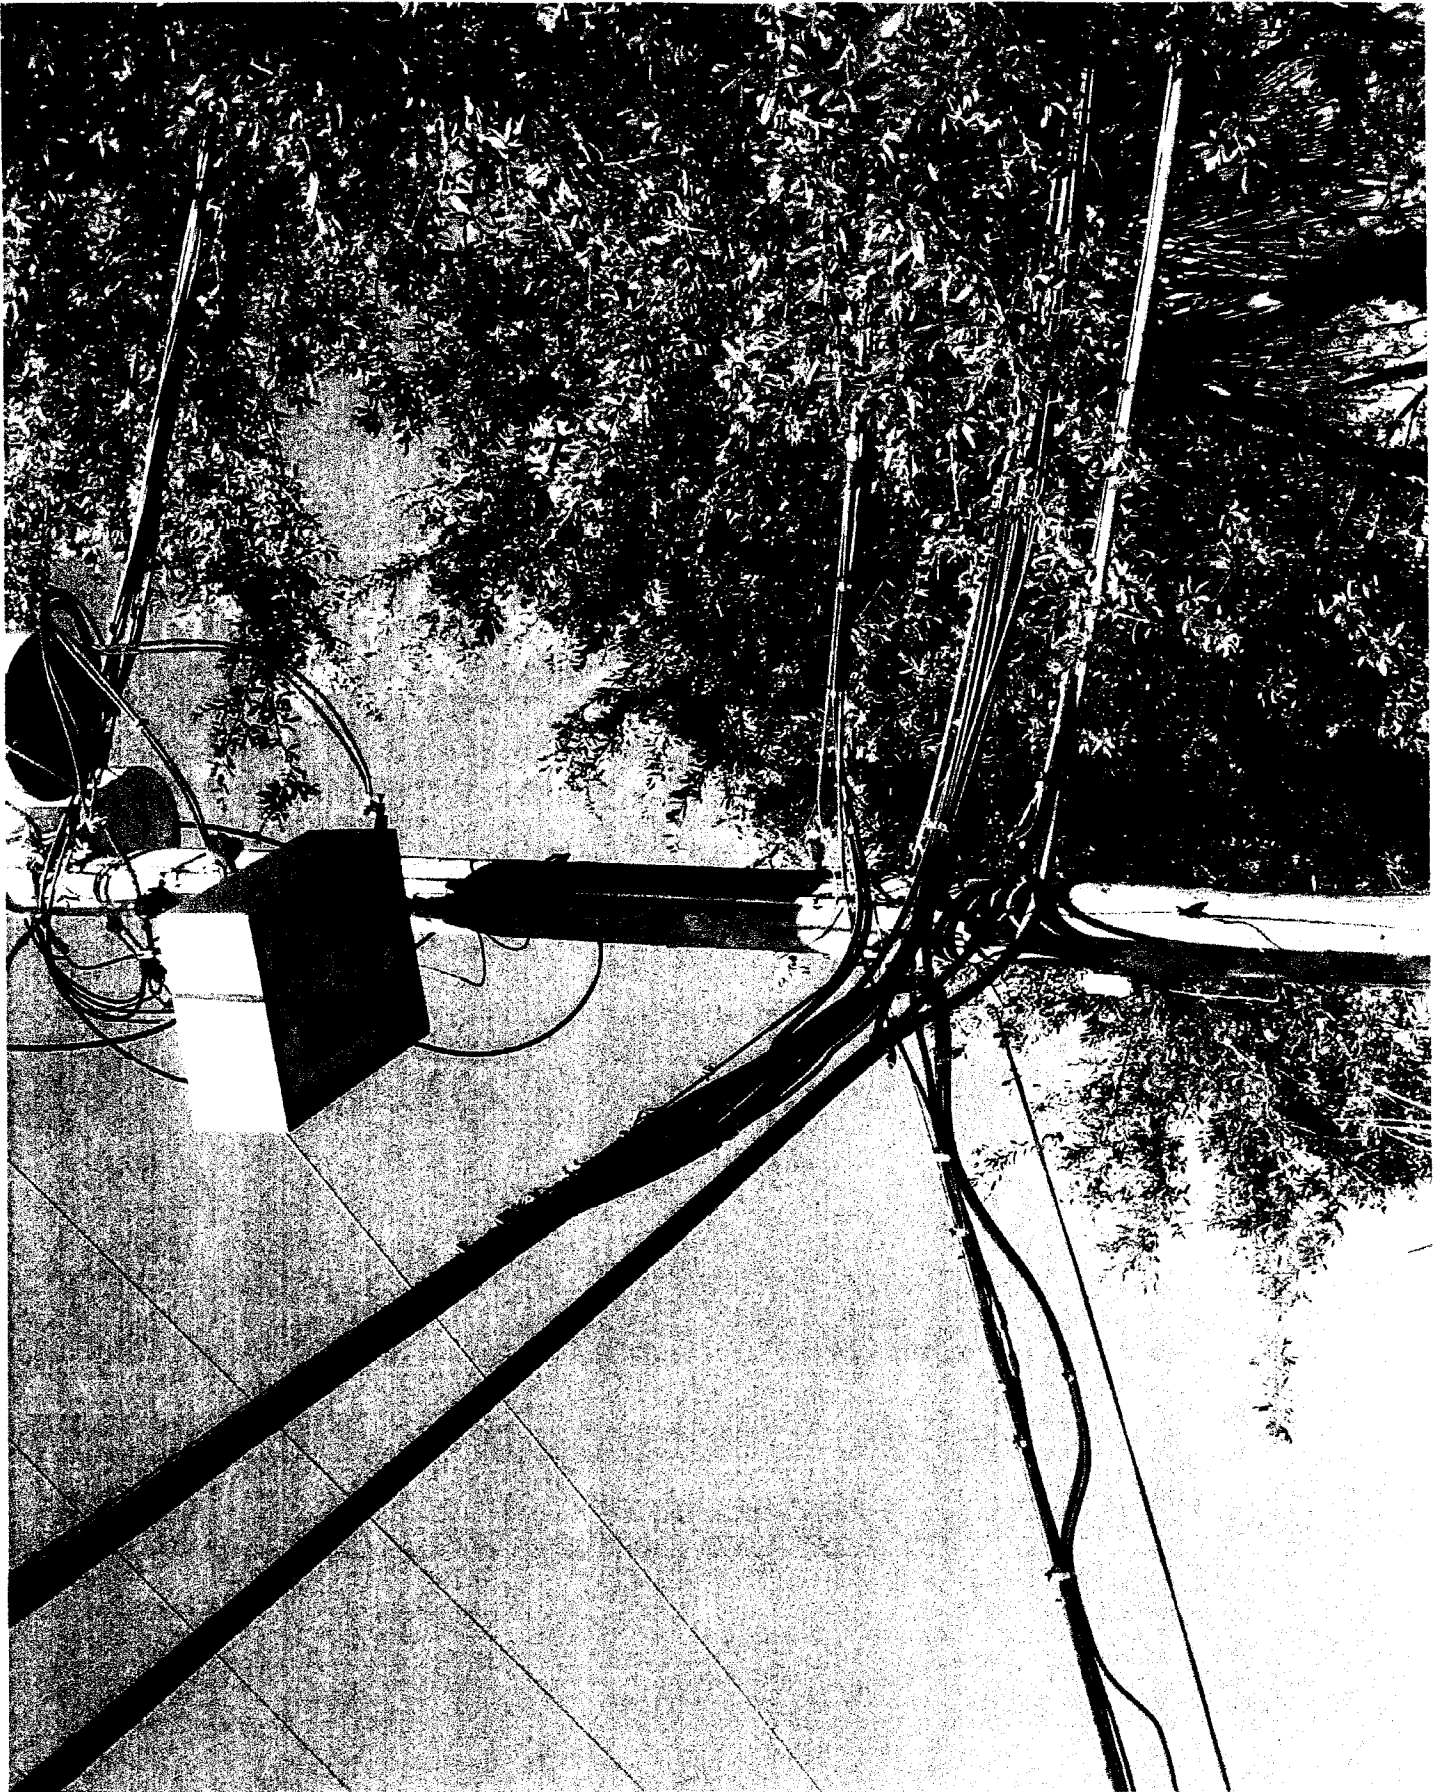
DOCUMENT 20

Documents 20 – 23 are photographs of facilities on North B Street west of Boulevard North near the University of Tampa. Documents 20 – 21 show a detail of an attachment with 10 – 12 cables in a larger bundle with a diameter of 3" – 4". Documents 22 – 23 illustrate the sag

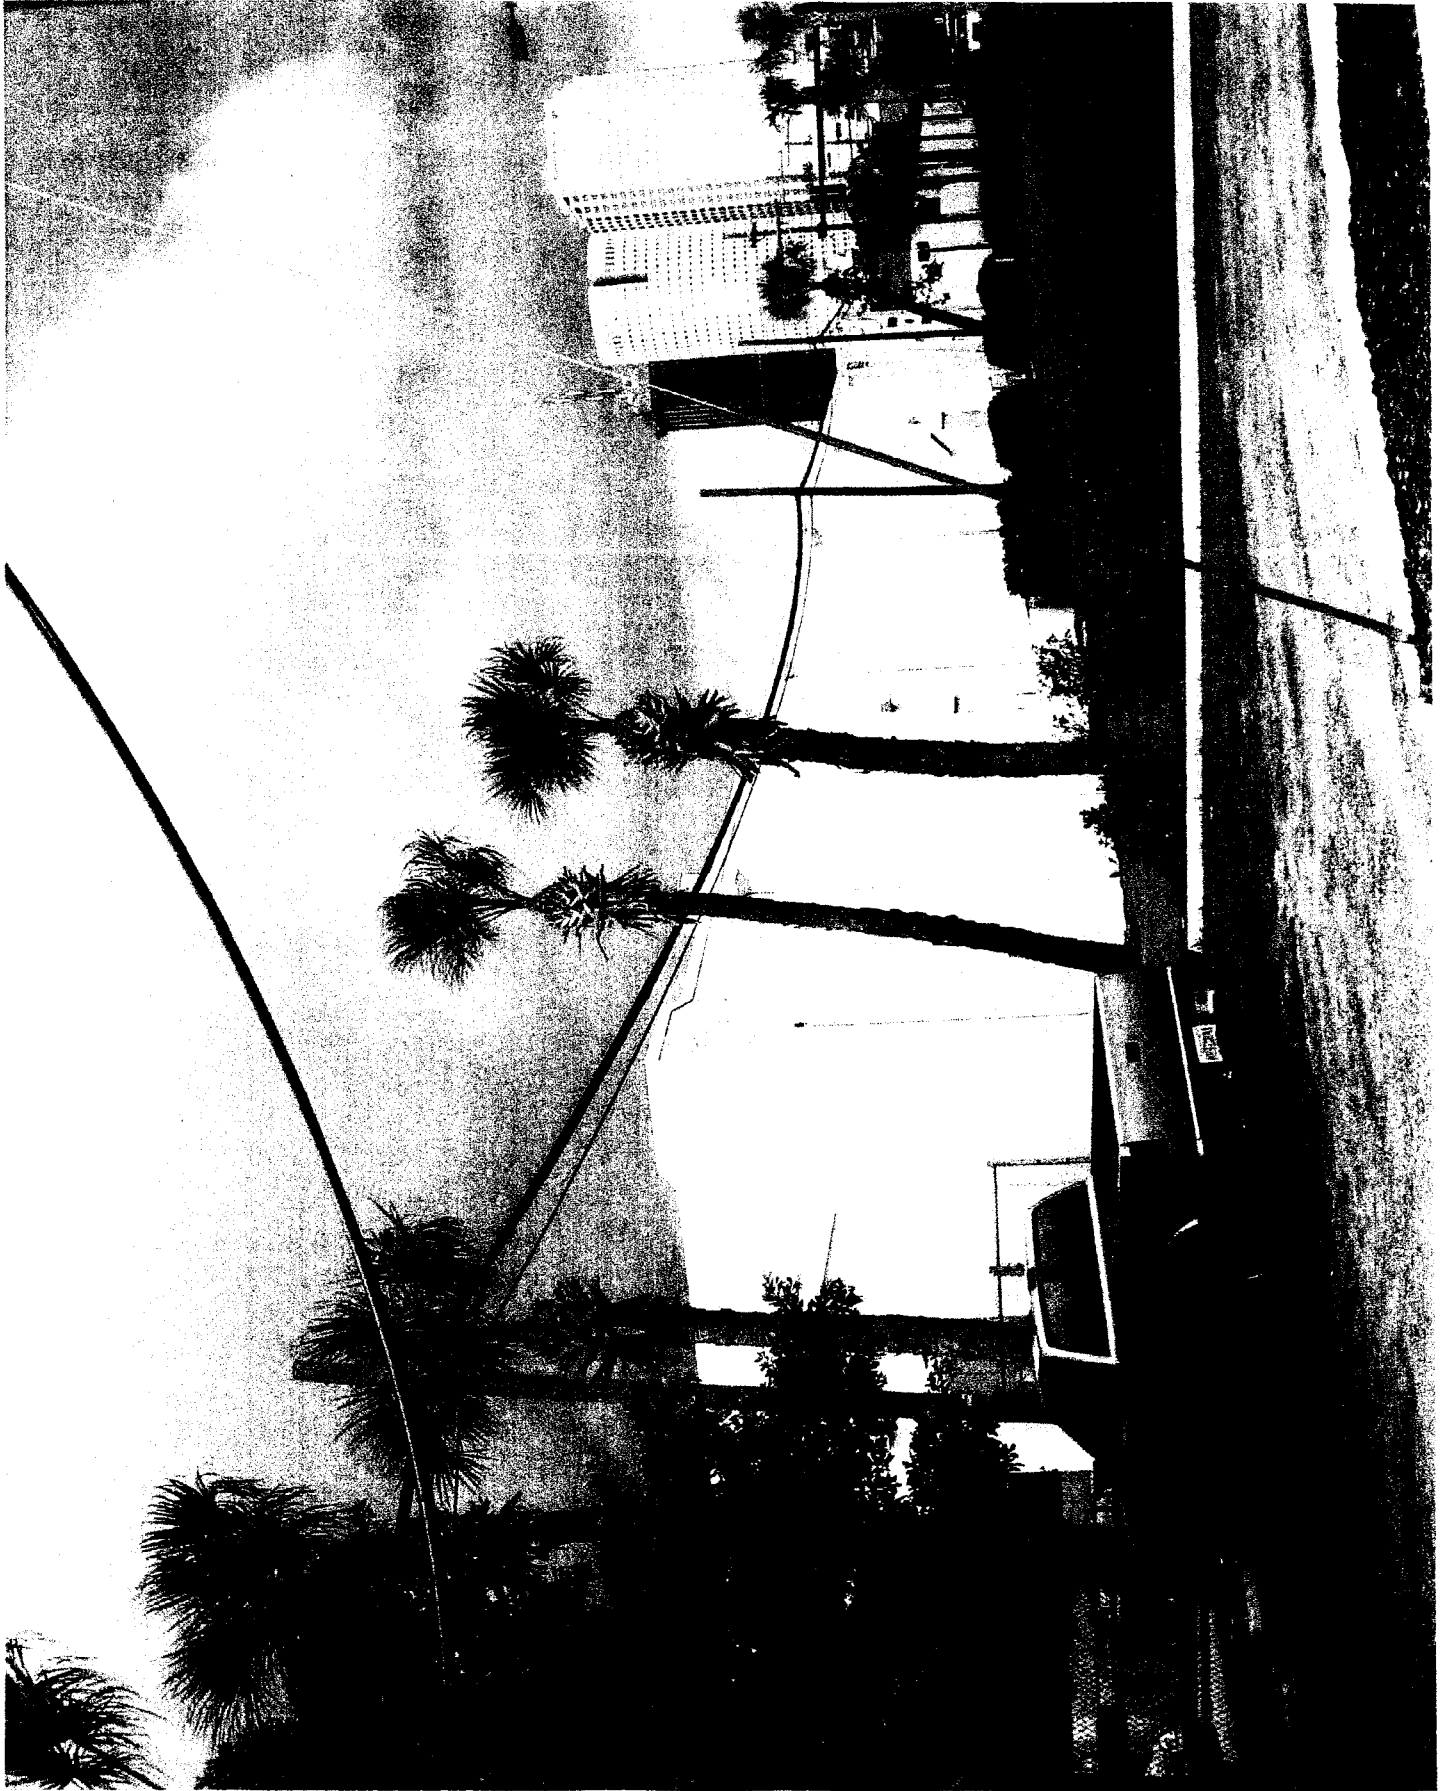
DOCUMENT 22

effect these attachments have on our poles. The cable shown in Document 23 illustrates a 6' – 8' sag at mid-span.
