COMMENTS
TAMPA ELECTRIC COMPANY
ON RULE 25-6.0342, FLORIDA ADMINISTRATIVE CODE

Illustrations of Various Overlashings

DOCKET NO. 060173-EU
EXHIBIT NO. ____ (TEC-1)

EXHIBIT OF
TAMPA ELECTRIC COMPANY

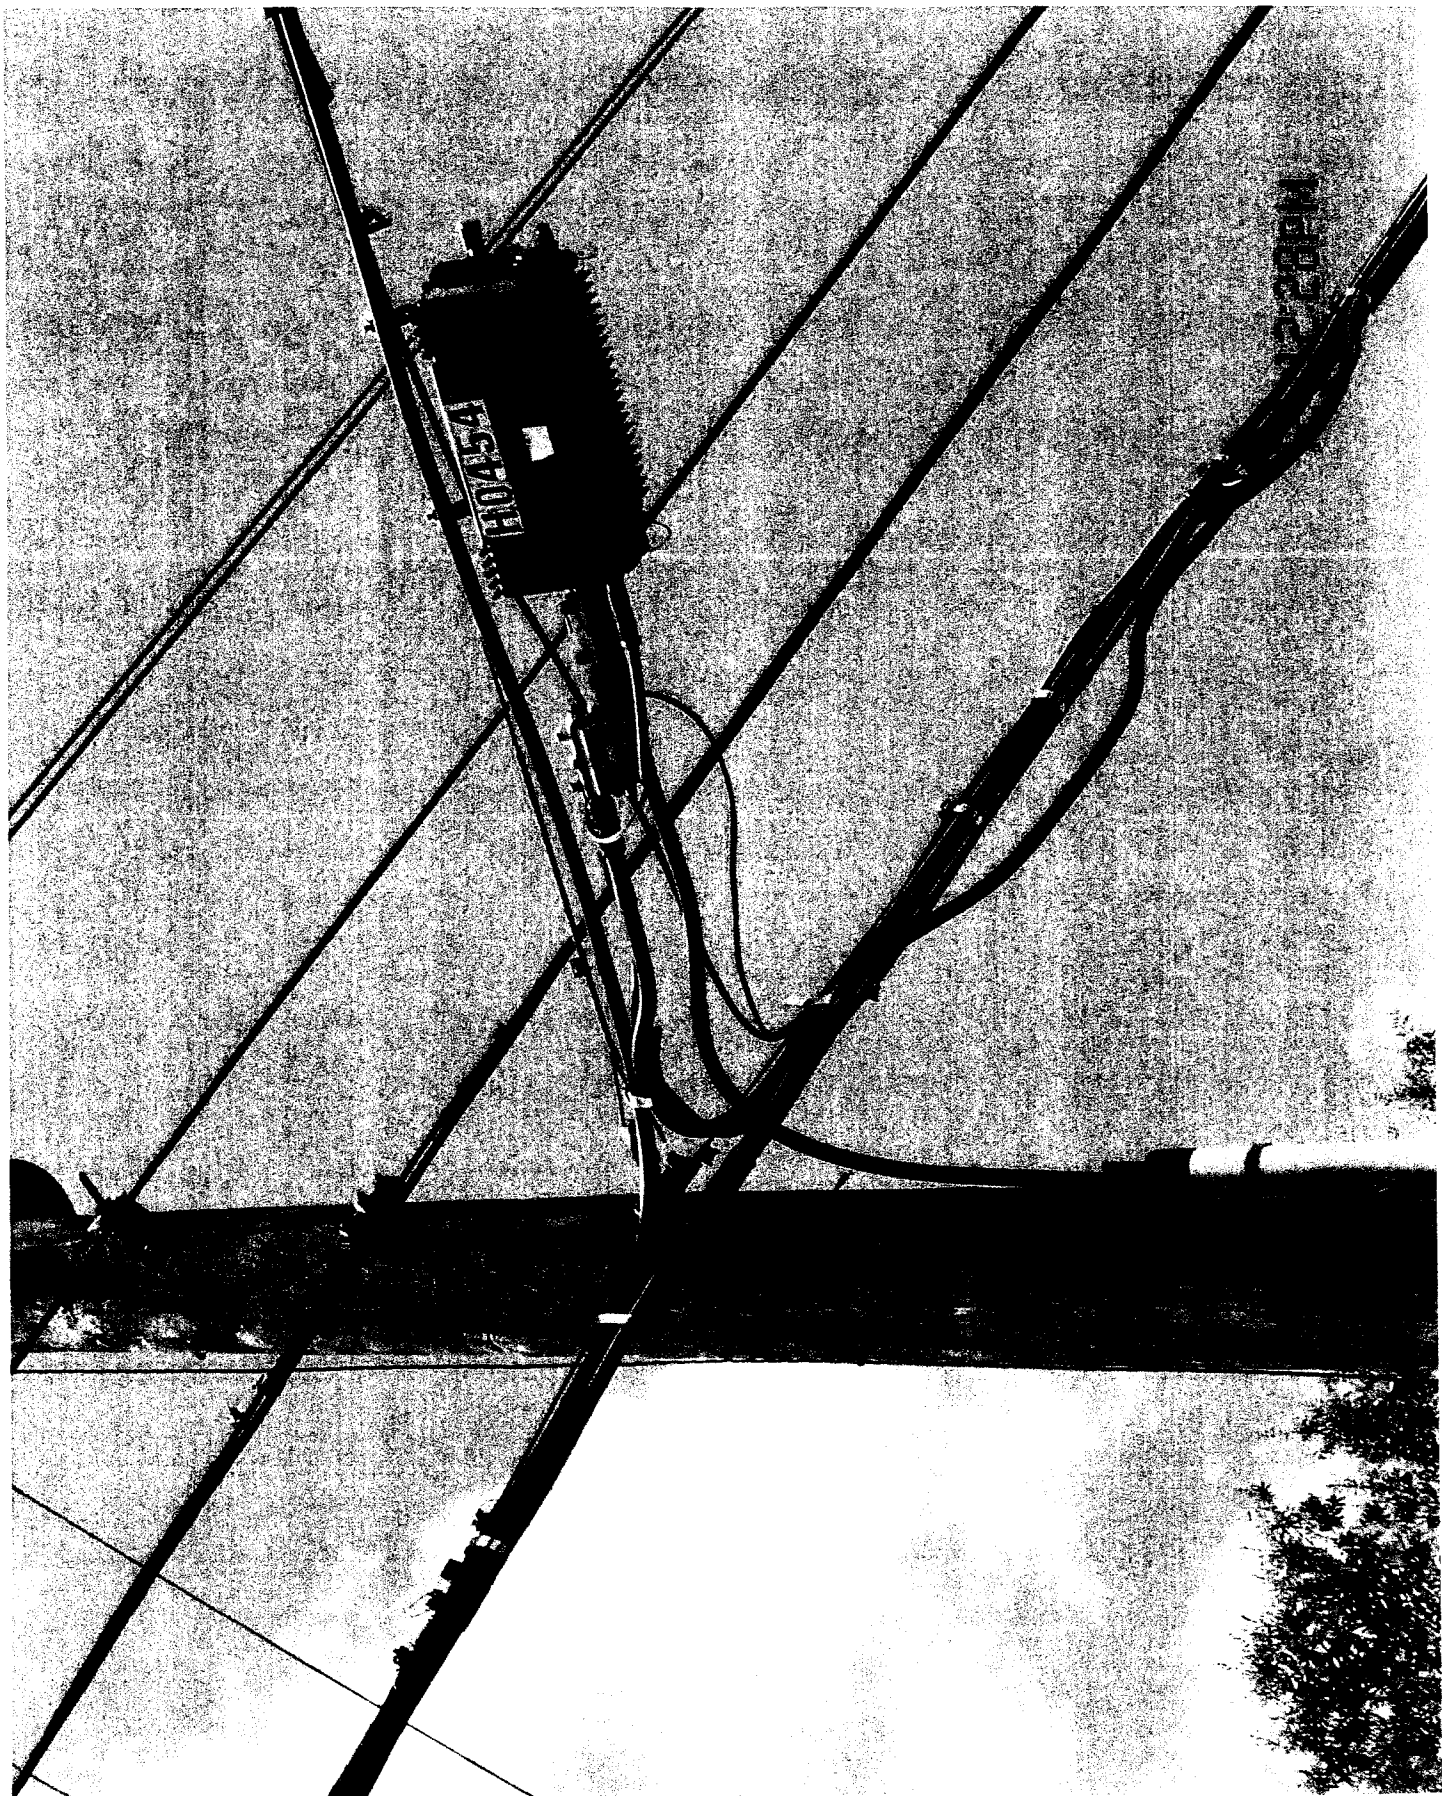
DOCUMENT 25

Documents 24 – 26 provide another example of an overlashed cable with numerous cables in a bundle with a diameter of 4" or more and has equipment attached.

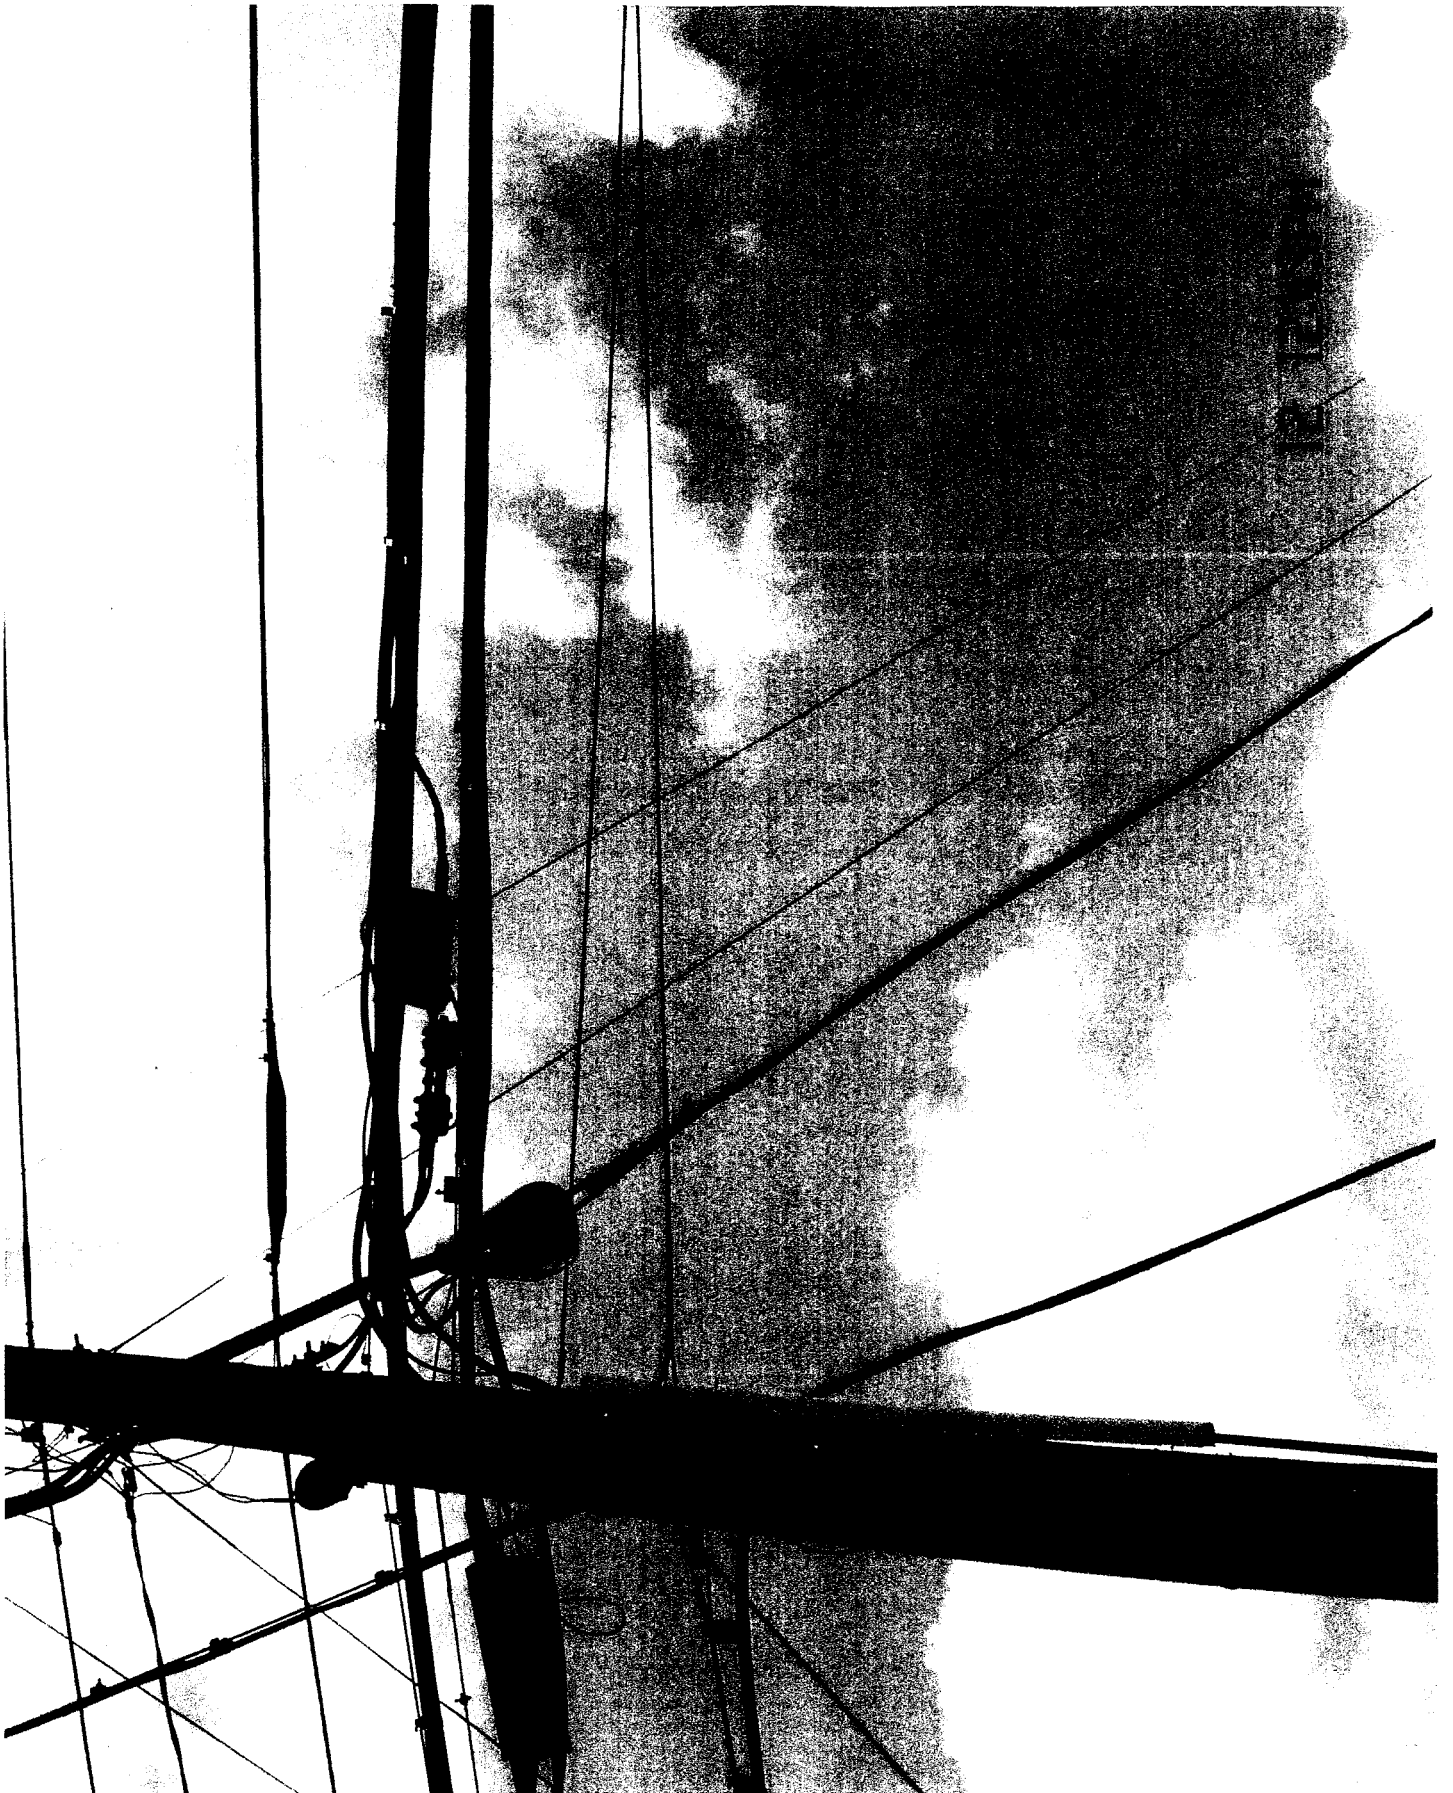
DOCUMENT 27

Document 27 shows the size of various cable attachments compared with Tampa Electric's street light bracket. These attachments are larger than the street light bracket which has a diameter of 2".
