**PHASE I ENVIRONMENTAL SITE ASSESSMENT  
CELIA SITE, CAMP ROAD  
NORTHERN ESCAMBIA COUNTY, FLORIDA**

**GULF POWER  
Pensacola, Florida**

**RMS TIMBERLANDS, LLC  
Cantonment, Florida**

**081028-0100  
March 2009**

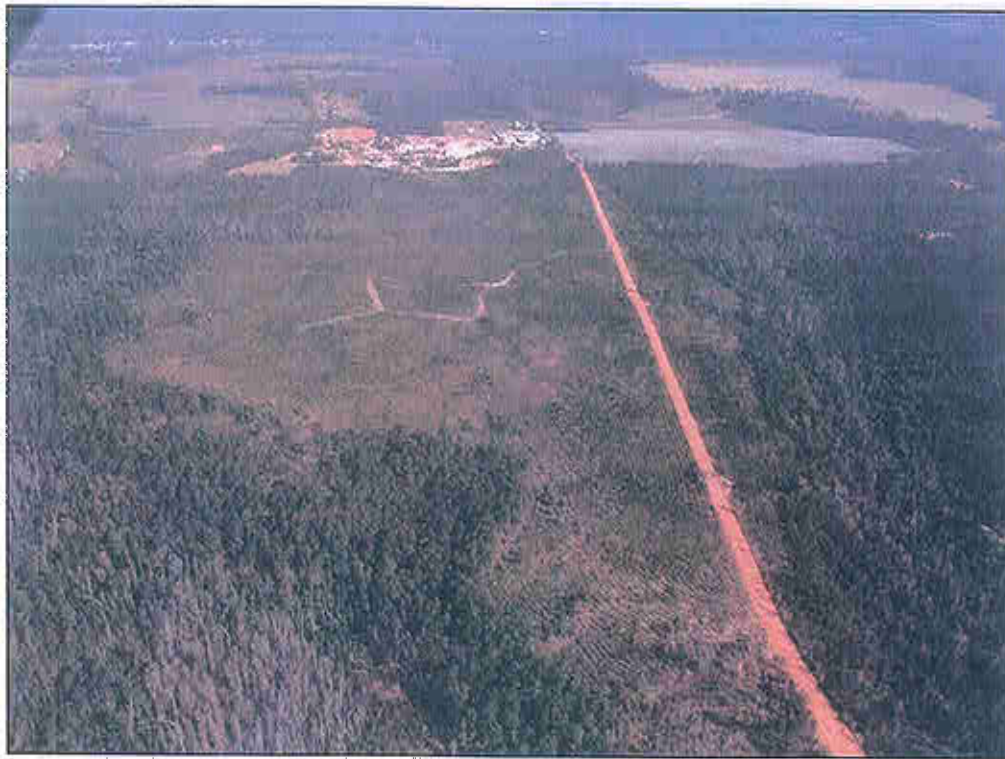
Photograph No. 2. View, looking north, from the air, of the northern portion of the subject property located along Camp Road, with the former landfill visible along the northern property boundary.

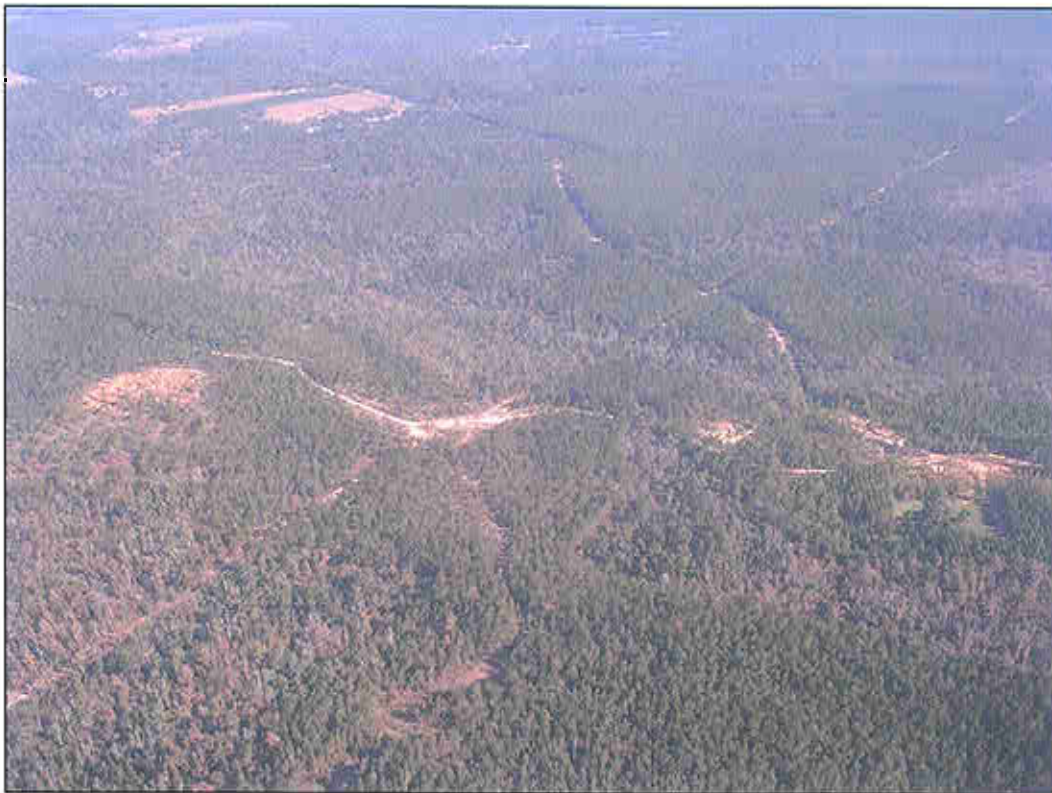
Photograph No. 4.

View, looking northeast, from the air, of the southeastern portion of the subject property, with pipeline, unimproved roadways, and feed plots.

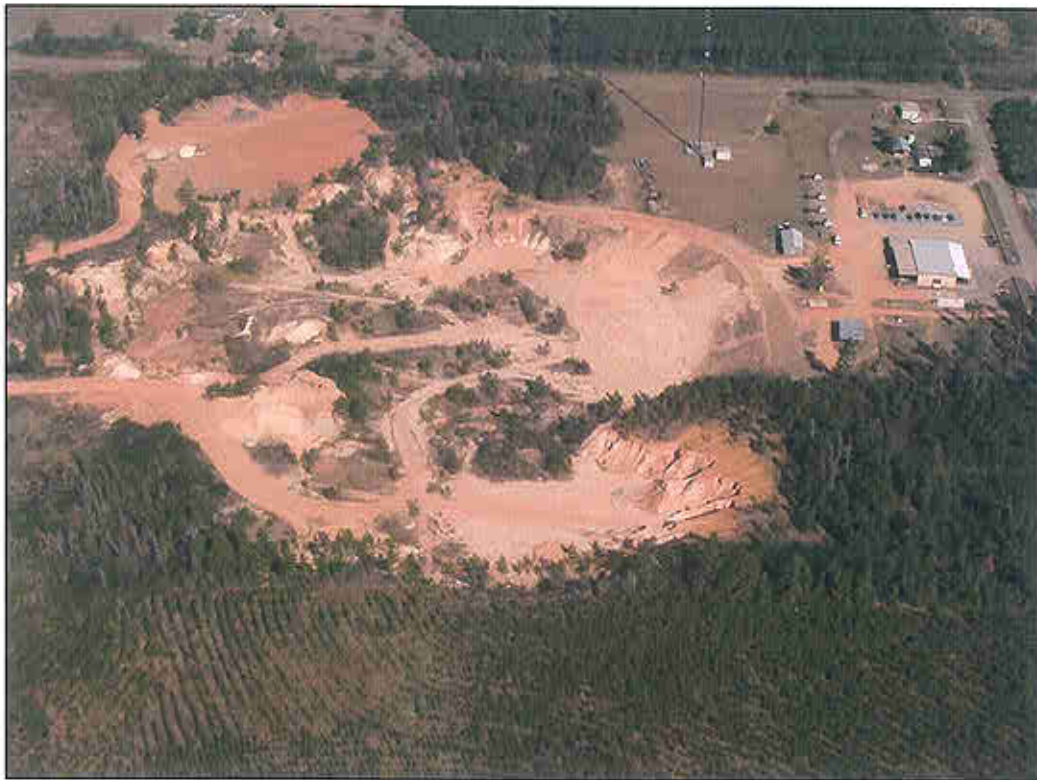
Photograph No. 10. View, looking north, from the air, of the Escambia County Road Department facility and borrow pit on the northern adjacent property.

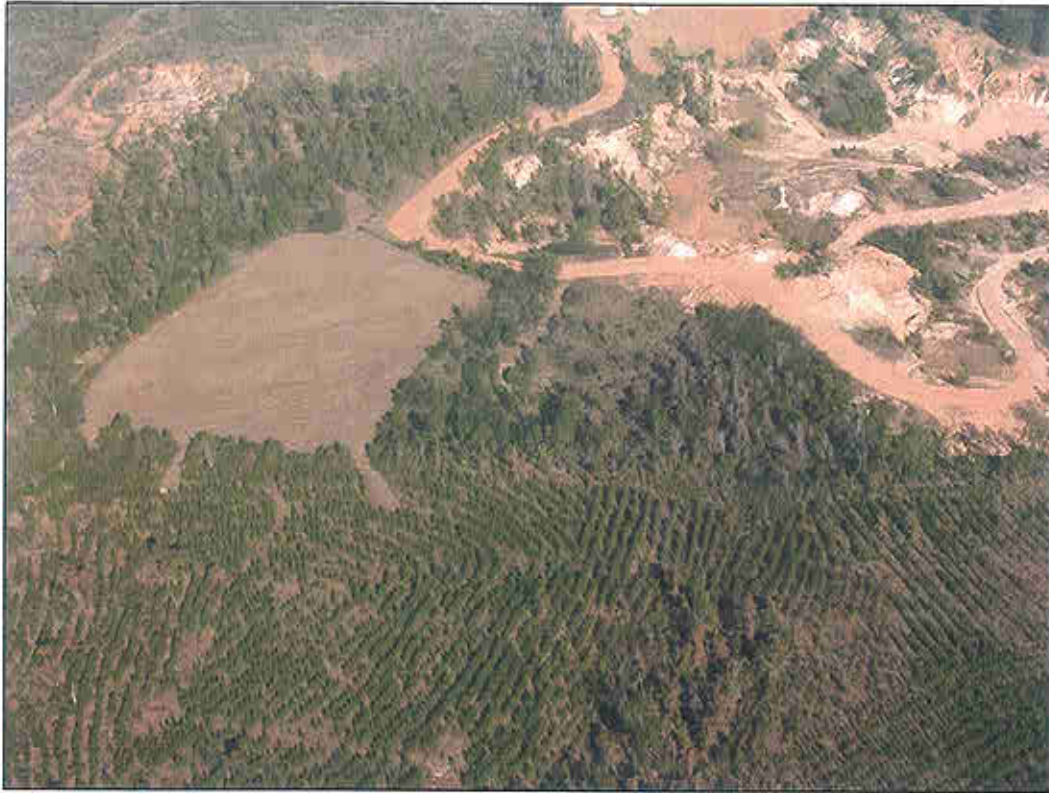
Photograph No. 11. View, looking north, from the air, of the former landfill (cleared area) and borrow pit located on the northern adjacent property.

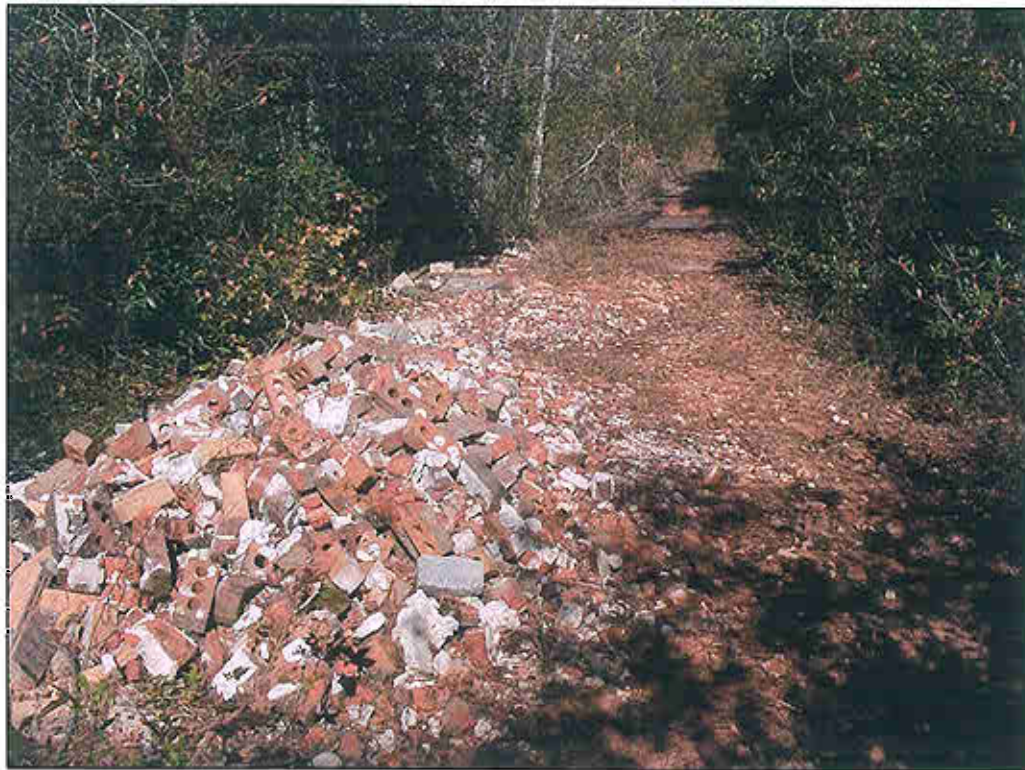
Photograph No. 18. View, looking north, of a pile of bricks observed along one of the unpaved roadways adjacent to Mitchell Creek on the northwestern portion of the subject property.

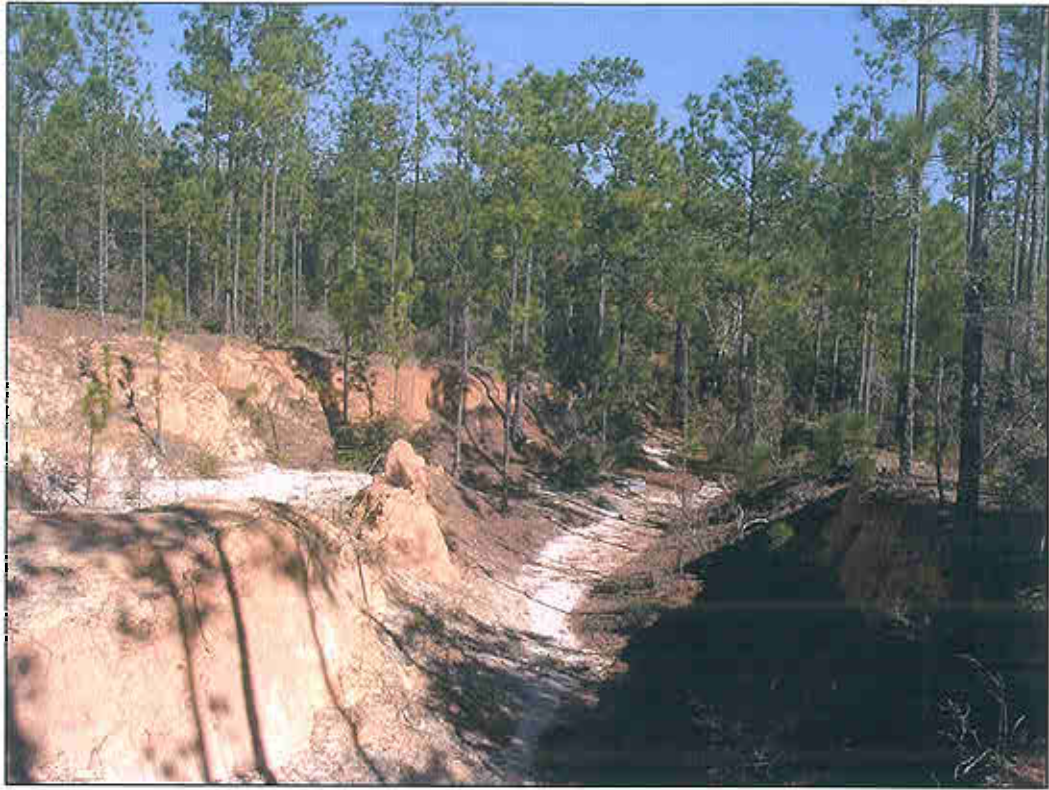
Photograph No. 19. View, looking east, of one of Mitchell Creek's eroded gully areas, located on the southeastern portion of the subject property.

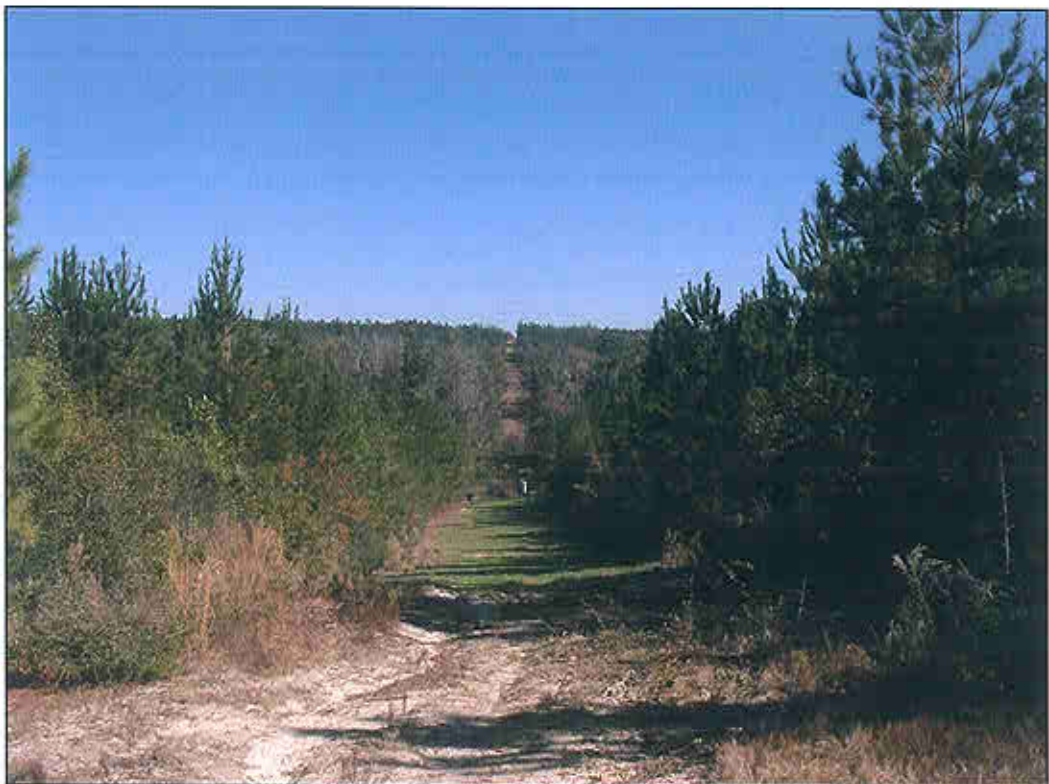
Photograph No. 20. View, looking northeast, of the cleared pipeline, located on the southern portion of the subject property, with a hunt stand and feed plot visible.

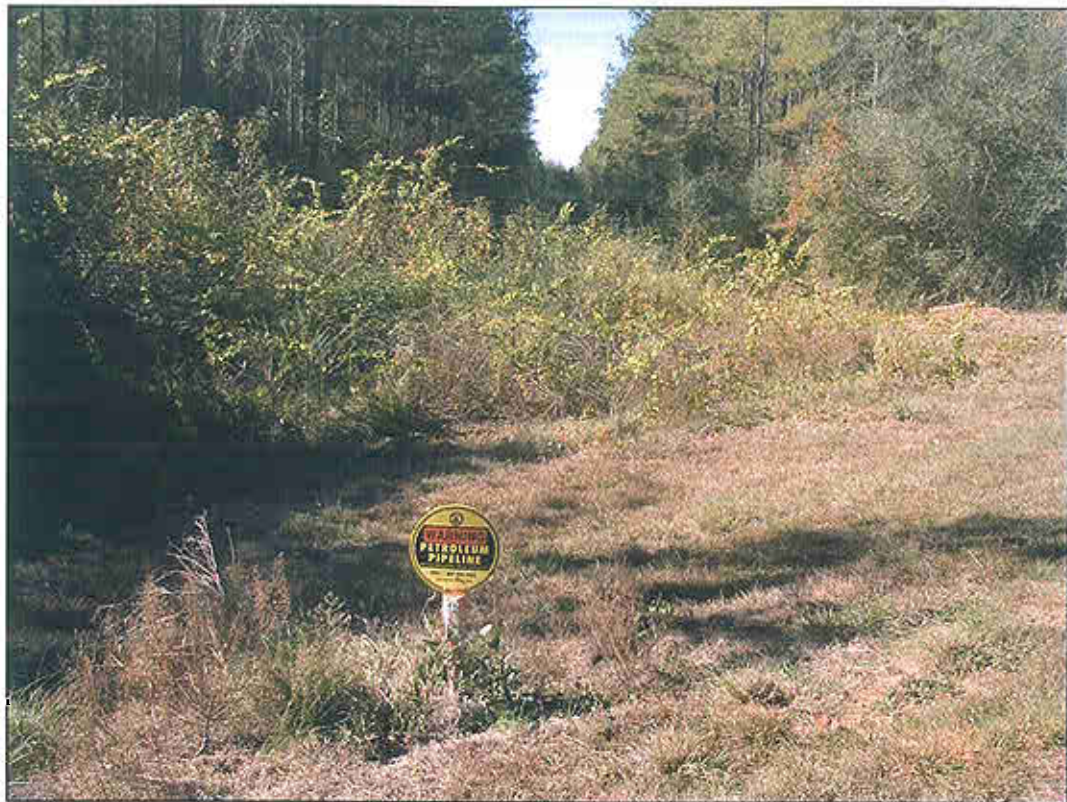
The presence of the underground petroleum pipeline on the southern portion of the subject property is considered a *de minimis* condition. There is no record of any releases or discharges associated with this pipeline.

Photograph No. 21. View, looking southwest, from Cox Road, of the cleared pipeline, located on the southern portion of the subject property.

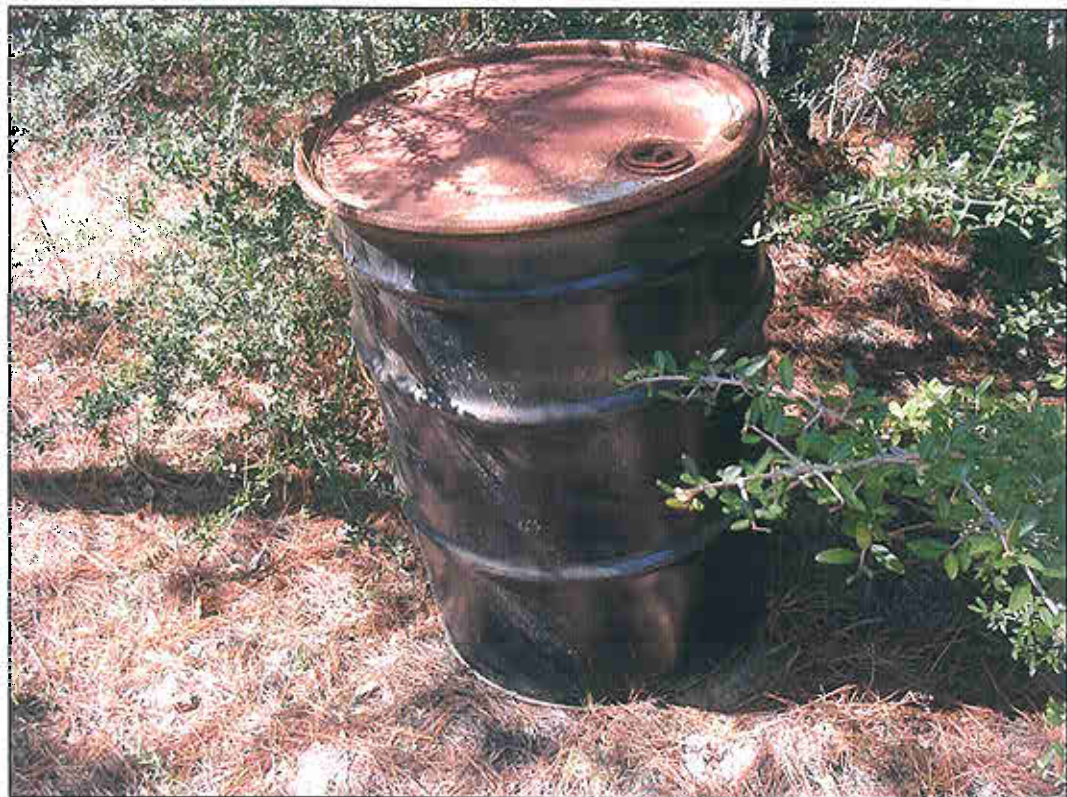
Photograph No. 22. View of a feed drum located near one of the hunt stands on the subject property.

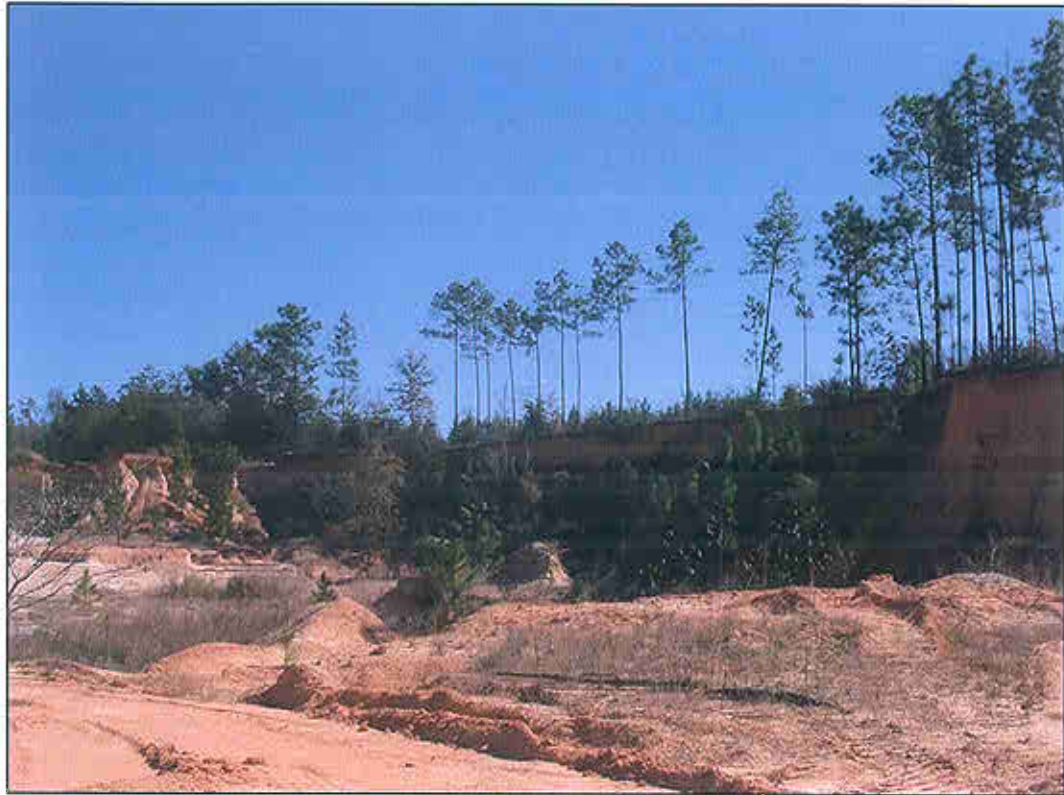
Photograph No. 25. View, looking east, of the northern adjacent borrow pit.
