Duke Energy (Bernier) - (CONFIDENTIAL) Exh A [to notice of intent to request confidential classification], information contained in 8/29/19 and 8/30/19, late-filed exhibits to deposition of Messrs. Swartz, Toms, and Salvarezza.

Duke Energy Bartow ST 40" Upgrade Blade Test in Takasago Validation Rigor at MHPS

Bartow RCA Summary

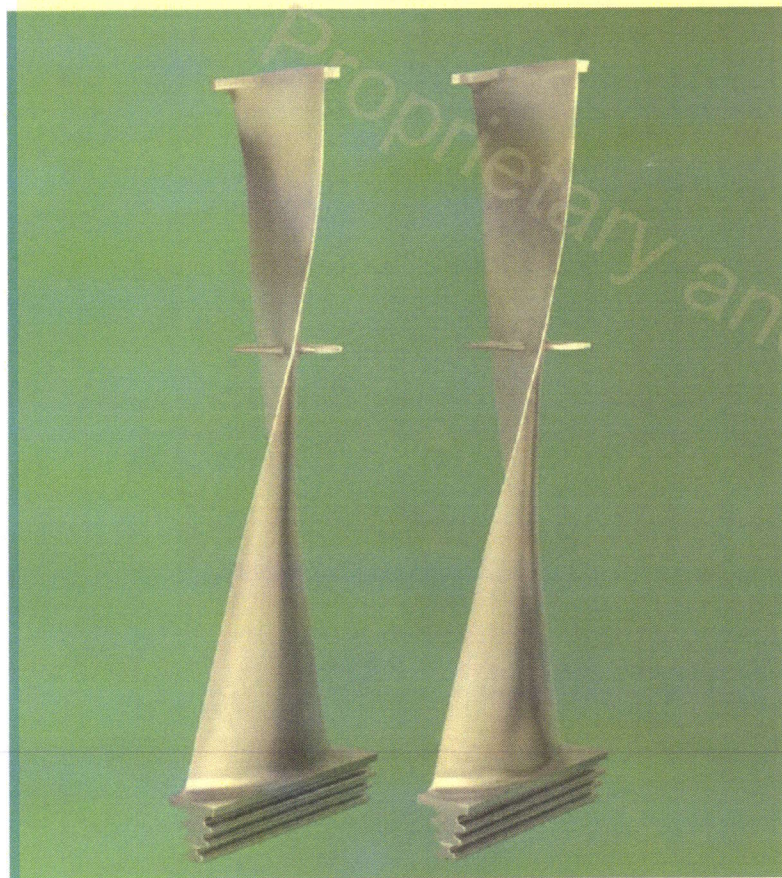
40" L-0 upgrade blade for high loading

- Once the root cause was understood MHPS developed an upgraded 40" L-0 blade specifically to operate the conditions present at Bartow. **(Note : this is not required across the fleet)**

Upgraded 40"

40" Old

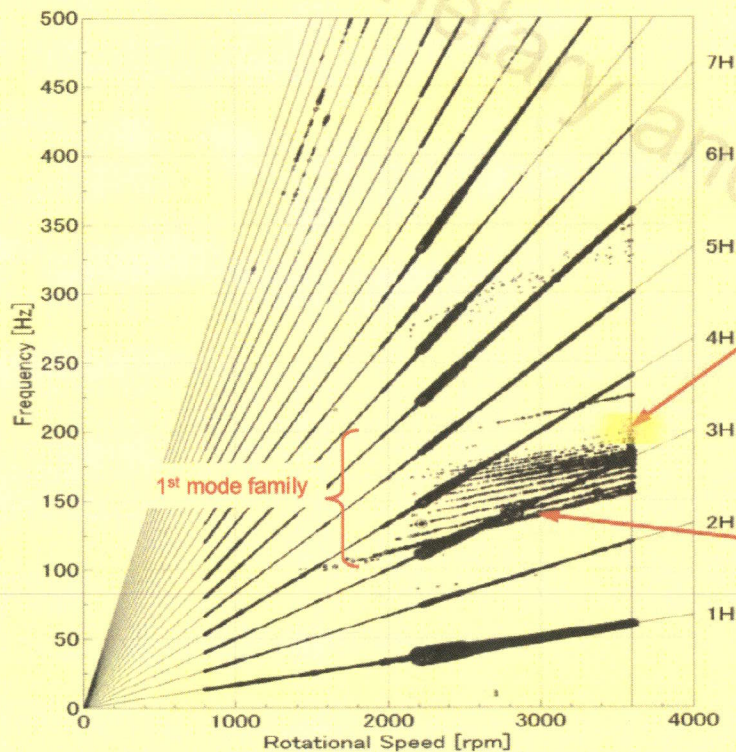
To certify reliability of Upgraded 40" L-0 Blade, the blade frequency (harmonic resonance frequency) were measured by the air jet test and the mechanical damping of the high nodal diameter was measured by the electromagnetic vibration test.

The electromagnetic exciter can excite any high nodal diameter mode at the rated rotational speed.

The blade frequencies and responses of harmonic resonance are measured by Air jet test

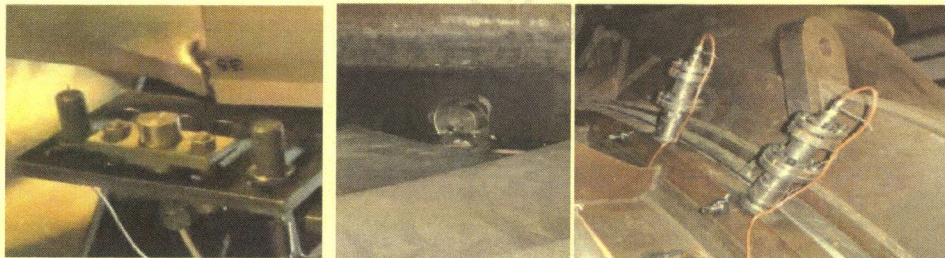
The blade vibration amplitude was measured by the BVM sensors set close to the tips of the blades.

The specification of BVM system (specification of sensor, specification of analyzing system etc.) is the same as field verification testing.

Factory Test

Field Test

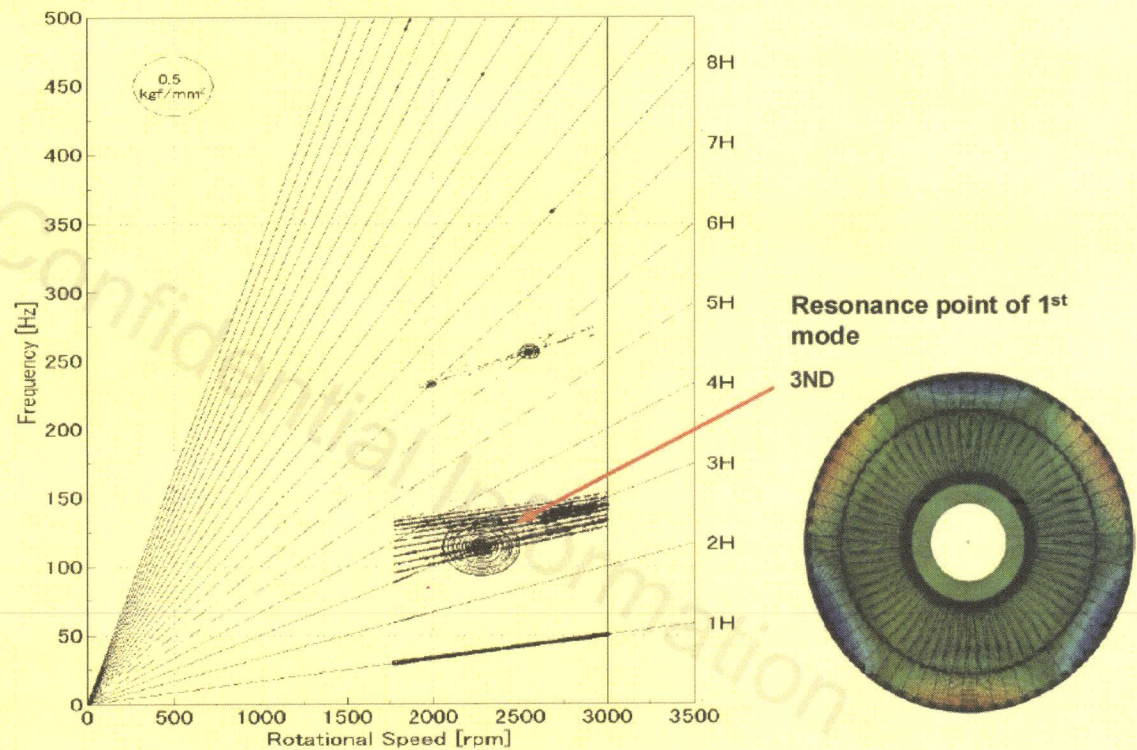
Example of Measurement Result of Air Jet Testing

Resonance points of each mode was confirmed by air excitation while decreasing the rotational speed.

Rotational speed of shroud and stub contact was confirmed by the change in the blade vibration characteristic.

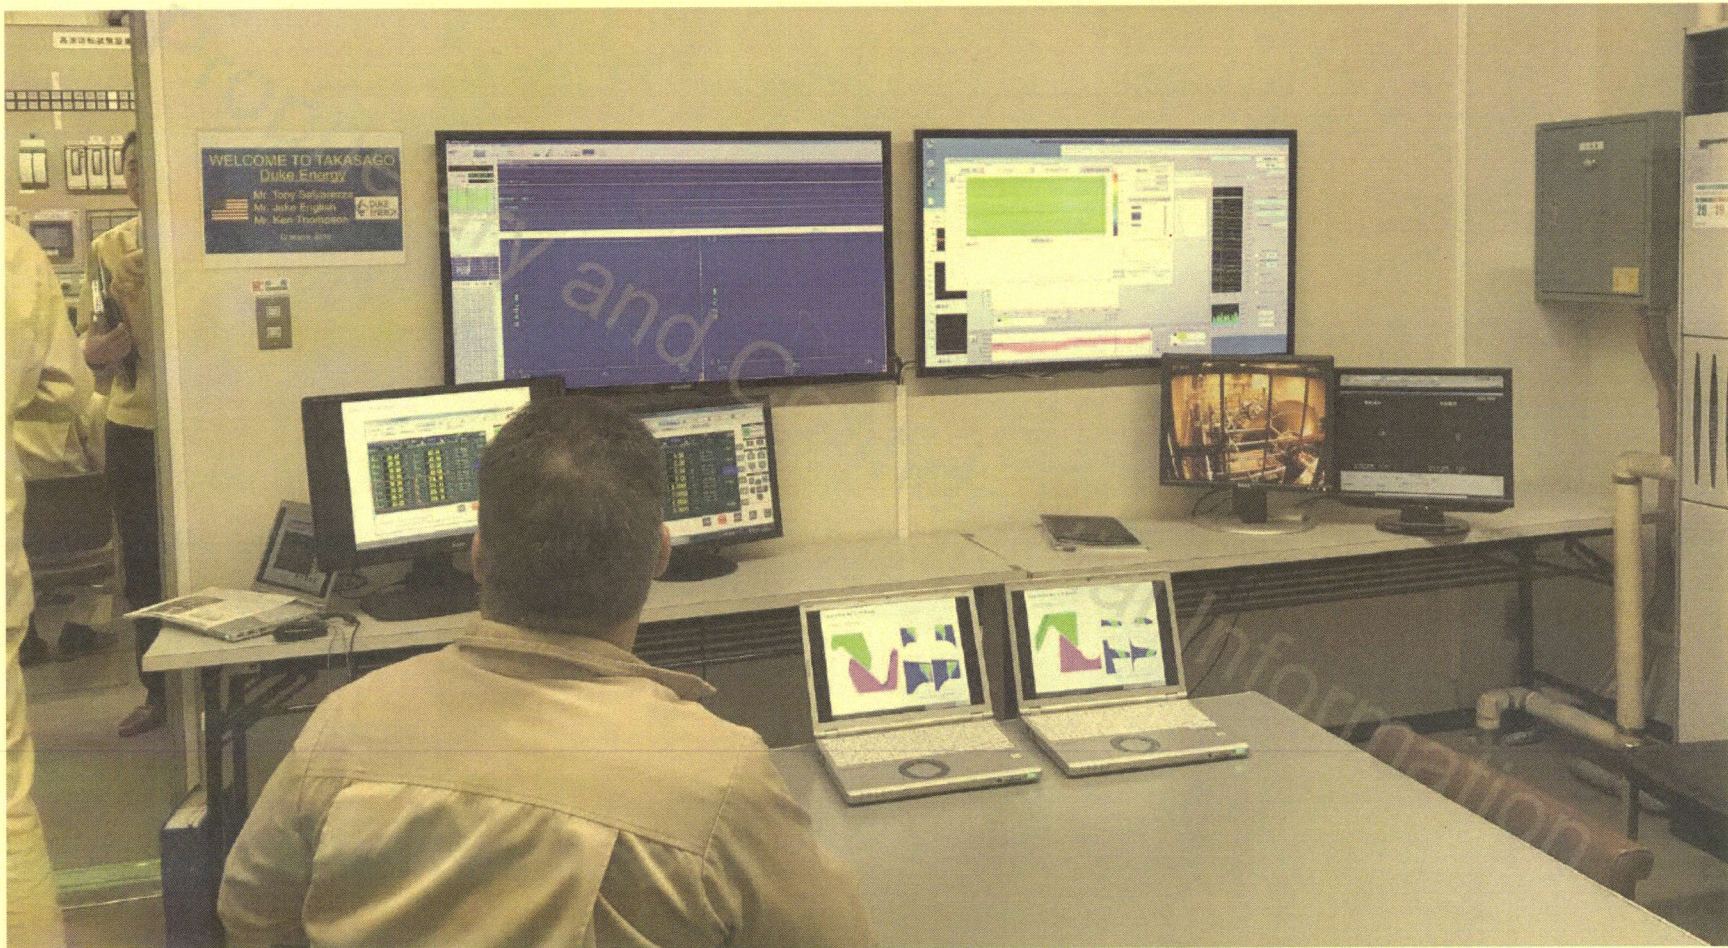
Summary and Test Results

- Campbell diagram showed sufficient margins for all vibration modes
- Higher level of mechanical damping observed during the test validated the calculations
- In-house testing proved that the upgrade blade can operate at higher blade loading that is enough to produce desired output for Bartow station
- New blades will be installed in the steam turbine in Nov 2019 along with Blade Vibration Monitoring

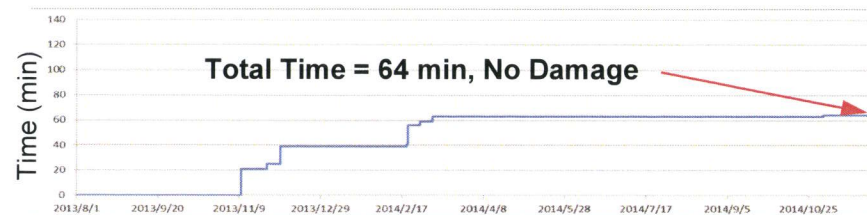
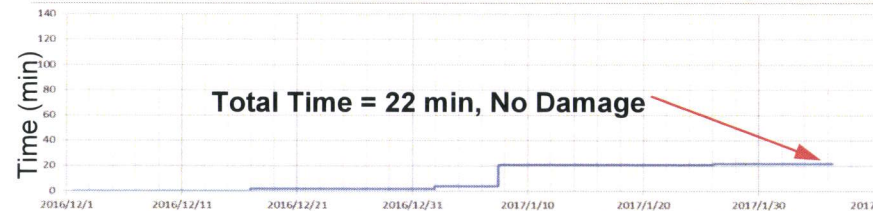
- Damage accumulates with High Load Bypass Operation of 4th GT Blending In or Out at 4C or 4D , High Mach #
- Accumulated damage below is based on time spent conducting 4th GT Bypass on C or D + Mach# > 0.55

Period 2 – C Bypass Accumulation – No Stub Damage (Gov)

Period 5 – C Bypass Accumulated Time – No Stub Damage (Gov)

Period 5 – D Bypass Accumulated Time – Stub Damage (Gen)
