Docket No. 20210001-EI
Cross-Examination
Hearing Exhibit

Short title: DEF's Confidential Response to OPC's POD 5, Q22

**Generator, Stator Core Seals, Inspection and
Replacement, SGen5-1000A and SGen6-1000A**

PB3-13-0008-GN-EN-01

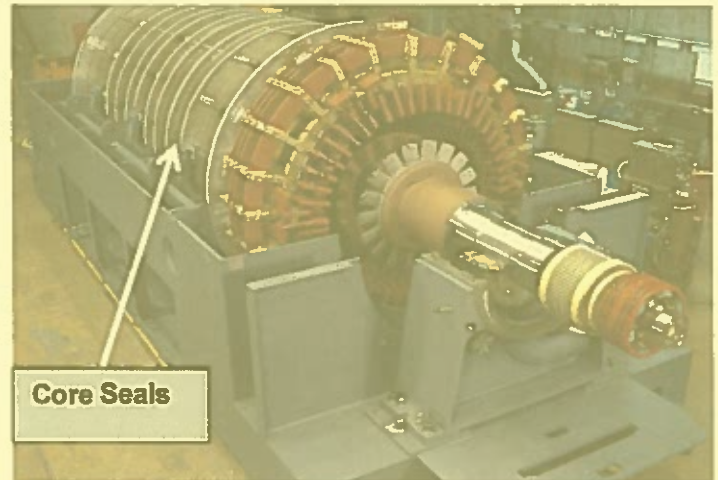
Figure 2: Photo of Generator with Upper Frame Removed.

Figures 1 and 2 show the locations of the core seals in relation to the overall generator. The seals are located in 10 places; each seal is 360 degrees around the stator core.

Siemens recommends performing visual inspection of core seals at all medium and major inspections. For inspection, the interior of the generator can be accessed through four upper frame covers and two cooler access covers.

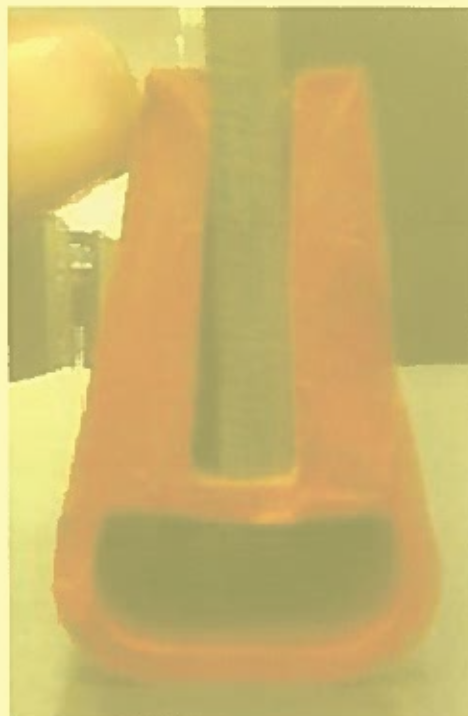
Figure 4: Improved Core Seal Design.

Siemens has developed an improved core seal design which is comprised of silicone rubber that will adhere to the stator frame (see Figure 4). The improved seal design reduces the risk of seal displacement because a reliable bond is formed between the seals and the steel frame rings. Extra seal rigidity is provided by the long extension legs in the seal, which extend around the steel plate allowing greater bonding surface area.

Replacement of displaced core seals will restore the overall cooling efficiency of the generator.

It is recommended that replacement of core seals be implemented by Siemens authorized personnel only. Please contact your Siemens representative for further information.
