**DOCKET NO. 060198-EI  
FLORIDA POWER & LIGHT COMPANY**

**IN RE: REQUIREMENT FOR INVESTOR-OWNED  
ELECTRIC UTILITIES TO FILE ONGOING STORM  
PREPAREDNESS PLANS AND IMPLEMENTATION  
COST ESTIMATES.**

**JOHN A. HARRIS  
(RESPONSE TO CITY OF NORTH MIAMI PETITION)**

3                   **DIRECT TESTIMONY OF JOHN A. HARRIS**

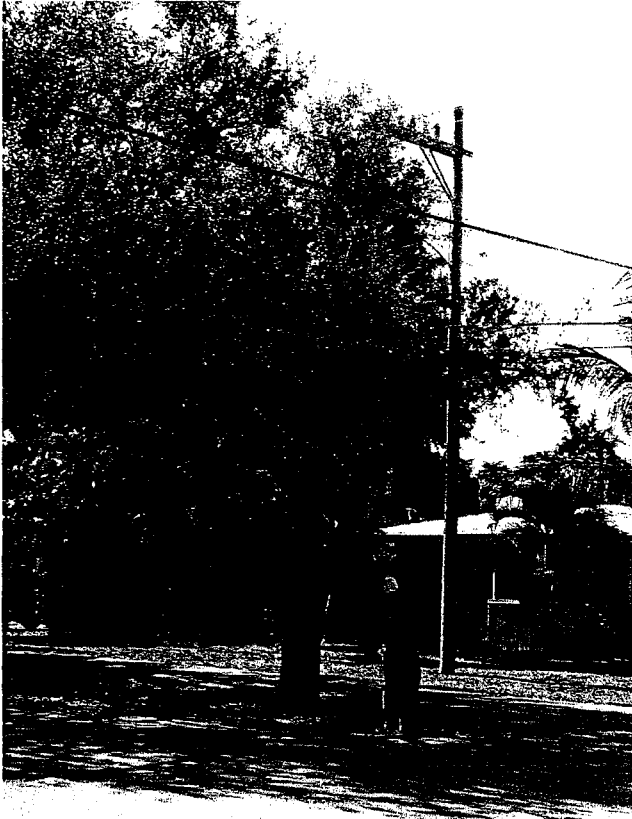
Photo 1: Live Oak tree in center median of NE 8 Avenue, on the south side of corner of NE 8 Avenue and NE 119 Street in North Miami, Florida. Live Oak was trimmed for line clearance in upper canopy and for road clearance in lower canopy. See old pruning cut for road clearance in center of photo (dark cut wound with callous wood surrounding cut), and new stub cut at right side of tree canopy approximately directly over the head of John Harris. The re-growth of canopy in the upper canopy is a natural response to the level of trimming done to V cut, or directionally prune, this tree away from electric lines overhead (3 phase feeder lines). Approximately 30% of the canopy was removed for line clearing, and 10% of the canopy for road clearance. The trimming done for line clearance appears to have been done in compliance with applicable codes, regulations and standards. In contrast, the trimming for road clearance did not follow the applicable standards because it left the large stub cut.

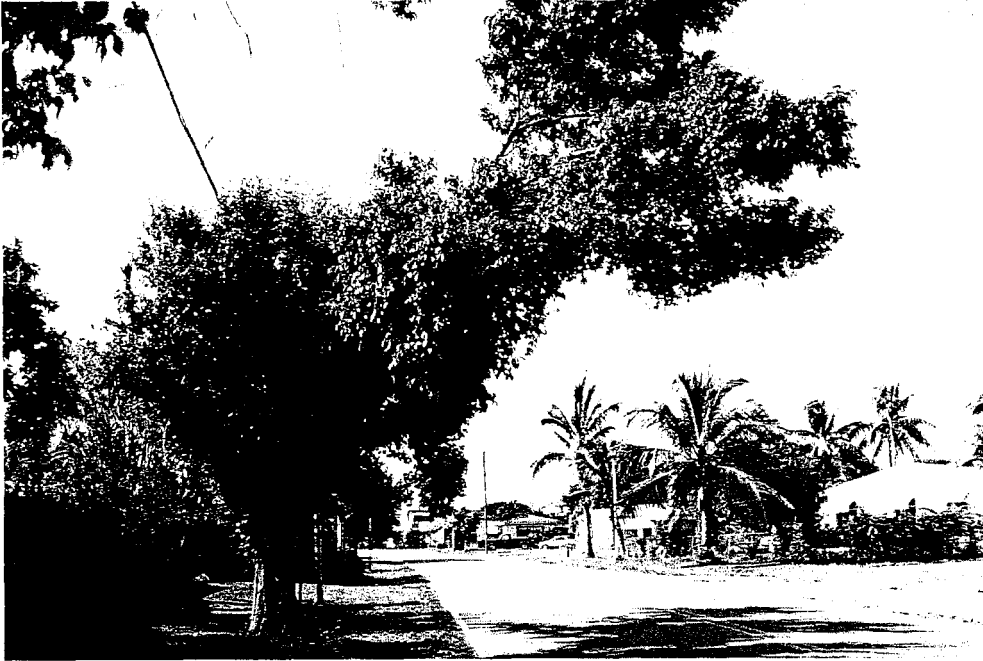
1  
2 Photo 2: A *Ficus benjamina* tree that has been trimmed for line clearance, for road  
3 clearance, and by the property owner for driveway clearance and size/shape. This tree is  
4 on the south side of the T intersection for NE 12 Avenue and NE 107/108 Street in North  
5 Miami, Florida. It is on the west side of the residence's driveway. This species is exempt  
6 from trimming or pruning standards in the City of North Miami. The aesthetic value of  
7 this tree is low, and it could be one of the trees that are referenced by the City of North  
8 Miami Direct Testimonies. Approximately 25-35% of the canopy was removed for line  
9 clearance, 10-15% for road clearance, and 20-35% for driveway clearance and shaping,  
10 for a total canopy removed of 55-65% for this tree (there is some overlap of canopy  
11 removal percentages among trimmers). This tree is an example for trees that would be

12 better to remove than maintain by trimming; due to costs for all three entities and the  
13 appearance of the tree today. The trimming done for line clearance appears to have been  
14 done in compliance with applicable codes, regulations and standards (including the  
15 City's, even though *Ficus benjamina* are exempt). The additional trimming for road  
16 clearance and by the property owner is the main cause for the imbalanced canopy  
17 appearance shown in the photograph.  
18

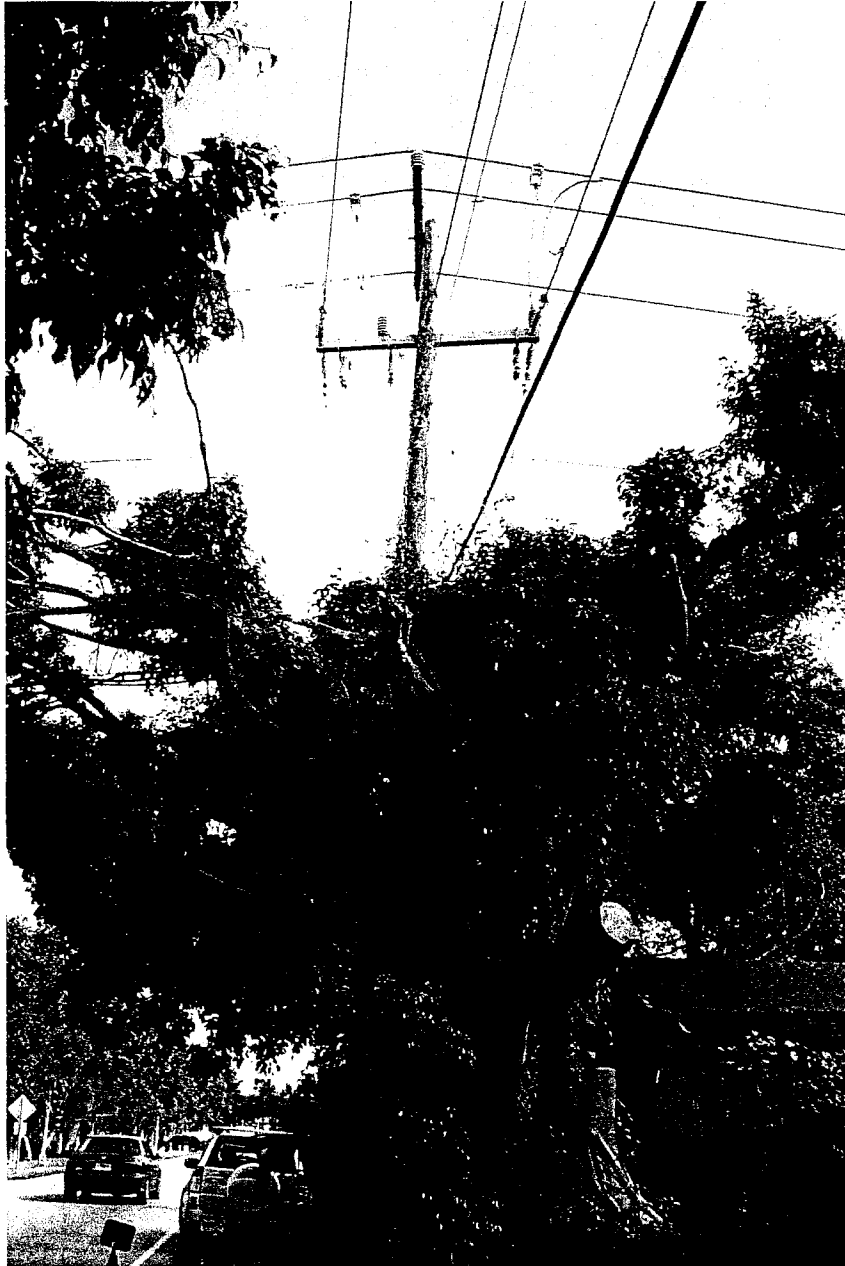
1  
2 Photo 3: A second *Ficus benjamina* tree at same location, to east of driveway. This tree is  
3 showing decline from the major leaders removed by property owner for driveway  
4 clearance. It may need removal within the next few years due to decline and rot in the  
5 main leaders and trunk of the tree. This tree, due to declining health condition and the  
6 location near the road and utilities, would be considered a Risk Tree by the tree  
7 evaluation standards of the International Society of Arboriculture. The decline in health  
8 is mainly due to the additional trimming for driveway clearance and/or road clearance,  
9 which removed approximately 35-50% of the canopy. The line clearance trimming  
10 removed approximately 30-35% of the canopy, which is within the applicable standards.  
11

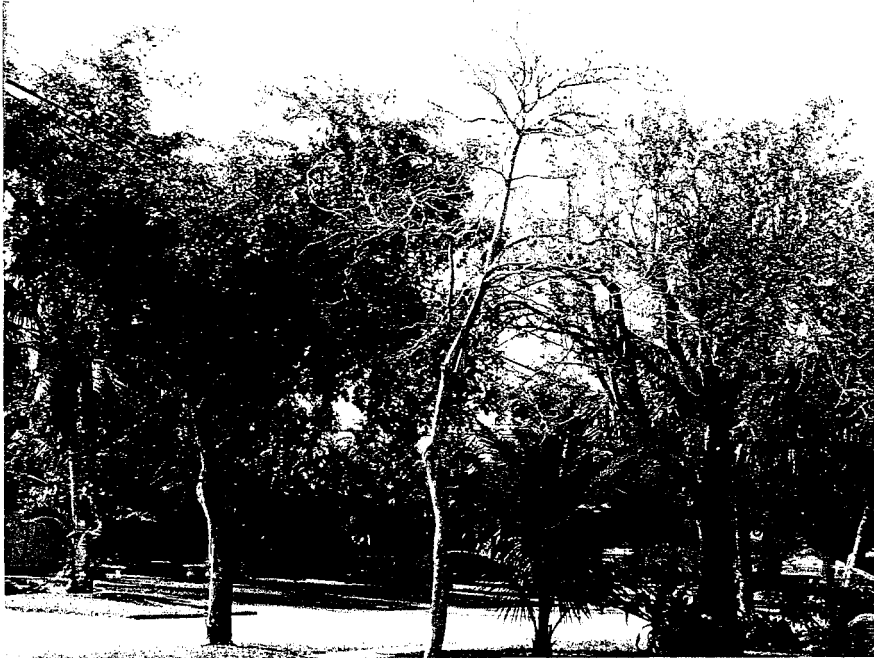
1  
2 Photo 4: A Black Olive tree (left side of photo) that was trimmed for line clearance and  
3 Live Oak tree (right side of photo) that was trimmed or hatracked by property owner or  
4 their contractor. Trees are in residential front yard and Right-of-Way at NW of corner of  
5 NE 11 Place and NE 123 Street. A dead smaller/younger Black Olive tree is in center of  
6 photo and is in west side Right-of-Way on NE 11 Place. The larger Black Olive to left  
7 side was V cut for line clearance by FPL. The trimming of the larger Black Olive for line  
8 clearance appears to have been done in compliance with applicable codes, regulations  
9 and standards, with re-growth of the canopy following the directional pruning  
10 expectations. In contrast, the hatracking of the Live Oak cut back every leader on the  
11 Live Oak to large (approximately 6-10 inch diameters) diameter stubs that have sprouted

12 reactionary growth with rotting wood seen at cut points. This is inconsistent with  
13 accepted guidelines and, probably as a result, the Live Oak is showing signs of decline  
14 with chlorotic colored foliage and less foliage in canopy than desirable for health of this  
15 size tree (amount of live woody tissue). In contrast, the Black Olive trimmed for line  
16 clearance shows regrowth of canopy and healthier colored foliage. The dead Black Olive  
17 in center of photo is not under or within clearance distances of electric lines.  
18

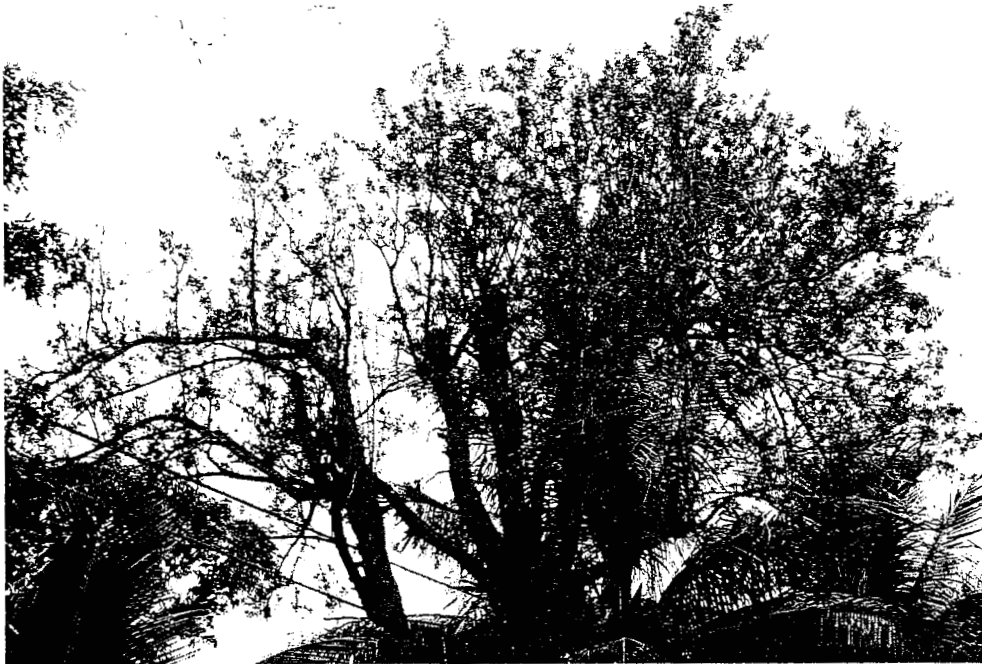
1  
2 Photo 5: Closeup of the upper canopy of the Live Oak from Photo 4, showing the cut  
3 ends and conditions of canopy from hatracking.  
4

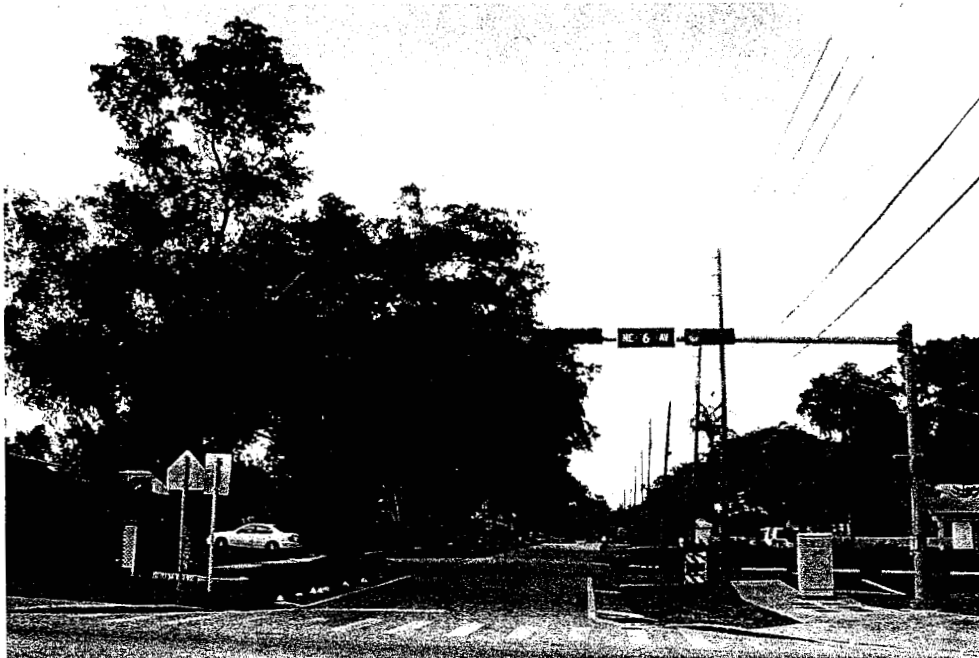
5  
6 Photo 6: Looking west from the corner of NE 6 Avenue and NE 107 Street, the north side  
7 of the street has a 3 phase feeder line, with only smaller maturing trees planted under the  
8 lines (a Crape Myrtle is under the lines). The south side of the street is planted with Black  
9 Olive trees that provide canopy and shade to the road and properties. This is an example  
10 of good planning for continued utility reliability based on keeping trees outside a  
11 potential conflict with the overhead lines.  
12

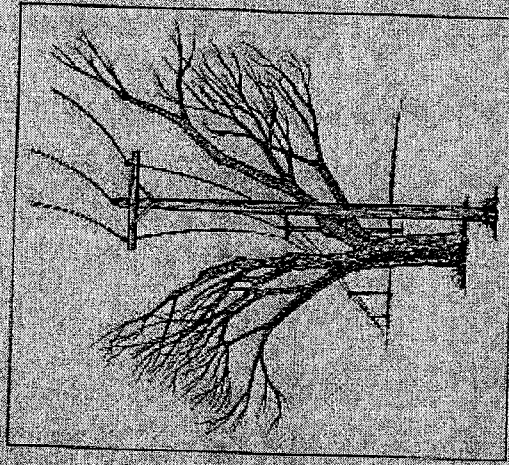
Figure 9. Directional pruning (also known as neutral pruning) encourages growth away from existing lines.

The effect of directional pruning on the shape of the tree depends on the tree's natural growth habit and where the tree is relative to the facility. Trees growing directly beneath facilities assume a different shape than trees growing beside them (Figure 10). Removal of overhanging limbs may or may not be appropriate, depending on the type of facility, tree species, or other site conditions (Figure 11).

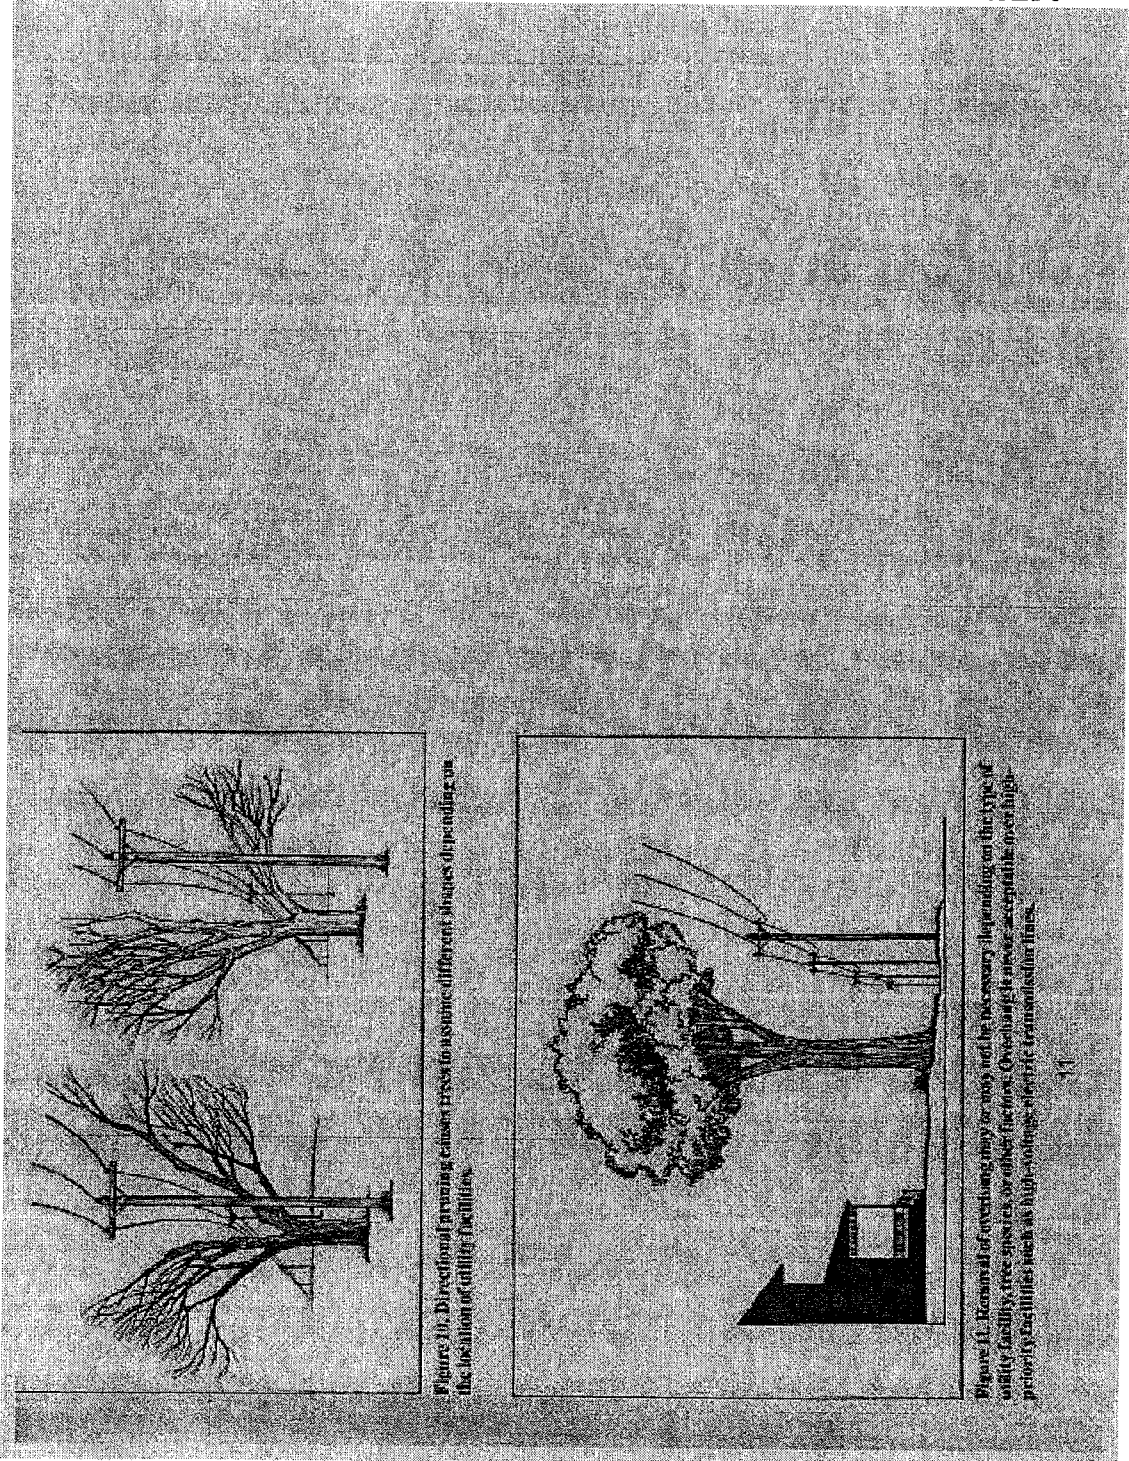
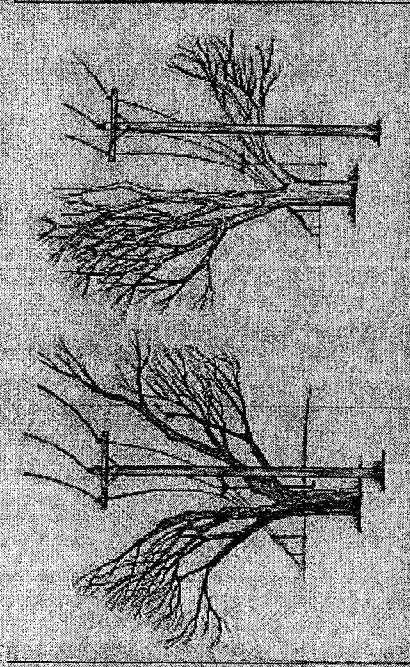
Figure 10. Directional pruning causes trees to assume different shapes depending on the location of utility facilities.

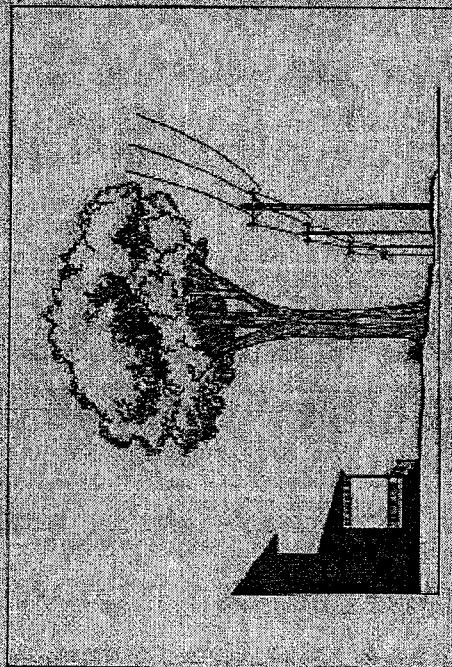
Figure 11. Minimal of overhang may or may not be necessary depending on the type of utility facility, tree species, or other factors. Overhang is more acceptable over high-voltage facilities such as high-voltage electric transmission lines.

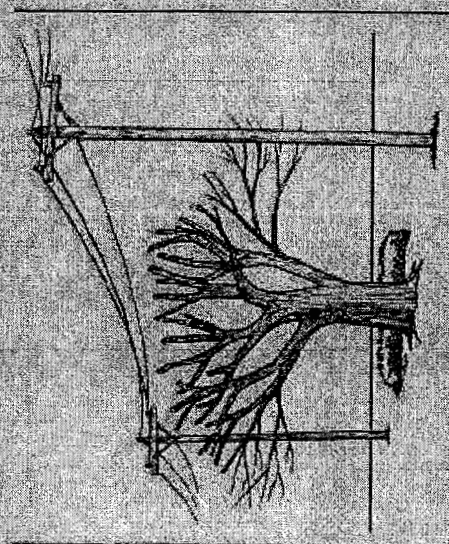
Figure 12. Rounding over, topping, or stubbing severely damages trees and is now a discredited practice.

Rounding over or *topping* is the now discredited practice of indiscriminately snubbing the entire crown of a tree (Figure 12). In this process, a series of heading cuts are made between lateral branches, rather than at the lateral. This once widespread practice is now considered unacceptable because it severely damages trees and encourages rapid re-growth. Many tree species respond to heading, topping, rounding over or other severe treatments with a flush of fast-growing sprouts, which can rapidly overtake conductors (Figure 13).

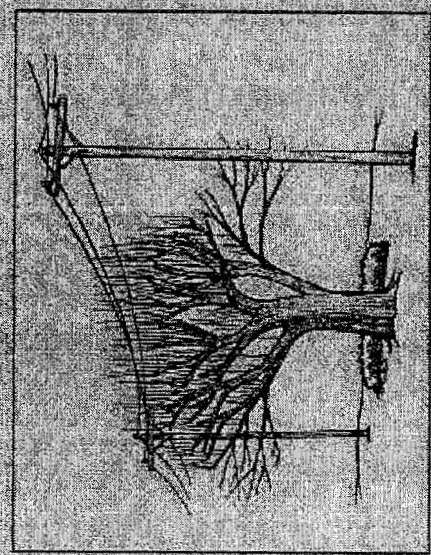
Figure 13. More trees required to maintain cover of thick bush of light growing sprouts already back over the electric facilities.

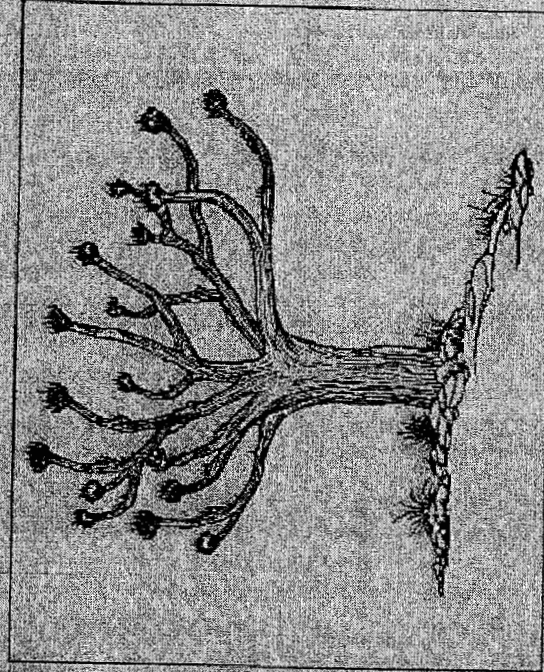
Figure 14. The practice of pollarding requires annual removal of all apical growth, with the intention of the woody stems that occur at the nodes of branches. Rounding over or stubbing is not the same as pollarding. Pollarding is generally not practical under utility facilities.

Pollarding is an established pruning method that maintains certain species of trees and shrubs at a predetermined size by systematically removing annual growth. Many people mistakenly refer to this indiscriminate rounding over and heading of trees to reduce their size as *pollarding* (Figure 14).
