**DATE:** November 16, 2009  
**TO:** Ann Cole, Commission Clerk - PSC, Office of Commission Clerk  
**FROM:** Dan Hoppe, Director, Division of Service, Safety & Consumer Assistance *AMC*  
**RE:** Docket No. 090368-EI - Review of the Continuing Need and Costs Associated With Tampa Electric Company's 5 Combustion Turbines and Big Bend Rail Facility

# **Status of the Big Bend Station Railroad Unloading Project and the Combustion Turbines at Big Bend and Bayside Stations - October 23, 2009**

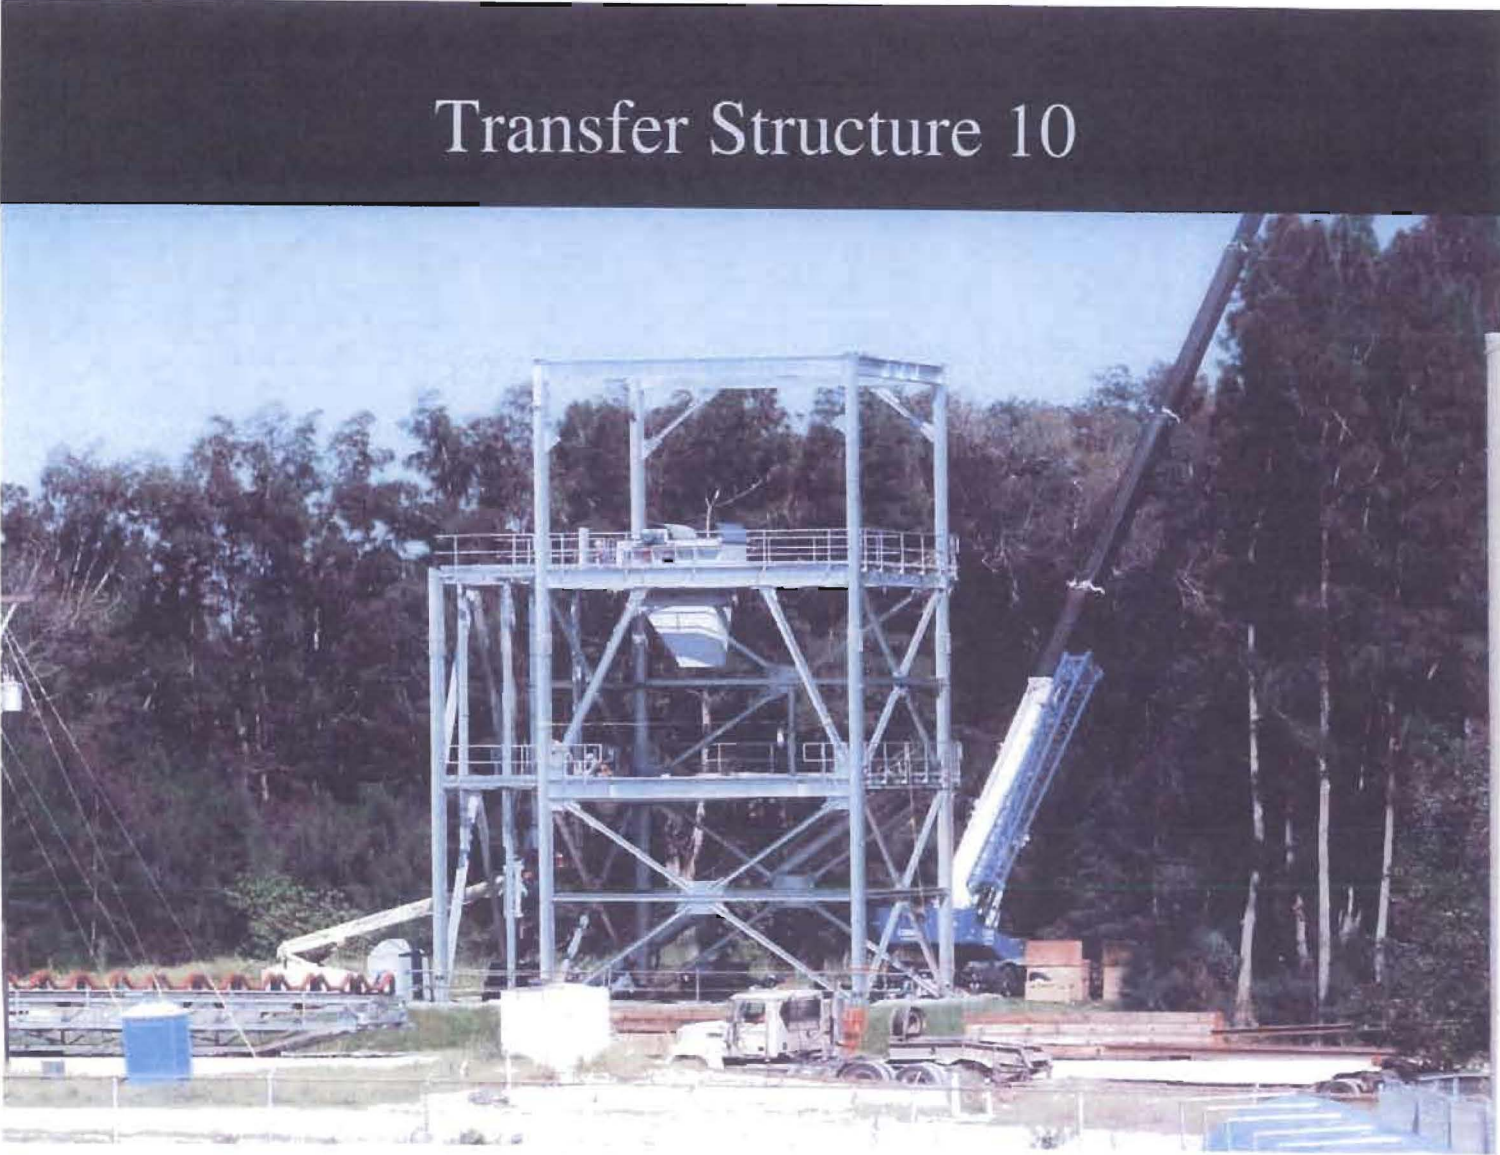
On left side of Transfer Structure 10, the section of conveyor belt to the unloading pit has been installed. The section of conveyor belt between this transfer structure and Transfer Structure 11(will come out of page) is being assembled on the ground and will be lifted into place upon completion.

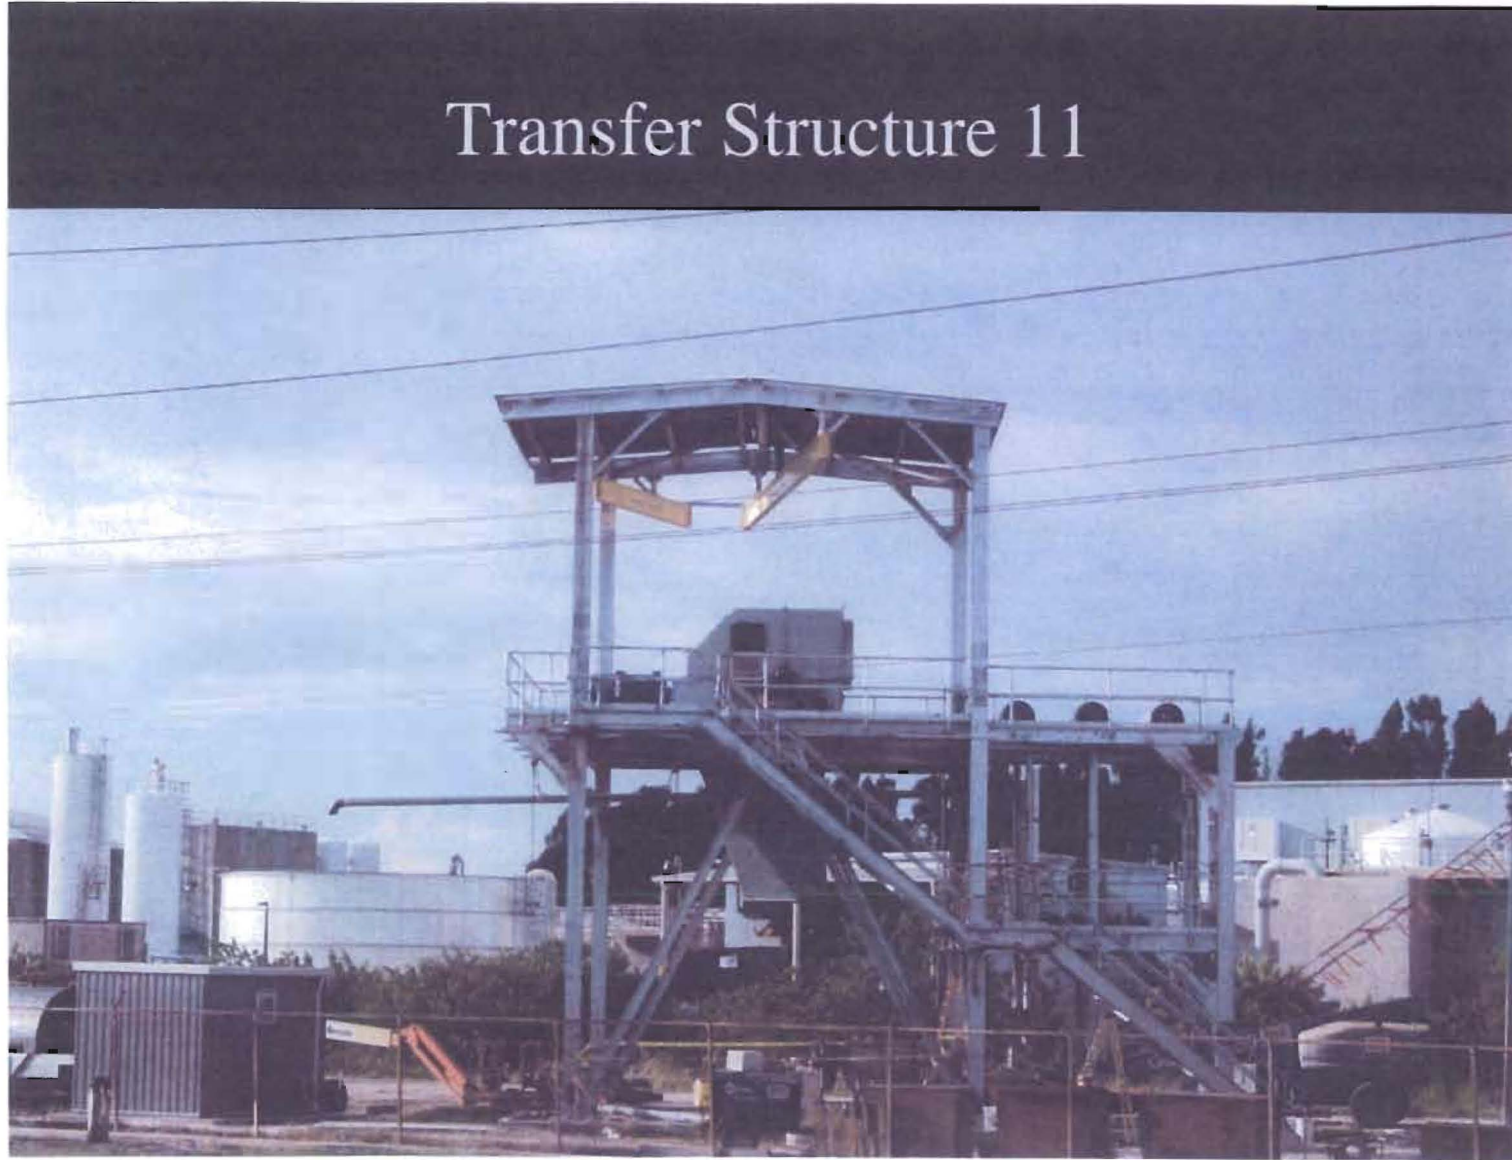
On left side of Transfer Structure 11, the section of conveyor belt to Transfer Structure 12 has been installed. On right side of Transfer Structure 11, the section of conveyor belt to Transfer Structure 10 is being assembled on the ground and will be lifted into place upon completion.

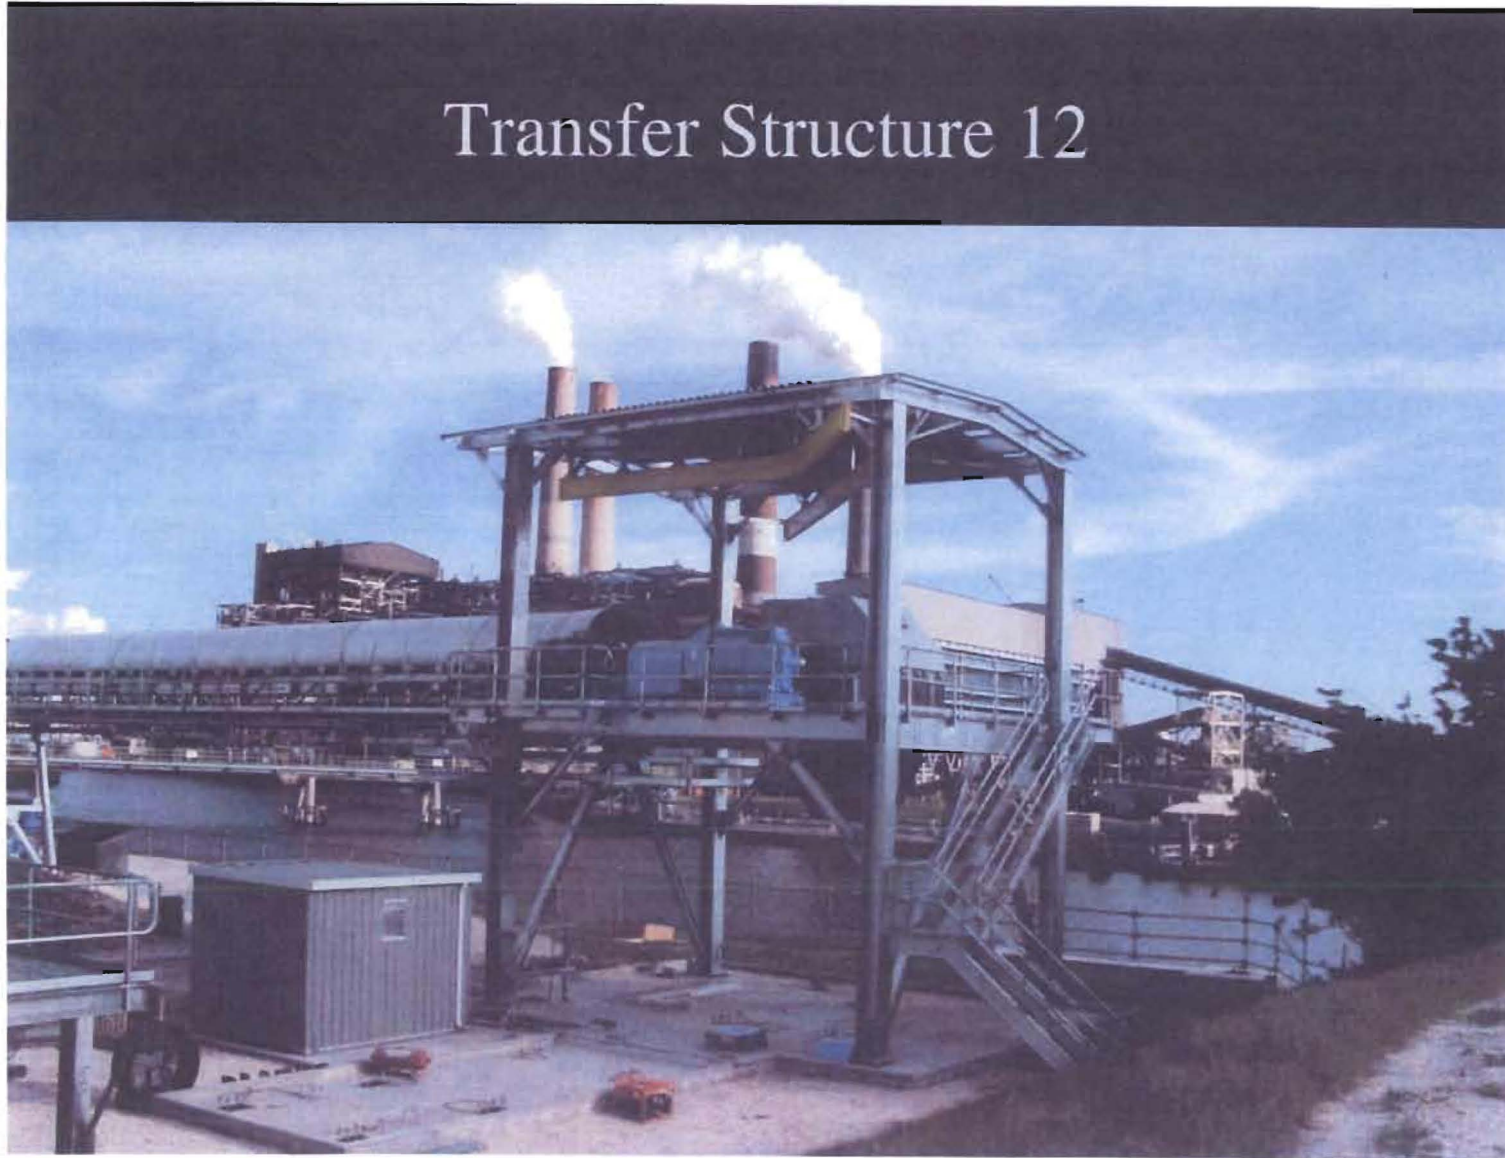
Section of conveyor belt from Transfer Structure 12 to Transfer Structure 13 will span the canal. It is being assembled on the ground and, upon completion, will be raised into place from a barge. The span concrete supports(at base of railing near water) have been poured.

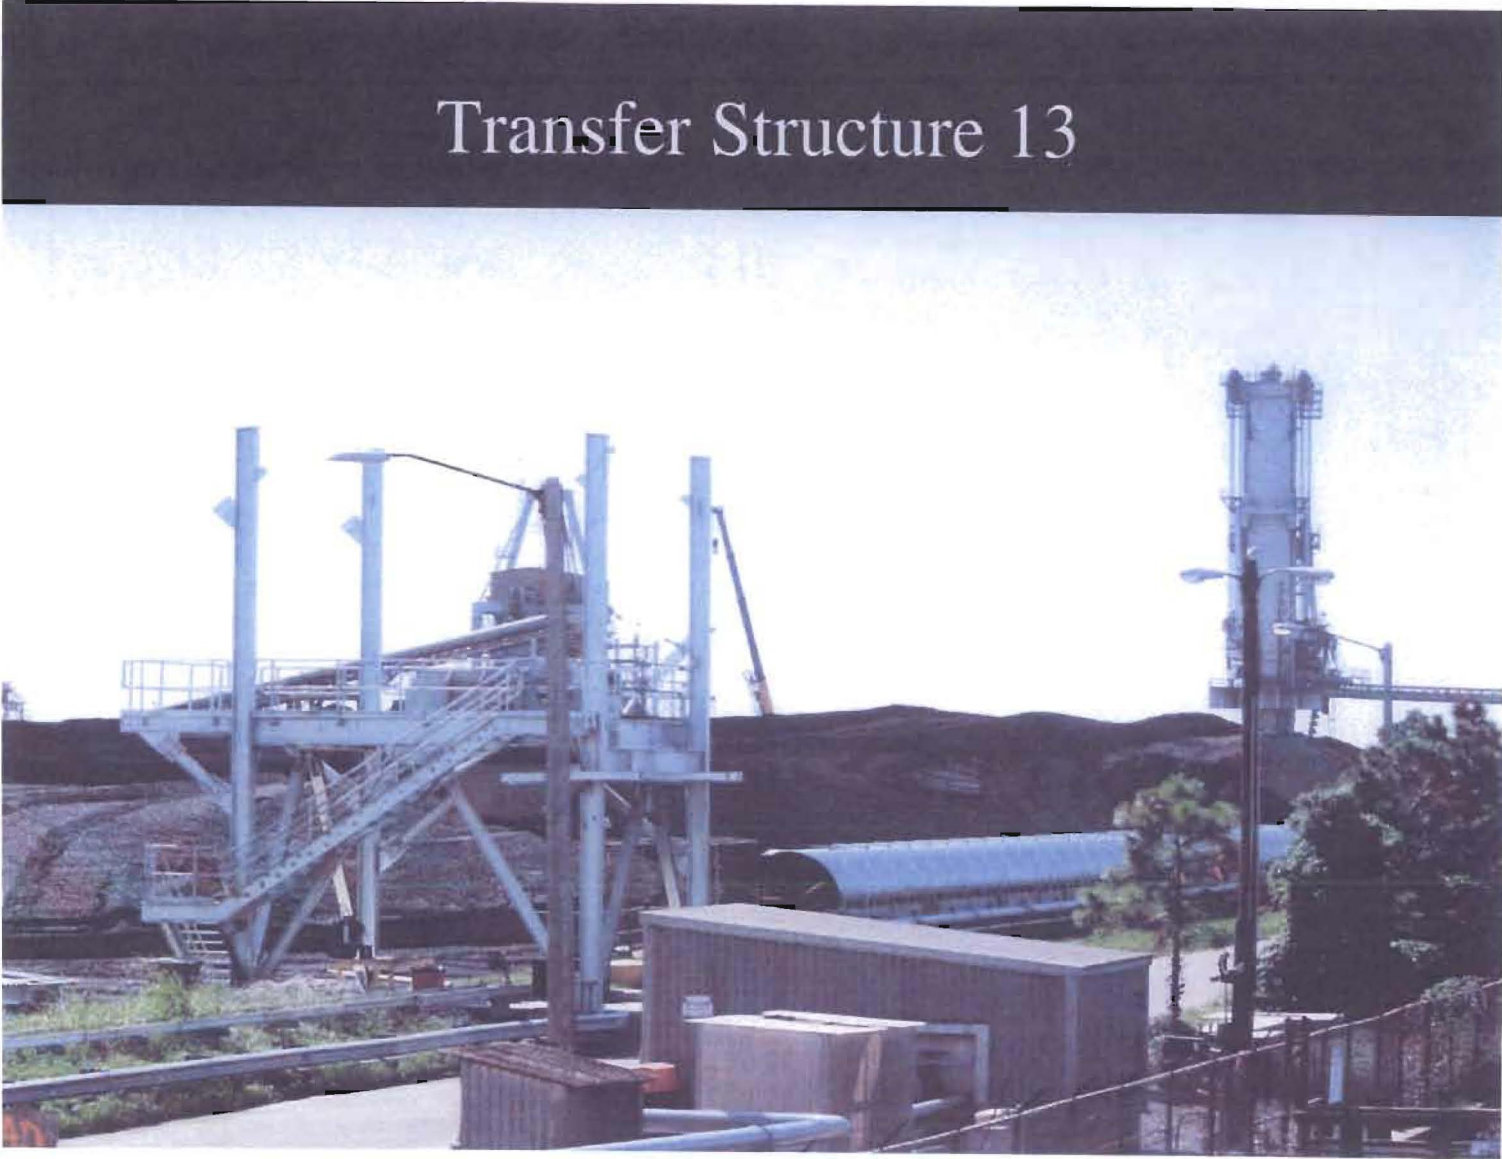
Progress has been made on Transfer Structure 13. Most notably, the roof and over head crane trolley have been installed. The concrete supports(for section of belt spanning canal from Transfer Structure 12) have also been poured.

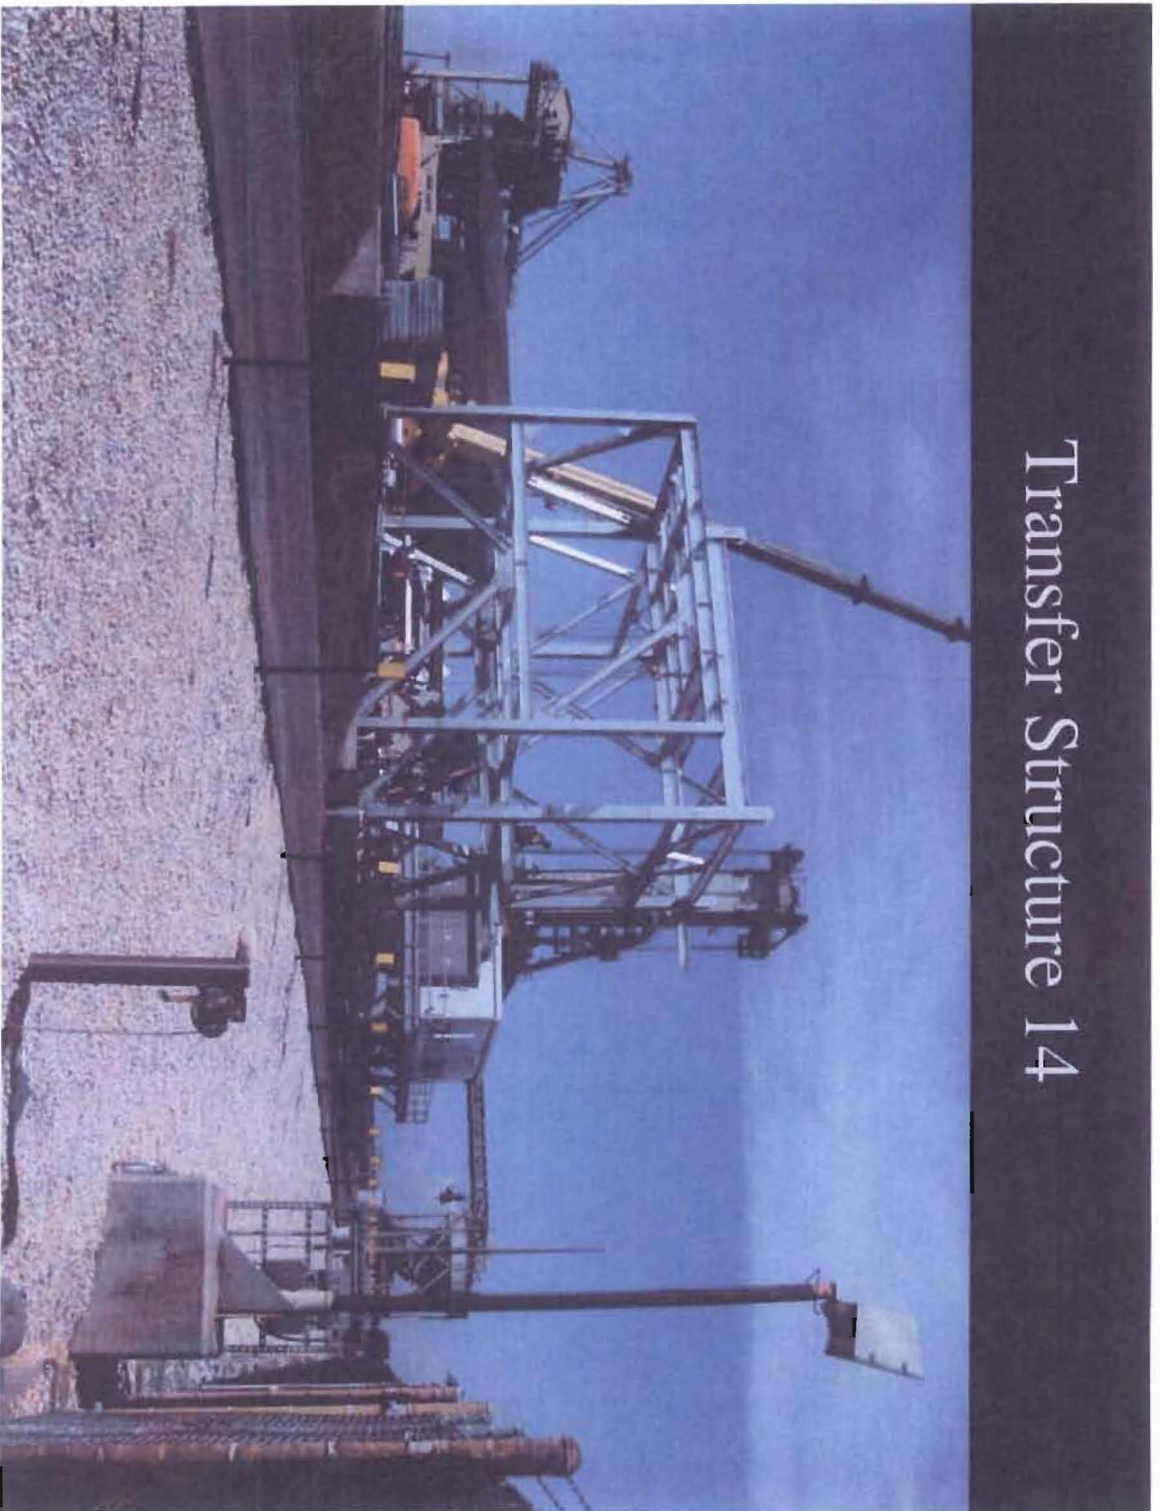
## Transfer Structure 14

Paralleling the roadway, the conveyor belt form Transfer Structure 13, has been installed.

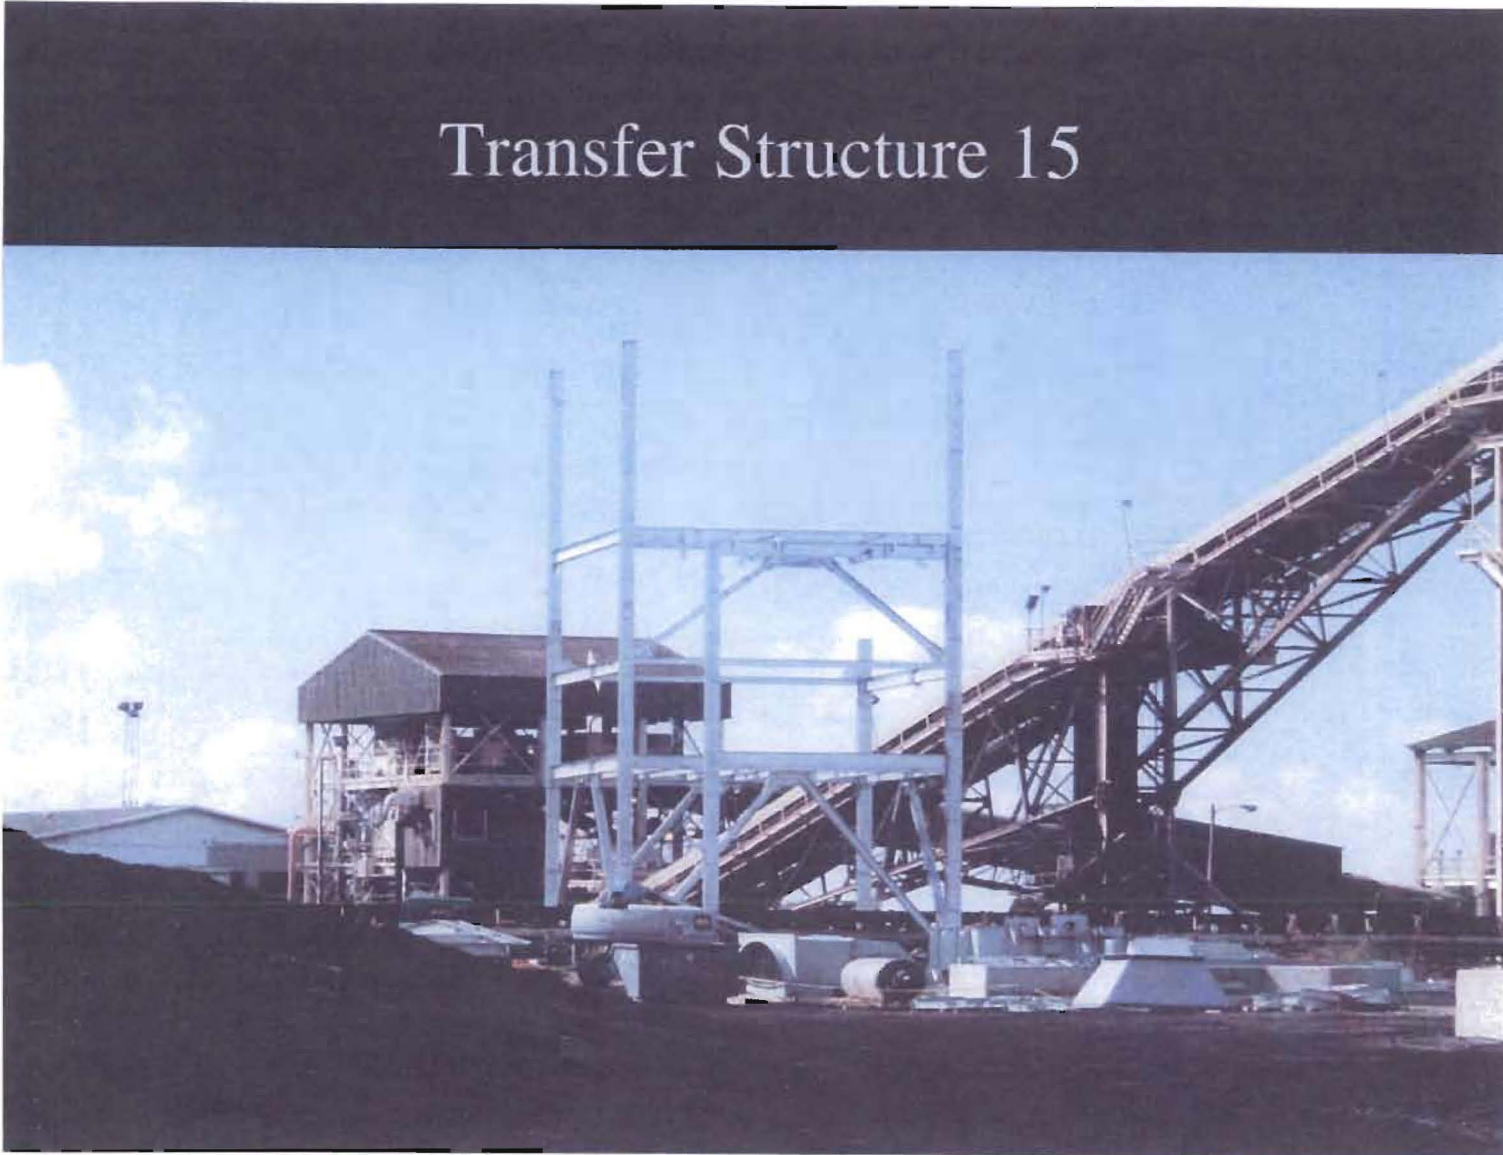
Minor progress has been made on Transfer Structure 15. NOTE: There is now a Transfer Structure 16 which did not exist at the time these photos were taken and it is at about the same level of construction as Transfer Structure 15.
