NOTICE OF COMPLAINT

Re: Docket No. 20180087-EI - Complaint against Florida Power & Light Company regarding safety of transformers supplying power to six residential buildings in South Winds Condominium, by Manuel Blanco.

MANUEL BLANCO'S COMPLAINT
DATED APRIL 3, 2018
TO
THE FLORIDA PUBLIC SERVICE COMMISSION
RE
FLORIDA POWER & LIGHT COMPANY
PURSUANT TO
FLORIDA ADMINISTRATIVE CODE
RULE 25-22.036 AND RULE 28-106.104

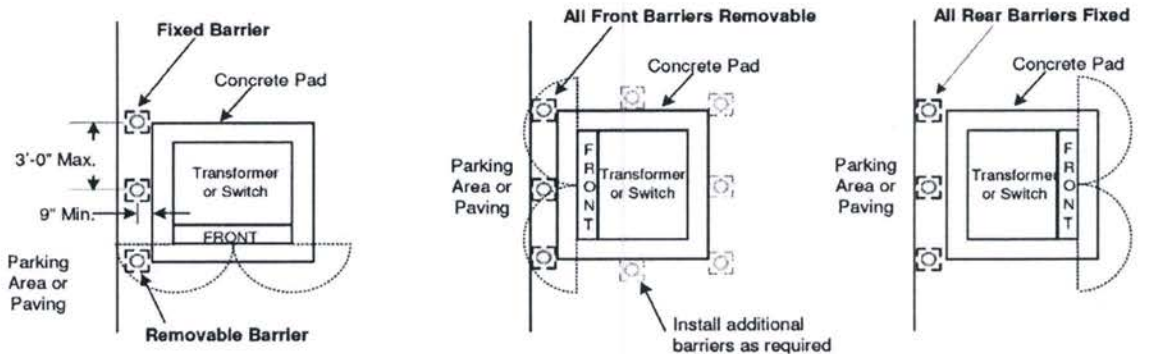
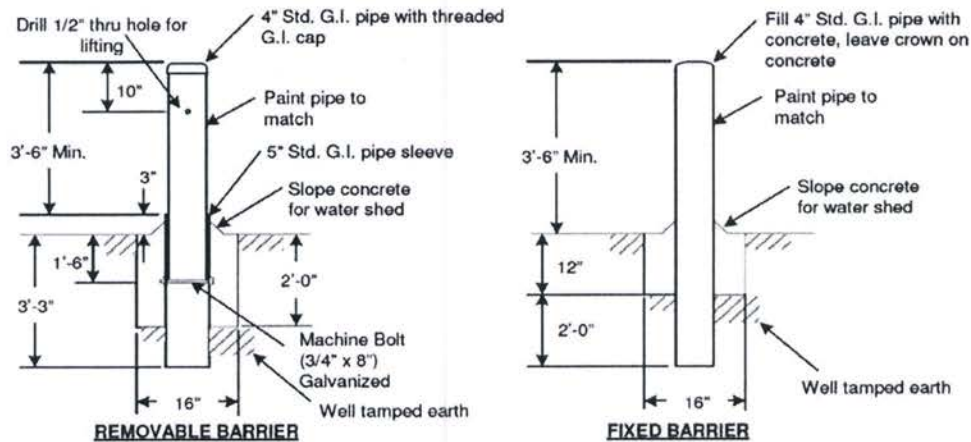
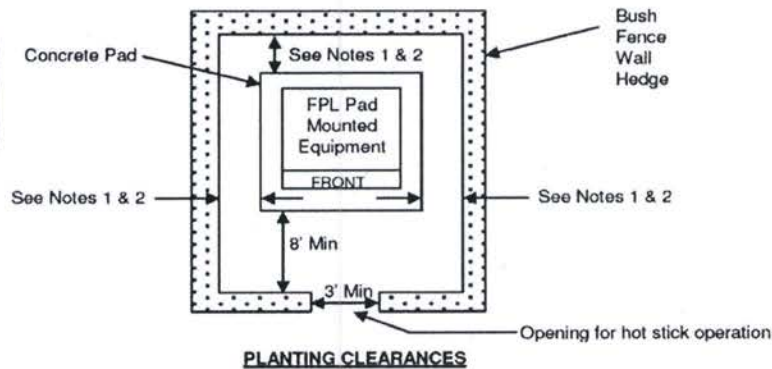
FIGURE V-1
Protective Barrier and Planting Clearances for Padmounted Transformers and Switches

Note 1: Padmounted Transformers and pad may be located minimum 3' on both sides and back side only. An 8' minimum is required on the front side for access and hot stick operation.

Note 2: Padmounted Switches and Cap Banks require 8 feet of clearance on all sides.

5. EXHIBIT A is a copy of FPL Edition March 2017 Electric Service Standards, Section V, Page 3 of 6, titled "V. REQUIREMENTS FOR TRANSFORMERS SITUATED ON CUSTOMER PROPERTY", hereinafter referred to as "FPLESS", which states:

"Padmounted Transformers and pad may be located minimum 3' [3 feet] on both sides and back side only."

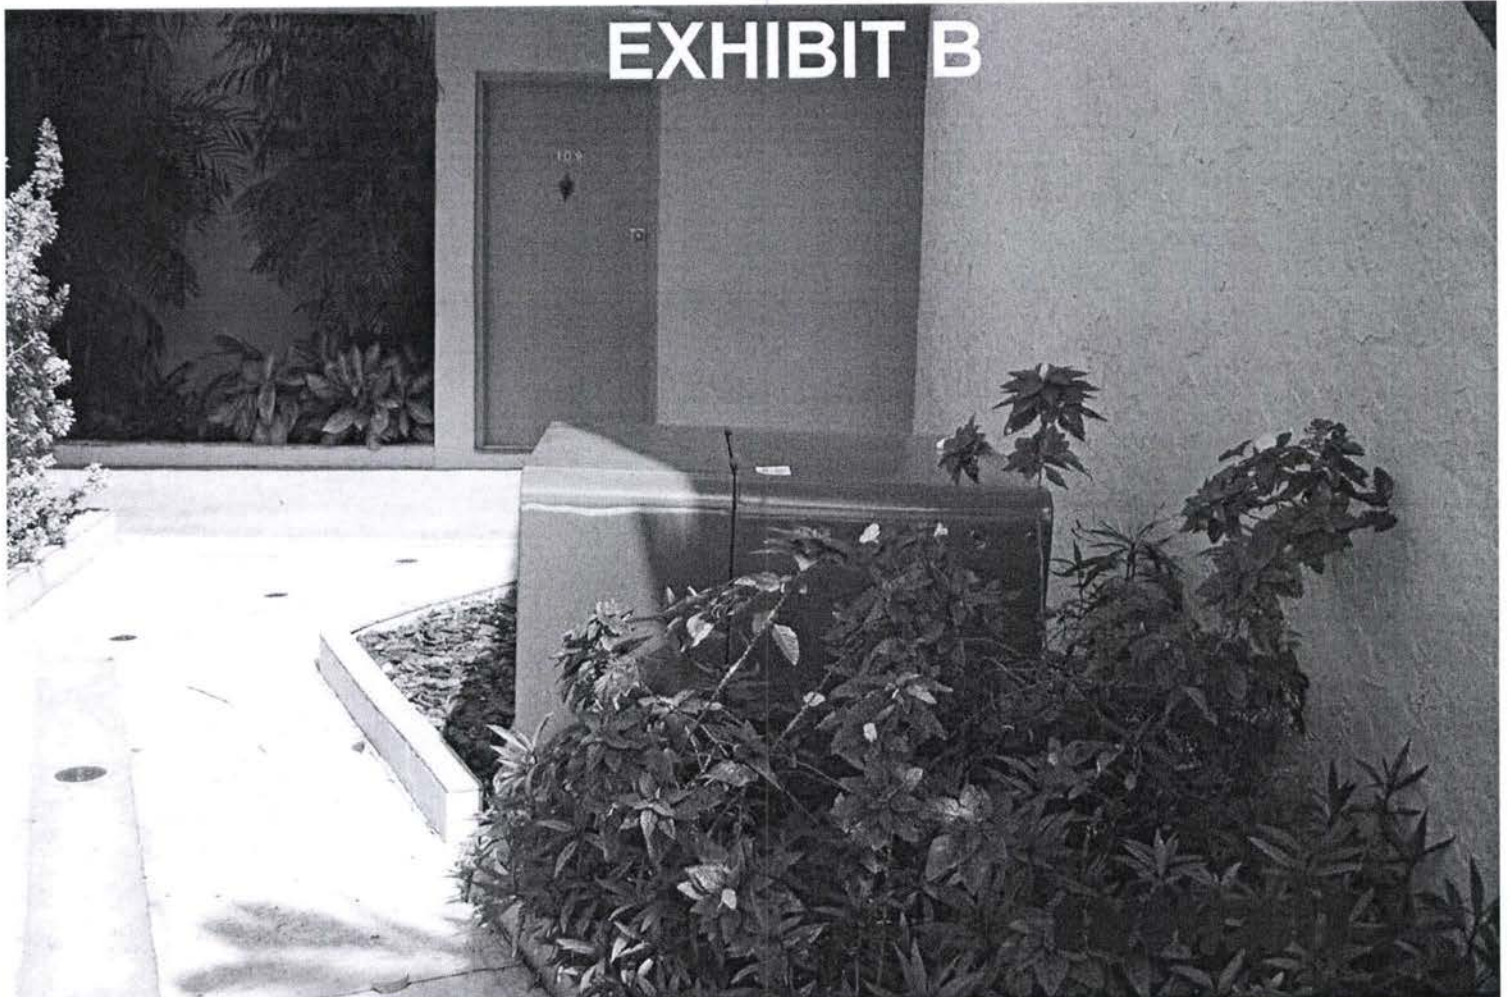
EXHIBIT B is a photo in color taken 4/1/2018 of the liquid-filled transformer installed west of Building 9300 between the walkway and the stairway. The distance between this transformer and the main door of the condo unit is 15.83 feet. The distance between the back of this transformer and the stairway is 1.25 feet. This transformer at ground level was not designed to withstand flooding caused by a hurricane and therefore flooding could cause this transformer to explode or electrify the water near the transformer long enough to electrocute any person touching the water. This transformer requires clearance for cooling its liquid. The installation of this transformer does not meet the minimum clearance on its back required by FPLESS and does not utilize at least one of the methods to minimize fire hazards described in 2012NESC for outdoor installations of liquid-filled transformers.

FPL's liquid-filled transformer installed west of Building 9300 in South Winds Condominium

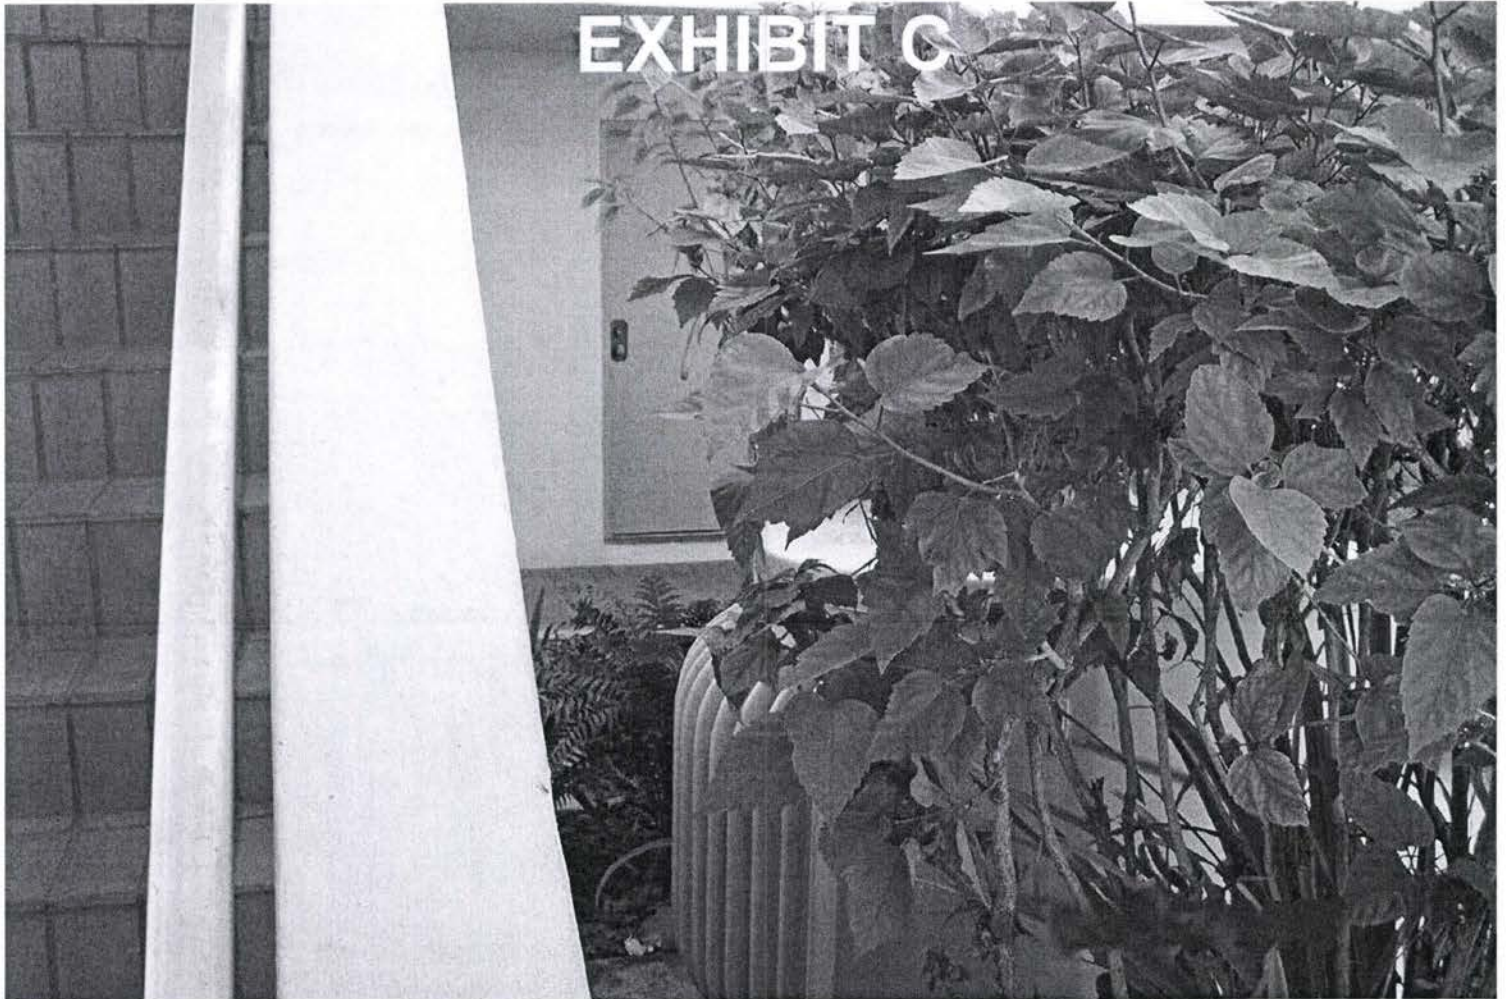
EXHIBIT C is a photo in color taken 4/1/2018 of the liquid-filled transformer installed east of Building 9300 between the walkway and the stairway. The distance between the transformer and the main door of the condo unit is 16.17 feet. The distance between the back of the transformer and the stairway is 1.42 feet. This transformer at ground level was not designed to withstand flooding caused by a hurricane and therefore flooding could cause this transformer to explode or electrify the water near the transformer long enough to electrocute any person touching the water. This transformer requires clearance for cooling its liquid. The installation of this transformer does not meet the minimum clearance on its back required by FPLESS and does not utilize at least one of the methods to minimize fire hazards described in 2012NESC for outdoor installations of liquid-filled transformers.

FPL's liquid-filled transformer installed east of Building 9300 in South Winds Condominium

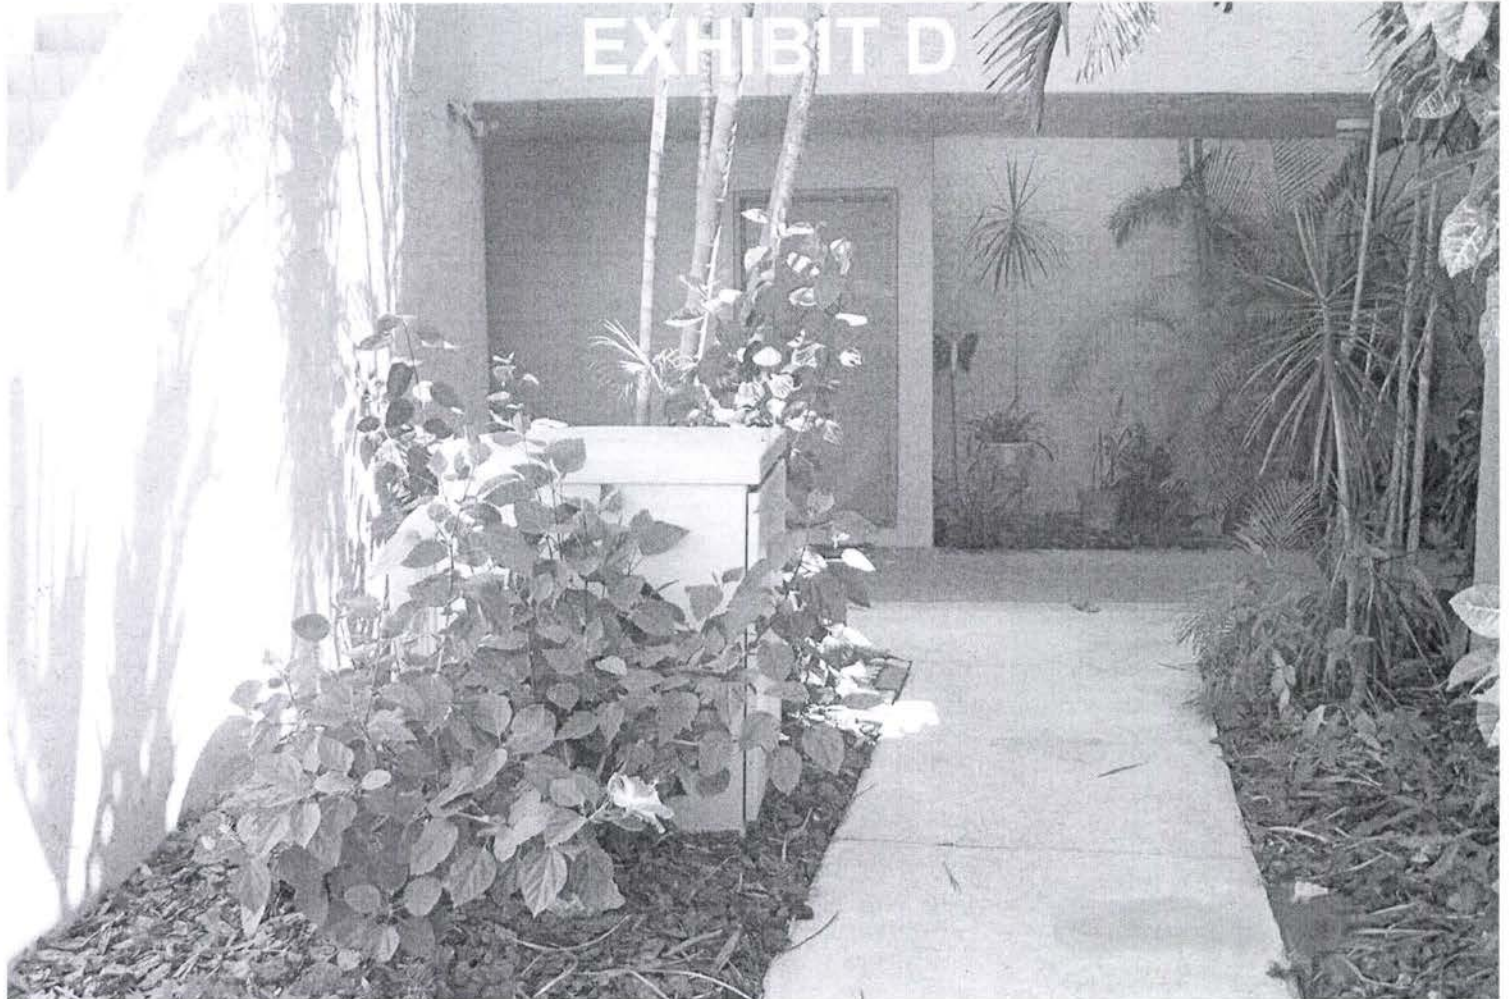
EXHIBIT D is a photo in color taken 4/1/2018 of the liquid-filled transformer installed northeast of Building 9310 between the walkway and the stairway. The distance between the transformer and the main door of the condo unit is 16.50 feet. The distance between the back of the transformer and the stairway is 1.58 feet. This transformer at ground level was not designed to withstand flooding caused by a hurricane and therefore flooding could cause this transformer to explode or electrify the water near the transformer long enough to electrocute any person touching the water. This transformer requires clearance for cooling its liquid. The installation of this transformer does not meet the minimum clearance on its back required by FPLESS and does not utilize at least one of the methods to minimize fire hazards described in 2012NESC for outdoor installations of liquid-filled transformers.

FPL's liquid-filled transformer installed northeast of Building 9310 in South Winds Condominium

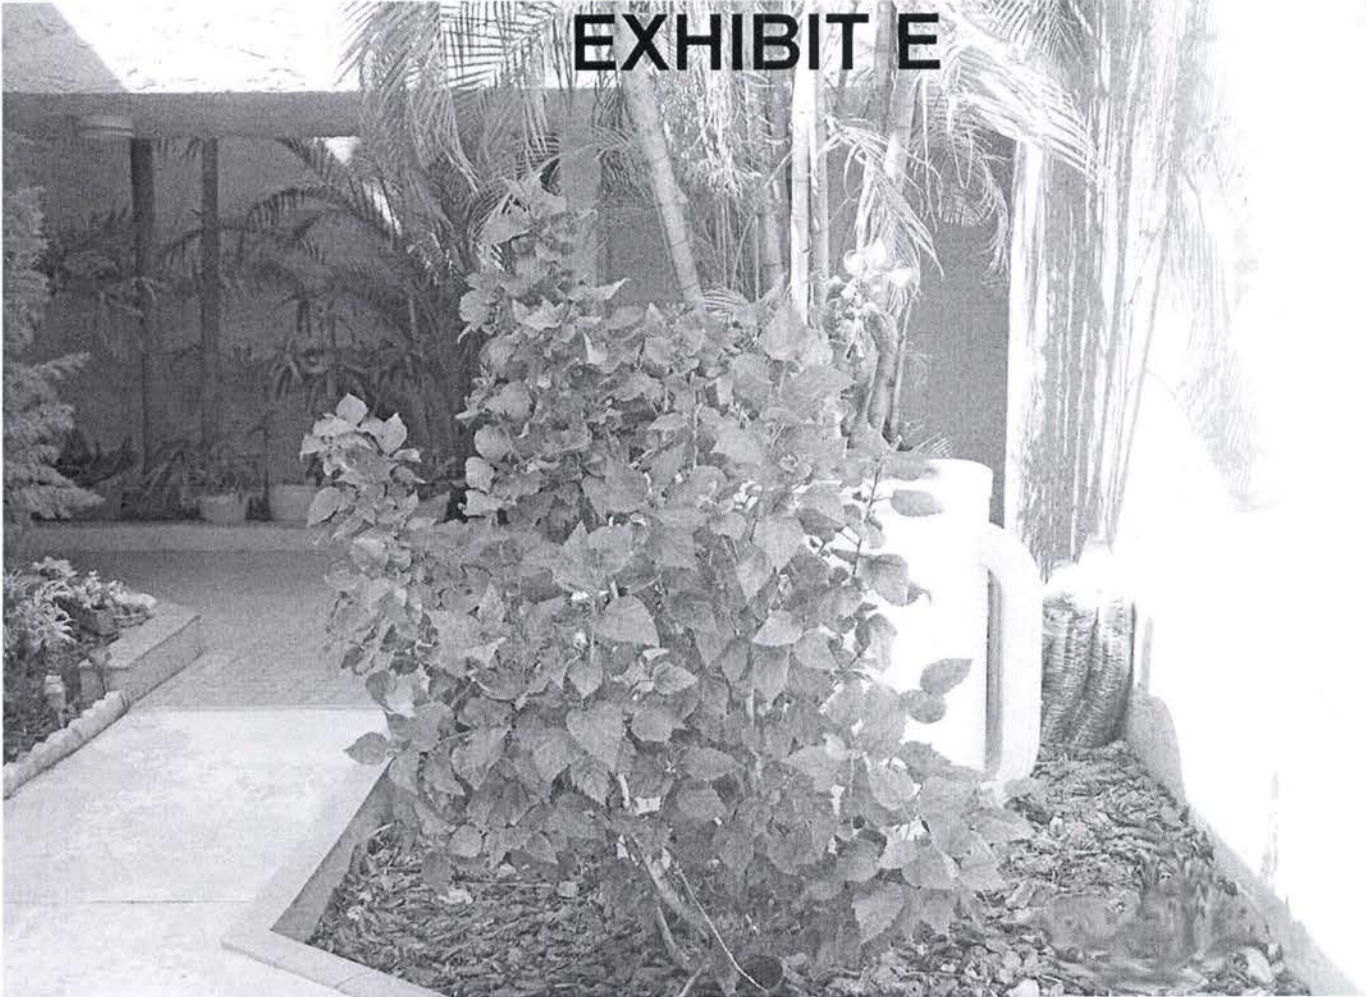
EXHIBIT E is a photo in color taken 4/1/2018 of the liquid-filled transformer installed southeast of Building 9310 between the walkway and the stairway. The distance between the transformer and the main door of the condo unit is 15.67 feet. The distance between the back of the transformer and the stairway is 1.42 feet. This transformer at ground level was not designed to withstand flooding caused by a hurricane and therefore flooding could cause this transformer to explode or electrify the water near the transformer long enough to electrocute any person touching the water. This transformer requires clearance for cooling its liquid.

The installation of this transformer does not meet the minimum clearance on its back required by FPLESS and does not utilize at least one of the methods to minimize fire hazards described in 2012NESC for outdoor installations of liquid-filled transformers.

FPL's liquid-filled transformer installed southeast of Building 9310 in South Winds Condominium

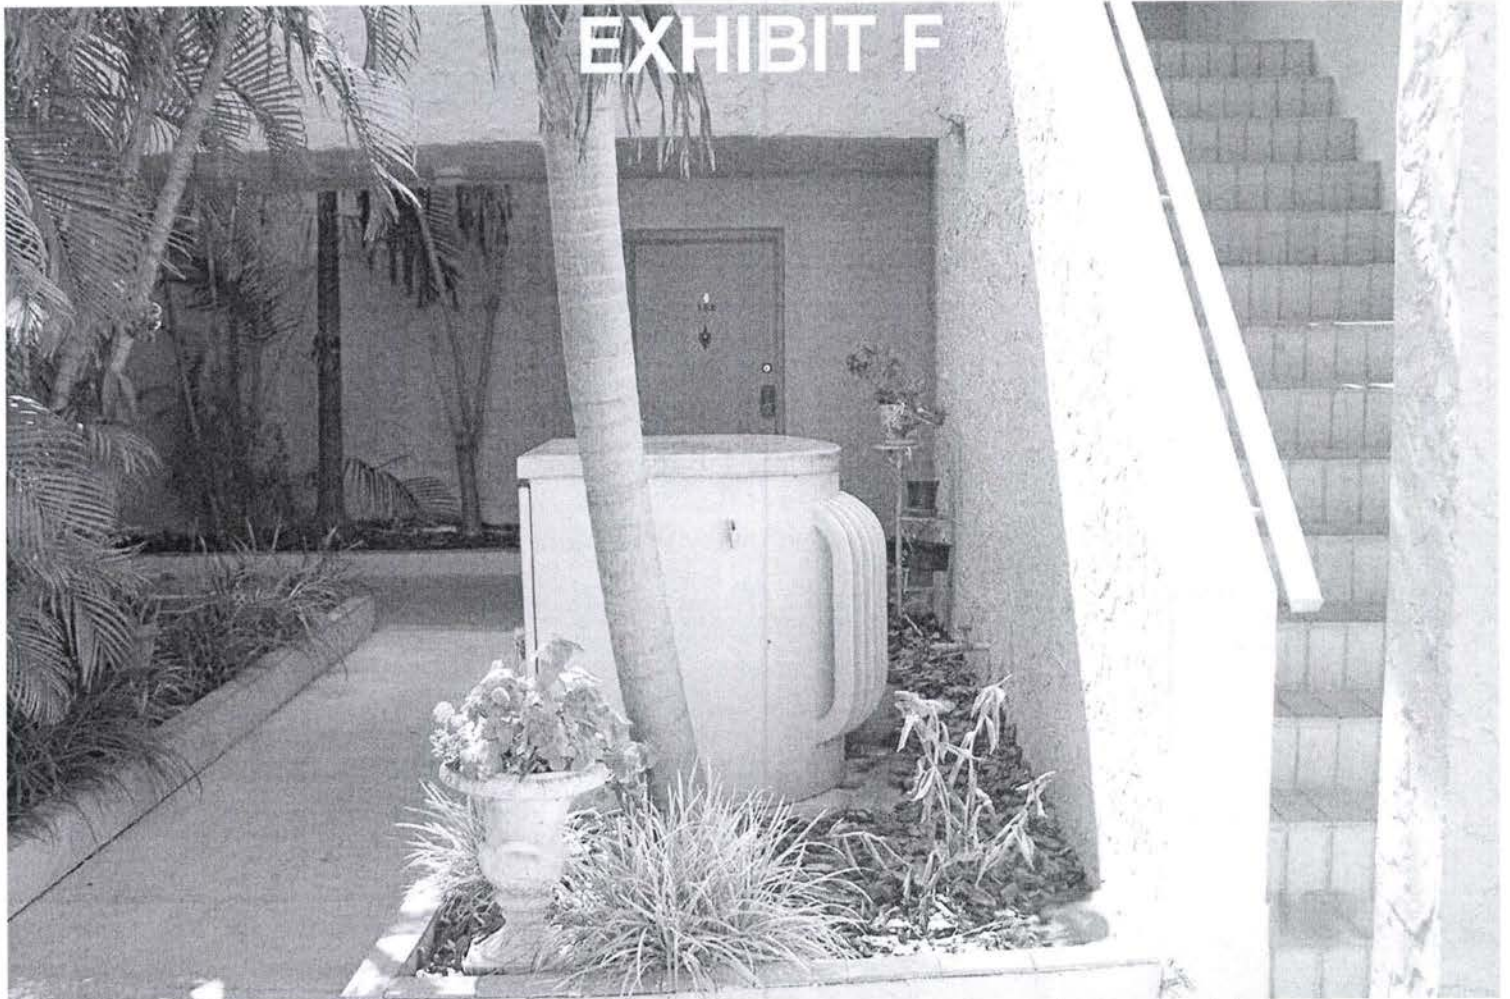
EXHIBIT F is a photo in color taken 4/1/2018 of the liquid-filled transformer installed east of Building 9320 between the walkway and the stairway. The distance between the transformer and the main door of the condo unit is 15.50 feet. The distance between the back of the transformer and the stairway is 1.54 feet. This transformer at ground level was not designed to withstand flooding caused by a hurricane and therefore flooding could cause this transformer to explode or electrify the water near the transformer long enough to electrocute any person touching the water. This transformer requires clearance for cooling its liquid. The installation of this transformer does not meet the minimum clearance on its back required by FPLESS and does not utilize at least one of the methods to minimize fire hazards described in 2012NESC for outdoor installations of liquid-filled transformers.

FPL's liquid-filled transformer installed east of Building 9320 in South Winds Condominium

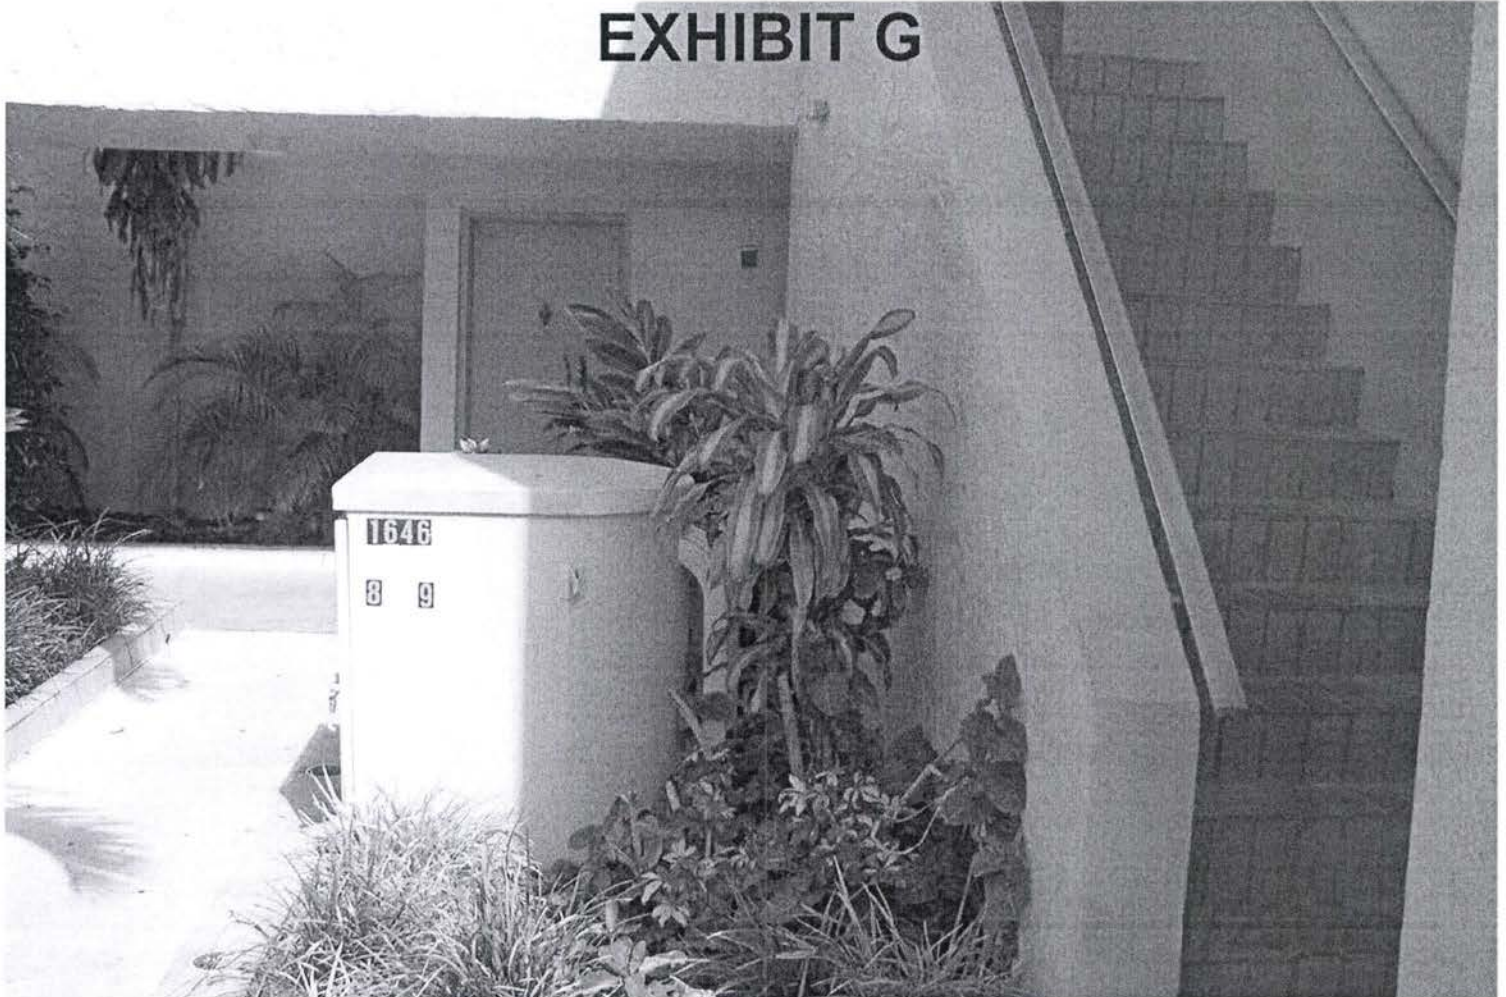
EXHIBIT G is a photo in color taken 4/1/2018 of the liquid-filled transformer installed west of Building 9340 between the walkway and the stairway. The distance between the transformer and the main door of the condo unit is 15.42 feet. The distance between the back of the transformer and the stairway is 1.54 feet. This transformer at ground level was not designed to withstand flooding caused by a hurricane and therefore flooding could cause this transformer to explode or electrify the water near the transformer long enough to electrocute any person touching the water. This transformer requires clearance for cooling its liquid. The installation of this transformer does not meet the minimum clearance on its back required by FPLESS and does not utilize at least one of the methods to minimize fire hazards described in 2012NESC for outdoor installations of liquid-filled transformers.

FPL's liquid-filled transformer installed west of Building 9340 in South Winds Condominium

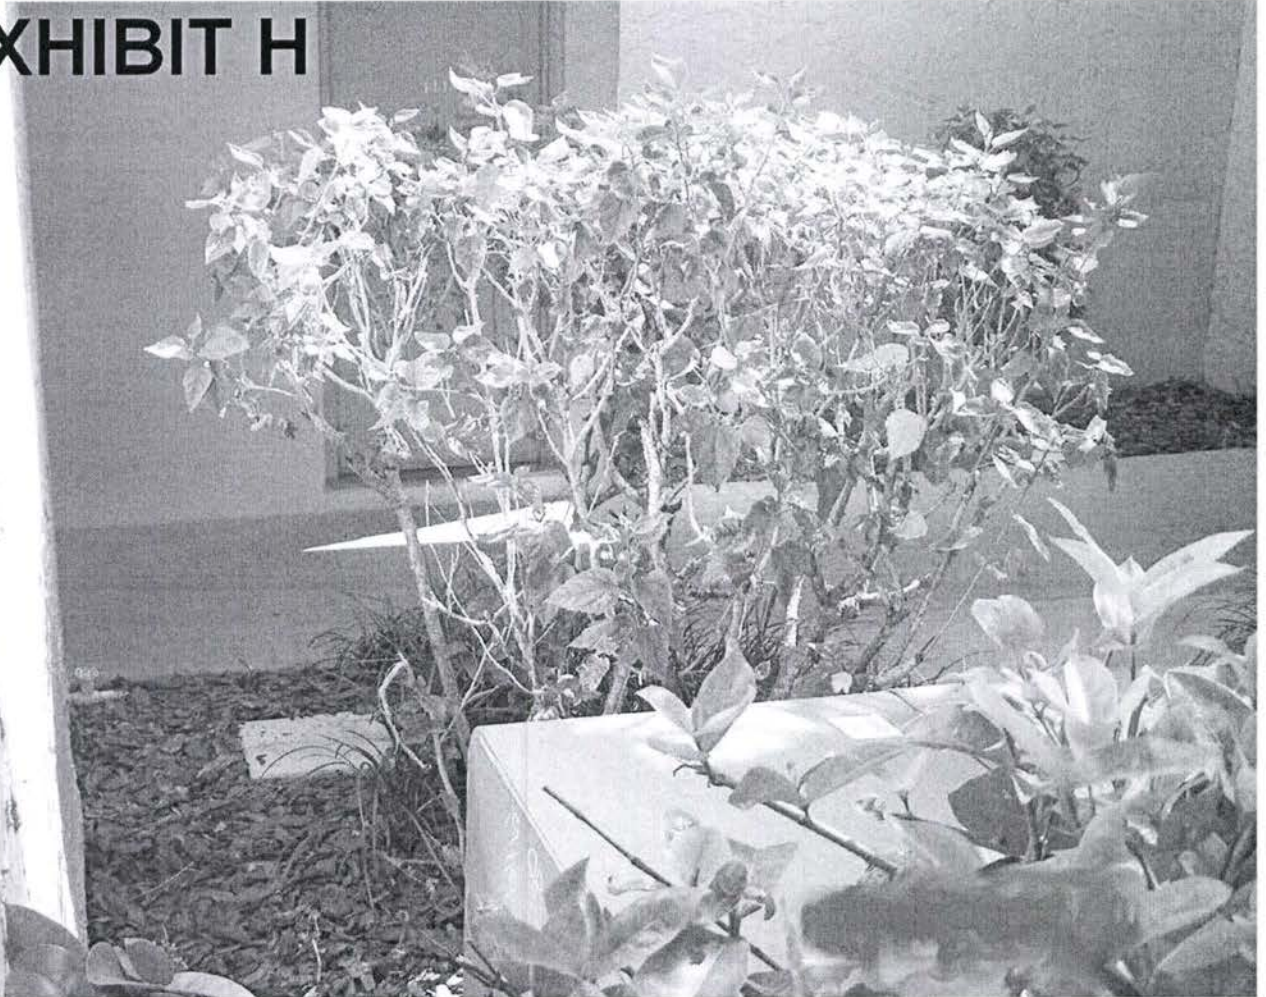
EXHIBIT H is a photo in color taken 4/1/2018 of the liquid-filled transformer installed northeast of Building 9311 between the walkway and the stairway. The distance between the transformer and the main door of the condo unit is 17.58 feet. The distance between the back of the transformer and the stairway is 1.83

feet. This transformer at ground level was not designed to withstand flooding caused by a hurricane and therefore flooding could cause this transformer to explode or electrify the water near the transformer long enough to electrocute any person touching the water. This transformer requires clearance for cooling its liquid. The installation of this transformer does not meet the minimum clearance on its back required by FPLESS and does not utilize at least one of the methods to minimize fire hazards described in 2012NESC for outdoor installations of liquid-filled transformers.

FPL's liquid-filled transformer installed northeast of Building 9311 in South Winds Condominium

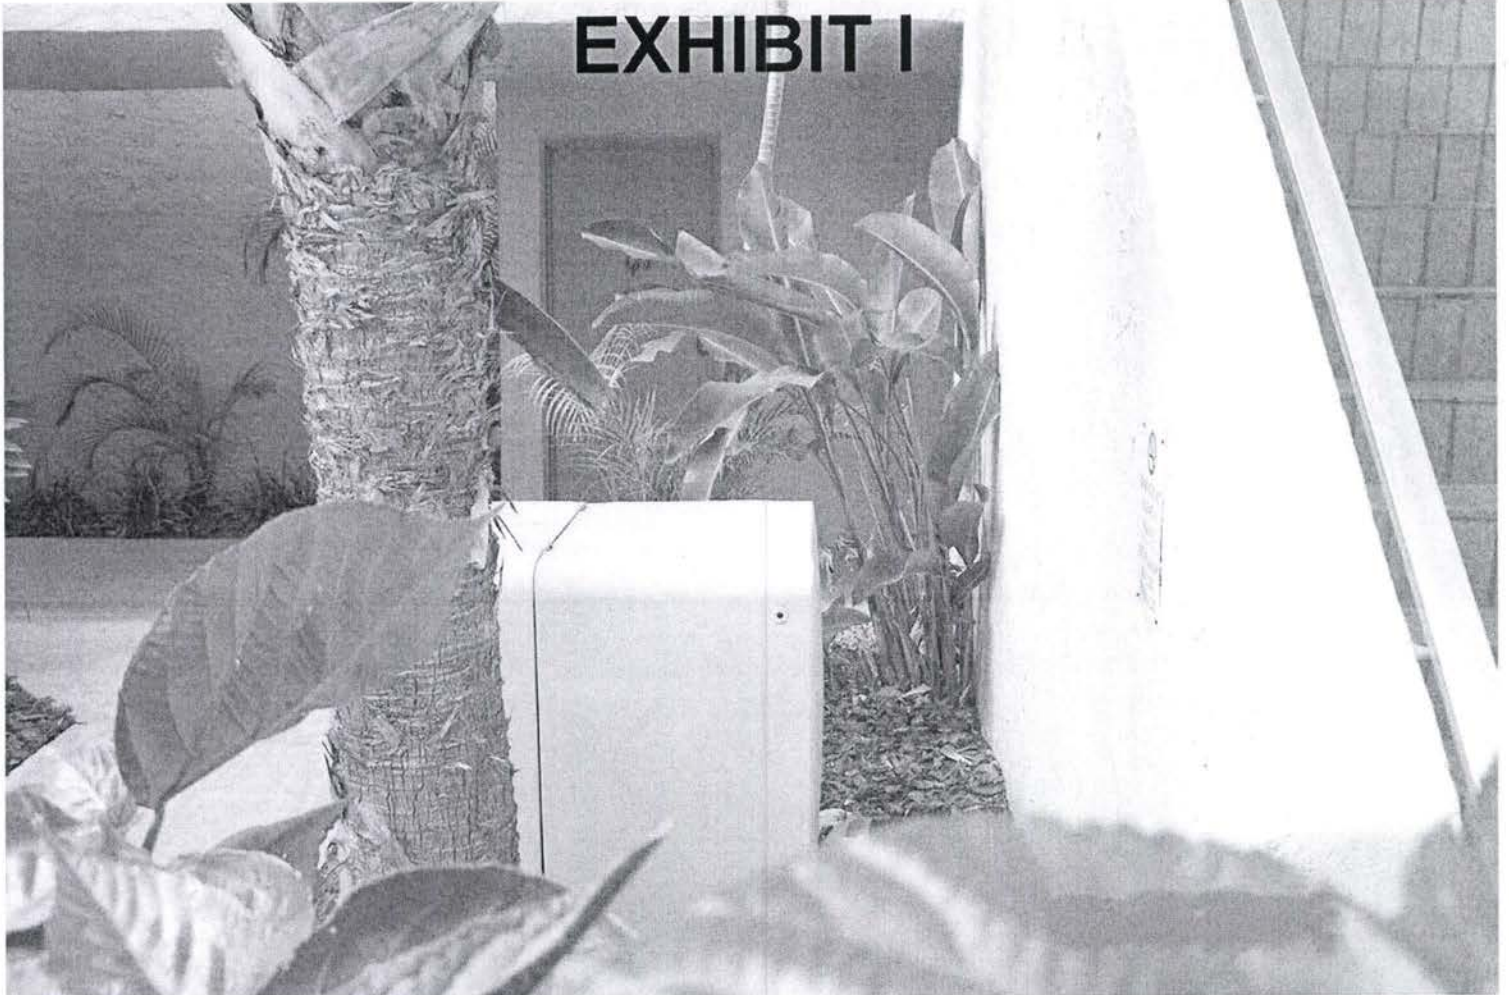
EXHIBIT I is a photo in color taken 4/1/2018 of the liquid-filled transformer installed southeast of Building 9311 between the walkway and the stairway. The distance between the transformer and the main door of the condo unit is 15.21 feet. The distance between the back of the transformer and the stairway is 1.83 feet. This transformer at ground level was not designed to withstand flooding caused by a hurricane and therefore flooding could cause this transformer to explode or electrify the water near the transformer long enough to electrocute any person touching the water. This transformer requires clearance for cooling its liquid. The installation of this transformer does not meet the minimum clearance on its back required by FPLESS and does not utilize at least one of the methods to minimize fire hazards described in 2012NESC for outdoor installations of liquid-filled transformers.

FPL's liquid-filled transformer installed southeast of Building 9311 in South Winds Condominium

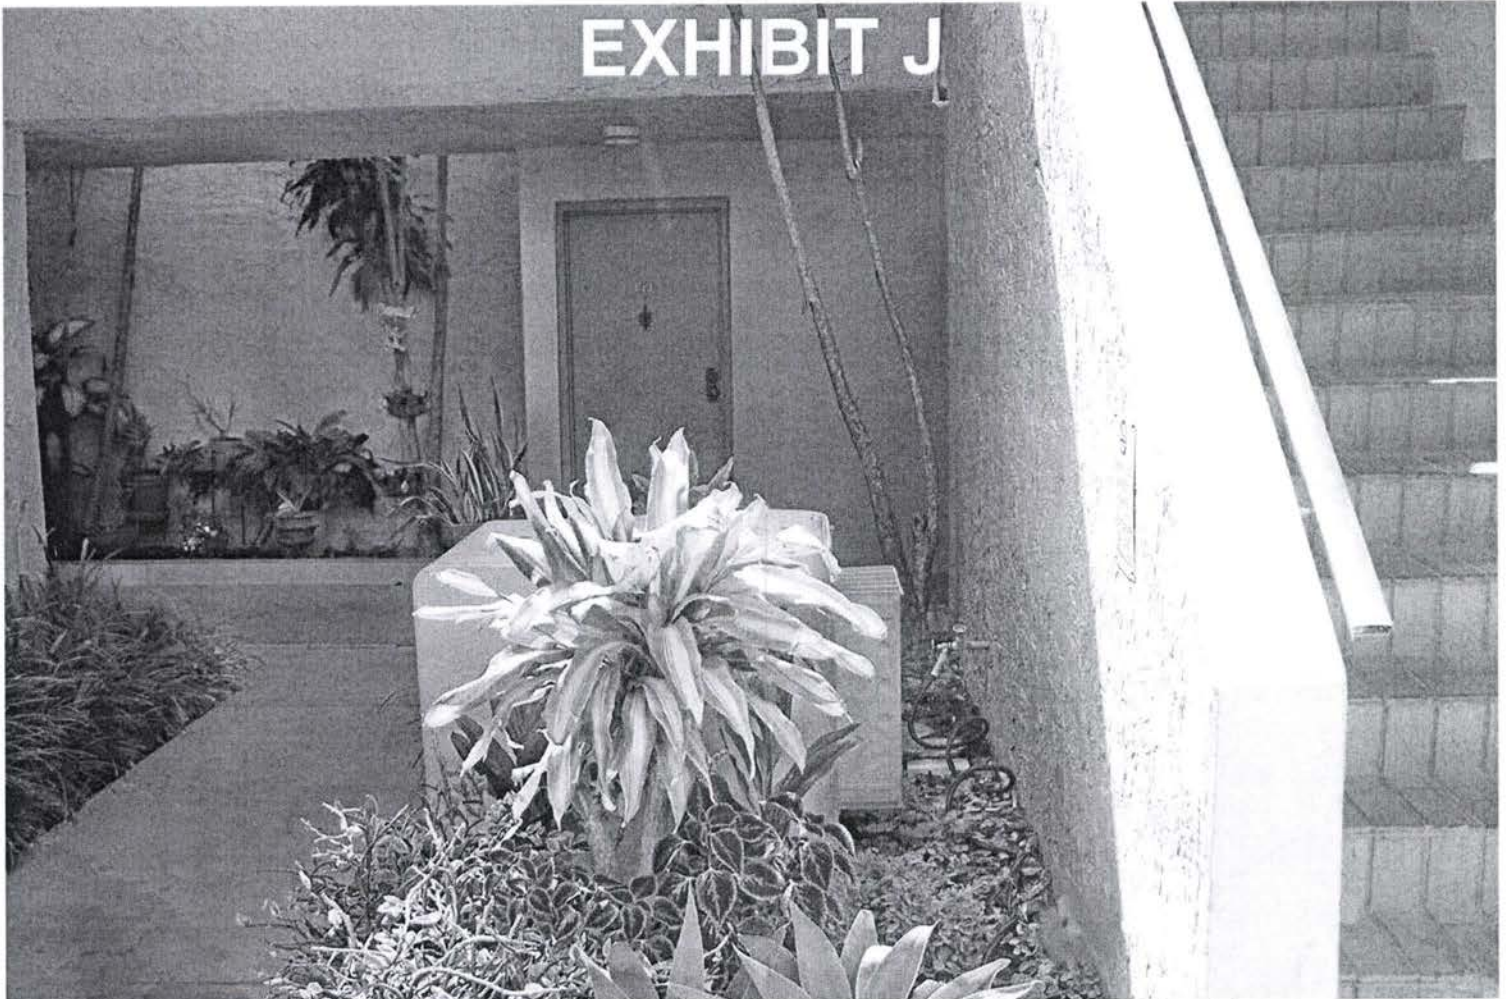
EXHIBIT J is a photo in color taken 4/1/2018 of the liquid-filled transformer installed east of Building 9301 between the walkway and the wall of the stairway. The distance between the transformer and the main door of the condo unit is 15.58 feet. The distance between the back of the transformer and the stairway is 1.25 feet. This transformer at ground level was not designed to withstand flooding caused by a hurricane and therefore flooding could cause this transformer to explode or electrify the water near the transformer long enough to electrocute any person touching the water. This transformer requires clearance for cooling its liquid. The installation of this transformer does not meet the minimum clearance on its back required by FPLESS and does not utilize at least one of the methods to minimize fire hazards described in 2012NESC for outdoor installations of liquid-filled transformers.

FPL's liquid-filled transformer installed east of Building 9301 in South Winds Condominium

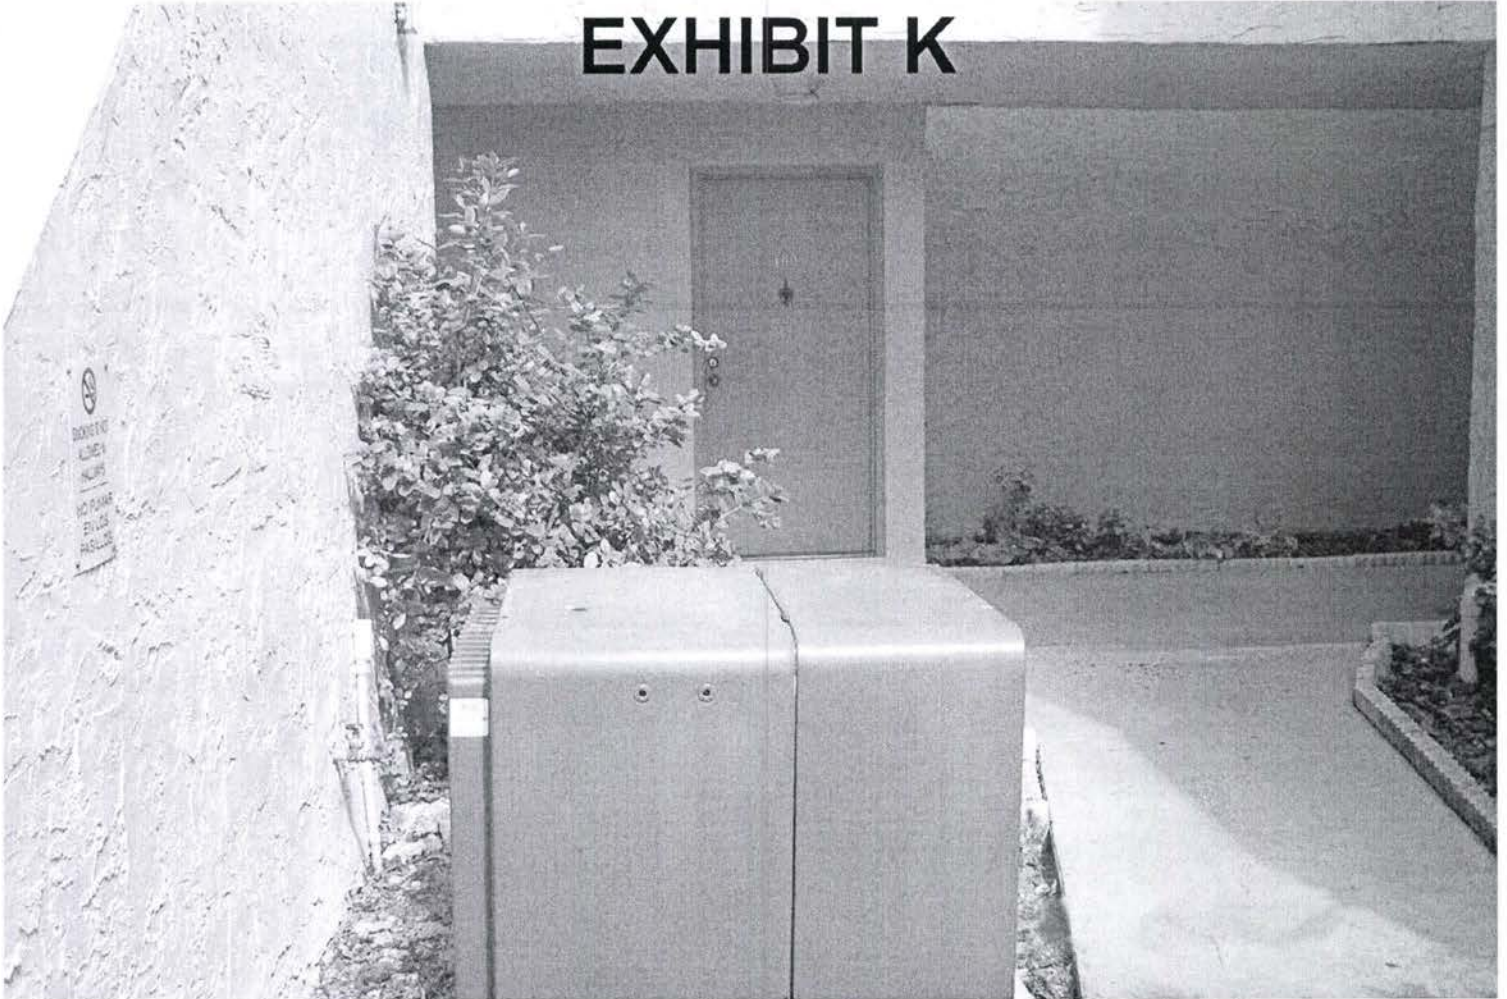
EXHIBIT K is a photo in color taken 4/1/2018 of the liquid-filled transformer installed west of Building 9301 between the walkway and the stairway. The distance between the transformer and the main door of the condo unit is 15.33 feet. The distance between the back of the transformer and the stairway is 1.33 feet. This transformer at ground level was not designed to withstand flooding caused by a hurricane and therefore flooding could cause this transformer to explode or electrify the water near the transformer long enough to electrocute any person touching the water. This transformer requires clearance for cooling its liquid. The installation of this transformer does not meet the minimum clearance on its back required by FPLESS and does not utilize at least one of the methods to minimize fire hazards described in 2012NEC for outdoor installations of liquid-filled transformers.

FPL's liquid-filled transformer installed west of Building 9301 in South Winds Condominium

Manuel Blanco respectfully requests this relief: (1) that this commission orders FPL to have every transformer in South Winds Condominium meet the minimum three feet clearance on the back of each transformer as required by its Electrical Service Standards; (2) that this commission orders FPL to have every liquid-filled transformer in South Winds Condominium meet the requirements of the 2012 edition of the National Electrical Safety Code for outdoor installations of liquid-filled transformers; (3) that this commission orders FPL to provide clear and convincing evidence to this commission that its transformers in South Winds Condominium can withstand being immersed in water during a hurricane without exploding or electrifying the water near the transformer long enough to electrocute any person touching the water.
