## Deer Creek RV Golf & Country Club, Inc.

Re: Docket No. 20190071-WS – Application for a Staff-Assisted Rate Case in Polk County by Deer Creek RV Golf & Country Club, Inc.

The purpose of this correspondence is to provide updated information related to Deer Creek's (DCU) efforts to address an uncompensated water loss issue first reported to Commission staff during a conference call on June 12, 2019. At that time, DCU indicated to Commission staff its intent to request proforma recovery of four projects to address the difference between the potable water purchased from Polk County Utilities and the potable water sold to its customers. (See Attachment A)

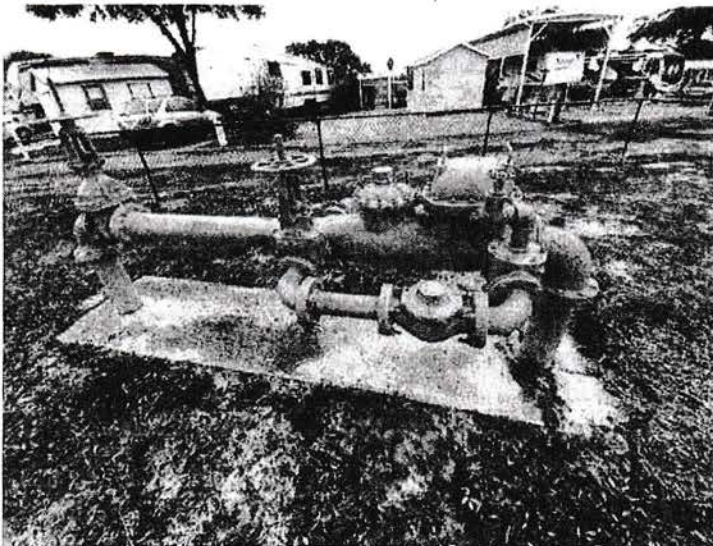
Meter at Fawn Ridge:

The meter pictured below is the meter type installed at Regal Ridge, Mockingbird, and Fawn Ridge

The accuracy of the meters located in Mockingbird and Regal Ridge cannot be determined due to the fact that the meter installations are in pits. Doppler type testing equipment will not work in these confines.

4. In October 2019, DCU solicited vendor bids to test and verify the accuracy of the master meters serving the Fawn Ridge, Mocking Bird, and Regal Ridge communities. All three of the meters are Hersey - Model MFMII compound meters with metered bypass fire flow capability. Two of the meters, Mocking Bird and Regal Ridge, are located below ground in concrete vaults. As a result of the solicitation for bids to test and certify the meters and fire flow assemblies, DCU has subsequently learned that the meters and fire flow assemblies are obsolete, out of production and unserviceable because of a lack of replacement parts. Additionally, it was learned that current conventional Doppler meter testing equipment will not work on the two meters located in the concrete meter vaults due to spacing requirements for the testing equipment. No vendor bids were received when solicited in September 2019. Currently, DCU is in negotiations and exploring other options, with Polk County Utilities and the resident Home Owners Associations (HOA), concerning the replacement of the three master meters and their fire flow assemblies. (See Attachment C)
