FLORIDA PUBLIC SERVICE COMMISSION

FOR THE HEARING DATED 03/26/2024 IN DOCKET 20240001

Docket No. 20240001-EI
Comprehensive Exhibit List for Entry into Hearing Record
(March 26-27, 2024)

TURKEY POINT UNIT 4 ROOT CAUSE EVALUATION RE:
GENERATOR LOCKOUT FROM LOSS OF EXCITER RAP-11

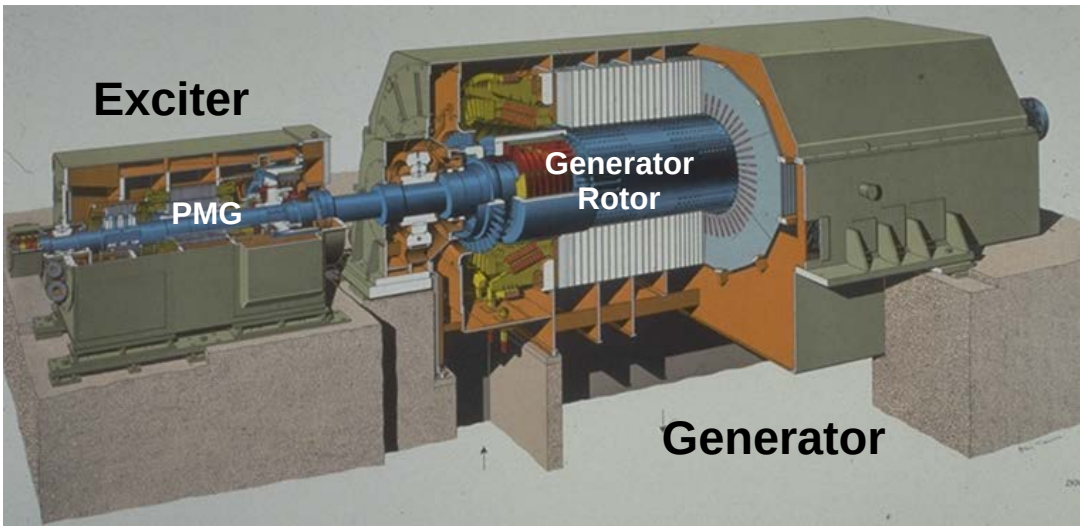
Figure 4 - Generator Exciter Configuration

A. Yes. Exhibit No. ___ (RAP-11) is a copy of the Turkey Point Nuclear Unit 4 Reactor Trip Due to Gen Lockout from Loss of Exciter Root Cause Evaluation (RCE).

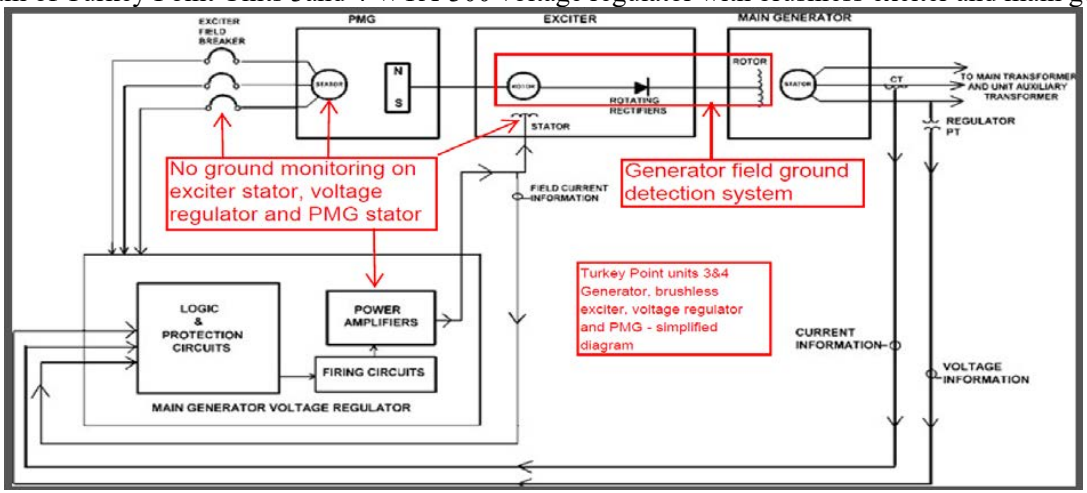
Simplified diagram of Turkey Point Units 3and 4 WTA-300 voltage regulator with brushless exciter and main generator:

- Turkey Point units 3 and 4 have Generator field ground monitoring system and do not have exciter field ground monitoring. Generator field ground system monitors ground on Generator rotor, rectifier diode wheel and exciter rotor (armature). Exciter field ground monitors continuous ground on exciter stator (field), Voltage Regulator, cables and PMG stator.
- Point Beach WTA-300B installed in 2000 have exciter field ground monitoring addition to the generator field ground monitor system. PB voltage regulator drawing no: 97-MK365SAA. 64B is Generator field ground detector and 64F is exciter field ground detector.

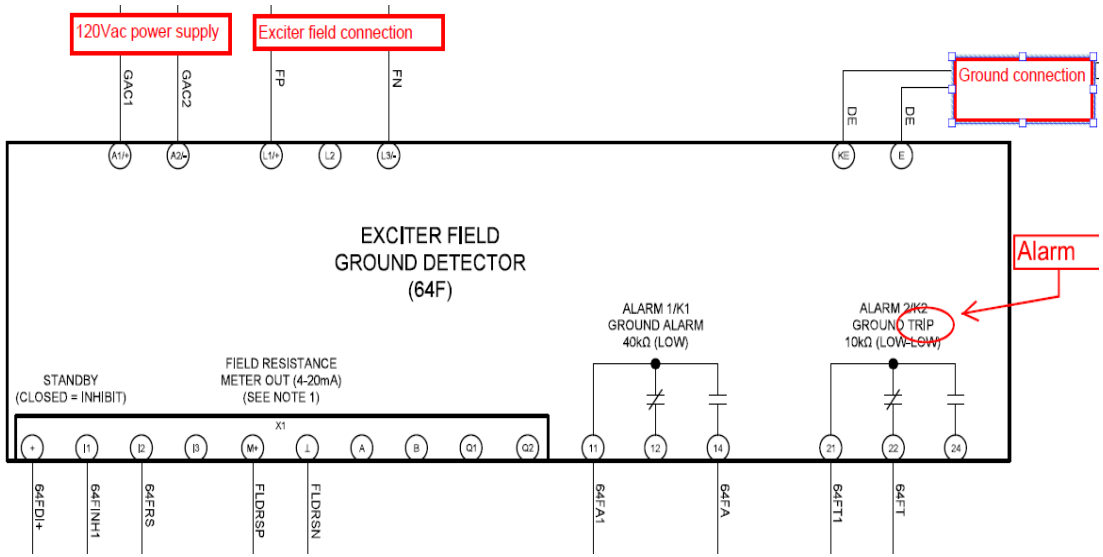
Bender ISO 685-D ground detector module

- Bender module ISO-685D has digital display of ground resistance with two level alarm settings. Bender module also have analog output to use for plant DCS / PI to give ground resistance trend. Bander module ISO-685 is installed in couple of FPL fossil units and going to be installed on all Toshiba steam units.
- Basler (voltage regulator OEM) has BE1-64F ground relay with two adjustable alarm setting. Basler relay do not have digital indication and analog output for ground resistance measurement.
- Power supply for exciter field ground is 120Vac which can be connected to existing generator field ground detector power supply. Alarm contact can be parallel to Generator field ground annunciator. Trip level alarm can be group in to “Voltage Regulator Trouble” for immediate operator action – control shutdown.

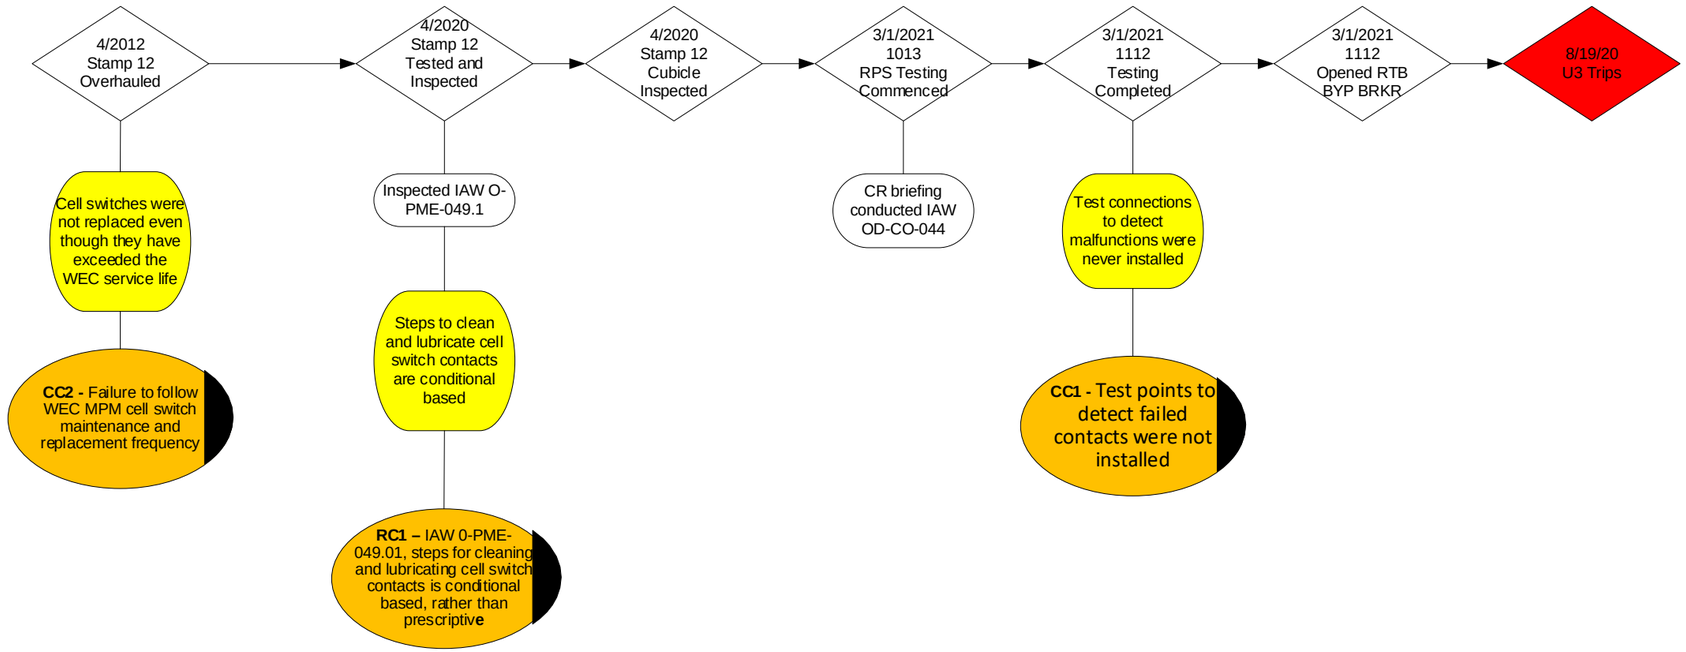
Attachment 7: Event and Causal Factor (E&CF) Analysis

Hazard	Barrier	Assessment (Missing Barrier, Barrier Not Used, Inadequate Barrier, Successful Barrier)	Target	Insights
				would not have resulted in a unit trip, it is indicative of an age related failure. **CC2 - Failure to follow WEC MPM cell switch maintenance and replacement frequency**

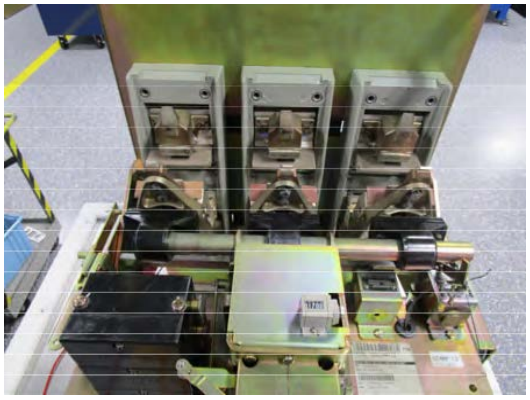
The UVTA reset arm was restrained to allow the breaker to be closed, the breaker was manually closed. These photos show that this NC contact changed state when the breaker was closed. Also verified was that there was no interference from closing the breaker.

Breaker Open, Switch Contact Closed

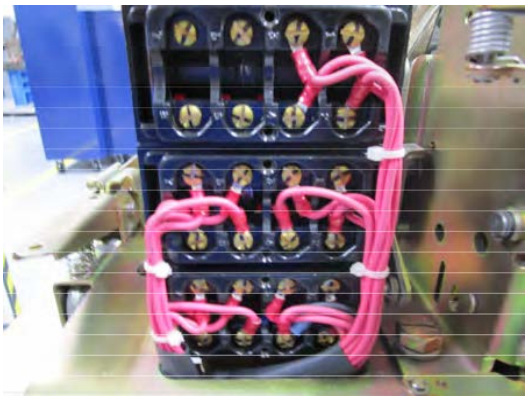
Front of Auxiliary Switches

The front auxiliary switch covers were removed, and the switches were visually inspected. No concerns were found, and the switch contacts appeared to be properly lubricated.

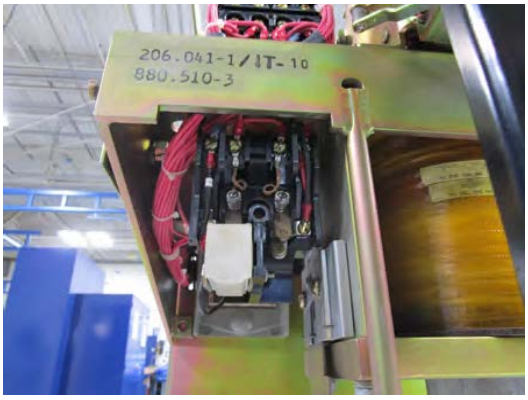
Control Relay with Front Cover Removed

The front cover of the control relay was removed, and the relay was visually inspected, no concerns were found.

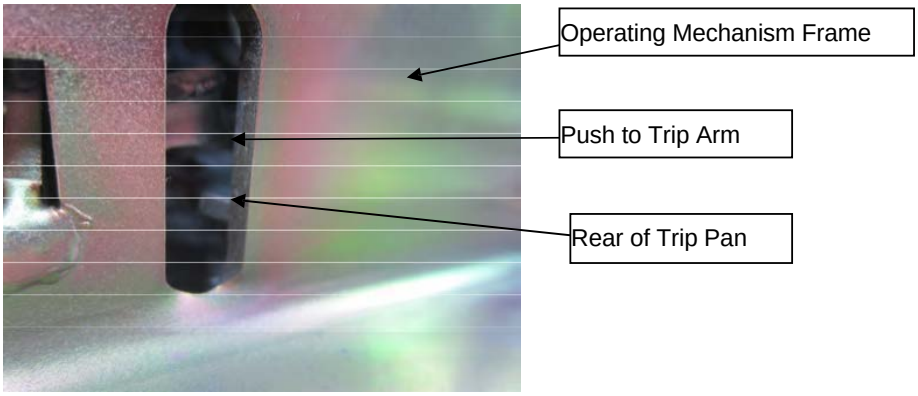
Operating Mechanism Inspection Hole

The breaker trip force measured and found acceptable:	18.1 ounces
The distance to trip was measured and found acceptable:	0.101”
The breaker trip bar to platform height was measured and found acceptable:	L. H. 0.084”
R.H. 0.094”

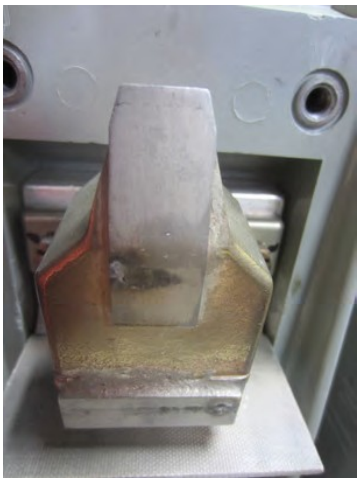
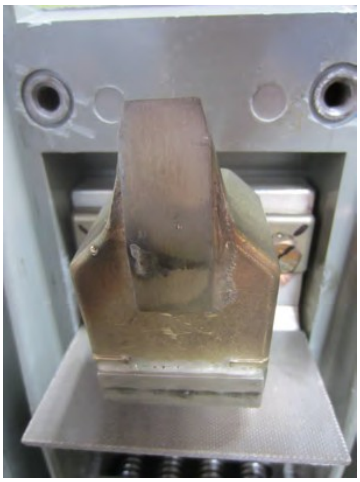
Stationary Arcing Contacts

These values were greater than expected. Photos were taken of these contacts and then the contacts were cleaned with Scotchbrite and isopropyl alcohol. Additional photos were taken to show the cleaned contacts.

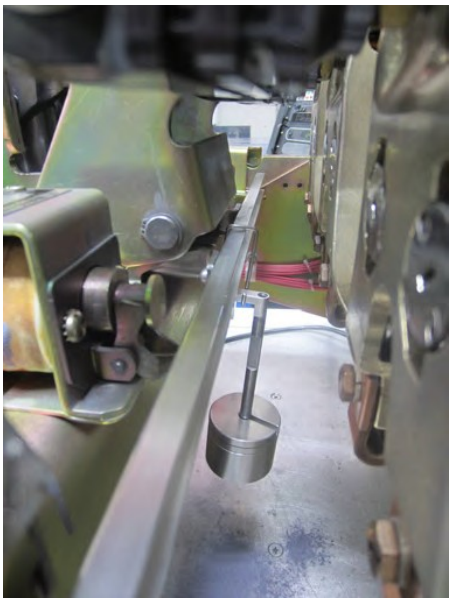
The focus of the investigation moved to the Shunt Trip Attachment.
The moving core of the shunt trip was held in to contact the stationary core, simulating the energization of the shunt trip coil. In this position an attempt was made to manually close the breaker, the breaker was trip free as was expected. The moving core was then released, and it returned to the original position. A visible gap was verified between the shunt trip attachment trip paddle and the operating mechanism trip bar. The moving core was then rotated while moving the core into the stationary core and verified that each time it returned to the original position. This was performed 12 times or at approximately 30 degree intervals. This test verified that the moving core and brass tube that it moves through is free to move without effecting the operation of the STA.

Trip Lever / Bar Gap Measured (0.031" – 0.203"): 0.130"

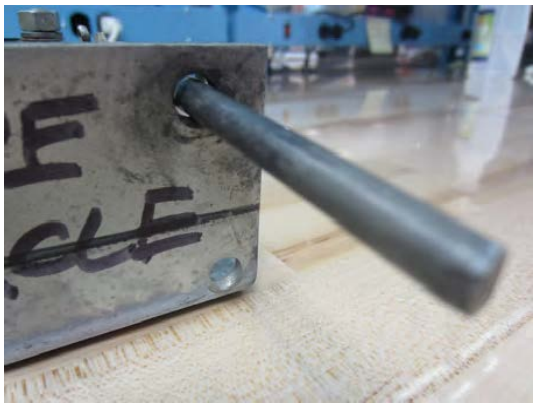
Left-Side Switch

The push rod of the cell switches were lubricated with a foreign lubrication and the return springs were not lubricated with anything. These two locations are to be lubricated with Molybdenum Disulfide in Isopropyl Alcohol (53701GW) lubricant during maintenance intervals.

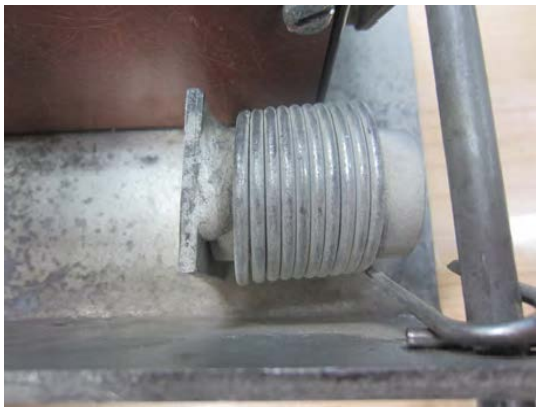
Left-Side Switch

The front switch covers were removed and both switches appeared to have grease that had hardened on the contacts.

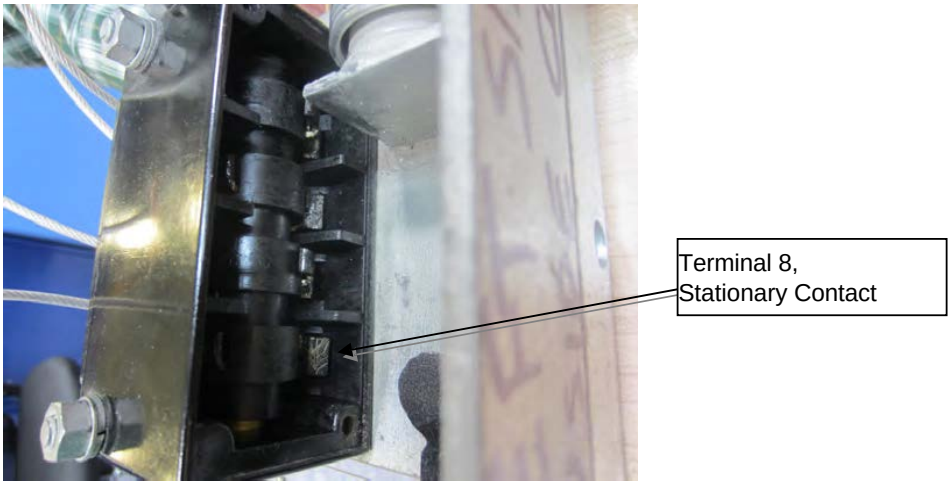
The rear cover of the switch was removed, the contact rotor can be seen moving. The resistance was then measured between the terminal screws and the stationary contacts. It was a closed circuit between terminal 7 and the top stationary contact, it was an open circuit between terminal 8 and the bottom stationary contact. The switch plunger was cycled 50 times while monitoring the switch contacts. Switch contacts 1, 2 and 3 changed state each time the plunger was cycled. Switch contact 4 (terminals 7 & 8) remained open for each of the cycles. The bottom stationary contact associated with terminal 8 appears to be out of place as seen in the photo below.

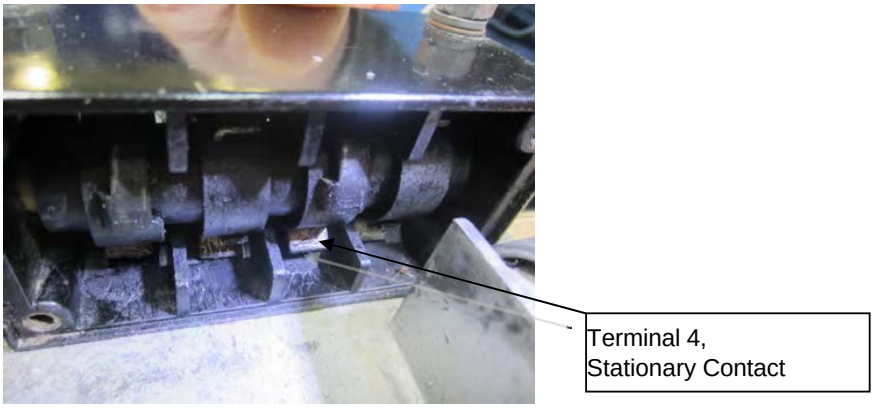
Switch Contact 2, Terminal 4

The rear cover of the switch was removed, the contact rotor can be seen moving. The resistance was then measured between the terminal screws and the stationary contacts. It was a closed circuit between terminal 3 and the top stationary contact, it was an open circuit between terminal 4 and the bottom stationary contact. The switch plunger was cycled 50 times while monitoring the switch contacts. Switch contacts 1, 3 and 4 changed state each time the plunger was cycled. Switch contact 2 (terminals 3 & 4) remained open for each of the cycles. The bottom stationary contact associated with terminal 4 appears to be out of place as seen in the photo below.

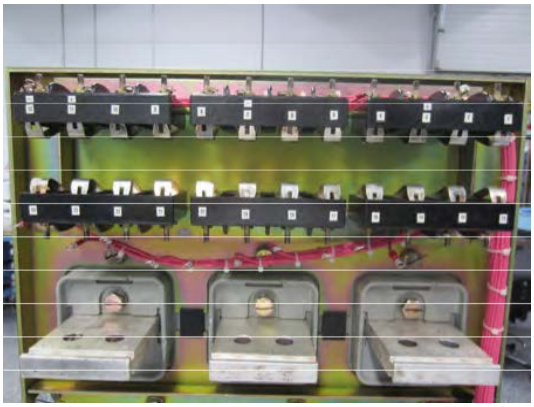
Disassembled Control Relay No issues were found with the control

relay assembly.

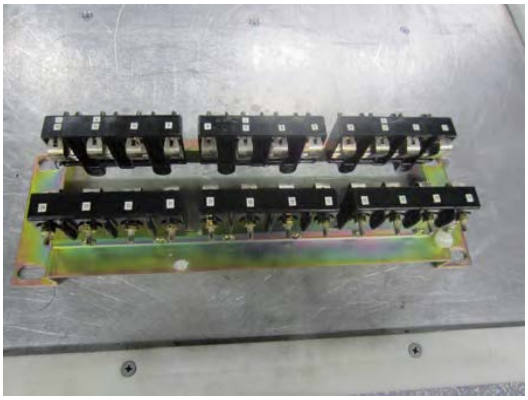
Secondary Contact Assembly Removed

No issues were found with the secondary contact assembly.

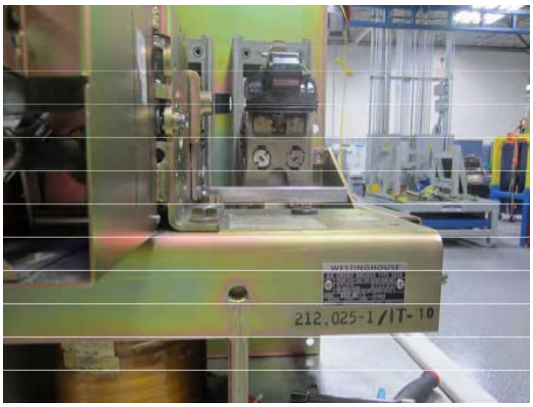
Disassembled STA

The STA was visually inspected and disassembled, no issues were found.

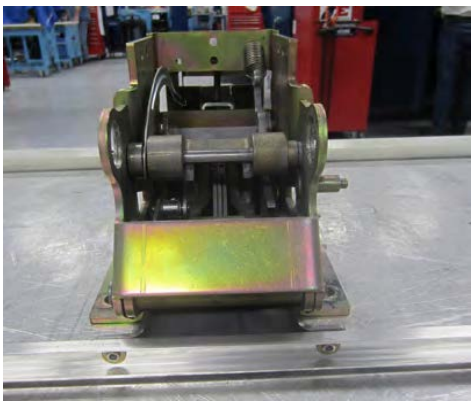
Side of UVTA

The visual inspection of the UVTA did not provide anything to be concerned about.

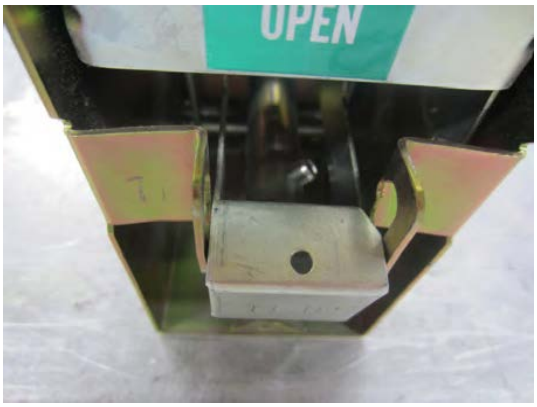
The breaker lock-out tabs on the front of the operating mechanism were found to be slightly bent, however the breaker operated without incident during all mechanical and electrical testing. If these tabs had been bent enough to prevent the Push to Trip button from fully returning to the reset position the linkage within the mechanism could prevent the breaker from closing or could cause a situation that the breaker might close, but not remain closed. These photos show that without the face plate attached to the operating mechanism the Push to Trip button is free to fall below its normal position. This is not a concern as it shows that the tabs are not tight enough to hold the Push to Trip button.

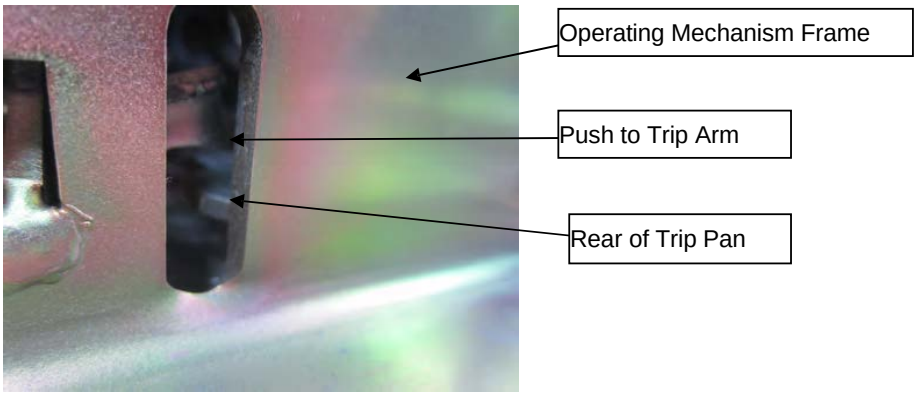
In either of these two positions above the Push to Trip lever would not make contact with the rear of the trip pan.

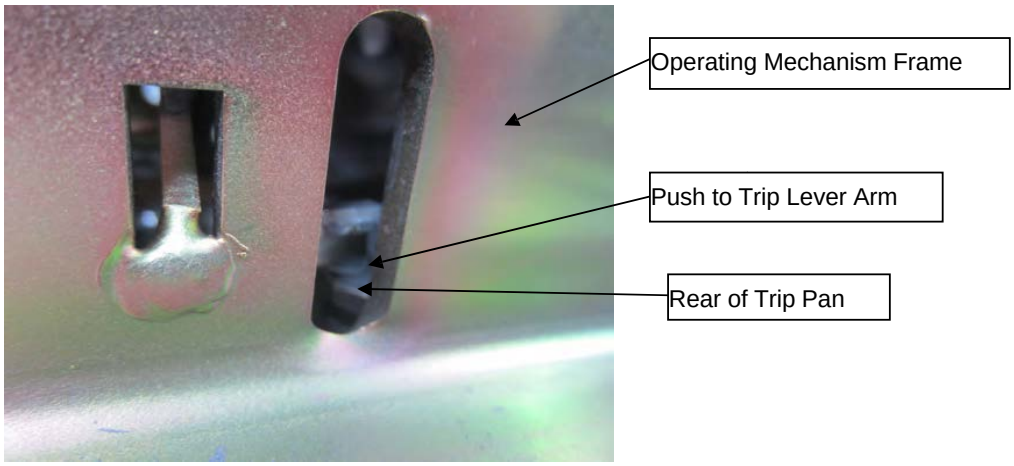
If the Push to Trip button is held in like shown below, or if the breaker lock-out tabs on the front of the operating mechanism are bent sufficiently to hold this button in the Push to Trip lever would make contact with the rear of the trip pan. This scenario could cause the breaker to be trip free and it would not close, or if the trip pan was only partially held down the breaker may have closed, but the operating mechanism trip faces may not have been completely seated and a shock in the area of the breaker cell could cause the breaker to open. Either of these cases could cause the breaker to open unexpectedly.

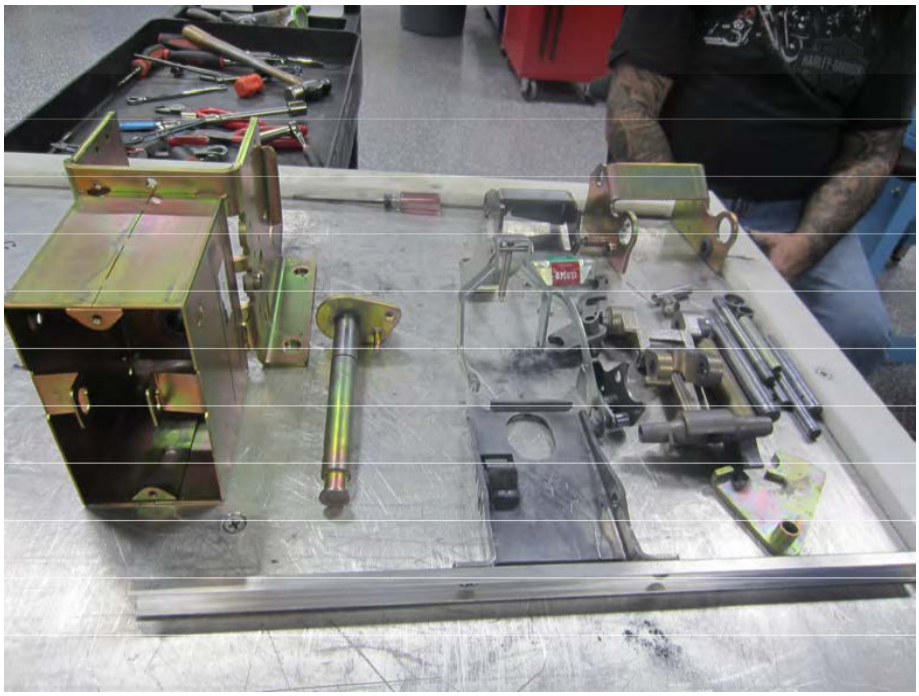
Operating Mechanism Inspection Hole

The operating mechanism was disassembled and visually inspected. No issues were found.

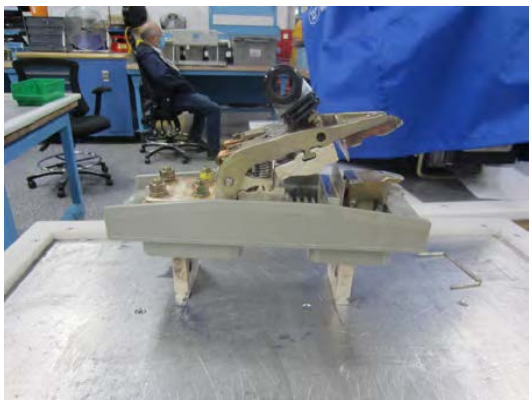
Phase 'A' Removed

The pole bases were removed one at a time and were not disassembled at this time.

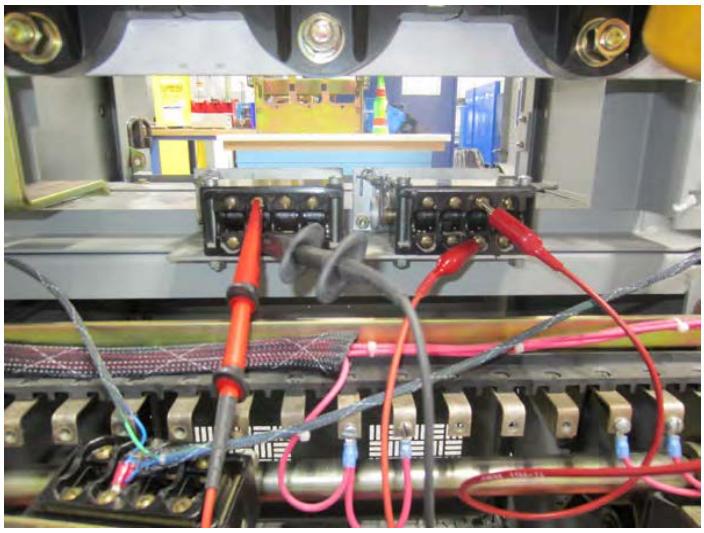
Rear of Test Cell and Cell Switches

Cell Switch Monitoring Set-up

The Right-Side Switch is monitoring a Normally Open contact on switch terminals 3 and 4. The Left-Side Switch is monitoring a Normally Closed contact on switch terminals 5 and 6.

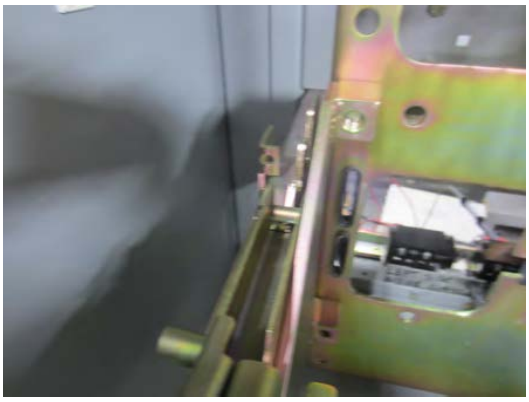
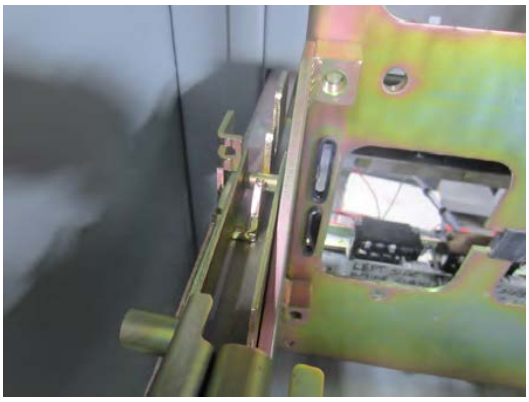
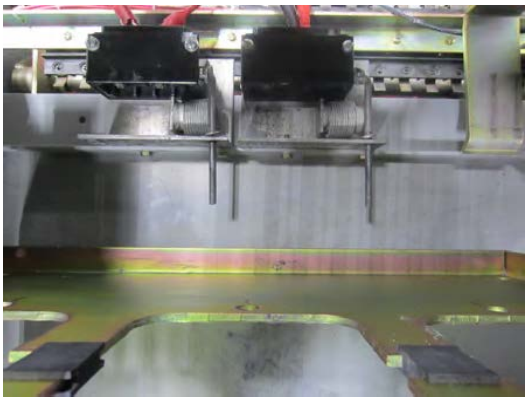
Breaker Frame Located before the Cell Positioning Stop Bracket

The next series of photos are showing the breaker frame location as defined by the cell positioning stop bracket with Disconnected, Test and Connected positioning slots and then the distance between the cell switch plungers and the rear of the breaker panel.

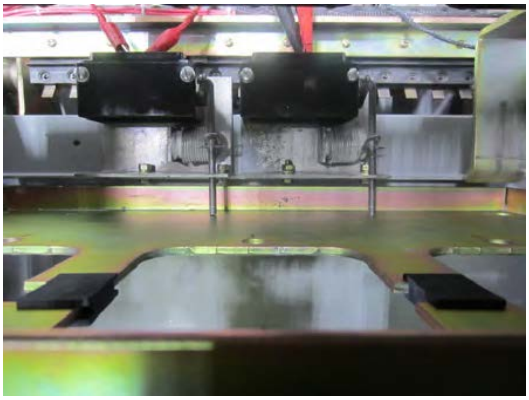
Breaker Frame Located in the Connect Position Stop Bracket

Right-Side Switch Monitoring (NO) --- Left-Side Switch Monitoring (NC)
