DOCKET NO.: 20200001-EI

WITNESS: Jeffrey Swartz

FOURTH AMENDMENT TO
CONTRACT FOR PURCHASE OF STEAM TURBINE GENERATOR

Bartow 4S Root Cause Analysis – Evaluation of Contributing Factors

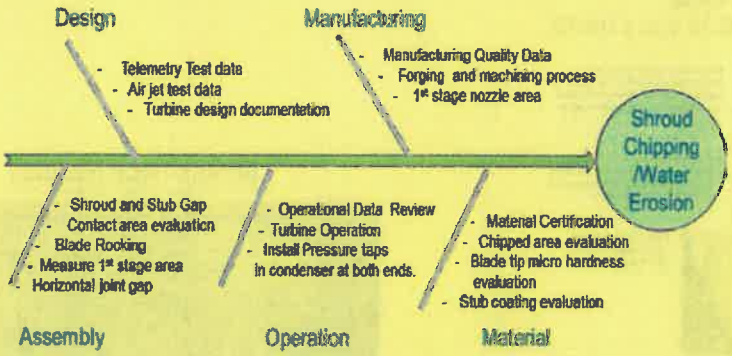
Period 3 - Blade Shroud Chipping RCA

Recent operational findings on the bypass operation do not impact the root cause finding, but do impact the corrective action.

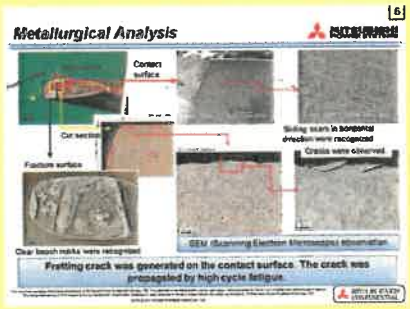
Period 1 Snubber Fretting Fatigue
Presented 9/18/13

Period 3 Shroud Heavy Wear
Presented 5/26/16 and 11/9/16

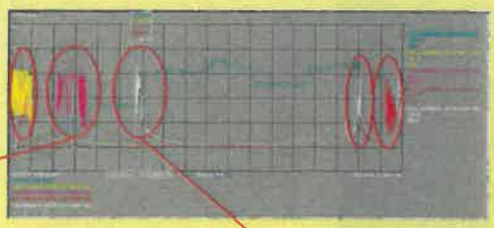
Evaluation of GT blends during 2014 telemetry test

- During the 2014 telemetry test 2 GT blends were recorded.
- The GT blends produced a 2x response in blade stress.

Further investigation :
- Create complete data set of available IP Bypass exhaust temps, pressures and vibration
- Characterize 'severity of blends
- CFD of condenser / exhaust flows
- Model blade response from blend stimulus
- Validate model with Telemetry Test data

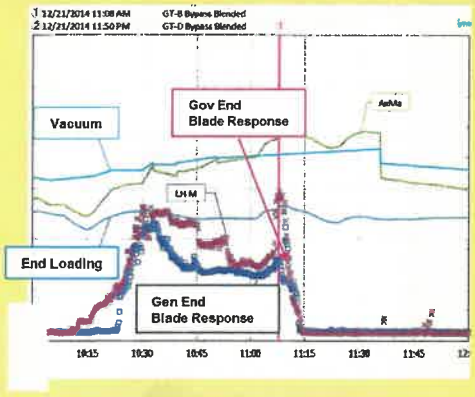
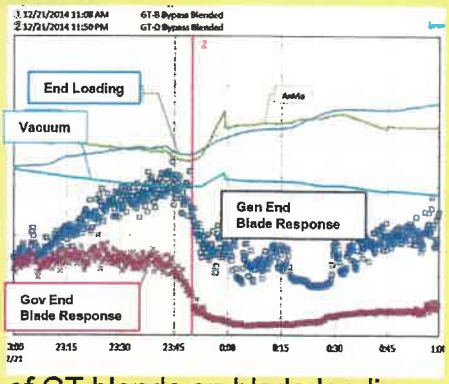
Blend in "B"

Blend in "D"

Further investigation is required to understand the impact of GT blends on blade loading

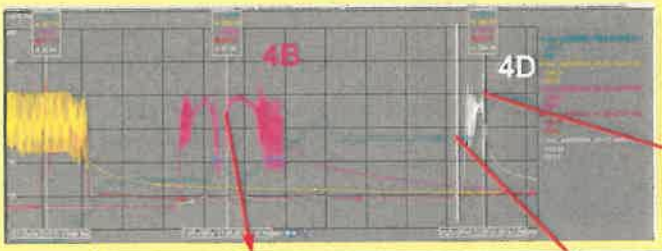
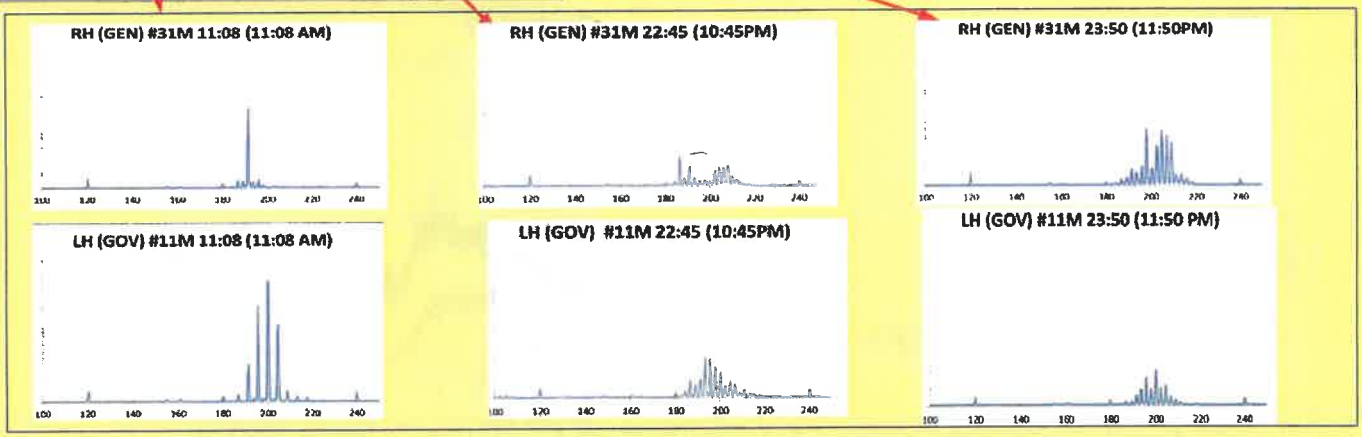
IP Bypass Configuration

Blade response during bypass operation is also Non-synchronous 16 Nodal Diameter response around 200 Hz

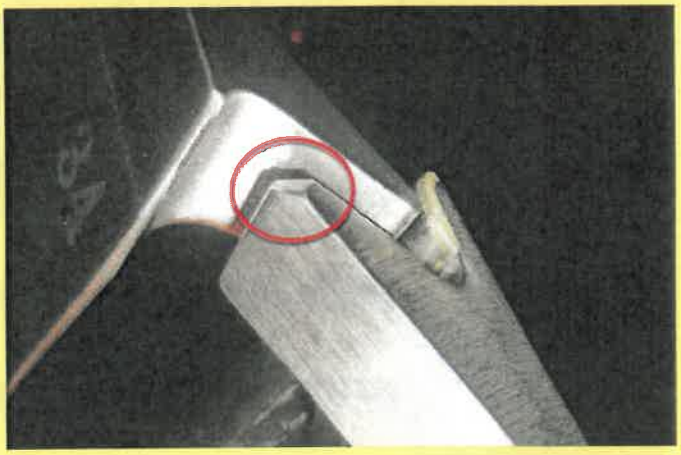
Shroud Chipping Resolution

- Along with mid span damage, Edge chipping on the shroud was observed on Bartow blades.

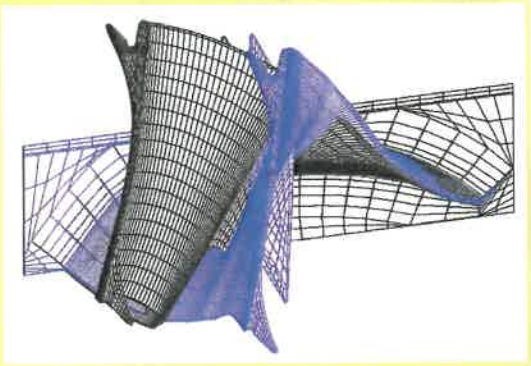
Test Results

- Analysis of Non-synchronous response show frequencies close to 200Hz region and composed of axial mode shape with higher nodal diameter.
- Fretting at stubs was evaluated with the telemeter test results.

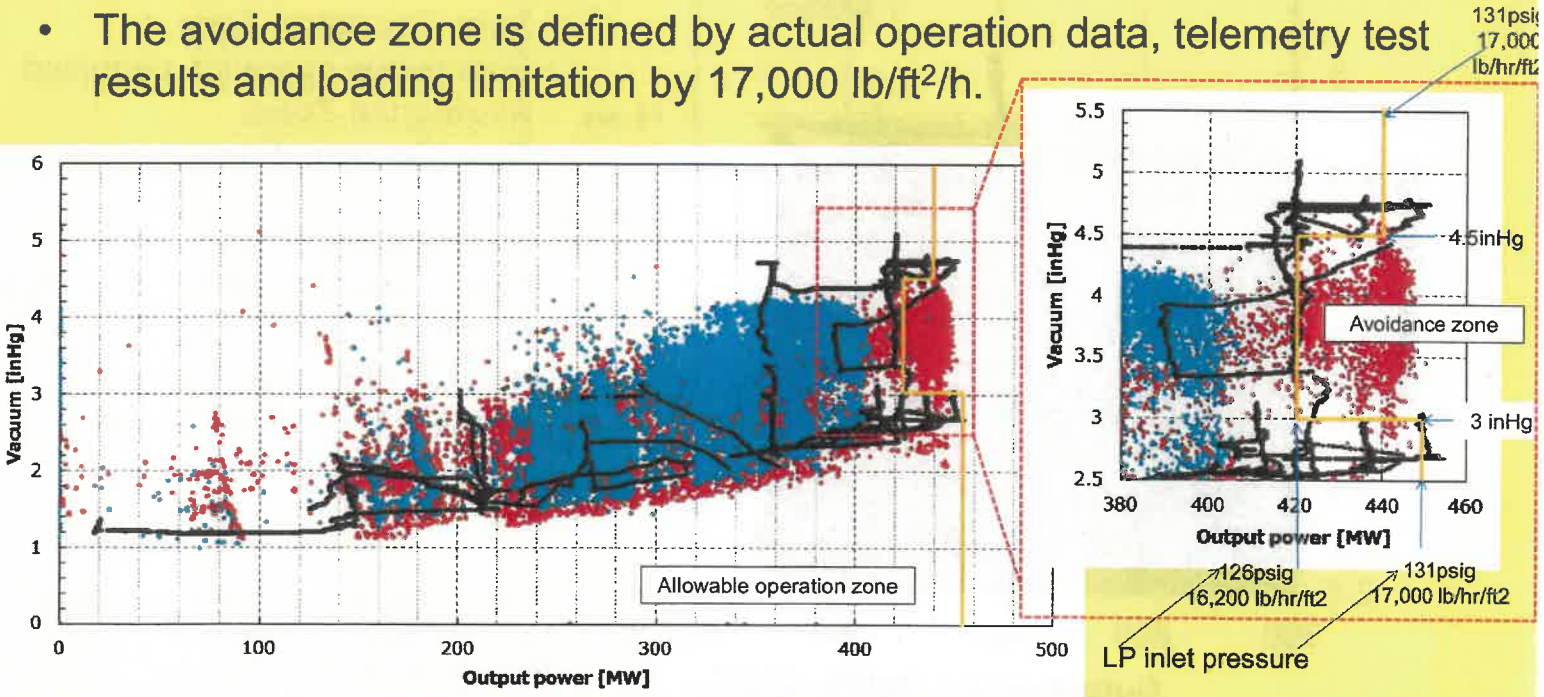
Results: Stub Fretting Fatigue Evaluation

- Based on Fretting Fatigue analysis, avoidance zone was created for safe operation of the L0 blades.
- The avoidance zone is defined by actual operation data, telemetry test results and loading limitation by 17,000 lb/ft^2/h.

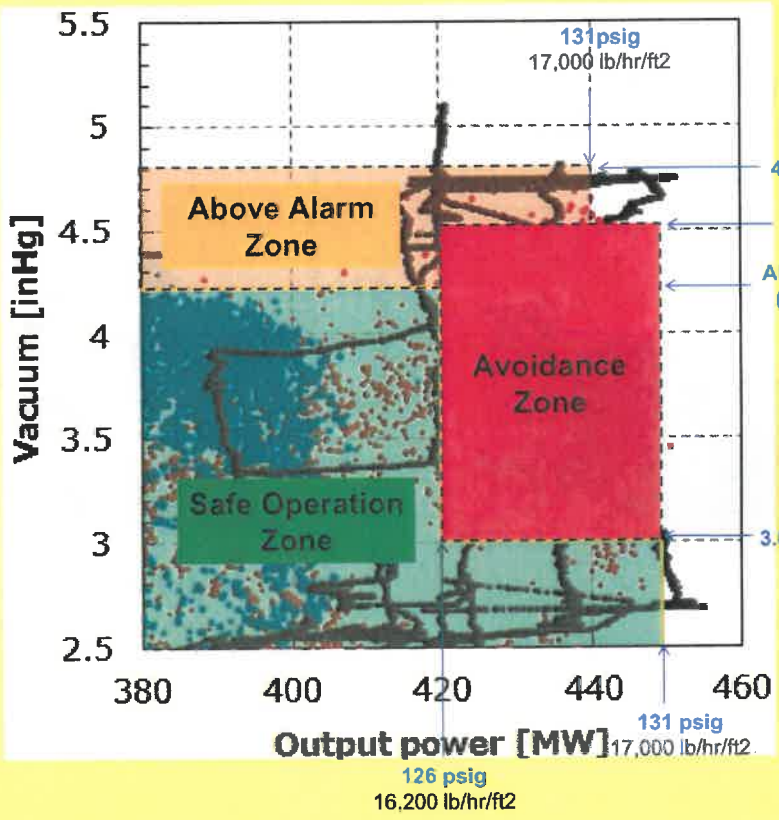
40" L0 Blade Limits

- Based on Fretting fatigue and HCF evaluation of the blade below "Avoidance Zone" is established

Safe Operation Zone:
Continuous operation permitted.

Avoidance Zone:
Operation is not recommended.

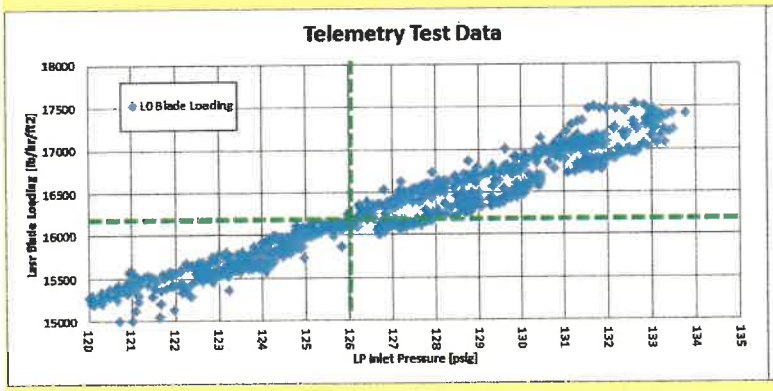
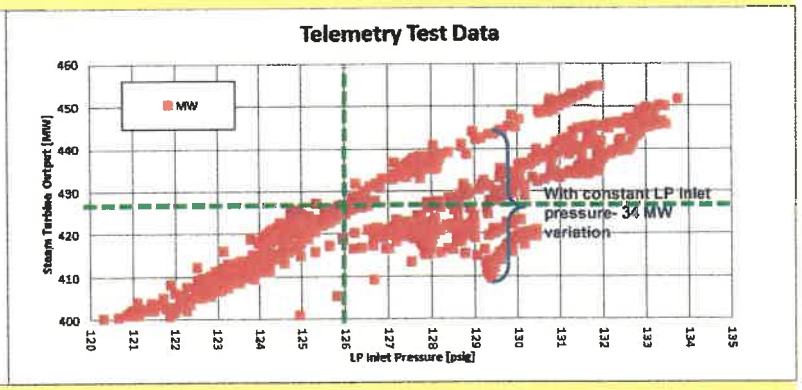
Operational Limits

- Based on L0 blade review for operation above 3 inHg, maximum allowed load on L0 blade is set at 16,200 lb/hr/ft^2.
- Review of test data shows that 16,200 lb/hr/ft^2 can be achieved with LP inlet pressure of 126psig and unit output as 426.7MW. (12/22 17:30Hrs)
- With constant LP inlet pressure, variation of power output is observed. This is largely related to loading change in HP and IP sections.
- If more steam is put through HP section, higher output greater than 426MW can be achieved by keeping LP inlet pressure under 126psig or L0 blade loading under 16,200 lb/hr/ft^2 .

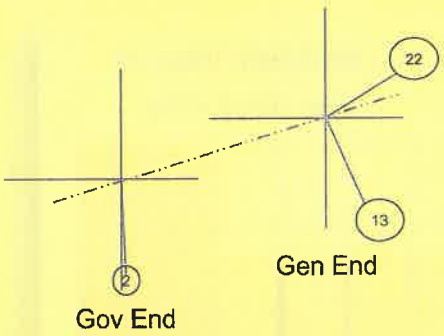
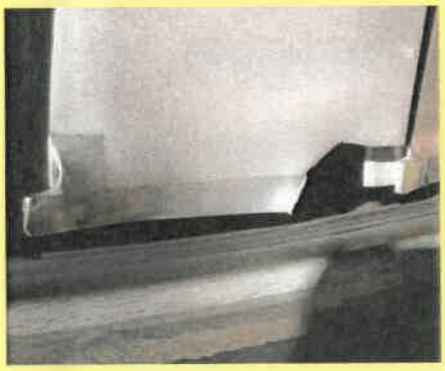
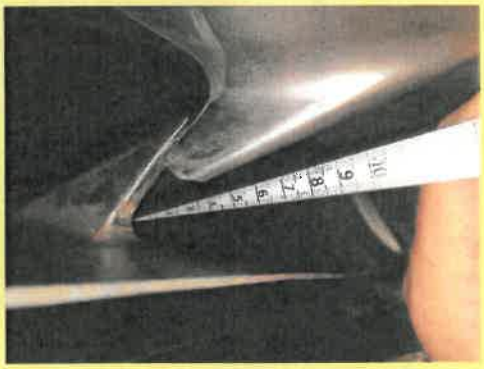
Blade Inspection – Oct 2018

Gen End Blade #13

Gen End Blade #22

Gov End Blade #2

Gen End Blade #55

Gen End Blade #yy

Significant mass loss consistent with vibration observations
Damage started after 5 weeks of operation

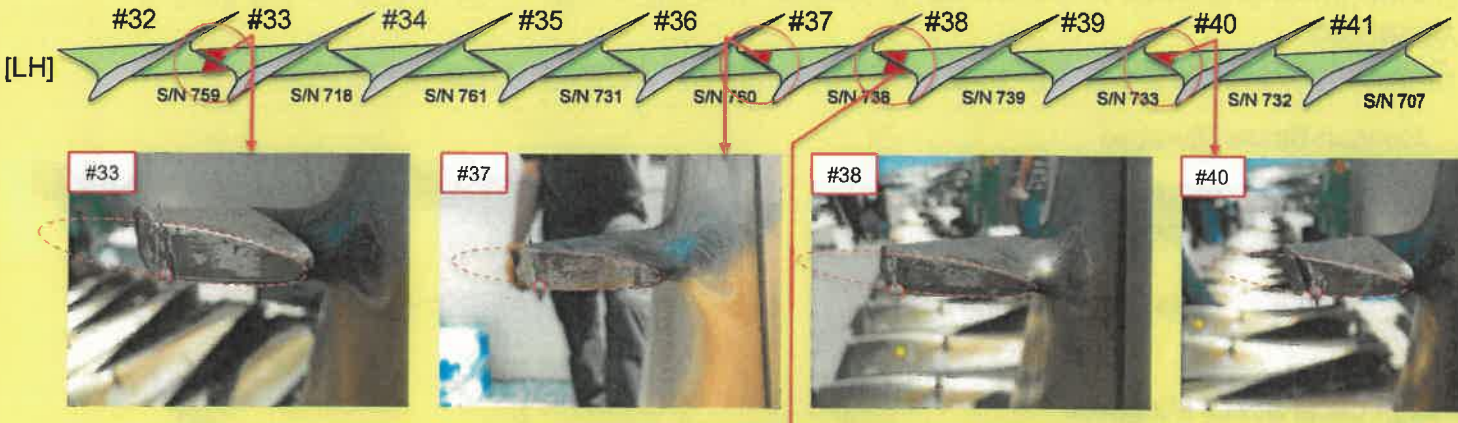
Failure at Stub of Original Blades

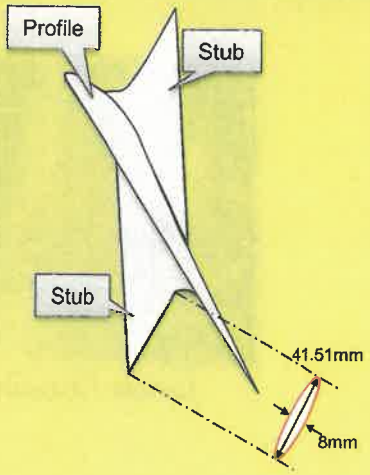
- Original blade has no crowning/chamfer at stub. Local stress is high and crack is initiated at edge of stub.

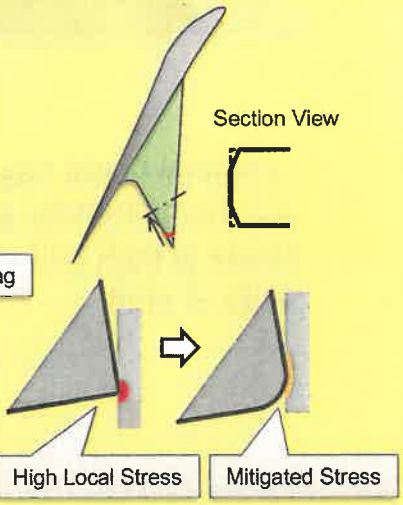
High Local Stress Mitigation

If stub surface is tilted in horizontal or vertical direction, high local stress on the stub is observed.
Crowning was applied to the edge of stub contact to avoid the high local stress.

Following picture shows stub contact surface of stub coated blade with crowning from November 2014 to April 2016. There was no high stress contact mark at edge of stub and the contact condition was good.
It is recommended to apply crowning without coating, to prevent high local stress.

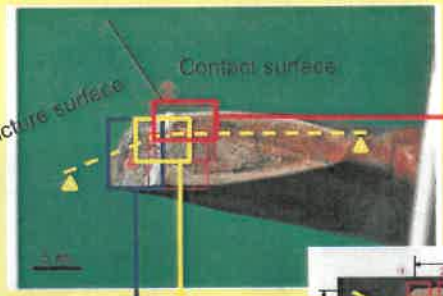
Failure Blades at Site (Stub)

- Mitsubishi recommended that the Duke ST operate at or below 420MW to ensure proper loading on the LP turbine and L-0 blades
- Mitsubishi evaluated modification of L-0 blades to increase output from 420MW up to 450MW
- X-ray and mold tests were conducted by customer on the governor end L-0 blades in March 2013. Customer analysis indicates fretting wear on the contact surface of mid span stub.

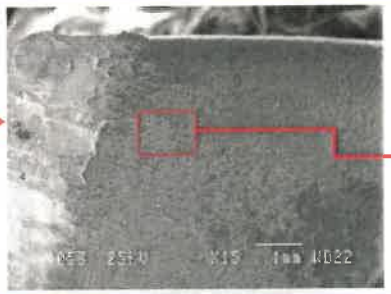
Contact surface

Sliding scars in horizontal direction were recognized.

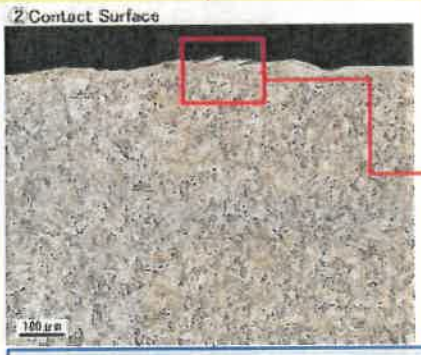
Fracture surface

Clear beach marks were recognized

Cracks were observed.

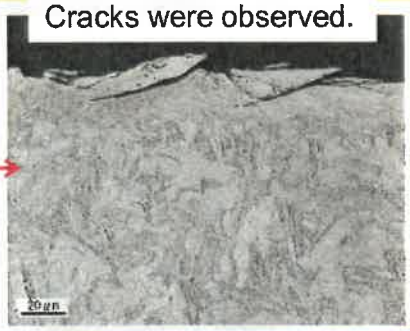
SEM (Scanning Electron Microscope) observation

Fretting crack was generated on the contact surface. The crack was propagated by high cycle fatigue.

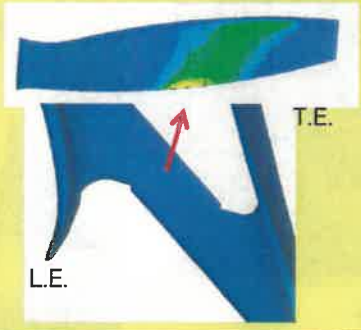
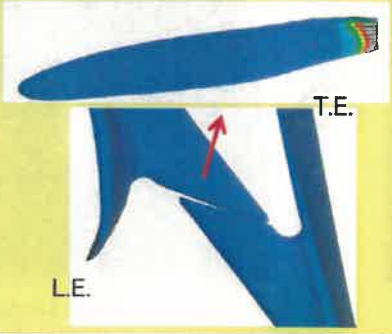
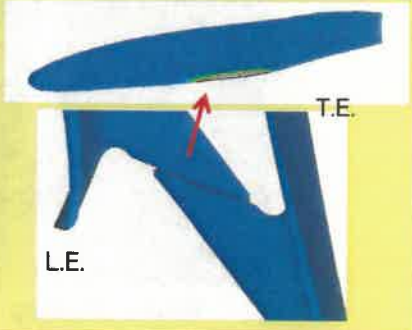
Local pressure increases with tilted contact surface.

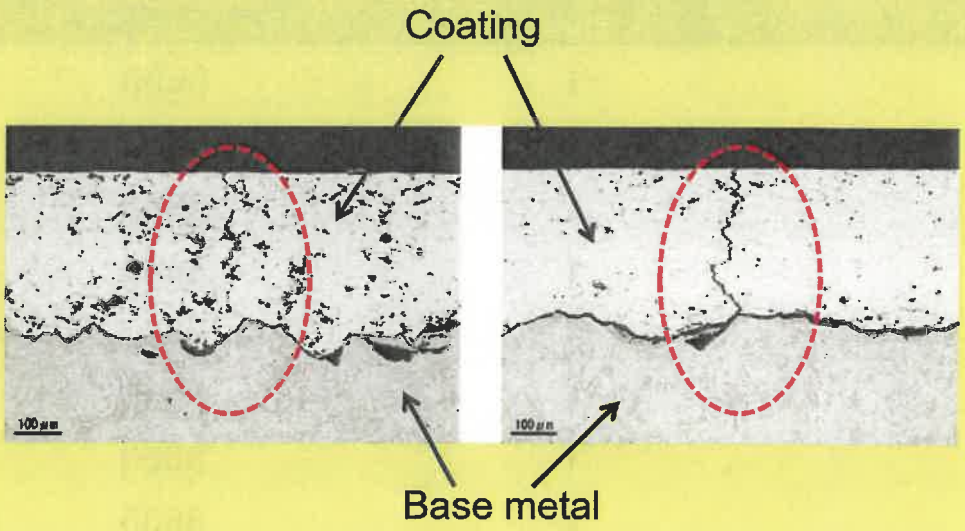
Bending Test Result

It is confirmed by the bending test that any crack that initiates in the coating will not propagate into base material.

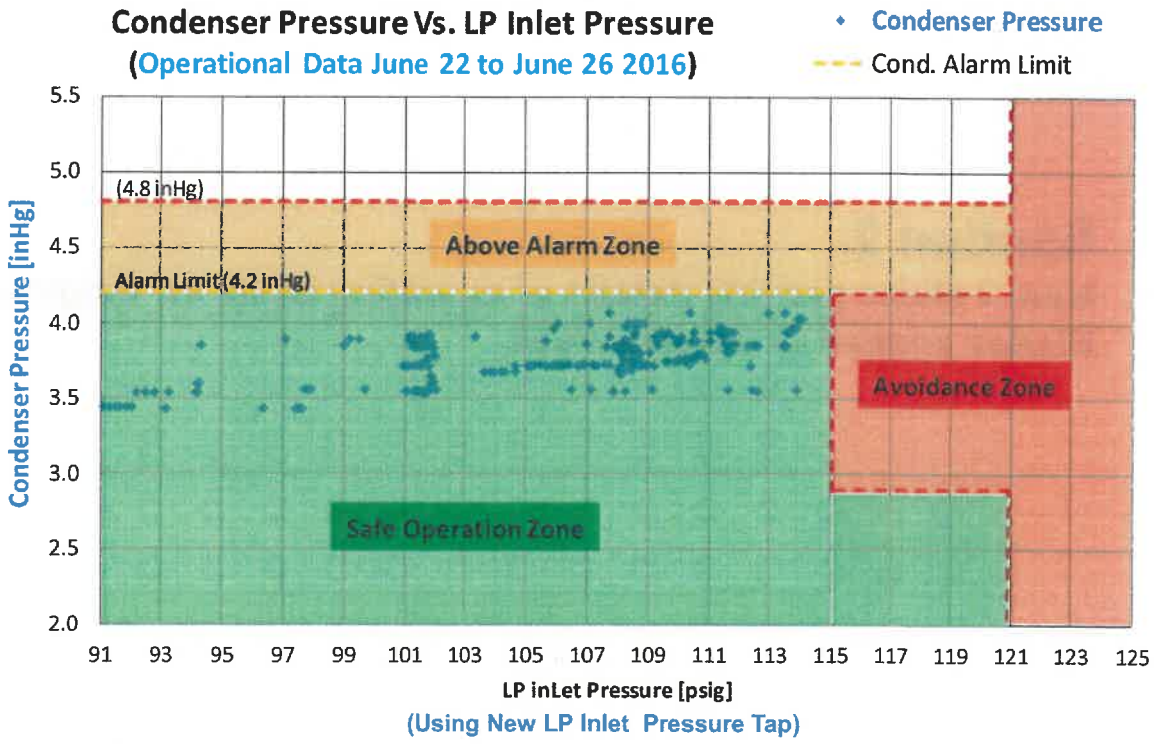
- With 3.2% pressure drop, the limits for **new LP inlet pressure tap** will be
  - **Below 3 inHg ⇨ Less than 121 psig**
  - **Between 3 inHg and 4.5 inHg ⇨ Less than 115 psig**
  - **Between 4.5 inHg and 4.8 inHg ⇨ Less than 121 psig**

LP inlet pressure limits are same as before but adjusted due to transducers calibration and location change.

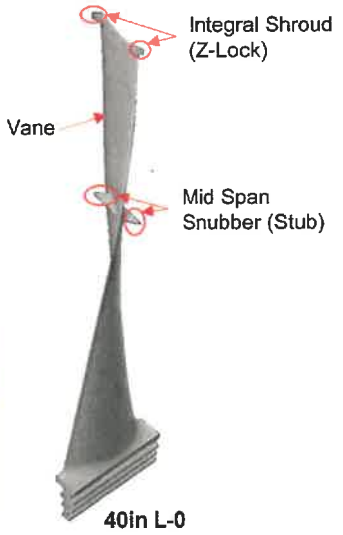
Bartow Blade Operating Summary

Period	Operating Time	Blade Type	Major Damage
Period 1	2009 - 2012	Type 1	Mid Span Snubber Only 
Period 2	2012 - 2014	Type1	No Significant Damage 
Period 3	Dec 2014 – Apr 2016	HVOF Stellite Mid Span Type 3	Shroud Only 
Period 4	Jun 2016 – Oct 2016	HVOF Stellite Mid Span + HVOF Stellite Shroud Type 3	Vane + Snubber (Note 1) 
Period 5	Dec 2016 – Feb 2017	Type 1	Mid Span Snubber Only

Note 1 – Period 4 did not show shroud fretting fatigue / contact wear damage.

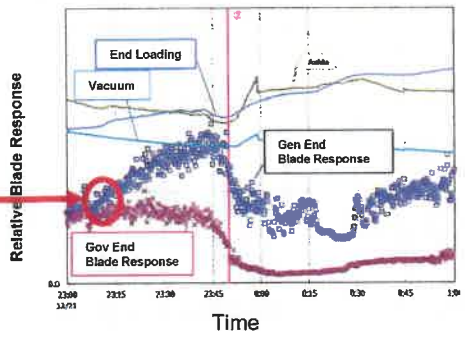
Bypass Blend D – Gen End Excitation

- Based on the telemetry test data available for blade response during bypass operation, dropping below the saturation temperature line did not show a blade response

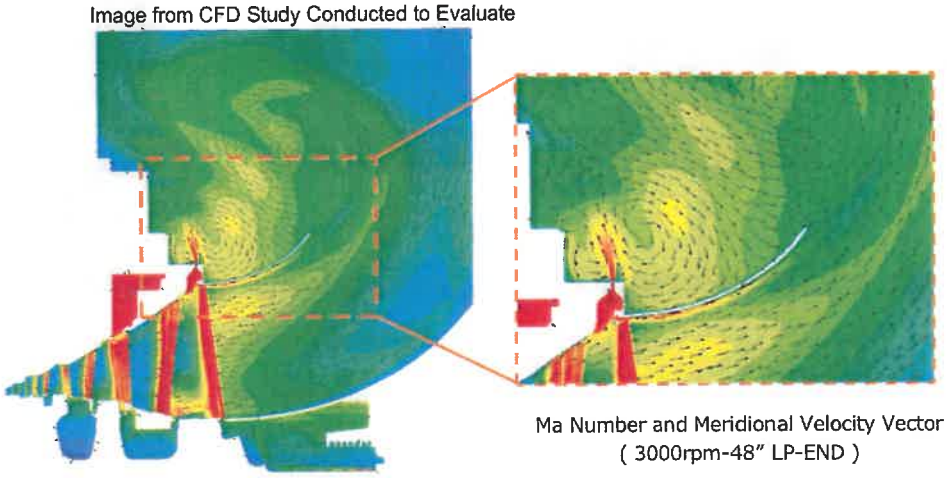
Image from CFD Study Conducted to Evaluate

- CFD confirms no re-entry of water spray / steam into the steam path (No aspiration occurs)

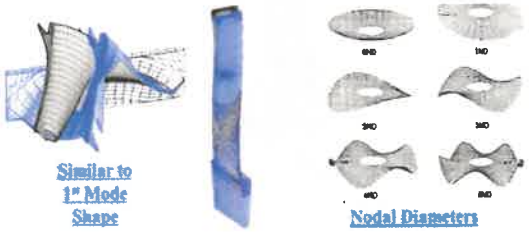
Root Cause Analysis has identified all blade damage from Period 1 thru Period 5 has been identified as Dynamic Loads from Non-Synchronous Self Excited Vibration (Flutter)

Note : Non-synchronous 1st Mode Higher Nodal Diameters response was presented March 18th 2015 , prior to Period 3 RCA

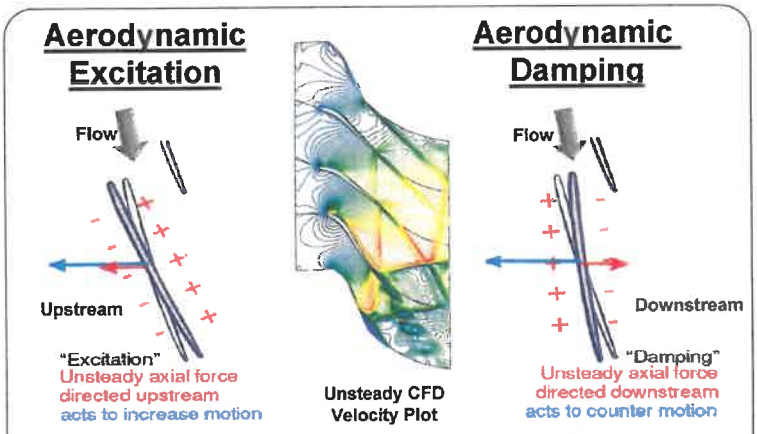
- Blade response is measured during Telemetry Testing and analytically predicted at around 16th Nodal Diameter of the first mode (approx. 200Hz).
- The Notable Non-synchronous Vibration is caused by aero-dynamic flow and observed as the Multiple Modes Response (180Hz-230Hz).

- Cycles accumulate at 12,000 cycles per minute at 200 Hz

- Alternating component of pressure shown as (Red) at mid point of travel
- Motion (Blue) at midpoint of vibration cycle

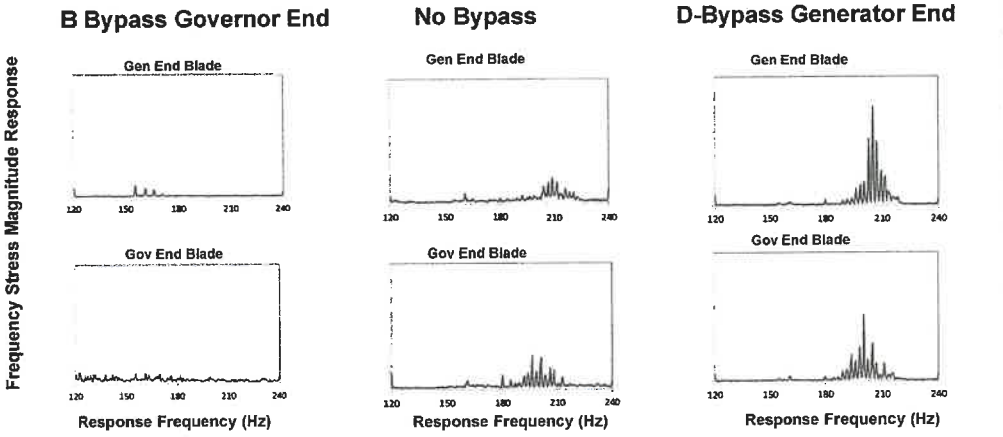
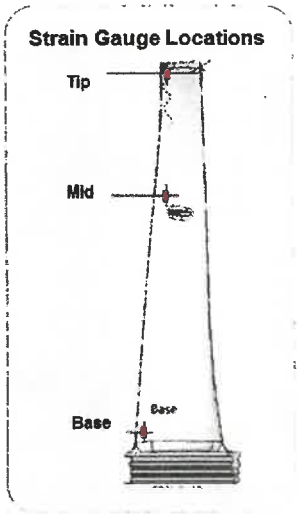
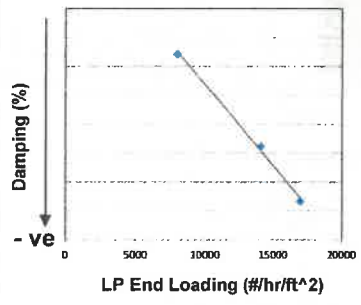
Frequency Response from Telemetry Test :

- Peeks at 120, 180, 240Hz are per Rev Responses
- Peeks between 180 to 230Hz are High Nodal Diameter responses of the First Cantilever Mode. These frequencies are associated with Non-Synchronous Self Excited Vibration

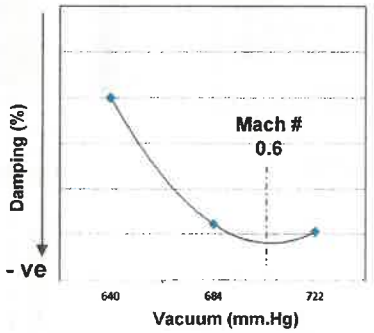
Aerodynamic Damping as Fn of LP End Loading

- Aerodynamic damping decreases with higher LP End Loading

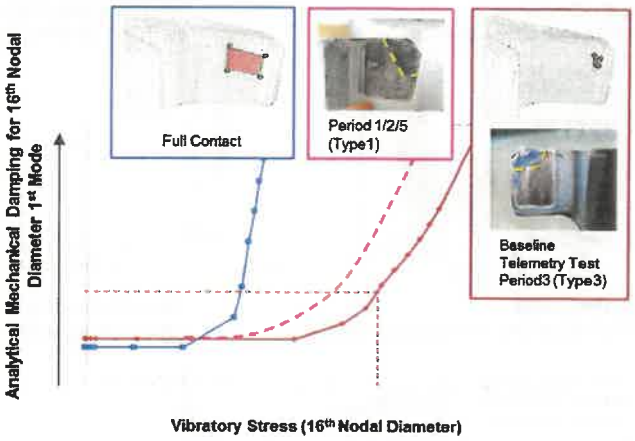
Vibratory Stress vs Mechanical Logarithmic Damping (16ND)

Analytical damping results are intended to understand drivers for blade response, absolute blade response was established from Telemetry Test

- Type 3 Blades established the baseline blade response from the telemetry test.
- Type 3 Blades were found to have lower damping than Type 1 Blades due to smaller contact area

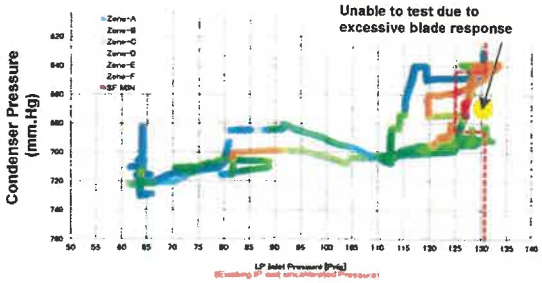
Blade Response vs Pressure and Condenser Pressure

- Outside of the originally developed design space, blade response becomes sensitive to operating conditions.
  Example : At 16,500 #/hr/ft^2 there is a 10X change in blade response based on condenser pressure

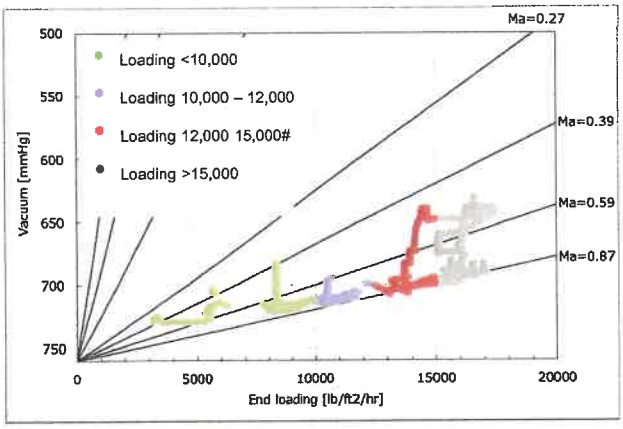
Blade Response – Design Margin (Red High / Blue Low)
Example : Shroud Fretting Fatigue

- The avoidance zone established in 2015 was developed to prevent operation in the region which measured high blade response.

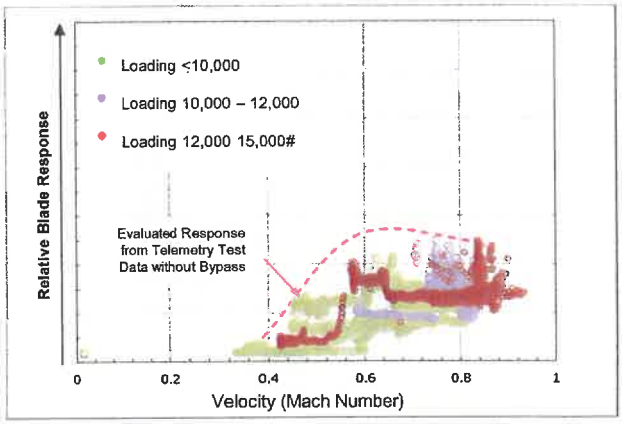
Blade Response as a Function of Mach Number – without Bypass

- Below 15,000 lb/hr/ft^2 Blade Response becomes dominated by Mach Number

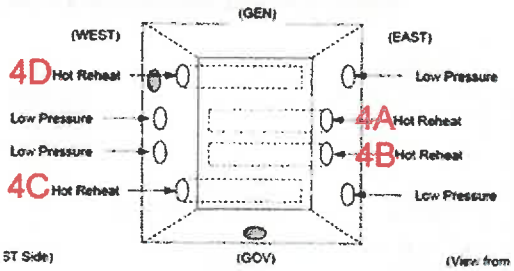
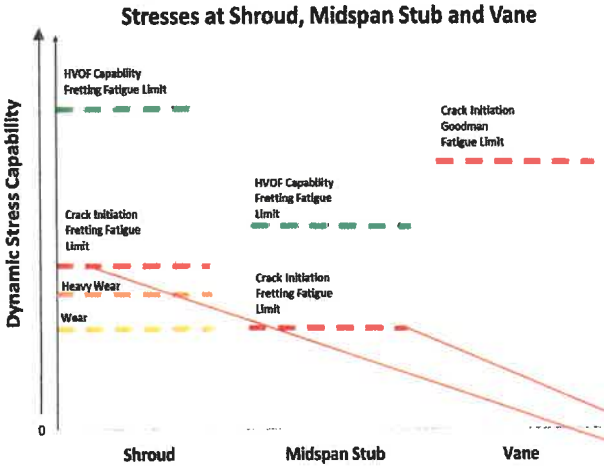
Blade Response as a Function of Bypass Operation

- Bypass C Operation increases response on Governor End Blades
- Bypass D Operation increases response on Generator End Blades

- Operation with Bypass D and C Produce a 1.5X Increase in blade response on the blades closest to the bypass
- Operation with Bypass A and B did not show an increase in blade response over none Bypass Operation

- Limited Blade Response data during Bypass is available with the operation before and after Dec 2014 Telemetry Testing being assumed to have remained the same change in response.

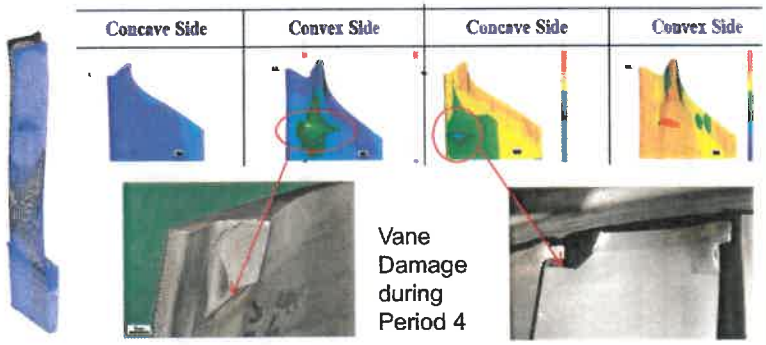
Material Capability – Material Test Data

- Estimated Blade Response can be evaluated against Material Capability for Shroud, Mid Span Stub, and Vane

- Vane - Goodman Fatigue Limit Based on 1st Mode Stress Distribution

- Shroud / Stub Fretting Fatigue Damage based on fretting material testing

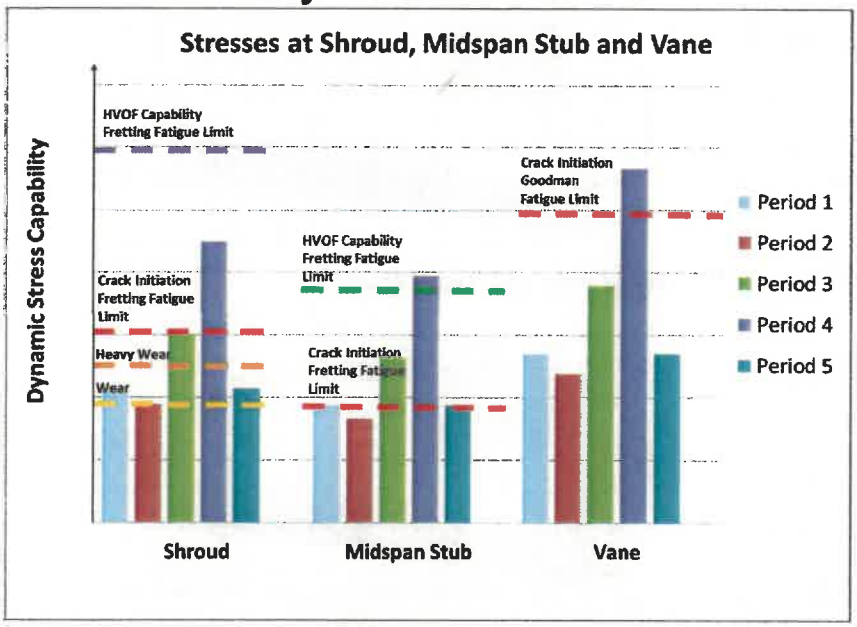
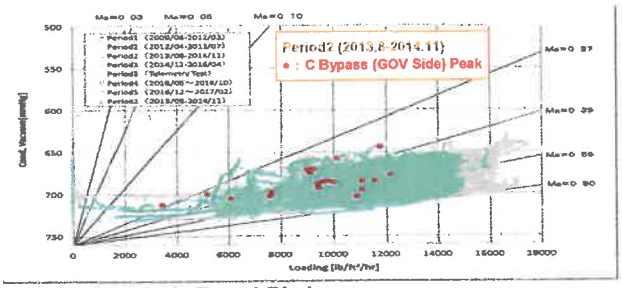
Stress Summary – Period 1 thru 5

- **Period 1 – Mid Span Stub Cracking**
  High LP Loading but increased mechanical damping from Type 1 blade over baseline telemetry test
- **Period 2 – No Major Damage**
  Reduced LP Loading over Period 1, reduced bypass operation loading over period 5, light wear observed on shroud
- **Period 3 – Shroud Cracking**
  High LP Loading identified in Telemetry Test. Mid Span Stub protected by HVOF
- **Period 4 – Vane Cracking**
  Reduced Loading. Application of HVOF reduces mechanical damping increasing amplitude of response. With HVOF protecting Shroud and Stub, the limiting location becomes the Vane
- **Period 5 – Mid Span Stub Cracking**
  Reduced Loading with longer periods of bypass operation at High Mach Number over Period 2. No HVOF Protection

- Damage observed in all 5 Periods of operation is consistent Blade Response vs Capability Model

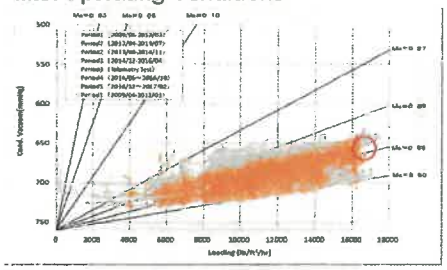
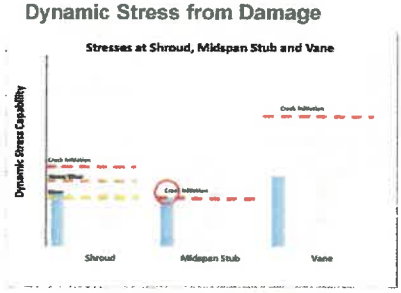
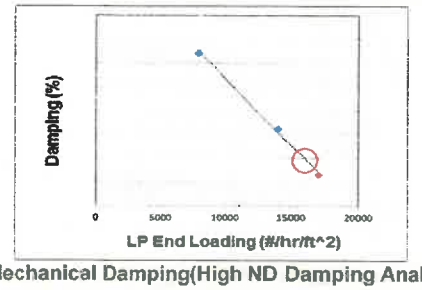
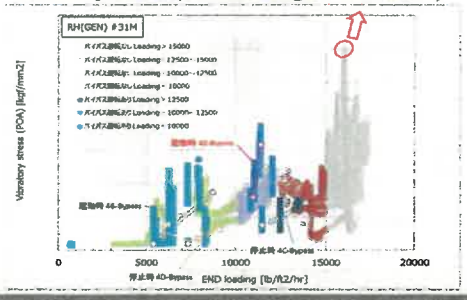
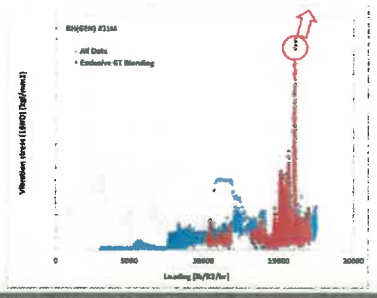
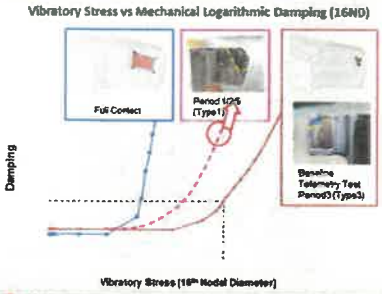
Period 1 – Stub Cracking

Operation at higher loads than Period 3, but Type 1 Blade has improved damping over Type 3 in Telemetry Test

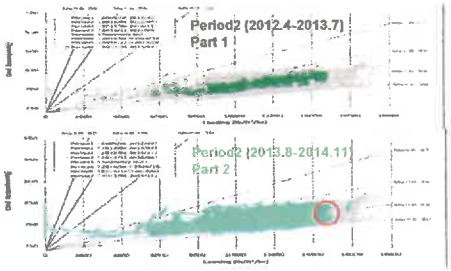
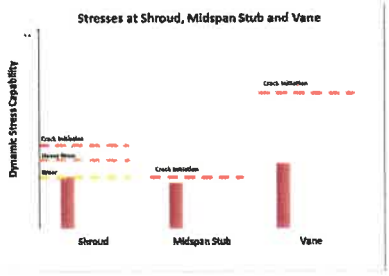
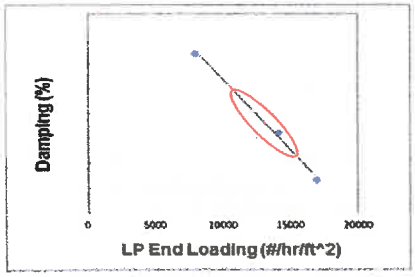
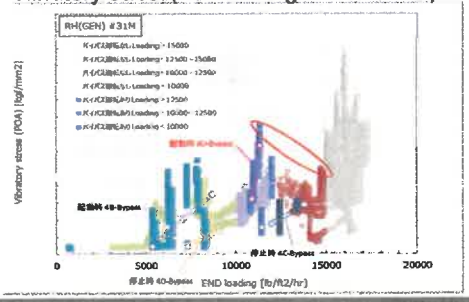
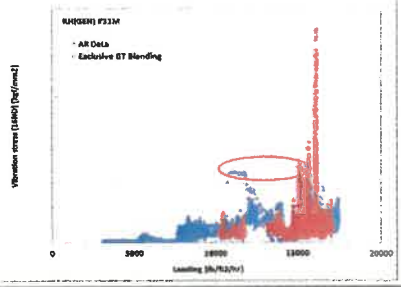
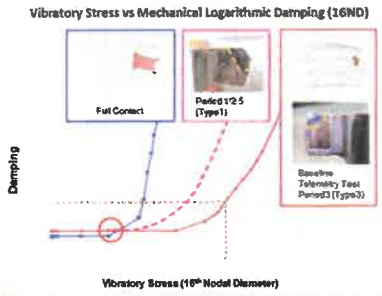
Period 2 – No Major Damage, Minor Shroud Chipping

Reduced LP Loading over Period 1, reduced bypass operation loading over period 5, light wear observed on shroud

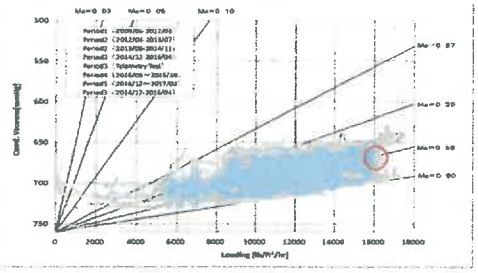
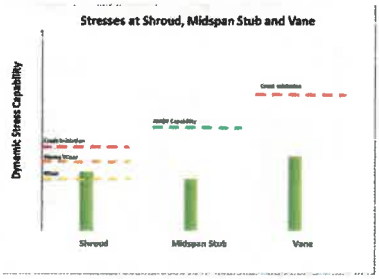
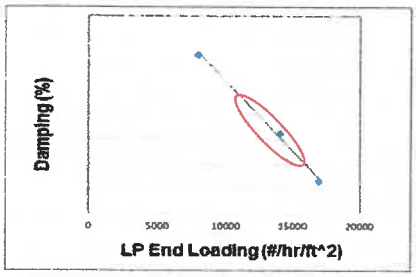
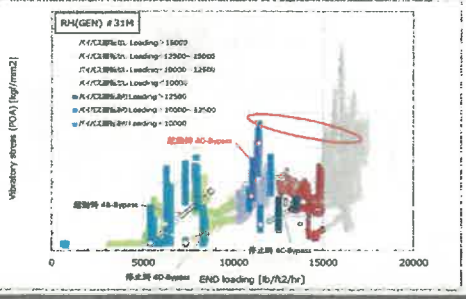
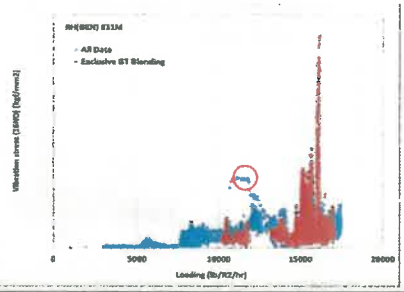
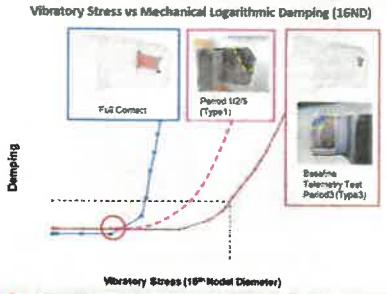
Period 3 – Shroud Cracking - Outside Avoidance Zone

Outside of avoidance zone, bypass operation becomes most limiting. With HVOF on Mid Span Stub no cracking is predicted.

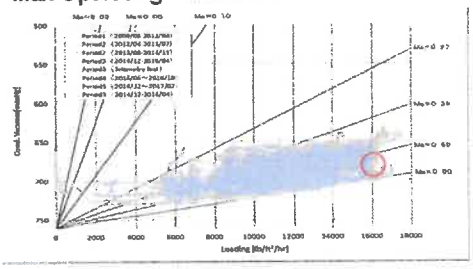
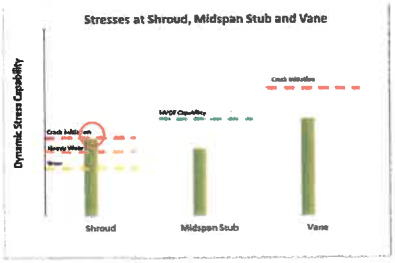
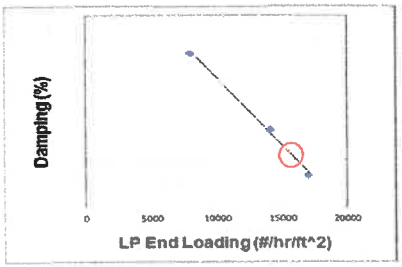
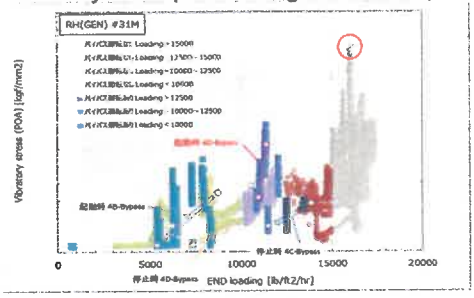
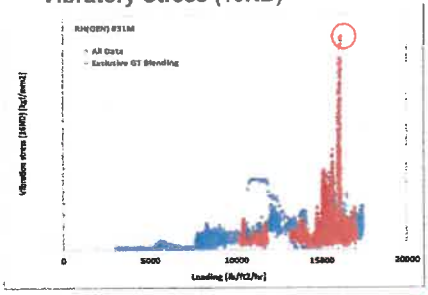
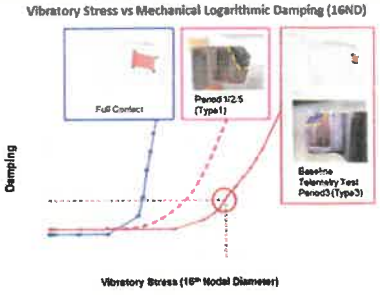
Period 3 – Shroud Cracking– Inside avoidance zone

High blade response established in Telemetry Test. Mid Span Stub protected by HVOF. Shroud become limiting location.

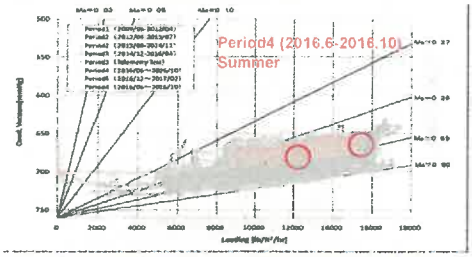
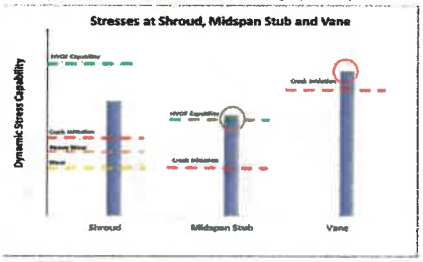
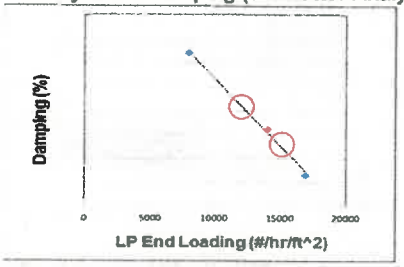
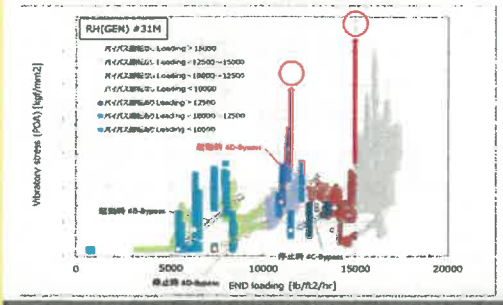
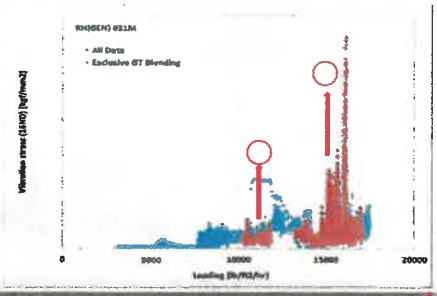
Period 4 – Vane + Stub Cracking

Reduced LP Loading. Application of HVOF reduces mechanical damping increasing amplitude of response. With HVOF protecting the Shroud and Stub, the limiting location becomes the Vane

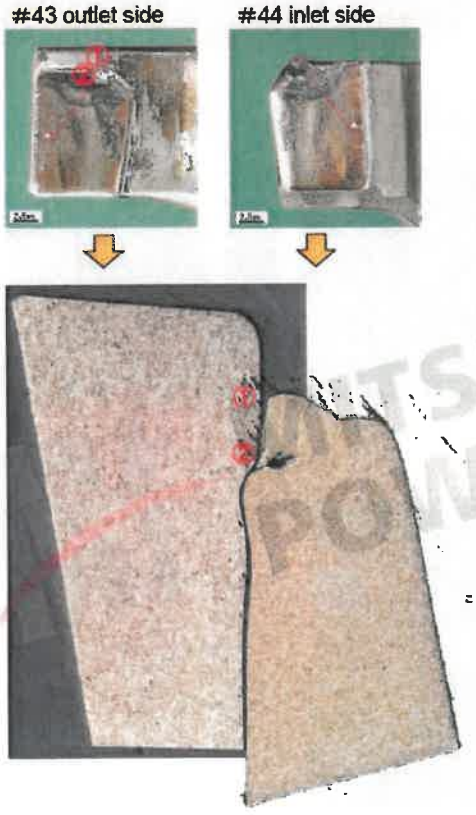
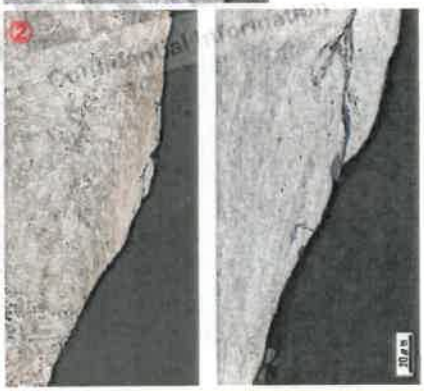
Blade Inspection Results

#42 outlet #43 inlet	#43 outlet #44 inlet	#44 outlet #45 inlet	#45 outlet ----
Outlet side contact surface				
Inlet side contact surface				----

Shroud Chipping is starting at same location for all blades

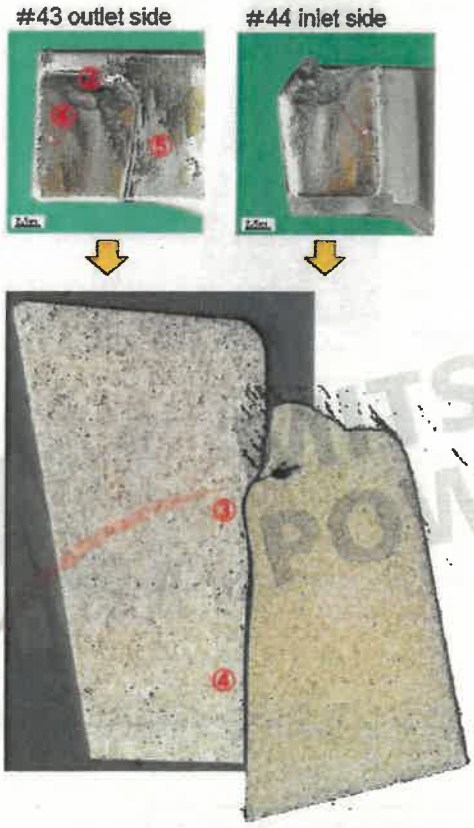
- Fine cracks, caused by fretting fatigue, are found near the end of contact part with local deformation of inlet side of #44 blade.

- Plasticity is found in concave part of local deformation.

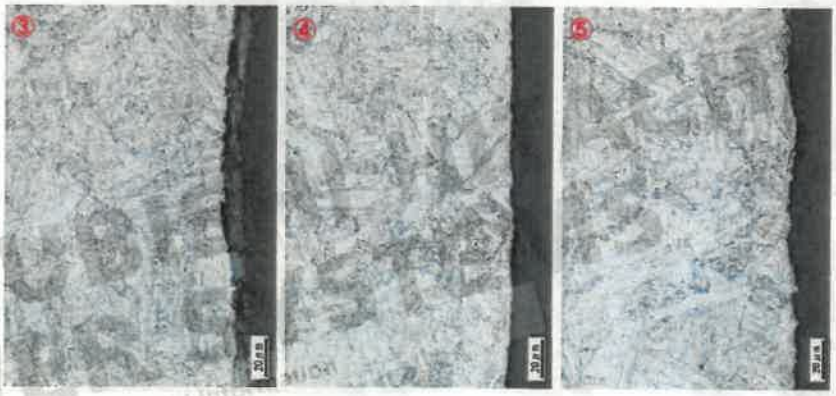
Metallurgical Evaluation of Blades

Microscopic observation was performed on the same sections in contact condition for each of outlet side of #43 blade and inlet side of #44 blade.

- ③: Oxide scale was found on black surface of local deformation area.
- ④: Dark brown surface of worn and thinned part is free of oxide scale and smoother than non-contact surface of ⑤.

Oxide scale with local deformation observed on black surface

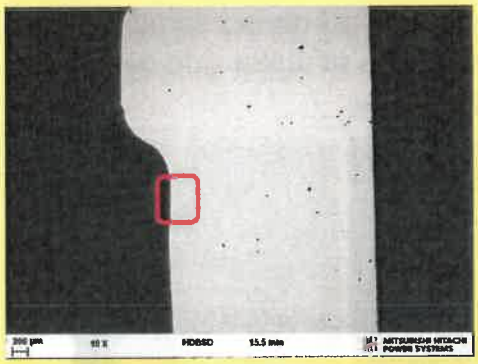
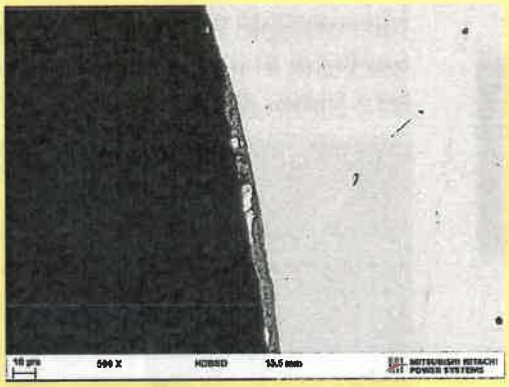
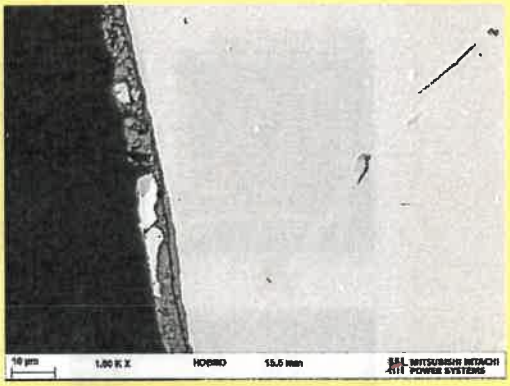
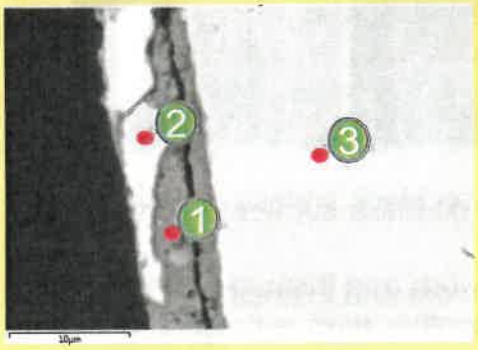
Metallurgical Evaluation of Blades

Location	Semi-Qualitative EDS analysis of elements detected (wt%)							
	O	Si	Cr	Mn	Fe	Ni	Cu	Nb
1	25.97	0.44	7.67	0.41	61.59	1.84	1.18	0.00
2	0	0.35	18.15	0.95	70.12	9.35	0.08	1.00
3	0	0.33	15.86	0.54	73.65	4.91	3.58	1.14

- Oxidation/corrosion was observed on the trailing edge contact surface of the tip shroud.
- Material removal from wear is from abrasion.

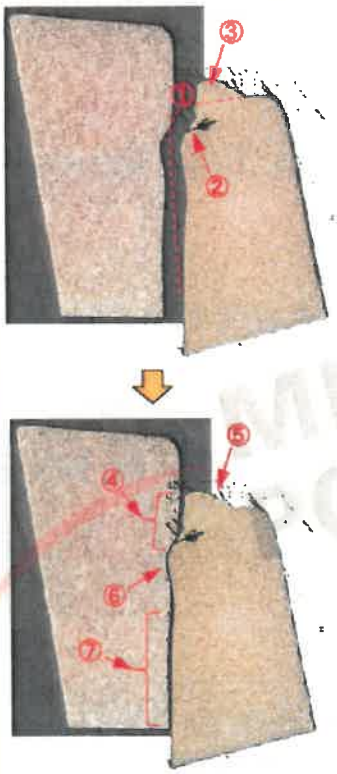
Images of initial contact conditions

① Partial local contact at the top and tip of blade

② Fretting fatigue crack generated in local area

③ Local deformation is generated along with the crack

⑤ HCF crack is generated.

⑥ Local wear generated by high surface pressure & excessive sliding. Oxide scale developed by heat generation (black surface).

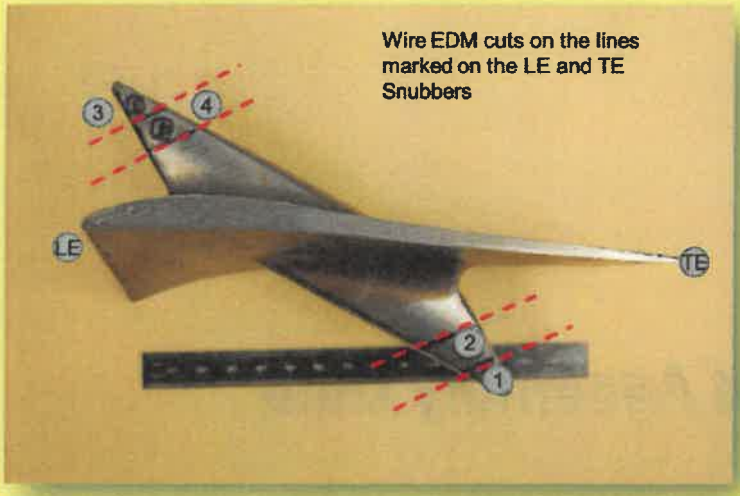
⑦ Worn by wear debris

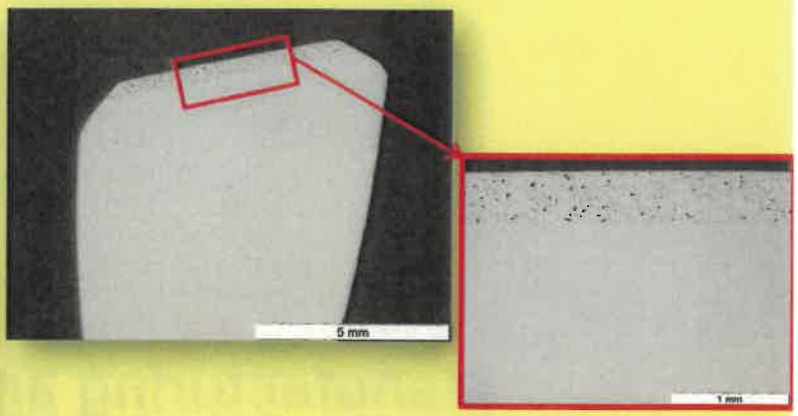
⑧ Partial defect was caused by fretting fatigue crack which was generated and propagated in high surface pressure and sliding area (black surface).

※⑦ & ⑧ progressed at the same time

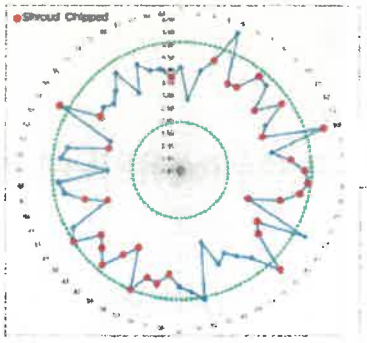
Shroud Gap Data in 2014 Assembly

Row Average Gap = 3.9mm

Criteria: Shroud 1.9mm to 5.1mm Average, with no single blade above 6.0mm.

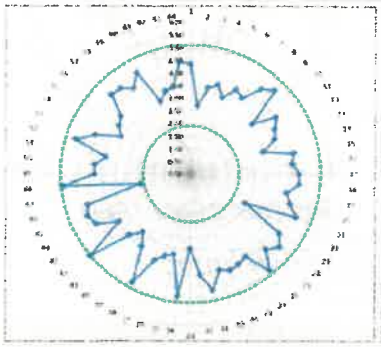
Shroud Gap Data in 2016 Dis-Assembl

Row Average Gap = 4.2mm

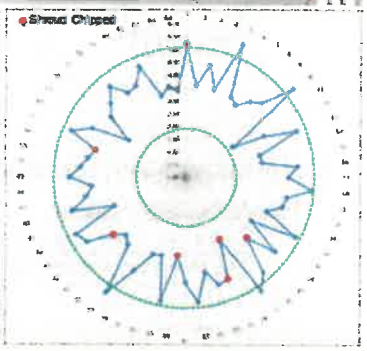
Shroud Gap Data in 2014 Assembly

Row Average Gap = 3.9mm

No clear relationship between gaps and shroud chipping
