DOCKET NO.: 20200001-EI

WITNESS: Jeffrey Swartz

FOURTH AMENDMENT TO
CONTRACT FOR PURCHASE OF STEAM TURBINE GENERATOR

Bartow 4S Root Cause Analysis – Evaluation of Contributing Factors

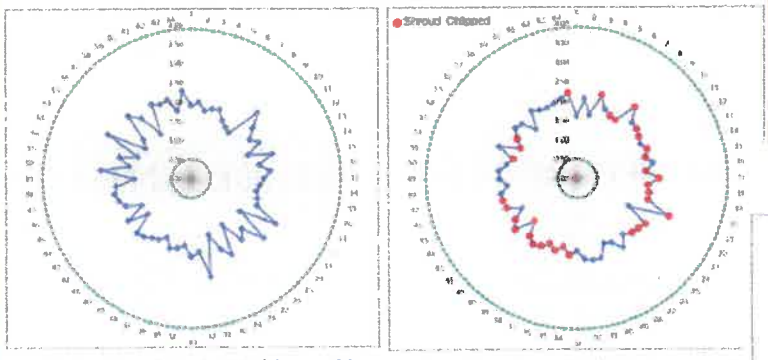
LH and RH shroud average gaps are nearly same
No clear relationship between gap and shroud chipping

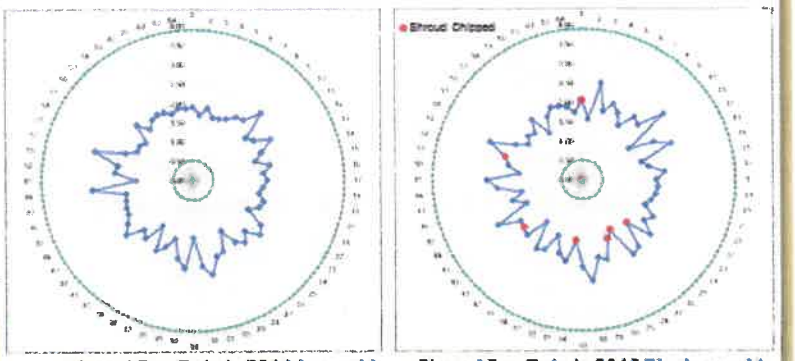
Shroud Gap Data in 2016 Dis-Assemb

Row Average Gap = 1.9mm

Criteria: Stub 0.5mm to 3.9mm Average, with no single blade above 4.8mm

LH and RH stub average gaps are nearly same.
No clear relationship between gap and shroud chipping.

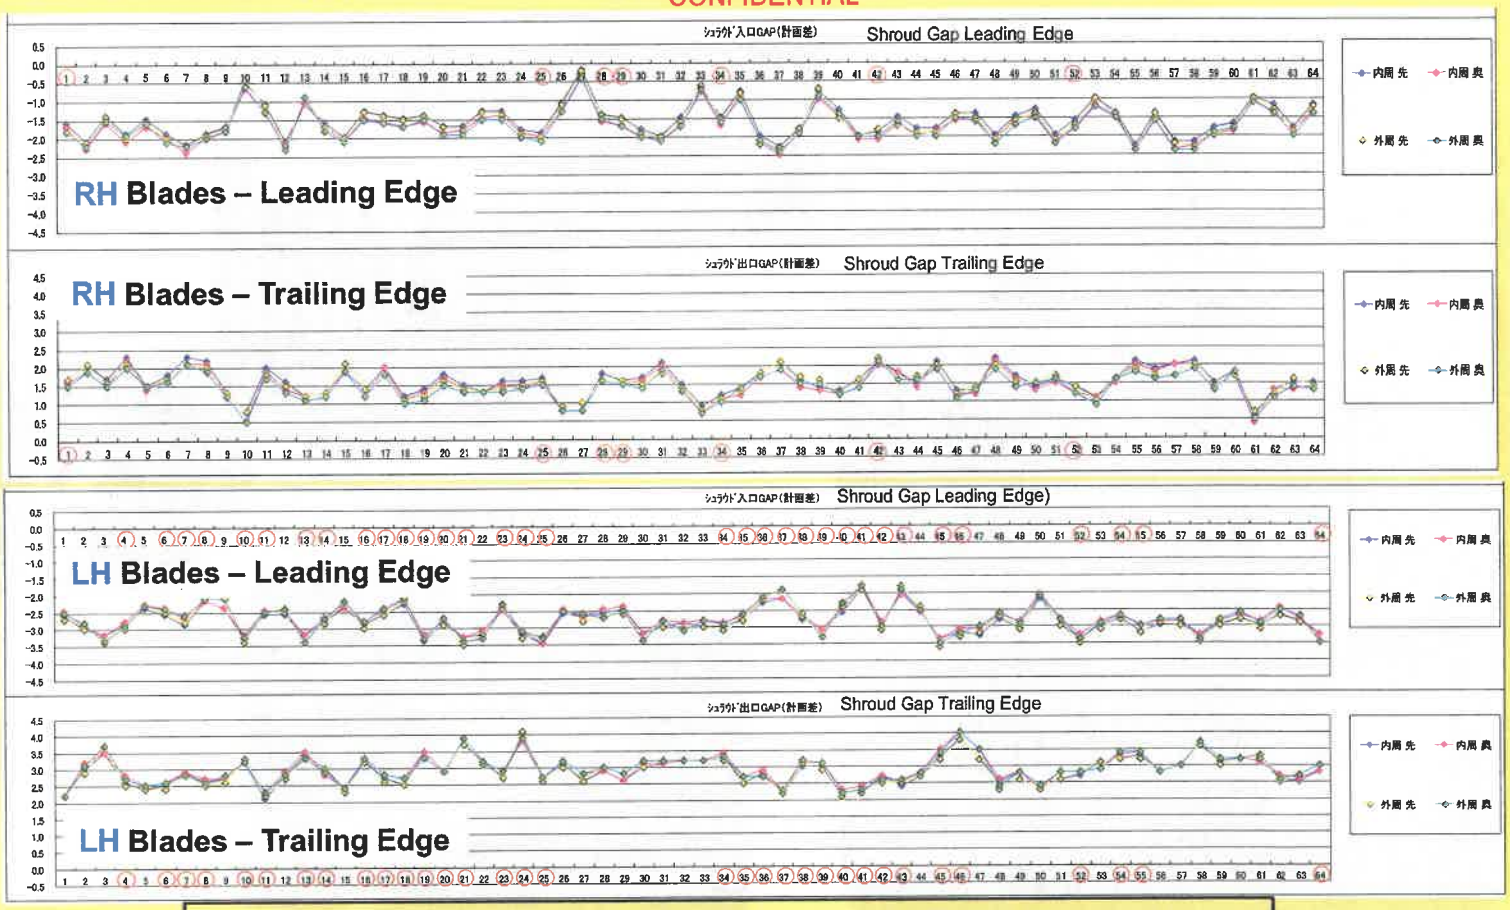
Box Gauge Measurement Results - 2014 blades

Blade manufacturing data show variation within criteria

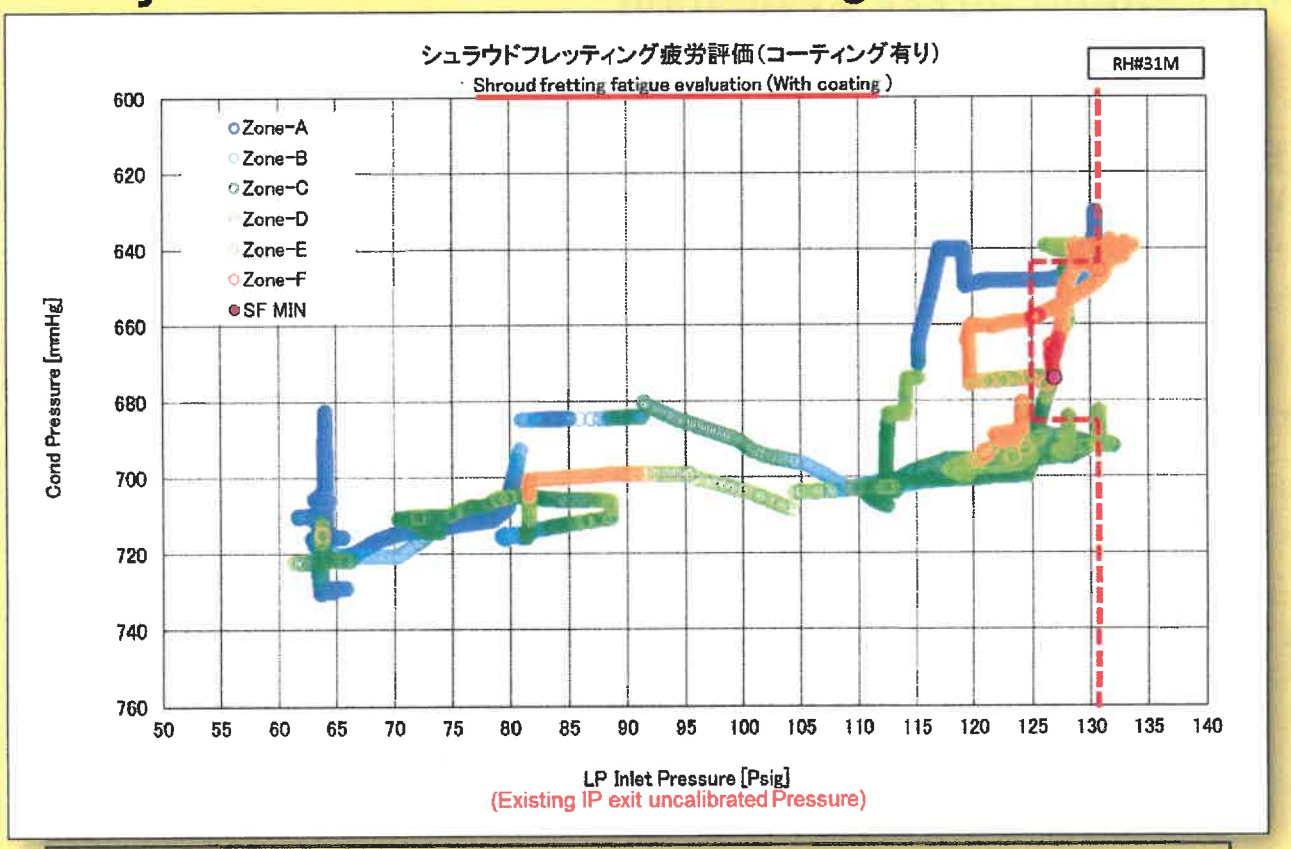
Telemetry Test Results – Shroud Fretting

Fretting fatigue calculations for shroud with coating show acceptable margins outside avoidance zone

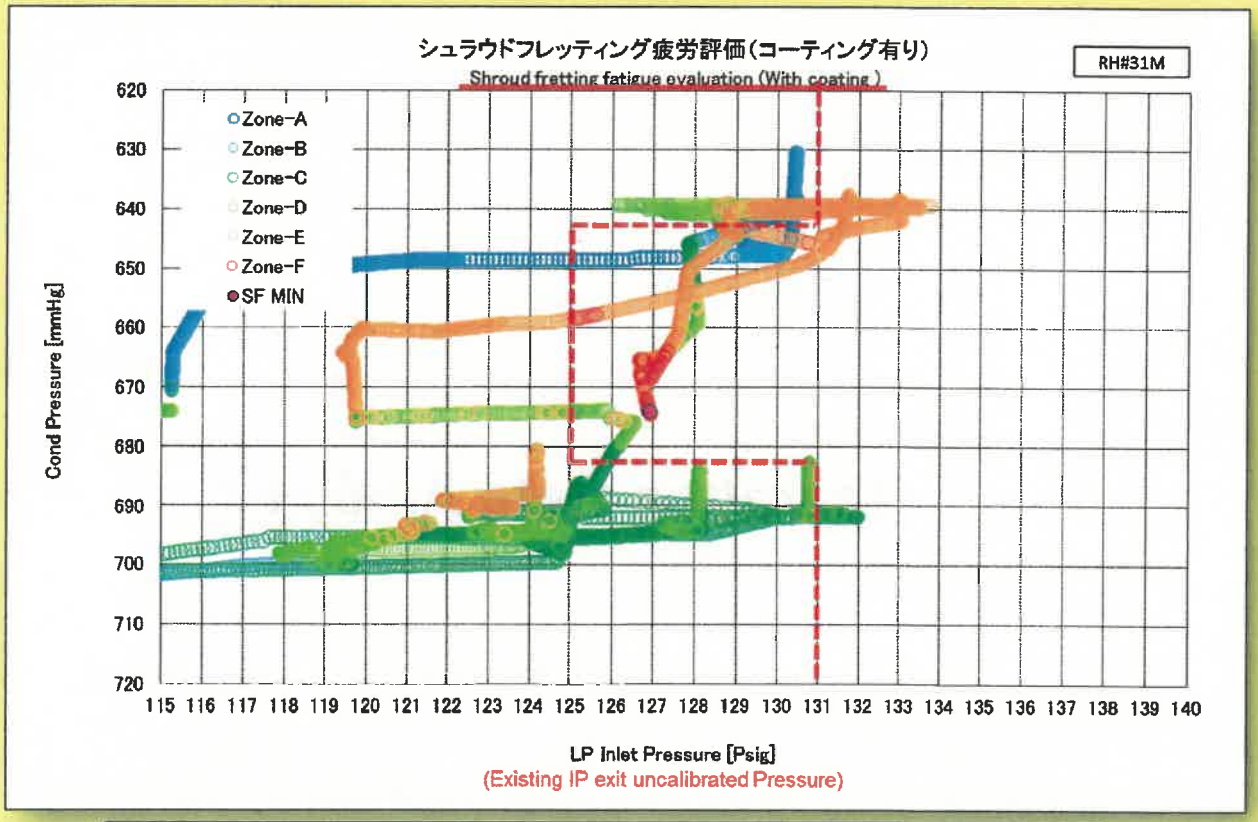
Telemetry Test Data – Shroud Fretting

Fretting fatigue calculations for shroud with coating show acceptable margins outside avoidance zone

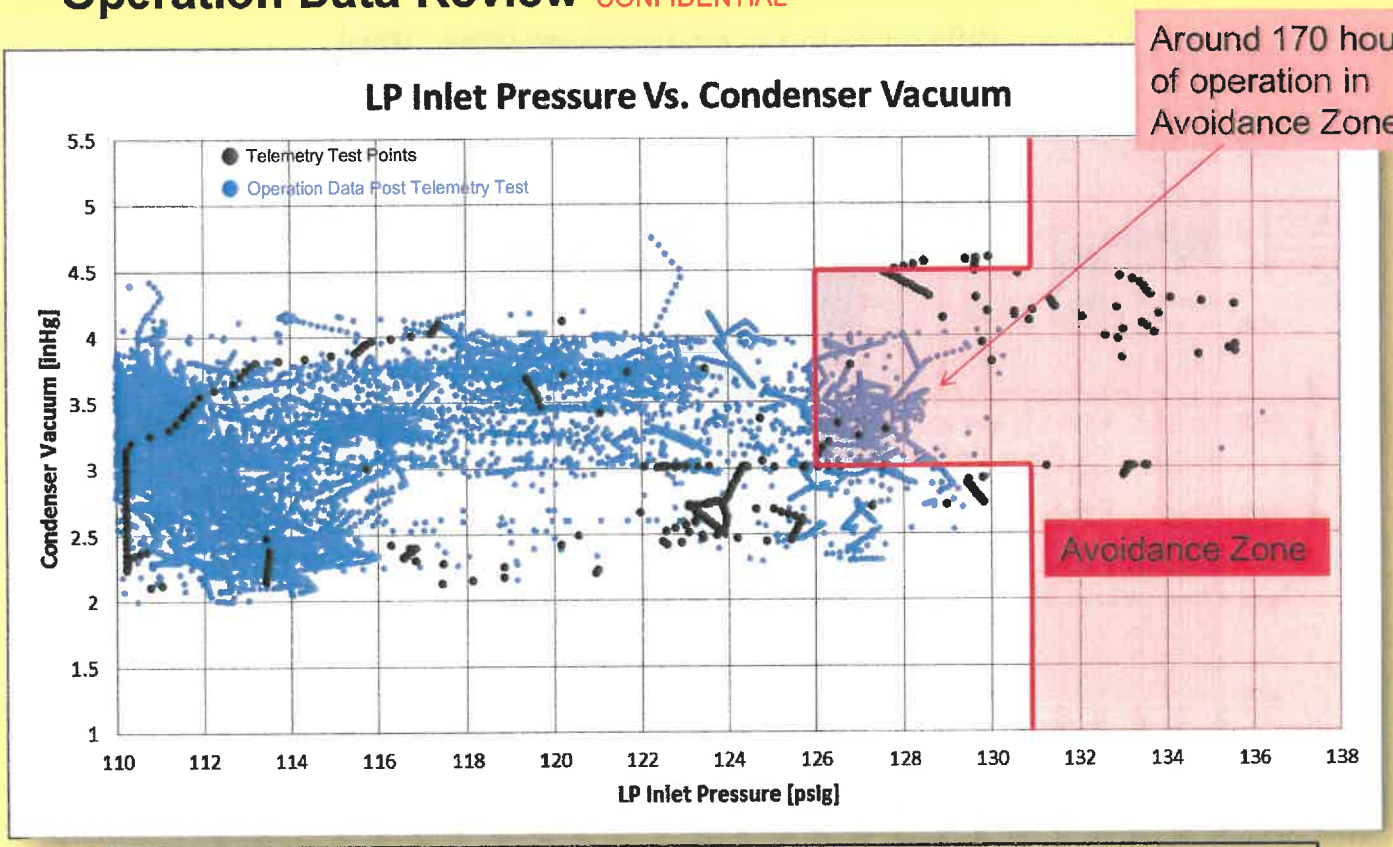
Operation Data Review CONFIDENTIAL

170+ hours of operation in avoidance zone with a response frequency ~200Hz = 1.2E8 Cycles

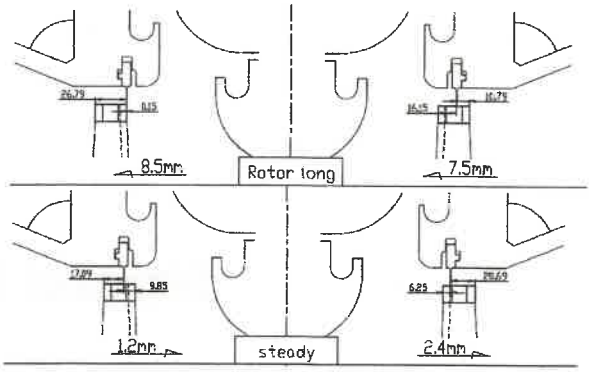
Seal Position for L-0 Blades

Operating data shows +2mm Rotor Long to Design

Operating DE at Gen End (RH) L-0 = +0.8mm Rotor Long

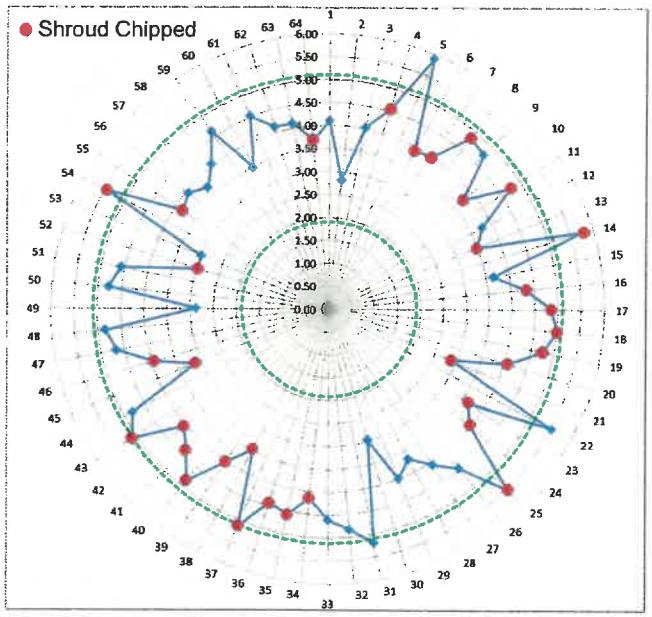
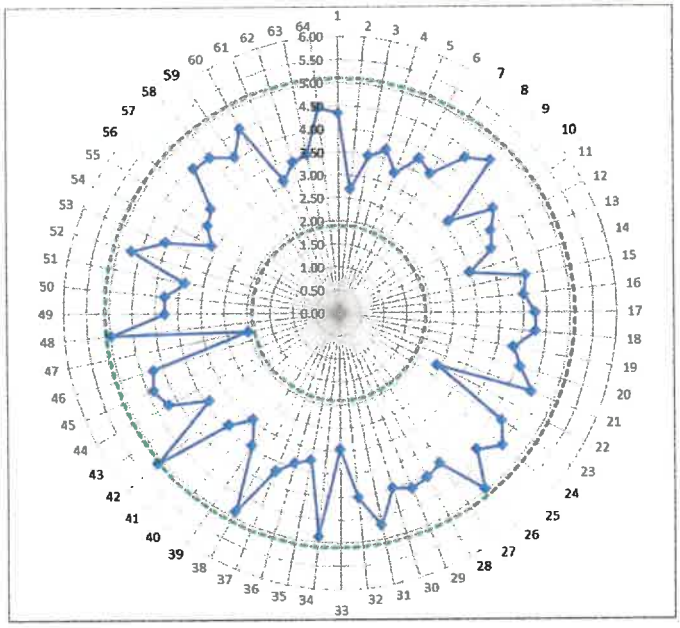
2014 Blade LH (Gov. End) Shroud Gap Data

Row Average Gap = 3.9mm

Row Average Gap = 4.2mm

Criteria: Shroud 1.9mm to 5.1mm Average, with no single blade above 6.0mm.

No clear relationship between gaps and shroud chipping

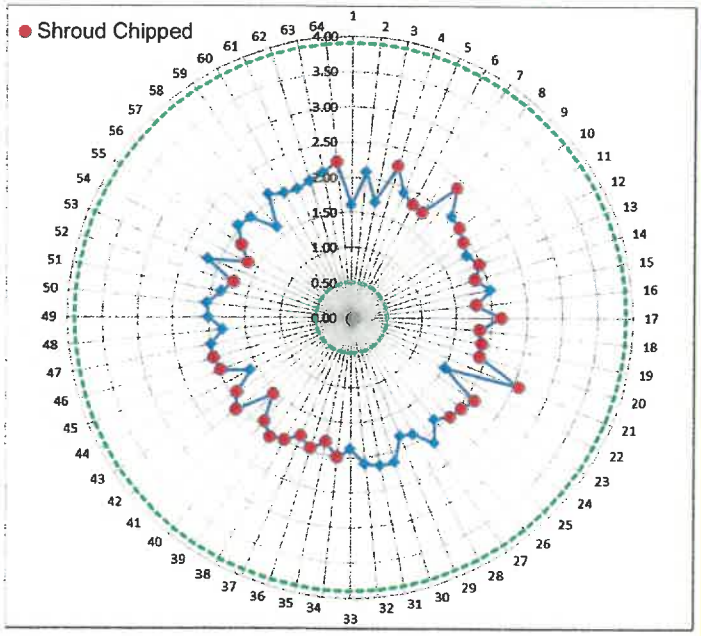
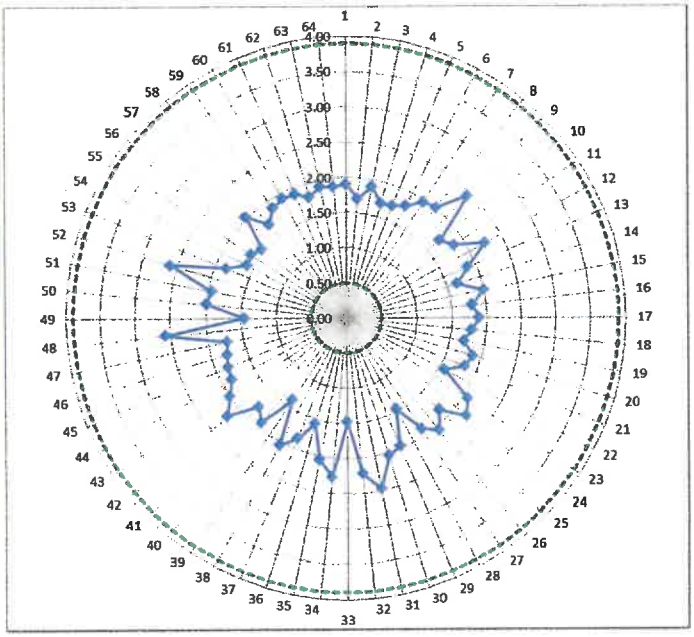
2014 Blade LH (Gov. End) Stub Gap Data

Row Average Gap = 1.9mm

Criteria: Stub 0.5mm to 3.9mm Average, with no single blade above 4.8mm.

No clear relationship between gaps and shroud chipping

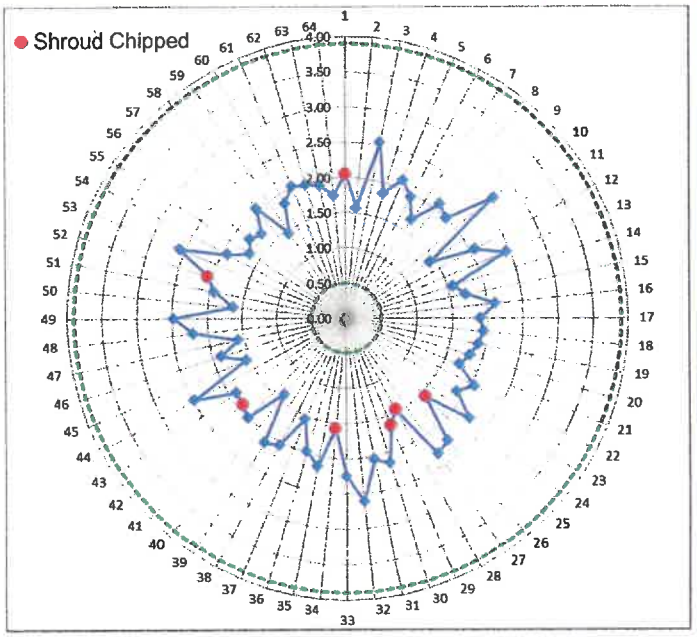
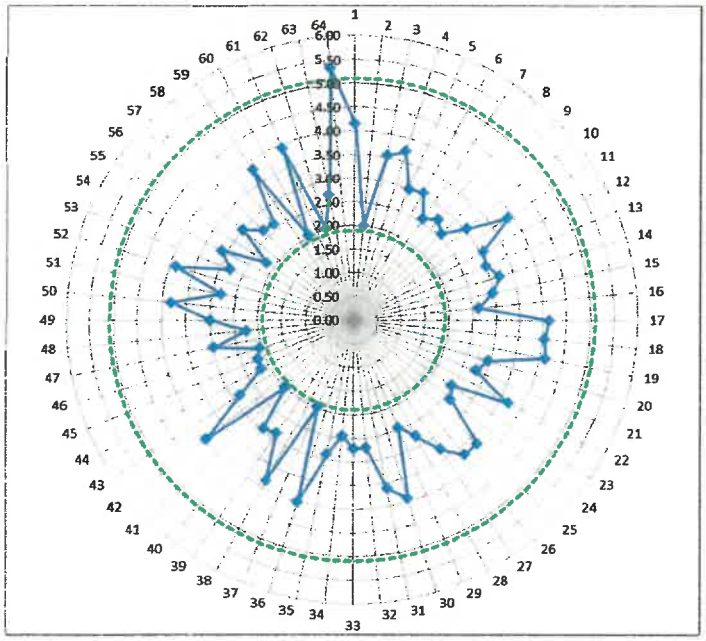
2014 Blade RH (Gen. End) Stub Gap Data

Row Average Gap = 1.9mm

Criteria: Stub 0.5mm to 3.9mm Average, with no single blade above 4.8mm.

No clear relationship between gaps and shroud chipping

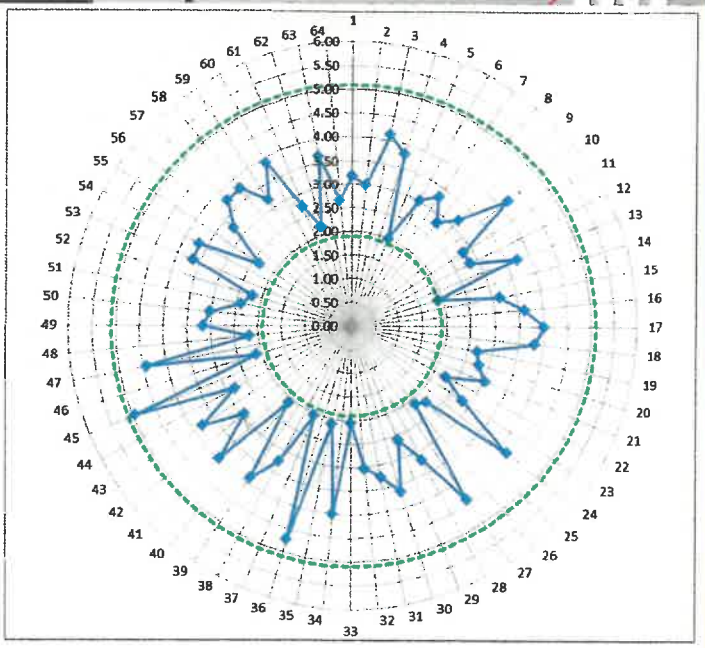
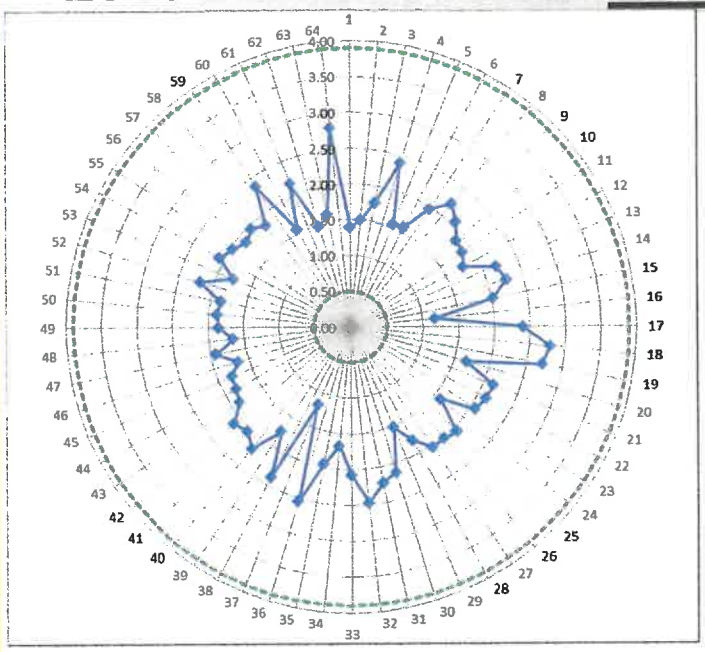
LH – Gov. End

Row Average Gap = 3.1 mm

Criteria: Shroud 1.9mm to 5.1mm Average, with no single blade above 6.0mm.

Shroud gaps are with in criteria at both Governor and Generator ends.

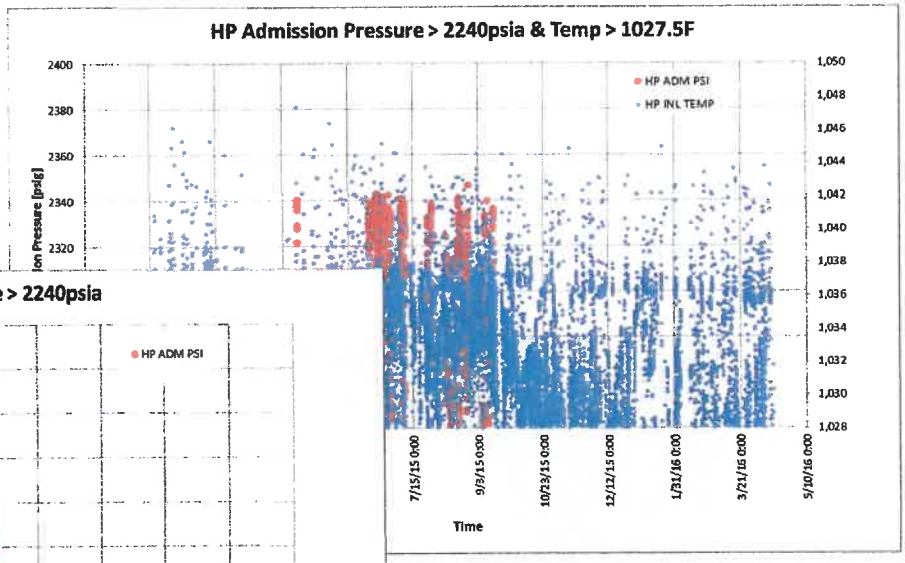
Barrow Steam Turbine Operational Limits

Around 170 hours of operation in Avoidance Zone with a resonance of ~200Hz can accumulate significant fatigue cycles

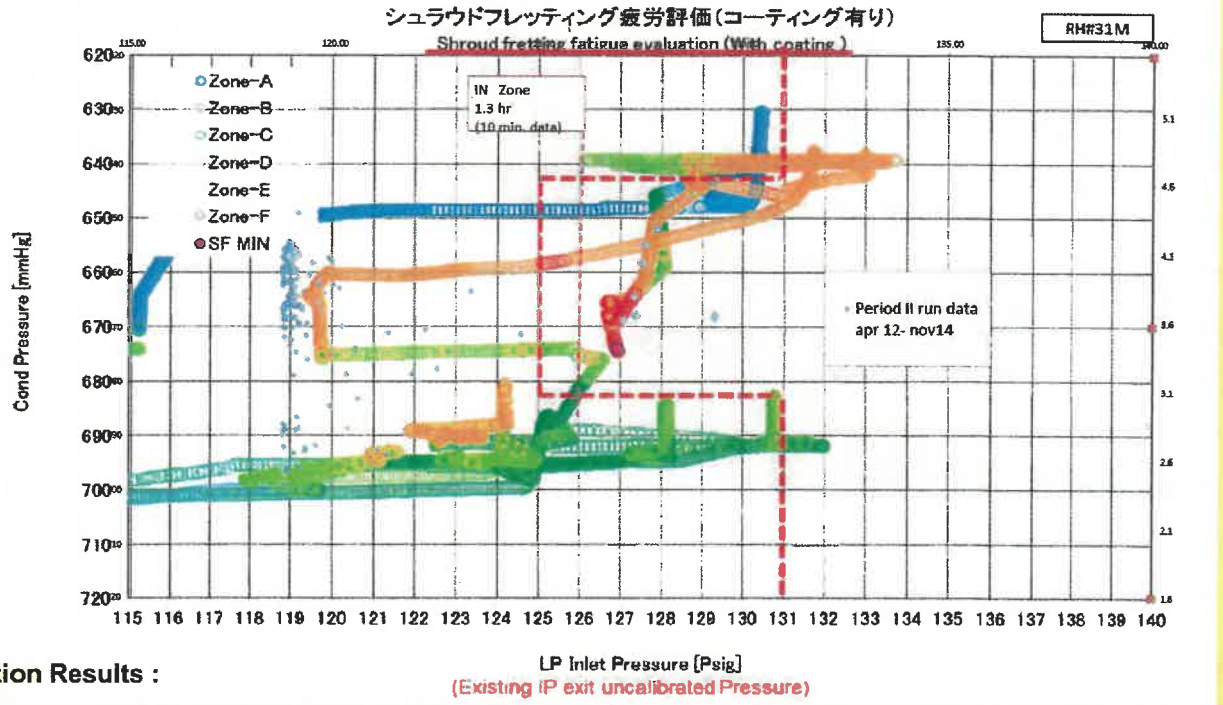
Location	Blades	Service	Mid Span Snubber	Shroud	Disposition
Gen End	Type 1	5 yrs	No significant damage	12 minor chips	Scheduled change out to blades with midspan HVOF
Gov End	Type 1	2 yrs	No significant damage	3 minor chips	Scheduled change out to blades with midspan HVOF

1.2) Operating Time 2 : Apr 2012 to Nov 2014
Minimal operation in the avoidance zone.
Minor chipping observed.

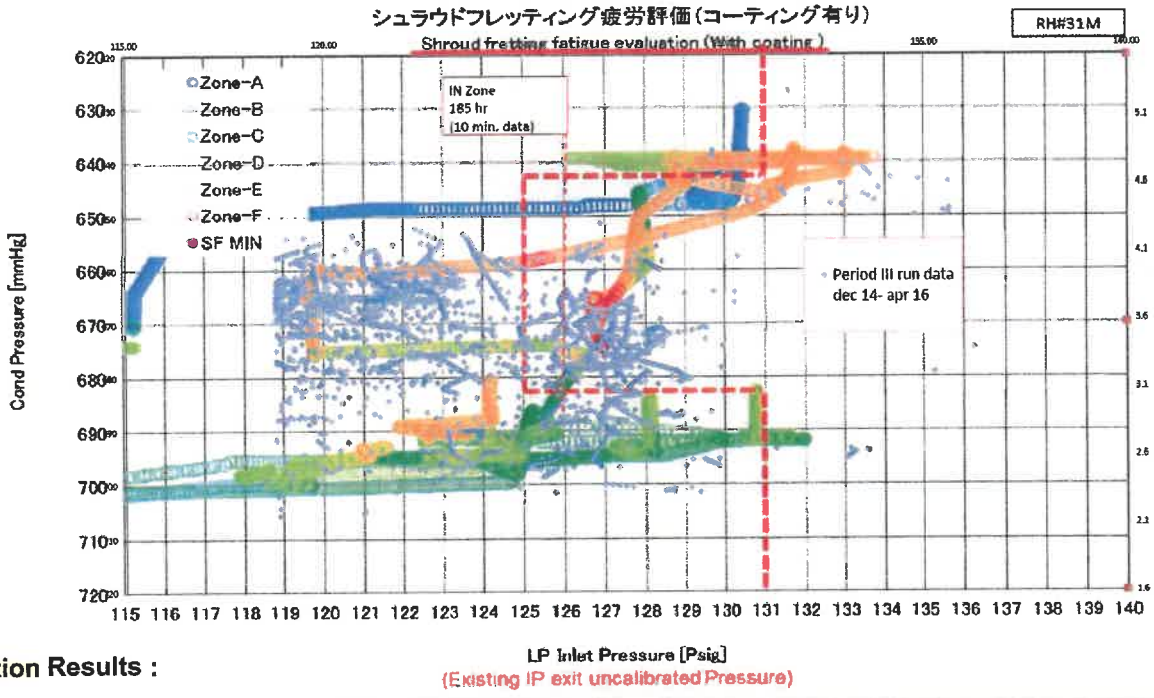
Location	Blades	Service	Mid-Span Snubber	Shroud	Disposition
Gen End	Type 3 + HVOF	15 Months	No significant damage	7 minor chips	Fit for continued operation. Shroud contact on all blades.
Gov End	Type 3 + HVOF	15 Months	No significant damage	33 chips including significant damage	Replace row as free shroud contact has bee lost on 1 blade.

1.3) Operating Time 3 : Dec 2014 to Apr 2016
Significant operation in the avoidance zone.
Significant damage observed on the blades.

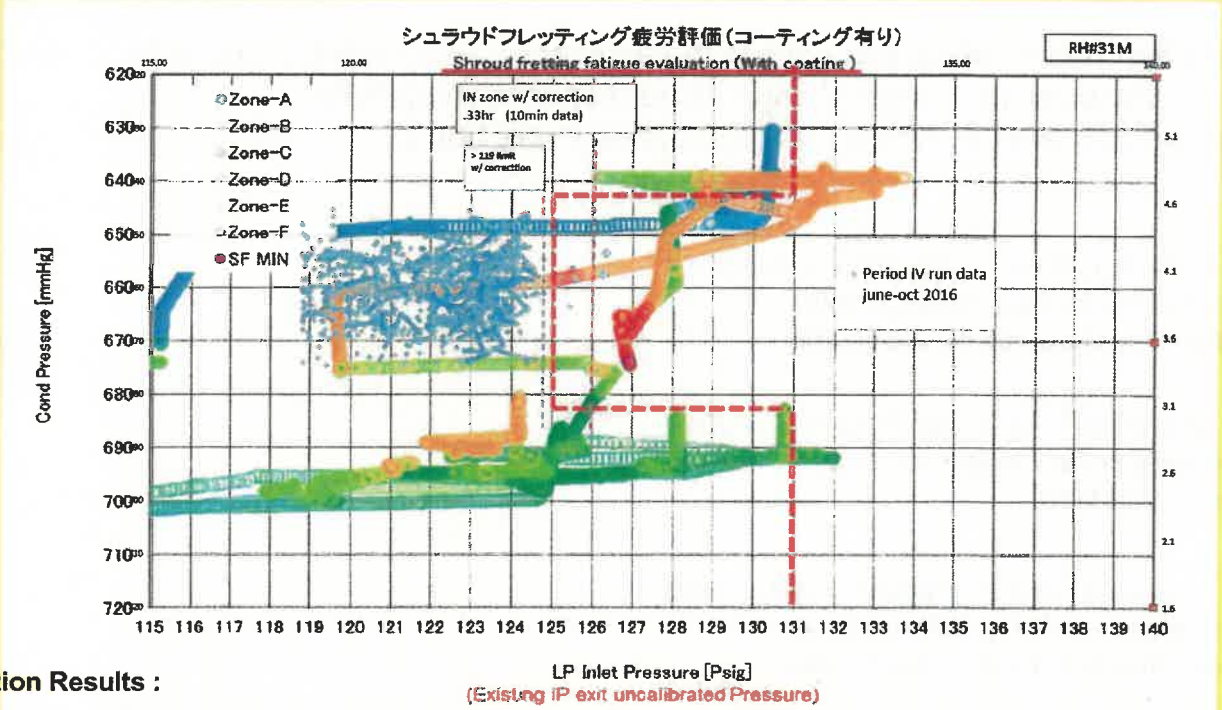
Location	Blades	Service	Mid Span Snubber	Shroud	Disposition
Gen End	Type 3 + HVOF++	4 Months	No significant damage	7 minor chips	Fit for continued operation. Shroud contact on all blades.
Gov End	Type 3 + HVOF++	4 Months	No significant damage	33 significant damage	Replace row as free shroud contact has bee lost on 1 blade.

1.4) Operating Time 4 : Jun 2016 to Oct 2016
RCA evaluation has not been completed.
Operating data has not bee provided beyond, only summaries of MW and LP Pressure vs Time.

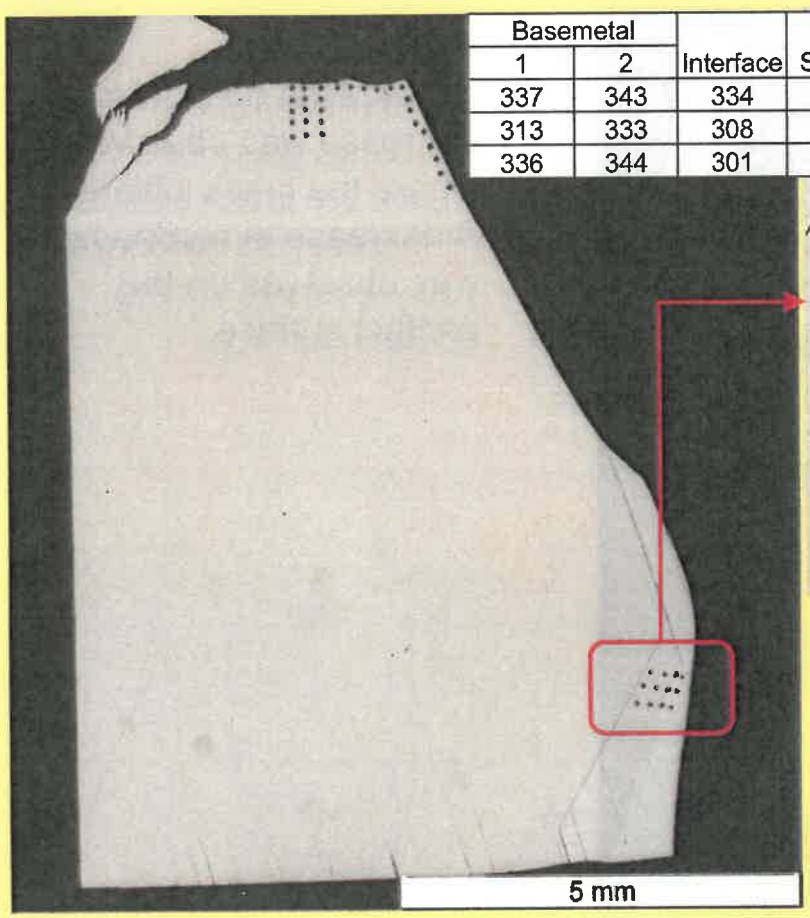
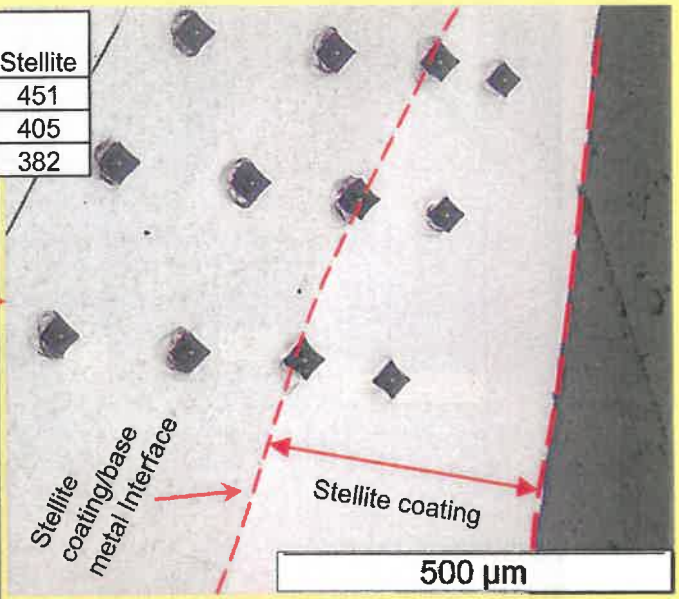
- From hardness observation no significant decrease was observed where the crack initiated.
- A decrease in hardness was observed on the contact surface.

- No significant hardness variation was observed within the base metal as a result of stellite welding.

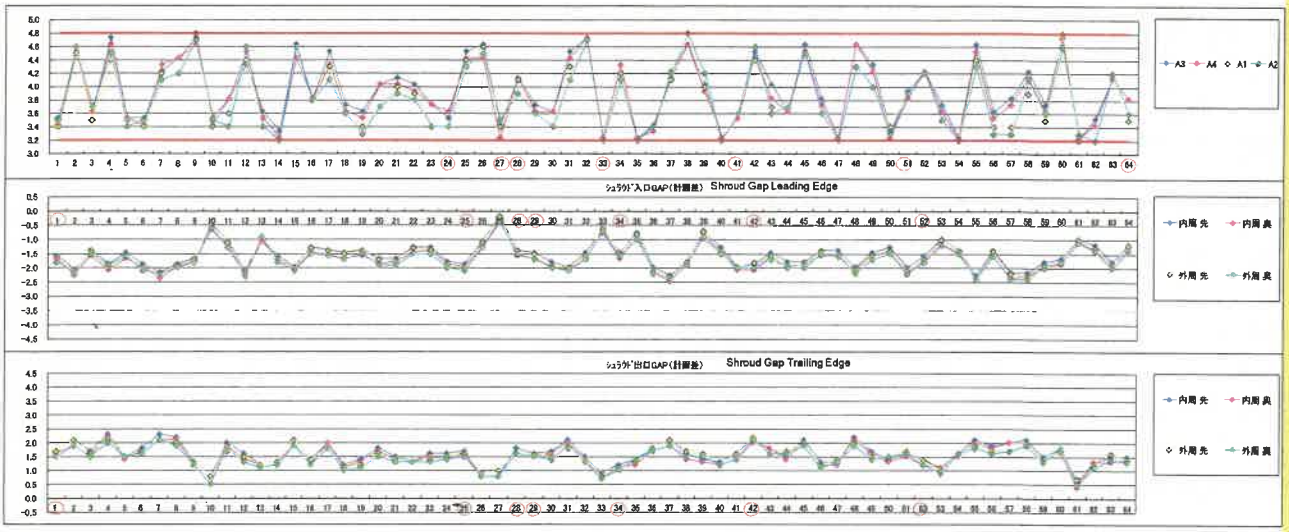
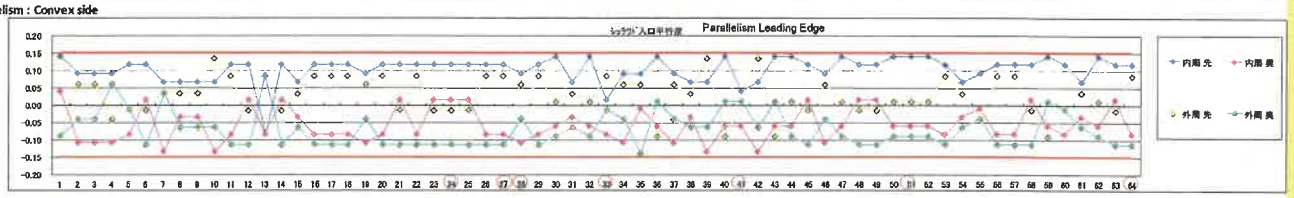
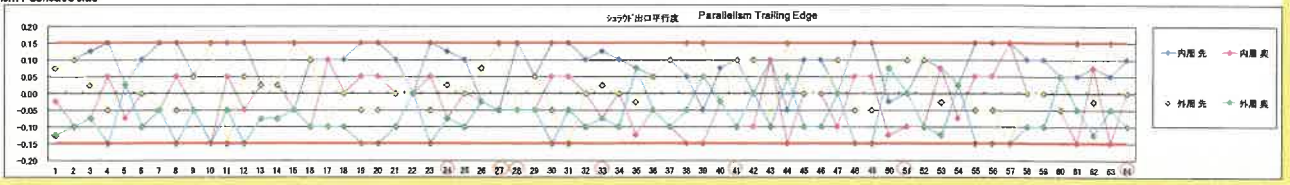
3.1) Measurement Results RH (Gen End) 2014 blades

Shroud GAP ○ : Shrouds with Damage

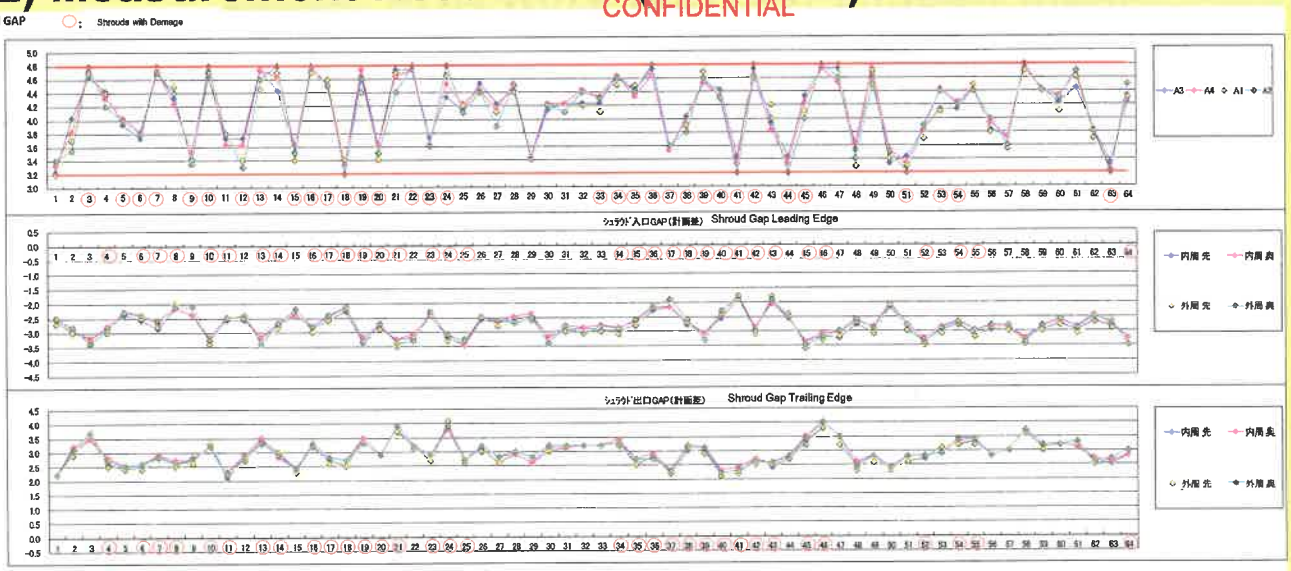
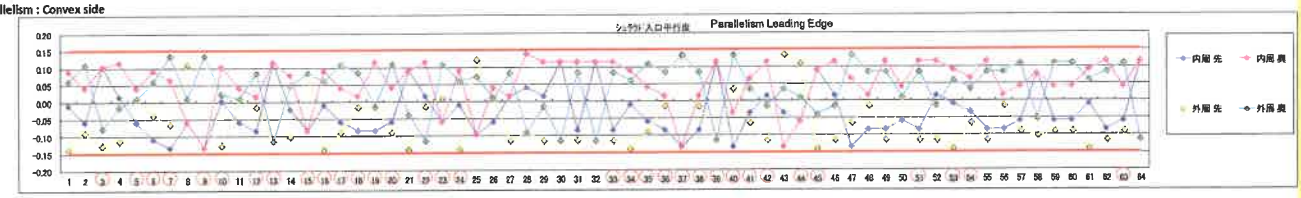
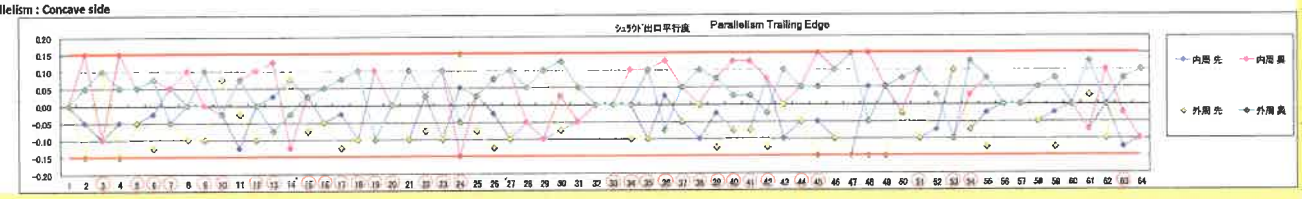
3.2) Measurement Results LH (Gov End) 2014 blades

Shroud GAP ○: Shrouds with Damage

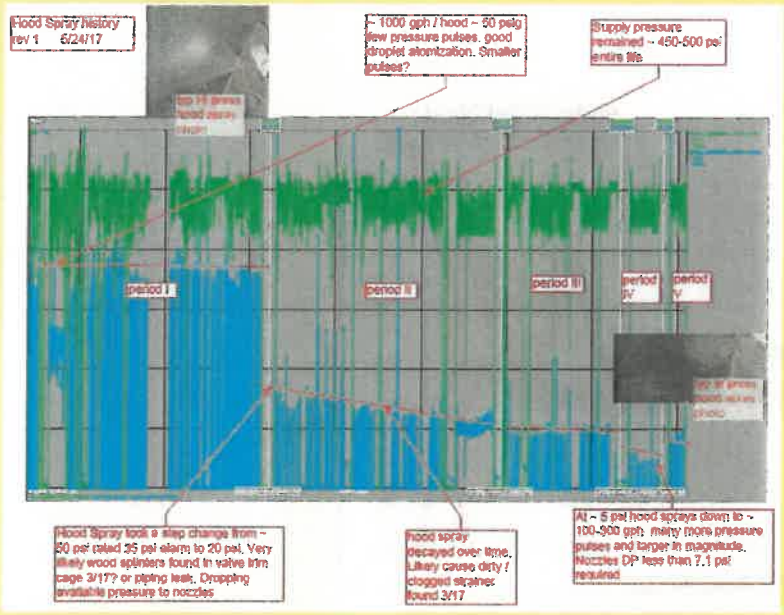
The chart below demonstrates what happened to hood spray pressure over time. The decay in water pressure at the hood spray nozzles will yield reduced atomization as these style of nozzle rely on pressure drop to create a vortex inside the nozzle that causes atomization thru centripetal force. The effect of reduced atomization was verified during a test just prior to unit restart in April 2017. A key concern of poor atomization is the effect it might have on generating dynamic pressures which the L-0 blades might see as large water droplets evaporate in the exhaust stream.

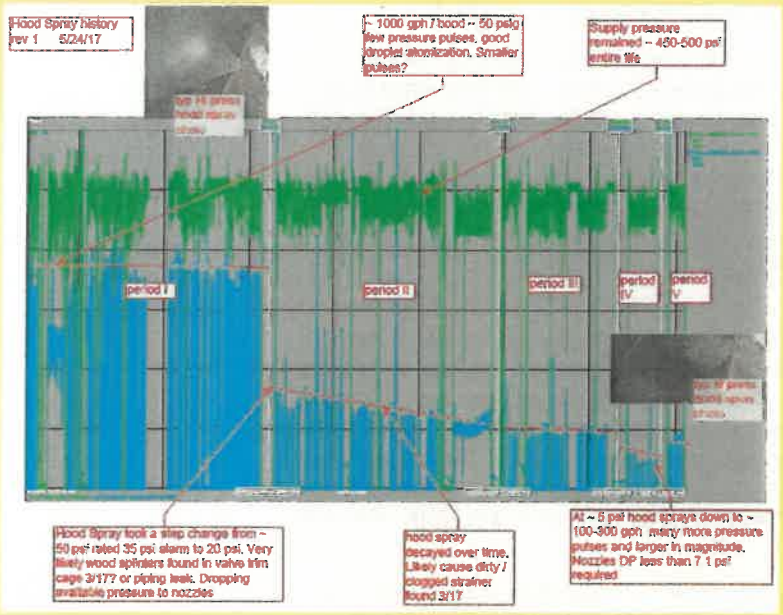
Careful attention was also paid to the hood spray pressure over time. This was found to steadily decrease over successive Periods. Maintenance of the valve in Spring 2017 revealed debris in the valve passageways. Review of historical records also indicate the strainer ahead of the valve had filled with debris in prior years' operating.

The chart below demonstrates what happened to hood spray pressure over time. The decay in water pressure at the hood spray nozzles will yield reduced atomization as these style of nozzle rely on pressure drop to create a vortex inside the nozzle that causes atomization thru centripetal force. The effect of reduced atomization was verified during a test just prior to unit restart in April 2017. A key concern of poor atomization is the effect it might have on generating dynamic pressures which the L-0 blades might see as large water droplets evaporate in the exhaust stream.

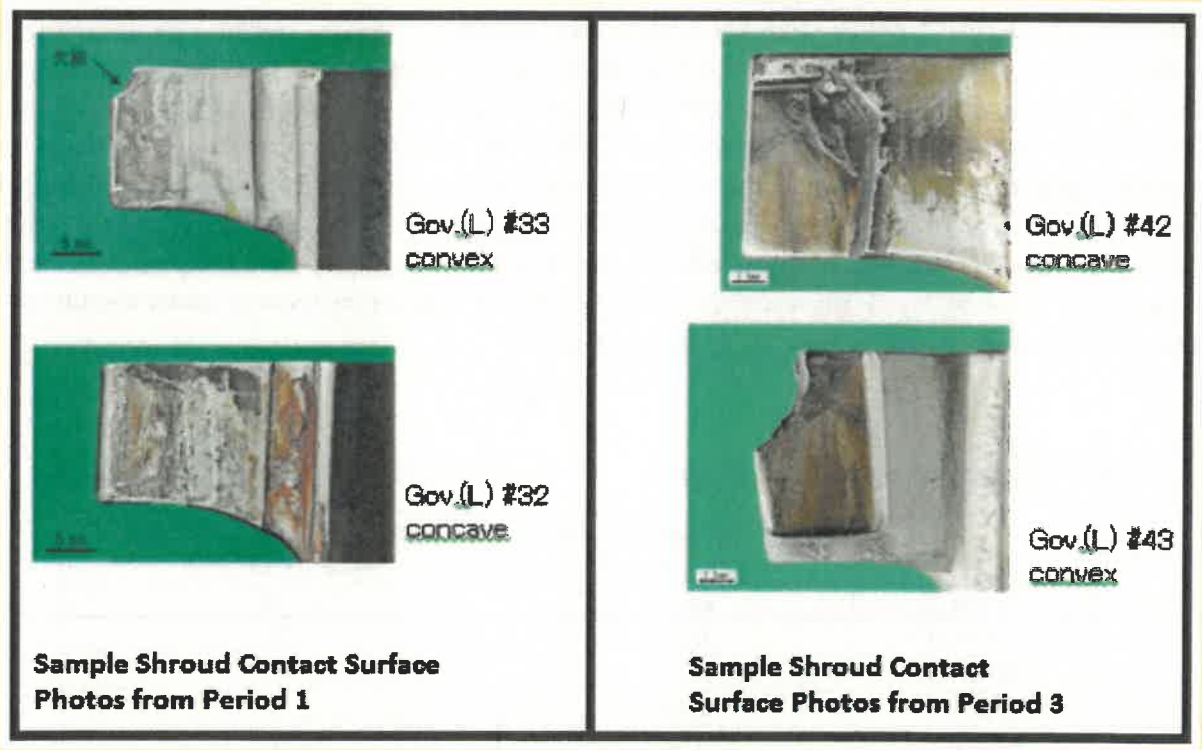
Figure 1 -- Comparative Photos of Shroud Contact Surface Wear for Periods 1 and 3

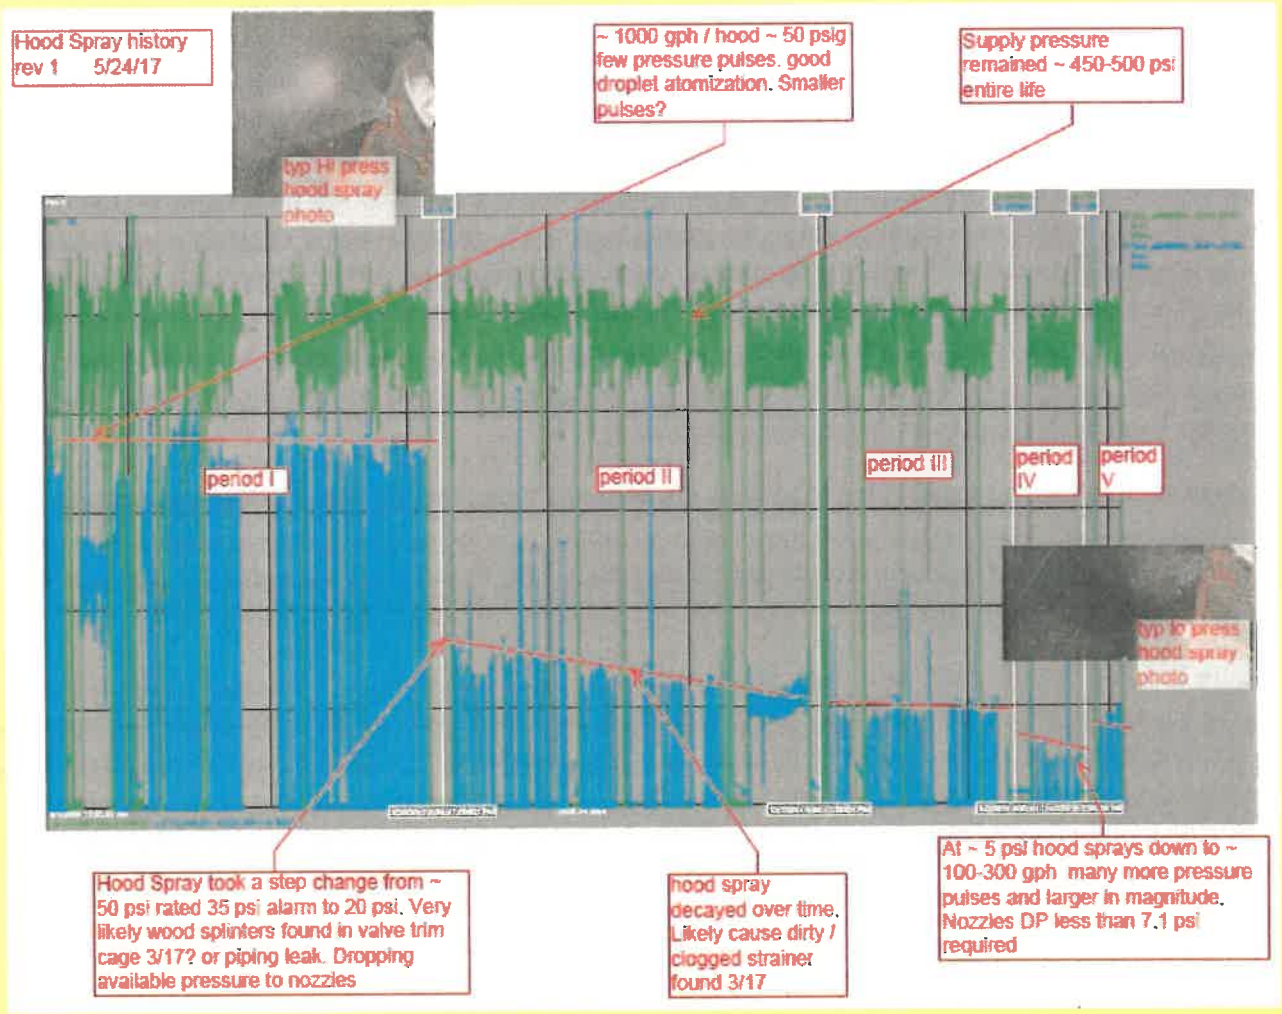
Figure 2 -- Hood Spray Pressure Degradation Over Periods 1-5

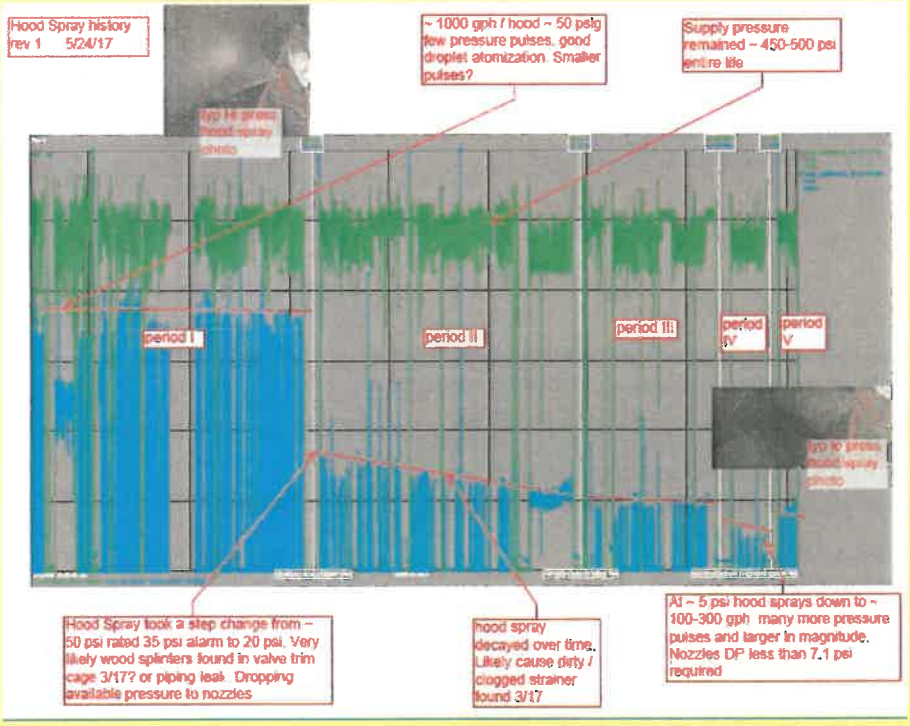
Careful attention was also paid to the hood spray pressure over time. This was found to steadily decrease over successive Periods. Maintenance of the valve in spring 2017 revealed debris in the valve passageways. Review of historical records also indicate the strainer ahead of the valve had filled with debris in prior years.

The chart below shows what happened to hood spray pressure over time. The decay in water pressure at the hood spray nozzles will have reduced atomization as these style of nozzle rely on pressure drop to create a vortex inside the nozzle that causes atomization thru centripetal force. The effect of reduced atomization was verified during a test just prior to unit restart in April 2017. A key concern of poor atomization is the effect it might have on generating dynamic pressures which the L-0 blades might see as large water droplets evaporate in the exhaust stream.

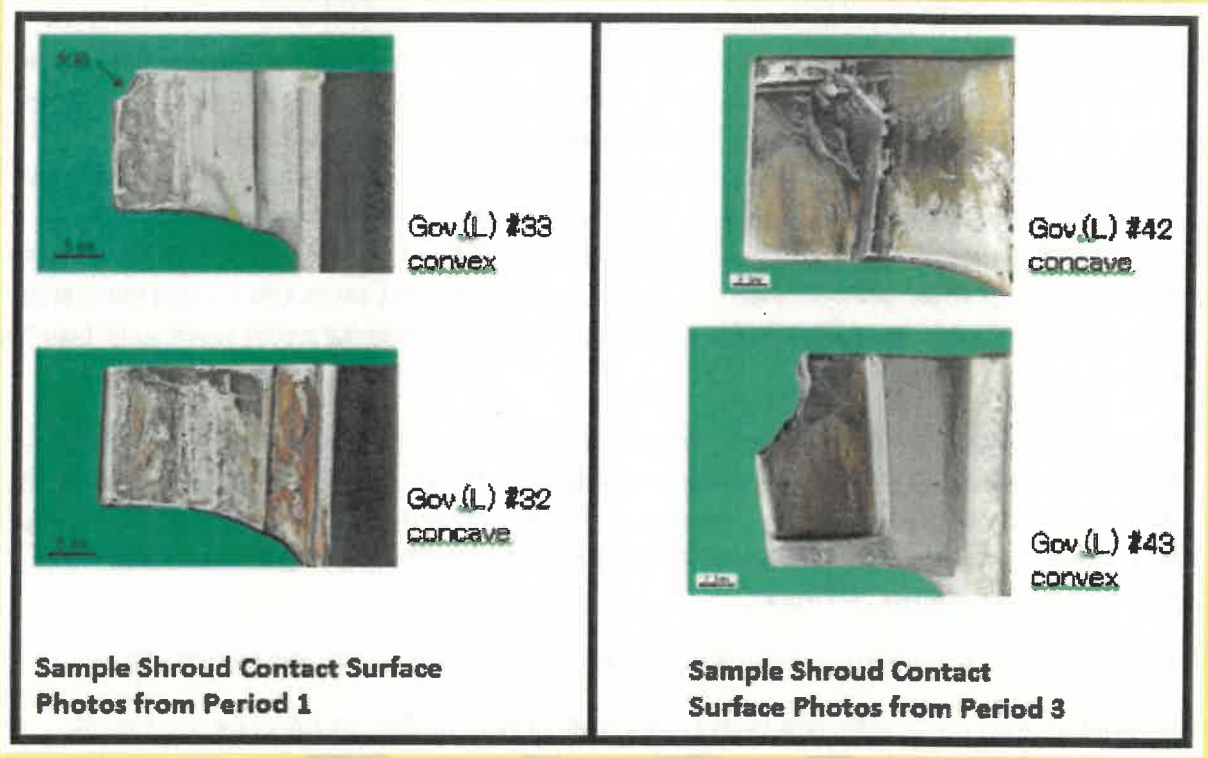
Figure 1 –Photos of Shroud Contact Surface Wear for Periods 1 and 3
