DOCKET NO.: 20200001-EI

WITNESS: Jeffrey Swartz

FOURTH AMENDMENT TO
CONTRACT FOR PURCHASE OF STEAM TURBINE GENERATOR

Bartow 4S Root Cause Analysis – Evaluation of Contributing Factors

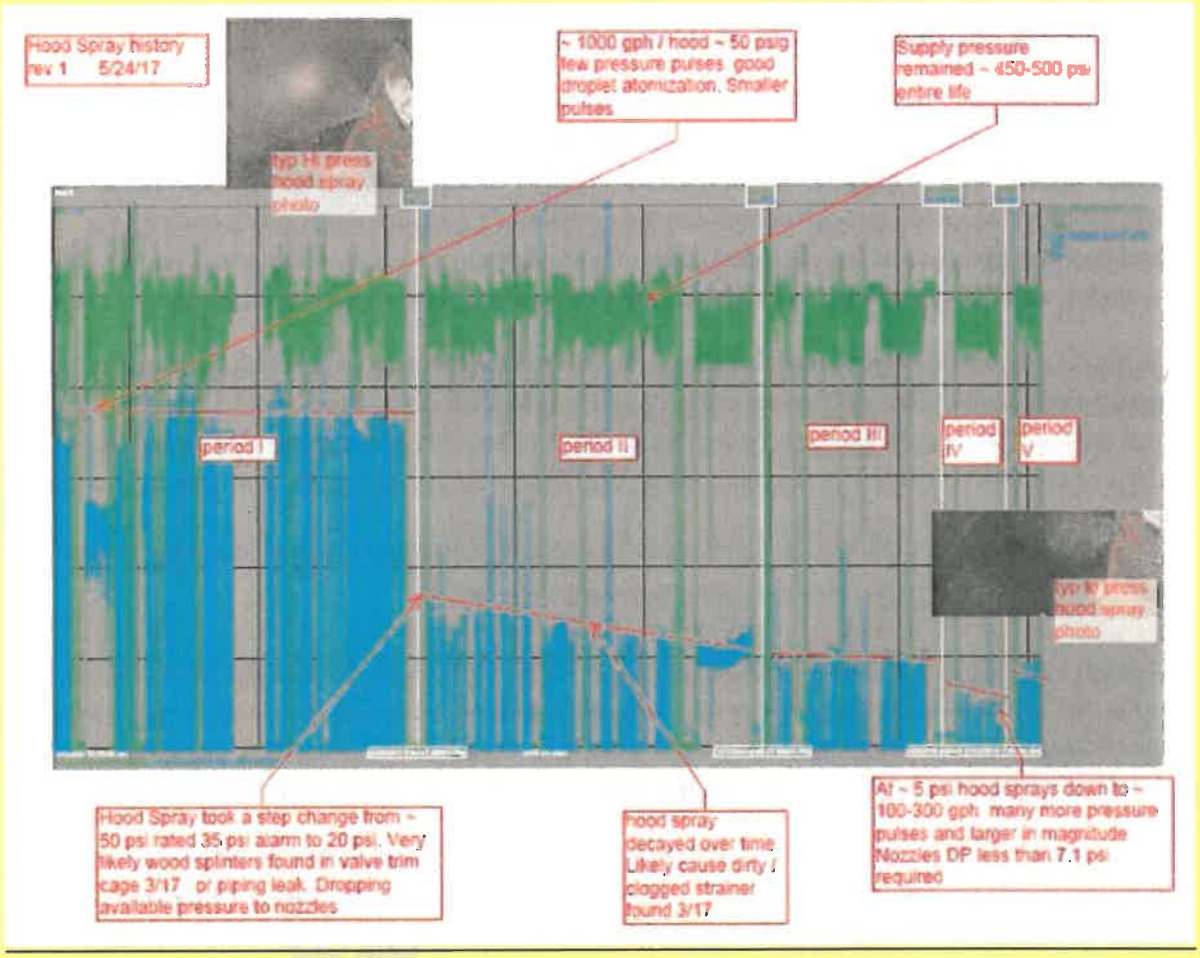
At the kind of hood spray pressures shown in Figure 2, the atomization of the hood sprays would have been poor. Larger water droplets will cause pressure pulses as evaporation occurs, during times when the LP exhaust steam temperatures are elevated during blending.

Figure 2 – Hood Spray Pressure Degradation Over Periods 1-5

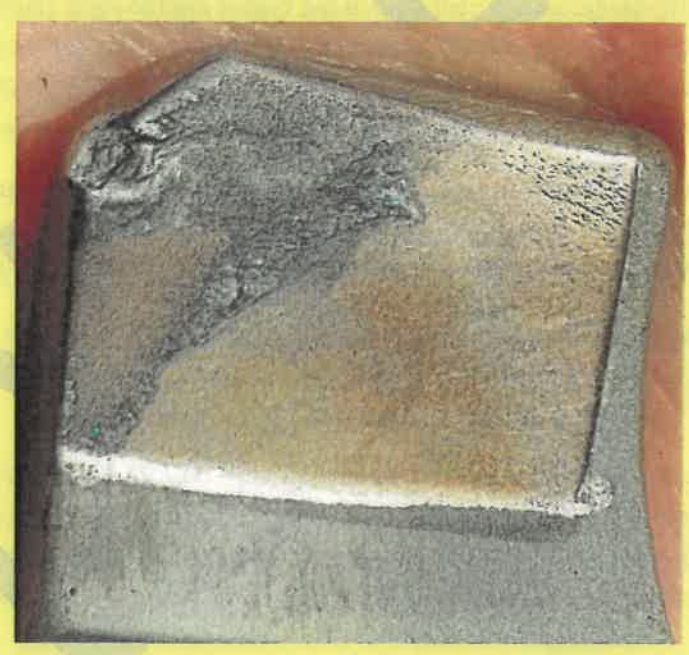
Figure 4 – Photo of an L-0 blade Z-Lock from Period 5 Showing Contact Surface Wear

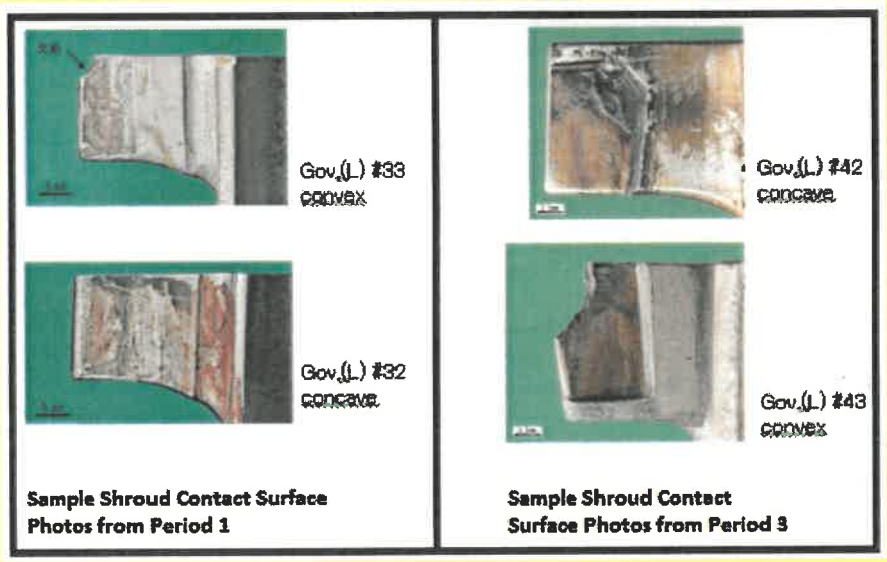
By a considerable margin, Period 1 had the greatest amount of run hours in exceedance of the "avoidance zone" relative to total operating hours – 2,466 out of 21,734 total hours. However, blade damage was relegated to five (5) broken mid-span snubbers on the turbine end of the machine and a minimal degree of fretting on the shroud Z-Lock contact surfaces for both turbine and generator ends of the machine.

Conversely, during Period 3, there were only 240 hours (out of 10,286 total hours) of operation in the "avoidance zone", approx. 11 hours of which occurred during the instrumented blade telemetry test performed by MHPS in December 2014. Even with a significantly fewer number of "avoidance zone" hours for Period 3 relative to Period 1 – a factor of 10 fewer hours for Period 3 – there was significantly greater amounts of blade damage and fretting on both ends of the machine. While the amount of Z-Lock wear is not quantified for Periods 1 and 3, photographic evidence suggests that the amount of wear is much greater for Period 3, as shown below in Figure 1. It is therefore difficult to conclude that damage to the L-0 blades in Period 3 is solely due to unit operation above the exhaust flow limit.

Figure 1 -- Comparative Photos of Shroud Contact Surface Wear for Periods 1 and 3

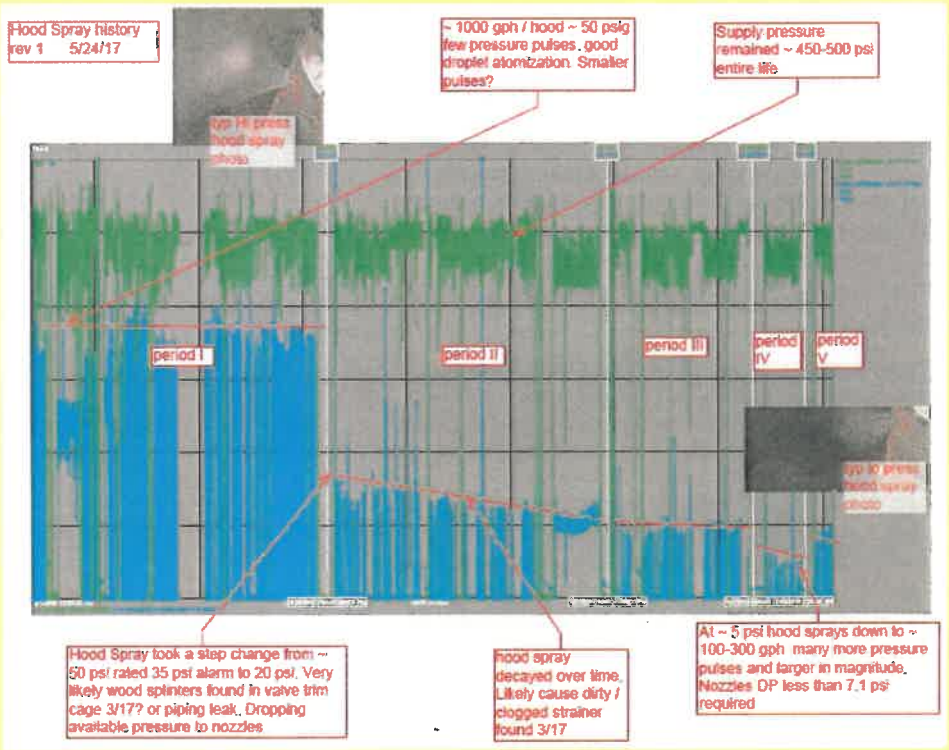
Figure 2 -- Hood Spray Pressure Degradation Over Periods 1-5

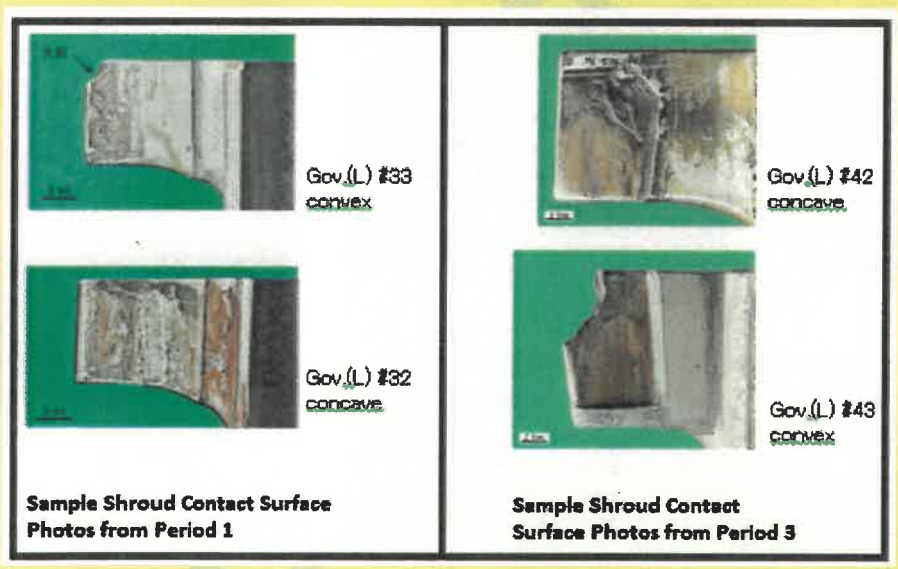
Conversely, during Period 3, there were only 240 hours (out of 10,286 total hours) of operation in the "avoidance zone", approx. 11 hours of which occurred during the instrumented blade telemetry test performed by MHPS in December 2014. Even with a significantly fewer number of "avoidance zone" hours for Period 3 relative to Period 1 – a factor of 10 fewer hours for Period 3 – there was significantly greater amounts of blade damage and fretting on both ends of the machine. While the amount of Z-Lock wear is not quantified for Periods 1 and 3, photographic evidence suggests that the amount of wear is much greater for Period 3, as shown below in Figure 1. It is therefore difficult to conclude that damage to the L-0 blades in Period 3 is solely due to unit operation above the exhaust flow limit.

Figure 1 -- Comparative Photos of Shroud Contact Surface Wear for Periods 1 and 3

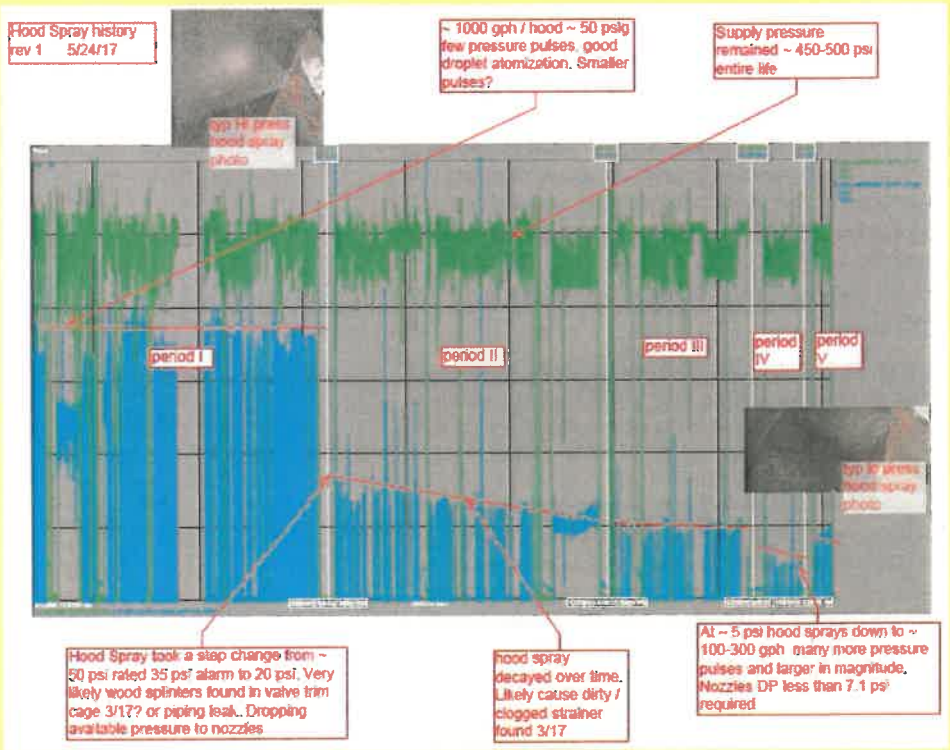
Figure 2 -- Hood Spray Pressure Degradation Over Periods 1-5

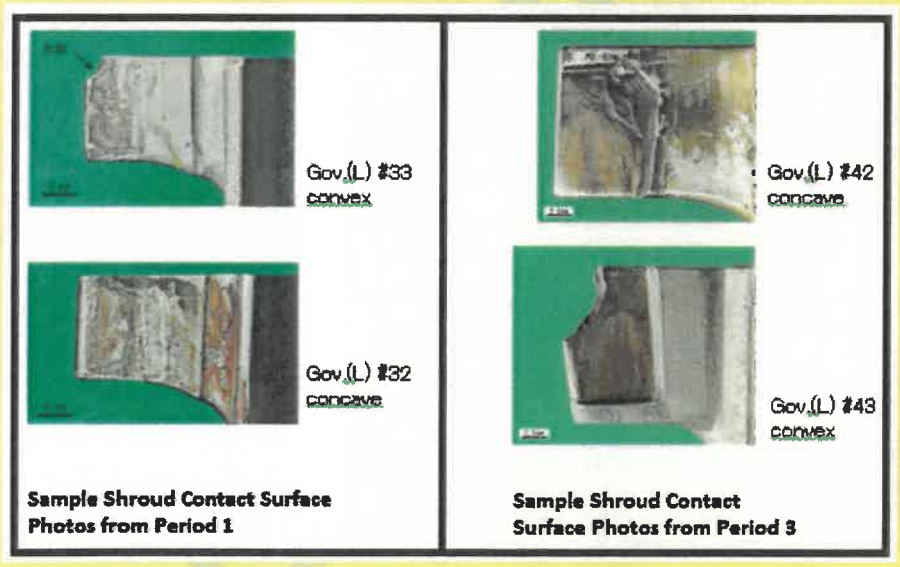
Conversely, during Period 3, there were only 240 hours (out of 10,286 total hours) of operation in the "avoidance zone", approx. 11 hours of which occurred during the instrumented blade telemetry test performed by MHPS in December 2014. Even with a significantly fewer number of "avoidance zone" hours for Period 3 relative to Period 1 – a factor of 10 fewer hours for Period 3 – there was significantly greater amounts of blade damage and fretting on both ends of the machine. While the amount of Z-Lock wear is not quantified for Periods 1 and 3, photographic evidence suggests that the amount of wear is much greater for Period 3, as shown below in Figure 1. It is therefore difficult to conclude that damage to the L-0 blades in Period 3 is solely due to unit operation above the exhaust flow limit.

Figure 1 -- Comparative Photos of Shroud Contact Surface Wear for Periods 1 and 3

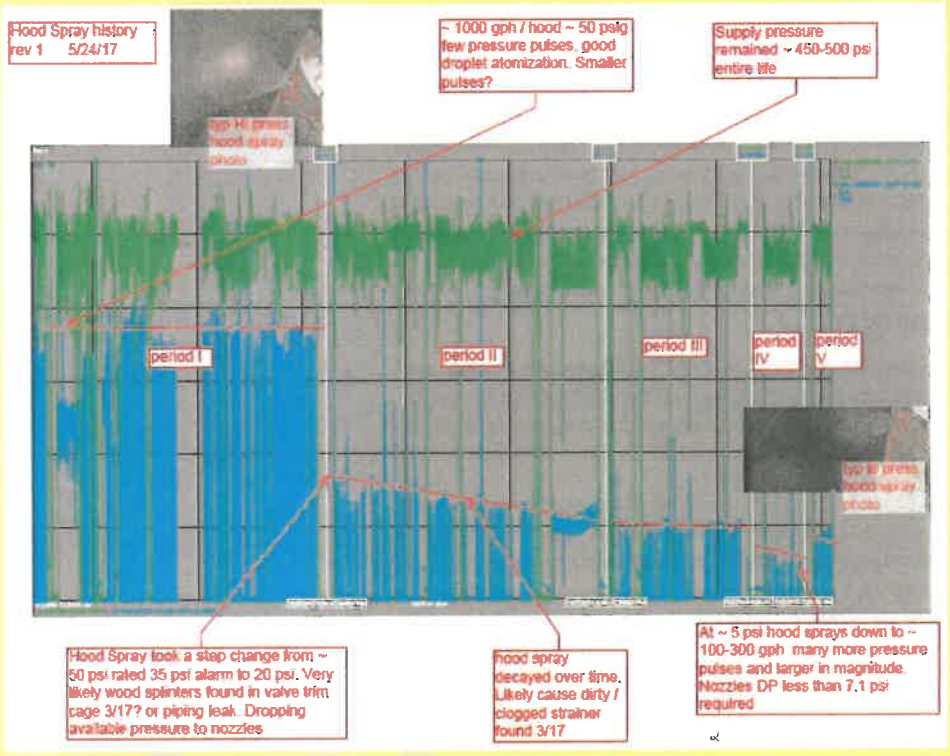
Figure 2 -- Hood Spray Pressure Degradation Over Periods 1-5

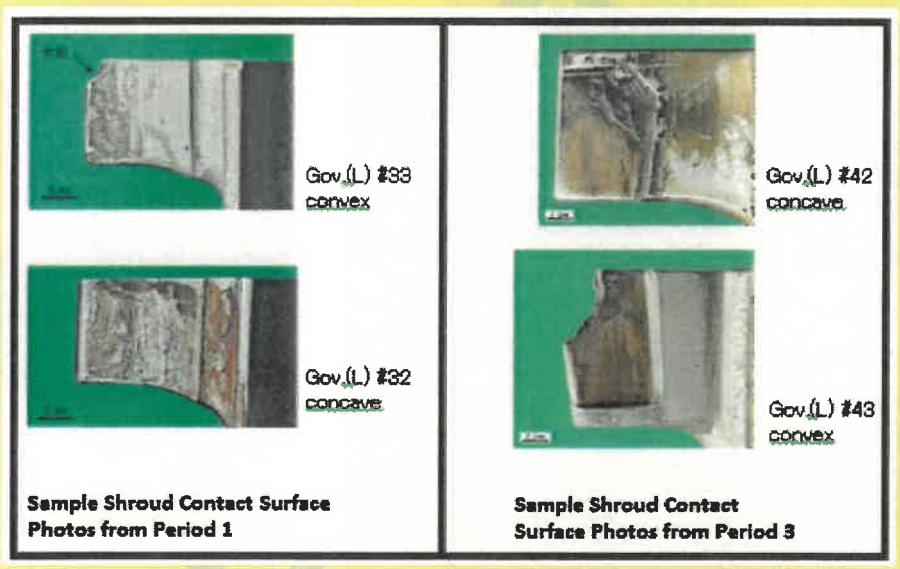
Conversely, during Period 3, there were only 240 hours (out of 10,286 total hours) of operation in the "avoidance zone", approx. 11 hours of which occurred during the instrumented blade telemetry test performed by MHPS in December 2014. Even with a significantly fewer number of "avoidance zone" hours for Period 3 relative to Period 1 – a factor of 10 fewer hours for Period 3 – there was significantly greater amounts of blade damage and fretting on both ends of the machine. While the amount of Z-Lock wear is not quantified for Periods 1 and 3, photographic evidence suggests that the amount of wear is much greater for Period 3, as shown below in Figure 1. It is therefore difficult to conclude that damage to the L-0 blades in Period 3 is solely due to unit operation above the exhaust flow limit.

Figure 1 -- Comparative Photos of Shroud Contact Surface Wear for Periods 1 and 3

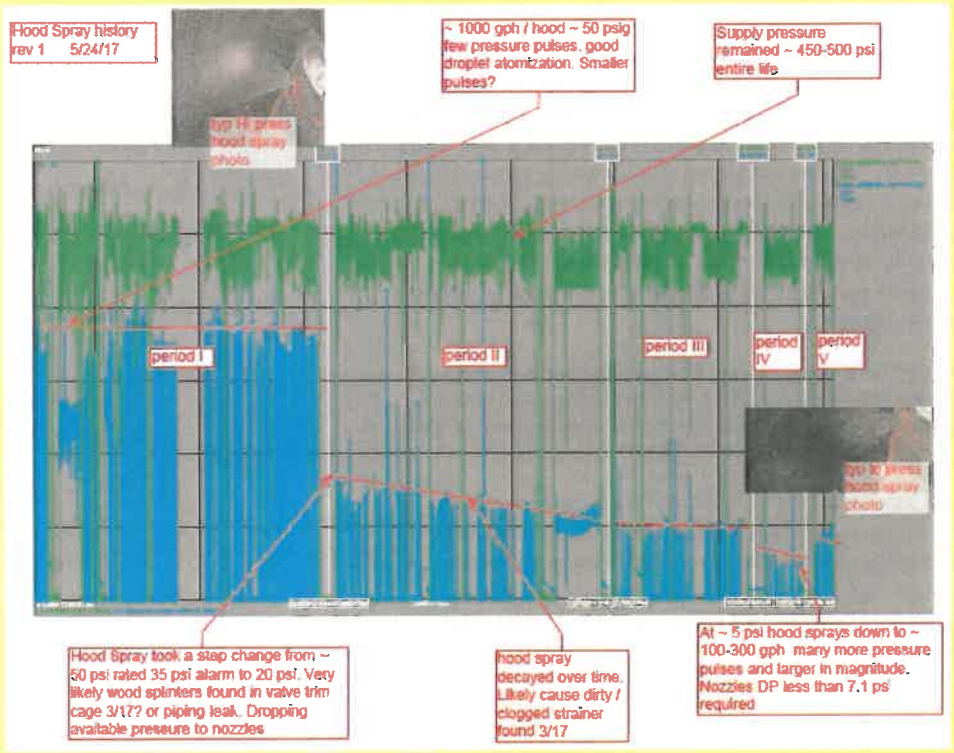
Figure 2 -- Hood Spray Pressure Degradation Over Periods 1-5

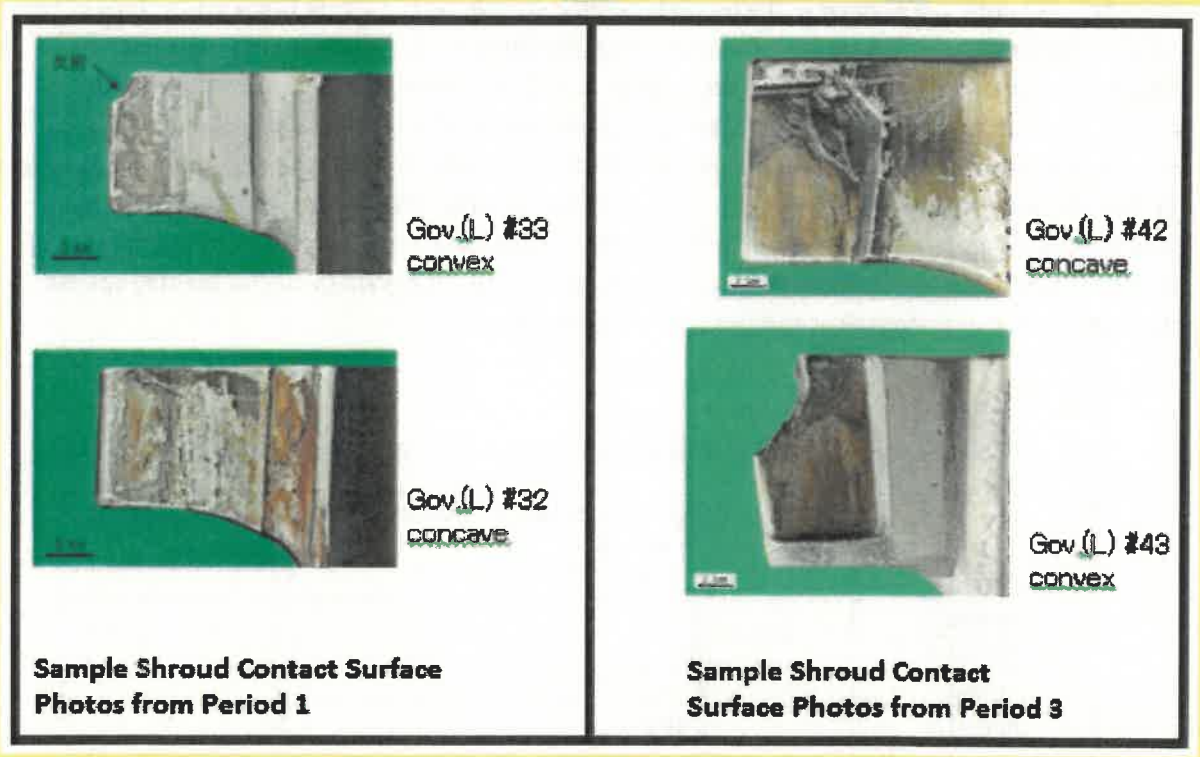
Conversely, during Period 3, there were only 240 hours (out of 10,286 total hours) of operation in the "avoidance zone", approx. 11 hours of which occurred during the instrumented blade telemetry test performed by MHPS in December 2014. Even with a significantly fewer number of "avoidance zone" hours for Period 3 relative to Period 1 – a factor of 10 fewer hours for Period 3 – there was significantly greater amounts of blade damage and fretting on both ends of the machine. While the amount of Z-Lock wear is not quantified for Periods 1 and 3, photographic evidence suggests that the amount of wear is much greater for Period 3, as shown below in Figure 1. It is therefore difficult to conclude that damage to the L-0 blades in Period 3 is solely due to unit operation above the exhaust flow limit.

Figure 1 -- Comparative Photos of Shroud Contact Surface Wear for Periods 1 and 3

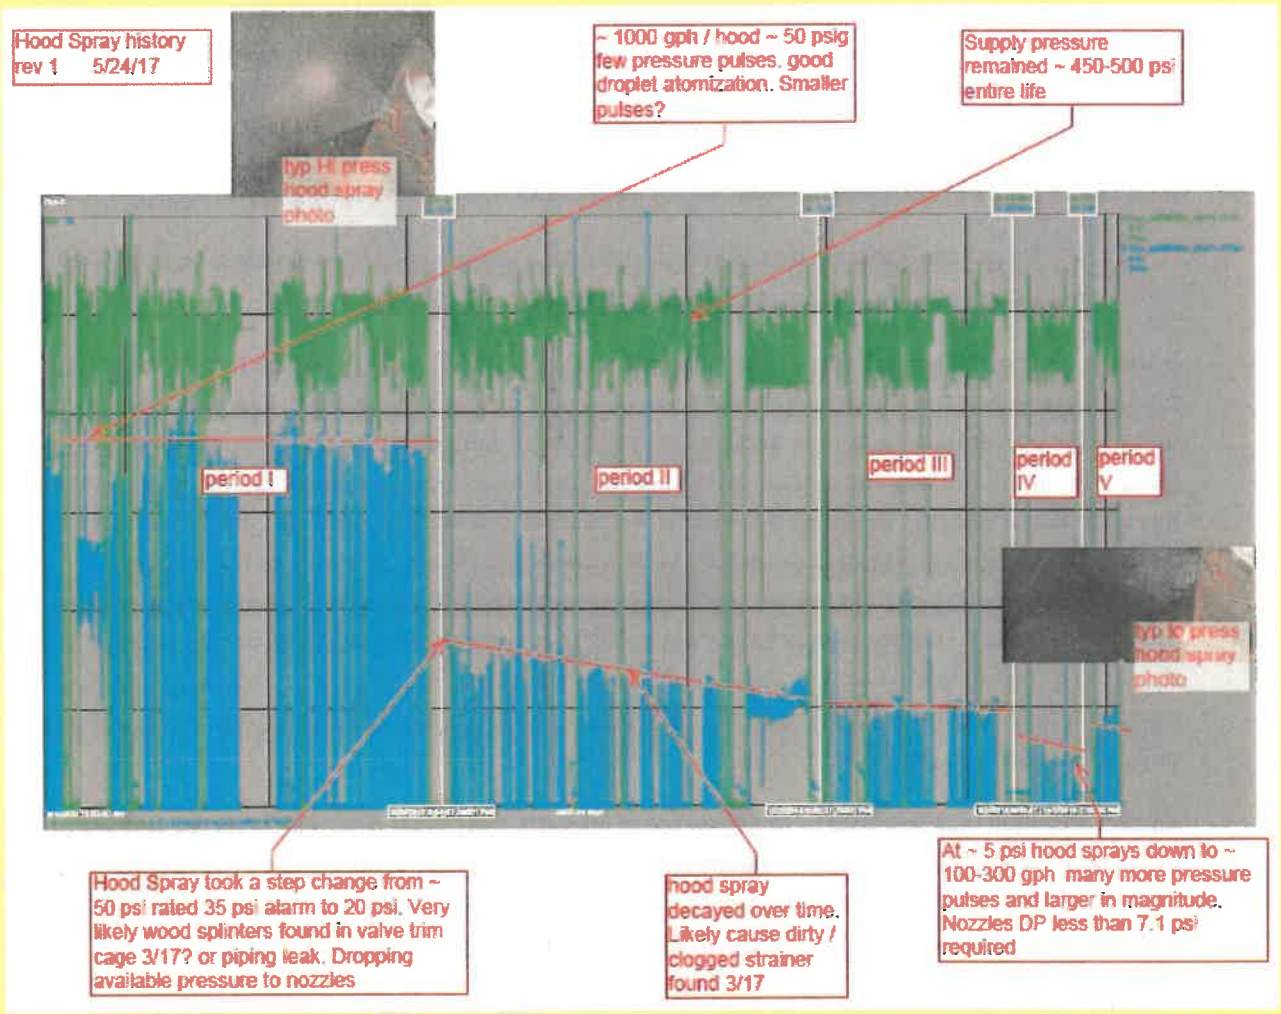
Figure 2, below, demonstrates what happened to hood spray pressure over time. The decay in water pressure at the hood spray nozzles will yield reduced atomization as these style of nozzle rely on pressure drop to create a vortex inside the nozzle that causes atomization through centripetal force. The effect of reduced atomization was verified during a test just prior to unit restart in April 2017. A key concern of poor atomization is the effect it might have on generating dynamic pressures which the L-0 blades might see as large water droplets evaporate in the exhaust stream.

Figure 2 -- Hood Spray Pressure Degradation Over Periods 1-5

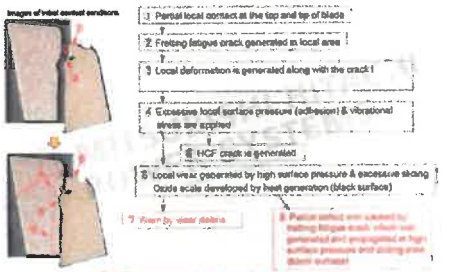
Damage Mechanism Identified

Capability of HVOF Confirmed

- The contact surface coating did not show any cracks, deformation or wear.
- Average uniform thickness was around 0.45~0.46 mm on the areas of contact between the LE and TE snubbers.

HVOF coating on the stub prevented fretting or any other surface damage

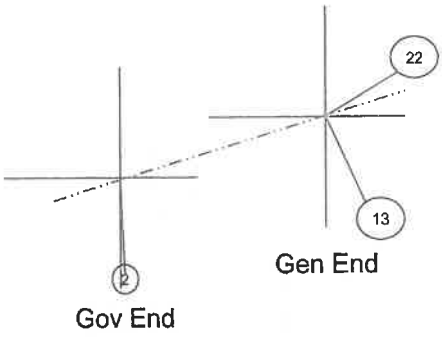
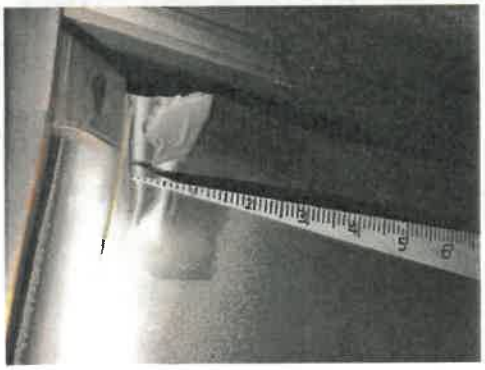
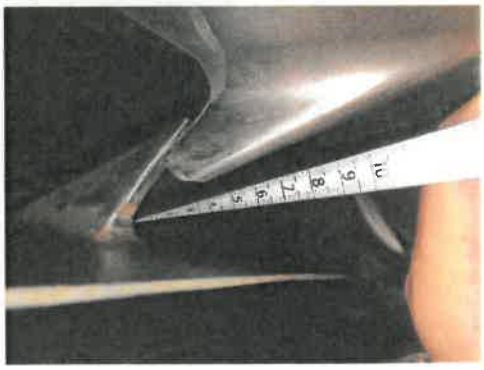
Blade Inspection – Oct 2016

Gen End Blade #13

Gen End Blade #22

Gov End Blade #2

Gen End Blade #55

Significant mass loss consistent with vibration observations
Damage started after 5 weeks of operation

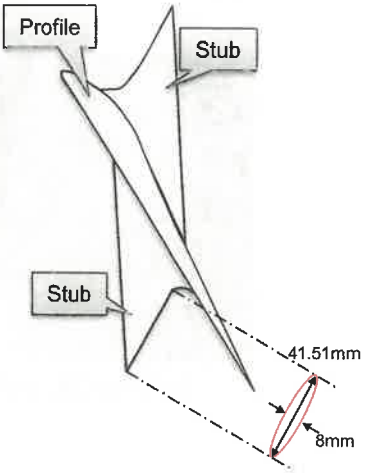
Failure at Stub of Original Blades

- Original blade has no crowning/chamfer at stub. Local stress is high and crack is initiated at edge of stub.

If stub surface is tilted in horizontal or vertical direction, high local stress on the stub is observed.
Crowning was applied to the edge of stub contact to avoid the high local stress.

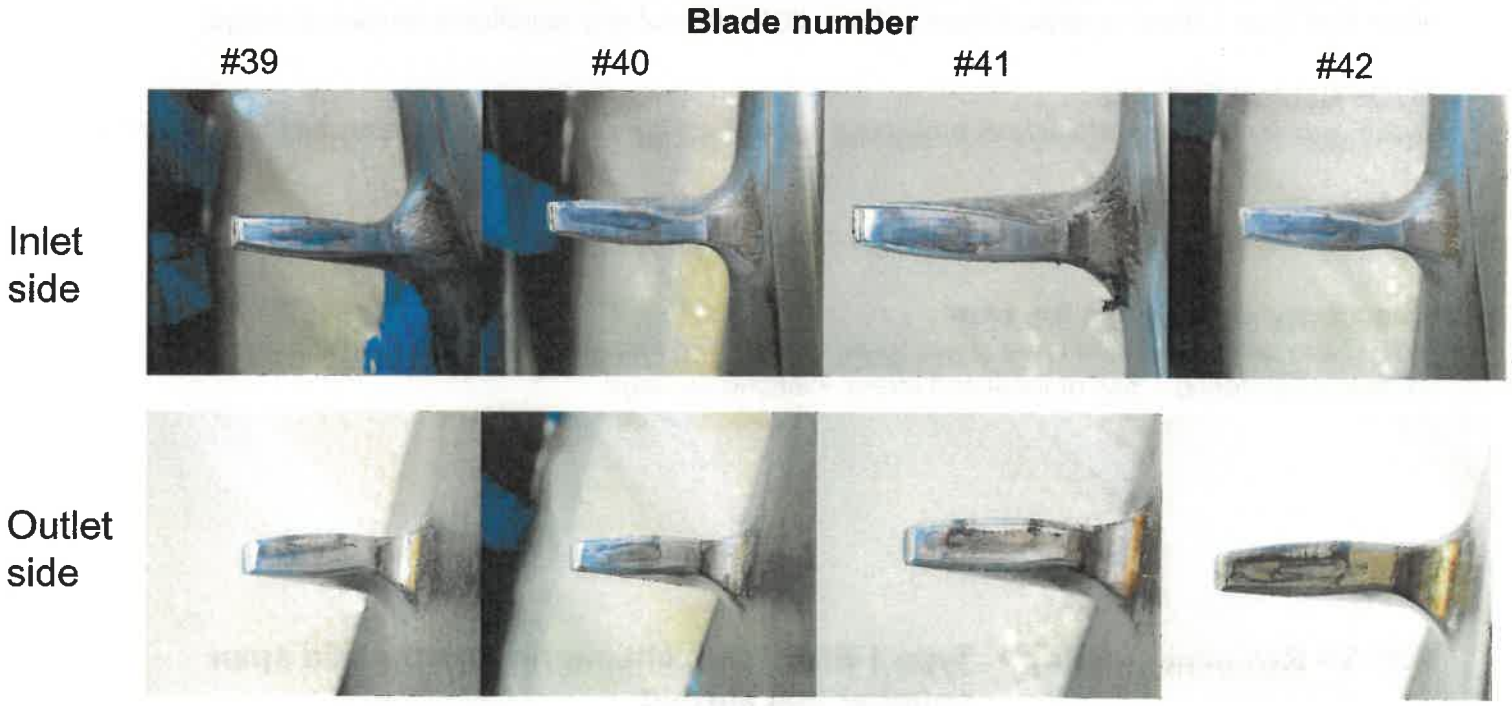
Effect of Crowning

Following picture shows stub contact surface of stub coated blade with crowning from November 2014 to April 2016. There was no high stress contact mark at edge of stub and the contact condition was good.
It is recommended to apply crowning without coating, to prevent high local stress.

Contact area is maintained large enough not to impact damping

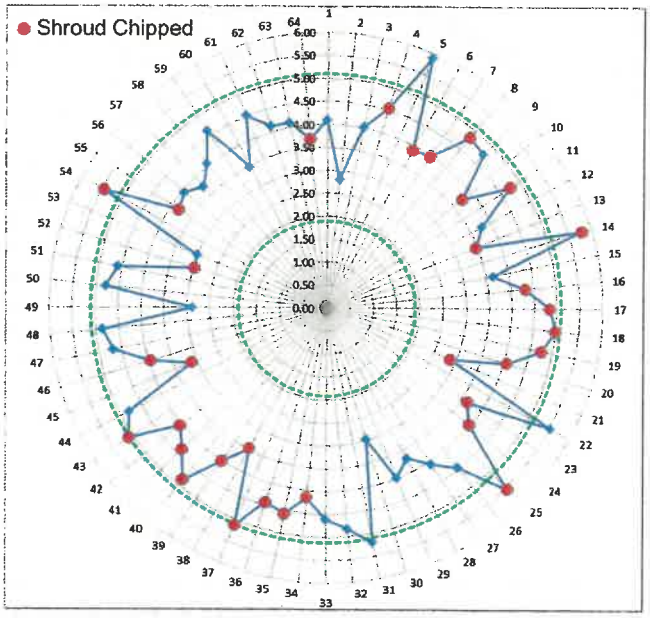
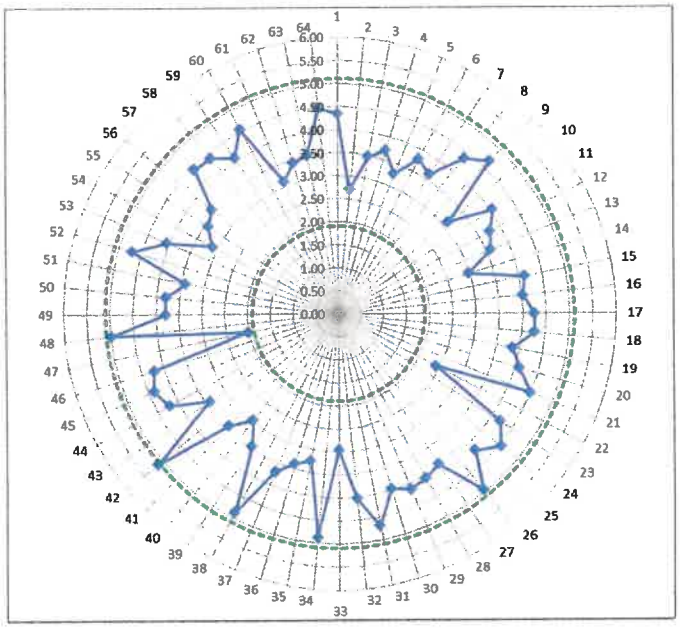
2014 Blade LH (Gov. End) Shroud Gap Data

Row Average Gap = 3.9mm

Row Average Gap = 4.2mm

Criteria: Shroud 1.9mm to 5.1mm Average, with no single blade above 6.0mm.

No clear relationship between gaps and shroud chipping

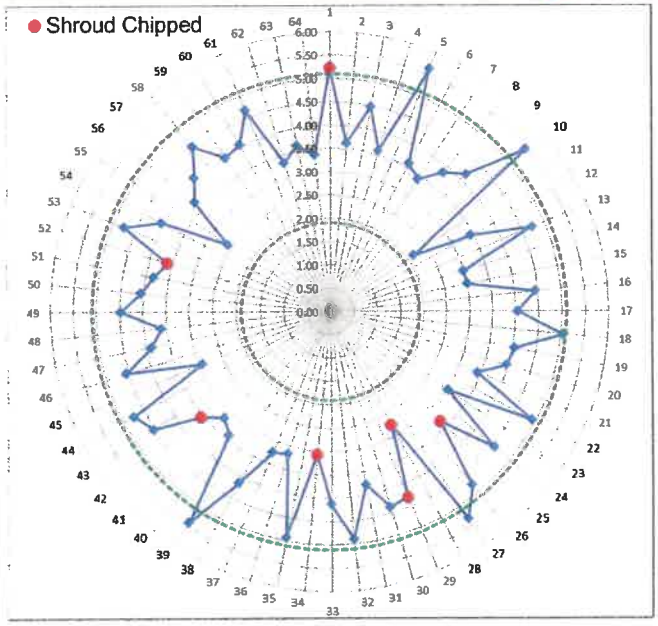
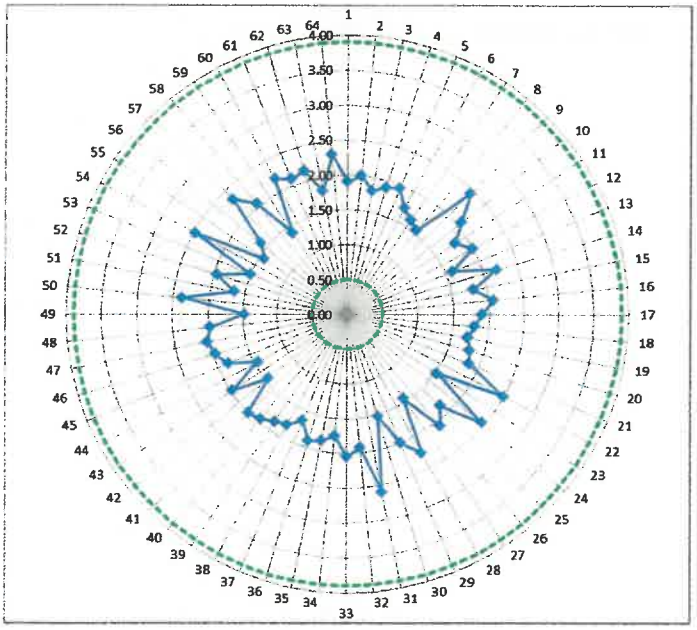
2014 Blade RH (Gen. End) Shroud Gap Data

Row Average Gap = 3.9mm

Row Average Gap = 4.0mm

Criteria: Shroud 1.9mm to 5.1mm Average, with no single blade above 6.0mm.

No clear relationship between gaps and shroud chipping

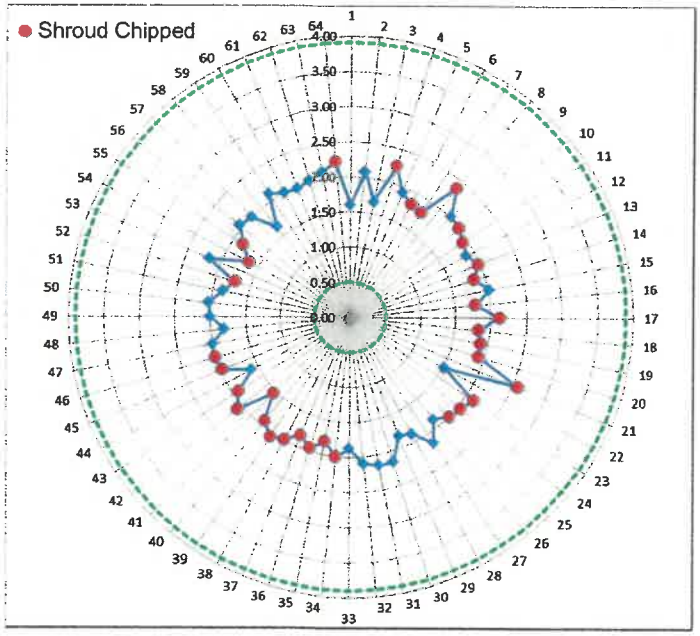
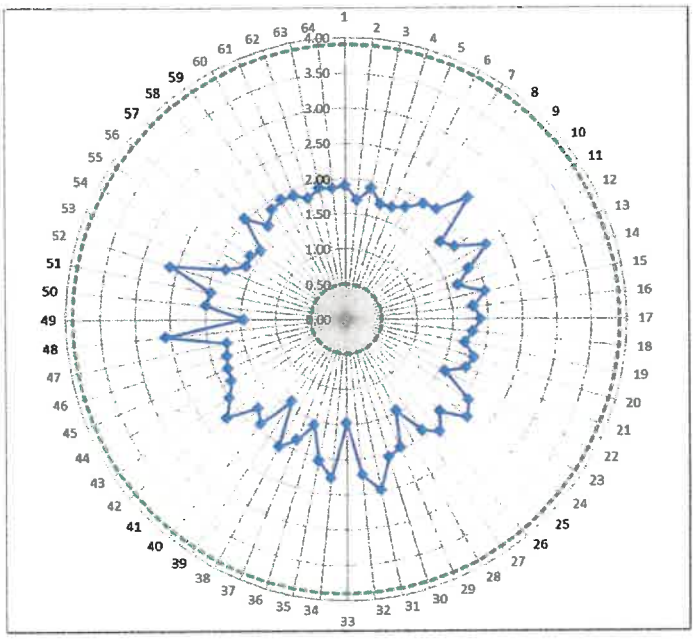
2014 Blade LH (Gov. End) Stub Gap Data

Row Average Gap = 1.9mm

Criteria: Stub 0.5mm to 3.9mm Average, with no single blade above 4.8mm.

No clear relationship between gaps and shroud chipping

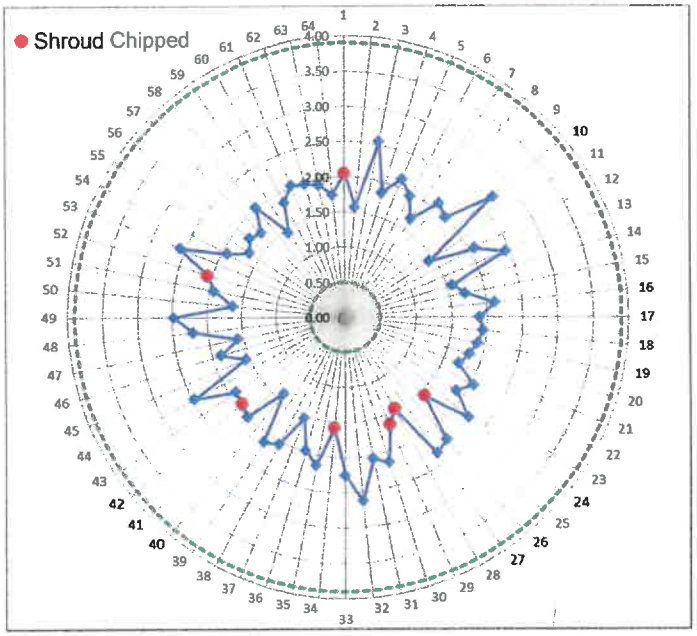
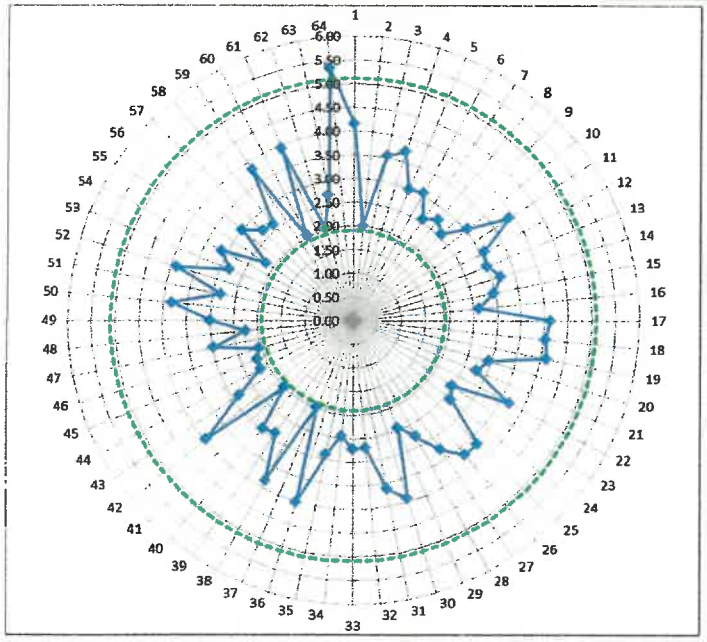
2014 Blade RH (Gen. End) Stub Gap Data

Row Average Gap = 1.9mm

Criteria: Stub 0.5mm to 3.9mm Average, with no single blade above 4.8mm.

No clear relationship between gaps and shroud chipping

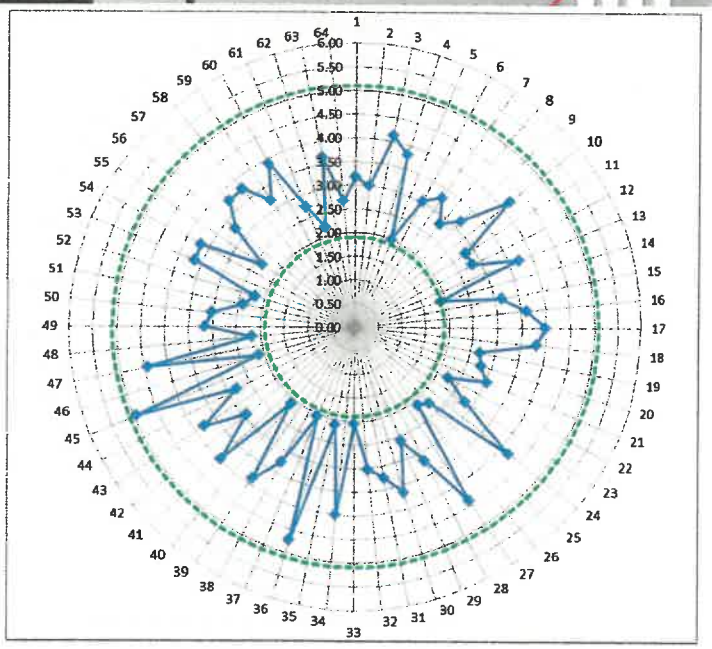
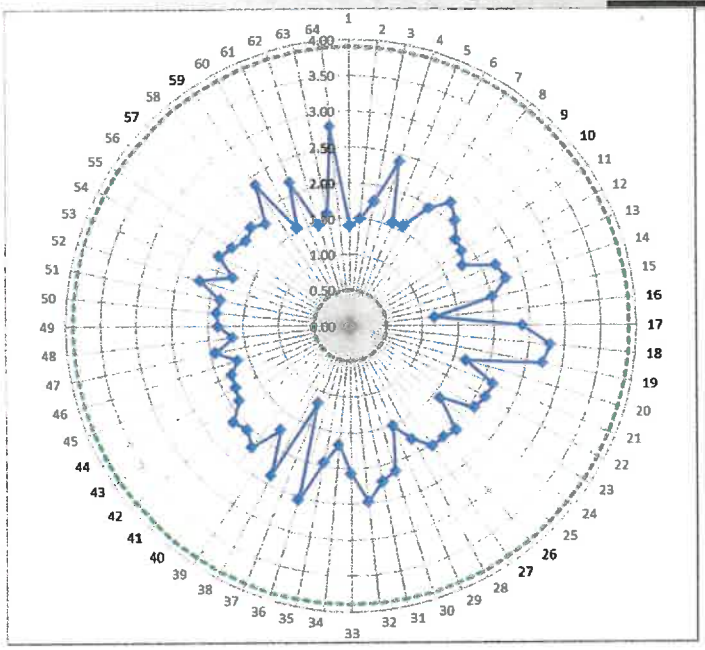
Row Average Gap = 3.1 mm

Criteria: Shroud 1.9mm to 5.1mm Average, with no single blade above 6.0mm.

Shroud gaps are with in criteria at both Governor and Generator ends.

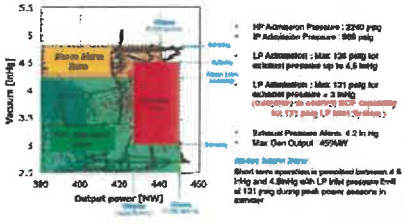
Bartow Steam Turbine Operational Limits

Around 170 hours of operation in Avoidance Zone with a resonance of ~200Hz can accumulate significant fatigue cycles

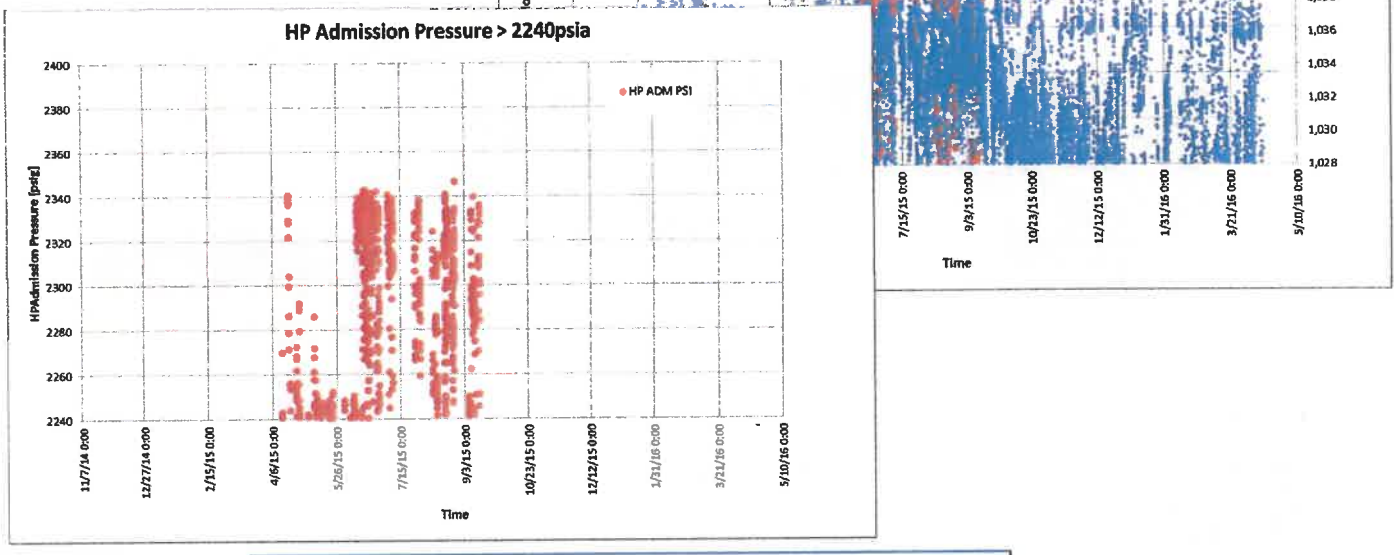
Operation Data Review

HP Admission conditions higher than allowable limit.

Reference information only.
No recommendations identified at this time.

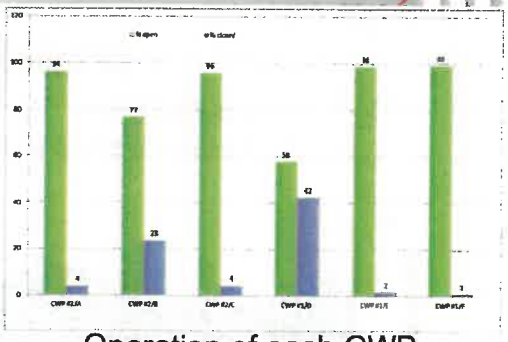
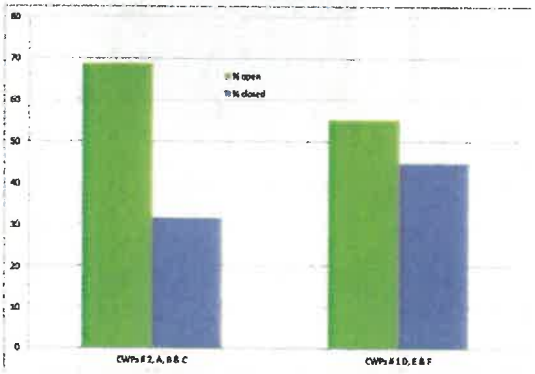
Operation of each CWP

Heat is removed asymmetrically between the Gen and Gov End

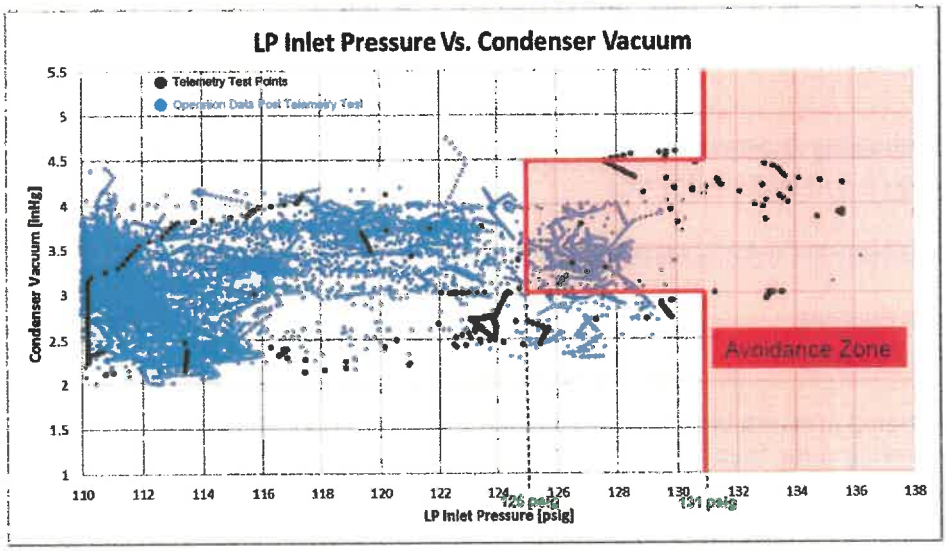
LP Avoidance zone :
For Condenser Vacuum <3" Hg, IP Exhaust Pressure should be maintained below 131 psig
For Condenser Vacuum >3" Hg and < 4.5" Hg, IP Exhaust Pressure should be maintained below 125 psig
For Condenser Vacuum > 4.5" Hg, IP Exhaust Pressure should be maintained below 131 psig
Any individual excursion into the avoidance zone should not exceed 10 minutes in duration.
This avoidance zone has been established based on the RCAs re-evaluation of the shroud stresses in order to maintain sufficient design margin to achieve long term operation of the blades without reoccurrence of damage.

This recommendation is shown pictorially in the figure below as presented on Friday June 3rd :

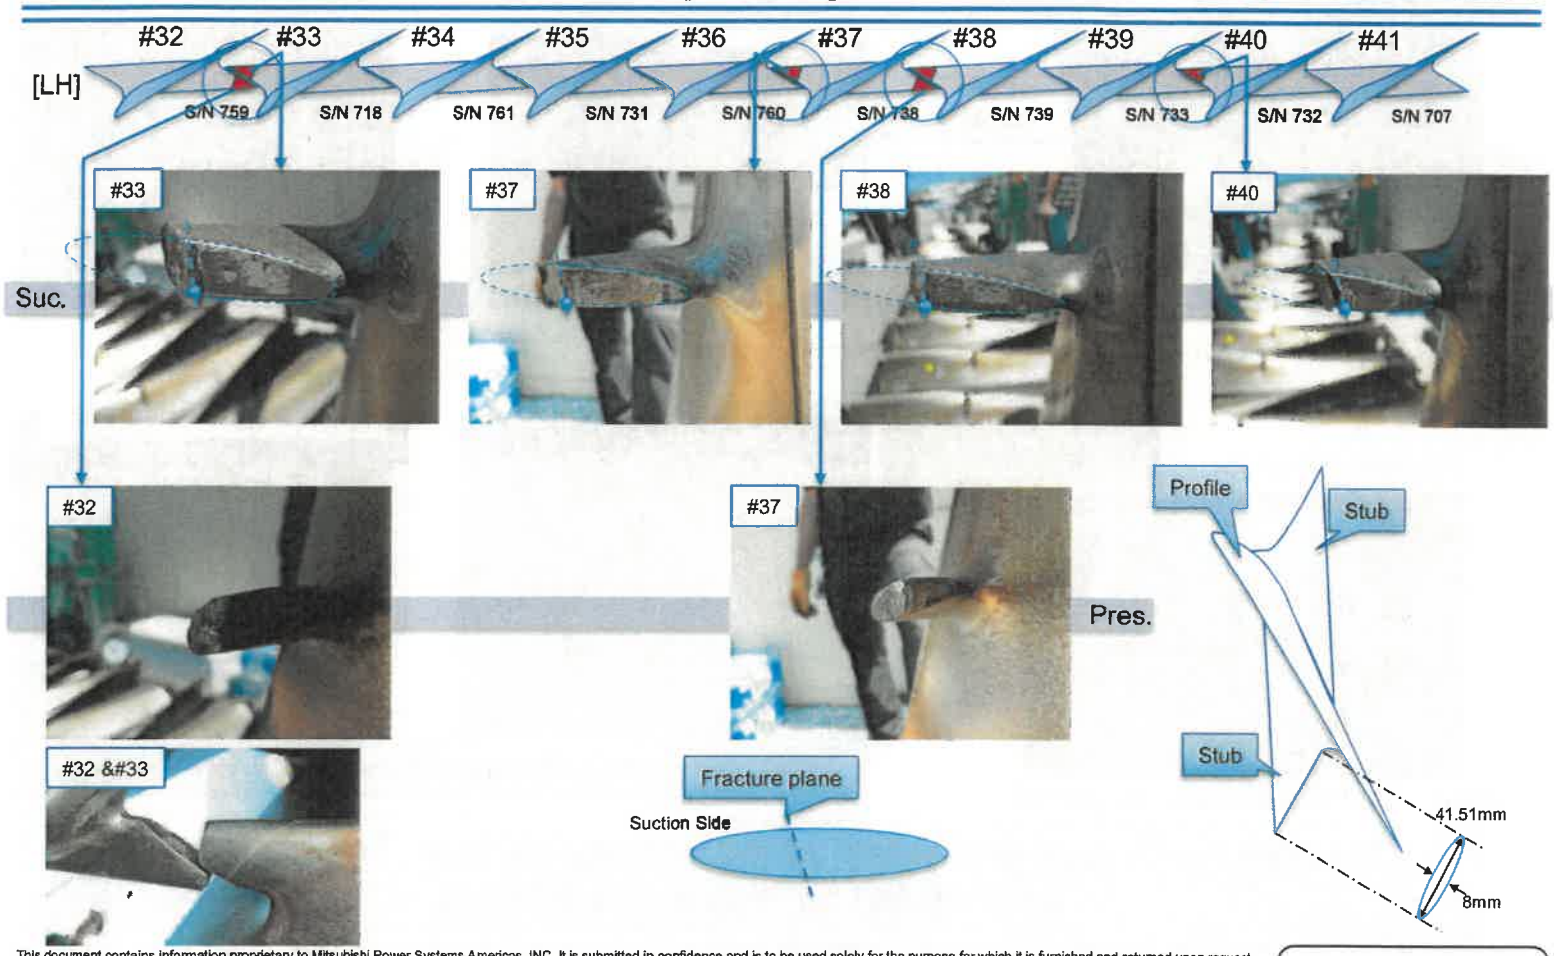
Background of L-0 Blades

- Mitsubishi recommended that the Duke ST operate at or below 420MW to ensure proper loading on the LP turbine and L-0 blades
- Mitsubishi evaluated modification of L-0 blades to increase output from 420MW up to 450MW
- X-ray and mold tests were conducted by customer on the governor end L-0 blades in March 2013. Customer analysis indicates fretting wear on the contact surface of mid span stub.

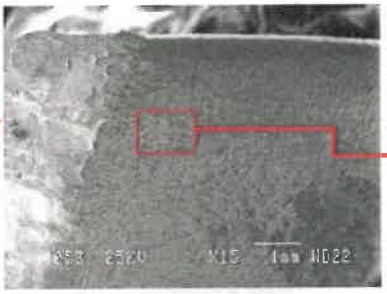
Contact surface

Sliding scars in horizontal direction were recognized.

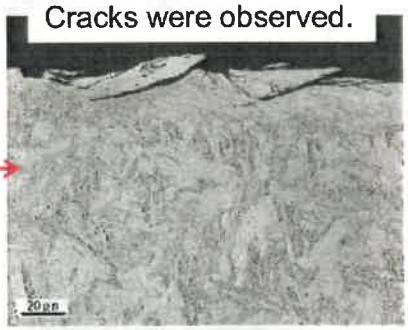
Fracture surface

Clear beach marks were recognized

Cracks were observed.

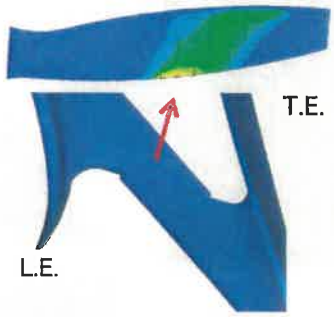
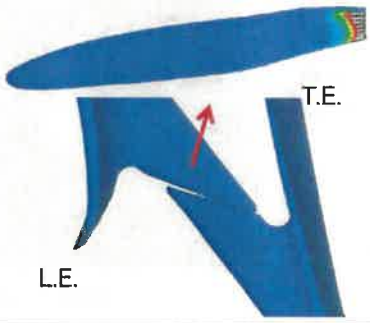
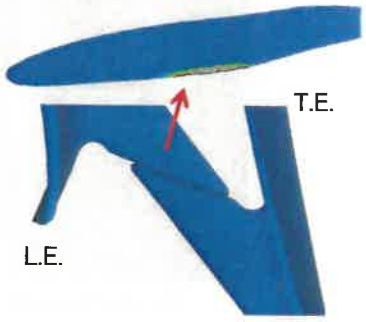
Root Cause Analysis

Deformation or tilt of stub at higher load

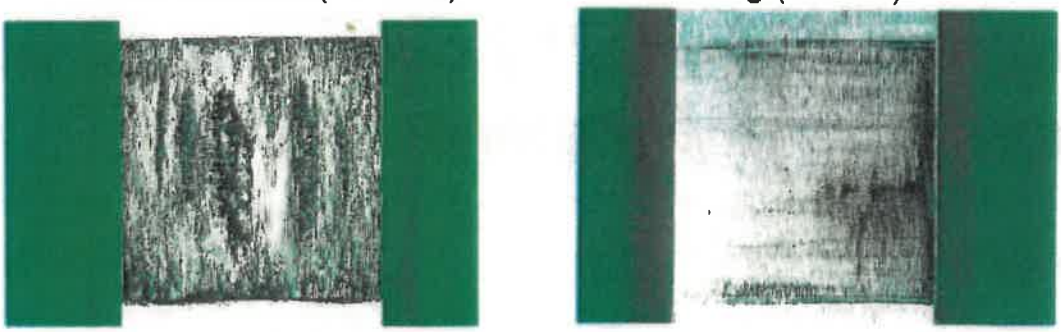
- Wear test with large slip is conducted using coated and uncoated blade material (17-4PH).
- Wearing characteristics of coating is much better than raw material.

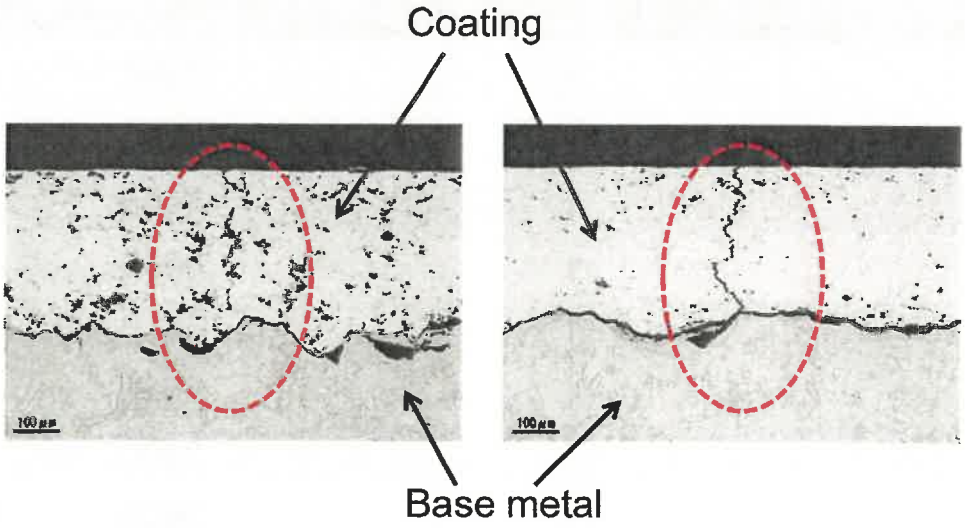
Mitigation 3: Stellite Coating

It is confirmed by the bending test that any crack that initiates in the coating will not propagate into base material.

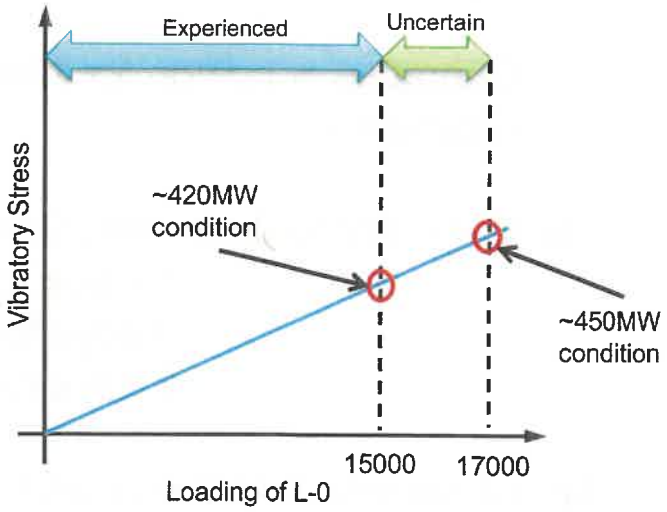
Flutter vibration

7: Verification test is performed except for high load condition

- First three modes are well tuned.
- There is no data or experience above 15000 lb/hr/ft^2
