DOCKET NO.: 20200001-EI

WITNESS: Jeffrey Swartz

FOURTH AMENDMENT TO
CONTRACT FOR PURCHASE OF STEAM TURBINE GENERATOR

Bartow 4S Root Cause Analysis – Evaluation of Contributing Factors

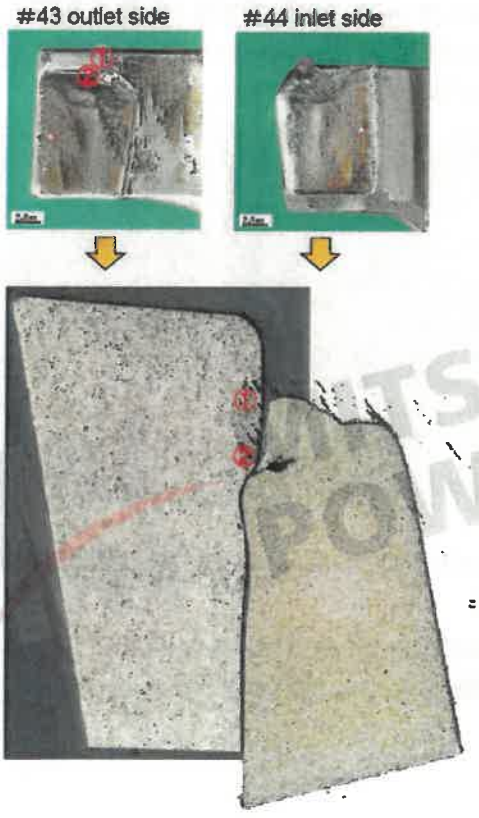
#42 outlet #43 inlet	#43 outlet #44 inlet	#44 outlet #45 inlet	#45 outlet ----
Outlet side contact surface				
Inlet side contact surface				----

Shroud Chipping is starting at same location for all blades

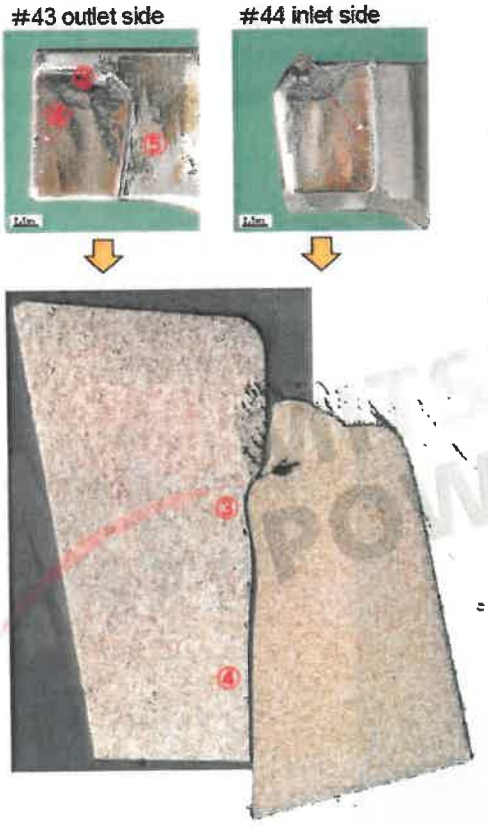
- Plasticity is found in concave part of local deformation.

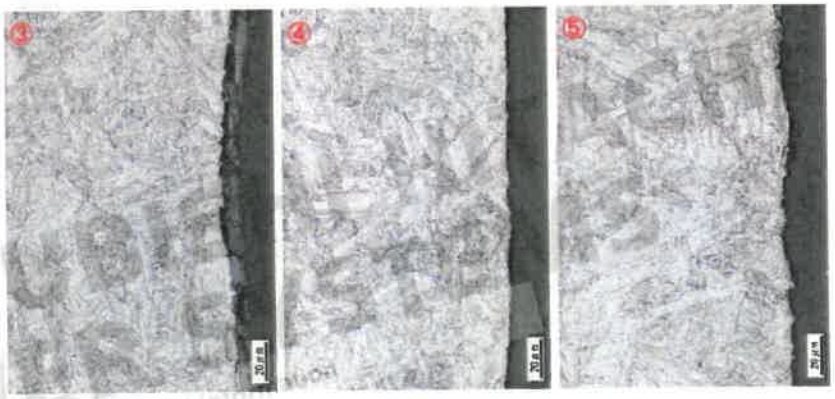
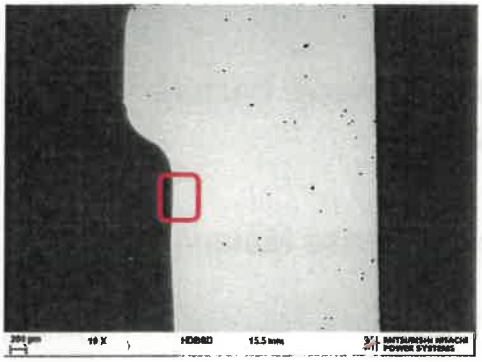
Metallurgical Evaluation of Blades

Microscopic observation was performed on the same sections in contact condition for each of outlet side of #43 blade and inlet side of #44 blade.

- ③: Oxide scale was found on black surface of local deformation area.
- ④: Dark brown surface of worn and thinned part is free of oxide scale and smoother than non-contact surface of ⑤.

Oxide scale with local deformation observed on black surface

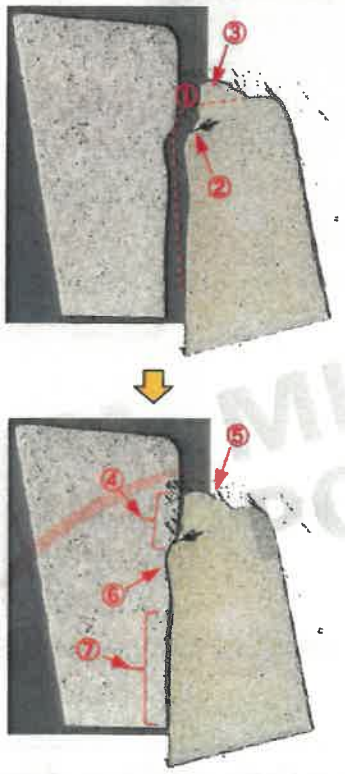
Images of initial contact conditions

① Partial local contact at the top and tip of blade

② Fretting fatigue crack generated in local area

③ Local deformation is generated along with the crack

⑤ HCF crack is generated.

⑥ Local wear generated by high surface pressure & excessive sliding. Oxide scale developed by heat generation (black surface).

⑦ Worn by wear debris

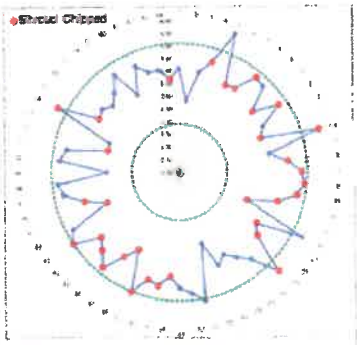
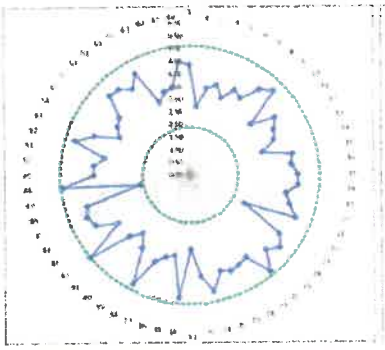
2014 Blade LH (Gov. End) Shroud Gap Data

Row Average Gap = 3.9mm

Row Average Gap = 4.2mm

Criteria: Shroud 1.9mm to 5.1mm Average, with no single blade above 6.0mm.

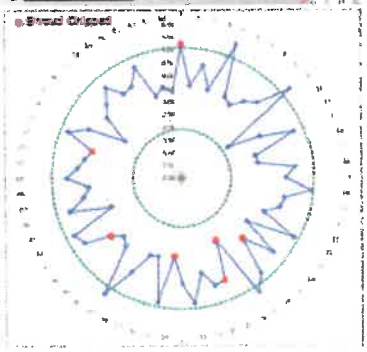
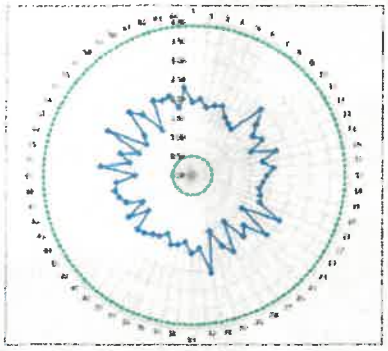
2014 Blade RH (Gen. End) Shroud Gap Data

Row Average Gap = 3.9mm

No clear relationship between gaps and shroud chipping

LH and RH shroud average gaps are nearly same
No clear relationship between gap and shroud chipping

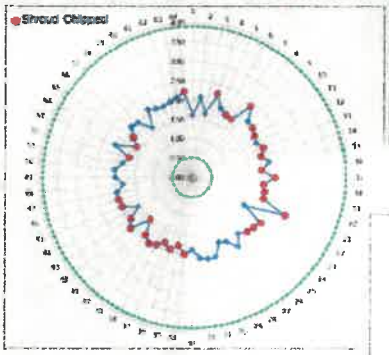
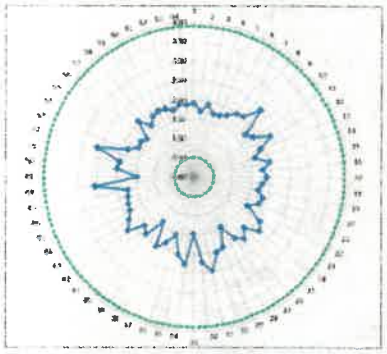
2014 Blade LH (Gov. End) Stub Gap Data

Row Average Gap = 1.9mm

Criteria: Stub 0.5mm to 3.9mm Average, with no single blade above 4.8mm.

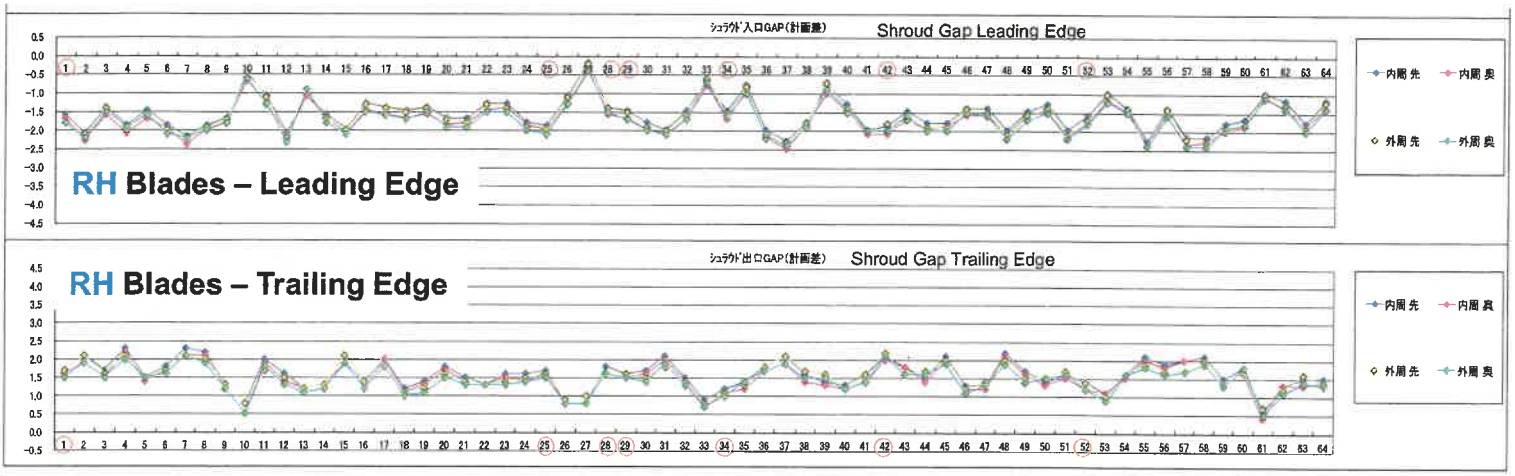
Box Gauge Measurement Results - 2014 blades

Blade manufacturing data show variation within criteria

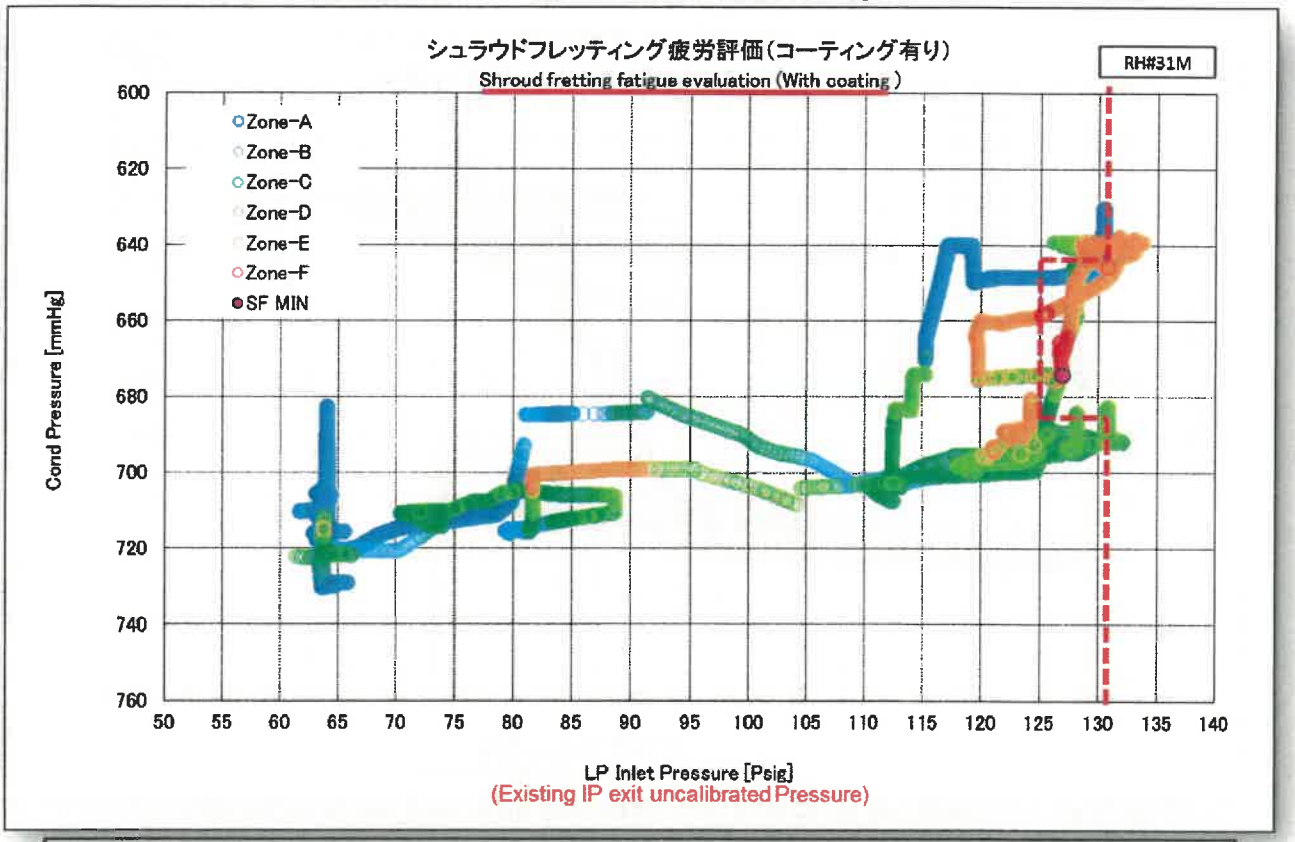
Telemetry Test Results – Shroud Fretting

Fretting fatigue calculations for shroud with coating show acceptable margins outside avoidance zone

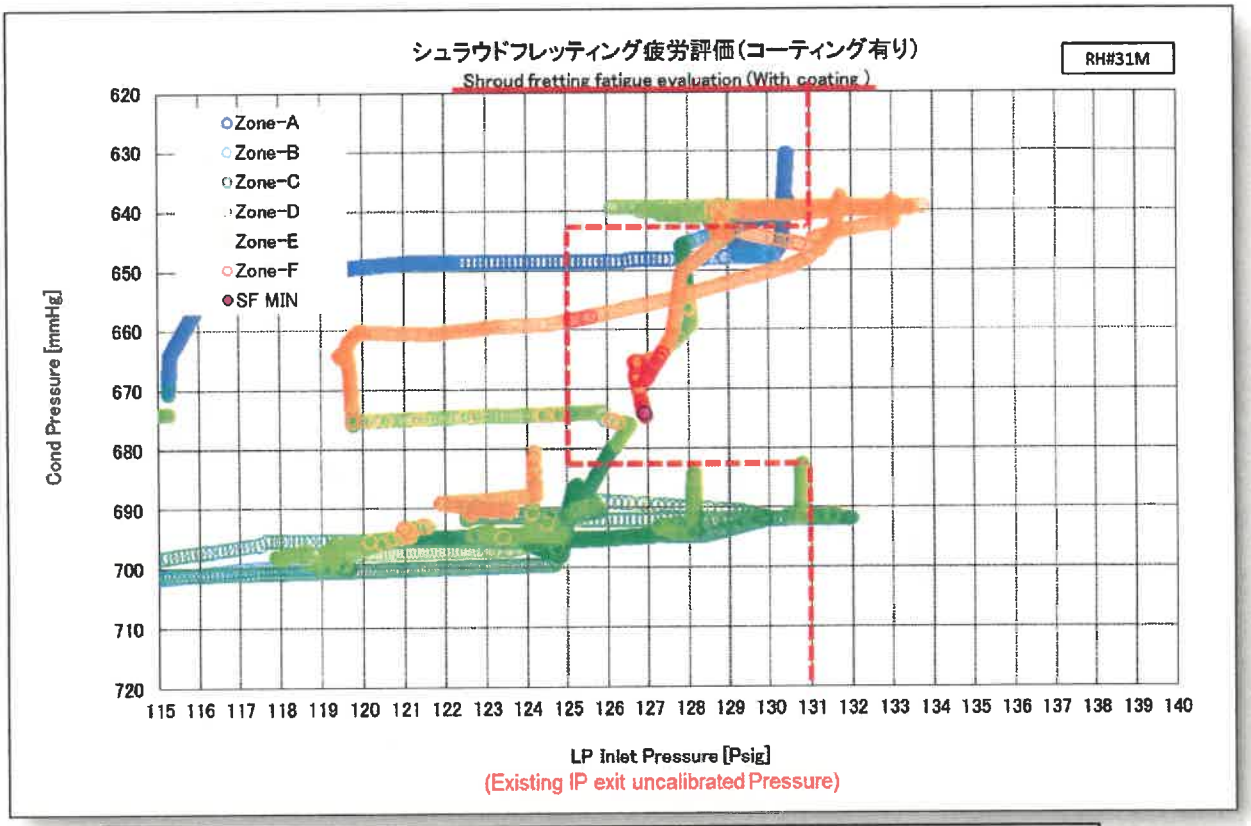
Telemetry Test Data – Shroud Fretting

Fretting fatigue calculations for shroud with coating show acceptable margins outside avoidance zone

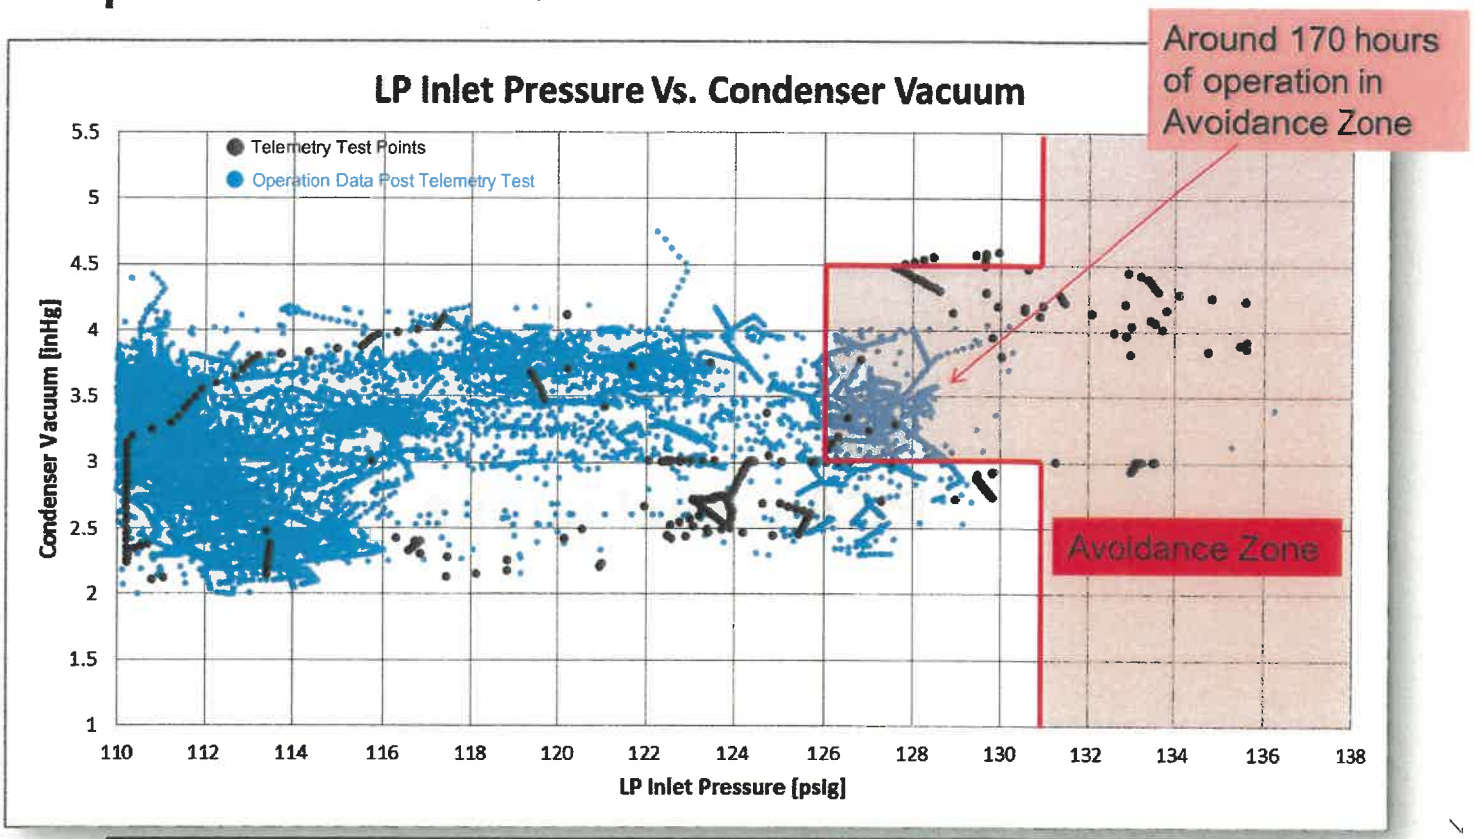
Operation Data Review

170+ hours of operation in avoidance zone with a response frequency ~200Hz = 1.2E8 Cycles

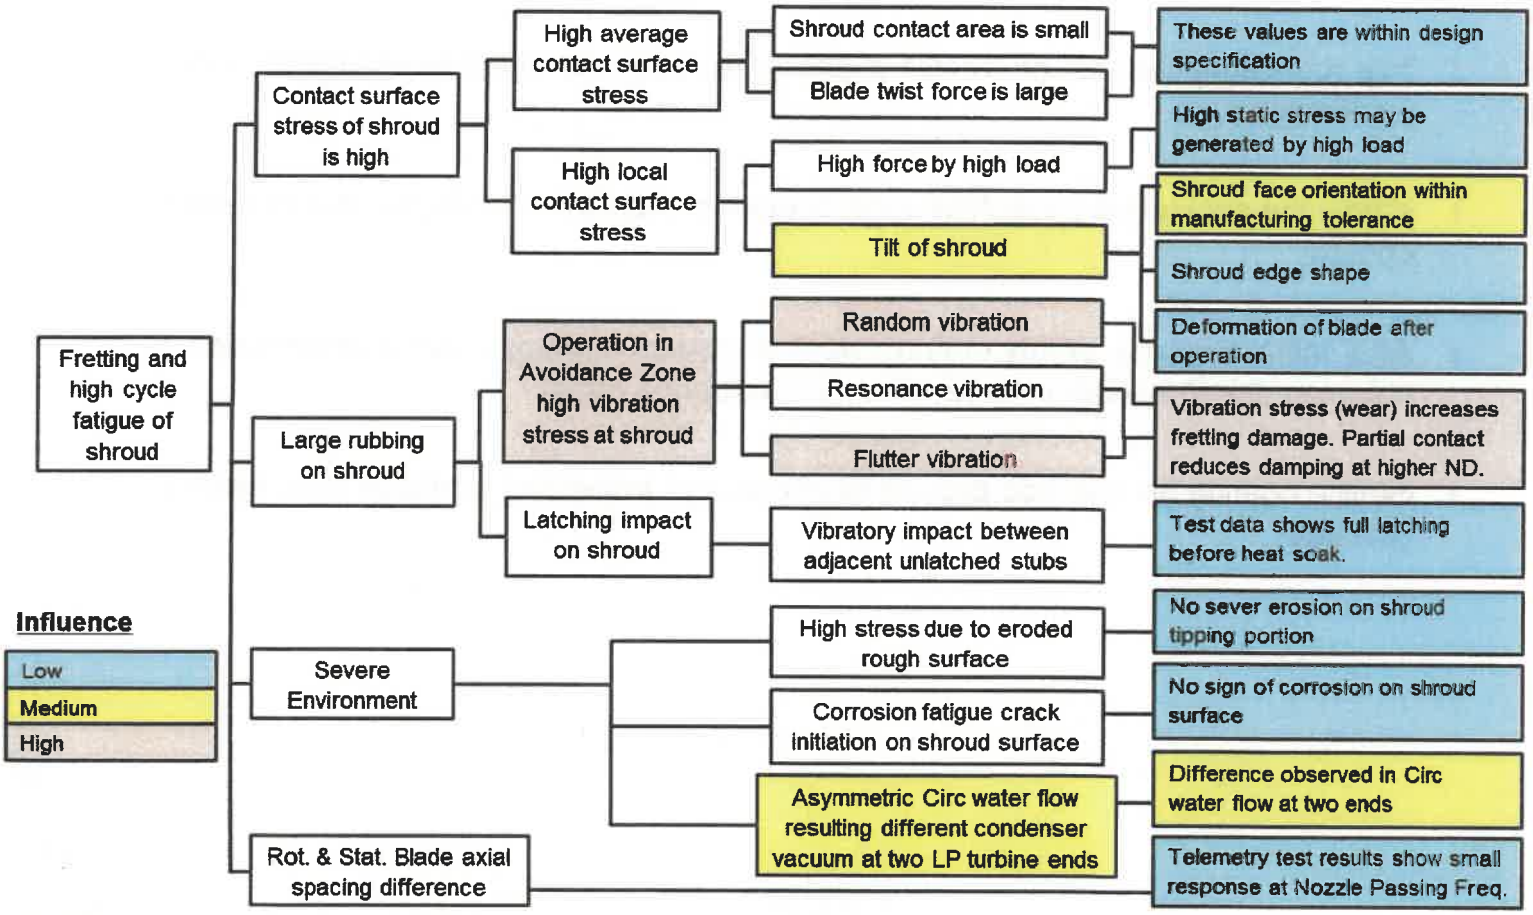
RCA Conclusions

- The root cause for start of shroud chipping has been identified as operation in the avoidance zone.
- Within the avoidance zone, high local contact pressure is developed due to partial contact.
- After initial chipping, nearly uniform wear of contact surface indicate progression of chipping due to operation at resonance (avoidance zone).
- Stellite coating on stub has proven its effective at protecting surfaces from fretting damage.

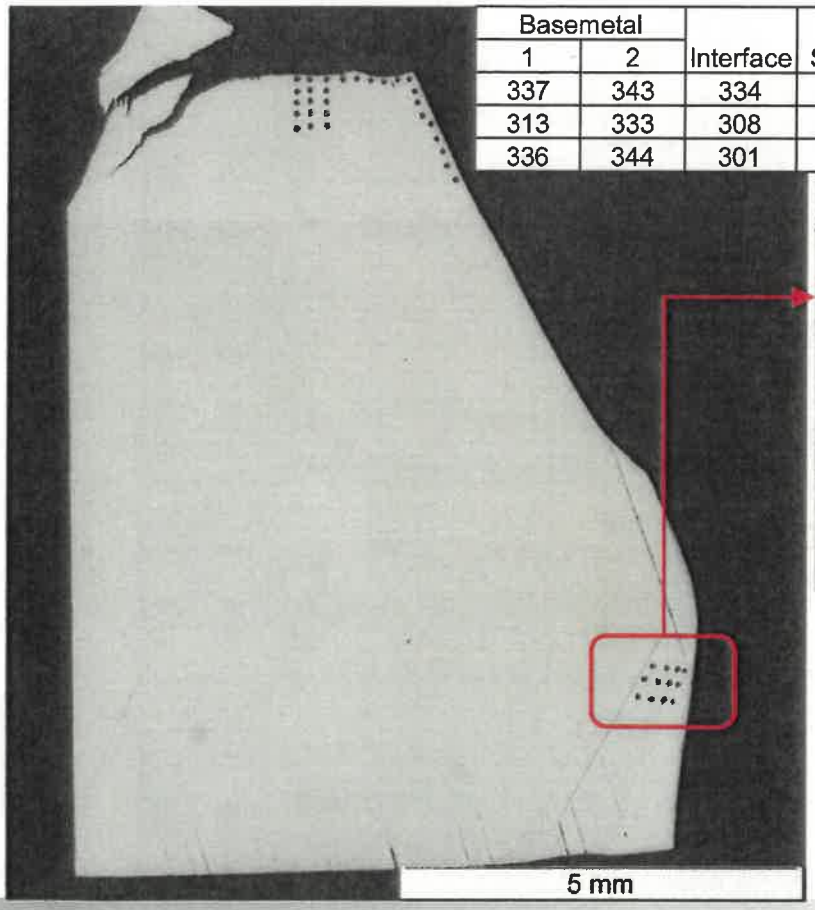
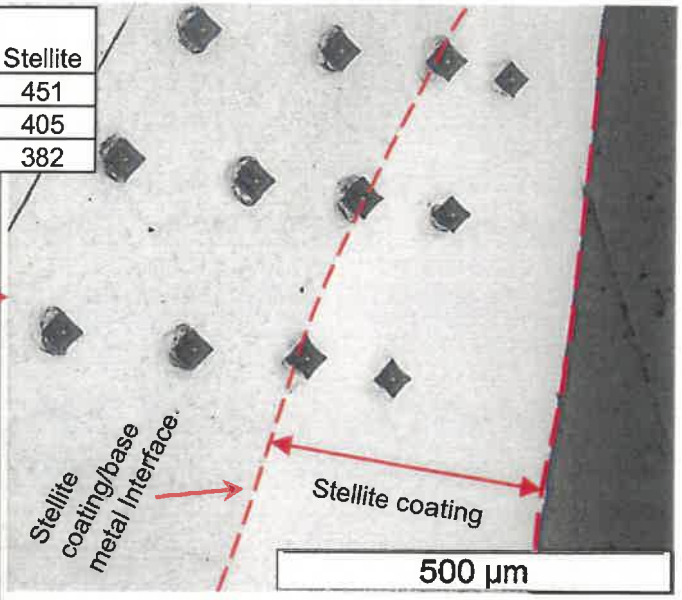
2- Hardness Variation basemetal, Interface and Stellite Coating

Basemetal		Interface	Stellite
1	2		
337	343	334	451
313	333	308	405
336	344	301	382

- No significant hardness variation was observed within the base metal as a result of stellite welding.

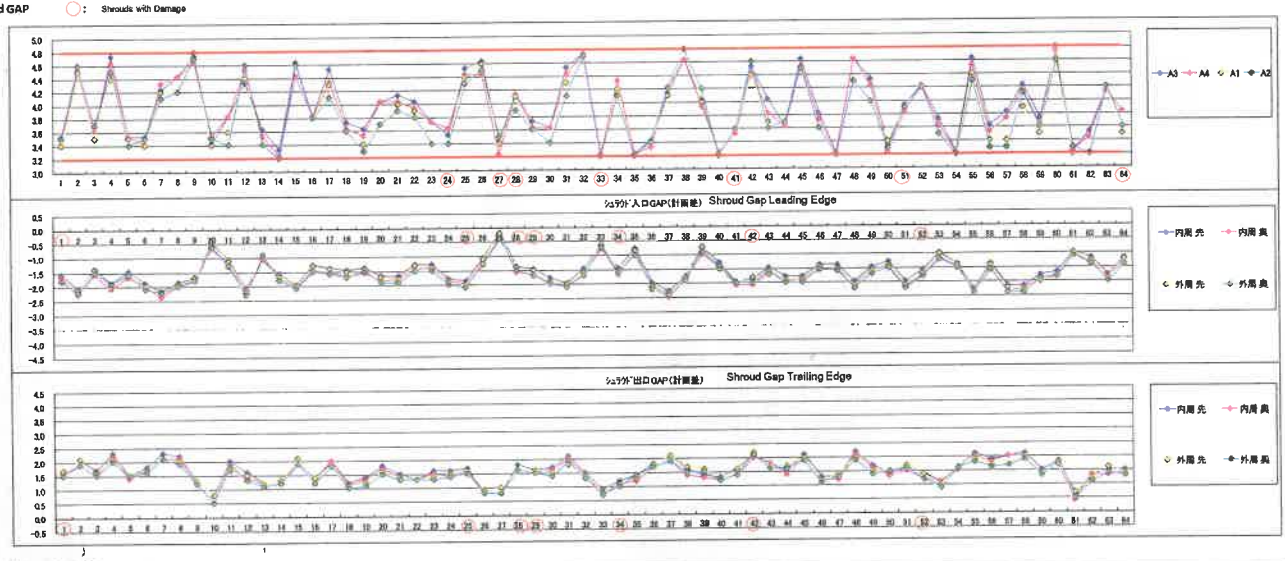
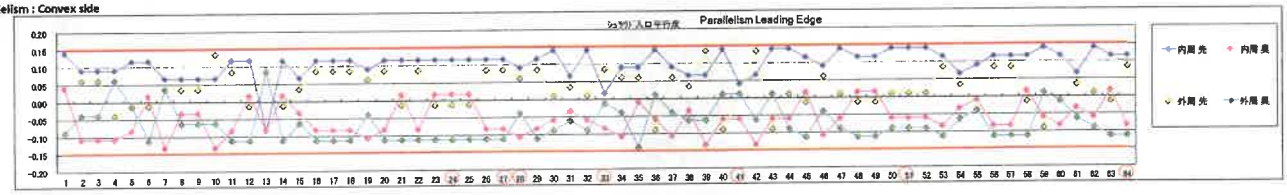
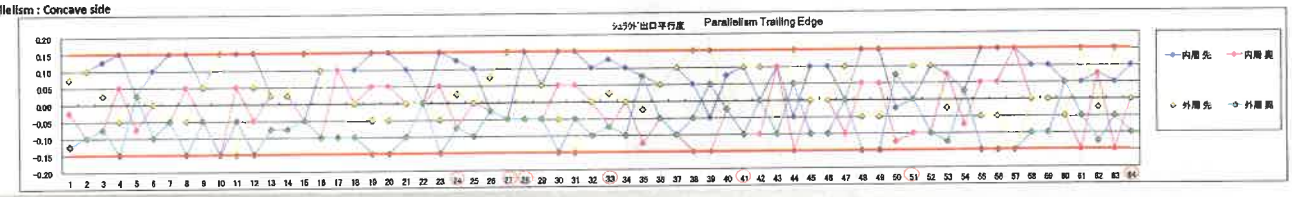
3.1) Measurement Results RH (Gen End) 2014 blades

Shroud GAP ○: Shrouds with Damage

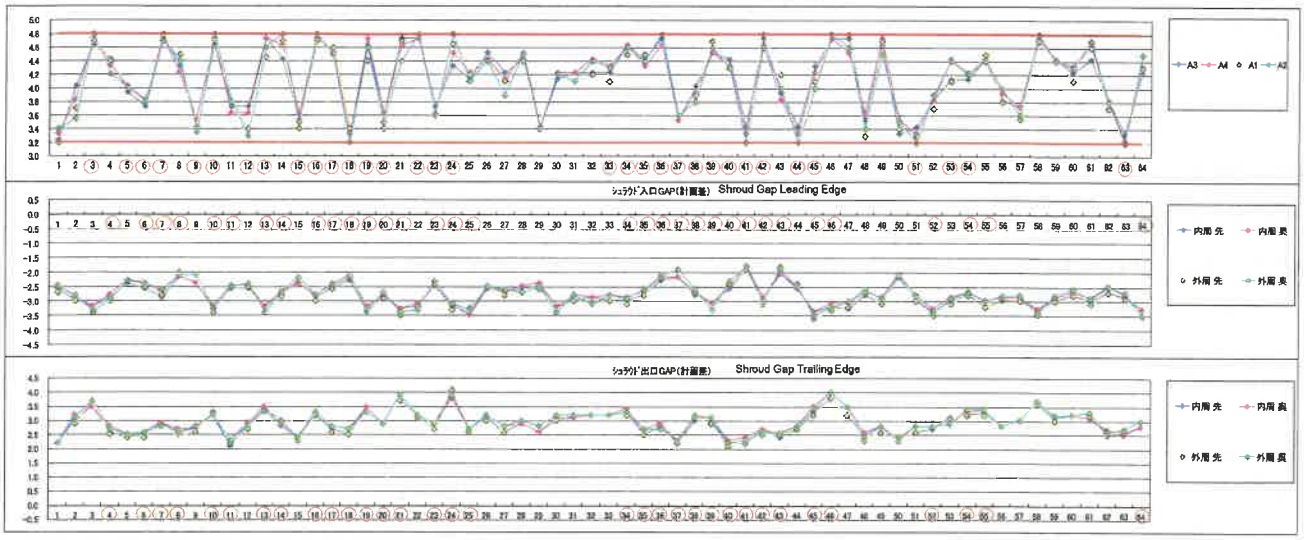
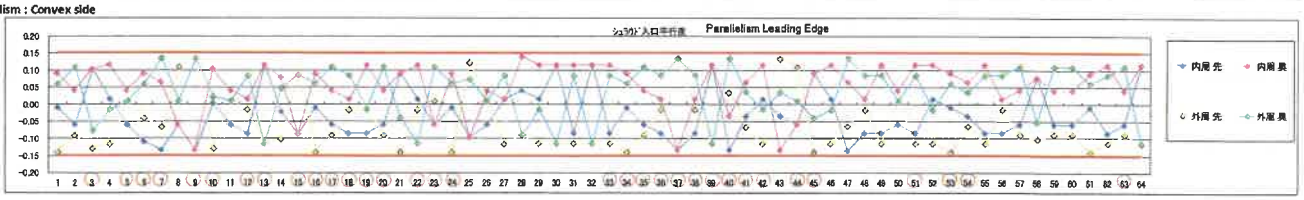
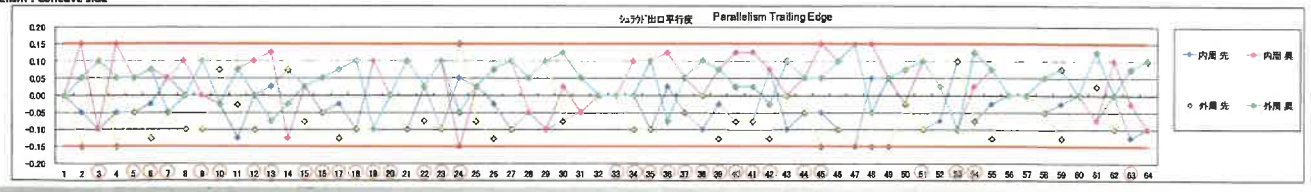
3.2) Measurement Results LH (Gov End) 2014 blades

Shroud GAP ○ : Shrouds with Damage
