In re: Emergency Complaint and Petition
Requesting Initiation of Show Cause Proceedings
Against Verizon Florida, LLC for Willful
Violation of Rules 25-4.036 and 25-4.038, Florida
Administrative Code by Bright House Networks
Information Services (Florida) LLC and Bright
House Networks, LLC

**EMERGENCY COMPLAINT AND PETITION
REQUESTING INITIATION OF SHOW CAUSE
PROCEEDINGS FOR WILLFUL VIOLATION OF RULES
25-4.036 AND 25-4.038, FLORIDA ADMINISTRATIVE CODE**

SUMMARY OF INSPECTION OF VERIZON FiOS FACILITIES IN WESTCHESTER COUNTY FOR UNSAFE AND NONSTANDARD SUBSCRIBER INSTALLATION PRACTICES.

**SUMMARY OF INSPECTION OF VERIZON FiOS FACILITIES IN
THE COUNTY OF NASSAU FOR UNSAFE AND NONSTANDARD
SUBSCRIBER INSTALLATION PRACTICES.**

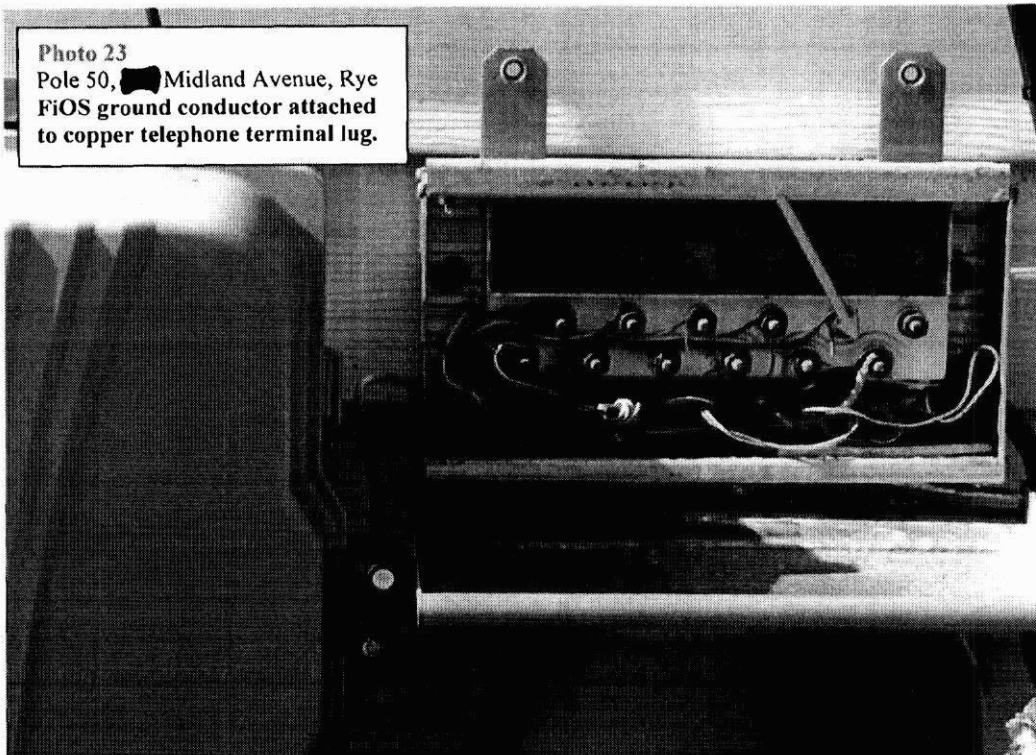
- 47. Pole (no #), [REDACTED] Grapal Street
FiOS not grounded.
- 48. Pole 50, [REDACTED] Midland Avenue
FiOS ground conductor attached to copper telephone terminal lug. (Photo 23)
- 49. Pole W11, [REDACTED] Palisade Road
FiOS ground conductor attached to unbonded driven electrode.
- 50. Pole 7, [REDACTED] Palisade Road
FiOS ground conductor spliced at copper telephone terminal.
- 51. Pole 2, [REDACTED] Richard Place
FiOS ONT and FiOS ground block ground conductors attached to same ground lug on screw of Romex connector. (Photo 24)

Photo 23
Pole 50, [REDACTED] Midland Avenue, Rye
FiOS ground conductor attached
to copper telephone terminal lug.

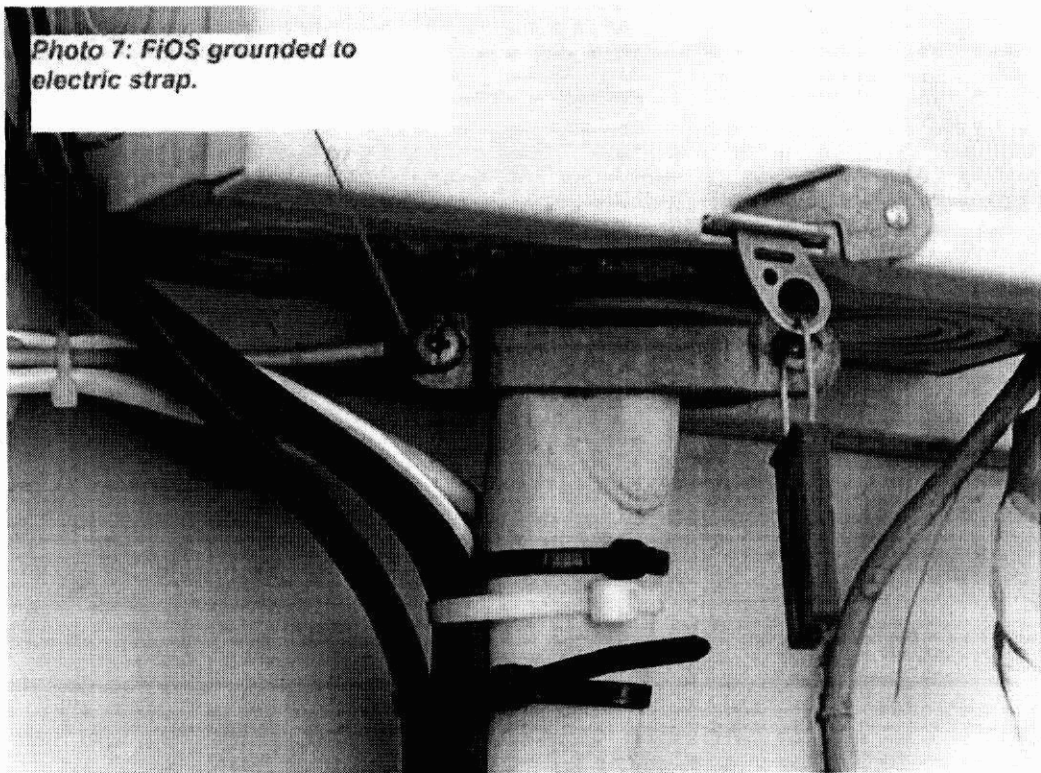
10) Pole 101: [REDACTED] Mansfield Pl.
FiOS grounded to electric strap (Photo 7)

Photo 7: FiOS grounded to electric strap.

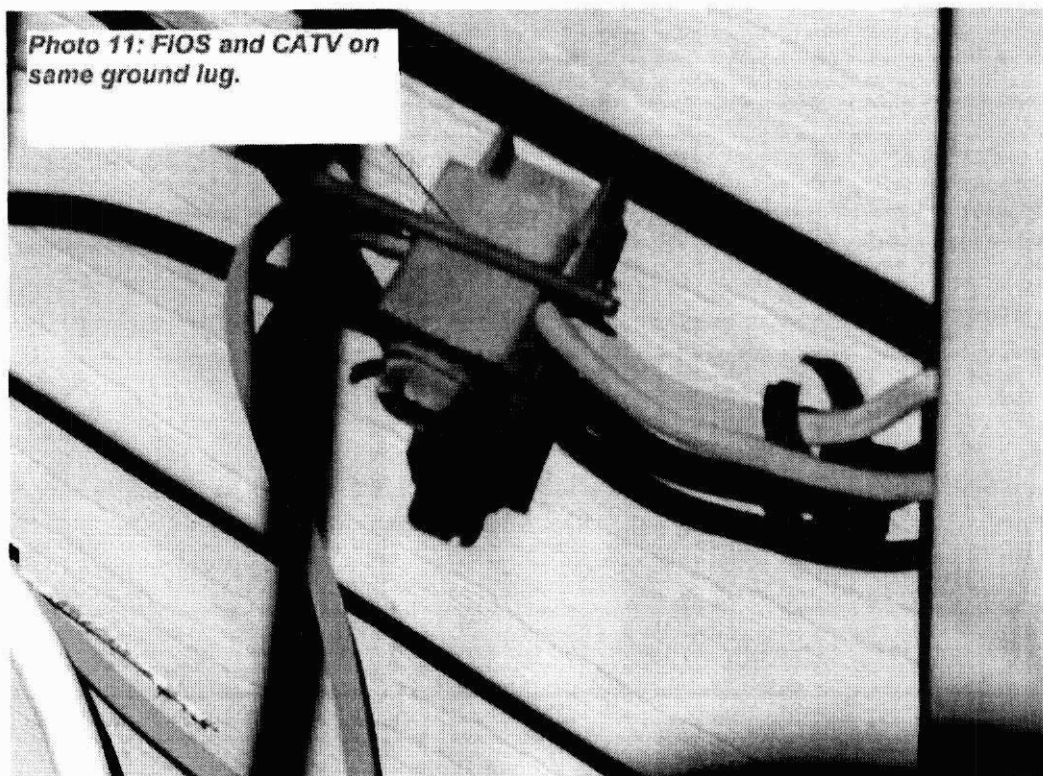
42) Pole 59657: [REDACTED] Blauvelt Ave.
FiOS and CATV on same ground lug. (Photo 11)

Photo 11: FIOS and CATV on same ground lug.
