BEFORE THE FLORIDA PUBLIC SERVICE COMMISSION

In re: Florida Power & Light Company's)
Petition for Issuance of a Storm Recovery)
Financing Order)

DOCKET NO. 060038-EI
Filed: March 31, 2006

JAMES S. BYERLEY, P.E.

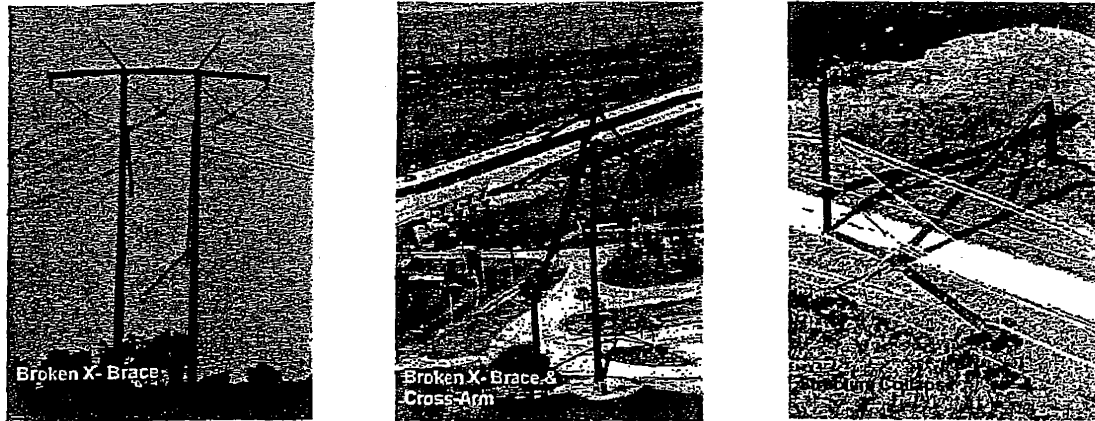
Figure 21 Failure Mechanism

A structure can only be as strong as the weakest link. As this foundation (Structure #16Z212) was being pulled out of the ground, there was not enough strength to resist or enough weight to overcome the uplift. Once this foundation gave, the structure tilted over and triggered a cascade event which brought down several adjacent structures (one structure from the north and up to three or four from the south).

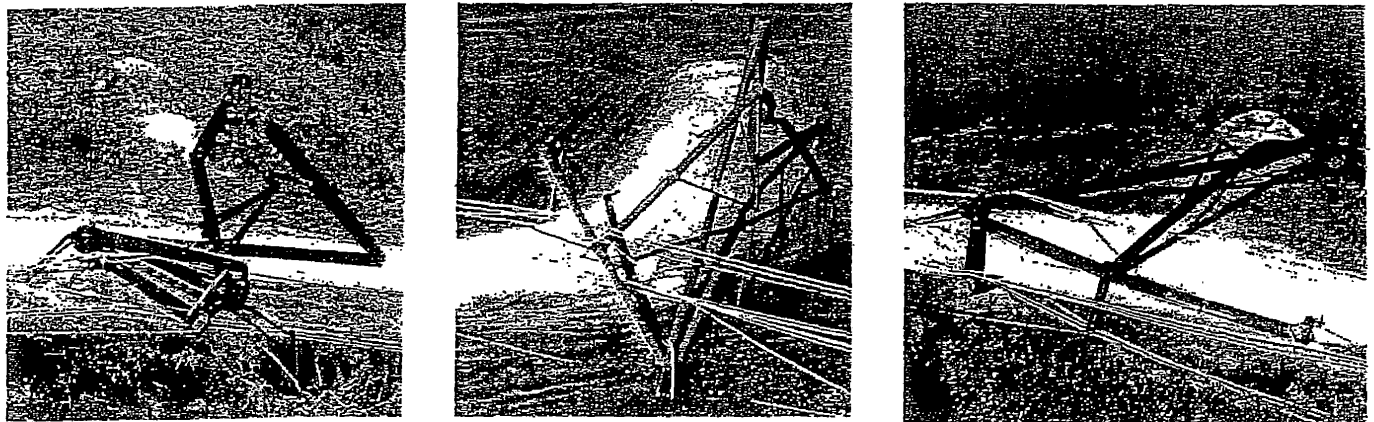
Figure 22 Structures Subject to Severe Torsional Stress

There is also evidence of welding failure at the area of circumferential joints, longitudinal seams, and even at full-penetration connections. Due to large movements created by the structural collapse, it is difficult to determine the causes. However, it is suspected that these weld damages are the results of secondary failure modes that happened after structural collapse.

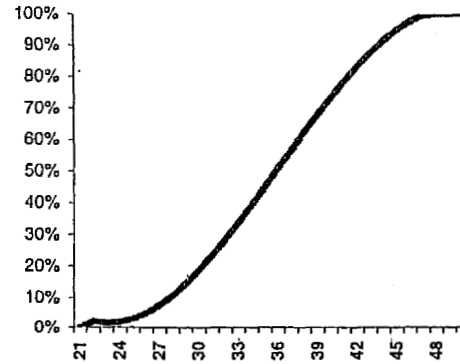
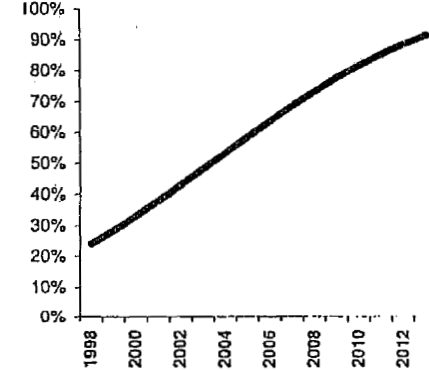
CREOSOTE WOOD POLES FAILURE RATE vs POLE AGE POPULATION FAILURE RATE

If no action is taken the creosote wood population will continue to deteriorate (see graphs below)

In 1998, 26% of the creosote wood pole population failed to meet Standards and therefore, need either bracing and treatment, or replacement. This problem will only deteriorate as the creosote wood pole population ages.

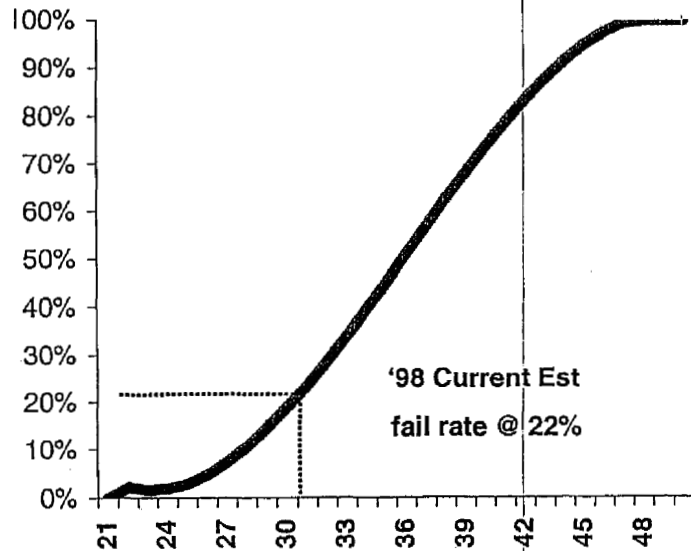
FAILURE RATE vs POLE AGE

From '98 study, increase estimated @ 6%/year till 2003 based on 10 yr plan

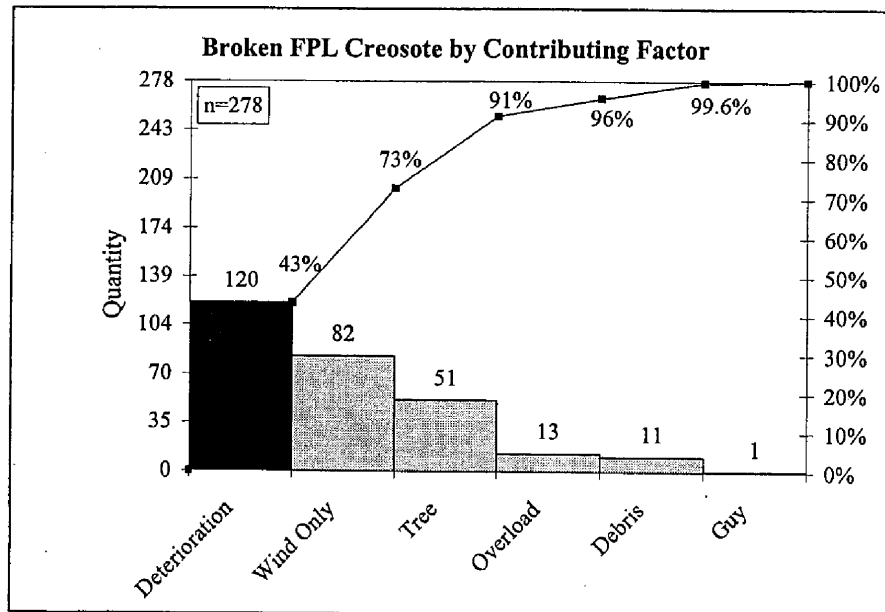
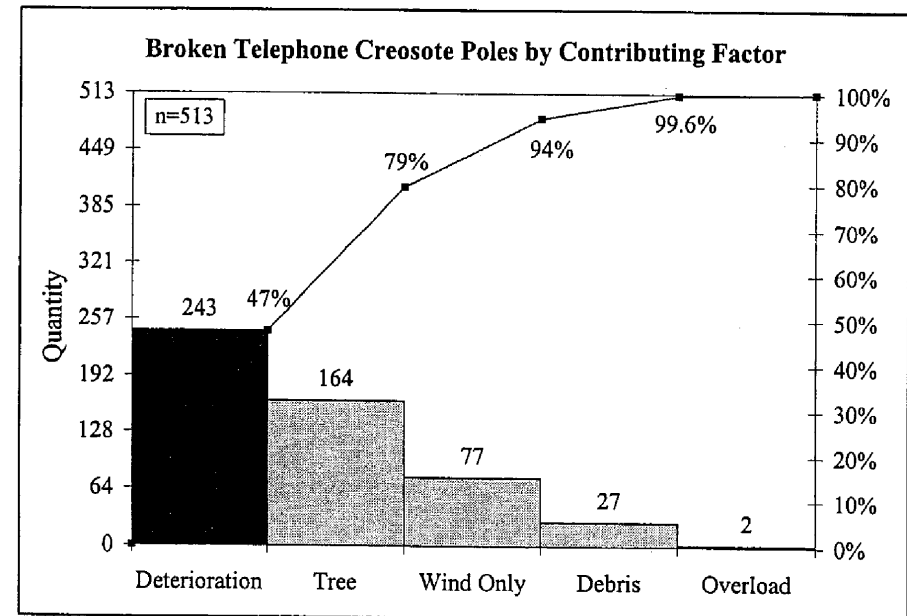
Broken Creosote Poles

Pole Type	Broken	Population	Difference
CCA	35%	40%	-5%
Concrete	6%	9%	-3%
Creosote	45%	34%	12%
Penta	14%	18%	-3%

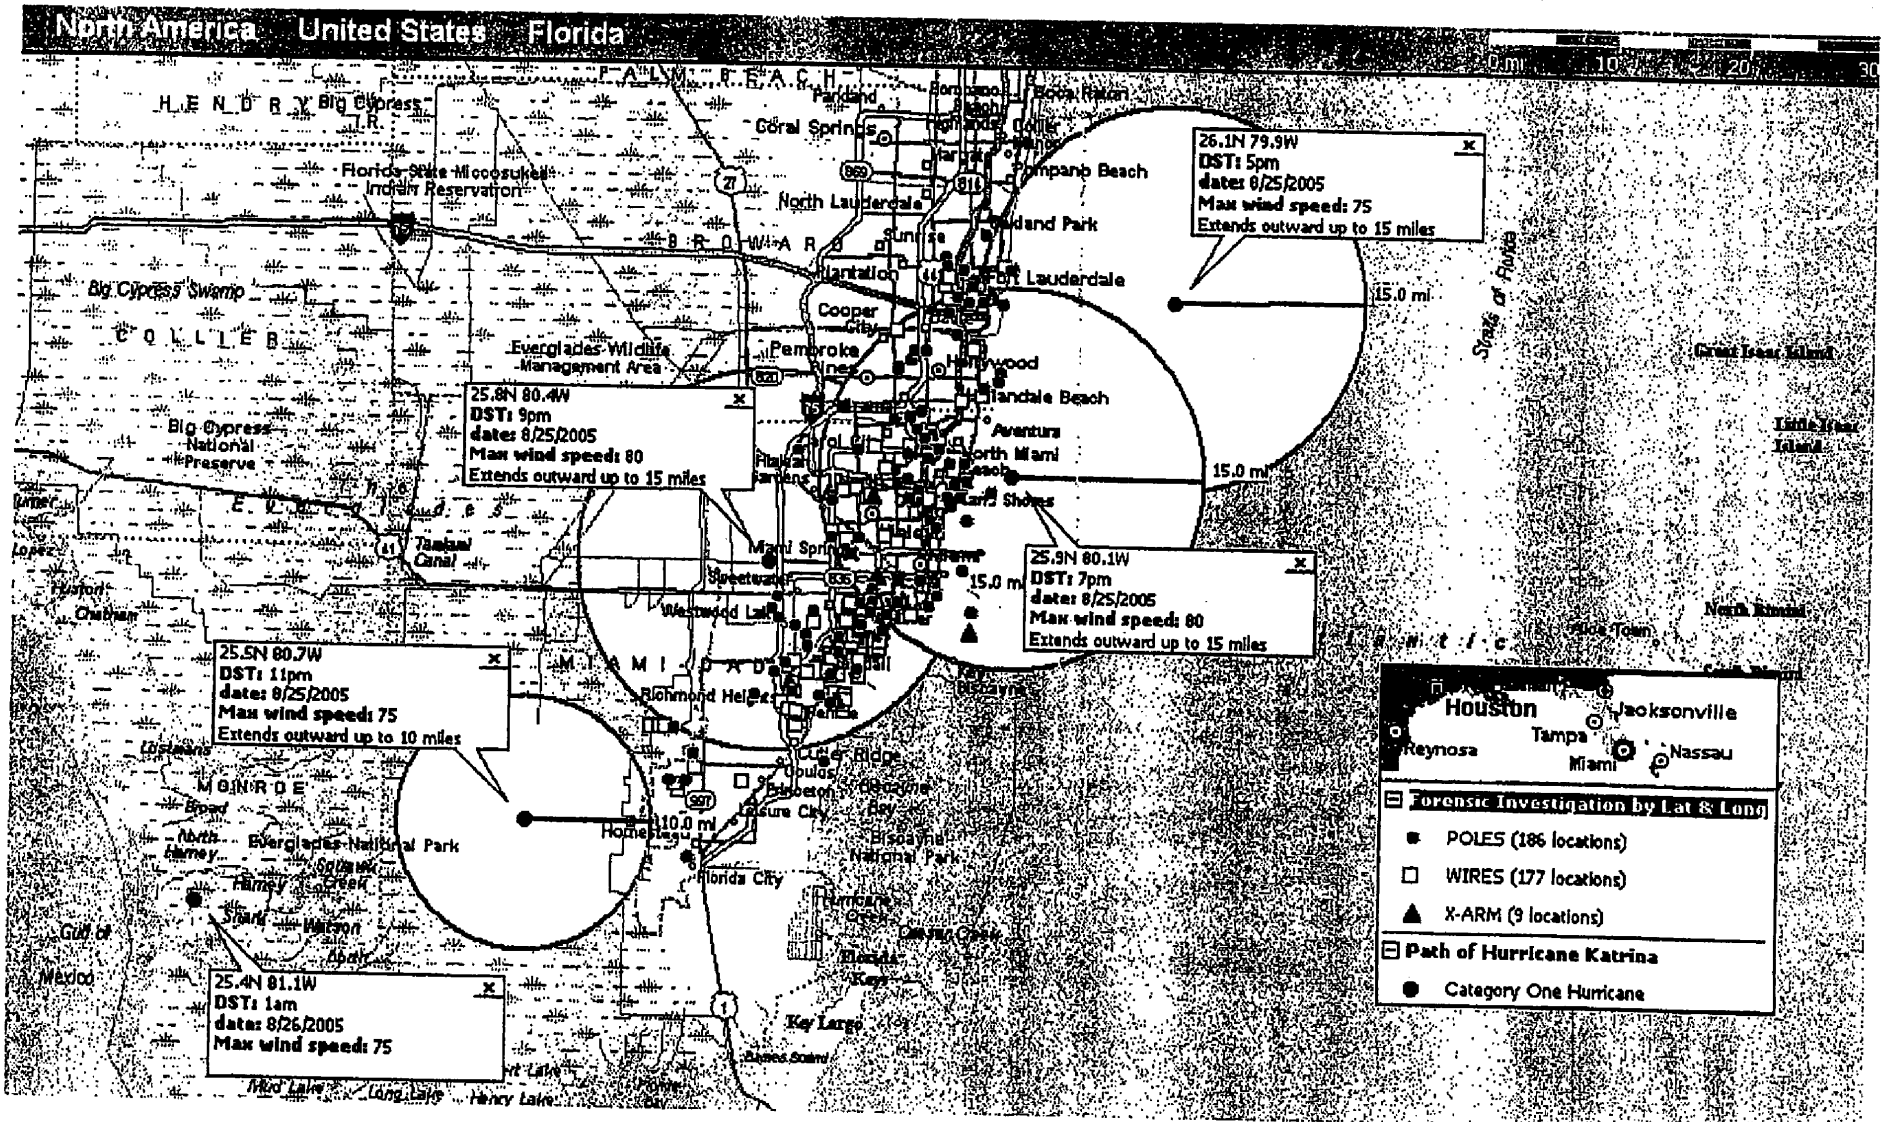
Observations by forensic team immediately after Hurricane Katrina

The following findings are based on the analysis of the observations by the forensic team on the damage caused by Hurricane Katrina

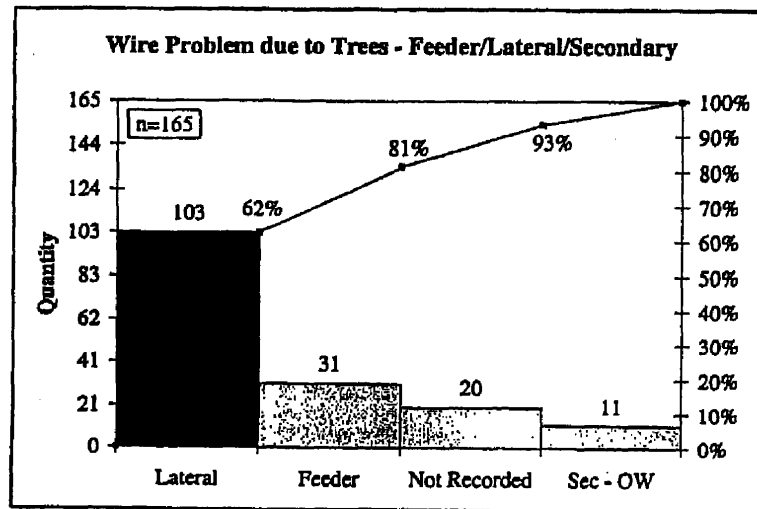
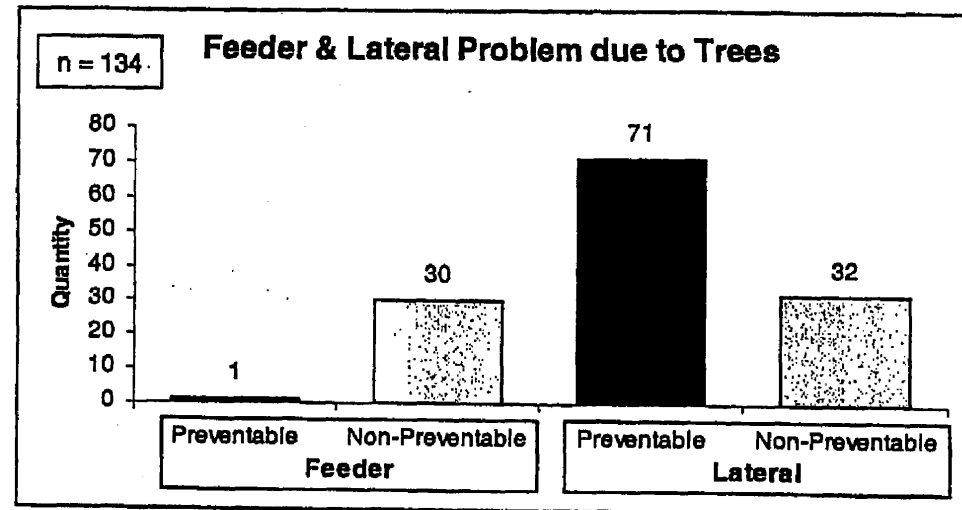
Wind Damage - Conductors

- 93% of conductor damage observed was caused by trees

- 62% of the conductor damage caused by trees were on laterals
- Only 3% of the feeder tree-related conductor damage was preventable
- 69% of the lateral tree-related conductor damage was preventable

Trees and tree branches in the lateral lines was a significant cause of preventable interruptions and conductor damage

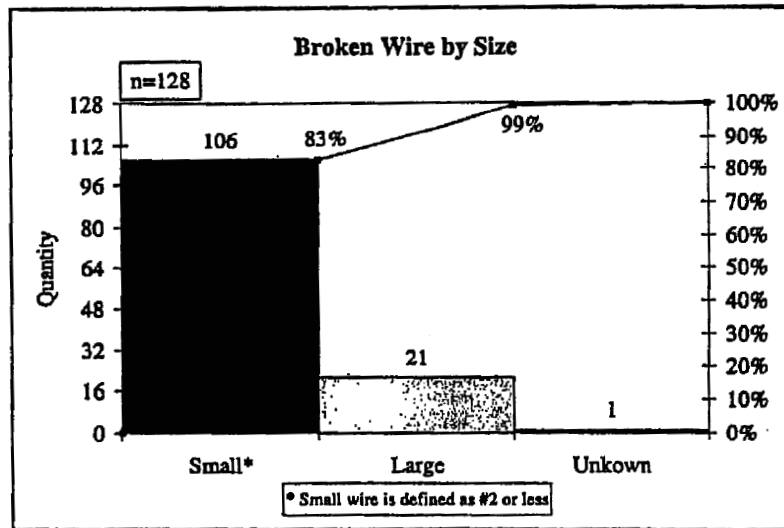
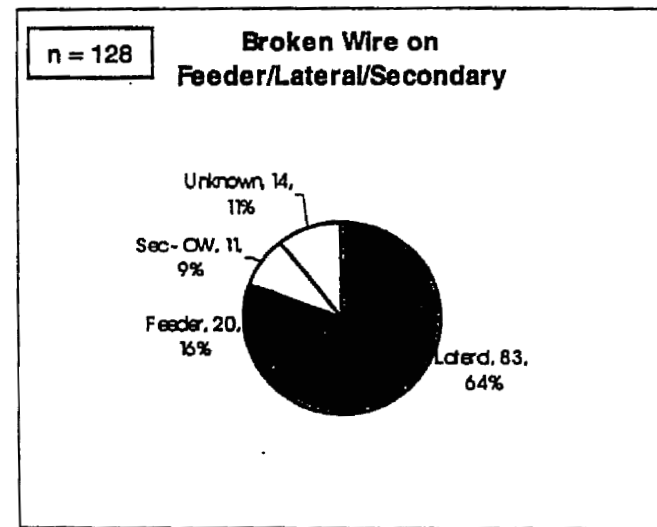
Wind Damage - Conductors

- 83% of the conductor damaged observed was small wire (#2T or smaller)
- 77% of splices issued in 2004 hurricane season were for #2T or smaller

- 64% of the damaged small wire conductor was lateral conductor
- 16% of the damaged small wire conductor was feeder conductor

Lateral small wire was a significant factor in the interruptions and conductor damage

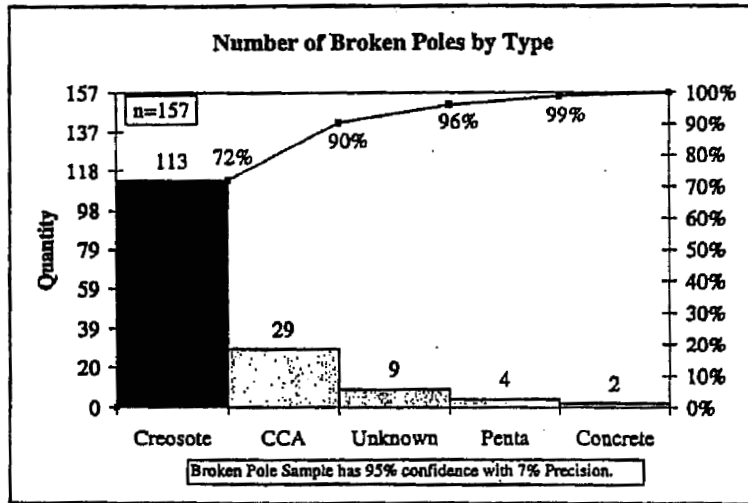
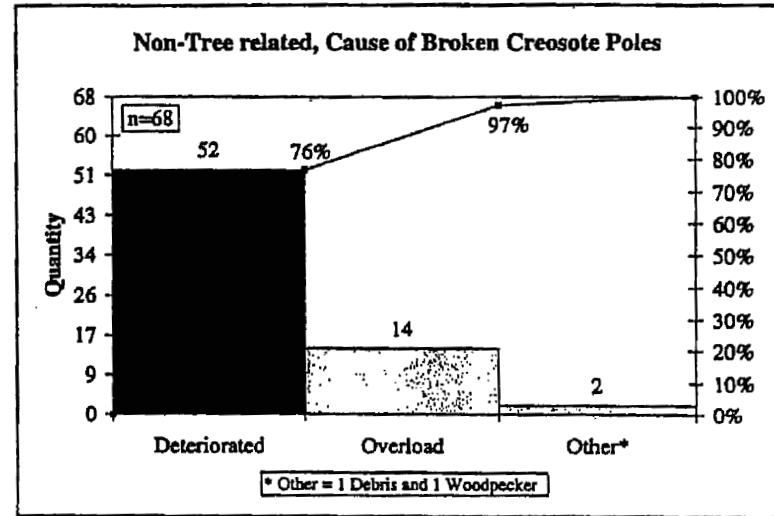
Wind Damage - Poles

In Dade and Broward County only 1035 out of 343,233 poles (.3%) were replaced during the restoration from Hurricane Katrina

- 50% of damage to distribution poles was tree related
- **72% of damaged poles were the creosote poles**

- 76% of the non-tree related damaged creosote poles is due to deterioration
- 58% of the damaged deteriorated creosote poles were on laterals

Aged creosote poles were a significant factor in the poles that were damaged during the hurricane

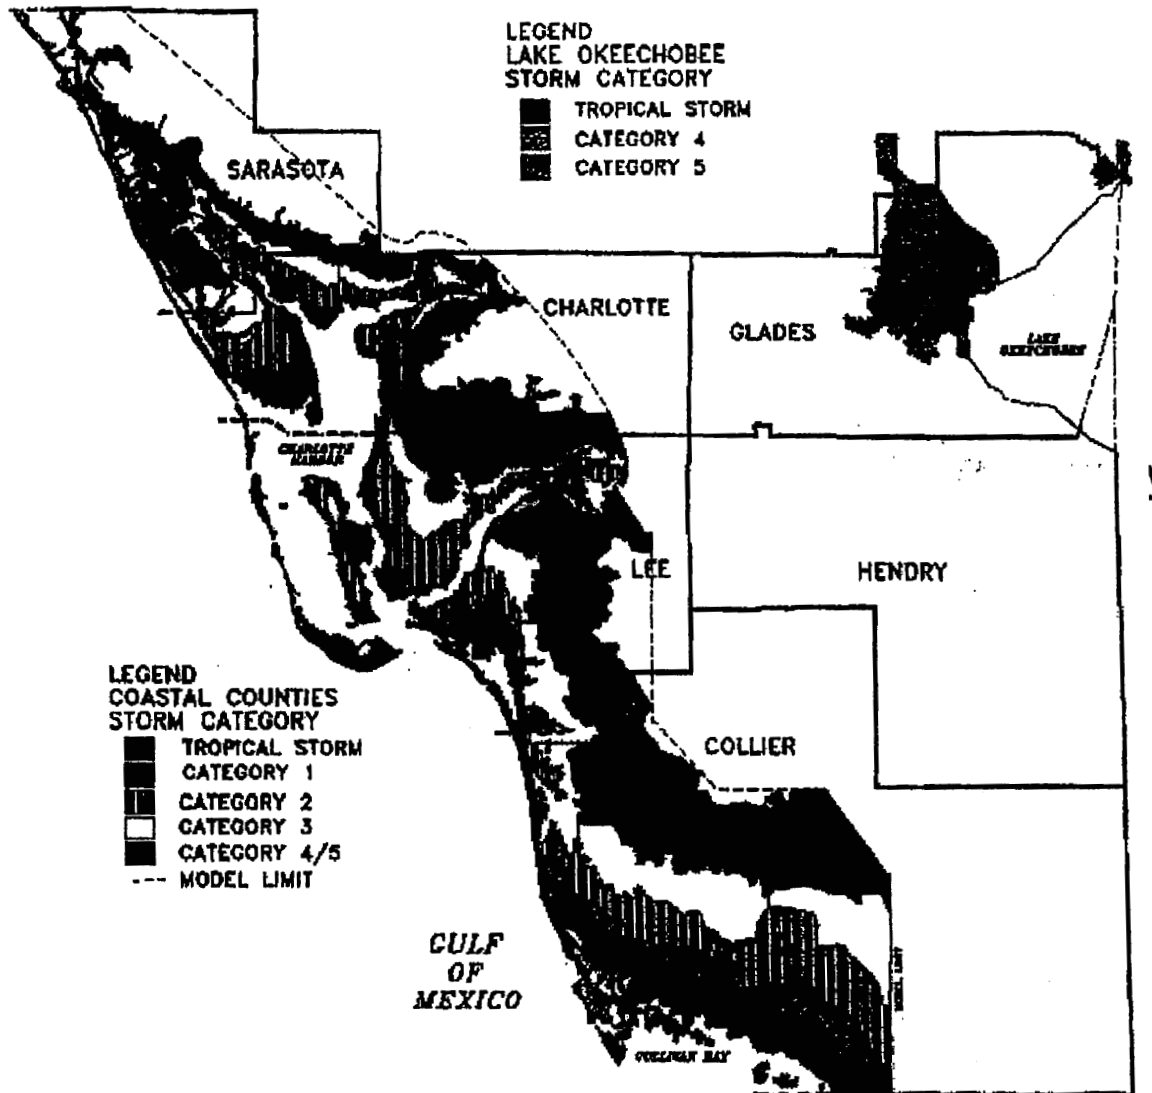
Storm Surge Damage

Storm Surge impacts in two ways:

- Physical damage by the wave action right on the coast
- Flood damage by the quickly rising water miles inland from the coast

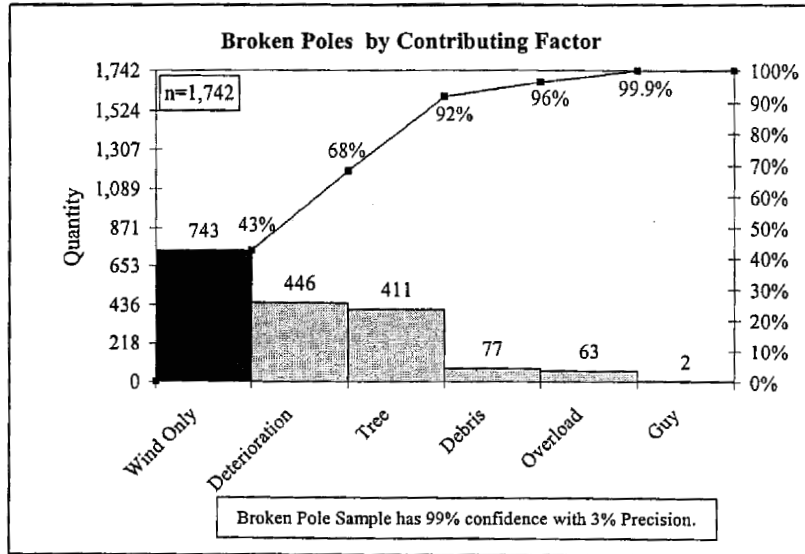
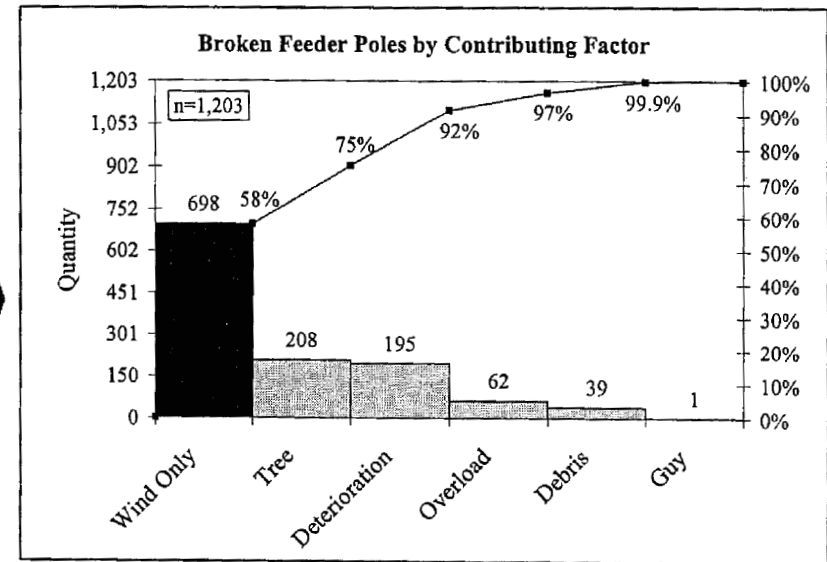
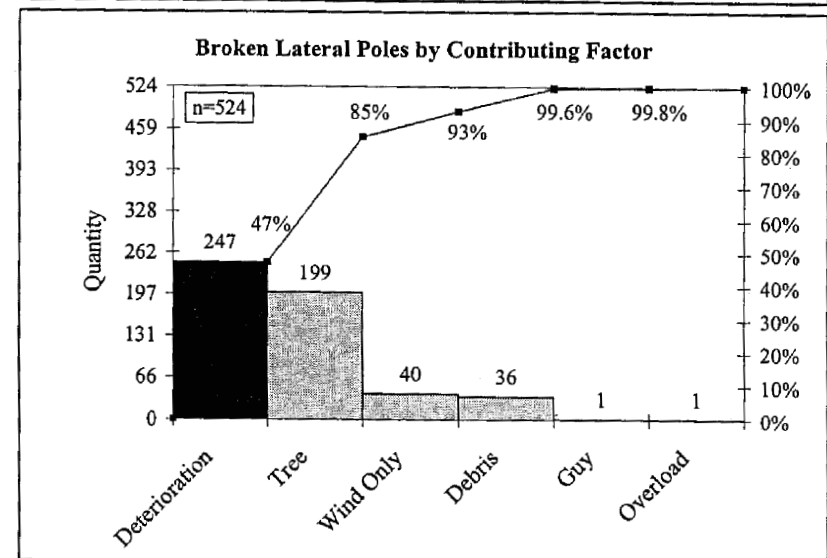
Broken Poles by Contributing Factor

- **40 - 46% of broken poles were due to wind only with 99% confidence.**
- Observed 58% of broken feeder poles were due to wind only.
- Observed 47% of broken lateral poles had some degree of deterioration.
