BRR 4S L-0 Background

The Bartow Combined Cycle Steam Turbine 4s (COE mid-2009) last stage blade (L-0) issues started with a routine visual inspection that lead to a forced outage in 2012 after just 3 years of in service time. Several cracks and chips were found on the blade mid-span snubbers and tip z-notches of the turbine end row. The generator end was undamaged and turbine end L-0's were replaced. The OEM concluded in a root cause investigation the cause of the issue was last stage steam flow rates beyond their design limits forcing non synchronous blade vibrations and subsequent wear and fatigue of the mating blade contact surfaces. At that time, the OEM required a limit to the IP exhaust pressure to limit steam flow into the LP section to the original design limit thus restricting output. The unit continued to run at the original design conditions until a more rugged design upgrade was developed and made available.

# Bartow Steam Turbine RCA Review Addendum Presentation Nov 17<sup>th</sup> 2016

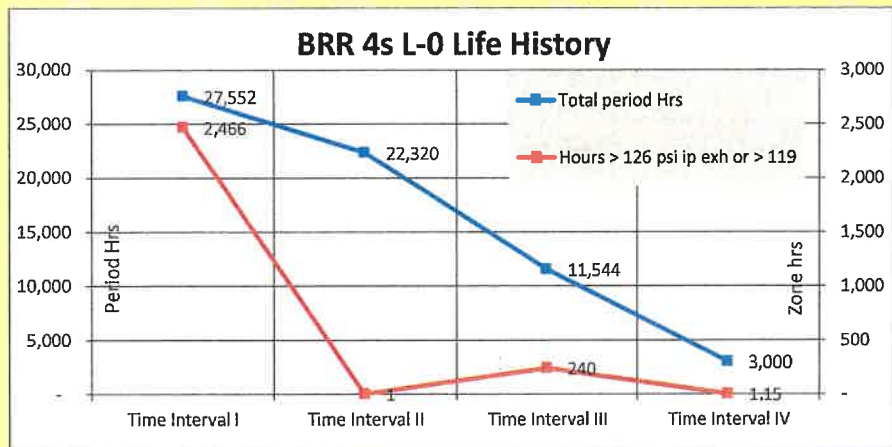
The expected blade life predictions of the latest blade configuration compared to the actual field experience is the driver for the study in attachment A of steam turbine output and operating pressures versus time. There is one particular fact and clear apparent path forward that can be seen in this data. The Table below from the attachment presents the fact that the more we modified the blades, the shorter the time before contact surface failure despite the fact we have continued operate the unit with lower steam flows that fall mostly within the OEM limits for the original design.

Inspection of the data reveal that the original design in time intervals 1 and 2 only had the mid-span snubber failure of the original turbine end (TE) blades - and the 1st time interval nearly 2500 hours of operation was above the OEM limit. In time interval 2, no failures occurred and there was only 1 hours of operation slightly above the limit. This means that the generator end (GE) blades ran nearly 50,000 hours with no failures.

This is in contrast to time interval 3 where failures occurred after only 11.5 khrs of operation with only 240 hours above the original limit – and interval 4 with only 3 khrs of operation and just over only 1 hour above the original flow limit. The data clearly suggest that returning to the original design, and limiting the IP exhaust pressure to 123 psig (not sure I'm reading that right off the graph), which will give approximately 400 to 405 MW with 4x1 operation, will give much more acceptable life than the modified design.

For these reasons the recommended direction on the current repair ( fall 2016) is to return to the original blade design (no hard facing) with reasonable operational restrictions on steam flows and pressure limits. These restrictions need to be part of the control logic and not an operator or supervision option to interpret.

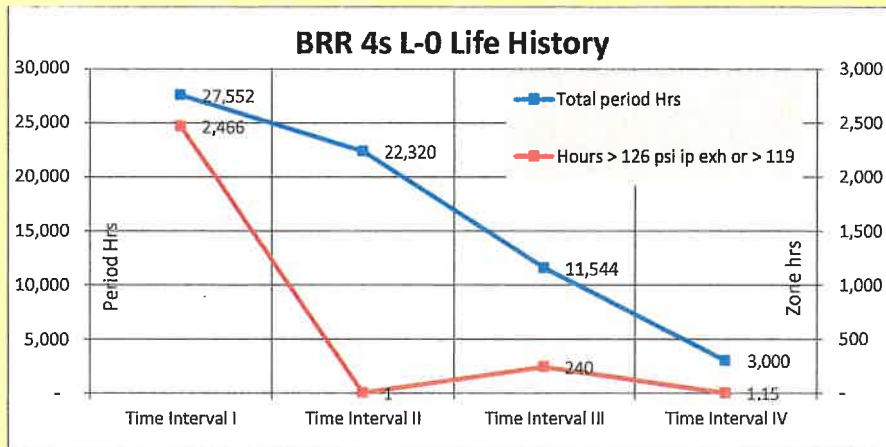
The expected blade life predictions of the latest blade configuration compared to the actual field experience is the driver for the study in attachment A of steam turbine output and operating pressures versus time. There is one particular fact and clear apparent path forward that can be seen in this data. The Table below from the attachment presents the fact that the more we modified the blades, the shorter the time before contact surface failure despite the fact we have continued operate the unit with lower steam flows that fall mostly within the OEM limits for the original design.

Inspection of the data reveal that the original design in time intervals 1 and 2 only had the mid-span snubber failure of the original turbine end (TE) blades – and the 1<sup>st</sup> time interval nearly 2500 hours of operation was above the OEM limit. In time interval 2, no failures occurred and there was only 1 hours of operation slightly above the limit. This means that the generator end (GE) blades ran nearly 50,000 hours with no failures.

This is in contrast to time interval 3 where failures occurred after only 11.5 khrs of operation with only 240 hours above the original limit – and interval 4 with only 3 khrs of operation and just over only 1 hour above the original flow limit. The data clearly suggest that returning to the original design, and limiting the IP exhaust pressure to 123 psig (not sure I'm reading that right off the graph), which will give approximately 400 to 405 MW with 4x1 operation, will give much more acceptable life than the modified design.

For these reasons the recommended direction on the current repair ( fall 2016) is to return to the original blade design (no hard facing) with reasonable operational restrictions on steam flows and pressure limits. These restrictions need to be part of the control logic and not an operator or supervision option to interpret.

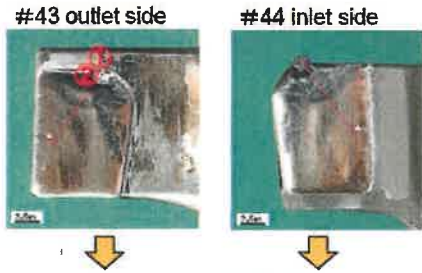
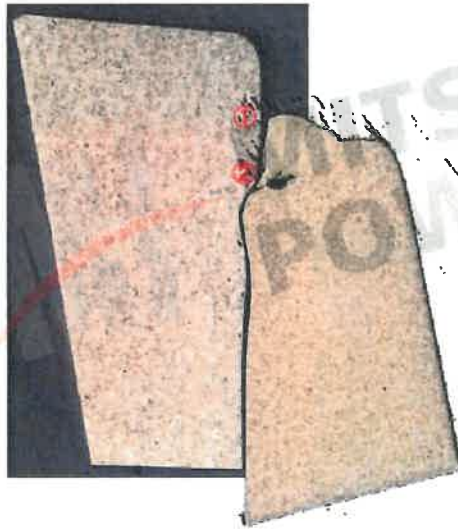
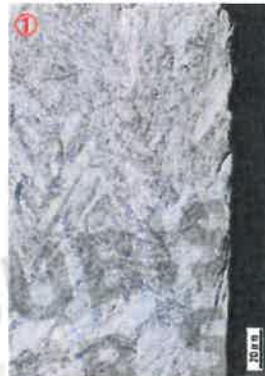
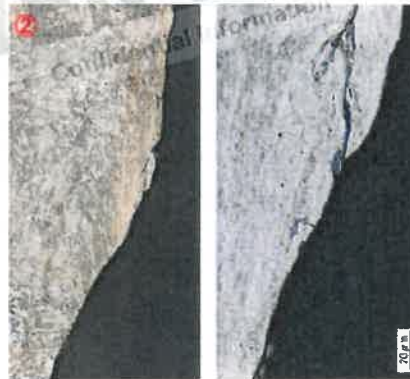
# Metallurgical Evaluation of Blades

Microscopic observation was performed on the same sections in contact condition for each of outlet side of #43 blade and inlet side of #44 blade.

- Fine cracks, caused by fretting fatigue, are found near the end of contact part with local deformation of inlet side of #44 blade.
- Plasticity is found in concave part of local deformation.

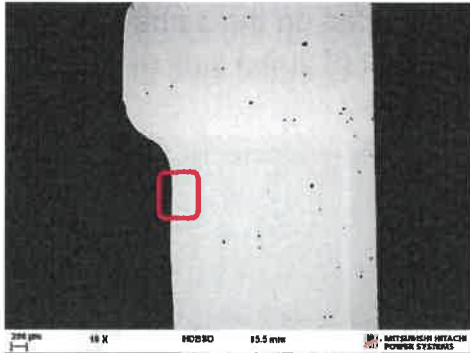
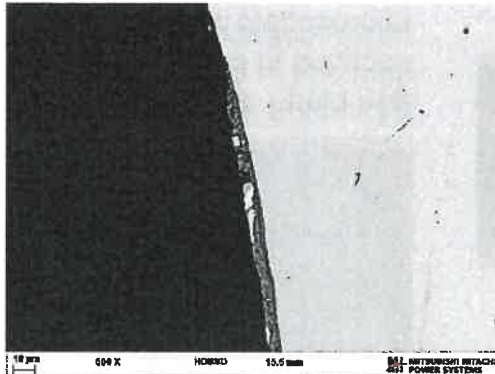
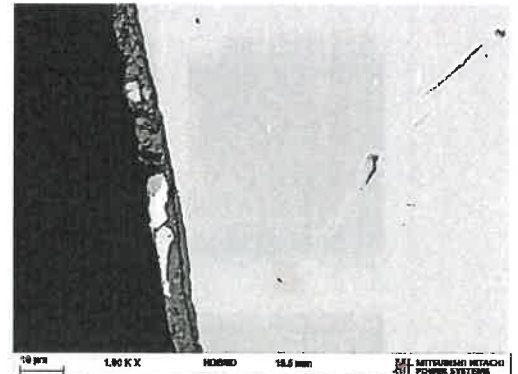
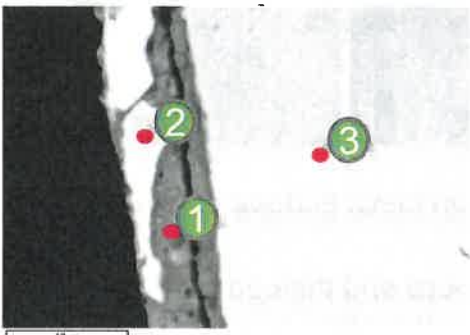
# Metallurgical Evaluation of Blades

Location	Semi-Qualitative EDS analysis of elements detected ( wt% )							
	O	Si	Cr	Mn	Fe	Ni	Cu	Nb
1	25.97	0.44	7.67	0.41	61.59	1.84	1.18	0.00
2	0	0.35	18.15	0.95	70.12	9.35	0.08	1.00
3	0	0.33	15.86	0.54	73.65	4.91	3.58	1.14

- Oxidation/corrosion was observed on the trailing edge contact surface of the tip shroud.
- Material removal from wear is from abrasion.

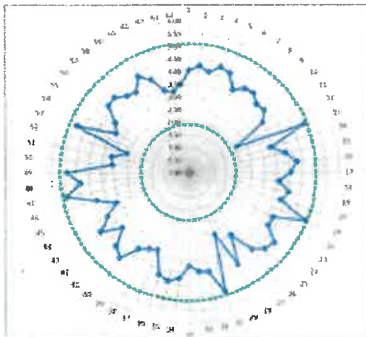
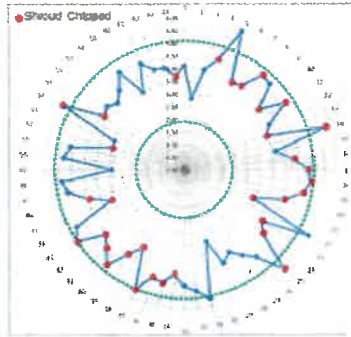
### 2014 Blade LH (Gov. End) Shroud Gap Data

**Row Average Gap = 3.9mm**

Criteria: Shroud 1.9mm to 5.1mm Average, with no single blade above 6.0mm.

No clear relationship between gaps and shroud chipping

**Row Average Gap = 4.2mm**

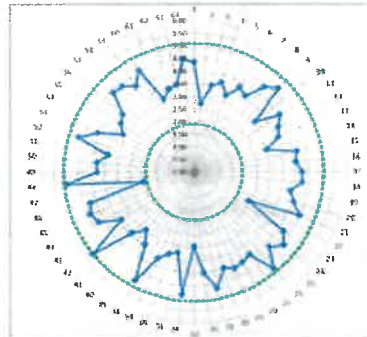
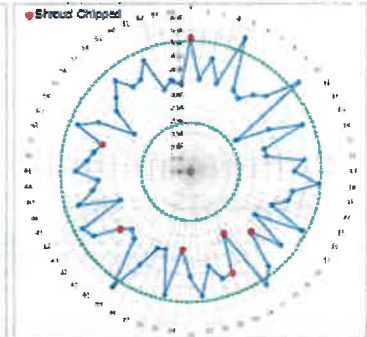
### 2014 Blade RH (Gen. End) Shroud Gap Data

**Row Average Gap = 3.9mm**

Criteria: Shroud 1.9mm to 5.1mm Average, with no single blade above 6.0mm.

No clear relationship between gaps and shroud chipping

**Row Average Gap = 4.0mm**

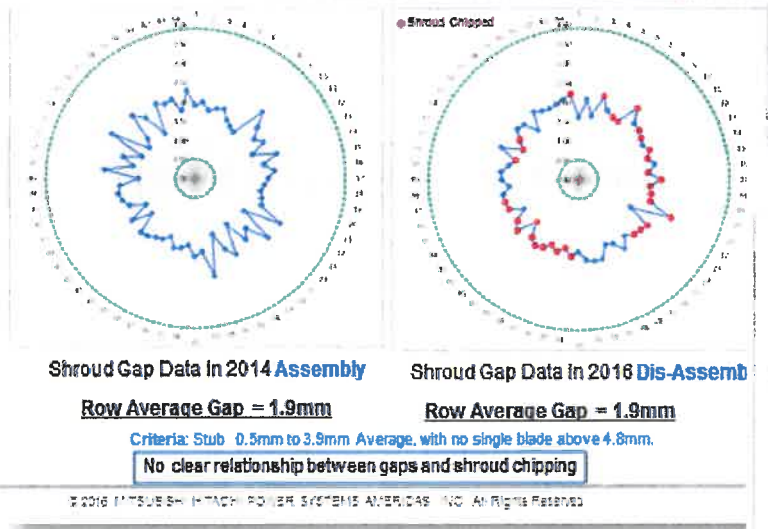
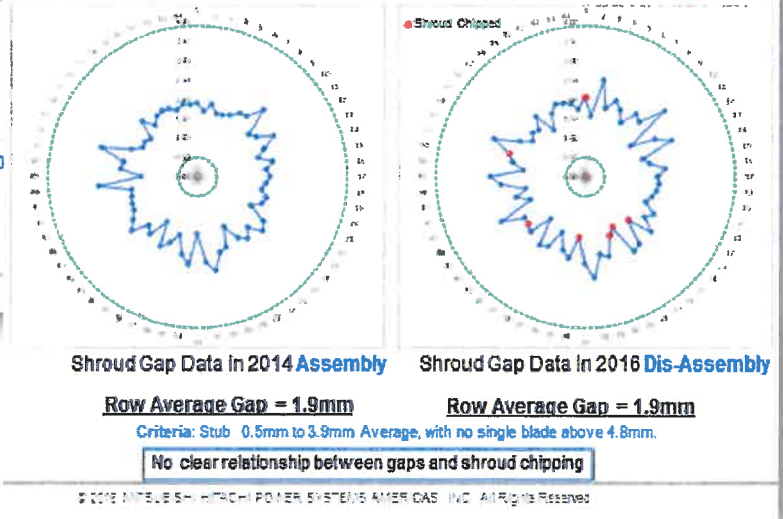
# Stub Gap Data

**LH and RH stub average gaps are nearly same.  
No clear relationship between gap and shroud chipping.**

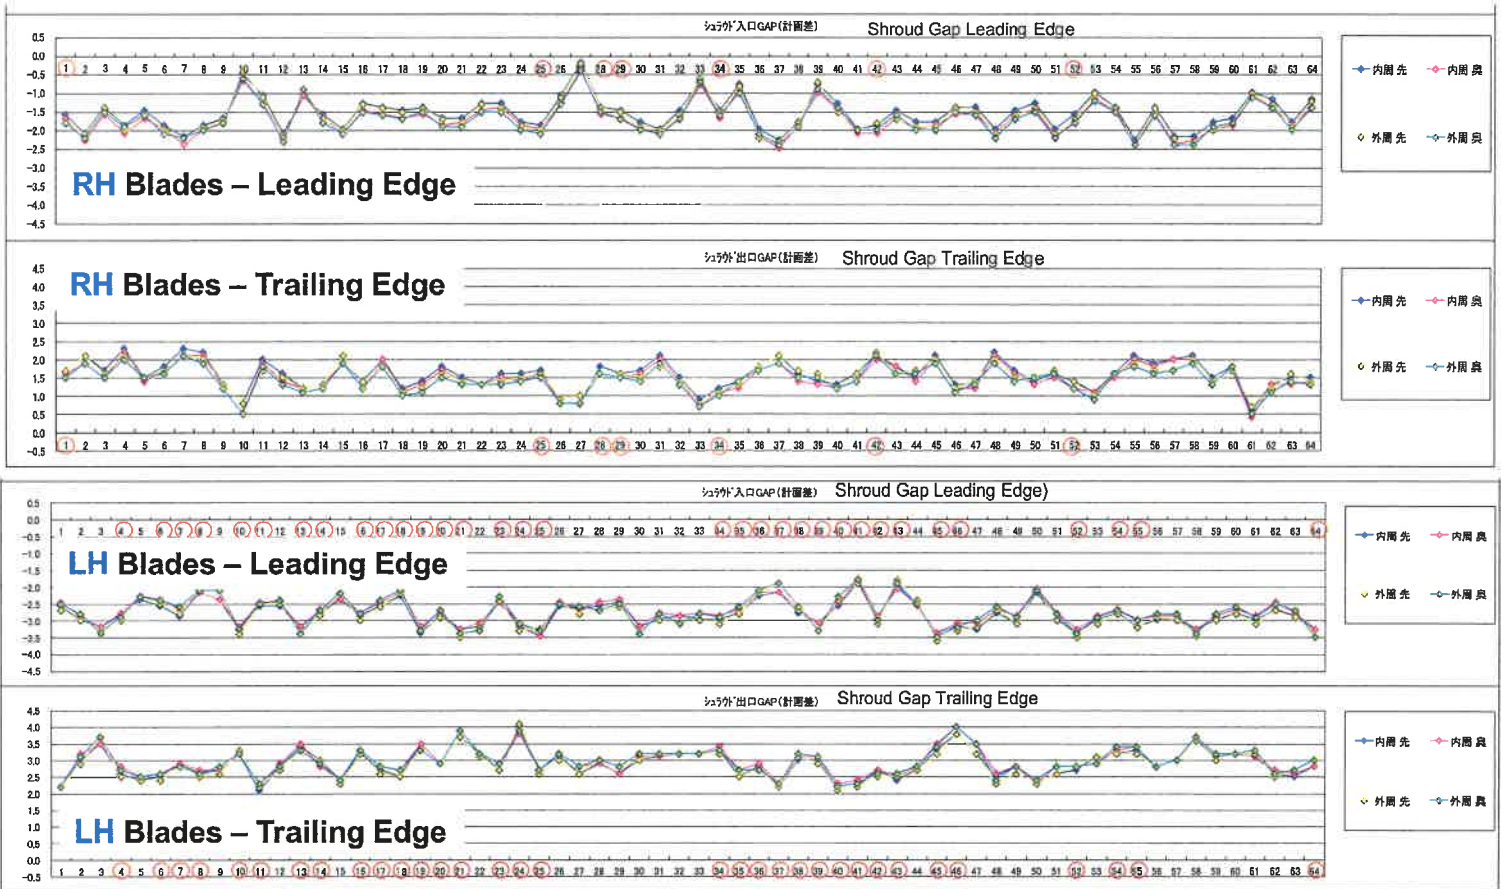
# Box Gauge Measurement Results - 2014 blades EF20190001BARTOW LFE4-000030

**Blade manufacturing data show variation within criteria**

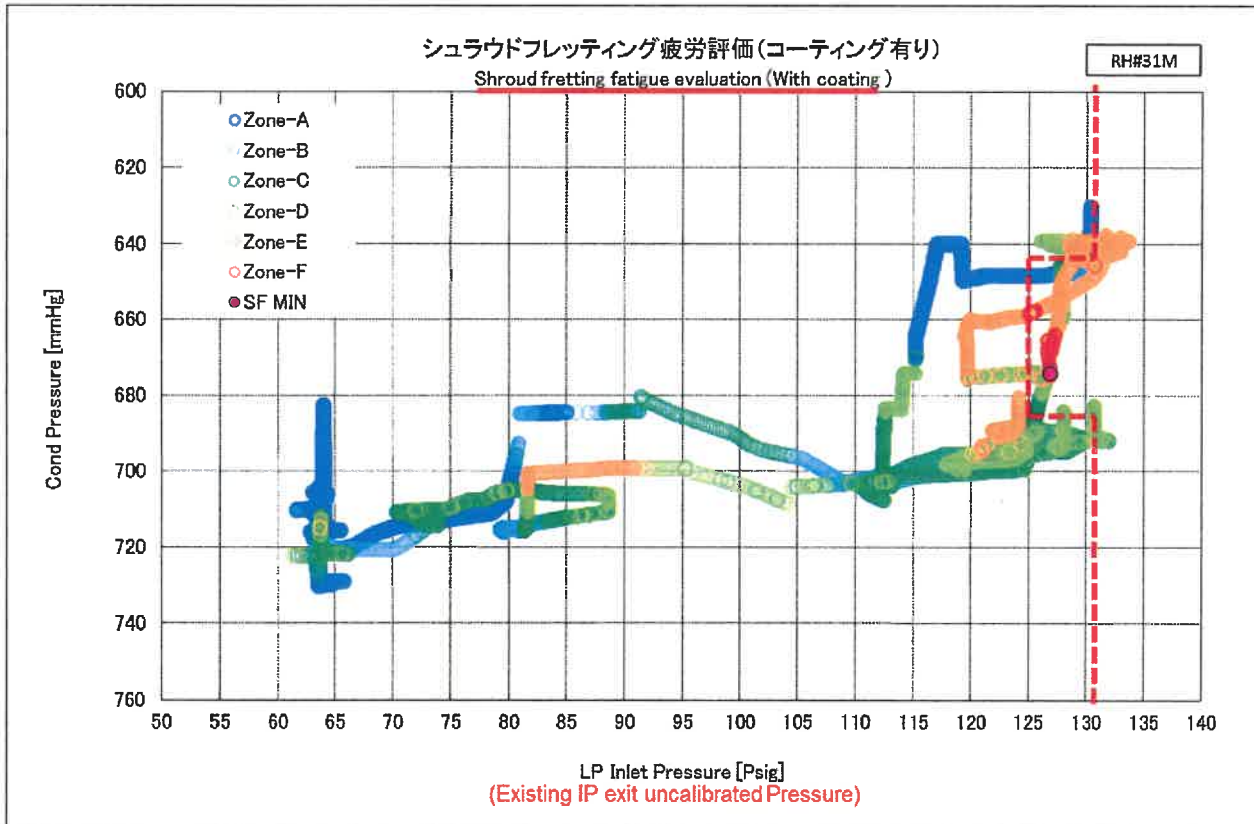
# Telemetry Test Results – Shroud Fretting

**Fretting fatigue calculations for shroud with coating show acceptable margins outside avoidance zone**

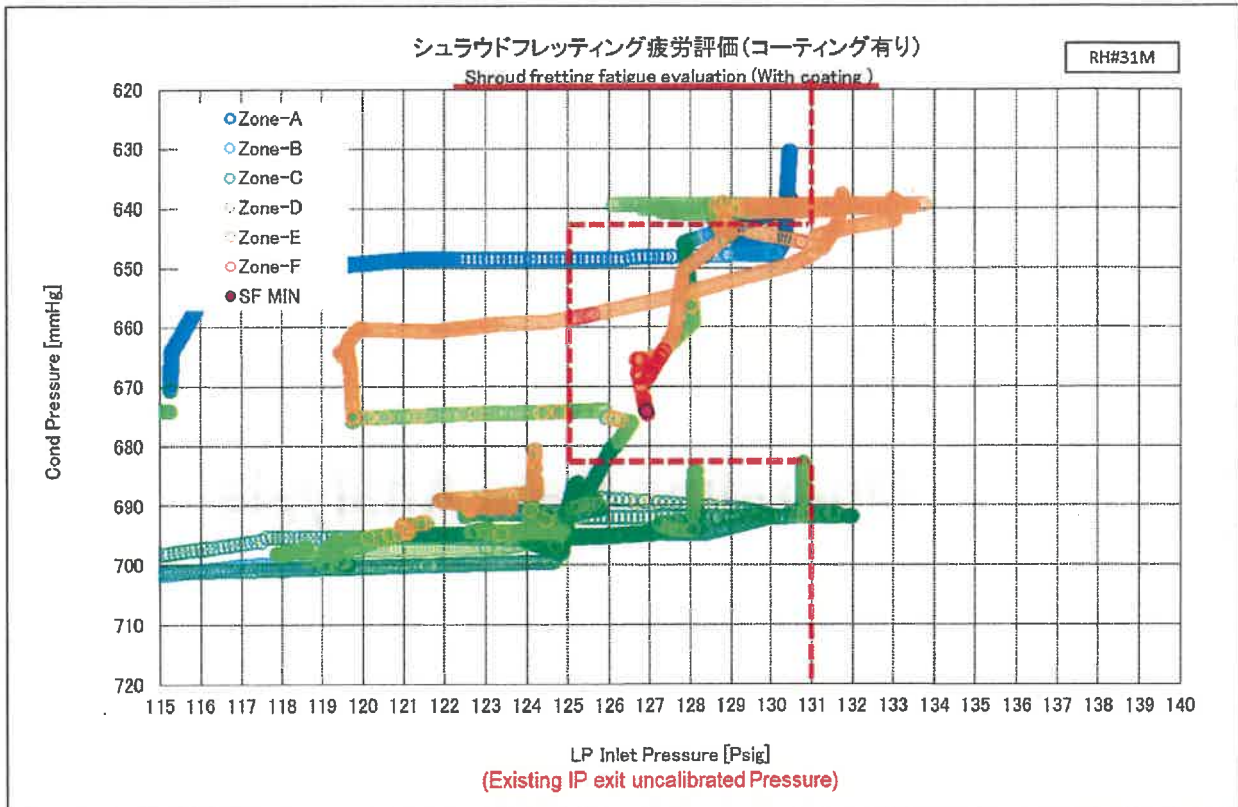
## Telemetry Test Data – Shroud Fretting

Fretting fatigue calculations for shroud with coating show acceptable margins outside avoidance zone

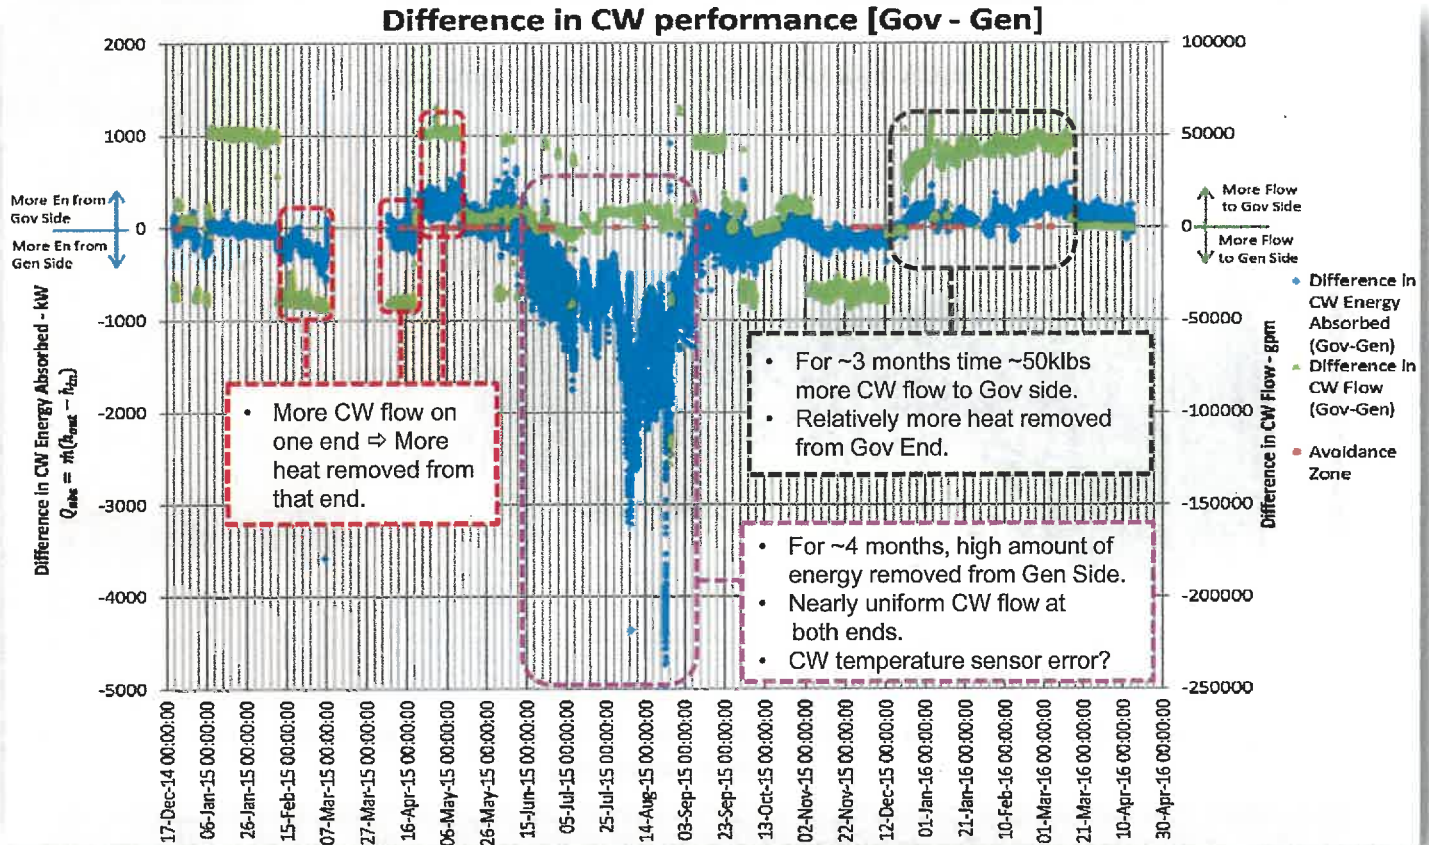
# Condenser Circulating Water (CW) flow analysis

**Asymmetric circulating water flow may explain difference in water erosion observed**  
**Not enough data to draw any conclusion on blade shroud damage**

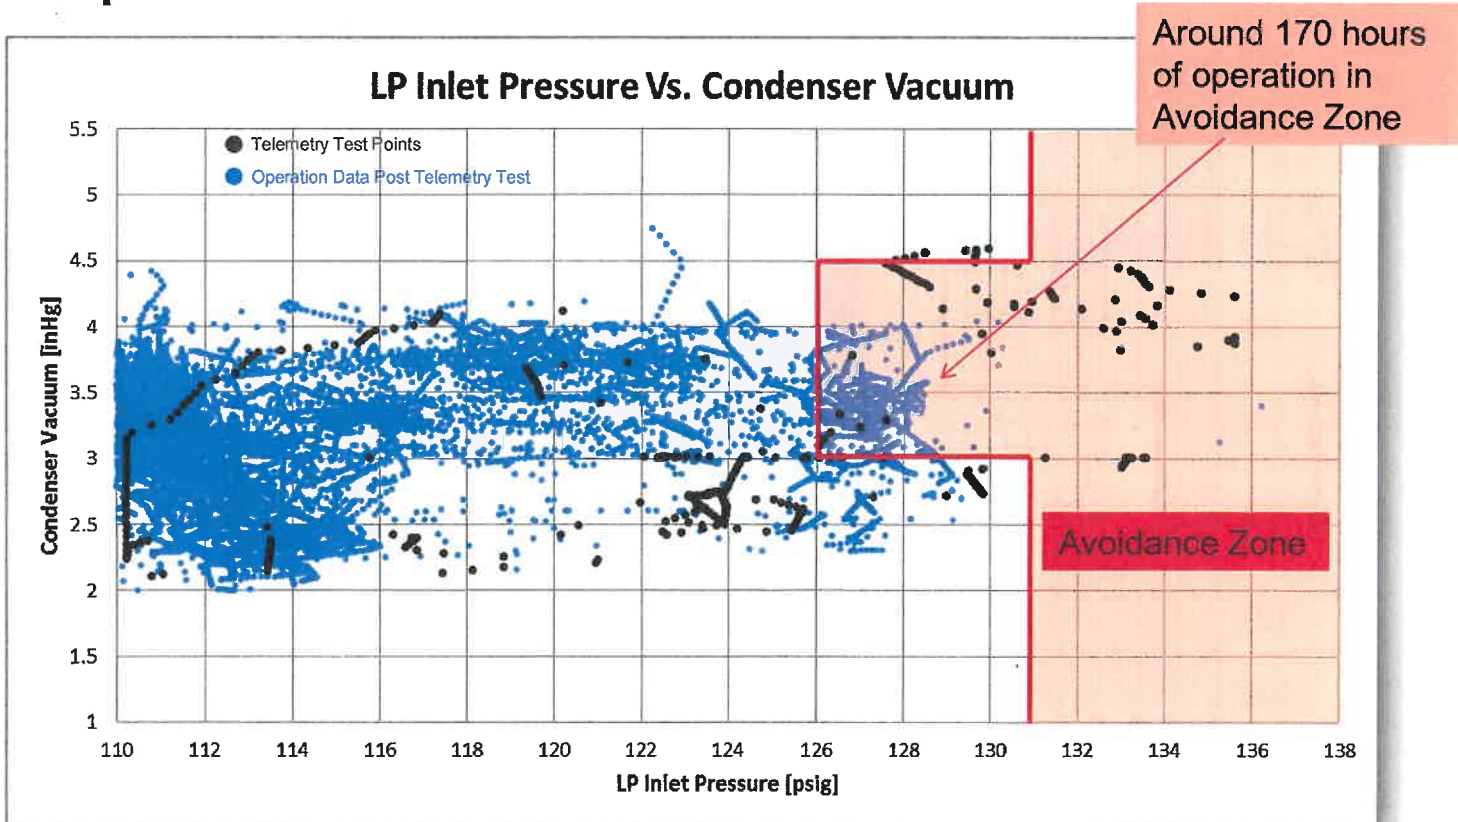
# Operation Data Review

**170+ hours of operation in avoidance zone with a response frequency ~200Hz = 1.2E8 Cycles**

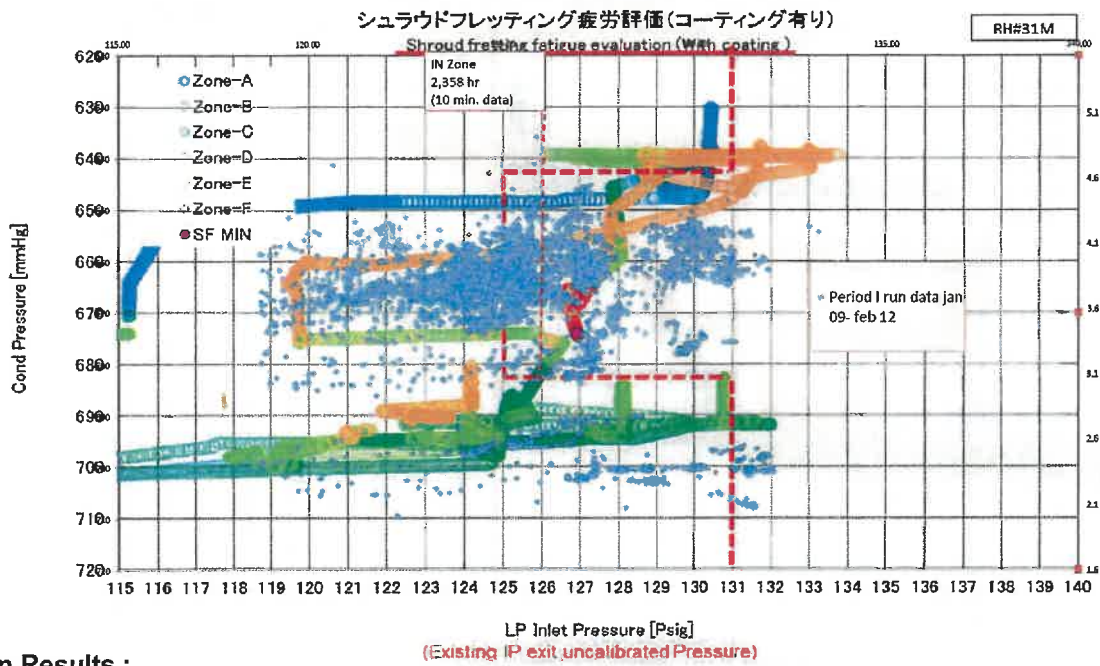
1.1) Operating Time 1 : Jan 2009 to Feb 2012

Location	Blades	Service	Mid Span Snubber	Shroud	Disposition
Gen End	Type 1	3 yrs	No significant damage	No significant damage	Continue operation until 2014 planned replacement
Gov End	Type 1	3 yrs	5 Major Chip	3 minor chips	Replace blades as continues midspan chipping could results in a free standing blade

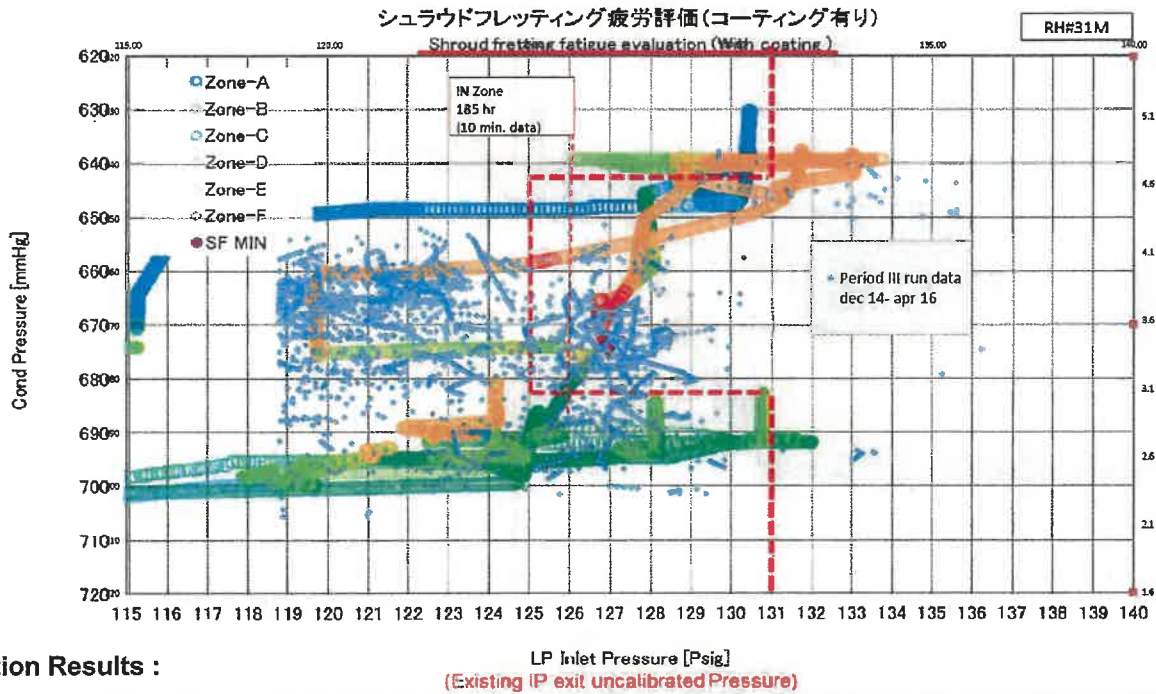
1.3) Operating Time 3 : Dec 2014 to Apr 2016

Inspection Results :

Location	Blades	Service	Mid Span Snubber	Shroud	Disposition
Gen End	Type 3 + HVOF	15 Months	No significant damage	7 minor chips	Fit for continued operation. Shroud contact on all blades.
Gov End	Type 3 + HVOF	15 Months	No significant damage	33 chips including significant damage	Replace row as free shroud contact has been lost on 1 blade.

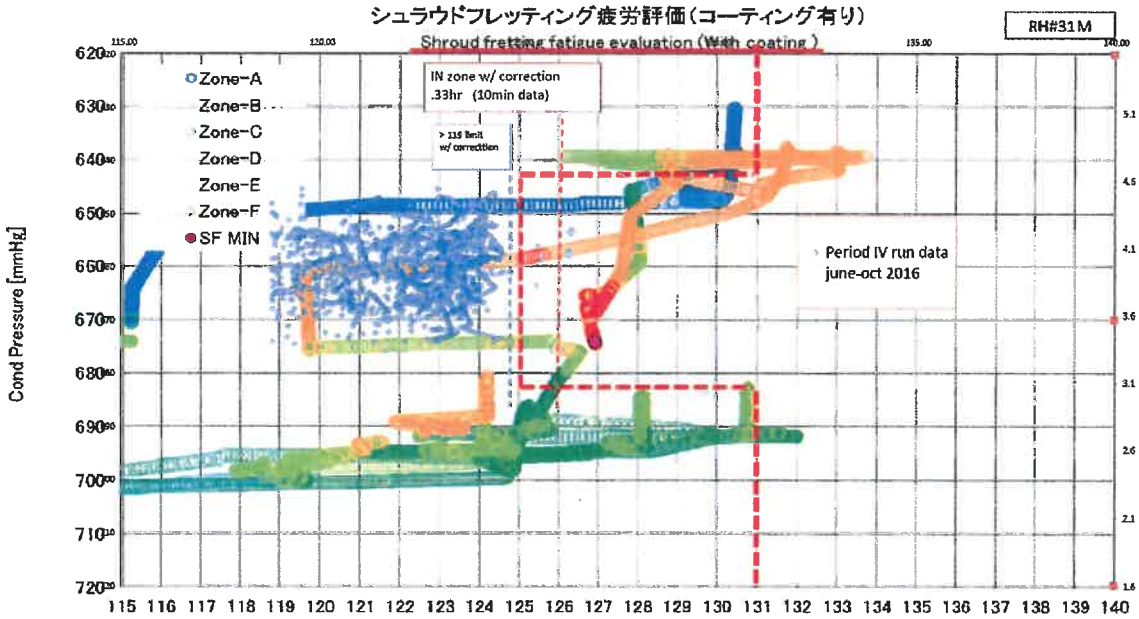
1.4) Operating Time 4 : Jun 2016 to Oct 2016

Inspection Results :

Location	Blades	Service	Mid Span Snubber	Shroud	Disposition
Gen End	Type 3 + HVOF++	4 Months	No significant damage	7 minor chips	Fit for continued operation. Shroud contact on all blades.
Gov End	Type 3 + HVOF++	4 Months	No significant damage	33 significant damage	Replace row as free shroud contact has been lost on 1 blade.

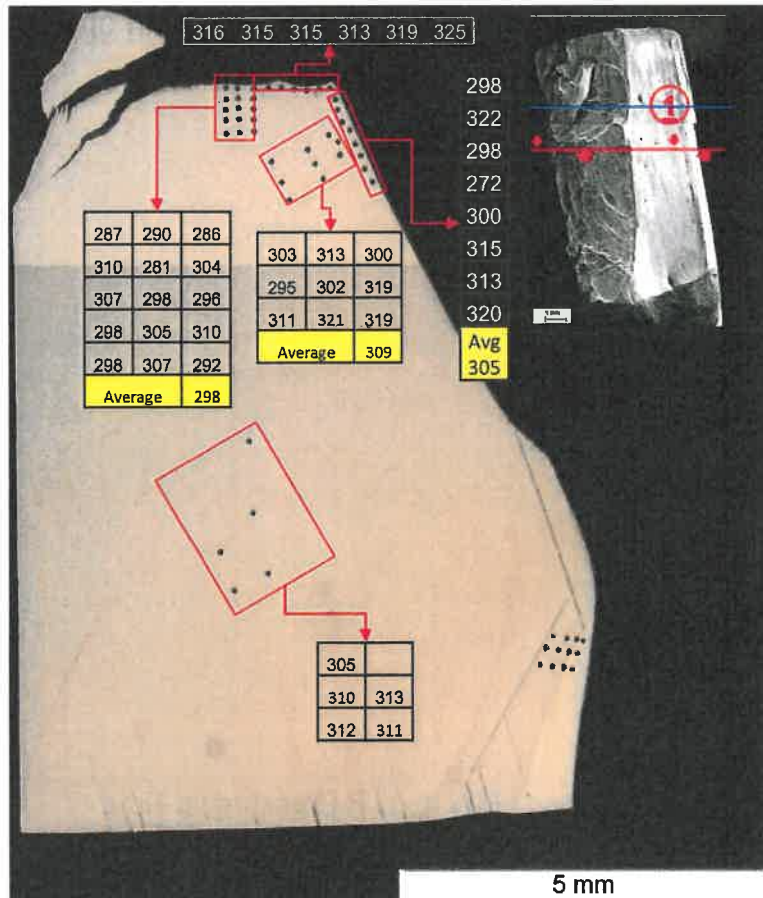
## 2 - Hardness Variation – Presented

- From hardness observation no significant decrease was observed where the crack initiated.
- A decrease in hardness was observed on the contact surface.

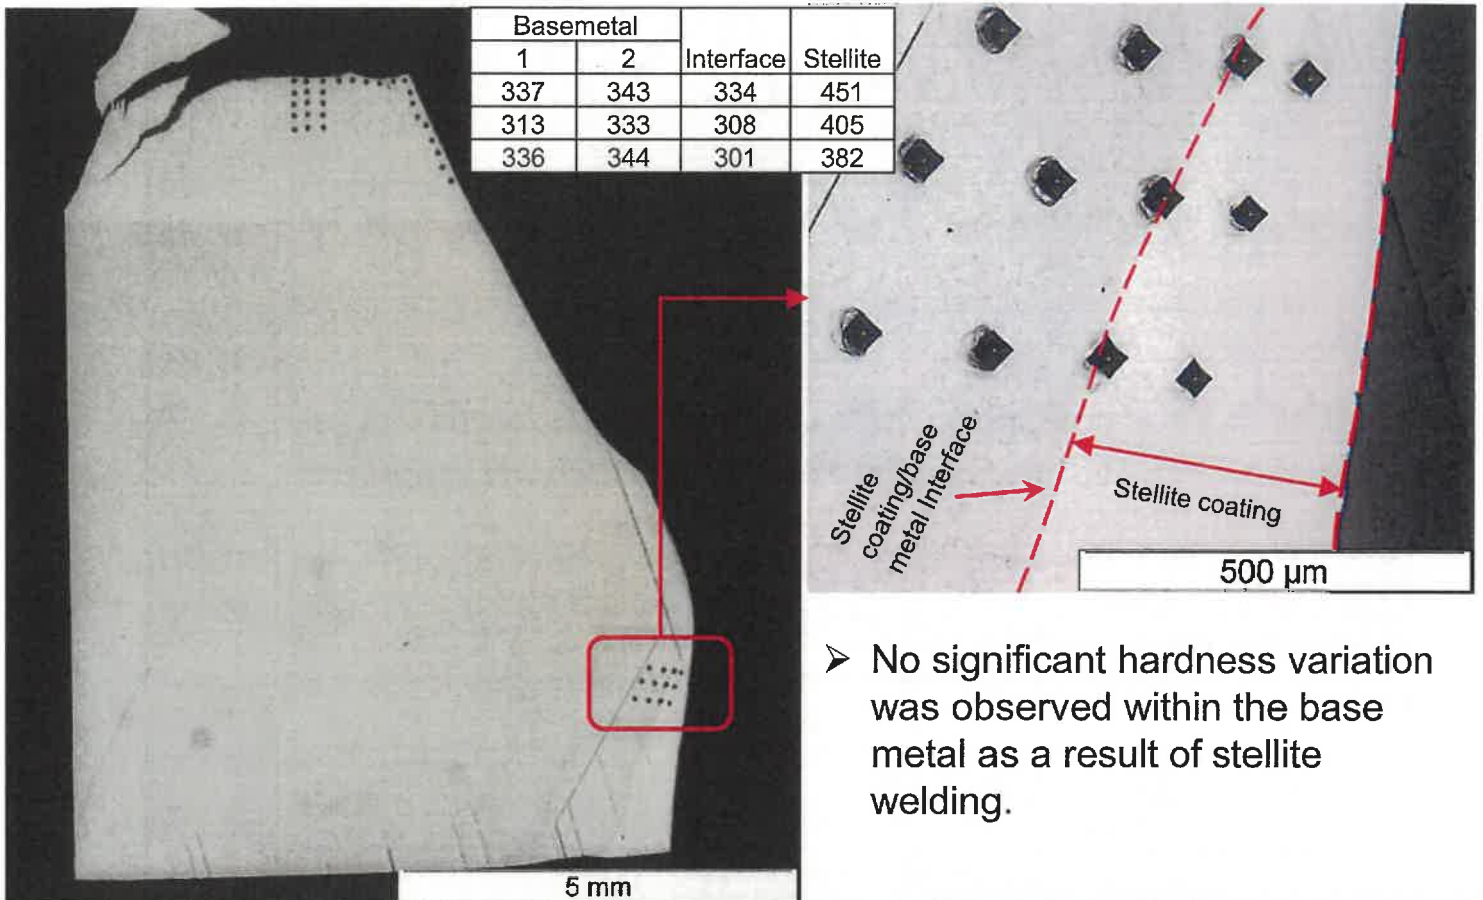
## 2- Hardness Variation basemetal, Interface and Stellite Coating

- No significant hardness variation was observed within the base metal as a result of stellite welding.

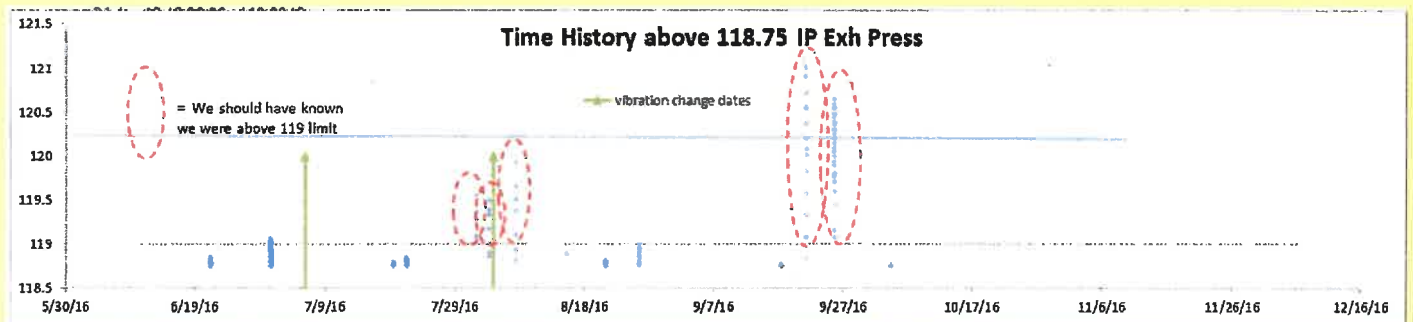
Oct 2016 photo of gen end #22. Three blades failed similar this GE # 13 and TE #2. Adequate mass loss to drive recorded Vibration step changes below.

June 2016  
Blades New  
both ends

Oct 2016 routine visual inspection to verify OEM eng. opinion that vibration changes were NOT caused by mass loss . Outage resulted in replacement of both rows of blades. Returned to service Dec 2016

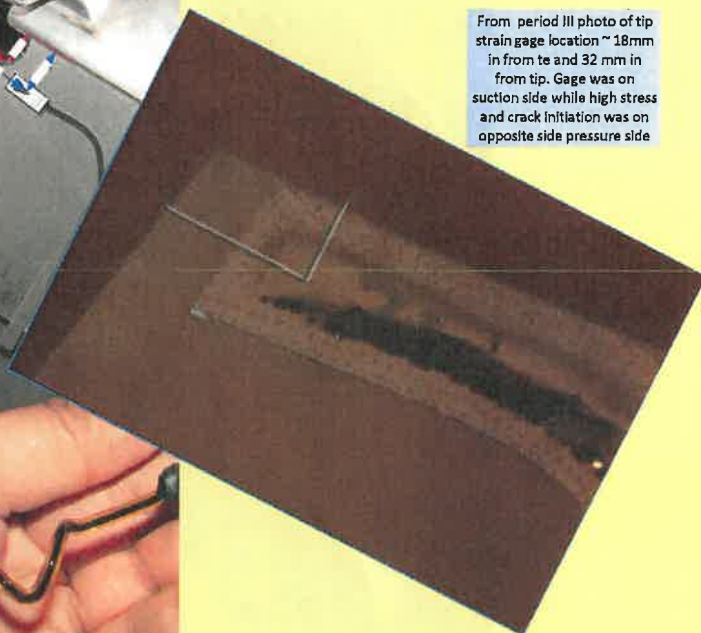
From period III photo of tip strain gage location ~ 18mm in from te and 32 mm in from tip. Gage was on suction side while high stress and crack initiation was on opposite side pressure side

The blades at Bartow were standard MHI type 3(welded) , but had design modifications of that included chamfers, radius, and HVOF hard face on mating surfaces. MHI tested an earlier version in the field (dec 2014) with strain gages at three locations each end. They were at the base, the middle near the snubber, and at the tip shown above near the z lock latch or lock up tip shroud. MHI knew this was a high stress area. They approved limited operation in an identified "zone" from this testing. In fact the testing included > ~ 10 hours in the zone to properly map it with steam flows and condenser back pressures. The original supplied blades, post run, were analyzed for amount of time in the zone. Period I 2009-2012 ran 2,466 hrs in the "zone" and had blade tip damage but never a material loss as large as Period IV Jun-Oct 2016 shown above.

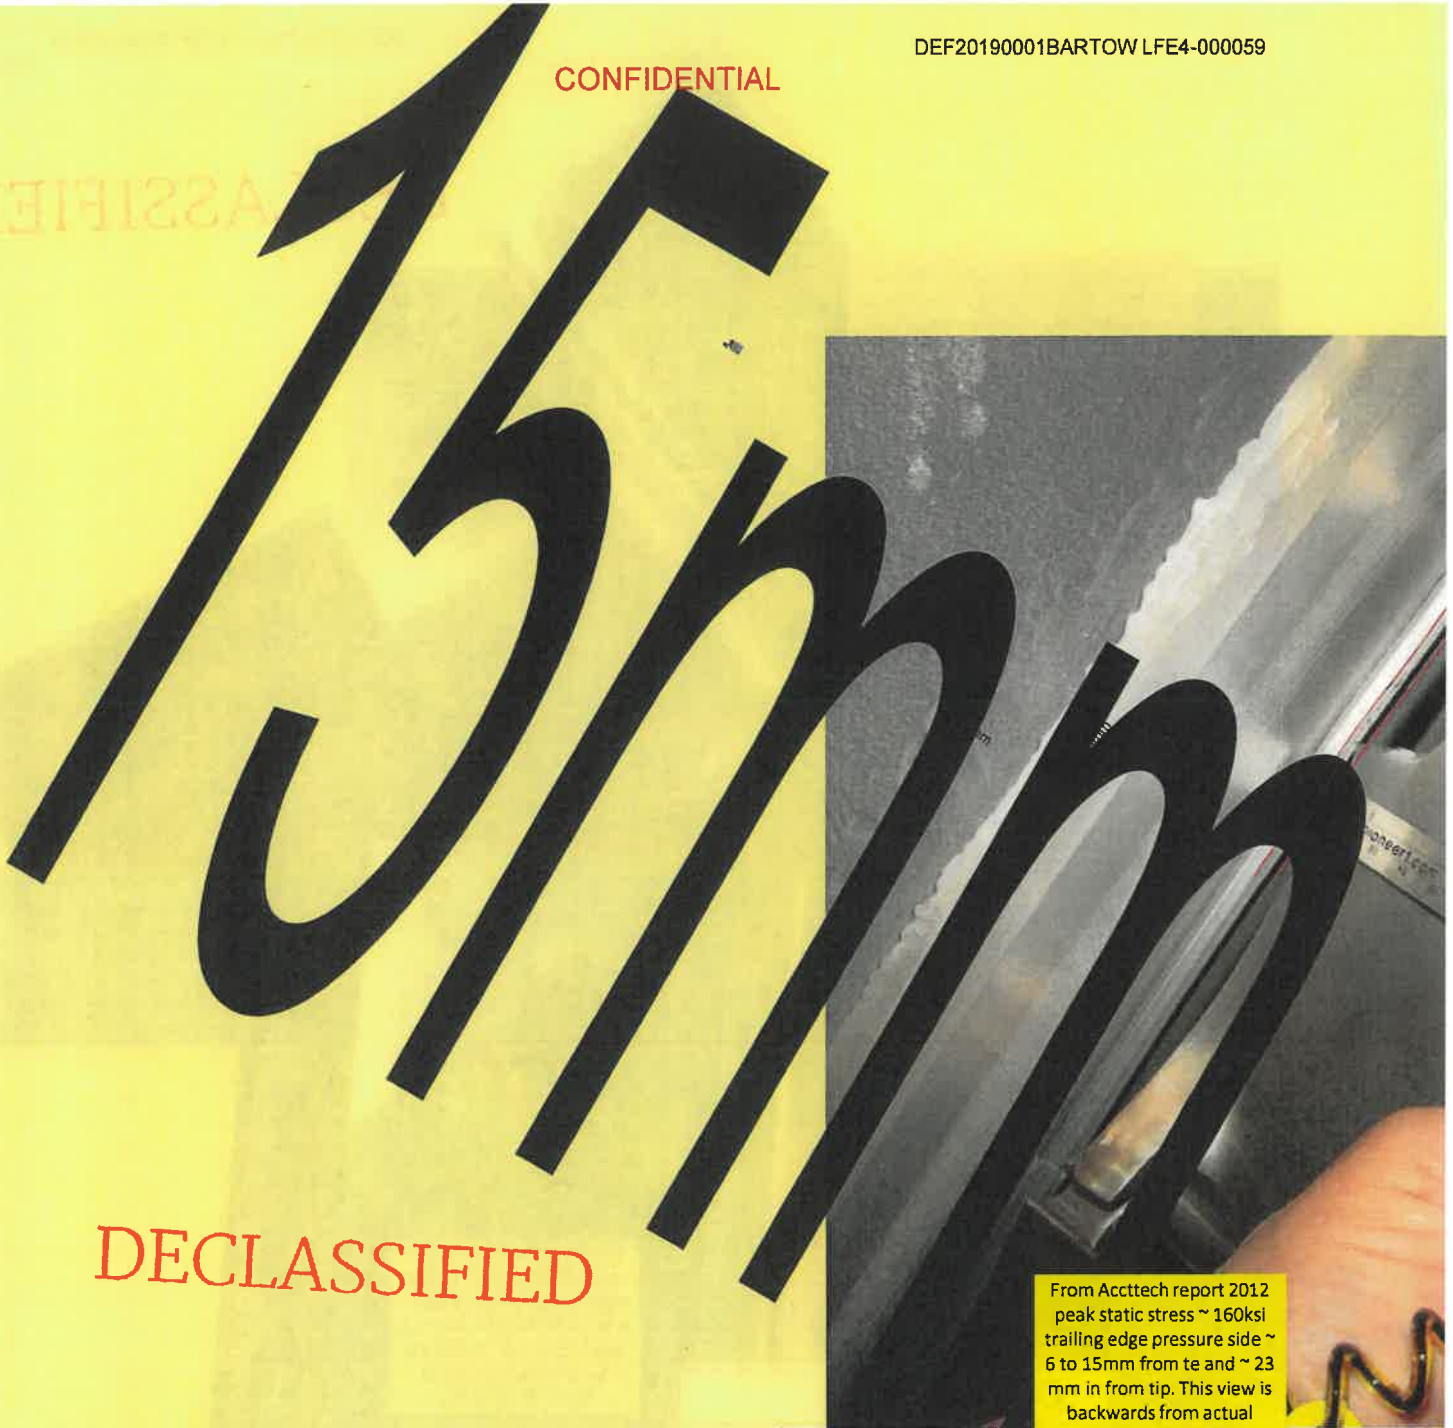
From Acctech report 2012  
 peak static stress ~ 160ksi  
 trailing edge pressure side ~  
 6 to 15mm from te and ~ 23  
 mm in from tip. This view is  
 backwards from actual  
 photo of blade #22

From MHI 2012 Period I RCA  
 presentation. Confirming  
 high static stress area where  
 Period IV cracks initiated.

Finite element analysis performed after 2012 failure showed the crack starting point area had stresses above yield and the design would need to be "yielded down". This is possible because full section of blades was not above yield. This was not a concern with earlier failures, because the air foil was not liberating just contact face wear on mid span snubber and z lock tip. Partial tip and snubber loss was possible. The 2016 work re confirmed the high stress area and an earlier presentation 2012 by MHI supports the pressure side of the blade tip below the latch has high stress. The crack started at nearly the same spot as the predicted high stress area.

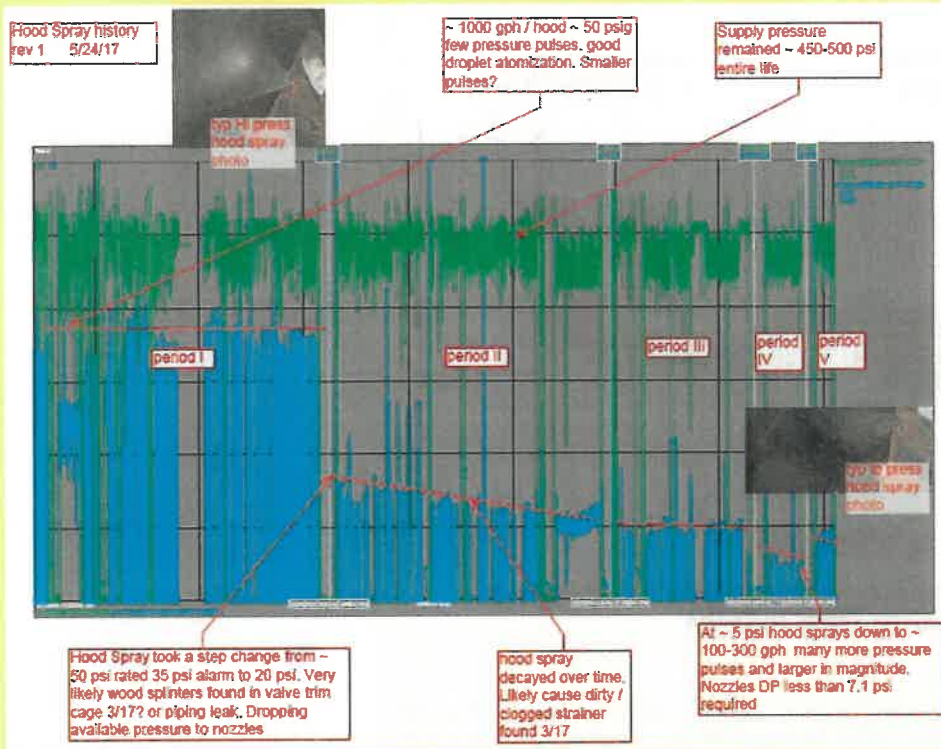
Figure 2 – Hood Spray Pressure Degradation Over Periods 1-5

Figure 2, below, demonstrates what happened to hood spray pressure over time. The decay in water pressure at the hood spray nozzles will yield reduced atomization as these style of nozzle rely on pressure drop to create a vortex inside the nozzle that causes atomization thru centripetal force. The effect of reduced atomization was verified during a test just prior to unit restart in April 2017. A key concern of poor atomization is the effect it might have on generating dynamic pressures which the L-0 blades might see as large water droplets evaporate in the exhaust stream.

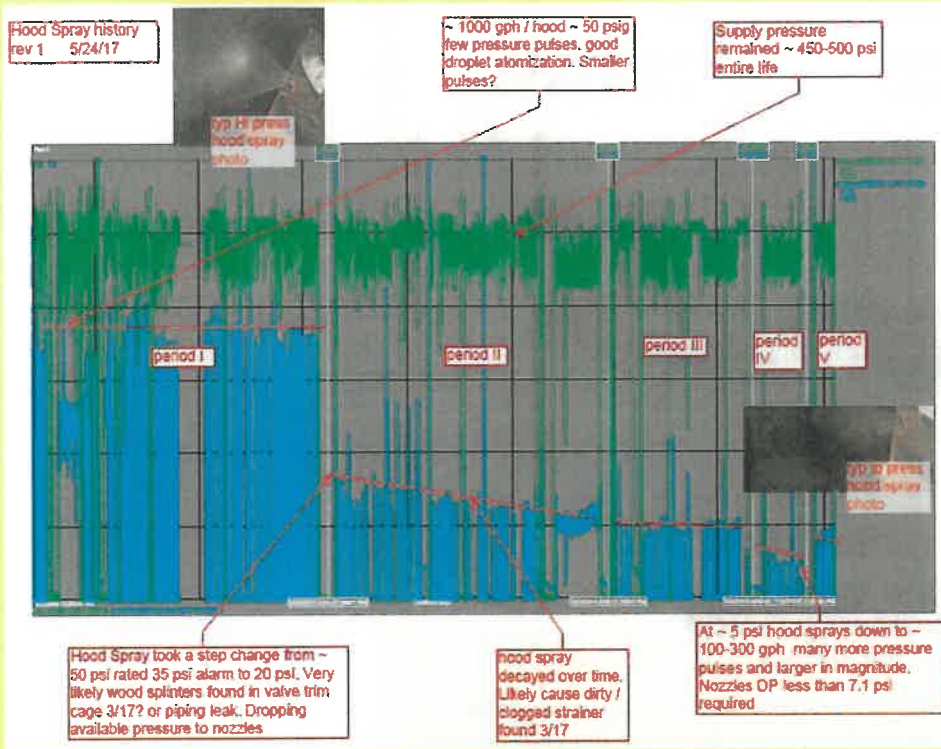
Figure 2 -- Hood Spray Pressure Degradation Over Periods 1-5

Figure 2, below, demonstrates what happened to hood spray pressure over time. The decay in water pressure at the hood spray nozzles will yield reduced atomization as these style of nozzle rely on pressure drop to create a vortex inside the nozzle that causes atomization thru centripetal force. The effect of reduced atomization was verified during a test just prior to unit restart in April 2017. A key concern of poor atomization is the effect it might have on generating dynamic pressures which the L-0 blades might see as large water droplets evaporate in the exhaust stream.

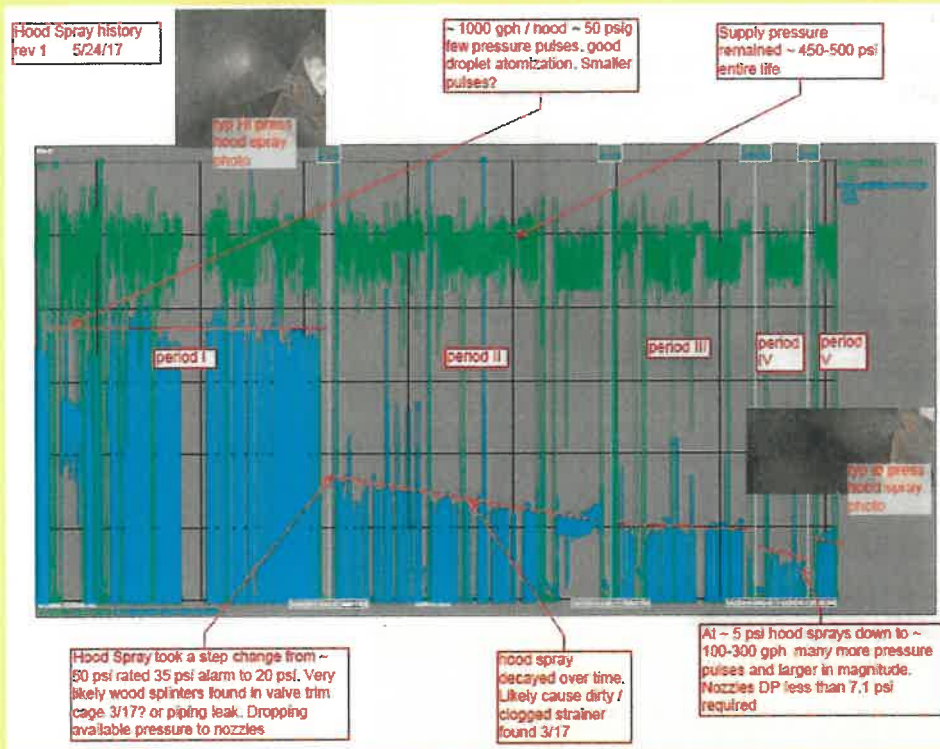
Figure 2 -- Hood Spray Pressure Degradation Over Periods 1-5

Figure 2, below, demonstrates what happened to hood spray pressure over time. The decay in water pressure at the hood spray nozzles will yield reduced atomization as these style of nozzle rely on pressure drop to create a vortex inside the nozzle that causes atomization thru centripetal force. The effect of reduced atomization was verified during a test just prior to unit restart in April 2017. A key concern of poor atomization is the effect it might have on generating dynamic pressures which the L-0 blades might see as large water droplets evaporate in the exhaust stream.

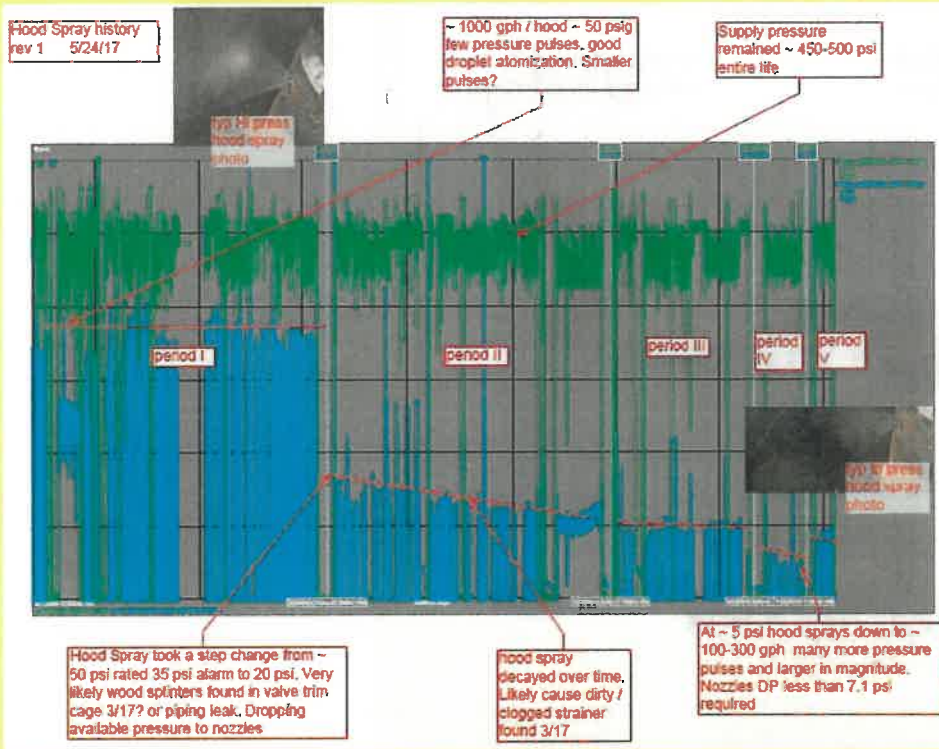
Figure 2 -- Hood Spray Pressure Degradation Over Periods 1-5

Figure 2, below, demonstrates what happened to hood spray pressure over time. The decay in water pressure at the hood spray nozzles will yield reduced atomization as these style of nozzle rely on pressure drop to create a vortex inside the nozzle that causes atomization thru centripetal force. The effect of reduced atomization was verified during a test just prior to unit restart in April 2017. A key concern of poor atomization is the effect it might have on generating dynamic pressures which the L-0 blades might see as large water droplets evaporate in the exhaust stream.
