BRR 4S L-0 Background

The Bartow Combined Cycle Steam Turbine 4s (COE mid-2009) last stage blade (L-0) issues started with a routine visual inspection that lead to a forced outage in 2012 after just 3 years of in service time. Several cracks and chips were found on the blade mid-span snubbers and tip z-notches of the turbine end row. The generator end was undamaged and turbine end L-0's were replaced. The OEM concluded in a root cause investigation the cause of the issue was last stage steam flow rates beyond their design limits forcing non synchronous blade vibrations and subsequent wear and fatigue of the mating blade contact surfaces. At that time, the OEM required a limit to the IP exhaust pressure to limit steam flow into the LP section to the original design limit thus restricting output. The unit continued to run at the original design conditions until a more rugged design upgrade was developed and made available.

# Bartow Steam Turbine RCA Review Addendum Presentation Nov 17<sup>th</sup> 2016

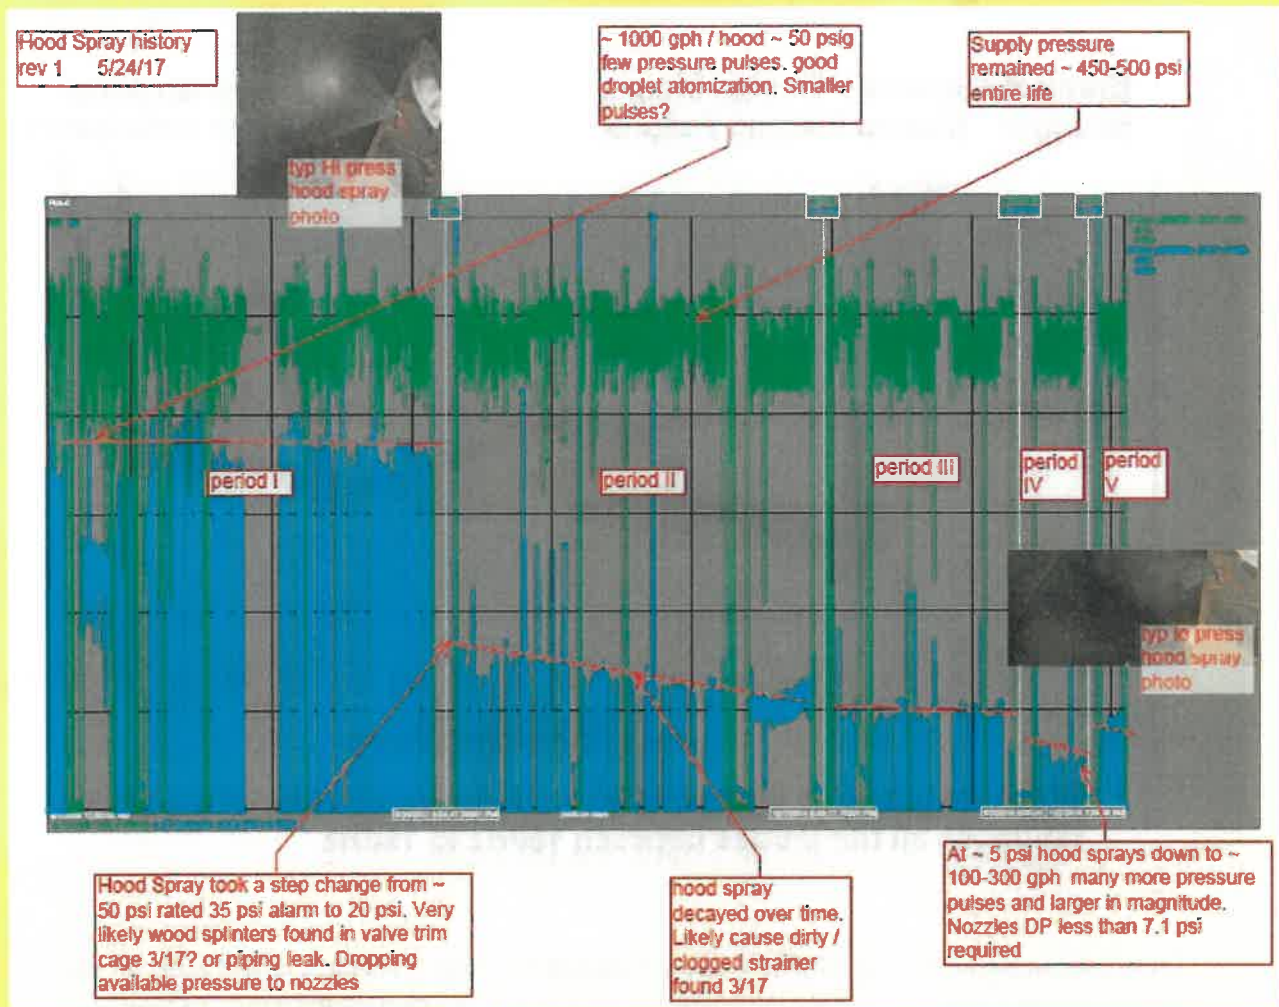
Figure 2 -- Hood Spray Pressure Degradation Over Periods 1-5

Figure 2, below, demonstrates what happened to hood spray pressure over time. The decay in water pressure at the hood spray nozzles will yield reduced atomization as these style of nozzle rely on pressure drop to create a vortex inside the nozzle that causes atomization through centripetal force. The effect of reduced atomization was verified during a test just prior to unit restart in April 2017. A key concern of poor atomization is the effect it might have on generating dynamic pressures which the L-0 blades might see as large water droplets evaporate in the exhaust stream.

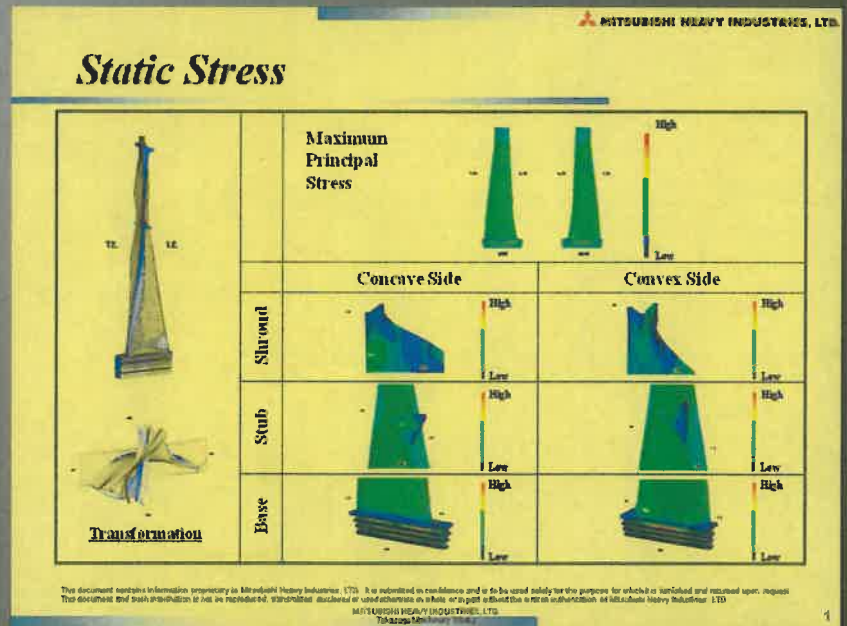
The yield stress was shown in orange. Although the local stress on the blade root exceeds the yield stress this is not problem because it is 80% of the allowable stress (as discussed with Harry Carbone in the meeting). Note that the stub does not exceed the yield stress.

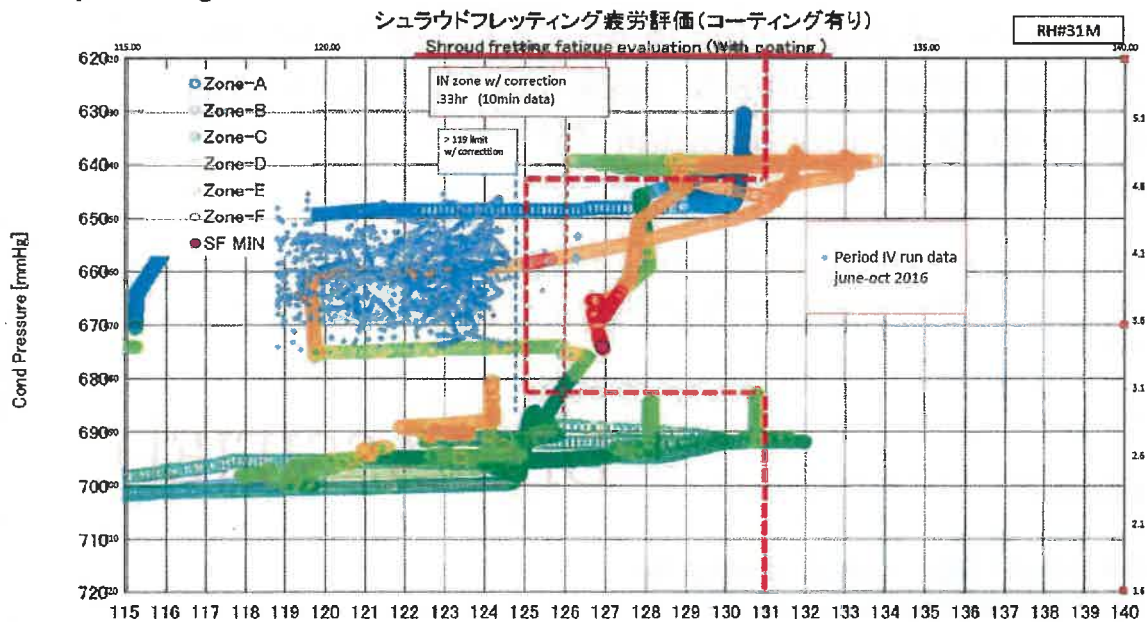
1.4) Operating Time 4 : Jun 2016 to Oct 2016

Inspection Results :

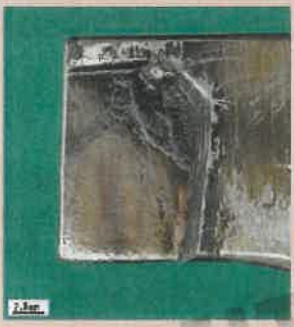
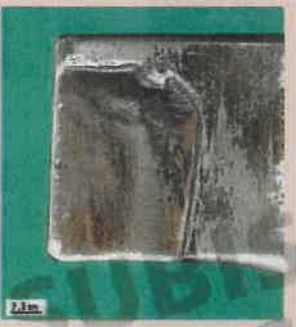
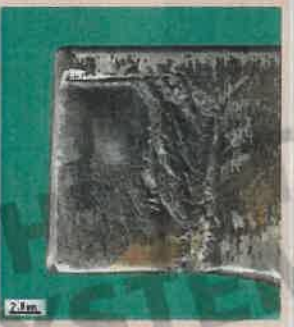
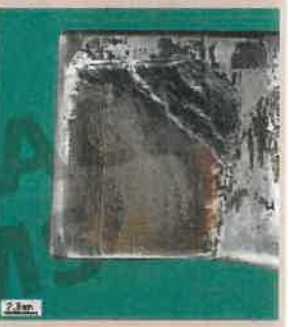
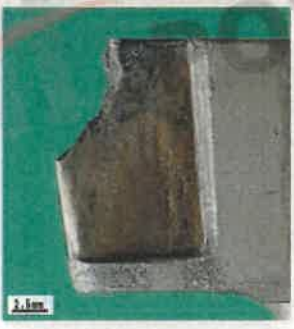
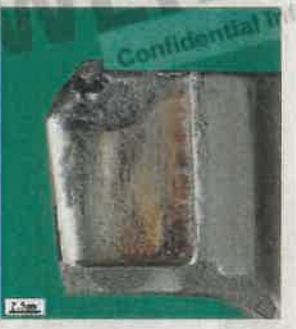
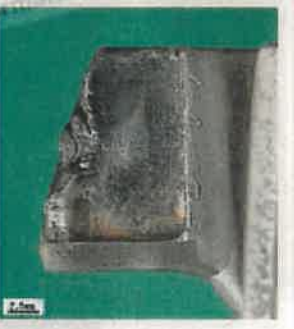
**Shroud Chipping is starting at same location for all blades**

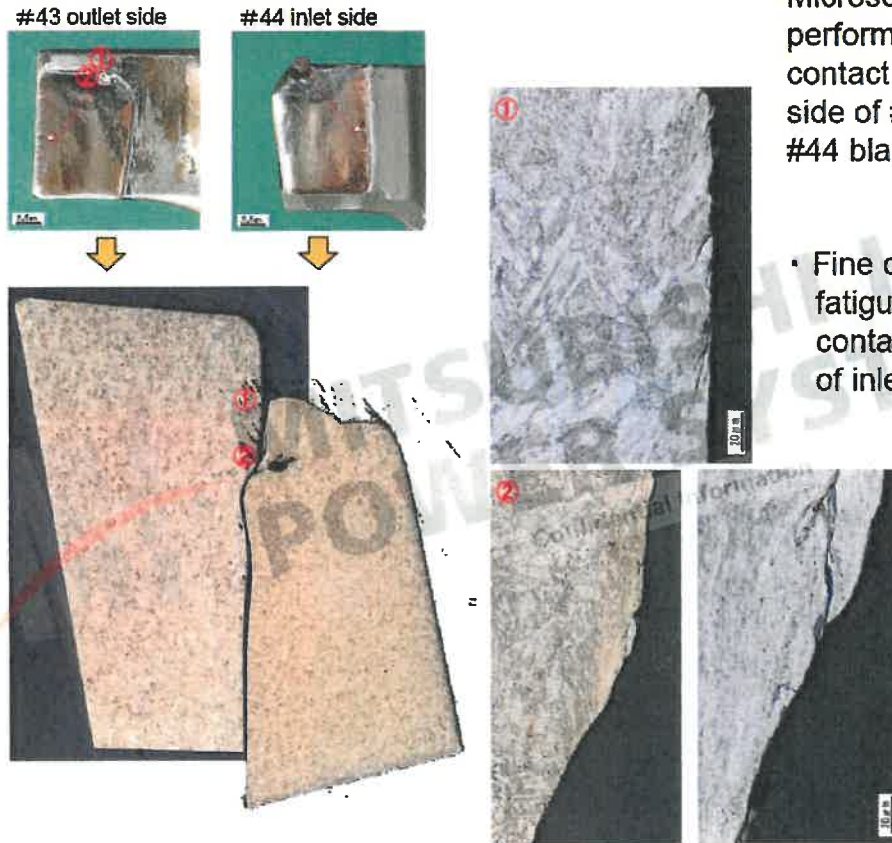
## Metallurgical Evaluation of Blades

Microscopic observation was performed on the same sections in contact condition for each of outlet side of #43 blade and inlet side of #44 blade.

- Fine cracks, caused by fretting fatigue, are found near the end of contact part with local deformation of inlet side of #44 blade.

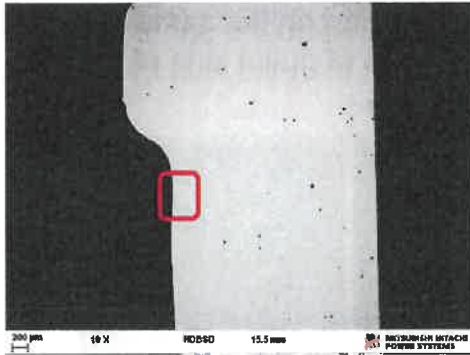
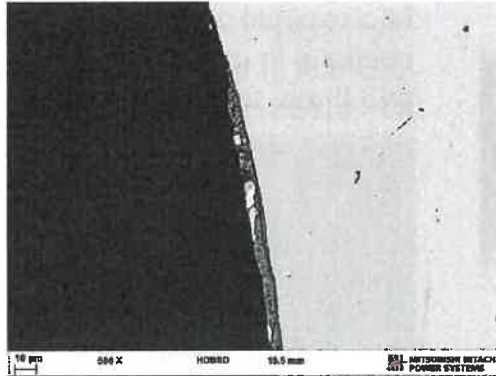
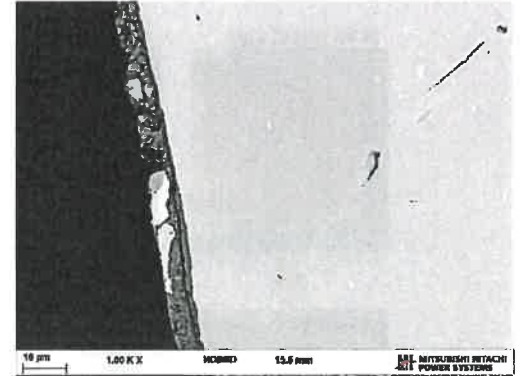
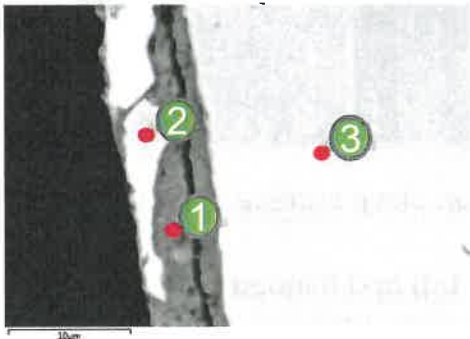
# Metallurgical Evaluation of Blades

- Oxidation/corrosion was observed on the trailing edge contact surface of the tip shroud.
- Material removal from wear is from abrasion.

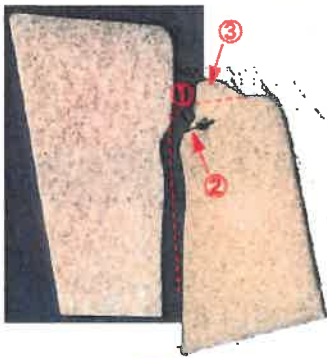
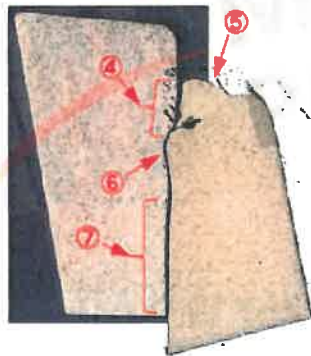
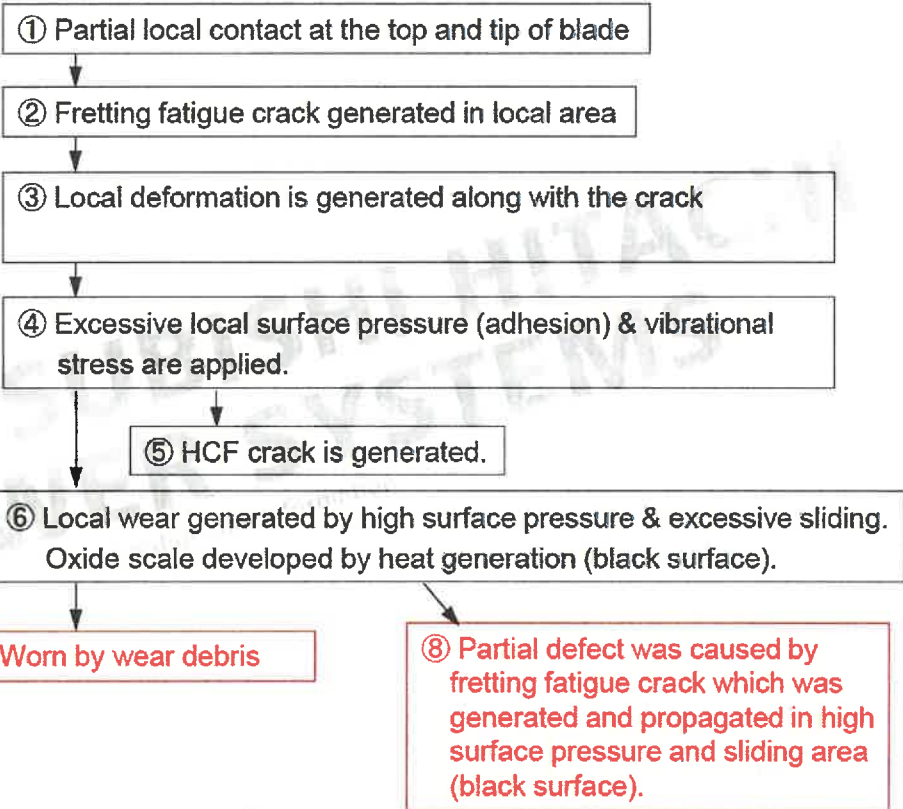
Images of initial contact conditions

# Damage Mechanism

※⑦ & ⑧ progressed at the same time

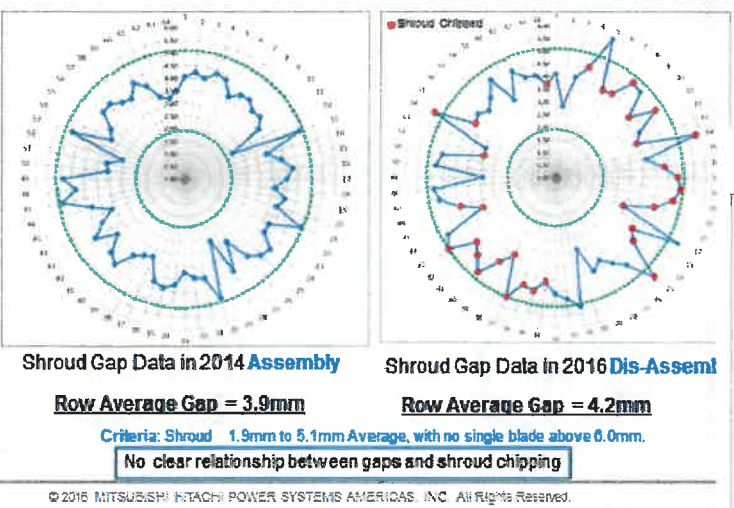
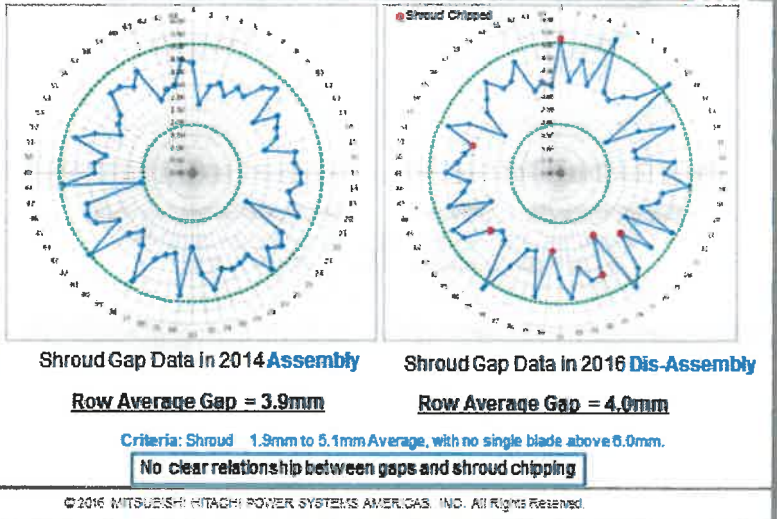
## 2014 Blade LH (Gov. End) Shroud Gap Data

**LH and RH shroud average gaps are nearly same  
No clear relationship between gap and shroud chipping**

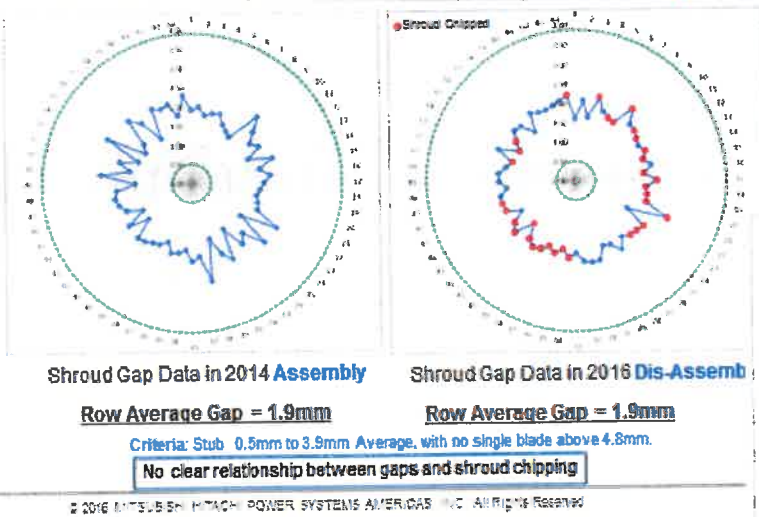
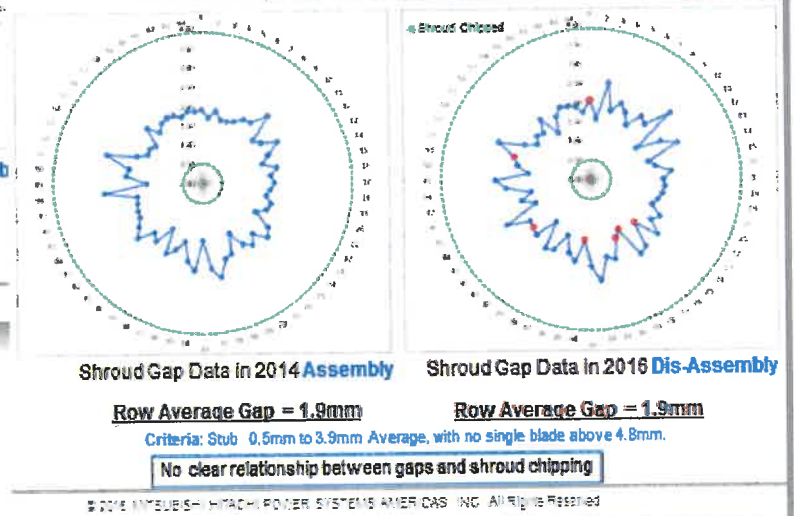
## 2014 Blade LH (Gov. End) Stub Gap Data

**LH and RH stub average gaps are nearly same.  
No clear relationship between gap and shroud chipping.**

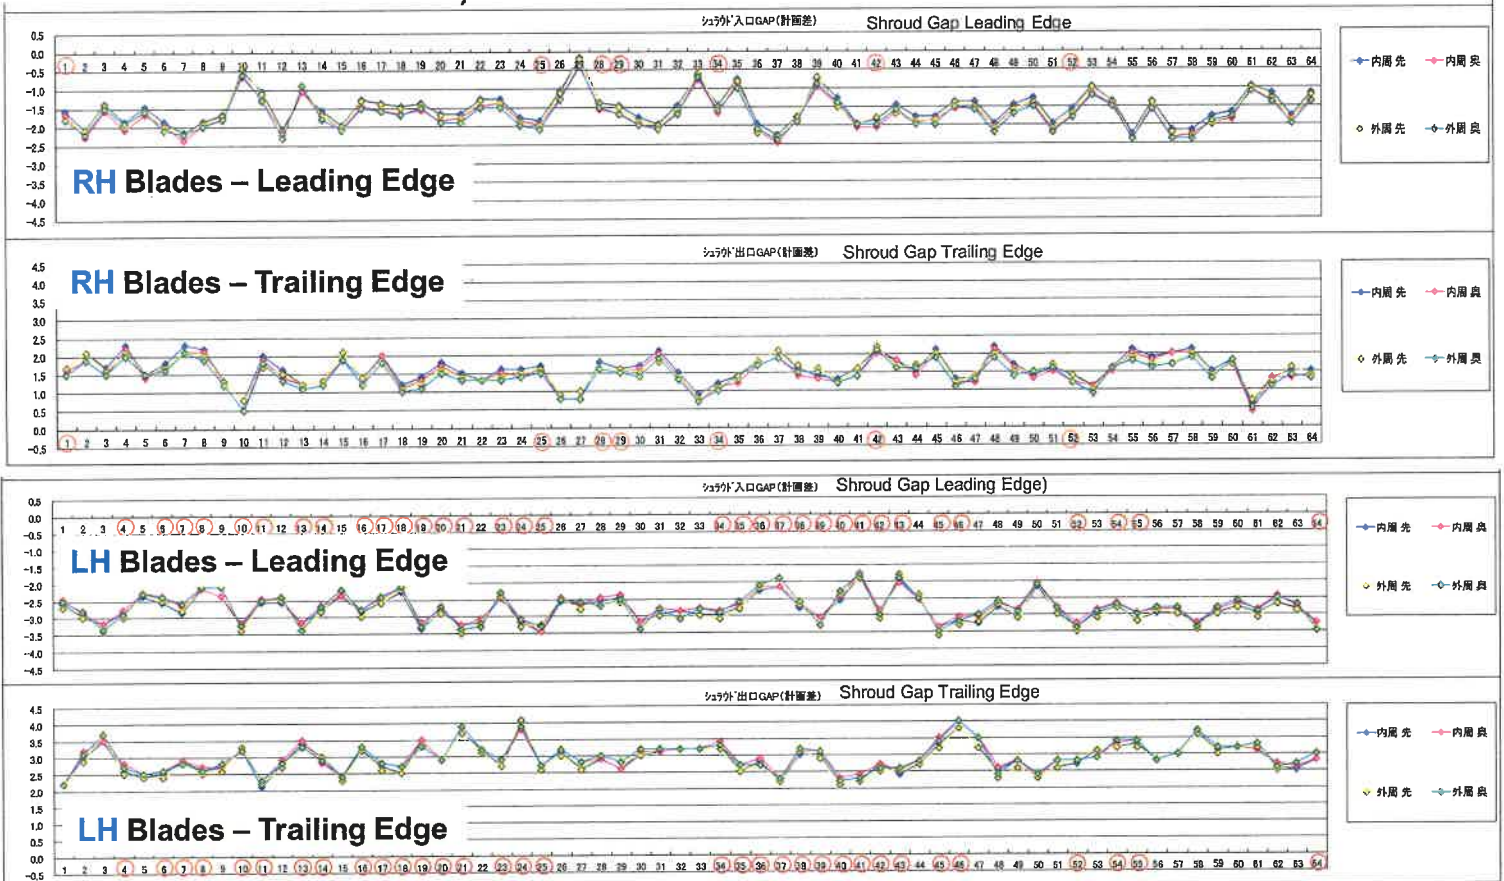
# Box Gauge Measurement Results - 2014 blades

**Blade manufacturing data show variation within criteria**

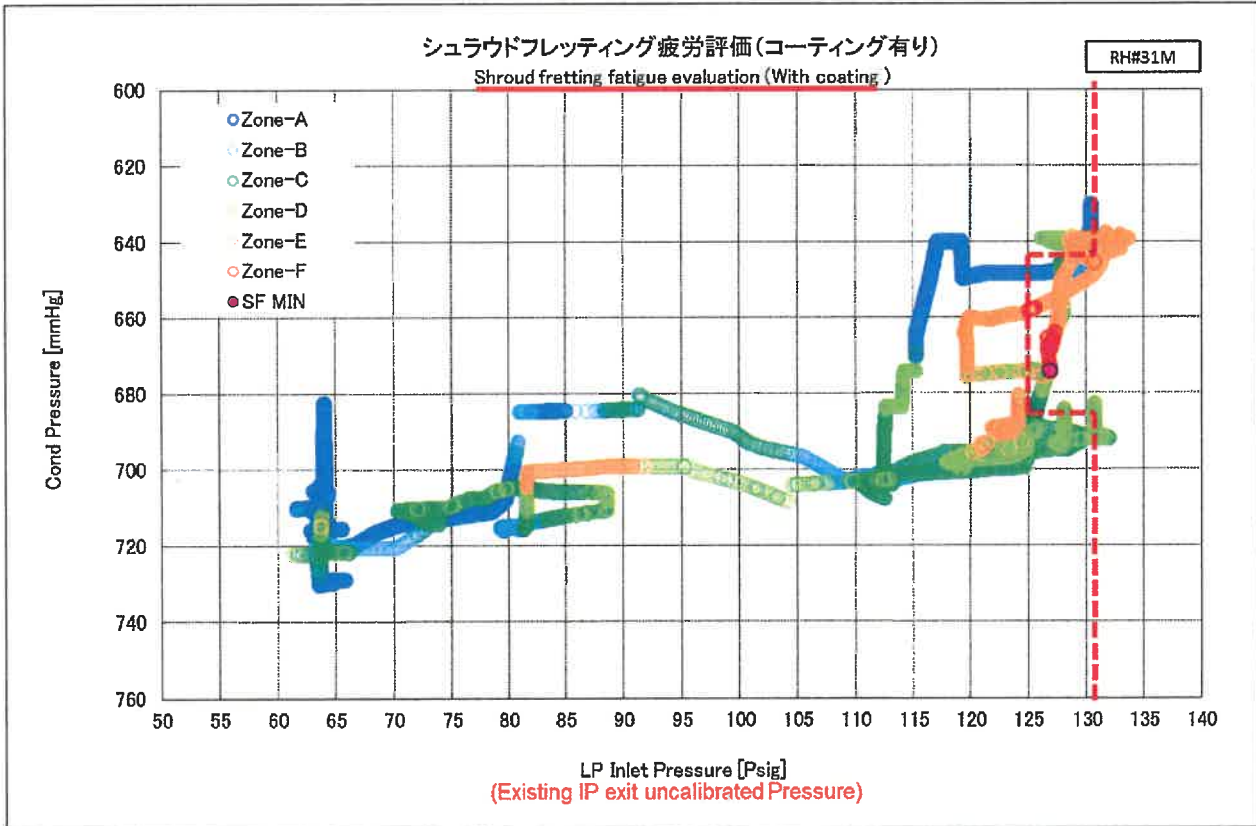
# Telemetry Test Results – Shroud Fretting

**Fretting fatigue calculations for shroud with coating show acceptable margins outside avoidance zone**

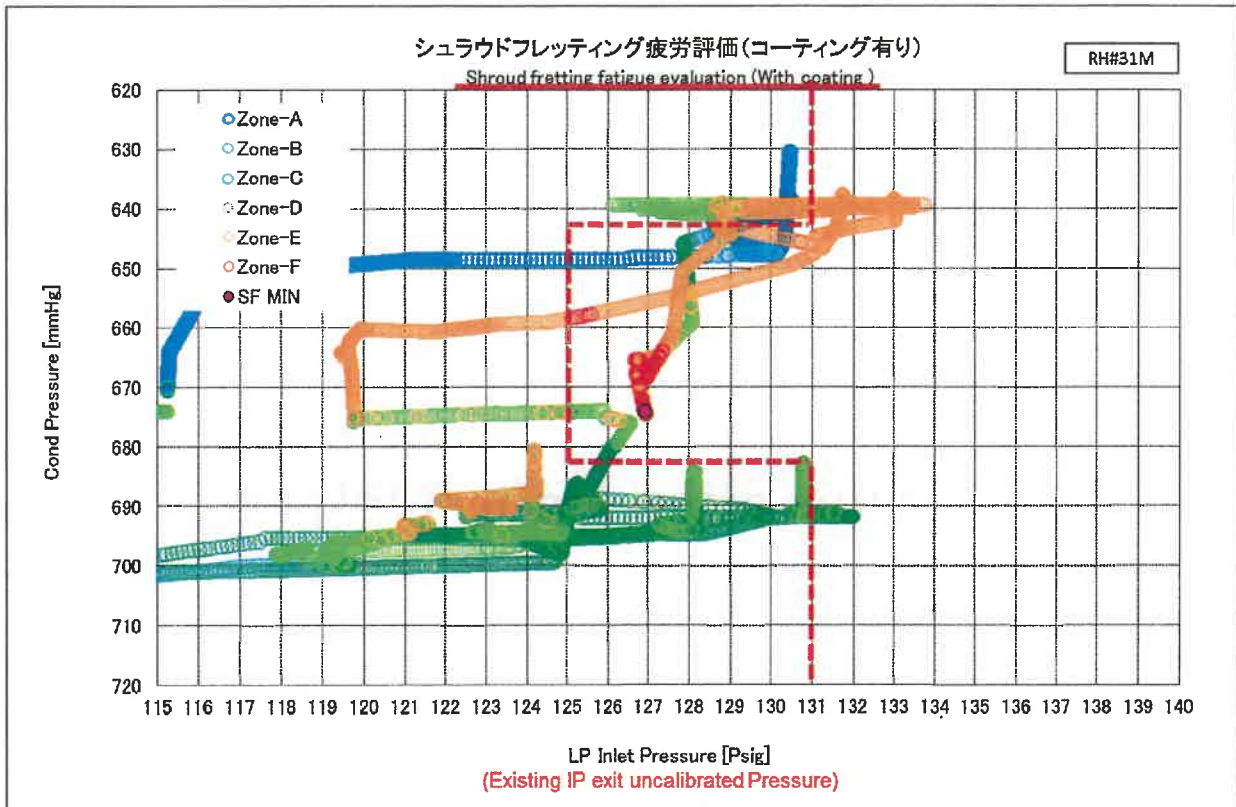
# Telemetry Test Data – Shroud Fretting

**Fretting fatigue calculations for shroud with coating show acceptable margins outside avoidance zone**

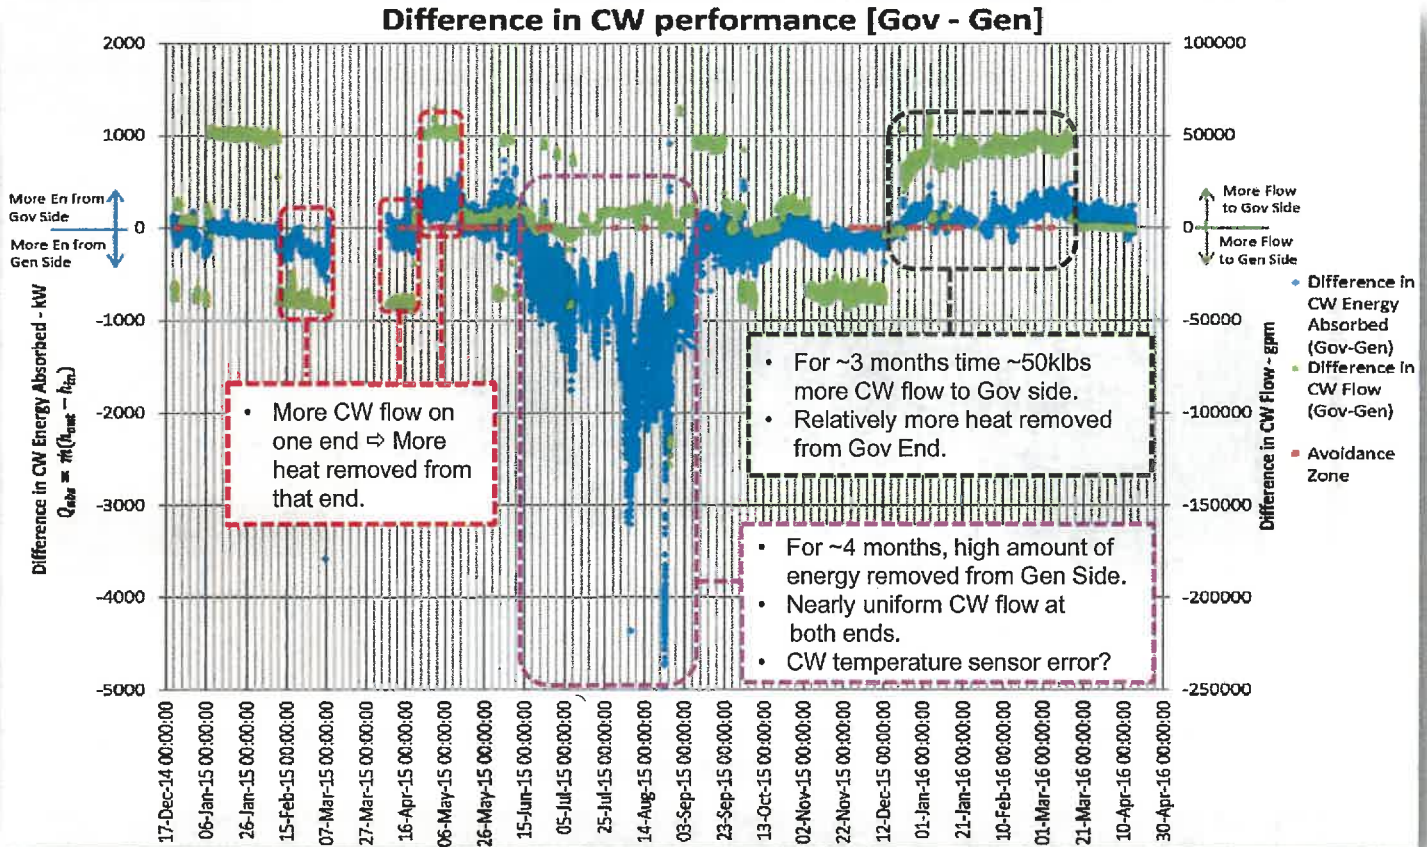
# Condenser Circulating Water (CW) flow analysis

**Asymmetric circulating water flow may explain difference in water erosion observed  
Not enough data to draw any conclusion on blade shroud damage**

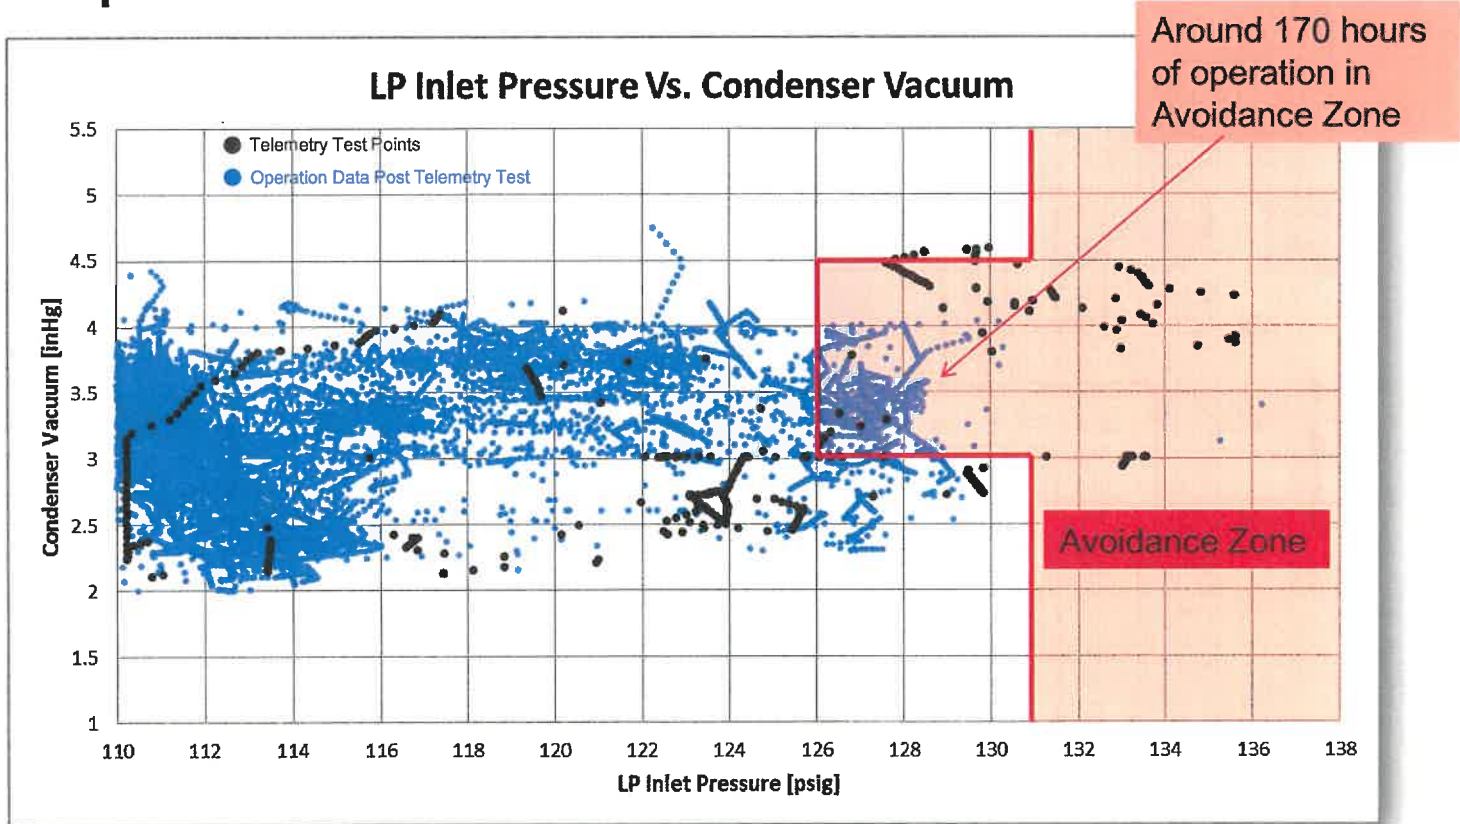
# Operation Data Review

**170+ hours of operation in avoidance zone with a response frequency ~200Hz = 1.2E8 Cycles**

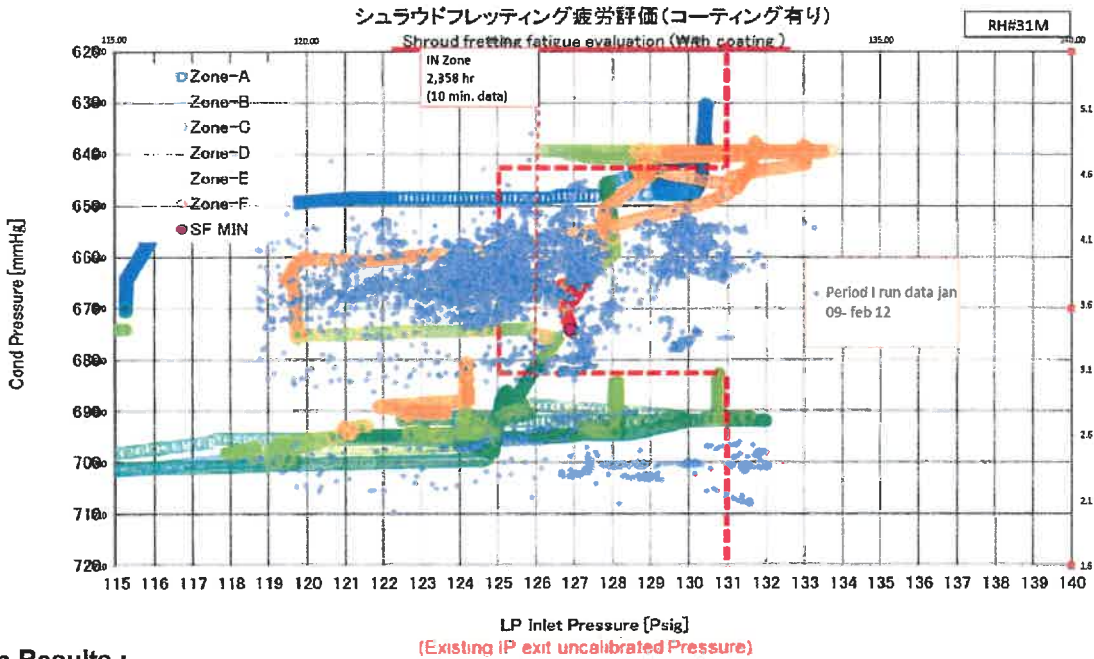
Location	Blades	Service	Mid Span Snubber	Shroud	Disposition
Gen End	Type 1	3 yrs	No significant damage	No significant damage	Continue operation until 2014 planned replacement
Gov End	Type 1	3 yrs	5 Major Chip	3 minor chips	Replace blades as continues midspan chipping could results in a free standing blade

1.1) Operating Time 1 : Jan 2009 to Feb 2012  
Significant operation in the avoidance zone.  
Significant damage observed on the blades.

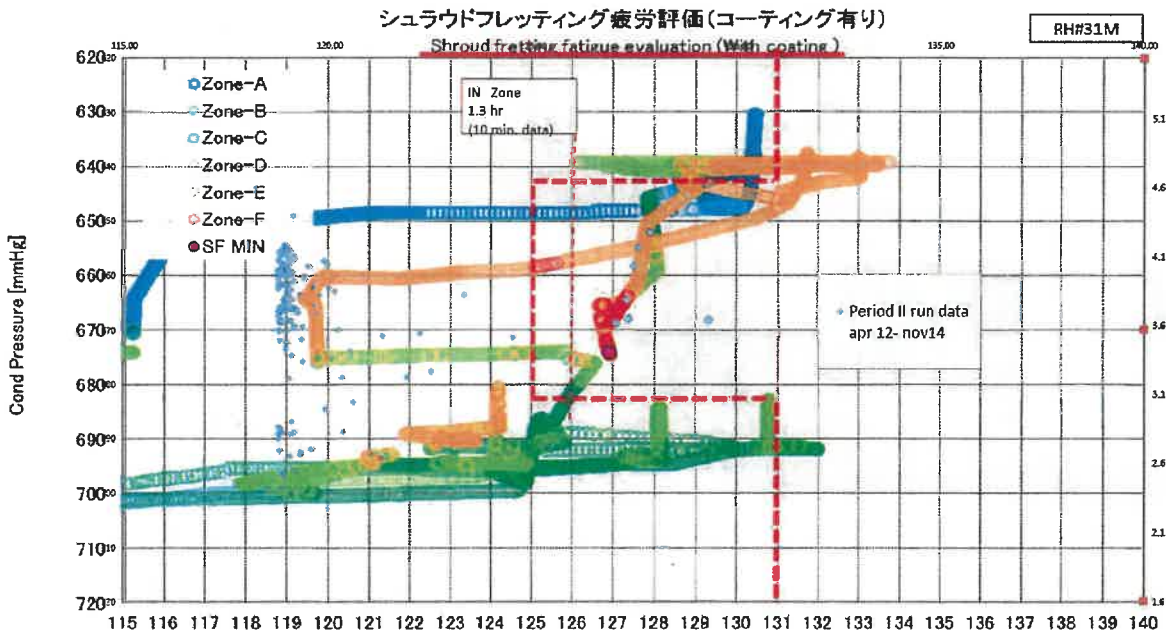
Location	Blades	Service	Mid Span Snubber	Shroud	Disposition
Gen End	Type 1	5 yrs	No significant damage	12 minor chips	Scheduled change out to blades with midspan HVOF
Gov End	Type 1	2 yrs	No significant damage	3 minor chips	Scheduled change out to blades with midspan HVOF

1.2) Operating Time 2 : Apr 2012 to Nov 2014  
Minimal operation in the avoidance zone.  
Minor chipping observed.

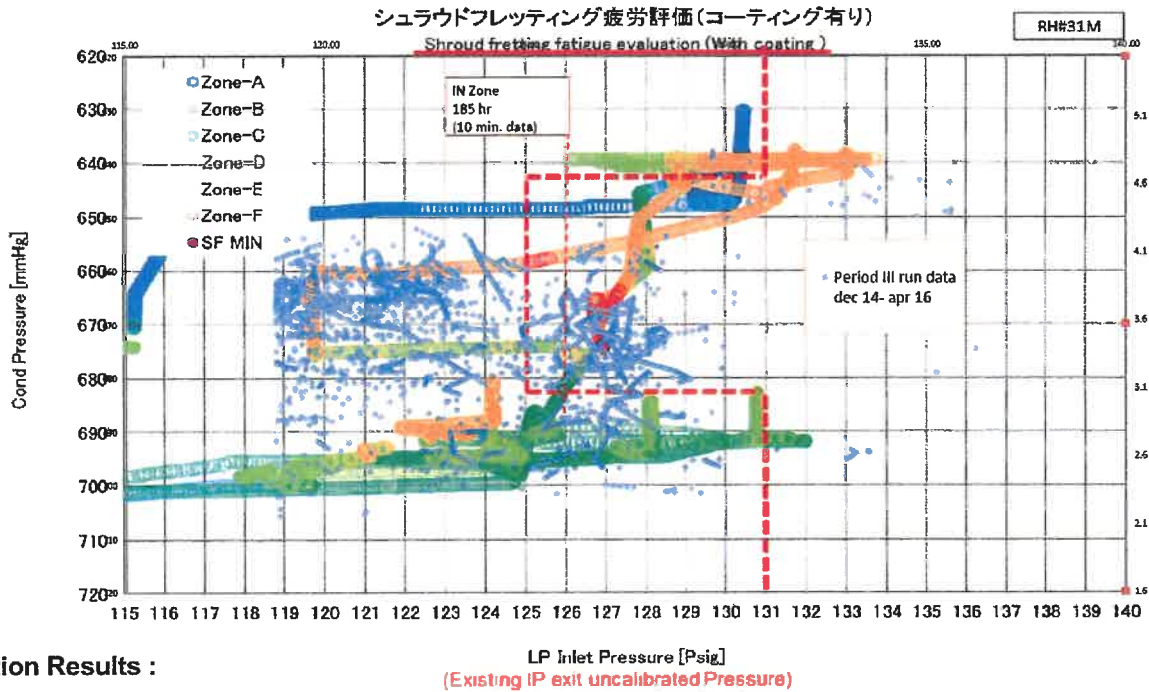
Location	Blades	Service	Mid Span Snubber	Shroud	Disposition
Gen End	Type 3 + HVOF	15 Months	No significant damage	7 minor chips	Fit for continued operation. Shroud contact on all blades.
Gov End	Type 3 + HVOF	15 Months	No significant damage	33 chips including significant damage	Replace row as free shroud contact has been lost on 1 blade.

1.3) Operating Time 3 : Dec 2014 to Apr 2016  
Significant operation in the avoidance zone.  
Significant damage observed on the blades.

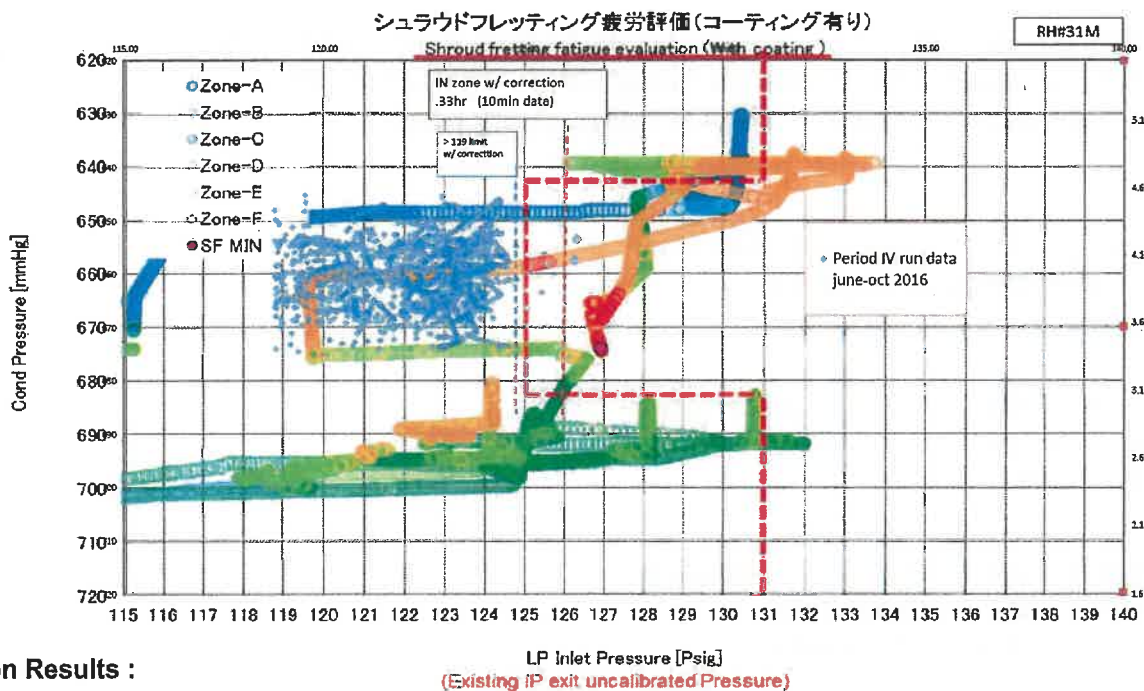
1.4) Operating Time 4 : Jun 2016 to Oct 2016

Location	Blades	Service	Mid Span Snubber	Shroud	Disposition
Gen End	Type 3 + HVOF++	4 Months	No significant damage	7 minor chips	Fit for continued operation. Shroud contact on all blades.
Gov End	Type 3 + HVOF++	4 Months	No significant damage	33 significant damage	Replace row as free shroud contact has been lost on 1 blade.

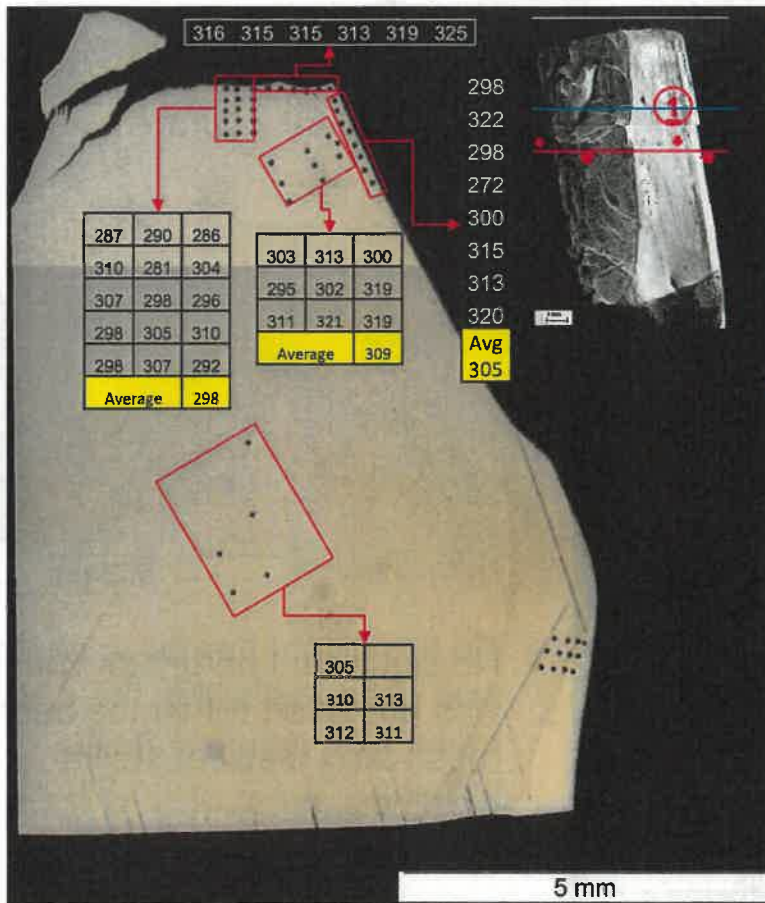
## 2 - Hardness Variation – Presented

- From hardness observation no significant decrease was observed where the crack initiated.
- A decrease in hardness was observed on the contact surface.

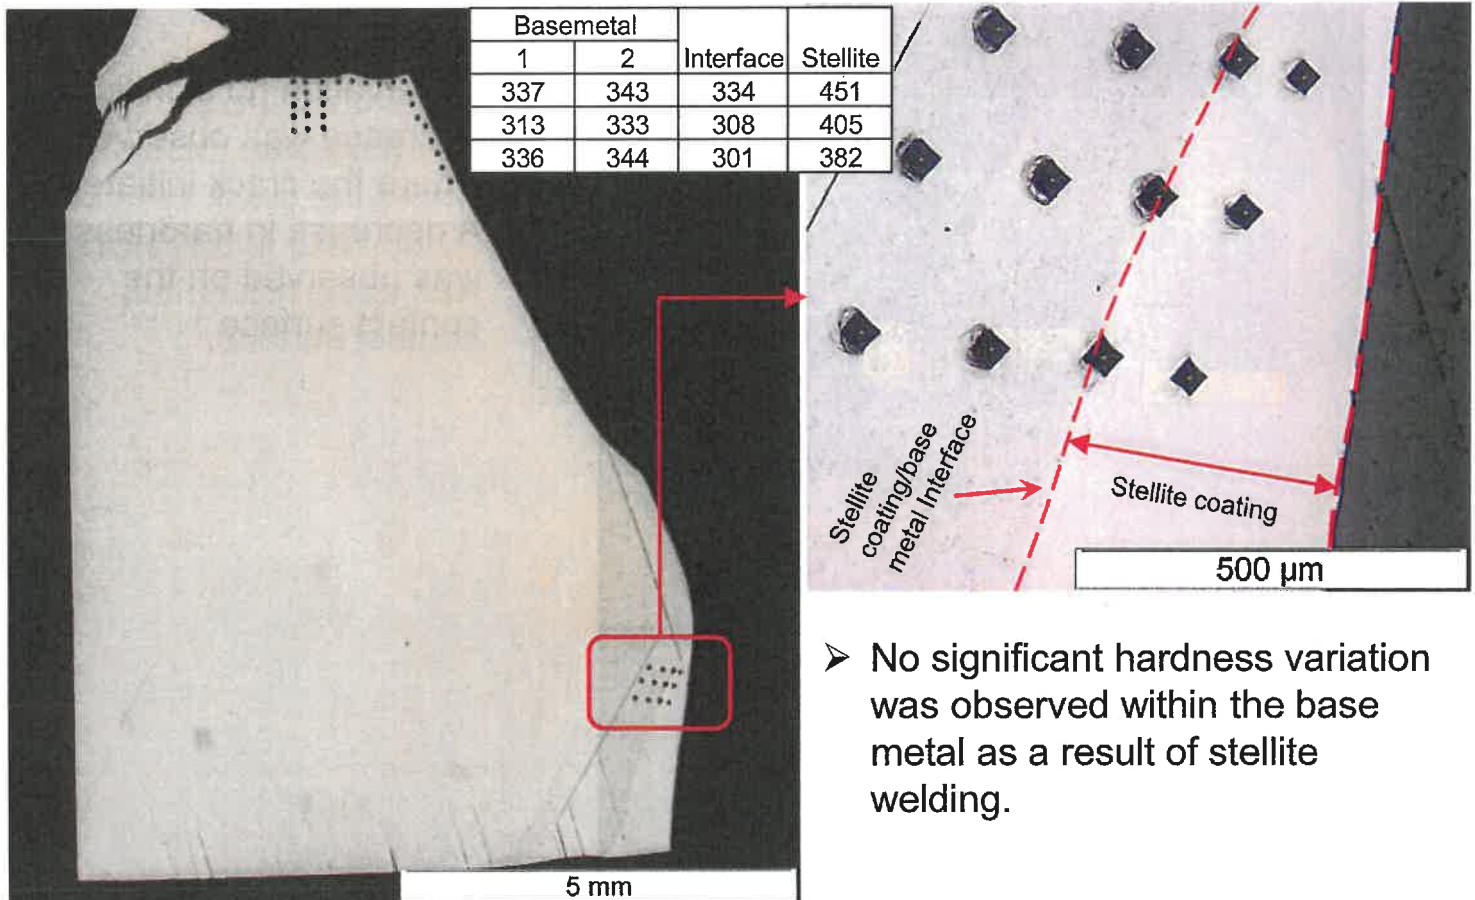
## 2- Hardness Variation basemetal, Interface and Stellite Coating

➤ No significant hardness variation was observed within the base metal as a result of stellite welding.
