**BEFORE THE FLORIDA PUBLIC SERVICE COMMISSION**

| wastewater rates in Brevard, Citrus, Duval, | ) | DOCKET NO. 20250052-WS |

**DIRECT TESTIMONY OF**

**JACOB FREEMAN**

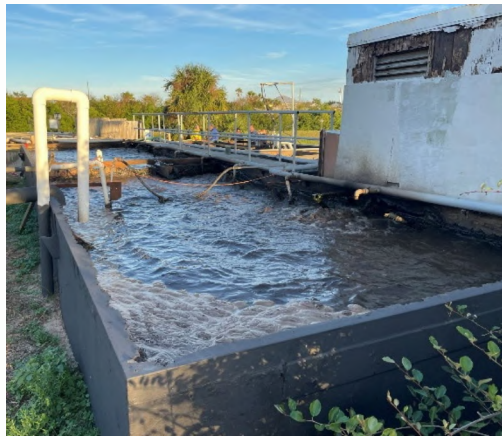
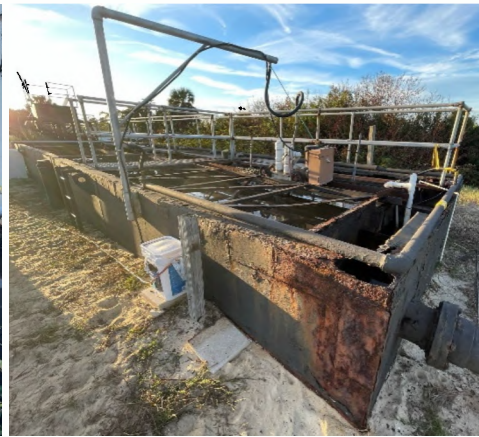
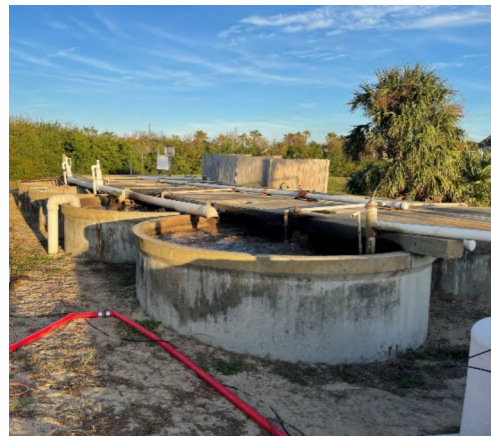
The two steel ("Plant 1" top left and "Plant 3" right) and concrete ("Plant 2" bottom) package plants making up the treatment facility at acquisition. Note poor condition of all steel equipment, tanks, and structures.

**A.** As was discussed in the summaries of enforcement action against the North Peninsula system under previous ownership, the wastewater treatment plant was in extremely poor condition at the time of acquisition. All three package plants that make up the facility are in failing condition. Both steel plants have been repeatedly repaired, but with negligible effect on the overall condition of the tanks, which continue to have leaks and exhibit bowing walls. The concrete tank has experienced a wall failure, which resulted in the release of wastewater since CSWR Florida took ownership. Each of these package plants has reached the end of its useful life and further repairs will not significantly extend the life or meaningfully remedy each plant's problems. The previous ownership's attempt at repairs failed to address the deteriorating condition of the facility, as evidenced by the repeated enforcement action demanding more adequate repairs to the treatment infrastructure. While the plant did not often violate permitted limits (with the exception of chloride levels in the groundwater monitoring and anecdotal observations of discolored effluent by CSWR Florida's third-party engineers that have not been captured in DMR sampling), the overall deteriorating condition puts North Peninsula facility at risk of catastrophic failure, which would cause service

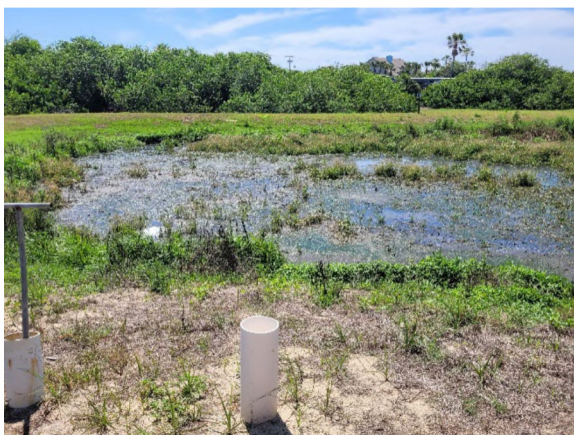
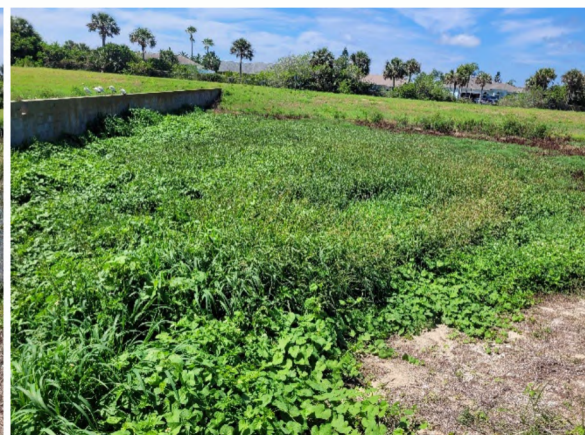
Rapid infiltration basins at time of acquisition. Note accumulation of solids, ponding of effluent, and vegetation overgrowth indicating dysfunction and poor maintenance.

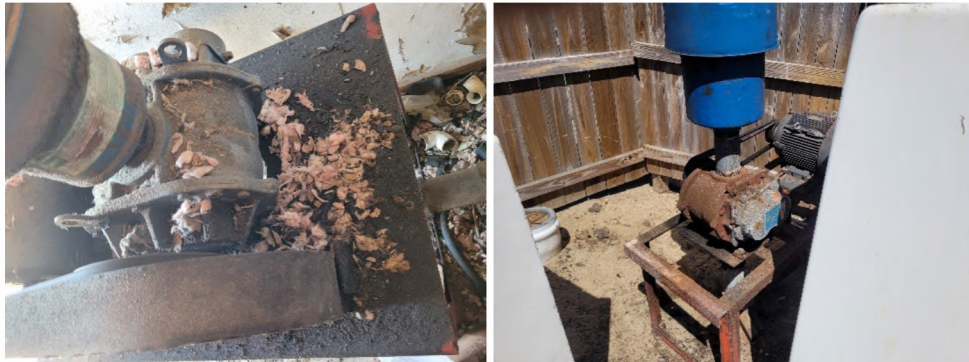
7  
8 *Poor condition of blowers at acquisition with signs of rodent nesting.*

17 Aeration system improvements have consisted of repairs and replacement of  
18 damaged air lines, diffusers, blowers, sludge returns, and installation of a sound  
19 dampening barrier around blowers following continued complaints regarding excessive

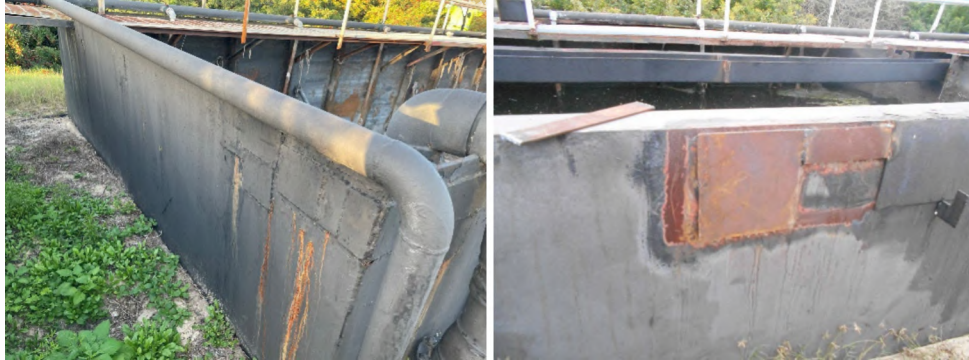
10  
11 *Examples of steel tanks and equipment deterioration at close and examples of the numerous*  
12 *poorly installed welded patches on the tanks.*

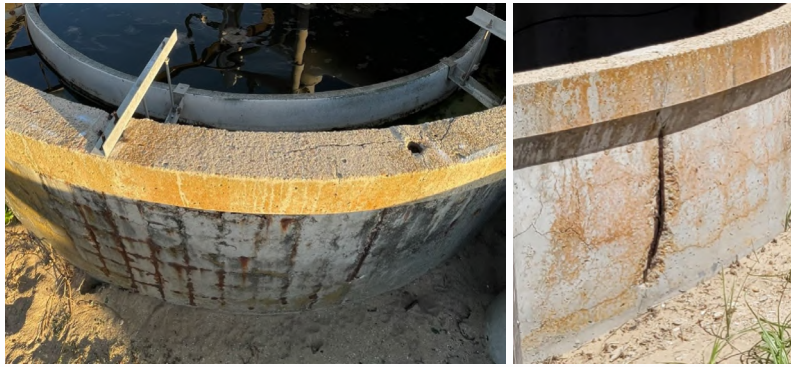
*Examples of cracking and exposed rebar in concrete tanks.*

12 concrete package plant being used for flow equalization was found to be in similarly  
13 poor condition, with cracked concrete and exposed rebar in many places. Indeed, that  
14 plant has experienced a catastrophic wall failure since its acquisition. These issues  
15 demonstrated that repairs to the existing facility were not a workable long-term  
16 solution.

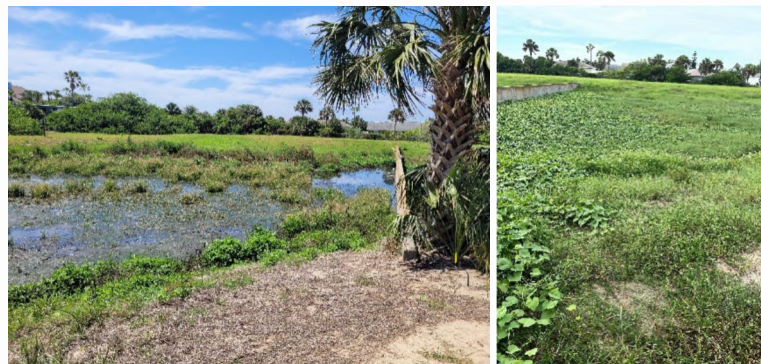
*Examples of overgrowth of vegetation in rapid infiltration basins.*

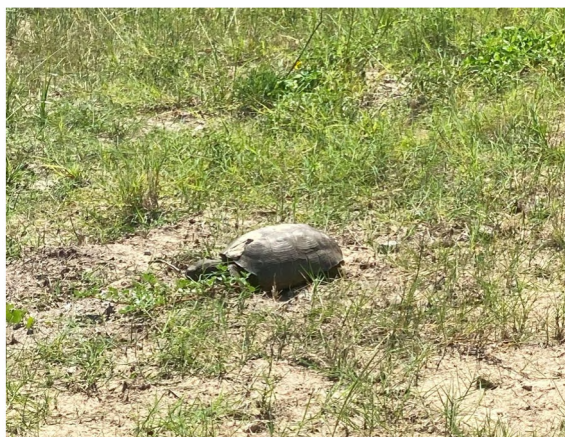
15 Regardless of which of the first two options were selected, CSWR Florida  
16 determined an additional issue that would need to be addressed is the impact on a  
17 threatened species of wildlife (gopher tortoises) living in the rapid infiltration basins at  
18 the treatment facility. This would require either approved relocation of the tortoises  
19 during required construction activity or permitting and protection of the area occupied  
20 by the tortoises during construction activities. The costs associated with these measures  
21 further reduce the viability of either of the first two options.

2 *Protected Gopher Tortoise creating obstacles to regular operations, maintenance activities*  
3 *and construction projects (pictured in rapid infiltration basin)*

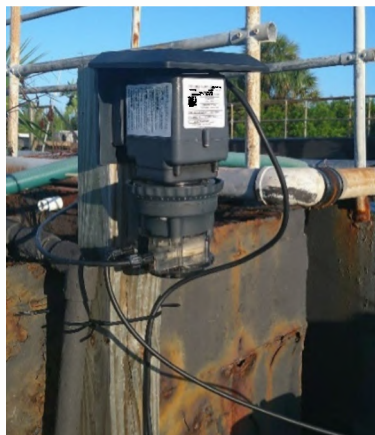
9  
10 *Repaired chemical feed pump.*

7 Disinfection system improvements consisted of repairing the chemical feed  
8 pump to ensure proper dosage and patching a leak in the chlorine contact chamber.

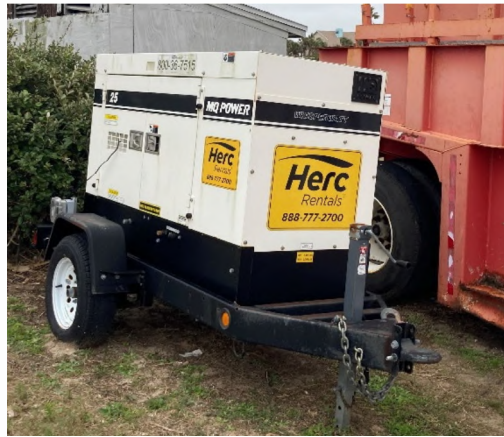
*Mobile generator placed temporarily at North Peninsula site.*

11 Repairs to the electrical system included repairs and replacements of failed  
12 panels, blower timers, pumps, breakers, and placement of a temporary generator on the  
13 site.

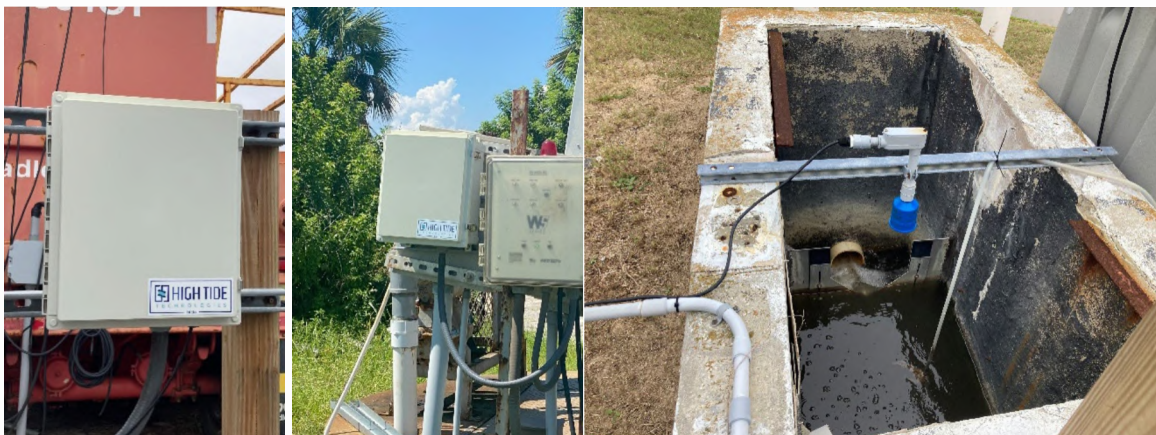
*New remote monitoring units installed at the treatment plant (left) and lift stations (center).*

*New monitoring equipment including flow meter (right) installed at the treatment plant.*

Improvements to monitoring systems included installation of remote monitoring equipment on collection system lift stations, replacement of various meters that had failed but are necessary for sampling requirements, repairs to a groundwater sampling well, and connection of equipment to the remote monitoring system. The remote monitoring unit installed at the treatment plant will be able to be moved to the new lift station that will convey wastewater to the City of Ormond Beach's system in the future.

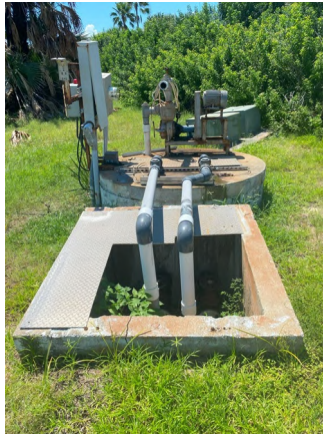
10 *New discharge piping installed on lift station.*

1 basins included mowing and tilling the basins and replacing the discharge valve  
2 controlling flow from the plant to the rapid infiltration basins. Collection system  
3 repairs included completing a CCTV inspection to identify damaged lines, repairs to  
4 those lines, and repairs to damaged manhole rings to reduce inflow and infiltration of  
5 stormwater into the system. Improvements to lift stations have included replacement  
6 of damaged or poorly performing pumps, repairs to discharge lines, repairs to pump  
7 rails and chains, replacement of level transducers, and repairs to electrical and control  
8 systems. Discharge piping has been replaced on the main lift station as well.

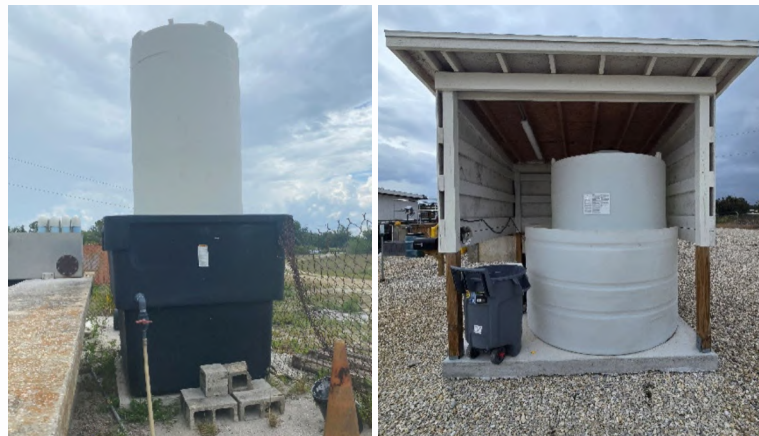
14  
15 *Disinfection chemical storage before (left) and after (right) improvement.*

4           At acquisition, the disinfection chemical storage was an elevated spill tote with  
5 chemical storage above. Although this provided spill containment and allowed  
6 chemicals to be distributed to the contact chamber without a chemical pump, delivered  
7 chemicals still would have to be pumped up into the tank upon arrival. In addition, the  
8 disinfection chemicals and tank were exposed to sunlight, which accelerates the  
9 breakdown of the chemicals and thereby reduces the efficacy of the disinfection  
10 process. A new spill tote and chemical storage tank with a chemical feed pump have  
11 been installed at ground level and the chemical storage tank has been covered by a  
12 shade structure to eliminate the issue with UV exposure. This will also allow for more  
13 precise dosing for disinfection and tracking of chemical inventory.

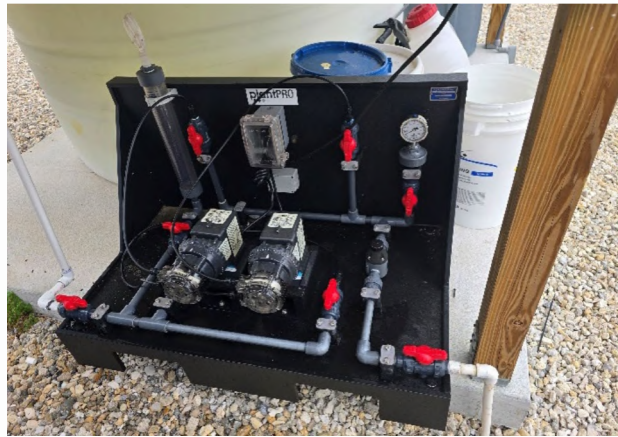
*New chemical feed pump system for precise dosing of sodium hypochlorite.*

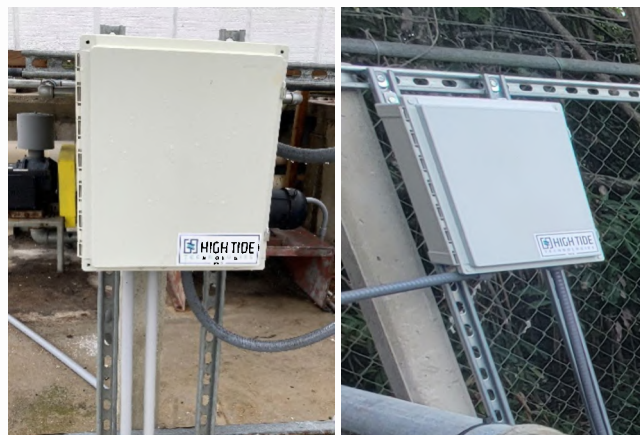
*Remote monitoring equipment installed at the wastewater treatment plant (left) and lift stations (right).*

At acquisition, no remote monitoring equipment was present at the wastewater treatment facility or lift stations, and the other monitoring equipment at the plant was either in poor condition or missing entirely. New remote monitoring equipment has been installed at the treatment plant and at each lift station. A new flow meter has also been installed to allow for active measurement of flow through the remote monitoring system.

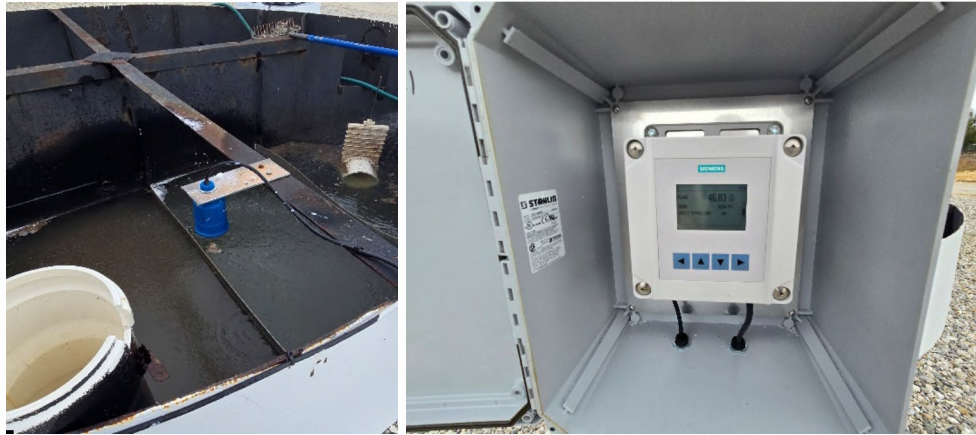
*New ultrasonic flow meter in weir box (left) and meter controller (right).*

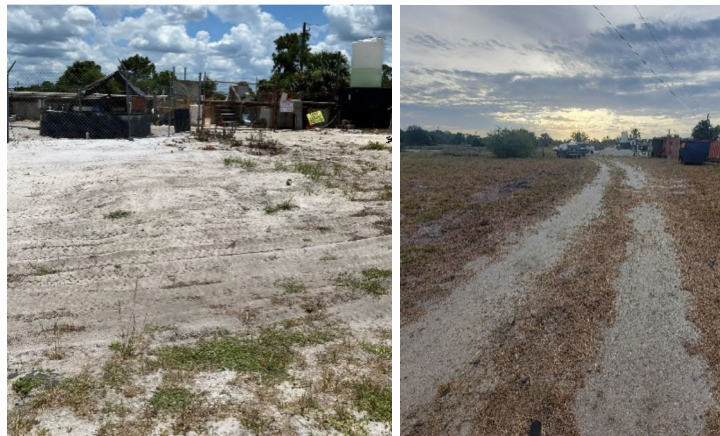
7  
8 *Typical degraded condition of roads and surfaces at acquisition.*

2 At the time CSWR Florida acquired the system, the access road and gravel  
3 throughout the site were eroded, crushed, and poorly maintained, with bare spots and  
4 nuisance vegetation growing throughout. To maintain facility access and operational  
5 access throughout the site, new gravel has been applied and nuisance vegetation  
6 removed.

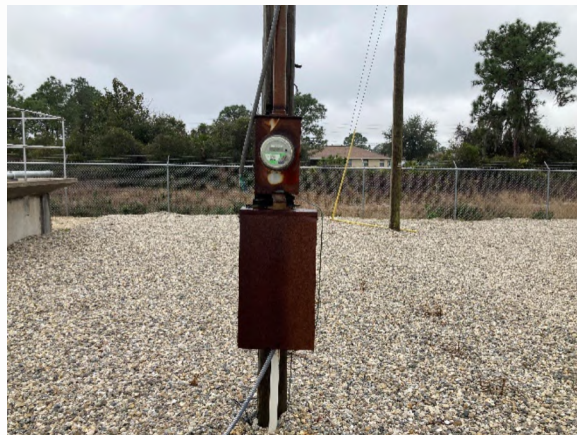
*Extremely corroded existing 200 amp power supply.*

To facilitate improvements and upgrades to the treatment processes at the Sebring Ridge facility, electrical upgrades will be required at the facility. This will include upgrading from a 200 amp service to a 400 amp service and replacing the current power supply and control panels, as appropriate, to meet the needs of upgraded equipment and to replace damaged or corroded electrical equipment. The new power supply will also include the means to connect an emergency generator to the system and prevent service interruption in the event of a power outage.

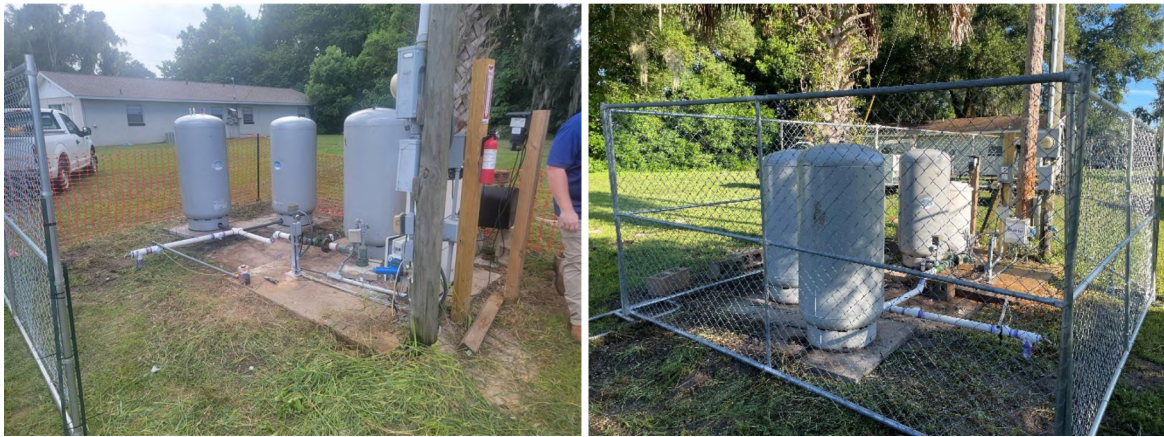
1 completed at each system. The severely deteriorated hydropneumatic tanks CSWR-  
2 Florida acquired from Sunshine included one that experienced a catastrophic tank  
3 failure (i.e., an explosion) shortly after closing, which shows the system's previous  
4 ownership failed to maintain system components in accordance with FDEP  
5 requirements. Indeed, CSWR-Florida identified hydropneumatic tanks at twenty-two  
6 of the twenty-three Sunshine system sites that did not meet minimum FDEP standards.

11  
12 *Oakcrest Villas hydro-pneumatic tank explosion. Failed tank with damaged fencing (left) and*  
13 *damage to other water assets (right).*

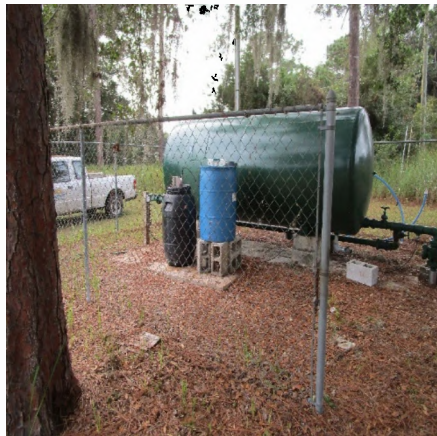
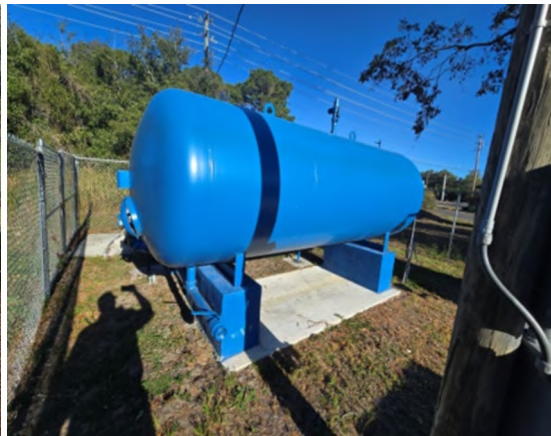
2 *Before (Left) & After (Right): Hydro-pneumatic tank replacement (current tank leaking and at*  
 3 *risk of failure) - Ashley Heights system.*

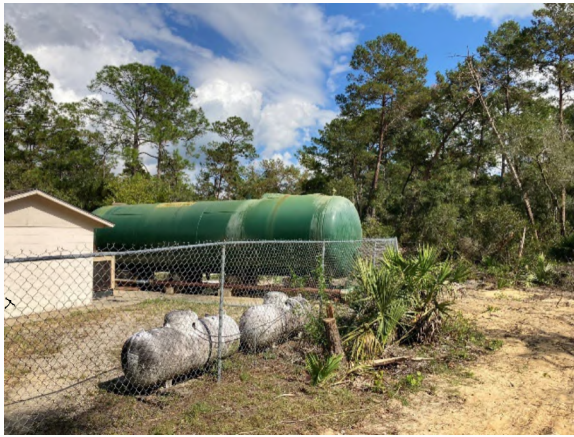
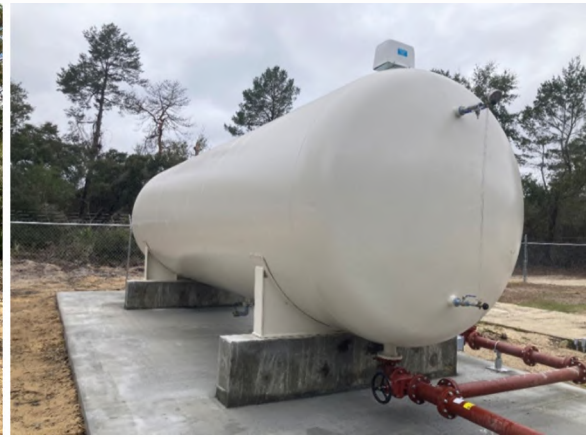
2 *Before (Left) & After (Right): Hydro-pneumatic tank replacement - Ponderosa Pines system.*

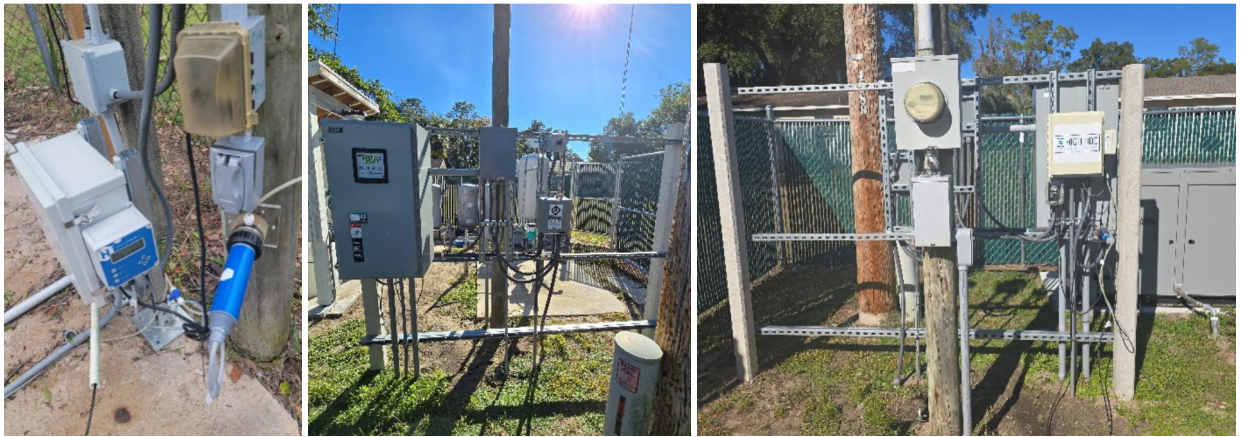
6 *Before (Left) & After (Right): Electrical Panel Improvements - Eleven Oaks system.*

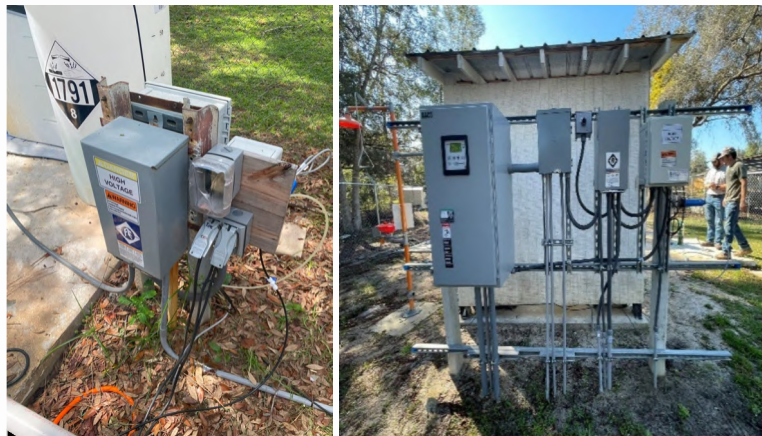
2 *Before (Left) & After (Center & Right): New Electric Panels - Oakcrest Villas system.*

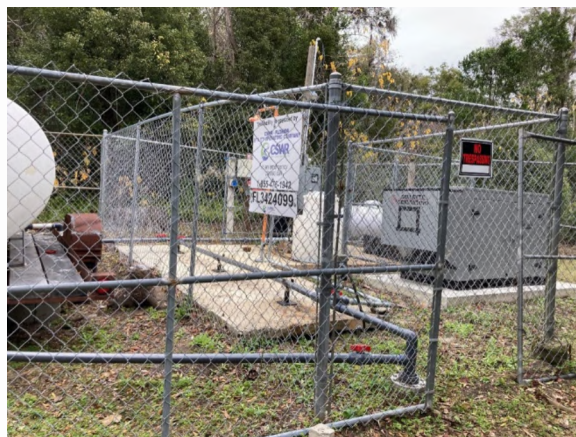
4 *Before (Left) & After (Right): Electrical panel improvements - Pondarosa Pines system.*

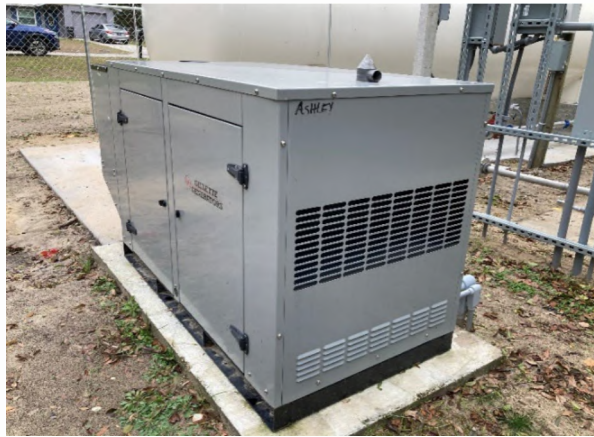
6 *Emergency generator installation - Eleven Oaks system*

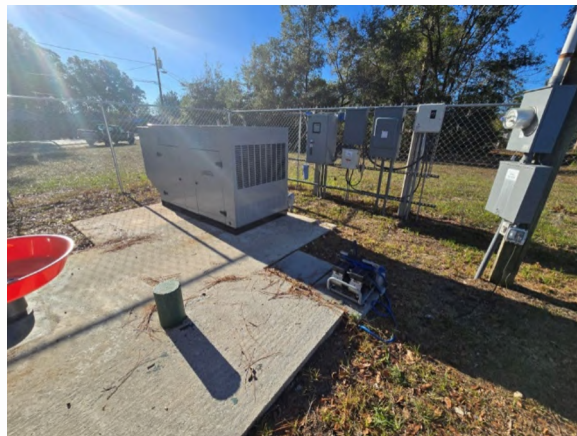
*Emergency generator installation - Ashley Heights system.*

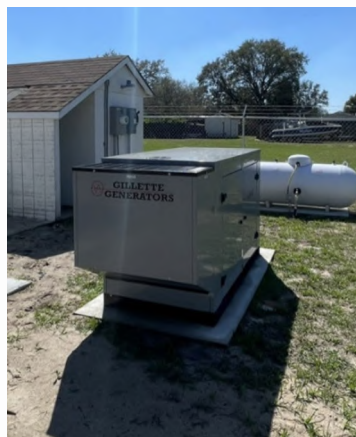
*New generator - Belleview Oaks Estates system.*

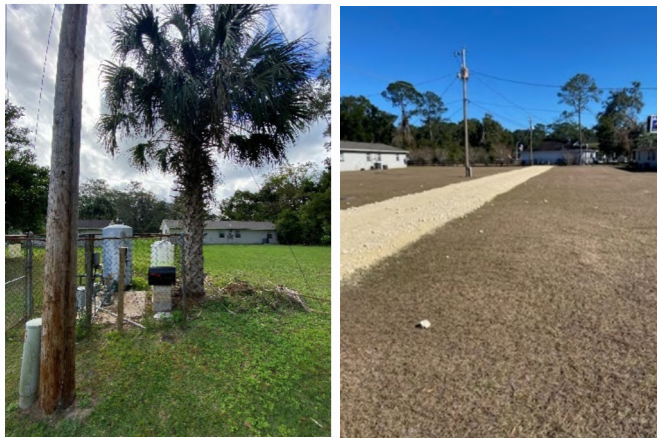
2 *New fencing - Emil-Mar system. (Note: similar fencing improvements have been made at all*  
 3 *Sunshine water sites)*

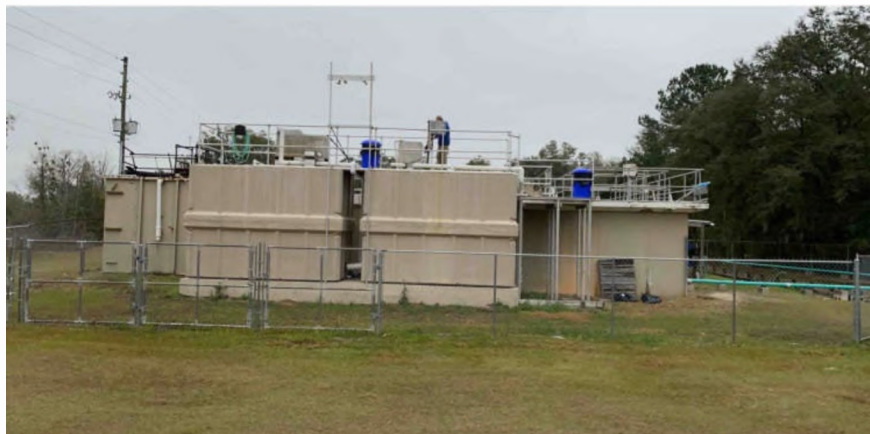
- 14 • Ongoing failure to meet total nitrogen limits
- 15 • Ongoing failure to meet total suspended solids limits
- 16 • Many areas of damage to concrete tanks indicating poor tank condition

*Ground level overview photo of Lancfair WWTF at acquisition.*

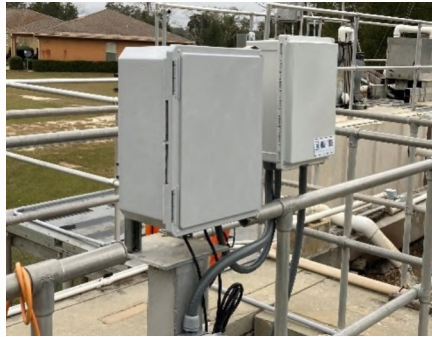
5  
6 *Newly installed remote monitoring equipment at the Landfair facility and lift stations*  
7 *(example at treatment plant)*

1 A. Improvements made to date to the Landfair wastewater system include installation of  
2 remote monitoring equipment at the wastewater treatment facility including all six lift  
3 stations. The remote monitoring unit installed at the treatment plant will be able to be  
4 moved to the new treatment facility in the future.

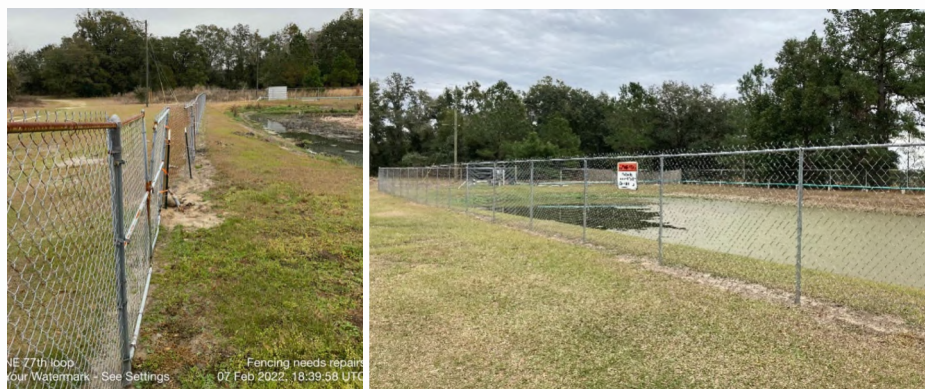
8 Damaged fencing was identified at the treatment facility, rapid infiltration  
9 basins, and lift stations 1 and 2. Adequate fencing is important to prevent members of  
10 the public from entering utility sites, both to protect the equipment and ensure its safe  
11 and reliable operation and to protect the public from potential injury or illness due to  
12 exposure to wastewater and wastewater equipment. To ensure site security and public  
13 safety all fencing has been repaired.

14  
15 *Example of damaged (left) and repaired (right) fencing at the Landfair treatment facility.*

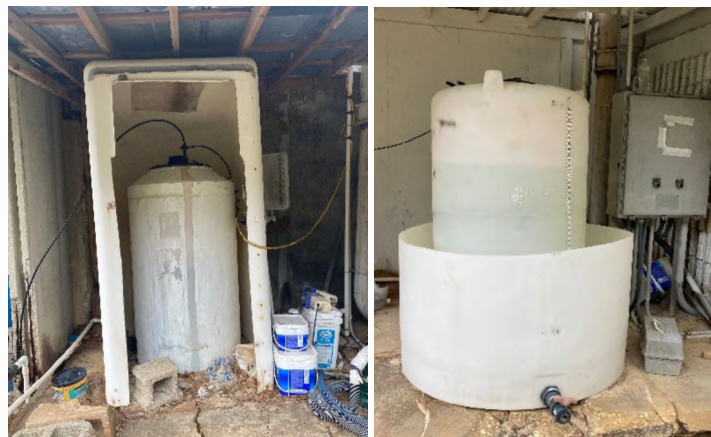
7 At acquisition, no spill containment was present for the sodium hypochlorite  
8 disinfection chemicals. This means if a spill occurred the chemicals could flow freely  
9 on and into the ground, potentially damaging the environment or exposing operators to  
10 disinfection chemicals. A spill containment drum was installed to contain potential  
11 spills of the chemicals.

12  
13 *Sodium hypochlorite storage before (left) and after (right) addition of spill catching drum.*

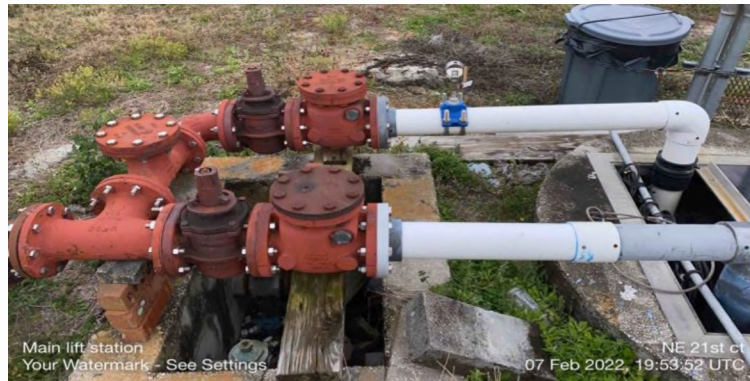
1 stations. Portions of the aeration apparatus in the aeration basin were not functioning  
2 properly, indicating damage to some of the drop pipes and diffusers. These needed to  
3 be repaired to maintain proper function of the treatment facility until the plant  
4 replacement can be completed. The discharge and bypass piping of the main lift station  
5 were in very poor condition at the time of acquisition, with rusting piping and damaged  
6 valves supported by stacks of loose brick and rotting wood. The piping has been  
7 replaced to ensure proper function and to prevent a support failure resulting in service  
8 interruption.

*Main lift station piping at acquisition with brick and rotting wood supports.*

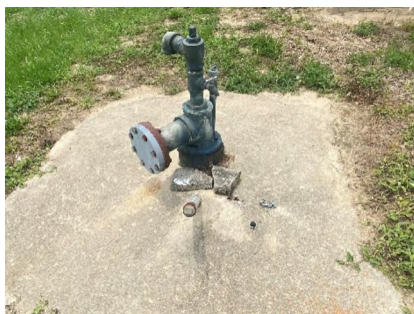
18  
19 *Out of service well now properly decommissioned and removed.*

14 A. To date, CSWR Florida has completed several improvements to the Landfair drinking  
15 water system. First, the out of service well was properly decommissioned. Proper  
16 decommissioning of wells is important to prevent potential contamination of  
17 groundwater and to eliminate tripping hazards from the utility site.

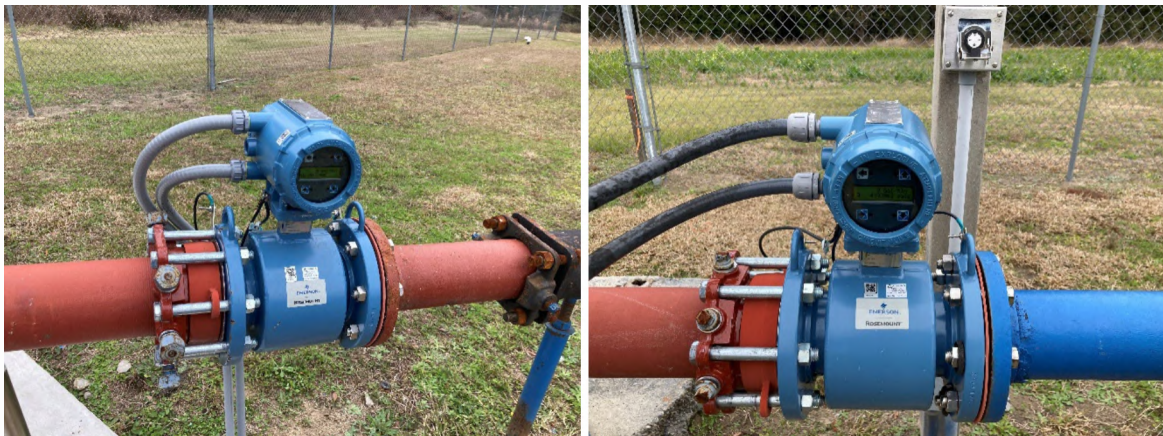
6  
7 *New flow meters installed for Well 2 (left) and Well 3 (right).*

20 The well pad for well 2 has been replaced, and flow meters have been installed  
21 on both active wells. Active flow metering allows for greater operational awareness

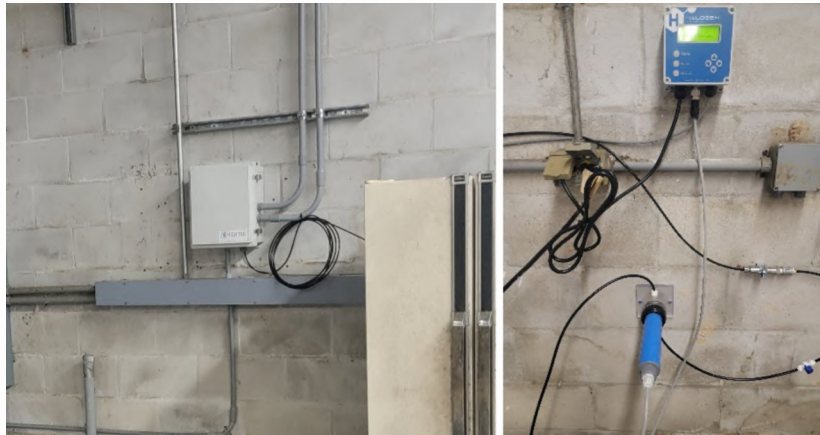
*New Remote monitoring unit (left) and continuous chlorine analyzer (right).*

8 Remote monitoring equipment has been installed at the water site. With the  
9 installation of the remote monitoring equipment, a continuous chlorine analyzer was  
10 also installed. These analyzers actively monitor to ensure that adequate chlorine  
11 residual is maintained in drinking water, which prevents bacteriological contamination  
12 issues in the drinking water and reduces manual testing requirements.

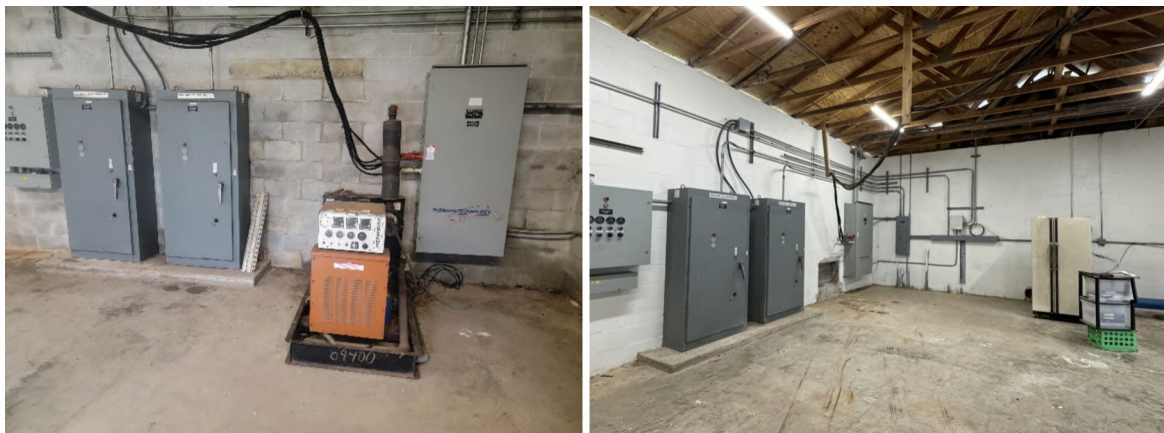
*Before (left) and after (right) removal of stationary generator. Also note painting of building interior.*

The out of service stationary generator has been removed so that, in the future, a new stationary generator can be installed. Once a new stationary generator is installed, the mobile generator that currently is permanently connected to the system can be disconnected so that it can be mobilized to provide emergency power to the nearby Landfair wastewater treatment facility and any of the lift stations in its collection system during power outages.

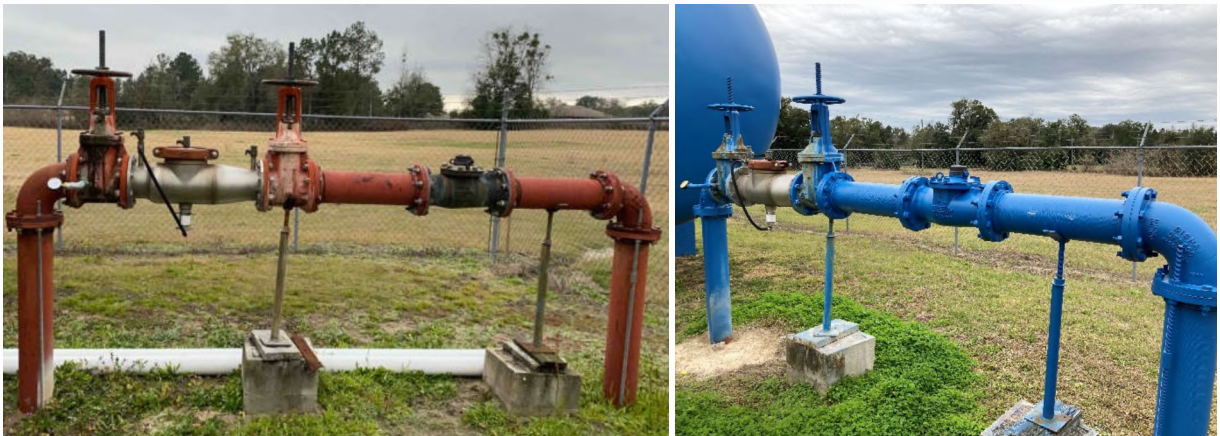
Much of the equipment, piping, and structures on the site had either deteriorating protective coatings or lacked such coatings entirely. Maintaining paint and coatings on equipment is important to prevent deterioration due to exposure and to

5  
6 *Examples of piping and valves before (left) and after (right) recoating.*

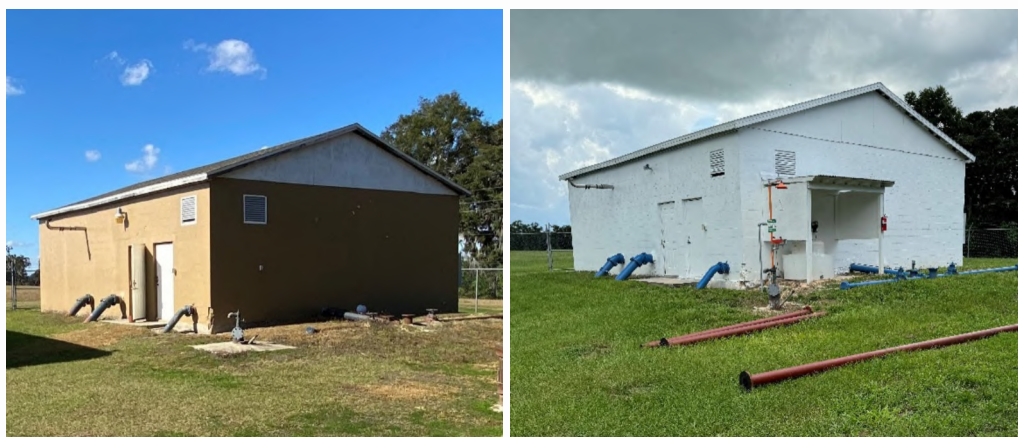
7  
8 *Treatment, pumping, and control building before (left) and after (right) recoating.*

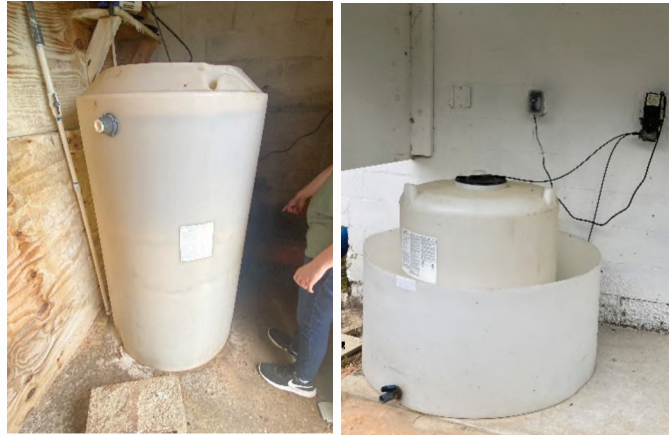
9 At acquisition, the disinfection system at the water plant did not have any proper

1 form of chemical containment. Without proper containment, spilled chemicals can  
2 cause damage to the environment, present a hazard to operators, or damage equipment.  
3 CSWR Florida has installed chemical containment at the water system site.

4  
5 *Chlorine storage before (left) and after (right) installation of spill containment.*

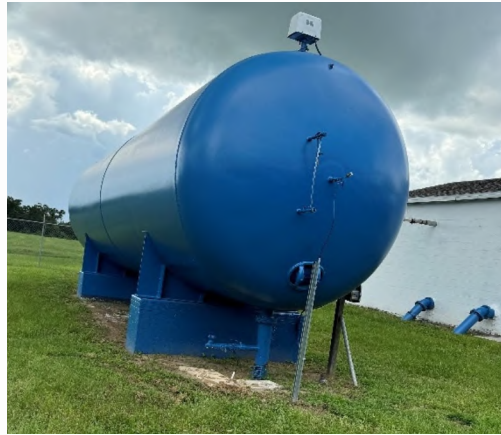
- 15            • The surge tank and control panels for booster pumps were in poor condition.
- 16            • The system's hydropneumatic tank was not properly certified and cannot be  
17            recertified due to age. Additionally, the hydropneumatic tank is massively  
18            oversized for the system, meaning ongoing maintenance costs would be much  
19            higher than for an appropriately sized tank.

3 *Oversized uncertified hydropneumatic tank to be replaced with appropriately sized and*  
4 *certified tank.*

19 CSWR Florida plans to replace the existing hydropneumatic tank with a 5,000-gallon

1 tank that has proper certification for use in drinking water.

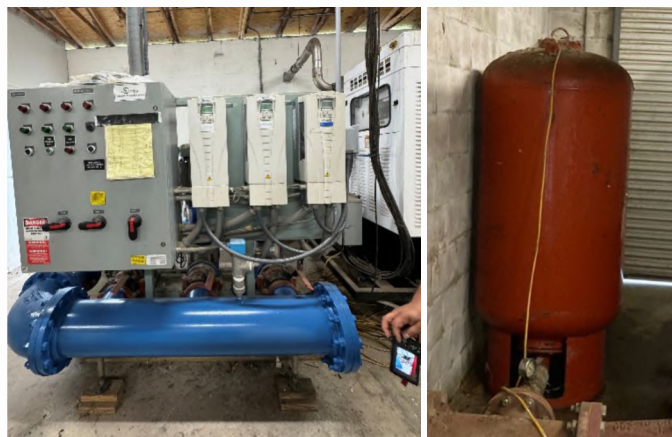
5 The control systems and surge tank connected to the booster pump system are  
6 in poor condition due to age and poor maintenance practices. The surge tank is rusted,  
7 has deteriorating coatings and is unnecessary due to the variable frequency drives  
8 (“VFDs”). To ensure the system can function properly, CSWR Florida will replace the  
9 controls and the surge tank.

11 *Booster pump control system (left) and surge tank (right)*

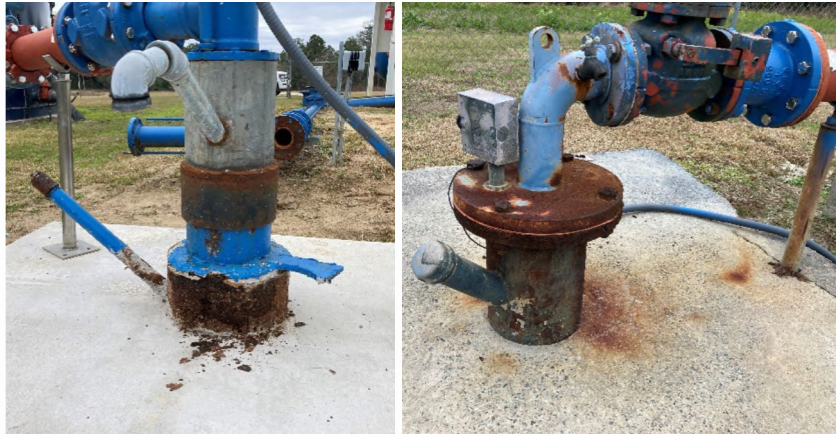
appropriate. In addition, immediately notable issues include rust to the exposed well casings, damaged above ground piping and equipment coatings, and potentially underperforming well pumps. CSWR Florida will perform the required evaluations and will make whatever repairs, upgrades, or refurbishments are required.

*Well 2 (left) and well 3 (right) showing rusting on well columns, damaged coatings on attached equipment, exposed wiring, etc.*

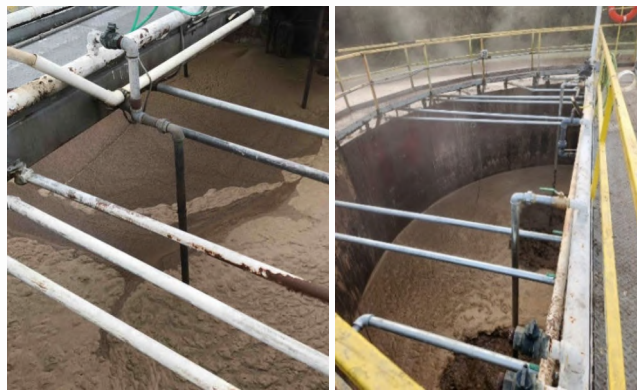
21 A. Improvements have been made to the facility's aeration equipment. A damaged air  
22 header for the digester was replaced. Leaking air headers reduce the air supply (in this  
23 case to the digester), which impedes the breakdown of sludge, resulting in higher  
24 sludge hauling costs. Deteriorated drop legs and diffusers have been replaced, and  
25 areas where drop legs and diffusers had been removed previously and not replaced had

1 new drop legs and diffusers installed. Deteriorated or removed drop legs and diffusers  
2 reduce the efficacy of aeration treatment by creating poor diffusion patterns, reducing  
3 air flow in leaks, and creating uneven aeration in basins. Restoring the aeration system  
4 will result in greater oxygen transfer to water, which improves biological treatment  
5 processes, improves mixing and mechanical breakdown of wastewater solids, and  
6 eliminates dead spots where mixing does not occur and solids can accumulate in the  
7 aeration basin, which results in reduced treatment capacity. A failed blower motor was  
8 also replaced to restore treatment effectiveness and facility resiliency by allowing for  
9 greater air supply and blower redundancy in the event of blower failures and during  
10 maintenance activities.

11  
12 *Examples of Aeration headers and drop pipes before and after replacement.*

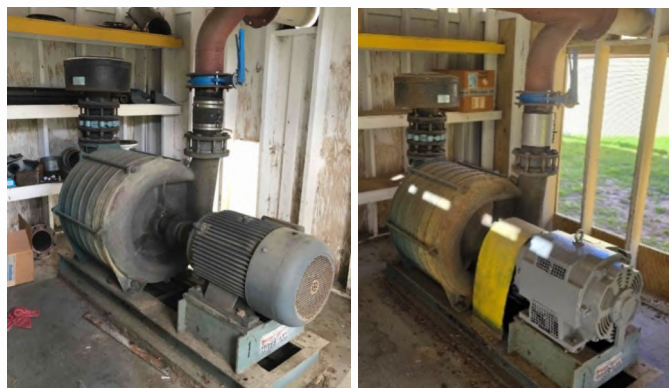
13  
14 *Blower motor before (left) and after (right) replacement, also repair work to blower building*  
15 *underway at time of photo.*

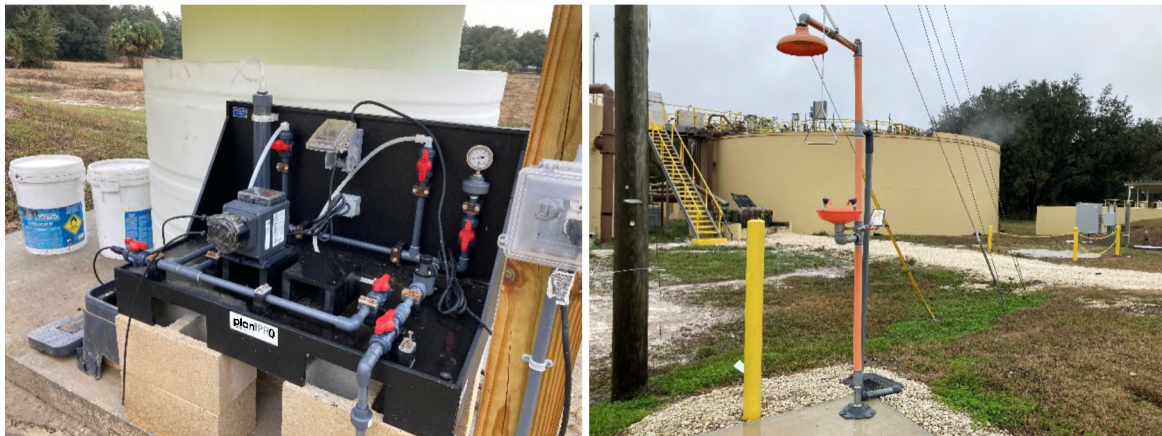
12 A. As I previously noted, at acquisition the disinfection system lacked any sort of shade  
13 structure over the disinfection chemicals (sodium hypochlorite), and the feed system  
14 used a continuous rate dosing pump. With no shade structure the chemical drum is  
15 exposed to ultraviolet light in sunlight, which leads to a breakdown in the potency of  
16 disinfection chemicals, which requires higher dosing rates and higher chemical costs.  
17 A continuous dosing rate system also leads to higher chemical costs because it does not  
18 adjust chemical dosing based on factors such as time of day or active flow rate through  
19 the disinfection system. CSWR Florida has installed a new shade structure and a new

7  
8 *New variable chemical dosing pump (left) and emergency chemical shower and eyewash*  
9 *station (right)*

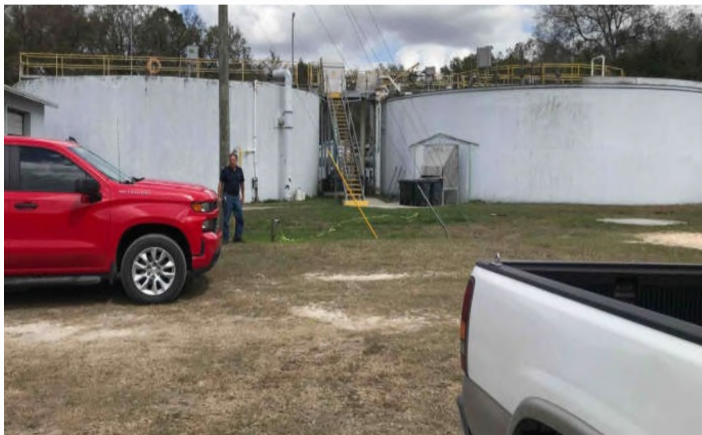
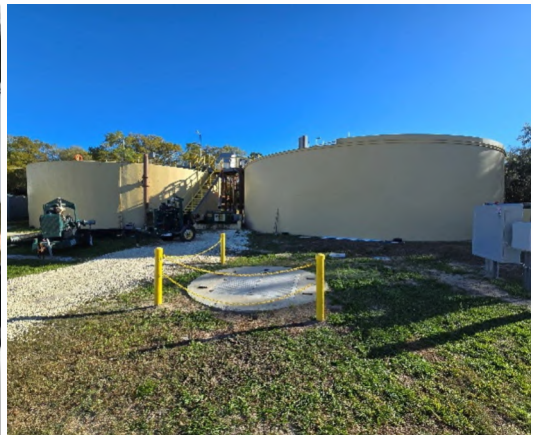
1 condition on the blower building, damaged or missing handrails and catwalks around  
2 the treatment facility, and deteriorating coatings on the facility's tanks, pipes, and other  
3 equipment. Repairs and regular maintenance of basic facility structures like these are  
4 important to protect equipment and materials stored within. Handrails and catwalks  
5 are essential to operator safety. Structure and equipment coatings are essential to  
6 protect equipment and halt corrosion processes that can lead to failures and reduce  
7 useful life. CSWR Florida has made the appropriate structure repairs, recoated all  
8 tanks, structures, and appropriate equipment, and made repairs and improvements to  
9 the catwalk and handrail systems, including repainting all handrails and stairs in high  
10 visibility coatings to enhance operator safety.

*Facility tanks before (left) and after (right) recoating.*

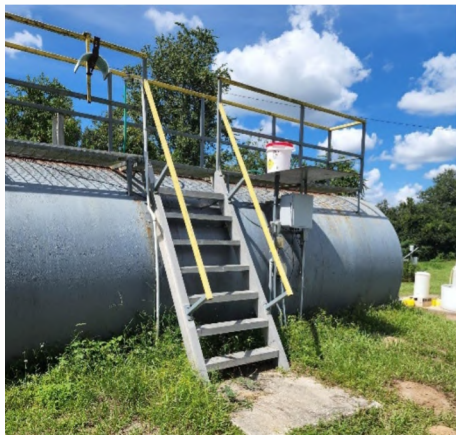
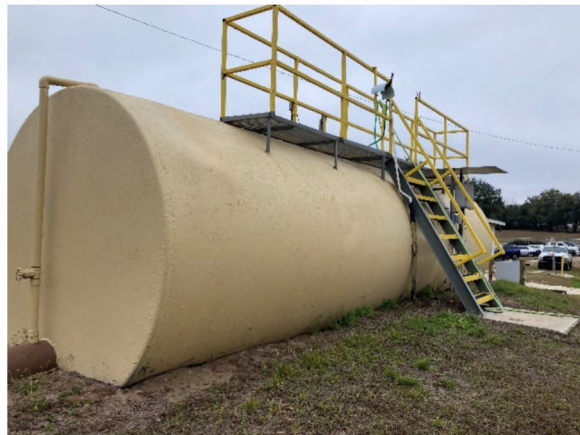
*Disinfection mixing tank before (left) and after (right) recoating and repainting handrails*

*and stair treads.*

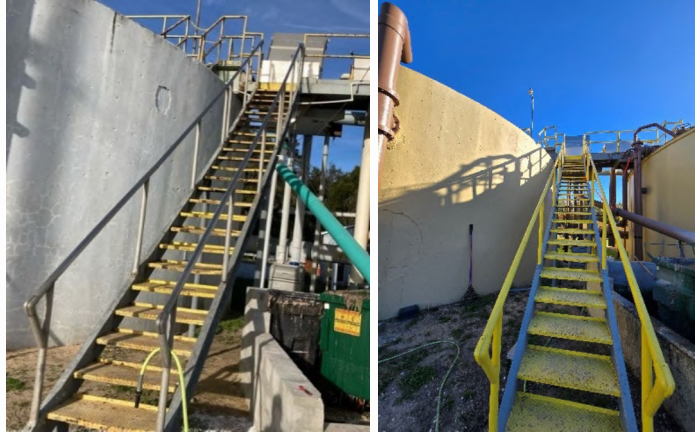
*Main access stairs before (left) and after recoating and adding high visibility paint.*

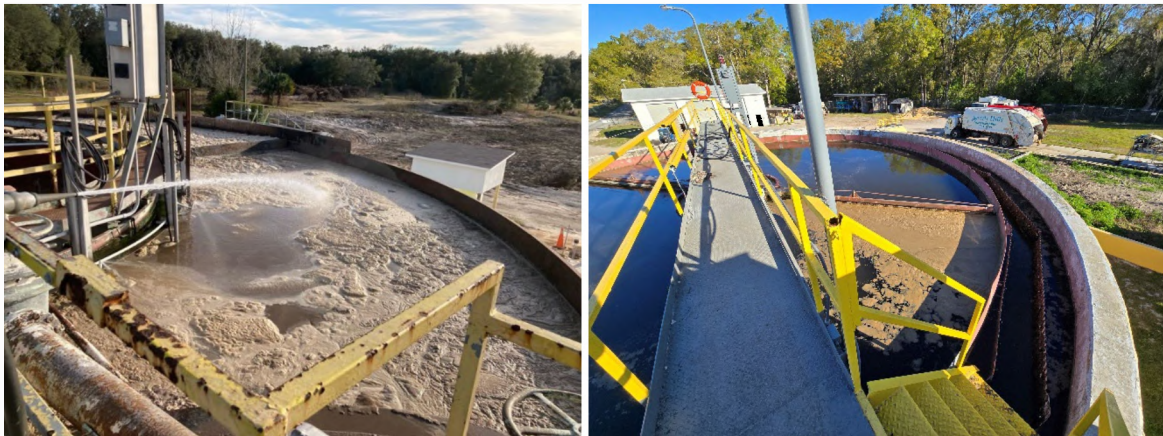
*Typical conditions of handrails before (left) and after (right) recoating.*
