**BEFORE THE FLORIDA PUBLIC SERVICE COMMISSION**

| wastewater rates in Brevard, Citrus, Duval, | ) | DOCKET NO. 20250052-WS |

**DIRECT TESTIMONY OF**

**JACOB FREEMAN**

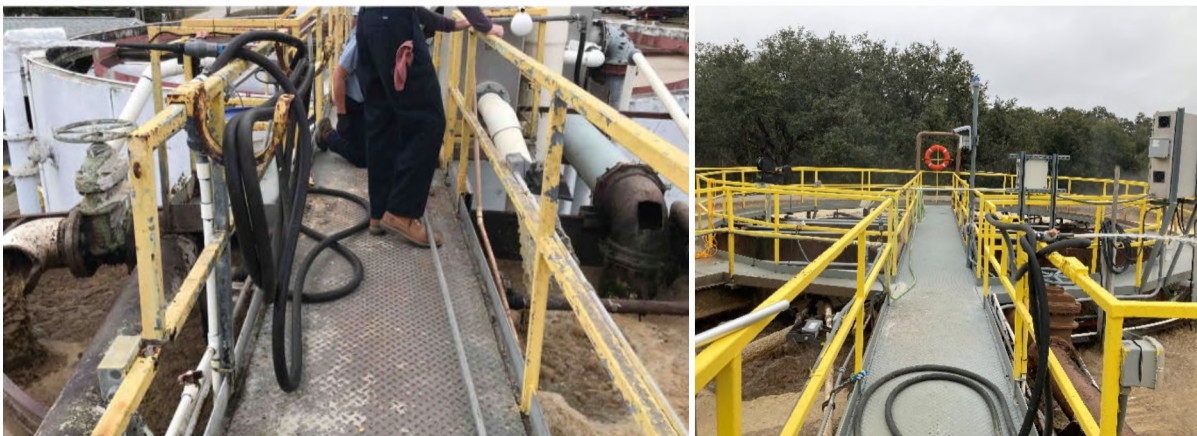
*Typical condition of catwalks and rails before (left) and after (right) improvements.*

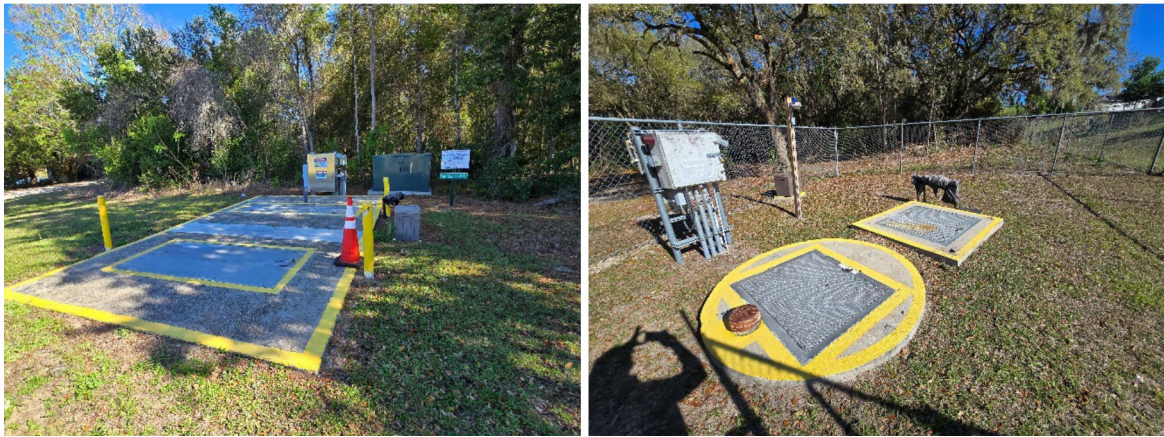
*Examples of high visibility paint application to tripping hazards.*

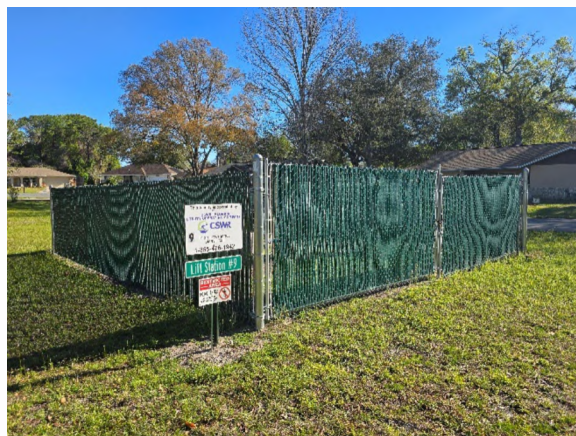
*Example of new fencing installed at lift stations.*

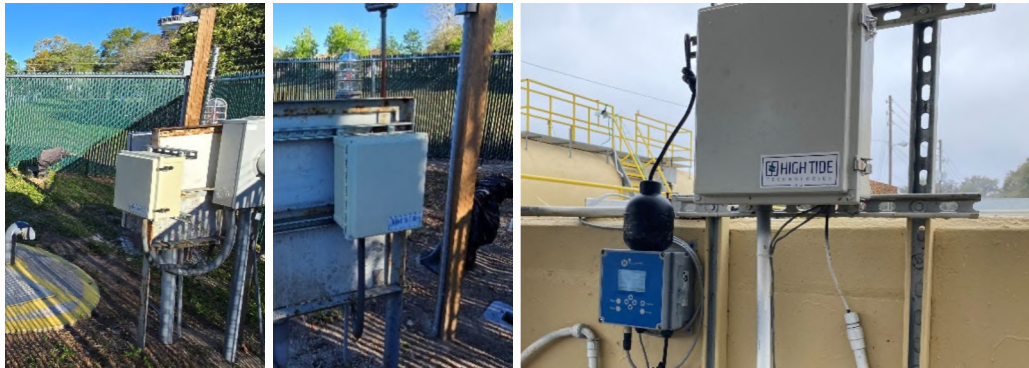
At acquisition, the facility and lift stations also did not include remote monitoring equipment. Remote monitoring equipment has been installed at the

8  
9 *Examples of new remote monitoring equipment installed at the lift stations (left and center)*  
10 *and the treatment plant (right).*

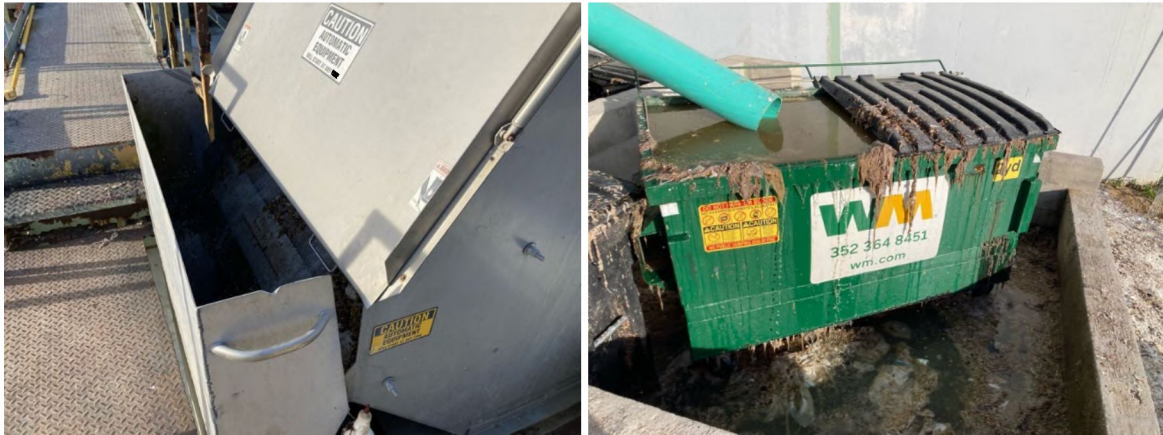
3  
4           *Overwhelmed hydrosieve (right) resulting in overflows of wastewater at the nuisance solids*  
5           *collection dumpster (left).*

23 treatment plant. To resolve this problem, the out of service lime stabilization basin will  
24 be converted into an influent surge basin, the existing hydrosieve will be relocated to  
25 this tank, and one or two additional hydrosieves will be installed to split the flow and

1           thereby prevent the system from being overwhelmed. This will also require pumping  
2           modifications to then convey the screened wastewater to the existing headworks.

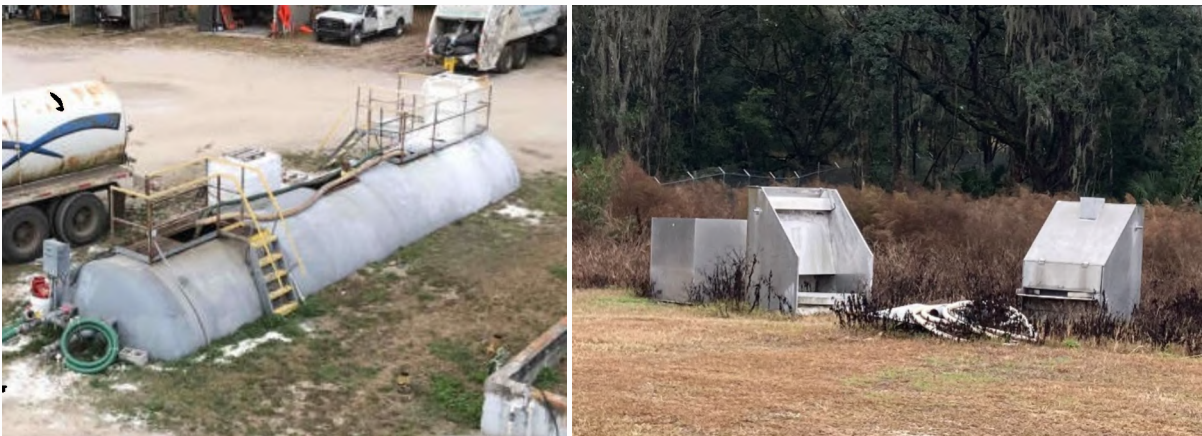
6  
7           *Out of service lime stabilization tank to be converted to influent surge basin (left) and*  
8           *additional hydrosieves on site to be repaired for use (right)*

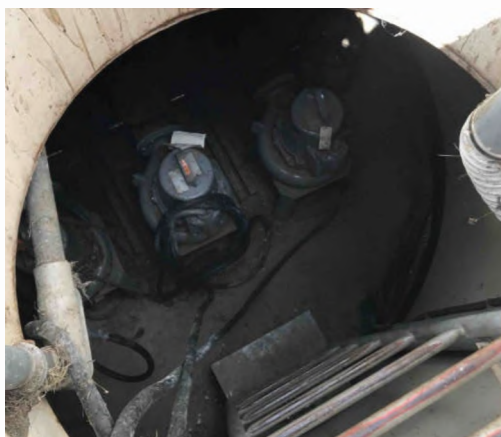
*Lift station 2 dry well basin*

9           Additional improvements will be made to the lift stations, including the  
10          installation of new guiderails at lift stations 5, 7, and 9 to aid in future pump  
11          maintenance. The control panels at lift stations 3, 4, 5, 6, and 12 are in poor condition  
12          and will be replaced to ensure reliable function. Finally, because lift station 2 is in poor  
13          condition and is an older-style dry well lift station, it will be replaced to ensure proper  
14          function.

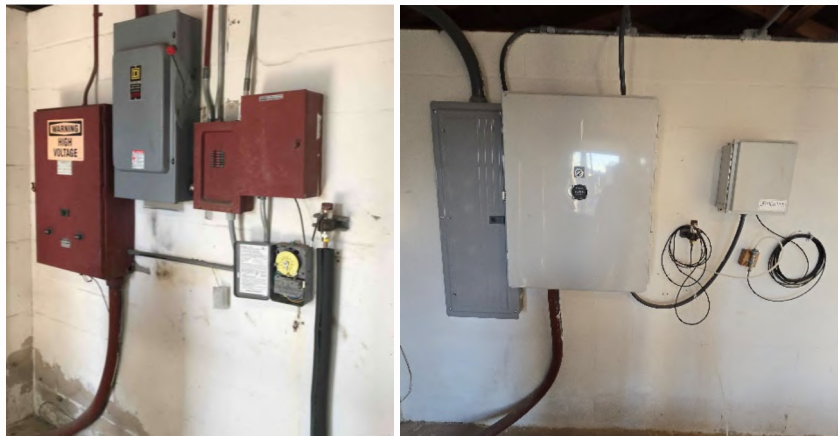
4  
5 *Well 6 electrical before (left) and after (right) replacement.*

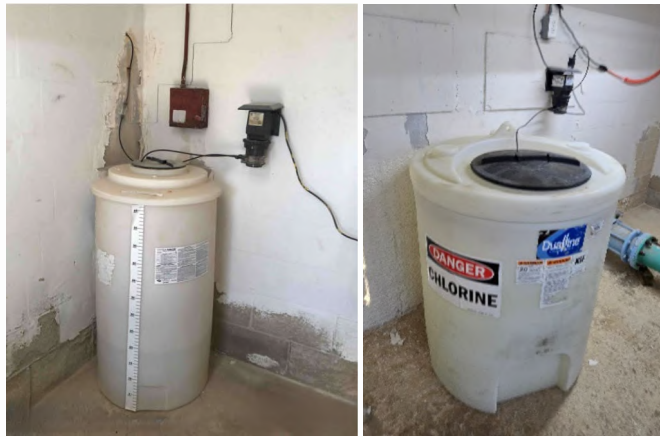
6 All sodium hypochlorite drums at the well sites were single wall drums with no  
7 spill containment. Due to the limited space for containment in the well houses, single  
8 walled drums were replaced with double walled drums at all nine well sites to help  
9 reduce the risks of spills and to contain spills that occur.

*Example of sodium hypochlorite drums before (left) and after (right) replacement in this cast at Well 6.*

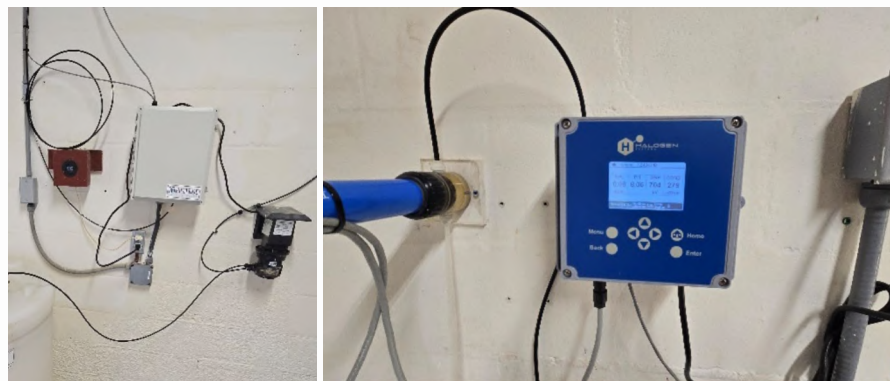
At acquisition, the well sites lacked remote monitoring and chlorine residual monitoring equipment. Remote monitoring equipment and a continuous chlorine analyzer have been installed. These analyzers actively monitor to ensure adequate chlorine residuals are maintained to prevent bacteriological contamination issues in the drinking water and to also reduce manual testing requirements.

*Examples of remote monitoring unit installed at each well site (left) and new chlorine residual monitoring equipment installed at each well site (right) (examples from Well 8 site).*

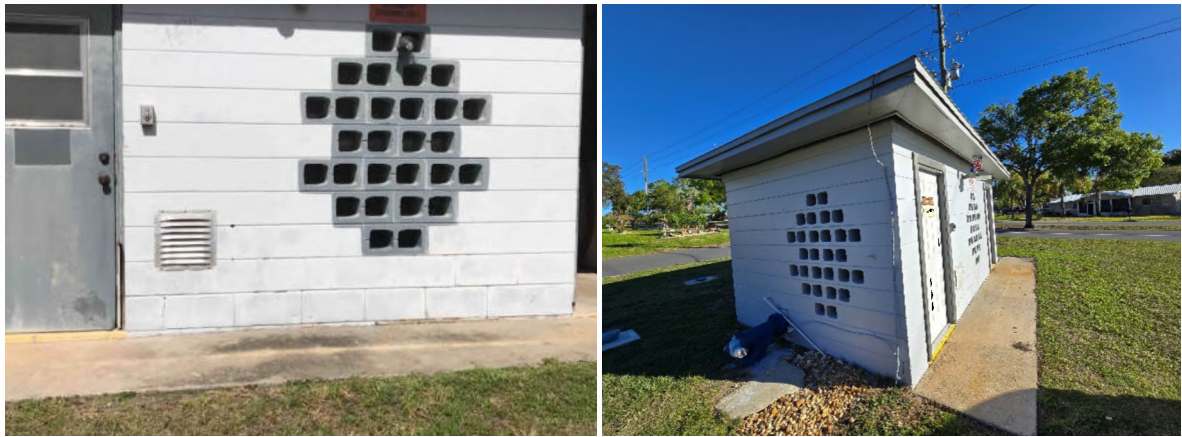
Various issues with well house structures were identified that required repairs or improvements. All cinder block buildings were painted and repaired, as necessary, to ensure their longevity. The roofs of the well houses at wells 8 and 9 were in poor condition and were replaced to protect the equipment inside.

*Example of before (left) and after (repainting) (example is the Well 5 well house)*

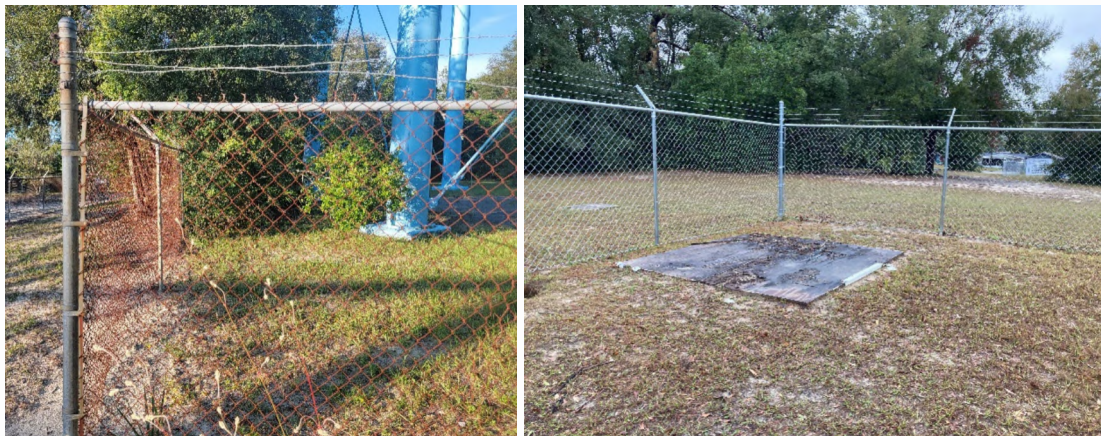
*Example of deteriorating (left) and replaced (right) fencing at Elevated Storage Tank 1.*

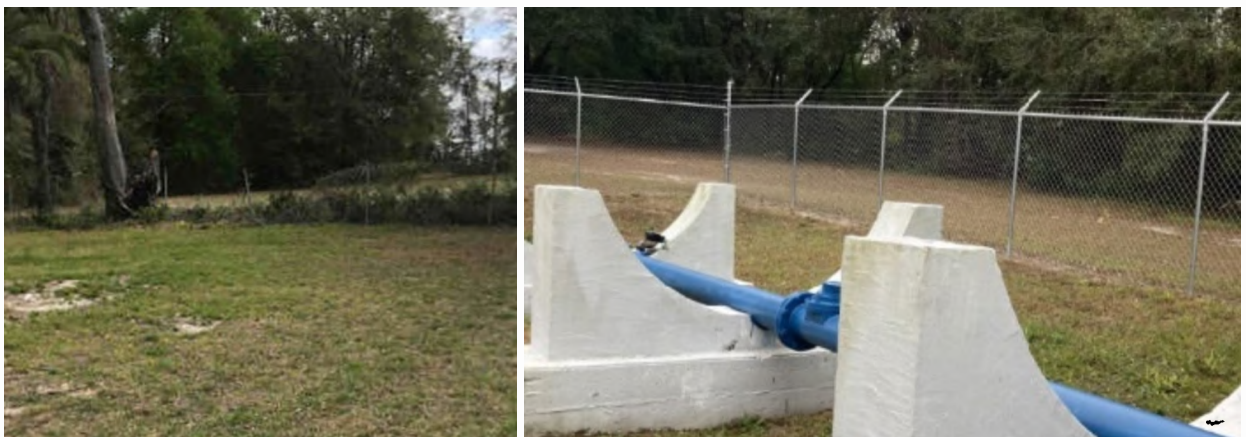
*Example of damaged (left) and new (right) fencing at Well 2 site.*

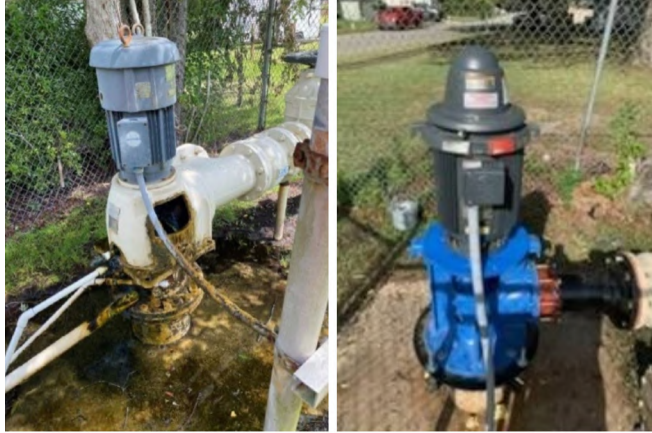
23 **A.** CSWR Florida has already completed several upgrades and improvements to the  
24 Neighborhood Utilities drinking water system. First, because well pump on Well 2 was  
25 in poor condition and failed shortly after acquisition, CSWR Florida replaced the pump

4  
5 *Well 2 pump before (left) and after replacement (right) well casing and wiring also replaced.*

1 to restore service to the system. Additional maintenance work was performed on the  
2 well itself, including clearing nuisance vegetation, replacing damaged piping, and  
3 installing a new flow meter.

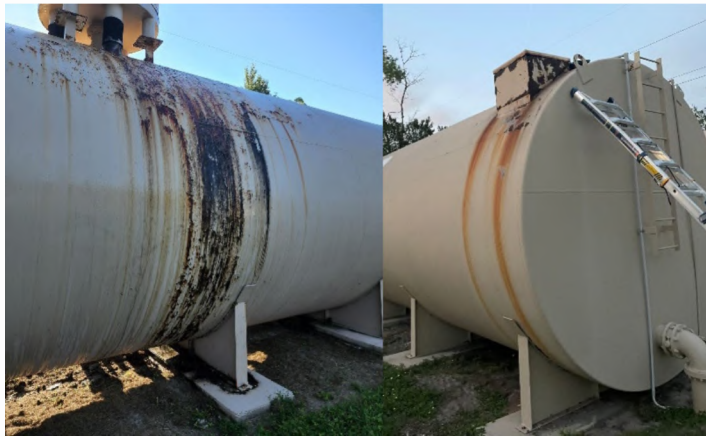
6 Tank inspections have been completed on all tanks at the Neighborhood  
7 Utilities site. As a result, it was determined that both ground storage tanks were in poor  
8 condition and would need to be replaced. The hydropneumatic tank was found to be  
9 in fair condition, so the interior and exterior of the tank was recoated to extend its useful  
10 life. A new compressor was also installed to maintain pressure and air gap in the  
11 hydropneumatic tank. The replacement of the ground storage tanks will take time for  
12 design, permitting, equipment lead time, and construction. To address the longer-term  
13 issues related to corrosion on Tank 2 until the it can be replaced, the exterior of Tank  
14 2 was recoated.

*Examples of rust on the ground storage tanks and general poor condition.*

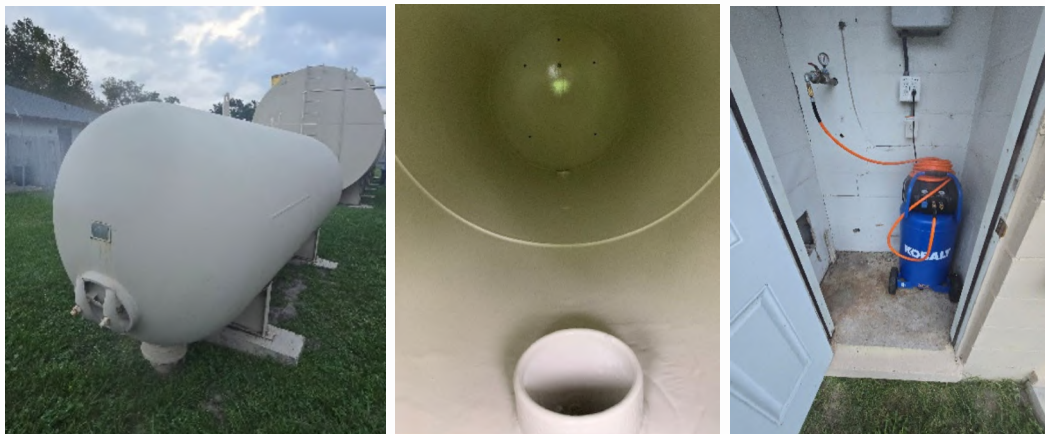
*Exterior recoating completed on Tank 2 and the aeration unit.*

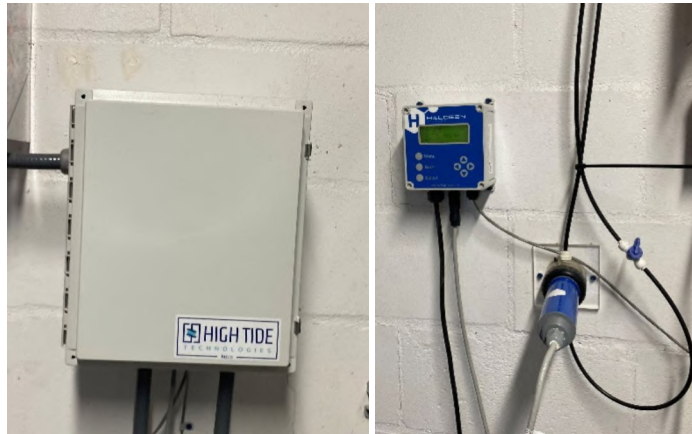
1 monitoring equipment at both locations and installed a continuous chlorine analyzer.  
2 These analyzers ensure that adequate chlorine residuals are maintained in drinking  
3 water to prevent bacteriological contamination issues in the drinking water and reduce  
4 manual testing requirements, and the remote monitoring equipment allows operators to  
5 monitor the analyzers to ensure they are performing as required.

7 *Remote monitoring unit (left) and continuous chlorine monitor installed at Neighborhood*

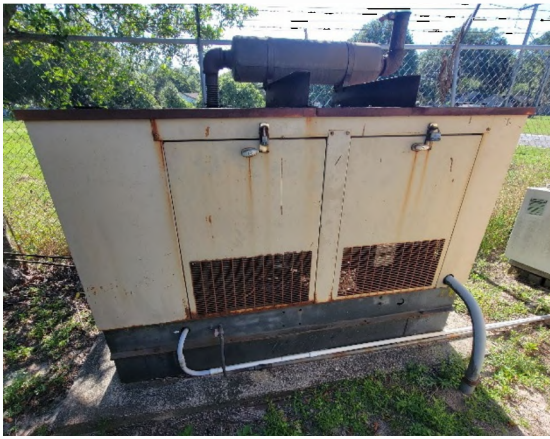
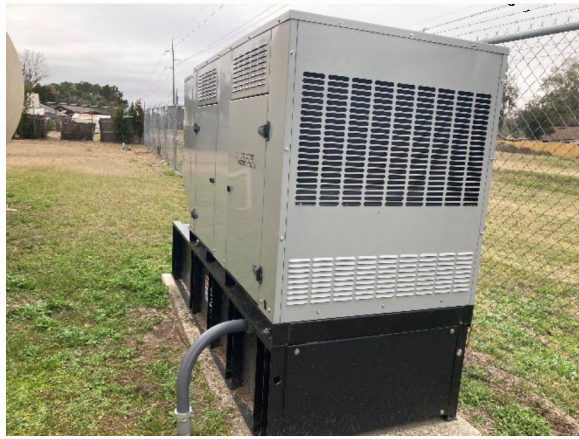
9 As I discussed in the compliance section of my testimony, the emergency  
10 generator has been nonfunctional since 2017 and has resulted in numerous warning  
11 letters and a Consent Order. CSWR Florida replaced the generator to ensure the facility  
12 can deliver uninterrupted service in the event of a power outage. Flood lighting has  
13 also been installed to ensure operators can safely complete maintenance activities after  
14 dark and during emergency maintenance responses.

2 *Emergency generator at Neighborhood Utilities before (left) and after (right) replacement.*

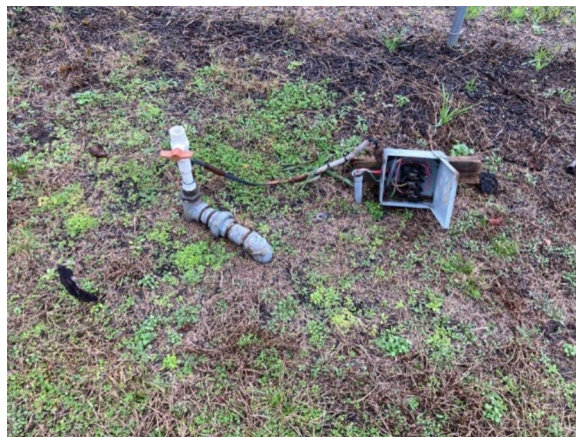
4 A. Further improvements are needed at the Neighborhood Utilities drinking water system  
5 to ensure the facilities are in safe and operable condition, that the facility can meet  
6 regulatory requirements, and that the facilities can be properly and adequately  
7 maintained. As previously testified, well 1 has been out of service for some time but  
8 was not properly abandoned by the prior owner. CSWR Florida will properly  
9 decommission and abandon the well to protect groundwater quality and eliminate a  
10 tripping hazard from the water treatment site.

11  
12 *Well 1 needs to be properly decommissioned and removed.*

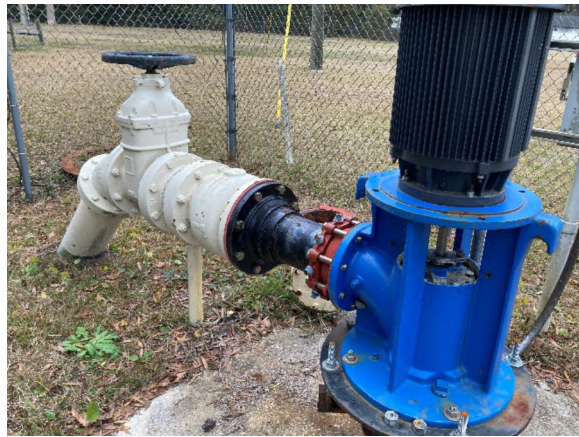
13 While the well pump and some of the piping was replaced, well 2 still requires  
14 additional rehabilitation work. The well is being evaluated to also determine if  
15 chemical treatment or subsurface casing repair is needed. A flow meter will be installed  
16 on the well and piping that has not already been coated with a protective coating yet  
17 will be properly painted. The well will also have a soft start controller installed to  
18 reduce risk of cavitation, reduce wear and tear on the motor, and reduce water hammer  
19 in the line connecting the pump to the treatment site.

*Well 2, new piping needs to be painted, flow meter needed, etc.*

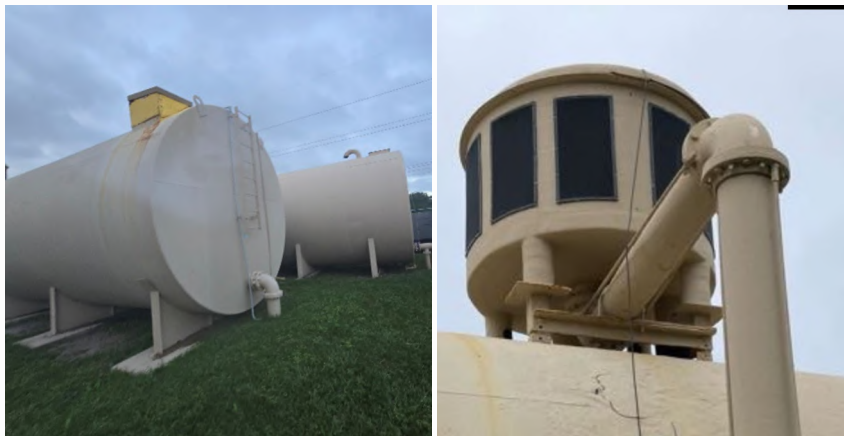
Tank 1 and tank 2 as the aeration treatment unit mounted on tank 2 are in poor condition. The two tanks will be replaced with a single, larger ground storage tank (a standpipe) and a new aeration treatment unit will be installed.

*Tanks 1 & 2 (left) to be replaced with a single larger ground storage tank and aeration treatment unit (right) to be replaced.*

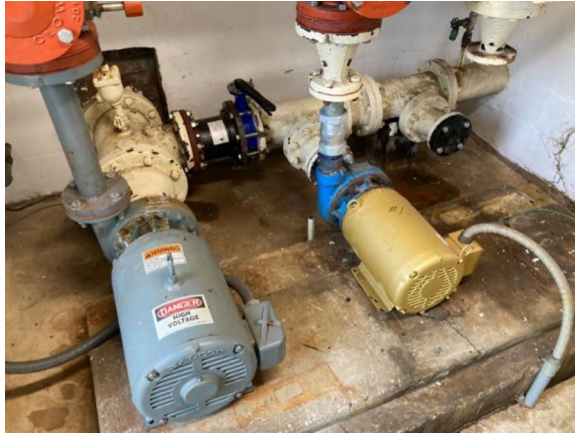
The high service pumps are in poor condition and are nearing the end of their useful lives. In addition, since closing on acquisition of the system, one of the three pumps has failed. To ensure the pumping system can continue to ensure adequate system pressure, the booster pumps will be replaced. The existing high service/booster pump system also does not include VFDs in the control system, which allows pumps to run at less than full power and allows pumps to be ramped up rather than starting at

4  
5 *Booster pumps in need of replacement, note empty pump flange from pump which failed since*  
6 *acquisition by CSWR Florida, emphasizing the poor condition of the pumps.*

1 full power. This helps to reduce power consumption, reduce wear and tear to pumps,  
2 and reduce pressure hammer when pumps turn on. CSWR Florida will install VFDs  
3 on the booster pump control system.

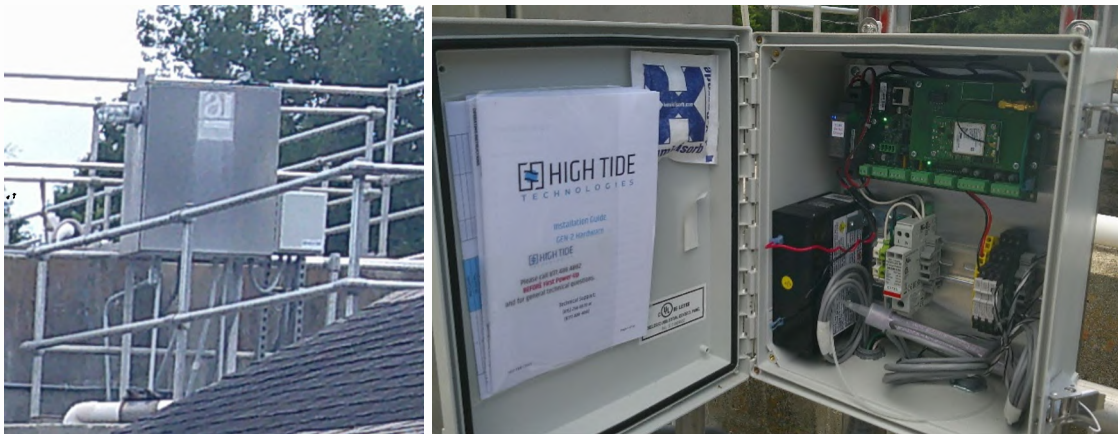
15  
16 *Newly installed remote monitoring equipment at the Tymber Creek facility and lift stations*  
17 *(example at treatment plant)*

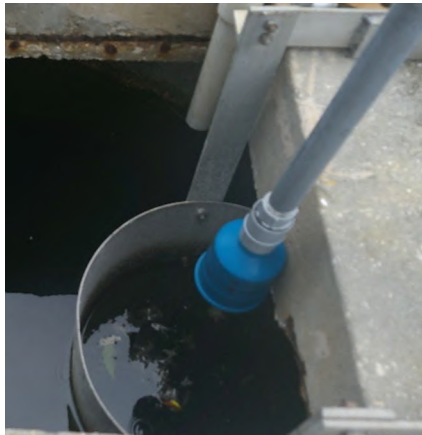
1 the older meter was in poor condition and could not communicate with the remote  
2 monitoring system.

3  
4 *New ultrasonic flow meter.*

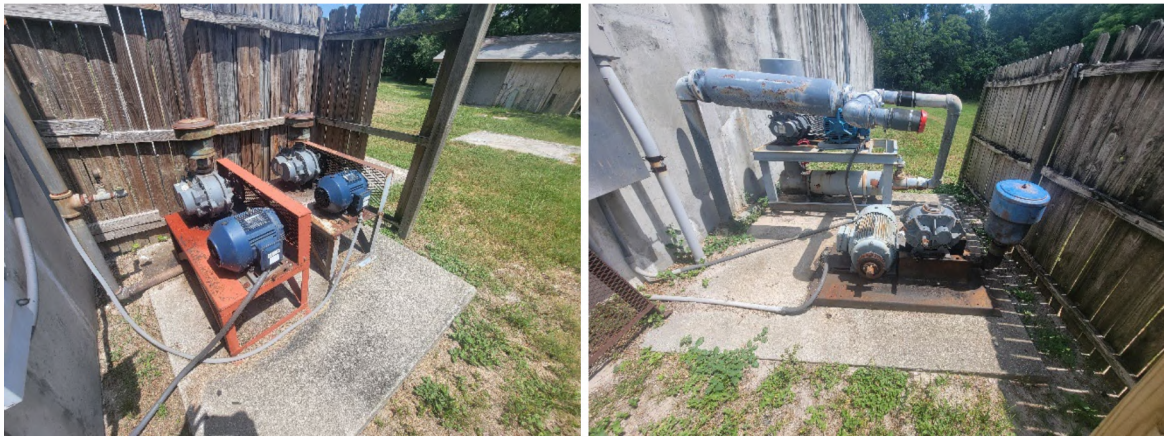
12 **A.** Further improvements are planned at the Tymber Creek wastewater system to resolve  
13 problems the previous owner failed to address. The blowers running the digester/surge  
14 tanks and aeration basins are in poor condition, with all blowers for the aeration basins  
15 nearing the end of their useful lives. In addition, one of the blowers for the digester  
16 and surge tanks failed prior to acquisition by CSWR Florida. The entire blower system  
17 for the aeration basins and the failed blower from the surge basin and digester system  
18 will be replaced.

*Surge basin / digester blowers (left) and aeration basin blowers (right)*

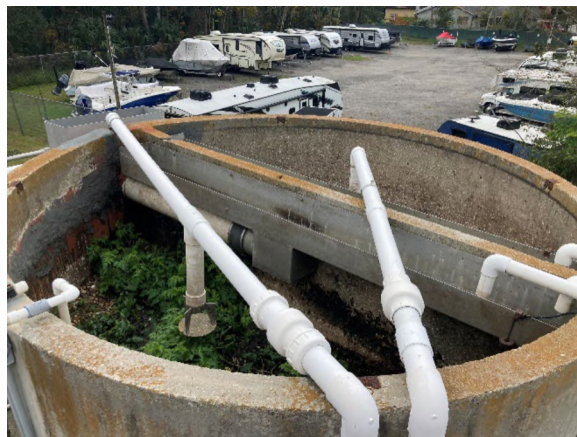
The facility's sand filters have some areas with impacted sludge preventing proper flow through the filter and allowing vegetation to grow in the filters. The sand filters provide additional removal of solids prior to discharge. The impaired function of the filters contributes to the ongoing daily maximum TSS limit exceedances. The sand filter media will be replaced to enhance solids removal.

*Sand filter with impacted sludge allowing vegetation growth.*

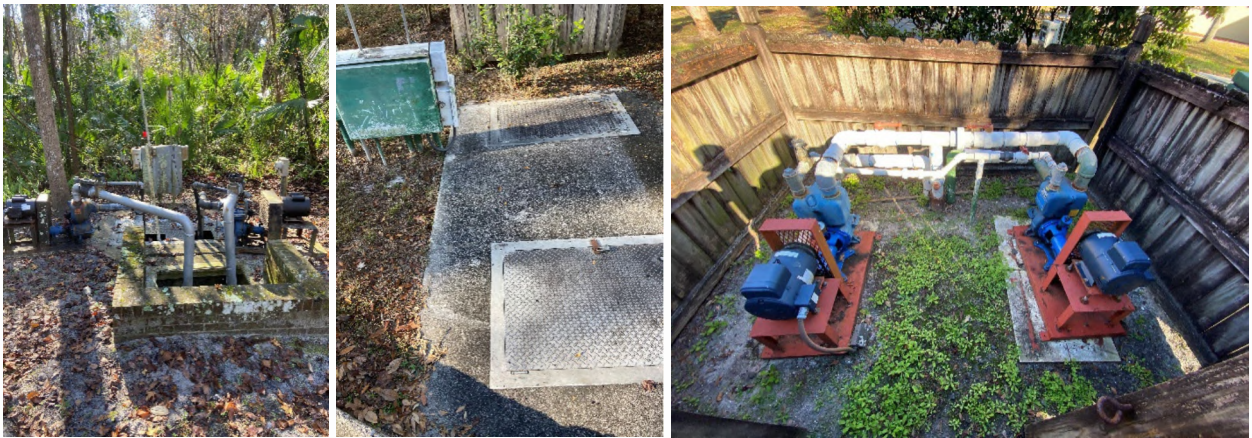
1 station 1. An evaluation by CSWR Florida showed that all three lift stations are located  
2 below the 100-year flood elevation and further found that all lift stations need  
3 significant rehabilitation. In addition, CSWR Florida determined that lift station 1 was  
4 poorly designed and cannot handle the flows it receives during high flow periods.  
5 Consequently, lift station 1 will be completely replaced and lift stations 2 and 3 will be  
6 rehabilitated, including adding riser rings to bring the top of the lift stations above the  
7 100-year flood level. Lift station 1 also lacks security fencing, so following  
8 replacement security fencing will be installed.

*Lift Stations 1 (left), 2 (center), and 3 (right).*

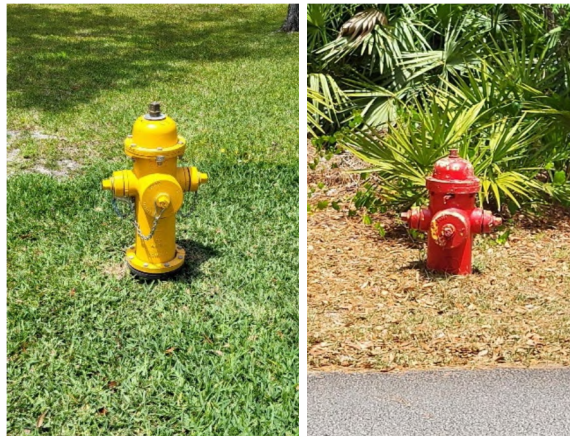
2     *Example of Tymber Creek fire hydrants (left is one replaced by CSWR Florida since taking*  
3                     *ownership of the system right is an original hydrant).*

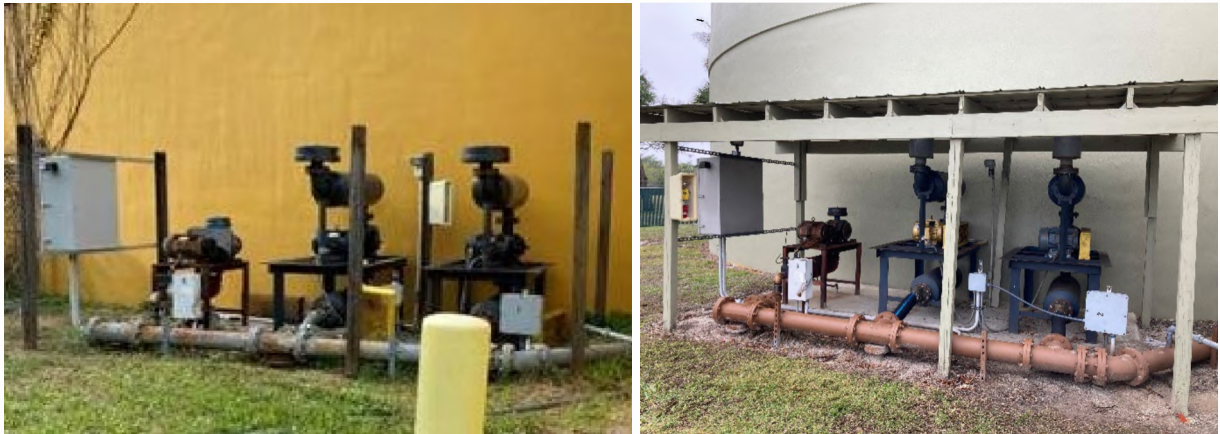
1 by CSWR Florida. For example, there was no shade structure installed over the  
2 blowers. Blowers become very hot during operation, which can lead to equipment  
3 overheating resulting in shutdowns and early wear and tear that reduces the useful life  
4 of equipment. CSWR Florida installed a shade structure to reduce overheating,  
5 repaired and replaced portions of the aeration piping to eliminate leaks and halt  
6 corrosion, and made improvements to the wiring and conduit.

7  
8 *New Shade structure over Aquarina blowers before (left) and after(right) improvement.*

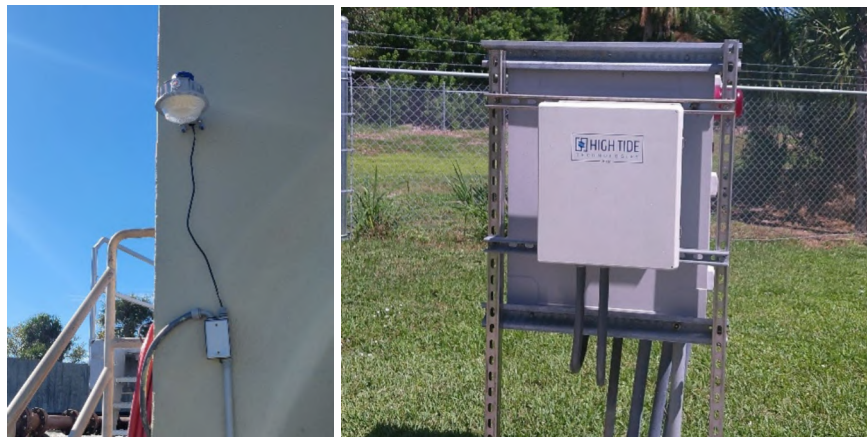
12  
13 *Example of new flood lights installed for safety in after-hours operations activities (left).*

14 *Example of remote monitoring units installed at Aquarina treatment plant and lift stations*  
15 *(right).*

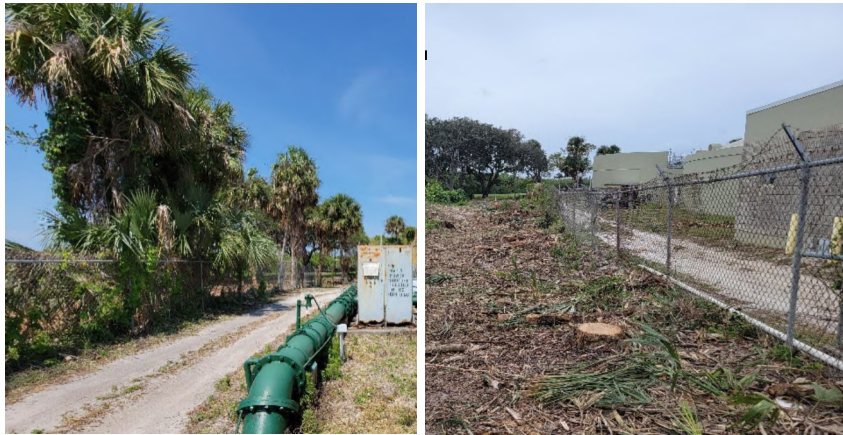
16 Several of the fence lines around the water and wastewater site were extremely  
17 overgrown with vegetation causing damage to the fencing. CSWR Florida has removed  
18 the nuisance vegetation and repaired the damaged fencing. Similarly, the effluent drain  
19 fields were found to be overgrown and the fencing surrounding the drain fields was

3  
4 *Fence lines damaged by vegetation overgrowth (left) and cleared fence line (right)*

1 completely overgrown. Vegetation has been removed from the drain field fence and  
2 controlled in the drain field.

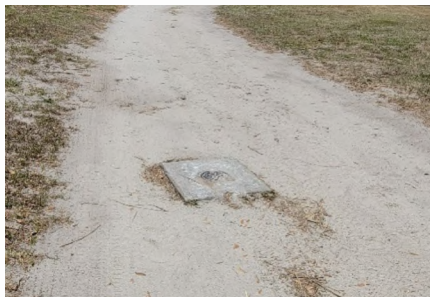
1 A. Further improvements are needed at the Aquarina wastewater system to ensure  
2 consistent compliance with regulatory requirements, to ensure the facility is in a safe  
3 and operable condition, and to ensure the facility can be properly maintained. To  
4 comply with FDEP monitoring requirements, a new monitoring well must be installed  
5 in the drain field area. Monitoring wells are wells with direct access to the upper water  
6 tables that under effect of the water that infiltrates into the ground through the drain  
7 field. Testing is periodically conducted to ensure groundwater limits are not exceeded  
8 as a result of the treated wastewater discharge. In addition, because one of the wells  
9 has been consistently dry for several years, the FDEP notified the previous ownership  
10 a new monitoring well would need to be installed. The non-functioning well caused  
11 previous ownership to consistently submit groundwater sampling results that stated

15  
16 *Example of monitoring well at Aquarina wastewater system requiring replacement adjacent*  
17 *to drain field.*

12 “No Sample Result.” Because FDEP will not accept “No Sample Result” reporting,  
13 CSWR Florida is working to install a new monitoring well as part of planned plant  
14 improvements, which will allow proper groundwater sampling to resume.

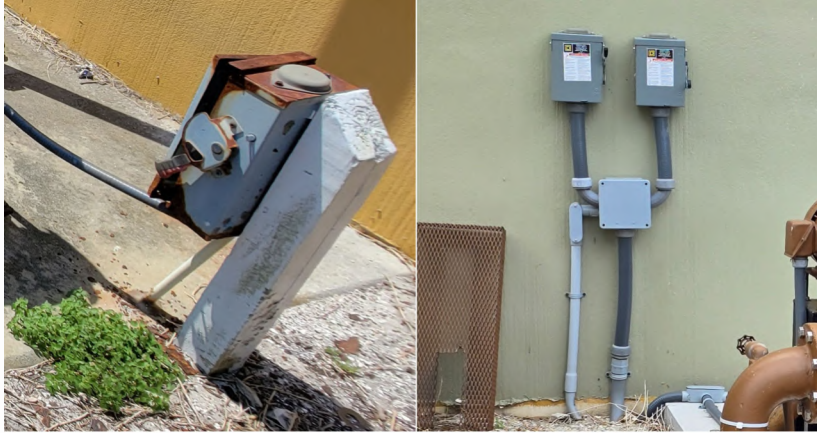
18 Throughout the Aquarina wastewater facility, various electrical and control  
19 panels are in poor condition, risking electrical failures, operator injury, and interruption  
20 in proper operation of treatment equipment. CSWR Florida is working to replace  
21 damaged panels, where appropriate as improvement projects are undertaken, as seen in

4  
5 *Example of power supply replacement for RAS/WAS pumps.*

1 the electrical service replacement to the RAS/WAS pumping system, which is shown  
2 below. Some electrical and control systems will also require improvement to handle  
3 new or upgraded replacement equipment.

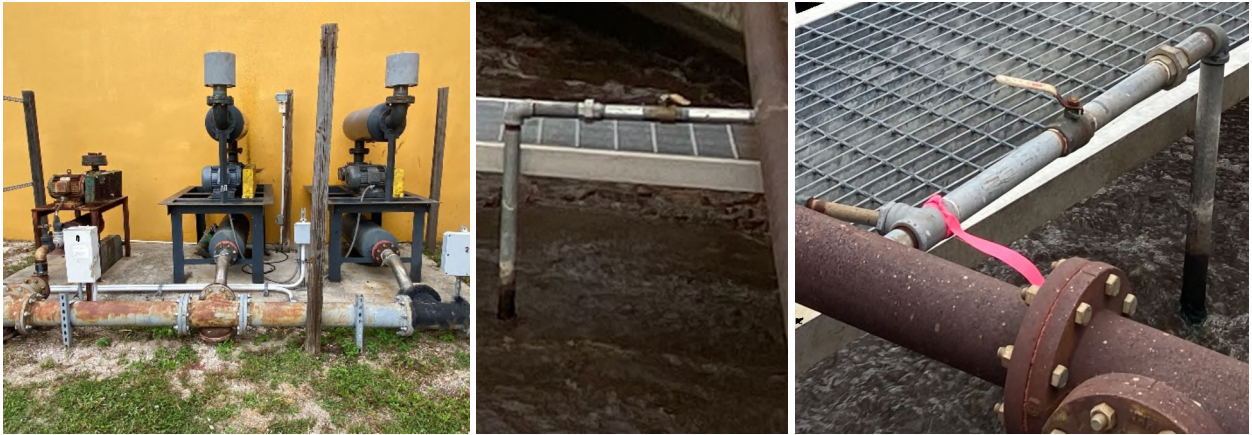
17 state of poor repair. Leaking pipes and poor aeration diffusion negatively affects  
18 treatment efficacy by reducing air delivered to the aeration basins. Aeration piping and  
19 diffusers will be repaired or replaced, as appropriate, to ensure proper treatment can

3 *Aging blowers in need of replacement (left) examples of aeration piping with rust on aeration*  
4 *headers, at water level, fittings and valves resulting in air leaks (center and right)*

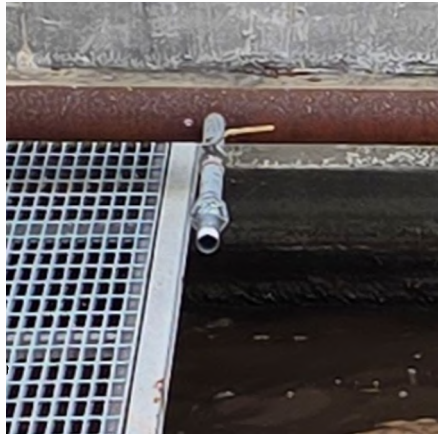
6 *Aeration piping with missing drop pipe indicating section of aeration basin not being*  
7 *aerated.*

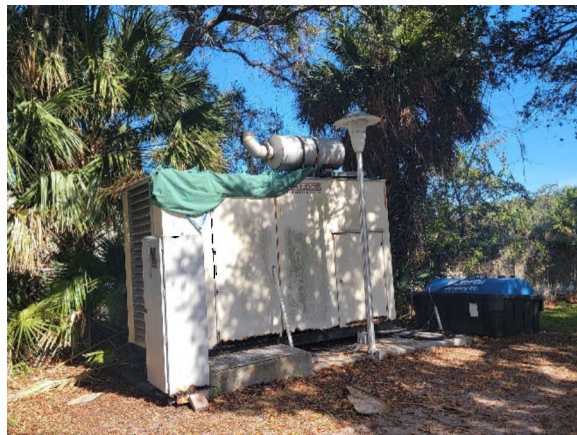
*Old generator shared by water and wastewater site which has reached the end of useful life.*

The irrigation pumping system is also aging and its pumps should be replaced to ensure proper function moving forward. General site improvements will also continue at the wastewater treatment site, including ongoing wastewater and aeration piping replacements as leaks or damage is identified, some remaining fencing repairs, access improvements, and housekeeping improvements. Miscellaneous repairs and improvements are also being completed in the collection system as leaking or damaged collection mains are identified and replaced. Finally, the generator supplying emergency power for the water and wastewater sites has reached the end of its useful life and will require replacement.

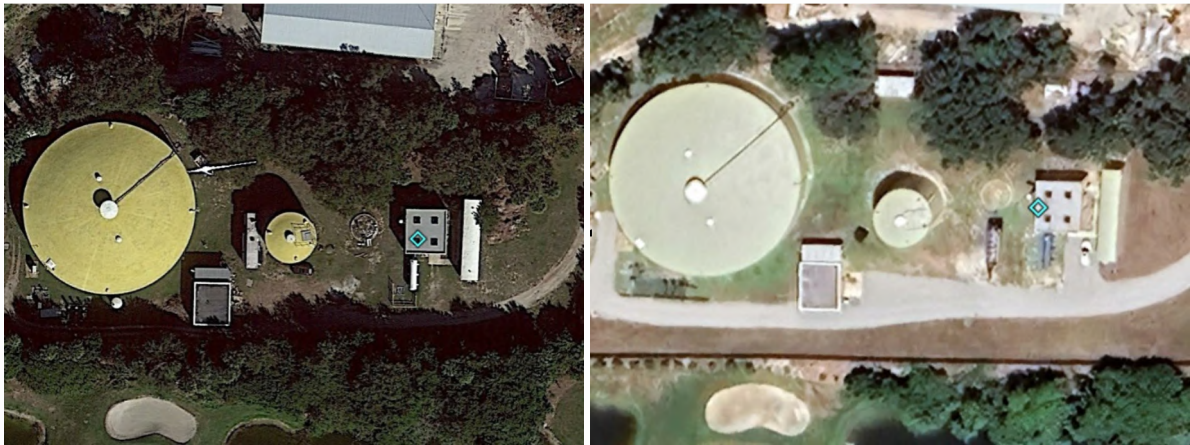
*Aerial view of the Aquarina water system at acquisition (left) and currently (right). Note recoated tanks, cleared vegetation and debris, new access roads, and temporary hydro-pneumatic tank on site.*

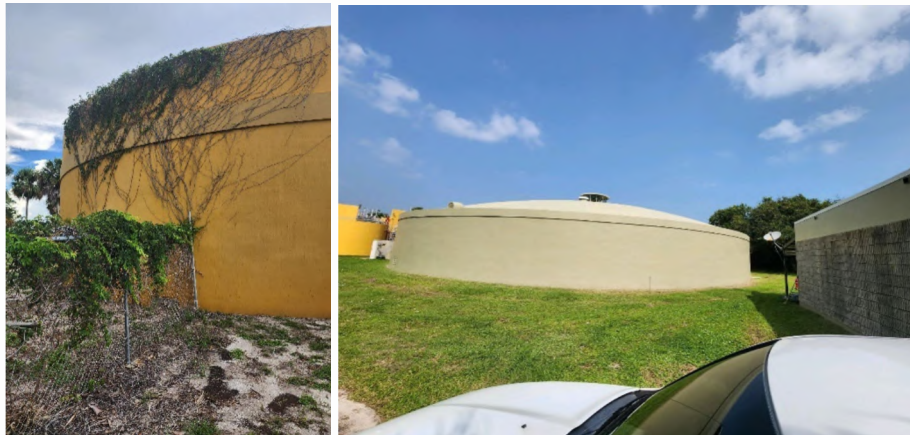
11  
12 *Irrigation and Fire Control Ground Storage tank before (left) and after (right) before and*  
13 *after inspection and recoating, note vegetation overgrowth removed from tank.*

1 tank and a separate potable water tank) were recoated to extend their useful lives, and  
2 the trash, debris, and vegetation overgrowth were removed from in and around the site.  
3 The hydropneumatic tank was inspected during the sand blasting and recoating process  
4 and multiple leaks were identified. CSWR Florida determined the hydropneumatic  
5 tank should therefore be removed from service and replaced. A temporary tank has  
6 been placed on site to maintain system pressure until the replacement tank can be  
7 designed, permitted, bid out, and installed.

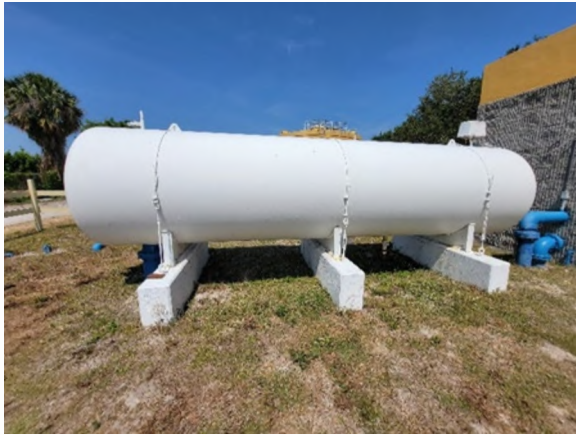
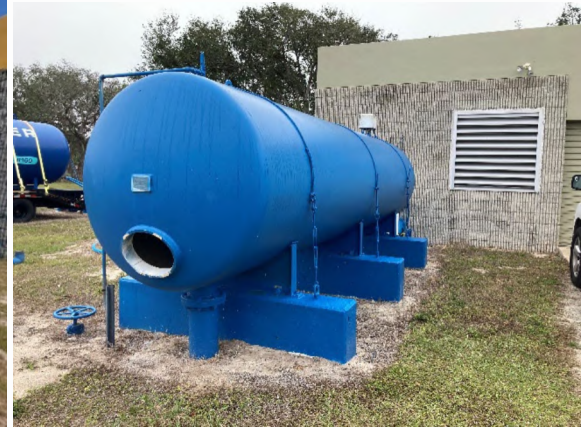
- Tanks were overdue for full interior and exterior inspection and evaluation for potential repairs and replacements. Inspection and recoating work revealed the hydropneumatic tank and many pinhole leaks and would need to be replaced,
- The system lacked remote monitoring and proper telemetry between system components for proper operational control,
- The distribution flow meter was damaged,
- The system lacked chlorine residual monitoring,
- Three fire hydrants were out of service,
- Well flow meters had reached end of their useful lives,
- Fencing was damaged around both the water and wastewater sites.

1  
2 *Hydro-pneumatic tank before (left) and after (right) exterior recoating, inspection for interior*  
3 *recoating halted improvements on tank when numerous pinhole leaks were identified, and*  
4 *tank was removed from service.*

**A.** Further improvements planned for the Aquarina water system include repairs and improvements to the distribution system. These include installation, repair, or replacement of isolation valves; replacing damaged mains; and installation, repair, or replacement of flushing hydrants. In addition, as I previously testified the facility's hydropneumatic tank was significantly rusted on both its interior and exterior leaks were noted during CSWR Florida's inspection, cleaning, and recoating efforts. As a result, we determined the tank would require replacement to prevent possible

1 contamination, service interruptions, or damage that would be caused if the tank failed  
2 catastrophically a (hydropneumatic tanks can explode). A temporary tank has been  
3 placed on site and a new permanent tank will be installed in the future. Finally, the  
4 generator supplying emergency power for the water and wastewater facility, which has  
5 reached the end of its useful life, will require replacement.

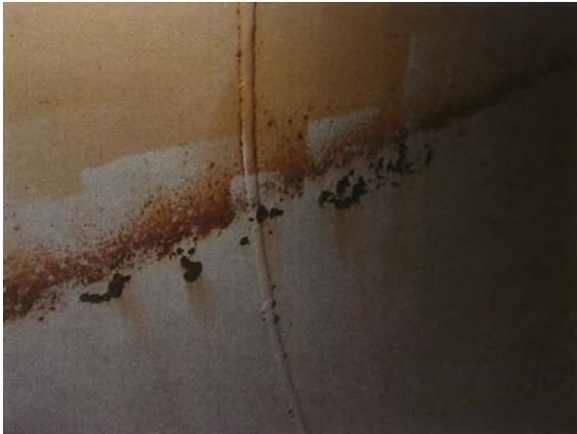
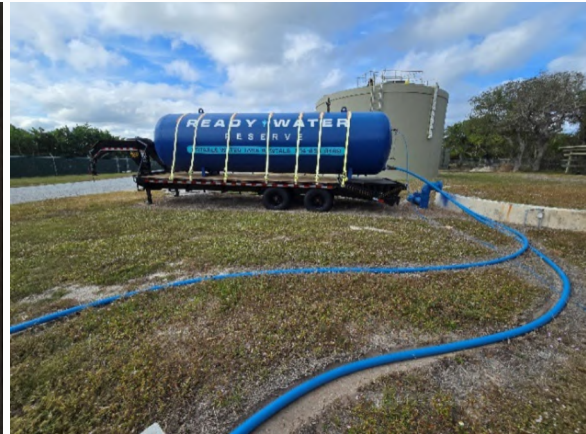
5  
6 *Example of pinhole leaks along waterline on interior (left) and temporary tank brought in to*  
7 *maintain service till tank replacement can be completed (right).*

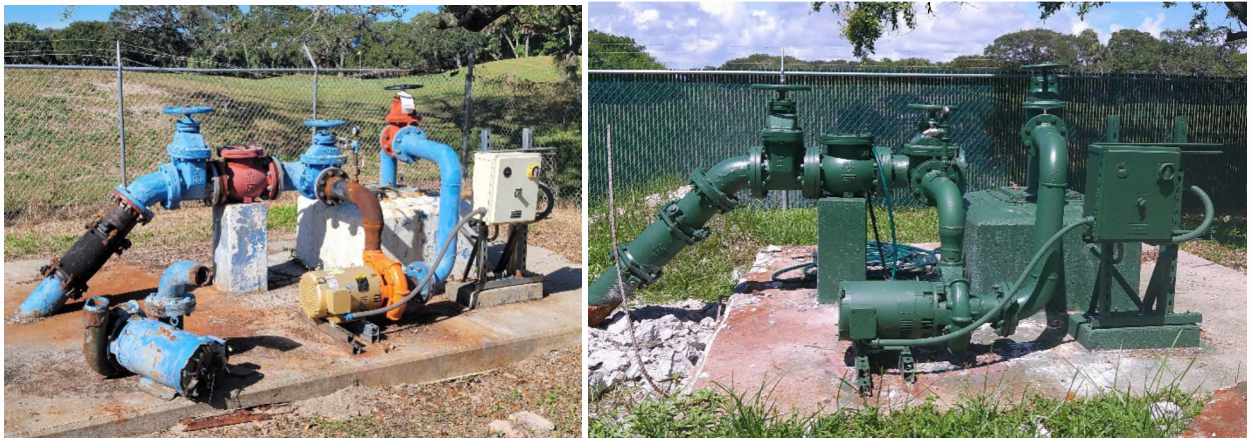
*Example of before (left) and after (right) repainting of above ground piping and equipment.*

8 In addition to recoating tanks, all exposed above ground piping at the treatment  
9 and well sites were recoated to extend their useful lives. Deteriorating coatings on  
10 piping can lead to accelerated deterioration and corrosion resulting in leaks and need  
11 for piping and equipment replacement. Where piping was damaged, segments were  
12 replaced.

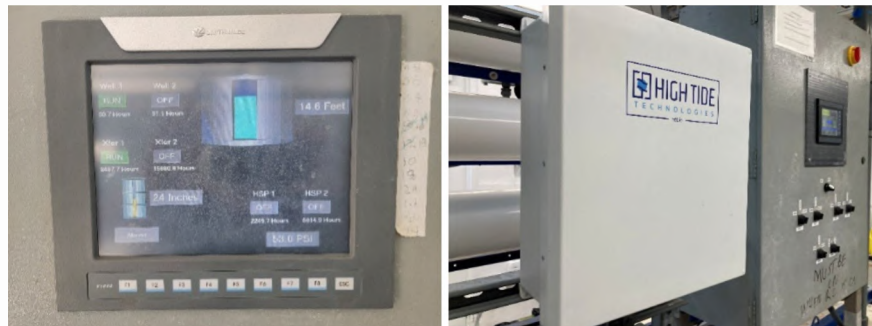
*Telemetry with tank levels (left) and new remote monitoring equipment (right).*

Various improvements have also been made to the electrical and monitoring systems at the Aquarina water system. This includes installing new flow meters for the wells and the distribution system, improving telemetry between tank monitoring equipment and control systems, and installation of remote monitoring equipment.

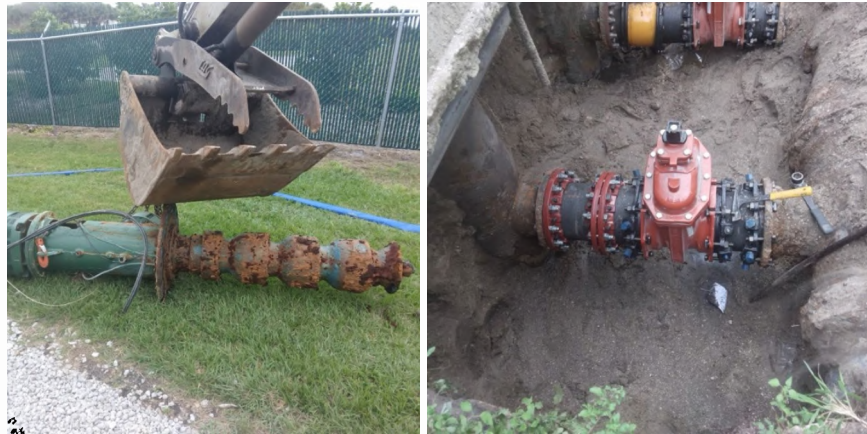
5  
6 *Rusted high pressure fire protection valves (left) removed and new valves installed (right)*

In addition to improvements to water production and treatment equipment, various improvements have been made to the distribution system and overall utility site. Three out of service fire hydrants have been replaced to ensure all areas can be served by the fire protection system. Additionally, CSWR Florida's evaluation of the high-pressure valves for the fire protection system showed they were severely corroded. The valves have been replaced to ensure adequate pressure can be provided in the fire protection system. Various line leaks and breaks also have been addressed

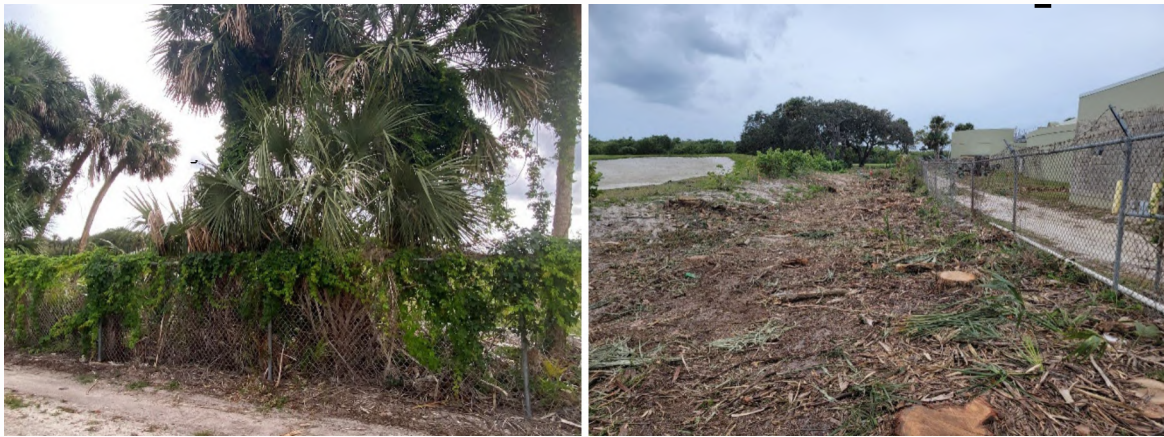
*Clearing of vegetation from facility fence line*
