**BEFORE THE FLORIDA PUBLIC SERVICE COMMISSION**

| wastewater rates in Brevard, Citrus, Duval, | ) | DOCKET NO. 20250052-WS |

**DIRECT TESTIMONY OF**

**JACOB FREEMAN**

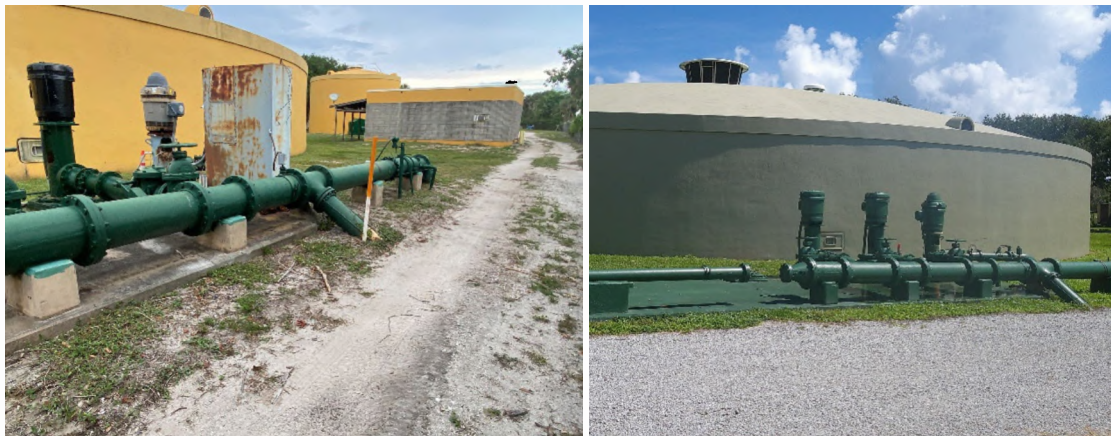
*Before (left) and after (right) access road improvements and piping and equipment recoating.*

1 to reduce water losses and eliminate areas vulnerable to contamination. Additional site  
2 improvements include rehabilitating the access roads, removing trash, debris, and  
3 nuisance vegetation from fence lines and throughout the site, and making repairs to site  
4 fencing throughout the water and wastewater portions of the utility site.

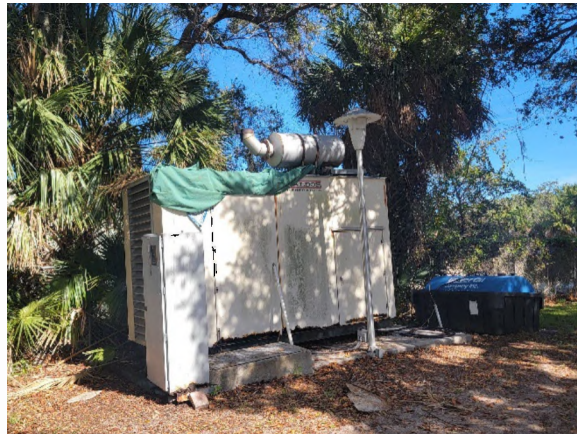
6  
7 *Old generator shared by water and wastewater site which has reached the end of useful life.*

1 contamination, service interruptions, or damage that would be caused if the tank failed  
2 catastrophically a (hydropneumatic tanks can explode). A temporary tank has been  
3 placed on site and a new permanent tank will be installed in the future. Finally, the  
4 generator supplying emergency power for the water and wastewater facility, which has  
5 reached the end of its useful life, will require replacement.

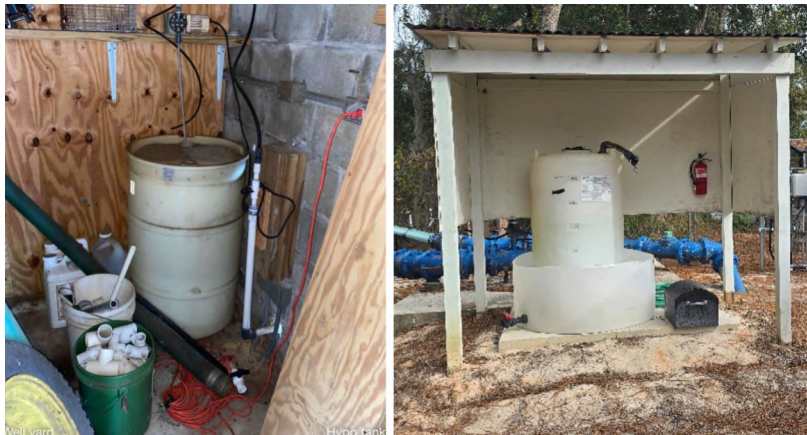
12  
13 *Disinfection system before (left) and after (right) improvement.*

4 A. Various improvements have been completed to date at the Tradewinds drinking water  
5 system. First, improvements were made to the disinfection system. At acquisition, the  
6 system consisted of a single 55-gallon drum with a feed pump located in the corner of  
7 a room full of trash and spare materials. Access to the drum was difficult and no spill  
8 protection was present. Additionally, there was no venting in the room to remove  
9 chlorine gas. A new pad and shade structure were installed outside the structure and a  
10 new drum with spill protection were installed to provide better access, better  
11 ventilation, and spill containment for the disinfection system.

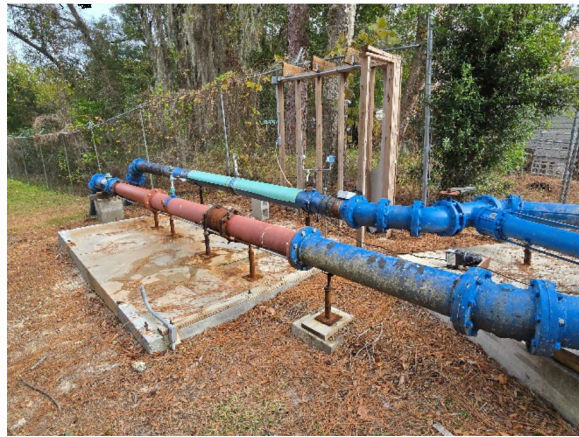
*Replaced segment of above ground piping*

14 At acquisition, the elevated storage tank needed evaluation to determine  
15 necessary long-term repairs to the tank. To evaluate the tank, it was power-washed and  
16 an engineering inspection was completed. A damaged section of above ground piping  
17 running from the primary well to the elevated storage tank has also been replaced.

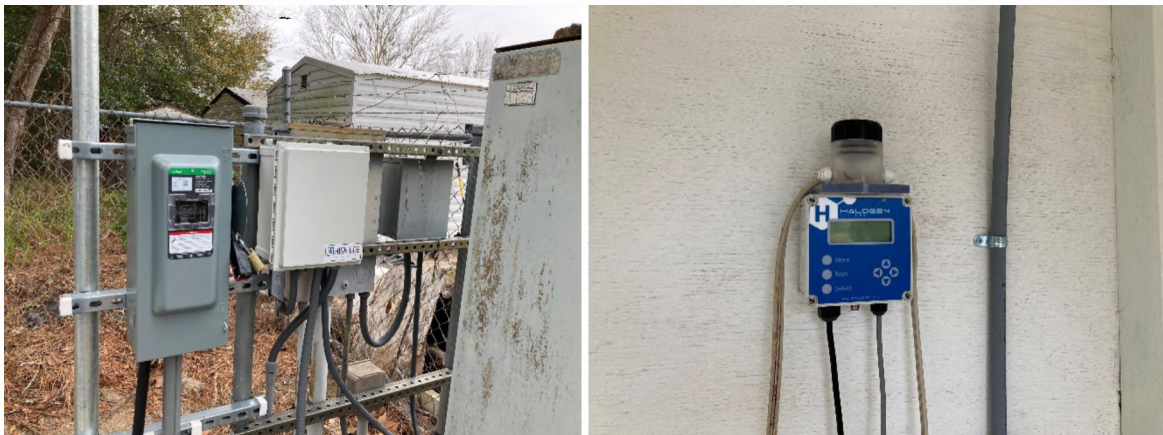
*New remote monitoring equipment (left) and new chlorine residual monitoring (right)*

No remote monitoring system was present at the time CSWR Florida acquired the system and the existing flow meters were in poor condition and could not communicate with a remote monitoring system. Remote monitoring equipment was installed along with new flow meters that can connect to the remote monitoring equipment. With the installation of the remote monitoring equipment, a continuous chlorine analyzer was also installed. These analyzers actively monitor to ensure that adequate chlorine residual is maintained in drinking water to prevent bacteriological contamination issues in the drinking water and reduce manual testing requirements.

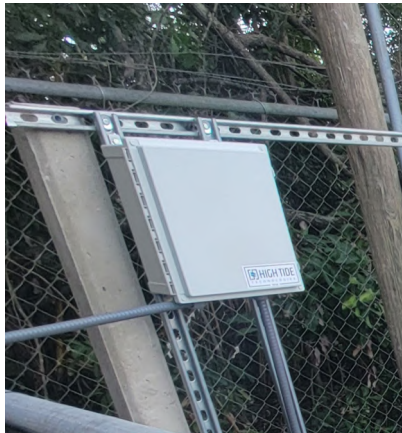
12  
13 *Example of remote monitoring units installed at all lift stations.*

3 A. The primary improvement completed to date at the Tradewinds wastewater system has  
4 been the installation of remote monitoring equipment at each lift station. As I noted  
5 earlier in my testimony, remote monitoring equipment allows live collection of data,  
6 providing continuous information on system performance and equipment status over  
7 time allowing for more precise and efficient operations, and providing operations staff  
8 with real-time information concerning system performance and equipment status. This  
9 allows for immediate identification of abnormal operating conditions and emergencies,  
10 often enabling operations staff to respond to and address problems before they can  
11 result in service interruptions.

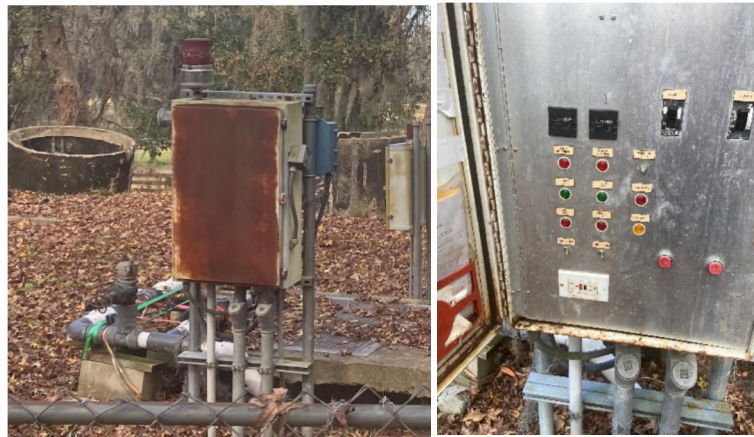
5 One of the lift stations has a control panel in poor condition with rust on the  
6 weatherproof box. This control panel and box will be replaced.

7  
8 *Damaged lift station control box.*

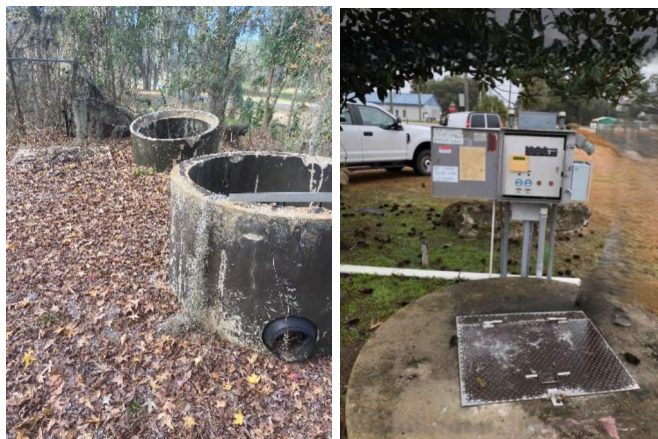
11  
12 *Damaged unused manhole rings, trash, and vegetation overgrowth at Tradewinds lift station*  
13 *site, including vegetation causing fence damage (left). Tradewinds lift station lacking*  
14 *fencing (right).*

1 mobile pump to be connected to the lift station for operation when pumps malfunction  
2 and during power outages. The discharge piping at this lift station is also in poor  
3 condition and will be replaced and bypass piping will be installed. In addition, many  
4 of the lift station sites have significant accumulation of trash, debris, discarded  
5 equipment and materials, and nuisance vegetation around the sites and site perimeters.  
6 These materials can cause damage to fencing and equipment and pose operational  
7 obstacles and hazards to operations staff. These materials are being removed from the  
8 sites. Finally, all the older lift stations have issues with fencing, either lacking fencing  
9 entirely or having areas with damaged fencing, which create issues with site security.  
10 CSWR Florida will install, repair, or replace fencing where necessary.

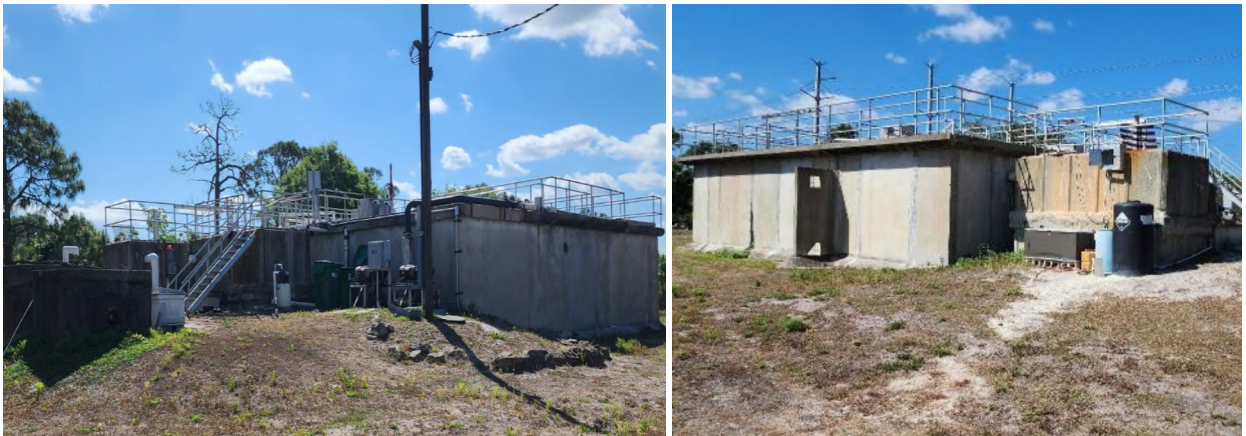
*Ground level views of the Sun Lake Estates wastewater treatment facility at acquisition.*

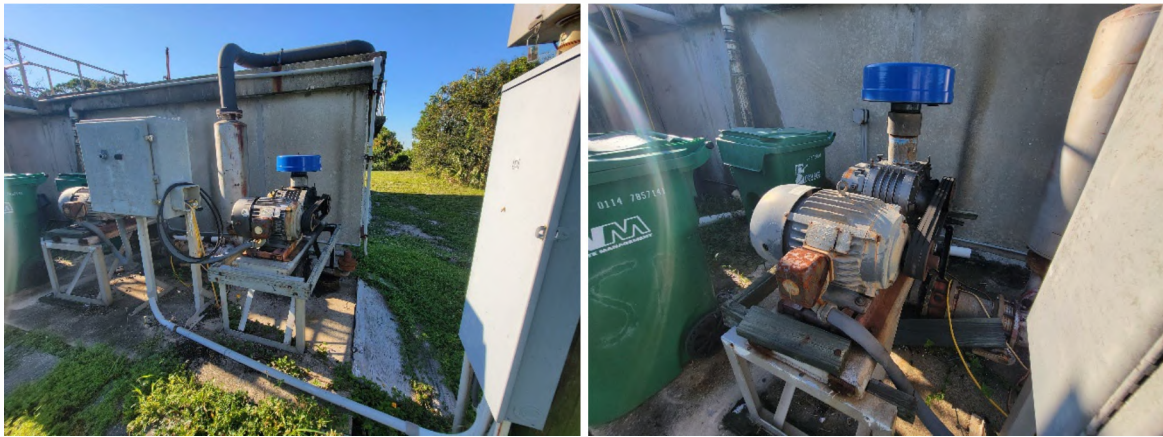
*Blowers at acquisition with poor condition motors, no belt shrouds or covers.*

10 A. At acquisition, the blower motors and blower control panel were reaching the end of  
11 their useful lives, and the blowers lacked belt shrouds and covers. Well-functioning  
12 blower motors ensure full power is delivered to the aeration system. Belt shrouds  
13 prevent debris from snagging in belts, which can prevent damage, and ensure operator  
14 safety. Shade covers protect the blowers from overheating and the elements and reduce  
15 ambient sound from the blower operation. These benefits extend the useful lives of the  
16 blowers and reduce the likelihood of noise complaints. A shade structure has been  
17 installed over the blowers to reduce overheating and protect the blowers from the  
18 elements, blower motors and control panel have been replaced, and belt shrouds and  
19 blower covers are in the process of being installed.

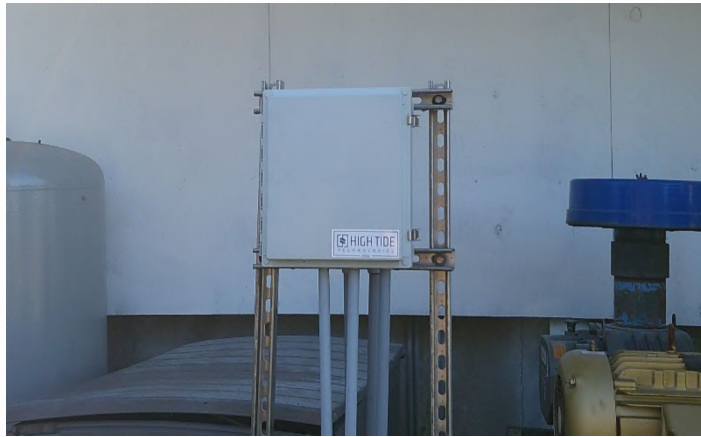
2 *New remote monitoring units are installed at treatment facility and l.ft station.*

10 No remote monitoring equipment was installed at the treatment plant or lift  
11 station at the time of acquisition, and no active flow monitoring equipment was present  
12 at the treatment plant. CSWR Florida has installed remote monitoring equipment at  
13 the treatment plant and the lift station. A new flow meter has also been installed to  
14 allow for active measurement of flow through the remote monitoring system. This  
15 included adding a weir plate and ultrasonic flow meter to the chlorine contact chamber.

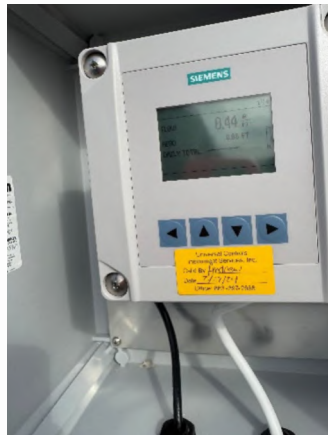
5 *New ultrasonic flow meter was installed in chlorine contact chamber. Top Left: contact*  
 6 *chamber pit with ultrasonic meter pointed at water surface, Top Right: weir plate allowing*  
 7 *for water level to be calibrated for flow rate, Bottom: meter controller.*

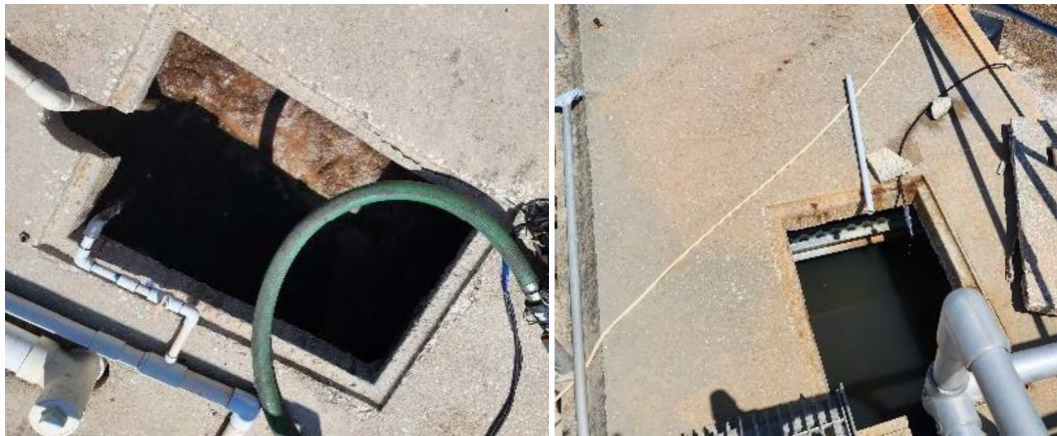
9 Some of the handrails around the facility treatment basins were loose to the touch and

1 offered little or no support; some of the handrails were installed at a lower than ideal  
2 height, which created the potential for falling over the rails and making them difficult  
3 to grab for support; and the digester and chlorine contact basins lacked covers, which  
4 created open leading edges where an operator could fall into a basin. The handrails  
5 have been secured, and handrail heights have been adjusted where necessary. Where  
6 it was possible to locate the covers for the uncovered basins, they were placed back  
7 over the open basins. Where covers were missing, new covers were fabricated and  
8 installed to ensure operator safety.

*Missing covers on basins posing hazard to operations staff.*

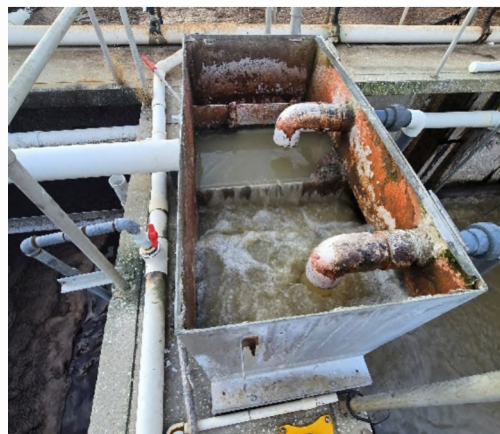
1                   *Condition of splitter box. Note interior rust and corrosion.*

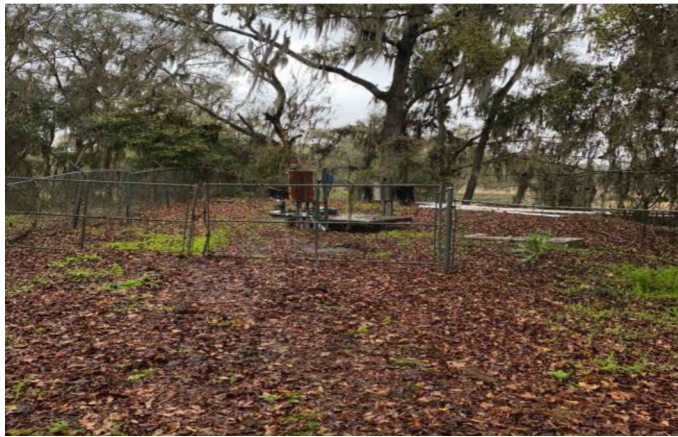
*Sandlin Woods Main Lift Station at the time of acquisition*

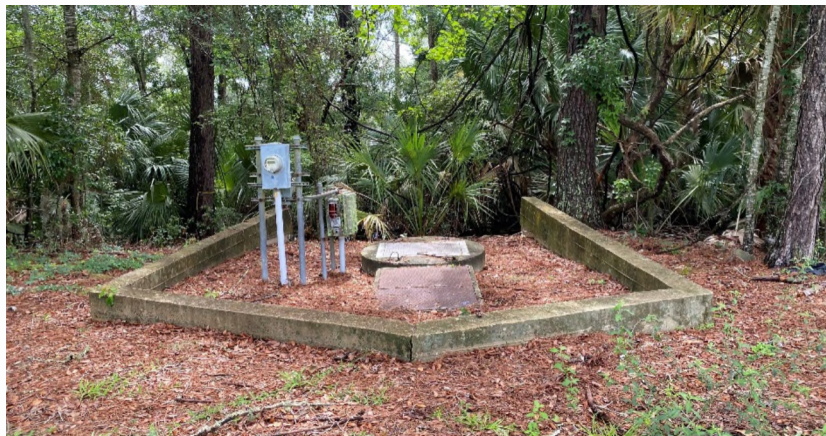
*security fencing.*

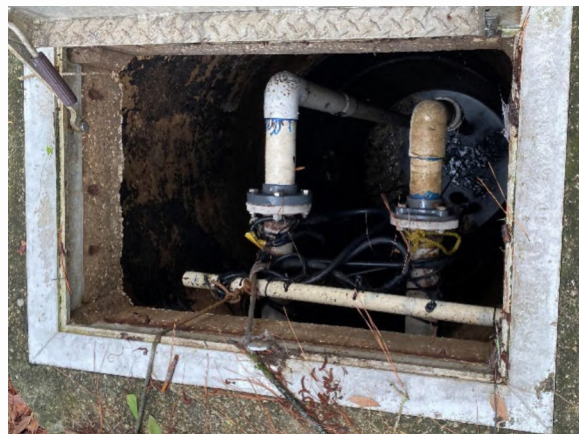
13  
14 *Note example of lack of guide rail lifting system for pump maintenance in the Sandlin Woods*  
15 *lift stations.*

1 the facilities are in a safe and operable condition, and to ensure the facilities can be  
2 maintained moving forward. All three lift stations require some common  
3 improvements. First, none of the lift stations included the means to connect an  
4 emergency generator. Being able to connect a generator allows lift stations to be  
5 operated during power failures with enough frequency to prevent service interruptions,  
6 backups, or overflows. None of the lift stations included guide rails for servicing lift  
7 station pumps. Rails make it safer and easier to lift pumps for service and help to  
8 extend the useful life of the pumps. Finally, the pumps in the lift stations were  
9 approaching the end of useful lives and no service records were available to enable  
10 CSWR Florida to determine if proper pump maintenance had been completed under  
11 previous ownership. To ensure the pumps are in good operable condition for the future,

12 all pumps have been slated for replacement.
