Title: Siemens Stator Ground Fault Report

## **ROOT CAUSE ANALYSIS – STATOR GROUND FAULT – ST. LUCIE NUCLEAR PLANT UNIT 1 GENERATOR**

**Michael Garmon  
Generator Service Engineering  
PG PR R&D GN GNS TIAM  
Orlando, FL.**

**August 23, 2019**

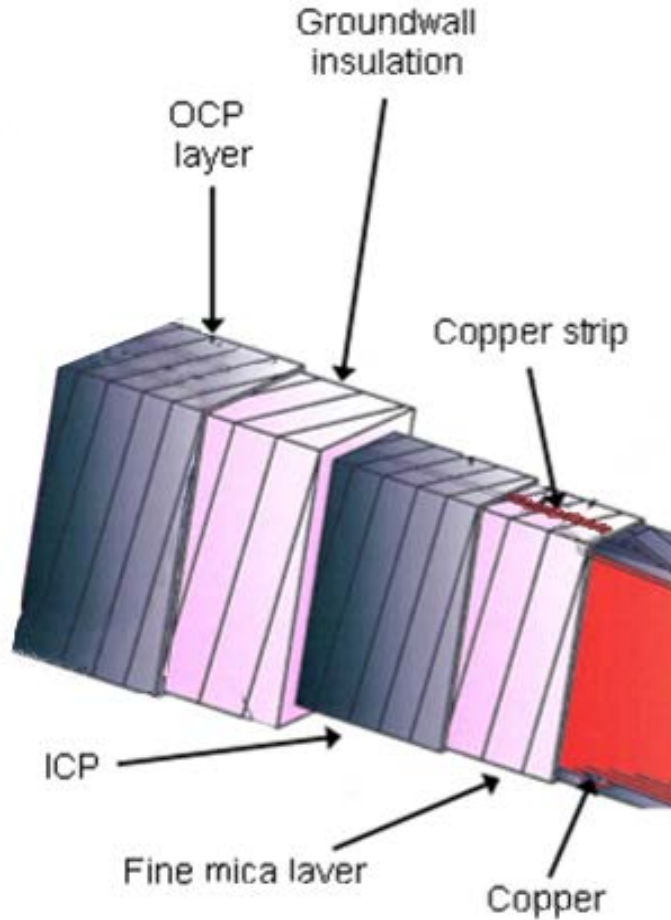
The St. Lucie Unit 1 stator winding configuration has an internal corona protection (ICP) system with a copper strip that runs along a semi-conductive tape that is applied to the stator bar before the ground wall insulation. This copper strip is connected to the copper strands near the turbine end (TE) side of the bar. See Figure 4 for an example bar insulation illustration.

The copper strip was electrically isolated from the copper strands, and it was determined that the fault through the stator winding insulation was from the outer corona protection (OCP) to the ICP. The copper strand bundle was concluded as not part of the fault.

**Figure 4. Stator Bar Insulation Example Illustration**

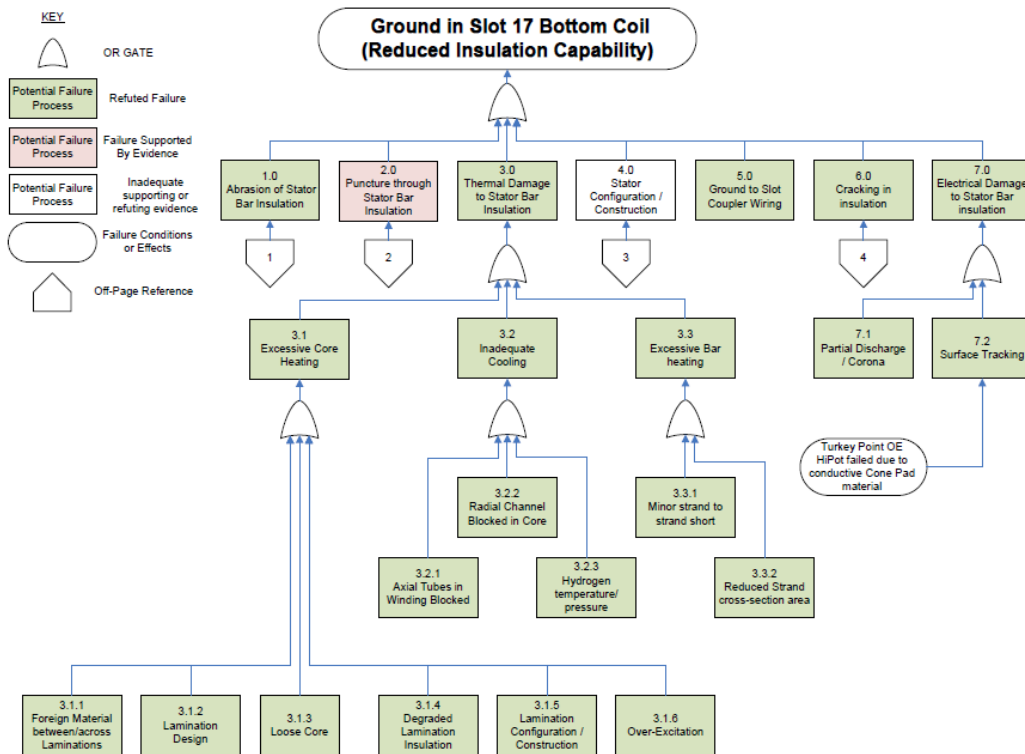
A fault tree considering potential hypothetical causes of a stator ground fault was used to guide the analysis. Seven secondary level elements were hypothesized, including thermal damage, insulation cracking, electrical damage, and material issues. By investigating the tertiary and lower level elements below each secondary element, the hypothetical potential causes were assigned as a probable root cause, contributor, or not a contributor. The fault tree is shown in detail in Appendix A.

Figure 11. Fault Tree

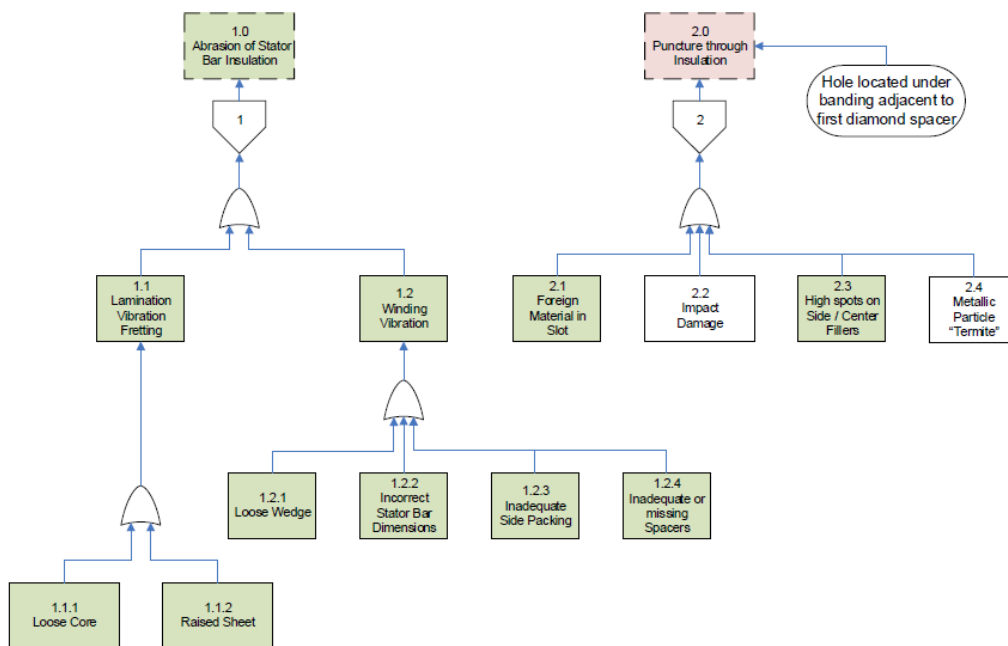
Figure 12. Fault Tree Hypotheticals, Continued

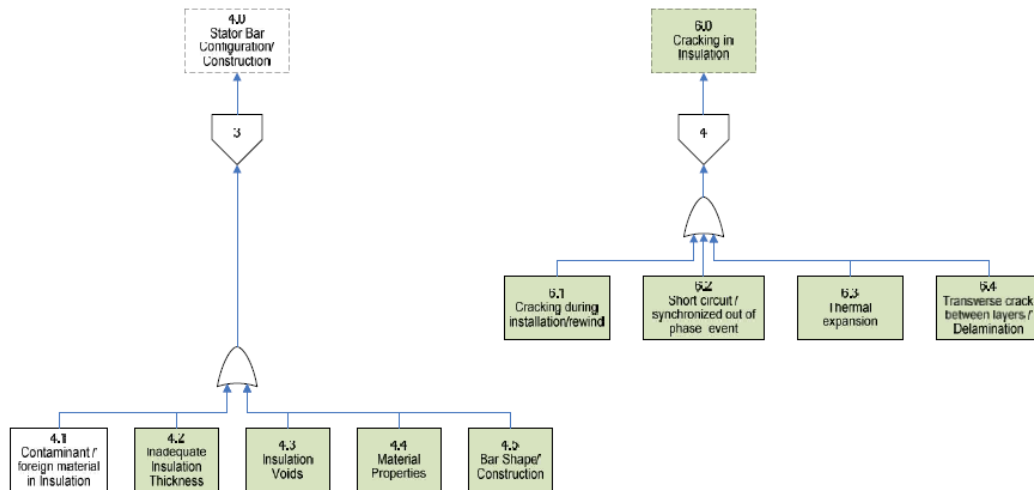
**Figure 13. Fault Tree Hypotheticals, Continued**
