DESCRIPTION: Late filed deposition Exhibit No. 4

DOCUMENTS: Panel deposition of Jeffrey Swartz, Anthony Salvarezza and C. Wayne Toms, August 30, 2019.

BRR 4S L-O Background

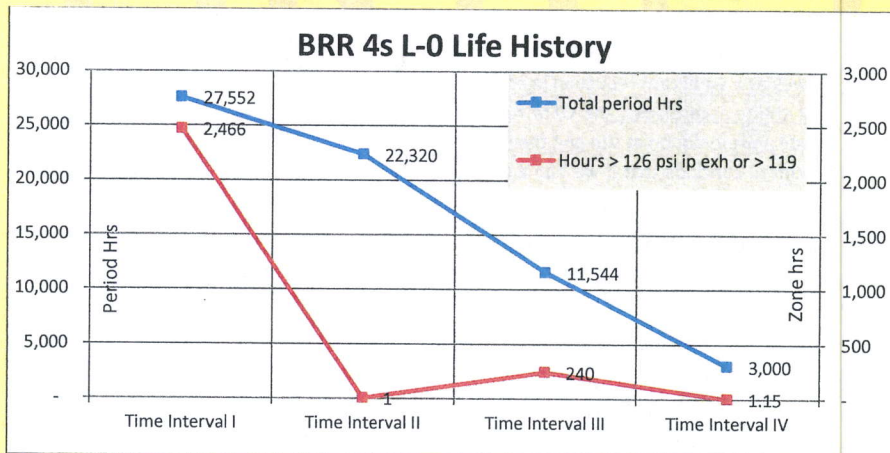
Inspection of the data reveal that the original design in time intervals 1 and 2 only had the mid-span snubber failure of the original turbine end (TE) blades – and the 1st time interval nearly 2500 hours of operation was above the OEM limit. In time interval 2, no failures occurred and there was only 1 hours of operation slightly above the limit. This means that the generator end (GE) blades ran nearly 50,000 hours with no failures.

This is in contrast to time interval 3 where failures occurred after only 11.5 khrs of operation with only 240 hours above the original limit – and interval 4 with only 3 khrs of operation and just over only 1 hour above the original flow limit. The data clearly suggest that returning to the original design, and limiting the IP exhaust pressure to 123 psig (not sure I'm reading that right off the graph), which will give approximately 400 to 405 MW with 4x1 operation, will give much more acceptable life than the modified design.

For these reasons the recommended direction on the current repair (fall 2016) is to return to the original blade design (no hard facing) with reasonable operational restrictions on steam flows and pressure limits. These restrictions need to be part of the control logic and not an operator or supervision option to interpret.

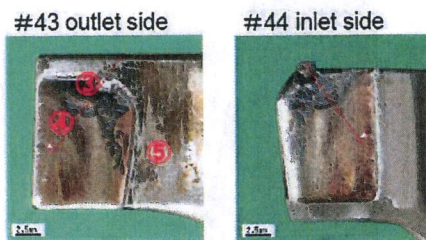
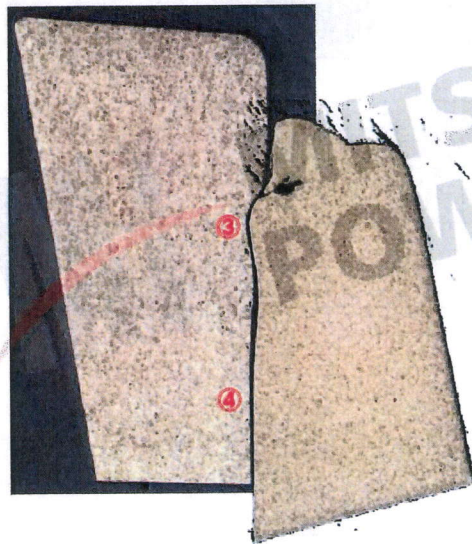
Metallurgical Evaluation of Blades

- Fine cracks, caused by fretting fatigue, are found near the end of contact part with local deformation of inlet side of #44 blade.

Fretting fatigue identified as crack initiation source.

Microscopic observation was performed on the same sections in contact condition for each of outlet side of #43 blade and inlet side of #44 blade.

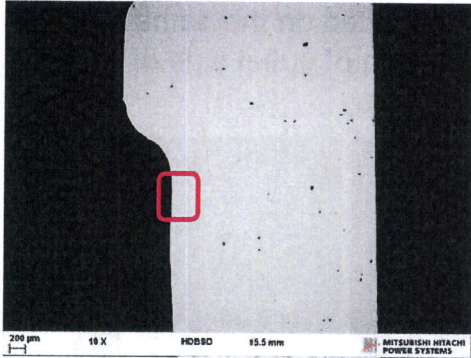
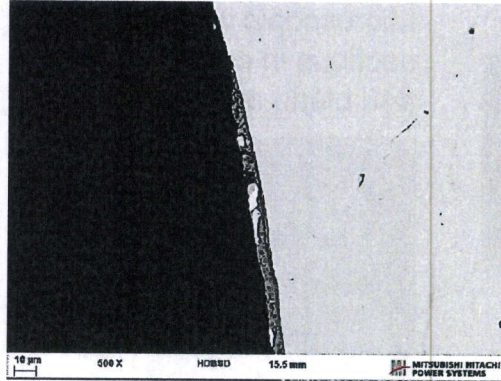
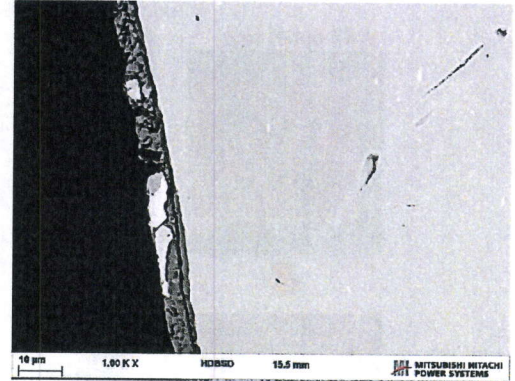
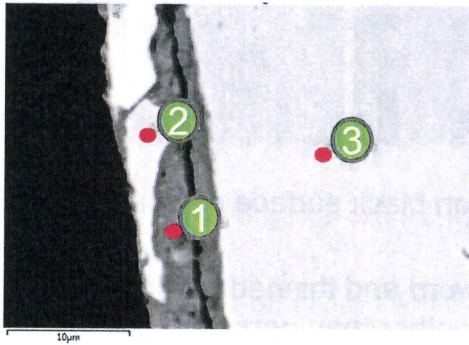
Metallurgical Evaluation of Blades

Location	Semi-Qualitative EDS analysis of elements detected (wt%)							
	O	Si	Cr	Mn	Fe	Ni	Cu	Nb
1	25.97	0.44	7.67	0.41	61.59	1.84	1.18	0.00
2	0	0.35	18.15	0.95	70.12	9.35	0.08	1.00
3	0	0.33	15.86	0.54	73.65	4.91	3.58	1.14

- Oxidation/corrosion was observed on the trailing edge contact surface of the tip shroud.
- Material removal from wear is from abrasion.

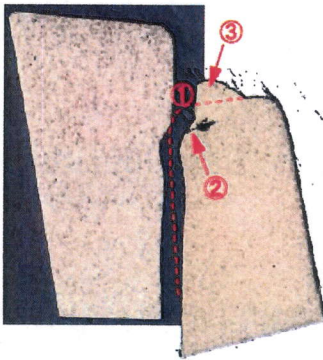
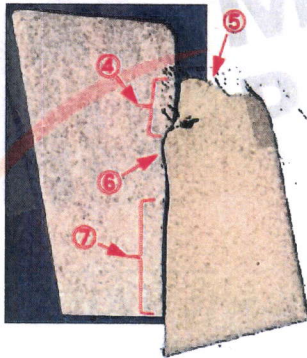
Images of initial contact conditions

① Partial local contact at the top and tip of blade

② Fretting fatigue crack generated in local area

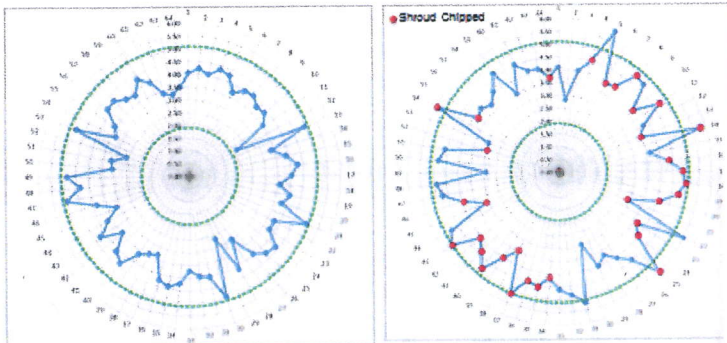
2014 Blade LH (Gov. End) Shroud Gap Data

Shroud Gap Data in 2014 **Assembly**Shroud Gap Data in 2016 **Dis-Assem****Row Average Gap = 3.9mm****Row Average Gap = 4.2mm**

Criteria: Shroud 1.9mm to 5.1mm Average, with no single blade above 6.0mm.

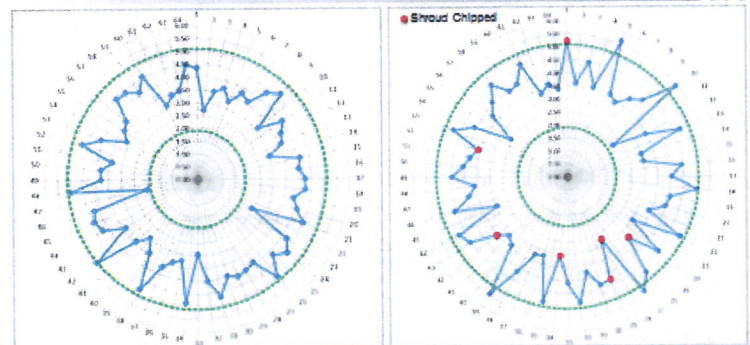
2014 Blade RH (Gen. End) Shroud Gap Data

Shroud Gap Data in 2014 **Assembly**Shroud Gap Data in 2016 **Dis-Assembly****Row Average Gap = 3.9mm****Row Average Gap = 4.0mm**

Criteria: Shroud 1.9mm to 5.1mm Average, with no single blade above 6.0mm.

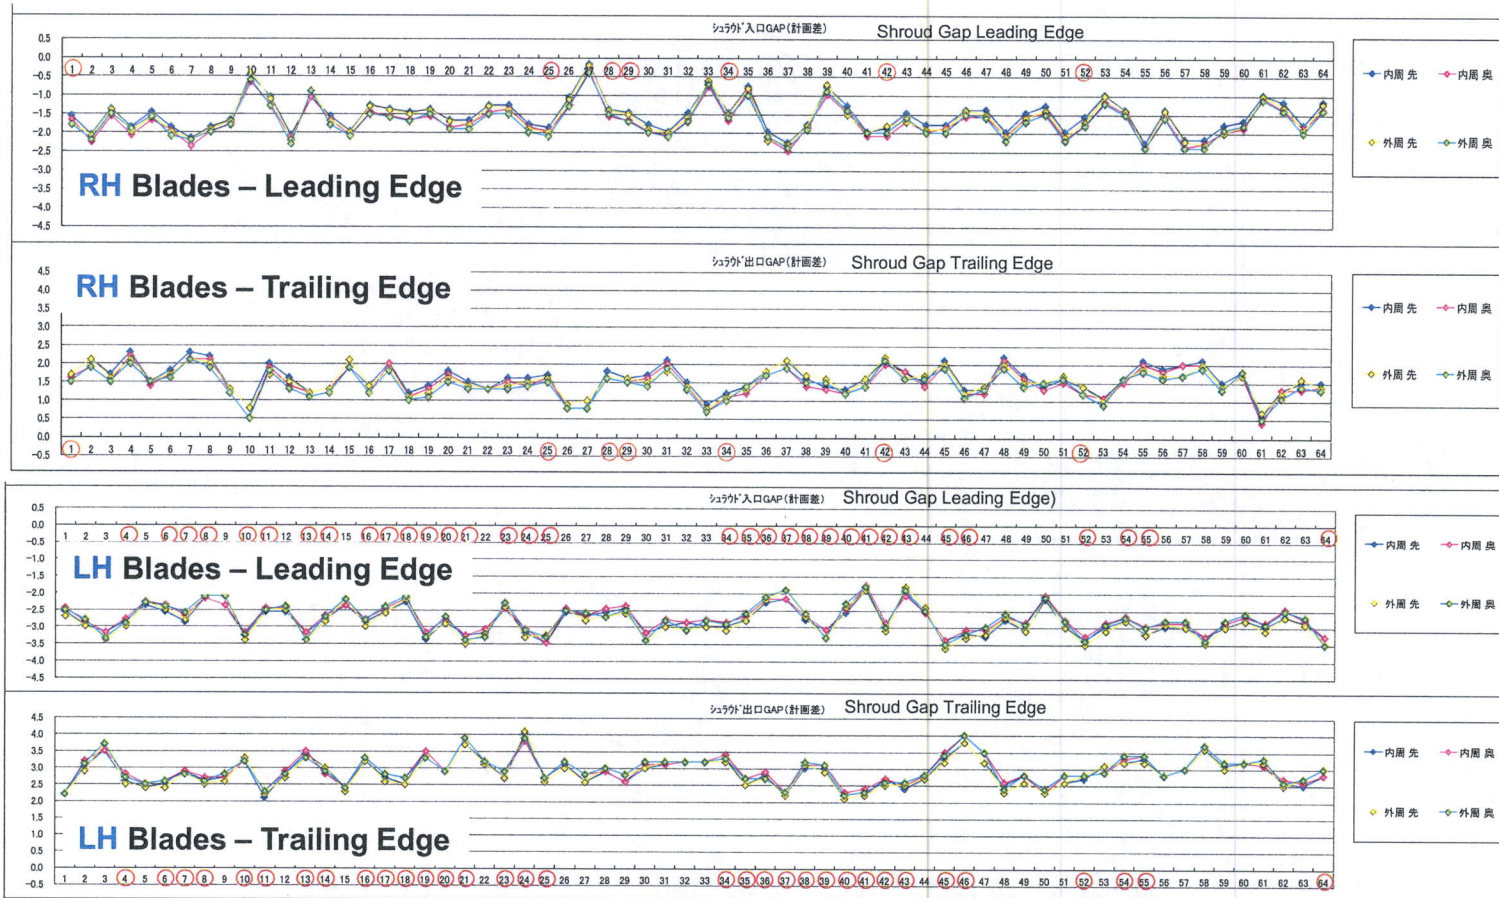
Box Gauge Measurement Results - 2014 blades

Blade manufacturing data show variation within criteria

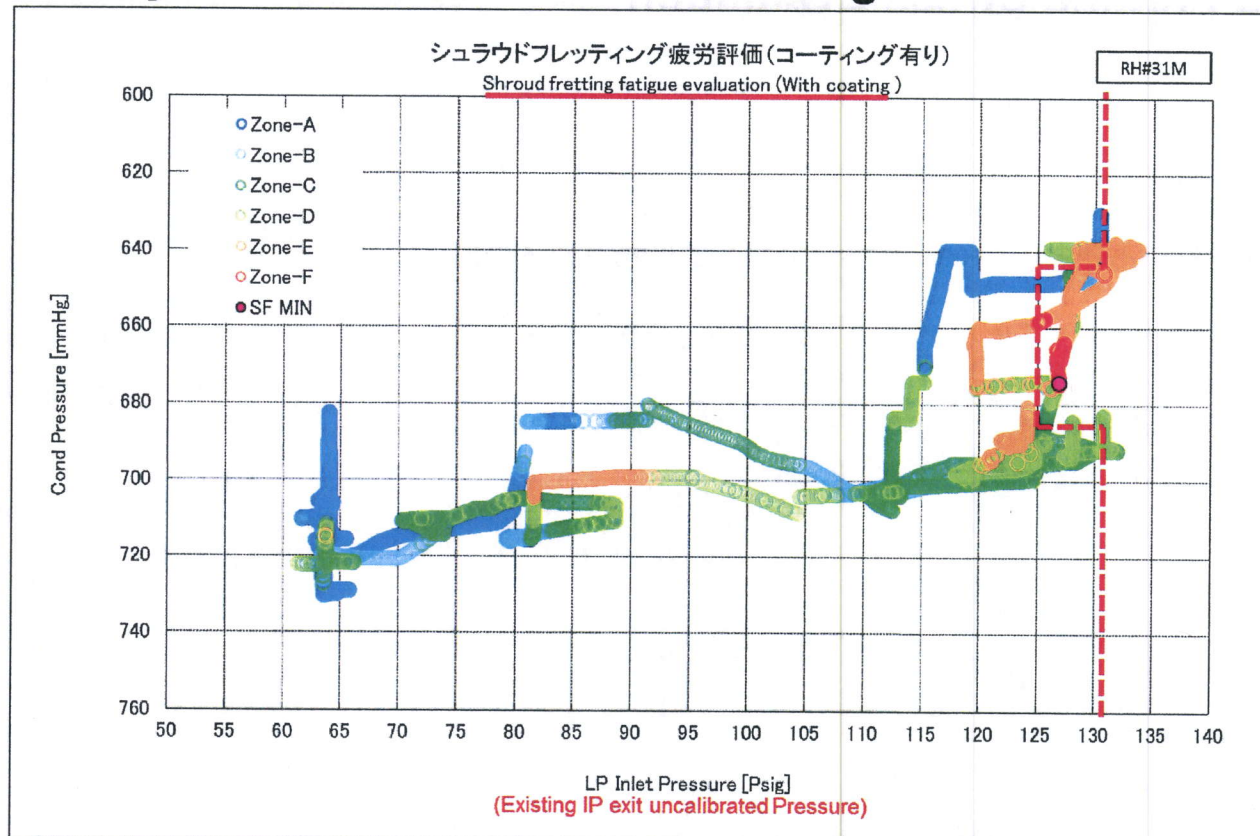
Telemetry Test Results – Shroud Fretting

Fretting fatigue calculations for shroud with coating show acceptable margins outside avoidance zone

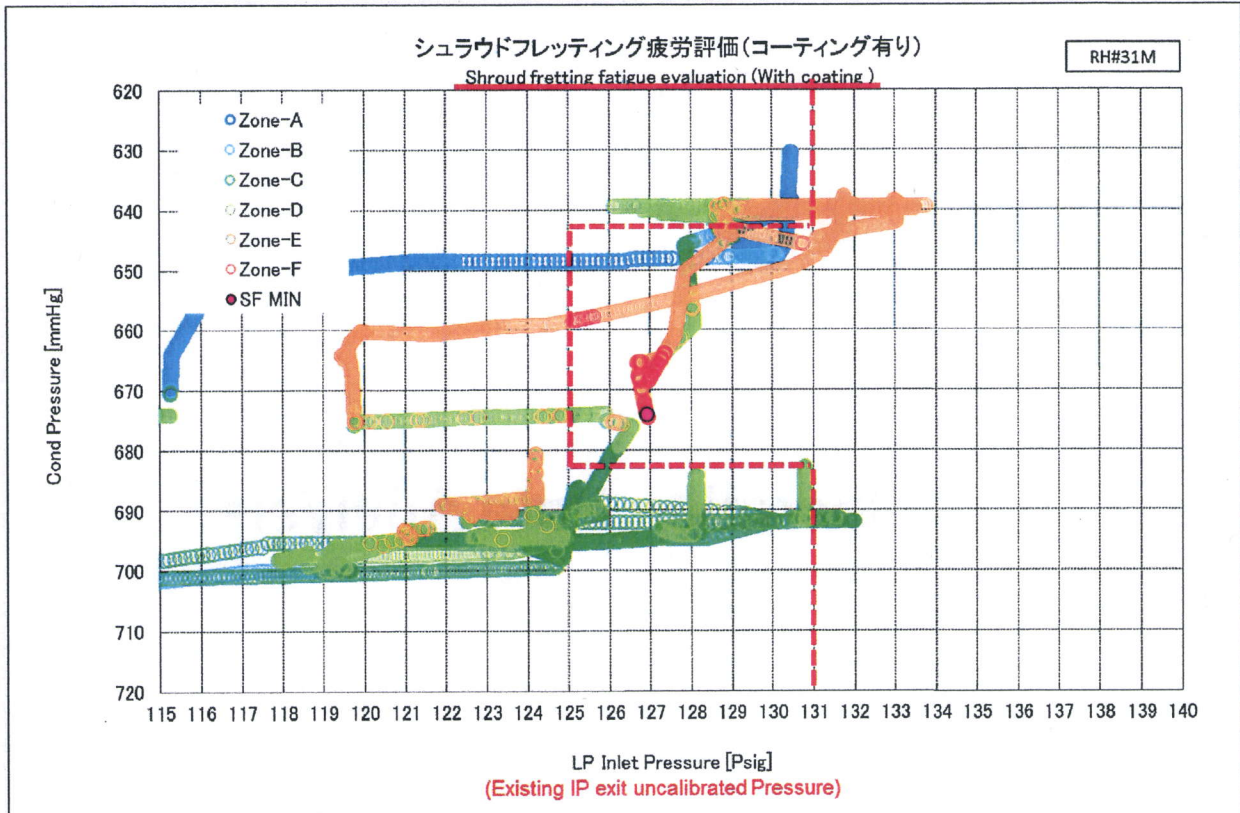
Telemetry Test Data – Shroud Fretting

Fretting fatigue calculations for shroud with coating show acceptable margins outside avoidance zone

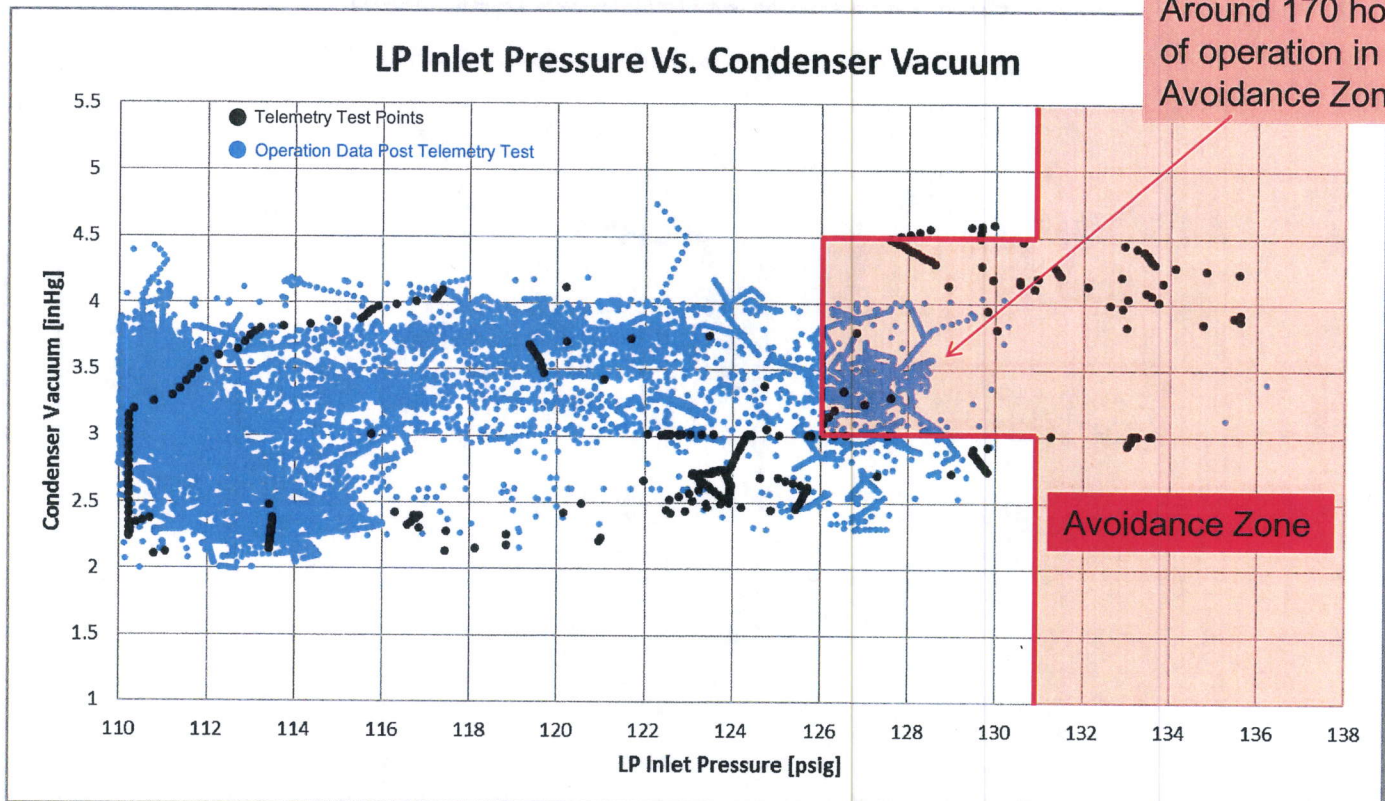
Operation Data Review

170+ hours of operation in avoidance zone with a response frequency ~200Hz = 1.2E8 Cycles

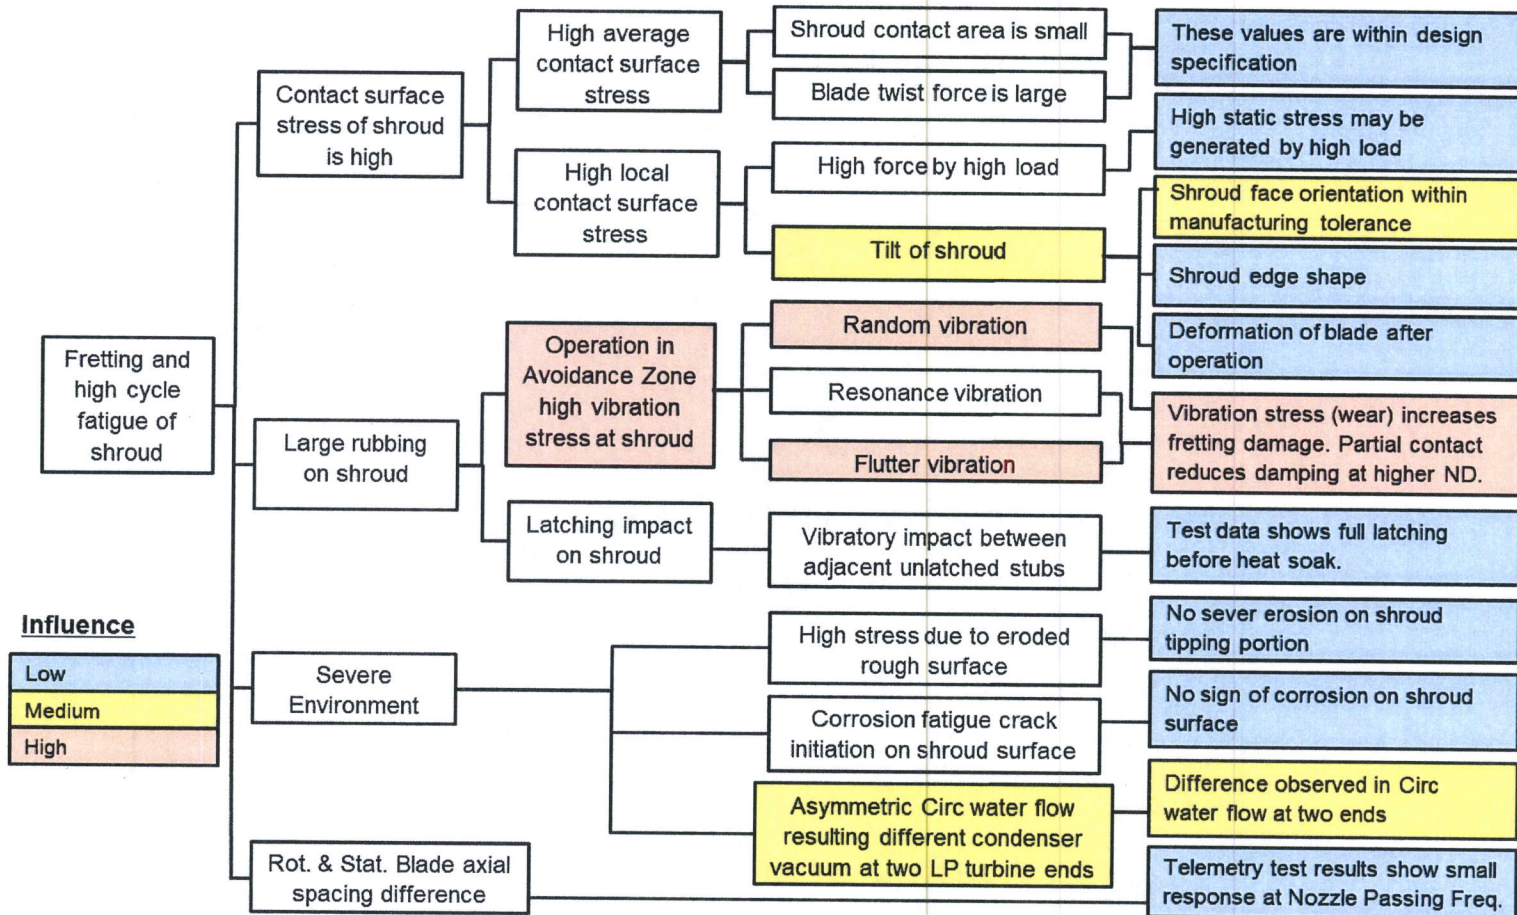
Blade Shroud Cause and Effect Diagram

- The root cause for start of shroud chipping has been identified as operation in the avoidance zone.
- Within the avoidance zone, high local contact pressure is developed due to partial contact.
- After initial chipping, nearly uniform wear of contact surface indicate progression of chipping due to operation at resonance (avoidance zone).
- Stellite coating on stub has proven its effective at protecting surfaces from fretting damage.

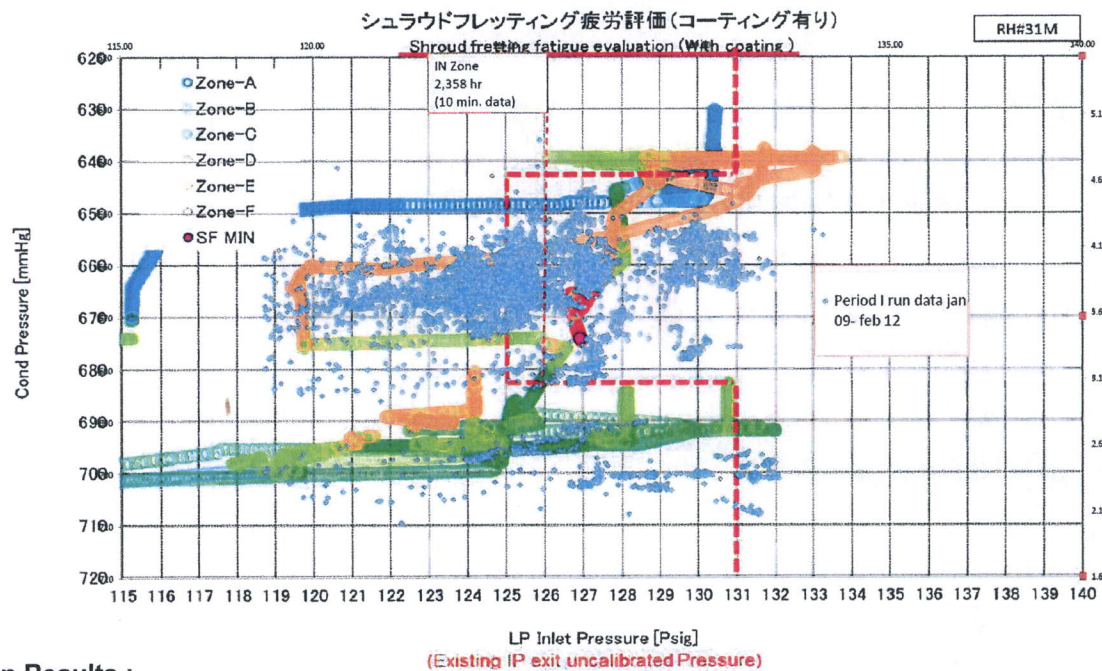
1.1) Operating Time 1 : Jan 2009 to Feb 2012

Location	Blades	Service	Mid Span Snubber	Shroud	Disposition
Gen End	Type 1	3 yrs	No significant damage	No significant damage	Continue operation until 2014 planned replacement
Gov End	Type 1	3 yrs	5 Major Chip	3 minor chips	Replace blades as continues midspan chipping could results in a free standing blade

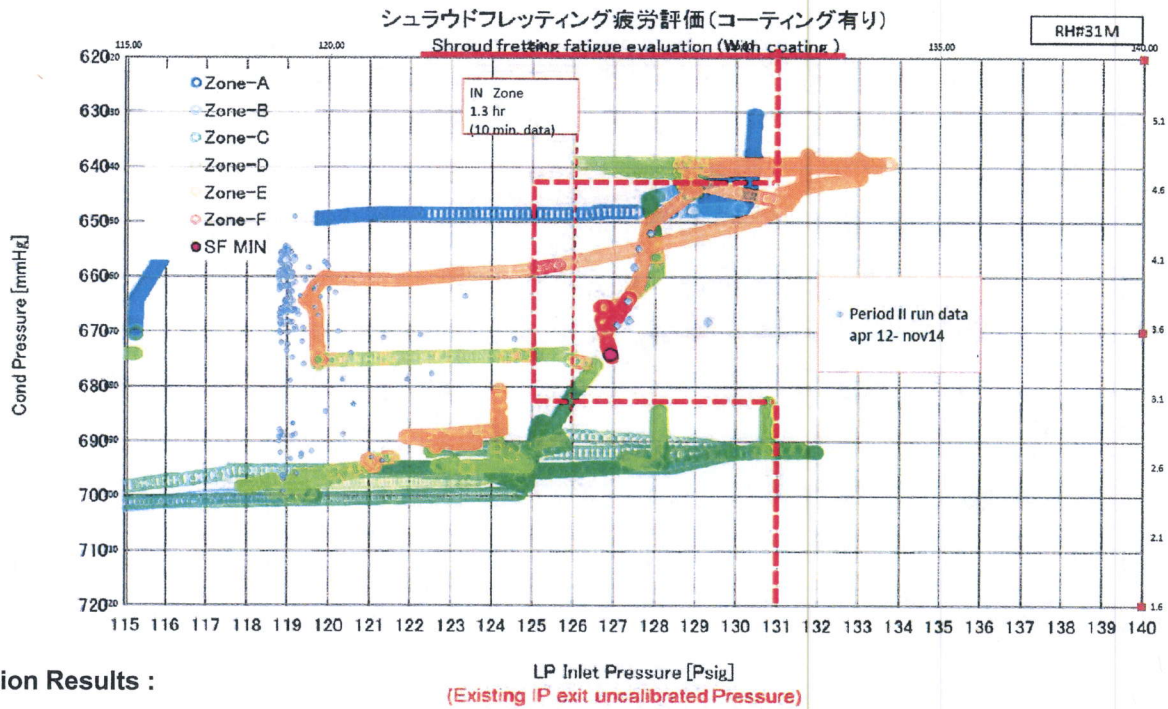
1.2) Operating Time 2 : Apr 2012 to Nov 2014

Location	Blades	Service	Mid Span Snubber	Shroud	Disposition
Gen End	Type 1	5 yrs	No significant damage	12 minor chips	Scheduled change out to blades with midspan HVOF
Gov End	Type 1	2 yrs	No significant damage	3 minor chips	Scheduled change out to blades with midspan HVOF

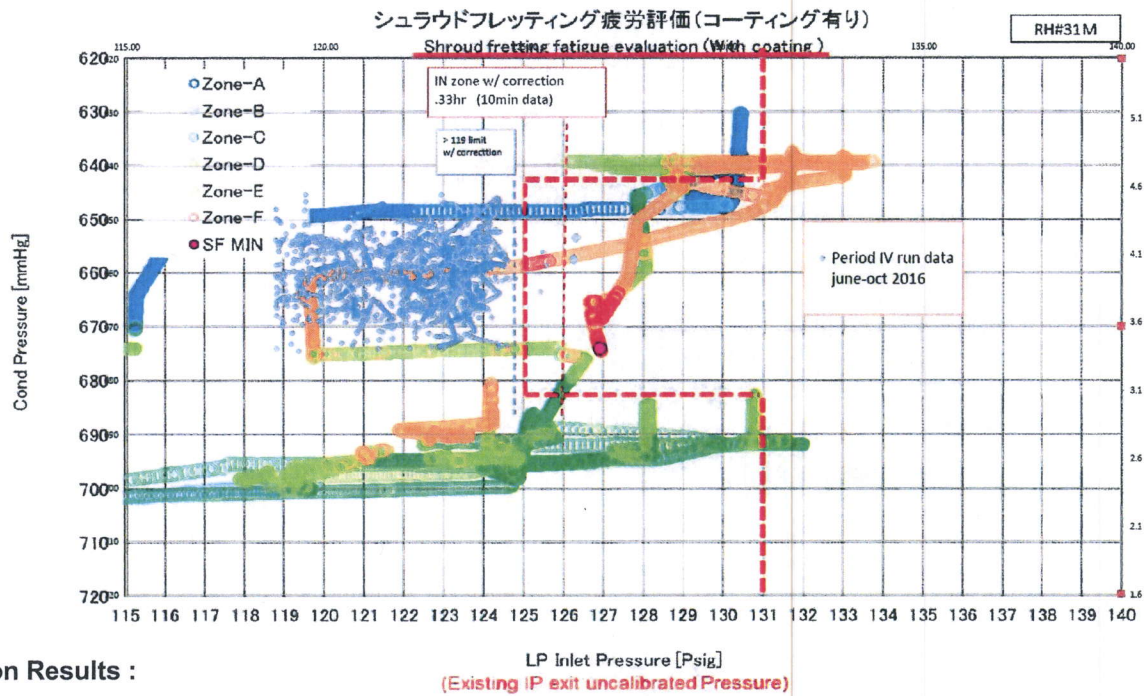
1.4) Operating Time 4 : Jun 2016 to Oct 2016

Location	Blades	Service	Mid Span Snubber	Shroud	Disposition
Gen End	Type 3 + HVOF++	4 Months	No significant damage	7 minor chips	Fit for continued operation. Shroud contact on all blades.
Gov End	Type 3 + HVOF++	4 Months	No significant damage	33 significant damage	Replace row as free shroud contact has bee lost on 1 blade.

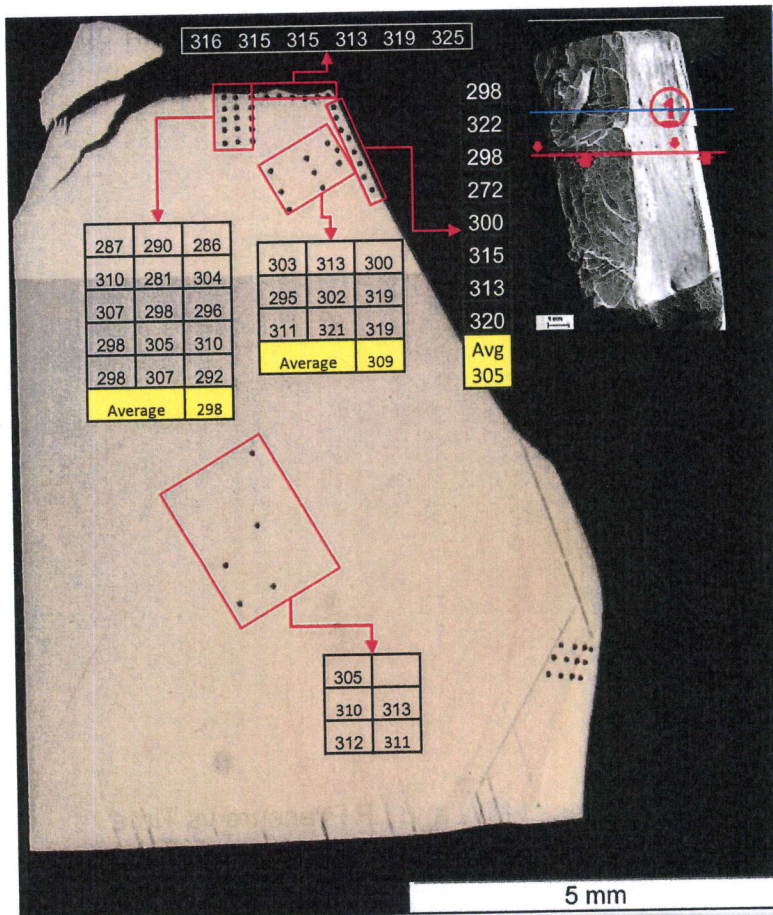
2 - Hardness Variation – Presented

- From hardness observation no significant decrease was observed where the crack initiated.
- A decrease in hardness was observed on the contact surface.

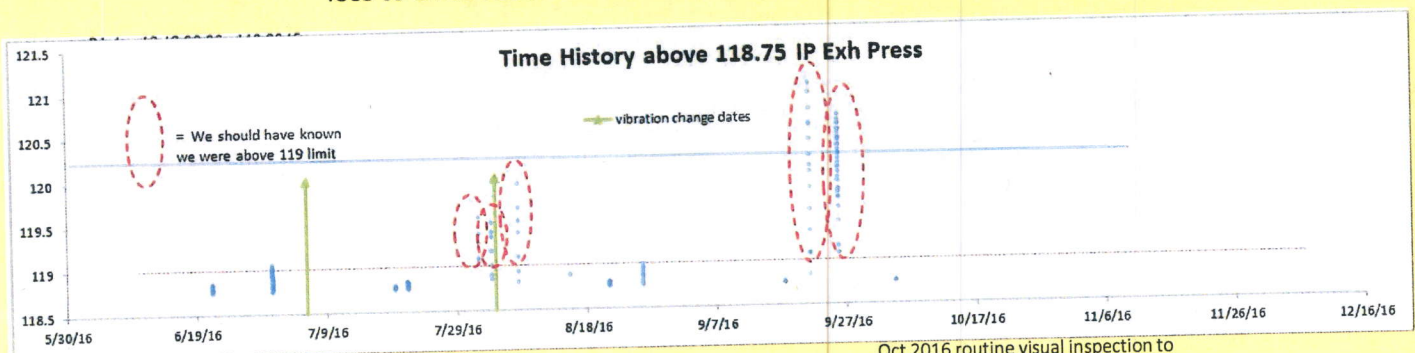
Oct 2016 photo of gen end #22. Three blades failed similar this GE # 13 and TE #2. Adequate mass loss to drive recorded Vibration step changes below.

Oct 2016 routine visual inspection to verify OEM eng. opinion that vibration changes were NOT caused by mass loss. Outage resulted in replacement of both rows of blades. Returned to service Dec 2016

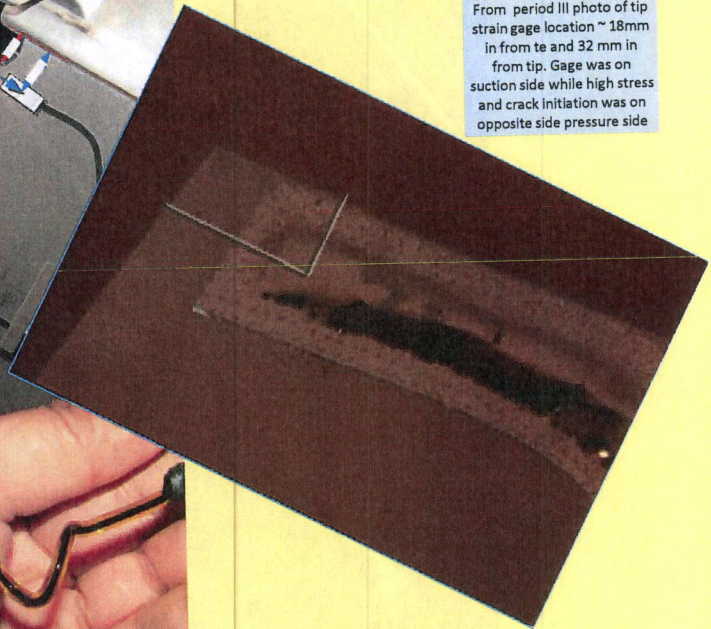
From period III photo of tip strain gage location ~ 18mm in from te and 32 mm in from tip. Gage was on suction side while high stress and crack initiation was on opposite side pressure side

The blades at Bartow were standard MHI type 3(welded) , but had design modifications of that included chamfers, radius, and HVOF hard face on mating surfaces. MHI tested an earlier version in the field (dec 2014) with strain gages at three locations each end. They were at the base, the middle near the snubber, and at the tip shown above near the z lock latch or lock up tip shroud. MHI knew this was a high stress area. They approved limited operation in an identified "zone" from this testing. In fact the testing included > ~ 10 hours in the zone to properly map it with steam flows and condenser back pressures. The original supplied blades, post run, were analyzed for amount of time in the zone. Period I 2009-2012 ran 2,466 hrs in the "zone" and had blade tip damage but never a material loss as large as Period IV Jun-Oct 2016 shown above.

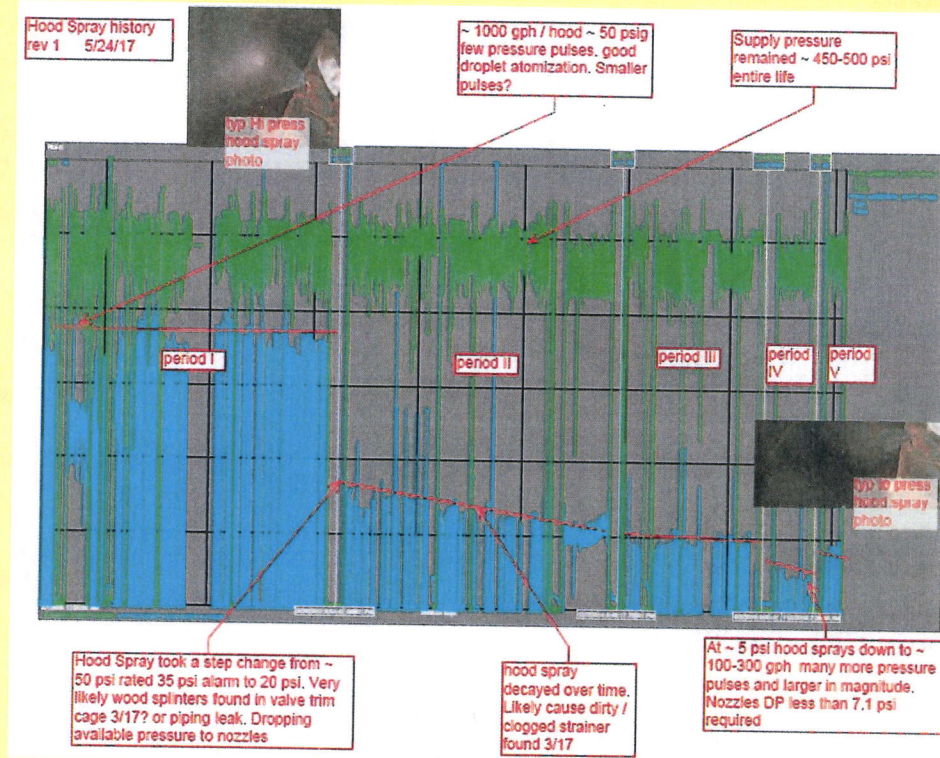
Figure 2 -- Hood Spray Pressure Degradation Over Periods 1-5

Figure 2, below, demonstrates what happened to hood spray pressure over time. The decay in water pressure at the hood spray nozzles will yield reduced atomization as these style of nozzle rely on pressure drop to create a vortex inside the nozzle that causes atomization thru centripetal force. The effect of reduced atomization was verified during a test just prior to unit restart in April 2017. A key concern of poor atomization is the effect it might have on generating dynamic pressures which the L-O blades might see as large water droplets evaporate in the exhaust stream.

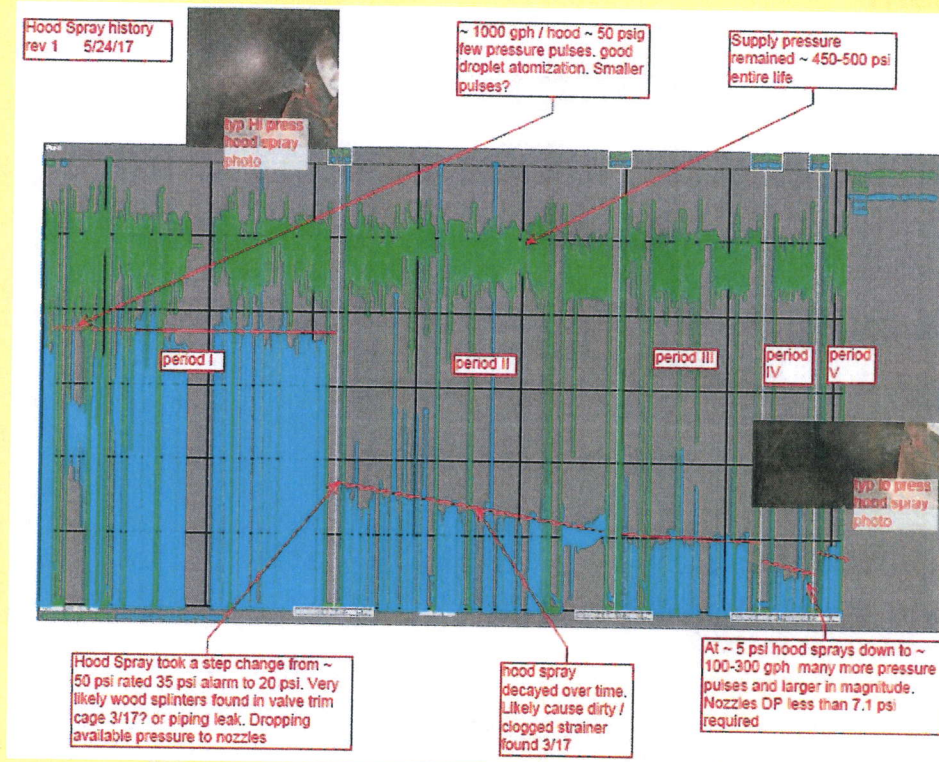
Figure 2 -- Hood Spray Pressure Degradation Over Periods 1-5

Figure 2, below, demonstrates what happened to hood spray pressure over time. The decay in water pressure at the hood spray nozzles will yield reduced atomization as these style of nozzle rely on pressure drop to create a vortex inside the nozzle that causes atomization thru centripetal force. The effect of reduced atomization was verified during a test just prior to unit restart in April 2017. A key concern of poor atomization is the effect it might have on generating dynamic pressures which the L-0 blades might see as large water droplets evaporate in the exhaust stream.

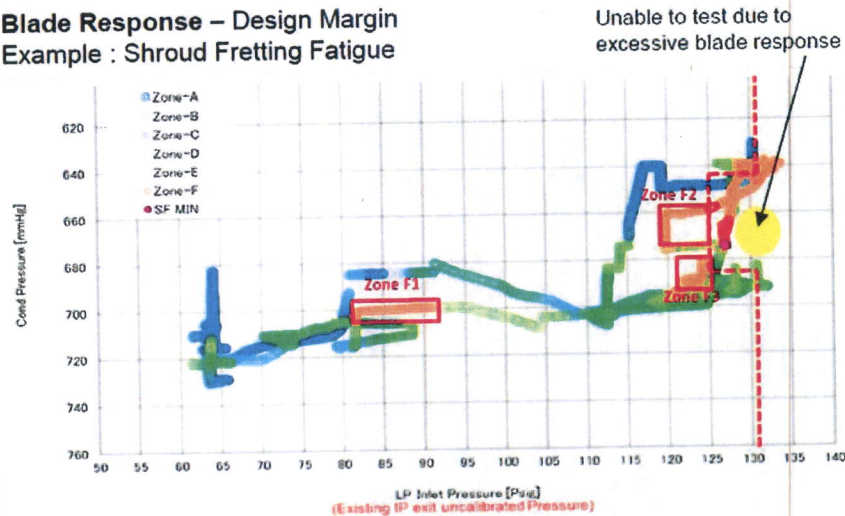
Blade Response – Design Margin Example : Shroud Fretting Fatigue

Based on data from the Period 3 blade strain gauge test in December 2014, MHPS identified areas (referred to as "Zones") where blade response was high, but still below the OEM design limit in the normal operation range of the LP turbine. The Duke RCA team defined these zones as Zone F1 through Zone F3 (shown by the red rectangles in Figure 3, below) and based on the PI historical data, calculated the amount of time the turbine spent in each zone for each period. MHPS did not provide any restriction of operation in Zones F1 through F3, only the exclusion zone identified by the dotted red line in Figure 3.

- Blade response is evaluated through the integration of the stress response all the modes between 180Hz to 120Hz

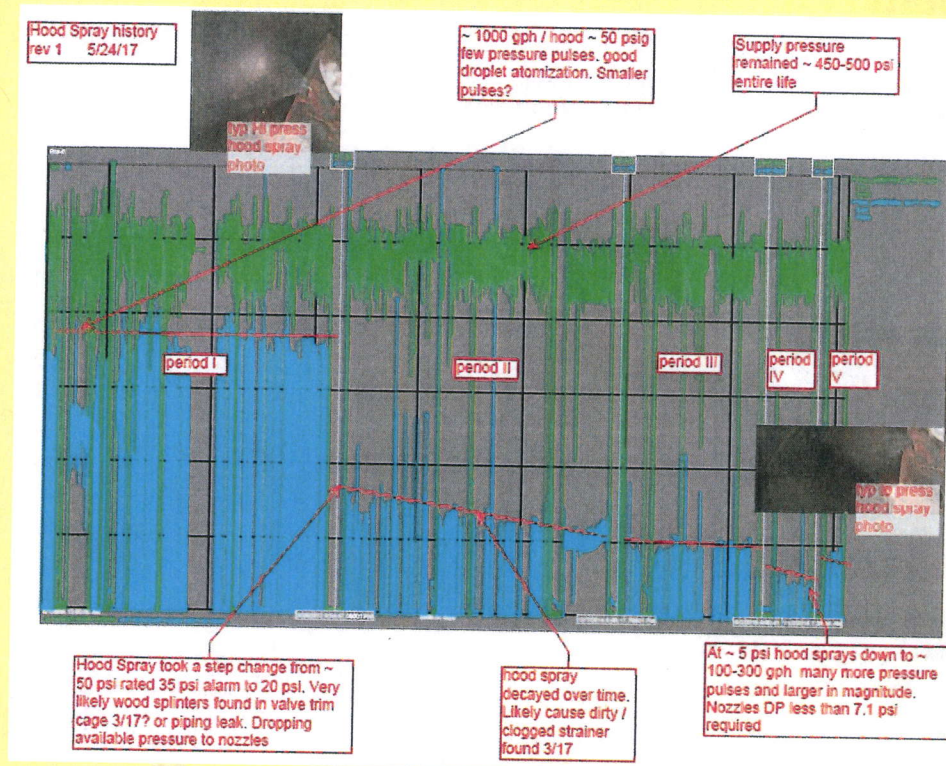
Figure 2 -- Hood Spray Pressure Degradation Over Periods 1-5

Figure 2, below, demonstrates what happened to hood spray pressure over time. The decay in water pressure at the hood spray nozzles will yield reduced atomization as these style of nozzle rely on pressure drop to create a vortex inside the nozzle that causes atomization thru centripetal force. The effect of reduced atomization was verified during a test just prior to unit restart in April 2017. A key concern of poor atomization is the effect it might have on generating dynamic pressures which the L-0 blades might see as large water droplets evaporate in the exhaust stream.

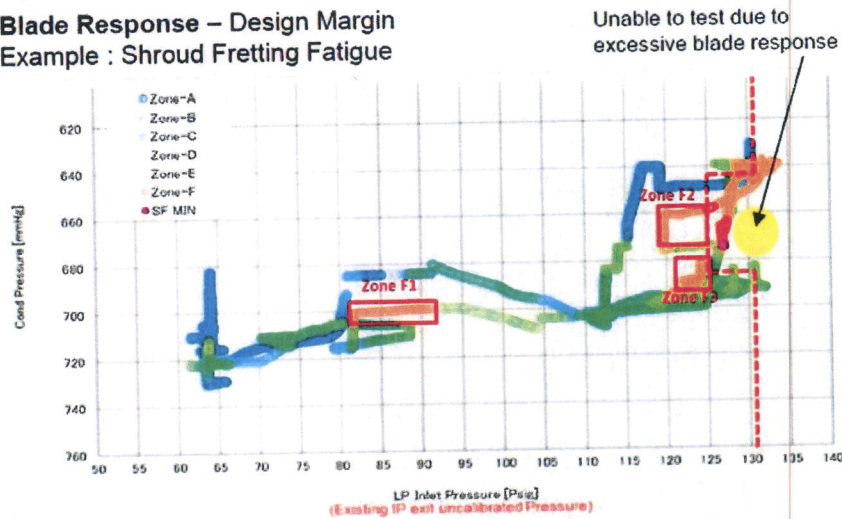
Blade Response – Design Margin
Example : Shroud Fretting Fatigue

Based on data from the Period 3 blade strain gauge test in December 2014, MHPS identified areas (referred to as "Zones") where blade response was high, but still below the OEM design limit in the normal operation range of the LP turbine. The Duke RCA team defined these zones as Zone F1 through Zone F3 (shown by the red rectangles in Figure 3, below) and based on the PI historical data, calculated the amount of time the turbine spent in each zone for each period.

- Blade response is evaluated through the integration of the stress response all the modes between 180Hz to 120Hz

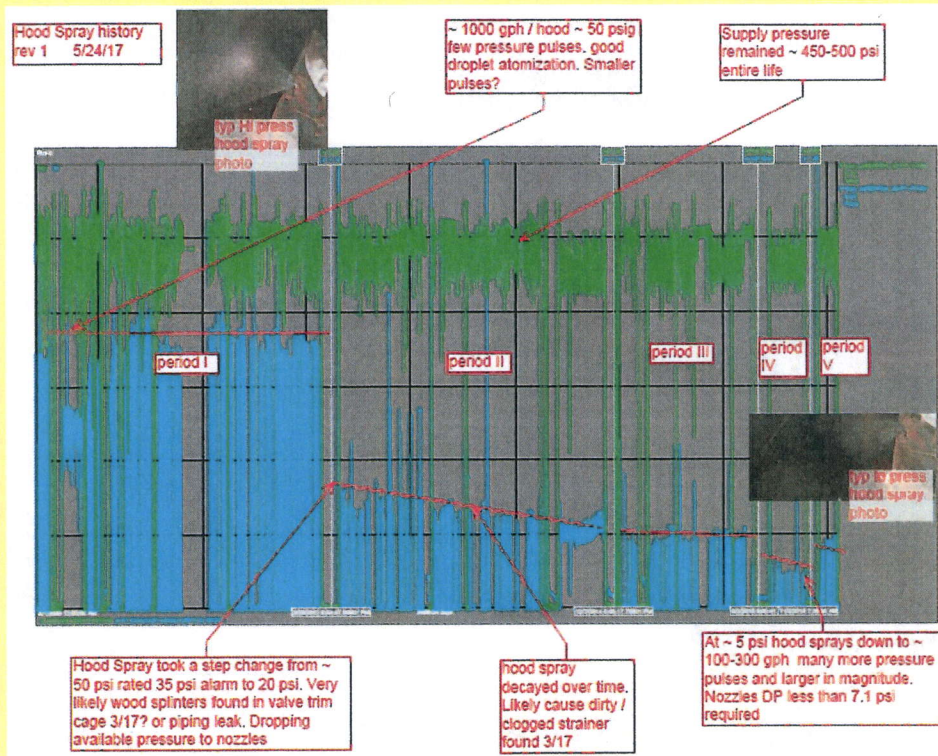
Figure 2 -- Hood Spray Pressure Degradation Over Periods 1-5

Figure 2, below, demonstrates what happened to hood spray pressure over time. The decay in water pressure at the hood spray nozzles will yield reduced atomization as these style of nozzle rely on pressure drop to create a vortex inside the nozzle that causes atomization thru centripetal force. The effect of reduced atomization was verified during a test just prior to unit restart in April 2017. A key concern of poor atomization is the effect it might have on generating dynamic pressures which the L-0 blades might see as large water droplets evaporate in the exhaust stream.

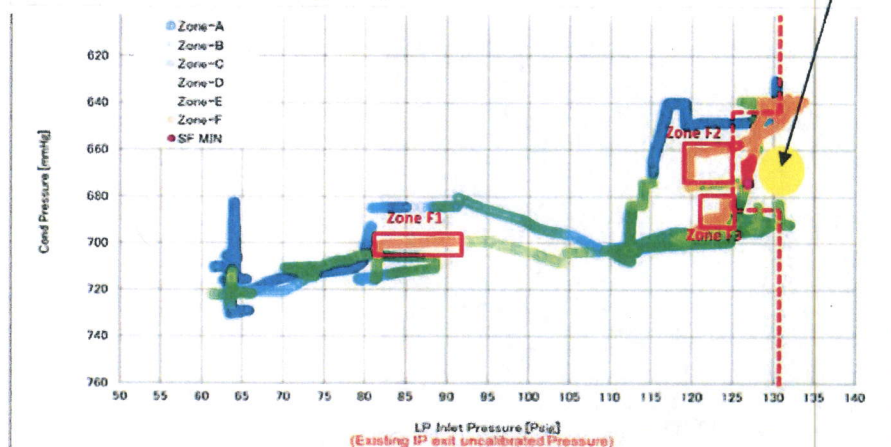
Blade Response – Design Margin
Example : Shroud Fretting Fatigue

Unable to test due to excessive blade response

- Blade response is evaluated through the integration of the stress response all the modes between 180Hz to 120Hz

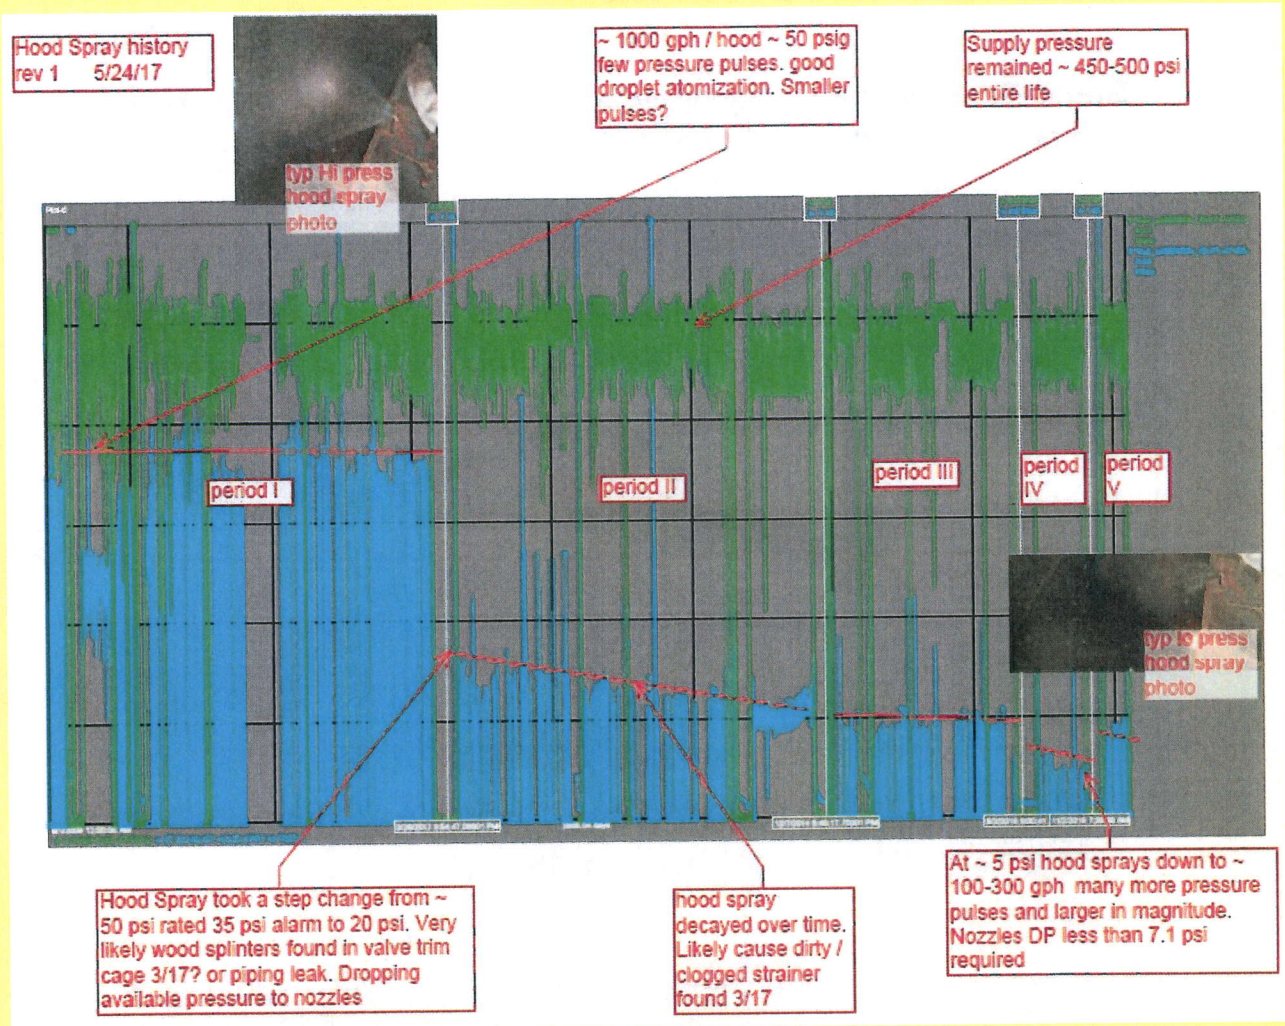
Figure 2 -- Hood Spray Pressure Degradation Over Periods 1-5

Figure 2, below, demonstrates what happened to hood spray pressure over time. The decay in water pressure at the hood spray nozzles will yield reduced atomization as these style of nozzle rely on pressure drop to create a vortex inside the nozzle that causes atomization through centripetal force. The effect of reduced atomization was verified during a test just prior to unit restart in April 2017. A key concern of poor atomization is the effect it might have on generating dynamic pressures which the L-O blades might see as large water droplets evaporate in the exhaust stream.

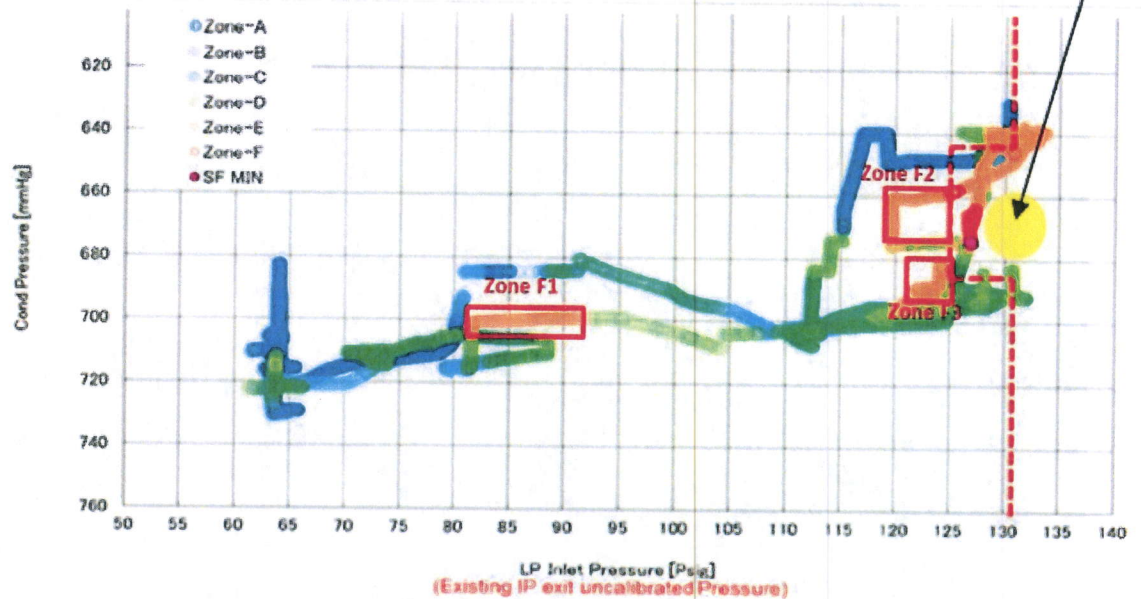
Blade Response – Design Margin
Example : Shroud Fretting Fatigue

Based on data from the Period 3 blade strain gauge test in December 2014, the OEM identified areas (referred to as “Zones”) where blade response was high, but still below the OEM design limit in the normal operation range of the LP turbine. The Duke RCA team defined these zones as Zone F1, Zone F2, and Zone F3 (shown by the red rectangles in Figure 3, below) and based on the PI historical data, calculated the amount of time the turbine spent in each zone for each period. The OEM did not provide any restriction(s) to operation in Zone F1, Zone F2, and/or Zone F3 – only restrictions relative to “operation in the avoidance zone” identified by the area of the graph to the right of the dotted red line in Figure 3.

- Blade response is evaluated through the integration of the stress response all the modes between 180Hz to 120Hz

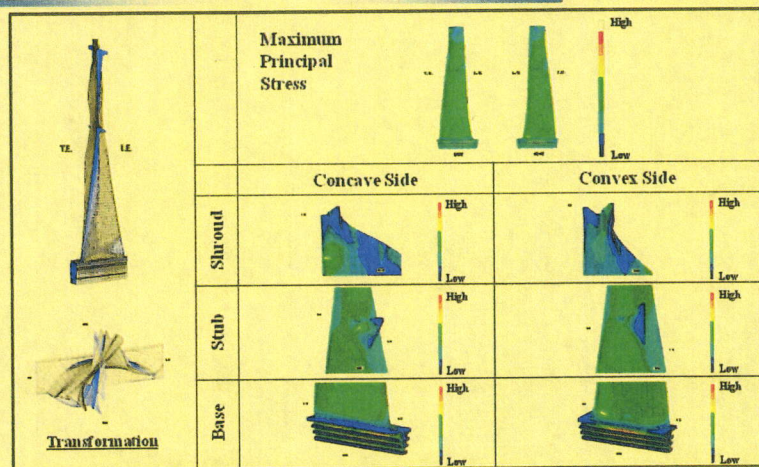
Static Stress

The yield stress was shown in orange. Although the local stress on the blade root exceeds the yield stress this is not problem because it is 80% of the allowable stress (as discussed with Harry Carbone in the meeting). Note that the stub does not exceed the yield stress.

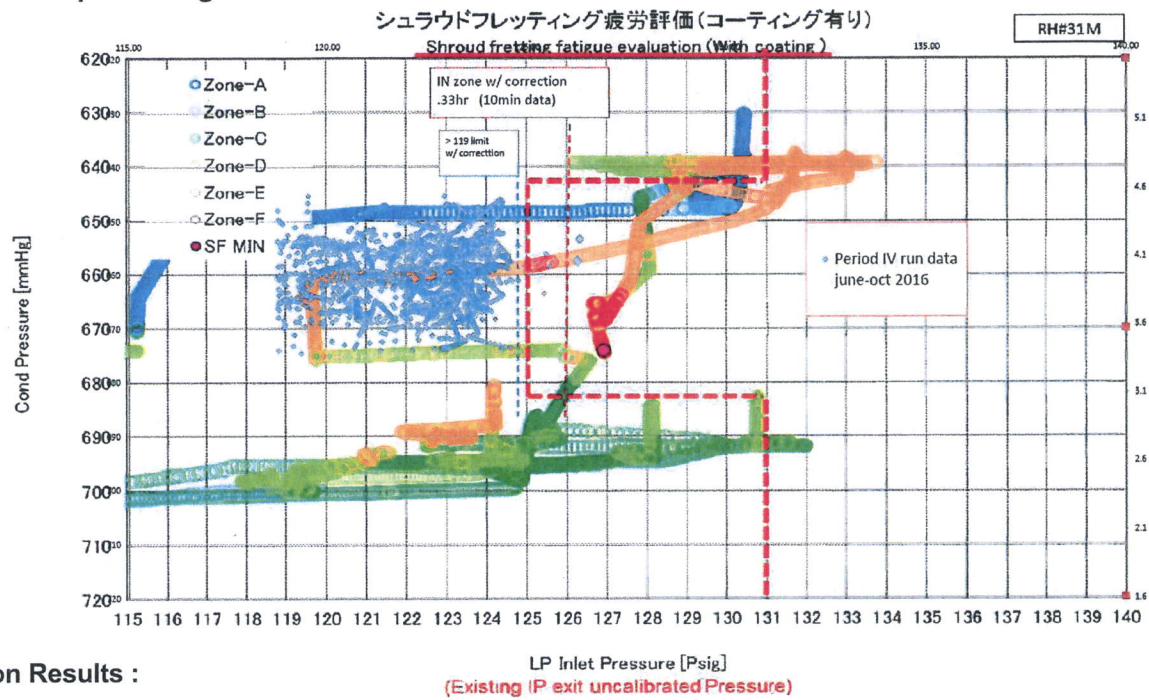
1.4) Operating Time 4 : Jun 2016 to Oct 2016

Location	Blades	Service	Mid Span Snubber	Shroud	Disposition
Gen End	Type 3 + HVOF++	4 Months	1 Liberation	3 Shroud Liberations	Replace Row
Gov End	Type 3 + HVOF++	4 Months	No significant damage	1 Shroud Liberation	Replace Row
