DESCRIPTION: Late filed deposition Exhibit No. 4

DOCUMENTS: Panel deposition of Jeffrey Swartz, Anthony Salvarezza and C. Wayne Toms, August 30, 2019.

BRR 4S L-O Background

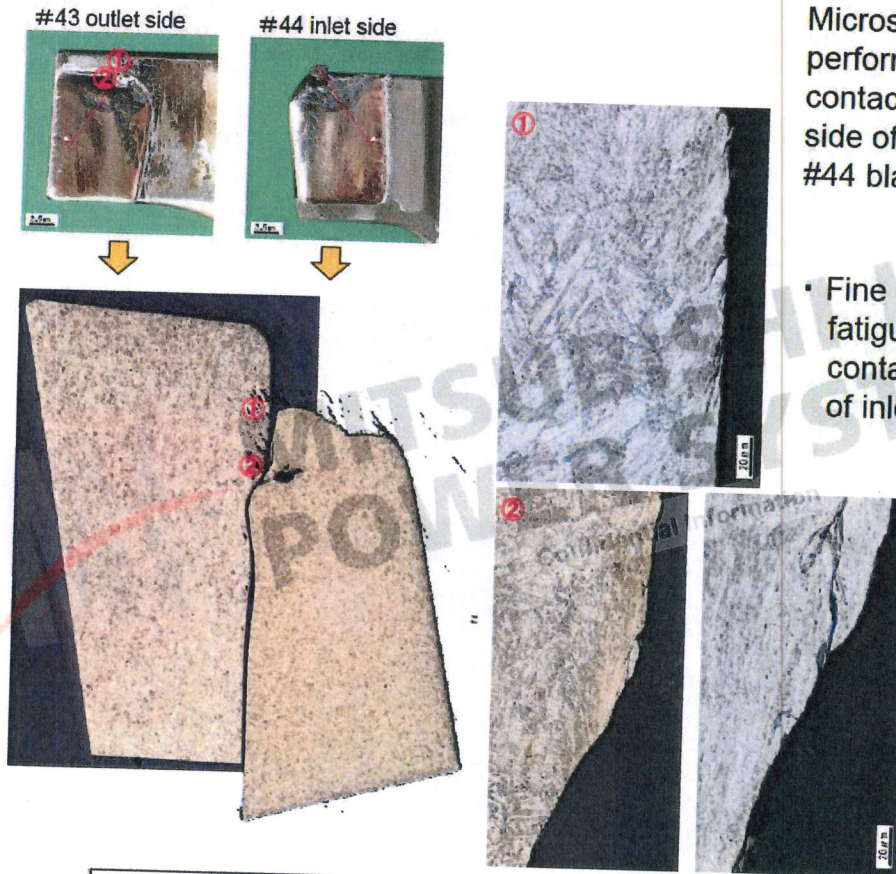
Metallurgical Evaluation of Blades

Microscopic observation was performed on the same sections in contact condition for each of outlet side of #43 blade and inlet side of #44 blade.

- Fine cracks, caused by fretting fatigue, are found near the end of contact part with local deformation of inlet side of #44 blade.

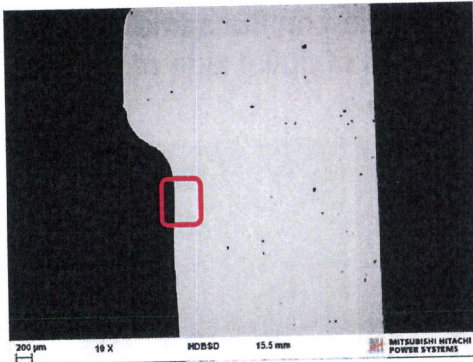
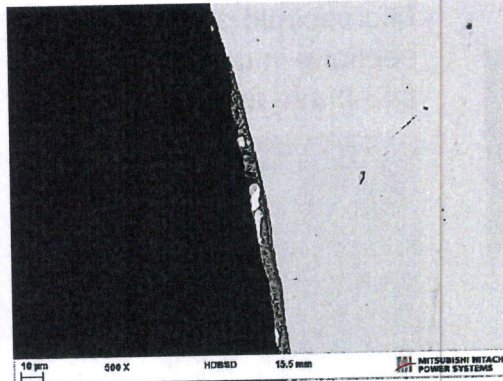
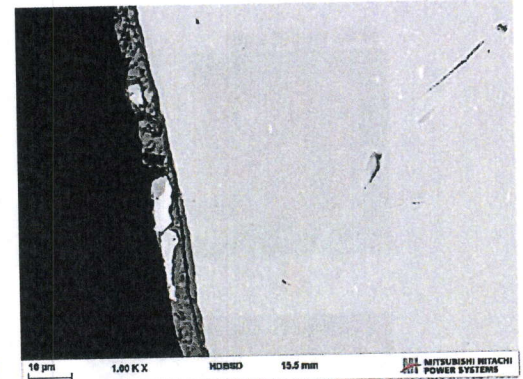
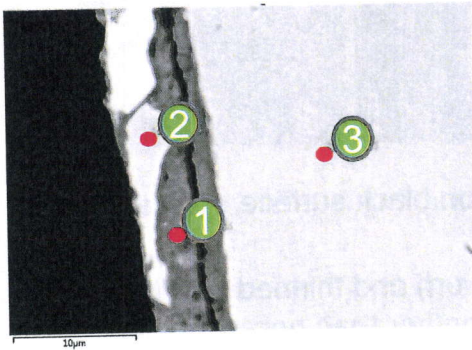
Metallurgical Evaluation of Blades

Oxide scale with local deformation observed on black surface

- Oxidation/corrosion was observed on the trailing edge contact surface of the tip shroud.
- Material removal from wear is from abrasion.

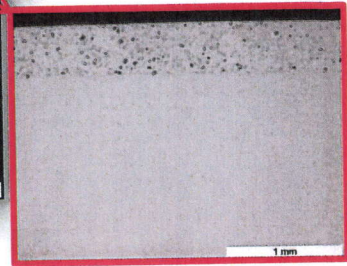
Stub Evaluation

- The contact surface coating did not show any cracks, deformation or wear.
- Uniform thickness was measured on the areas of contact between the LE and TE snubbers.

HVOF coating on the stub prevented fretting or any other surface damage

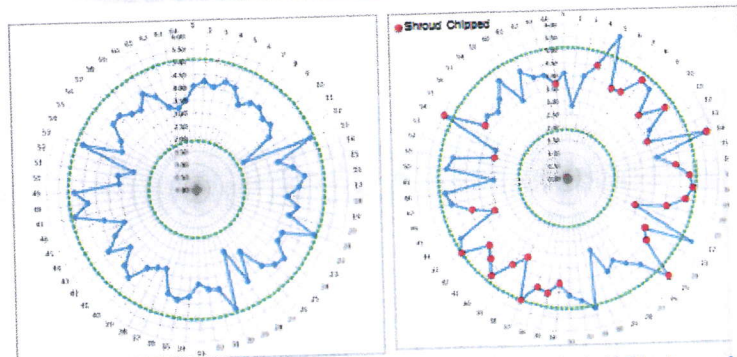
2014 Blade LH (Gov. End) Shroud Gap Data

Shroud Gap Data in 2014 **Assembly****Row Average Gap = 3.9mm**

Criteria: Shroud 1.9mm to 5.1mm Average, with no single blade above 6.0mm.

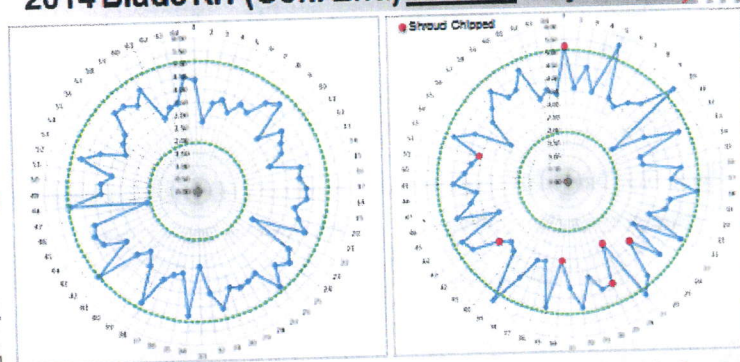
2014 Blade RH (Gen. End) Shroud Gap Data

Shroud Gap Data in 2014 **Assembly****Row Average Gap = 3.9mm**

Criteria: Shroud 1.9mm to 5.1mm Average, with no single blade above 6.0mm.

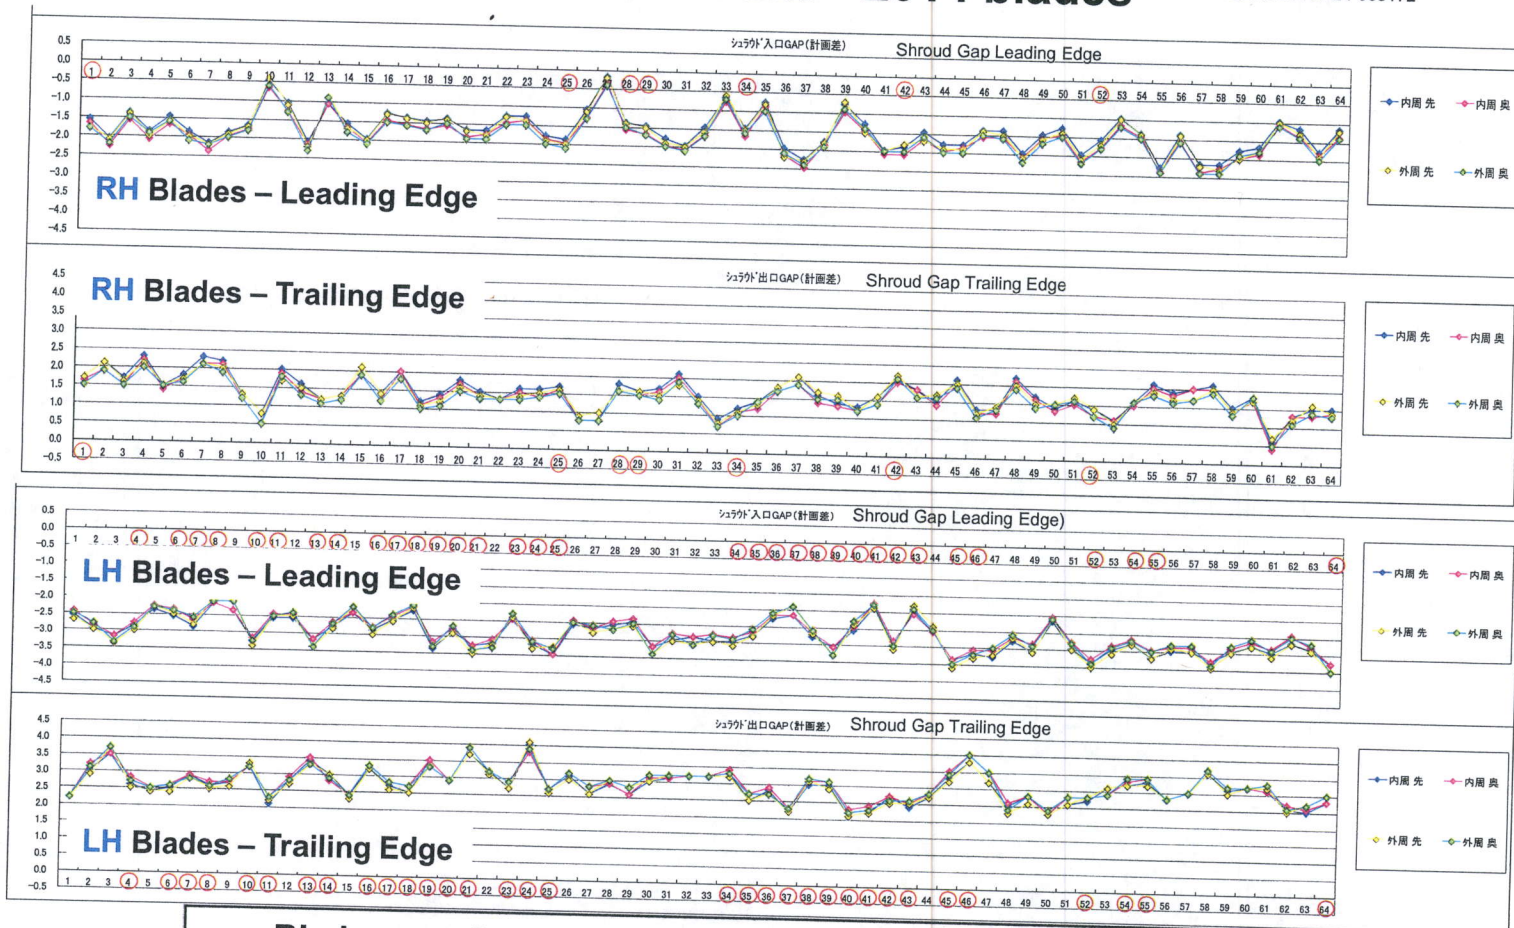
Box Gauge Measurement Results - 2014 blades

Blade manufacturing data show variation within criteria

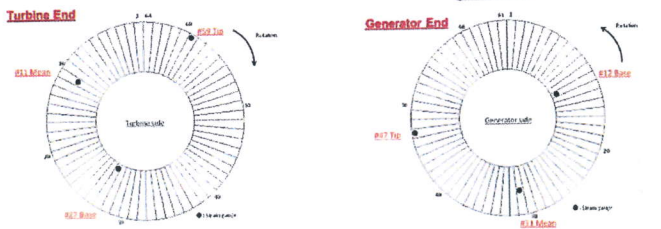
Strain Gage Locations

- Six strain gage were installed on LH and RH blades.
- Strain gage locations were selected
 - High Response sensitivity for vibration modes.
 - MHPS Experience

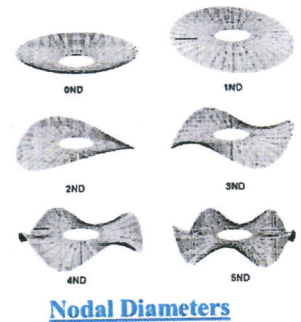
Test Results

- Analysis of Non-synchronous response show frequencies close to 200Hz region and composed of axial mode shape with higher nodal diameter.
- Fretting at stubs was evaluated with the telemetry test results.

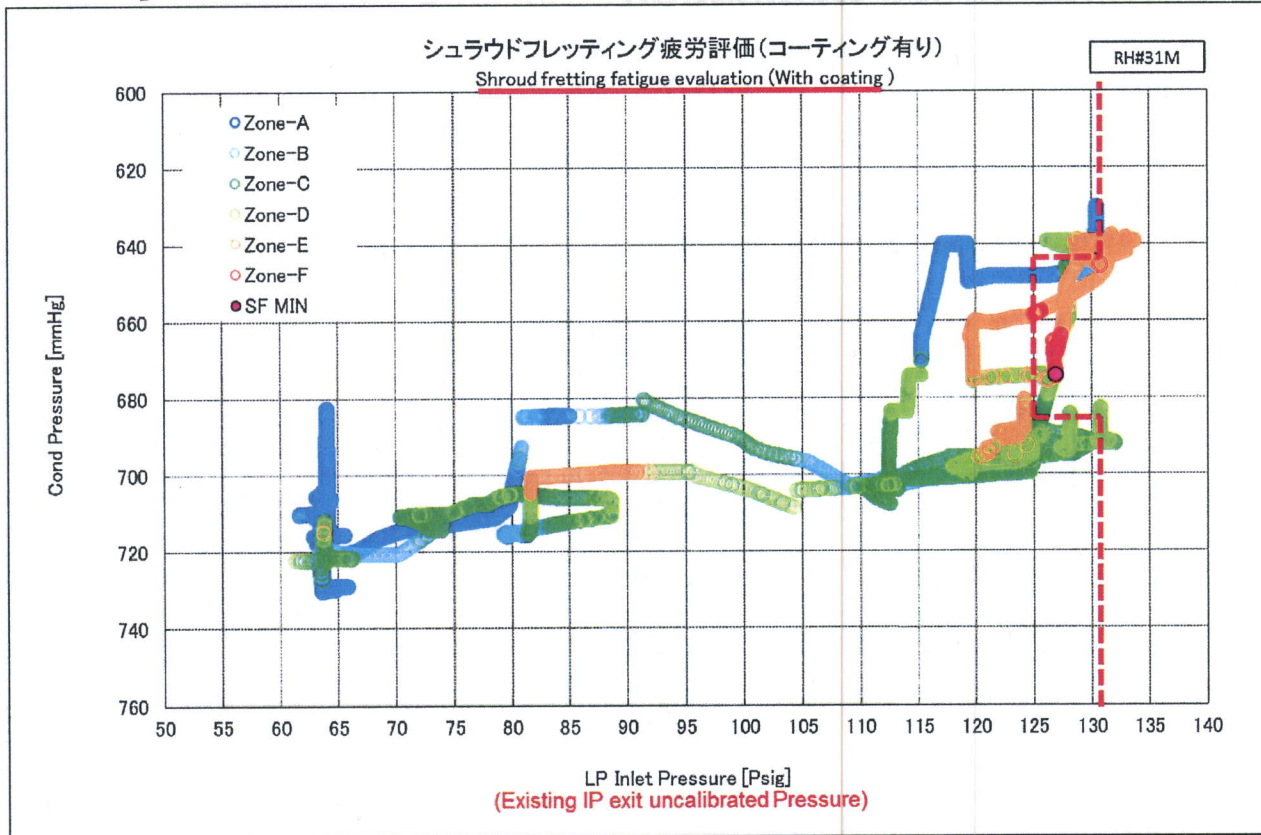
Telemetry Test Results – Shroud Fretting

Fretting fatigue calculations for shroud with coating show acceptable margins outside avoidance zone

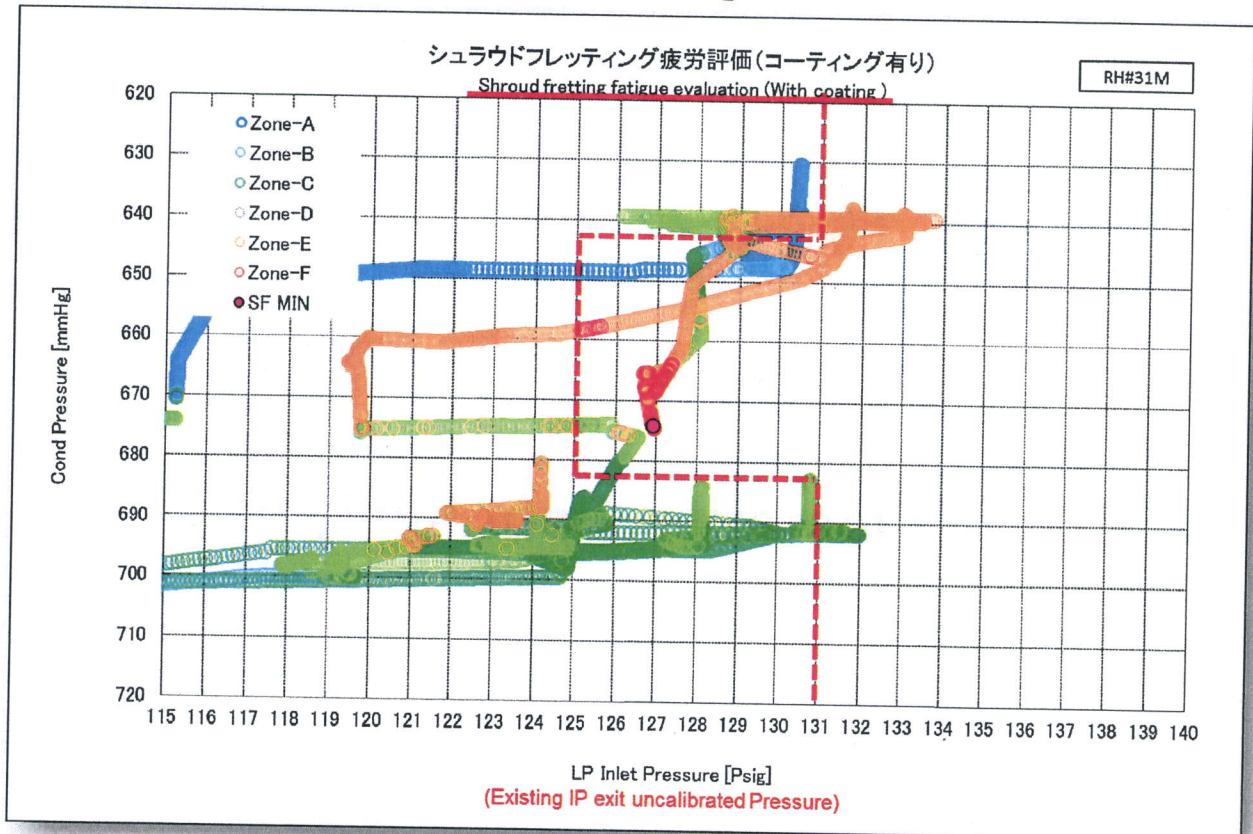
Telemetry Test Data – Shroud Fretting

Fretting fatigue calculations for shroud with coating show acceptable margins outside avoidance zone

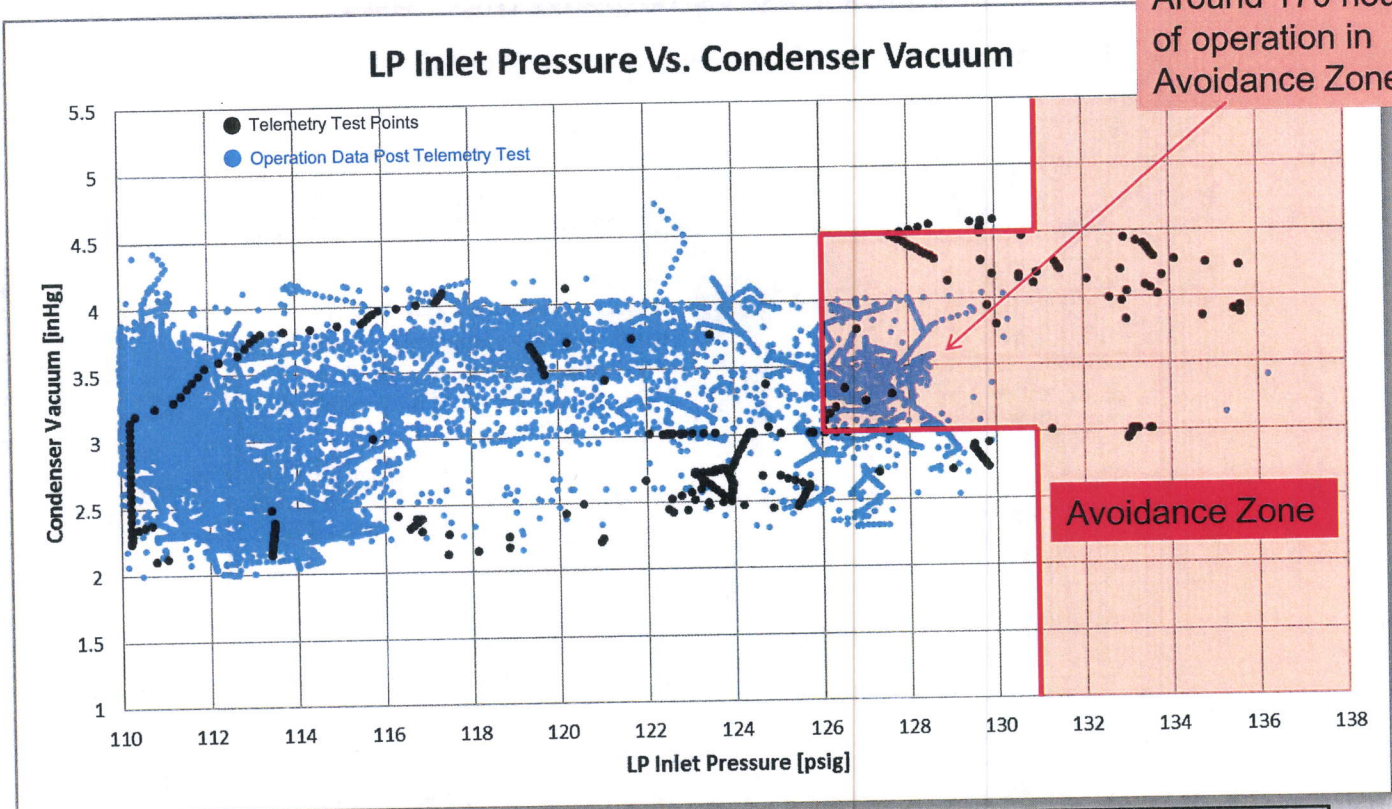
Around 170 hours
of operation in
Avoidance Zone

**170+ hours of operation in avoidance zone with a response
frequency $\sim 200\text{Hz} = 1.2\text{E}8$ Cycles**

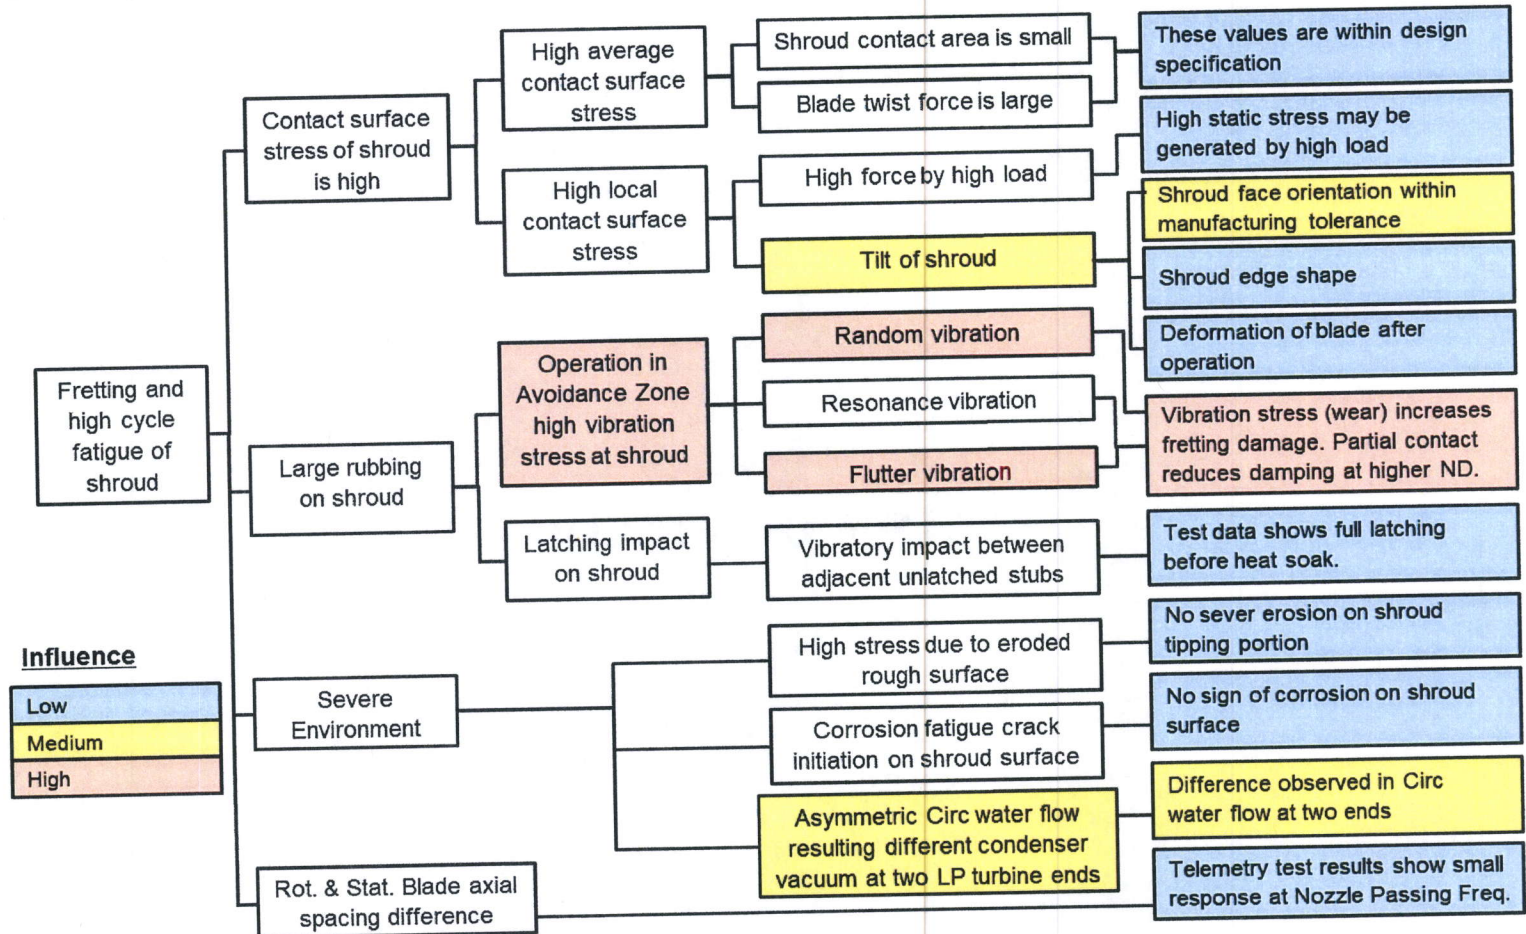
Blade Shroud Cause and Effect Diagram

- The root cause for start of shroud chipping has been identified as operation in the avoidance zone.
- Within the avoidance zone, high local contact pressure is developed due to partial contact.
- After initial chipping, nearly uniform wear of contact surface indicate progression of chipping due to operation at resonance (avoidance zone).
- Stellite coating on stub has proven its effective at protecting surfaces from fretting damage.

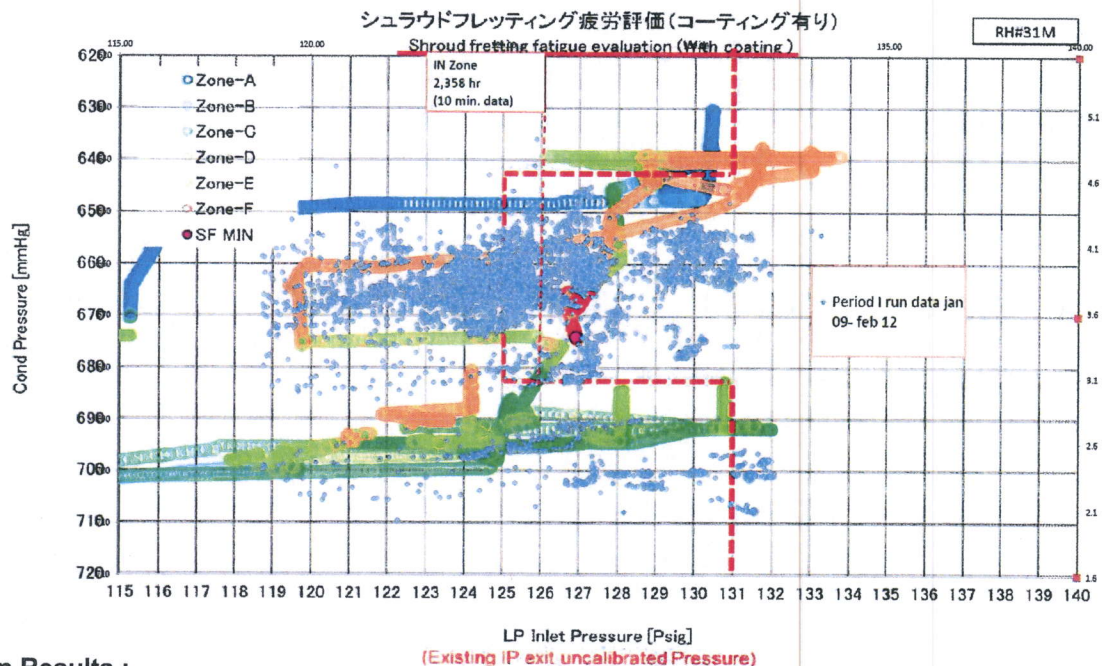
Location	Blades	Service	Mid Span Snubber	Shroud	Disposition
Gen End	Type 1	3 yrs	No significant damage	No significant damage	Continue operation until 2014 planned replacement
Gov End	Type 1	3 yrs	5 Major Chip	3 minor chips	Replace blades as continues midspan chipping could results in a free standing blade

1.1) Operating Time 1 : Jan 2009 to Feb 2012
Significant operation in the avoidance zone.
Significant damage observed on the blades.

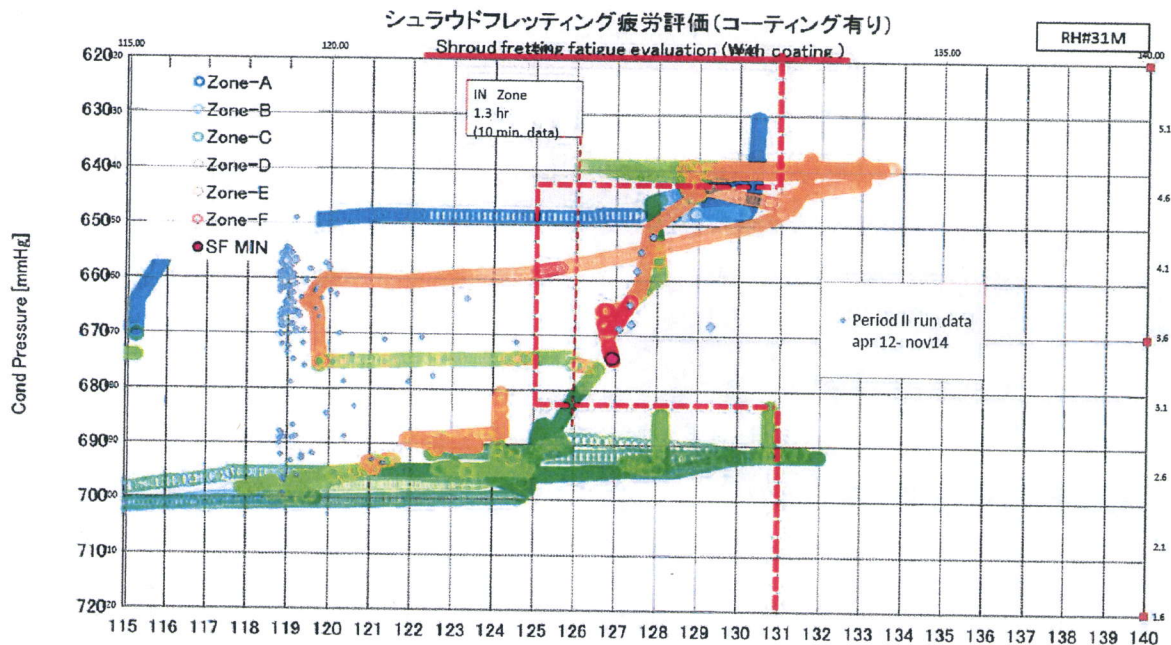
Location	Blades	Service	Mid Span Snubber	Shroud	Disposition
Gen End	Type 1	5 yrs	No significant damage	12 minor chips	Scheduled change out to blades with midspan HVOF
Gov End	Type 1	2 yrs	No significant damage	3 minor chips	Scheduled change out to blades with midspan HVOF

1.2) Operating Time 2 : Apr 2012 to Nov 2014
Minimal operation in the avoidance zone.
Minor chipping observed.

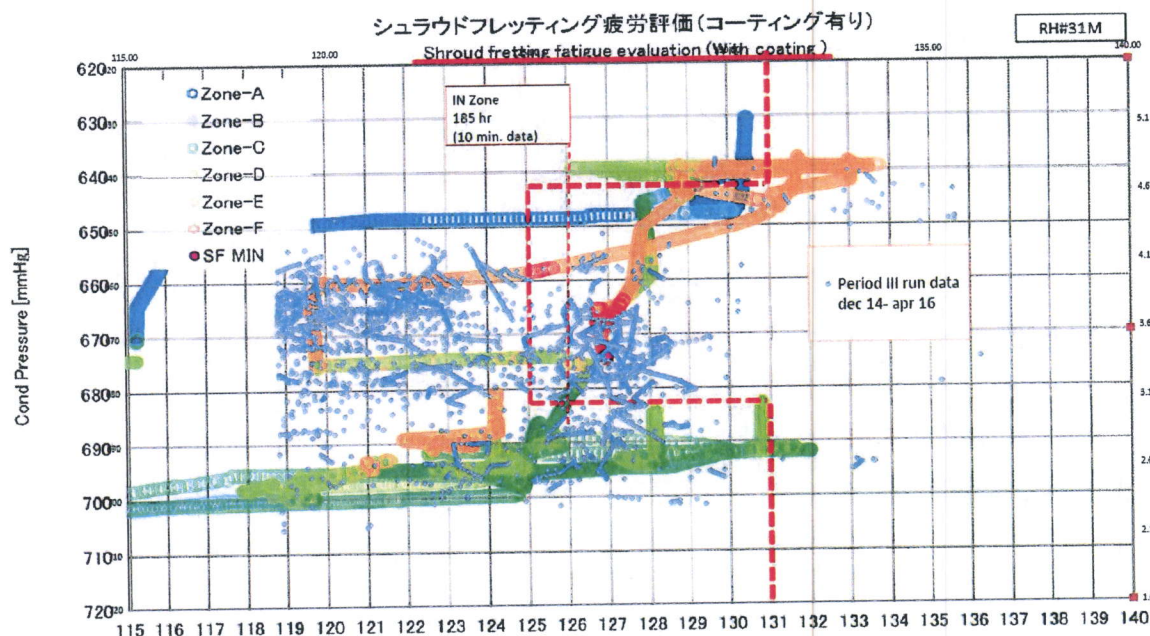
Location	Blades	Service	Mid Span Snubber	Shroud	Disposition
Gen End	Type 3 + HVOF	15 Months	No significant damage	7 minor chips	Fit for continued operation. Shroud contact on all blades.
Gov End	Type 3 + HVOF	15 Months	No significant damage	33 chips including significant damage	Replace row as free shroud contact has been lost on 1 blade.

1.3) Operating Time 3 : Dec 2014 to Apr 2016
Significant operation in the avoidance zone.
Significant damage observed on the blades.

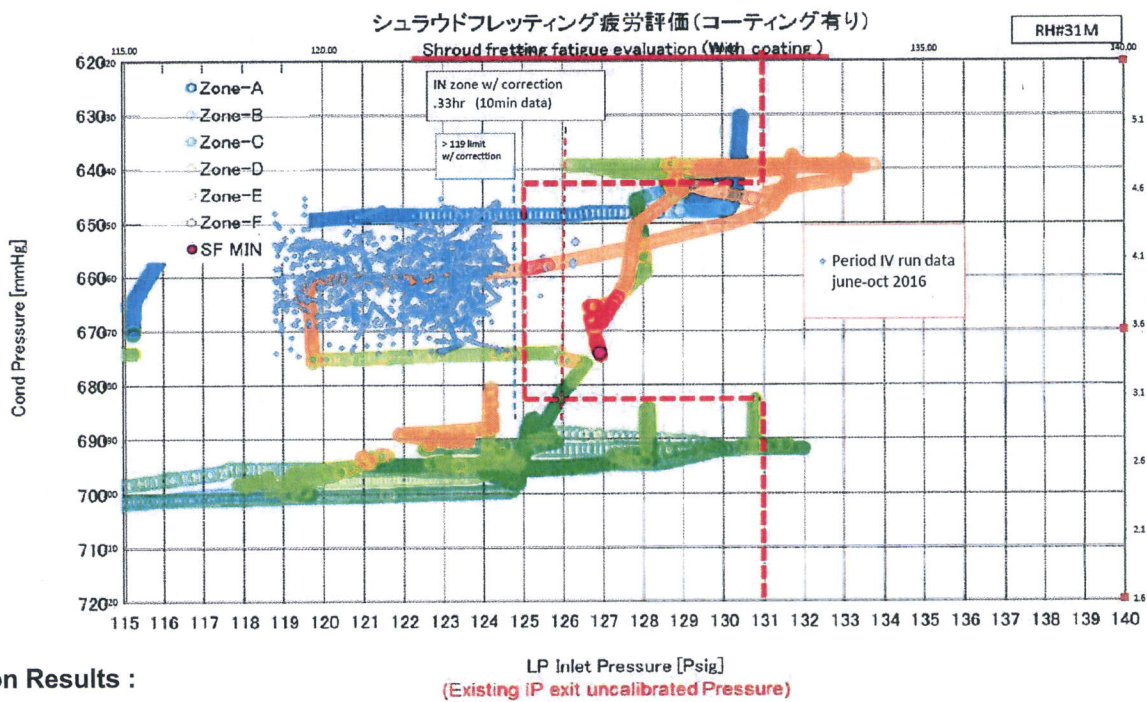
1.4) Operating Time 4 : Jun 2016 to Oct 2016

Location	Blades	Service	Mid Span Snubber	Shroud	Disposition
Gen End	Type 3 + HVOF++	4 Months	No significant damage	7 minor chips	Fit for continued operation. Shroud contact on all blades.
Gov End	Type 3 + HVOF++	4 Months	No significant damage	33 significant damage	Replace row as free shroud contact has been lost on 1 blade.

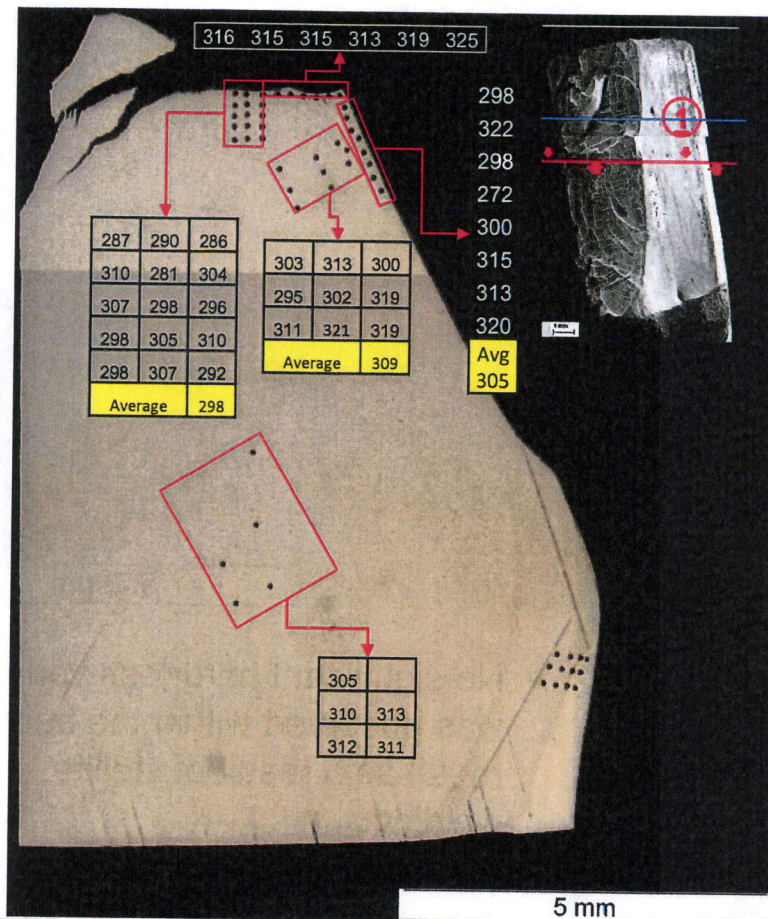
2 - Hardness Variation – Presented

- From hardness observation no significant decrease was observed where the crack initiated.
- A decrease in hardness was observed on the contact surface.

- No significant hardness variation was observed within the base metal as a result of stellite welding.

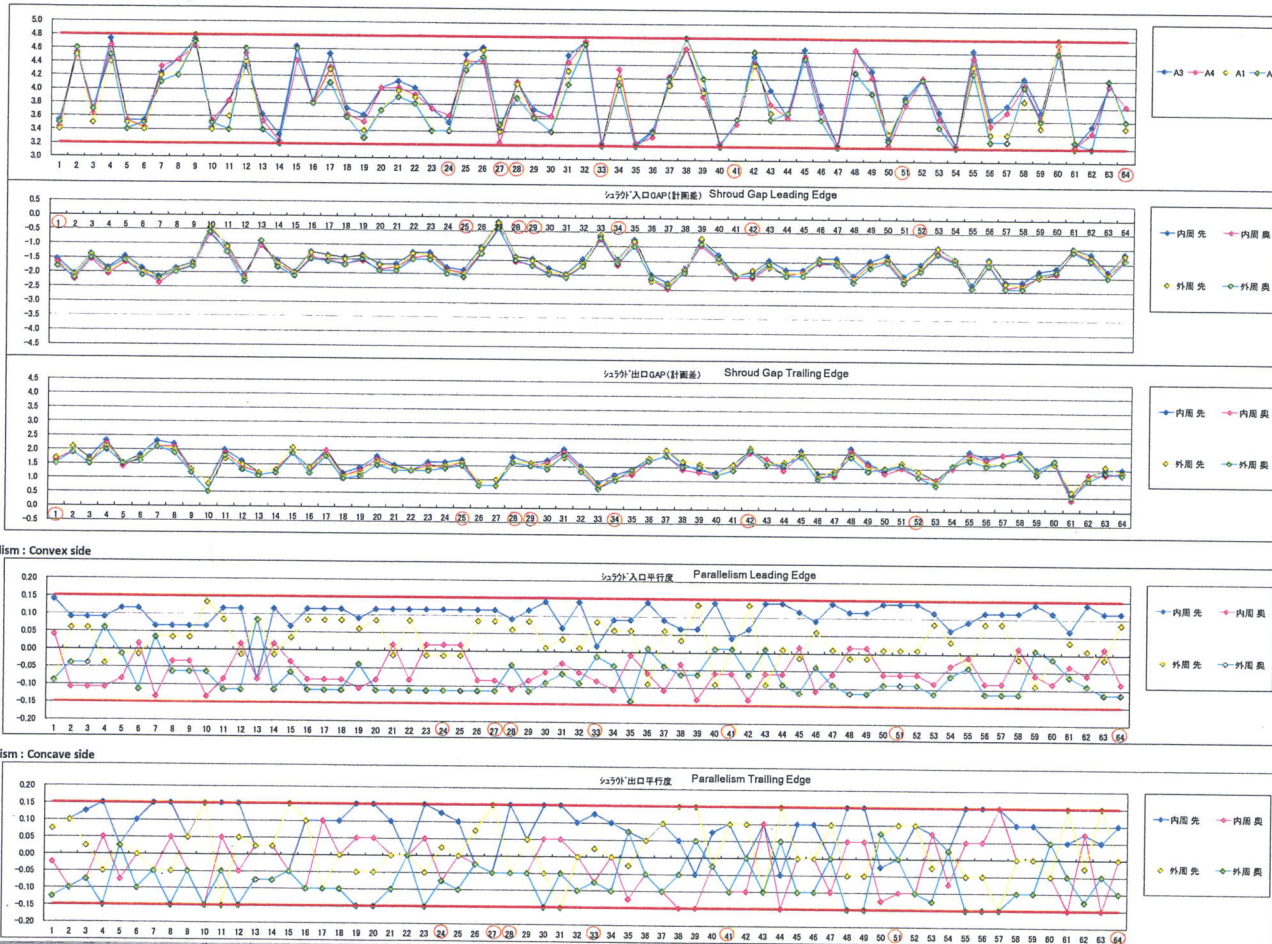
Shroud GAP

○ : Shrouds with Damage

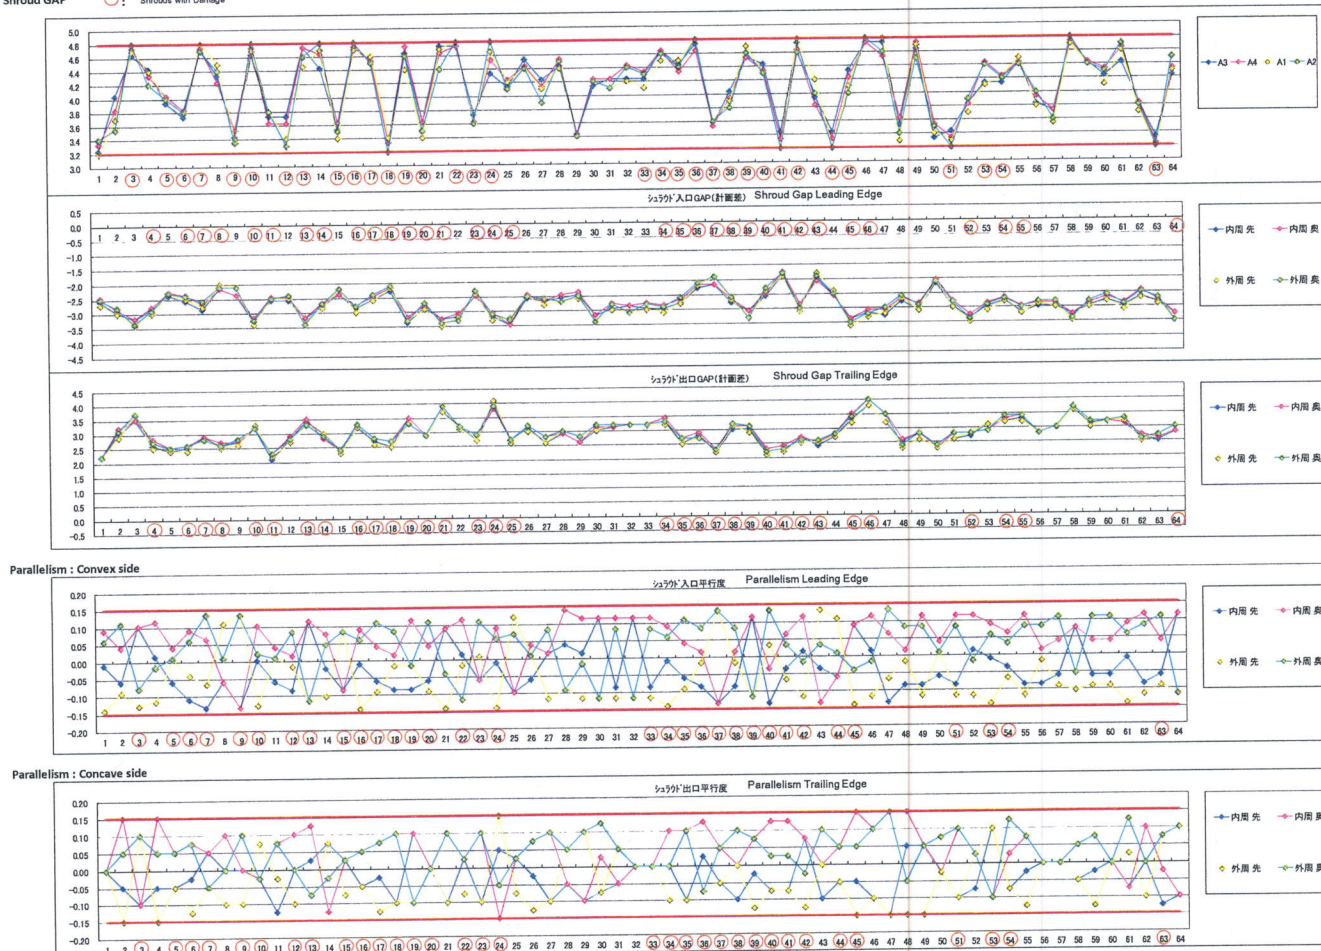
3.2) Measurement Results LH (Gov End) 2014 blades

Shroud GAP ○: Shrouds with Damage
