Exhibit No.	Witness	I.D. # As Filed	Exhibit Description
70	Richard A. Polich, P.E.	RAP-3	Bartow Combined Cycle Thermal Cycle. CONFIDENTIAL DN. 09202-2019, X-REF. 08773-2019
73	Richard A. Polich, P.E.	RAP-6	Bartow ST #1 LO Blade Upgrade To Achieve 450 MW, Dated September 18, 2013. CONFIDENTIAL DN. 09202-2019, X-REF. 08773-2019
74	Richard A. Polich, P.E.	RAP-7	Bartow RCA Review, Dated March 15, 2017. CONFIDENTIAL DN. 09202-2019, X-REF. 08773-2019
75	Richard A. Polich, P.E.	RAP-8	Update On 40'' Last Stage Blade, Dated 2015. CONFIDENTIAL DN. 09202-2019, X-REF. 08773-2019
80	Jeffrey Swartz	JS-2	Bartow Plant Root Cause Analysis. CONFIDENTIAL DN. 09061-2019
81	Jeffrey Swartz	JS-3	Bartow ST 40'' Blade Test. CONFIDENTIAL DN. 09061-2019
82	Jeffrey Swartz	JS-4	Bartow RCA Summary. CONFIDENTIAL DN. 09061-2019

Bartow ST#1 – L0 Blade Upgrade to Achieve 450MW

**Mitsubishi Power Systems
Americas, Inc.**

September 18th, 2013

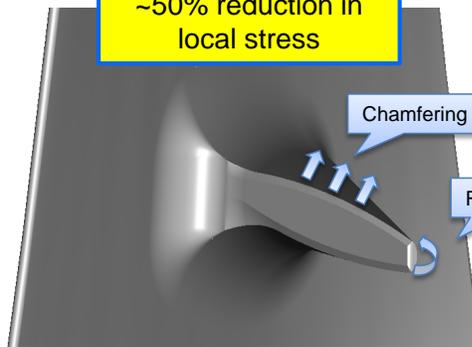
Before Crowning

- If stub surface is tilted in horizontal or vertical direction, high local stress on the stub is observed.
- Crowning is applied to the edge of stub contact to avoid the high local stress.

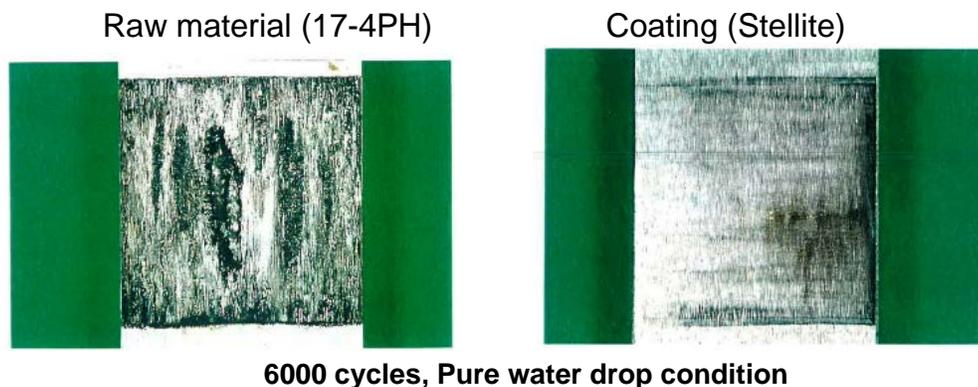
- Wear test with large slip is conducted using coated and uncoated blade material (17-4PH).
- Wearing characteristics of coating is much better than raw material.

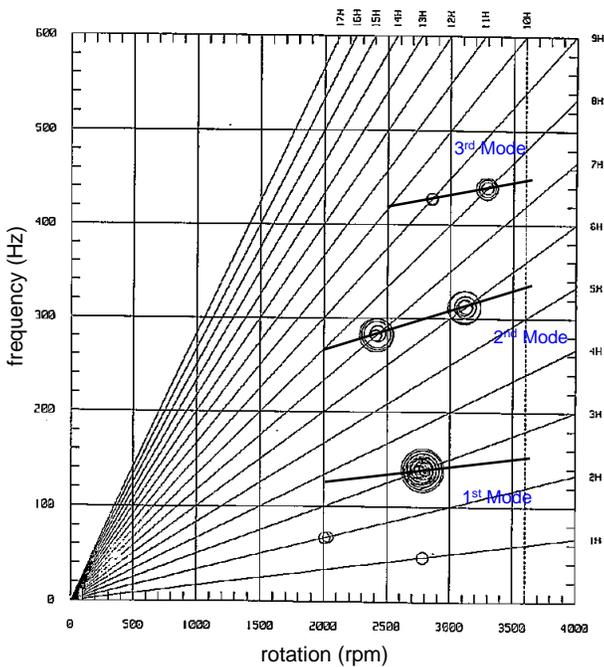
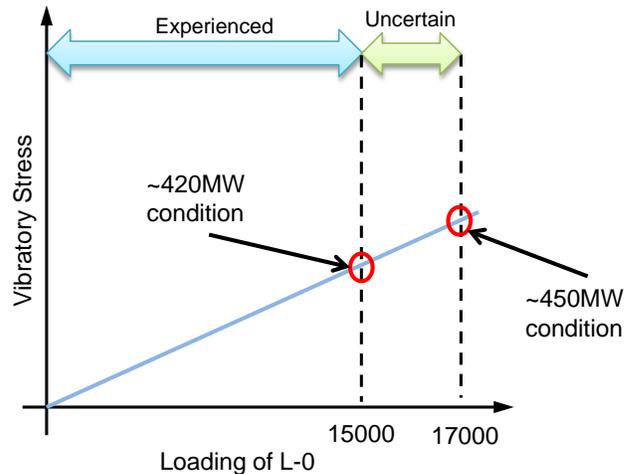
- First three modes are well tuned.
- There is no data or experience above 15000 lb/hr/ft²

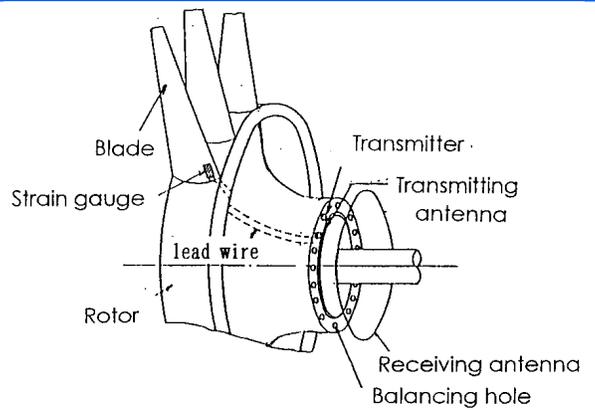
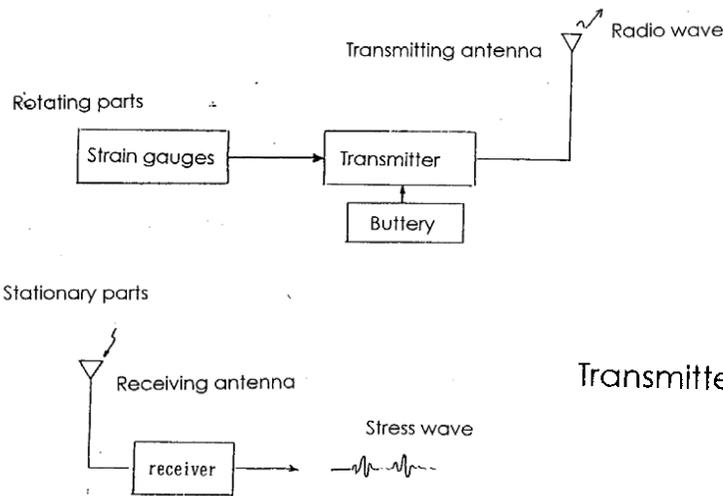
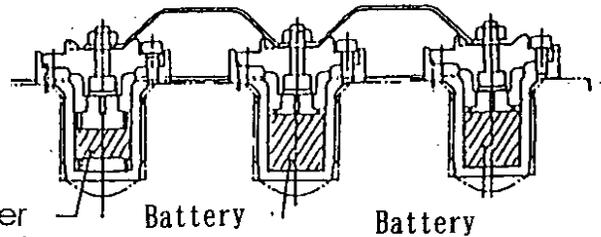
- Vibratory stress of moving blades are measured by telemetry system.
- Strain gauges and transmitters are mounted on blades and rotor.

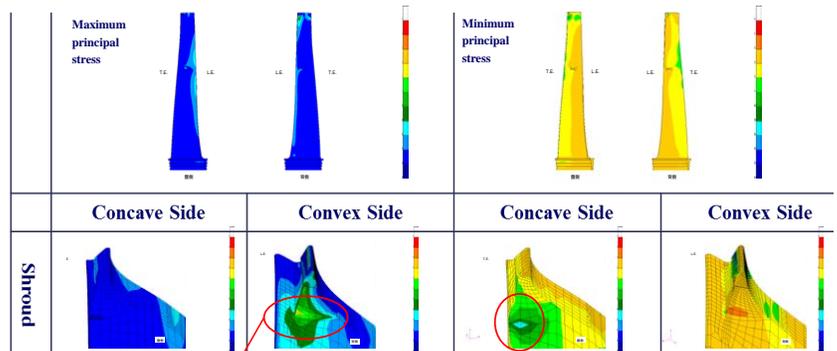
1st Mode Stress Distribution

Is the damage consistent with the stress analysis? - Yes

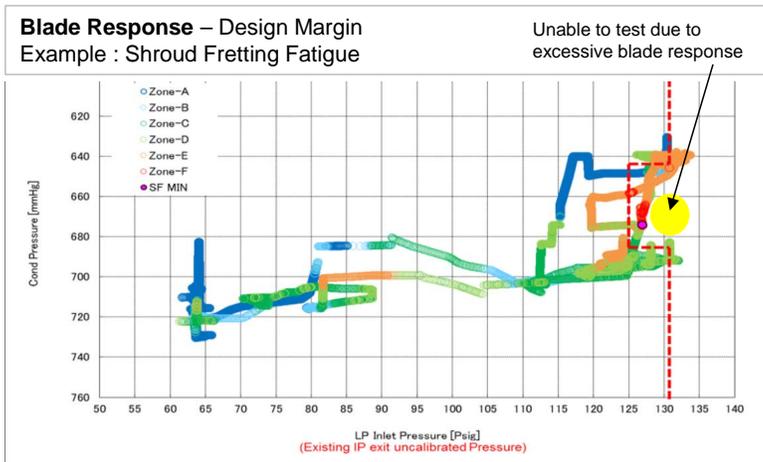
Damage Mechanism

- Blade response is evaluated through the integration of the stress response all the modes between 180Hz to 120Hz

Snubber fretting fatigue, shroud fretting fatigue and Vane High Cycle Fatigue are all calculated from the telemetry test with avoidance zone established to address all 3 cases.

Blade response is observed at around 16th Nodal Diameter of the first mode (approx. 200Hz). The Notable Non-synchronous Vibration is caused by aerodynamic flow and observed as the Multiple Modes Response (180Hz-220Hz).

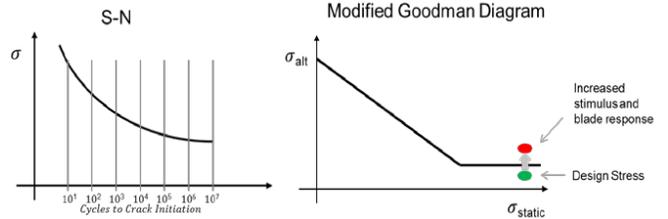
- Cycles accumulate at 12,000 cycles per minute at 200 Hz

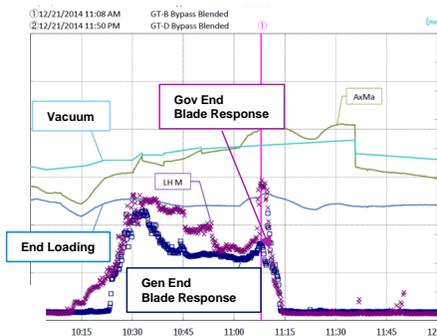
Blend in "B"

Further investigation is required to understand the impact of GT blends on blade loading

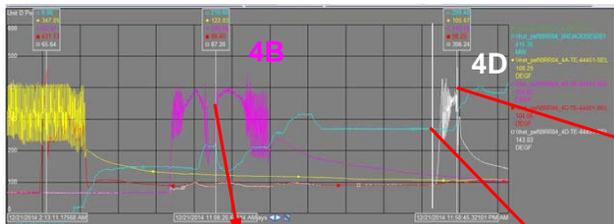
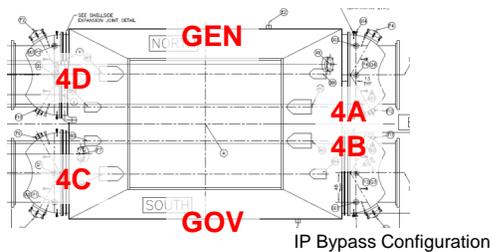
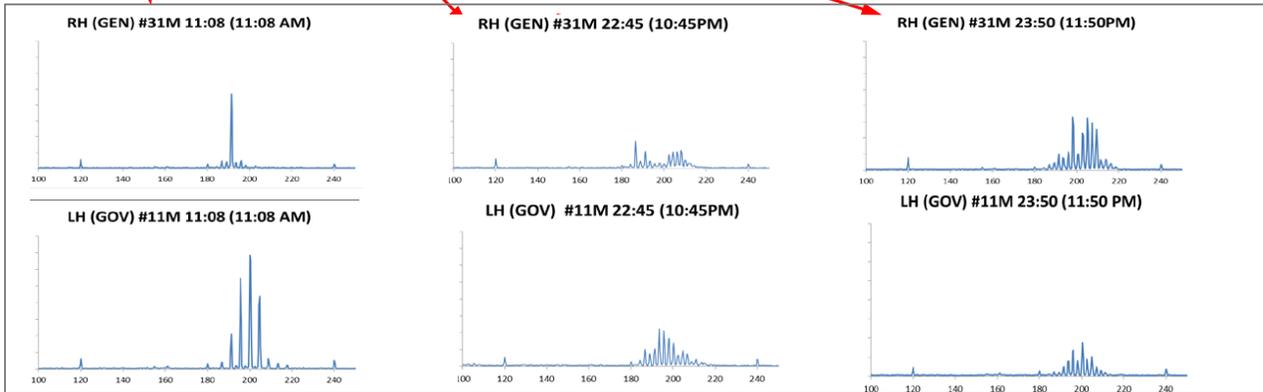
Telemetry Test Spectrum at GT Blending

Blade response during bypass operation is also Non-synchronous 16 Nodal Diameter response around 200 Hz

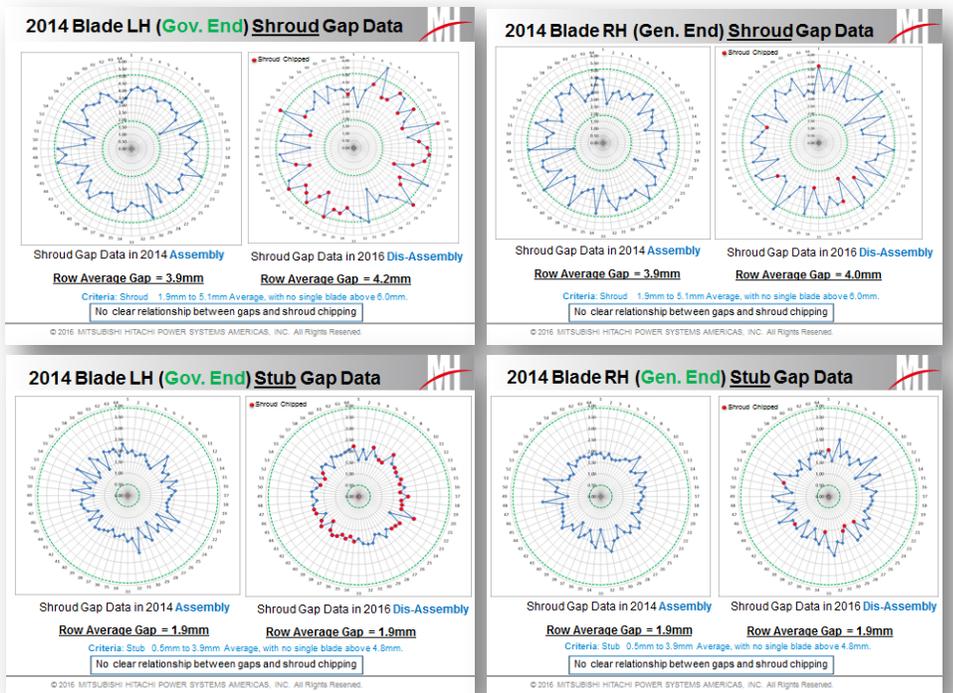
Shroud and Midspan Gap Data Evaluation

- Manufacturing Box Gauge Checks
 - Vane
 - Midspan
 - Shroud
- Assembly 4 Point Clearance Checks
 - Midspan
 - Shroud
- Correlation to damaged blades has not been identified.
- Evaluation completed for Periods 3,4,& 5.

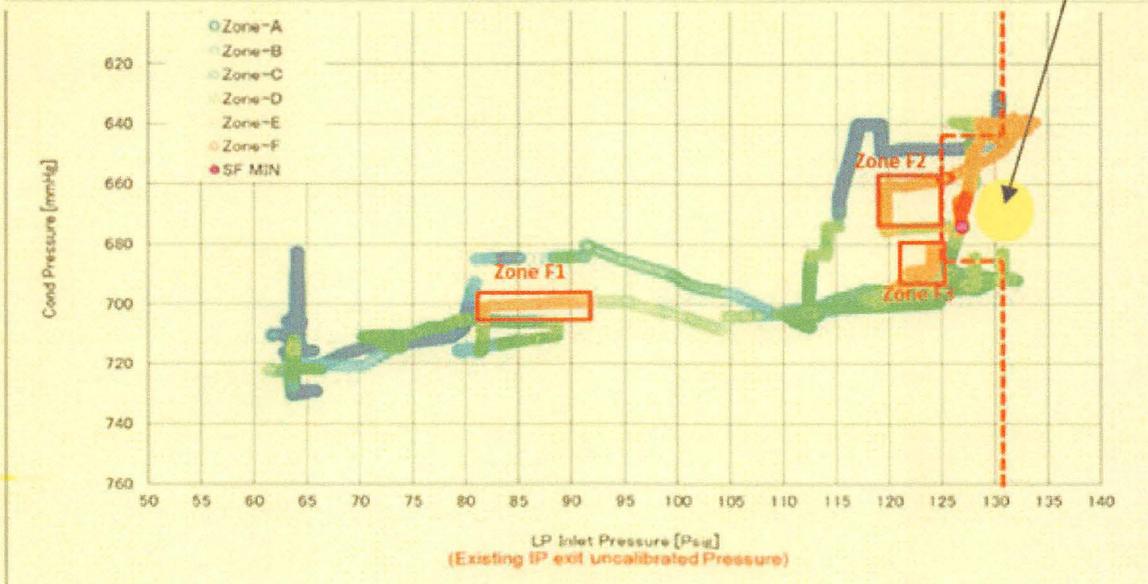
Blade Response – Design Margin
Example : Shroud Fretting Fatigue

Unable to test due to excessive blade response

- Blade response is evaluated through the integration of the stress response all the modes between 180Hz to 120Hz

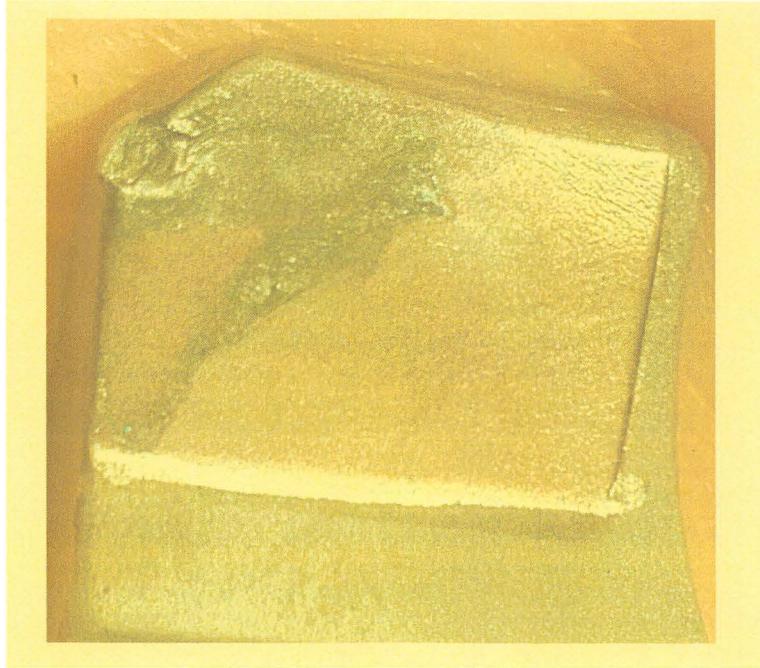
Figure 4 – Photo of an L-0 blade Z-Lock from Period 5 Showing Contact Surface Wear

Figure 4 shows the wear on one of the Period 5 Z-Locks. While varying degrees of wear are seen on the Period 5 Z-Locks, the wear is higher than what one would expect given the relatively low total turbine operating hours. Period 5's time in blend mode was consistent with those in other Periods and does not explain the amount of wear.

While the findings are not completely conclusive, there is good reason to believe that MHPS' design may be susceptible to damage when run in these zones. All Periods had hours in Zone F1 and F2. In addition, both on a percentage and absolute basis, Period 5 had a significant number of operating hours in this higher dynamic stress zone. Because each Period included run times in one or more zones and because each Period resulted in differing degrees of damage without direct correlation to the run times in those zones, it is difficult to conclude that operation within the zones is the cause of the L-0 blade failures. However, if the design margin on the blades is small, the blades may be susceptible to cracking, excessive wear, etc., when the unit either runs in or passes through these zones.

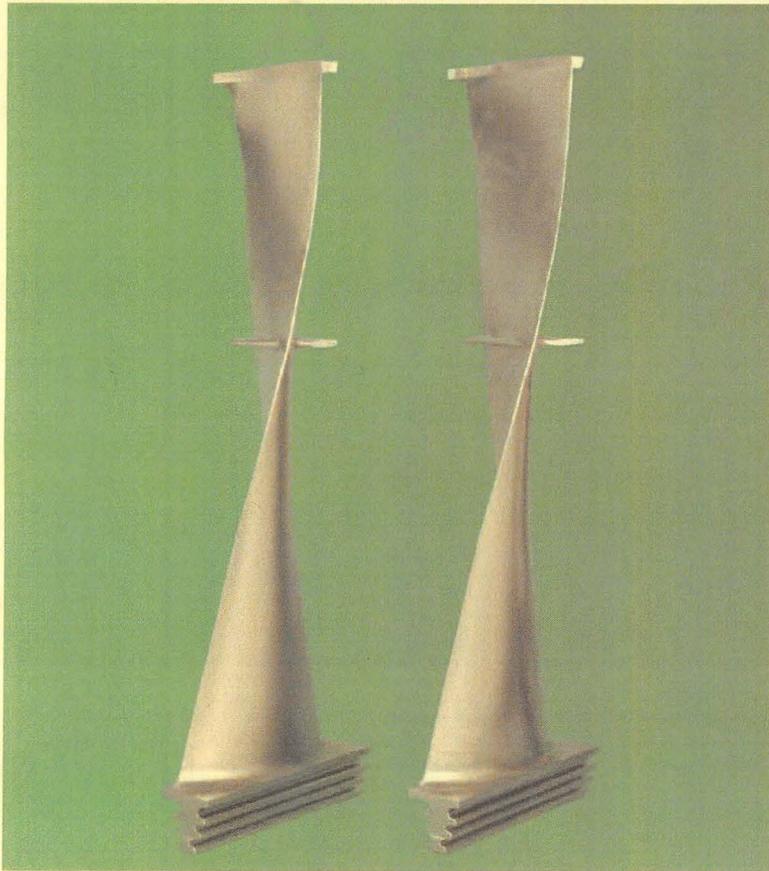
40" L-0 upgrade blade for high loading

- Once the root cause was understood MHPS developed an upgraded 40" L-0 blade specifically to operate the conditions present at Bartow. **(Note : this is not required across the fleet)**

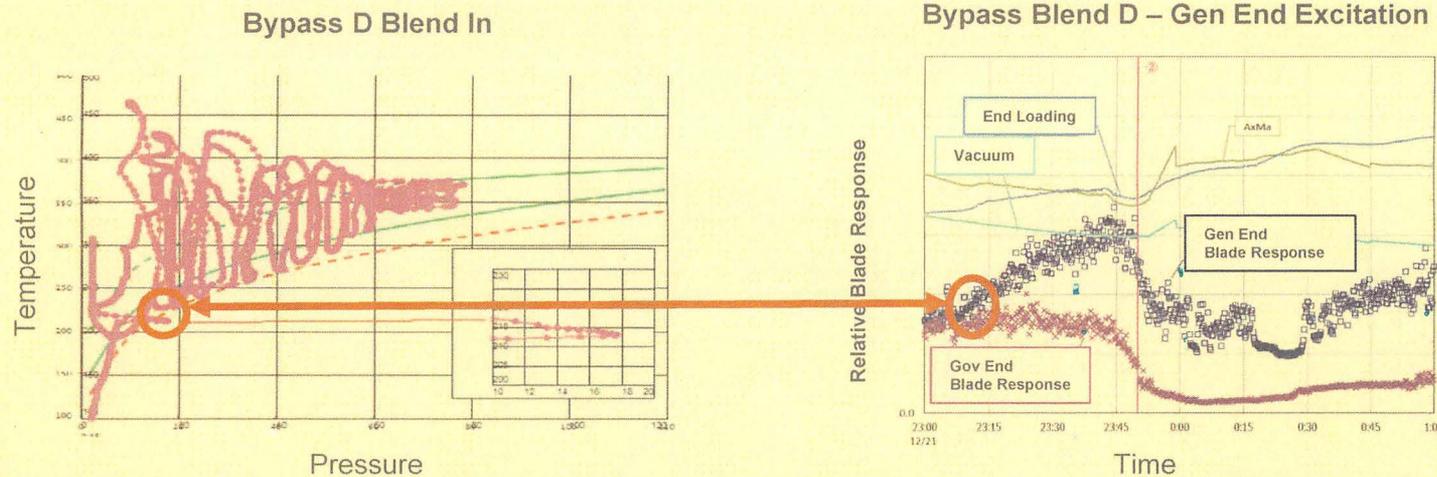
Bypass Operation - Does hitting the saturation line during bypass blending produce a forced response on the blade ?

During the telemetry test 2 blend in event were captured, but pipe accelerometers were not installed until Mid 2015. Based on Duke's evaluation of blends after installation of the accelerometers, dropping below the saturation line potentially produces a shock wave which excites the blades.

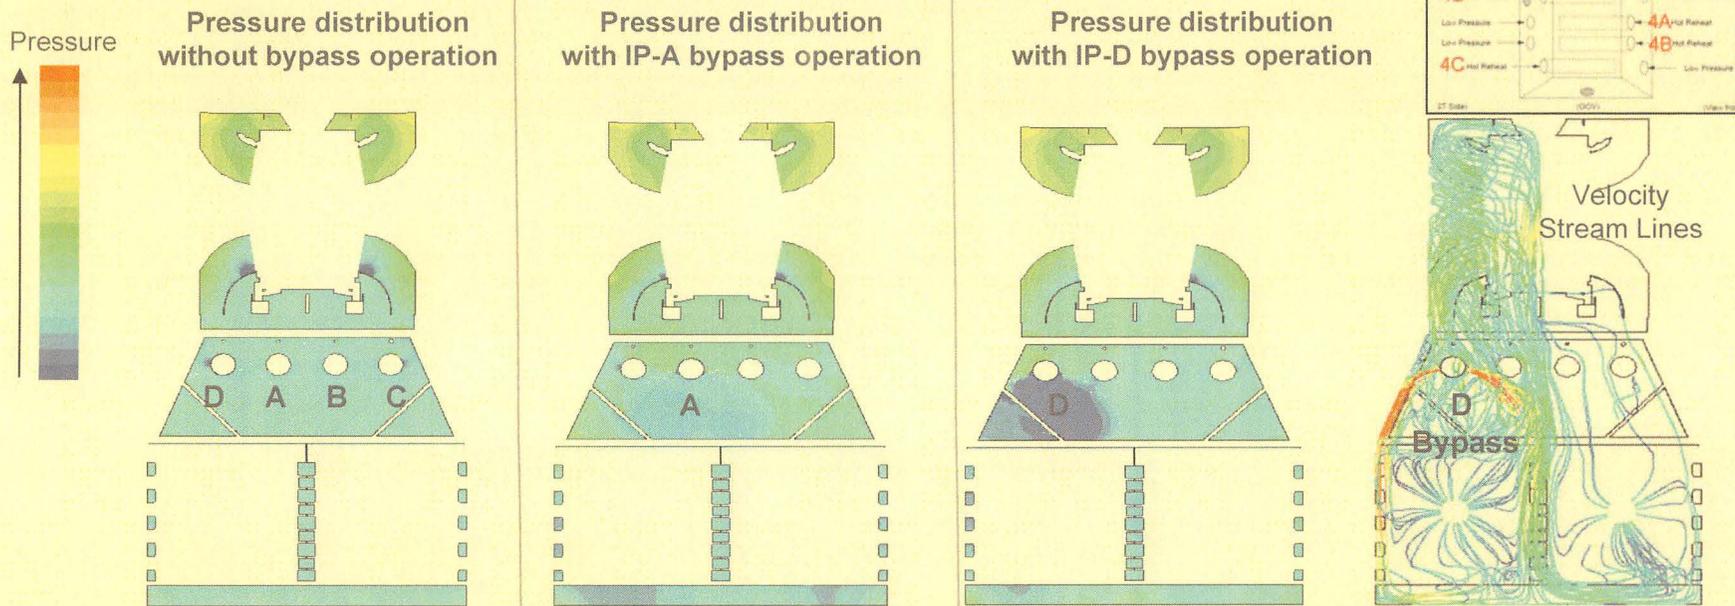
Does Bypass Operation Provide Stimulus to the blades?

- Increased blade response (1.5X Increase from C or D Bypass) was quantified through Telemetry Testing (Blade response was recorded and shown to be Non-Synchronous Self Excited Vibration (Flutter))
- A and B Bypass operation do not show increased blade response which is consistent with other 2on1 bypass configuration telemetry Tests.
- Bypass configuration within the condenser is unique to Bartow with C and D bypasses located close to the exhaust.
- Condenser heat load at 420MW is at the limit of the condenser specification. High velocities during 3 to 4 GT Bypass Operation

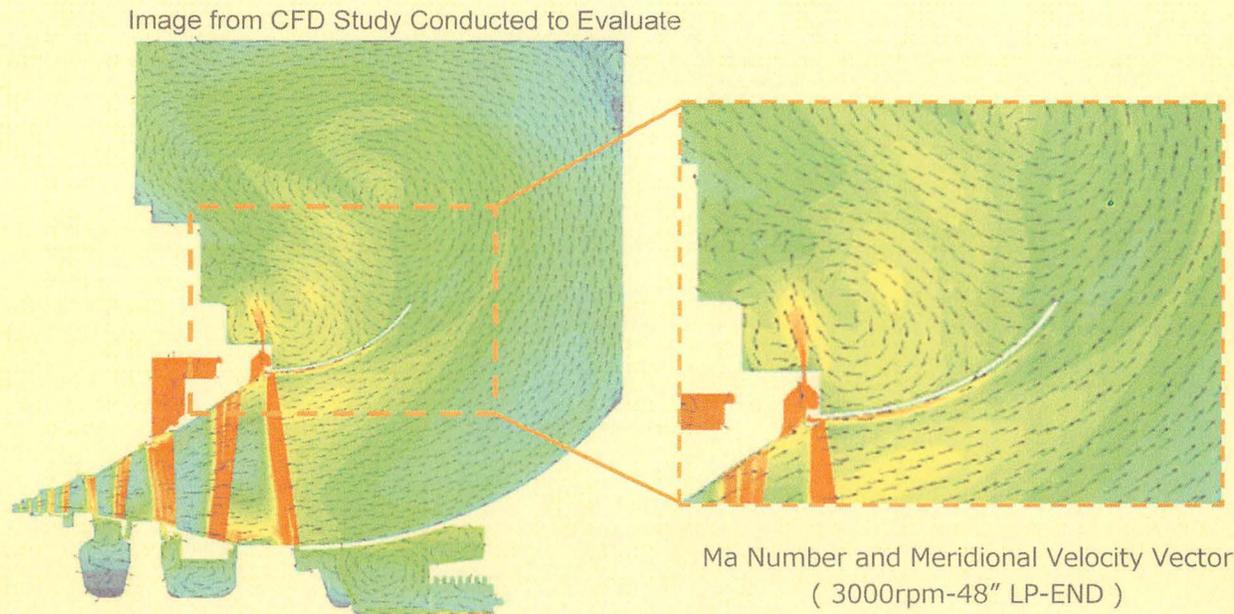
Are water droplet drawn back into steam path, or condensate prevented from leaving the steam path through aspiration?

- CFD confirms no re-entry of water spray / steam into the steam path (No aspiration occurs)

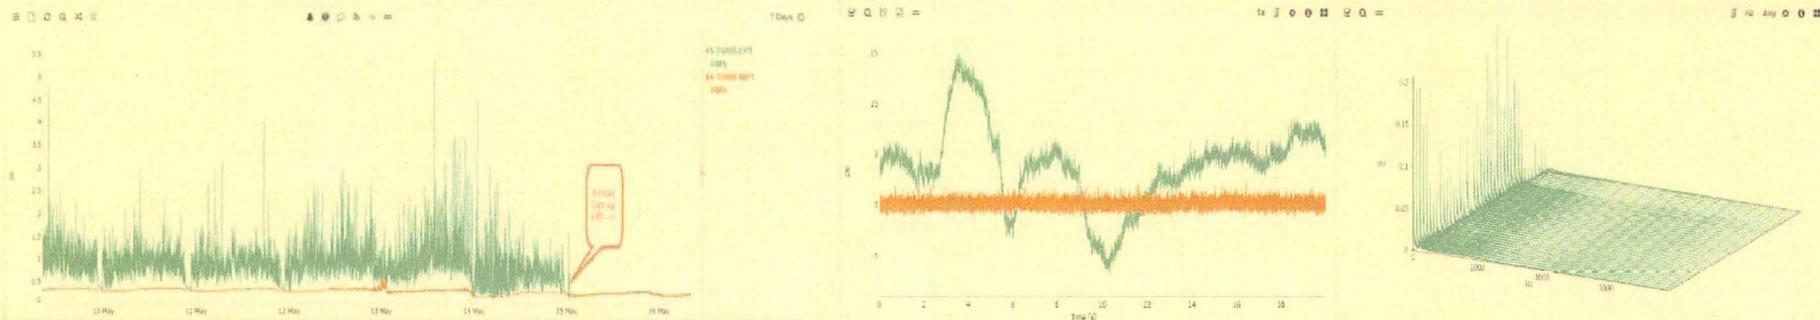
Dynamic pressure identified associated with Hood Sprays :

Pressure fluctuations did not have high frequency content, and identified pressure rising from 2.5" Hg to atmospheric pressure. No corresponding blade response identified during telemetry test.

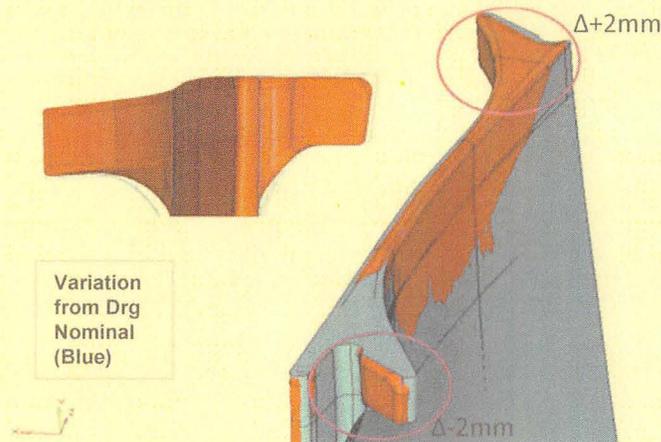
Geometry Evaluation – Type 3

- The blade response analysis has captured the worst case geometry variation. The baseline geometry for the blade response in the telemetry test was the Type 3 blade which shows the greatest geometry variation.
- Type 1 blade shows less distortion than the Type 3 Blades.

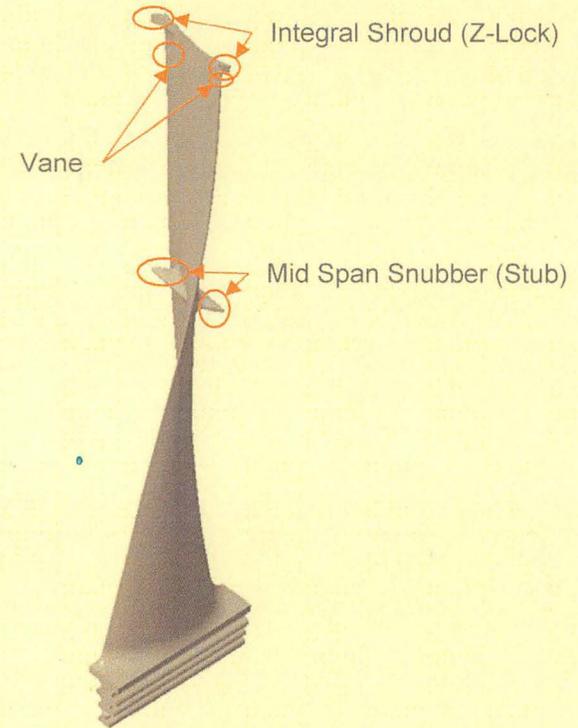
Blade damage occurs when : **Stress > Material Capability**

- Stress comes from Dynamic Loads superimposed on the steady state loads (Centrifugal + Steam Bending Loads).
- Limiting stress locations for 40" L-0 Blade :
 - 1) Mid Span Snubber
 - 2) Integral Shroud
 - 3) Vane HCF
- Dynamic Stresses are controlled by avoiding resonant operating conditions where the blade response frequency matches frequency of the stimulus, and ensuring adequate damping.

Root Cause Analysis has identified all blade damage from Period 1 thru Period 5 has been identified as Dynamic Loads from Non-Synchronous Self Excited Vibration (Flutter)

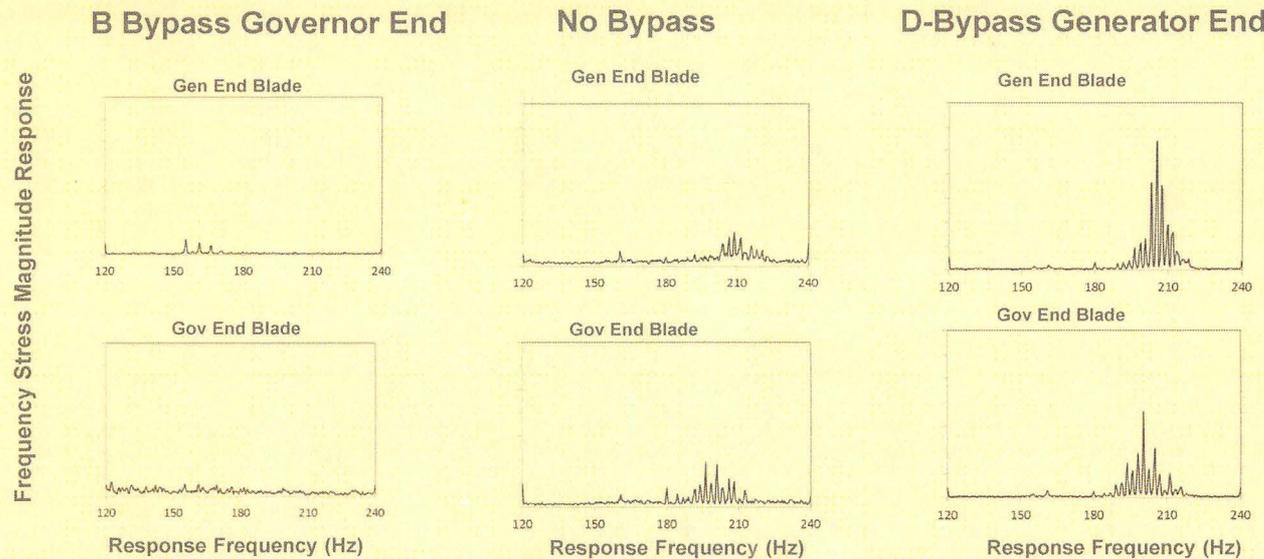
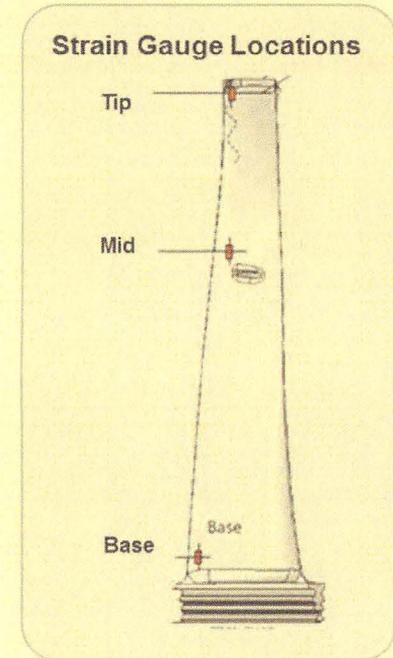
Frequency Response from Telemetry Test :

- Peaks at 120, 180, 240Hz are per Rev Responses
- Peaks between 180 to 230Hz are High Nodal Diameter responses of the First Cantilever Mode. These frequencies are associated with Non-Synchronous Self Excited Vibration

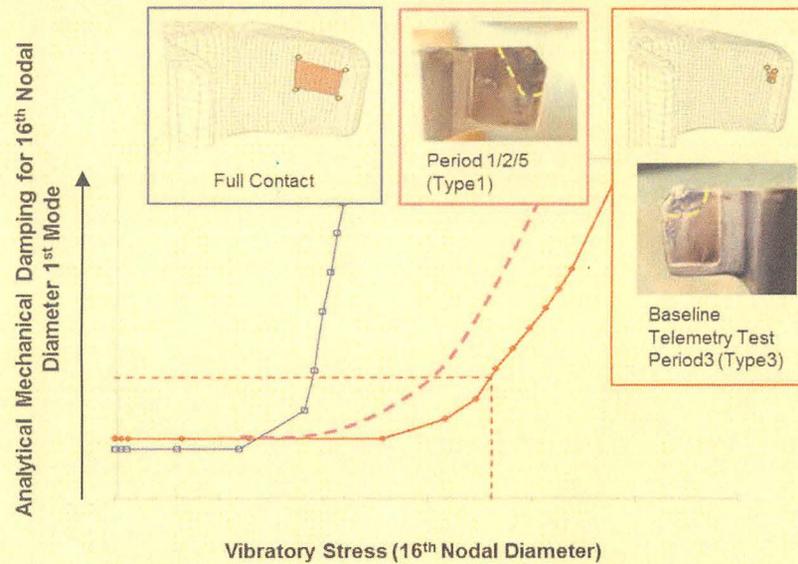
Vibratory Stress vs Mechanical Logarithmic Damping (16ND)

Analytical damping results are intended to understand drivers for blade response, absolute blade response was established from Telemetry Test

- Type 3 Blades established the baseline blade response from the telemetry test.
- Type 3 Blades were found to have lower damping than Type 1 Blades due to smaller contact area

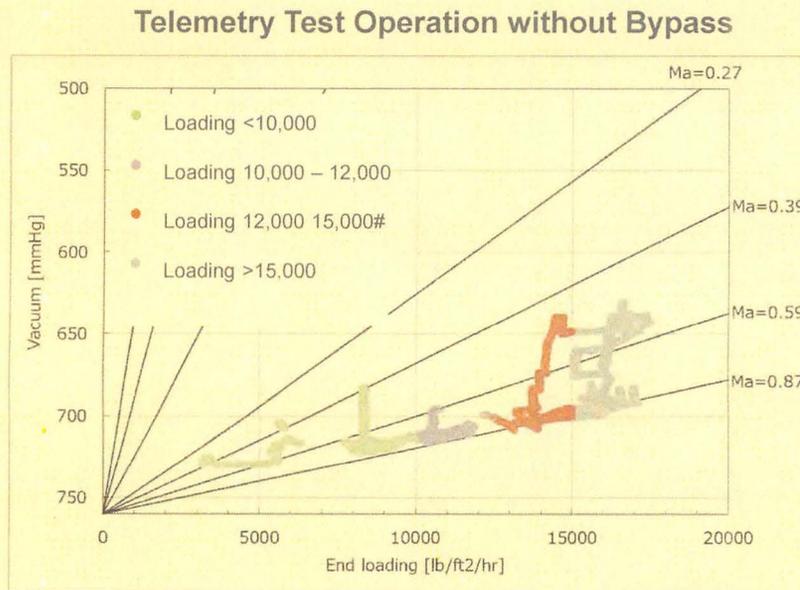
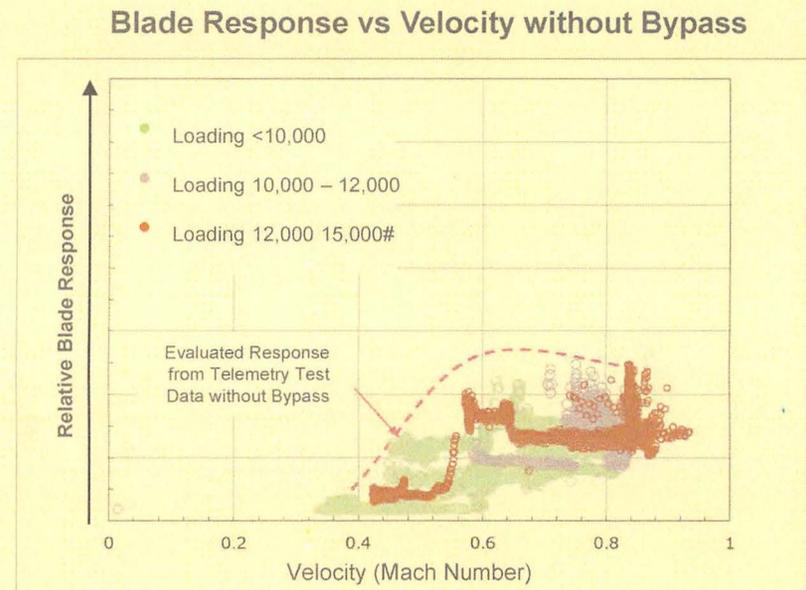
Blade Response as a Function of Mach Number – without Bypass

- Below 15,000 lb/hr/ft² Blade Response becomes dominated by Mach Number

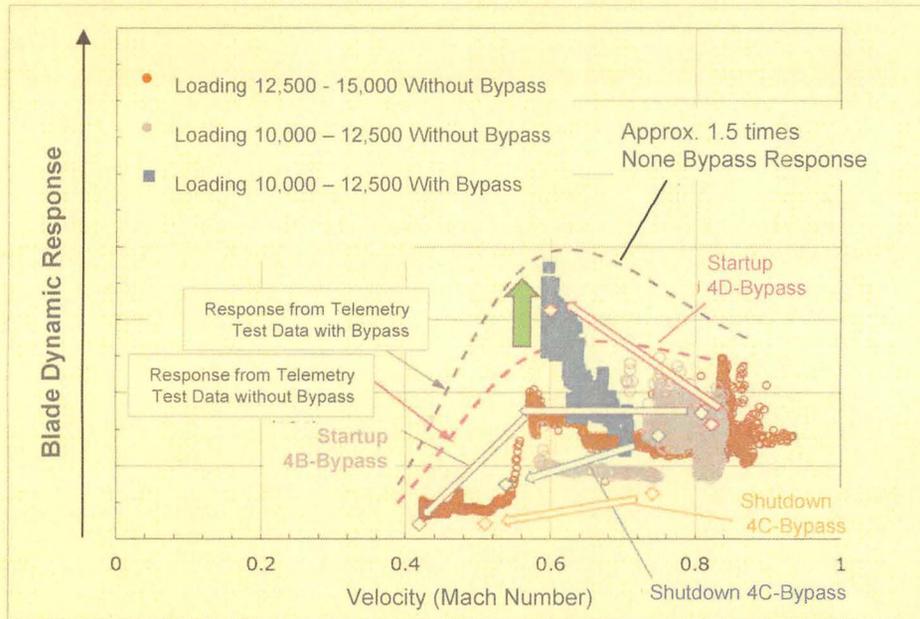
Blade Response as a Function of Bypass Operation

- Operation with Bypass D and C Produce a 1.5X Increase in blade response on the blades closest to the bypass
- Operation with Bypass A and B did not show an increase in blade response over none Bypass Operation
- Limited Blade Response data during Bypass is available with the operation before and after Dec 2014 Telemetry Testing being assumed to have remained the same change in response.

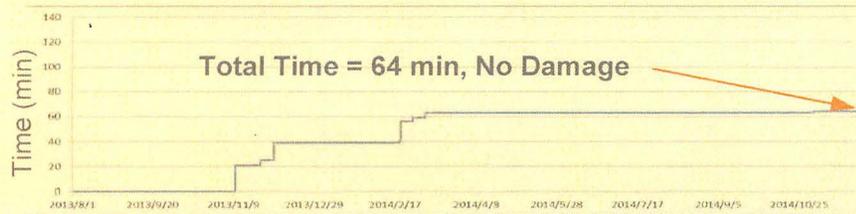
Period 2 – C Bypass Accumulation – No Stub Damage (Gov)

- Damage accumulates with High Load Bypass Operation of 4th GT Blending In or Out at 4C or 4D , High Mach #
- Accumulated damage below is based on time spent conducting 4th GT Bypass on C or D + Mach# > 0.55

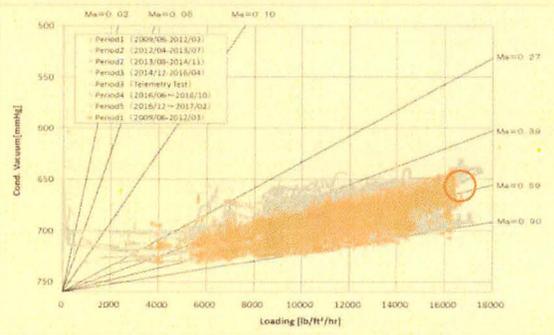
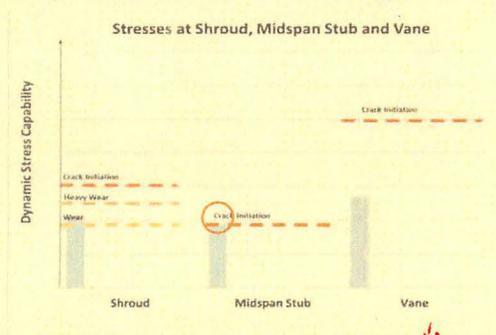
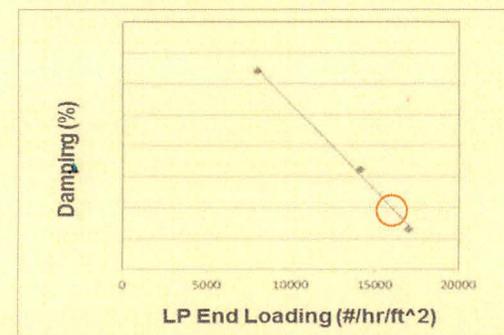
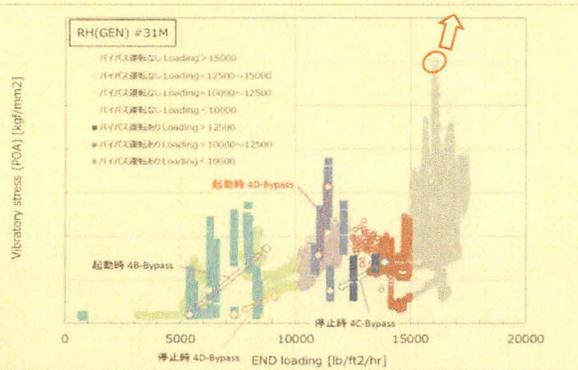
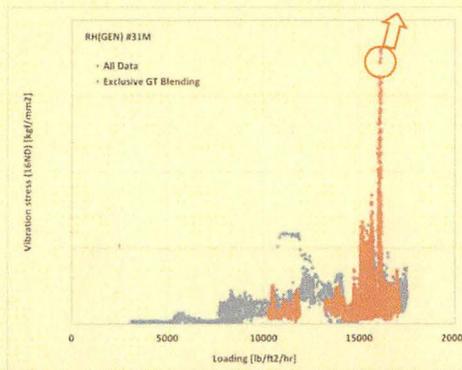
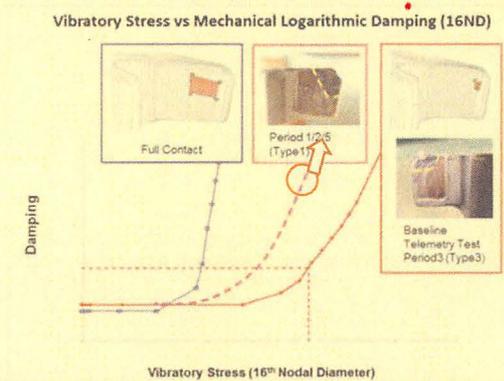
Period 1 – Stub Cracking

Operation at higher loads than Period 3, but Type 1 Blade has improved damping over Type 3 in Telemetry Test

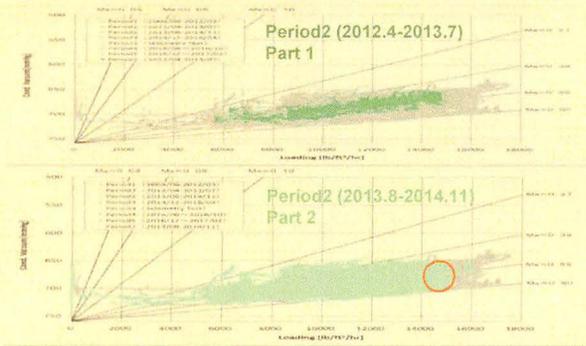
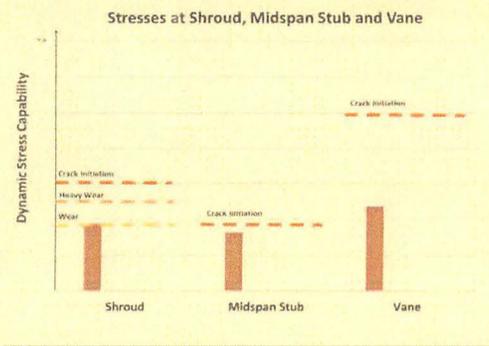
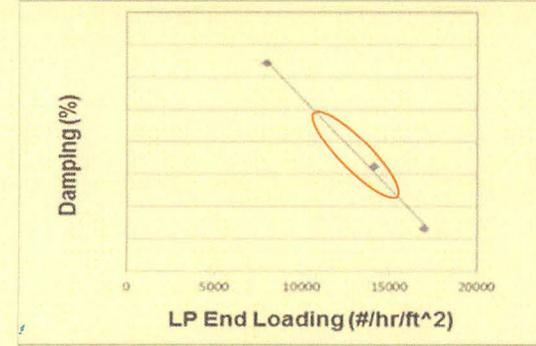
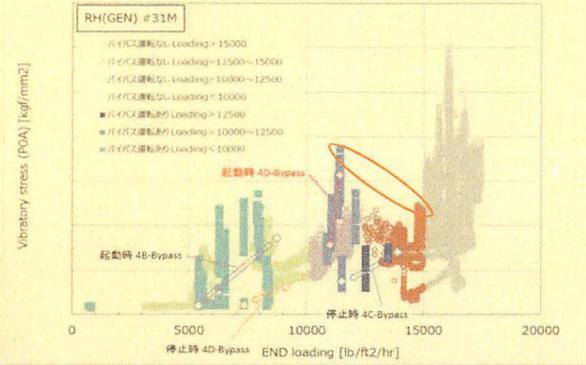
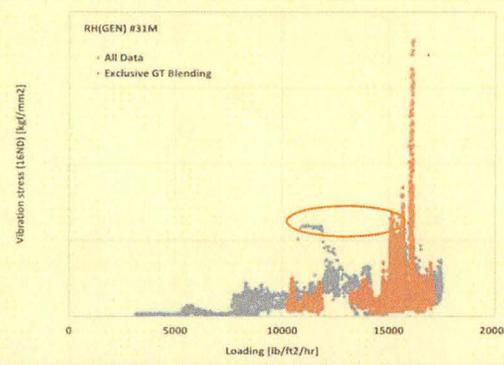
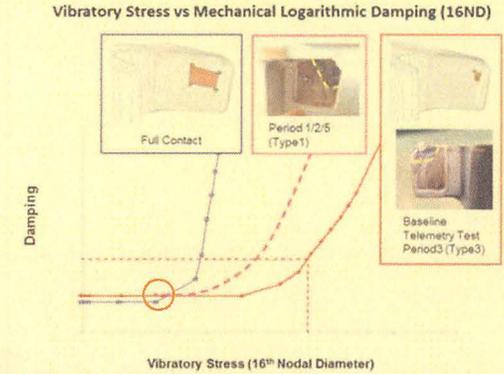
Period 2 – No Major Damage, Minor Shroud Chipping

Reduced LP Loading over Period 1, reduced bypass operation loading over period 5, light wear observed on shroud

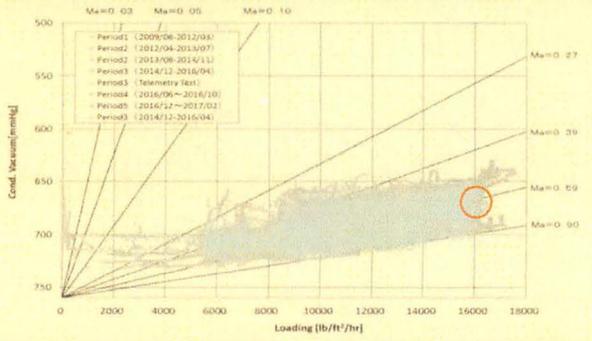
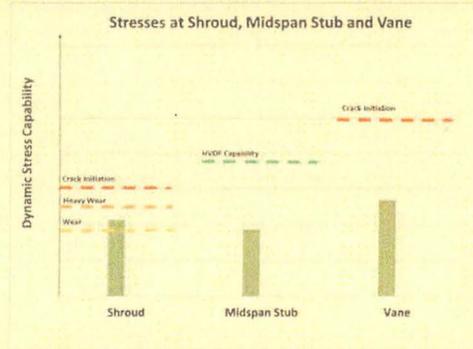
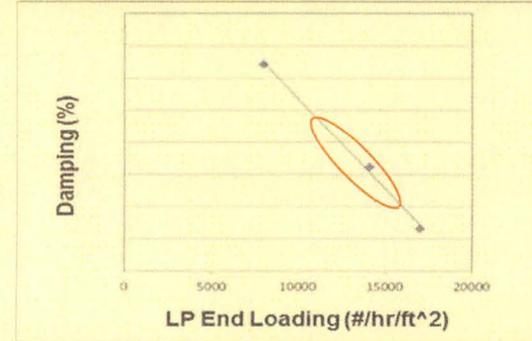
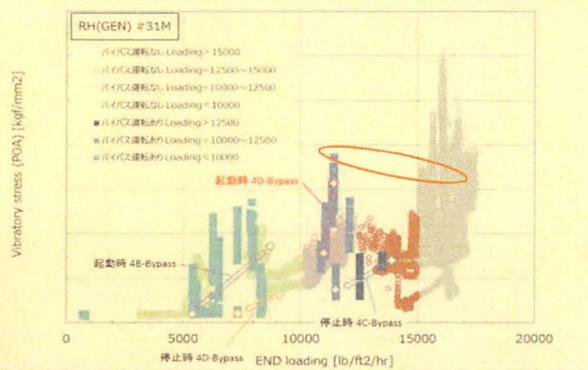
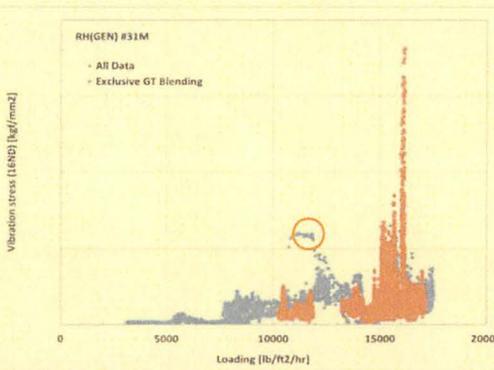
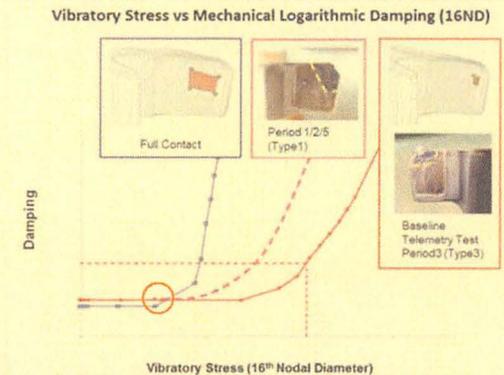
Period 3 – Shroud Cracking - Outside Avoidance Zone

Outside of avoidance zone, bypass operation becomes most limiting. With HVOF on Mid Span Stub no cracking is predicted.

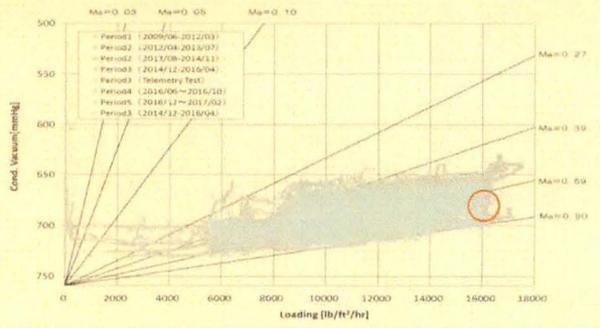
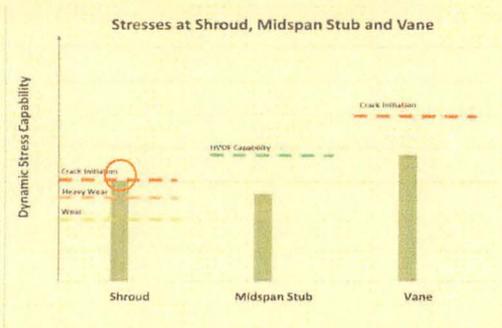
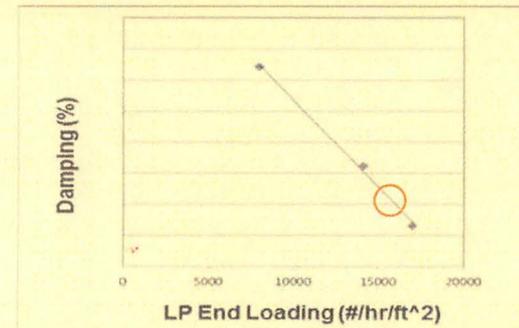
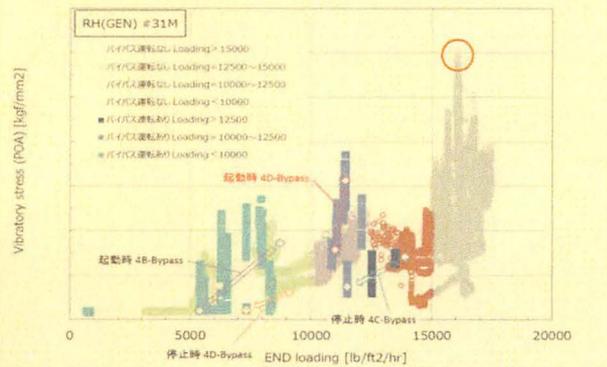
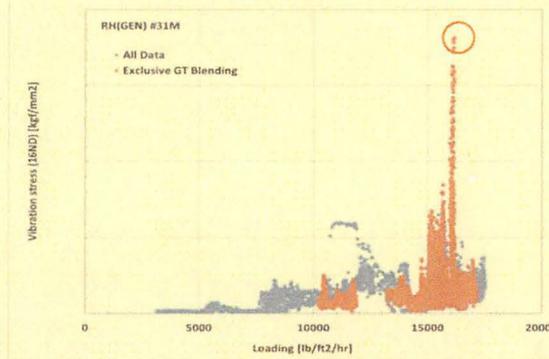
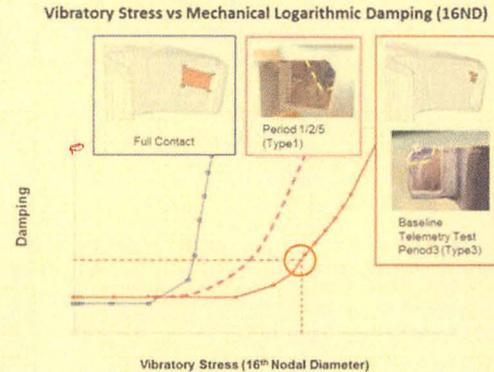
Period 3 – Shroud Cracking– Inside avoidance zone

High blade response established in Telemetry Test. Mid Span Stub protected by HVOF. Shroud become limiting location.

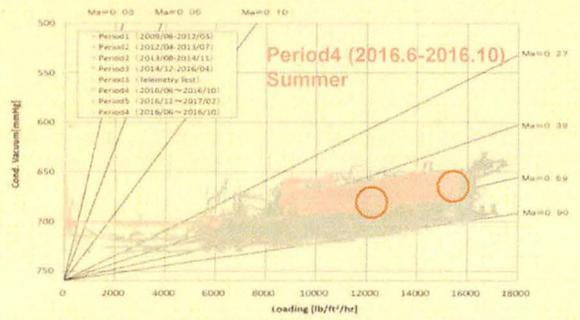
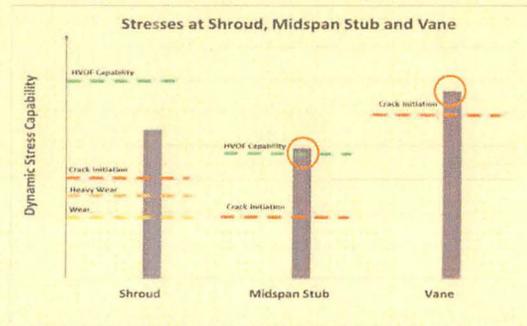
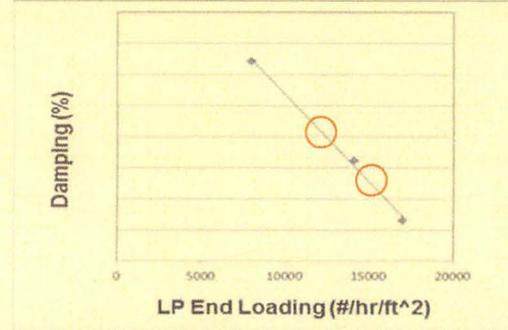
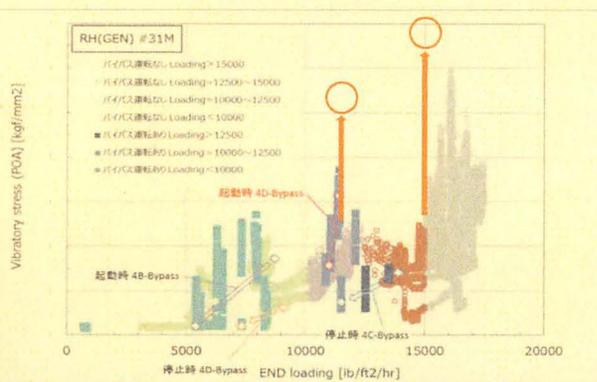
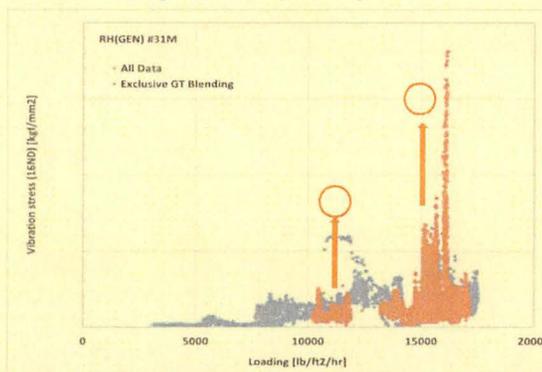
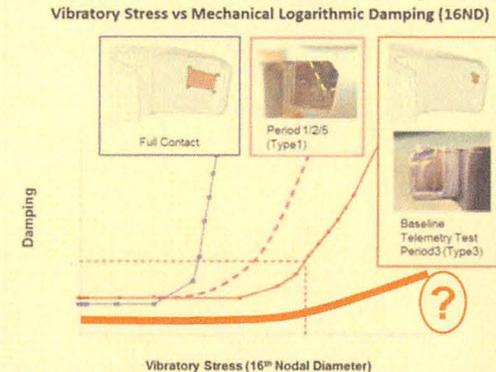
Period 4 – Vane + Stub Cracking

Reduced LP Loading. Application of HVOF reduces mechanical damping increasing amplitude of response. With HVOF protecting the Shroud and Stub, the limiting location becomes the Vane

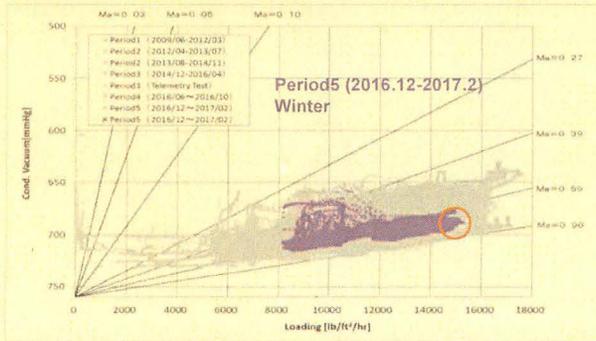
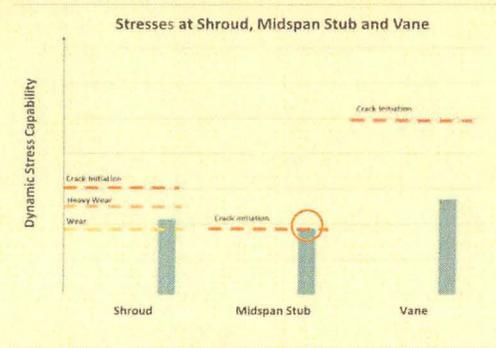
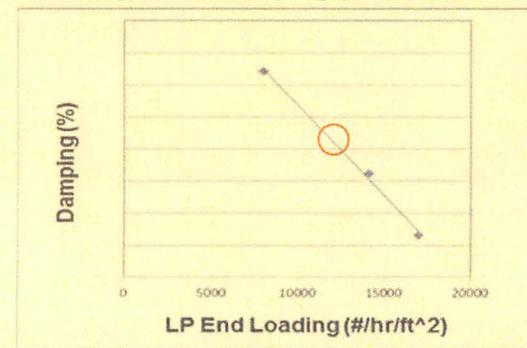
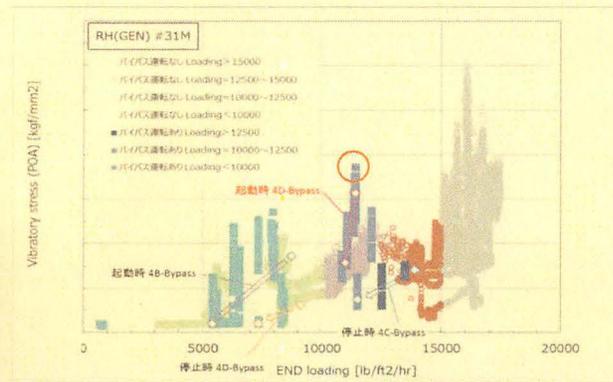
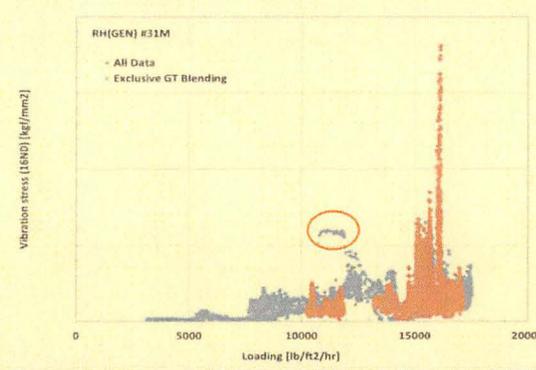
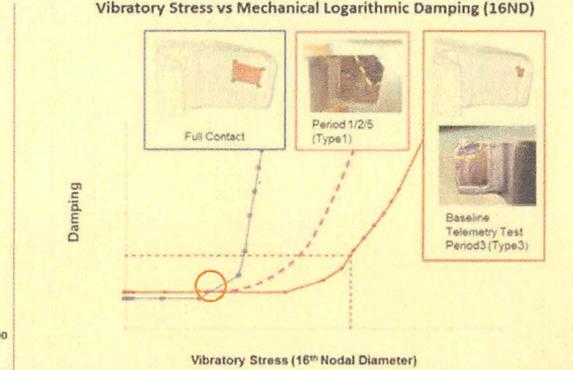
Period 5 – Stub Cracking

Reduced LP Loading over Period 2 with longer periods of bypass operation at High Mach Number. No HVOF Protection.
