**Before the
Florida Public Service Commission
Docket No. 970261-EI**

**PRELIMINARY
CRYSTAL RIVER UNIT 3 OUTAGE REVIEW**

**Direct Testimony of
WILLIAM K. JACOBS, JR., Ph.D.**

**On Behalf of
THE FLORIDA OFFICE OF PUBLIC COUNSEL**

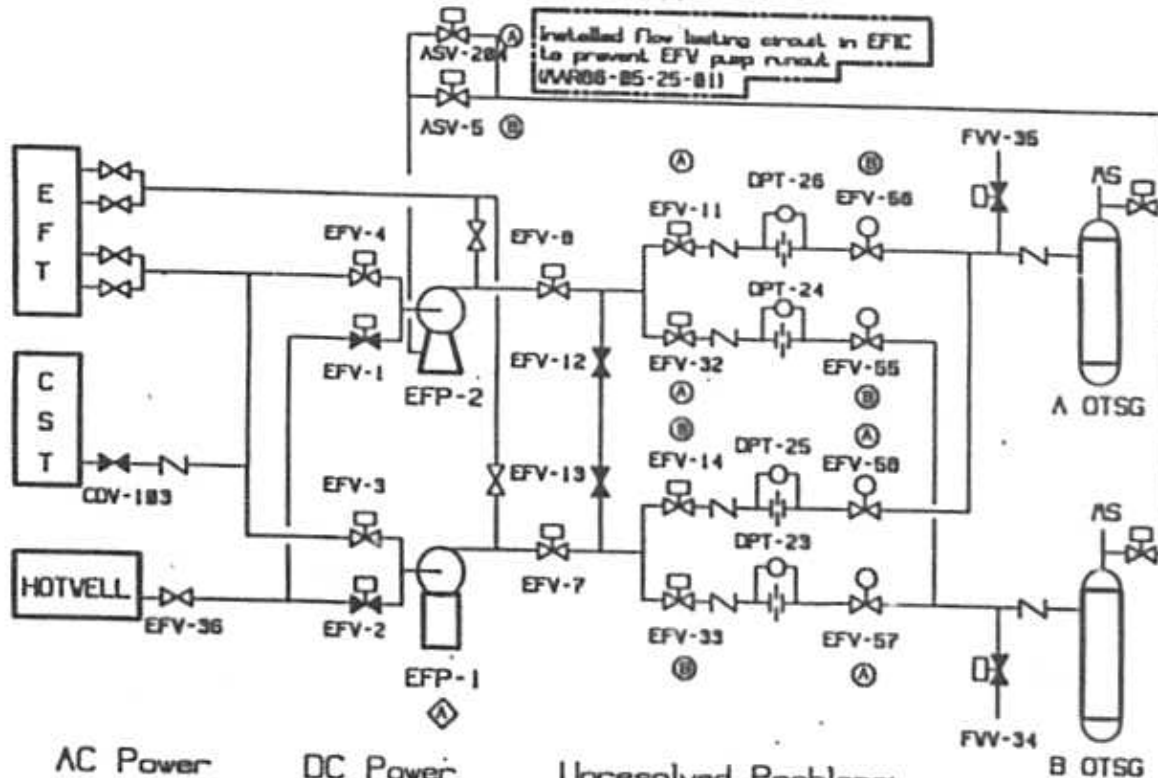
Configuration #6 - EFIC System Modified to Limit EFV Flow
 (December 1987)

- 2-2, 4-1 Previous problems not addressed
- 5-1 Cross-train dependency
- 5-2 Cycling of block valves to control OTSG level
- 5-3 Benefits of flow limiting change in Conf #6 negated by this change

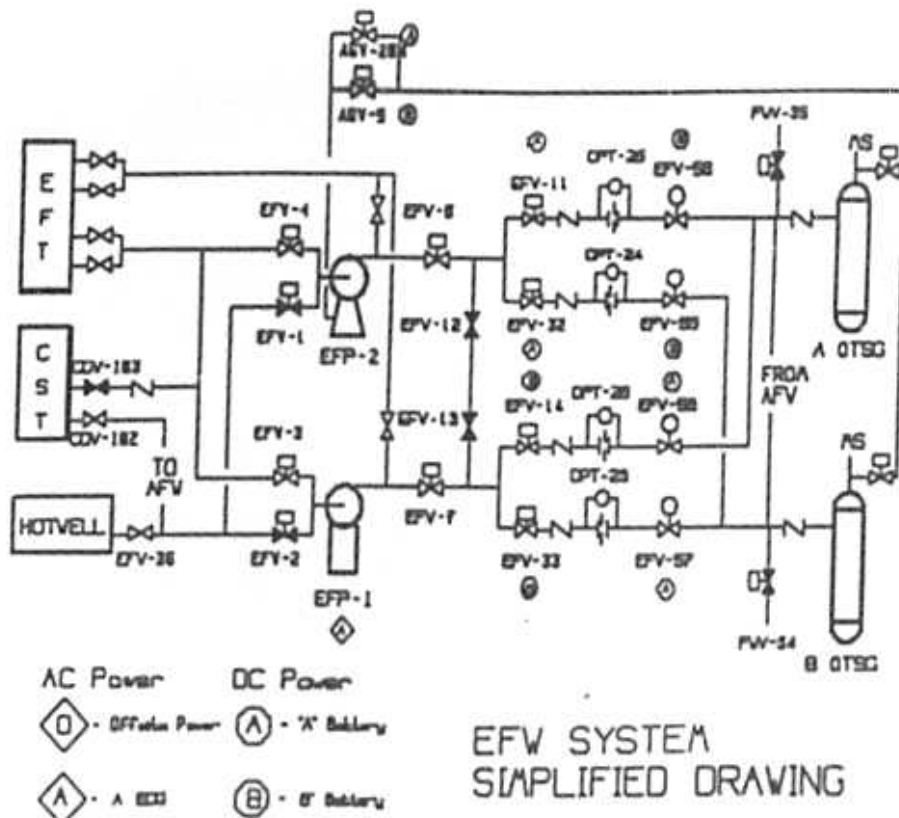
Figure 1

The Emergency Feedwater (EFW) system provides secondary coolant to the Once Through Steam Generators [AB,SG](OTSG) in the event the Main Feedwater System [SJ](FW) is rendered inoperable and is unable to perform this function. The EFW system has two equipment trains (See Figure 1). Each train is capable of feeding both OTSG's. The two trains take suction from a common line. The flow control valves associated with each pump operate on DC power. The valves are normally open and require DC power to close and are open in the standby mode. EFP-1 is motor-driven and is aligned to the 'A' Emergency Diesel Generator during LOOP conditions. EFP-2 is turbine-driven; motive steam is supplied from the Main Steam [SA](MS) header. The system includes two valves, ASV-5 and ASV-204, which open to admit steam to EFP-2 when EFW actuates. The valves are installed in parallel with one another. Only one of the valves must open in order to start the pump. ASV-5 receives an OPEN command from an actuation of the 'B' EFIC train.
