Re: Indianwood Development Corporation  
v. Indiantown Company, Inc.

**Docket No. 990173-W/S  
Filed: February 12, 1999**

INDIANTOWN COMPANY/INDIANWOOD  
INDIANTOWN, FLORIDA

INDIANWOOD SUBDIVISION DEVELOPMENT  
OBSERVATION AND EVALUATION  
OF WATER AND  
WASTEWATER FACILITIES

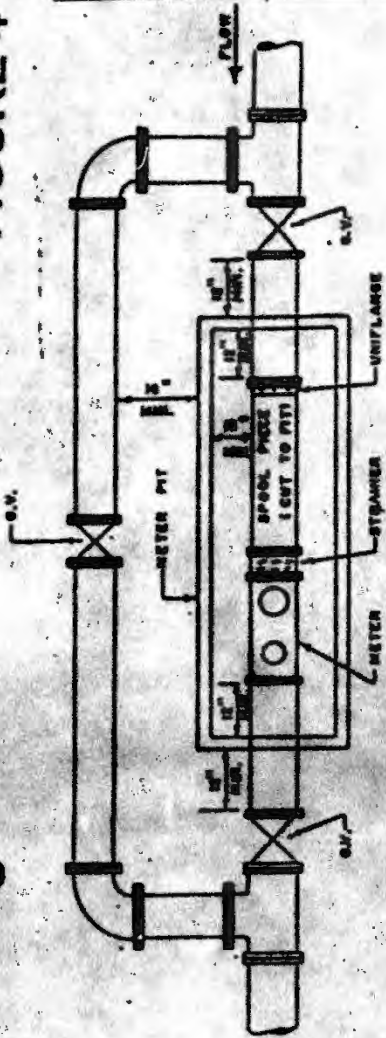
FIGURE 4

Current meter vault standards are shown in Figure 4. The existing meter vault does not comply with current standards.

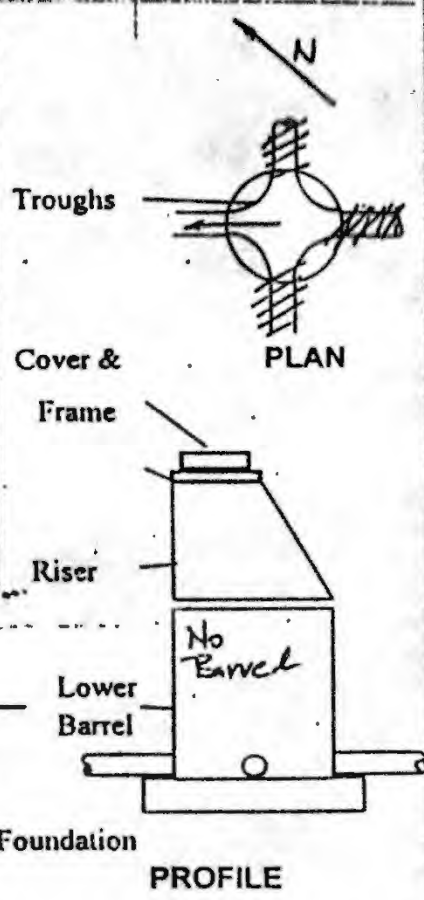
City: <b>Indiantown</b>	Location: <b>Indianwood Sub.</b>	Inspection by: <b>RMS/SJD</b>	
Date: <b>May 5, 1998</b>	Day: <b>Tuesday</b>	Time: <b>1:00</b>	<b>AM/PM</b>
Location: <b>MH6 Flush Type</b>		Zone:	
Inspector: <b>RMS/SJD</b>		Weather: <b>Clear &amp; Hot</b>	Temp: <b>80° F</b>

Item	Construction Material	Condition
COVER	Cast Iron (Vulcan Y-1344-I Type)	Good
FRAME	Cast Iron	Good
CHIMNEY	Brick and Mortar	Good
STEPS	None	
CORBEL WORK	None	
RISER WALLS	Concrete	Good
BARREL WALLS	Concrete	Good
BENCH	Concrete	Good
TROUGHS	Concrete	Good

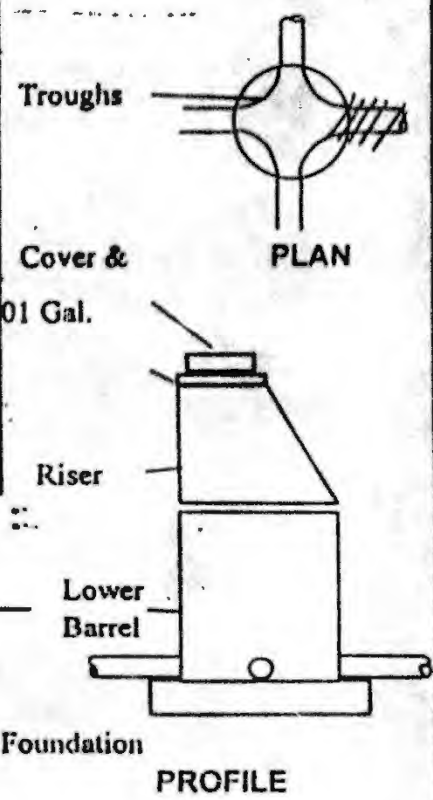
City: <u>Indiantown</u>	Location: <u>Indianwood Sub.</u>	Inspection by: <u>RMS/SJD</u>	
Date: <u>May 5, 1998</u>	Day: <u>Tuesday</u>	Time: <u>1:00</u>	<u>AM/PM</u>
Location: <u>MH No. 18</u>	Zone: _____		
Inspector: <u>RMS/SJD</u>	Weather: <u>Clear &amp; Hot</u>	Temp: <u>80° F</u>

Item	Construction Material	Condition
COVER	Cast Iron (Vulcan Y-1344-I Type)	Good
FRAME	Cast Iron	Good
CHIMNEY	Brick and Mortar	Good
STEPS	None	
CORBEL WORK	None	
RISER WALLS	Concrete	Minor Infiltration < 01 Gal.
BARREL WALLS	Concrete	Good
BENCH	Concrete	Good
TROUGHS	Concrete	Good

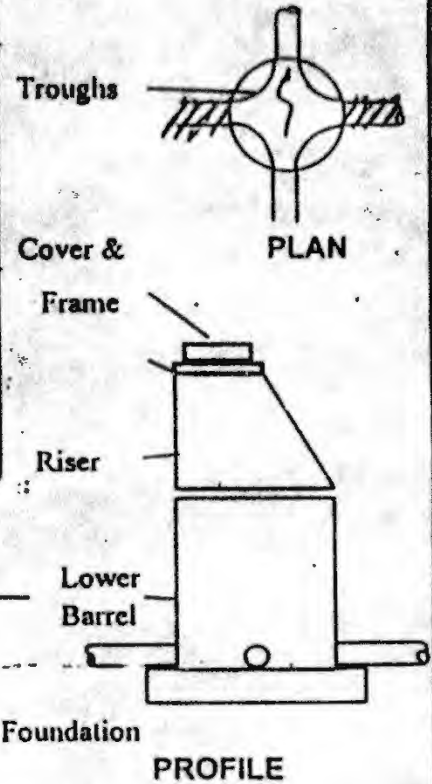
Item	Construction Material	Condition
COVER	Cast Iron	Good
FRAME	Cast Iron	Good
CHIMNEY	Brick and Mortar	Good
STEPS	None	
CORBEL WORK	None	
RISER WALLS	Concrete	Good
BARREL WALLS	Concrete	Good
BENCH	Concrete	Good
TROUGHS	Concrete	Good

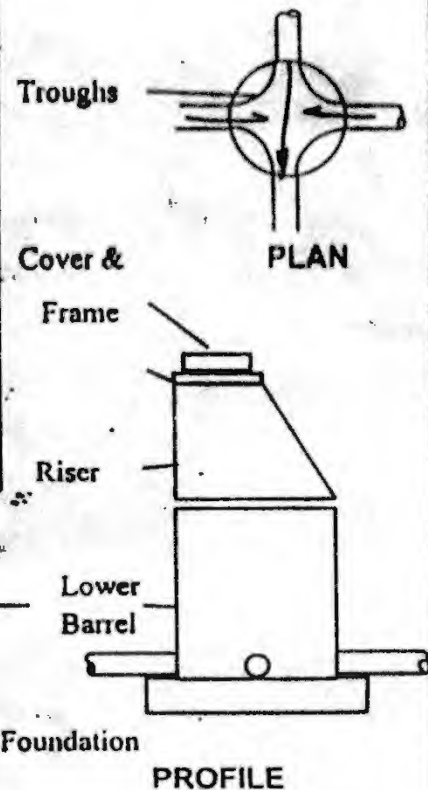
Item	Construction Material	Condition
COVER	Cast Iron (Vulcan Y-1344-I Type)	Good
FRAME	Cast Iron	Good
CHIMNEY	Brick and Mortar	Good
STEPS	None	
CORBEL WORK	None	
RISER WALLS	Concrete	Good
BARREL WALLS	Concrete	Good
BENCH	Concrete	Good
TROUGHS	Concrete	Good

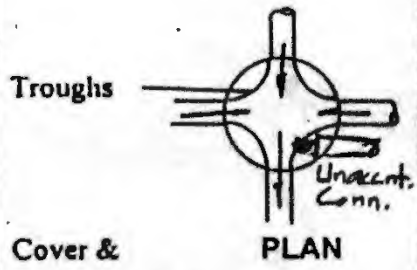
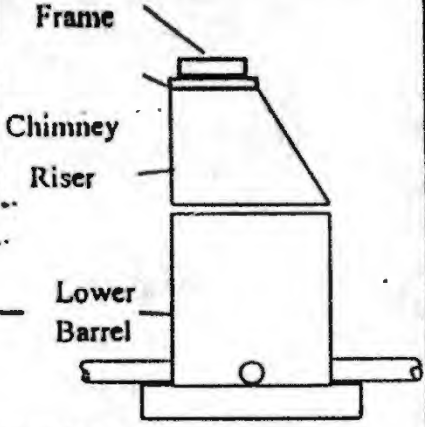
Item	Construction Material	Condition
COVER	Cast Iron (Vulcan Y-1344-I Type)	Good
FRAME	Cast Iron	Good
CHIMNEY	Brick and Mortar	Good
STEPS	None	
CORBEL WORK	None	
RISER WALLS	Concrete	Good
BARREL WALLS	Concrete	Good
BENCH	Concrete	Good
TROUGHS	Concrete	Good

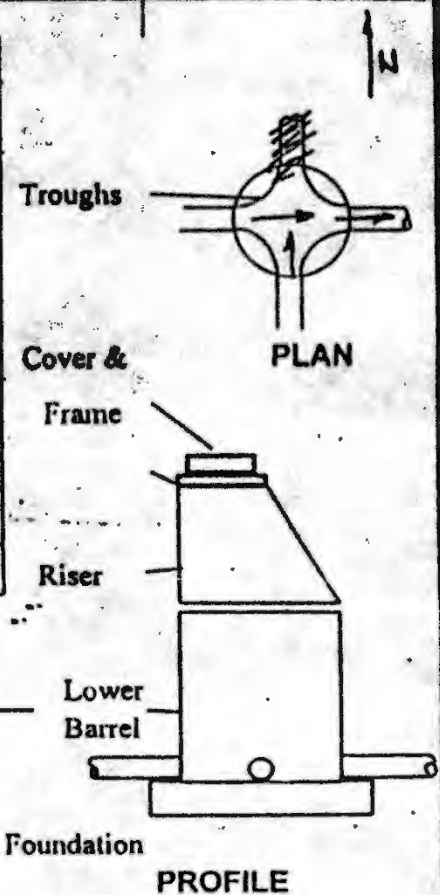
Item	Construction Material	Condition
COVER	Cast Iron (Vulcan Y-1344-I Type)	Good
FRAME	Cast Iron	Good
CHIMNEY	Brick and Mortar	Good
STEPS	None	
CORBEL WORK	None	
RISER WALLS	Concrete	Good
BARREL WALLS	Concrete	Good
BENCH	Concrete	Good
TROUGHS	Concrete	Good

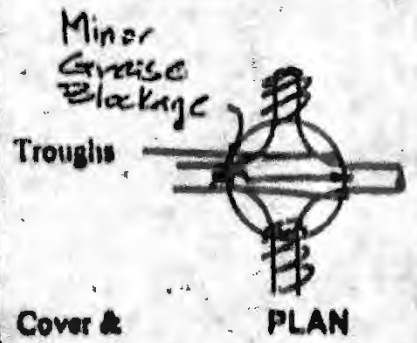
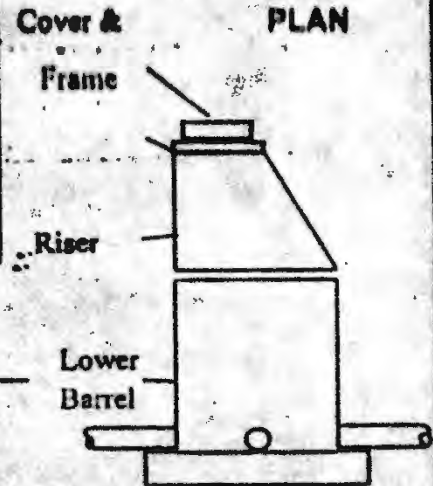
Item	Construction Material	Condition
COVER	Cast Iron (YUKON Y-1344-I Type)	Good
FRAME	Cast Iron	Good
CHIMNEY	Brick and Mortar	Good
STEPS	None	
CORBEL WORK	None	
RISER WALLS	Concrete	Good
BARREL WALLS	Concrete	Good
BENCH	Concrete	Good
TROUGHS	Concrete	Good

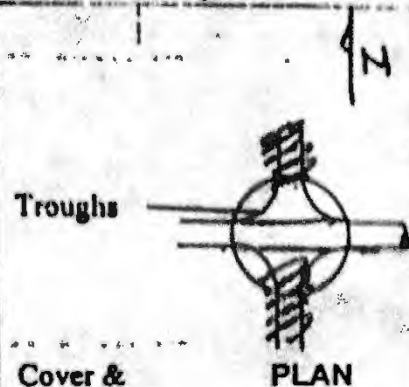
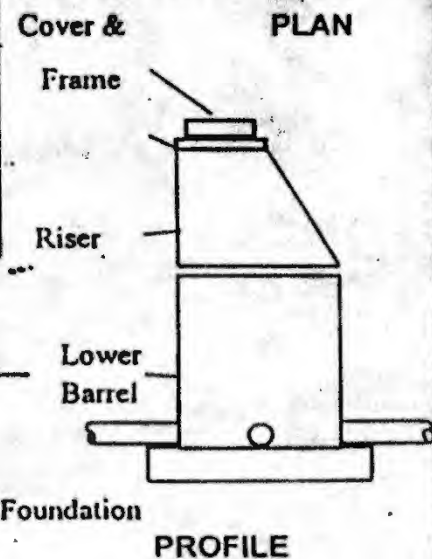
Item	Construction Material	Condition
COVER	Cast Iron (Vulcan Y-1344-I Type)	Good
FRAME	Cast Iron	Good
CHIMNEY	Brick and Mortar	Good
STEPS	None	
CORBEL WORK	None	
RISER WALLS	Concrete	Good
BARREL WALLS	Concrete	Good
BENCH	Concrete	Good
TROUGHES	Concrete	Good

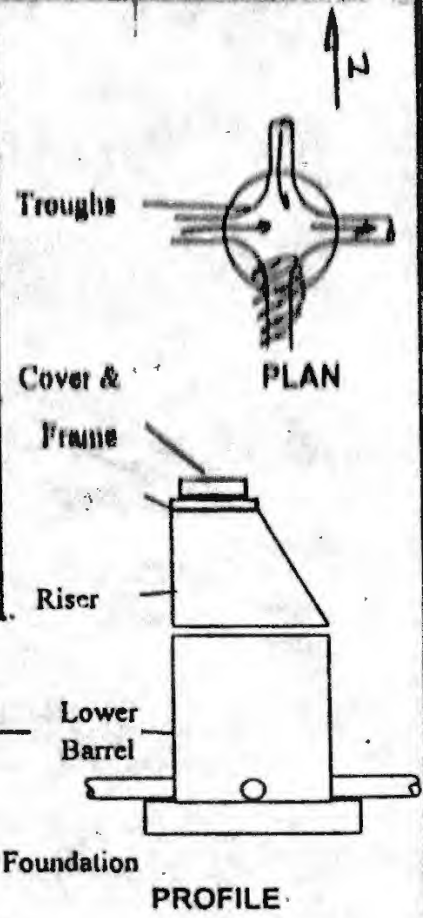
Item	Construction Material	Condition
COVER	Cast Iron (Vulcan Y-1344-I Type)	Good
FRAME	Cast Iron	Good
CHIMNEY	Brick and Mortar	Good
STEPS	None	
CORBEL WORK	None	
RISER WALLS	Concrete	Good
BARREL WALLS	Concrete	Good
BENCH	Concrete	Good
TROUGHS	Concrete	Good

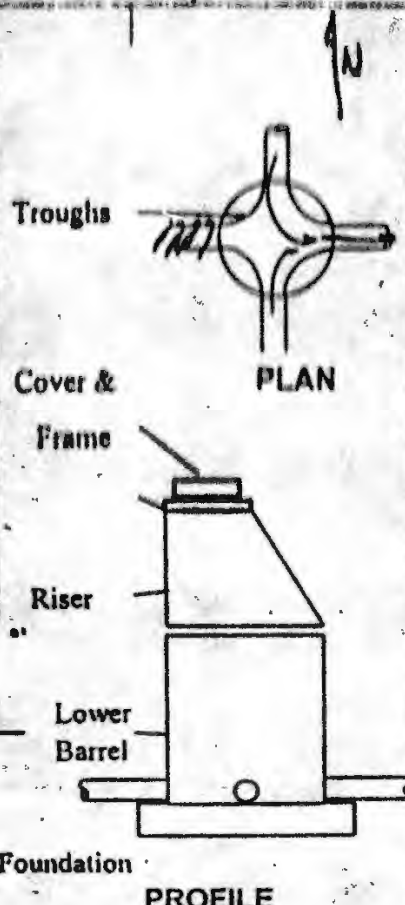
Item	Construction Material	Condition
COVER	Cast Iron (Vulcan Y-1344-I Type)	Good
FRAME	Cast Iron	Good
CHIMNEY	Brick and Mortar	Good
STEPS	None	
CORBEL WORK	None	
RISER WALLS	Concrete	Good
BARREL WALLS	Concrete	Good
BENCH	Concrete	Good
TROUGHS	Concrete	Good

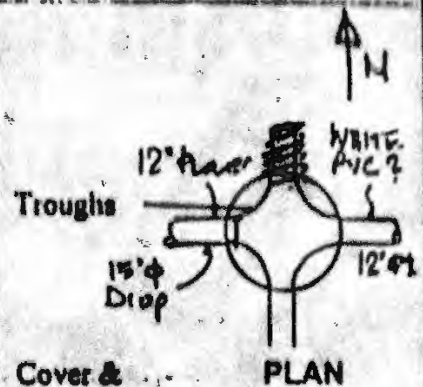
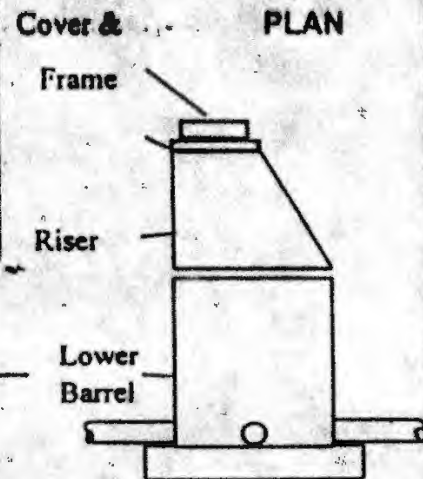
Item	Construction Material	Condition
COVER	Cast Iron (Vulcan Y-1344-I Type)	Good
FRAME	Cast Iron	Good
CHIMNEY	Brick and Mortar	Good
STEPS	None	
CORBEL WORK	None	
RISER WALLS	Concrete	Good
BARREL WALLS	Concrete	Good
BENCH	Concrete	Good
TROUGHS	Concrete	Good

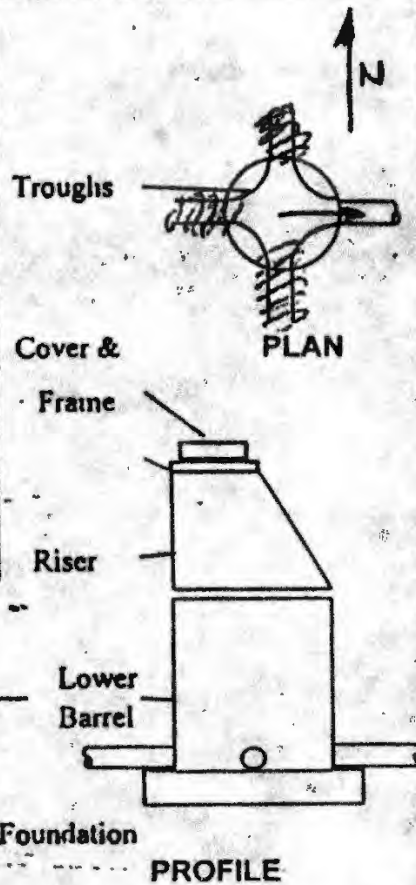
Item	Construction Material	Condition
COVER	Cast Iron (Vulcan Y-1344-I Type)	Good
FRAME	Cast Iron	Good
CHIMNEY	Brick and Mortar	Good
STEPS	None	
CORBEL WORK	None	
RISER WALLS	Concrete	Good
BARREL WALLS	Concrete	Good
BENCH	Concrete	Good
TROUGHES	Concrete	Good

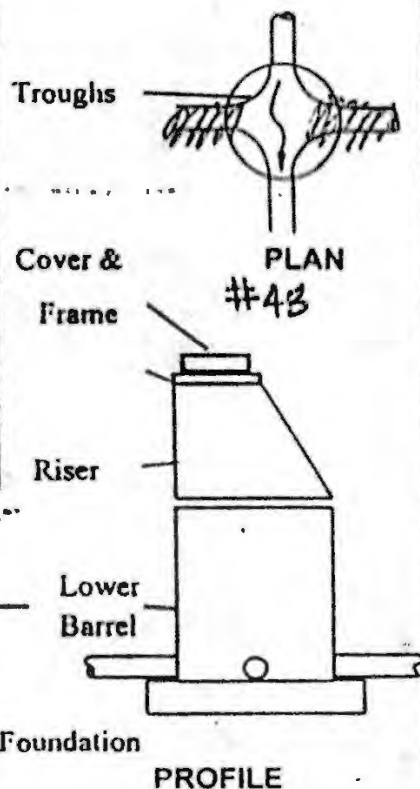
Item	Construction Material	Condition
COVER	Cast Iron (Vulcan Y-1344-I Type)	Good
FRAME	Cast Iron	Good
CHIMNEY	Brick and Mortar	Good
STEPS	None	
CORBEL WORK	None	
RISER WALLS	Concrete	Good
BARREL WALLS	Concrete	Good
BENCH	Concrete	Good
TROUGHS	Concrete	Good
