**BEFORE THE FLORIDA
PUBLIC SERVICE COMMISSION**

**DOCKET NO. 06038-EI
FLORIDA POWER & LIGHT COMPANY**

**IN RE: FLORIDA POWER & LIGHT COMPANY'S PETITION FOR
ISSUANCE OF A STORM RECOVERY FINANCING ORDER**

Technical Report: Post Hurricane Wilma Engineering Analysis

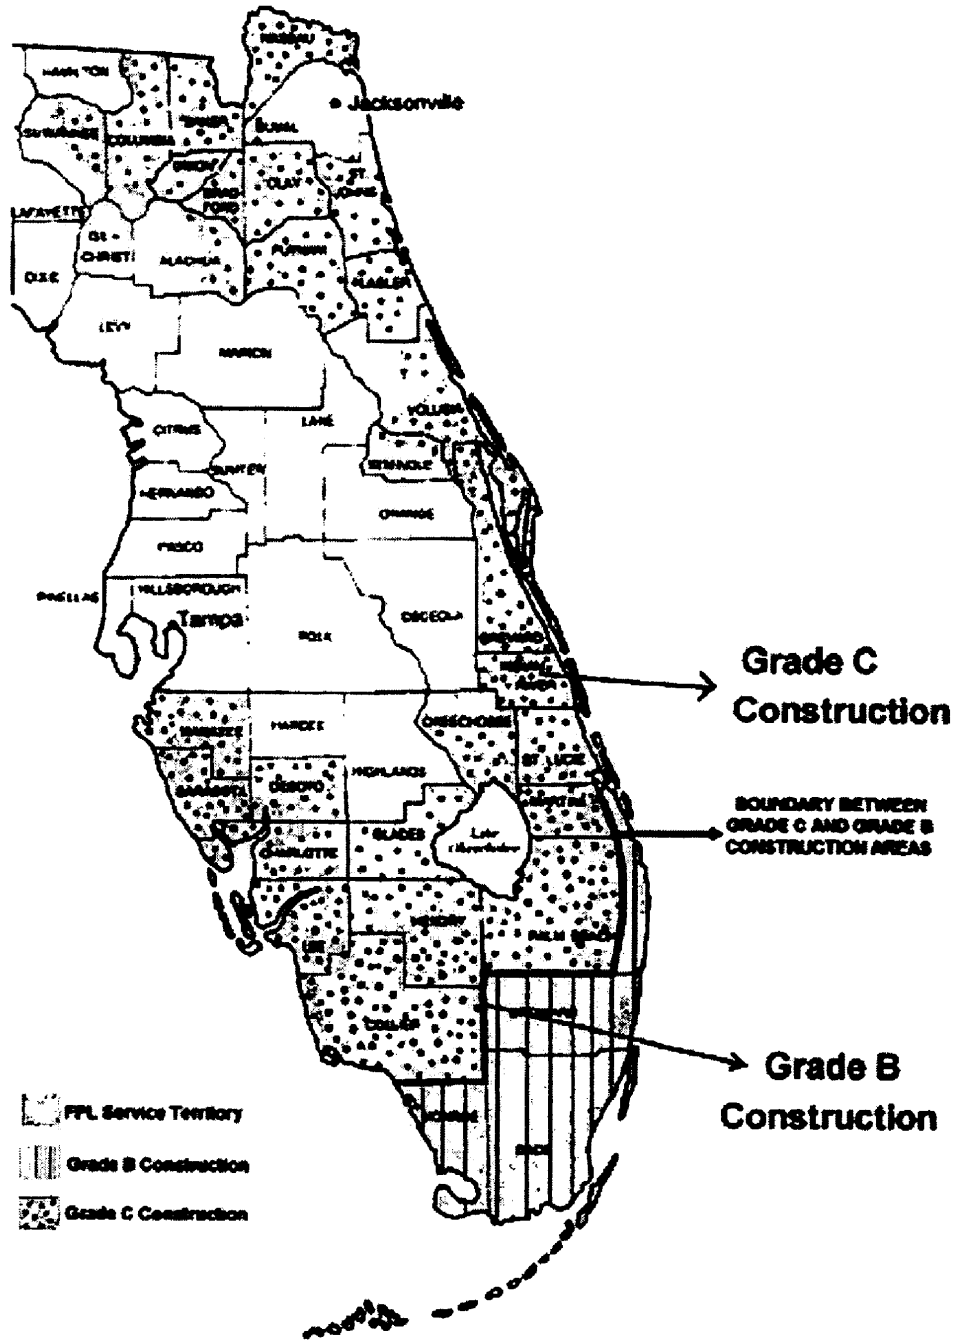
Figure 2-3. Map showing FPL grade of construction requirements (DERM Figure 2) from 1993 to 2004. Outside of these years, FPL specifies Grade B for the entire service territory.

Based on an internal FPL study of historical hurricane patterns, in 1993, FPL decided to allow Grade C construction in parts of its service territory considered less likely to encounter extreme wind conditions. During this time, the following areas were still required to build to Grade B: Monroe County, Dade County, Broward County, and the coastal areas of Palm Beach County and Martin County (see Figure 2-3). This is the requirement that presently exists in the DERM.

Therefore, the present design standard of FPL is for all distribution poles to be designed to Grade B, even though this is not currently reflected in the DERM. From 1993 to 2004, Grade C was allowed in areas serving about 42% of all customer accounts (customer connections in this area prior to 1993 were built to Grade B construction). Even though Grade C construction was allowed, it is uncertain as to the extent of poles that conform to only Grade C. An audit described in the FPL internal document "Grade B and Grade C Construction" showed that 12 out of 14 field inspected sites met Grade B standards even though FPL required only Grade C. Further analysis in this document makes the argument that Grade B construction is cost-effective.

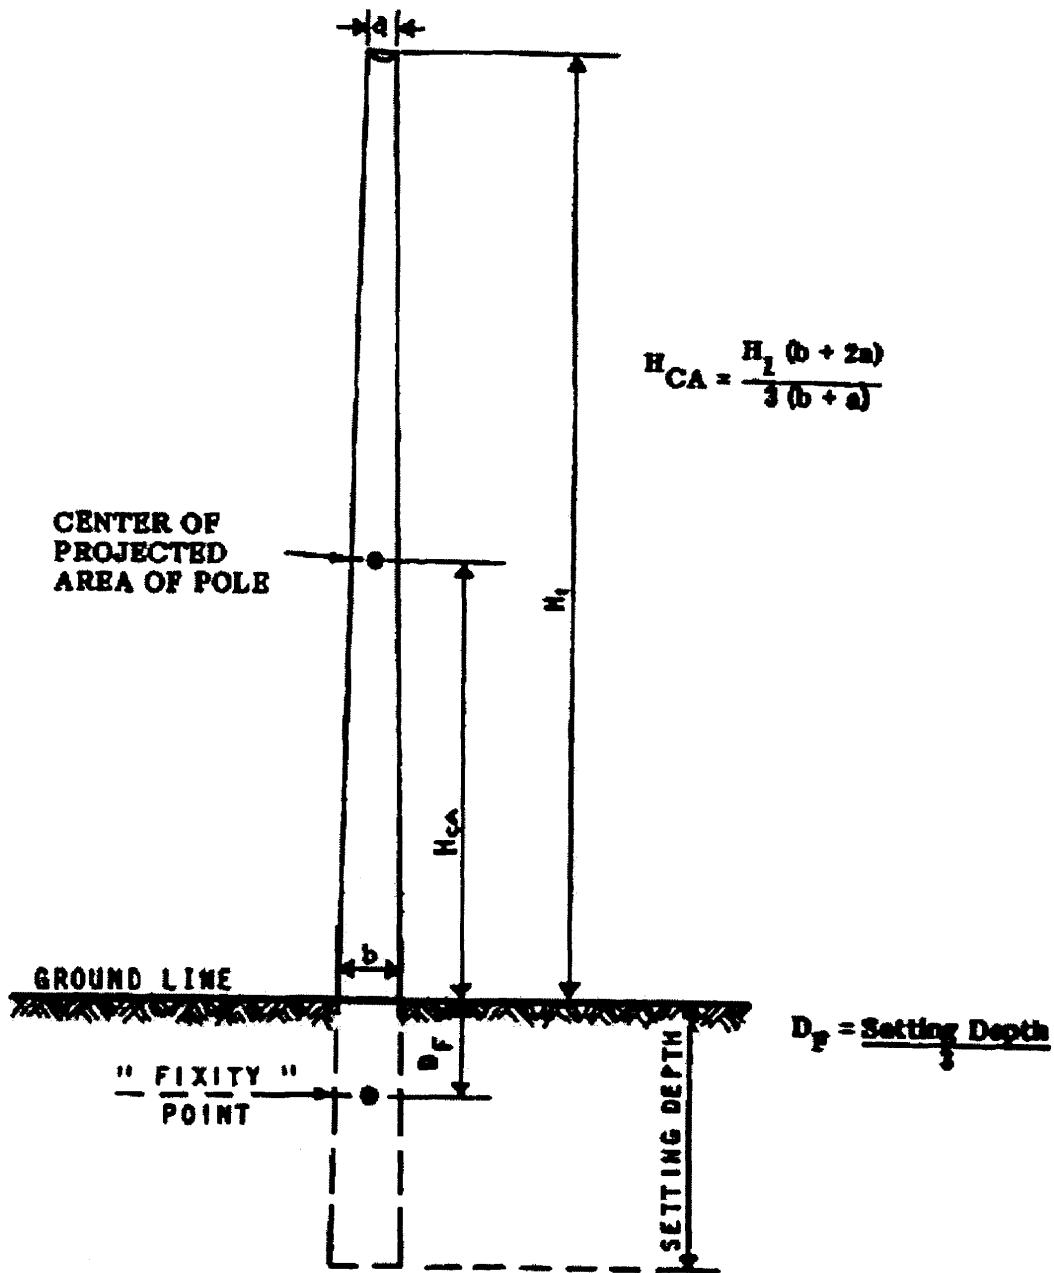
Figure 2-5. Dimensions Used in Calculating Wind Load on Poles (DERM Figure 3)

The DERM assumes that the point of greatest fiber stress occurs below the ground line at a point one-third the distance from the ground line to the base of the pole (see Figure 2-5). This point is referred to as the “fixity point.”

As a practical matter, FPL distribution poles have shown to nearly always break at or above the ground line. Actual calculations will typically not differ substantially whether using the fixity point or ground line, but FPL should further investigate this issue.

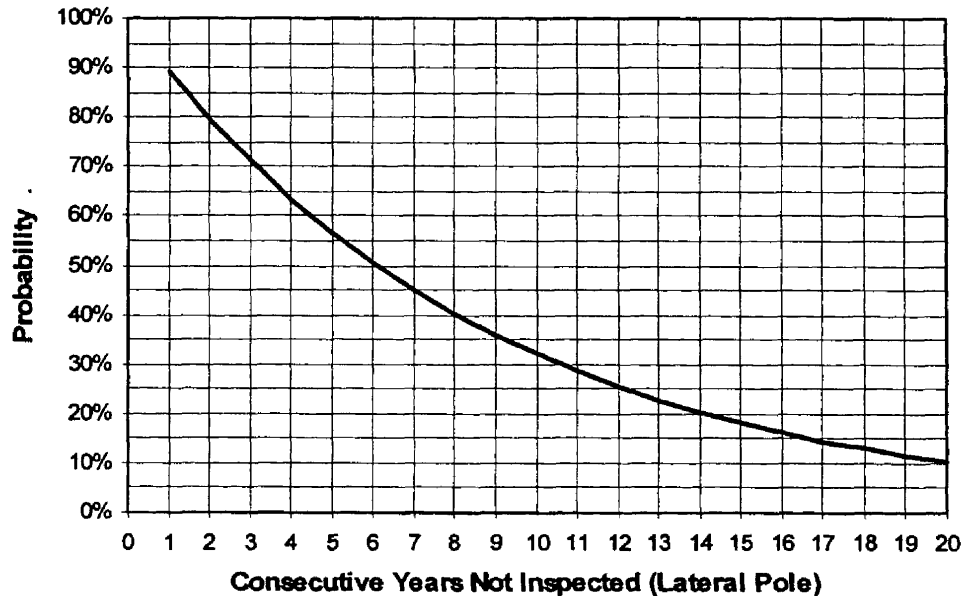
Figure 4-4. Probability of Lateral Poles Not Being Inspected for Multiple Consecutive Years.

With these assumptions, there are about 95,848 touchpoints per year on lateral poles, which implies a “touchpoint rate” of 11.34% per year. For a Poisson process, this means that the probability of a pole not being touched in a given year is equal to $e^{-0.1134} = 89.28\%$. It is then straightforward to compute the probability of a pole not being touched in consecutive years. A graph of these probabilities is shown in Figure 4-4.

Figure 4-4 shows that, for the above assumptions, about 32% of poles will not be inspected over a ten-year period, and about 18% of poles will not be inspected over a fifteen-year period. If it is assumed that each lateral touchpoint involves an average of two poles instead of one pole (due to crews inspecting adjacent structures), about 10% of poles will not be inspected over a ten-year period, and about 3.3% of poles will not be inspected over a fifteen-year period. Considering the uncertainty of assumptions in this calculation, KEMA feels that between 80% and 90% of all lateral poles will be inspected over a 15-year period.

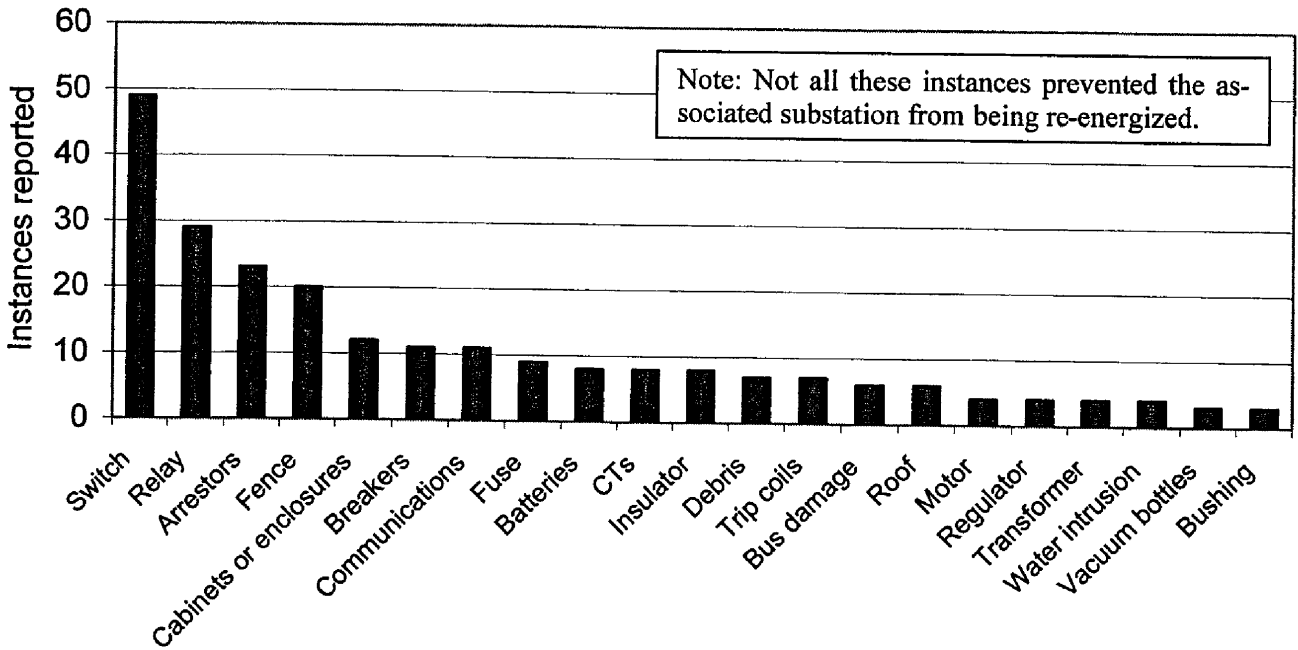
Figure 6-2. Types of substation equipment requiring repair or replacement after Wilma.

Data provided by FPL indicates a total of 364 substations were inspected for damage following the storm. As outlined in the previous section, 61 of those substations required some level of equipment replacement. The remaining 303 substations were reported to have varying levels of minor damage that required some on-site repairs of equipment or systems or no damage at all. The types of equipment noted for repair at all substations inspected and the number of incidences noted for each category are detailed in Figure 6-2. For those substations where equipment repair or replacement was required, the categories of equipment were distributed as shown in Figure 6-3.

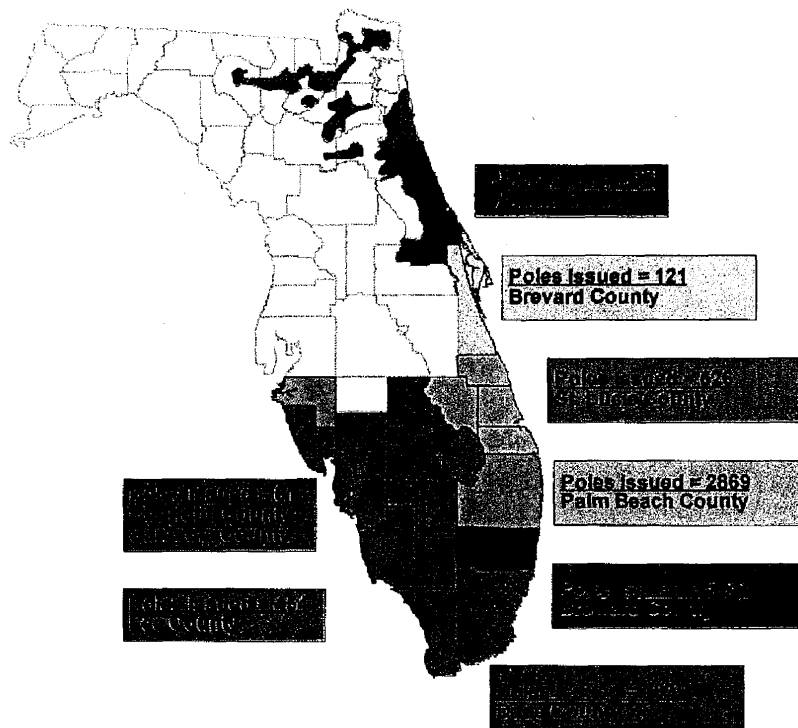
Figure 7-4. Total counts of distribution poles issued by county during Hurricane Wilma

Actual pole breakage data by county is based on records of poles issued during the hurricanes by FPL. As FPL can replace both FPL and third party broken poles during hurricane restoration, this data needs to be interpreted carefully against forensic and population data.

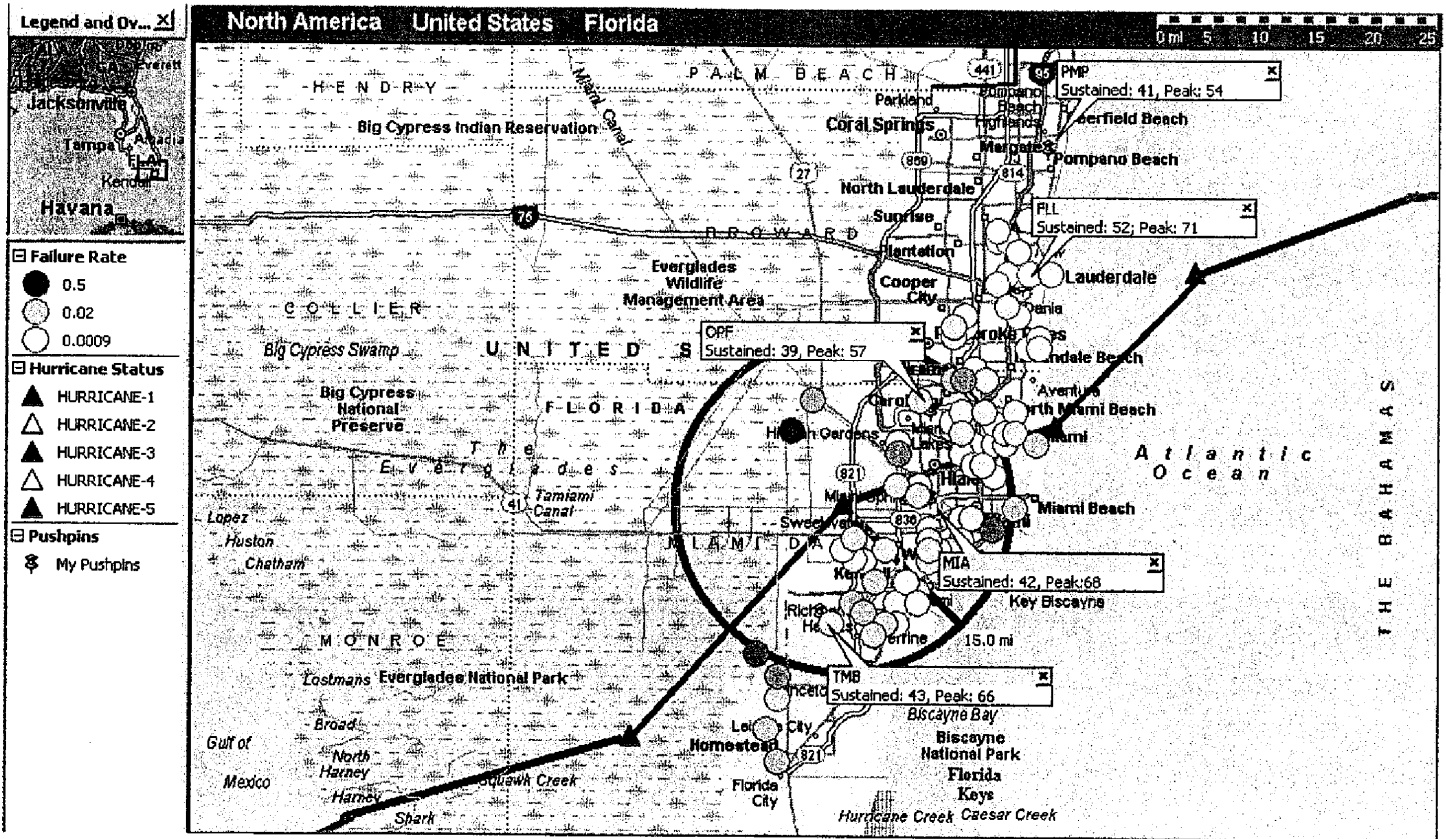
Figure 7-11 Pole failure rate for Hurricane Katrina

The geographic representation of pole failure rates for Katrina shows a much more equal impact over the affected area compared to Wilma. This hurricane had different attributes such as traveling direction, wind speeds and resulted in different pole breakage behavior such as higher impact of falling trees, as has been investigated and reported before.

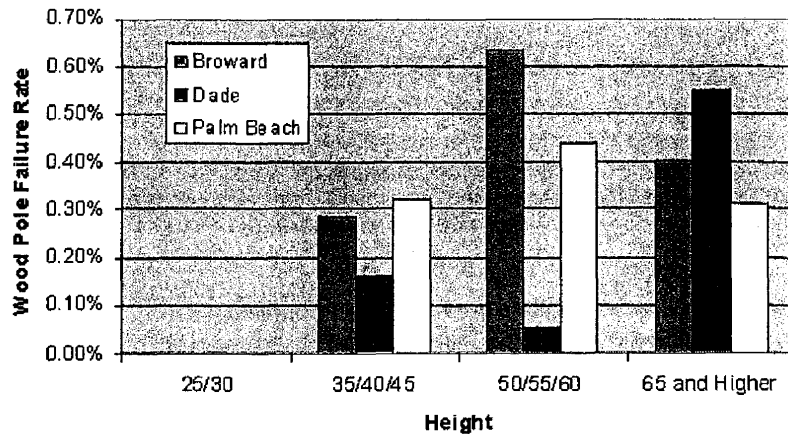
Figure 7-15. FPL owned wood pole failure rates (not adjusted) by height and county.

Compared to other counties, Broward County shows the highest failure rates in general, corresponding to the findings in Table 7-10, and Palm Beach shows the highest failure rates for poles with recent vintages (after 1992).

It was not possible to generate failure rates per pole class or feeder versus lateral, as the accounting data does not provide for pole class information. The following graph shows the unadjusted failure rates by pole height (with pole height being extracted from the accounting data).

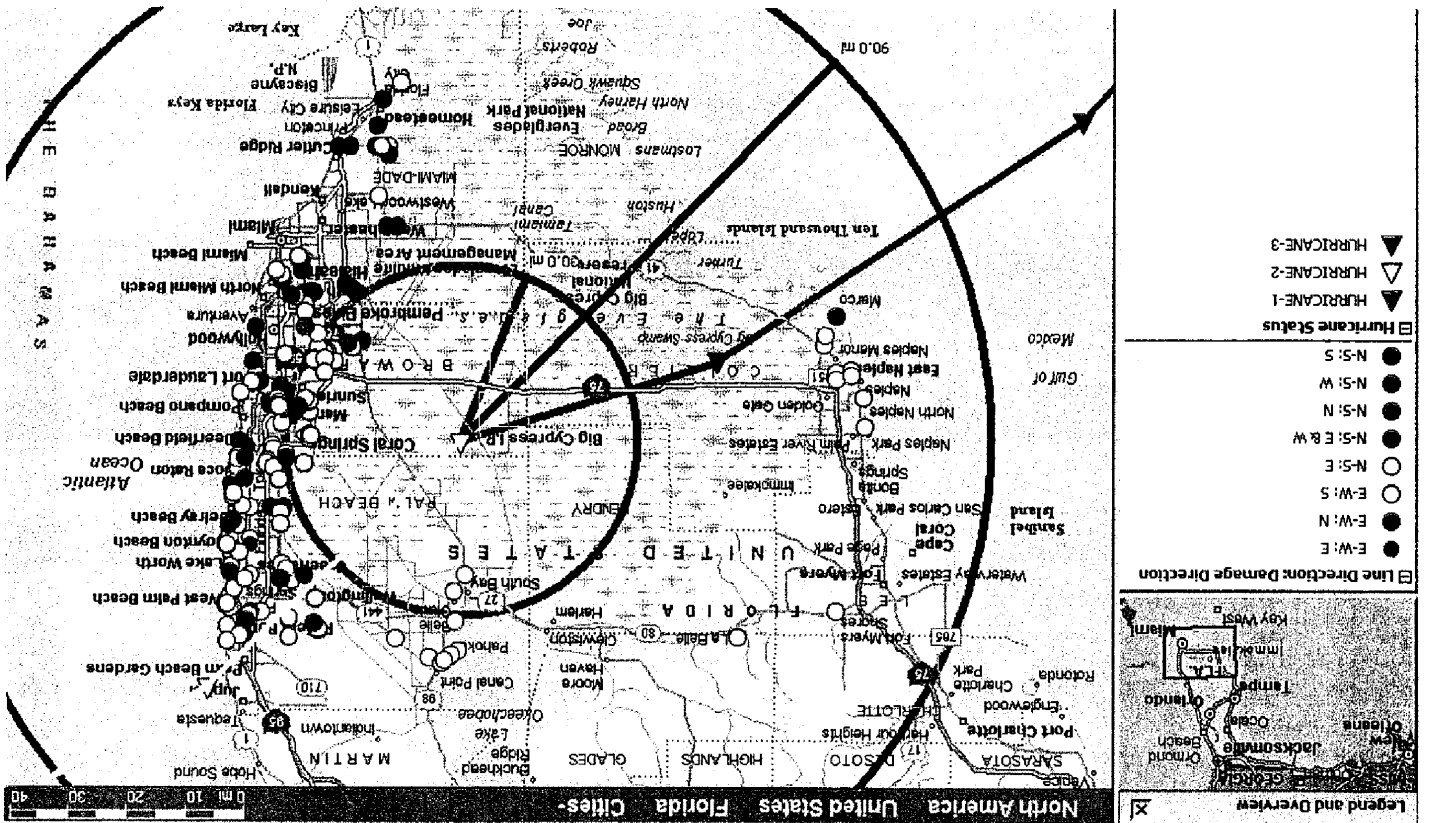
Figure 7-19. Circuit orientation and direction of falling poles for Hurricane Wilma

The North-South oriented circuits falling quasi randomly to the East and West, could indicate a failure mechanism where the front side of the storm either breaks or conditions the poles and the back side of the storm takes out the conditioned poles. Such poles could lean and get smashed back by the back side of the storm, breaking the pole upon sudden impact. This could explain the number of CCA feeder poles broken by wind only on the East side of Palm Beach County (refer to Figure 7-10), most affected by the back side of Hurricane Wilma. The East-West oriented circuits falling to the North (red dots), show failures that are difficult to prevent as the wind comes through shielded areas (South to North). An extended root cause analysis during the forensic study may have supported targeted engineering solutions in this area.

The highest wind speeds are typically recorded to the south of the path (wind speeds plus movement of the system) for an eastwards traveling storm in the Northern hemisphere. For a westwards traveling storm this will be to the north of the path. Consequently, it can be expected that Hurricane Wilma had strongest storms to the south of its path and Hurricane Katrina to the north of its path. The following graph shows circuit orientation and the falling direction of broken poles.
