RE: Annual Storm Hardening Reports of the Municipal and Cooperative Electric Utilities Pursuant to Rule 25-6.0343, F.A.C

Please add the following Storm Hardening Reports of the municipal and cooperative electric utilities for calendar year 2006 to Case Management, Docket Number 070000. The attached reports are the first filings pursuant to Rule 25-6.0343, F.A.C. If you have any questions, please let me know. Thank you.

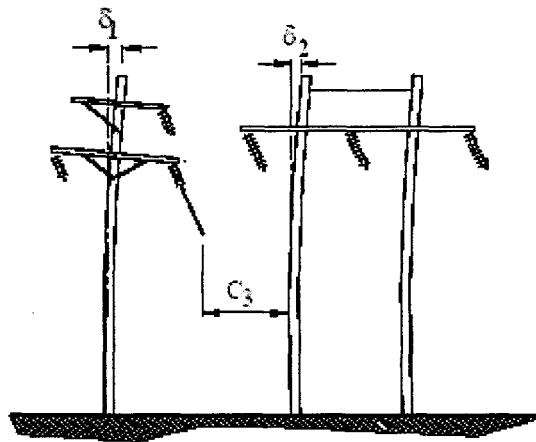
FIGURE 5-11: CLEARANCE BETWEEN CONDUCTORS OF ONE LINE AND STRUCTURE OF ANOTHER

The separation between lines will depend upon the spans and sags of the lines as well as how structures of one line match up with structures of another. In order to avoid the unreasonable task of determining separation of structures span-by-span, a standard separation value should be used, based on a worst case analysis. Thus if structures of one line do not always line up with those of the other, the separation determined in section 5.6.2 should be based on the assumption that the structure of one line is located next to the mid-span point of the line that has the most sag.
