RE: Docket No. 080248-SU; Tierra Verde Utilities, Inc.'s Application for an Increase in Wastewater Rates Increase in Pinellas County, Florida  
Our File No.: 30057.156

3(a) The "TV Sewer Mains" project reflects the effort to clean and video inspect two portions of the Tierra Verde collection system. The gravity main and manholes situated in the Pinellas Bayway right-of-way and the area west of the Pinellas Bayway along and adjacent to Madonna Avenue had not been cleaned and inspected for many years. A total of 6,229 LF of 18" diameter pipe was cleaned and inspected along the Pinellas Bayway. A total of 21,250 LF of 8" diameter pipe and manholes were inspected west of the Pinellas Bayway along Madonna Avenue. The project is justified for the following reasons:

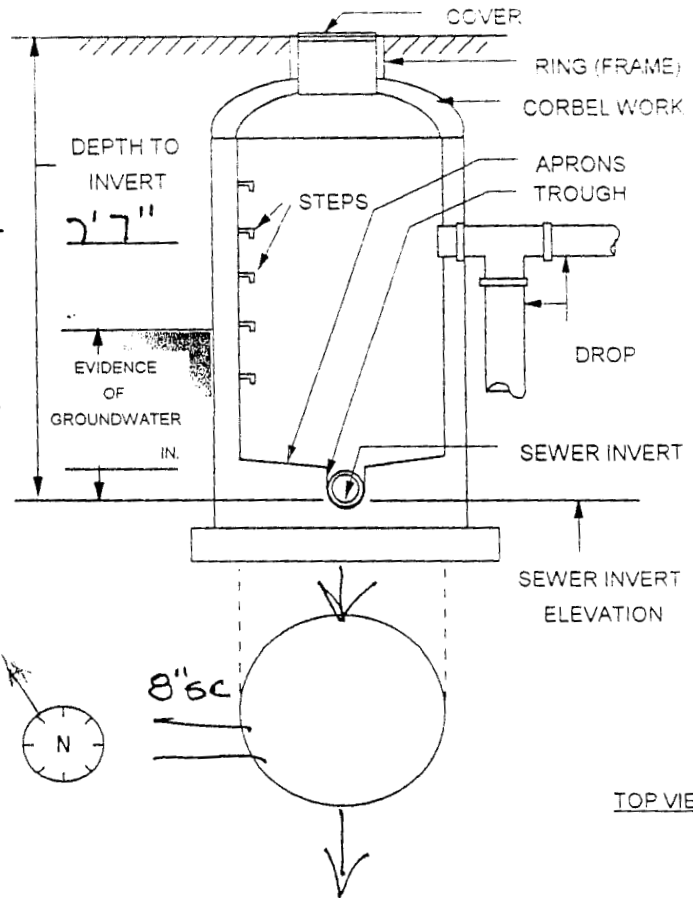
CONDITION OF FIT: \_\_\_\_\_  
 GOOD [ ] LOOSE [X] BROKEN [ ] SEALED [ ]  
 NUMBER OF HOLES 1 SIZE 1 IN.  
 OPEN [X] CLOSED [ ]

CONDITION: SOUND [ ] BROKEN [ ] LOOSE [X]  
RUST HEAVY  
 GRADE: AT [X] ABOVE [ ] BELOW [ ] \_\_\_\_\_ IN.  
 OFFSET: NO [X] YES [ ] \_\_\_\_\_ IN.

CORBEL AND WALLS: OTHER: \_\_\_\_\_  
 CONSTRUCTION: BRICK [X] PRECAST [ ] OTHER [X]  
 CONDITION: GOOD [ ] DETERIORATING [X]  
 LIGHT [ ] MEDIUM [ ] HEAVY [X]

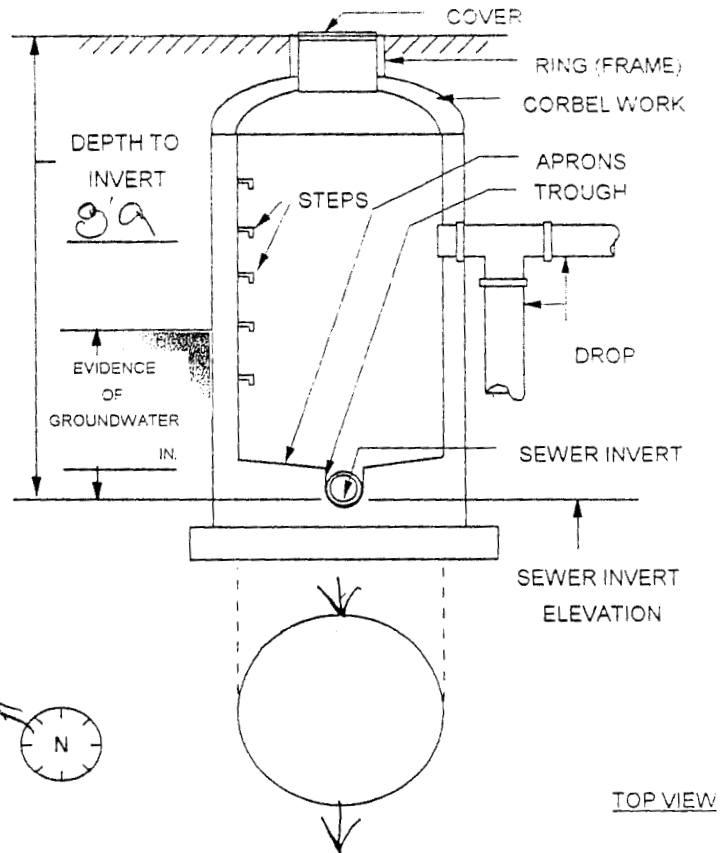
REMARKS: Conflicting M.H. C.I.P. Runs Thru Storm M.H.

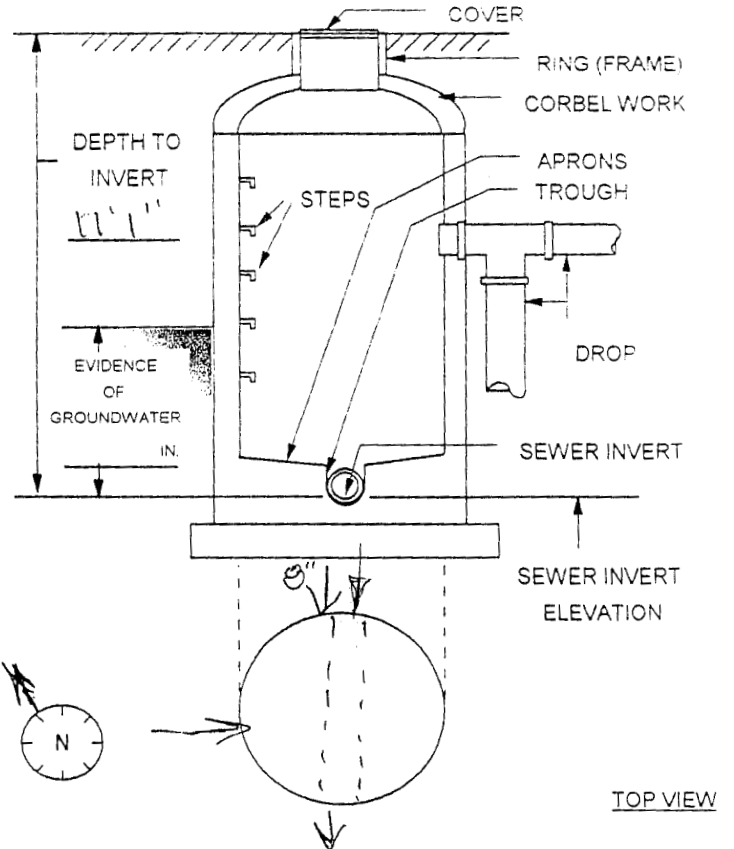
REMARKS: MH Frame Rusting Heavy

FRAME Rustic Heavy

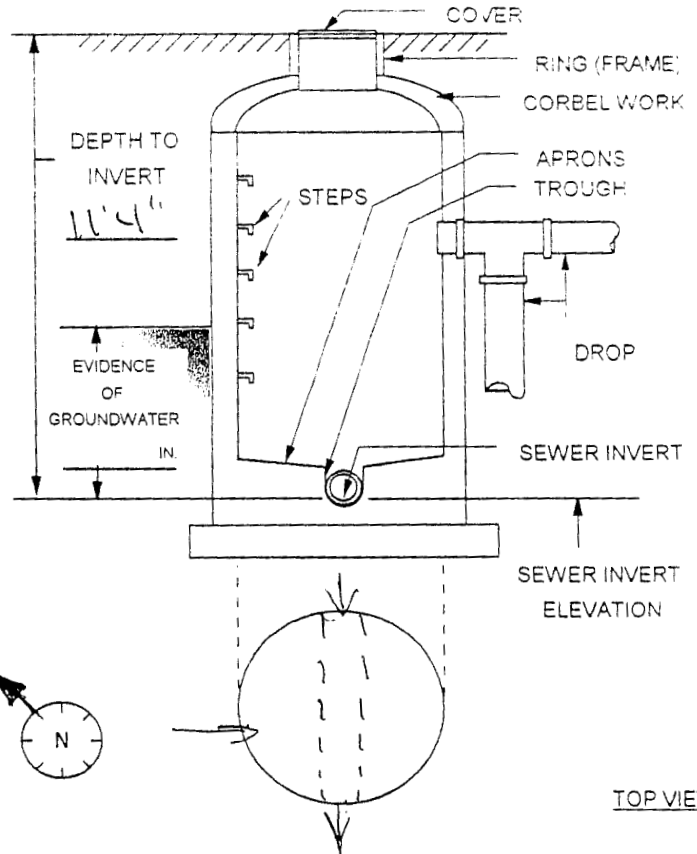
MANHOLE FRAME RUSTING HEAVY

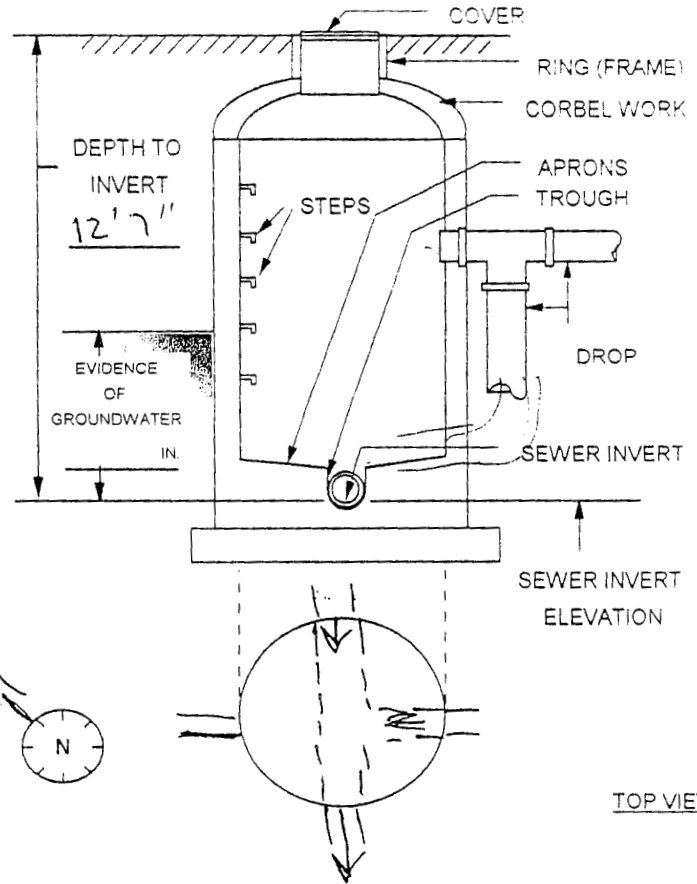
REMARKS: FRAME RUSTING HEAVY

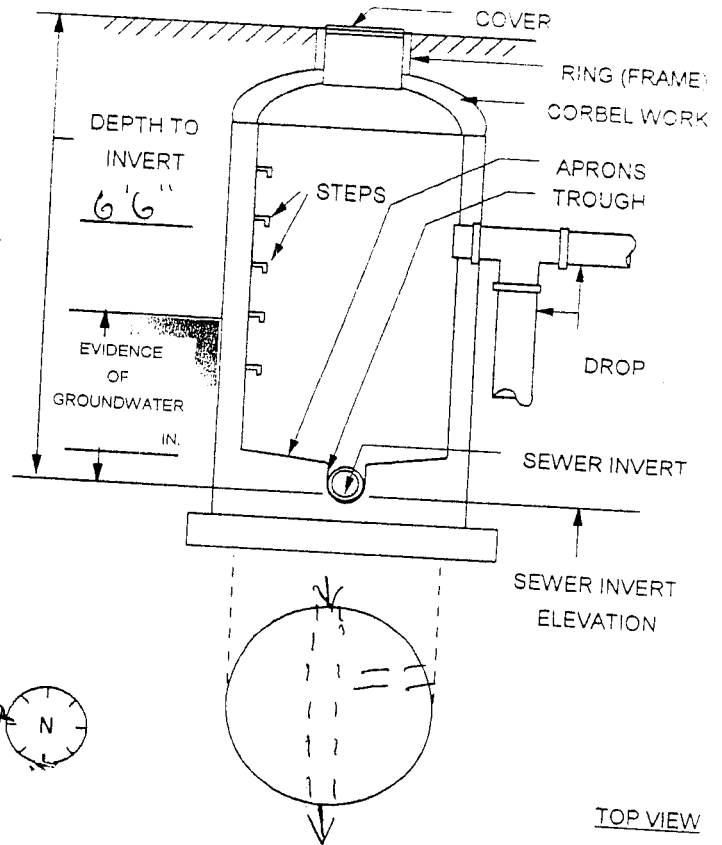
MANHOLE # BW-20 MINI SYSTEM BW STREET [ ] EASEMENT [ ]

REMARKS: APRON Deterioration

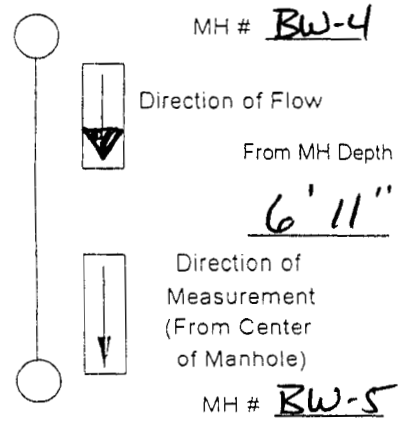
Ref No	Footage	Remarks	Leaks GPM	Clock Ref	Photo Inc
	0	START INSPECTION @ MH # BW-4			
	196	END OF VCP START CIP			
	202	CAMERA CANNOT GO ANY FURTHER DUE TO BUILD-UP IN CAST IRON PIPE.			
		WILL SET-UP FOR A REVERSAL			
*		THIS CAST IRON PIPE IS A CONFLICTING MANHOLE # BW-5

Special Notes  
\* CONFLICTING MANHOLE

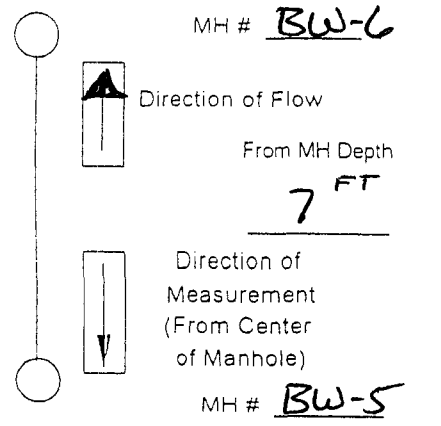
Ref No	Footage	Remarks	Leaks GPM	Clock Ref	Photo No
	0	START INSPECTION @ MH#BW-6			
	91	BISC 6" <sup>PVC</sup> <del>PEP</del> / HVY GREASE / LEAK	1/4	12	
	182	END OF VCP START CIP.			
		CAMERA CANNOT GO ANY FURTHER			
		DUE TO BUILD-UP OF MINERALS			
		END OF INSPECTION @			
		CONFLICTING MH#BW-5

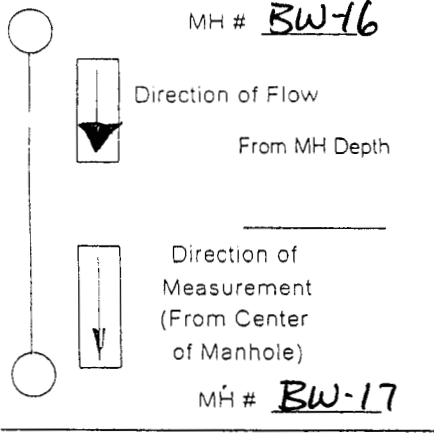
Ref No	Footage	Remarks	Leaks GPM	Clock Ref	Photo No
	0	START INSPECTION @ MH# BW-16			
	179	BISC 6" VCP / LEAKING	1	12	
	339	END OF INSPECTION @ MH# BW-17

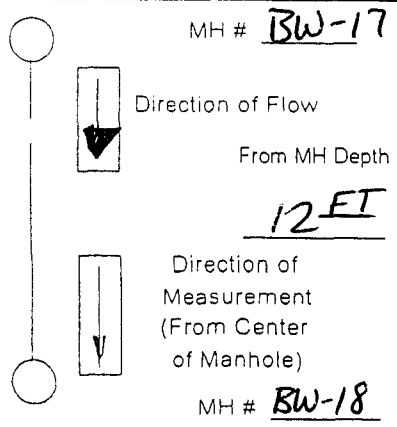
Ref No.	Footage	Remarks	Leaks GPM	Clock Ref	Photo No.
	0	START INSPECTION @ MH# BW-17			
	38	BISC 6" PVC		11	
	187	BISC 6" PVC		1	
	253	BISC 6" PVC / LEAKING	2 1/4	11	
	306	CAMERA UNDER WATER			
	330	CAMERA OUT OF WATER			
	331	END INSPECTION @ MH# BW-18

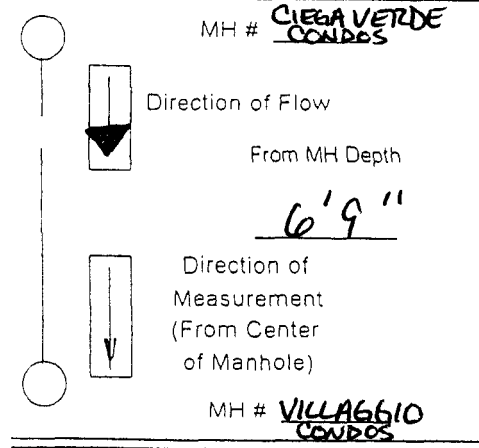
Ref No	Footage	Remarks	Leaks GPM	Clock Ref.	Photo No.
	0	START INSPECTION			
	30	BEGIN SAG 2"			
	48	END SAG			
	140	BEGIN SAG 2"			
	155	END SAG			
	181	END OF INSPECTION

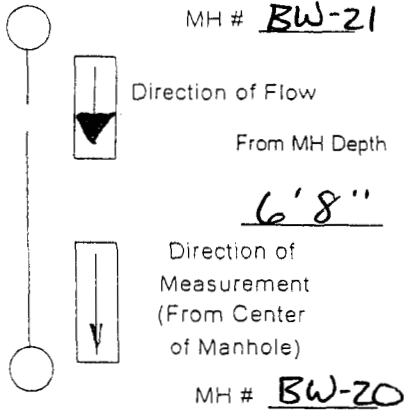
Ref. No.	Footage	Remarks	Leaks GPM	Clock Ref.	Photo No.
	0	START INSPECTION @ MH# BW-21			
	8	OFFSET JOINT 3/4"		3	
	29	BEGIN SAG 1"			
	36	SAG 2"			
	67	SC 8" VCP/CAPPED		8-11	
	72	END SAG			
	74	END INSPECTION @ MH# BW-20

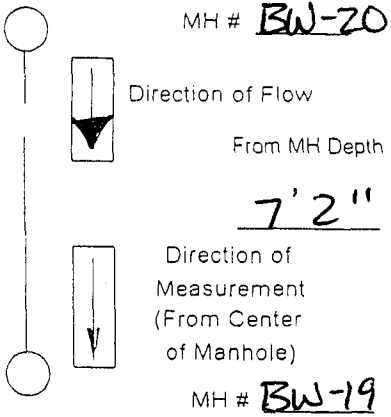
Ref No	Footage	Remarks	Leaks GPM	Clock Ref	Photo No
	0	START INSPECTION @ MH# BW-20			
	2	RCP/OFFSET 1/2"		12-12	
	84	SC 6" VCP/CAPPED		9-12	
	221	SC 6" VCP/CAPPED		9-12	
	244	LCP W/MS → 246		12	
	245	RCP		12-12	
	250	END OF INSPECTION @ MH# BW-19

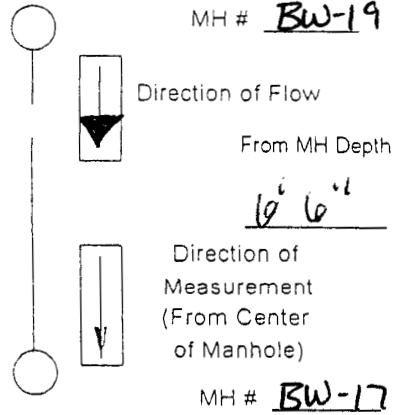
Ref No	Footage	Remarks	Leaks GPM	Clock Ref	Photo No
	0	START INSPECTION @ MH# BW-19			
	3	RCP @ JT		9-12	
	11	RCP/LCP → 15		12-12	
	15	RCP W/MS LEAKING	2	12	
	17	RCP W/MS		12-1	
	153	RT @ JT LIGHT		2	
	168	RT @ JT LIGHT		11	
	176	BEGIN SAG 1"			
	178	LCP W/MS LEAKING → 184	1/2	12	
	182	CAMERA UNDER WATER			
		WILL USE JETTER TO DRAW THE WATER DOWN			
	189	DROP INTO MANHOLE			
	190	END OF VCP START PVC			
	193	END OF INSPECTION @ MH# BW-17

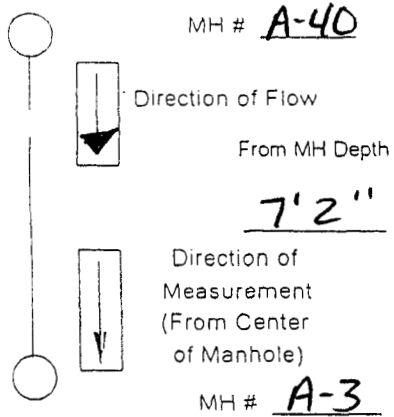
Ref No.	Footage	Remarks	Leaks GPM	Clock Ref	Photo No.
	0	START INSPECTION @ MH# A-40			
	31	CAMERA CAN NOT GO ANY FURTHER DUE TO BUBBLES IN LINER. WILL SET-UP FOR A REVERSAL.

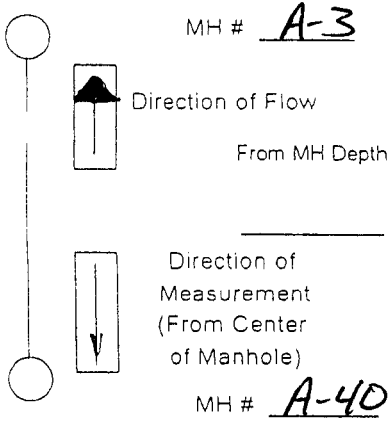
Ref No	Footage	Remarks	Leaks GPM	Clock Ref.	Photo No
	0	START INSPECTION @ MH# A-3			
	16	CAMERA CAN NOT GO ANY FURTHER DUE TO BUBBLES IN LINER

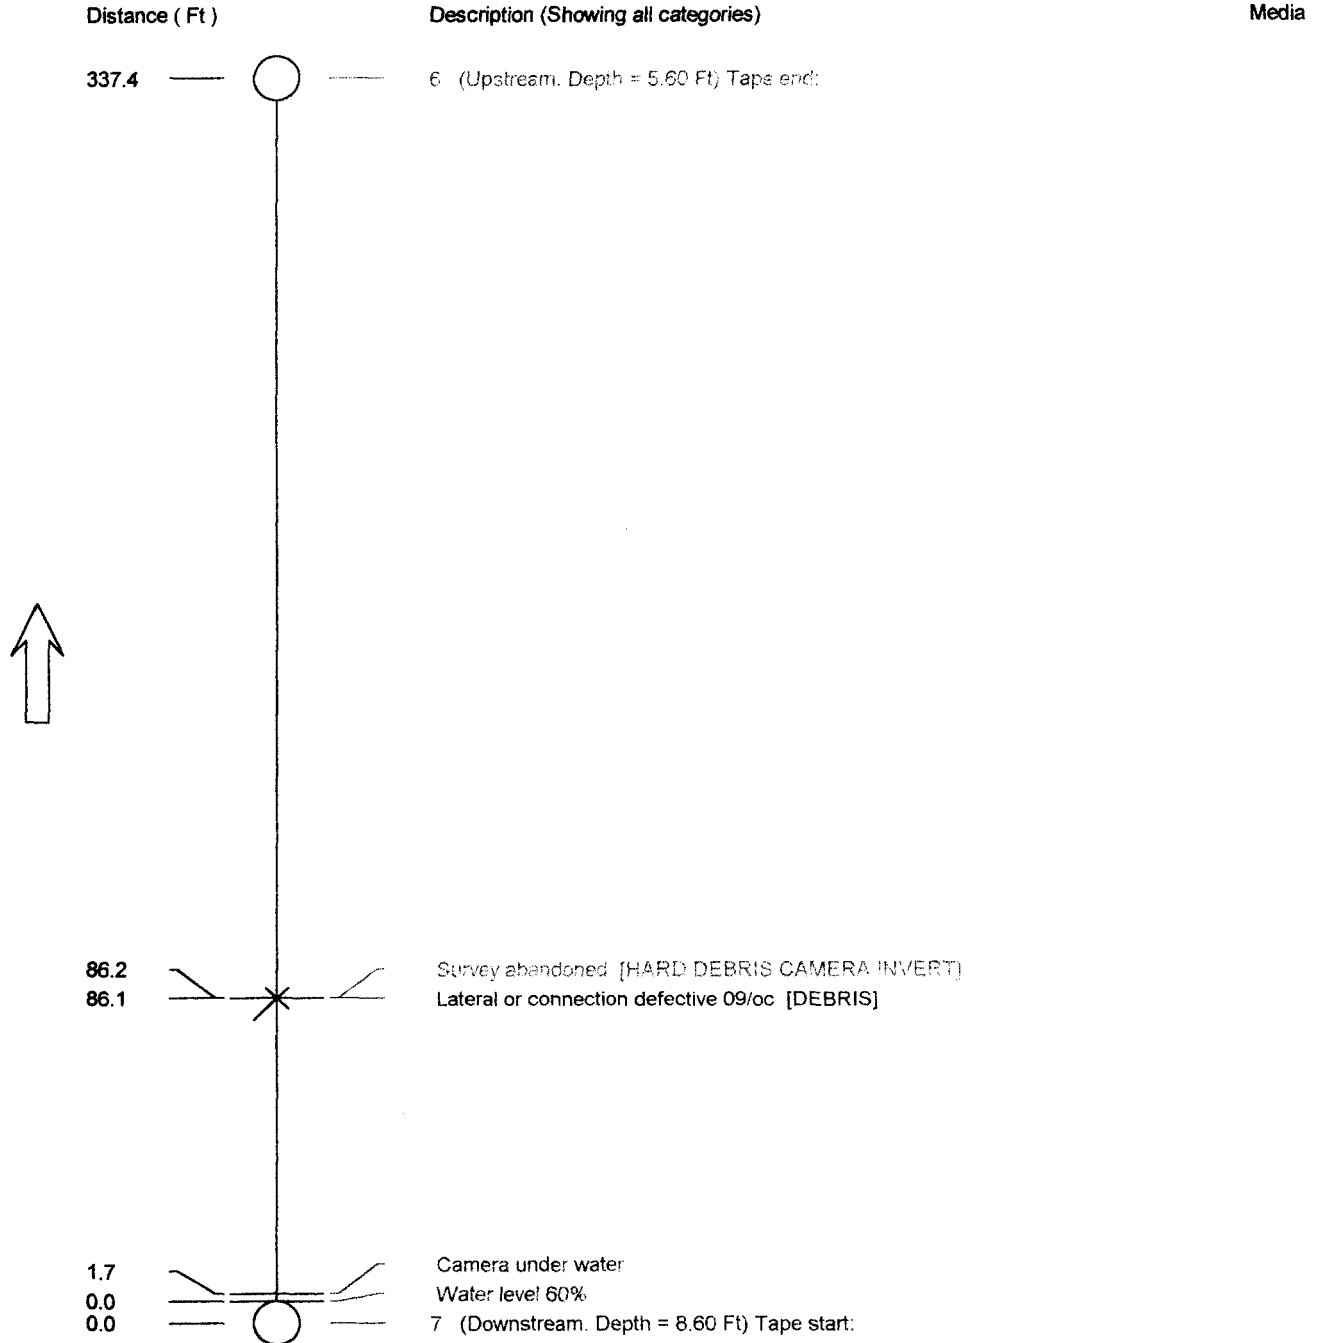
<b>Job</b>	<b>Contract</b>	<b>Cassette 1</b>	<b>Surveyed On</b> 07/23/2004	<b>Sheet</b> 5
<b>Operator</b> BMN	<b>Van Reference</b>	<b>Weather</b> Dry		
<b>Road Name</b> 8TH AVE N		<b>Place Name</b> TIERRA VERDE		
<b>Location type</b> Light road (rural roads with lighter traffic, town & city back streets)				
<b>Surface</b>				
<b>Survey purpose</b> Sample survey to determine asset condition				
<b>Pipe Use</b> Foul	<b>Schedule length</b> 337.4 Ft	<b>From</b> 7	<b>Depth</b> 8.60 Ft	
<b>Shape</b> Circular	<b>Size</b> 8 by Ins	<b>To</b> 6	<b>Depth</b> 5.60 Ft	
<b>Material</b> Vitrified clay	<b>Joint spacing</b> Ft	<b>Direction</b> Up		
<b>Lining</b>	<b>Year laid</b>	<b>Cat</b> A	<b>Pre-clean</b> Y	<b>Last cleaned</b>
<b>General note</b> SUBMERGED UNTIL 1.7' SEE SHEET 14.		<b>Structural</b>	<b>Service</b>	<b>Construction</b>
<b>Location note</b> HARD DEBRIS AT LATERAL 86.1'

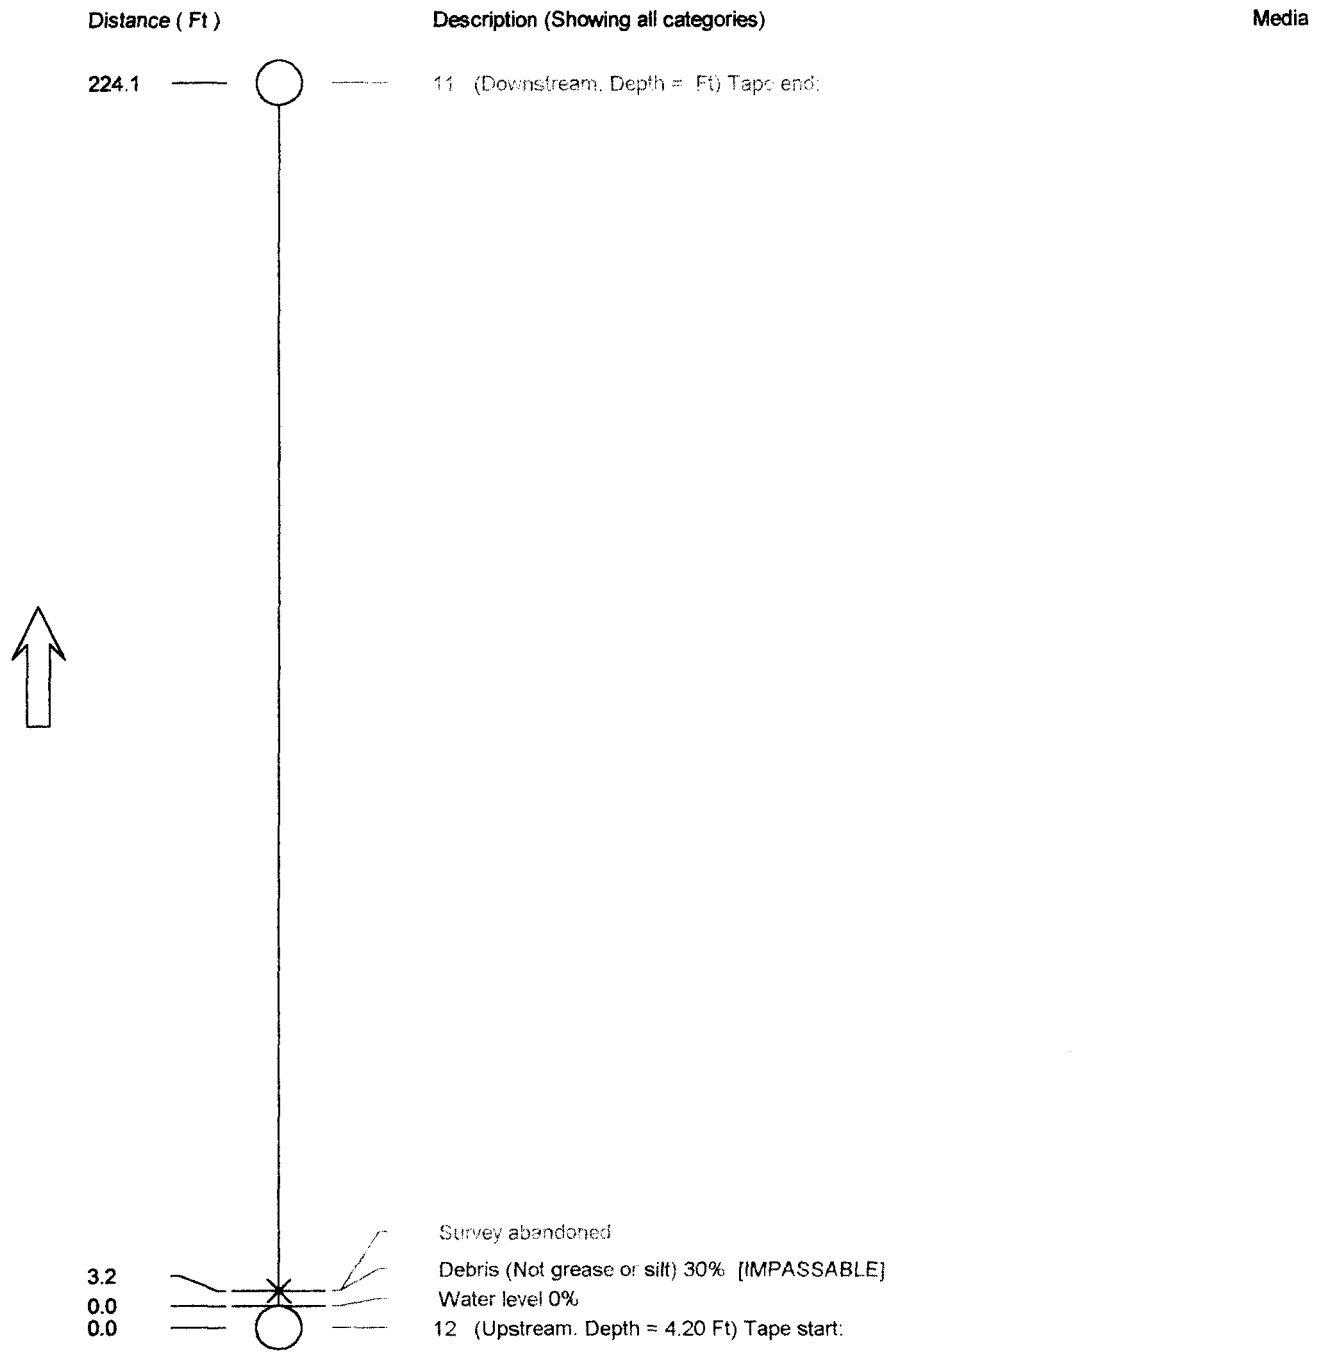
<b>Job</b> Operator BMN	<b>Contract</b> Van Reference	<b>Cassette</b> 1	<b>Surveyed On</b> 07/23/2004	<b>Sheet</b> 7
<b>Road Name</b> SW 5TH CT.		<b>Place Name</b> TIERRA VERDE		
<b>Location type</b> Light road (rural roads with lighter traffic, town & city back streets)				
<b>Surface</b>				
<b>Survey purpose</b> Sample survey to determine asset condition				
<b>Pipe Use</b> Foul	<b>Schedule length</b> 224.1 Ft	<b>From</b> 12	<b>Depth</b> 4.20 Ft	
<b>Shape</b> Circular	<b>Size</b> 8 by ins	<b>To</b> 11	<b>Depth</b> Ft	
<b>Material</b> Polyvinyl chloride	<b>Joint spacing</b> Ft	<b>Direction</b> Down		
<b>Lining</b>	<b>Year laid</b>	<b>Cat</b> A	<b>Pre-clean</b> Y	<b>Last cleaned</b>
<b>General note</b> SEE SHEET 15		<b>Structure</b>	<b>Service</b>	<b>Construction</b>
<b>Location note</b> 3.2' HARD DEBRIS		<b>Material</b>

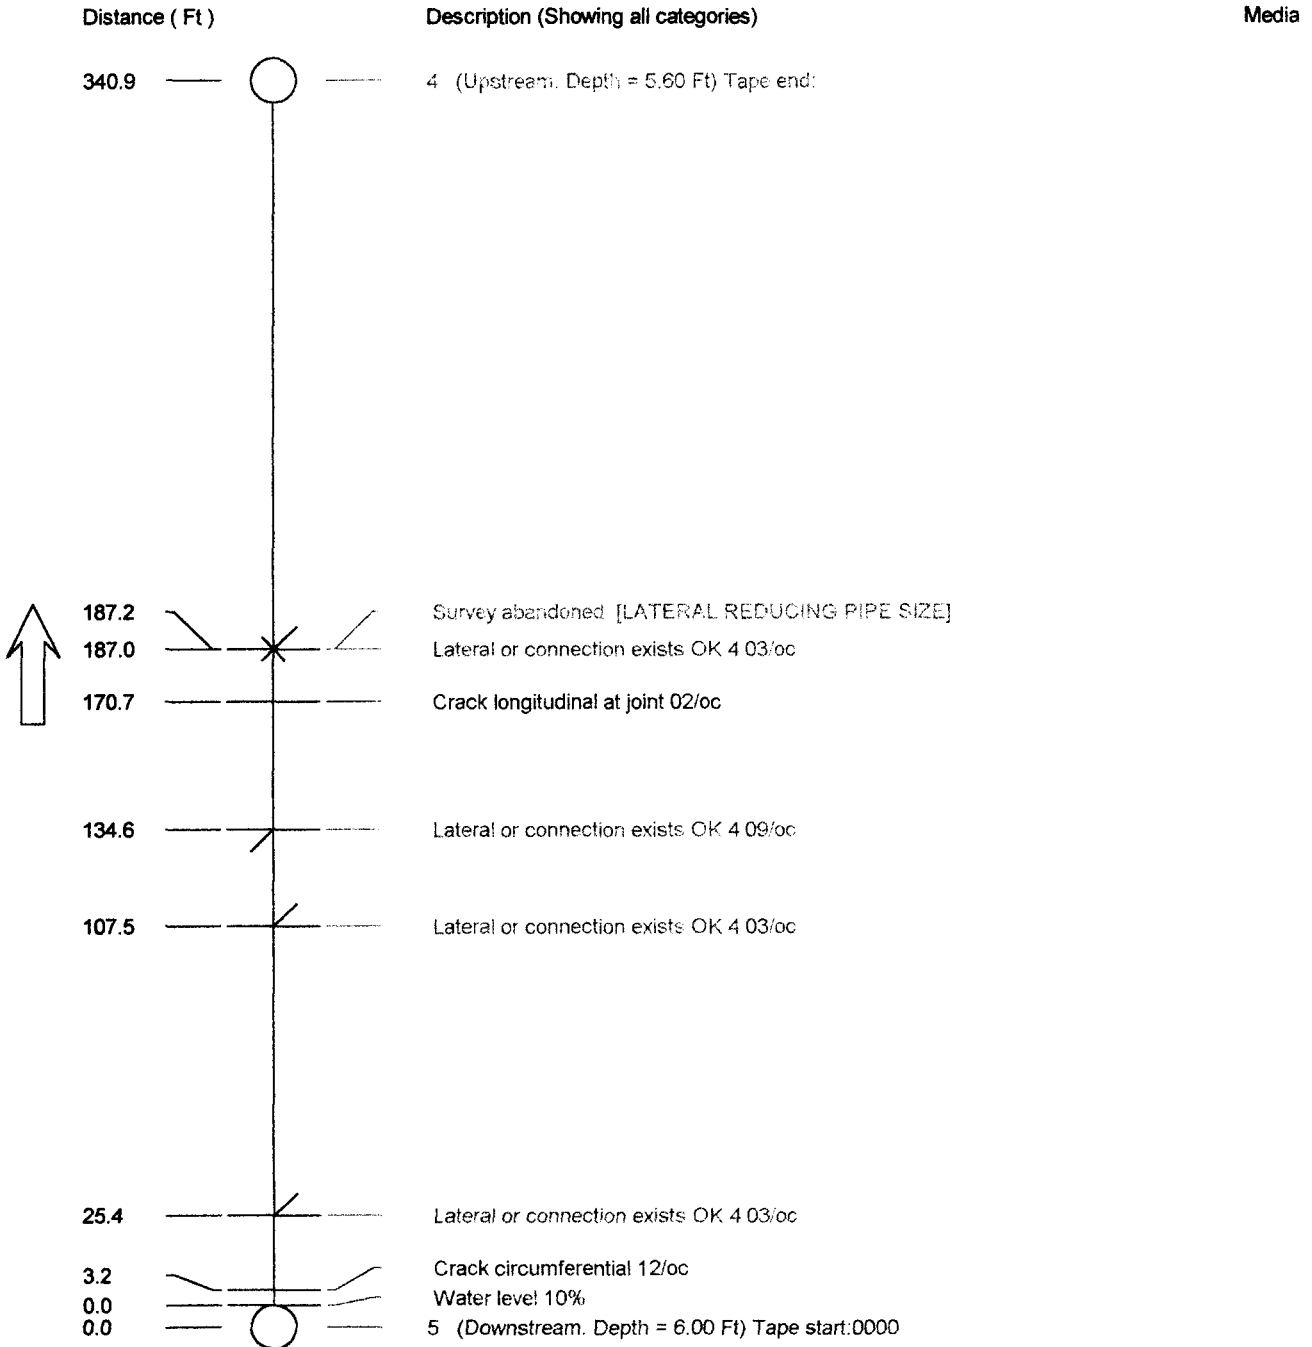
<b>Job</b>	<b>Contract</b>	<b>Cassette 2</b>	<b>Surveyed On</b> 07/30/2004	<b>Sheet</b> 13
<b>Operator</b> BMN	<b>Van Reference</b>	<b>Weather</b> Dry		
<b>Road Name</b> 8TH AVE N		<b>Place Name</b> TIERRA VERDE		
<b>Location type</b> Light road (rural roads with lighter traffic, town & city back streets)				
<b>Surface</b>				
<b>Survey purpose</b> Sample survey to determine asset condition				
<b>Pipe Use</b> Foul	<b>Schedule length</b> 340.9 Ft	<b>From</b> 5	<b>Depth</b> 6.00 Ft	
<b>Shape</b> Circular	<b>Size</b> 8 by Ins	<b>To</b> 4	<b>Depth</b> 5.60 Ft	
<b>Material</b> Vitrified clay	<b>Joint spacing</b> Ft	<b>Direction</b> Up		
<b>Lining</b>	<b>Year laid</b> Cat A	<b>Pre-clean</b> Y	<b>Last cleaned</b>	
<b>General note</b> SEE SHEET 12 FOR REVERSE SETUP		<b>Structural</b>	<b>Service</b>	<b>Condition</b>
<b>Location note</b> 187' PIPE SIZE REDUCED BY 4" LATERAL		Manufactured	Open	Good

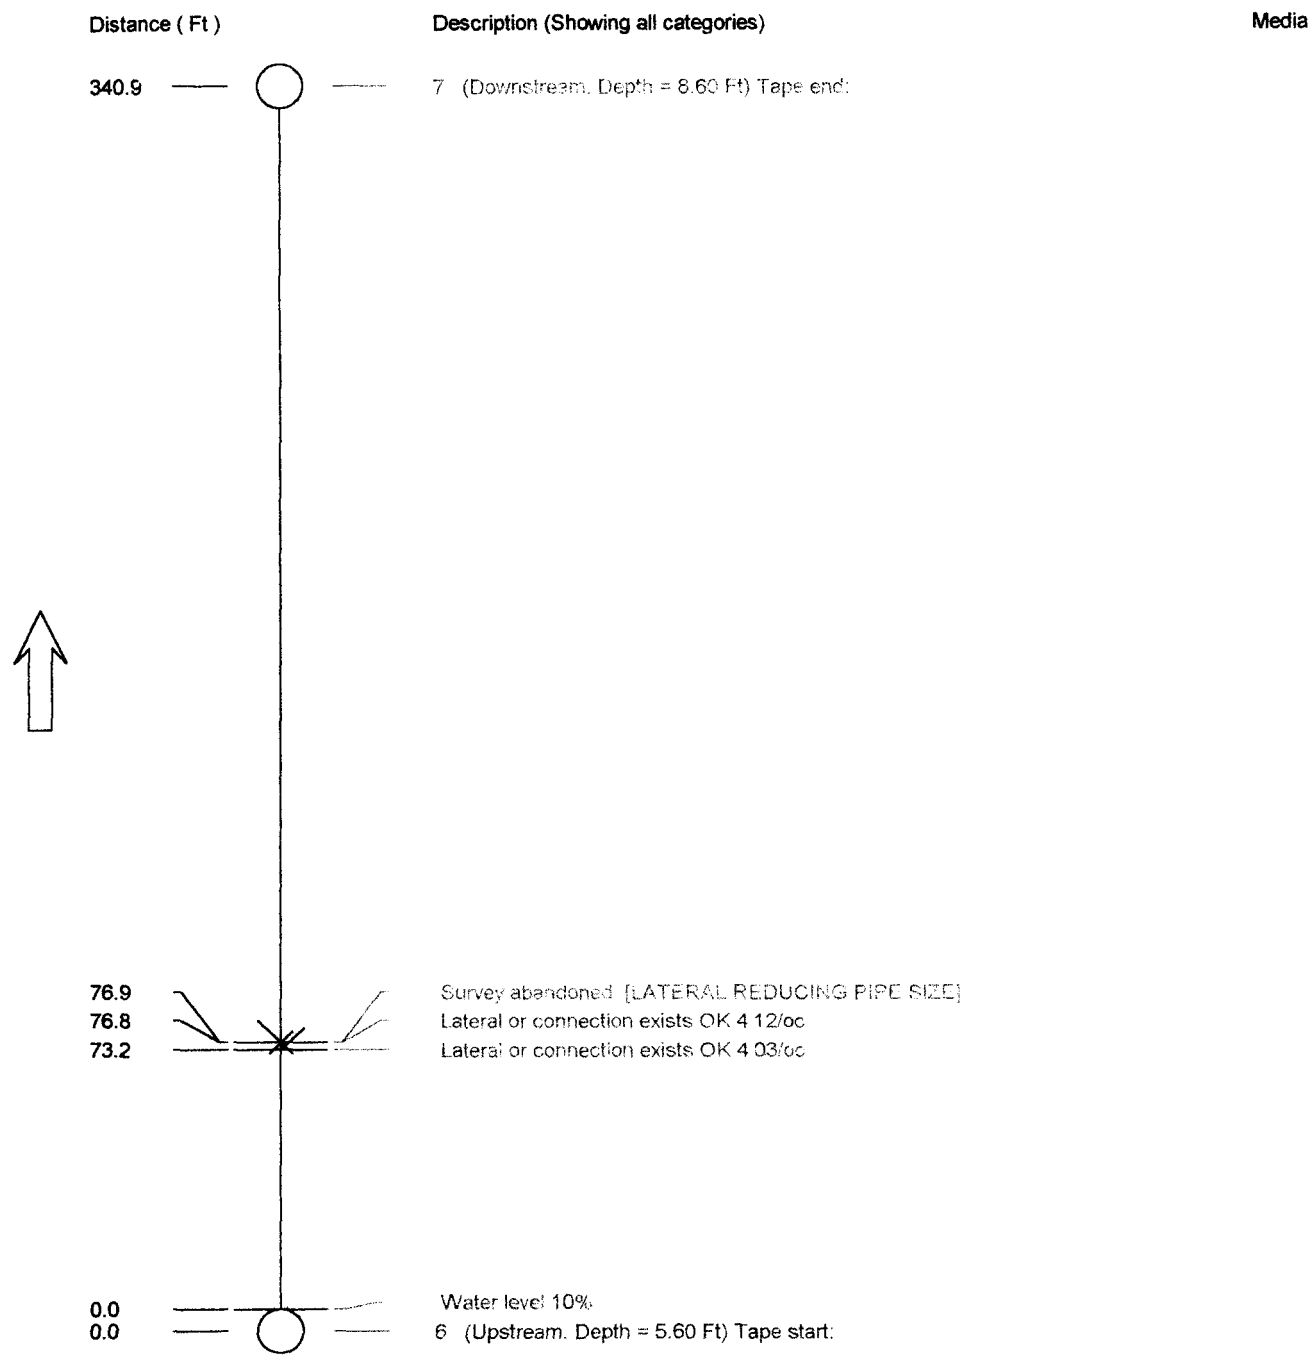
<b>Job</b>	<b>Contract</b>	<b>Cassette 2</b>	<b>Surveyed On</b> 07/30/2004	<b>Sheet</b> 14
<b>Operator</b> BMN	<b>Van Reference</b>	<b>Weather</b> Dry		
<b>Road Name</b> 8TH AVE N		<b>Place Name</b> TIERRA VERDE		
<b>Location type</b> Light road (rural roads with lighter traffic, town & city back streets)				
<b>Surface</b>				
<b>Survey purpose</b> Sample survey to determine asset condition				
<b>Pipe Use</b> Foul	<b>Schedule length</b> 340.9 Ft	<b>From</b> 6	<b>Depth</b> 5.60 Ft	
<b>Shape</b> Circular	<b>Size</b> 8 by ins	<b>To</b> 7	<b>Depth</b> 8.60 Ft	
<b>Material</b> Vitrified clay	<b>Joint spacing</b> Ft	<b>Direction</b> Down		
<b>Lining</b>	<b>Year laid</b>	<b>Cat</b> A	<b>Pre-clean</b> Y	<b>Last cleaned</b>
<b>General note</b> SEE SHEET 5 FOR REVERSE SET UP		<b>Structural</b>	<b>Service</b>	<b>Construction</b>
<b>Location note</b> 76.9' PIPE DIM REDUCED BY 4" LATERAL		<b>Material</b>	<b>Height</b>	<b>Notes</b>

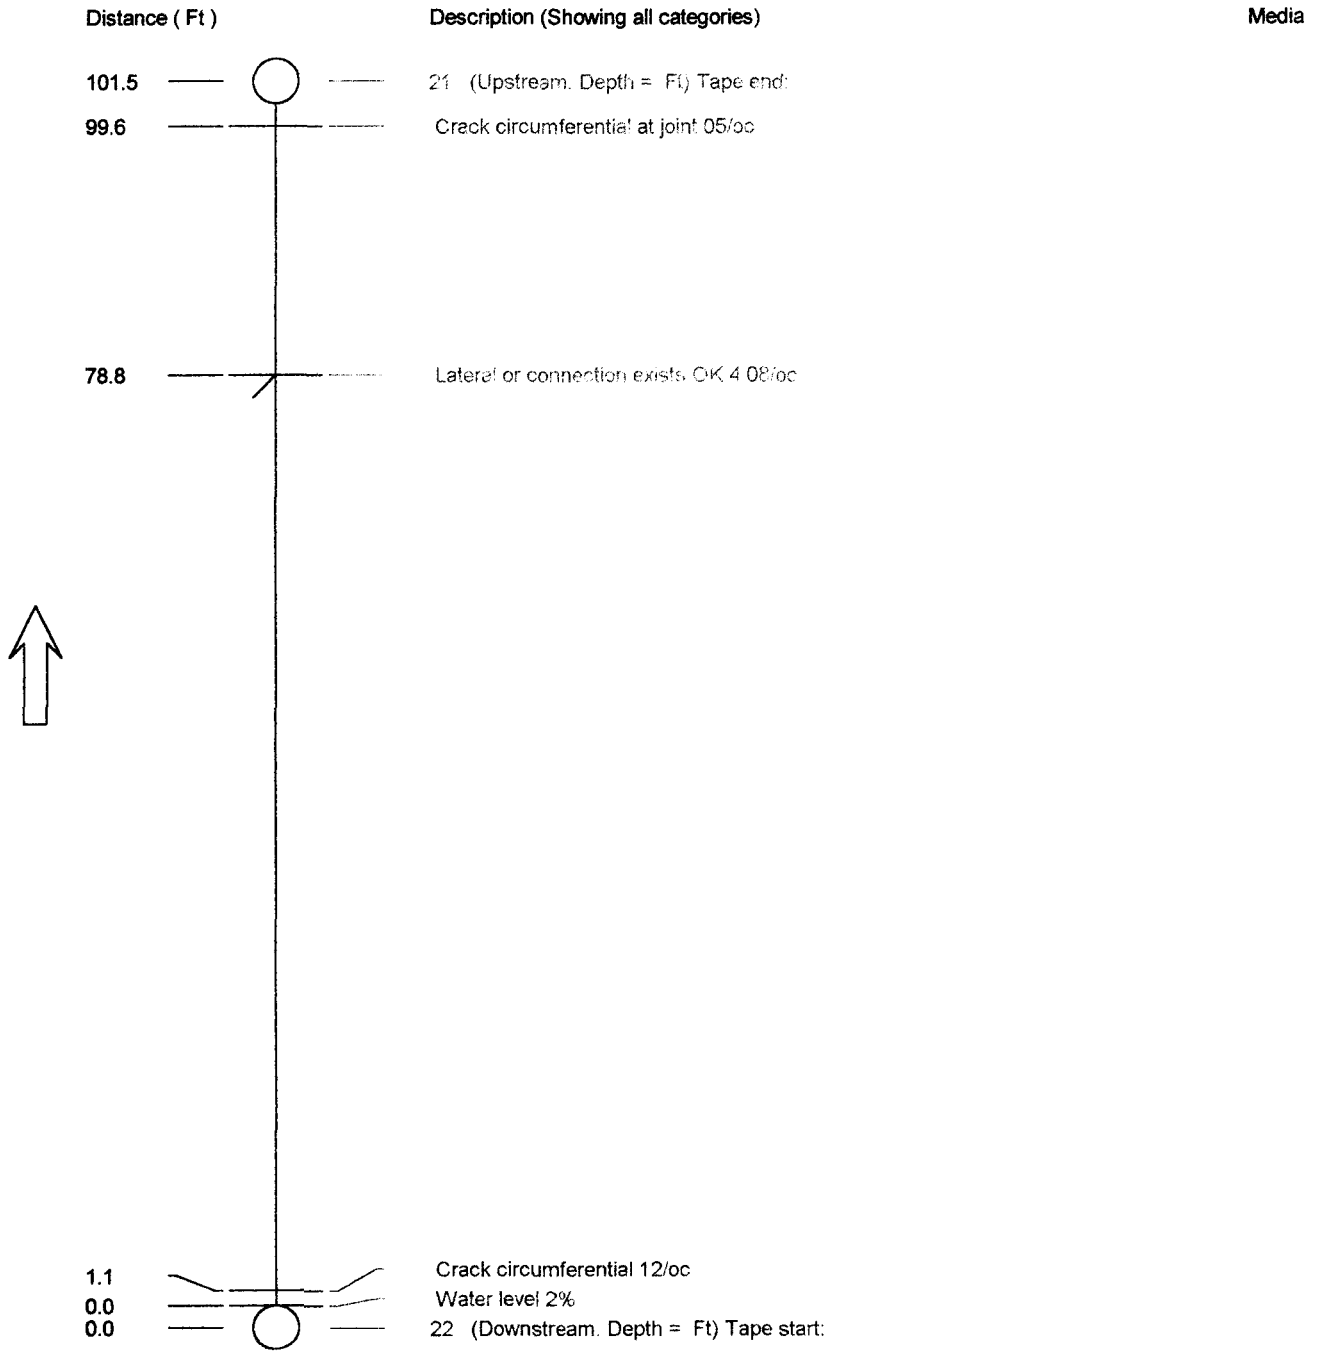
<b>Job</b> Operator DWH	<b>Contract</b> Van Reference	<b>Cassette</b> 3	<b>Surveyed On</b> 08/06/2004	<b>Sheet</b> 25
<b>Road Name</b> 8TH AVE N		<b>Place Name</b> TIERRA VERDE		
<b>Location type</b> Light road (rural roads with lighter traffic, town & city back streets)				
<b>Surface</b>				
<b>Survey purpose</b> Sample survey to determine asset condition				
<b>Pipe Use</b> Foul	<b>Schedule length</b> 101.5 Ft	<b>From</b> 22	<b>Depth</b>	<b>Ft</b>
<b>Shape</b> Circular	<b>Size</b> 8 by ins	<b>To</b> 21	<b>Depth</b>	<b>Ft</b>
<b>Material</b> Vitrified clay	<b>Joint spacing</b> Ft	<b>Direction</b> Up		
<b>Lining</b>	<b>Year laid</b> Cat A	<b>Pre-clean</b> Y	<b>Last cleaned</b>	
<b>General note</b>		Structural	Service	Crack circumferential
<b>Location note</b>		11/12/03

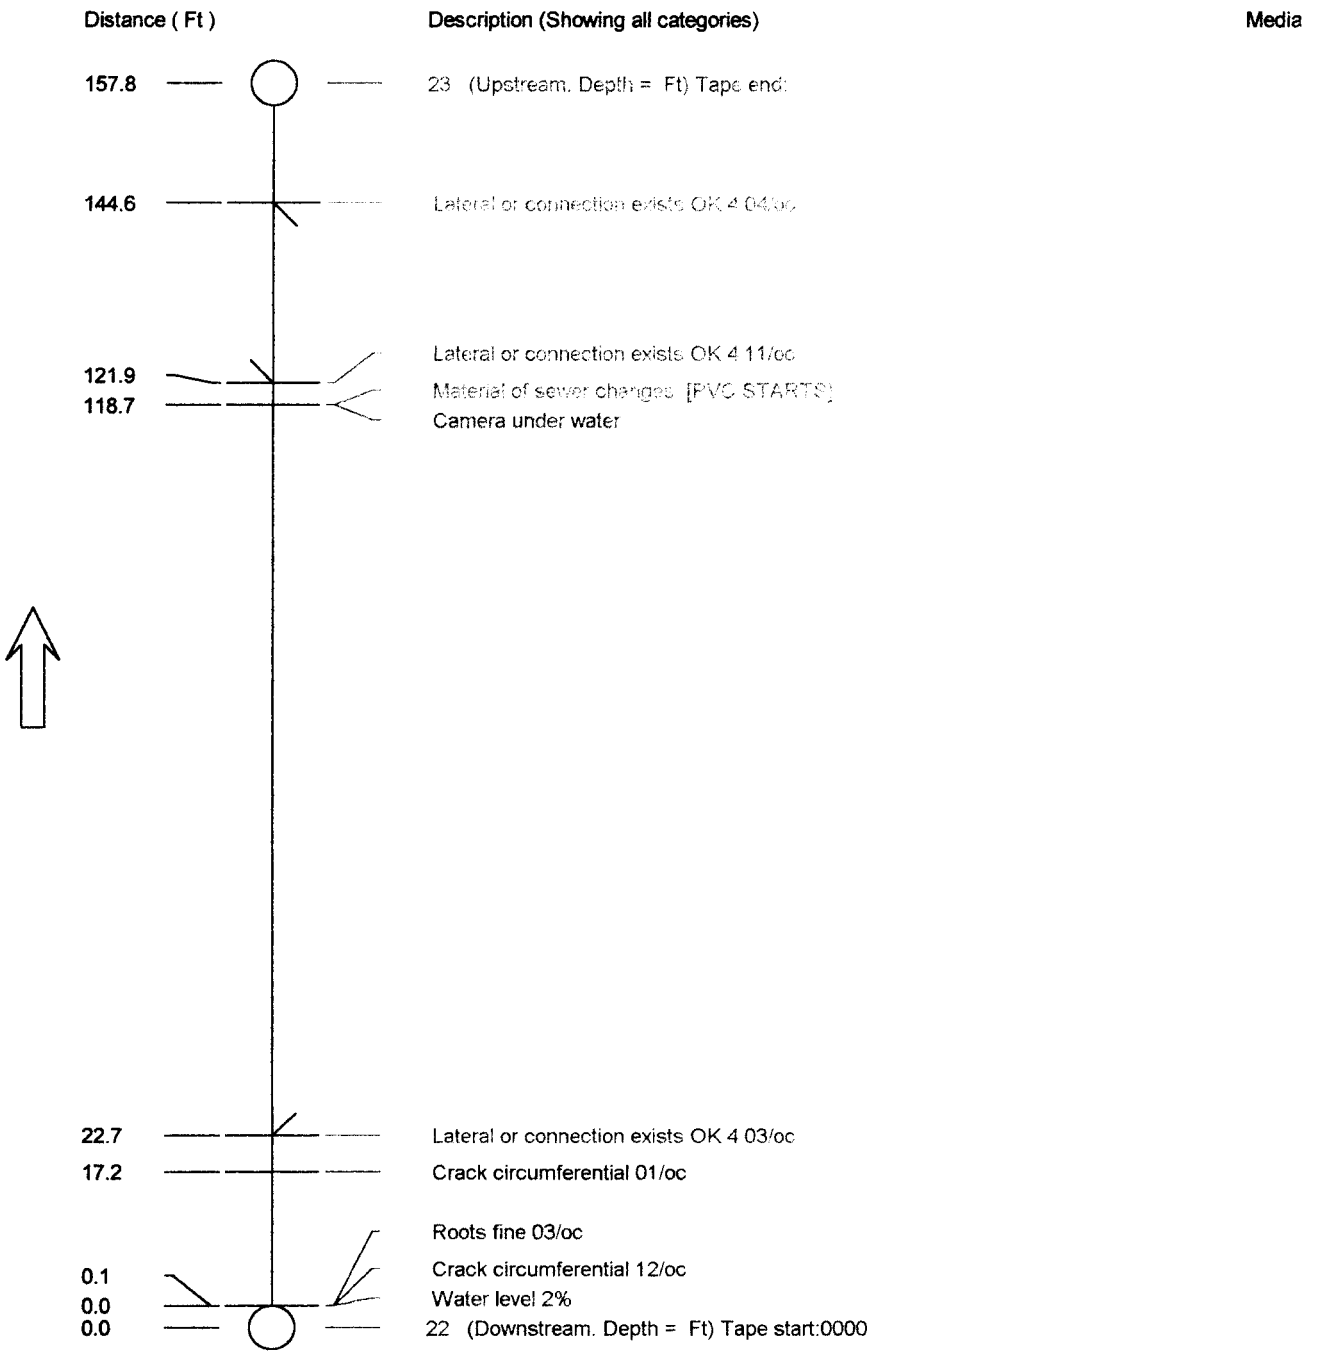
<b>Job</b> Operator DWH	<b>Contract</b> Van Reference	<b>Cassette</b> 4	<b>Surveyed On</b> 08/06/2004	<b>Sheet</b> 26
<b>Road Name</b> 8TH AVE N		<b>Place Name</b> TIERRA VERDE		
<b>Location type</b> Light road (rural roads with lighter traffic, town & city back streets)				
<b>Surface</b>				
<b>Survey purpose</b> Sample survey to determine asset condition				
<b>Pipe Use</b> Foul	<b>Schedule length</b> 157.8 Ft	<b>From</b> 22	<b>Depth</b>	<b>Ft</b>
<b>Shape</b> Circular	<b>Size</b> 8 by ins	<b>To</b> 23	<b>Depth</b>	<b>Ft</b>
<b>Material</b> Vitrified clay	<b>Joint spacing</b> Ft	<b>Direction</b> Up		
<b>Lining</b>	<b>Year laid</b> Cat A	<b>Pre-clean</b> Y	<b>Last cleaned</b>	
<b>General note</b>	Structural		Service	General
<b>Location note</b>	Location		...	...

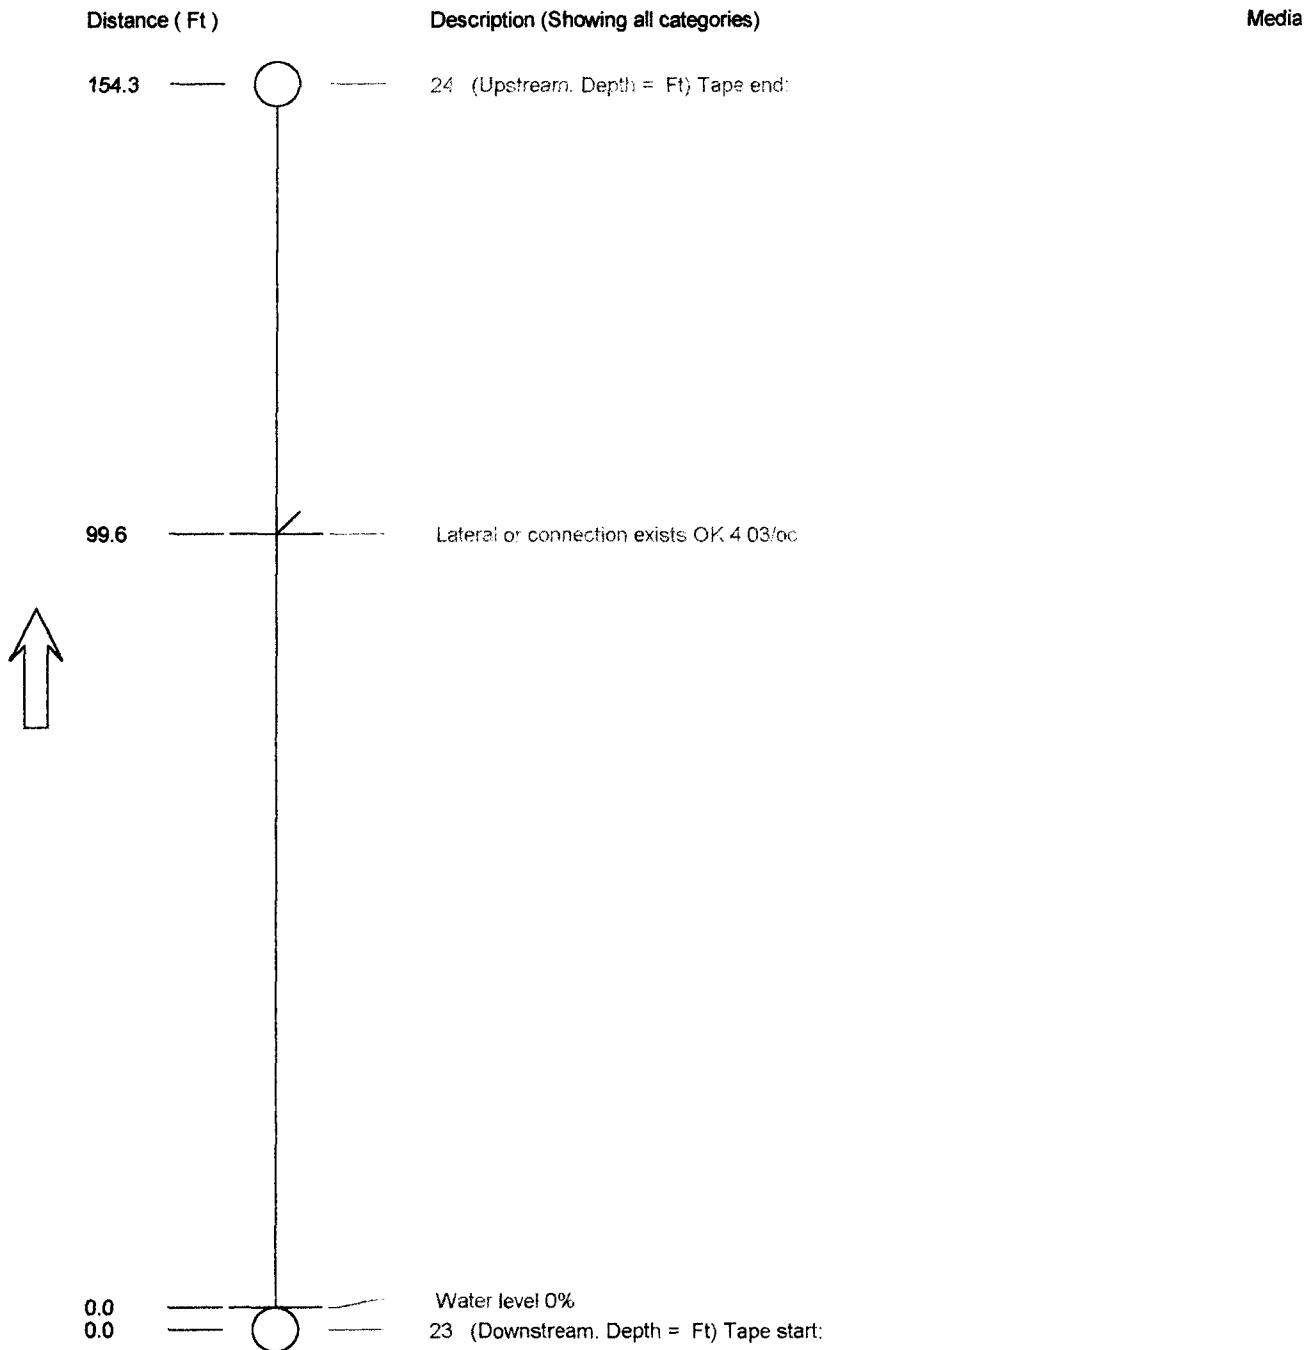
<b>Job</b>	<b>Contract</b>	<b>Cassette 4</b>	<b>Surveyed On</b> 08/06/2004	<b>Sheet</b> 27
<b>Operator</b> DWH	<b>Van Reference</b>	<b>Weather</b> Dry		
<b>Road Name</b> 8TH AVE N		<b>Place Name</b> TIERRA VERDE		
<b>Location type</b> Light road (rural roads with lighter traffic, town & city back streets)				
<b>Surface</b>				
<b>Survey purpose</b> Sample survey to determine asset condition				
<b>Pipe Use</b> Foul	<b>Schedule length</b> 154.3 Ft	<b>From</b> 23	<b>Depth</b>	<b>Ft</b>
<b>Shape</b> Circular	<b>Size</b> 8 by ins	<b>To</b> 24	<b>Depth</b>	<b>Ft</b>
<b>Material</b> Polyvinyl chloride	<b>Joint spacing</b> Ft	<b>Direction</b> Up		
<b>Lining</b>	<b>Year laid</b> Cat A	<b>Pre-clean</b> Y	<b>Last cleaned</b>	
<b>General note</b>		Structural	Service	Good Condition
<b>Location note</b>		Model: 1000	1/2" / 1"

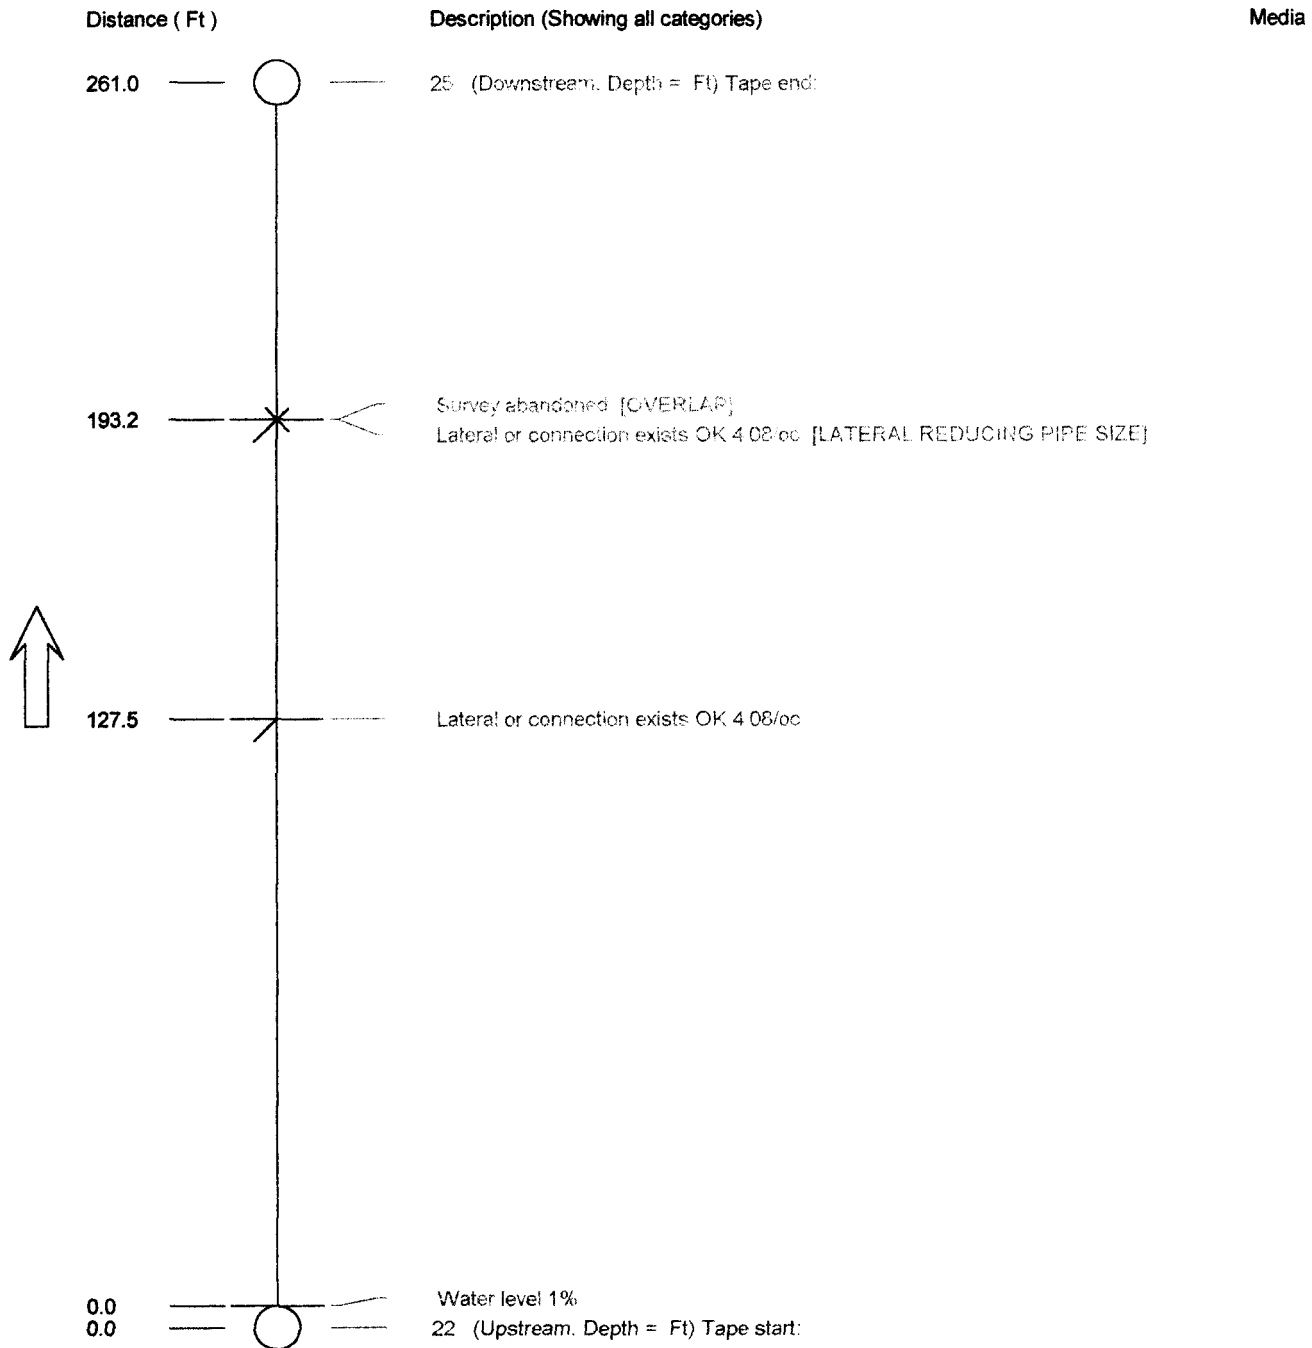
<b>Job</b>	<b>Contract</b>	<b>Cassette 4</b>	<b>Surveyed On</b> 08/06/2004	<b>Sheet</b> 28
<b>Operator</b> DWH	<b>Van Reference</b>	<b>Weather</b> Dry		
<b>Road Name</b> MONTE CRISTO		<b>Place Name</b> TIERRA VERDE		
<b>Location type</b> Light road (rural roads with lighter traffic, town & city back streets)				
<b>Surface</b>				
<b>Survey purpose</b> Sample survey to determine asset condition				
<b>Pipe Use</b> Foul	<b>Schedule length</b> 261.0 Ft	<b>From</b> 22	<b>Depth</b>	<b>Ft</b>
<b>Shape</b> Circular	<b>Size</b> 8 by Ins	<b>To</b> 25	<b>Depth</b>	<b>Ft</b>
<b>Material</b> Vitrified clay	<b>Joint spacing</b> Ft	<b>Direction</b> Down		
<b>Lining</b>	<b>Year laid</b> Cat A	<b>Pre-clean</b> Y	<b>Last cleaned</b>	
<b>General note</b>		Structural	Service	Construction
<b>Location note</b>		Material	Condition	Media
