RE: Docket No. 080248-SU; Tierra Verde Utilities, Inc.'s Application for an Increase in Wastewater Rates Increase in Pinellas County, Florida  
Our File No.: 30057.156

3(a) The "TV Sewer Mains" project reflects the effort to clean and video inspect two portions of the Tierra Verde collection system. The gravity main and manholes situated in the Pinellas Bayway right-of-way and the area west of the Pinellas Bayway along and adjacent to Madonna Avenue had not been cleaned and inspected for many years. A total of 6,229 LF of 18" diameter pipe was cleaned and inspected along the Pinellas Bayway. A total of 21,250 LF of 8" diameter pipe and manholes were inspected west of the Pinellas Bayway along Madonna Avenue. The project is justified for the following reasons:

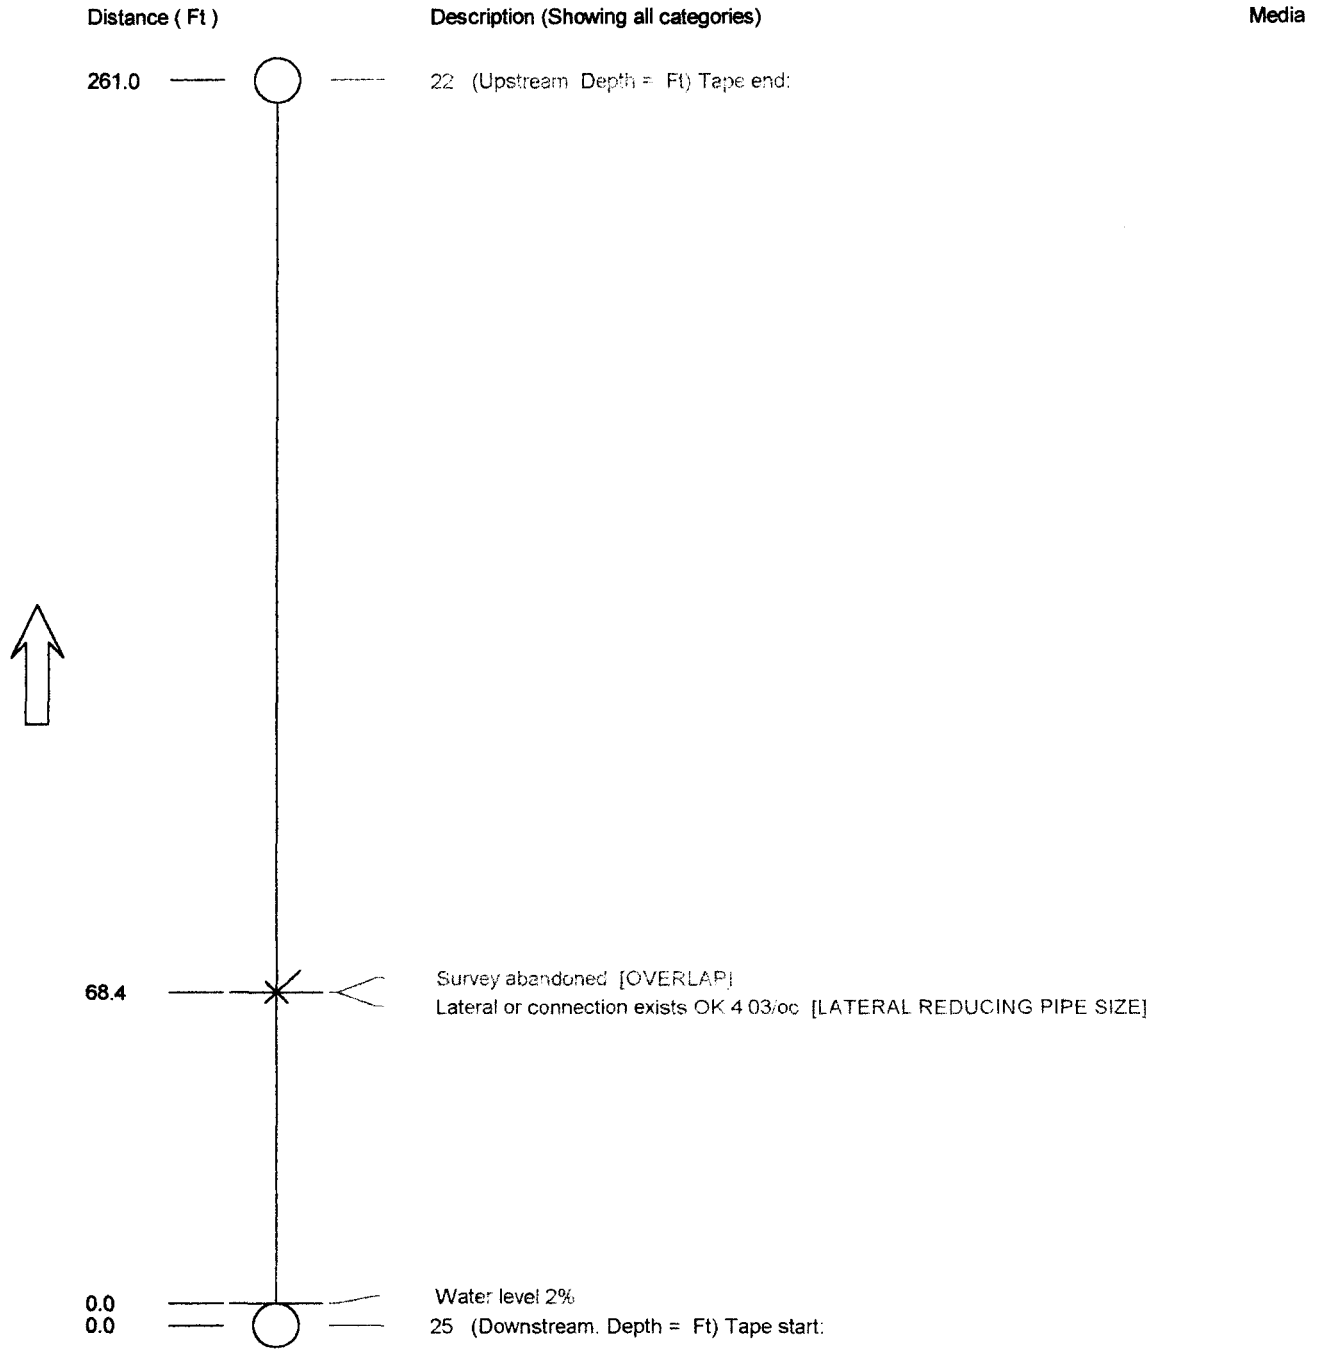
<b>Job</b> Operator DWH	<b>Contract</b> Van Reference	<b>Cassette</b> 4	<b>Surveyed On</b> 08/06/2004	<b>Sheet</b> 29
<b>Road Name</b> MONTE CRISTO		<b>Place Name</b> TIERRA VERDE		
<b>Location type</b> Light road (rural roads with lighter traffic, town & city back streets)				
<b>Surface</b>				
<b>Survey purpose</b> Sample survey to determine asset condition				
<b>Pipe Use</b> Foul	<b>Schedule length</b> 261.0 Ft	<b>From</b> 25	<b>Depth</b>	<b>Ft</b>
<b>Shape</b> Circular	<b>Size</b> 8 by ins	<b>To</b> 22	<b>Depth</b>	<b>Ft</b>
<b>Material</b> Vitrified clay	<b>Joint spacing</b> Ft	<b>Direction</b> Up		
<b>Lining</b>	<b>Year laid</b> Cat A	<b>Pre-clean</b> Y	<b>Last cleaned</b>	
<b>General note</b> SHEE SHEET 28 FOR REVERSE SETUP		<b>Structural</b>	<b>Service</b>	<b>Construction</b>
<b>Location note</b>		Medium	Low	High

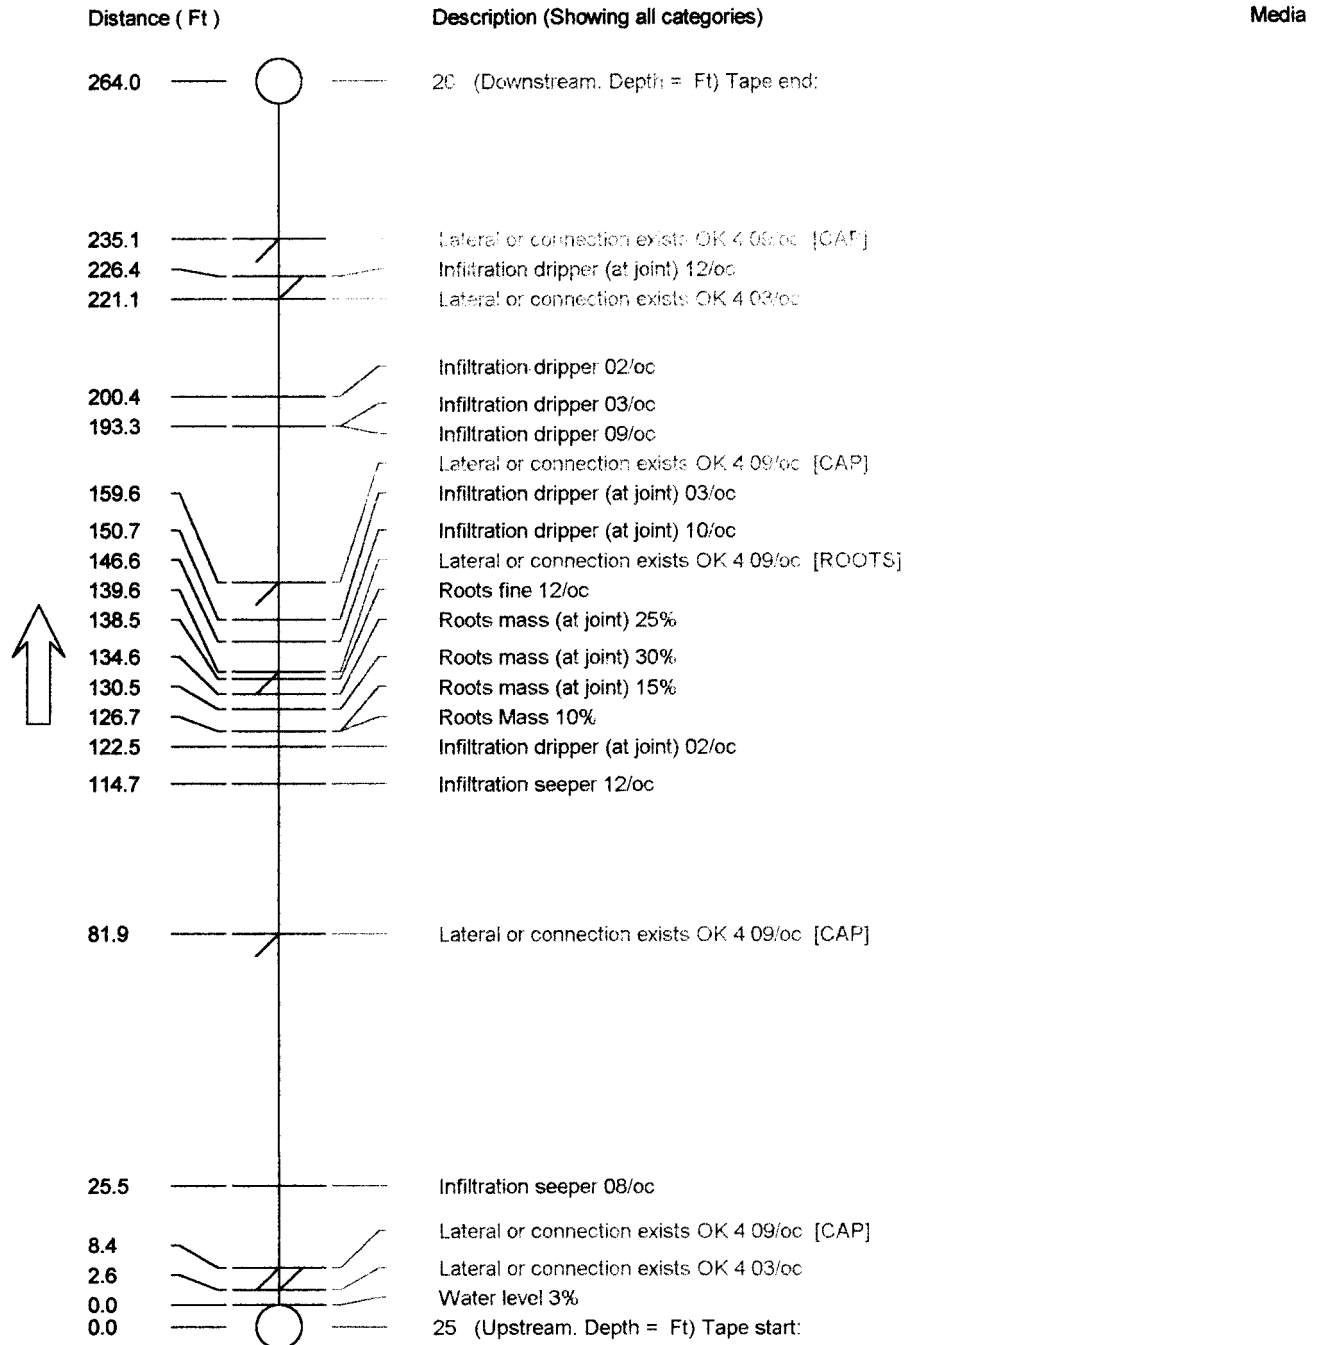
<b>Job</b>	<b>Contract</b>	<b>Cassette 4</b>	<b>Surveyed On</b> 08/06/2004	<b>Sheet</b> 30
<b>Operator</b> DWH	<b>Van Reference</b>	<b>Weather</b> Dry		
<b>Road Name</b> MONTE CRISTO		<b>Place Name</b> TIERRA VERDE		
<b>Location type</b> Light road (rural roads with lighter traffic, town & city back streets)				
<b>Surface</b>				
<b>Survey purpose</b> Sample survey to determine asset condition				
<b>Pipe Use</b> Foul	<b>Schedule length</b> 264.0 Ft	<b>From</b> 25	<b>Depth</b>	<b>Ft</b>
<b>Shape</b> Circular	<b>Size</b> 8 by ins	<b>To</b> 26	<b>Depth</b>	<b>Ft</b>
<b>Material</b> Vitrified clay	<b>Joint spacing</b> Ft	<b>Direction</b> Down		
<b>Lining</b>	<b>Year laid</b> Cat A	<b>Pre-clean</b> Y	<b>Last cleaned</b>	
<b>General note</b>		Structural	Service	Construction
<b>Location note</b>		Insulation	Condition

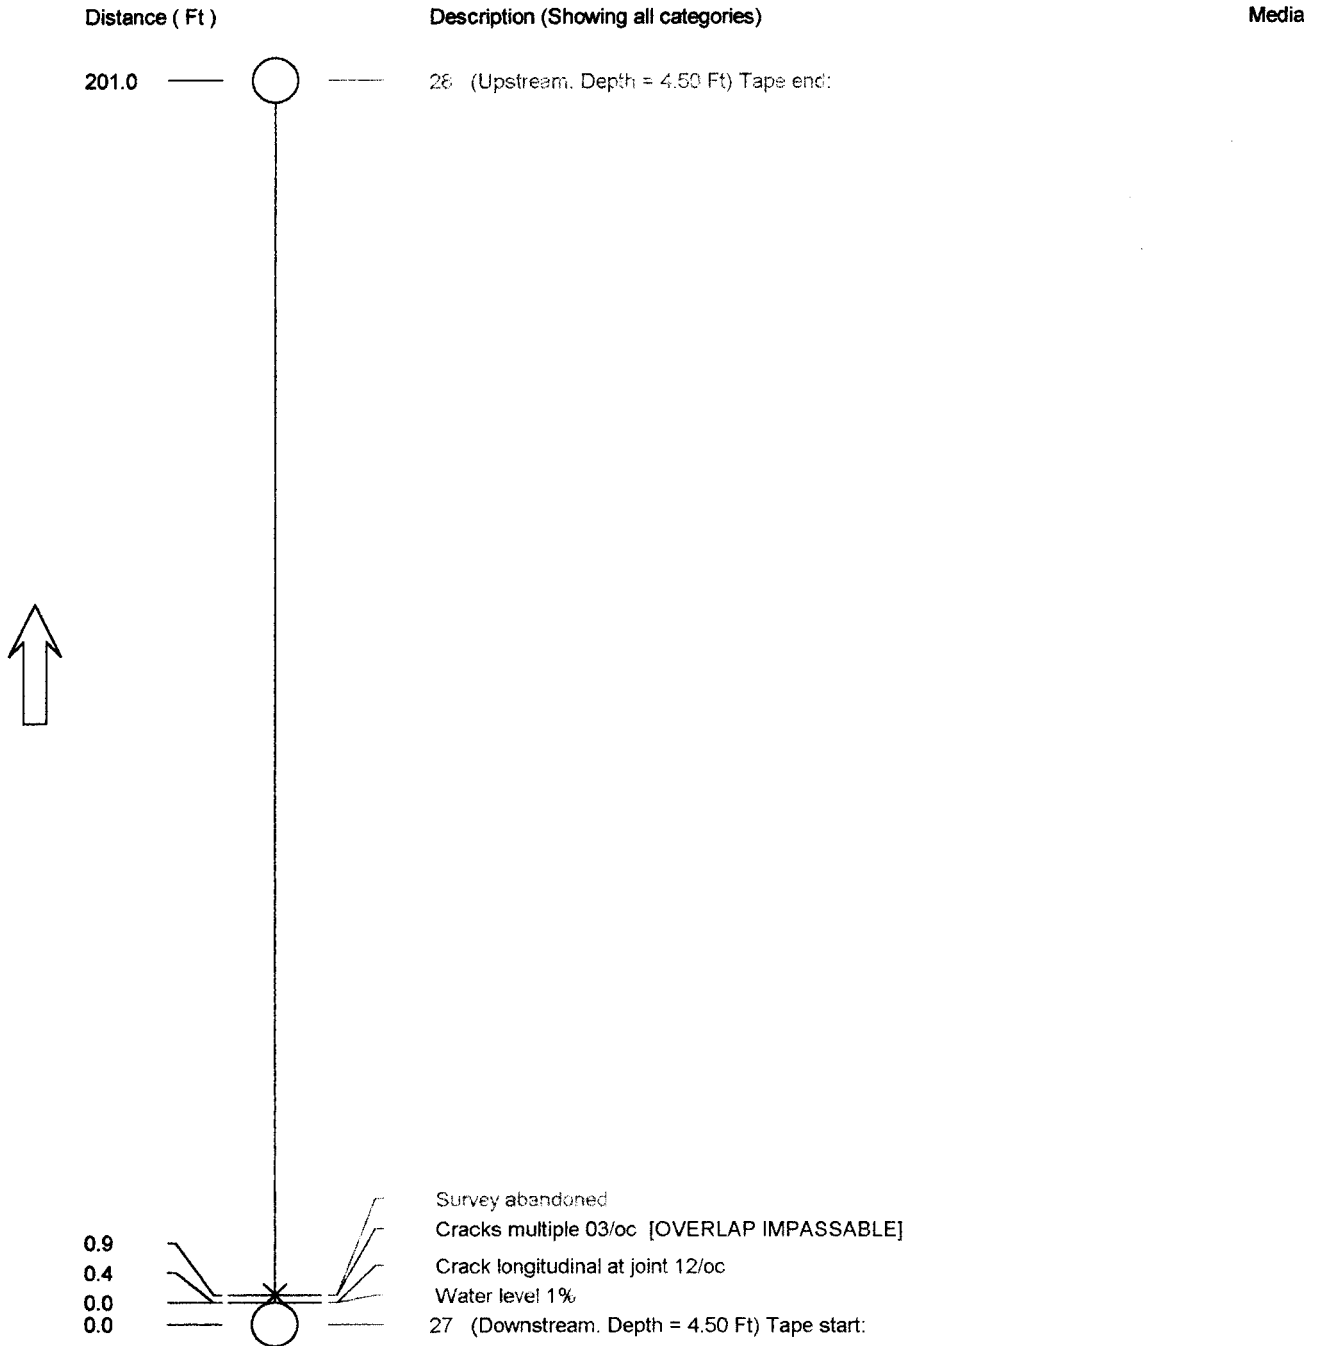
<b>Job</b> Operator DWH	<b>Contract</b> Van Reference	<b>Cassette</b> 4	<b>Surveyed On</b> 08/06/2004	<b>Sheet</b> 31
<b>Road Name</b> 8TH AVE N		<b>Place Name</b> TIERA VERDE		
<b>Location type</b> Light road (rural roads with lighter traffic, town & city back streets)				
<b>Surface</b>				
<b>Survey purpose</b> Sample survey to determine asset condition				
<b>Pipe Use</b> Foul	<b>Schedule length</b> 201.0 Ft	<b>From</b> 27	<b>Depth</b> 4.50 Ft	
<b>Shape</b> Circular	<b>Size</b> 8 by ins	<b>To</b> 28	<b>Depth</b> 4.50 Ft	
<b>Material</b> Vitrified clay	<b>Joint spacing</b> Ft	<b>Direction</b> Up		
<b>Lining</b>	<b>Year laid</b> Cat A	<b>Pre-clean</b> Y	<b>Last cleaned</b>	
<b>General note</b> SEE SHEET 33 FOR REVERSE SET UP		<b>Structural</b>	<b>Service</b>	<b>Constructional</b>
<b>Location note</b>		<b>Media</b>

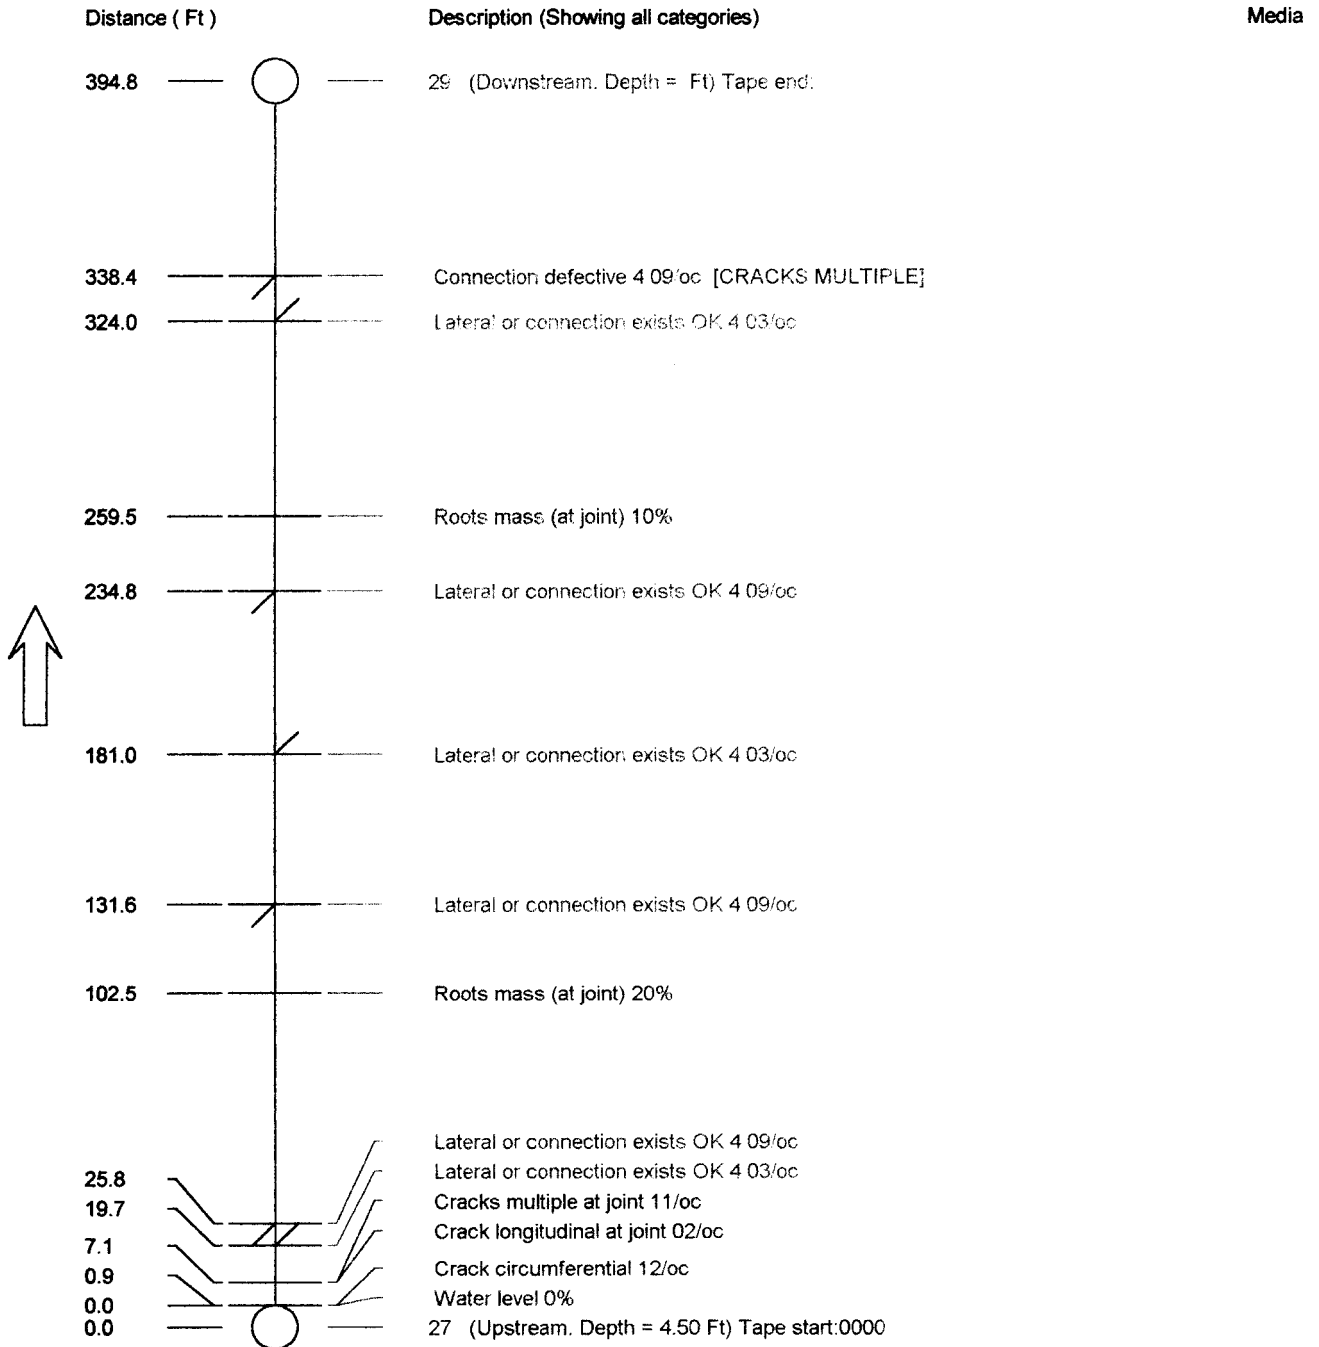
<b>Job</b> Operator DWH	<b>Contract</b> Van Reference	<b>Cassette</b> 4	<b>Surveyed On</b> 08/06/2004	<b>Sheet</b> 32
<b>Road Name</b> 8TH AVE N		<b>Place Name</b> TIERRA VERDE		
<b>Location type</b> Light road (rural roads with lighter traffic,town & city back streets)				
<b>Surface</b>				
<b>Survey purpose</b> Sample survey to determine asset condition				
<b>Pipe Use</b> Foul	<b>Schedule length</b> 394.8 Ft	<b>From</b> 27	<b>Depth</b> 4.50 Ft	
<b>Shape</b> Circular	<b>Size</b> 8 <b>by</b> Ins	<b>To</b> 29	<b>Depth</b> Ft	
<b>Material</b> Vitrified clay	<b>Joint spacing</b> Ft	<b>Direction</b> Down		
<b>Lining</b>	<b>Year laid</b> Cat A	<b>Pre-clean</b> Y	<b>Last cleaned</b>	
<b>General note</b>		Structural	Service	Operational
<b>Location note</b>		Minor	Major	Severe

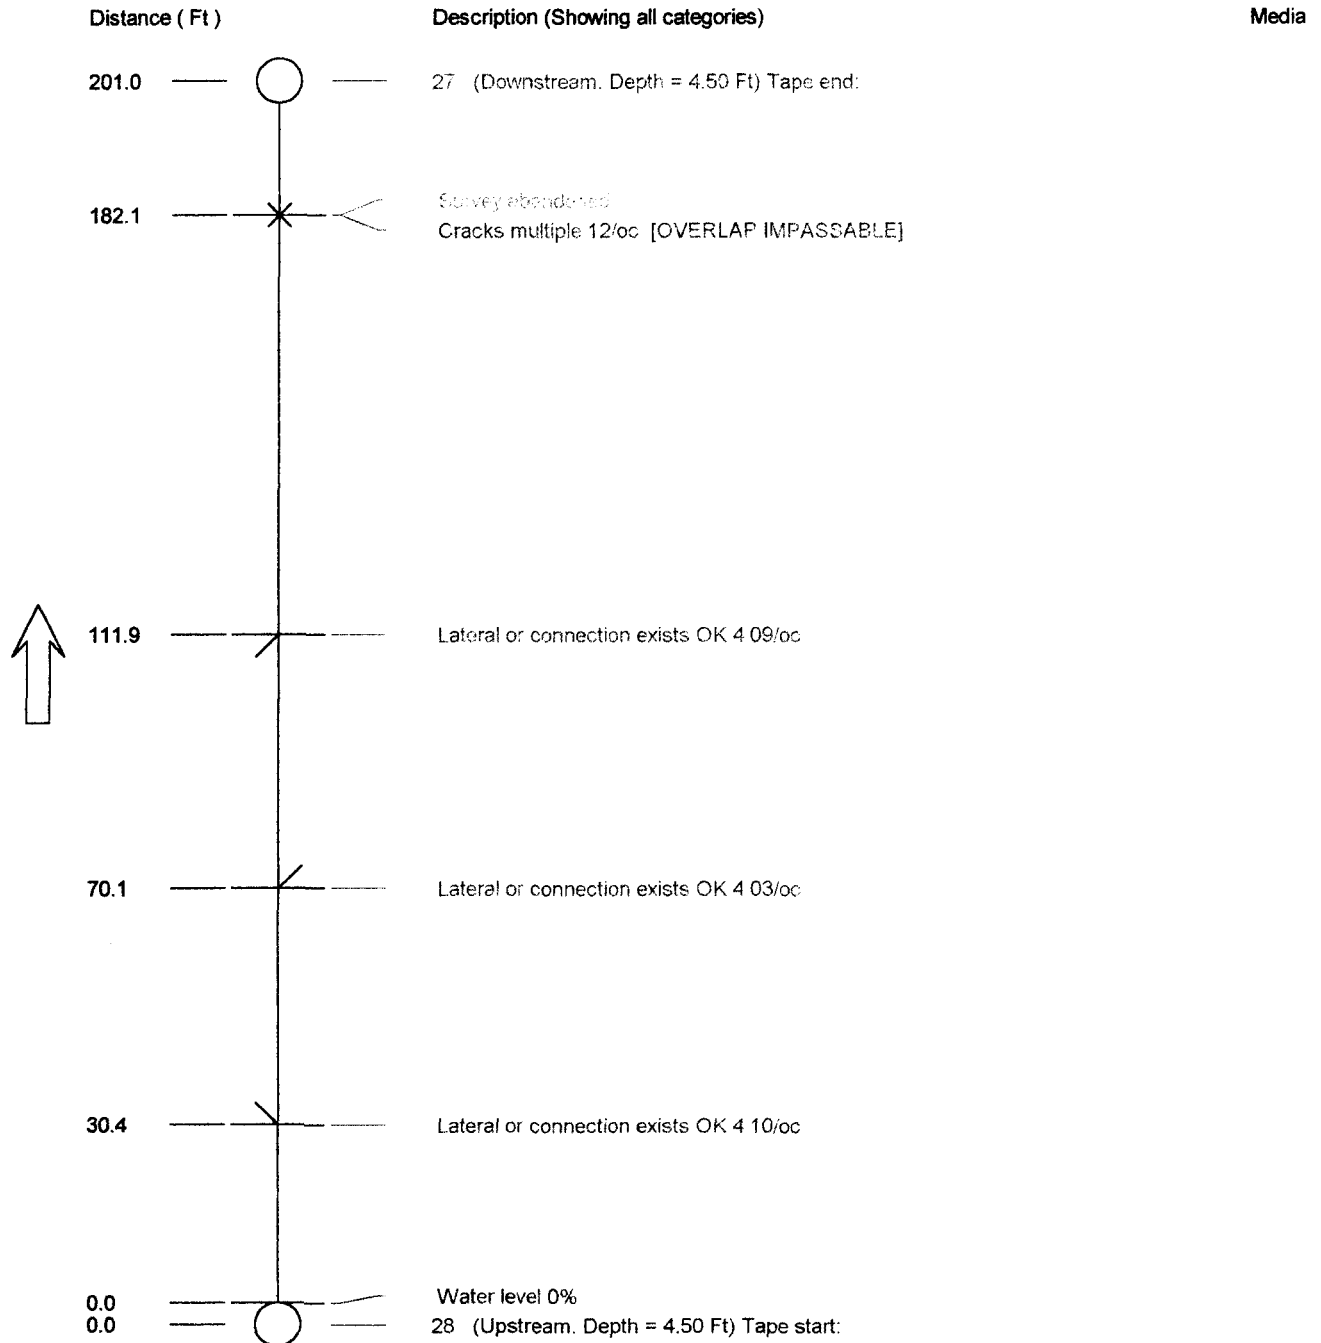
<b>Job</b>	<b>Contract</b>	<b>Cassette 5</b>	<b>Surveyed On</b> 08/09/2004	<b>Sheet</b> 33
<b>Operator</b> DWH	<b>Van Reference</b>	<b>Weather</b> Dry		
<b>Road Name</b> 8TH AVE N		<b>Place Name</b> TIERA VERDE		
<b>Location type</b> Light road (rural roads with lighter traffic, town & city back streets)				
<b>Surface</b>				
<b>Survey purpose</b> Sample survey to determine asset condition				
<b>Pipe Use</b> Foul	<b>Schedule length</b> 201.0 Ft	<b>From</b> 28	<b>Depth</b> 4.50 Ft	
<b>Shape</b> Circular	<b>Size</b> 8 by ins	<b>To</b> 27	<b>Depth</b> 4.50 Ft	
<b>Material</b> Vitrified clay	<b>Joint spacing</b> Ft	<b>Direction</b> Down		
<b>Lining</b>	<b>Year laid</b> Cat A	<b>Pre-clean</b> Y	<b>Last cleaned</b>	
<b>General note</b> SEE SHEET 31 FOR REVERSE SETUP		<b>Structural</b>	<b>Service</b>	<b>Construction</b>
<b>Location note</b>

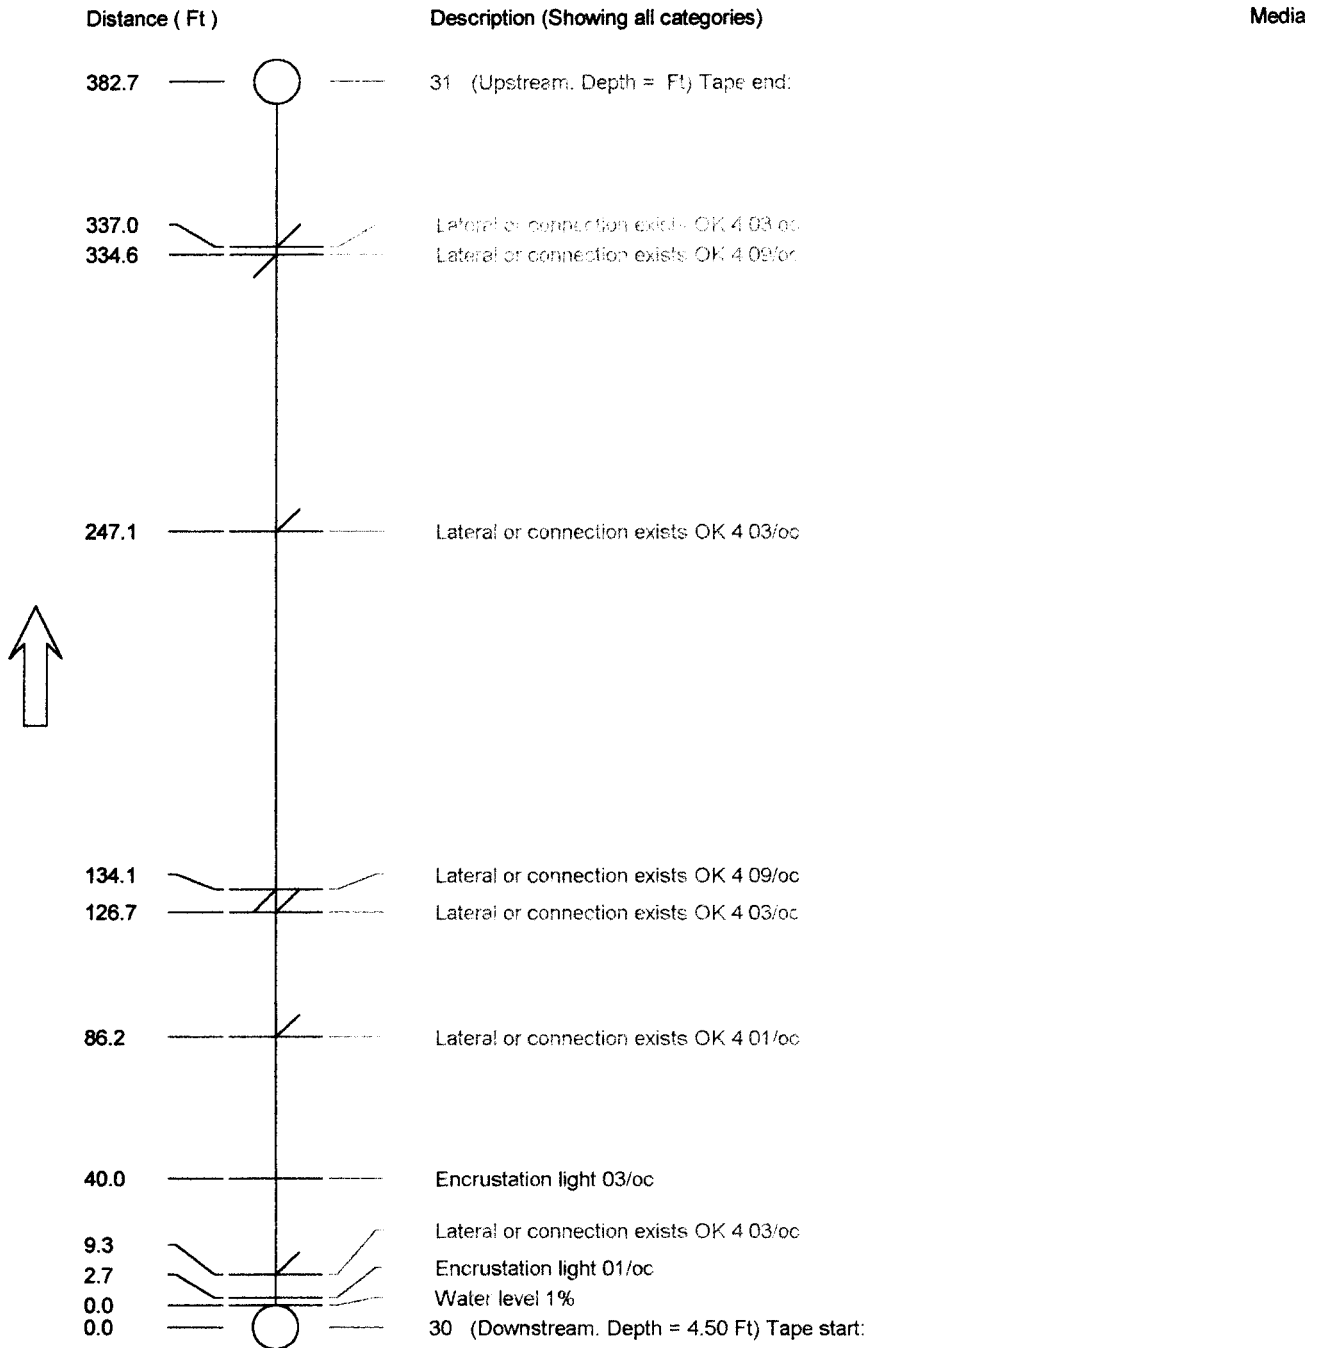
<b>Job</b>	<b>Contract</b>	<b>Cassette 5</b>	<b>Surveyed On</b> 08/09/2004	<b>Sheet</b> 34
<b>Operator</b> DWH	<b>Van Reference</b>	<b>Weather</b> Dry		
<b>Road Name</b> 8TH AVE N		<b>Place Name</b> TIERRA VERDE		
<b>Location type</b> Light road (rural roads with lighter traffic, town & city back streets)				
<b>Surface</b>				
<b>Survey purpose</b> Sample survey to determine asset condition				
<b>Pipe Use</b> Foul	<b>Schedule length</b> 382.7 Ft	<b>From</b> 30	<b>Depth</b> 4.50 Ft	
<b>Shape</b> Circular	<b>Size</b> 8 by ins	<b>To</b> 31	<b>Depth</b> Ft	
<b>Material</b> Vitrified clay	<b>Joint spacing</b> Ft	<b>Direction</b> Up	<b>Pre-clean</b> Y	<b>Last cleaned</b>
<b>Lining</b>	<b>Year laid</b> Cat A			
<b>General note</b>		Structural	Service	Constructional
<b>Location note</b>		Miscellaneous	...	...

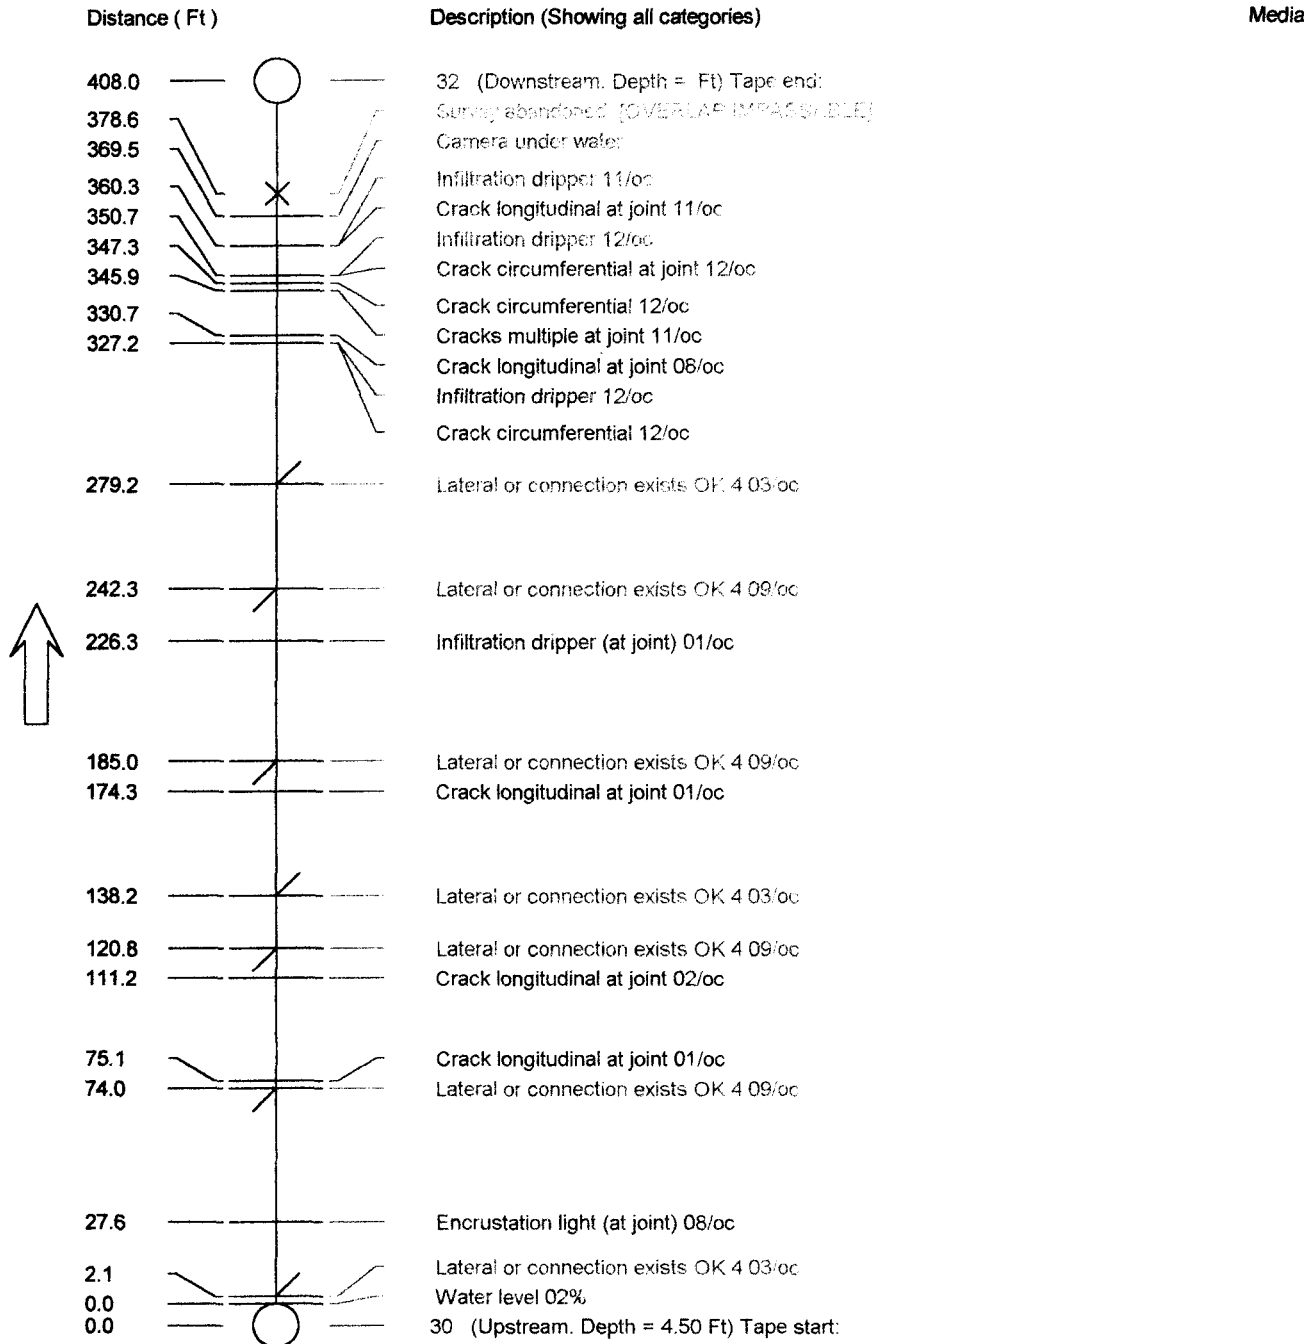
<b>Job</b> Operator DWH	<b>Contract</b> Van Reference	<b>Cassette</b> 5	<b>Surveyed On</b> 08/09/2004	<b>Sheet</b> 35
<b>Road Name</b> 8TH AVE N		<b>Place Name</b> TIERRA VERDE		
<b>Location type</b> Light road (rural roads with lighter traffic, town & city back streets)				
<b>Surface</b>				
<b>Survey purpose</b> Sample survey to determine asset condition				
<b>Pipe Use</b> Foul	<b>Schedule length</b> 408.0 Ft	<b>From</b> 30	<b>Depth</b> 4.50 Ft	
<b>Shape</b> Circular	<b>Size</b> 8 by ins	<b>To</b> 32	<b>Depth</b> Ft	
<b>Material</b> Vitrified clay	<b>Joint spacing</b> Ft	<b>Direction</b> Down		
<b>Lining</b>	<b>Year laid</b> Cat A	<b>Pre-clean</b> Y	<b>Last cleaned</b>	
<b>General note</b> SEE SHEET 37 FOR REVERSE SETUP		Structural	Service	Construction
<b>Location note</b>		Manufacture	Material	Installation

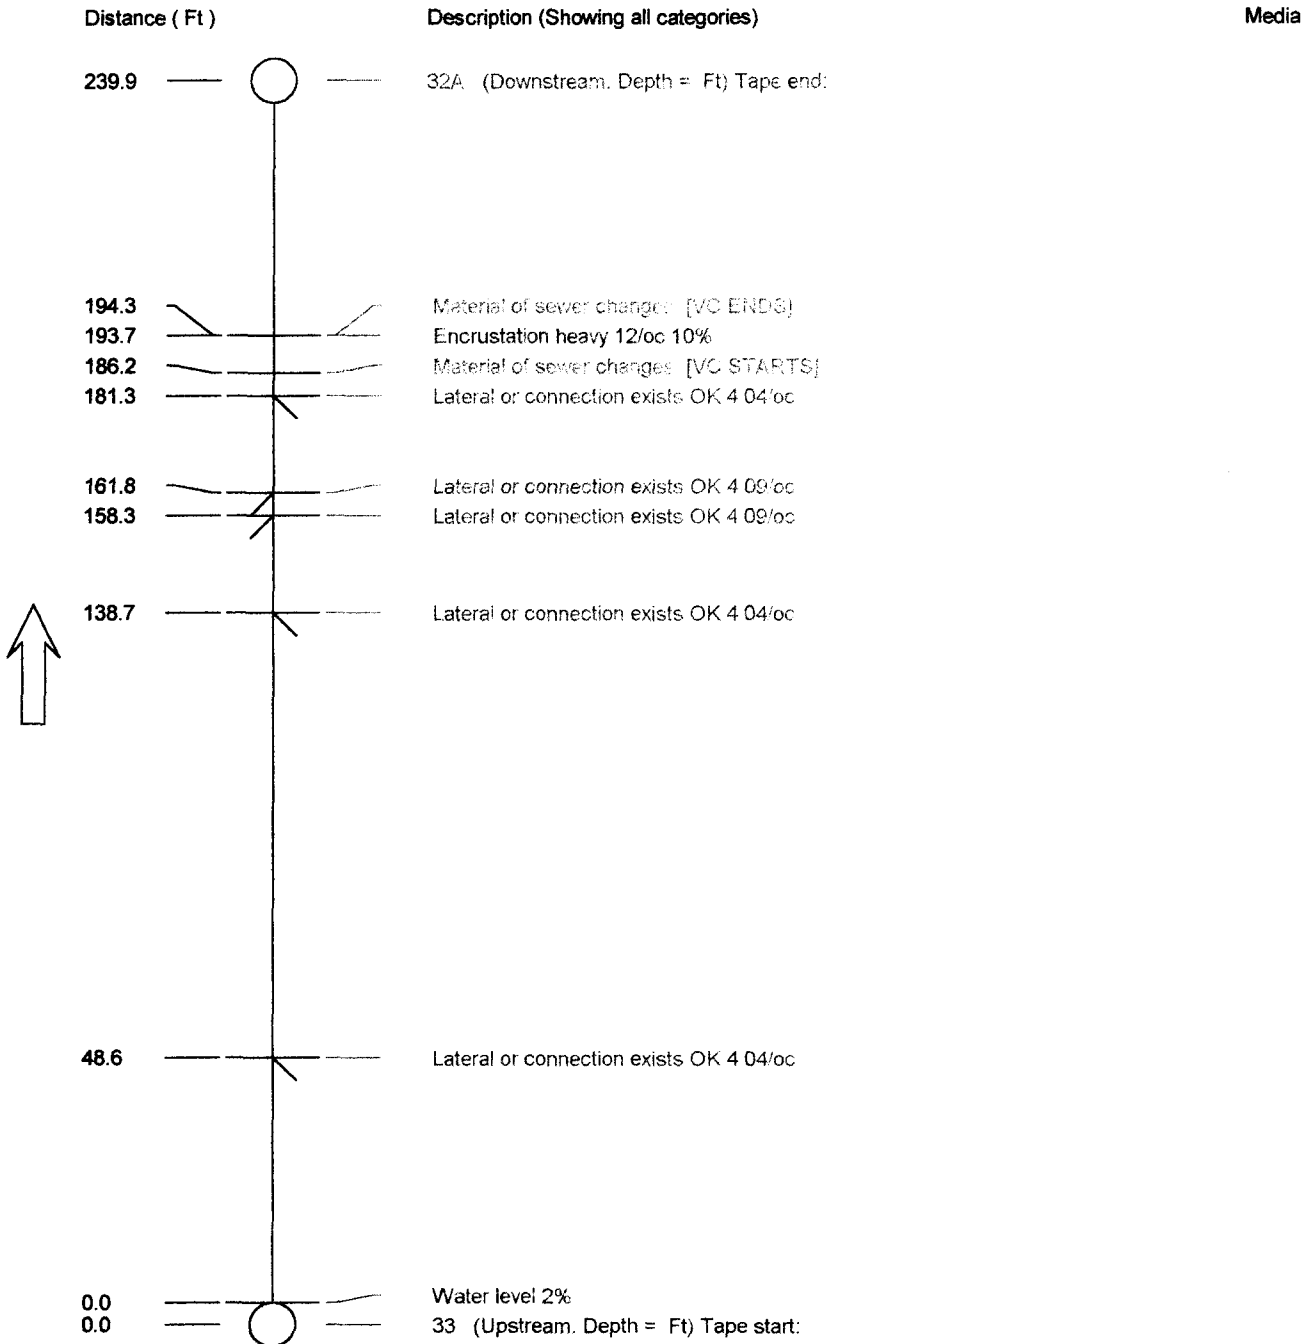
<b>Job</b>	<b>Contract</b>	<b>Cassette</b> 5	<b>Surveyed On</b> 08/09/2004	<b>Sheet</b> 36
<b>Operator</b> DWH	<b>Van Reference</b>	<b>Weather</b> Dry		
<b>Road Name</b> 8TH AVE N		<b>Place Name</b> TIERRA VERDE		
<b>Location type</b> Light road (rural roads with lighter traffic, town & city back streets)				
<b>Surface</b>				
<b>Survey purpose</b> Sample survey to determine asset condition				
<b>Pipe Use</b> Foul	<b>Schedule length</b> 239.9 Ft	<b>From</b> 33	<b>Depth</b>	<b>Ft</b>
<b>Shape</b> Circular	<b>Size by</b> Ins	<b>To</b> 32A	<b>Depth</b>	<b>Ft</b>
<b>Material</b> Polyvinyl chloride	<b>Joint spacing</b> Ft	<b>Direction</b> Down		
<b>Lining</b>	<b>Year laid</b> Cat A	<b>Pre-clean</b> Y	<b>Last cleaned</b>	
<b>General note</b>		Structural	Service	Condition
<b>Location note</b>		Miscellaneous	Other

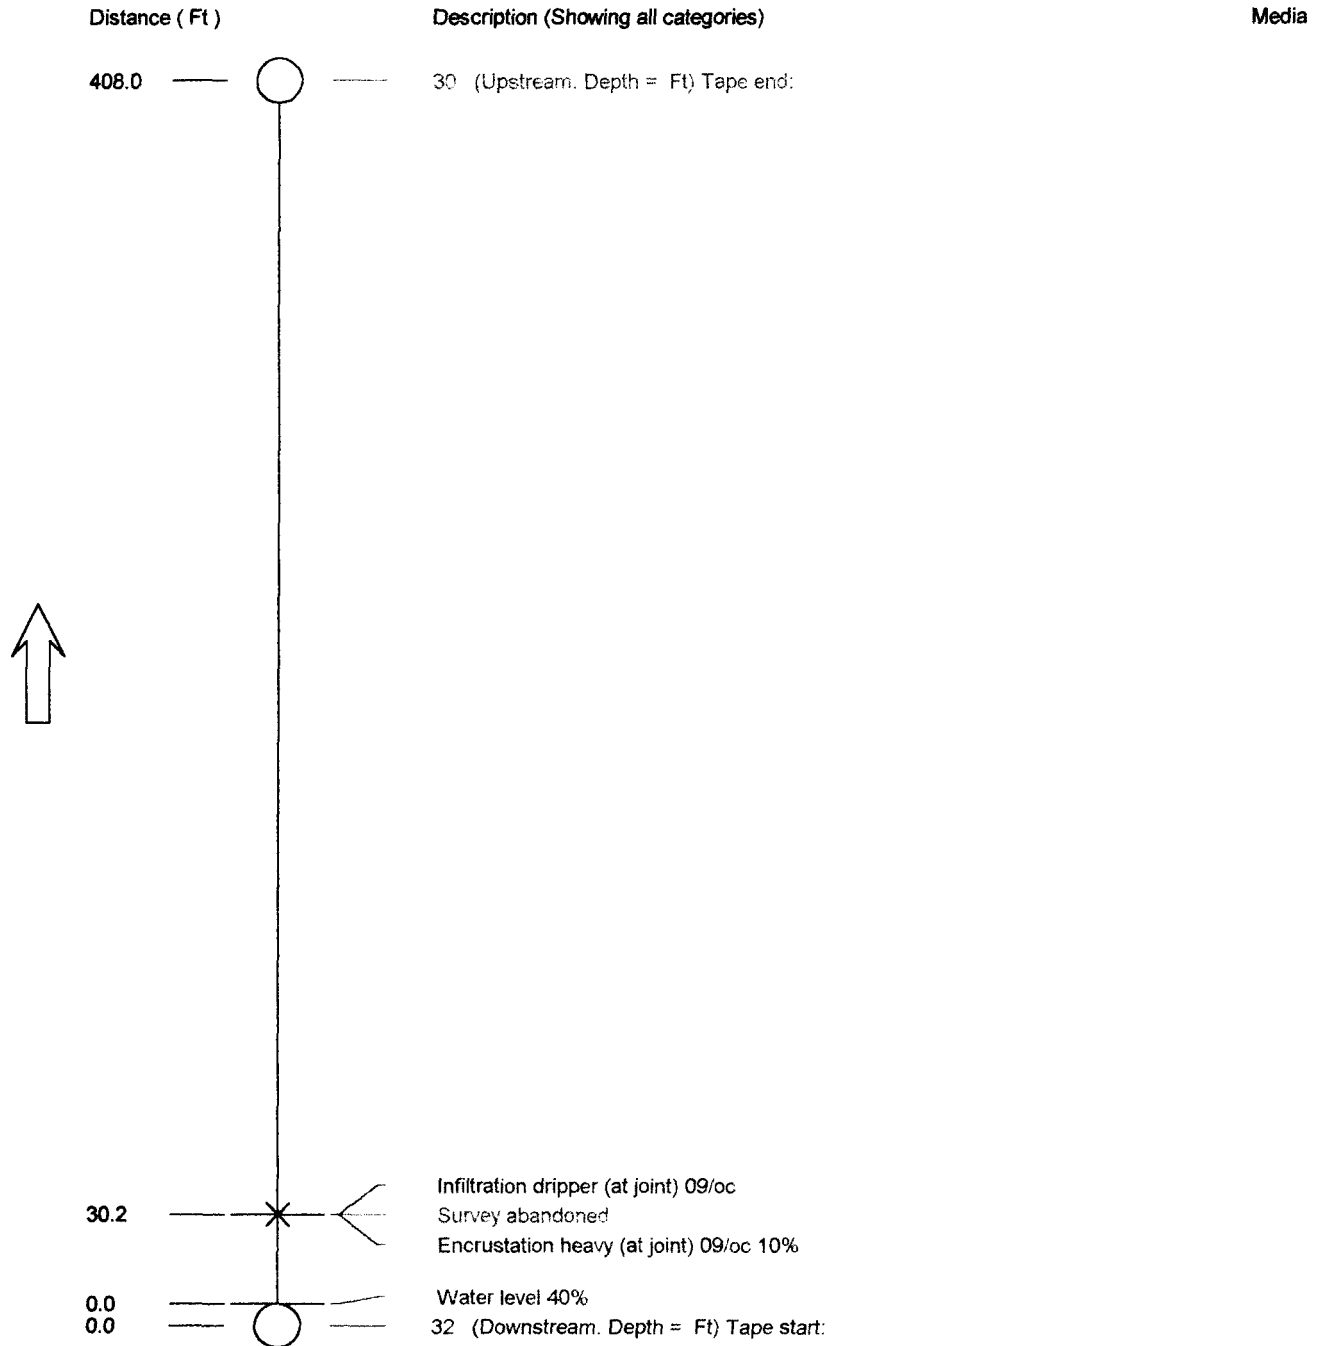
<b>Job</b> Operator DWH	<b>Contract</b> Van Reference	<b>Cassette</b> 5	<b>Surveyed On</b> 08/10/2004	<b>Sheet</b> 37
<b>Road Name</b> 8TH AVE N		<b>Place Name</b> TIERRA VERDE		
<b>Location type</b> Light road (rural roads with lighter traffic, town & city back streets)				
<b>Surface</b>				
<b>Survey purpose</b> Sample survey to determine asset condition				
<b>Pipe Use</b> Foul	<b>Schedule length</b> 408.0 Ft	<b>From</b> 32	<b>Depth</b>	<b>Ft</b>
<b>Shape</b> Circular	<b>Size by ins</b>	<b>To</b> 30	<b>Depth</b>	<b>Ft</b>
<b>Material</b> Vitrified clay	<b>Joint spacing</b> Ft	<b>Direction</b> Up		
<b>Lining</b>	<b>Year laid</b> Cat A	<b>Pre-clean</b> Y	<b>Last cleaned</b>	
<b>General note</b> SEE SHEET 35 FOR REVERSE SETUP			<b>Structural</b>	<b>Service</b>
<b>Location note</b>			<b>Mechanisms</b>	<b>Construction</b>

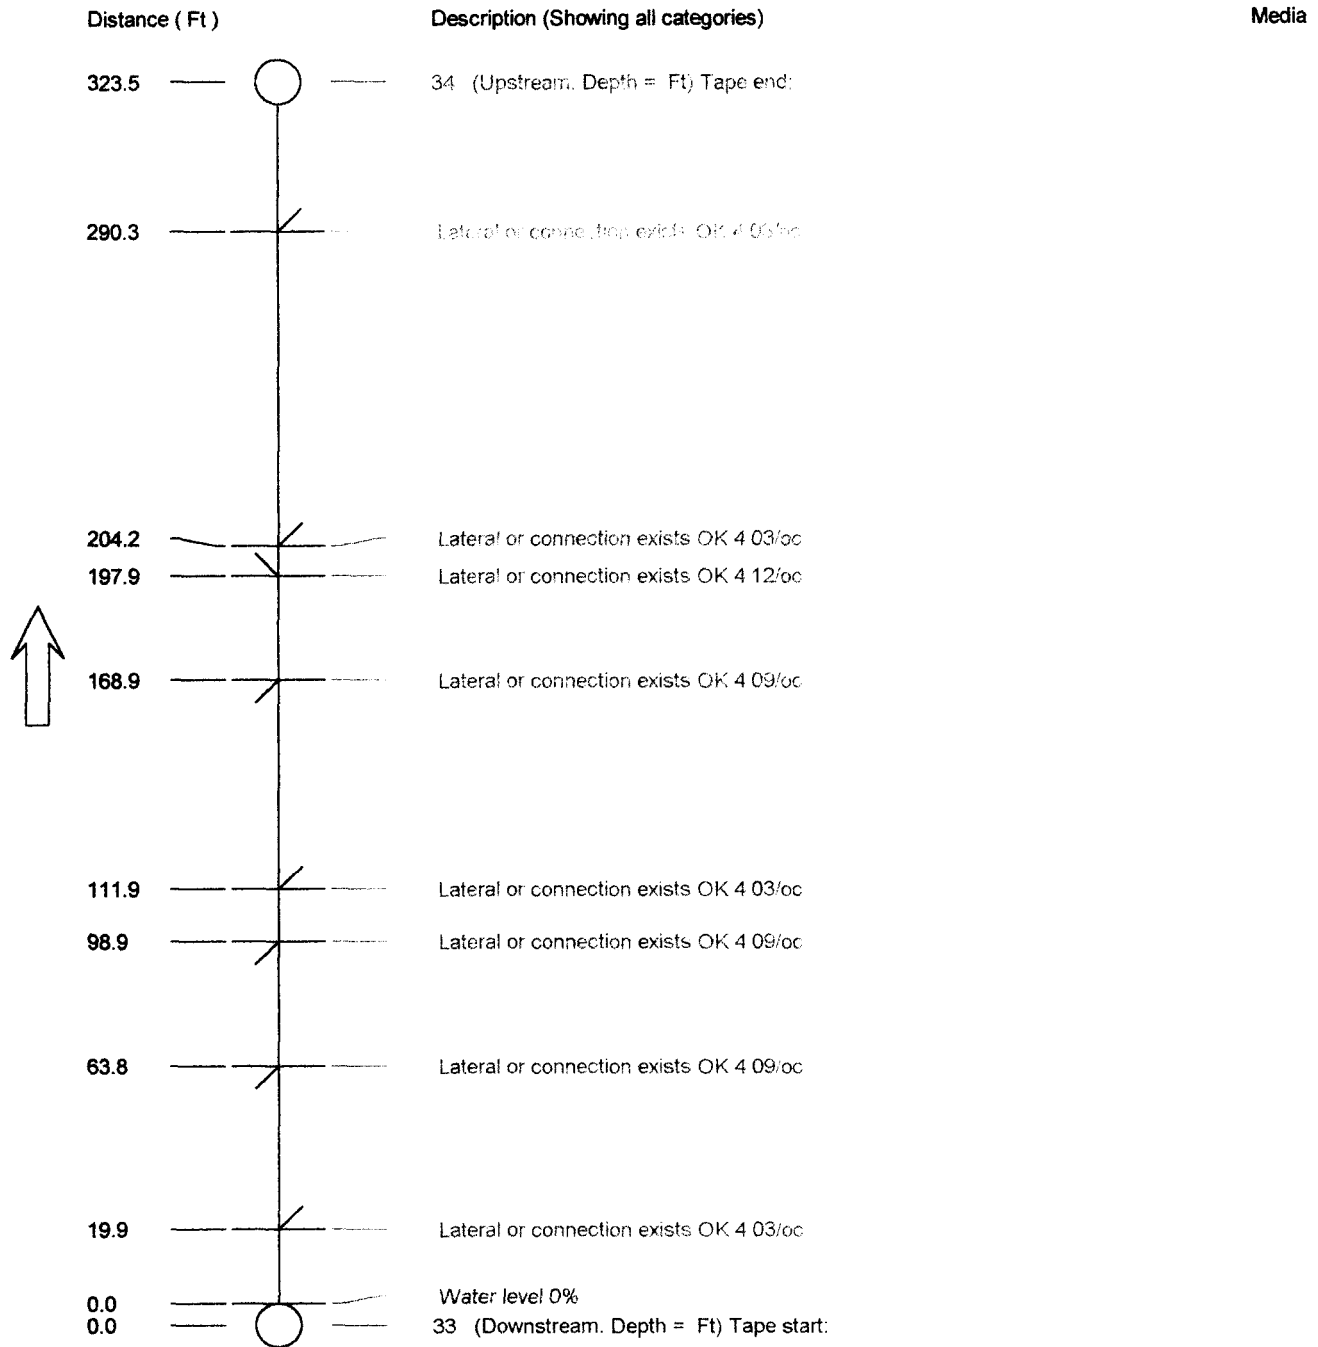
<b>Job</b>	<b>Contract</b>	<b>Cassette</b> 5	<b>Surveyed On</b> 08/10/2004	<b>Sheet</b> 38
<b>Operator</b> DWH	<b>Van Reference</b>	<b>Weather</b> Dry		
<b>Road Name</b> 8TH AVE N		<b>Place Name</b> TIERRA VERDE		
<b>Location type</b> Light road (rural roads with lighter traffic, town & city back streets)				
<b>Surface</b>				
<b>Survey purpose</b> Sample survey to determine asset condition				
<b>Pipe Use</b> Foul	<b>Schedule length</b> 323.5 Ft	<b>From</b> 33	<b>Depth</b>	<b>Ft</b>
<b>Shape</b> Circular	<b>Size by</b> Ins	<b>To</b> 34	<b>Depth</b>	<b>Ft</b>
<b>Material</b> Polyvinyl chloride	<b>Joint spacing</b> Ft	<b>Direction</b> Up		
<b>Lining</b>	<b>Year laid</b> Cat A	<b>Pre-clean</b> Y	<b>Last cleaned</b>	
<b>General note</b>		Structural	Service	Operational
<b>Location note</b>		Mid- to poor	Good	Good

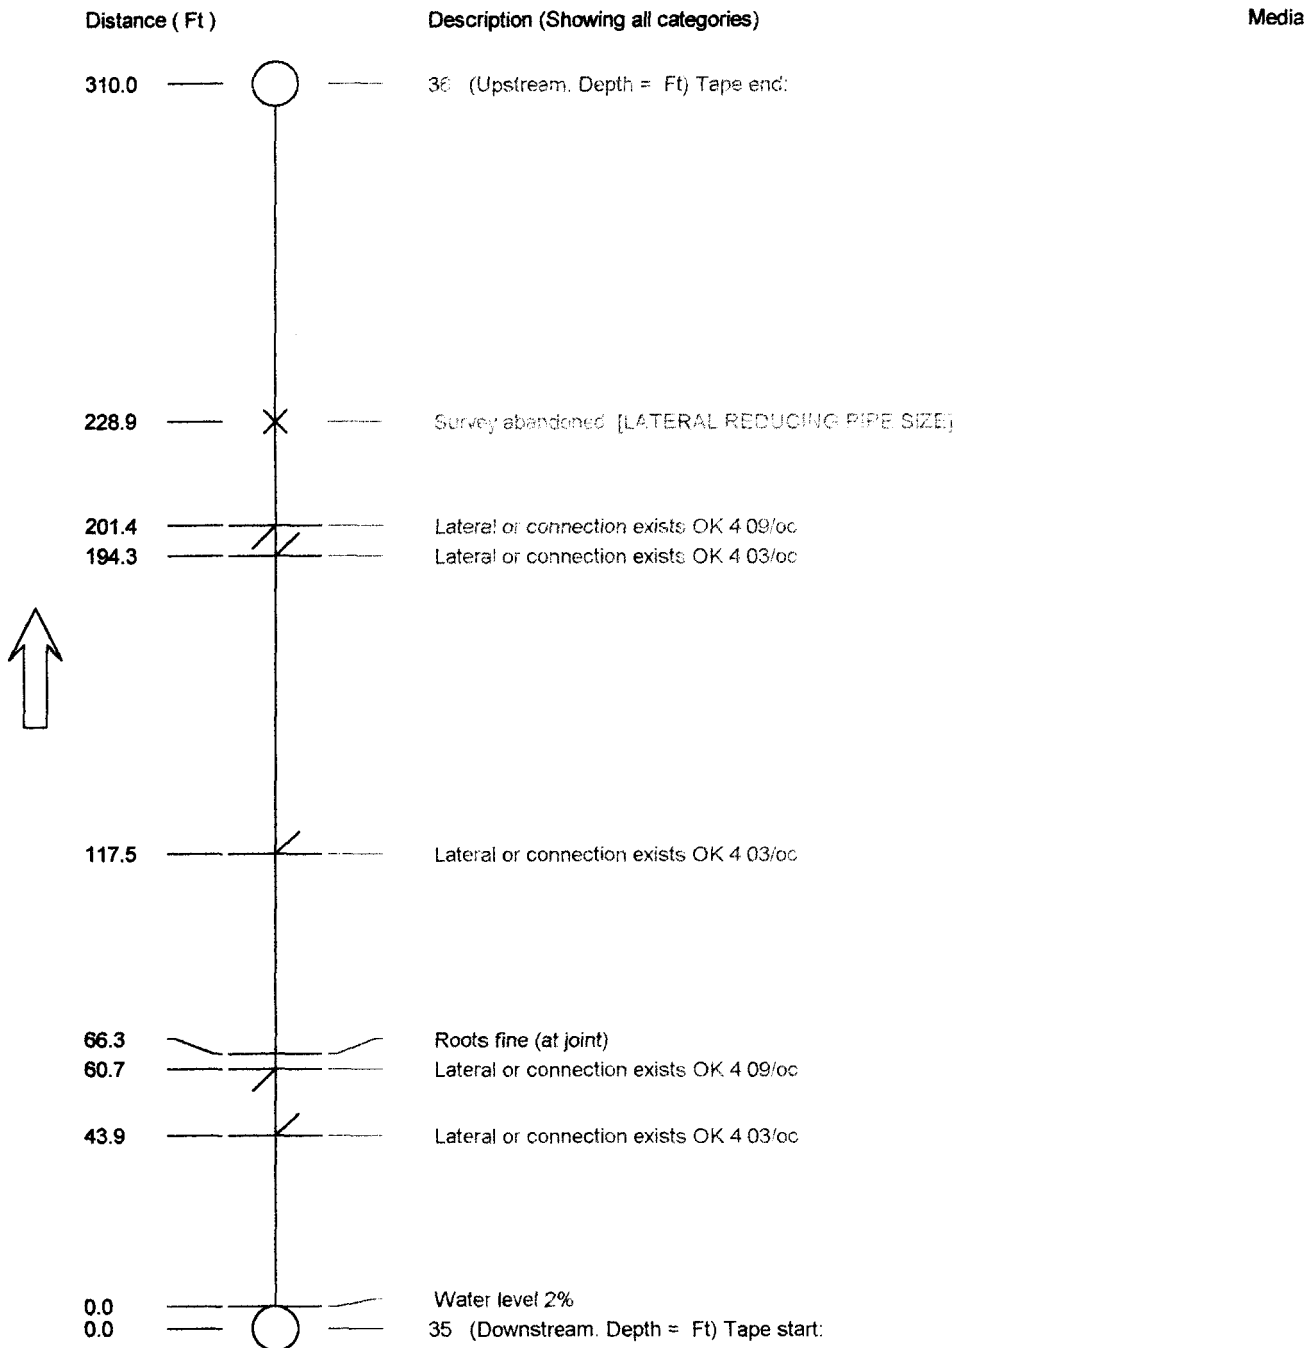
<b>Job</b>	<b>Contract</b>	<b>Cassette</b> 5	<b>Surveyed On</b> 08/10/2004	<b>Sheet</b> 39
<b>Operator</b> DWH	<b>Van Reference</b>	<b>Weather</b> Dry		
<b>Road Name</b> 7TH AVE N		<b>Place Name</b> TIERRA VERDE		
<b>Location type</b> Light road (rural roads with lighter traffic, town & city back streets)				
<b>Surface</b>				
<b>Survey purpose</b> Sample survey to determine asset condition				
<b>Pipe Use</b> Foul	<b>Schedule length</b> 310.0 Ft	<b>From</b> 35	<b>Depth</b>	<b>Ft</b>
<b>Shape</b> Circular	<b>Size</b> 8 <b>by</b> ins	<b>To</b> 36	<b>Depth</b>	<b>Ft</b>
<b>Material</b> Vitrified clay	<b>Joint spacing</b> Ft	<b>Direction</b> Up		
<b>Lining</b>	<b>Year laid</b> Cat A	<b>Pre-clean</b> Y	<b>Last cleaned</b>	
<b>General note</b>		Structural	Service	Construction
<b>Location note</b>		Material	Condition	Notes
