RE: Docket No. 080248-SU; Tierra Verde Utilities, Inc.'s Application for an Increase in Wastewater Rates Increase in Pinellas County, Florida  
Our File No.: 30057.156

3(a) The "TV Sewer Mains" project reflects the effort to clean and video inspect two portions of the Tierra Verde collection system. The gravity main and manholes situated in the Pinellas Bayway right-of-way and the area west of the Pinellas Bayway along and adjacent to Madonna Avenue had not been cleaned and inspected for many years. A total of 6,229 LF of 18" diameter pipe was cleaned and inspected along the Pinellas Bayway. A total of 21,250 LF of 8" diameter pipe and manholes were inspected west of the Pinellas Bayway along Madonna Avenue. The project is justified for the following reasons:

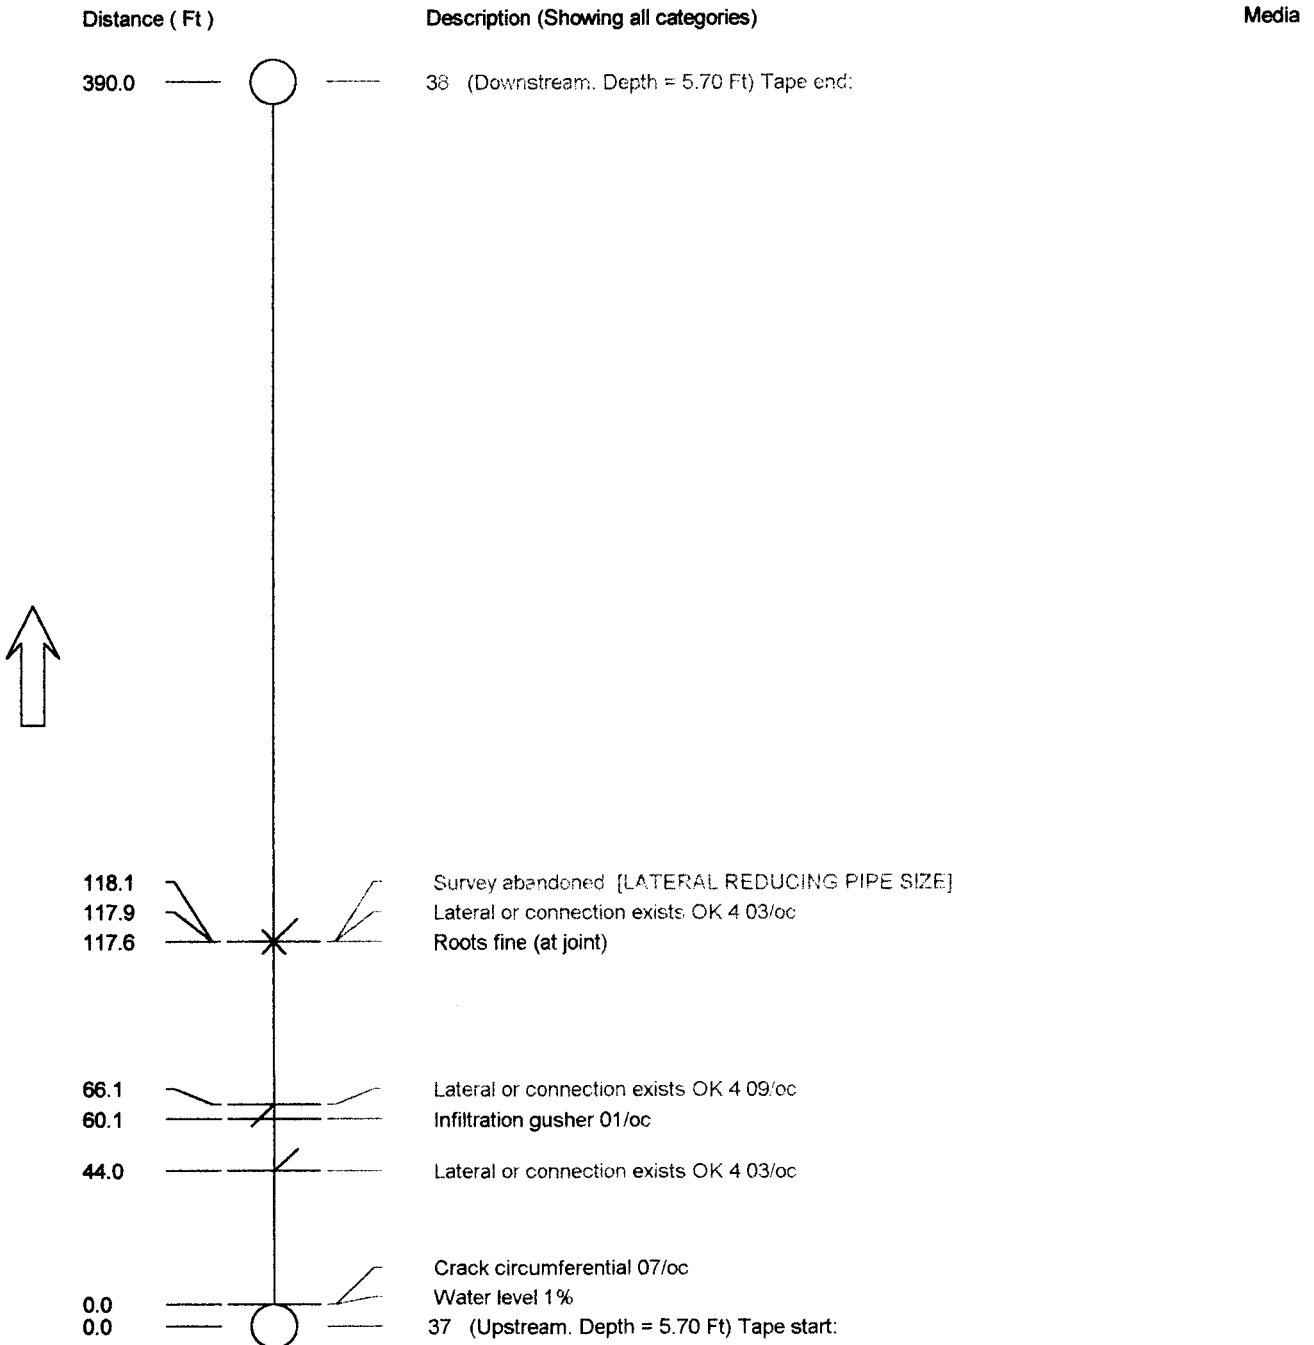
<b>Job</b>	<b>Contract</b>	<b>Cassette</b> 6	<b>Surveyed On</b> 08/10/2004	<b>Sheet</b> 40
<b>Operator</b> DWH	<b>Van Reference</b>	<b>Weather</b> Dry		
<b>Road Name</b> 7TH AVE N		<b>Place Name</b> TIERRA VERDE		
<b>Location type</b> Light road (rural roads with lighter traffic, town & city back streets)				
<b>Surface</b>				
<b>Survey purpose</b> Sample survey to determine asset condition				
<b>Pipe Use</b> Foul	<b>Schedule length</b> 390.0 Ft	<b>From</b> 37	<b>Depth</b> 5.70 Ft	
<b>Shape</b> Circular	<b>Size</b> 8 by ins	<b>To</b> 36	<b>Depth</b> 5.70 Ft	
<b>Material</b> Vitrified clay	<b>Joint spacing</b> Ft	<b>Direction</b> Down		
<b>Lining</b>	<b>Year laid</b> Cat A	<b>Pre-clean</b> Y	<b>Last cleaned</b>	
<b>General note</b> START OF TAPE 6		<b>Structural</b>	<b>Service</b>	<b>Constructional</b>
<b>Location note</b> SEE SHEET 100 FOR REVERSE SETUP		Misaligned	Blocked

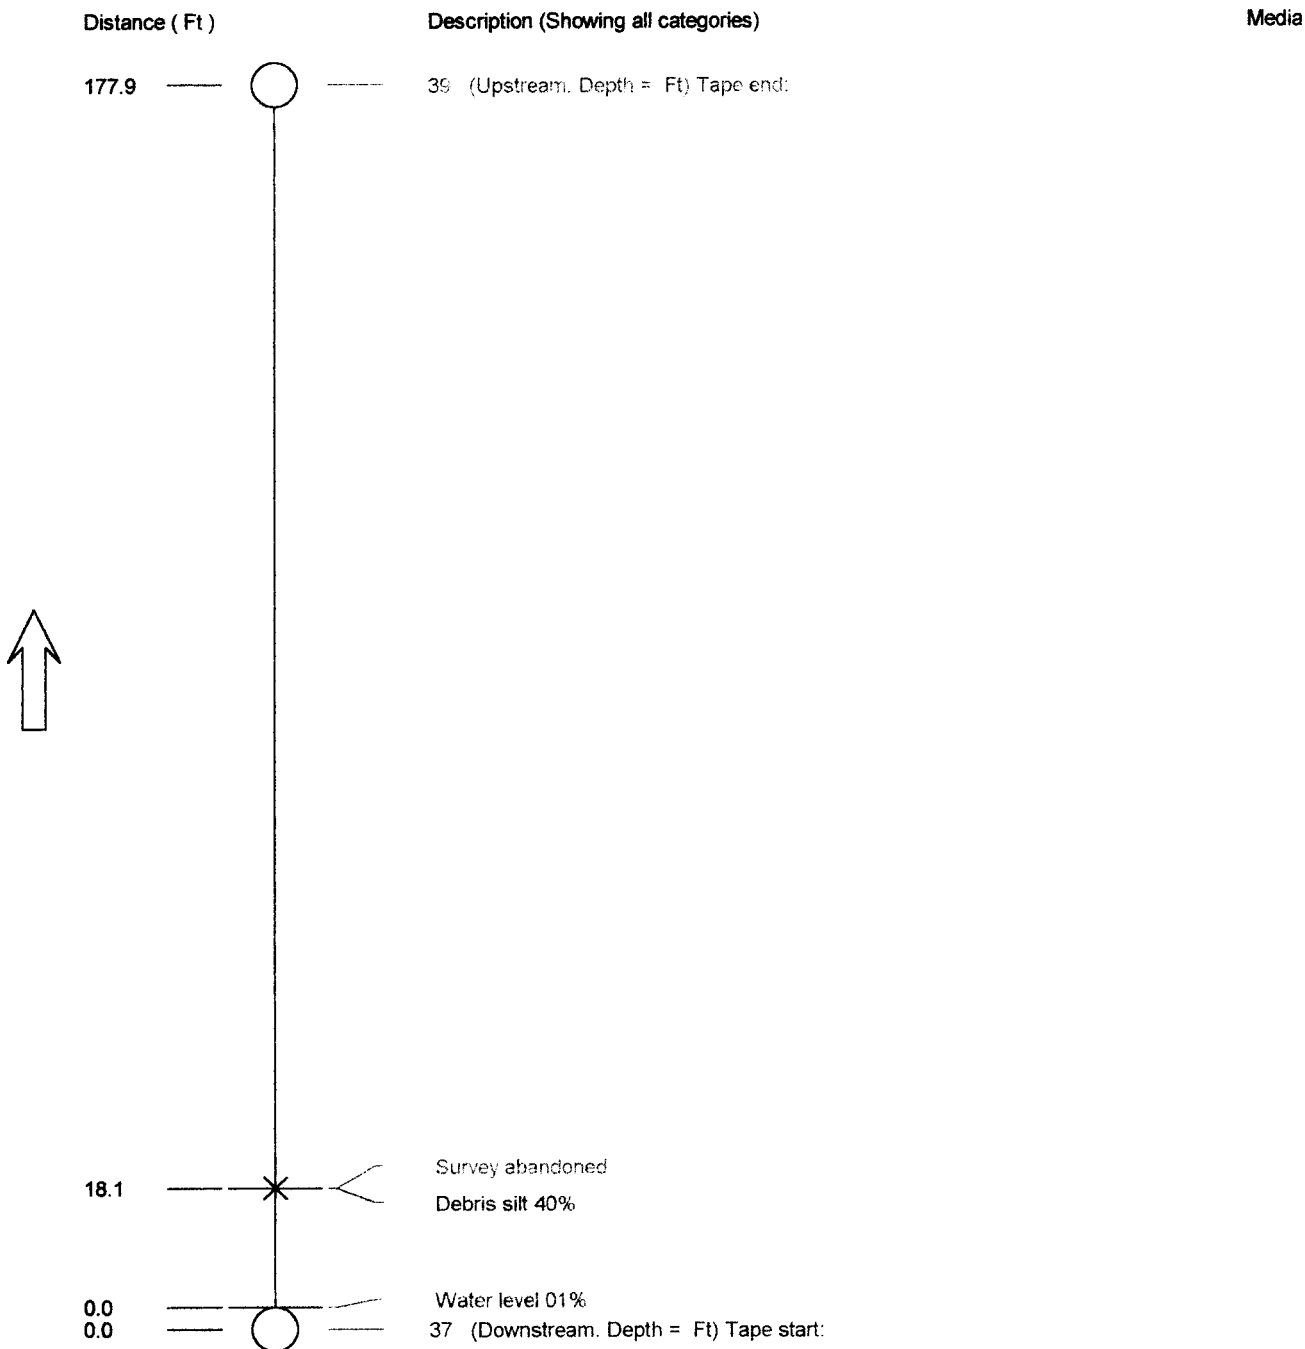
<b>Job</b>	<b>Contract</b>	<b>Cassette</b> 6	<b>Surveyed On</b> 08/10/2004	<b>Sheet</b> 41
<b>Operator</b> DWH	<b>Van Reference</b>	<b>Weather</b> Dry		
<b>Road Name</b> 7TH AVE N		<b>Place Name</b> TIERRA VERDE		
<b>Location type</b> Light road (rural roads with lighter traffic,town & city back streets)				
<b>Surface</b>				
<b>Survey purpose</b> Sample survey to determine asset condition				
<b>Pipe Use</b> Foul	<b>Schedule length</b> 177.9 Ft	<b>From</b> 37	<b>Depth</b>	<b>Ft</b>
<b>Shape</b> Circular	<b>Size</b> 8 <b>by</b> ins	<b>To</b> 39	<b>Depth</b>	<b>Ft</b>
<b>Material</b> Polyvinly chloride	<b>Joint spacing</b> Ft	<b>Direction</b> Up		
<b>Lining</b>	<b>Year laid</b> Cat A	<b>Pre-clean</b> Y	<b>Last cleaned</b>	
<b>General note</b> SEE SHEET 97 FOR REVERSE SETUP		Structural	Service	Constructional
<b>Location note</b>		Manhole/Inlet	Manhole	Manhole

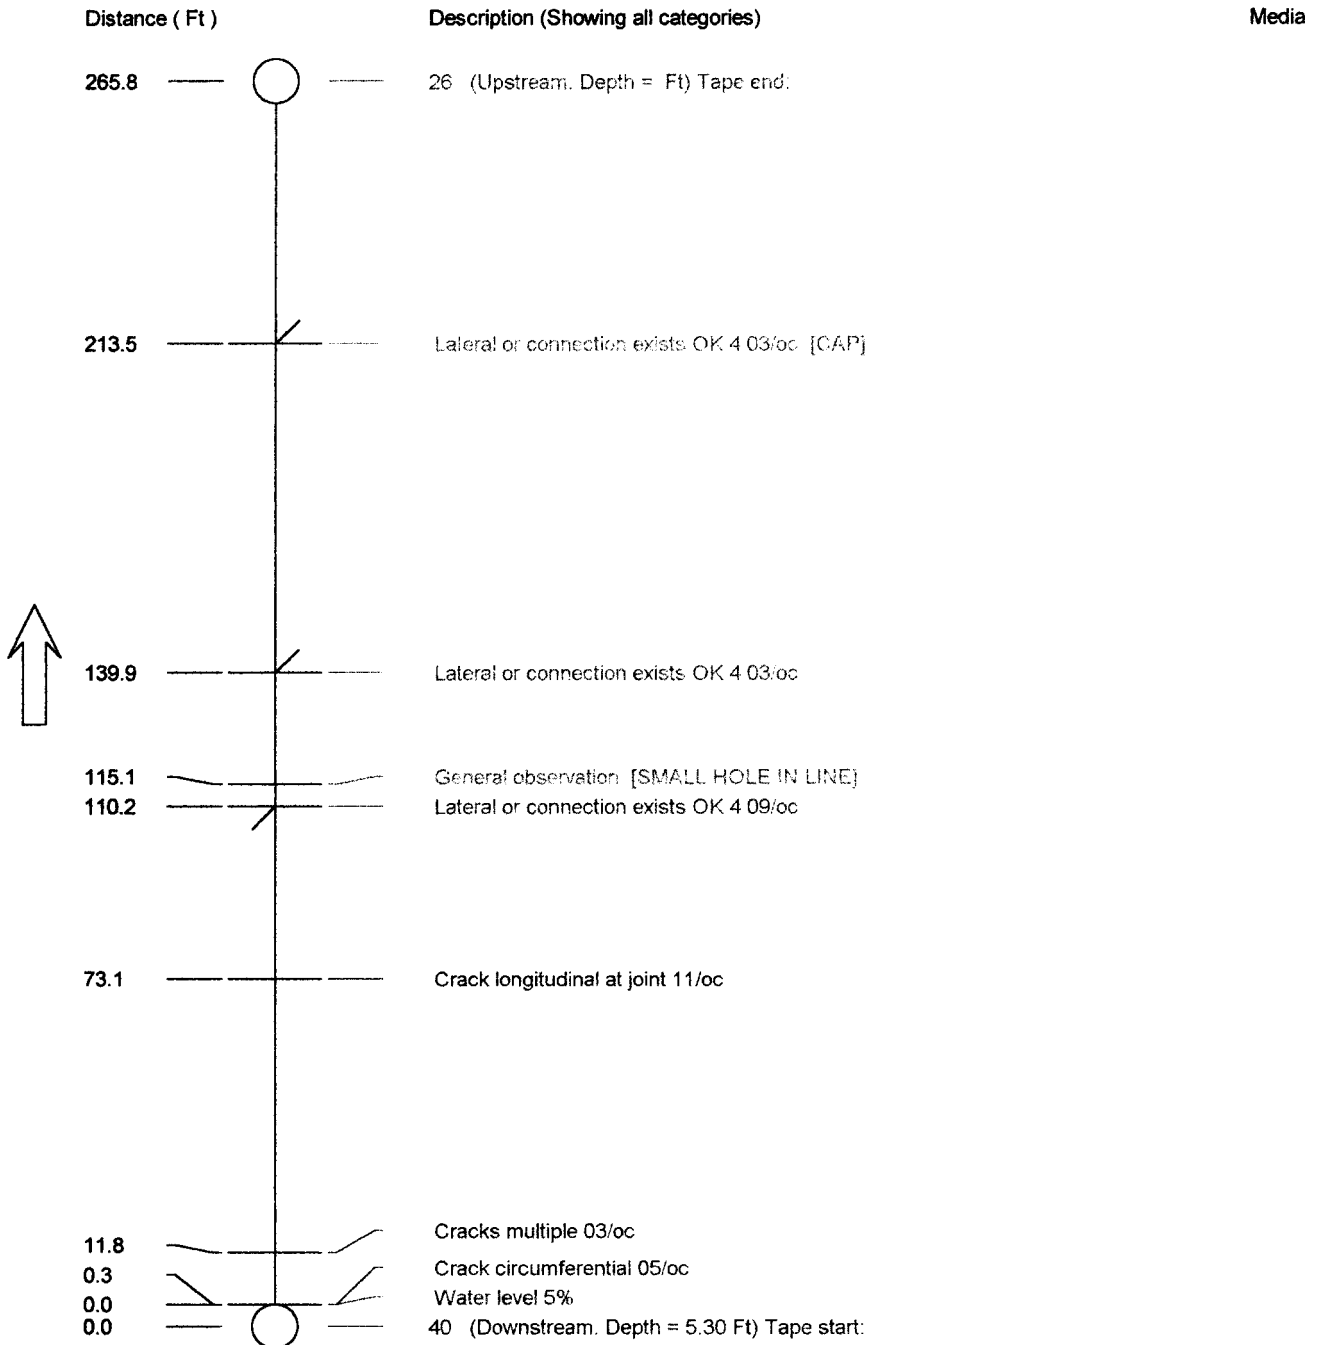
<b>Job</b>	<b>Contract</b>	<b>Cassette 6</b>	<b>Surveyed On</b> 08/10/2004	<b>Sheet</b> 42
<b>Operator</b> DWH	<b>Van Reference</b>	<b>Weather</b> Dry		
<b>Road Name</b> MONTE CRISTO		<b>Place Name</b> TIERRA VERDE		
<b>Location type</b> Light road (rural roads with lighter traffic, town & city back streets)				
<b>Surface</b>				
<b>Survey purpose</b> Sample survey to determine asset condition				
<b>Pipe Use</b> Foul	<b>Schedule length</b> 265.8 Ft	<b>From</b> 40	<b>Depth</b> 5.30 Ft	
<b>Shape</b> Circular	<b>Size</b> 8 by Ins	<b>To</b> 26	<b>Depth</b> Ft	
<b>Material</b> Vitrified clay	<b>Joint spacing</b> Ft	<b>Direction</b> Up		
<b>Lining</b>	<b>Year laid</b> Cat A	<b>Pre-clean</b> Y	<b>Last cleaned</b>	
<b>General note</b>		Structural	Service	Condition
<b>Location note</b>		Microleakage	None

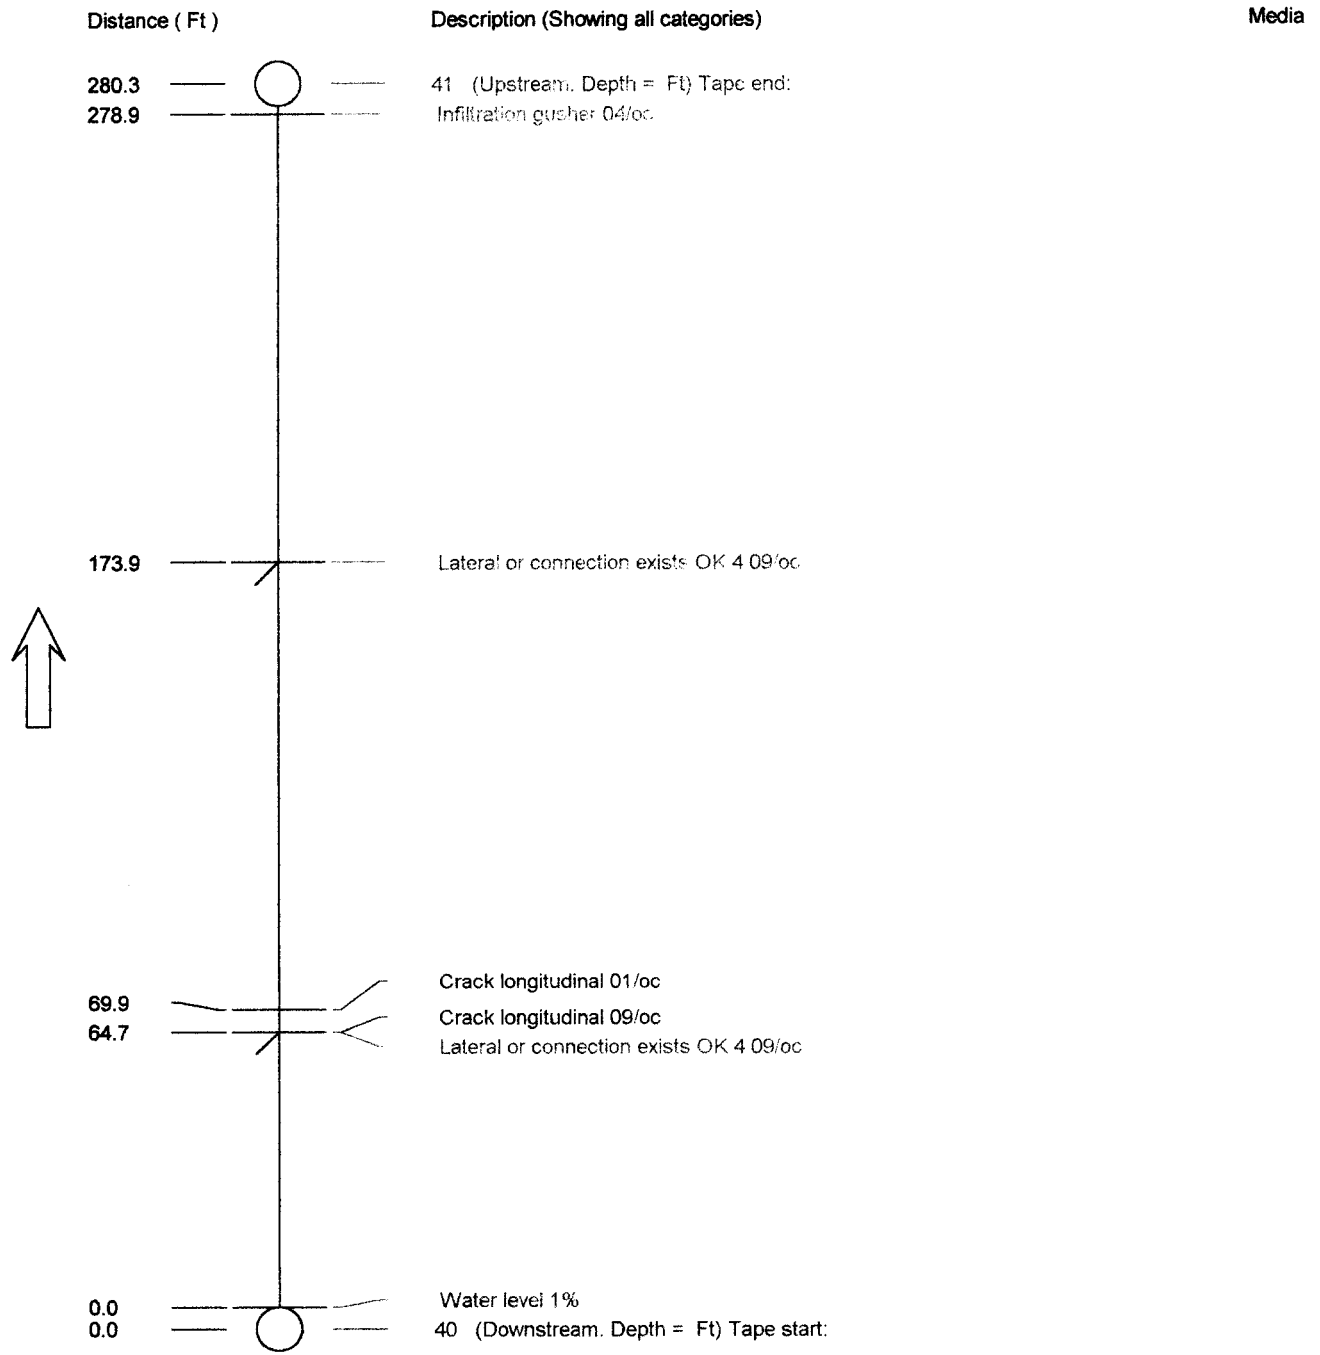
<b>Job</b> Operator DWH	<b>Contract</b> Van Reference	<b>Cassette</b> 6	<b>Surveyed On</b> 08/10/2004	<b>Sheet</b> 44
<b>Road Name</b> MADONNA BLVD.		<b>Place Name</b> TIERRA VERDE		
<b>Location type</b> Light road (rural roads with lighter traffic, town & city back streets)				
<b>Surface</b>				
<b>Survey purpose</b> Sample survey to determine asset condition				
<b>Pipe Use</b> Foul	<b>Schedule length</b> 280.3 Ft	<b>From</b> 40	<b>Depth</b> Ft	
<b>Shape</b> Circular	<b>Size</b> 8 by Ins	<b>To</b> 41	<b>Depth</b> Ft	
<b>Material</b> Vitrified clay	<b>Joint spacing</b> Ft	<b>Direction</b> Up		
<b>Lining</b>	<b>Year laid</b> Cat A	<b>Pre-clean</b> Y	<b>Last cleaned</b>	
<b>General note</b>		Structural	Service	Crack/Infect
<b>Location note</b>		Miscellaneous

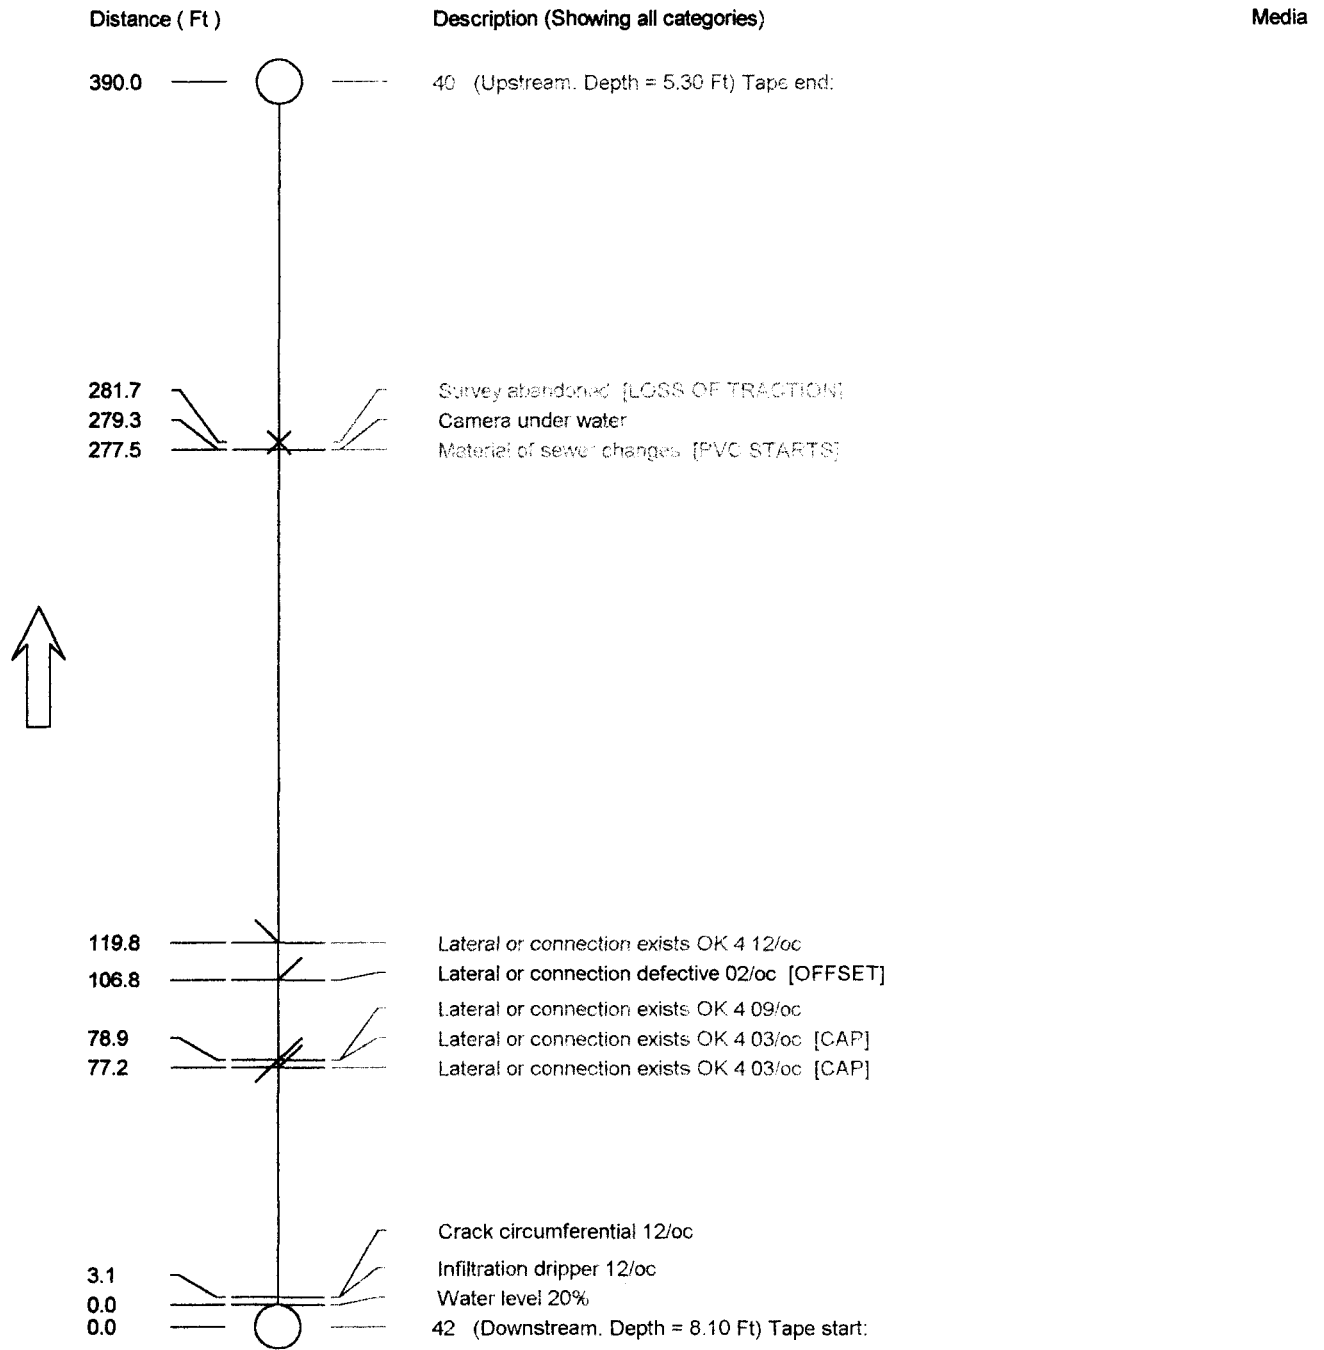
<b>Job</b>	<b>Contract</b>	<b>Cassette 6</b>	<b>Surveyed On</b> 08/11/2004	<b>Sheet</b> 45
<b>Operator</b> BMN	<b>Van Reference</b>	<b>Weather</b> Dry		
<b>Road Name</b> MONTE CRISTO		<b>Place Name</b> TIERRA VERDE		
<b>Location type</b> Light road (rural roads with lighter traffic, town & city back streets)				
<b>Surface</b>				
<b>Survey purpose</b> Sample survey to determine asset condition				
<b>Pipe Use</b> Foul	<b>Schedule length</b> 390.0 Ft	<b>From</b> 42	<b>Depth</b> 8.10 Ft	
<b>Shape</b> Circular	<b>Size</b> 8 by ins	<b>To</b> 40	<b>Depth</b> 5.30 Ft	
<b>Material</b> Vitrified clay	<b>Joint spacing</b> Ft	<b>Direction</b> Up		
<b>Lining</b>	<b>Year laid</b> Cat A	<b>Pre-clean</b> Y	<b>Last cleaned</b>	
<b>General note</b> SEE SHEET 49 FOR REVERSE SETUP		<b>Structural</b>	<b>Service</b>	<b>Constructional</b>
<b>Location note</b>

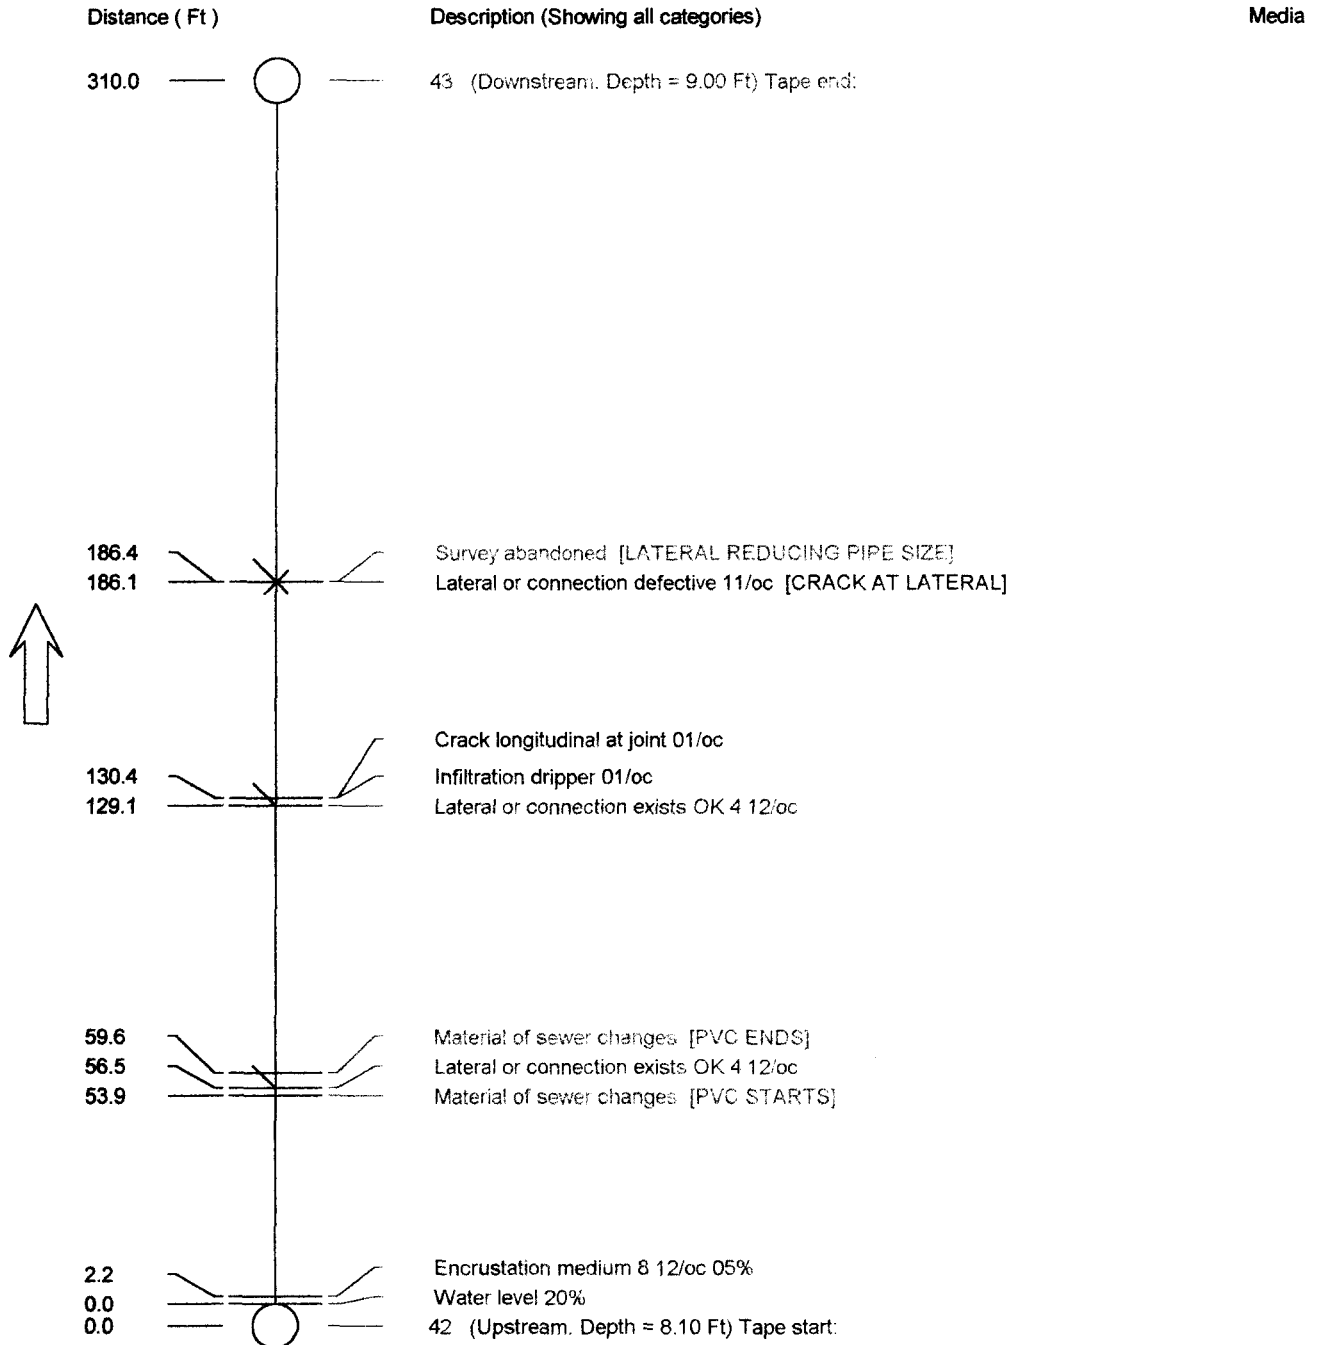
<b>Job</b>	<b>Contract</b>	<b>Cassette</b> 6	<b>Surveyed On</b> 08/11/2004	<b>Sheet</b> 46
<b>Operator</b> BMN	<b>Van Reference</b>	<b>Weather</b> Dry		
<b>Road Name</b> MONTE CRISTO		<b>Place Name</b> TIERRA VERDE		
<b>Location type</b> Light road (rural roads with lighter traffic, town & city back streets)				
<b>Surface</b>				
<b>Survey purpose</b> Sample survey to determine asset condition				
<b>Pipe Use</b> Foul	<b>Schedule length</b> 310.0 Ft	<b>From</b> 42	<b>Depth</b> 8.10 Ft	
<b>Shape</b> Circular	<b>Size</b> 8 by ins	<b>To</b> 43	<b>Depth</b> 9.00 Ft	
<b>Material</b> Vitrified clay	<b>Joint spacing</b> Ft	<b>Direction</b> Down		
<b>Lining</b>	<b>Year laid</b> Cat A	<b>Pre-clean</b> Y	<b>Last cleaned</b>	
<b>General note</b> see sheet 47 for reverse setup		Structural	Service	Continued
<b>Location note</b>		Miscellaneous

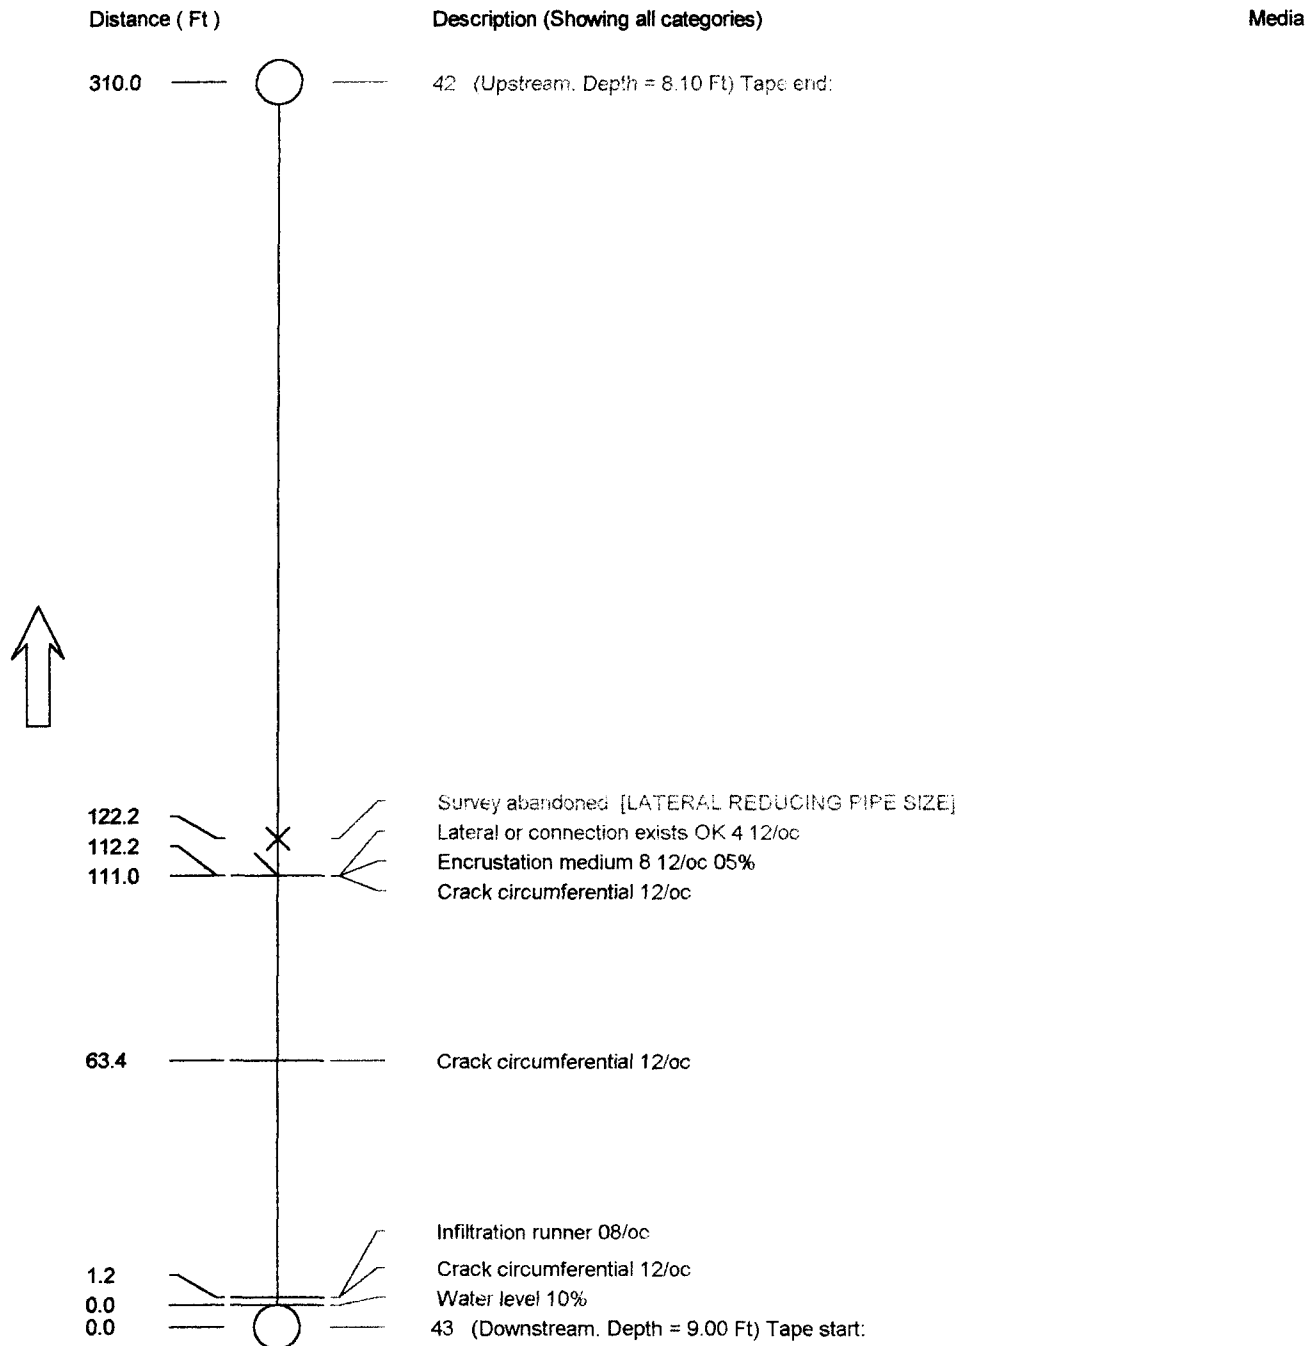
<b>Job</b>	<b>Contract</b>	<b>Cassette</b> 6	<b>Surveyed On</b> 08/11/2004	<b>Sheet</b> 47
<b>Operator</b> BMN	<b>Van Reference</b>	<b>Weather</b> Dry		
<b>Road Name</b> MONTE CRISTO		<b>Place Name</b> TIERRA VERDE		
<b>Location type</b> Light road (rural roads with lighter traffic, town & city back streets)				
<b>Surface</b>				
<b>Survey purpose</b> Sample survey to determine asset condition				
<b>Pipe Use</b> Foul	<b>Schedule length</b> 310.0 Ft	<b>From</b> 43	<b>Depth</b> 9.00 Ft	
<b>Shape</b> Circular	<b>Size</b> 8 by ins	<b>To</b> 42	<b>Depth</b> 8.10 Ft	
<b>Material</b> Vitrified clay	<b>Joint spacing</b> Ft	<b>Direction</b> Up		
<b>Lining</b>	<b>Year laid</b> Cat A	<b>Pre-clean</b> Y	<b>Last cleaned</b>	
<b>General note</b> SEE SHEET 46 FOR REVERSE SETUP		<b>Structural</b>	<b>Service</b>	<b>Quality/Defect</b>
<b>Location note</b>		Monell/In/out	Up/Down

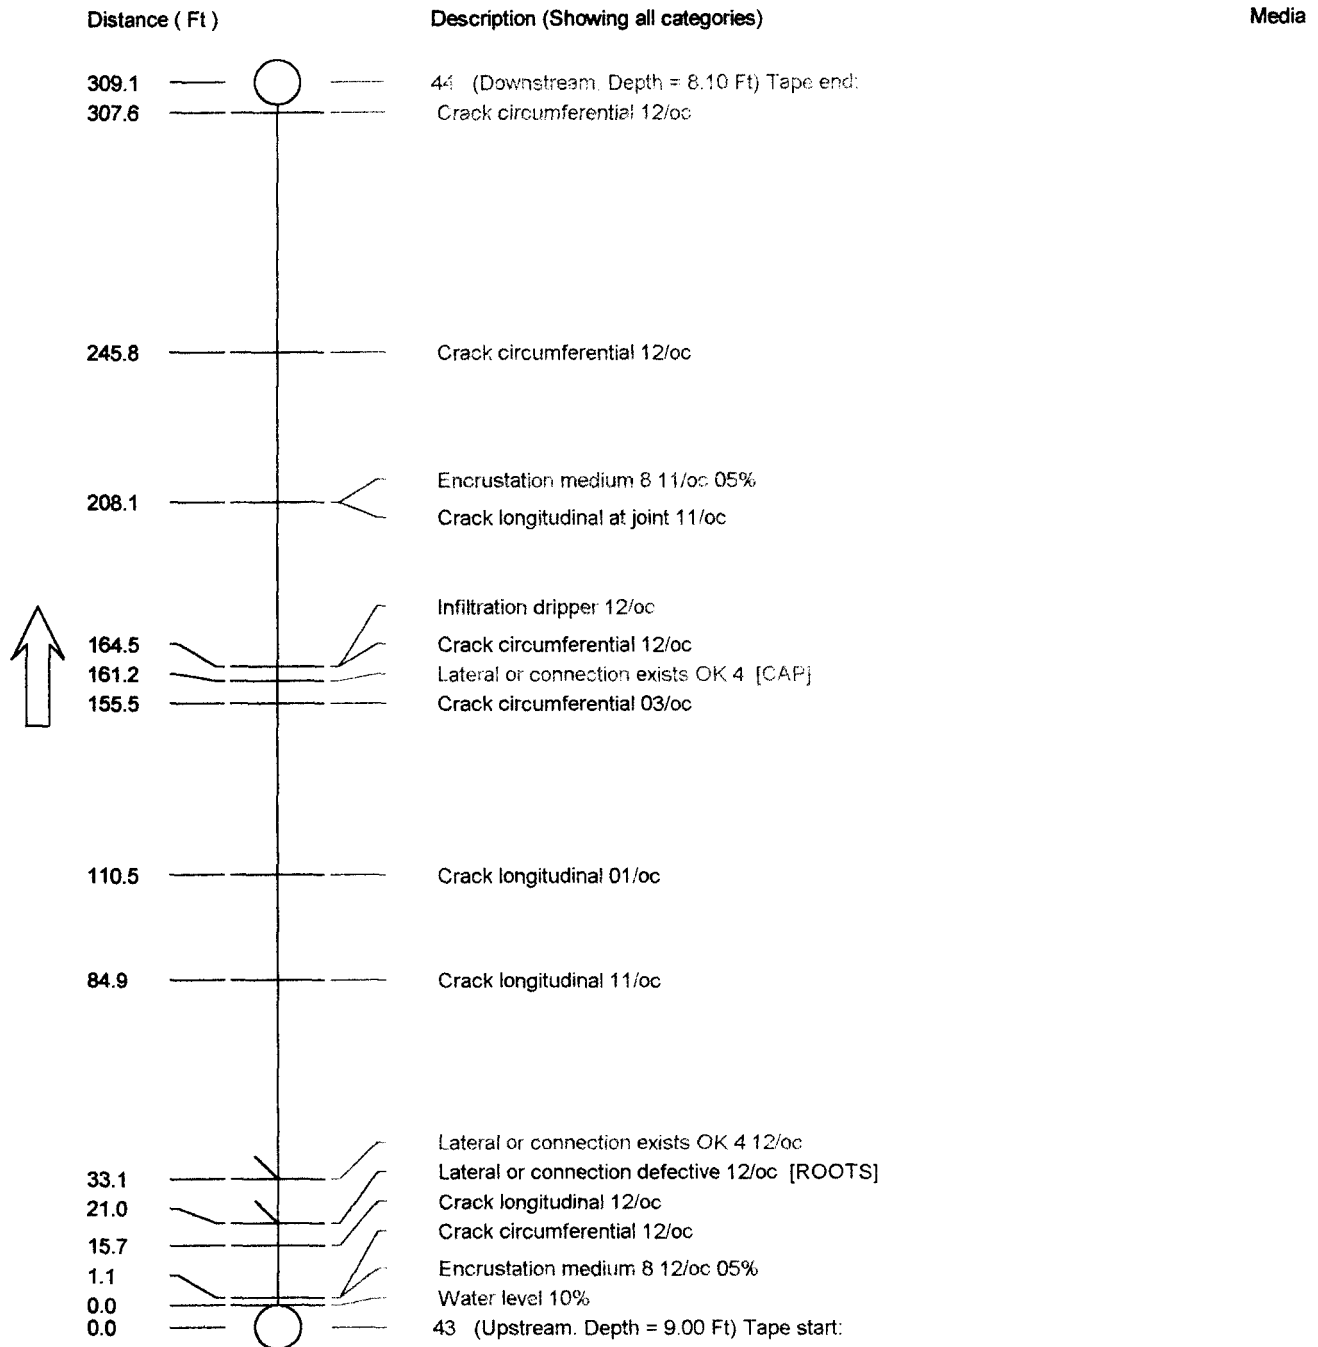
<b>Job</b>	<b>Contract</b>	<b>Cassette</b> 7	<b>Surveyed On</b> 08/11/2004	<b>Sheet</b> 48
<b>Operator</b> BMN	<b>Van Reference</b>	<b>Weather</b> Dry		
<b>Road Name</b> MONTE CRISTO		<b>Place Name</b> TIERRA VERDE		
<b>Location type</b> Light road (rural roads with lighter traffic, town & city back streets)				
<b>Surface</b>				
<b>Survey purpose</b> Sample survey to determine asset condition				
<b>Pipe Use</b> Foul	<b>Schedule length</b> 309.1 Ft	<b>From</b> 43	<b>Depth</b> 9.00 Ft	
<b>Shape</b> Circular	<b>Size</b> 8 by ins	<b>To</b> 44	<b>Depth</b> 8.10 Ft	
<b>Material</b> Vitrified clay	<b>Joint spacing</b> Ft	<b>Direction</b> Down		
<b>Lining</b>	<b>Year laid</b> Cat A	<b>Pre-clean</b> Y	<b>Last cleaned</b>	
<b>General note</b>		Structural	Service	Considered
<b>Location note</b>		Structural	Service	Considered

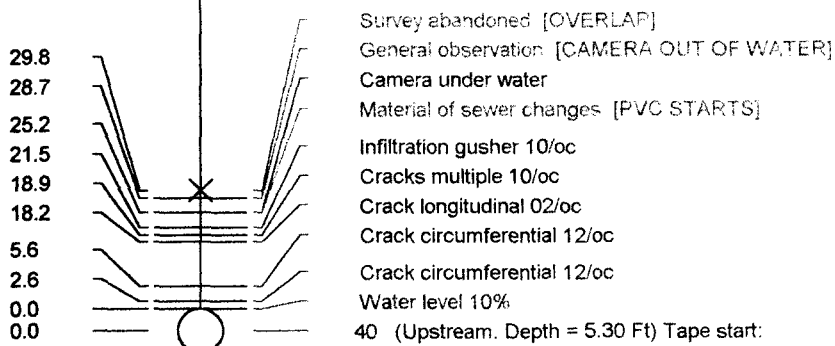
<b>Job</b>	<b>Contract</b>	<b>Cassette</b> 7	<b>Surveyed On</b> 08/11/2004	<b>Sheet</b> 49
<b>Operator</b> BMN	<b>Van Reference</b>	<b>Weather</b> Dry		
<b>Road Name</b> MONTE CRISTO		<b>Place Name</b> TIERRA VERDE		
<b>Location type</b> Light road (rural roads with lighter traffic, town & city back streets)				
<b>Surface</b>				
<b>Survey purpose</b> Sample survey to determine asset condition				
<b>Pipe Use</b> Foul	<b>Schedule length</b> 309.1 Ft	<b>From</b> 40	<b>Depth</b> 5.30 Ft	
<b>Shape</b> Circular	<b>Size</b> 8 by Ins	<b>To</b> 42	<b>Depth</b> 8.10 Ft	
<b>Material</b> Vitrified clay	<b>Joint spacing</b> Ft	<b>Direction</b> Down		
<b>Lining</b>	<b>Year laid</b> Cat A	<b>Pre-clean</b> Y	<b>Last cleaned</b>	
<b>General note</b> SEE SHEET 45 FOR REVERSE SETUP			<b>Structural</b>	<b>Service</b>
<b>Location note</b>			<b>Material</b>	<b>Other</b>

309.1 ——— ○ ——— 42 (Downstream. Depth = 8.10 Ft) Tape end:

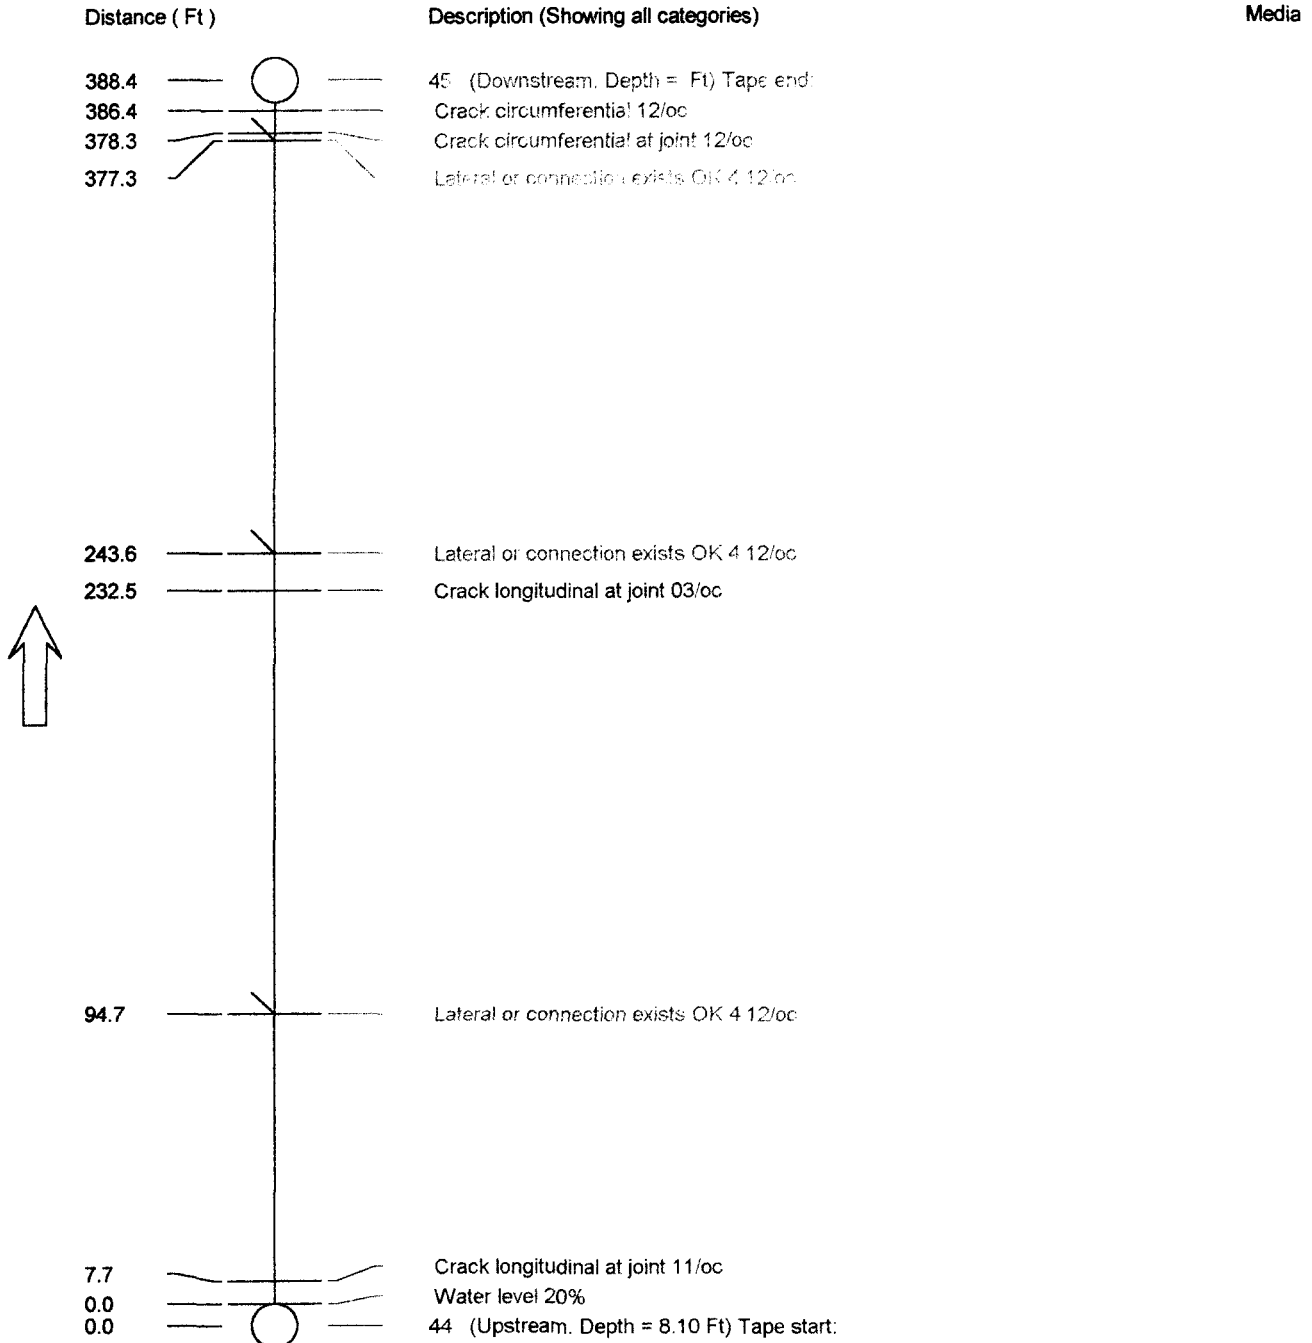
<b>Job</b>	<b>Contract</b>	<b>Cassette 7</b>	<b>Surveyed On</b> 08/11/2004	<b>Sheet</b> 50
<b>Operator</b> BMN	<b>Van Reference</b>	<b>Weather</b> Dry		
<b>Road Name</b> MONTE CRISTO		<b>Place Name</b> TIERRA VERDE		
<b>Location type</b> Light road (rural roads with lighter traffic, town & city back streets)				
<b>Surface</b>				
<b>Survey purpose</b> Sample survey to determine asset condition				
<b>Pipe Use</b> Foul	<b>Schedule length</b> 388.4 Ft	<b>From</b> 44	<b>Depth</b> 8.10 Ft	
<b>Shape</b> Circular	<b>Size</b> 8 <b>by</b> Ins	<b>To</b> 45	<b>Depth</b> Ft	
<b>Material</b> Vitrified clay	<b>Joint spacing</b> Ft	<b>Direction</b> Down		
<b>Lining</b>	<b>Year laid</b> Cat A	<b>Pre-clean</b> Y	<b>Last cleaned</b>	
<b>General note</b>		Structural	Service	Construction
<b>Location note</b>		Misalignment	by

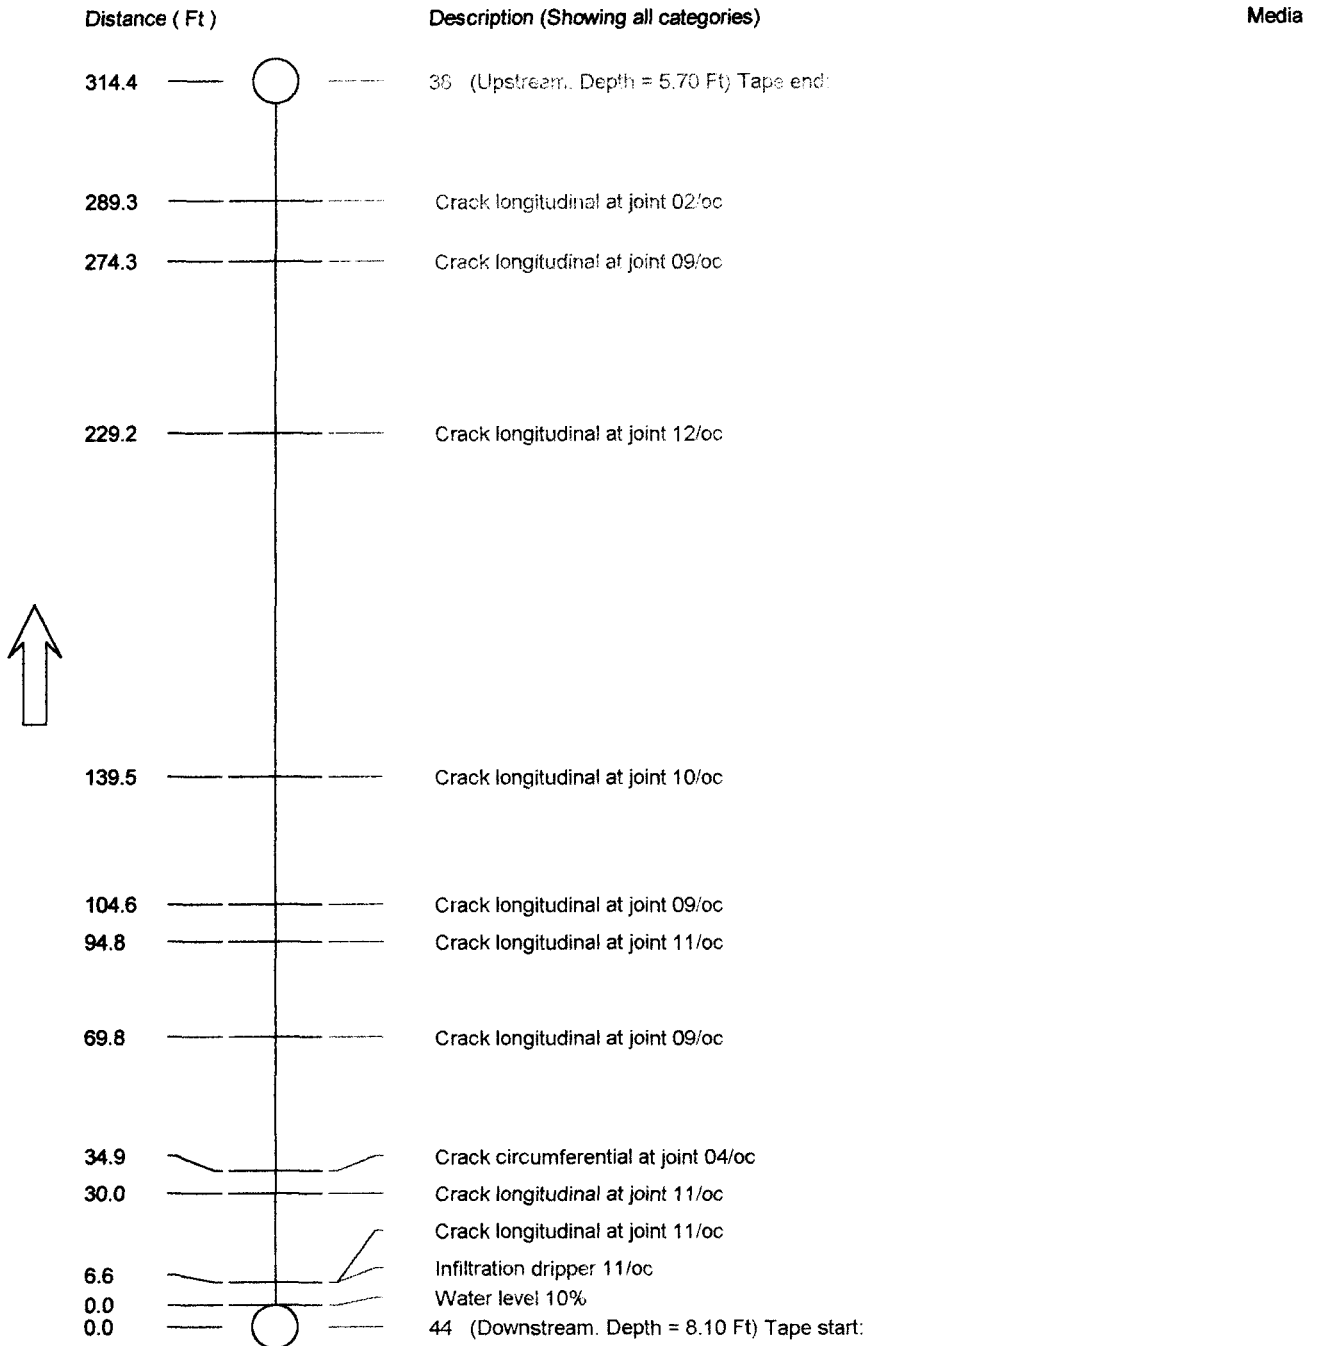
<b>Job</b>	<b>Contract</b>	<b>Cassette</b> 7	<b>Surveyed On</b> 08/11/2004	<b>Sheet</b> 51
<b>Operator</b> BMN	<b>Van Reference</b>	<b>Weather</b> Dry		
<b>Road Name</b> 4TH ST.		<b>Place Name</b> TIERRA VERDE		
<b>Location type</b> Light road (rural roads with lighter traffic, town & city back streets)				
<b>Surface</b>				
<b>Survey purpose</b> Sample survey to determine asset condition				
<b>Pipe Use</b> Foul	<b>Schedule length</b> 314.4 Ft	<b>From</b> 44	<b>Depth</b> 8.10 Ft	
<b>Shape</b> Circular	<b>Size</b> 8 by ins	<b>To</b> 38	<b>Depth</b> 5.70 Ft	
<b>Material</b> Vitrified clay	<b>Joint spacing</b> Ft	<b>Direction</b> Up		
<b>Lining</b>	<b>Year laid</b> Cat A	<b>Pre-clean</b> Y	<b>Last cleaned</b>	
<b>General note</b>		Structural	Service	Corrosion
<b>Location note</b>		Minor damage	Minor	Minor

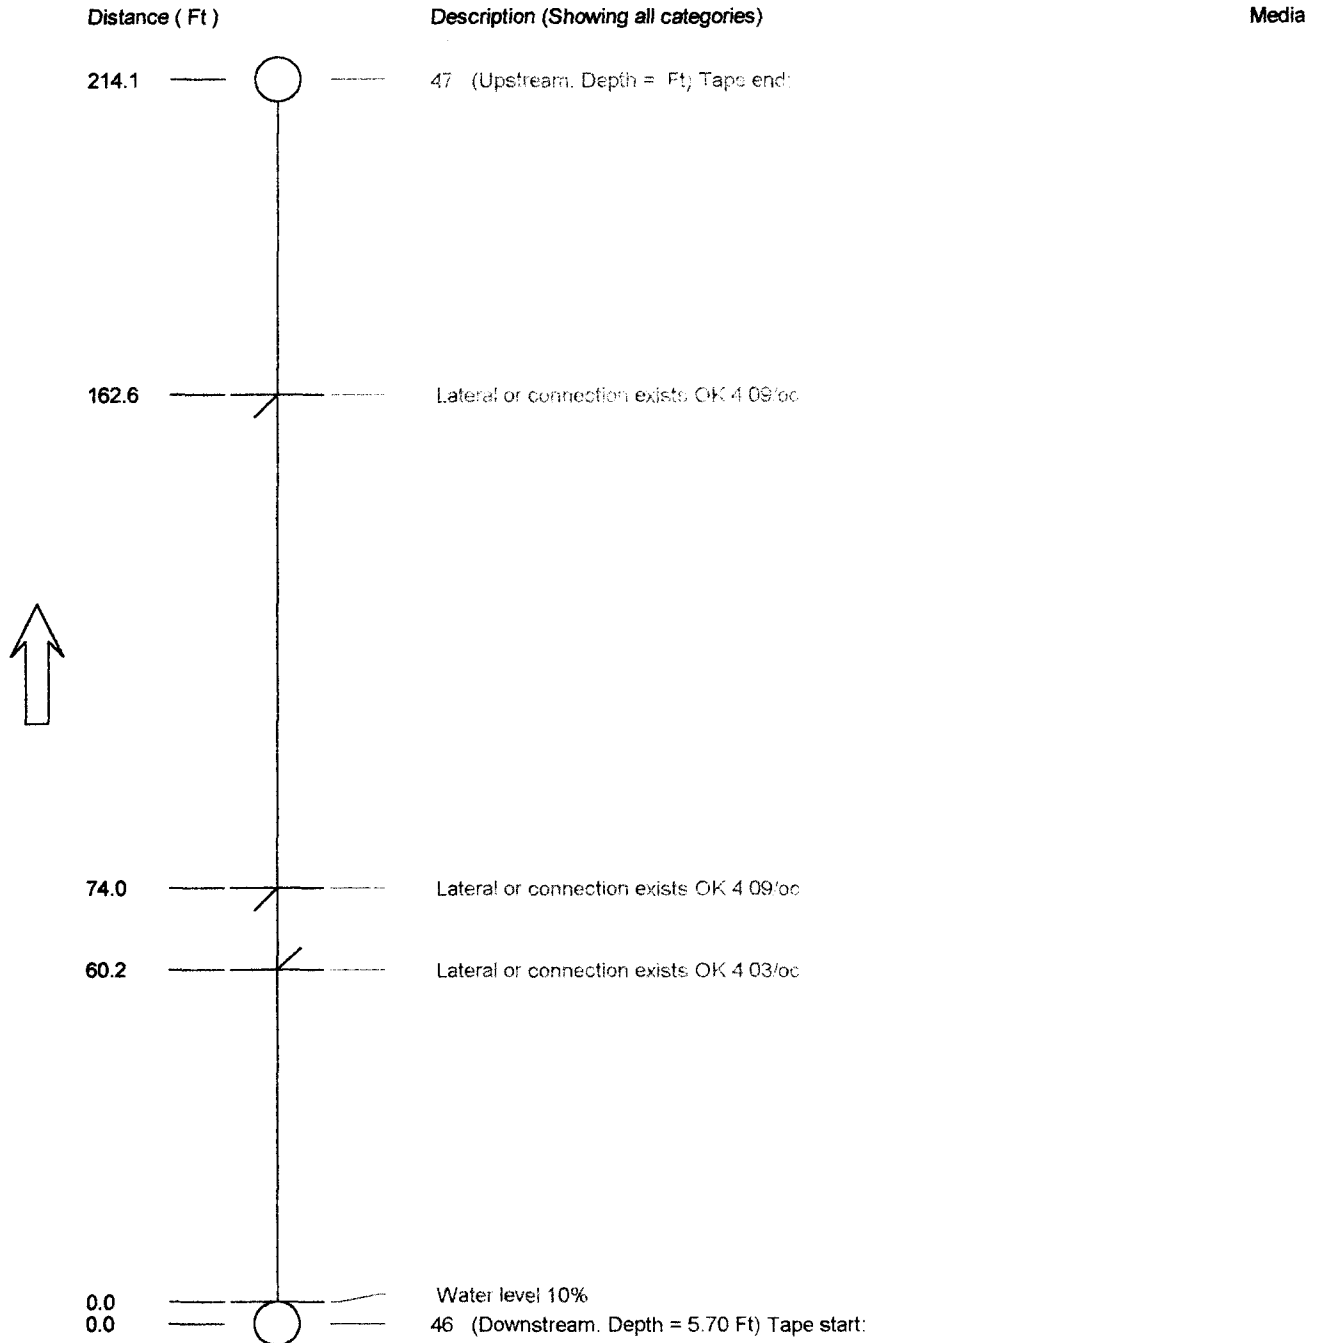
<b>Job</b>	<b>Contract</b>	<b>Cassette 7</b>	<b>Surveyed On</b> 08/11/2004	<b>Sheet</b> 52
<b>Operator</b> BMN	<b>Van Reference</b>	<b>Weather</b> Dry		
<b>Road Name</b> 6TH ST.		<b>Place Name</b> TIERRA VERDE		
<b>Location type</b> Light road (rural roads with lighter traffic, town & city back streets)				
<b>Surface</b>				
<b>Survey purpose</b> Sample survey to determine asset condition				
<b>Pipe Use</b> Foul	<b>Schedule length</b> 214.1 Ft	<b>From</b> 46	<b>Depth</b> 5.70 Ft	
<b>Shape</b> Circular	<b>Size</b> 8 by ins	<b>To</b> 47	<b>Depth</b> Ft	
<b>Material</b> Polyvinyl chloride	<b>Joint spacing</b> Ft	<b>Direction</b> Up		
<b>Lining</b>	<b>Year laid</b> Cat A	<b>Pre-clean</b> Y	<b>Last cleaned</b>	
<b>General note</b>		Structural	Service	Conventional
<b>Location note</b>		Mechanical	Specialty
