RE: Docket No. 080248-SU; Tierra Verde Utilities, Inc.'s Application for an Increase in Wastewater Rates Increase in Pinellas County, Florida  
Our File No.: 30057.156

3(a) The "TV Sewer Mains" project reflects the effort to clean and video inspect two portions of the Tierra Verde collection system. The gravity main and manholes situated in the Pinellas Bayway right-of-way and the area west of the Pinellas Bayway along and adjacent to Madonna Avenue had not been cleaned and inspected for many years. A total of 6,229 LF of 18" diameter pipe was cleaned and inspected along the Pinellas Bayway. A total of 21,250 LF of 8" diameter pipe and manholes were inspected west of the Pinellas Bayway along Madonna Avenue. The project is justified for the following reasons:

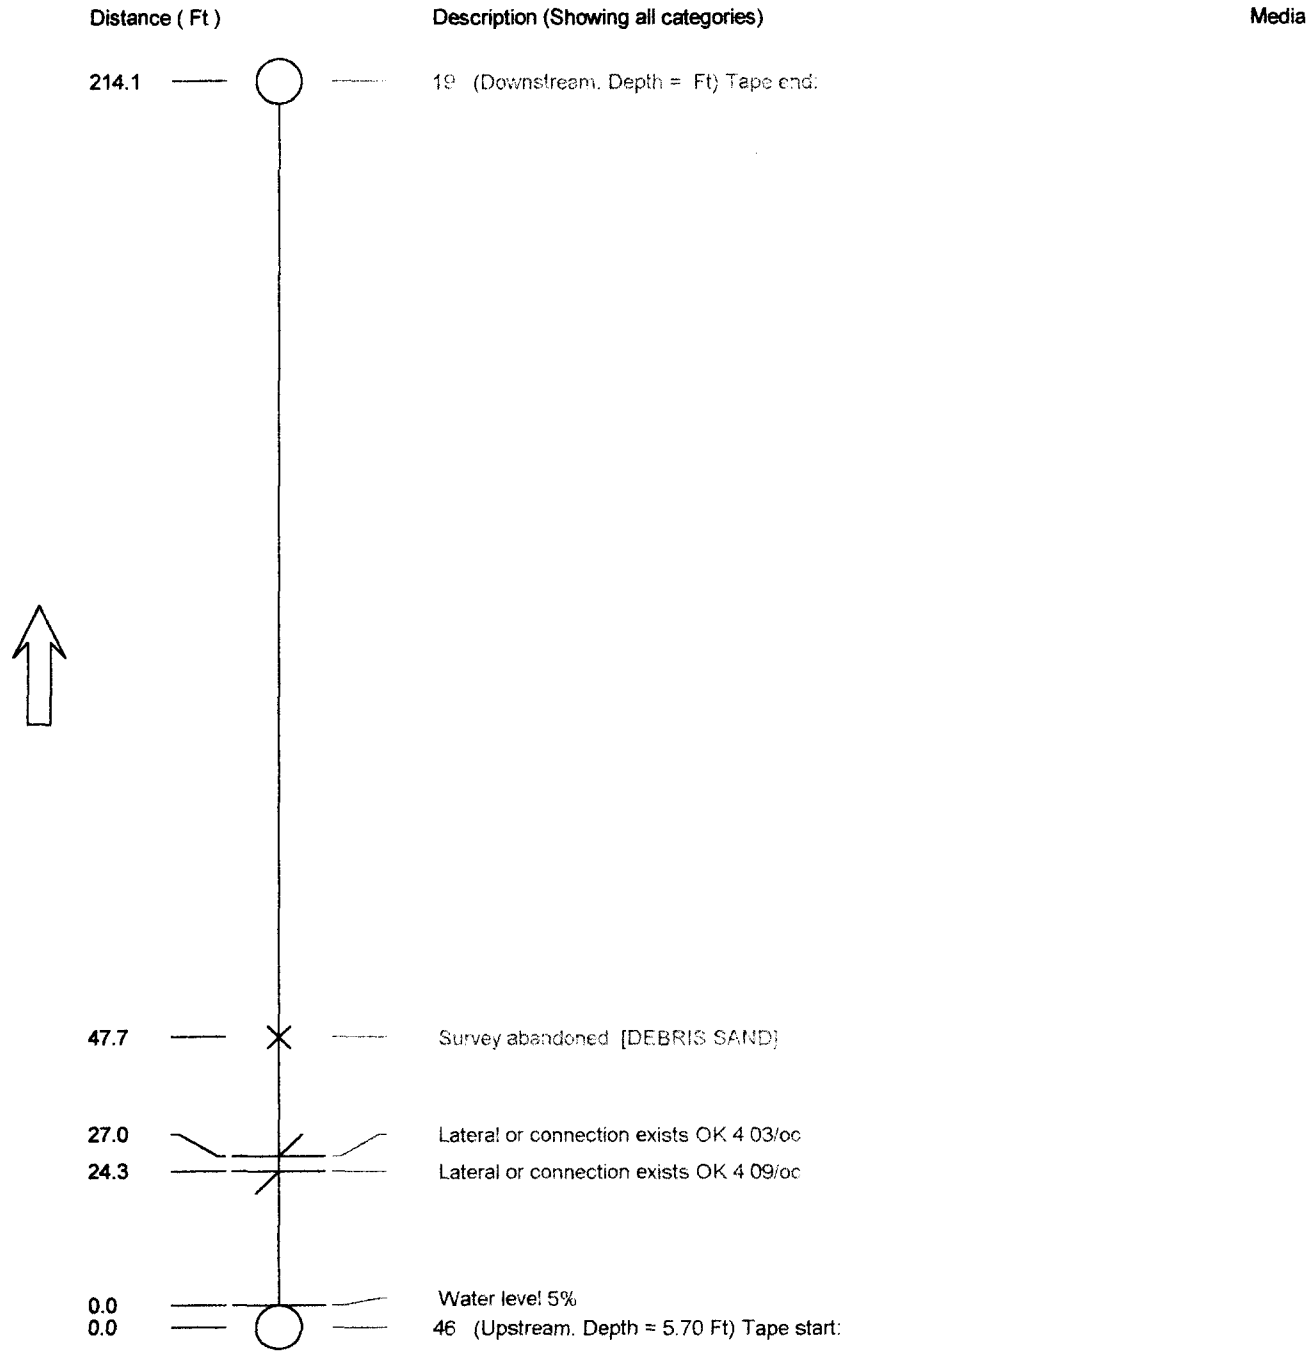
<b>Job</b>	<b>Contract</b>	<b>Cassette 7</b>	<b>Surveyed On</b> 08/11/2004	<b>Sheet</b> 53
<b>Operator</b> BMN	<b>Van Reference</b>	<b>Weather</b> Dry		
<b>Road Name</b> 6TH ST		<b>Place Name</b> TIERRA VERDE		
<b>Location type</b> Light road (rural roads with lighter traffic, town & city back streets)				
<b>Surface</b>				
<b>Survey purpose</b> Sample survey to determine asset condition				
<b>Pipe Use</b> Foul	<b>Schedule length</b> 214.1 Ft	<b>From</b> 46	<b>Depth</b> 5.70 Ft	
<b>Shape</b> Circular	<b>Size</b> 8 by ins	<b>To</b> 19	<b>Depth</b> Ft	
<b>Material</b> Polyvinyl chloride	<b>Joint spacing</b> Ft	<b>Direction</b> Down		
<b>Lining</b>	<b>Year laid</b> Cat A	<b>Pre-clean</b> Y	<b>Last cleaned</b>	
<b>General note</b> SEE SHEET 98		<b>Structural</b>	<b>Service</b>	<b>Construction</b>
<b>Location note</b>		<b>Media</b>

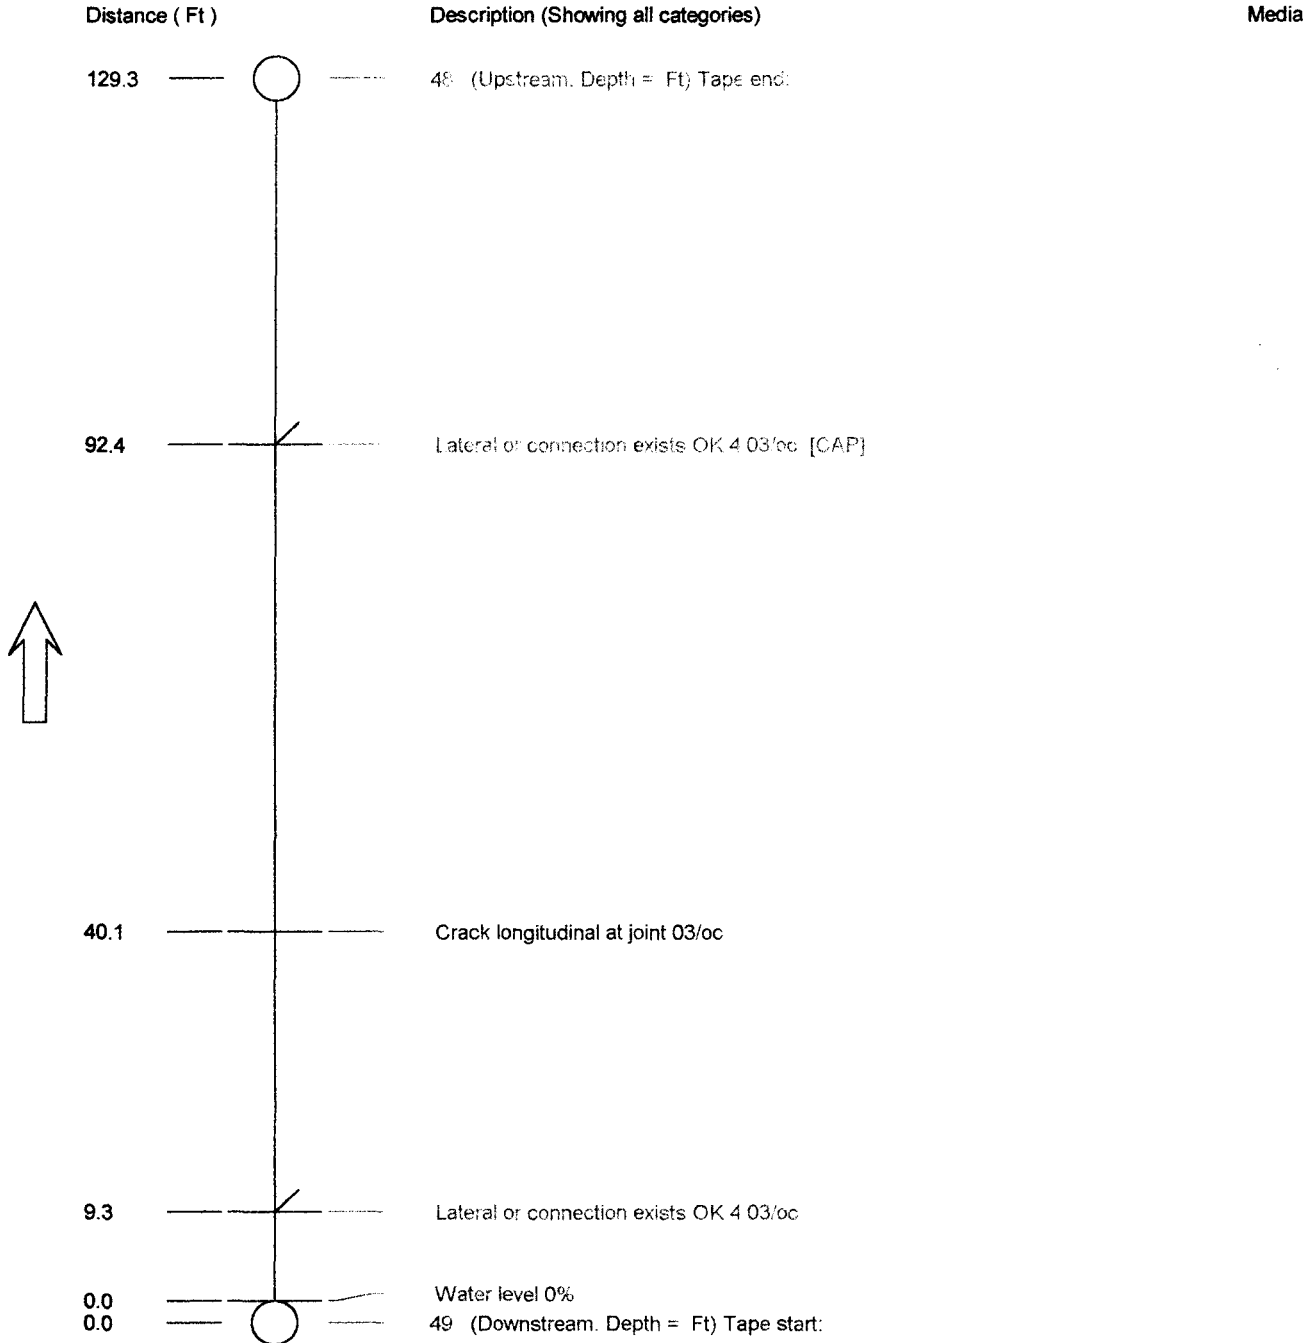
<b>Job</b>	<b>Contract</b>	<b>Cassette 7</b>	<b>Surveyed On</b> 08/11/2004	<b>Sheet</b> 54
<b>Operator</b> BMN	<b>Van Reference</b>	<b>Weather</b> Dry		
<b>Road Name</b> 8TH AVE N		<b>Place Name</b> TIERRA VERDE		
<b>Location type</b> Light road (rural roads with lighter traffic, town & city back streets)				
<b>Surface</b>				
<b>Survey purpose</b> Sample survey to determine asset condition				
<b>Pipe Use</b> Foul	<b>Schedule length</b> 129.3 Ft	<b>From</b> 49	<b>Depth</b>	<b>Ft</b>
<b>Shape</b> Circular	<b>Size</b> 8 <b>by</b> Ins	<b>To</b> 48	<b>Depth</b>	<b>Ft</b>
<b>Material</b> Vitrified clay	<b>Joint spacing</b> Ft	<b>Direction</b> Up		
<b>Lining</b>	<b>Year laid</b> Cat A	<b>Pre-clean</b> Y	<b>Last cleaned</b>	
<b>General note</b>		Structural	Service	Condition
<b>Location note</b>		Material	Notes	Remarks

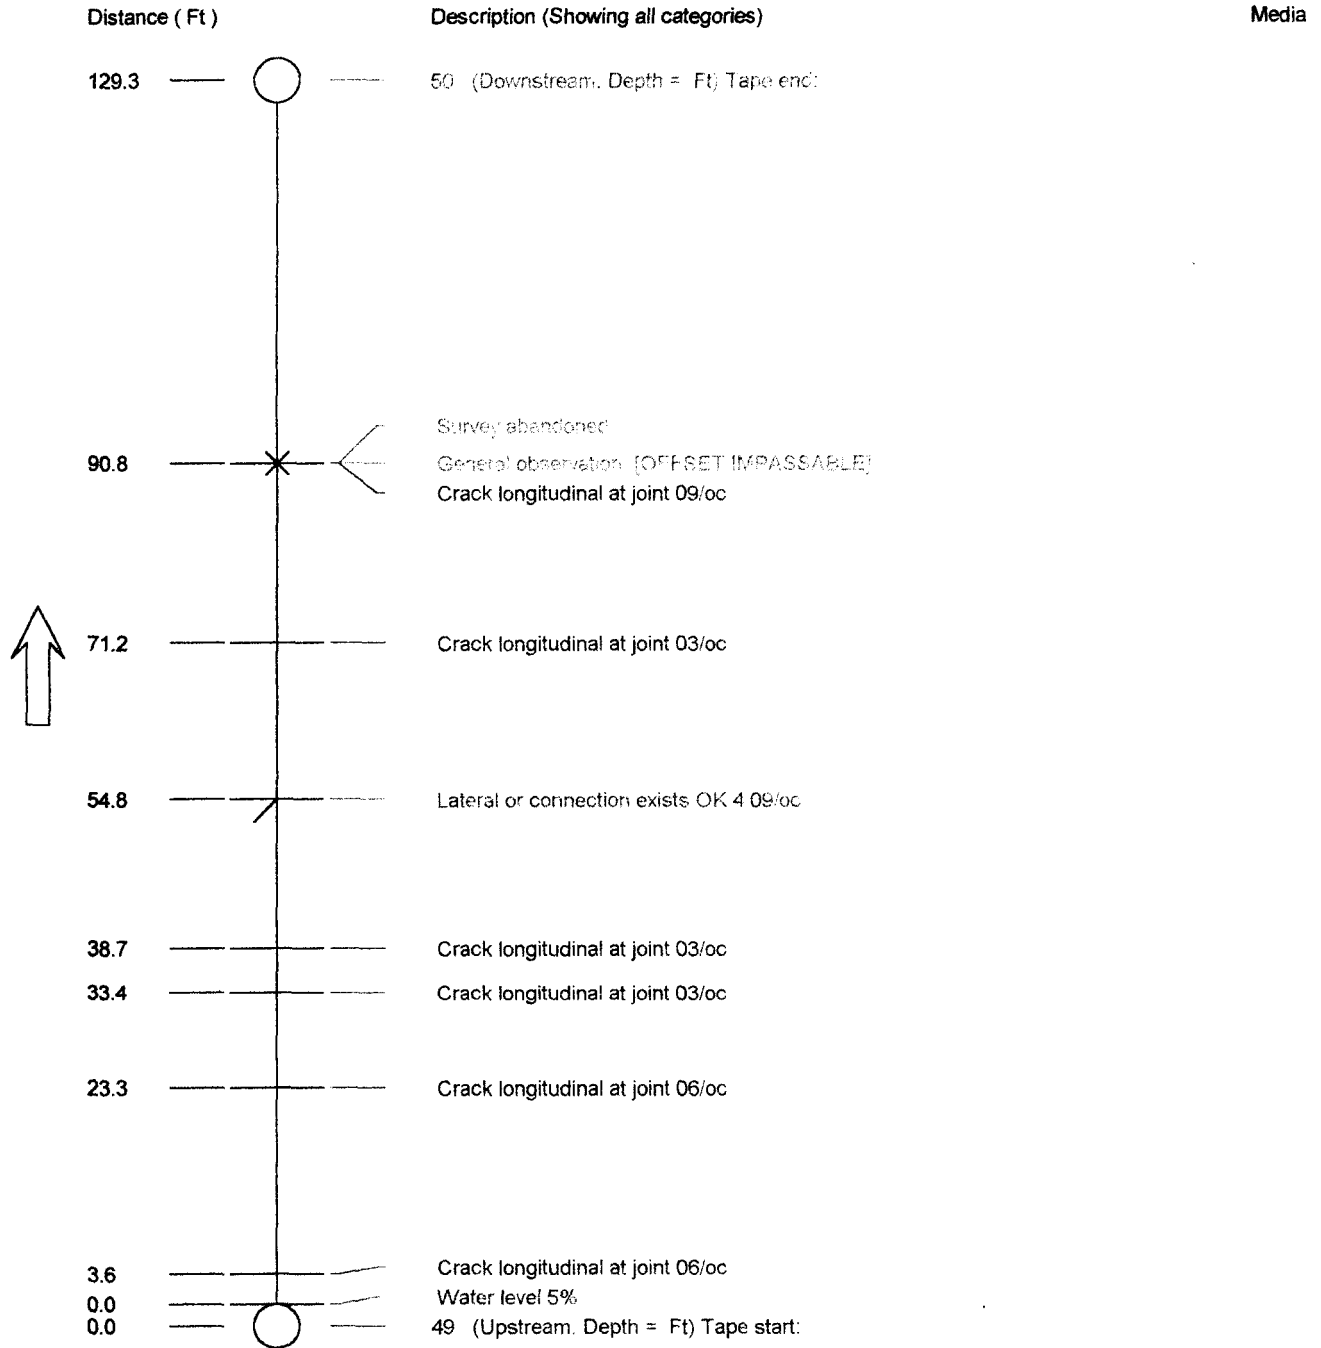
<b>Job</b>	<b>Contract</b>	<b>Cassette 7</b>	<b>Surveyed On</b> 08/11/2004	<b>Sheet</b> 55
<b>Operator</b> BMN	<b>Van Reference</b>	<b>Weather:</b> Dry		
<b>Road Name</b> 8YH AVE N		<b>Place Name</b> TIERRA VERDE		
<b>Location type</b> Light road (rural roads with lighter traffic, town & city back streets)				
<b>Surface</b>				
<b>Survey purpose</b> Sample survey to determine asset condition				
<b>Pipe Use</b> Foul	<b>Schedule length</b> 129.3 Ft	<b>From</b> 49	<b>Depth</b>	<b>Ft</b>
<b>Shape</b> Circular	<b>Size</b> 8 by ins	<b>To</b> 50	<b>Depth</b>	<b>Ft</b>
<b>Material</b> Vitrified clay	<b>Joint spacing</b> Ft	<b>Direction</b> Down		
<b>Lining</b>	<b>Year laid</b> Cat A	<b>Pre-clean</b> Y	<b>Last cleaned</b>	
<b>General note</b>		Structural	Service	Com/functional
<b>Location note</b>		Material	Age

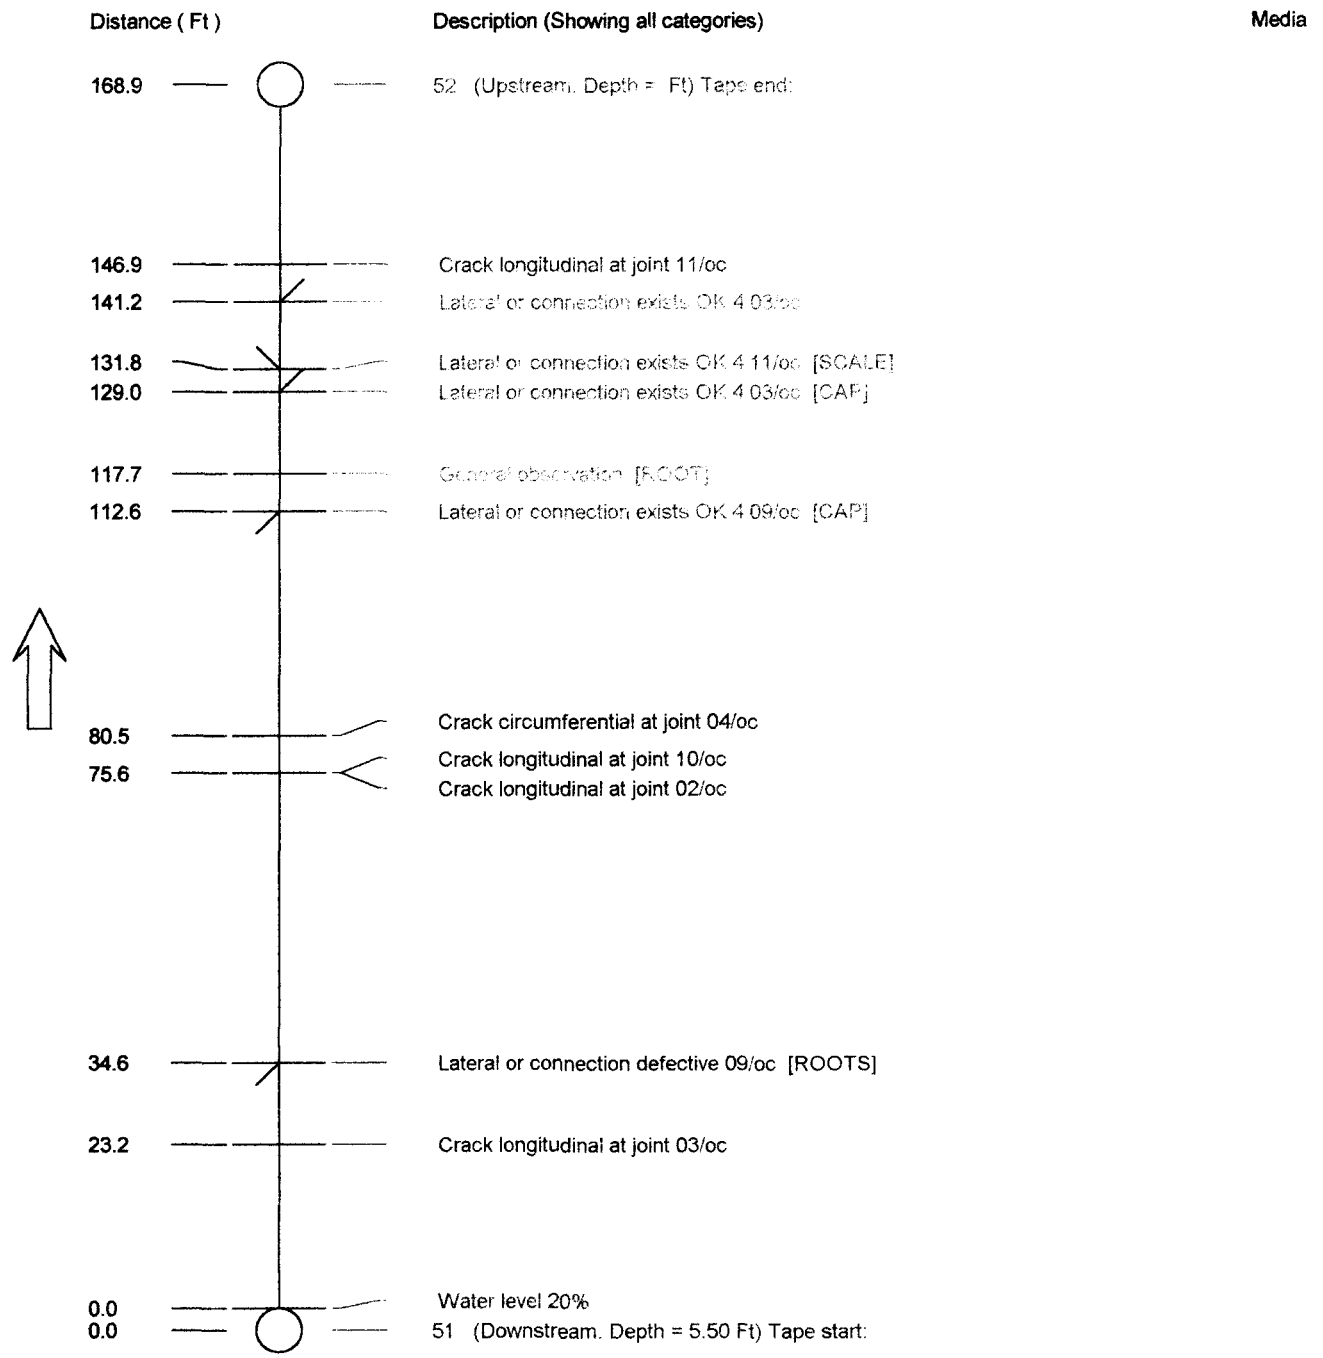
<b>Job</b>	<b>Contract</b>	<b>Cassette 8</b>	<b>Surveyed On</b> 08/12/2004	<b>Sheet</b> 56
<b>Operator</b> BMN	<b>Van Reference</b>	<b>Weather</b> Dry		
<b>Road Name</b> 8TH AVE N		<b>Place Name</b> TIERRA VERDE		
<b>Location type</b> Light road (rural roads with lighter traffic, town & city back streets)				
<b>Surface</b>				
<b>Survey purpose</b> Sample survey to determine asset condition				
<b>Pipe Use</b> Foul	<b>Schedule length</b> 168.9 Ft	<b>From</b> 51	<b>Depth</b> 5.50 Ft	
<b>Shape</b> Circular	<b>Size</b> 8 by Ins	<b>To</b> 52	<b>Depth</b> Ft	
<b>Material</b> Vitrified clay	<b>Joint spacing</b> Ft	<b>Direction</b> Up		
<b>Lining</b>	<b>Year laid</b> Cat A	<b>Pre-clean</b> Y	<b>Last cleaned</b>	
<b>General note</b>		Structural	Service	Condition
<b>Location note</b>		Material	Location

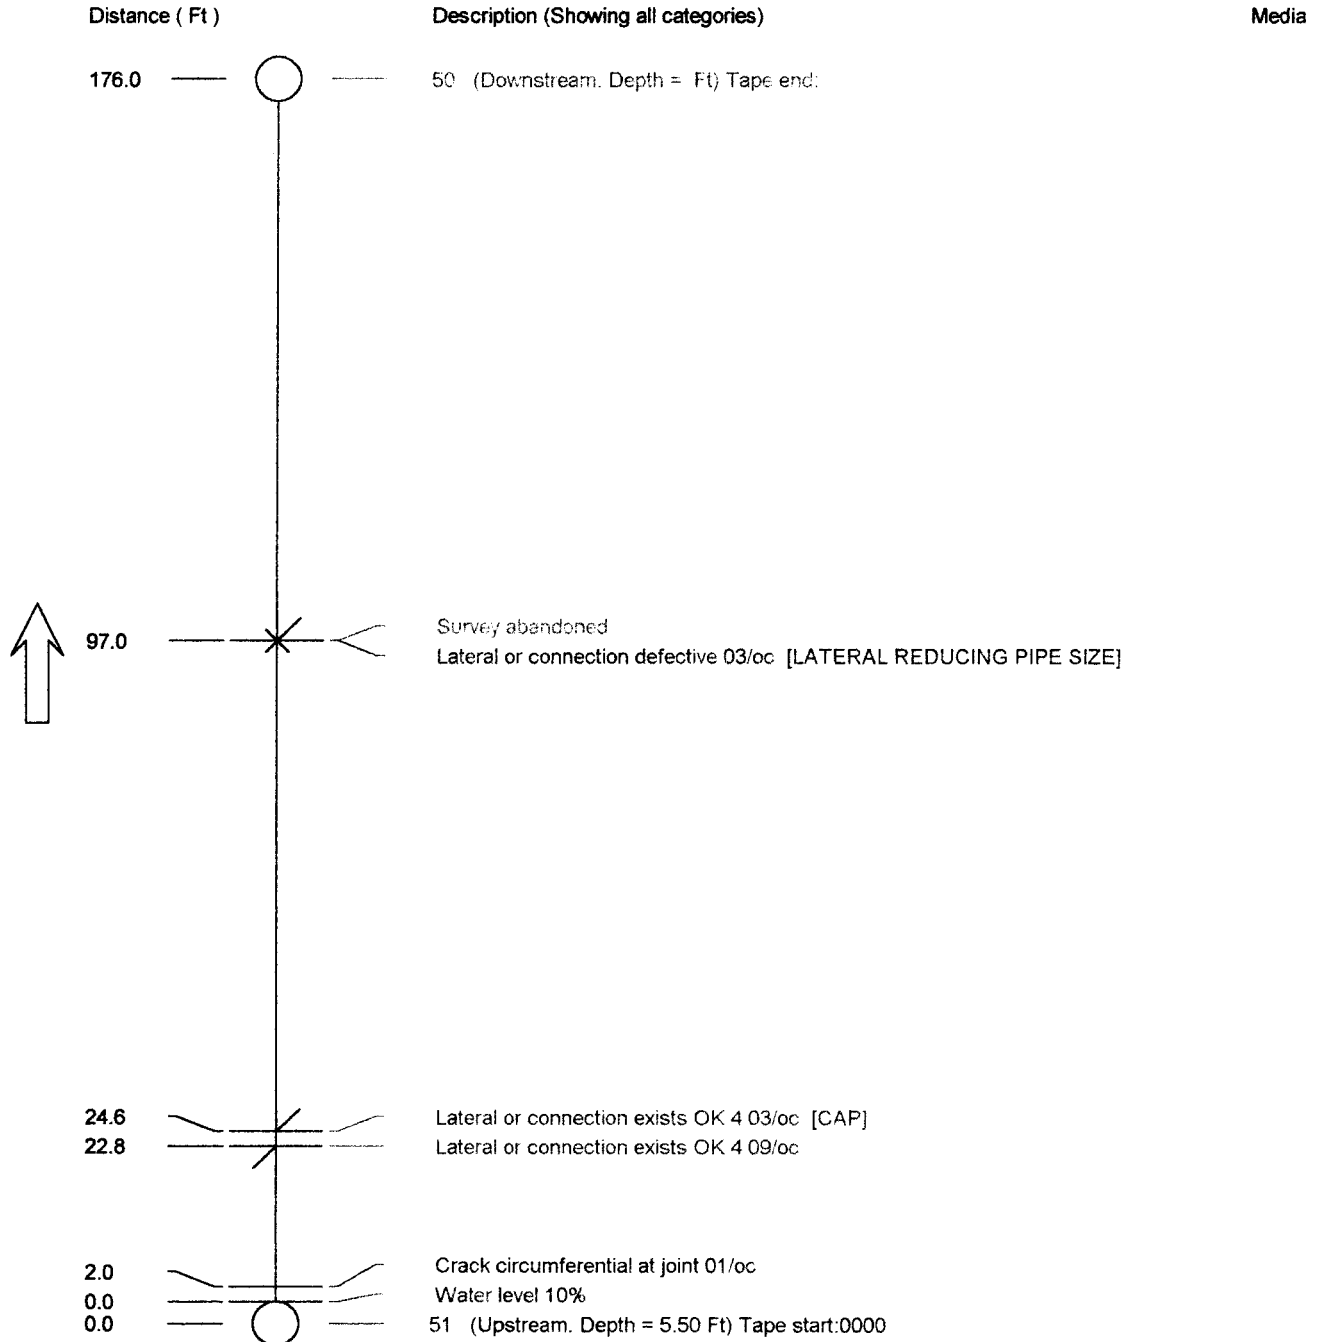
<b>Job</b>	<b>Contract</b>	<b>Cassette</b> 8	<b>Surveyed On</b> 08/12/2004	<b>Sheet</b> 57
<b>Operator</b> BMN	<b>Van Reference</b>	<b>Weather</b> Dry		
<b>Road Name</b> 8TH AVE N		<b>Place Name</b> TIERRA VERDE		
<b>Location type</b> Light road (rural roads with lighter traffic, town & city back streets)				
<b>Surface</b>				
<b>Survey purpose</b> Sample survey to determine asset condition				
<b>Pipe Use</b> Foul	<b>Schedule length</b> 176.0 Ft	<b>From</b> 51	<b>Depth</b> 5.50 Ft	
<b>Shape</b> Circular	<b>Size</b> 8 by ins	<b>To</b> 50	<b>Depth</b> Ft	
<b>Material</b> Vitrified clay	<b>Joint spacing</b> Ft	<b>Direction</b> Down		
<b>Lining</b>	<b>Year laid</b> Cat A	<b>Pre-clean</b> Y	<b>Last cleaned</b>	
<b>General note</b> SEE SHEET 93 FOR REVERSE SETUP		<b>Structural</b>	<b>Service</b>	<b>Construction</b>
<b>Location note</b>		<b>Miscellaneous</b>

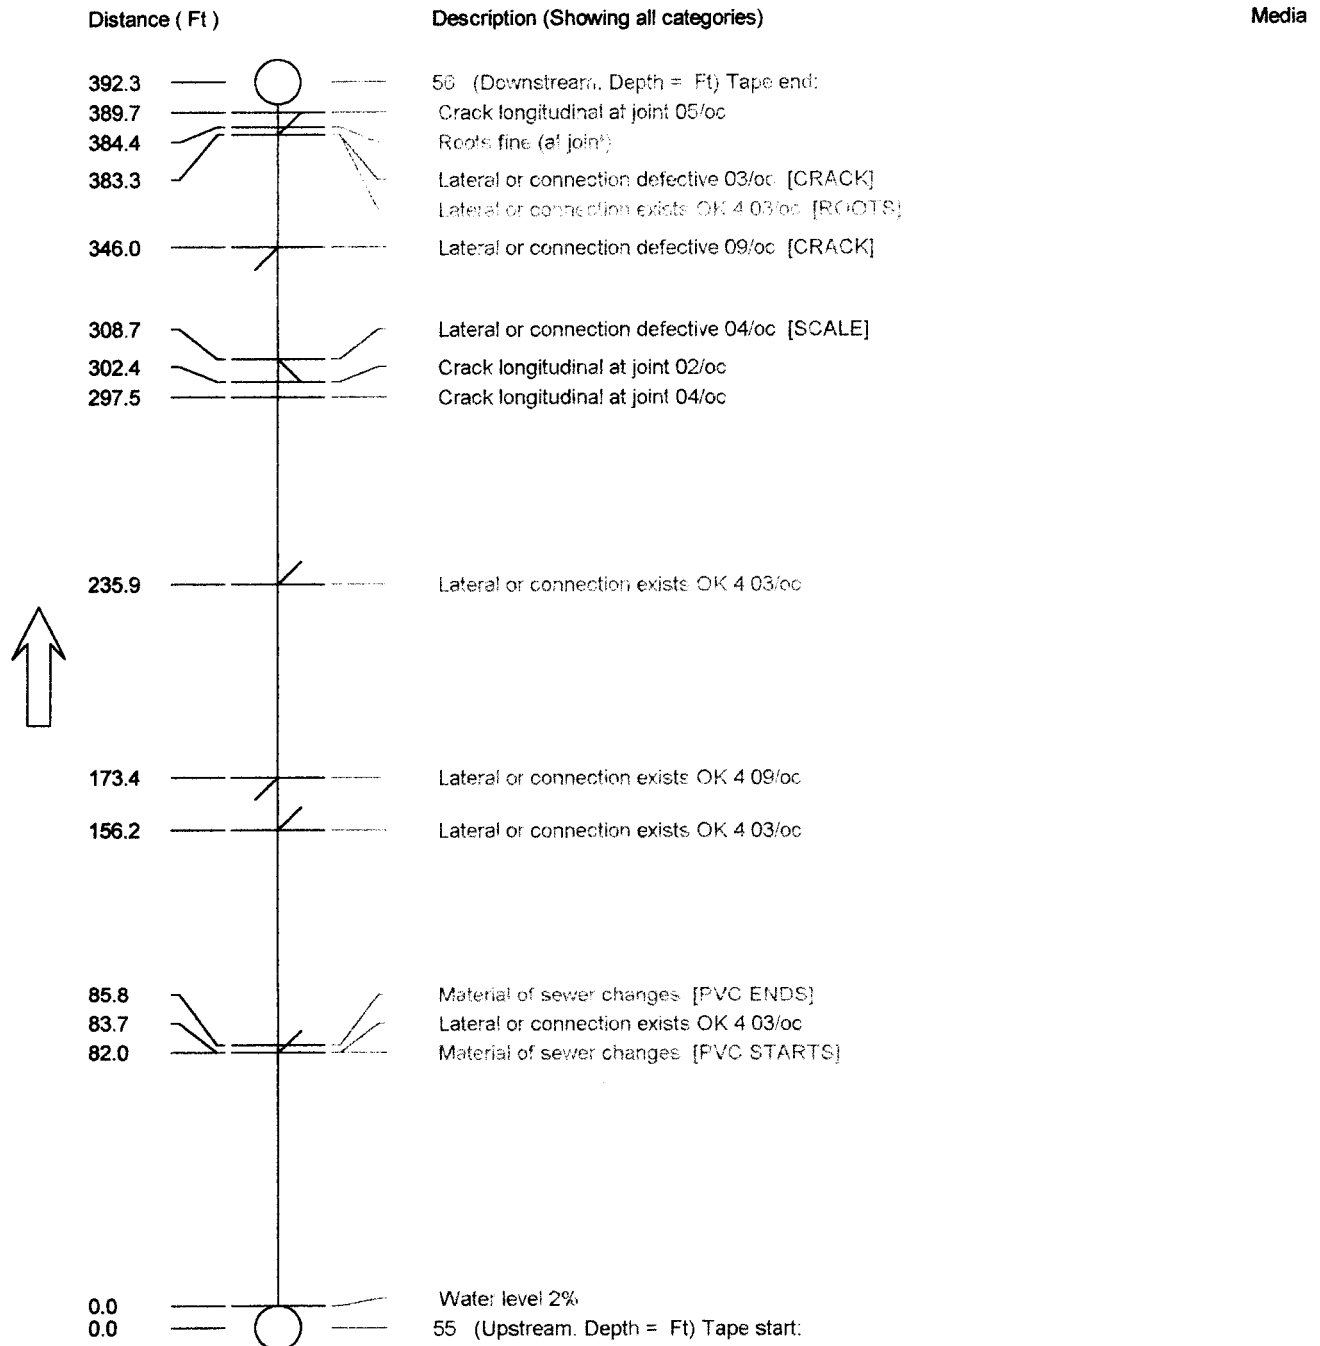
<b>Job</b>	<b>Contract</b>	<b>Cassette 8</b>	<b>Surveyed On</b> 08/12/2004	<b>Sheet</b> 58
<b>Operator</b> BMN	<b>Van Reference</b>	<b>Weather</b> Dry		
<b>Road Name</b> 1ST ST. W		<b>Place Name</b> TIERRA VERDE		
<b>Location type</b> Light road (rural roads with lighter traffic, town & city back streets)				
<b>Surface</b>				
<b>Survey purpose</b> Sample survey to determine asset condition				
<b>Pipe Use</b> Foul	<b>Schedule length</b> 392.3 Ft	<b>From</b> 55	<b>Depth</b>	<b>Ft</b>
<b>Shape</b> Circular	<b>Size</b> 8 by ins	<b>To</b> 56	<b>Depth</b>	<b>Ft</b>
<b>Material</b> Vitrified clay	<b>Joint spacing</b> Ft	<b>Direction</b> Down		
<b>Lining</b>	<b>Year laid</b> Cat A	<b>Pre-clean</b> Y	<b>Last cleaned</b>	
<b>General note</b>	Structural		Service	Construction
<b>Location note</b>	Material		Support

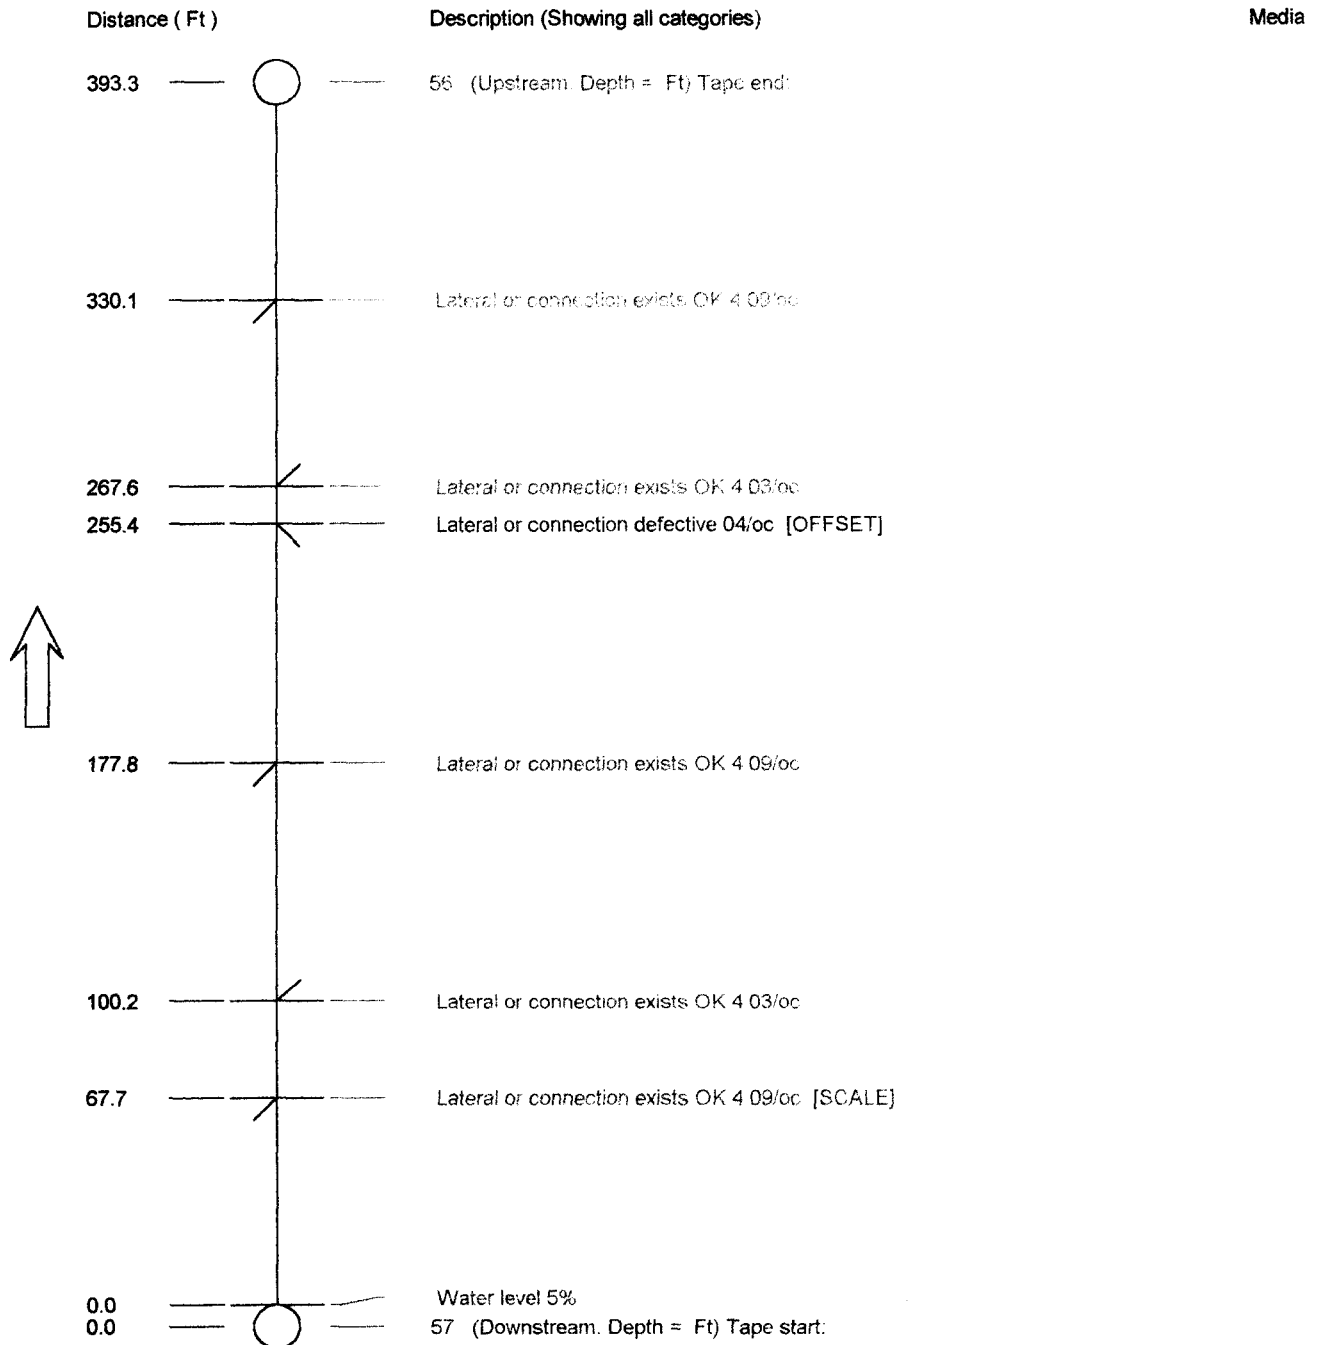
<b>Job</b>	<b>Contract</b>	<b>Cassette</b> 8	<b>Surveyed On</b> 08/12/2004	<b>Sheet</b> 59
<b>Operator</b> BMN	<b>Van Reference</b>	<b>Weather</b> Dry		
<b>Road Name</b> 1ST ST. W		<b>Place Name</b> TIERRA VERDE		
<b>Location type</b> Light road (rural roads with lighter traffic, town & city back streets)				
<b>Surface</b>				
<b>Survey purpose</b> Sample survey to determine asset condition				
<b>Pipe Use</b> Foul	<b>Schedule length</b> 393.3 Ft	<b>From</b> 57	<b>Depth</b>	<b>Ft</b>
<b>Shape</b> Circular	<b>Size</b> 8 by ins	<b>To</b> 56	<b>Depth</b>	<b>Ft</b>
<b>Material</b> Vitrified clay	<b>Joint spacing</b> Ft	<b>Direction</b> Up		
<b>Lining</b>	<b>Year laid</b> Cat A	<b>Pre-clean</b> Y	<b>Last cleaned</b>	
<b>General note</b>		<b>Structure</b>	<b>Service</b>	<b>Construction</b>
<b>Location note</b>

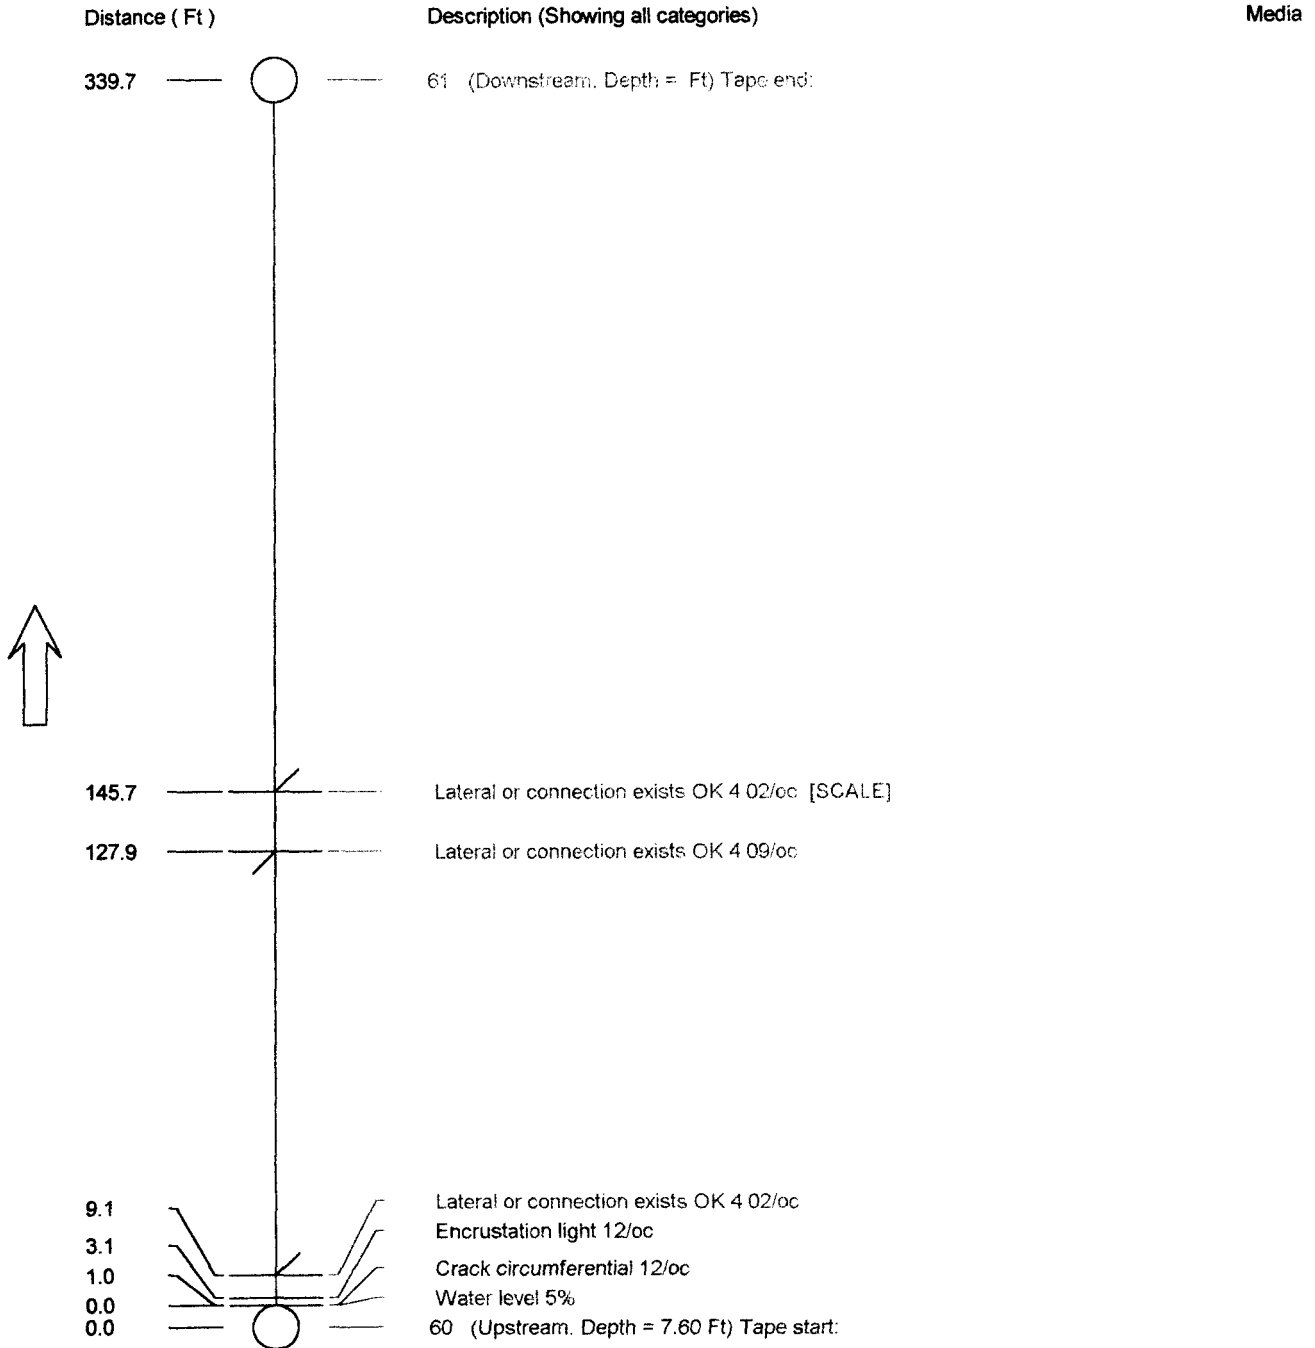
<b>Job</b>	<b>Contract</b>	<b>Cassette</b> 8	<b>Surveyed On</b> 08/16/2004	<b>Sheet</b> 60
<b>Operator</b> BMN	<b>Van Reference</b>	<b>Weather</b> Dry		
<b>Road Name</b> 2ND ST. W.		<b>Place Name</b> TIERRA VERDE		
<b>Location type</b> Light road (rural roads with lighter traffic, town & city back streets)				
<b>Surface</b>				
<b>Survey purpose</b> Sample survey to determine asset condition				
<b>Pipe Use</b> Foul	<b>Schedule length</b> 339.7 Ft	<b>From</b> 60	<b>Depth</b> 7.60 Ft	
<b>Shape</b> Circular	<b>Size</b> 8 by Ins	<b>To</b> 61	<b>Depth</b> Ft	
<b>Material</b> Vitrified clay	<b>Joint spacing</b> Ft	<b>Direction</b> Down		
<b>Lining</b>	<b>Year laid</b> Cat A	<b>Pre-clean</b> Y	<b>Last cleaned</b>	
<b>General note</b>		Structural	Service	Construction
<b>Location note</b>		Material	Condition	Notes

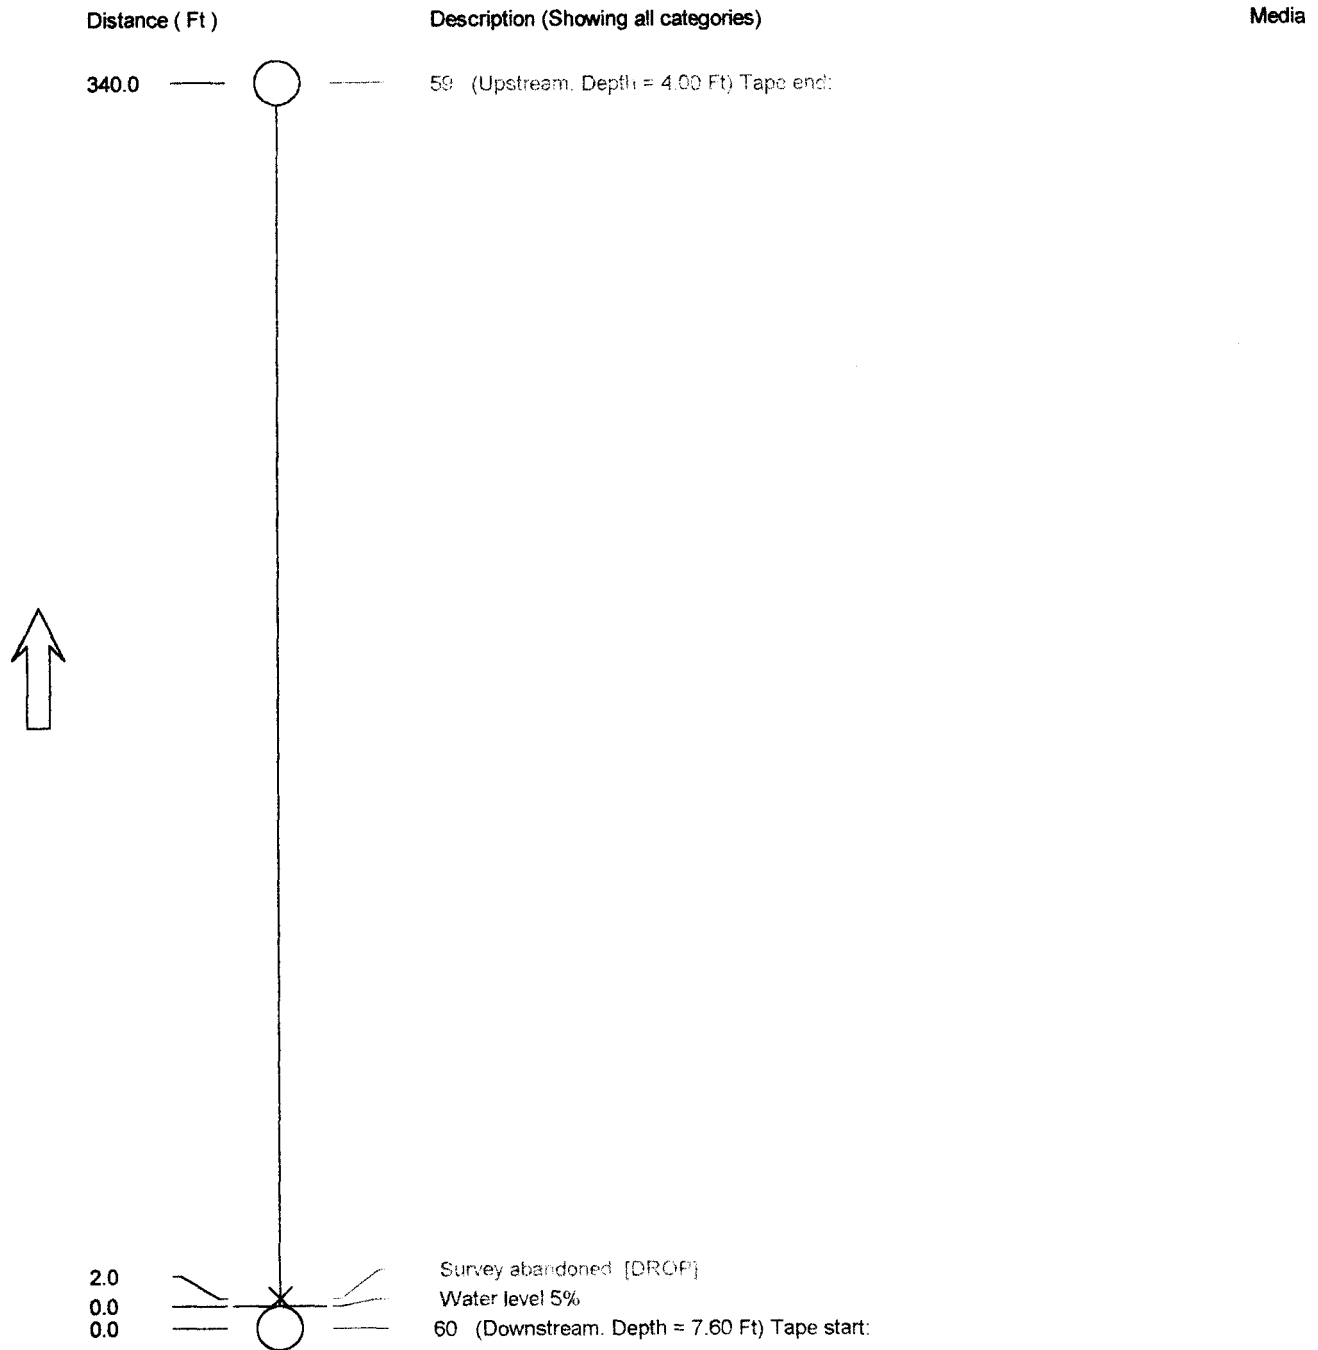
<b>Job</b>	<b>Contract</b>	<b>Cassette</b> 8	<b>Surveyed On</b> 08/16/2004	<b>Sheet</b> 62
<b>Operator</b> BMN	<b>Van Reference</b>	<b>Weather</b> Dry		
<b>Road Name</b> 2ND ST. W.		<b>Place Name</b> TIERRA VERDE		
<b>Location type</b> Light road (rural roads with lighter traffic, town & city back streets)				
<b>Surface</b>				
<b>Survey purpose</b> Sample survey to determine asset condition				
<b>Pipe Use</b> Foul	<b>Schedule length</b> 340.0 Ft	<b>From</b> 60	<b>Depth</b> 7.60 Ft	
<b>Shape</b> Circular	<b>Size</b> 8 by ins	<b>To</b> 59	<b>Depth</b> 4.00 Ft	
<b>Material</b> Vitrified clay	<b>Joint spacing</b> Ft	<b>Direction</b> Up		
<b>Lining</b>	<b>Year laid</b> Cat A	<b>Pre-clean</b> Y	<b>Last cleaned</b>	
<b>General note</b> SEE SHEET 63 FOR REVERSE SETUP		<b>Structural</b>	<b>Service</b>	<b>Condition</b>
<b>Location note</b>

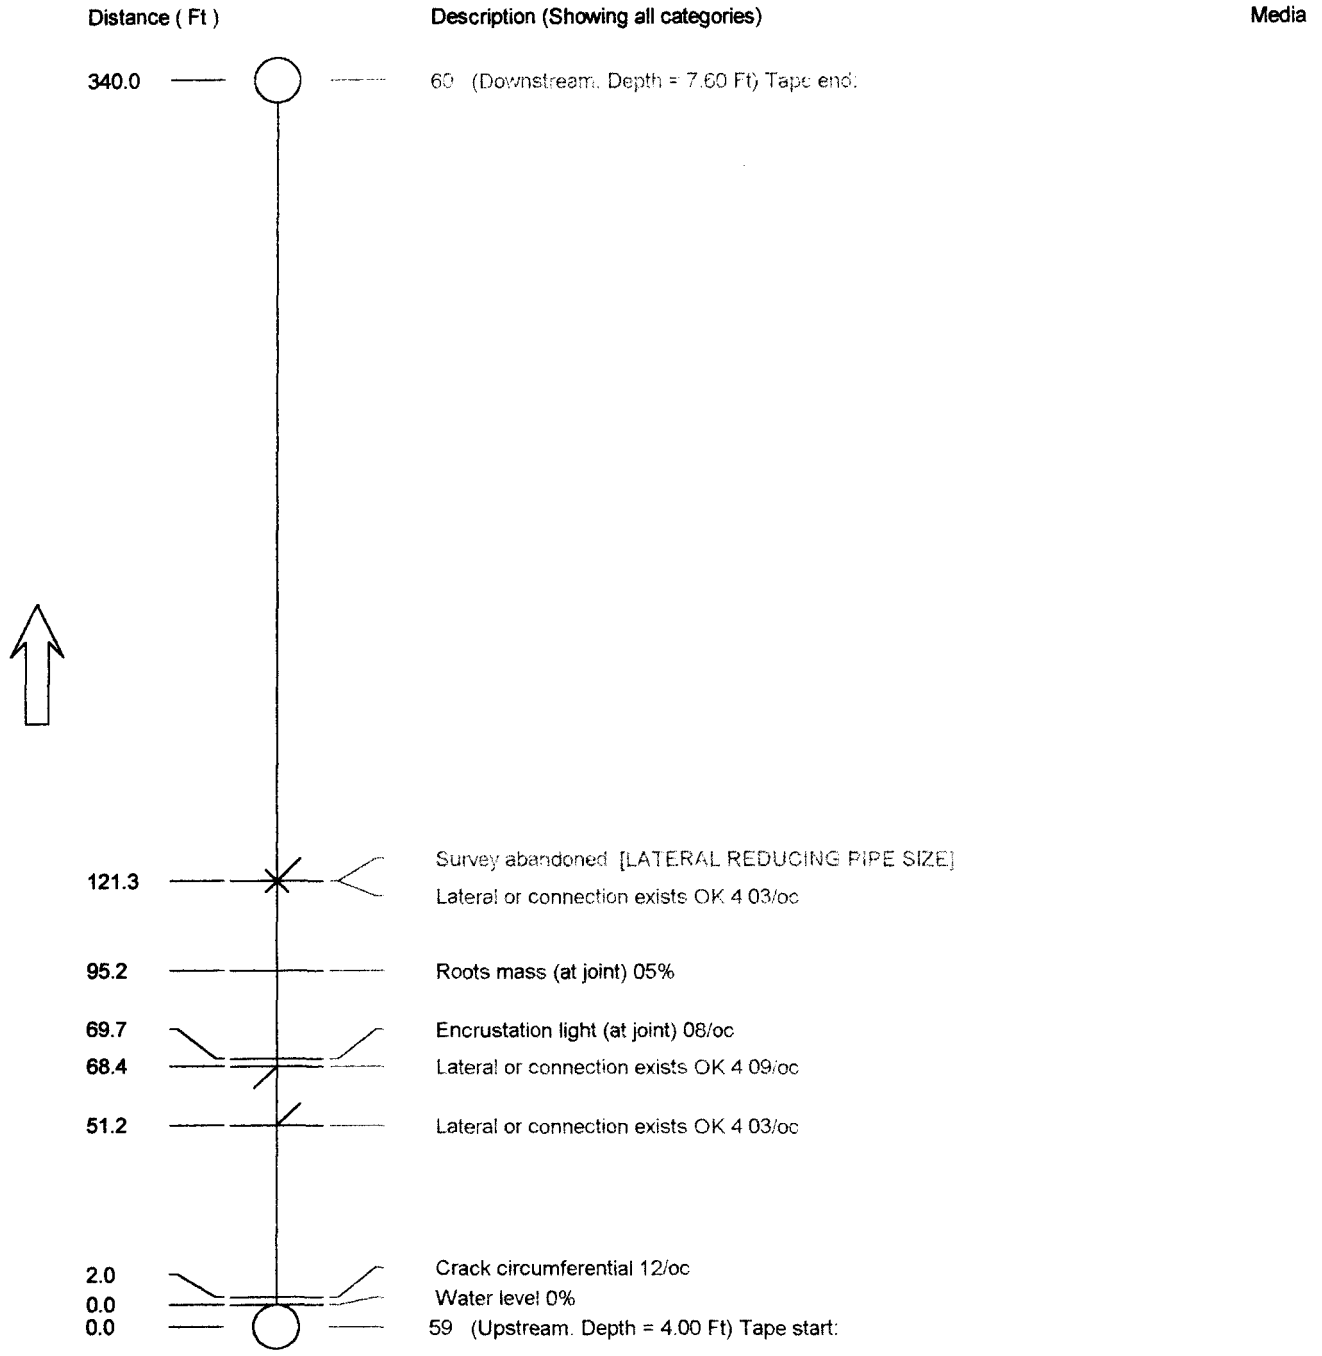
<b>Job</b>	<b>Contract</b>	<b>Cassette 9</b>	<b>Surveyed On</b> 08/16/2004	<b>Sheet</b> 63
<b>Operator</b> BMN	<b>Van Reference</b>	<b>Weather</b> Dry		
<b>Road Name</b> 2ND ST. W.		<b>Place Name</b> TIERRA VERDE		
<b>Location type</b> Light road (rural roads with lighter traffic, town & city back streets)				
<b>Surface</b>				
<b>Survey purpose</b> Sample survey to determine asset condition				
<b>Pipe Use</b> Foul	<b>Schedule length</b> 340.0 Ft	<b>From</b> 59	<b>Depth</b> 4.00 Ft	
<b>Shape</b> Circular	<b>Size</b> 8 by Ins	<b>To</b> 60	<b>Depth</b> 7.60 Ft	
<b>Material</b> Vitrified clay	<b>Joint spacing</b> Ft	<b>Direction</b> Down		
<b>Lining</b>	<b>Year laid</b> Cat A	<b>Pre-clean</b> Y	<b>Last cleaned</b>	
<b>General note</b> SEE SHEET 62 FOR REVERSE SETUP		<b>Structure</b>	<b>Service</b>	<b>Construction</b>
<b>Location note</b>		<b>Material</b>	<b>Condition</b>	<b>Notes</b>

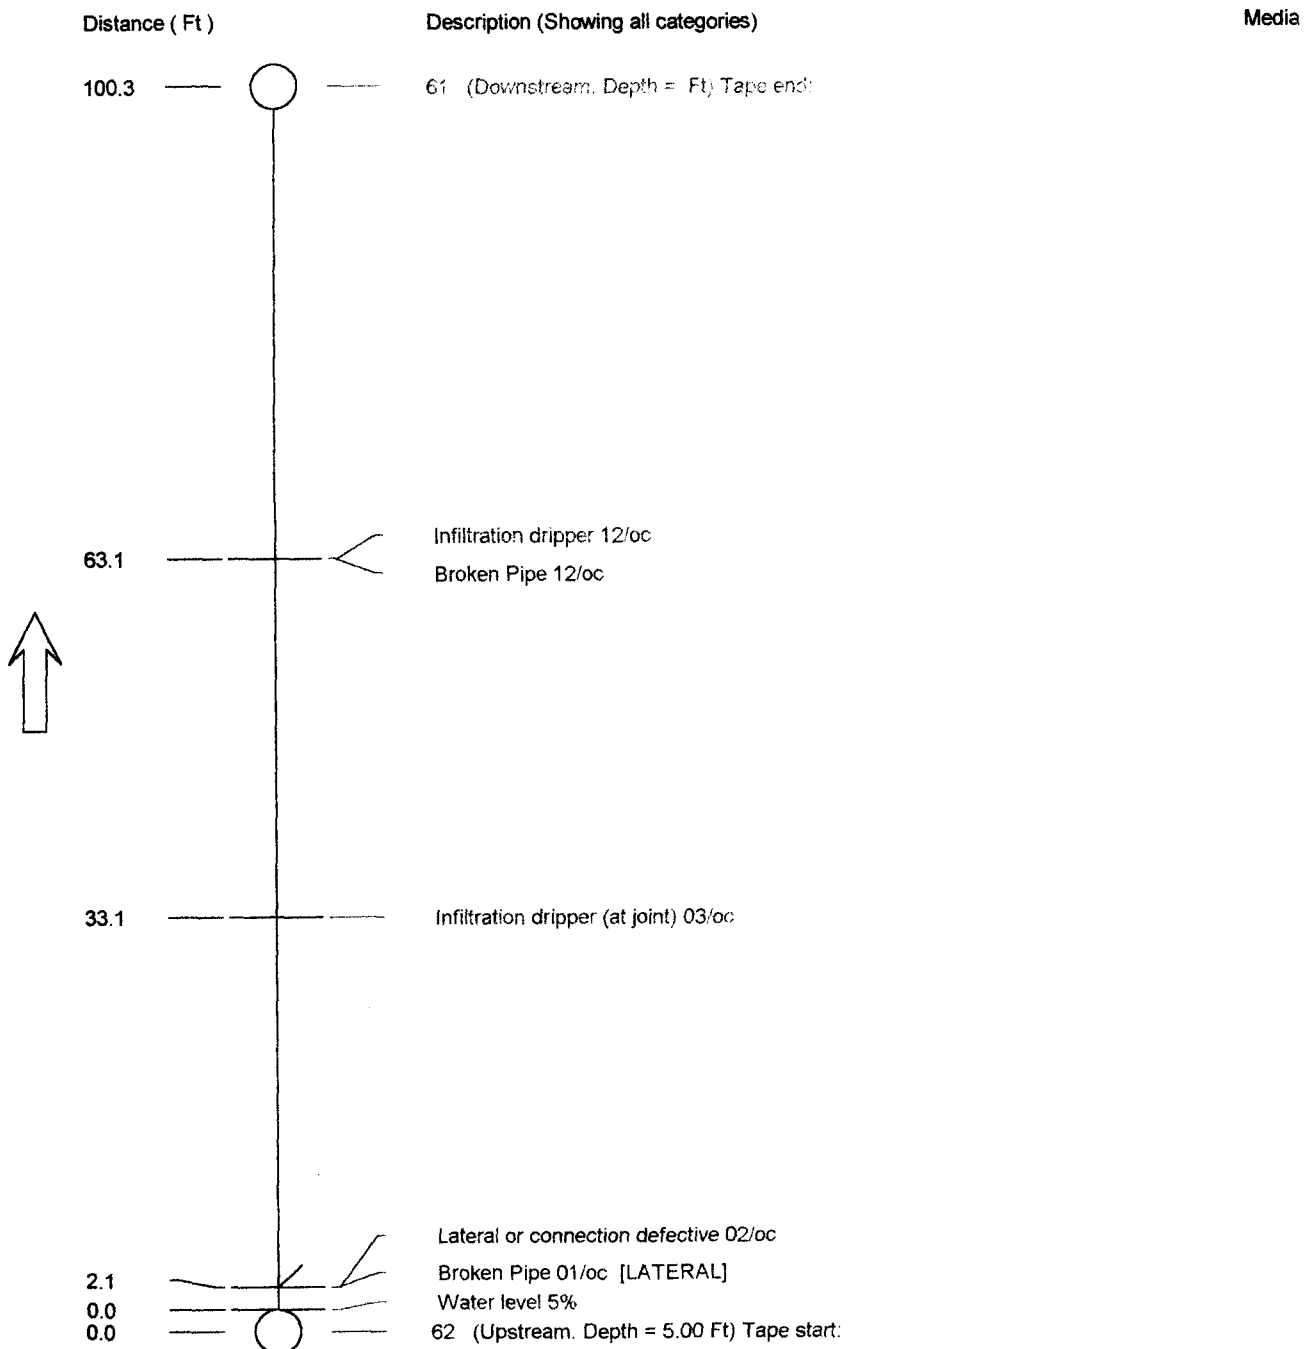
<b>Job</b>	<b>Contract</b>	<b>Cassette 9</b>	<b>Surveyed On</b> 08/16/2004	<b>Sheet</b> 64
<b>Operator</b> BMN	<b>Van Reference</b>	<b>Weather</b> Dry		
<b>Road Name</b> 1ST AVE. N.		<b>Place Name</b> TIERRA VERDE		
<b>Location type</b> Light road (rural roads with lighter traffic, town & city back streets)				
<b>Surface</b>				
<b>Survey purpose</b> Sample survey to determine asset condition				
<b>Pipe Use</b> Foul	<b>Schedule length</b> 100.3 Ft	<b>From</b> 62	<b>Depth</b> 5.00 Ft	
<b>Shape</b> Circular	<b>Size</b> 8 by ins	<b>To</b> 61	<b>Depth</b> Ft	
<b>Material</b> Vitrified clay	<b>Joint spacing</b> Ft	<b>Direction</b> Down		
<b>Lining</b>	<b>Year laid</b>	<b>Cat</b> A	<b>Pre-clean</b> Y	<b>Last cleaned</b>
<b>General note</b>		Structural	Service	Construction
<b>Location note</b>		Material	Access	Other
