RE: Docket No. 080248-SU; Tierra Verde Utilities, Inc.'s Application for an Increase in Wastewater Rates Increase in Pinellas County, Florida  
Our File No.: 30057.156

3(a) The "TV Sewer Mains" project reflects the effort to clean and video inspect two portions of the Tierra Verde collection system. The gravity main and manholes situated in the Pinellas Bayway right-of-way and the area west of the Pinellas Bayway along and adjacent to Madonna Avenue had not been cleaned and inspected for many years. A total of 6,229 LF of 18" diameter pipe was cleaned and inspected along the Pinellas Bayway. A total of 21,250 LF of 8" diameter pipe and manholes were inspected west of the Pinellas Bayway along Madonna Avenue. The project is justified for the following reasons:

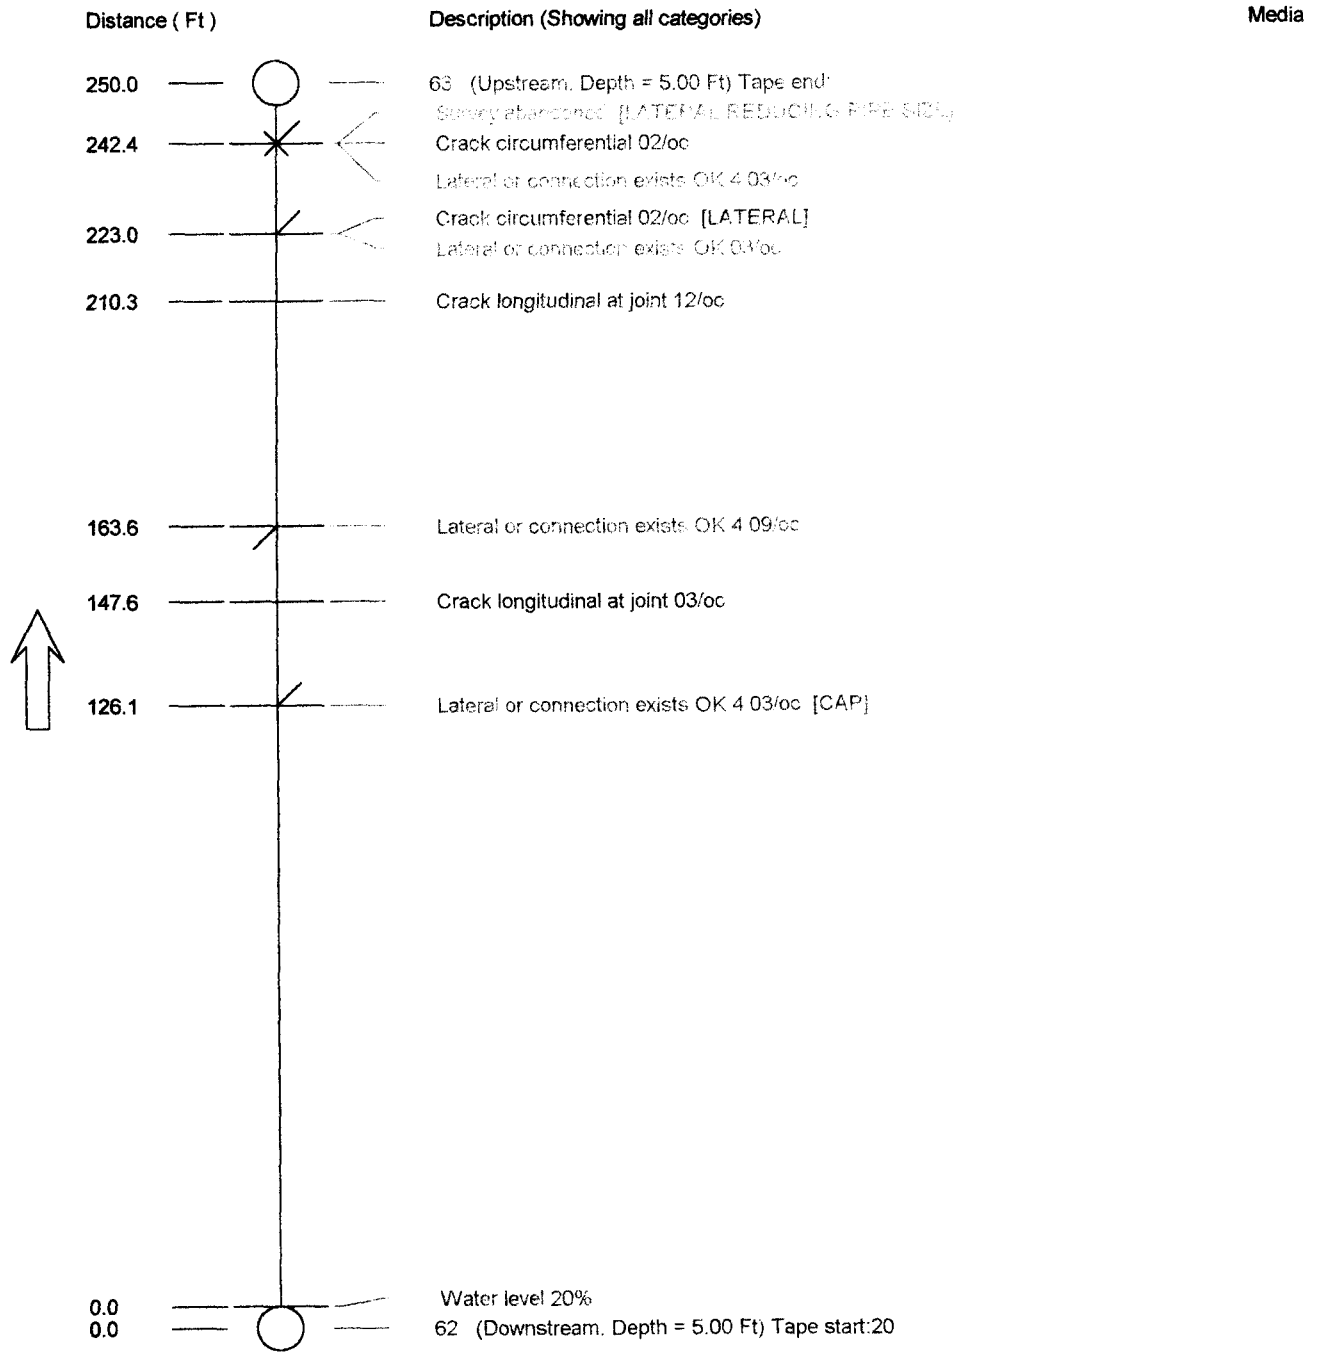
<b>Job</b>	<b>Contract</b>	<b>Cassette 9</b>	<b>Surveyed On</b> 08/16/2004	<b>Sheet</b> 65
<b>Operator</b> BMN	<b>Van Reference</b>	<b>Weather</b> Dry		
<b>Road Name</b> VACATED		<b>Place Name</b> TIERRA VERDE		
<b>Location type</b> Light road (rural roads with lighter traffic, town & city back streets)				
<b>Surface</b>				
<b>Survey purpose</b> Sample survey to determine asset condition				
<b>Pipe Use</b> Foul	<b>Schedule length</b> 250.0 Ft	<b>From</b> 62	<b>Depth</b> 5.00 Ft	
<b>Shape</b> Circular	<b>Size 8 by ins</b>	<b>To</b> 63	<b>Depth</b> 5.00 Ft	
<b>Material</b> Vitrified clay	<b>Joint spacing</b> Ft	<b>Direction</b> Up		
<b>Lining</b>	<b>Year laid</b> Cat A	<b>Pre-clean</b> Y	<b>Last cleaned</b>	
<b>General note</b> SEE SHEET 66 FOR REVERSE SETUP		<b>Structural</b>	<b>Service</b>	<b>Construction</b>
<b>Location note</b>		<b>Material</b>	<b>Media</b>

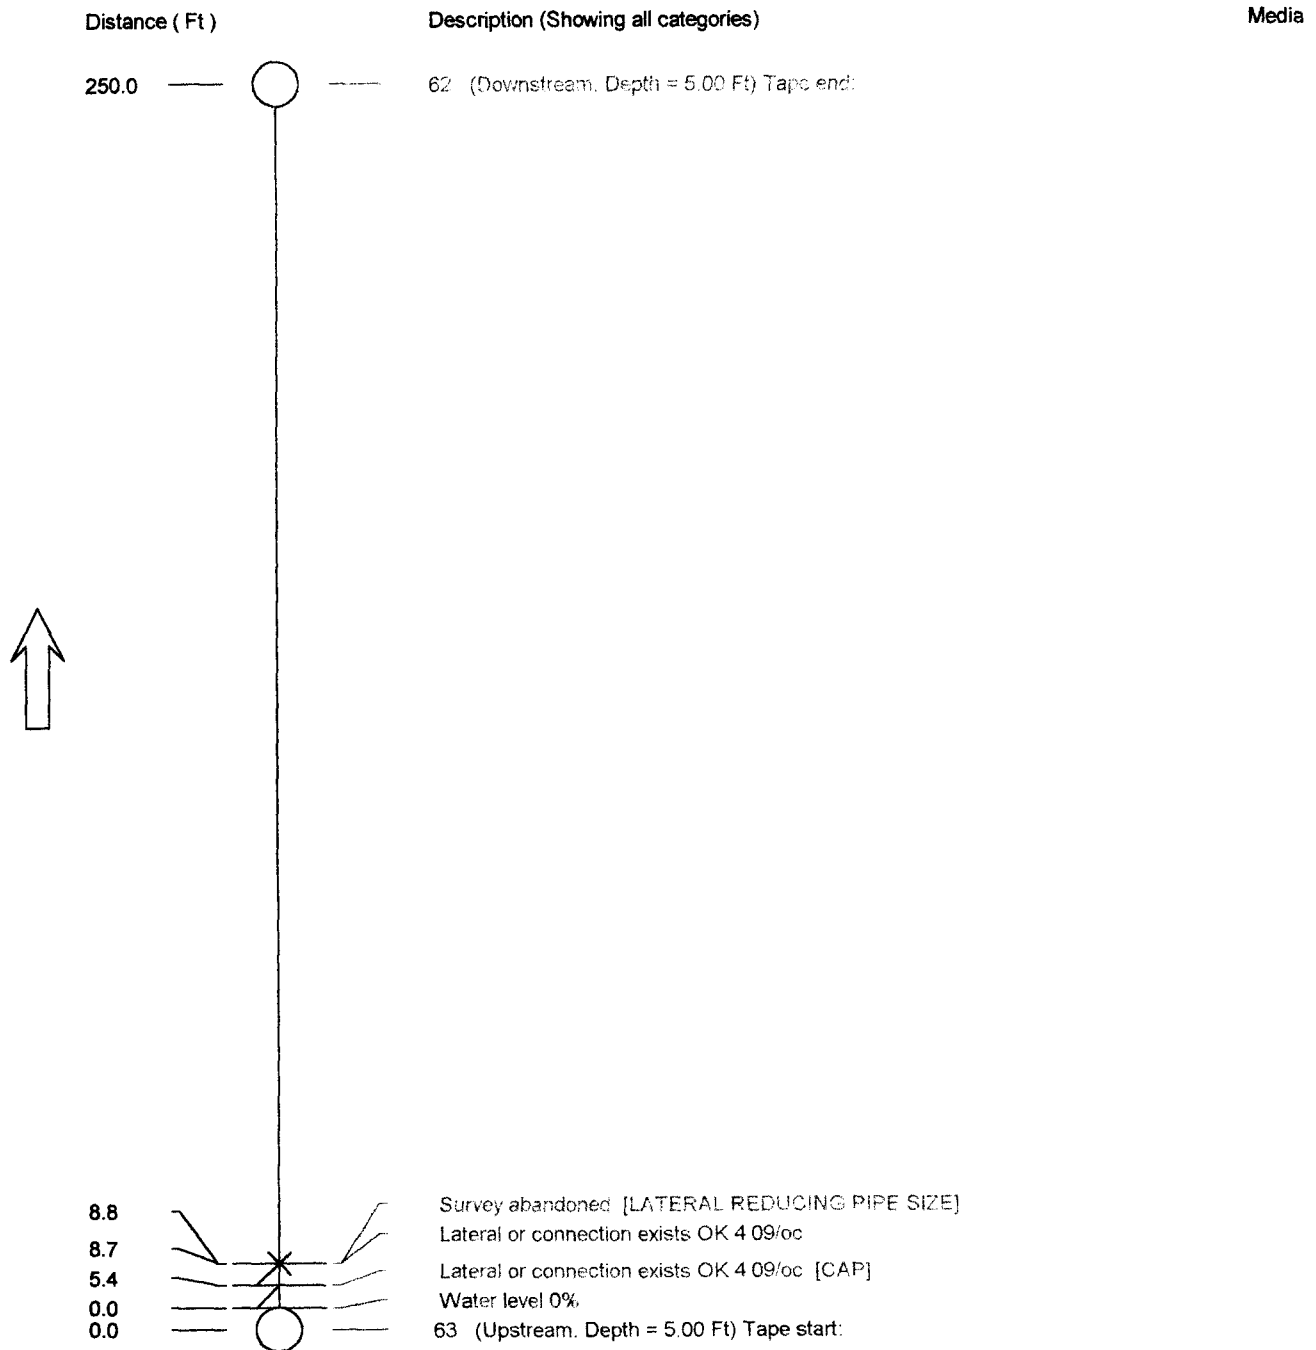
<b>Job</b>	<b>Contract</b>	<b>Cassette 9</b>	<b>Surveyed On</b> 08/16/2004	<b>Sheet</b> 66
<b>Operator</b> BMN	<b>Van Reference</b>	<b>Weather</b> Dry		
<b>Road Name</b> VACATED		<b>Place Name</b> TIERRA VERDE		
<b>Location type</b> Light road (rural roads with lighter traffic, town & city back streets)				
<b>Surface</b>				
<b>Survey purpose</b> Sample survey to determine asset condition				
<b>Pipe Use</b> Foul	<b>Schedule length</b> 250.0 Ft	<b>From</b> 63	<b>Depth</b> 5.00 Ft	
<b>Shape</b> Circular	<b>Size</b> 8 by Ins	<b>To</b> 62	<b>Depth</b> 5.00 Ft	
<b>Material</b> Vitrified clay	<b>Joint spacing</b> Ft	<b>Direction</b> Down		
<b>Lining</b>	<b>Year laid</b> Cat A	<b>Pre-clean</b> Y	<b>Last cleaned</b>	
<b>General note</b> SEE SHEET 65 FOR REVERSE SETUP		<b>Structural</b>	<b>Service</b>	<b>Ground material</b>
<b>Location note</b>

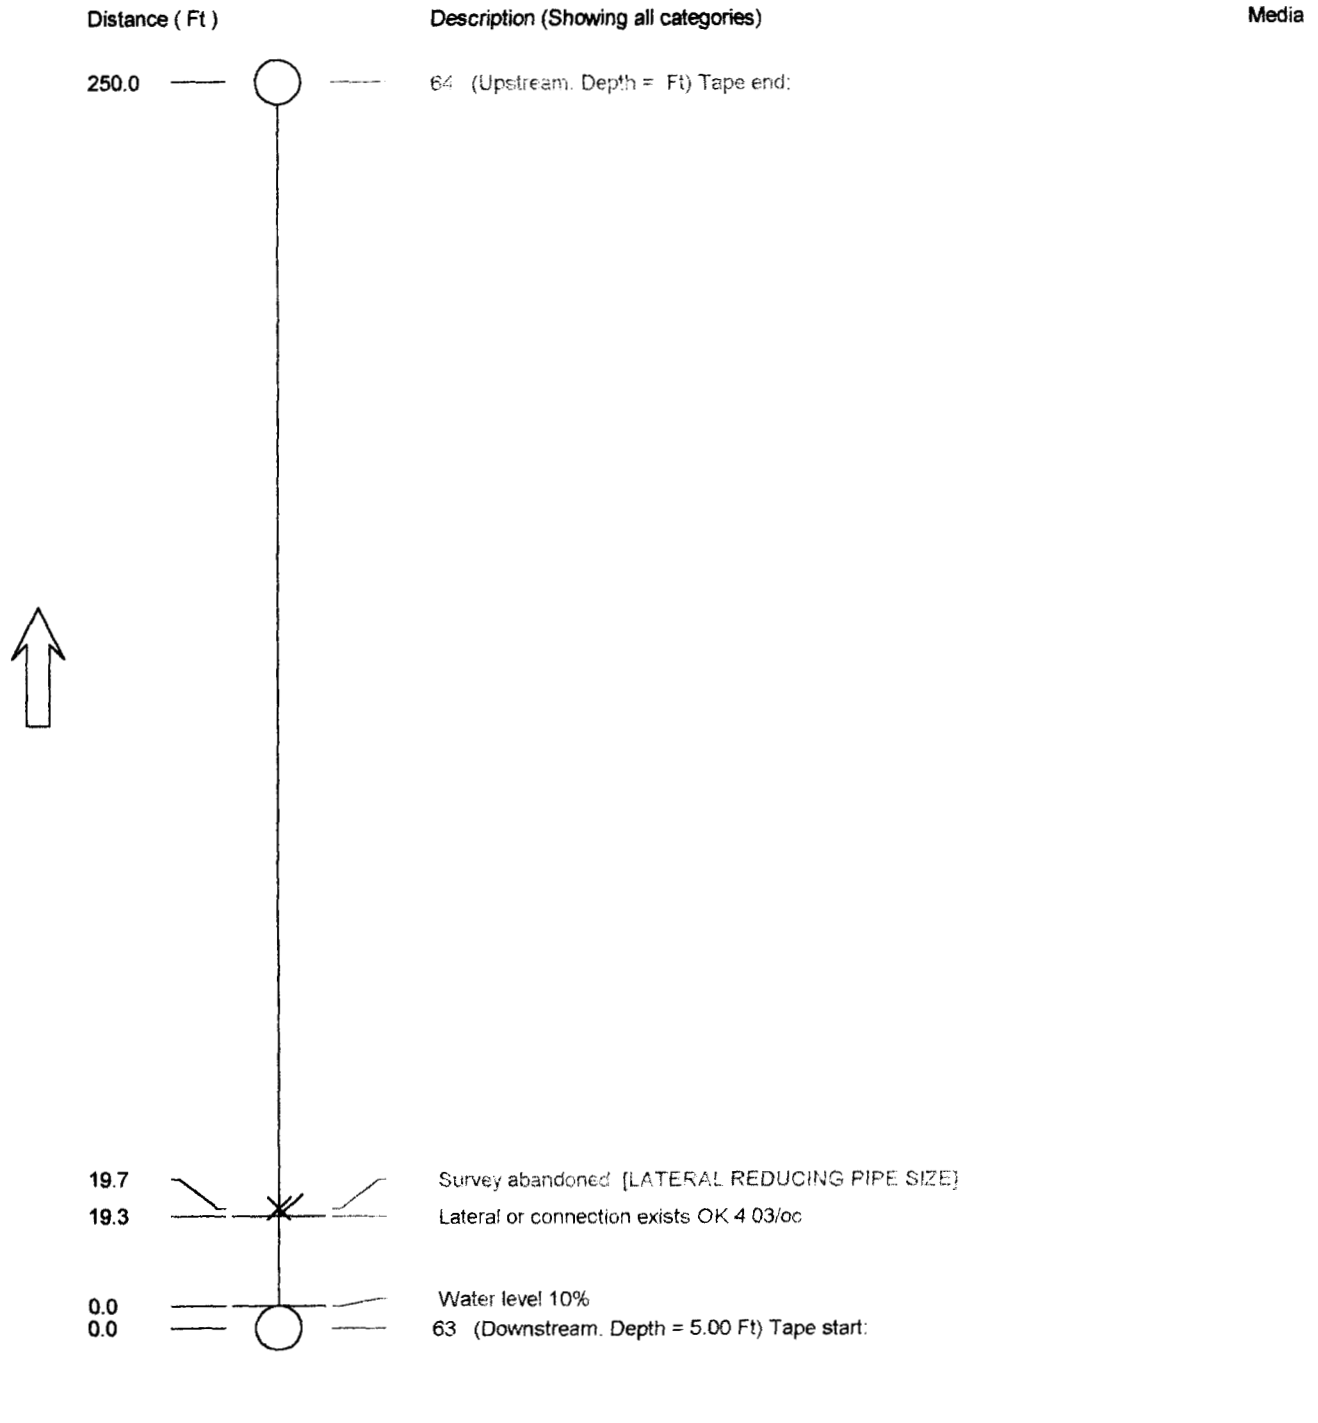
<b>Job</b>	<b>Contract</b>	<b>Cassette 9</b>	<b>Surveyed On</b> 08/16/2004	<b>Sheet</b> 67
<b>Operator</b> BMN	<b>Van Reference</b>	<b>Weather</b> Dry		
<b>Road Name</b> ALLEY		<b>Place Name</b> TIERRA VERDE		
<b>Location type</b> Light road (rural roads with lighter traffic, town & city back streets)				
<b>Surface</b>				
<b>Survey purpose</b> Sample survey to determine asset condition				
<b>Pipe Use</b> Foul	<b>Schedule length</b> 250.0 Ft	<b>From</b> 63	<b>Depth</b> 5.00 Ft	
<b>Shape</b> Circular	<b>Size</b> 8 by ins	<b>To</b> 64	<b>Depth</b> Ft	
<b>Material</b> Vitrified clay	<b>Joint spacing</b> Ft	<b>Direction</b> Up		
<b>Lining</b>	<b>Year laid</b> Cat A	<b>Pre-clean</b> Y	<b>Last cleaned</b>	
<b>General note</b> SEE SHEET 83 FOR REVERSE SETUP		<b>Structural</b>	<b>Service</b>	<b>Construction</b>
<b>Location note</b>

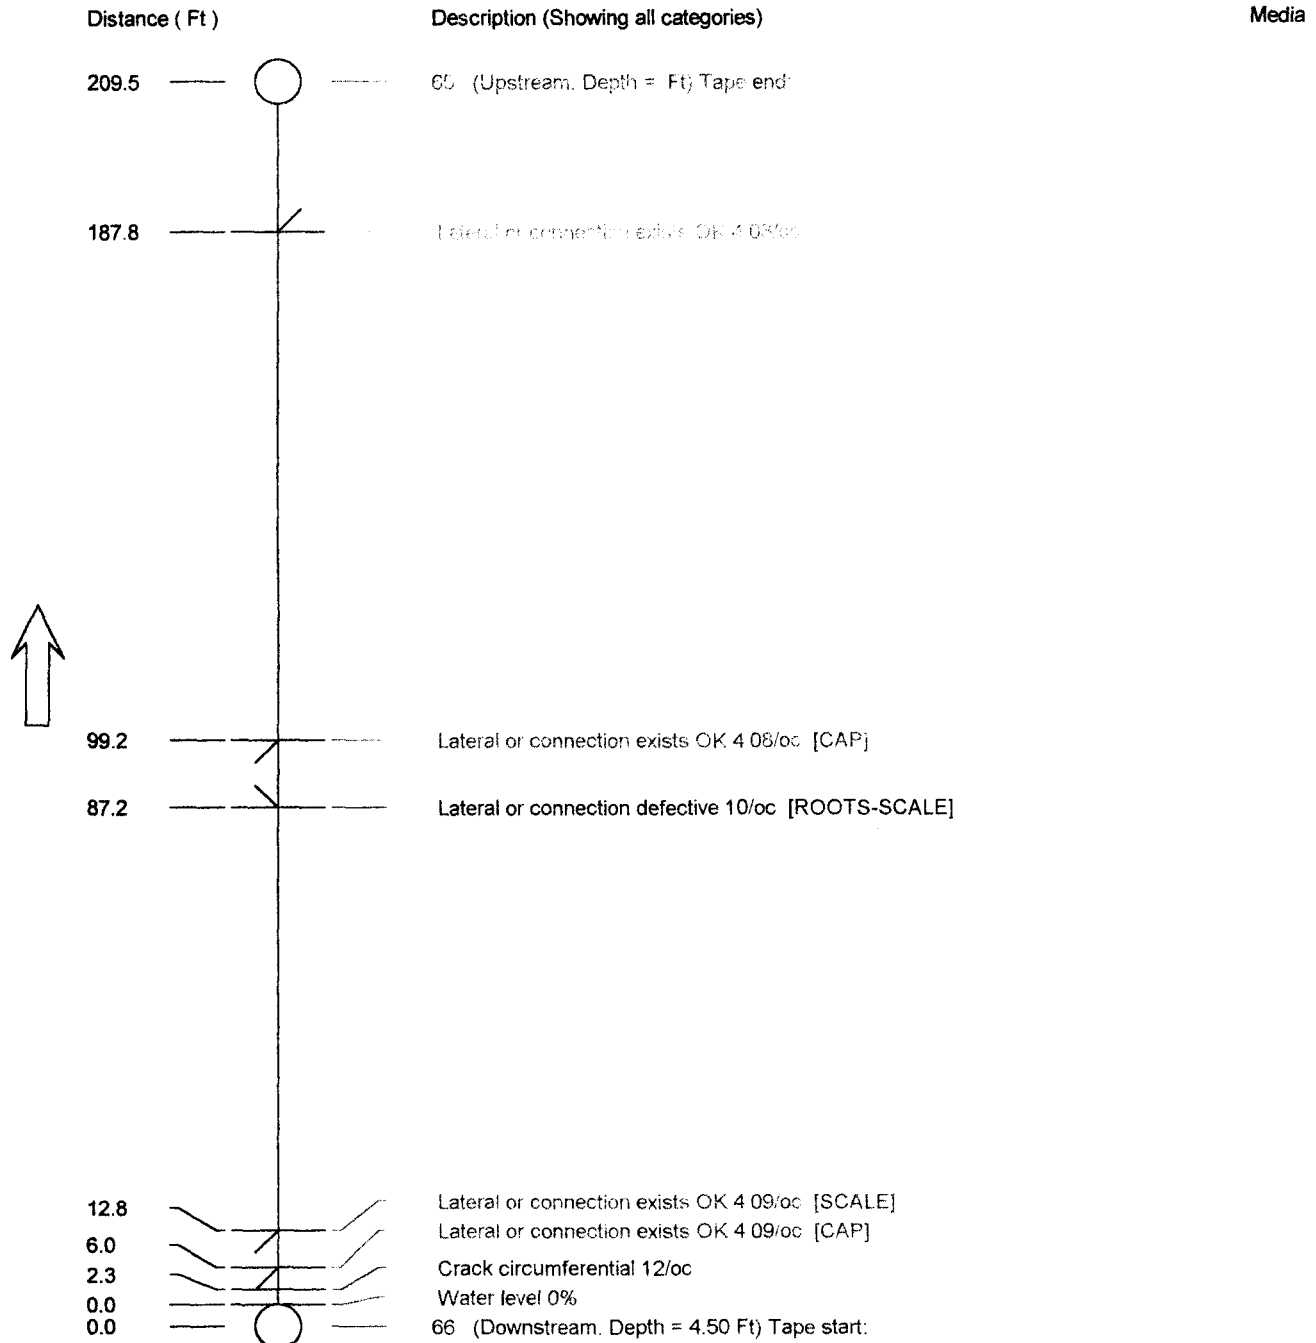
<b>Job</b>	<b>Contract</b>	<b>Cassette</b> 9	<b>Surveyed On</b> 08/16/2004	<b>Sheet</b> 68
<b>Operator</b> BMN	<b>Van Reference</b>	<b>Weather</b> Dry		
<b>Road Name</b> 4TH ST. W.		<b>Place Name</b> TIERRA VERDE		
<b>Location type</b> Light road (rural roads with lighter traffic, town & city back streets)				
<b>Surface</b>				
<b>Survey purpose</b> Sample survey to determine asset condition				
<b>Pipe Use</b> Foul	<b>Schedule length</b> 209.5 Ft	<b>From</b> 66	<b>Depth</b> 4.50 Ft	
<b>Shape</b> Circular	<b>Size</b> 8 by ins	<b>To</b> 65	<b>Depth</b> Ft	
<b>Material</b> Vitrified clay	<b>Joint spacing</b> Ft	<b>Direction</b> Up		
<b>Lining</b>	<b>Year laid</b> Cat A	<b>Pre-clean</b> Y	<b>Last cleaned</b>	
<b>General note</b>		Structural	Service	Construction
<b>Location note</b>		65 (upstream)	66 (downstream)

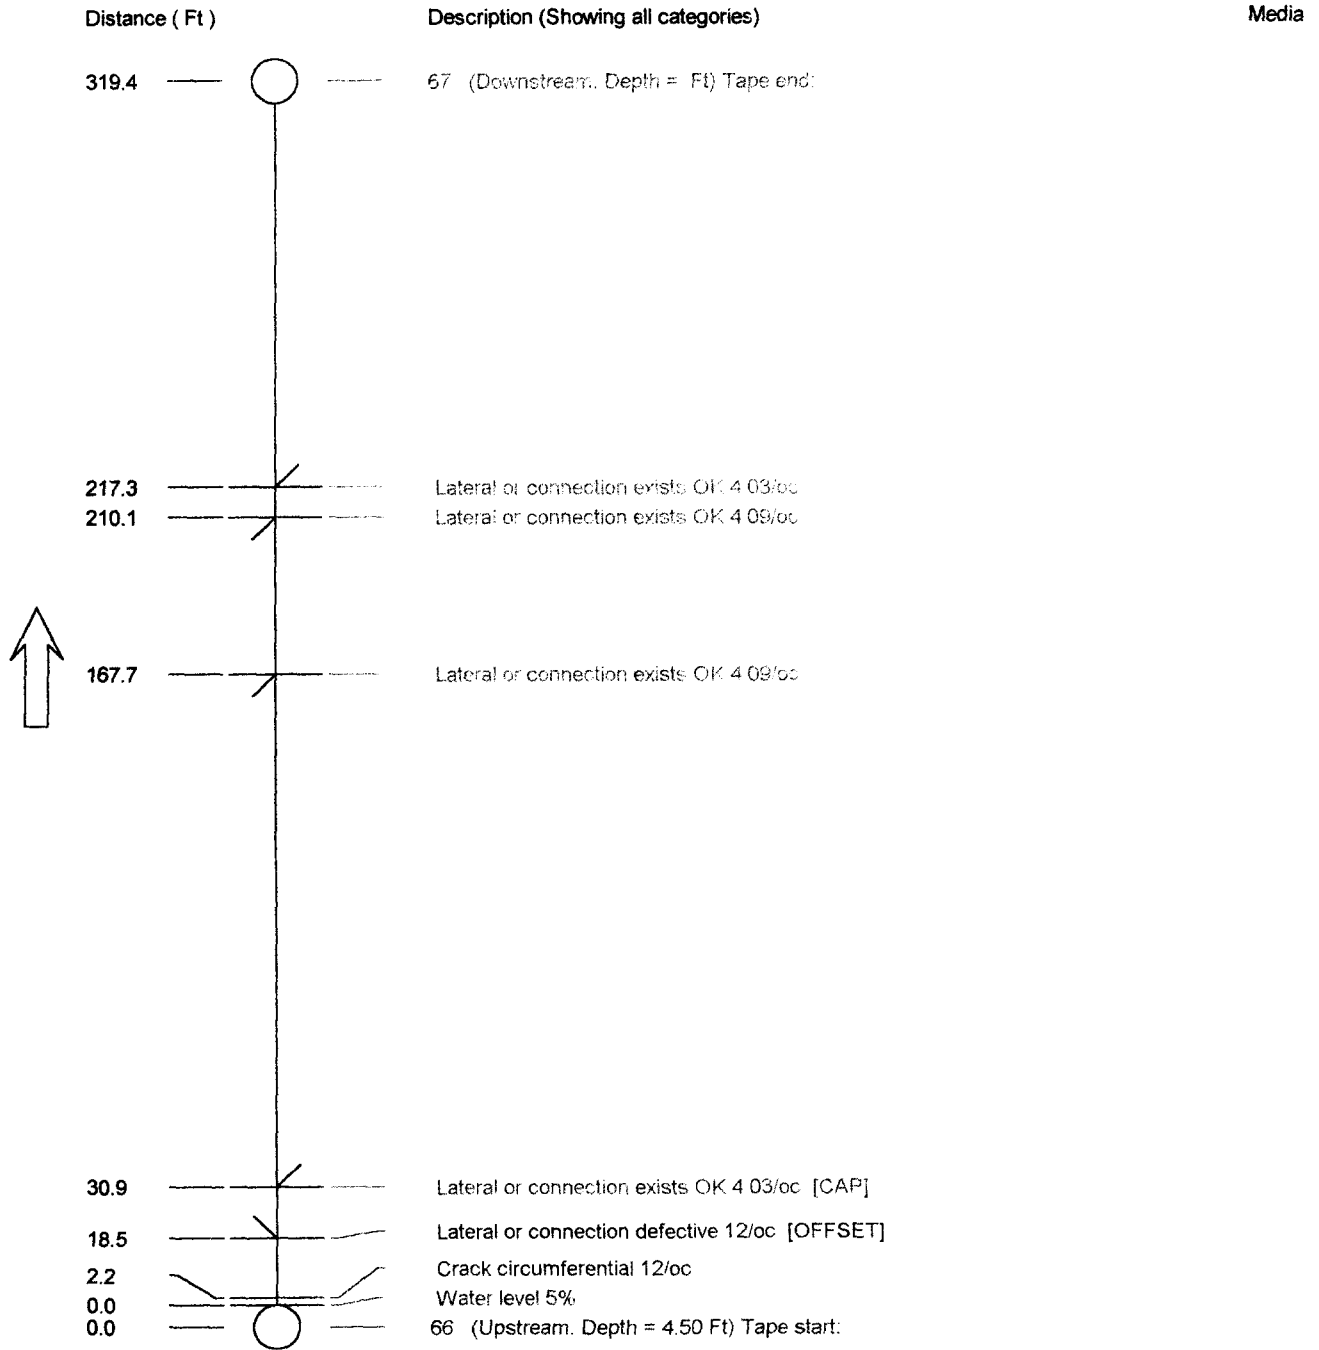
<b>Job</b>	<b>Contract</b>	<b>Cassette</b> 9	<b>Surveyed On</b> 08/16/2004	<b>Sheet</b> 69
<b>Operator</b> BMN	<b>Van Reference</b>	<b>Weather</b> Dry		
<b>Road Name</b> 3RD AVE. N.		<b>Place Name</b> TIERRA VERDE		
<b>Location type</b> Light road (rural roads with lighter traffic, town & city back streets)				
<b>Surface</b>				
<b>Survey purpose</b> Sample survey to determine asset condition				
<b>Pipe Use</b> Foul	<b>Schedule length</b> 319.4 Ft	<b>From</b> 66	<b>Depth</b> 4.50 Ft	
<b>Shape</b> Circular	<b>Size</b> 8 by ins	<b>To</b> 67	<b>Depth</b> Ft	
<b>Material</b> Vitrified clay	<b>Joint spacing</b> Ft	<b>Direction</b> Down		
<b>Lining</b>	<b>Year laid</b>	<b>Cat</b> A	<b>Pre-clean</b> Y	<b>Last cleaned</b>
<b>General note</b> PIPE ACCESS FITTING PULLING OFF		<b>Structural</b>	<b>Surface</b>	<b>Construction</b>
<b>Location note</b>

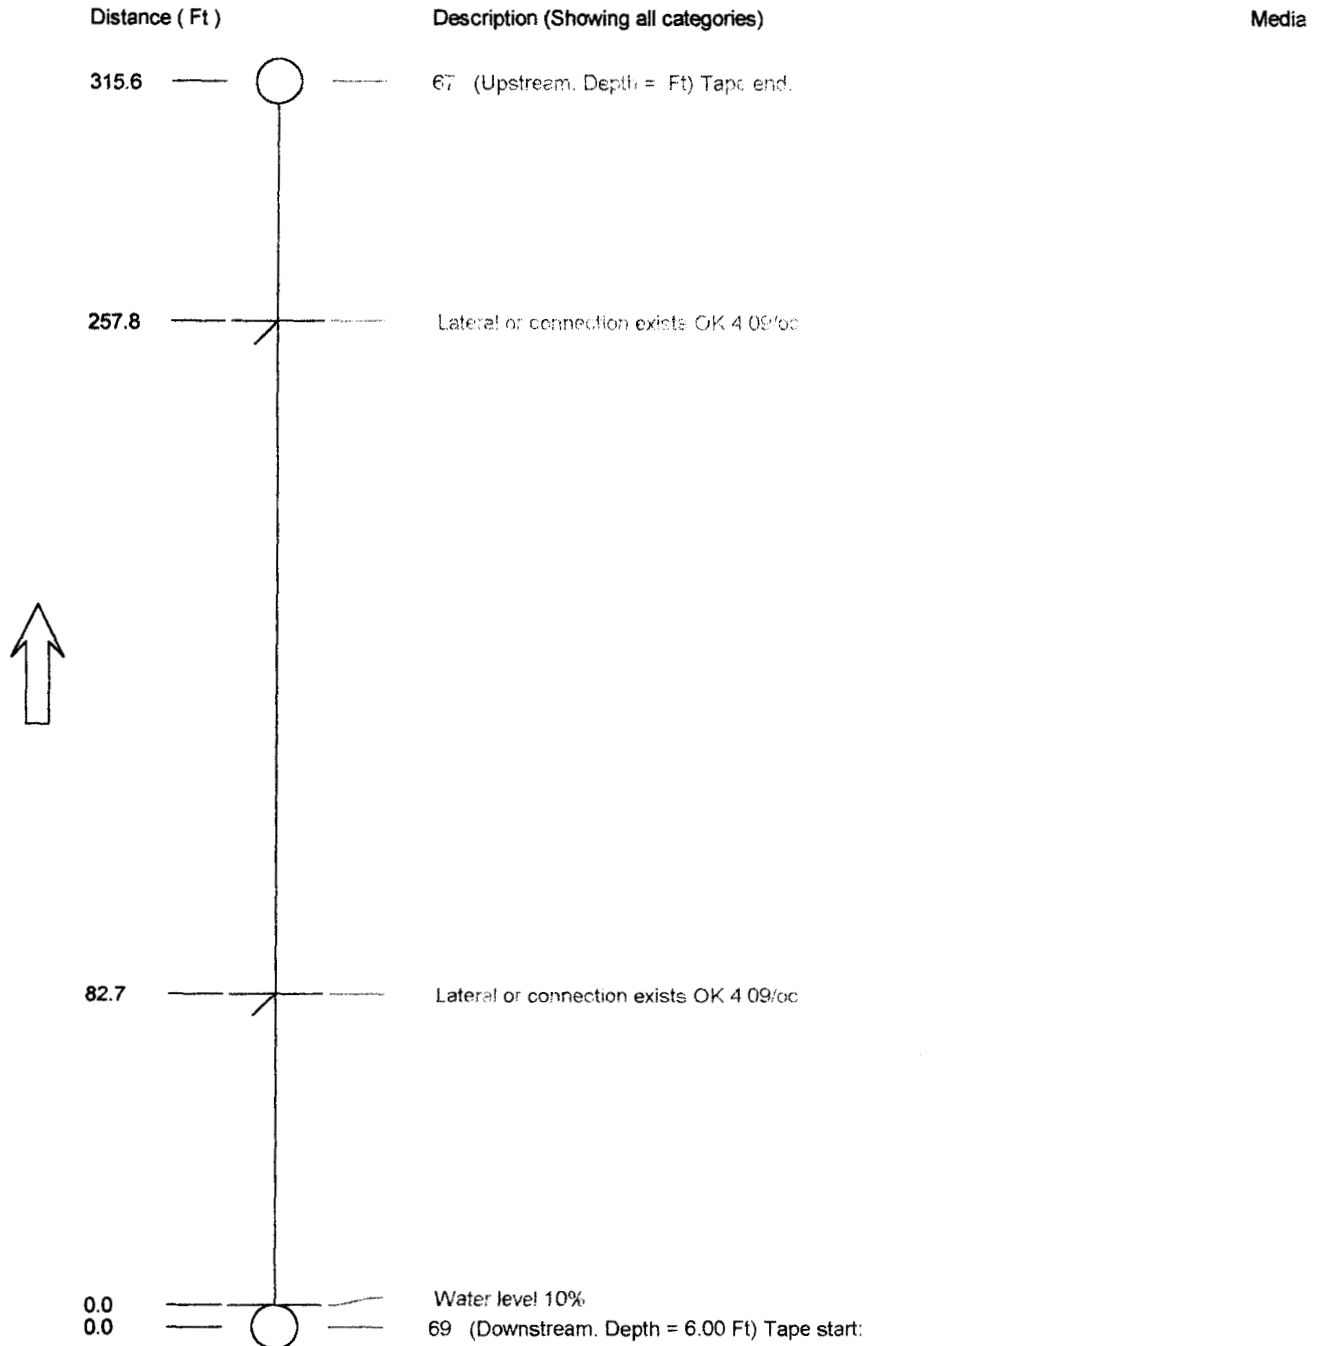
<b>Job</b>	<b>Contract</b>	<b>Cassette</b> 9	<b>Surveyed On</b> 08/16/2004	<b>Sheet</b> 70
<b>Operator</b> BMN	<b>Van Reference</b>	<b>Weather:</b> Dry		
<b>Road Name</b> 3RD AVE. N.		<b>Place Name</b> TIERRA VERDE		
<b>Location type</b> Light road (rural roads with lighter traffic, town & city back streets)				
<b>Surface</b>				
<b>Survey purpose</b> Sample survey to determine asset condition				
<b>Pipe Use</b> Foul	<b>Schedule length</b> 315.6 Ft	<b>From</b> 69	<b>Depth</b> 6.00 Ft	
<b>Shape</b> Circular	<b>Size</b> 8 by ins	<b>To</b> 67	<b>Depth</b> Ft	
<b>Material</b> Vitrified clay	<b>Joint spacing</b> Ft	<b>Direction</b> Up		
<b>Lining</b>	<b>Year laid</b> Cat A	<b>Pre-clean</b> Y	<b>Last cleaned</b>	
<b>General note</b>		Structural	Service	General condition
<b>Location note</b>		Mileage	By

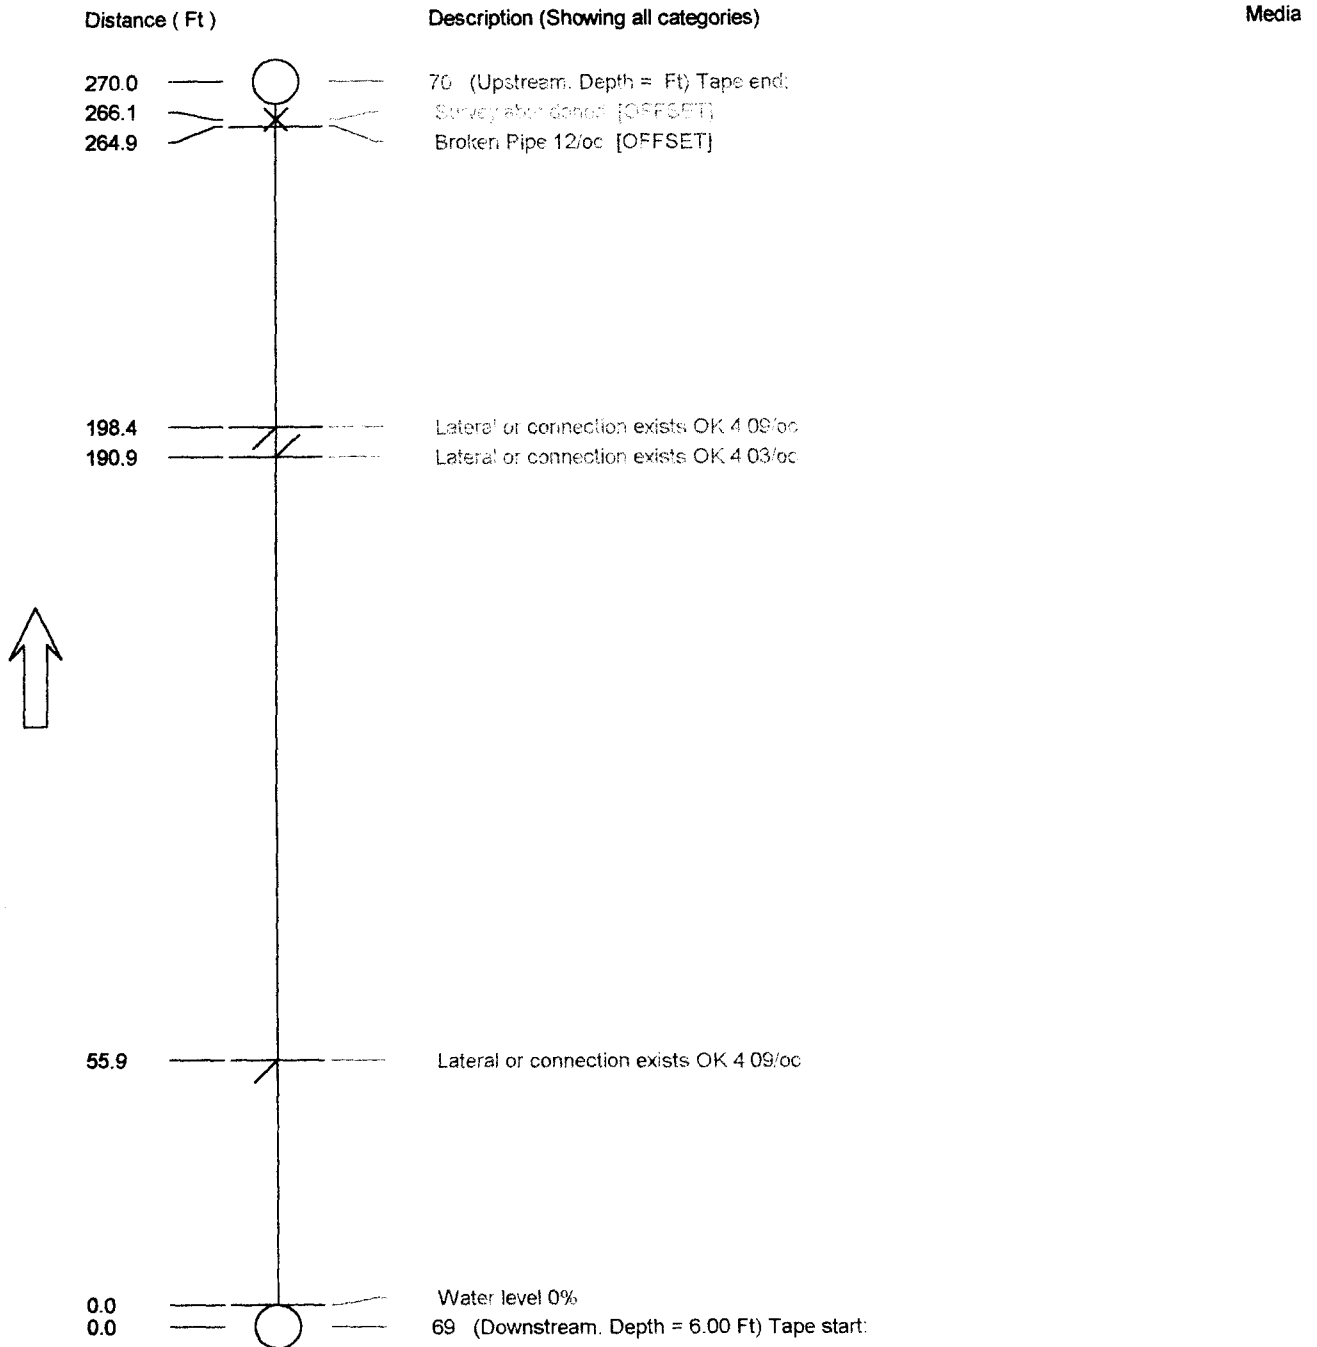
<b>Job</b> Operator BMN	<b>Contract</b> Van Reference	<b>Cassette</b> 9	<b>Surveyed On</b> 08/16/2004	<b>Sheet</b> 71
<b>Road Name</b> 3RD ST. W.		<b>Place Name</b> TIERRA VERDE		
<b>Location type</b> Light road (rural roads with lighter traffic, town & city back streets)				
<b>Surface</b>				
<b>Survey purpose</b> Sample survey to determine asset condition				
<b>Pipe Use</b> Foul	<b>Schedule length</b> 270.0 Ft	<b>From</b> 69	<b>Depth</b> 6.00 Ft	
<b>Shape</b> Circular	<b>Size</b> 8 by ins	<b>To</b> 70	<b>Depth</b> Ft	
<b>Material</b> Vitrified clay	<b>Joint spacing</b> Ft	<b>Direction</b> Up		
<b>Lining</b>	<b>Year laid</b> Cat A	<b>Pre-clean</b> Y	<b>Last cleaned</b>	
<b>General note</b>		Structural	Service	Construction
<b>Location note</b>		Miscellaneous

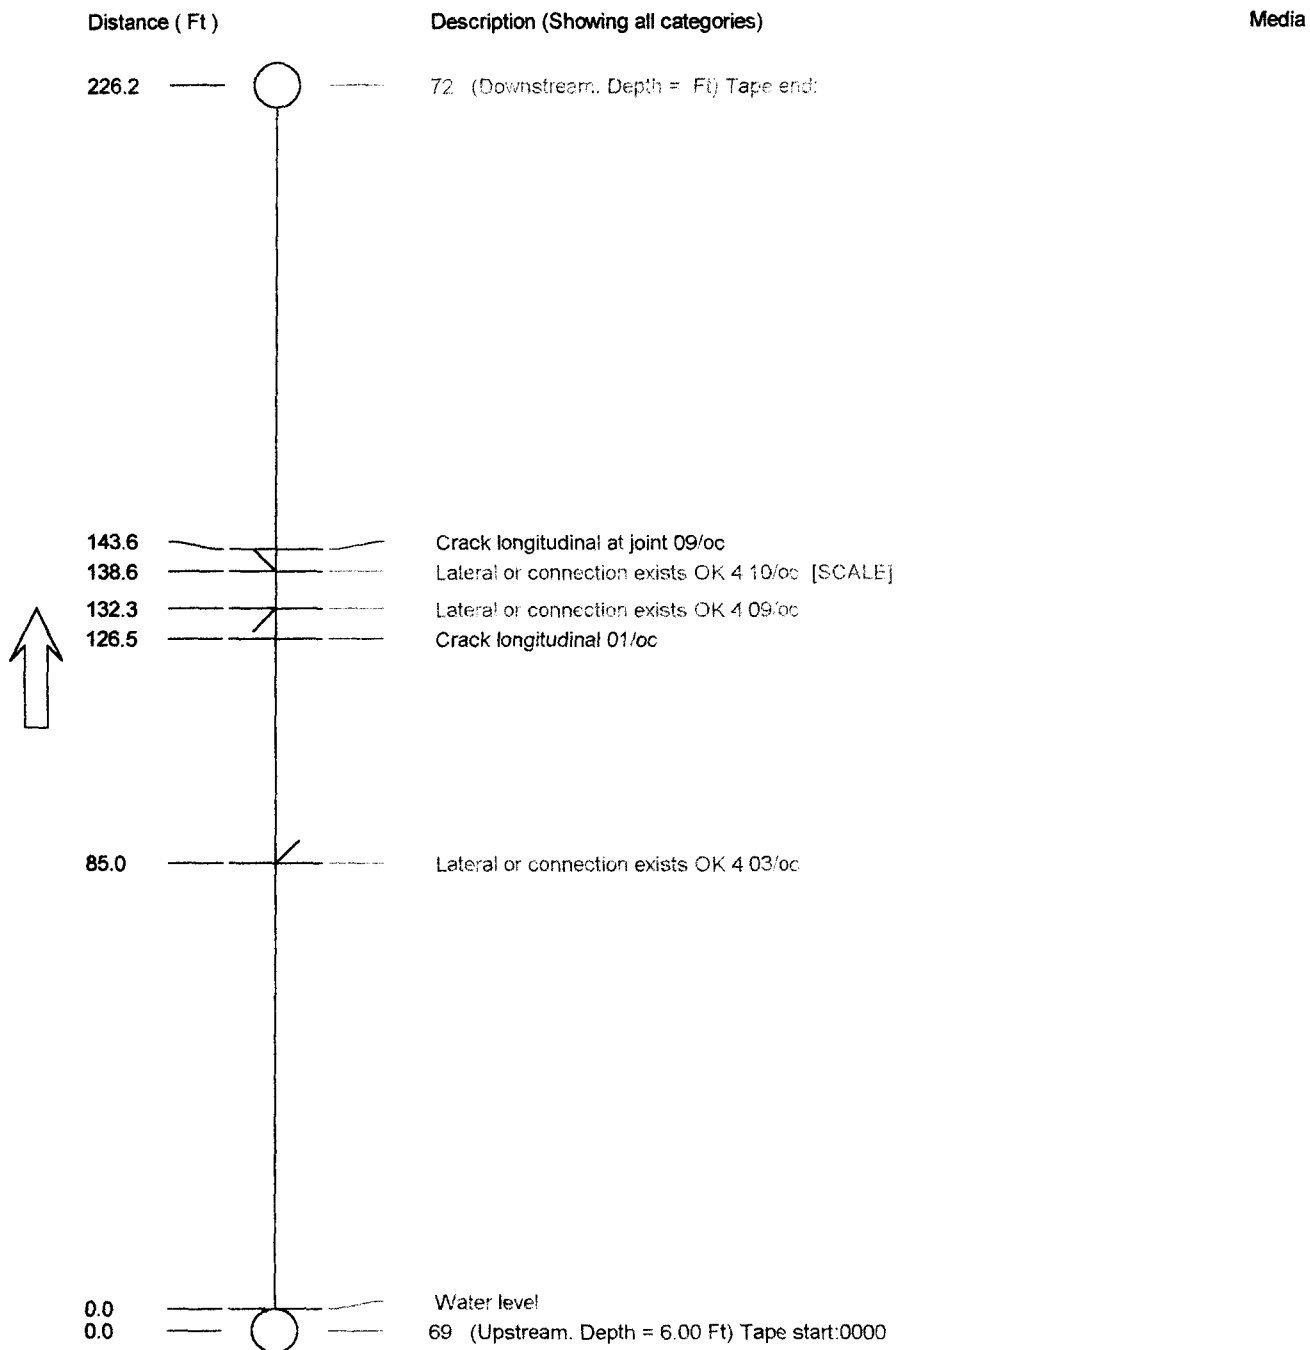
<b>Job</b>	<b>Contract</b>	<b>Cassette 9</b>	<b>Surveyed On</b> 08/16/2004	<b>Sheet</b> 72
<b>Operator</b> BMN	<b>Van Reference</b>	<b>Weather</b> Dry		
<b>Road Name</b> 3RD AVE. N.		<b>Place Name</b> TIERRA VERDE		
<b>Location type</b> Light road (rural roads with lighter traffic, town & city back streets)				
<b>Surface</b>				
<b>Survey purpose</b> Sample survey to determine asset condition				
<b>Pipe Use</b> Foul	<b>Schedule length</b> 226.2 Ft	<b>From</b> 69	<b>Depth</b> 6.00 Ft	
<b>Shape</b> Circular	<b>Size</b> 8 by ins	<b>To</b> 72	<b>Depth</b> Ft	
<b>Material</b> Vitrified clay	<b>Joint spacing</b> Ft	<b>Direction</b> Down		
<b>Lining</b>	<b>Year laid</b>	<b>Cat</b> A	<b>Pre-clean</b> Y	<b>Last cleaned</b>
<b>General note</b>		Structural	Service	Construction
<b>Location note</b>		Material	Joint

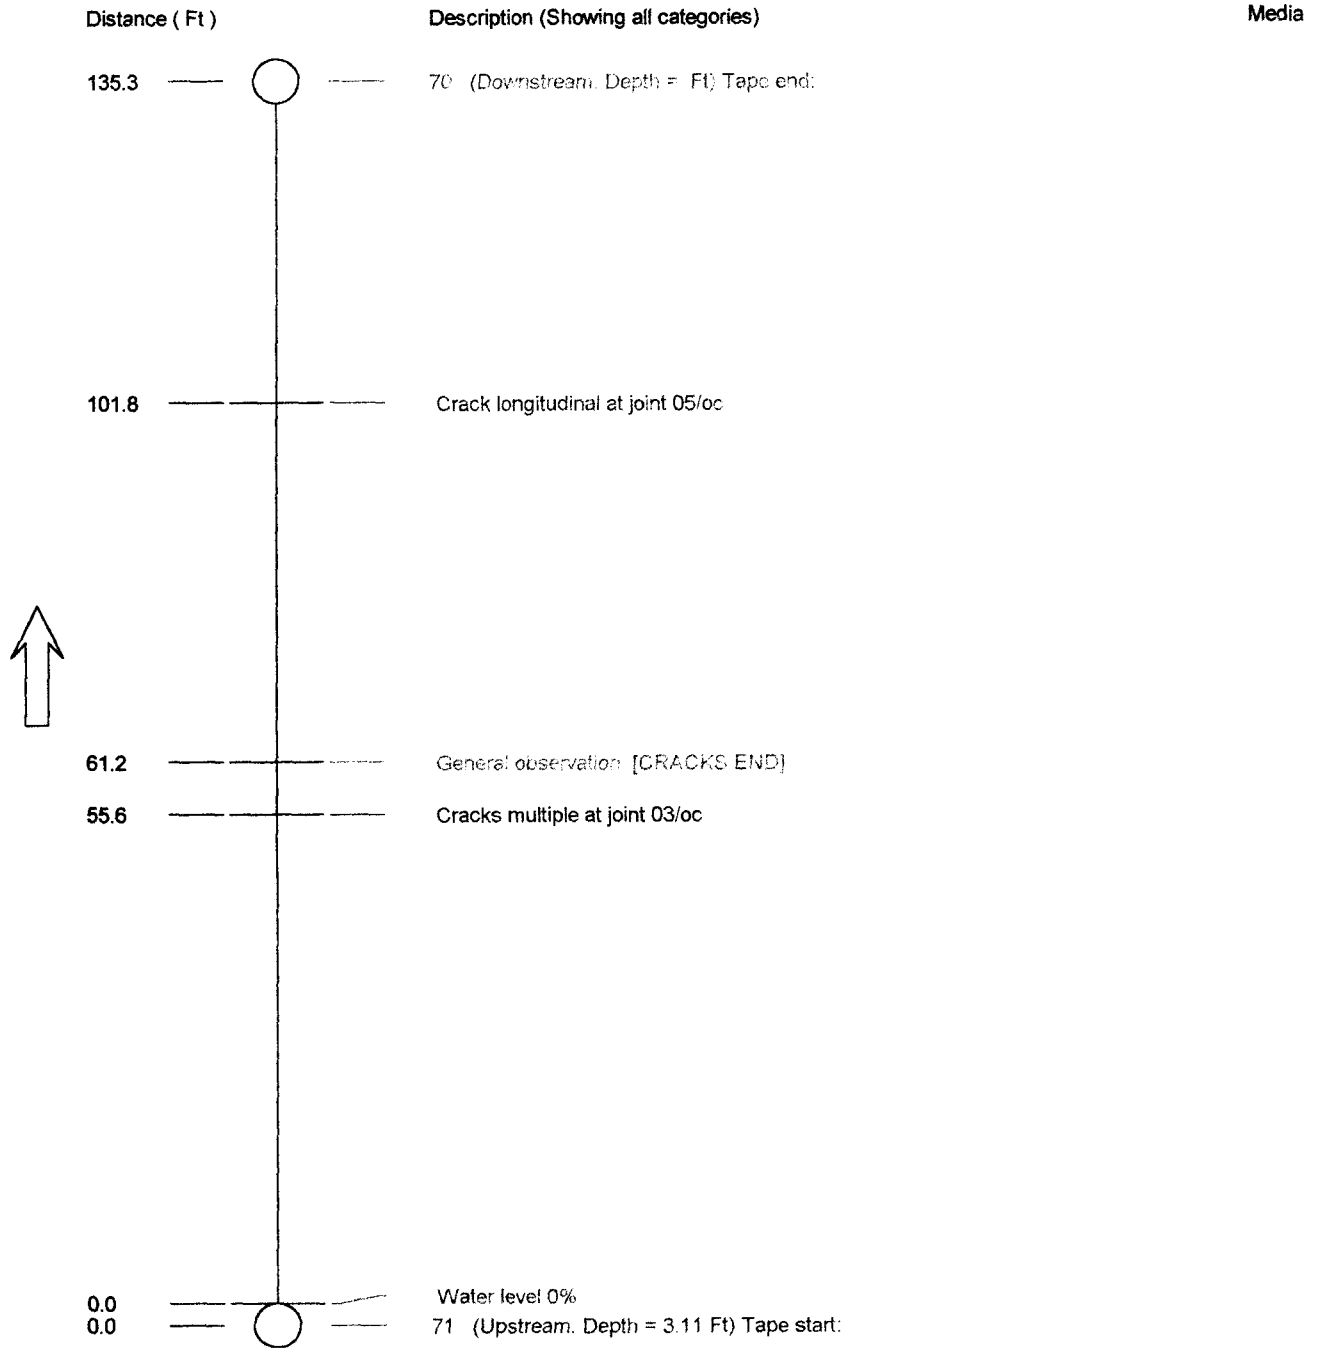
<b>Job</b>	<b>Contract</b>	<b>Cassette</b> 10	<b>Surveyed On</b> 08/16/2004	<b>Sheet</b> 73
<b>Operator</b> BMN	<b>Van Reference</b>	<b>Weather</b> Dry		
<b>Road Name</b> 2ND AVE. N.		<b>Place Name</b> TIERRA VERDE		
<b>Location type</b> Light road (rural roads with lighter traffic, town & city back streets)				
<b>Surface</b>				
<b>Survey purpose</b> Sample survey to determine asset condition				
<b>Pipe Use</b> Foul	<b>Schedule length</b> 135.3 Ft	<b>From</b> 71	<b>Depth</b> 3.11 Ft	
<b>Shape</b> Circular	<b>Size</b> 8 by ins	<b>To</b> 70	<b>Depth</b> Ft	
<b>Material</b> Vitrified clay	<b>Joint spacing</b> Ft	<b>Direction:</b> Down		
<b>Lining</b>	<b>Year laid</b>	<b>Cat</b> A	<b>Pre-clean</b> Y	<b>Last cleaned</b>
<b>General note</b>		Structural	Service	Cracks
<b>Location note</b>		Material	Condition	Location

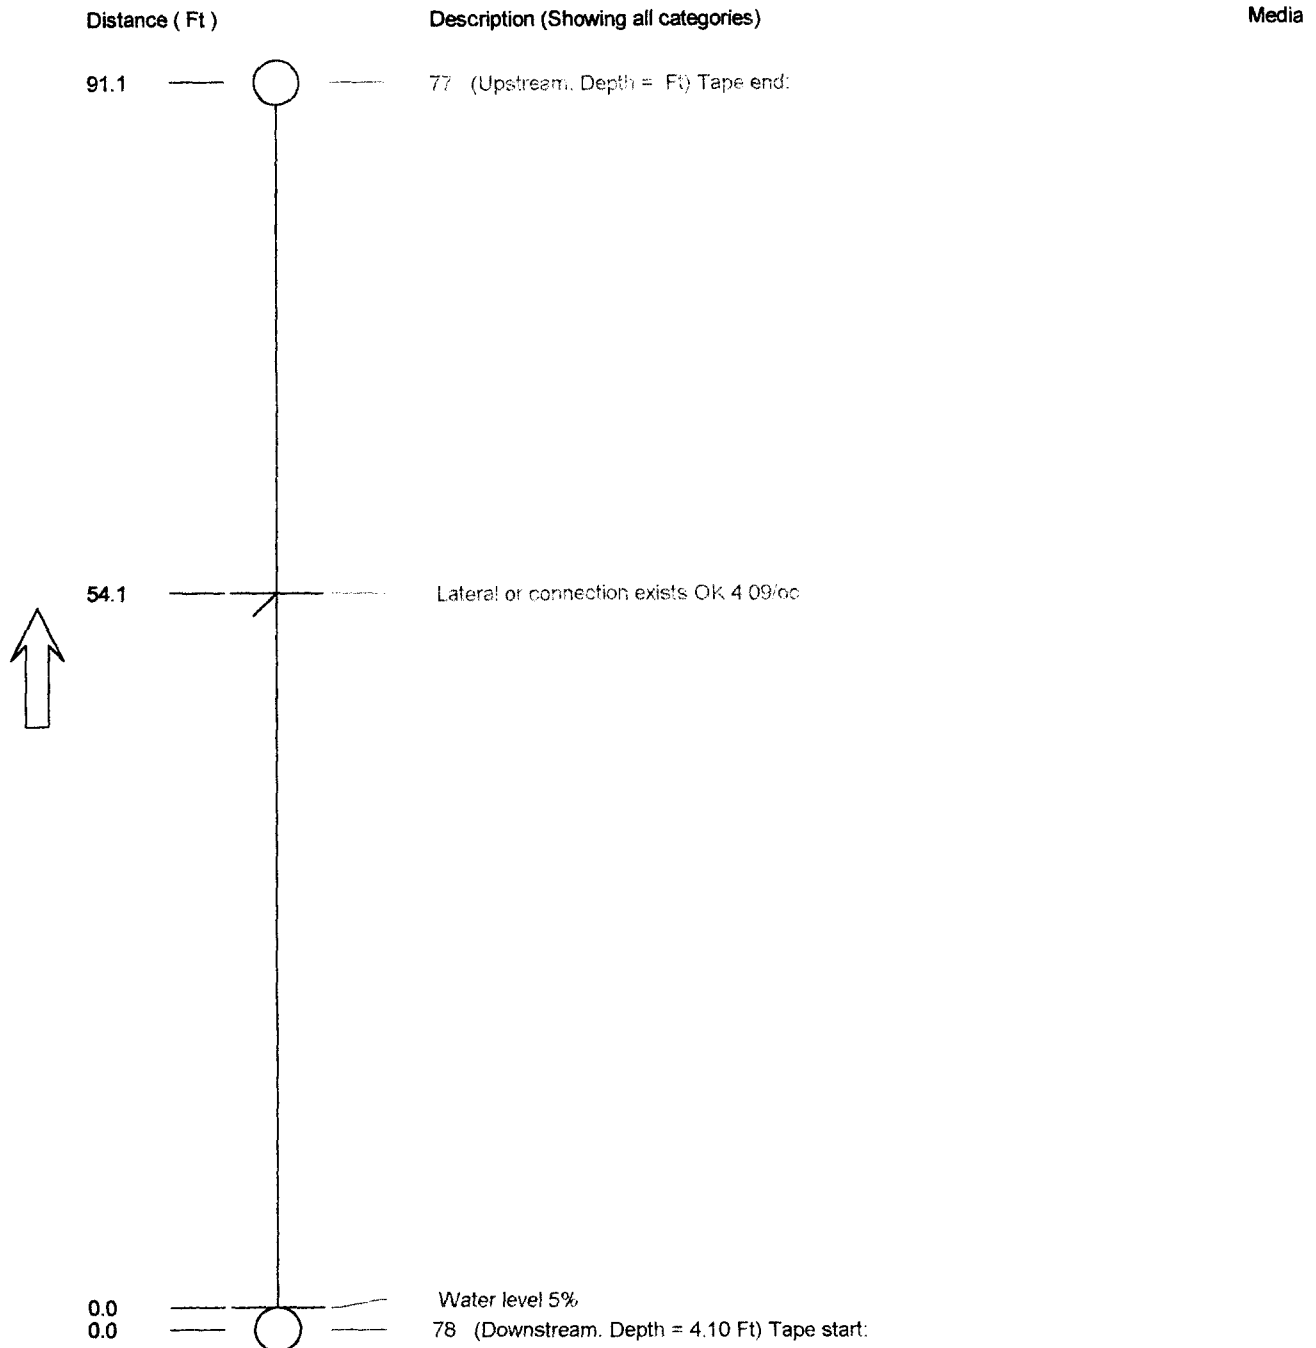
<b>Job</b>	<b>Contract</b>	<b>Cassette</b> 10	<b>Surveyed On</b> 08/17/2004	<b>Sheet</b> 74
<b>Operator</b> BMN	<b>Van Reference</b>	<b>Weather</b> Dry		
<b>Road Name</b> 3RD AVE. N.		<b>Place Name</b> TIERRA VERDE		
<b>Location type</b> Light road (rural roads with lighter traffic, town & city back streets)				
<b>Surface</b>				
<b>Survey purpose</b> Sample survey to determine asset condition				
<b>Pipe Use</b> Foul	<b>Schedule length</b> 91.1 Ft	<b>From</b> 78	<b>Depth</b> 4.10 Ft	
<b>Shape</b> Circular	<b>Size</b> 8 by ins	<b>To</b> 77	<b>Depth</b> Ft	
<b>Material</b> Vitrified clay	<b>Joint spacing</b> Ft	<b>Direction</b> Up		
<b>Lining</b>	<b>Year laid</b> Cat A	<b>Pre-clean</b> Y	<b>Last cleaned</b>	
<b>General note</b>		Structural	Service	Condition
<b>Location note</b>		Maintenance	Access	Notes

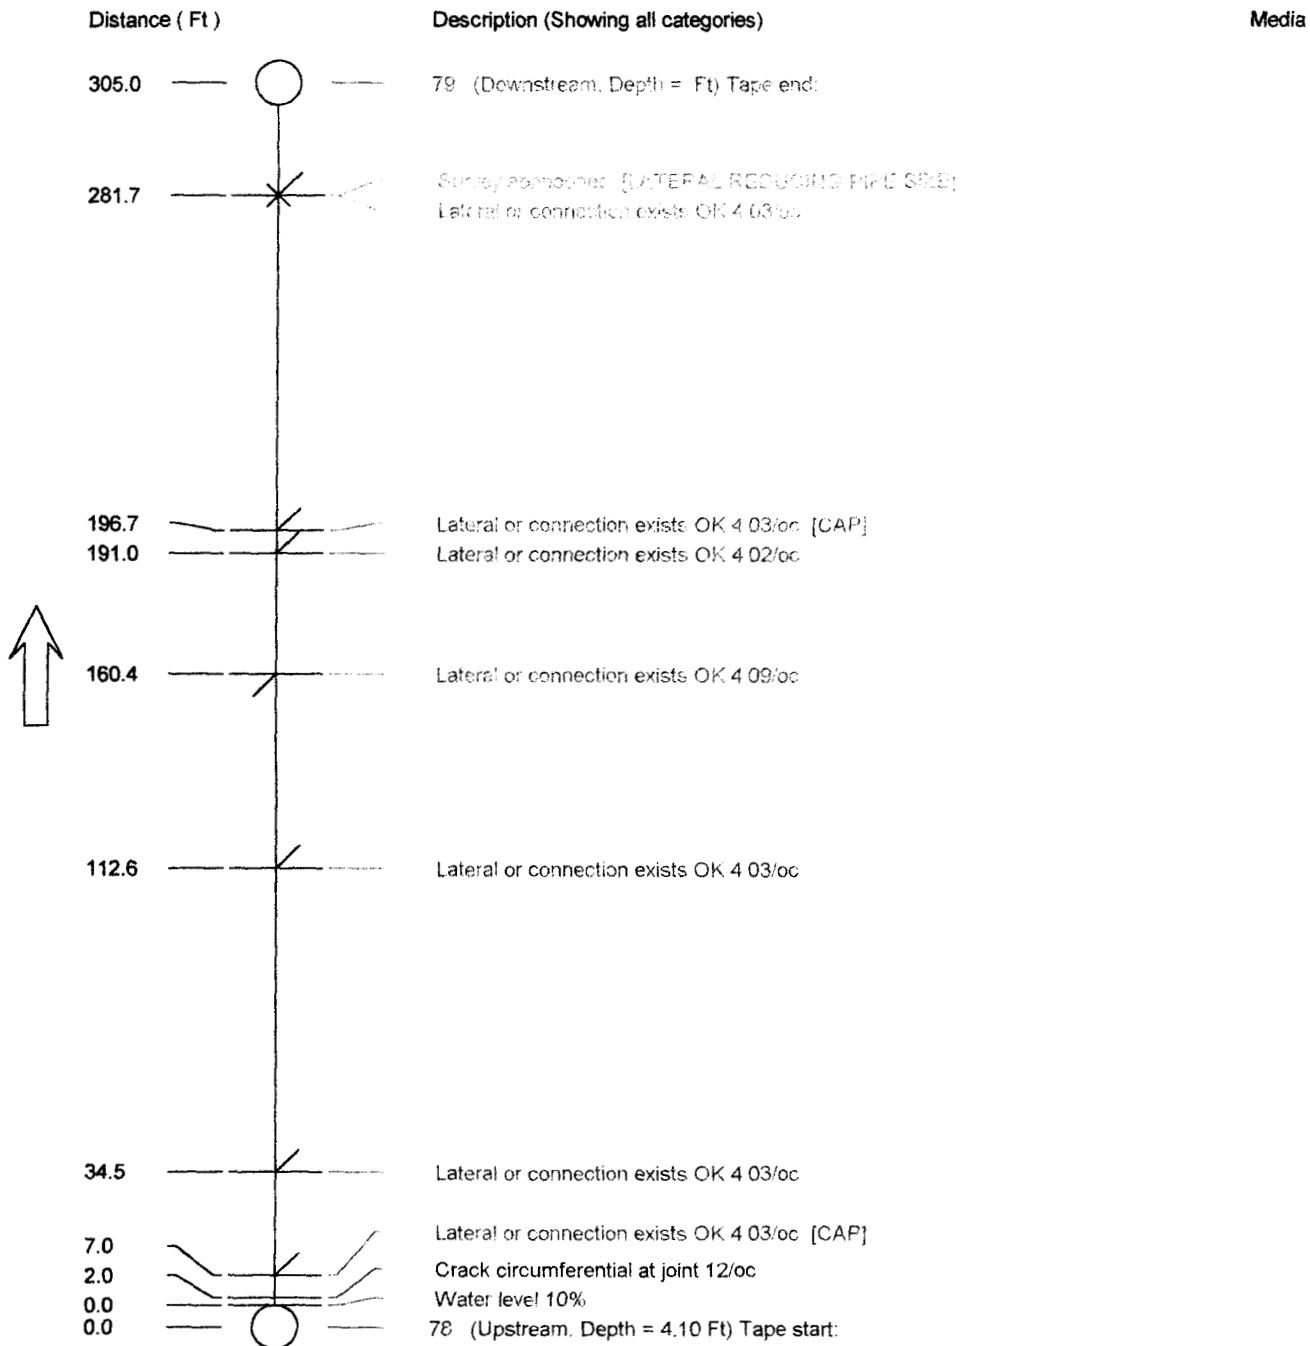
<b>Job</b>	<b>Contract</b>	<b>Cassette</b> 10	<b>Surveyed On</b> 08/17/2004	<b>Sheet</b> 75
<b>Operator</b> BMN	<b>Van Reference</b>	<b>Weather</b> Dry		
<b>Road Name</b> 3RD AVE. N.		<b>Place Name</b> TIERRA VERDE		
<b>Location type</b> Light road (rural roads with lighter traffic, town & city back streets)				
<b>Surface</b>				
<b>Survey purpose</b> Sample survey to determine asset condition				
<b>Pipe Use</b> Foul	<b>Schedule length</b> 305.0 Ft	<b>From</b> 78	<b>Depth</b> 4.10 Ft	
<b>Shape</b> Circular	<b>Size</b> 8 by ins	<b>To</b> 79	<b>Depth</b> Ft	
<b>Material</b> Vitrified clay	<b>Joint spacing</b> Ft	<b>Direction</b> Down		
<b>Lining</b>	<b>Year laid</b> Cat A	<b>Pre-clean</b> Y	<b>Last cleaned</b>	
<b>General note</b> SEE SHEET 77 FOR REVERSE SETUP			<b>Structural</b>	<b>Service</b>
<b>Location note</b>			<b>Construction</b>
