RE: Docket No. 080248-SU; Tierra Verde Utilities, Inc.'s Application for an Increase in Wastewater Rates Increase in Pinellas County, Florida  
Our File No.: 30057.156

3(a) The "TV Sewer Mains" project reflects the effort to clean and video inspect two portions of the Tierra Verde collection system. The gravity main and manholes situated in the Pinellas Bayway right-of-way and the area west of the Pinellas Bayway along and adjacent to Madonna Avenue had not been cleaned and inspected for many years. A total of 6,229 LF of 18" diameter pipe was cleaned and inspected along the Pinellas Bayway. A total of 21,250 LF of 8" diameter pipe and manholes were inspected west of the Pinellas Bayway along Madonna Avenue. The project is justified for the following reasons:

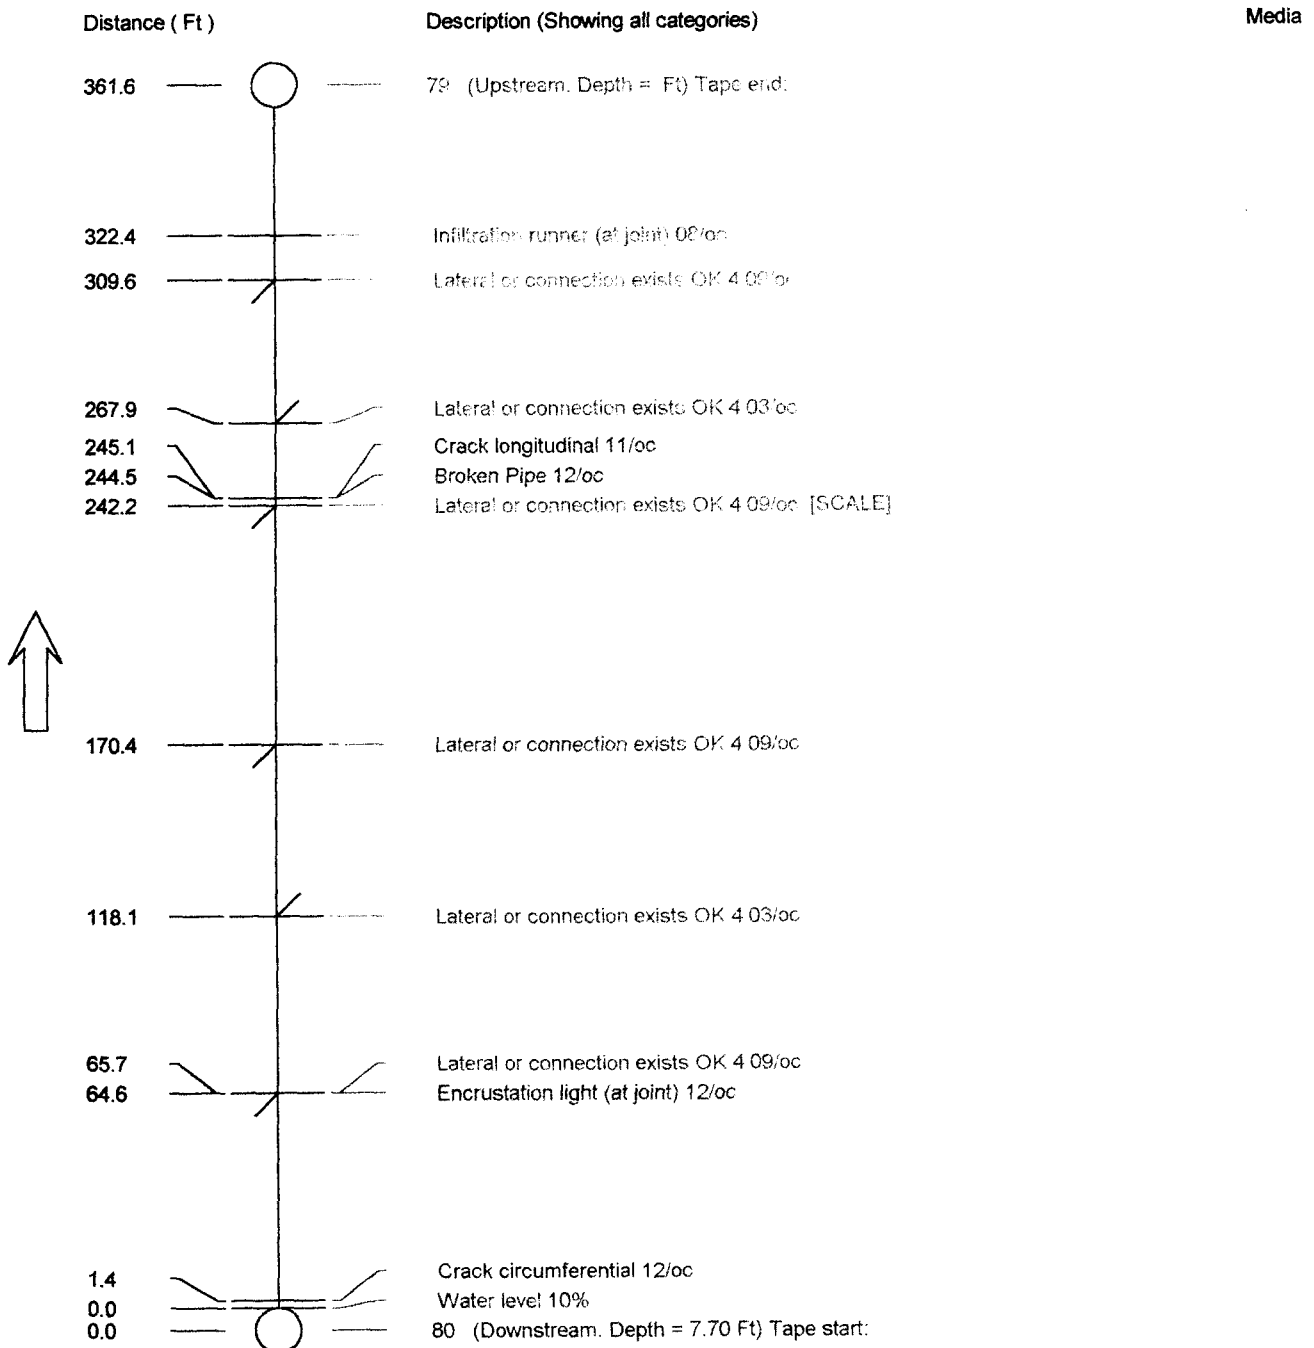
<b>Job</b>	<b>Contract</b>	<b>Cassette</b> 10	<b>Surveyed On</b> 08/17/2004	<b>Sheet</b> 76
<b>Operator</b> BMN	<b>Van Reference</b>	<b>Weather</b> Dry		
<b>Road Name</b> 3RD AVE. N.		<b>Place Name</b> TIERRA VERDE		
<b>Location type</b> Light road (rural roads with lighter traffic, town & city back streets)				
<b>Surface</b>				
<b>Survey purpose</b> Sample survey to determine asset condition				
<b>Pipe Use</b> Foul	<b>Schedule length</b> 361.6 Ft	<b>From</b> 80	<b>Depth</b> 7.70 Ft	
<b>Shape</b> Circular	<b>Size</b> 8 by ins	<b>To</b> 79	<b>Depth</b> Ft	
<b>Material</b> Vitrified clay	<b>Joint spacing</b> Ft	<b>Direction</b> Up		
<b>Lining</b>	<b>Year laid</b> Cat A	<b>Pre-clean</b> Y	<b>Last cleaned</b>	
<b>General note</b>		Structural	Service	Construction
<b>Location note</b>		Maintenance	Other

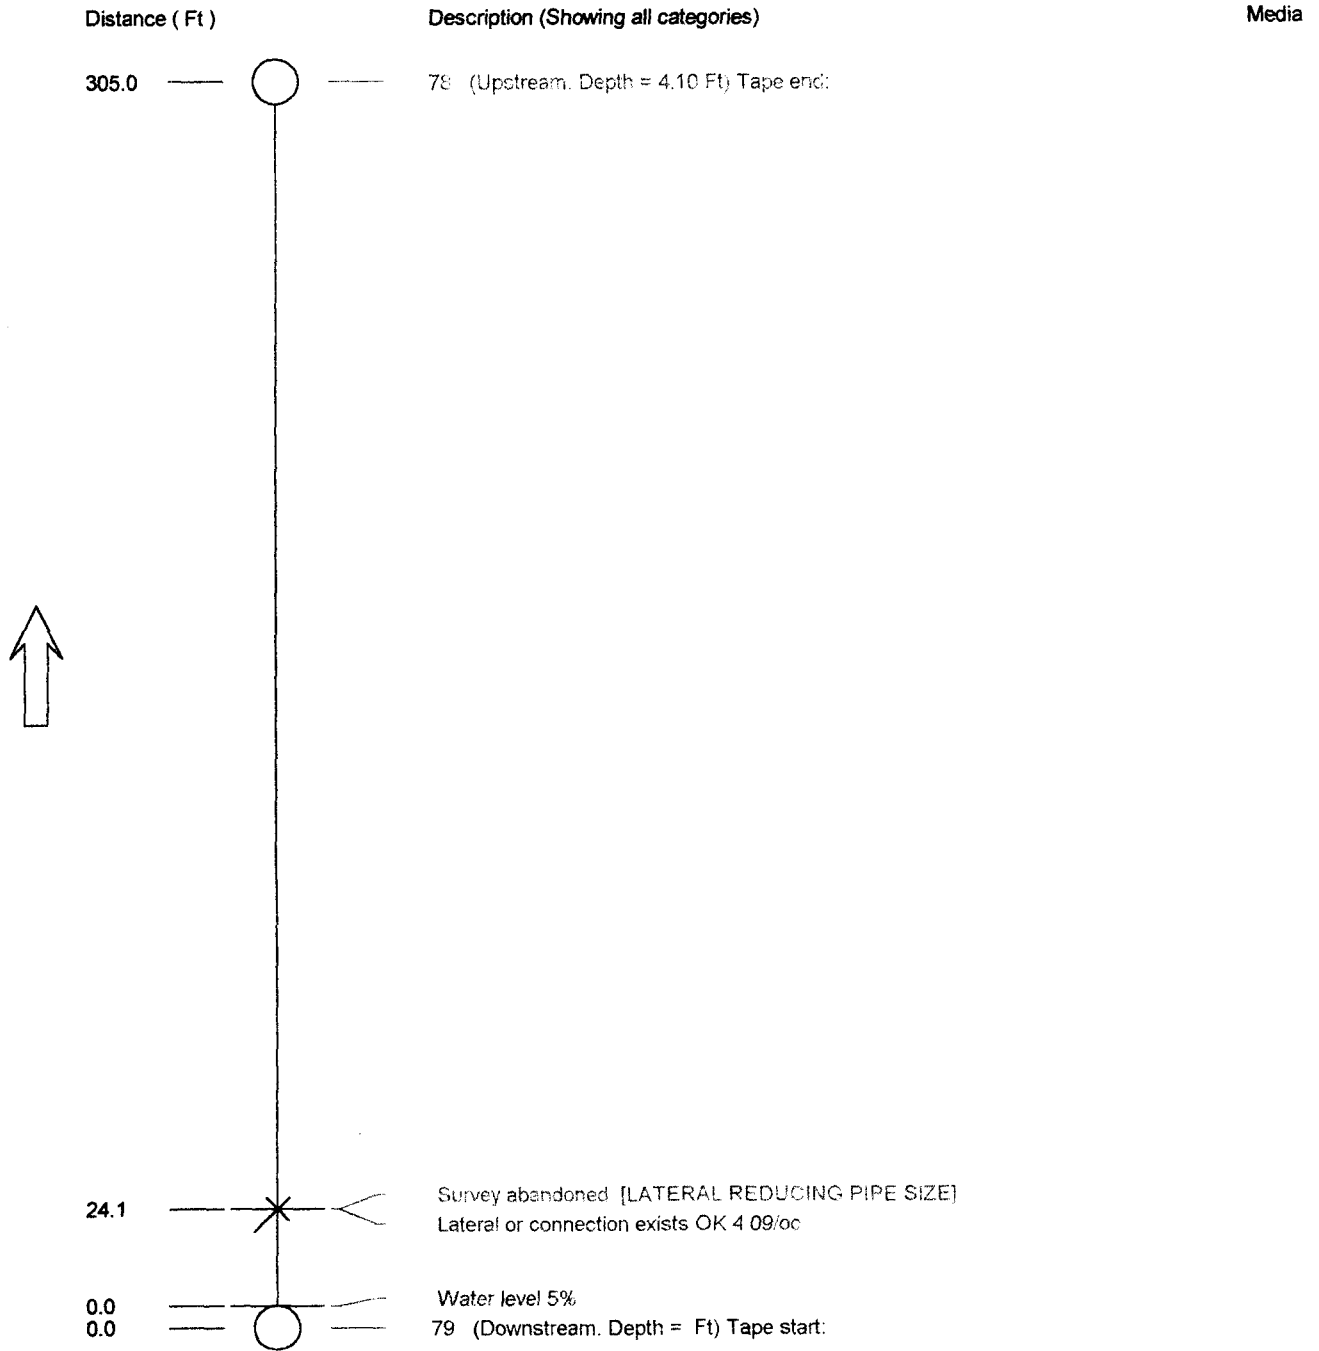
<b>Job</b>	<b>Contract</b>	<b>Cassette</b> 10	<b>Surveyed On</b> 08/17/2004	<b>Sheet</b> 77
<b>Operator</b> BMN	<b>Van Reference</b>	<b>Weather</b> Dry		
<b>Road Name</b> 3RD AVE. N.		<b>Place Name</b> TIERRA VERDE		
<b>Location type</b> Light road (rural roads with lighter traffic, town & city back streets)				
<b>Surface</b>				
<b>Survey purpose</b> Sample survey to determine asset condition				
<b>Pipe Use</b> Foul	<b>Schedule length</b> 305.0 Ft	<b>From</b> 79	<b>Depth</b>	<b>Ft</b>
<b>Shape</b> Circular	<b>Size</b> 8 by ins	<b>To</b> 78	<b>Depth</b>	4.10 Ft
<b>Material</b> Vitrified clay	<b>Joint spacing</b> Ft	<b>Direction</b> Up		
<b>Lining</b>	<b>Year laid</b> Cat A	<b>Pre-clean</b> Y	<b>Last cleaned</b>	
<b>General note</b> see sheet 75 for reverse setup		Structural	Service	Good/functional
<b>Location note</b>		Minor/leaking	None

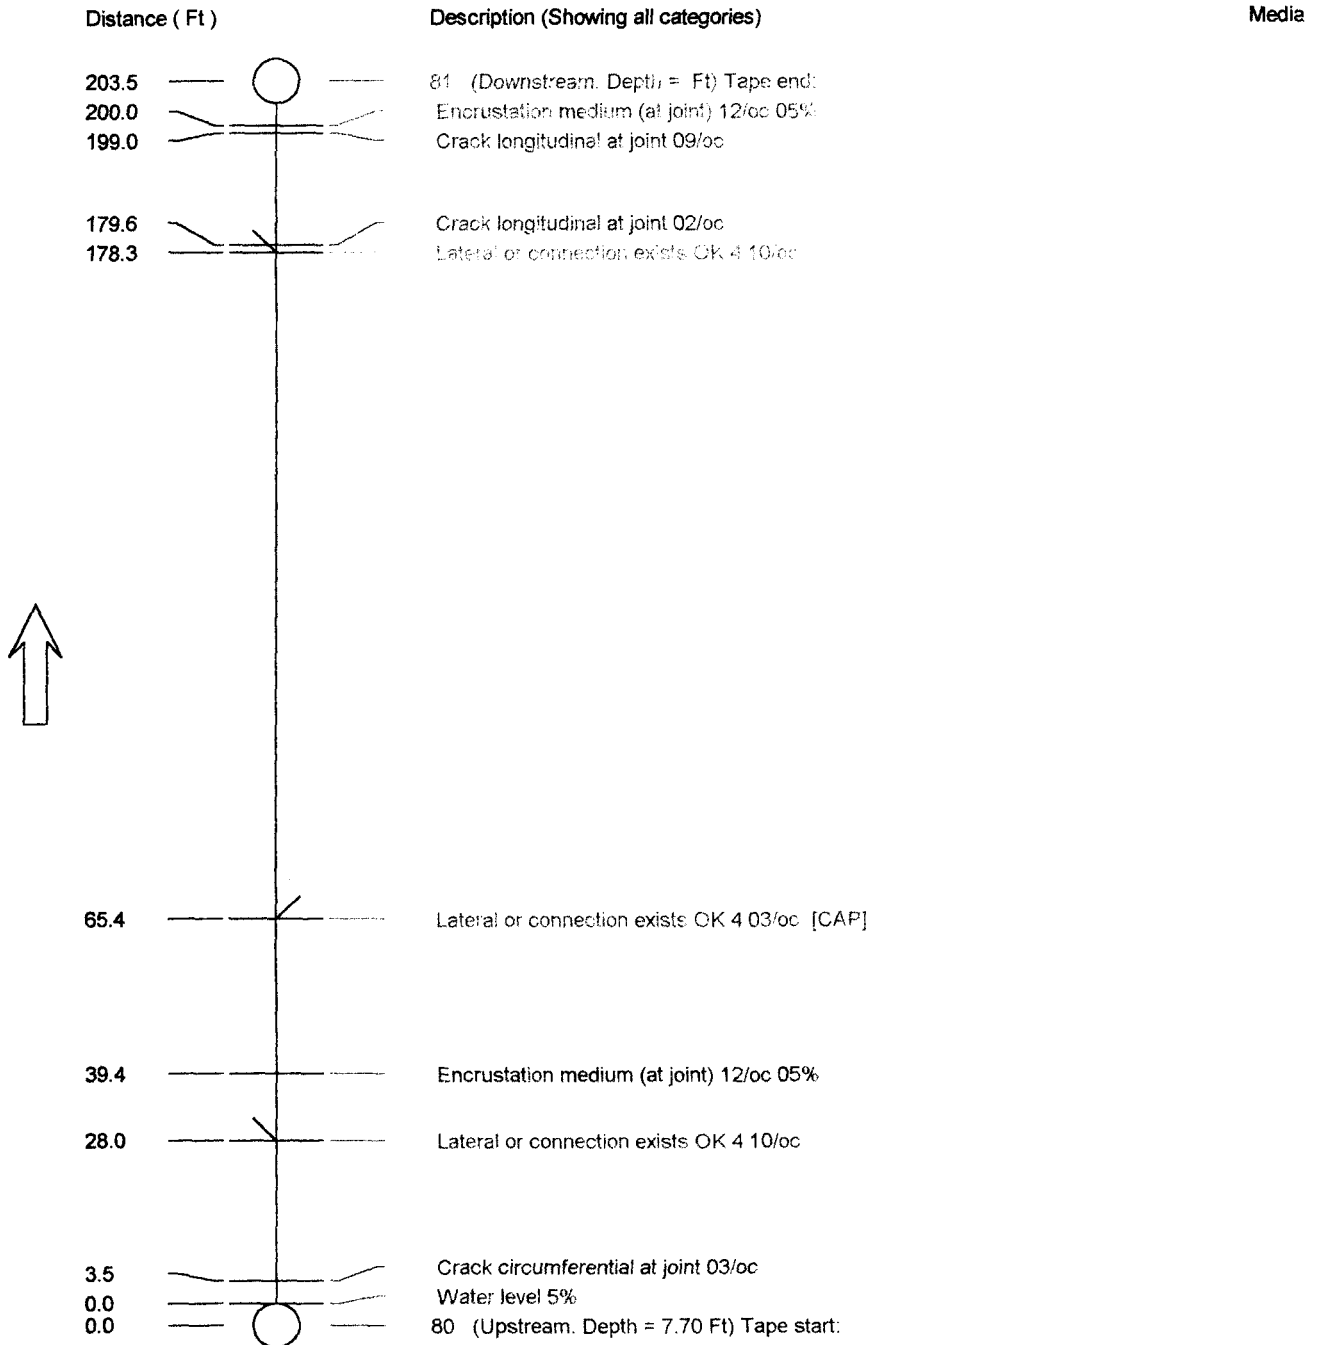
<b>Job</b>	<b>Contract</b>	<b>Cassette</b> 10	<b>Surveyed On</b> 08/17/2004	<b>Sheet</b> 78
<b>Operator</b> BMN	<b>Van Reference</b>	<b>Weather</b> Dry		
<b>Road Name</b> 3RD AVE. N.		<b>Place Name</b> TIERRA VERDE		
<b>Location type</b> Light road (rural roads with lighter traffic, town & city back streets)				
<b>Surface</b>				
<b>Survey purpose</b> Sample survey to determine asset condition				
<b>Pipe Use</b> Foul	<b>Schedule length</b> 203.5 Ft	<b>From</b> 80	<b>Depth</b> 7.70 Ft	
<b>Shape</b> Circular	<b>Size</b> 8 by ins	<b>To</b> 81	<b>Depth</b> Ft	
<b>Material</b> Vitrified clay	<b>Joint spacing</b> Ft	<b>Direction</b> Down		
<b>Lining</b>	<b>Year laid</b> Cat A	<b>Pre-clean</b> Y	<b>Last cleaned</b>	
<b>General note</b>		Structural	Service	Construction
<b>Location note</b>		Minor	Major	Severe

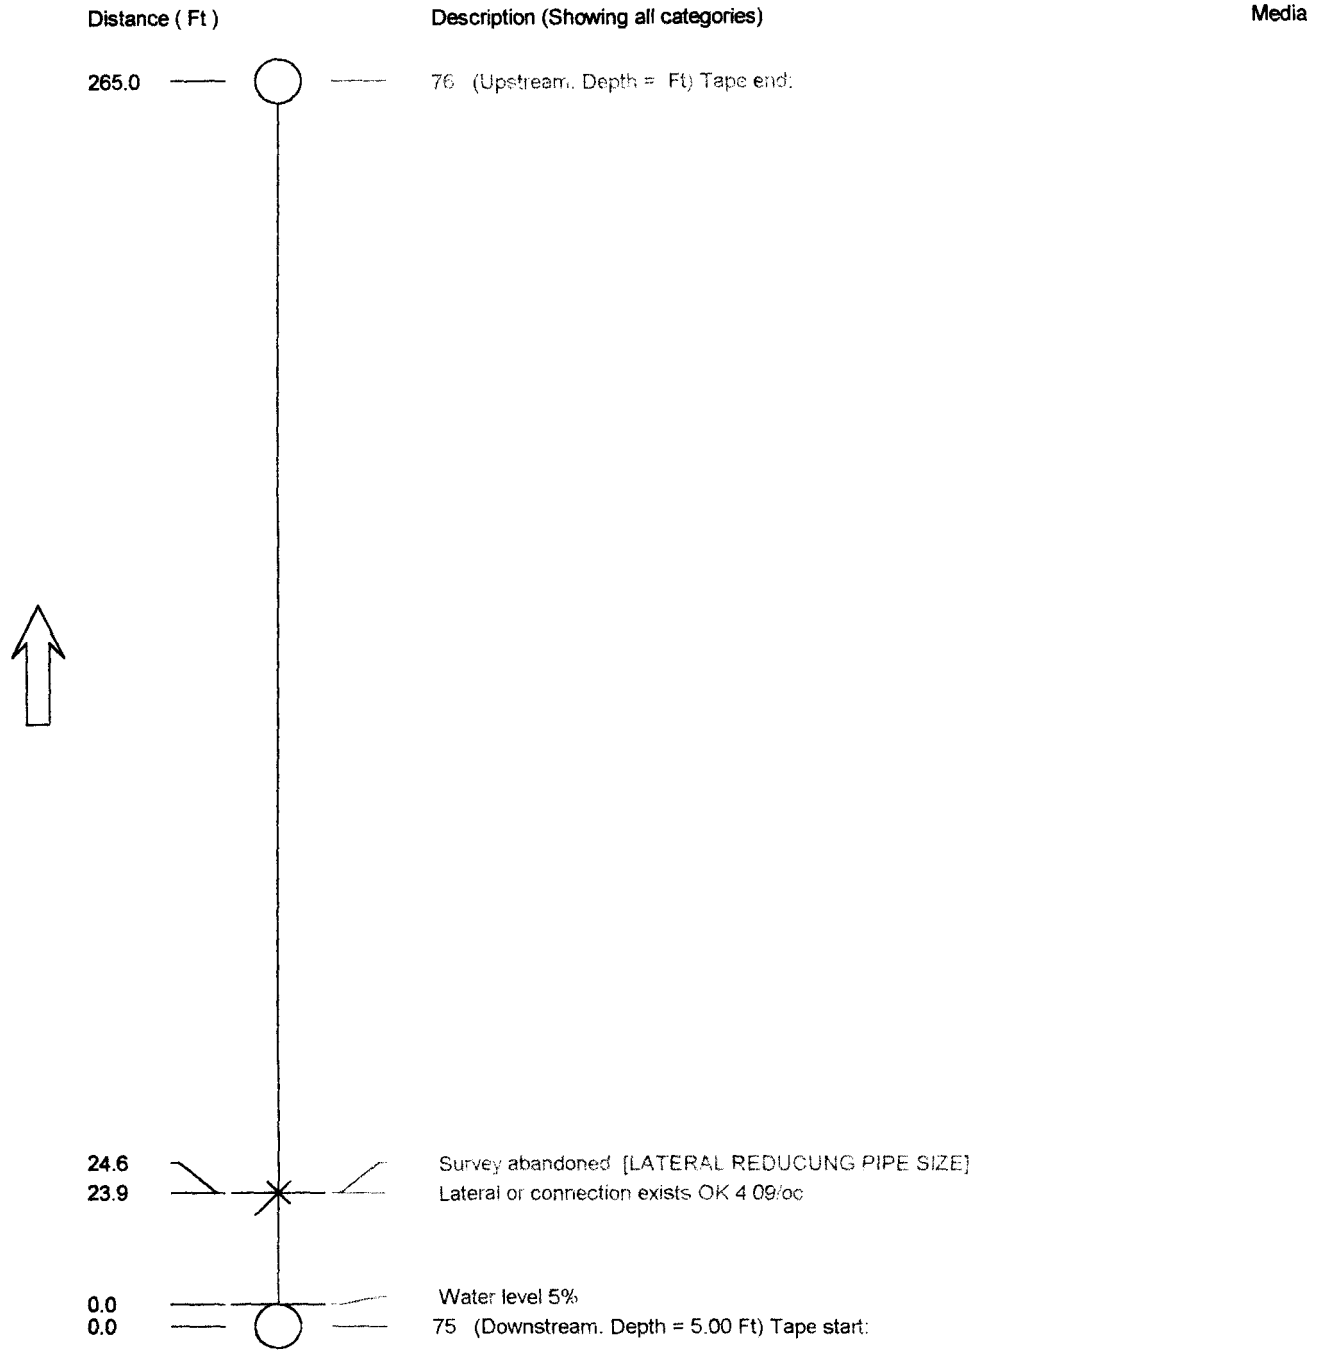
<b>Job</b>	<b>Contract</b>	<b>Cassette</b> 10	<b>Surveyed On</b> 08/17/2004	<b>Sheet</b> 79
<b>Operator</b> BMN	<b>Van Reference</b>	<b>Weather</b> Dry		
<b>Road Name</b> 3RD AVE. N.		<b>Place Name</b> TIERRA VERDE		
<b>Location type</b> Light road (rural roads with lighter traffic, town & city back streets)				
<b>Surface</b>				
<b>Survey purpose</b> Sample survey to determine asset condition				
<b>Pipe Use</b> Foul	<b>Schedule length</b> 265.0 Ft	<b>From</b> 75	<b>Depth</b> 5.00 Ft	
<b>Shape</b> Circular	<b>Size</b> 8 by ins	<b>To</b> 76	<b>Depth</b> Ft	
<b>Material</b> Vitrified clay	<b>Joint spacing</b> Ft	<b>Direction</b> Up		
<b>Lining</b>	<b>Year laid</b> Cat A	<b>Pre-clean</b> Y	<b>Last cleaned</b>	
<b>General note</b> SEE SHEET 90 FOR REVERSE SETUP		<b>Structural</b>	<b>Service</b>	<b>Construction</b>
<b>Location note</b>

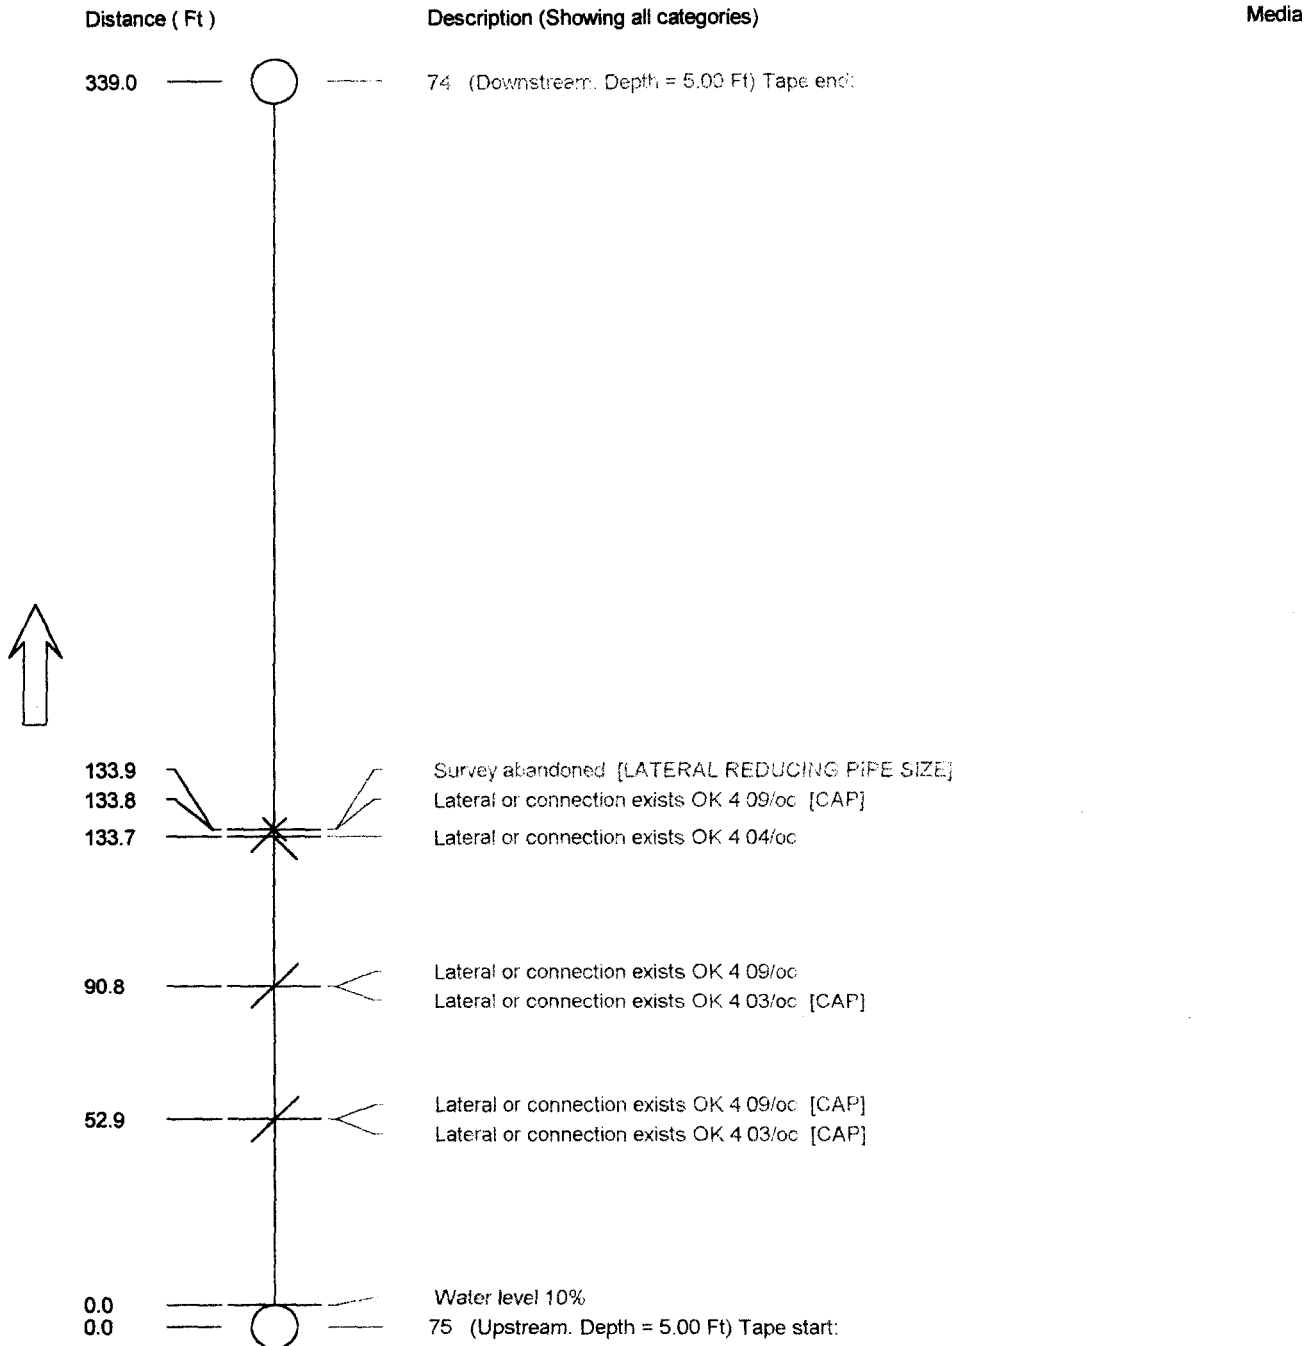
<b>Job</b>	<b>Contract</b>	<b>Cassette</b> 10	<b>Surveyed On</b> 08/17/2004	<b>Sheet</b> 80
<b>Operator</b> BMN	<b>Van Reference</b>	<b>Weather</b> Dry		
<b>Road Name</b> 3RD AVE. N.		<b>Place Name</b> TIERRA VERDE		
<b>Location type</b> Light road (rural roads with lighter traffic, town & city back streets)				
<b>Surface</b>				
<b>Survey purpose</b> Sample survey to determine asset condition				
<b>Pipe Use</b> Foul	<b>Schedule length</b> 339.0 Ft	<b>From</b> 75	<b>Depth</b> 5.00 Ft	
<b>Shape</b> Circular	<b>Size</b> 8 by ins	<b>To</b> 74	<b>Depth</b> 5.00 Ft	
<b>Material</b> Vitrified clay	<b>Joint spacing</b> Ft	<b>Direction</b> Down		
<b>Lining</b>	<b>Year laid</b> Cat A	<b>Pre-clean</b> Y	<b>Last cleaned</b>	
<b>General note</b> SEE SHEET 81 FOR REVERSE SET UP			<b>Structural</b>	<b>Service</b>
<b>Location note</b>			<b>Material</b>	<b>Condition</b>

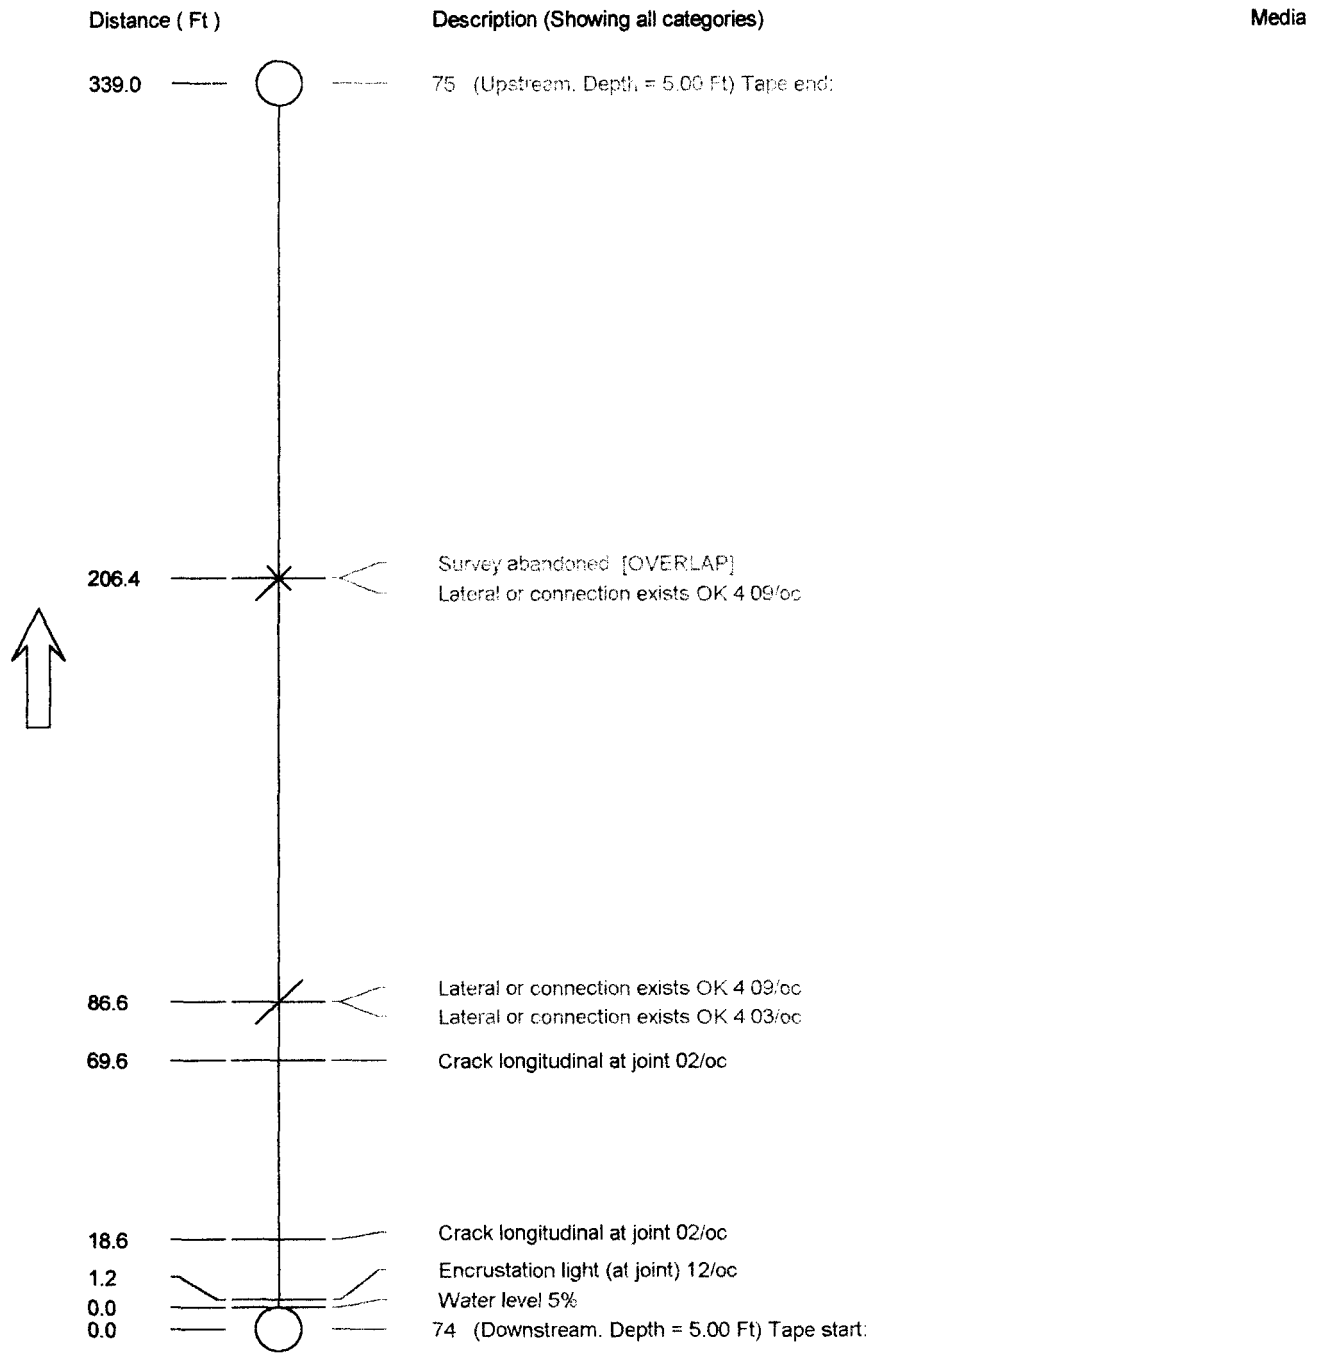
<b>Job</b>	<b>Contract</b>	<b>Cassette 10</b>	<b>Surveyed On</b> 08/17/2004	<b>Sheet</b> 81
<b>Operator</b> BMN	<b>Van Reference</b>	<b>Weather</b> Dry		
<b>Road Name</b> 3RD AVE. N.		<b>Place Name</b> TIERRA VERDE		
<b>Location type</b> Light road (rural roads with lighter traffic, town & city back streets)				
<b>Surface</b>				
<b>Survey purpose</b> Sample survey to determine asset condition				
<b>Pipe Use</b> Foul	<b>Schedule length</b> 339.0 Ft	<b>From</b> 74	<b>Depth</b> 5.00 Ft	
<b>Shape</b> Circular	<b>Size</b> 8 by ins	<b>To</b> 75	<b>Depth</b> 5.00 Ft	
<b>Material</b> Vitrified clay	<b>Joint spacing</b> Ft	<b>Direction</b> Up		
<b>Lining</b>	<b>Year laid</b> Cat A	<b>Pre-clean</b> Y	<b>Last cleaned</b>	
<b>General note</b> SEE SHEET 80 FOR REVERSE SET UP		<b>Structural</b>	<b>Active</b>	<b>Compliance</b>
<b>Location note</b>		<b>Flow direction</b>

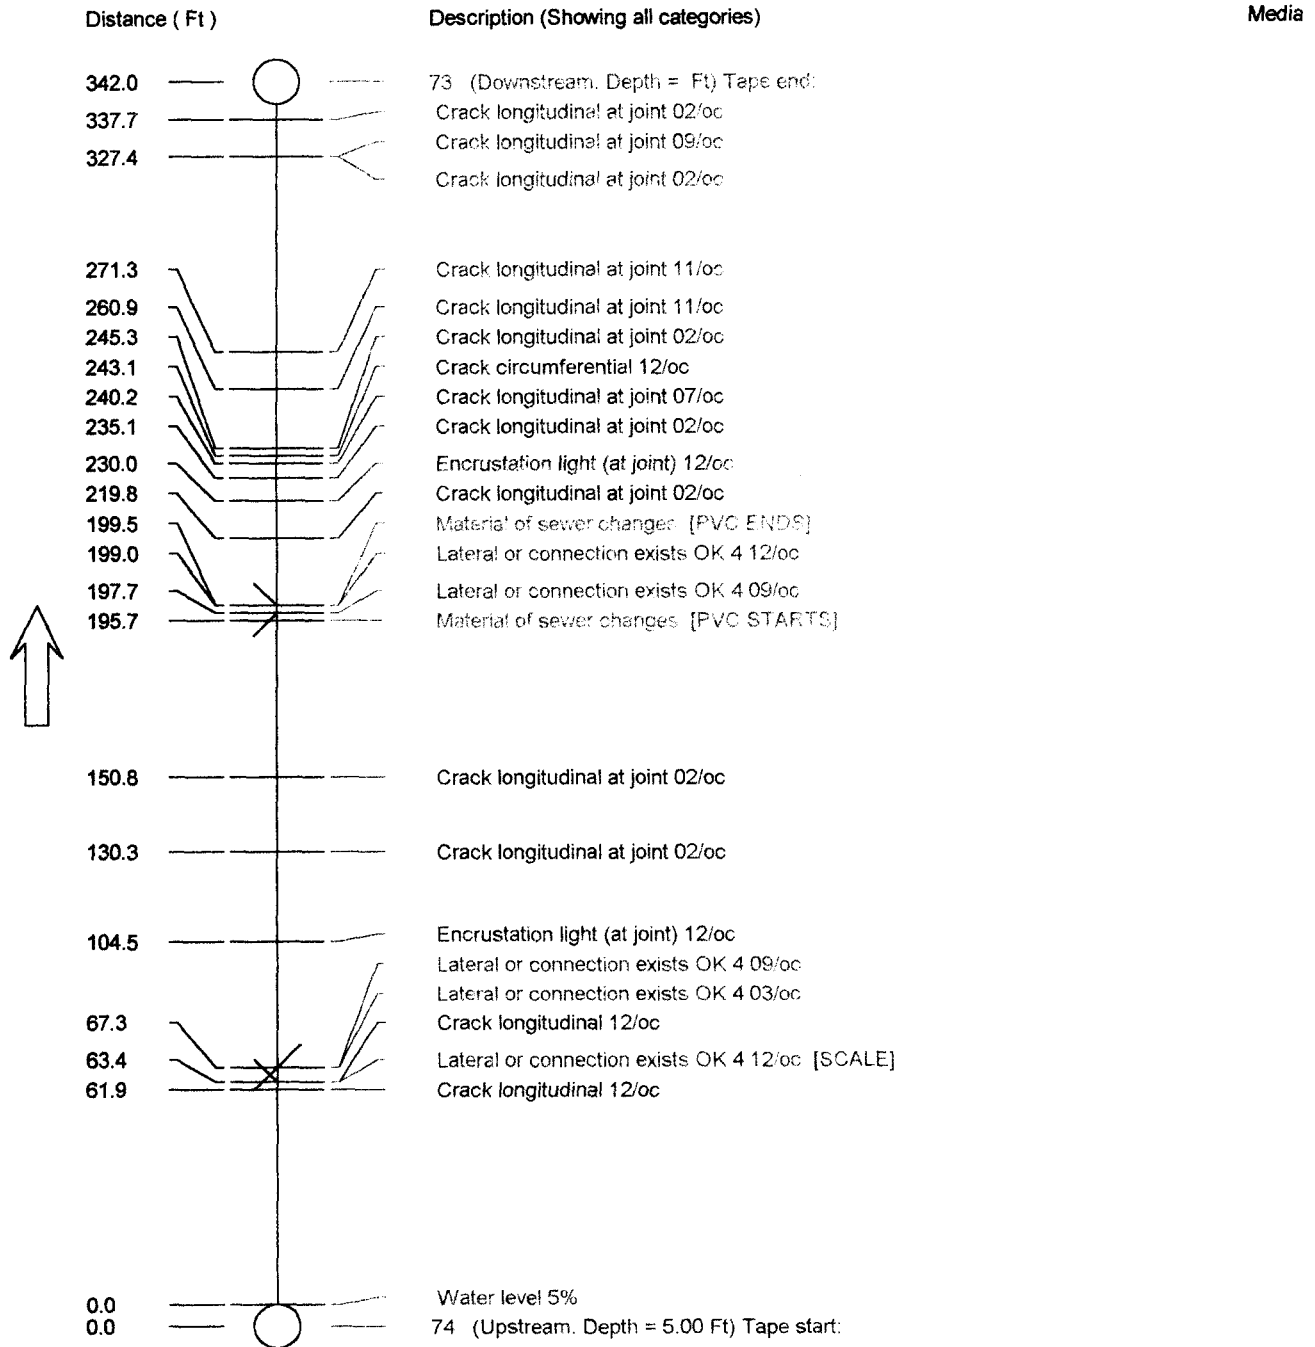
<b>Job</b>	<b>Contract</b>	<b>Cassette</b> 10	<b>Surveyed On</b> 08/17/2004	<b>Sheet</b> 82
<b>Operator</b> BMN	<b>Van Reference</b>	<b>Weather</b> Dry		
<b>Road Name</b> 3RD AVE. N.		<b>Place Name</b> TIERRA VERDE		
<b>Location type</b> Light road (rural roads with lighter traffic, town & city back streets)				
<b>Surface</b>				
<b>Survey purpose</b> Sample survey to determine asset condition				
<b>Pipe Use</b> Foul	<b>Schedule length</b> 342.0 Ft	<b>From</b> 74	<b>Depth</b> 5.00 Ft	
<b>Shape</b> Circular	<b>Size</b> 8 by ins	<b>To</b> 73	<b>Depth</b> Ft	
<b>Material</b> Vitrified clay	<b>Joint spacing</b> Ft	<b>Direction</b> Down		
<b>Lining</b>	<b>Year laid</b> Cat A	<b>Pre-clean</b> Y	<b>Last cleaned</b>	
<b>General note</b> TAPE 11 STARTS AT 203'			<b>Structural</b>	<b>Service</b>
<b>Location note</b>			<b>Material</b>	<b>Condition</b>

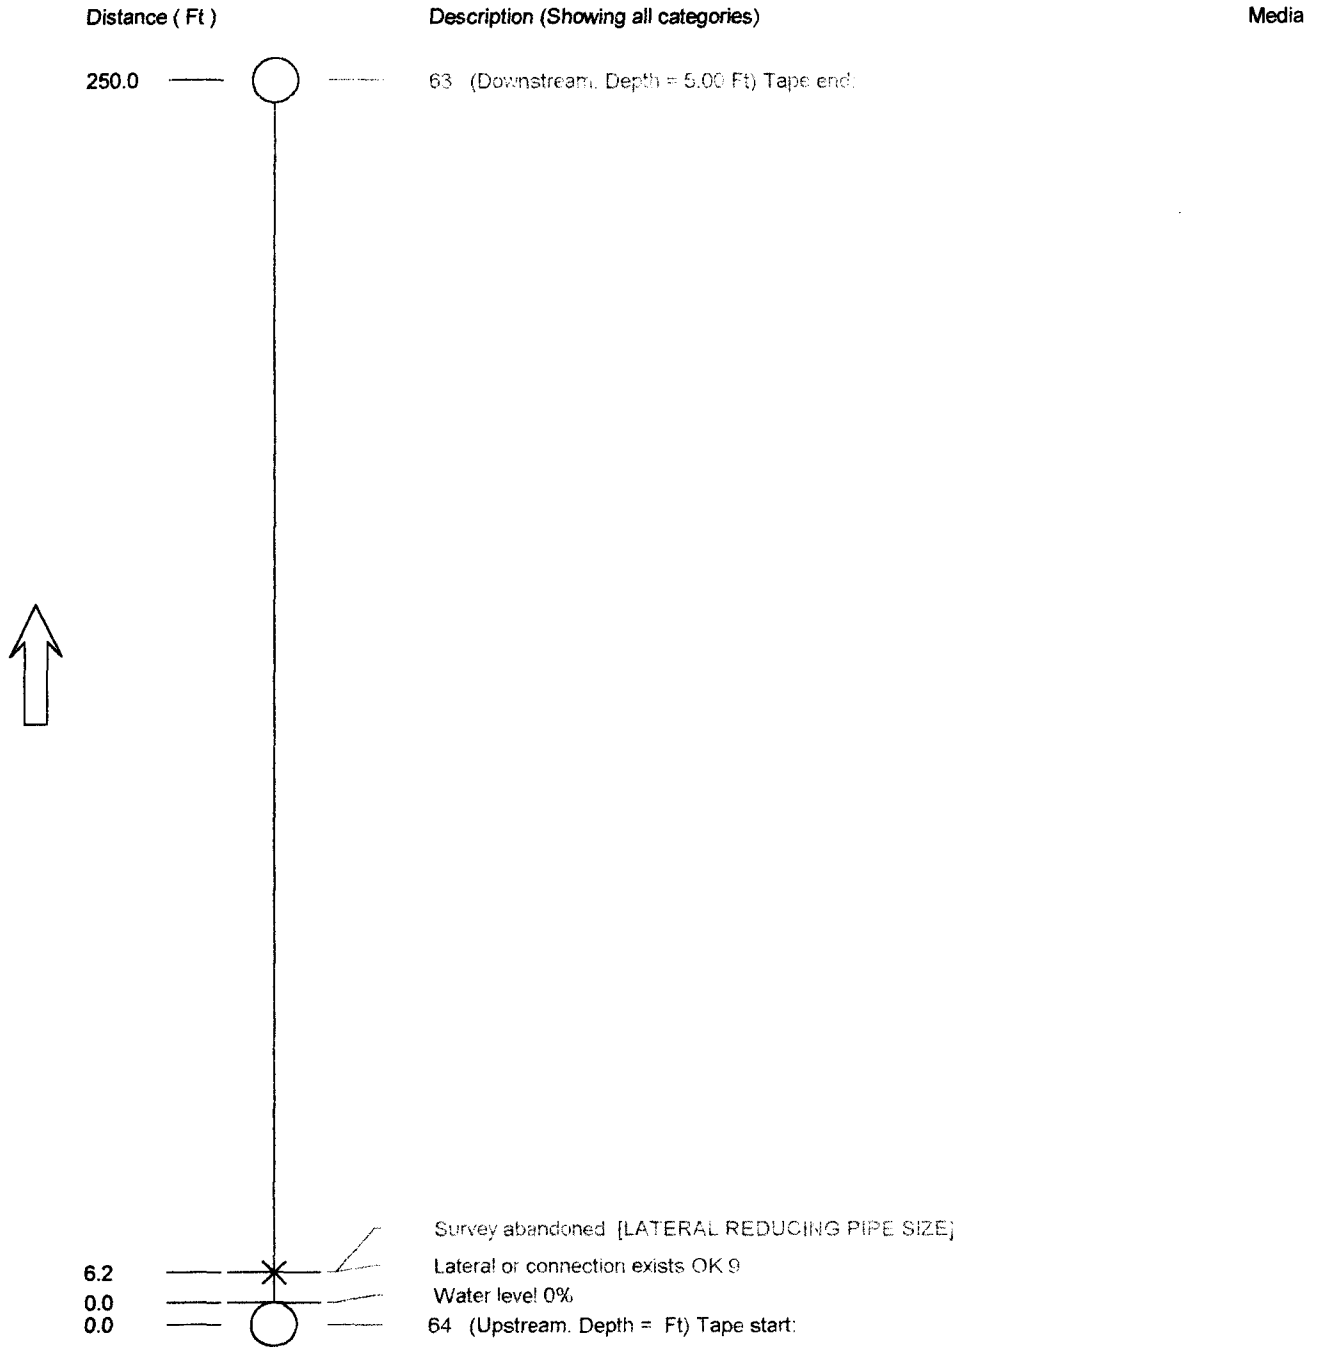
<b>Job</b>	<b>Contract</b>	<b>Cassette</b> 11	<b>Surveyed On</b> 08/17/2004	<b>Sheet</b> 83
<b>Operator</b> BMN	<b>Van Reference</b>	<b>Weather</b> Dry		
<b>Road Name</b> ALLEY		<b>Place Name</b> TIERRA VERDE		
<b>Location type</b> Light road (rural roads with lighter traffic, town & city back streets)				
<b>Surface</b>				
<b>Survey purpose</b> Sample survey to determine asset condition				
<b>Pipe Use</b> Foul	<b>Schedule length</b> 250.0 Ft	<b>From</b> 64	<b>Depth</b>	<b>Ft</b>
<b>Shape</b> Circular	<b>Size</b> 8 by ins	<b>To</b> 63	<b>Depth</b>	5.00 Ft
<b>Material</b> Vitrified clay	<b>Joint spacing</b> Ft	<b>Direction</b> Down		
<b>Lining</b>	<b>Year laid</b> Cat A	<b>Pre-clean</b> Y	<b>Last cleaned</b>	
<b>General note</b> SEE SHEET 67 FOR REVERSE SETUP		<b>Structural</b>	<b>Service</b>	<b>Construction</b>
<b>Location note</b>		<b>Material</b>	<b>Year</b>	<b>Notes</b>

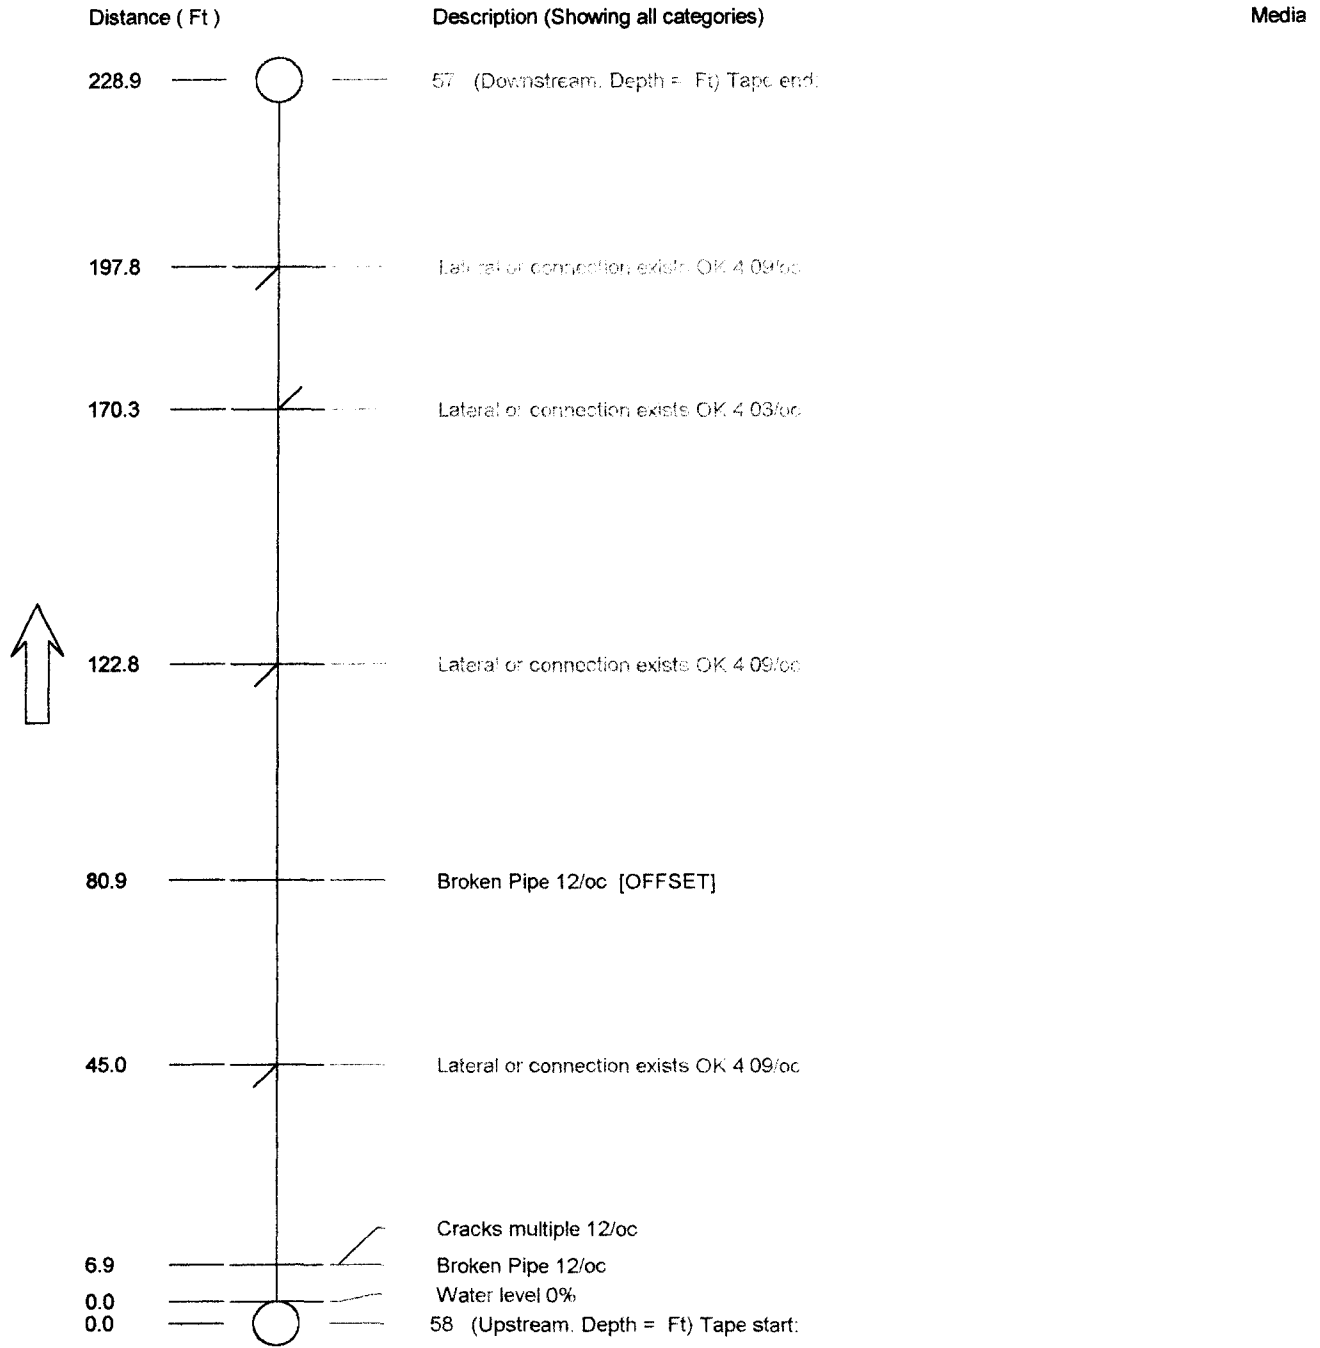
<b>Job</b>	<b>Contract</b>	<b>Cassette 11</b>	<b>Surveyed On</b> 08/17/2004	<b>Sheet</b> 85
<b>Operator</b> BMN	<b>Van Reference</b>	<b>Weather</b> Dry		
<b>Road Name</b> 1ST ST. W.		<b>Place Name</b> TIERRA VERDE		
<b>Location type</b> Light road (rural roads with lighter traffic, town & city back streets)				
<b>Surface</b>				
<b>Survey purpose</b> Sample survey to determine asset condition				
<b>Pipe Use</b> Foul	<b>Schedule length</b> 228.9 Ft	<b>From</b> 58	<b>Depth</b>	<b>Ft</b>
<b>Shape</b> Circular	<b>Size</b> 8 by ins	<b>To</b> 57	<b>Depth</b>	<b>Ft</b>
<b>Material</b> Vitrified clay	<b>Joint spacing</b> Ft	<b>Direction</b> Down		
<b>Lining</b>	<b>Year laid</b> Cat A	<b>Pre-clean</b> Y	<b>Last cleaned</b>	
<b>General note</b>	Structural		Service	Cracks multiple
<b>Location note</b>	Midstream

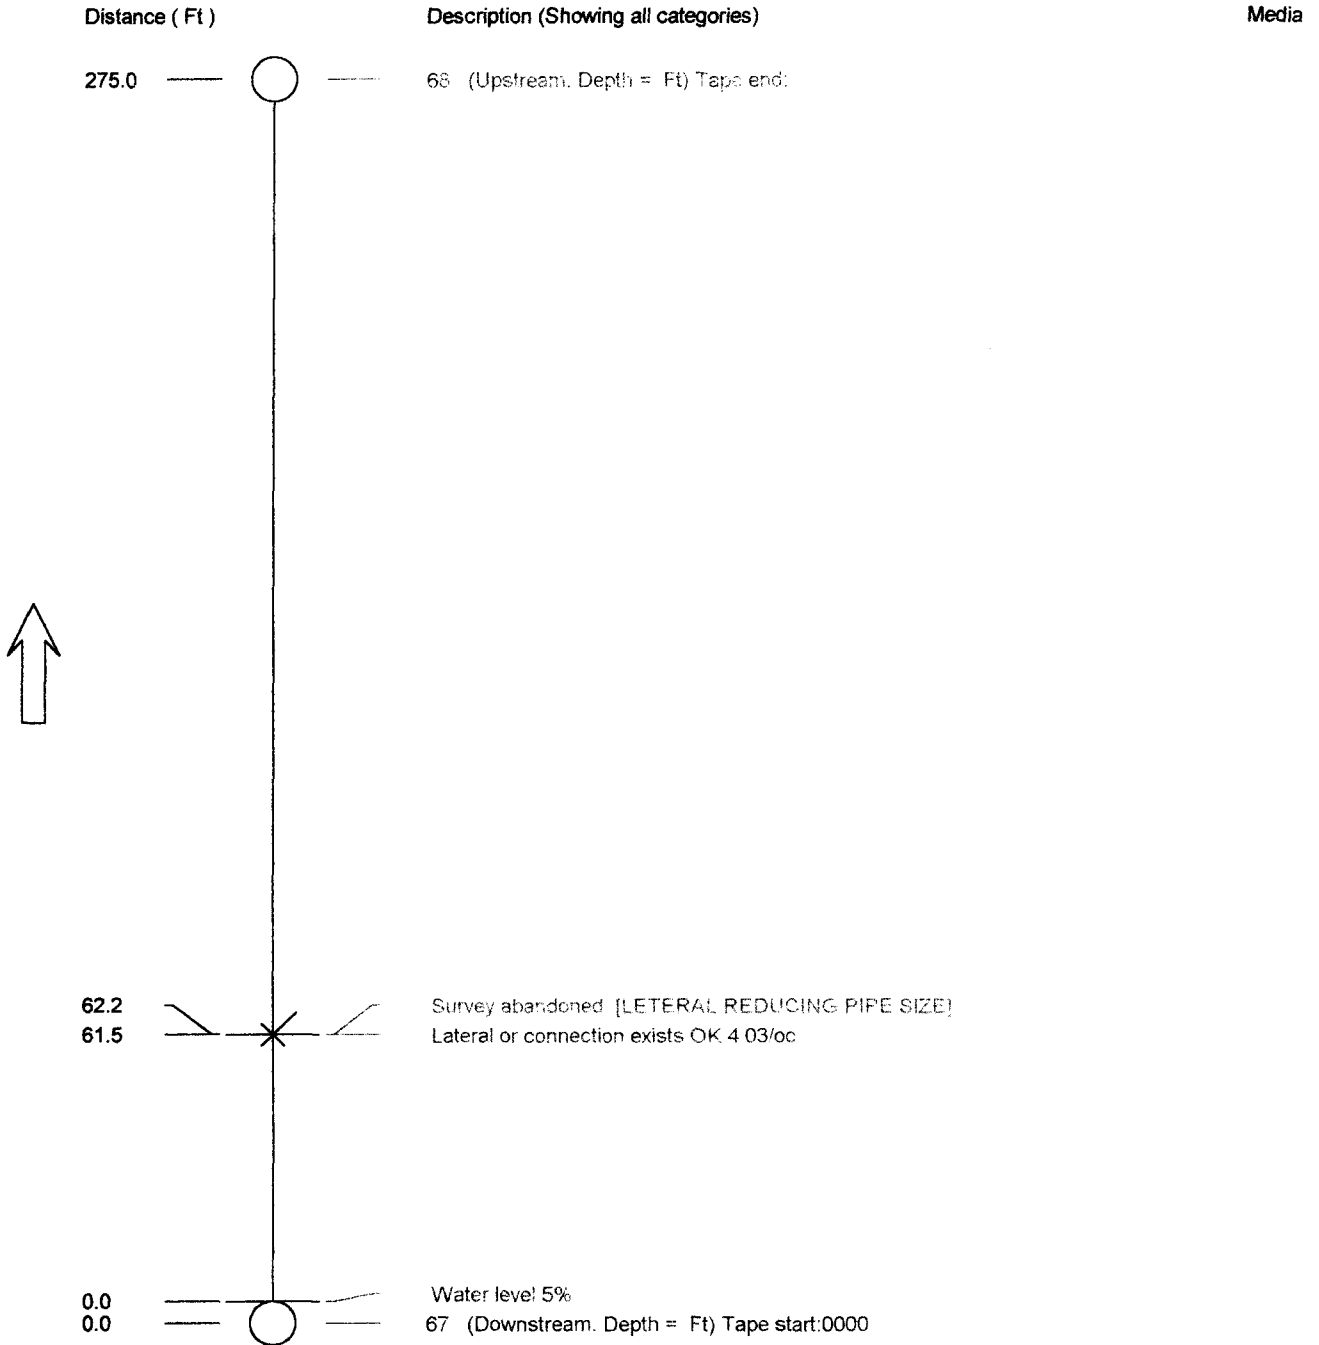
<b>Job</b>	<b>Contract</b>	<b>Cassette 11</b>	<b>Surveyed On</b> 08/17/2004	<b>Sheet</b> 86
<b>Operator</b> BMN	<b>Van Reference</b>	<b>Weather</b> Dry		
<b>Road Name</b> TIERRA VERDE		<b>Place Name</b>		
<b>Location type</b> Light road (rural roads with lighter traffic, town & city back streets)				
<b>Surface</b>				
<b>Survey purpose</b> Sample survey to determine asset condition				
<b>Pipe Use</b> Foul	<b>Schedule length</b> 275.0 Ft	<b>From</b> 67	<b>Depth</b>	<b>Ft</b>
<b>Shape</b> Circular	<b>Size</b> 8 by ins	<b>To</b> 68	<b>Depth</b>	<b>Ft</b>
<b>Material</b> Vitrified clay	<b>Joint spacing</b> Ft	<b>Direction</b> Up		
<b>Lining</b>	<b>Year laid</b> Cat A	<b>Pre-clean</b> Y	<b>Last cleaned</b>	
<b>General note</b> SEE SHEET 88 FOR REVERSE SETUP		<b>Structural</b>	<b>Service</b>	<b>Condition</b>
<b>Location note</b>		OK	OK	OK

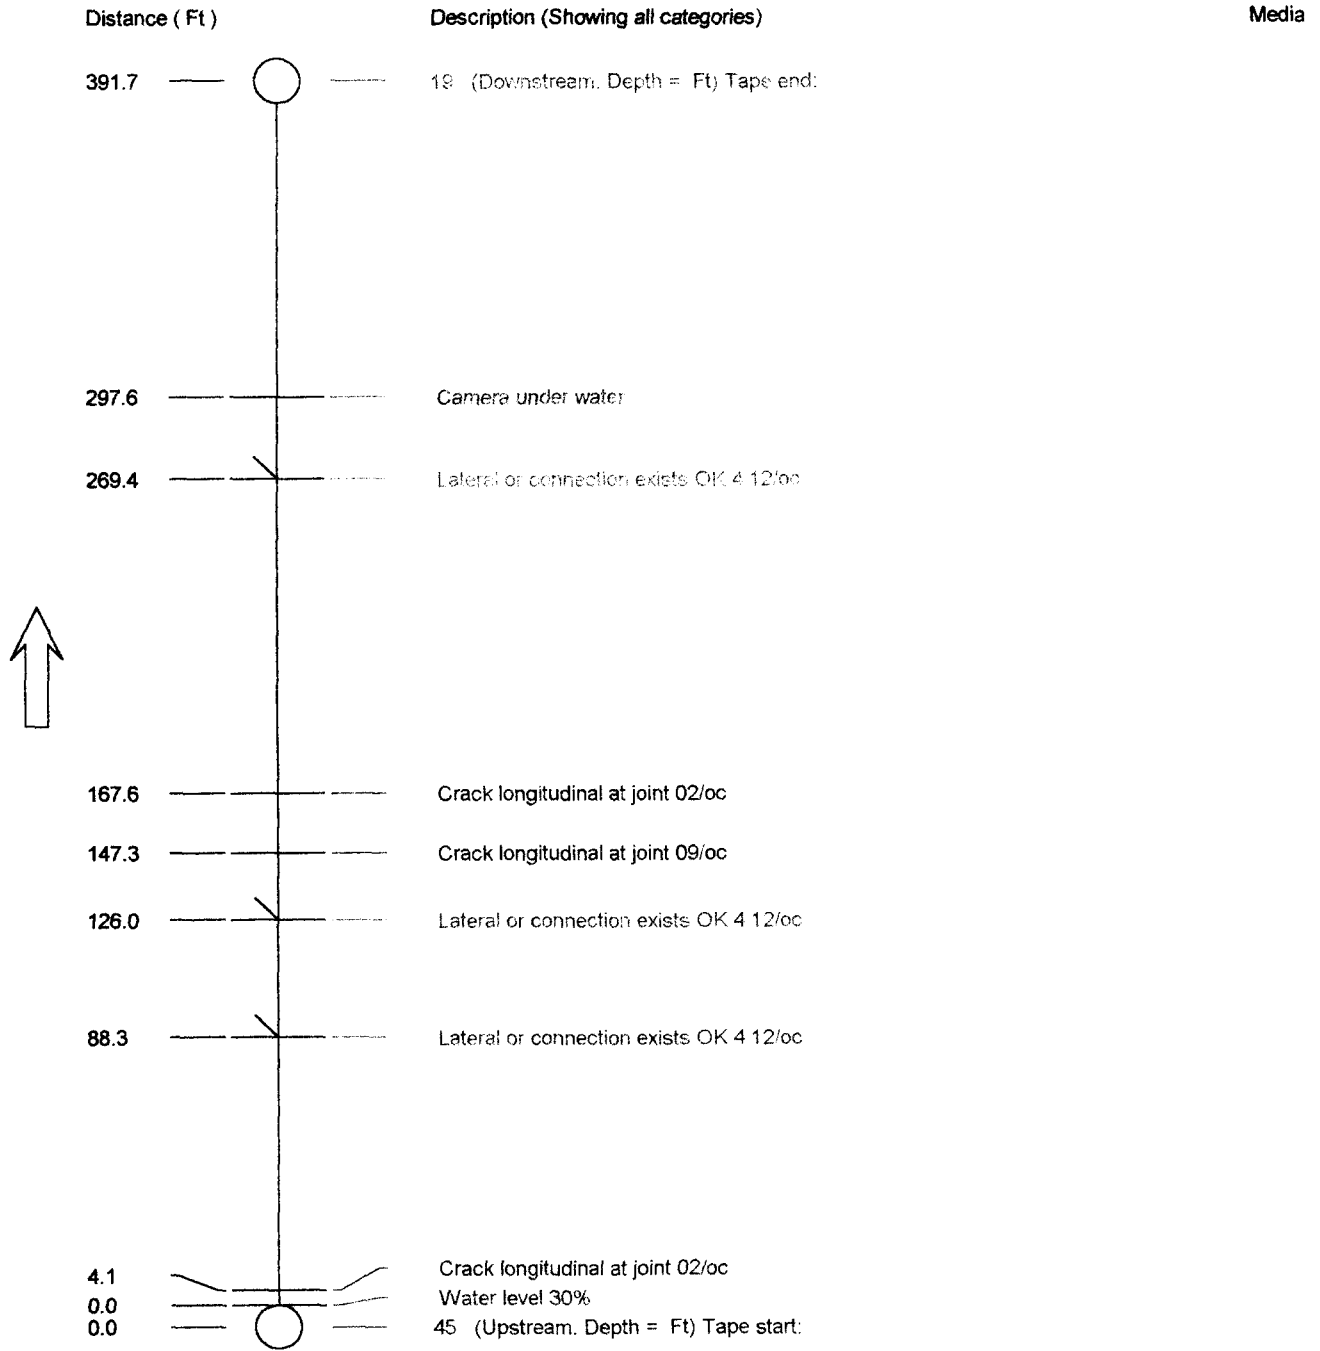
<b>Job</b>	<b>Contract</b>	<b>Cassette</b> 12	<b>Surveyed On</b> 08/19/2004	<b>Sheet</b> 102
<b>Operator</b> BMN	<b>Van Reference</b>	<b>Weather</b> Dry		
<b>Road Name</b> MONTE CRISTO		<b>Place Name</b> TIERRA VERDE		
<b>Location type</b> Light road (rural roads with lighter traffic, town & city back streets)				
<b>Surface</b>				
<b>Survey purpose</b> Sample survey to determine asset condition				
<b>Pipe Use</b> Foul	<b>Schedule length</b> 391.7 Ft	<b>From</b> 45	<b>Depth</b>	<b>Ft</b>
<b>Shape</b> Circular	<b>Size</b> 8 by Ins	<b>To</b> 19	<b>Depth</b>	<b>Ft</b>
<b>Material</b> Vitrified clay	<b>Joint spacing</b> Ft	<b>Direction</b> Down		
<b>Lining</b>	<b>Year laid</b>	<b>Cat</b> A	<b>Pre-clean</b> Y	<b>Last cleaned</b>
<b>General note</b> SEE SHEET 99/ VIDEO ALSO IN REVERSE		<b>Structural</b>	<b>Service</b>	<b>Crack/defect</b>
<b>Location note</b> AFTER REJET		Minor longitudinal	Light
