RE: Docket No. 080248-SU; Tierra Verde Utilities, Inc.'s Application for an Increase in Wastewater Rates Increase in Pinellas County, Florida  
Our File No.: 30057.156

3(a) The "TV Sewer Mains" project reflects the effort to clean and video inspect two portions of the Tierra Verde collection system. The gravity main and manholes situated in the Pinellas Bayway right-of-way and the area west of the Pinellas Bayway along and adjacent to Madonna Avenue had not been cleaned and inspected for many years. A total of 6,229 LF of 18" diameter pipe was cleaned and inspected along the Pinellas Bayway. A total of 21,250 LF of 8" diameter pipe and manholes were inspected west of the Pinellas Bayway along Madonna Avenue. The project is justified for the following reasons:

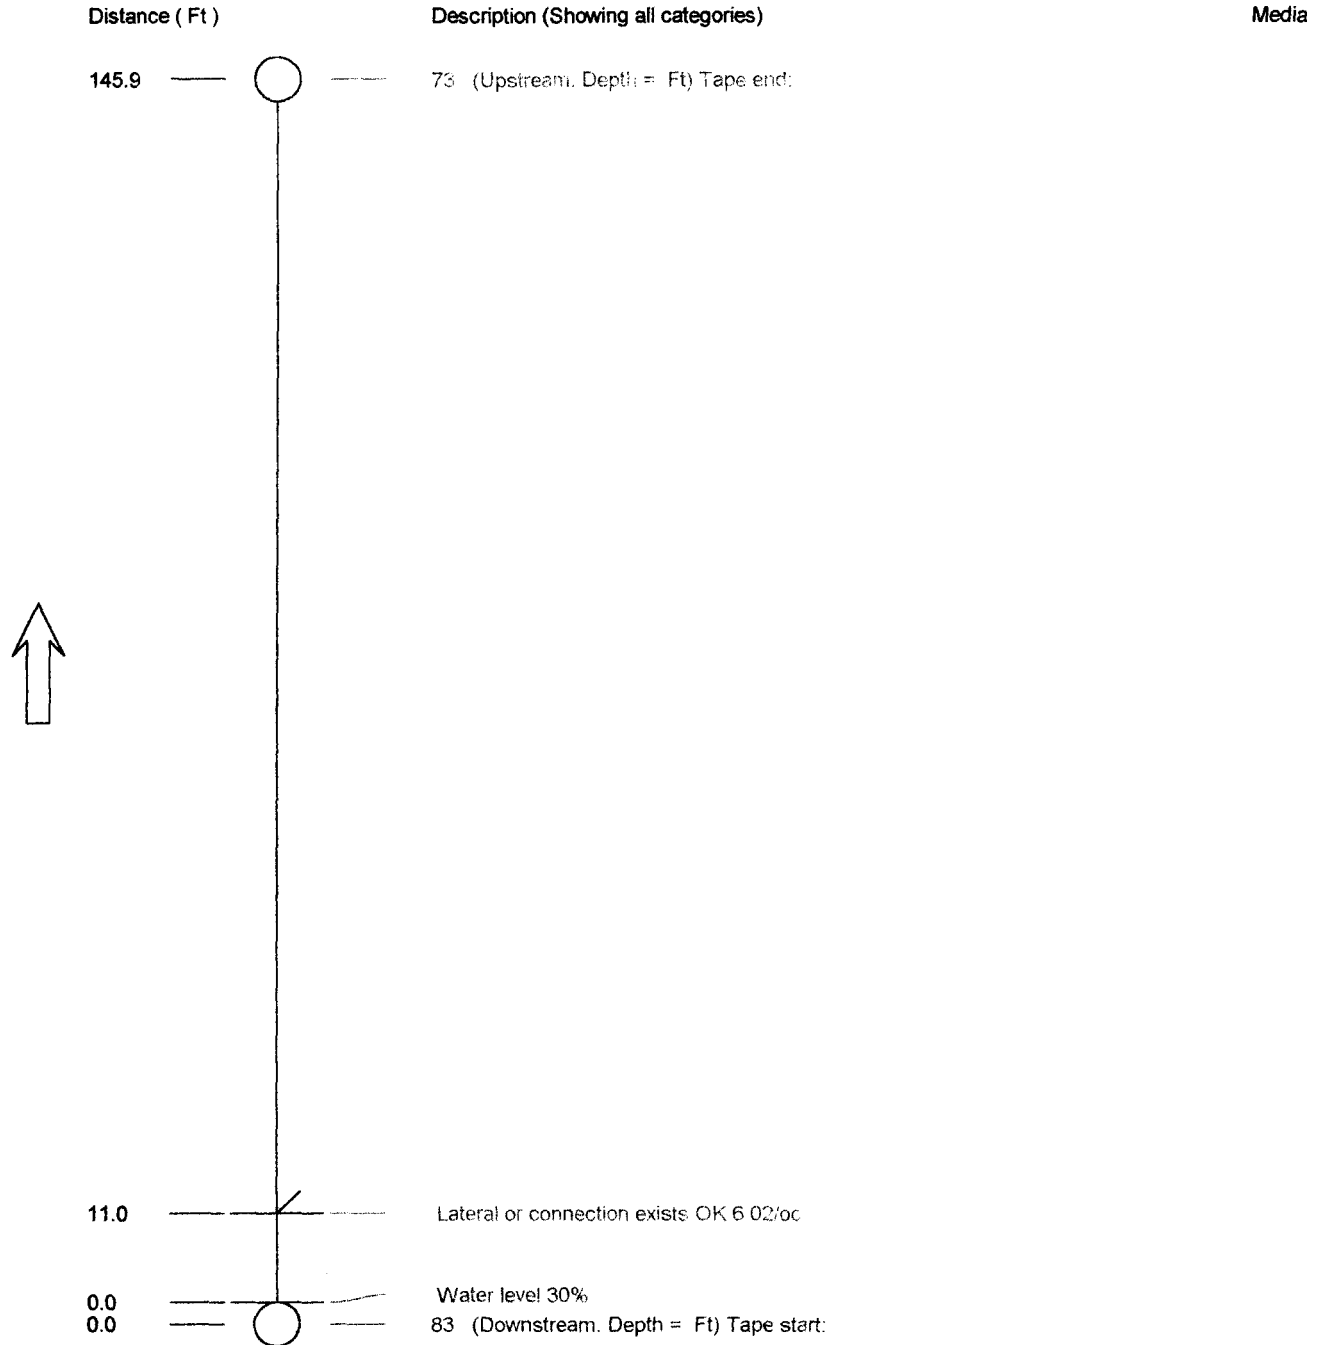
<b>Job</b> Operator BMN	<b>Contract</b> Van Reference	<b>Cassette</b> 13	<b>Surveyed On</b> 08/19/2004	<b>Sheet</b> 103
<b>Road Name</b> MADONNA BLVD.		<b>Place Name</b> TIERRA VERDE		
<b>Location type</b> Light road (rural roads with lighter traffic, town & city back streets)				
<b>Surface</b>				
<b>Survey purpose</b> Sample survey to determine asset condition				
<b>Pipe Use</b> Foul	<b>Schedule length</b> 145.9 Ft	<b>From</b> 83	<b>Depth</b>	<b>Ft</b>
<b>Shape</b> Circular	<b>Size</b> 12 by ins	<b>To</b> 73	<b>Depth</b>	<b>Ft</b>
<b>Material</b> Vitrified clay	<b>Joint spacing</b> Ft	<b>Direction</b> Up		
<b>Lining</b>	<b>Year laid</b> Cat A	<b>Pre-clean</b> Y	<b>Last cleaned</b>	
<b>General note</b> VIDEO ALSO IN REVERSE/HEAVY FLOW FEOM FORCE MAIN		<b>Structure:</b>	<b>Service:</b>	<b>General note:</b>
<b>Location note</b> HARD DEBRIS AT MH 73		<b>Structure:</b>	<b>Service:</b>	<b>General note:</b>
