STANDPIPE INSPECTION REPORT

JOB NO: (LEC) 22191-E DATE: 4/19/04 INSPECTOR: Team 13
TANK OWNER: Utilities Inc. of Florida OWNER'S ORDER NO: _____
OWNER'S REPRESENTATIVE: Mike Dunn TITLE: Primary Contact
MAILING ADDRESS: 200 Weathersfield Ave. PHYSICAL ADDRESS: 200 Weathersfield Ave.
CITY, STATE: Altamonte Springs, FL ZIP: 32714
COUNTY TANK IS LOCATED IN: Unknown SEISMIC ZONE OF COUNTY: 0
TELEPHONE: (407) 869-1919 FAX: (407) 869-6961
LOCATION OF TANK: LABRADOR RESERVOIR

ORIGINAL CONTRACT NO: unknown YEAR BUILT: 1970
ORIGINAL MANUFACTURER: unknown CAPACITY: 34,000 Gallon
DATE OF LAST INSPECTION: unknown TYPE: Potable
DIAMETER: 15' HEIGHT: 28'
TYPE CONSTRUCTION: WELDED: _____ RIVETED: _____ BOLTED: X
WHO IS CUSTOMER'S INSURANCE CARRIER: unknown

Utilities Inc. of Florida
34,000 Gallon Standpipe
(LEC) Job No. 22191-E

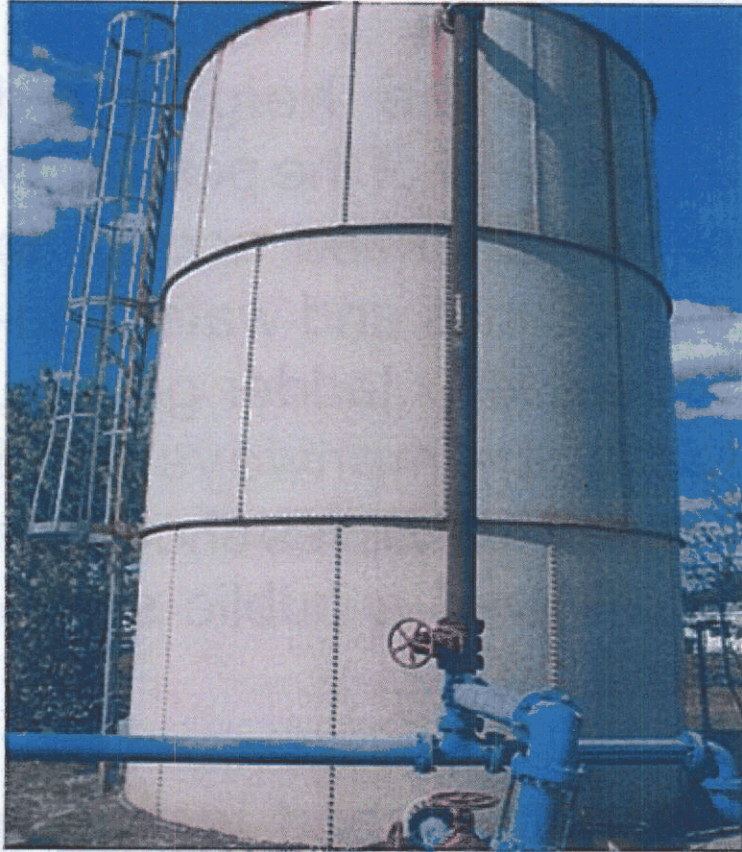
Photo shows the condition of the foundation. We recommend clearing any dirt, debris and other loose gravel away from the tank foundation, down to a minimum 6" below top of foundation as required by AWWA D100-96, Section 12.6.1: Foundations for flat bottom tanks. (see glossary pg. 3). This should be done by a local excavating company.

We further recommend repairing any cracks and spalling in the concrete with a commercial non-shrinking grout, then caulking around the base of the tank to foundation connection to prevent water from entering under the tank and sealing the foundation with a concrete sealant.

We also recommend electrically grounding the tank for lightning protection as required by OSHA, (general duty clause) (see glossary).
