Condition Analysis

Block: 01 Northwest Unit of the plant. Includes Gasification Unit, Brine Unit, Acid Unit, Coal Slurry Building, and pipe lines to flares.

Subblock: A On West side of Block 1. Contains Flare, pipe racks to flare, and conveyor belt.

Section: 01 Flare and associated structure.

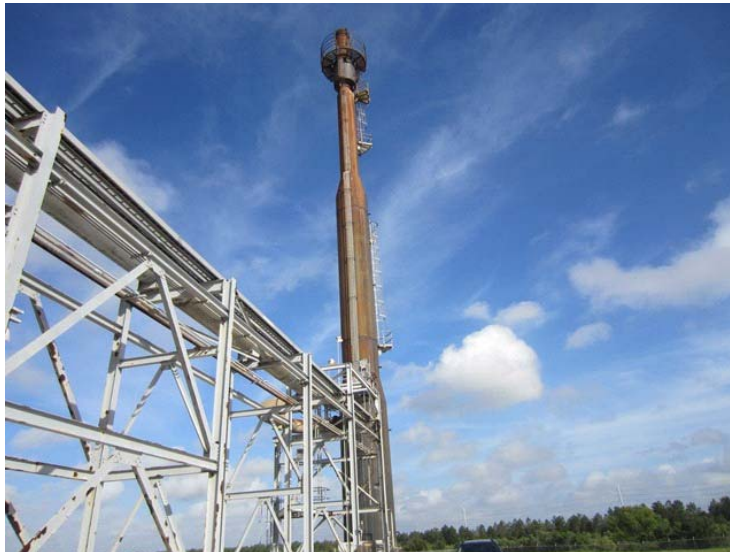
Comments: Heavy Corrosion at base of Flare

General view of stack

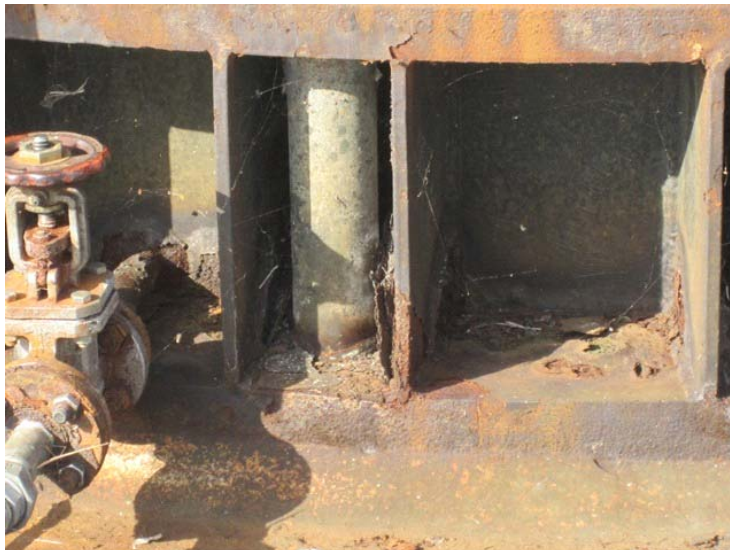
Corrosion Rating: 5.0 - 3% rust

Corrosion Type: B - Surface Rust

Priority: 3 - Wearout

Corrosion on stack

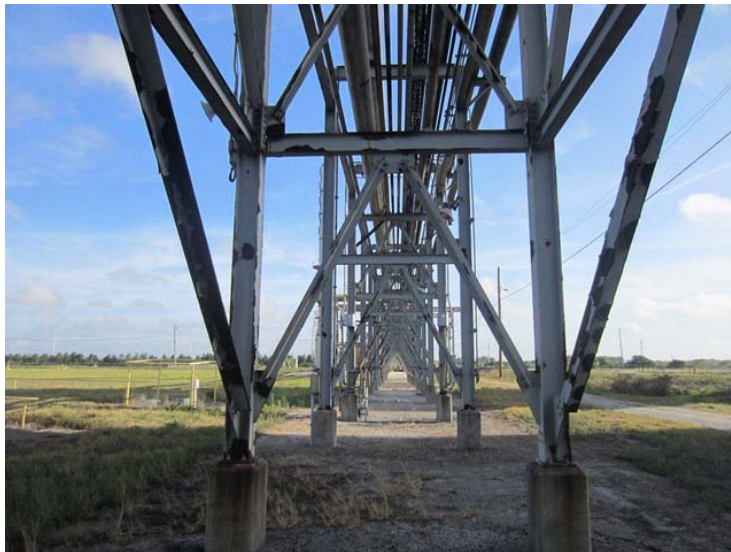
Environment Rating 3 - Moderate
Visibility: 5 - Moderate Traffic or Visibility
Corrosion Rating: 5.0 - 3% rust
Corrosion Type: E - Pitting or Rust Nodules
Priority: 4 - Substandard

Comments: Heavy Undercutting- Beginning Stages of Pittings.

General view of piperack

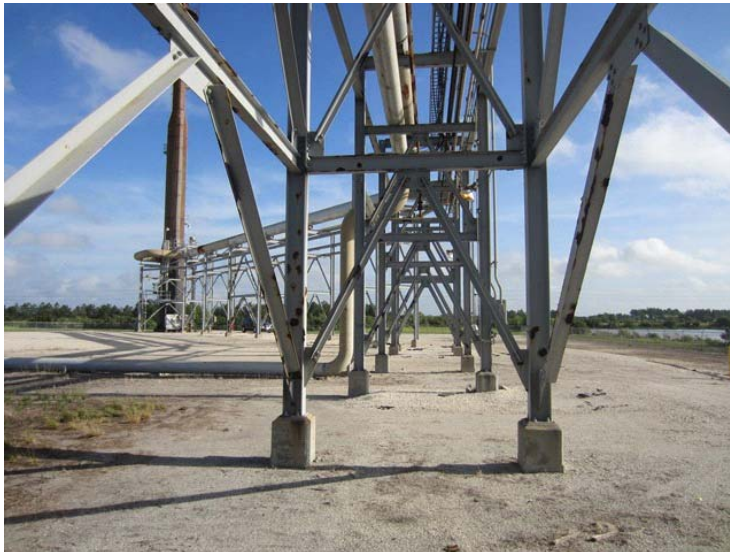
Environment Rating 3 - Moderate
Visibility: 5 - Moderate Traffic or Visibility
Corrosion Rating: 5.5 - 2% rust
Corrosion Type: E - Pitting or Rust Nodules
Priority: 4 - Substandard

Comments: Heavy Undercutting- Beginning Stages of Pittings.

General view of piperack

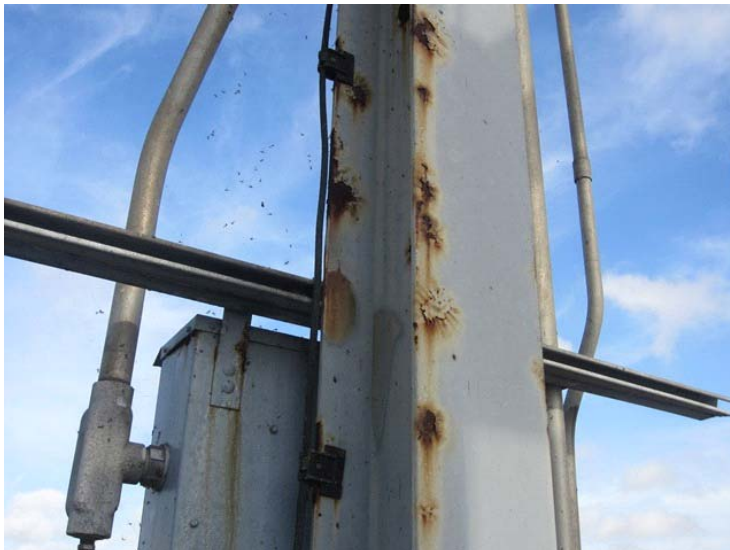
Corrosion on structure

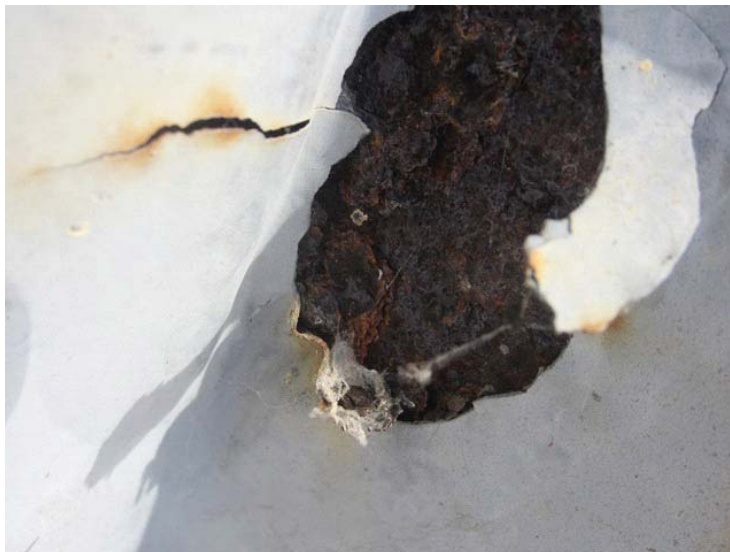
Environment Rating 3 - Moderate
Visibility: 5 - Moderate Traffic or Visibility
Corrosion Rating: 5.5 - 2% rust
Corrosion Type: E - Pitting or Rust Nodules
Priority: 4 - Substandard

Comments: Heavy Undercutting- Beginning Stages of Pittings.

Close up view of corrosion

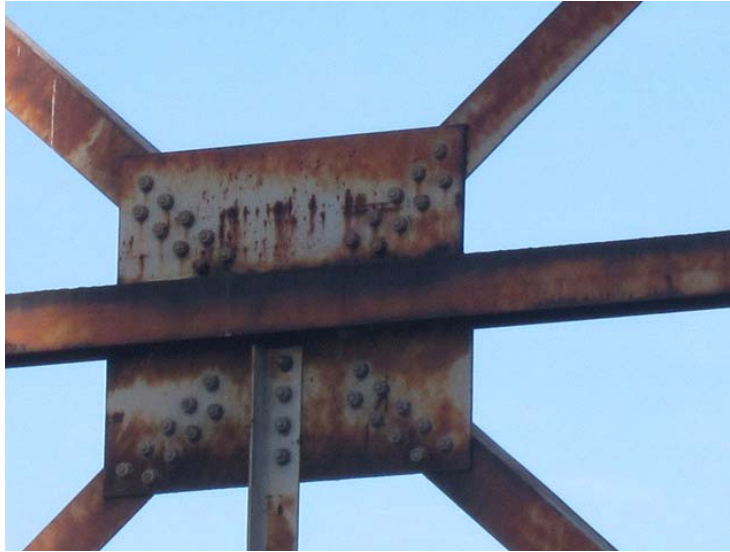
Corrosion Rating: 4.0 - 10% rust

Corrosion Type: C - Edge or Pinhole Corrosion

View of corrosion

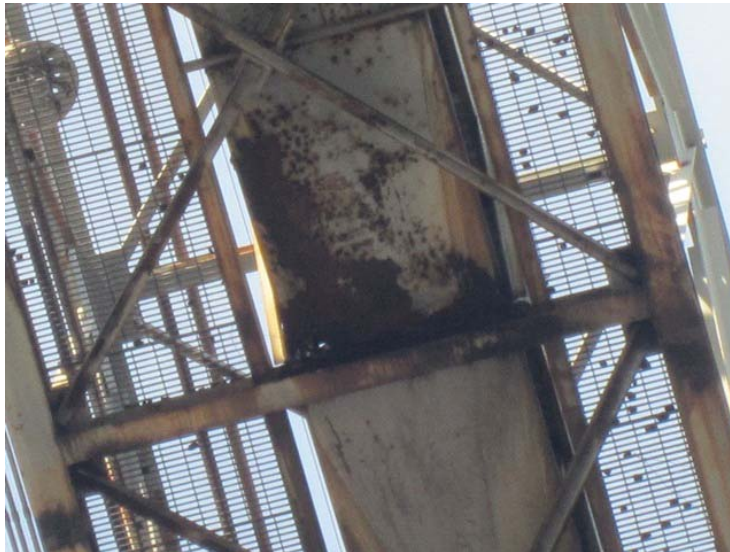
Corrosion Rating: 4.0 - 10% rust

Corrosion Type: C - Edge or Pinhole Corrosion

View of corrosion on structure

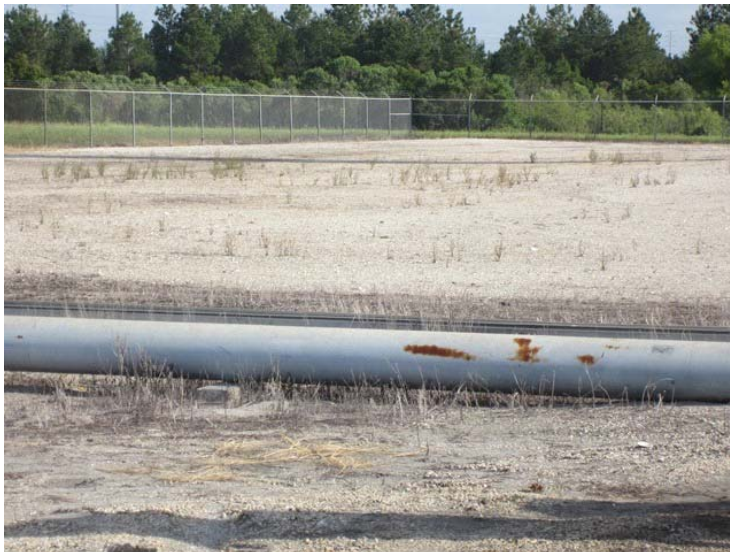
Environment Rating 3 - Moderate
Visibility: 6 - Low Traffic or Visibility
Corrosion Rating: 6.5 - 0.7% rust
Corrosion Type: B - Surface Rust
Priority: 2 - Optimum

Corrosion on pipe

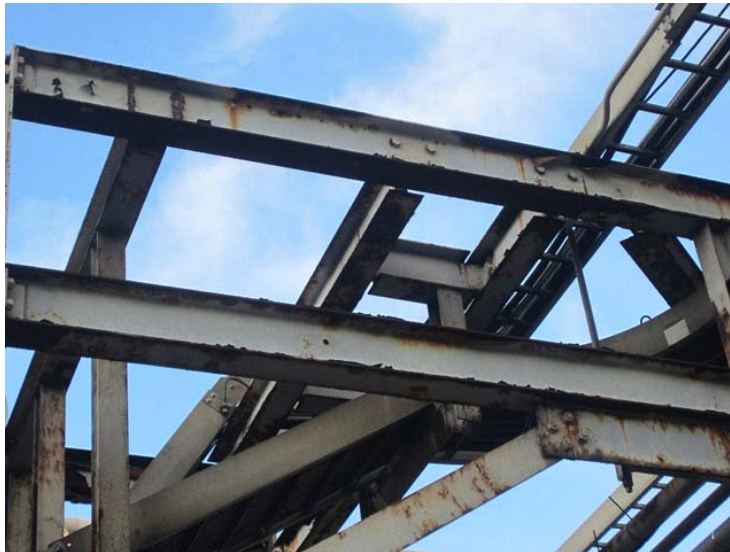
Corrosion Rating: 5.0 - 3% rust

Corrosion Type: D - Undercutting or Mill Scale

Comments: Heavy Undercutting

View of corrosion on structure

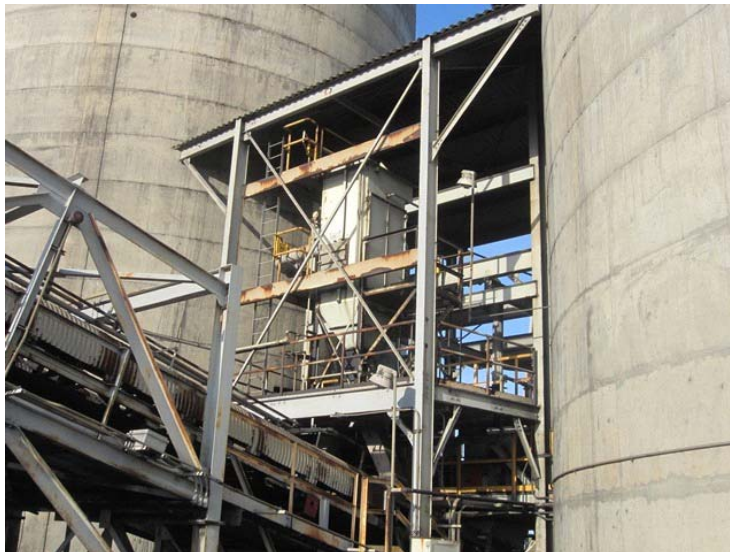
Corrosion Rating: 4.0 - 10% rust

Corrosion Type: C - Edge or Pinhole Corrosion

Comments: Heavy surface rust, edge corrosion.

General view of structure

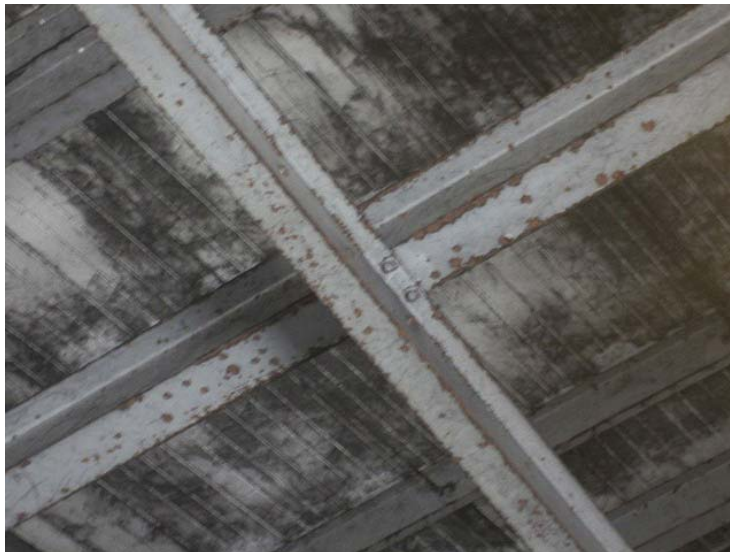
Environment Rating 3 - Moderate
Visibility: 6 - Low Traffic or Visibility
Corrosion Rating: 8.0 - 0.1% rust
Corrosion Type: D - Undercutting or Mill Scale
Priority: 4 - Substandard

Comments: Couldn't walk in building- Flooded with water.

View of corrosion on structure

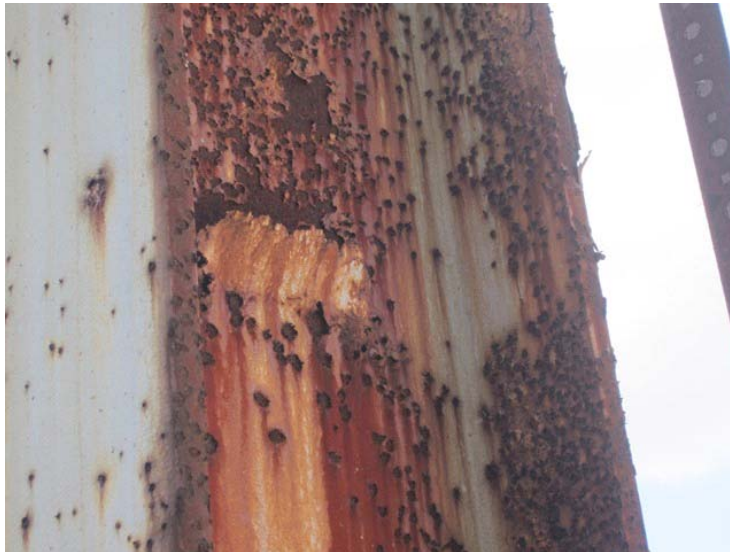
Corrosion Rating: 4.0 - 10% rust

Corrosion Type: E - Pitting or Rust Nodules

Priority: 1 - Advanced Corrosion

Severe corrosion on structure

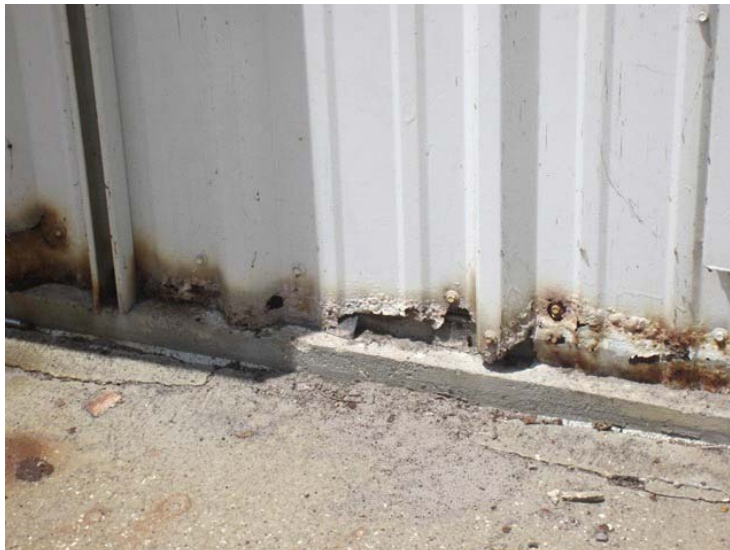
Comments: Corrosion on bottom edge of siding.

Corrosion at base of siding

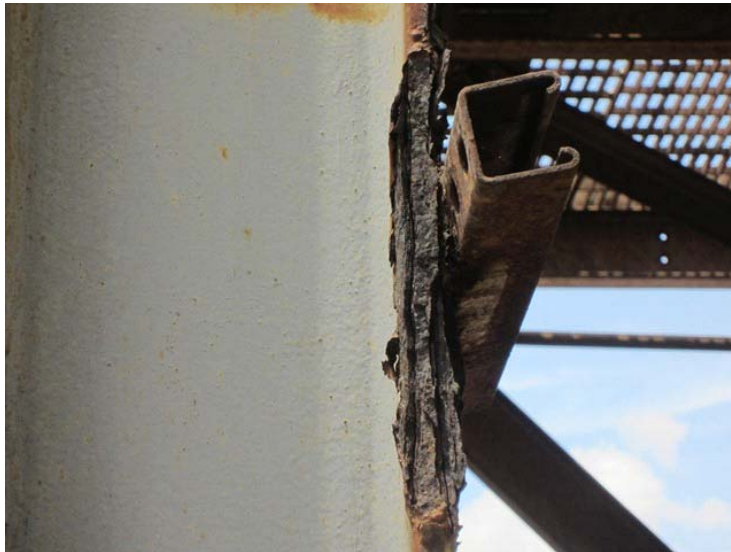
Corrosion Rating: 4.5 - 7% rust

Corrosion Type: F - Holes or Stratifications

Priority: 1 - Advanced Corrosion

Metal loss on structure

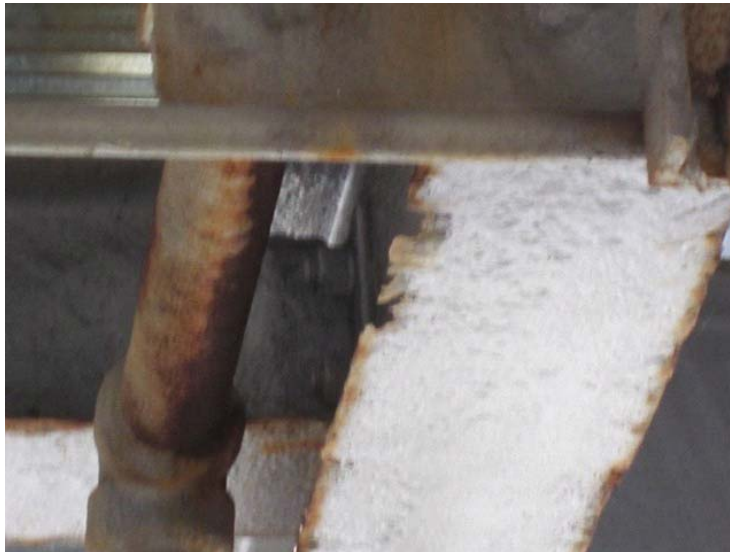
Comments: Localized- Miscellaneous Piping, Valves, Flanges. (Thin wall thickness.)

Corrosion on structure

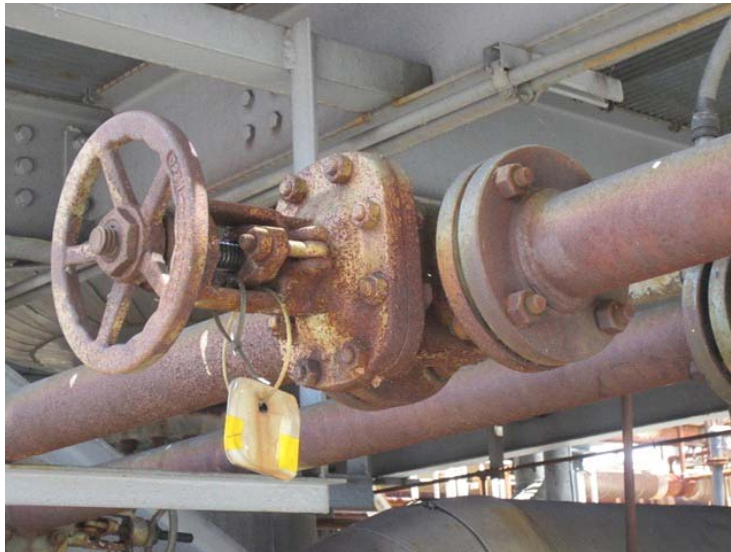
Comments: Localized- Miscellaneous Piping, Valves, Flanges. (Thin wall thickness.)

Corrosion on piping

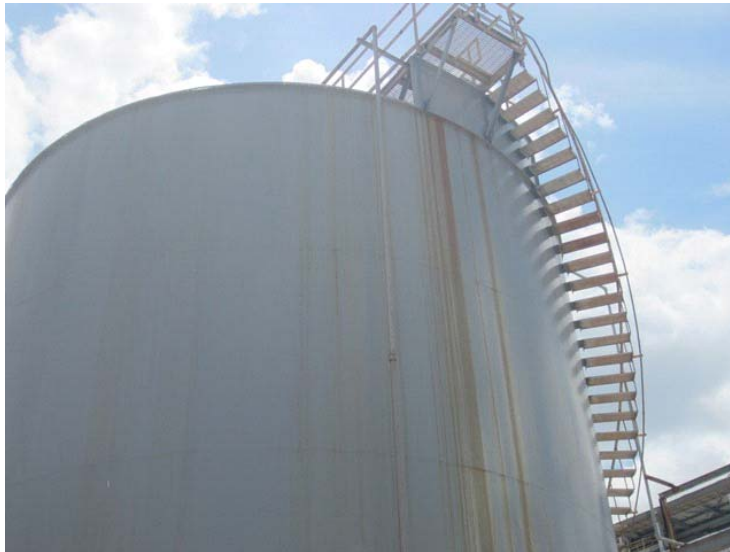
Comments: Tanks Fair- Handrails, Spiral Ladders, Piping need paint.

General view of Tank

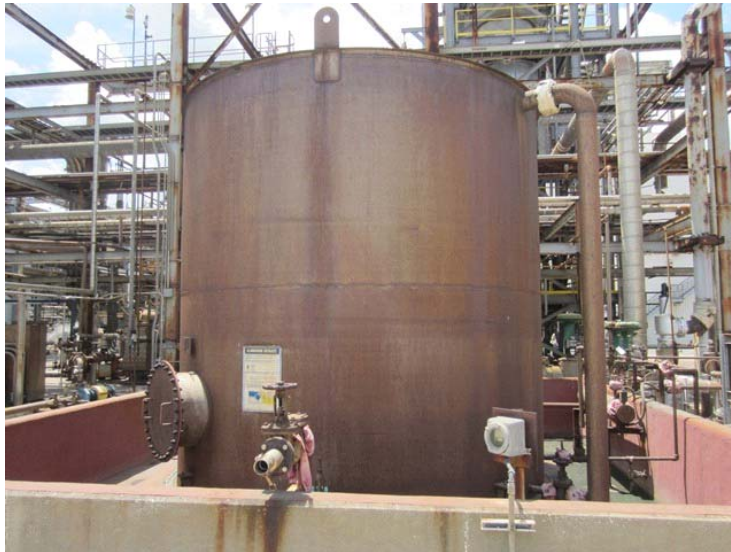
Comments: Tanks Fair- Handrails, Spiral Ladders, Piping need paint.

Corrosion on tank

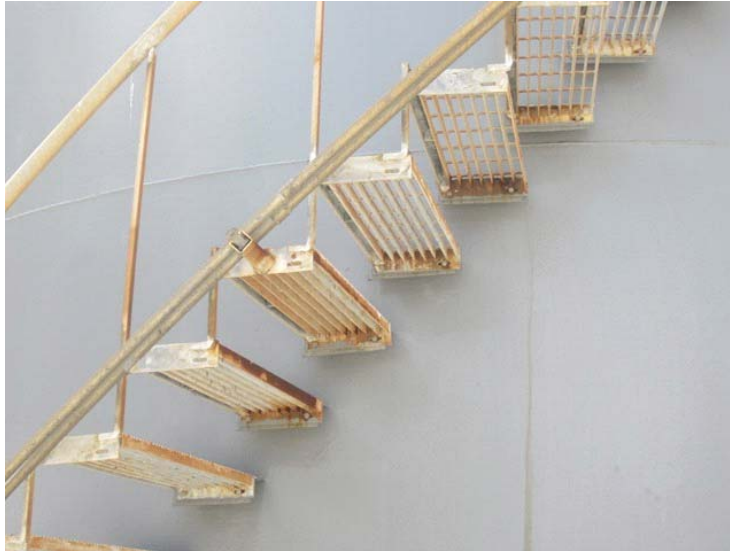
Comments: Tanks Fair- Handrails, Spiral Ladders, Piping need paint.

Corrosion on tank stairs

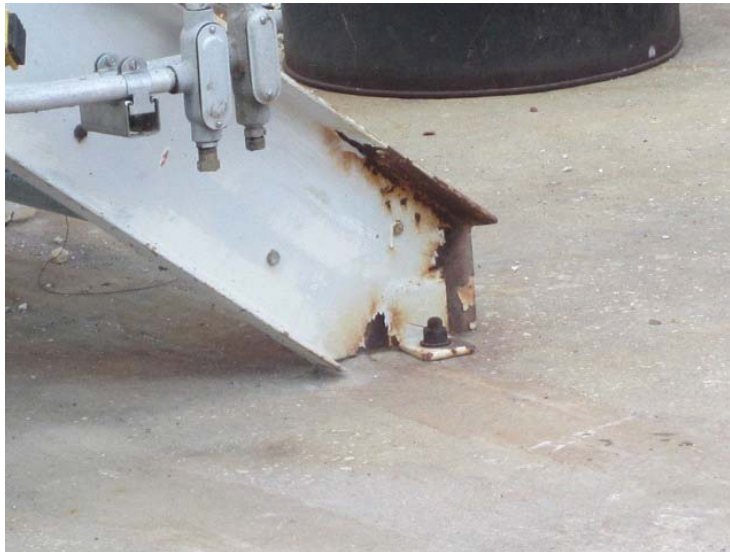
Priority: 4 - Substandard

View of corrosion

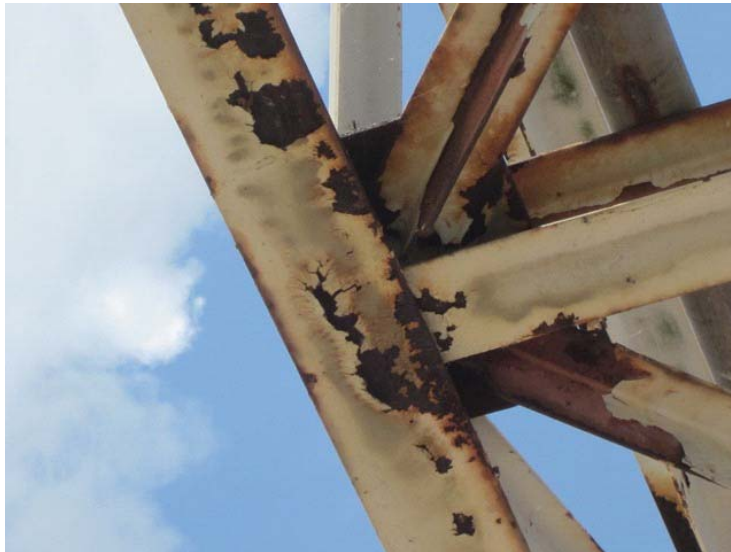
Priority: 4 - Substandard

View of undercutting rust

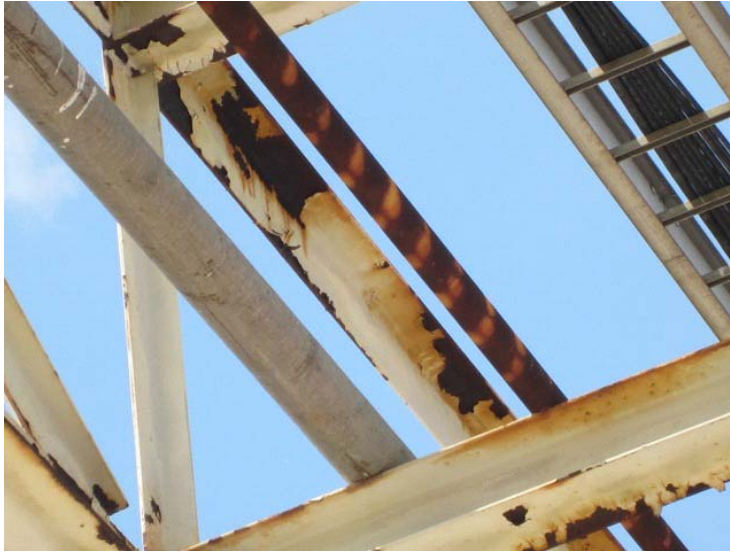
Corrosion Rating: 5.0 - 3% rust

Corrosion Type: D - Undercutting or Mill Scale

Priority: 4 - Substandard

Corrosion in section

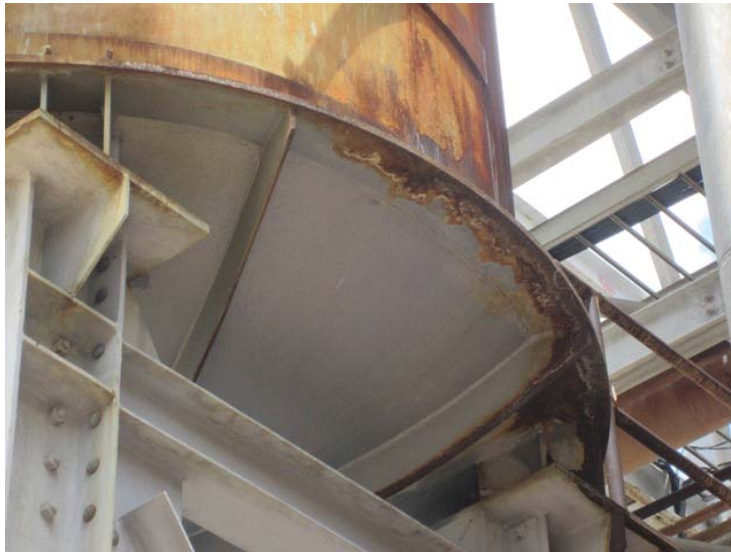
Corrosion Rating: 6.0 - 1% rust

Corrosion Type: B - Surface Rust

Corrosion on structure

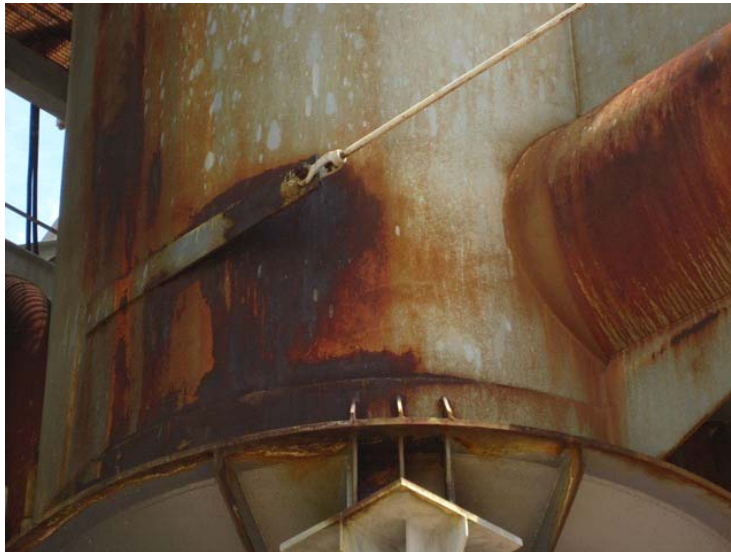
Corrosion Rating: 6.0 - 1% rust

Corrosion Type: B - Surface Rust

Close up view of corrosion

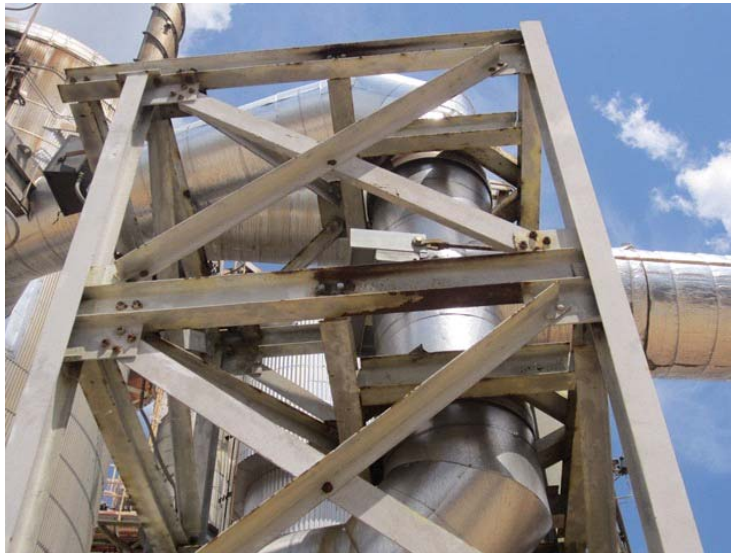
Comments: Undercutting on Preheater Structure.

View of structure

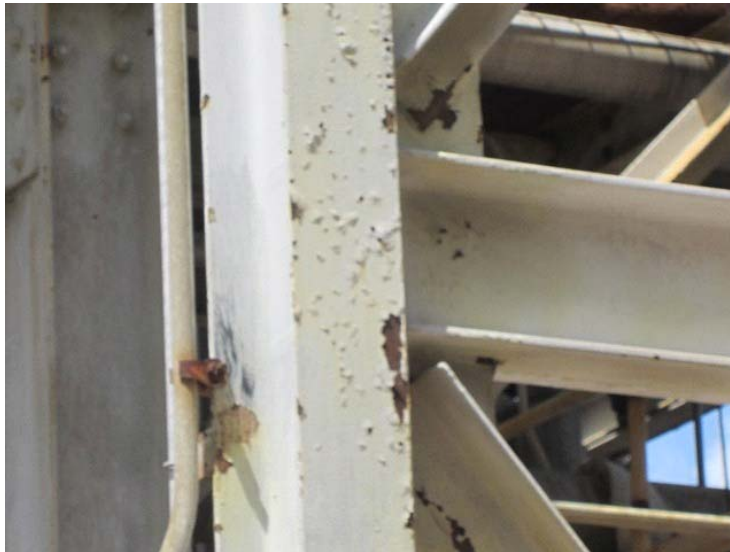
Comments: Localized, Undercutting on Structure Southeast side of Section.

Corrosion visible on structure

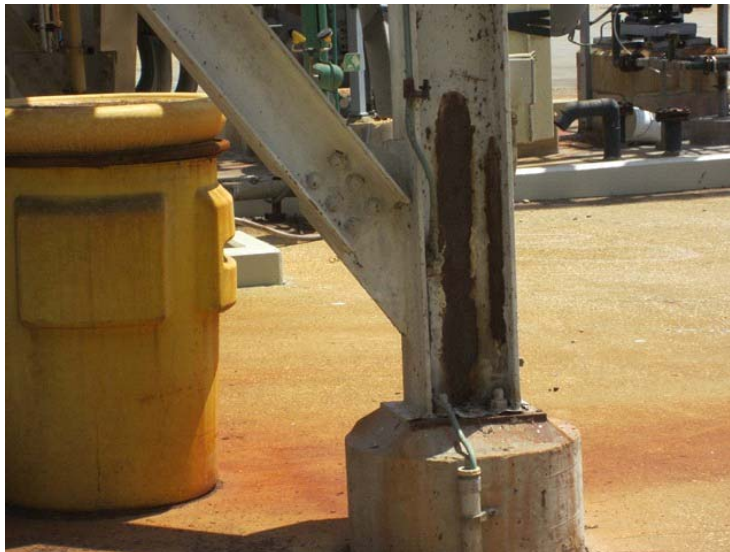
Comments: Edge of Corrosion on Structure. Some Undercutting on West side.

Corrosion on structure

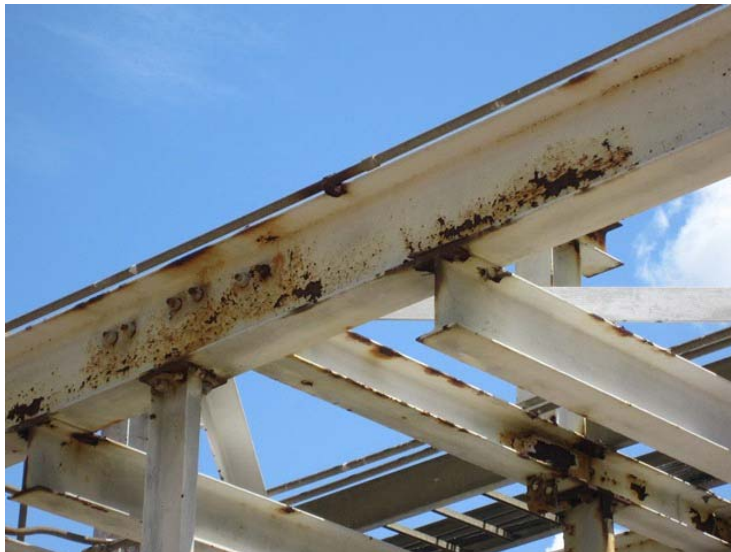
Comments: Edge of Corrosion on Structure. Some Undercutting on West side.

Corrosion on structural steel

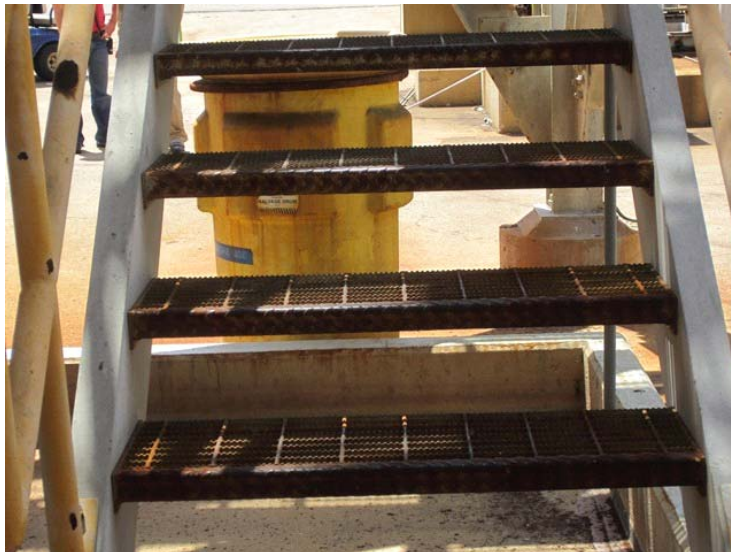
Comments: Edge of Corrosion on Structure. Some Undercutting on West side.

Corrosion on stairs

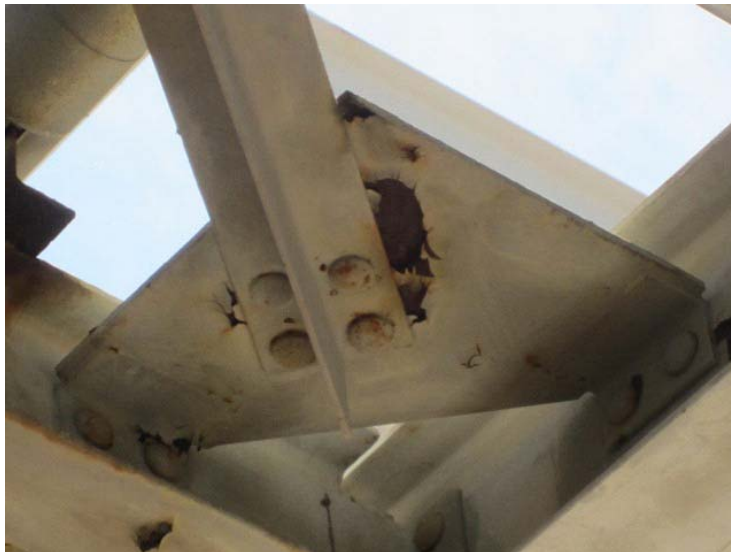
Corrosion Rating: 6.0 - 1% rust

Corrosion Type: D - Undercutting or Mill Scale

Corrosion on structure

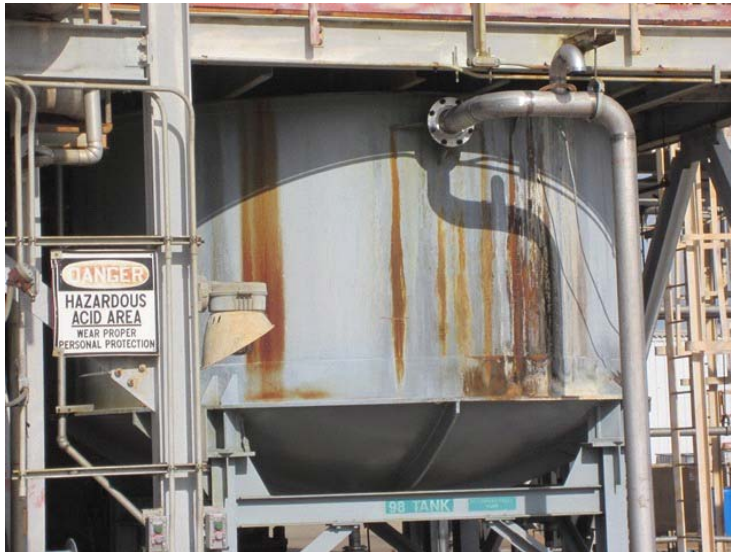
Corrosion Rating: 6.0 - 1% rust

Corrosion Type: C - Edge or Pinhole Corrosion

View of corrosion in section

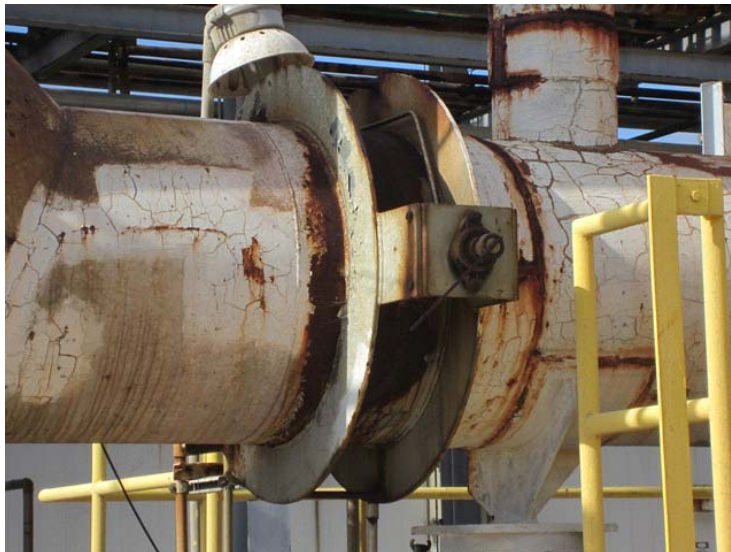
Corrosion Rating: 6.5 - 0.7% rust

Corrosion Type: D - Undercutting or Mill Scale

Corrosion on pipe

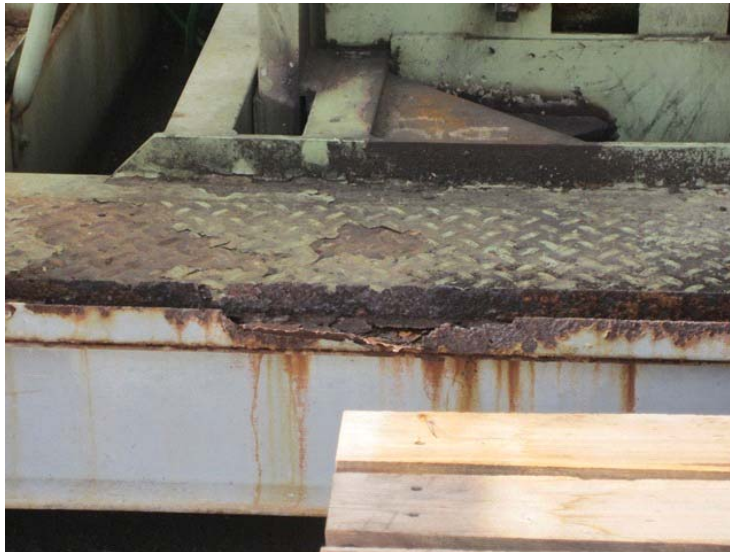
Comments: Localized- Miscellaneous structure and pipe in Section and Pumps on West side.

Metal loss on structure

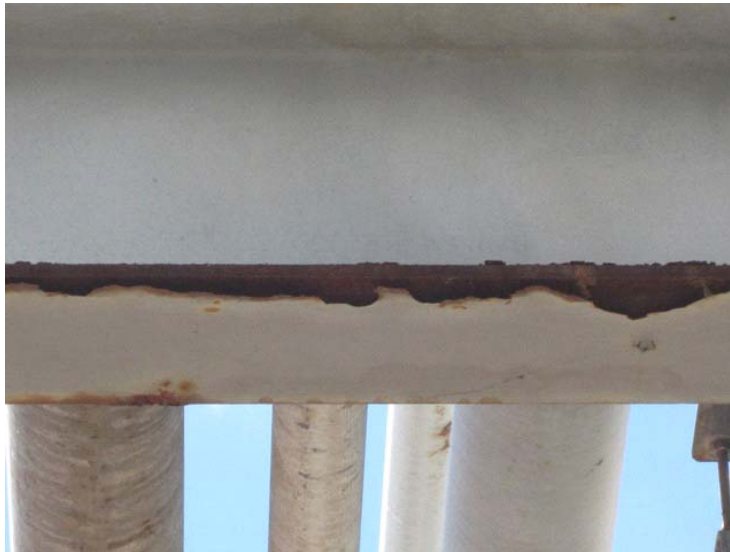
Environment Rating 3 - Moderate
Visibility: 5 - Moderate Traffic or Visibility
Corrosion Rating: 6.0 - 1% rust
Corrosion Type: D - Undercutting or Mill Scale
Priority: 3 - Wearout

Corrosion on structure

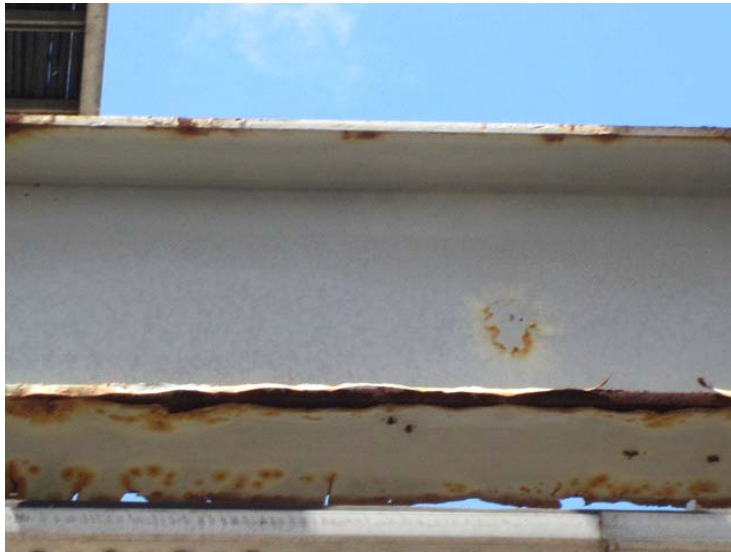
Environment Rating 3 - Moderate
Visibility: 5 - Moderate Traffic or Visibility
Corrosion Rating: 6.0 - 1% rust
Corrosion Type: D - Undercutting or Mill Scale
Priority: 3 - Wearout

Corrosion on structure

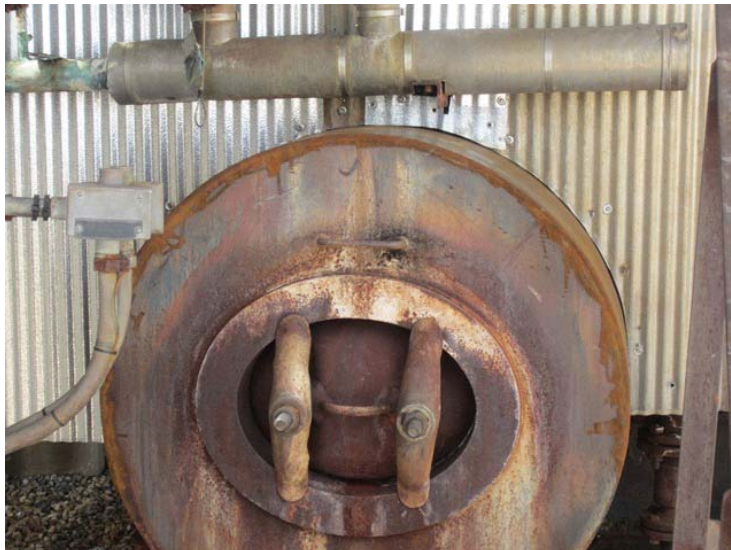
Corrosion on equipment

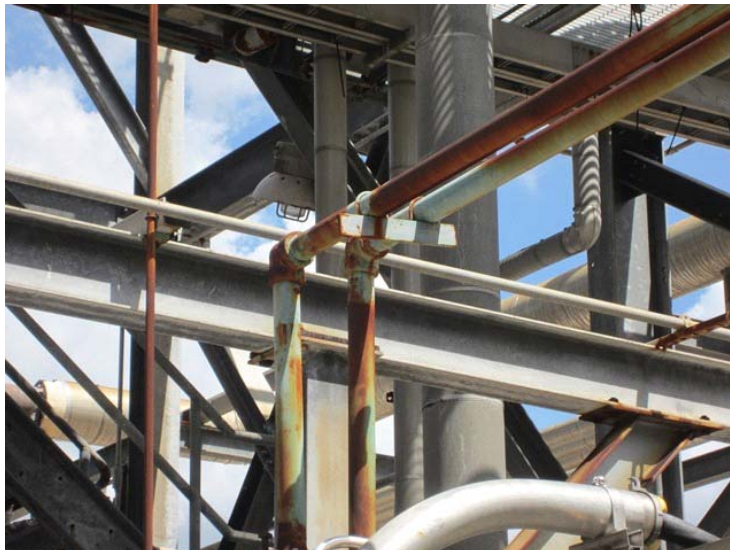
View of corrosion on piping

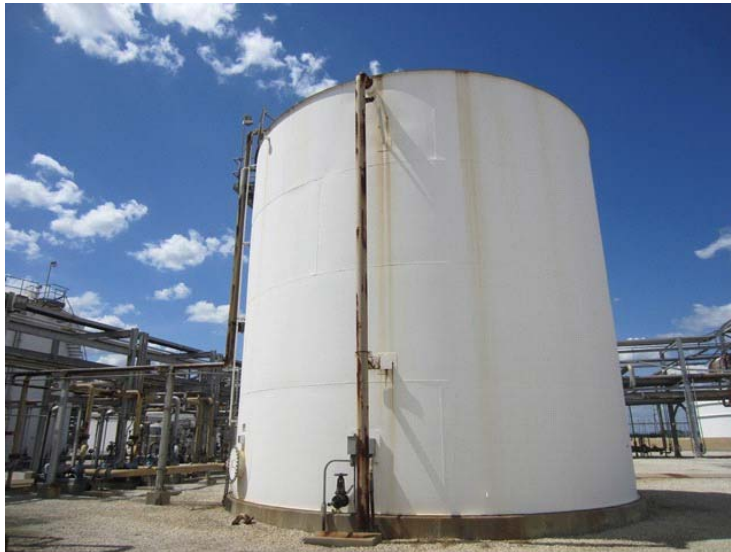
Environment Rating 3 - Moderate
Visibility: 3 - Tank Area
Corrosion Rating: 7.5 - 0.2% rust
Corrosion Type: D - Undercutting or Mill Scale
Priority: 7 - Fair

General view of tank

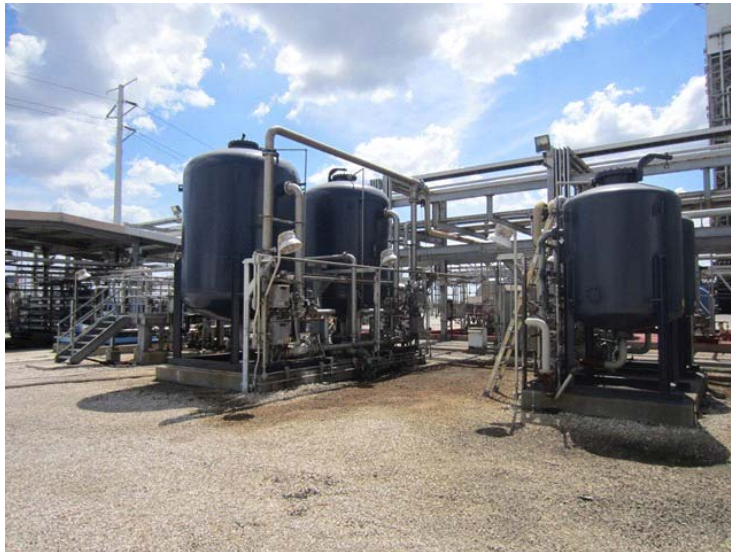
Environment Rating 3 - Moderate
Visibility: 3 - Tank Area
Corrosion Rating: 7.5 - 0.2% rust
Corrosion Type: D - Undercutting or Mill Scale
Priority: 7 - Fair

General view of tanks in section

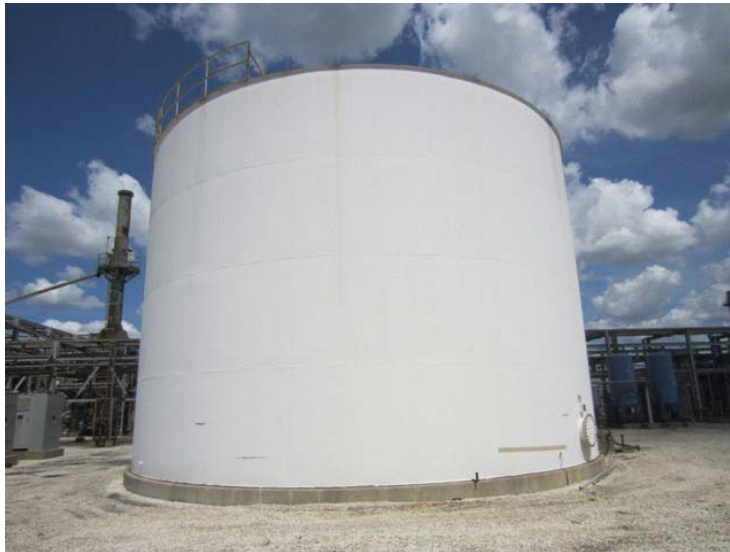
General view of tank in section

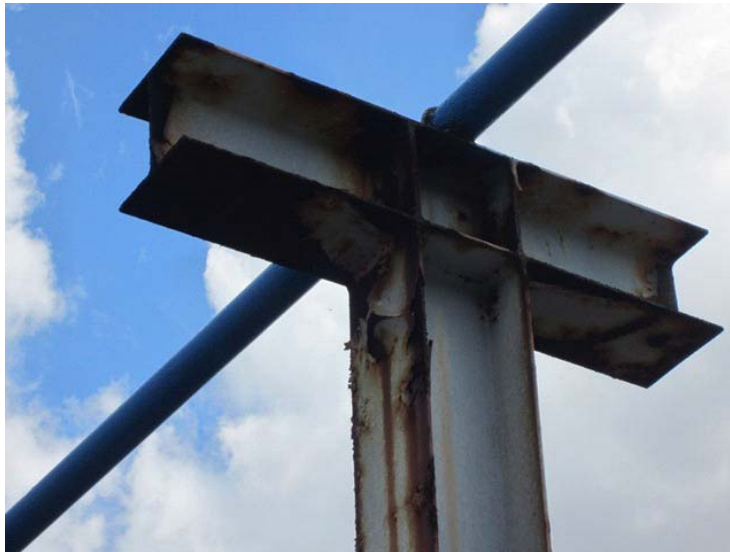
Corrosion on structure

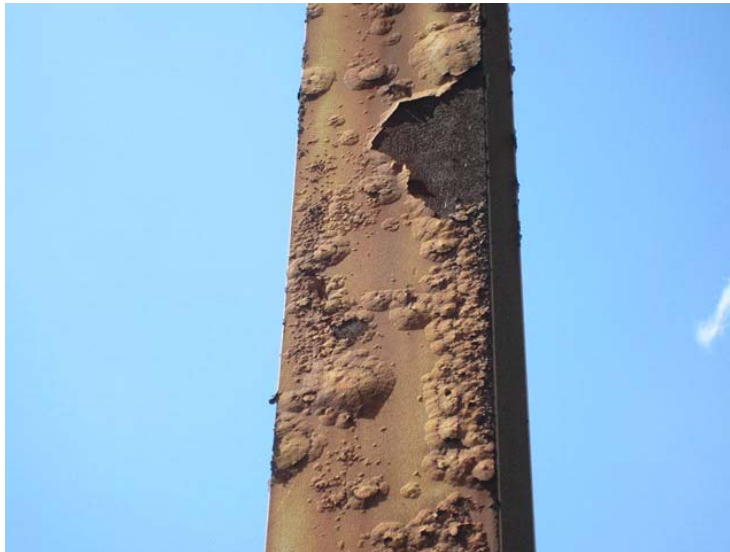
Priority: 4 - Substandard

Severe corrosion on structure

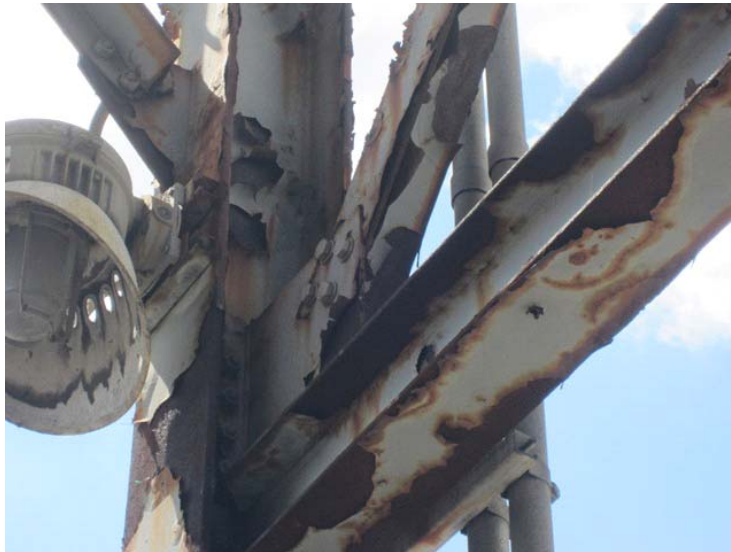
View of corrosion in section

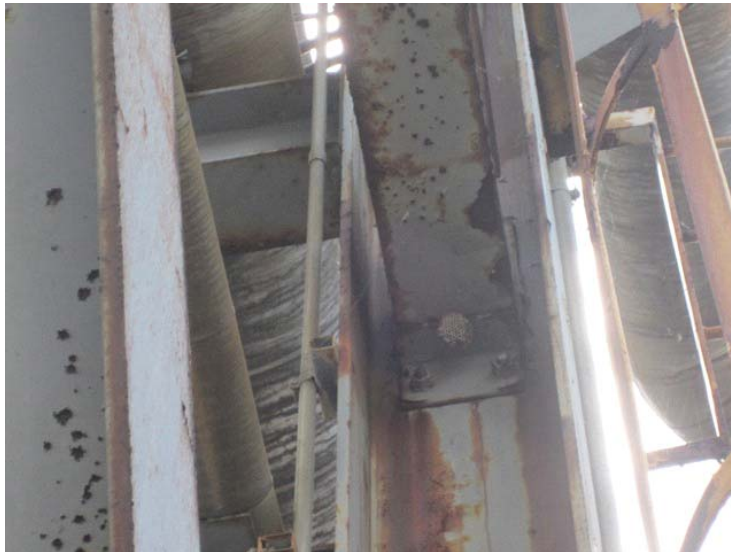
Corrosion on structure

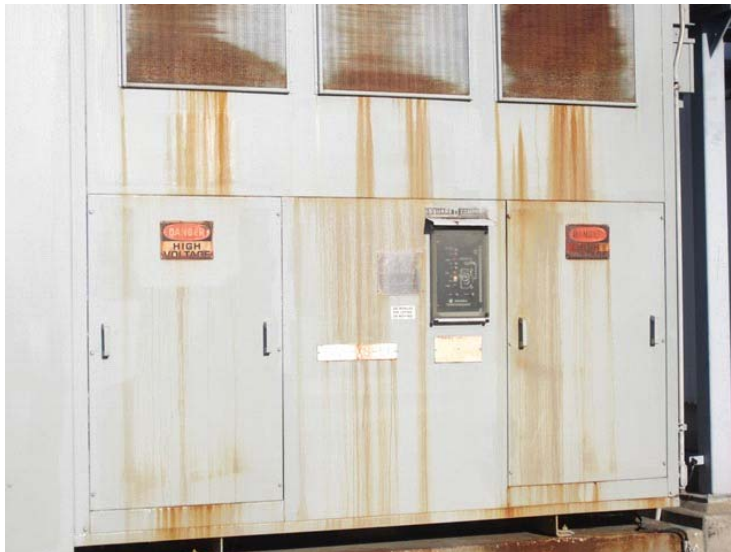
Environment Rating 3 - Moderate
Visibility: 5 - Moderate Traffic or Visibility
Corrosion Rating: 7.0 - 0.3% rust
Corrosion Type: C - Edge or Pinhole Corrosion
Priority: 7 - Fair

View of surface rust

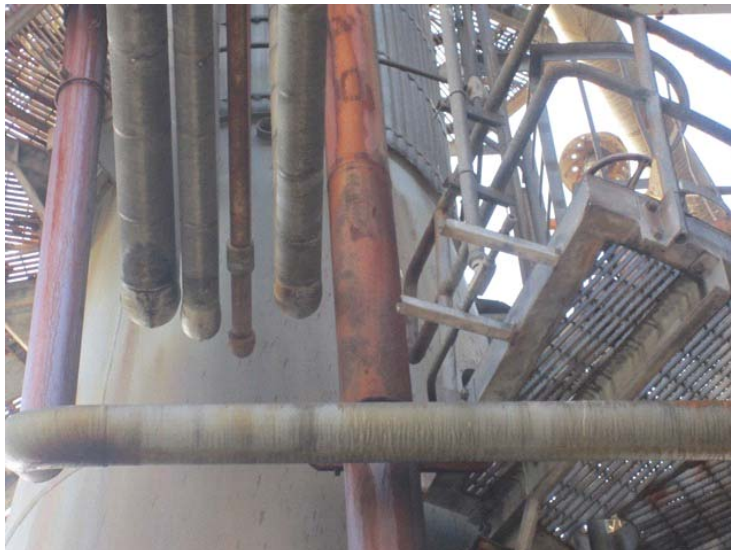
Corrosion on piping

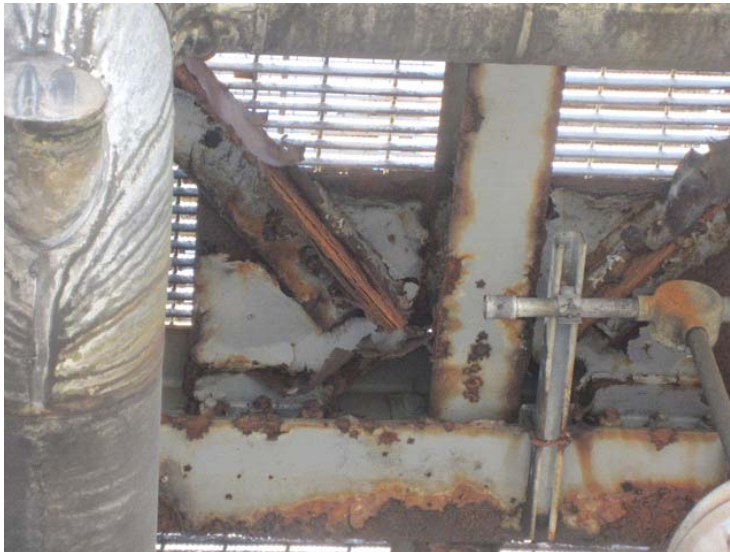
Comments: Metal Loss Throughout.

Severe corrosion on structure

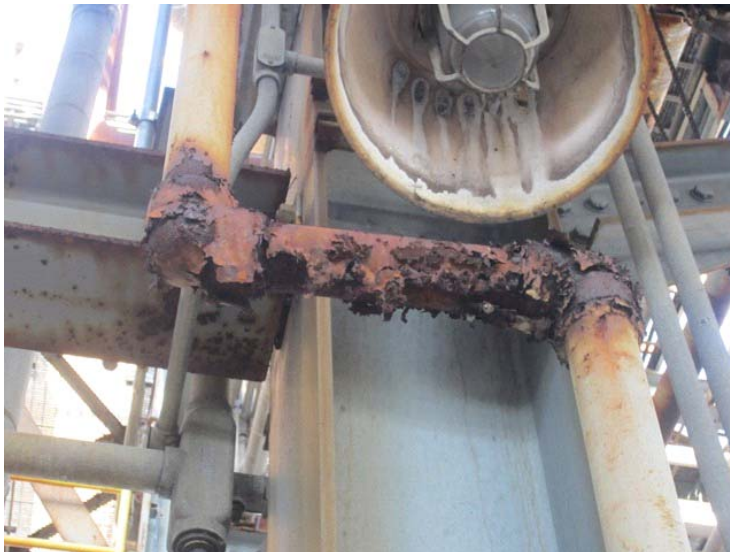
Corrosion Rating: 5.0 - 3% rust

Severe metal loss due to corrosion

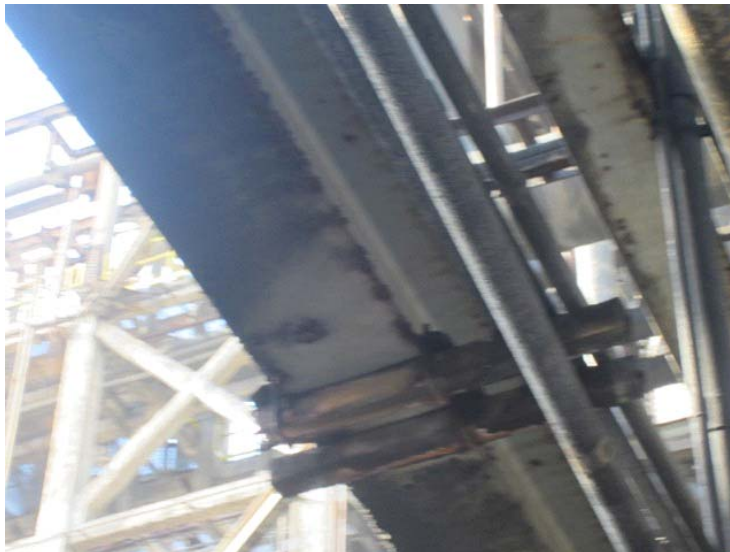
Corrosion on structure

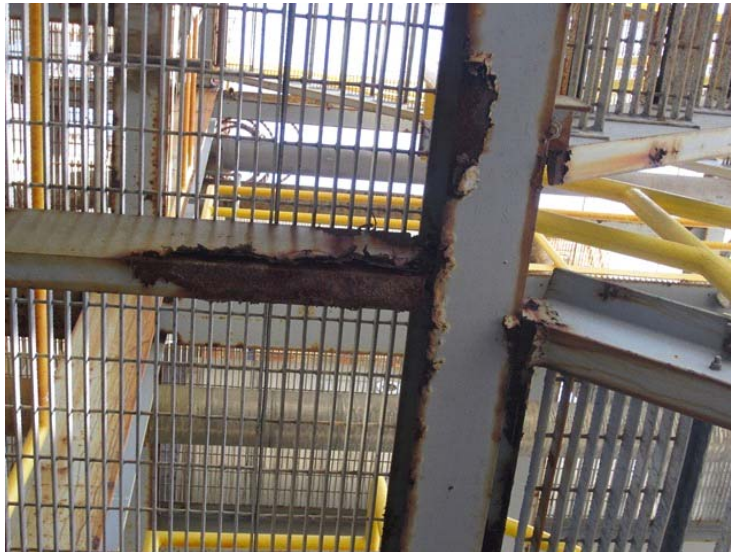
View of corrosion on structure

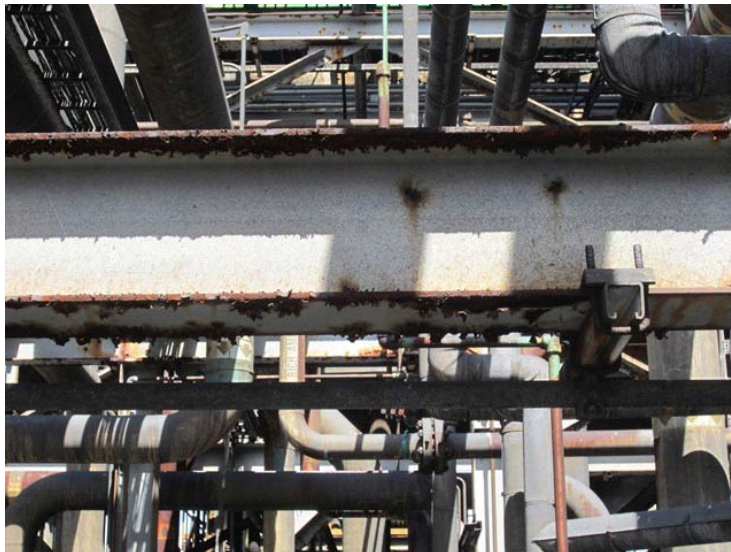
Corrosion on structure

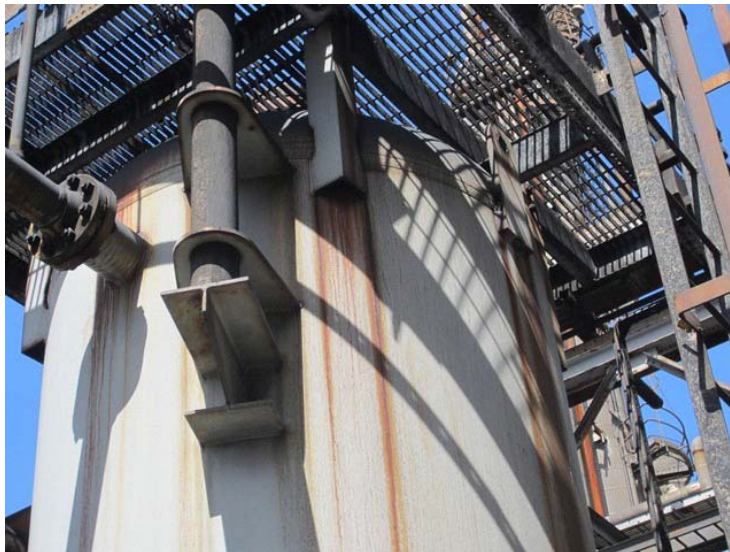
Corrosion on tower structure
