Condition Analysis

Block: 01 Northwest Unit of the plant. Includes Gasification Unit, Brine Unit, Acid Unit, Coal Slurry Building, and pipe lines to flares.

Subblock: A On West side of Block 1. Contains Flare, pipe racks to flare, and conveyor belt.

Section: 01 Flare and associated structure.

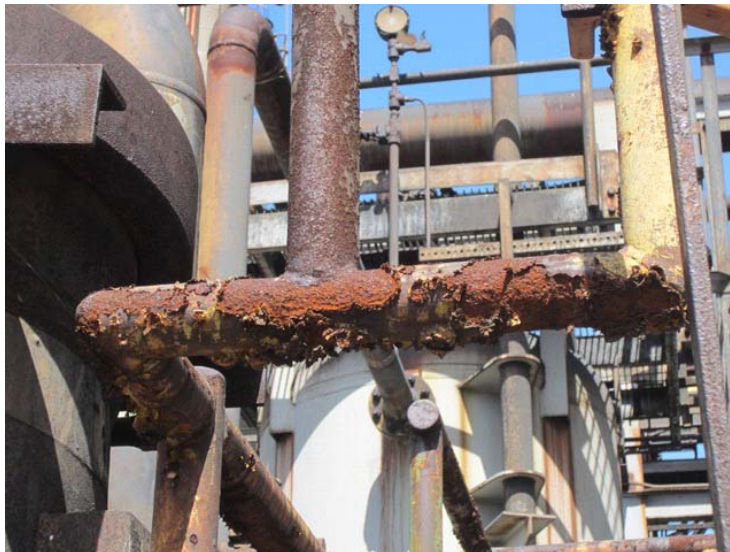
Heavy corrosion on piping

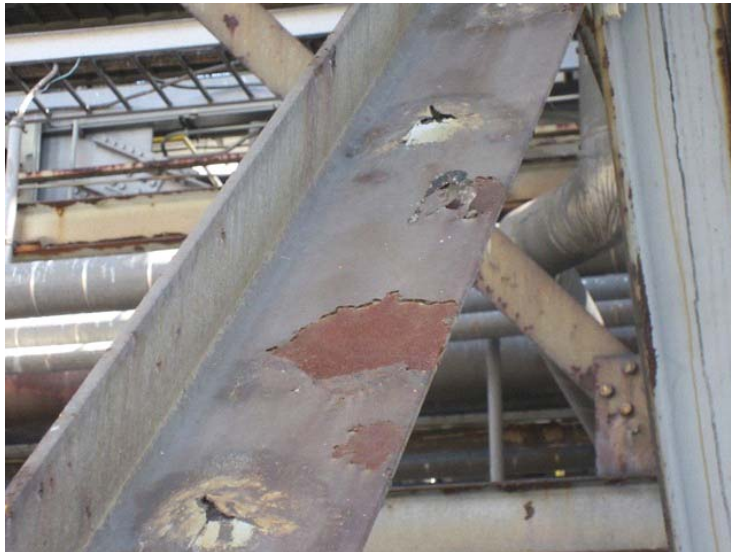
Visible undercutting on structure

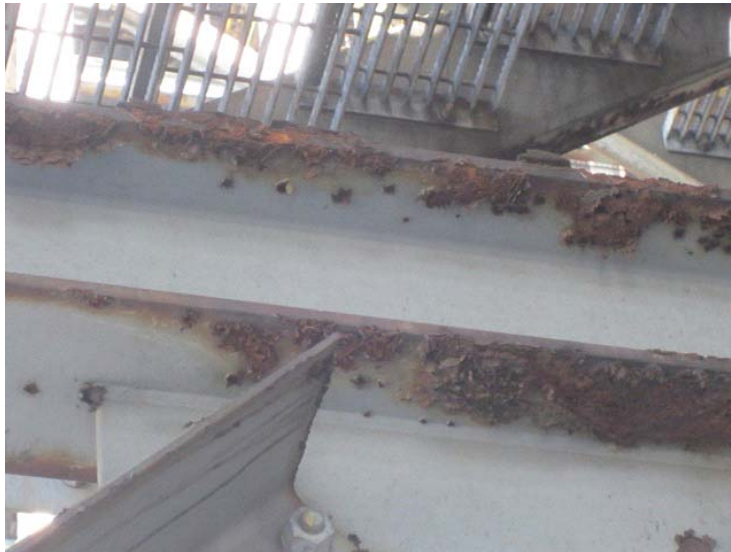
Heavy corrosion on structural steel

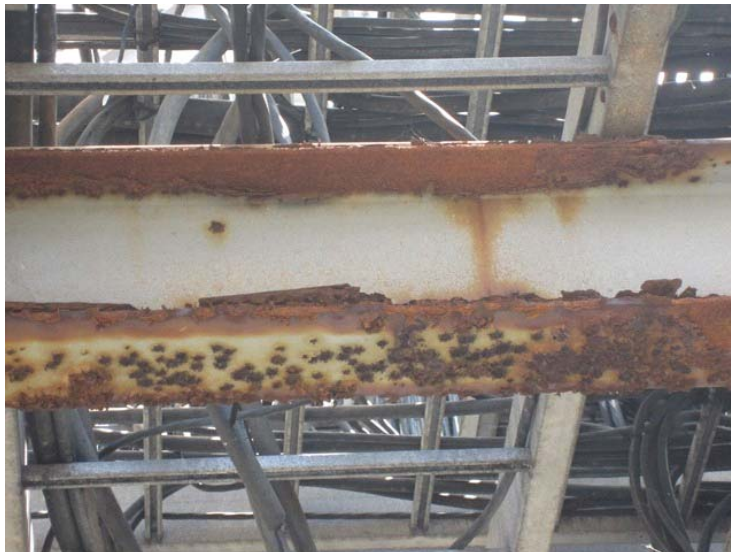
Corrosion on structural steel

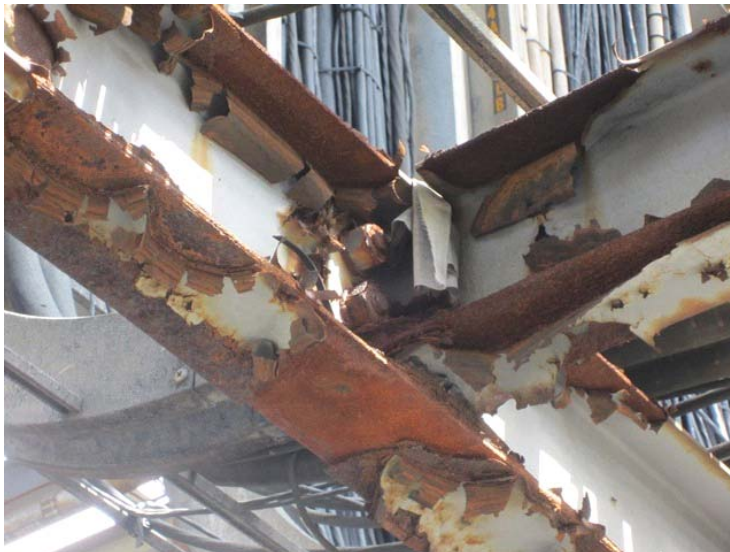
Undercutting rust on structure

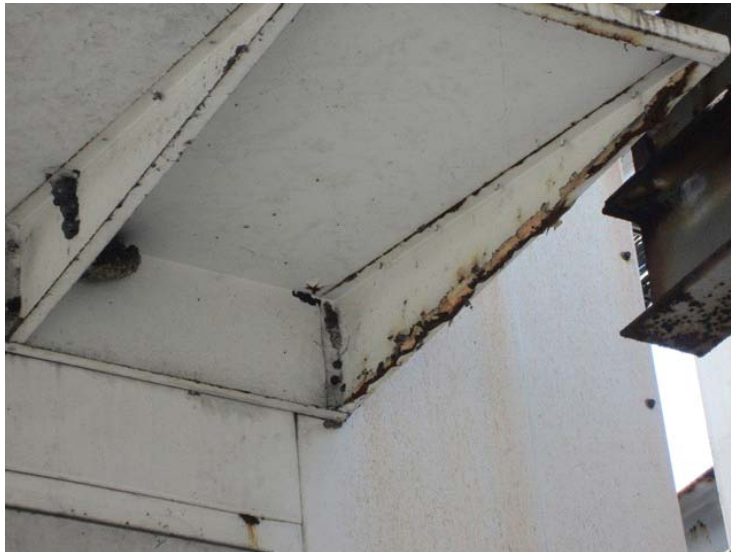
Corrosion on building structure

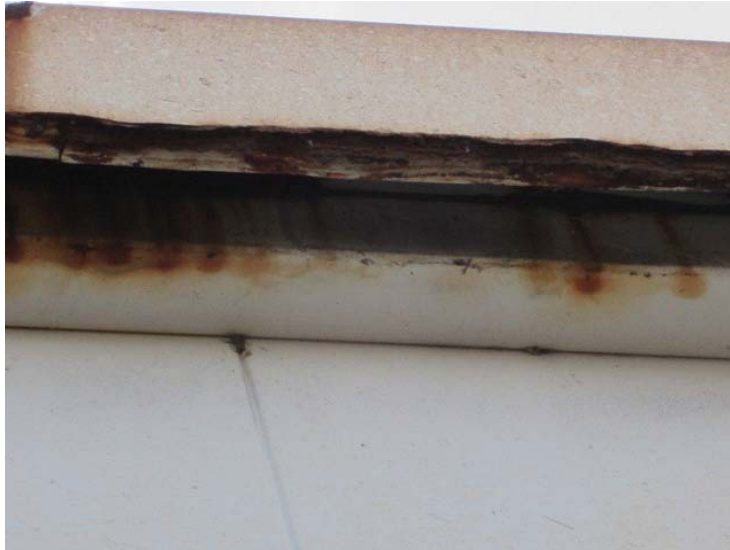
Severe corrosion on building structure

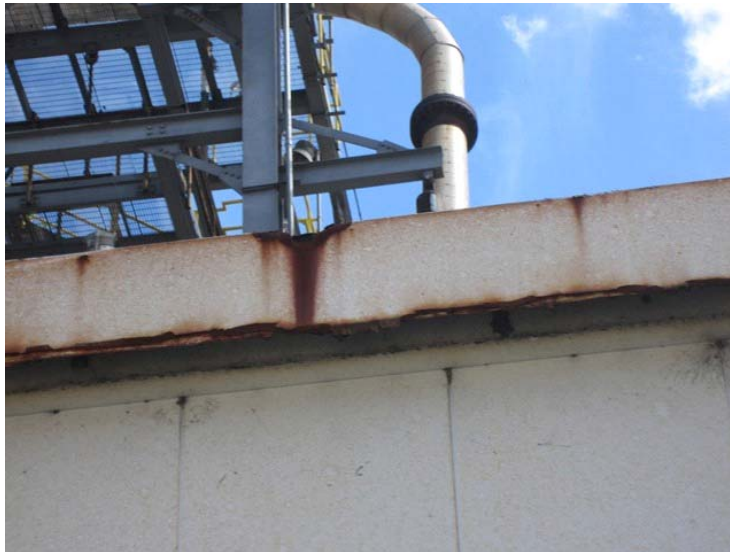
Heavy corrosion on building structure

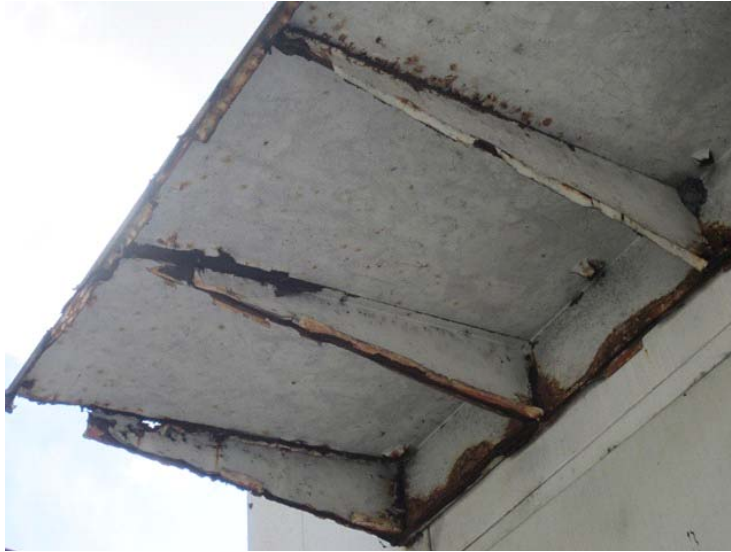
View of corrosion on building

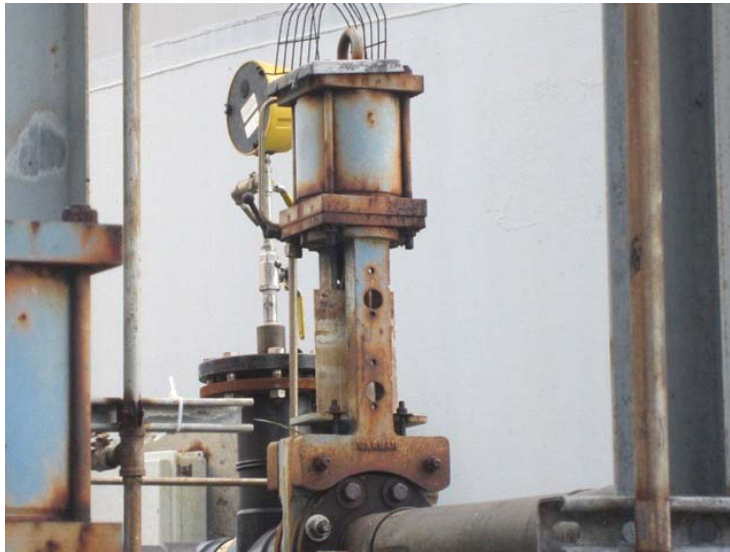
Comments: Optimum- Pinhole Corrosion Northwest side.

Corrosion on equipment

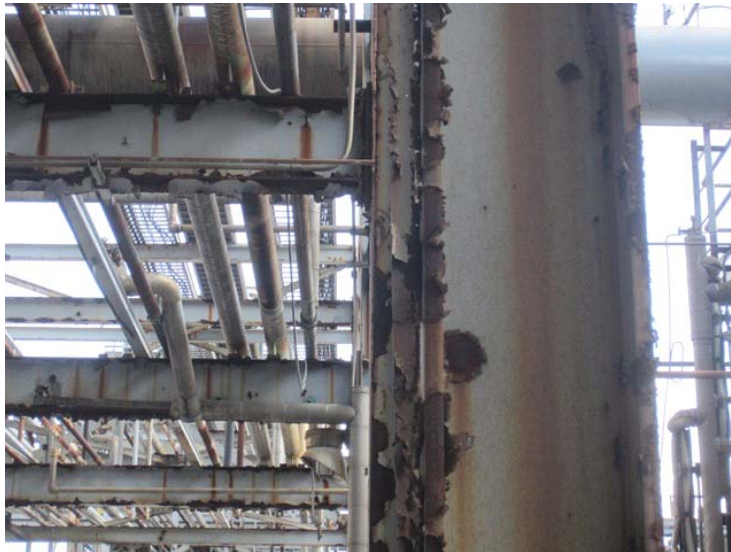
Corrosion on structure

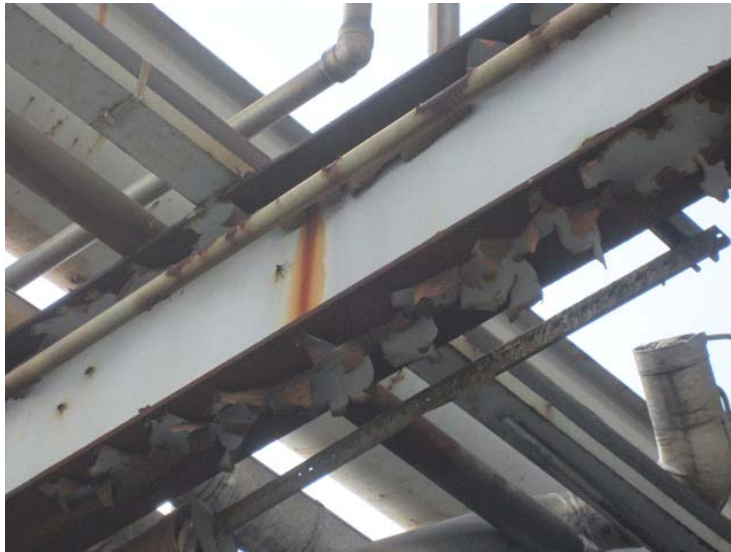
Heavy corrosion on structural steel

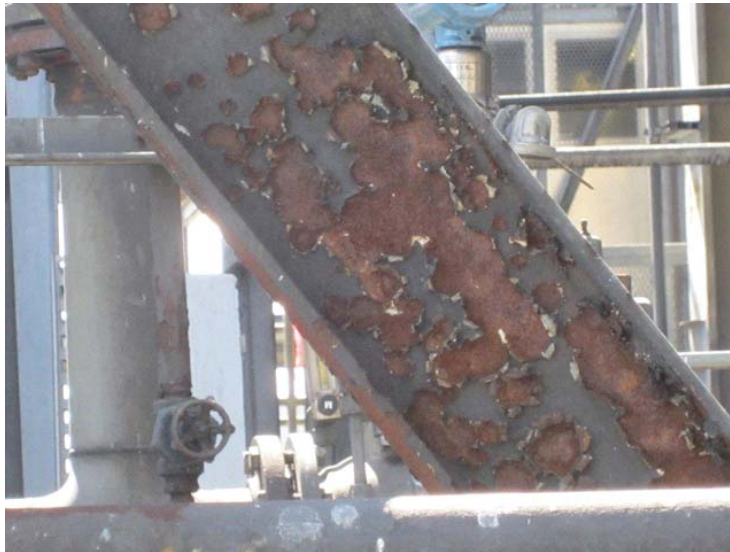
Corrosion Rating: 6.0 - 1% rust

Corrosion Type: D - Undercutting or Mill Scale

View of corrosion on structure

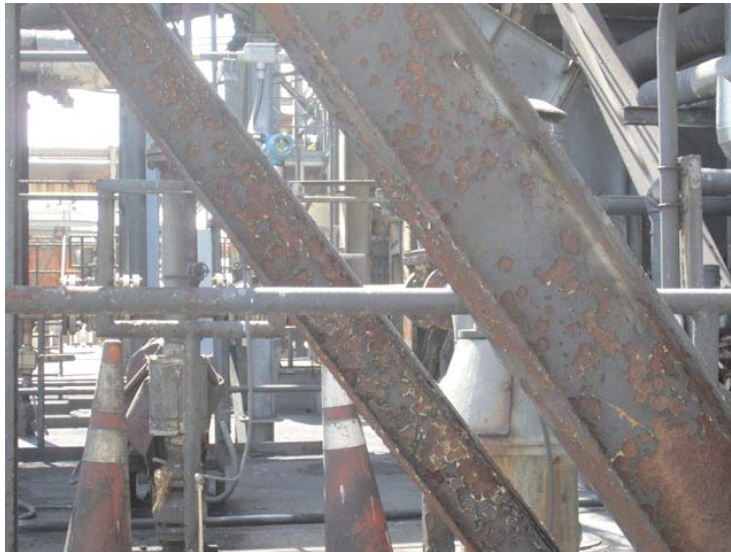
Corrosion Rating: 6.0 - 1% rust

Corrosion Type: D - Undercutting or Mill Scale

Heavy corrosion on structure

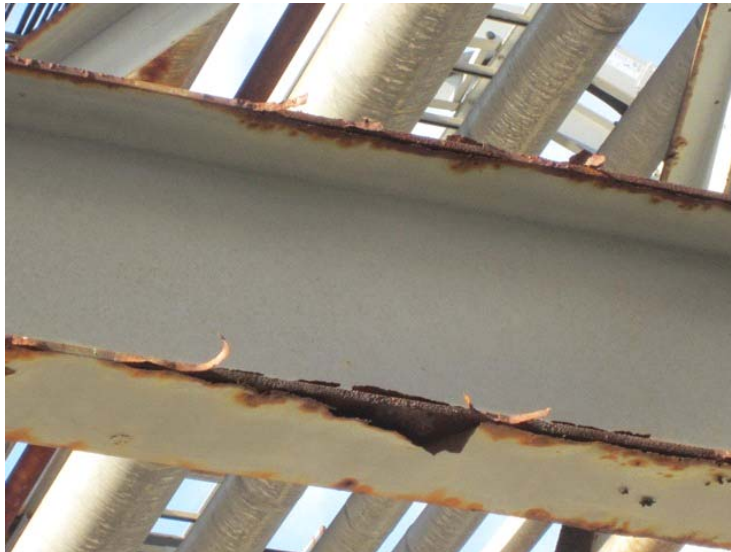
Comments: Heavy Corrosion Visible- Undercutting Throughout

View of corrosion occurring on structure

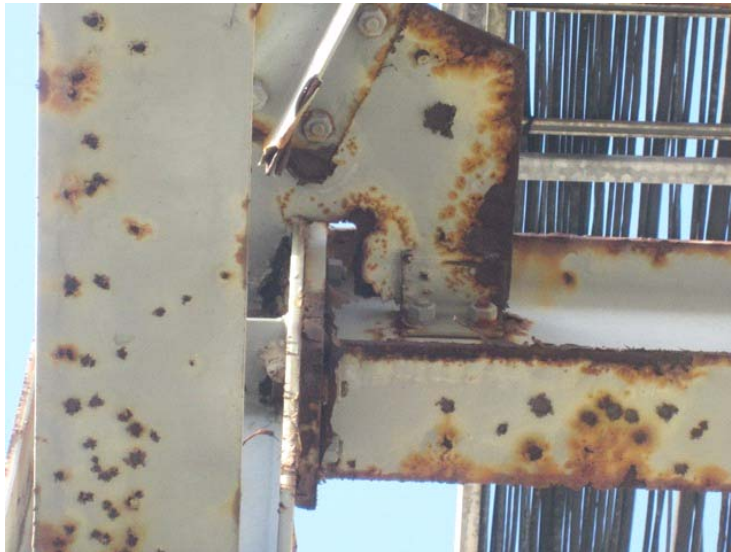
Comments: Heavy Corrosion Visible- Undercutting Throughout

Heavy corrosion on structure

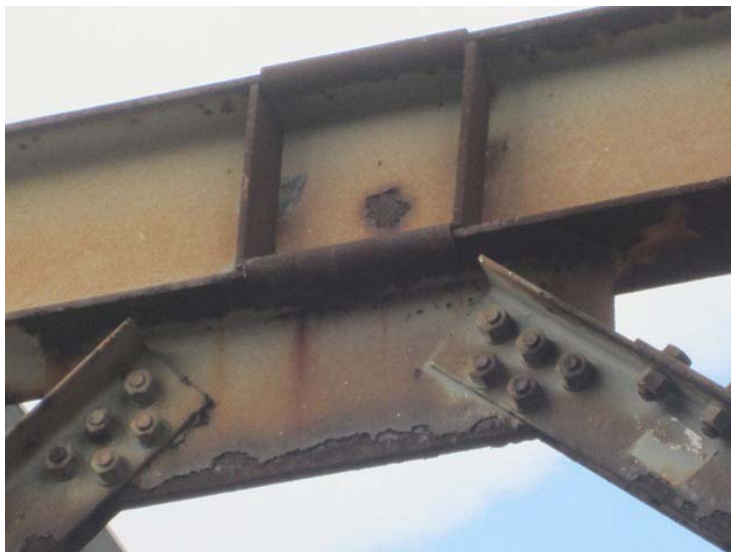
Corrosion on structural steel

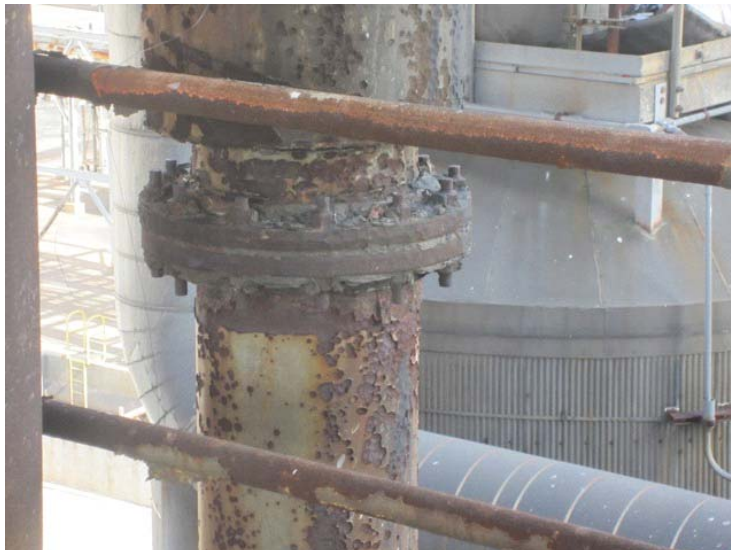
Heavy corrosion on pipe

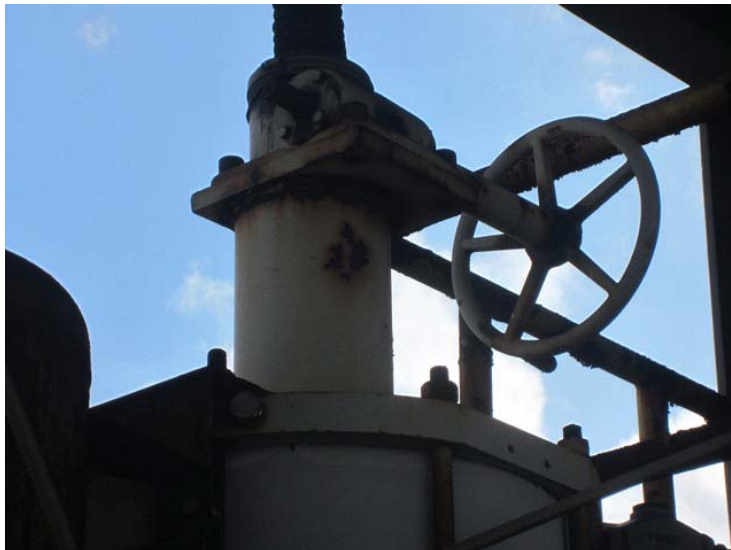
View of corrosion on valve

Comments: Localized-Flanges, Valves, and Pipe

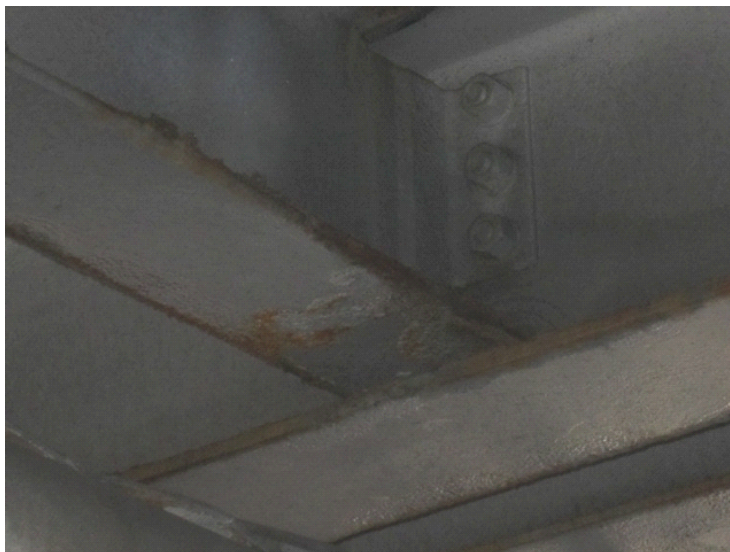
Corrosion on structure

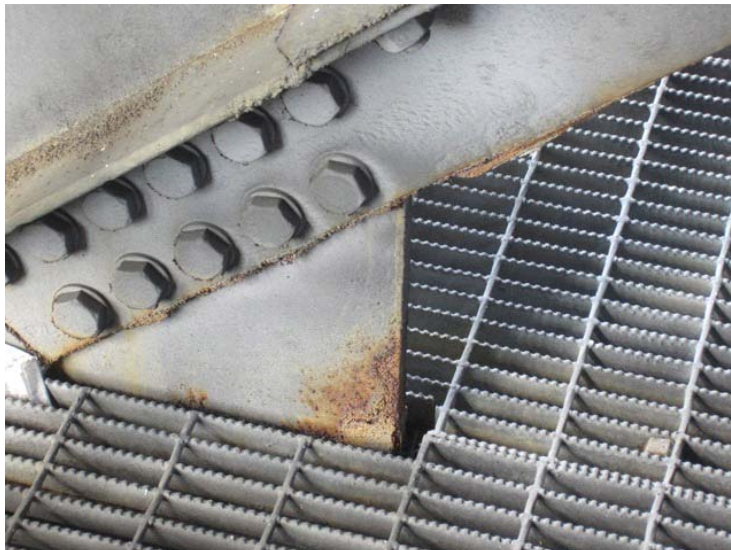
Corrosion on structural steel

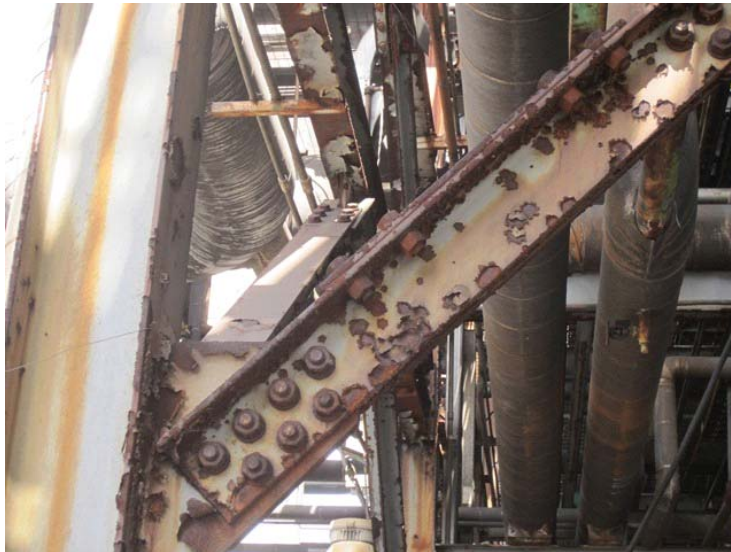
Priority: 1 - Advanced Corrosion

Corrosion on support structure

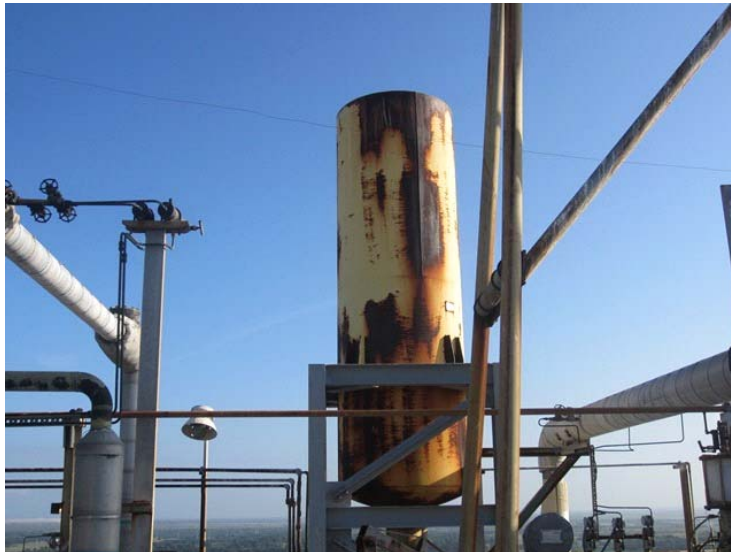
Heavy corrosion occurring

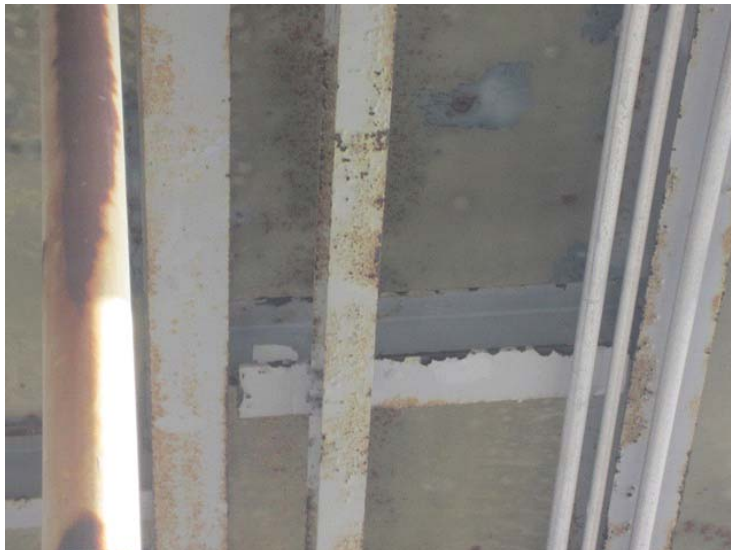
Comments: Pitting and Rust Nodules on Bottom of Roof Deck.

Corrosion on structure

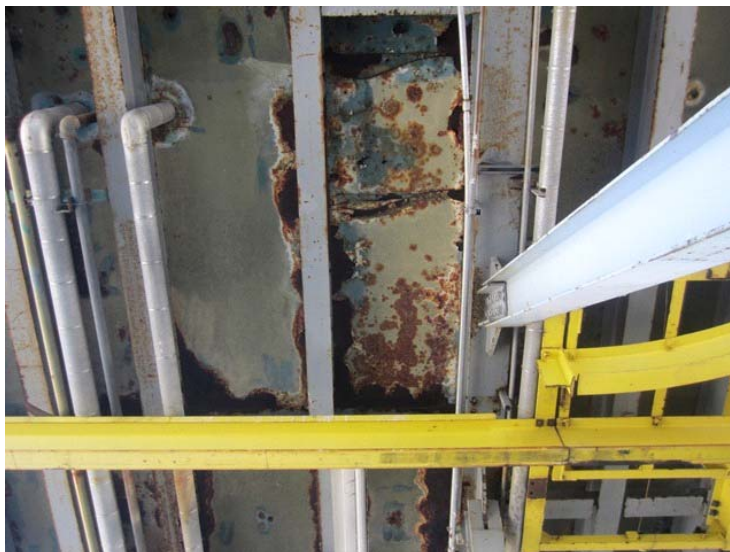
Comments: Pitting and Rust Nodules on Bottom of Roof Deck.

View of heavy corrosion

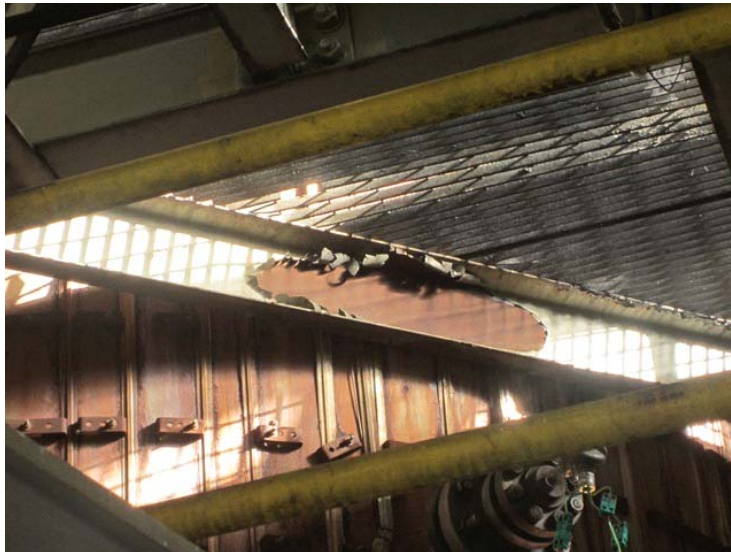
Comments: Localized Corrosion on Structure

Corrosion in section

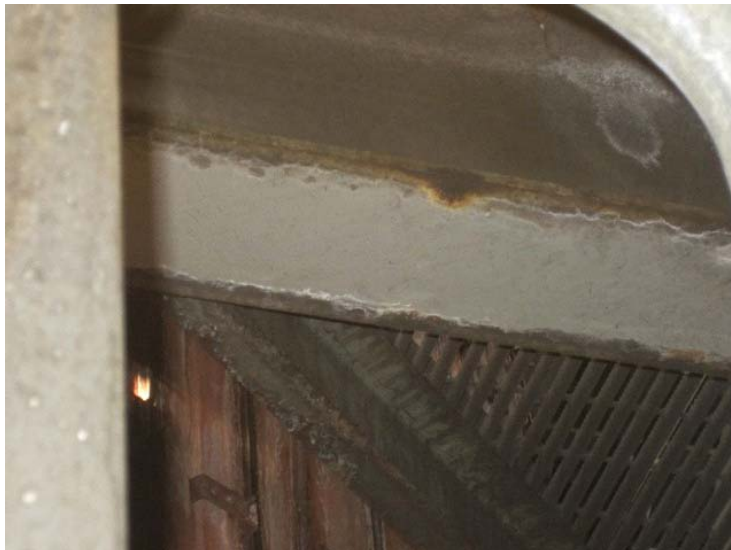
Corrosion on structure

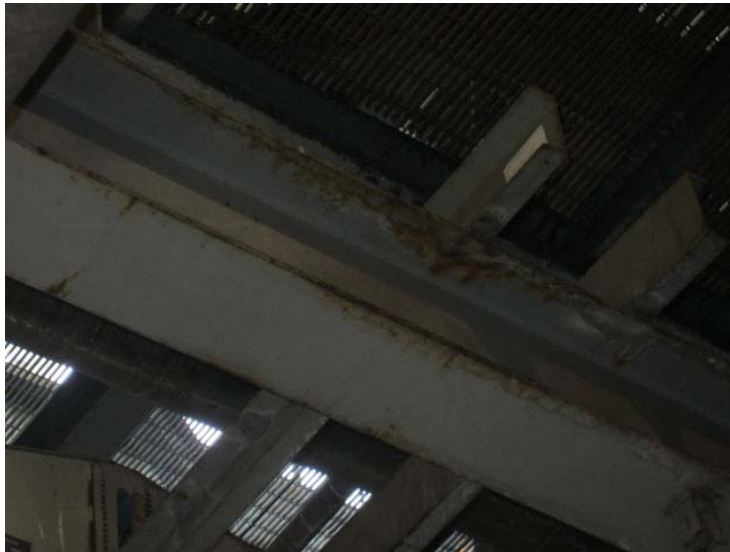
Edge corrosion occurring

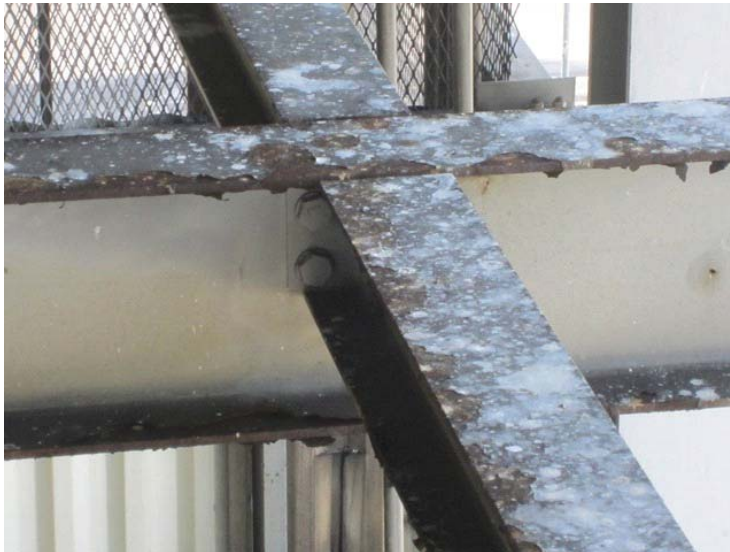
Comments: Heavy Undercutting and some Rust Nodules viewed

Corrosion on support structure

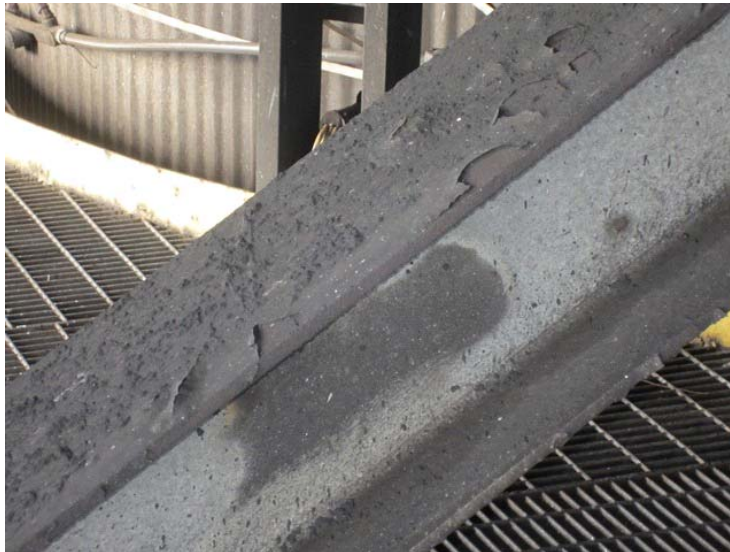
Comments: Heavy Undercutting and some Rust Nodules viewed

Undercutting visible on structure

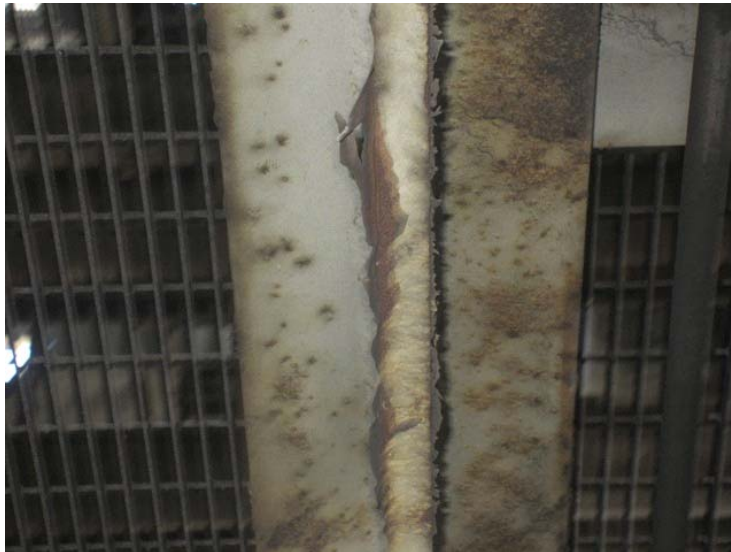
Comments: Heavy Undercutting and some Rust Nodules viewed

Corrosion on structure

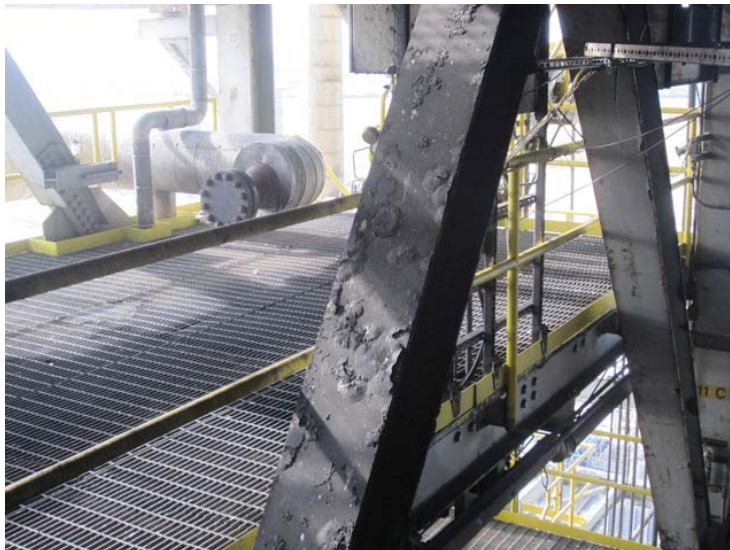
Comments: Heavy Corrosion Throughout

Rust nodules on structure

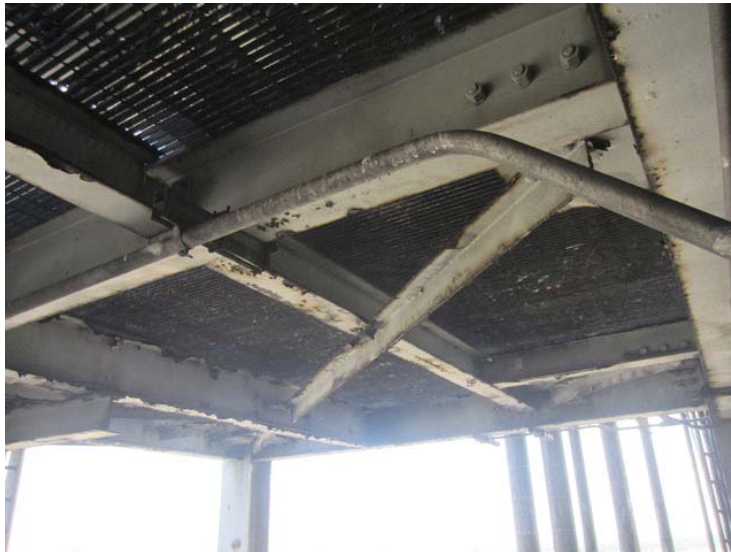
Comments: Heavy Corrosion Throughout

Corrosion on support structure

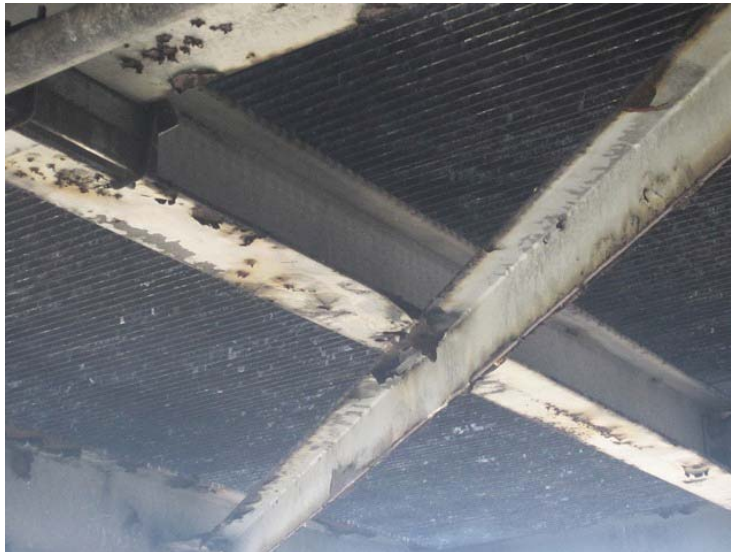
Comments: Heavy Corrosion Throughout

Close up view of corrosion

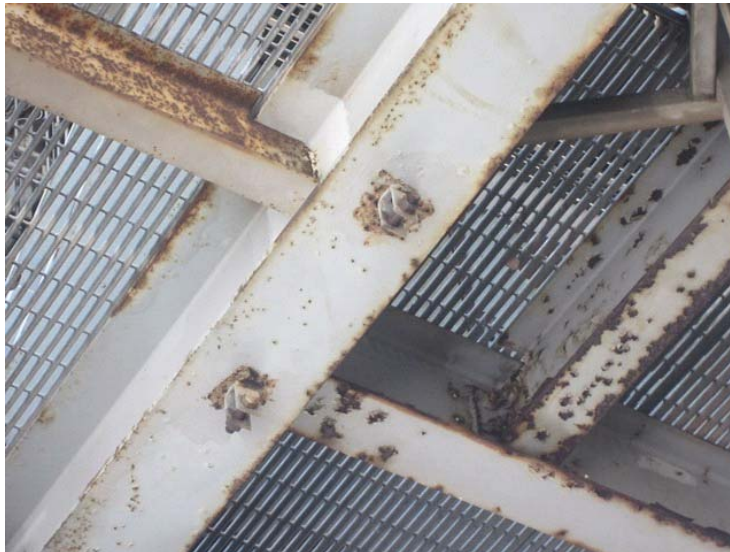
Comments: Heavy Corrosion Throughout

Corrosion on support structure

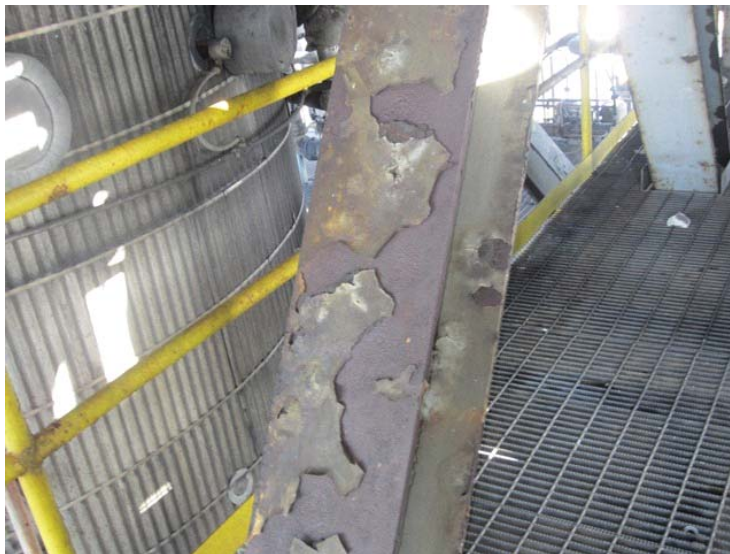
Corrosion Rating: 4.5 - 7% rust

Corrosion Type: F - Holes or Stratifications

Comments: Metal Loss Apparent

Undercutting visible on structure

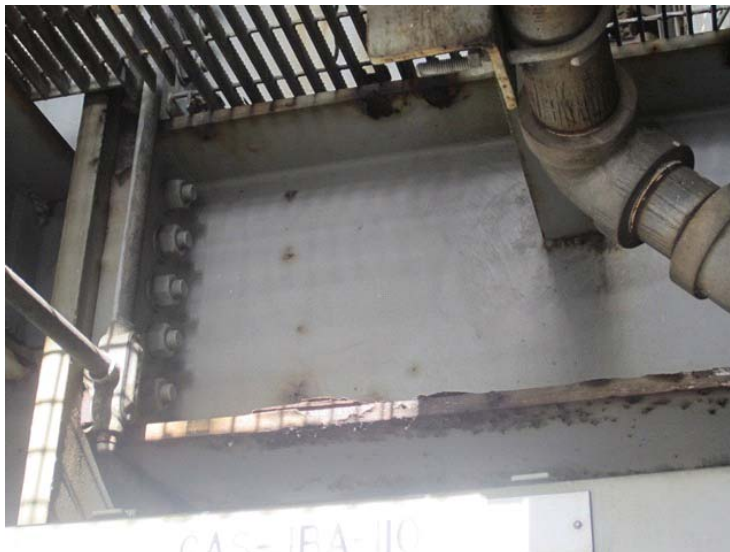
Comments: Metal Loss Apparent

Corrosion on structure

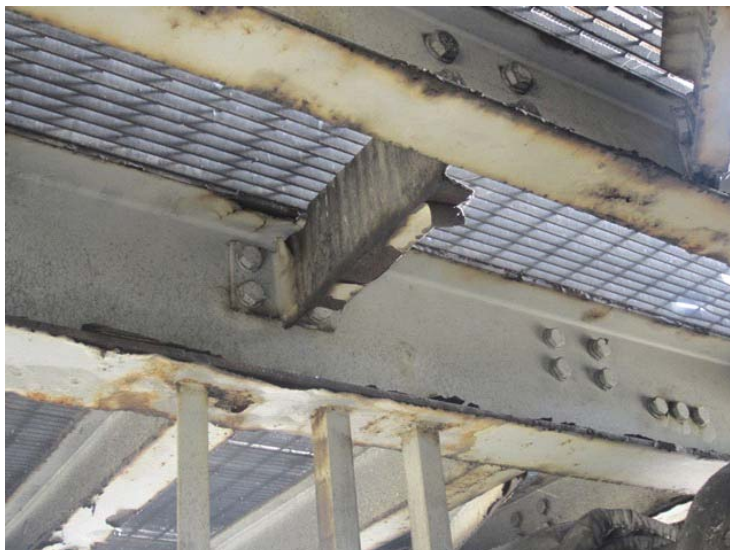
Edge corrosion on structure

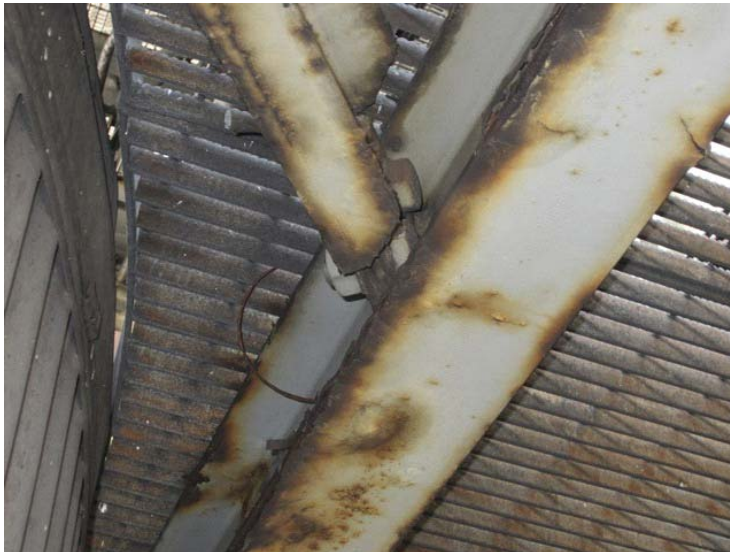
Comments: Metal Loss Apparent

Heavy edge corrosion

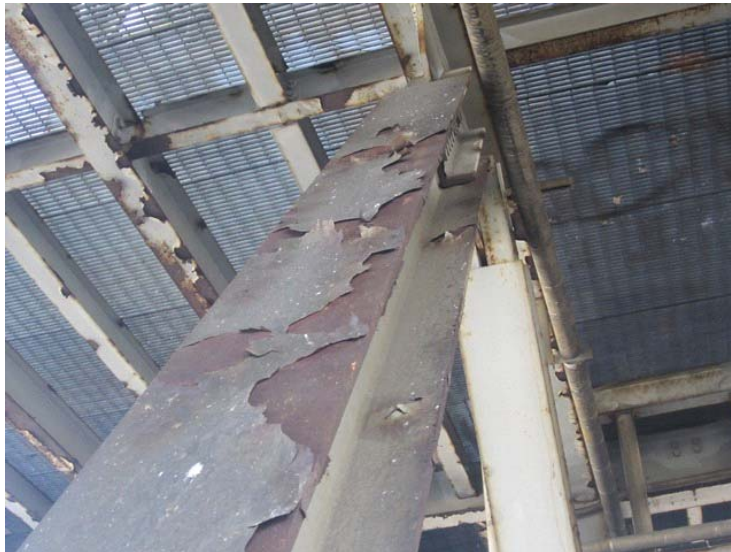
Comments: Metal Loss Apparent

View of corrosion on structure

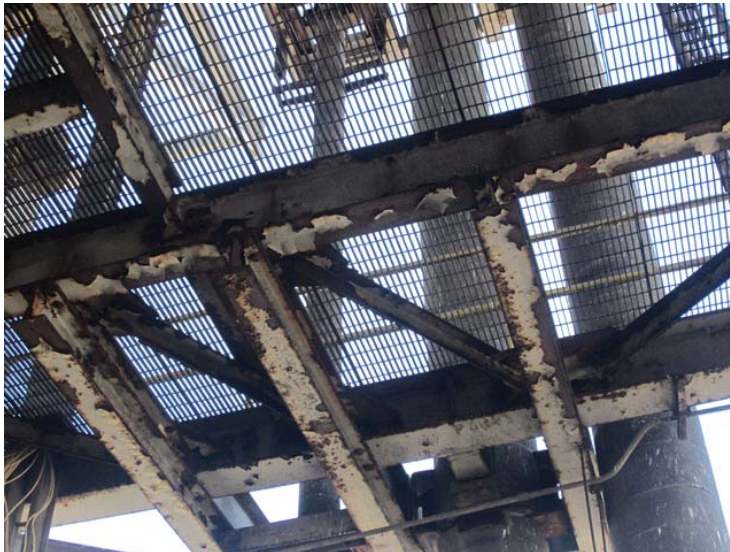
Comments: Metal Loss Apparent

Heavy corrosion on structure

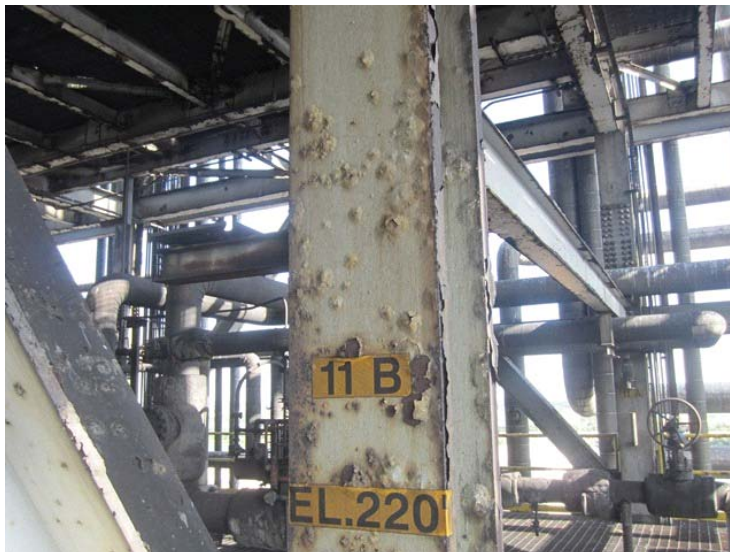
Comments: Pitting Apparent- Heavy Undercoating

Rust nodules on structural steel

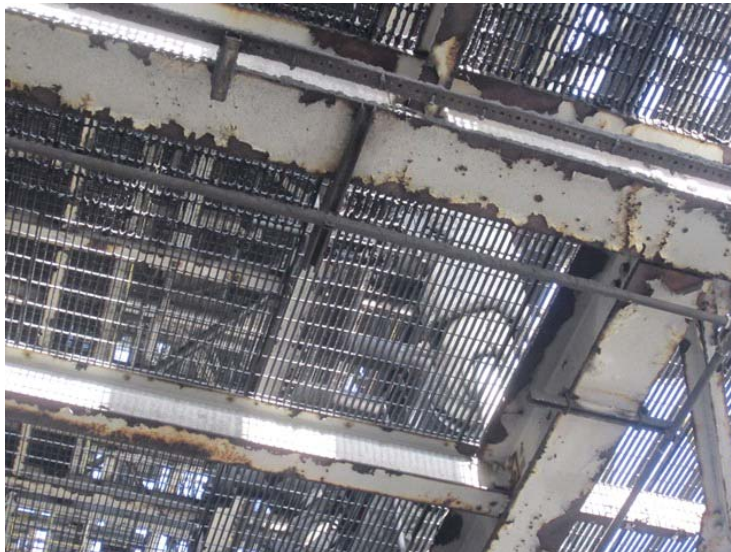
Comments: Pitting Apparent- Heavy Undercoating

Heavy corrosion on structure

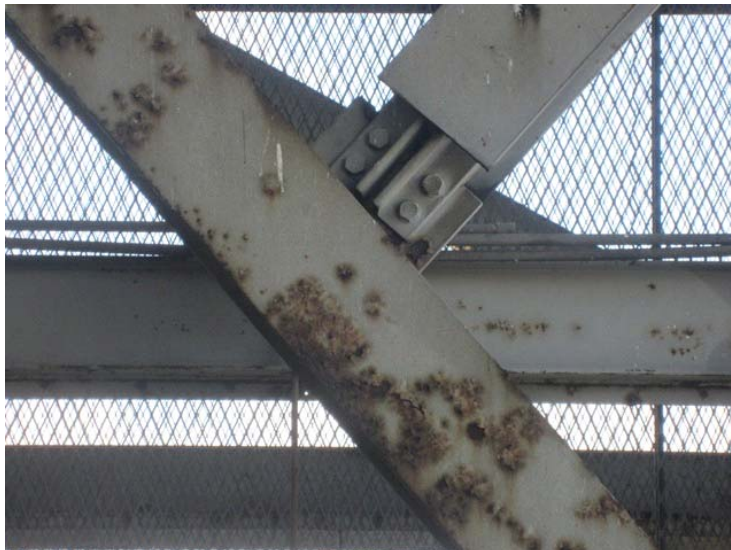
Corrosion on structure

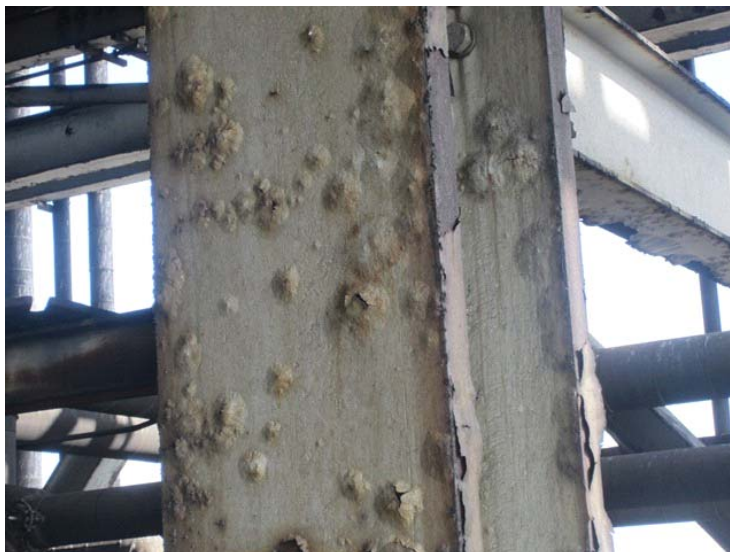
Rust nodules cover structure

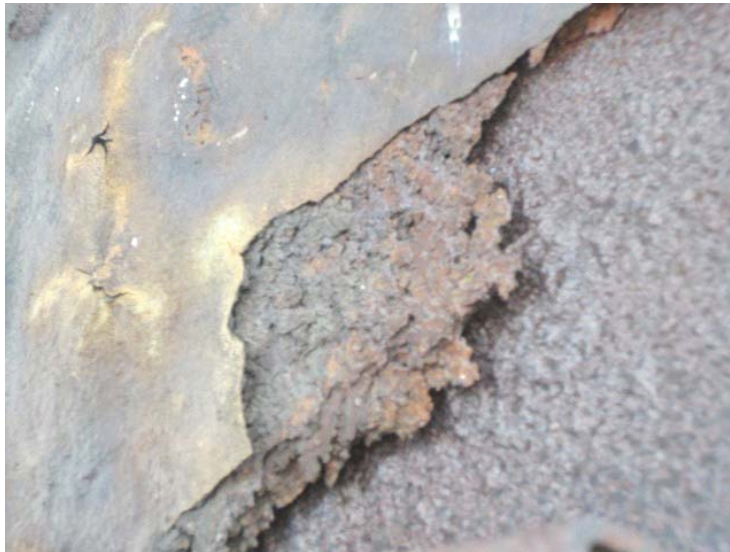
Close up view of metal loss

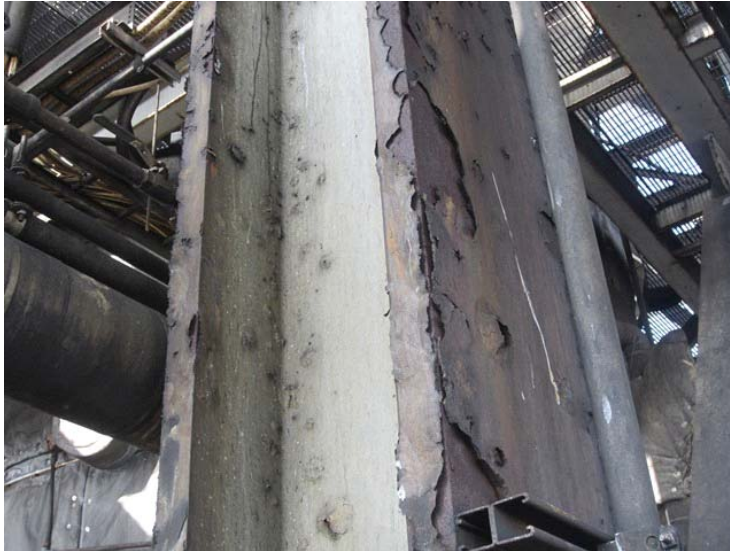
Corrosion on structure

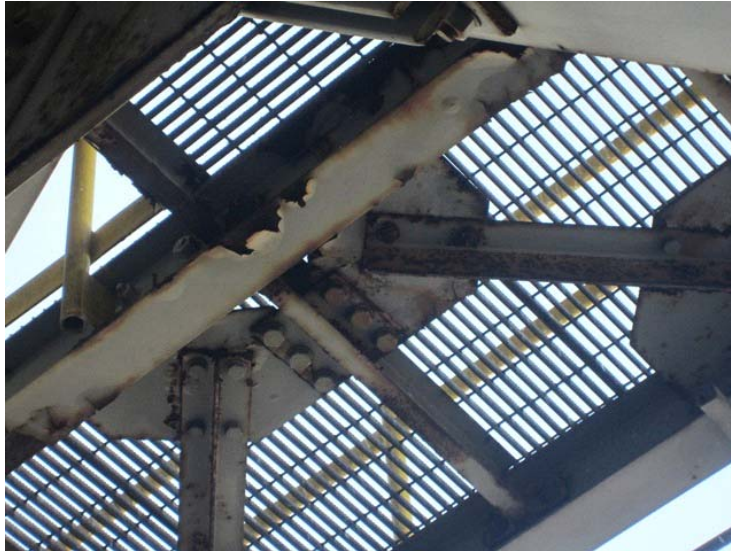
Undercutting visible on structure

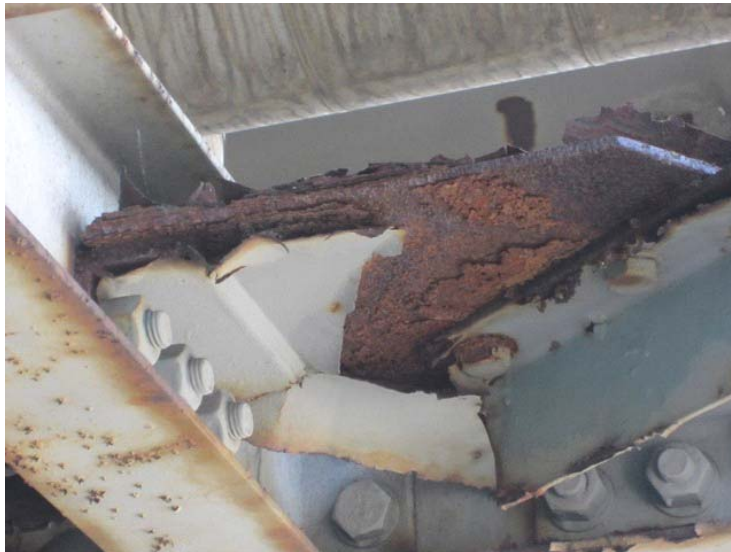
Heavy corrosion on supports

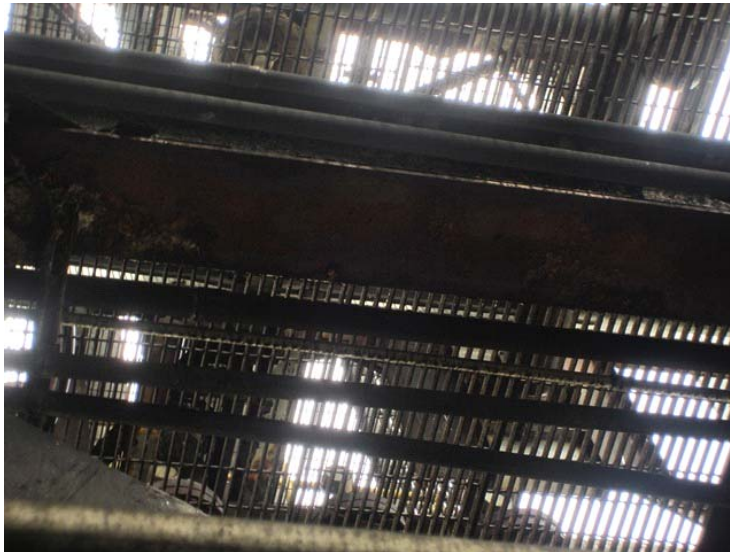
Heavy corrosion on support structure

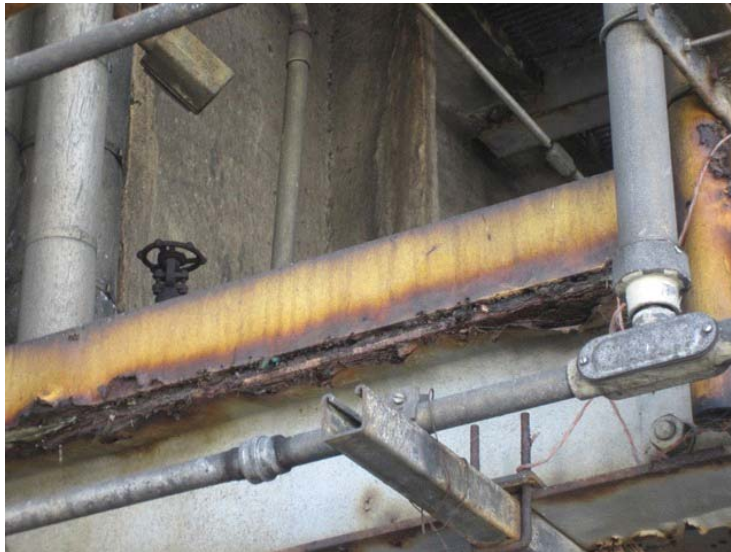
Heavy corrosion occurring

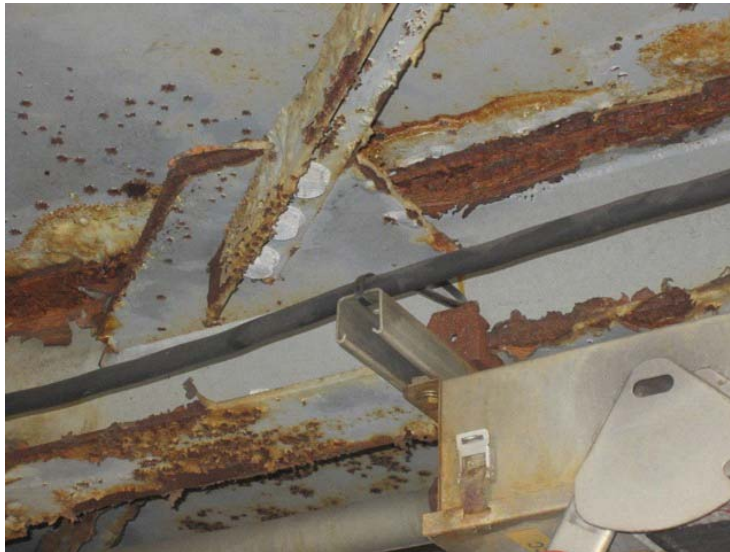
Heavy pitting rust

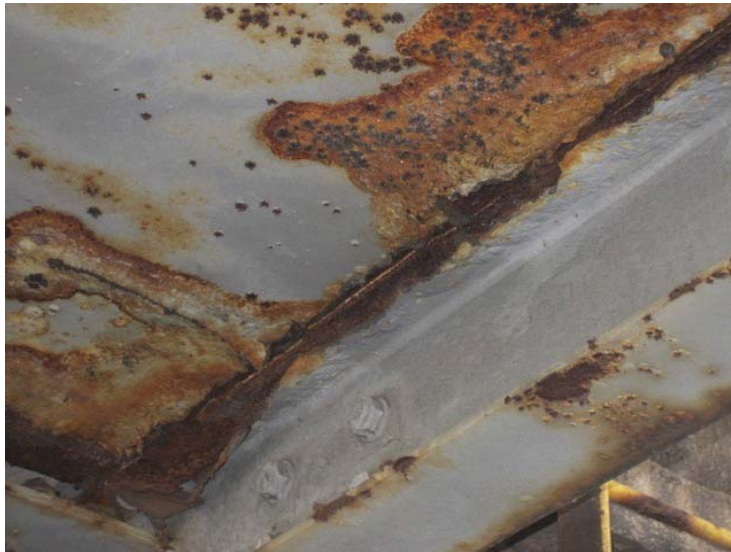
Pitting rust occurring

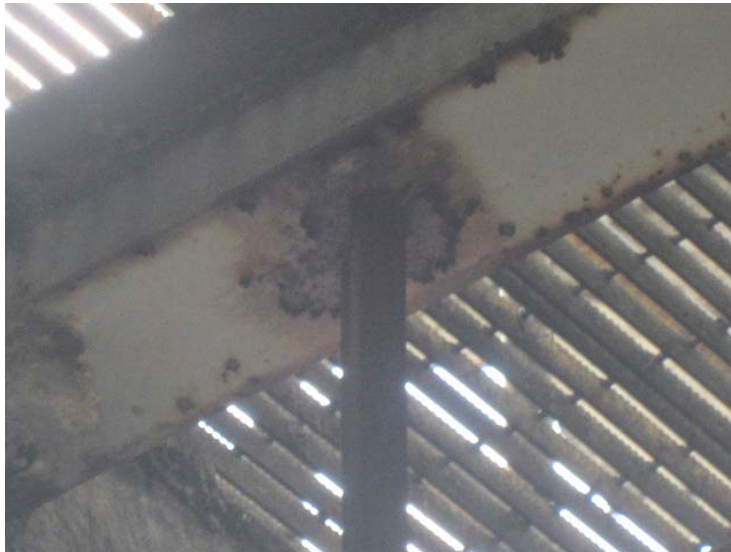
Heavy corrosion on structure

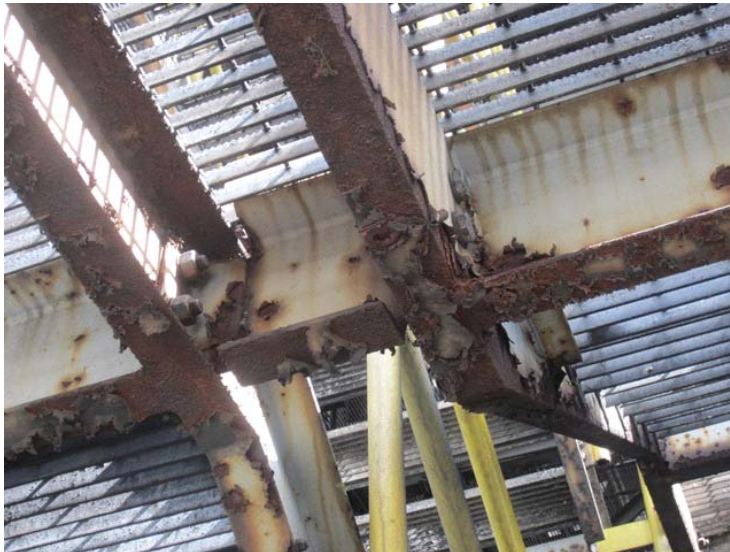
Comments: Heavy Undercoating, Pitting Visible and Metal Loss

Severe corrosion on structure
