Condition Analysis

Block: 01 Northwest Unit of the plant. Includes Gasification Unit, Brine Unit, Acid Unit, Coal Slurry Building, and pipe lines to flares.

Subblock: A On West side of Block 1. Contains Flare, pipe racks to flare, and conveyor belt.

Section: 01 Flare and associated structure.

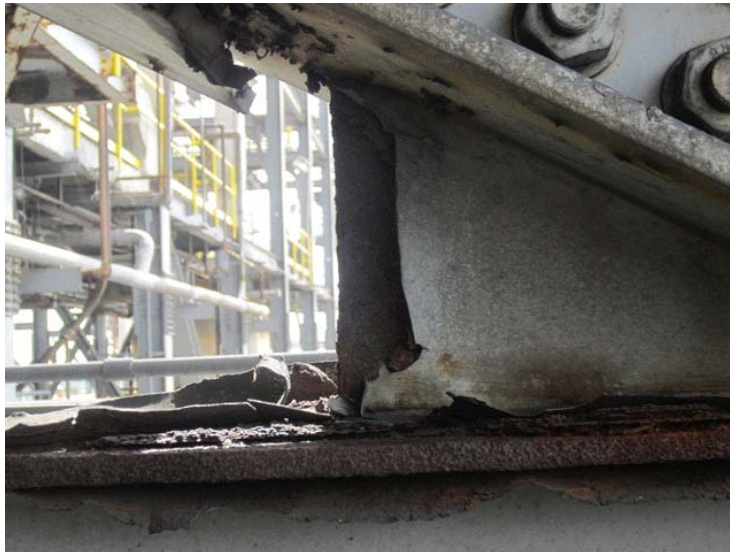
Comments: Heavy Undercoating, Pitting Visible and Metal Loss

Metal loss visible

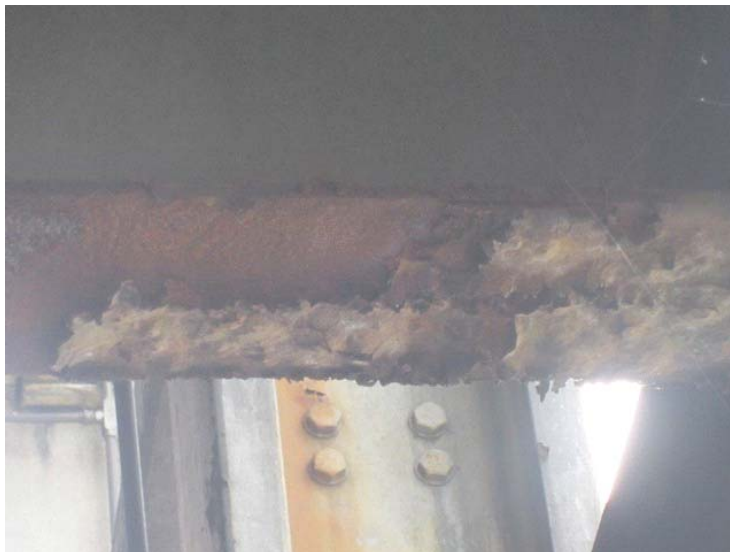
Comments: Heavy Undercoating, Pitting Visible and Metal Loss

Heavy corrosion on structural steel

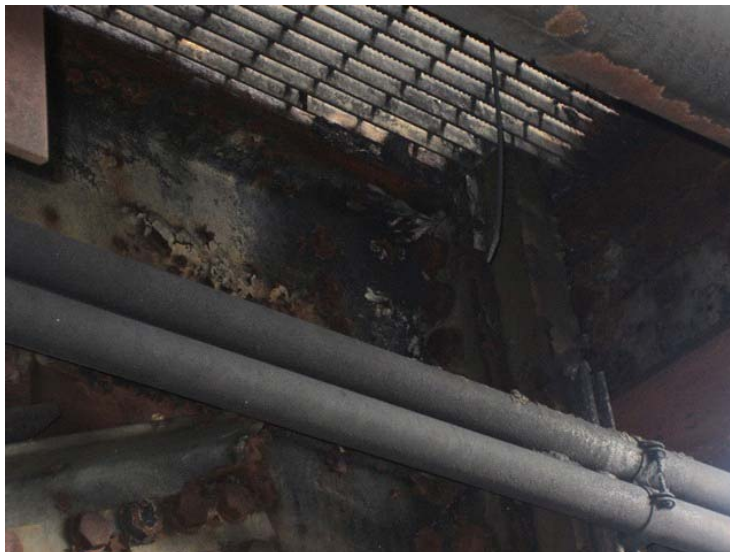
Comments: Heavy Undercoating, Pitting Visible and Metal Loss

View of corrosion on support structure

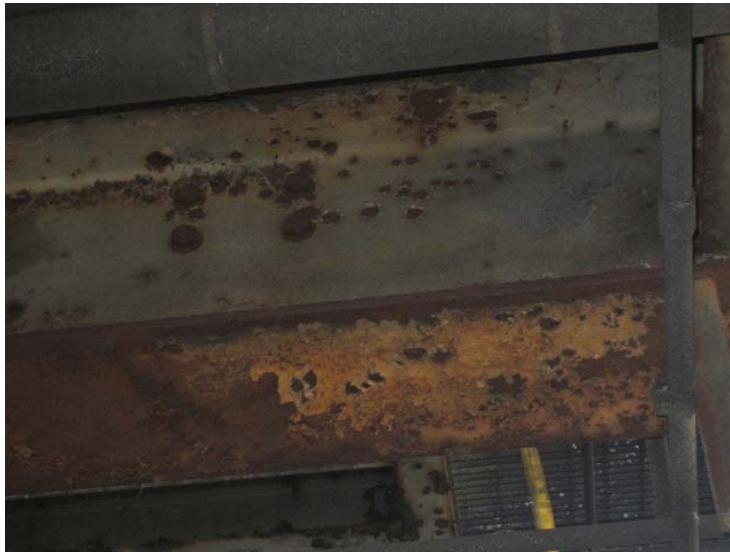
Comments: Heavy Undercoating, Pitting Visible and Metal Loss

Pitting rust on structure

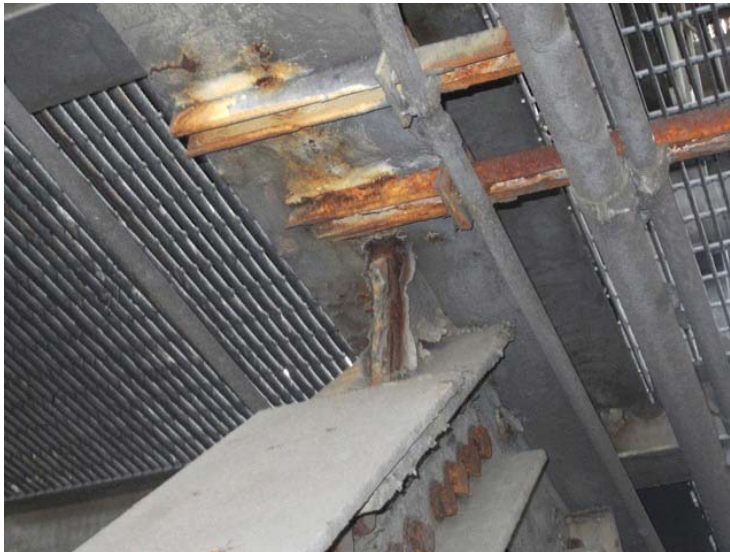
Comments: Heavy Corrosion- Metal Loss

View of corrosion on structure

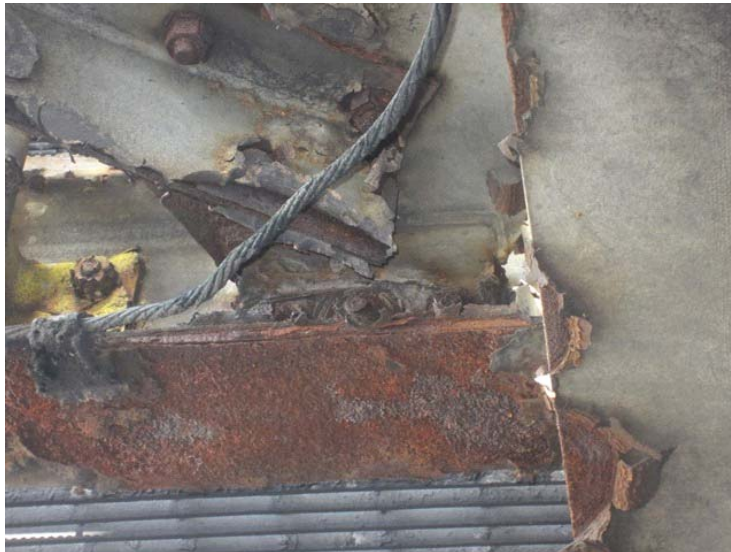
Comments: Heavy Corrosion- Metal Loss

Heavy corrosion occurring on structure

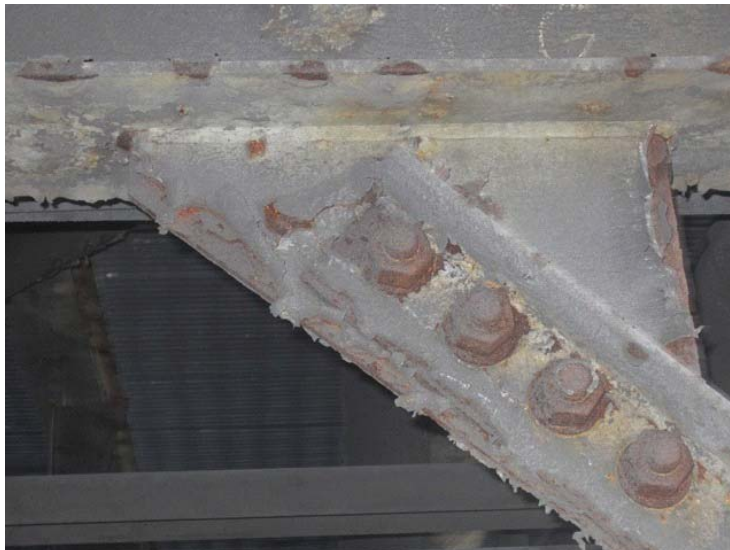
Corrosion on structure

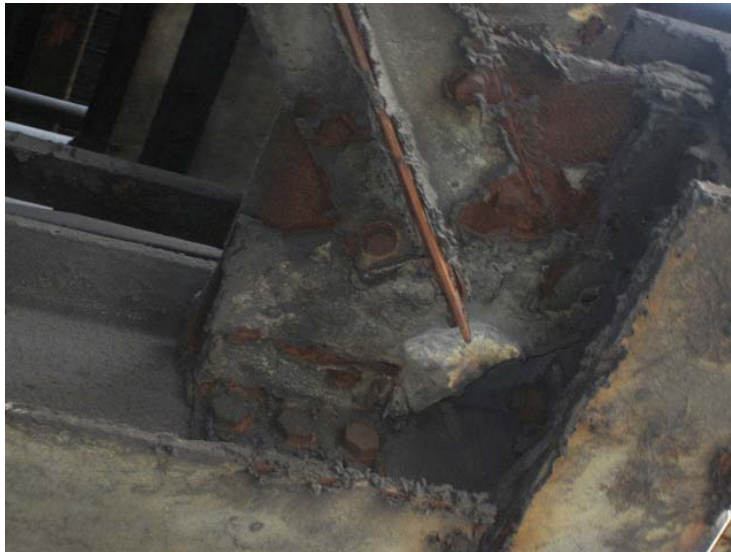
Comments: Very Hard to View Corrosion- Covered with Coal Dust

Heavy corrosion on structural supports

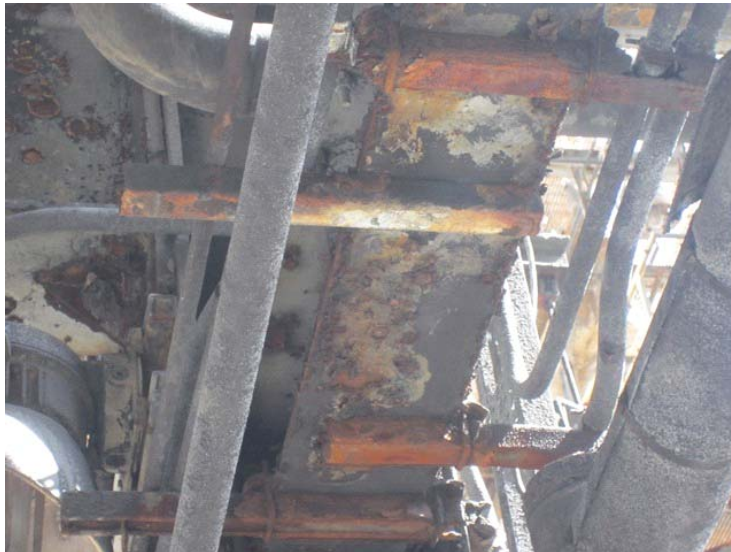
Comments: Very Hard to View Corrosion- Covered with Coal Dust

Corrosion occurring on structure

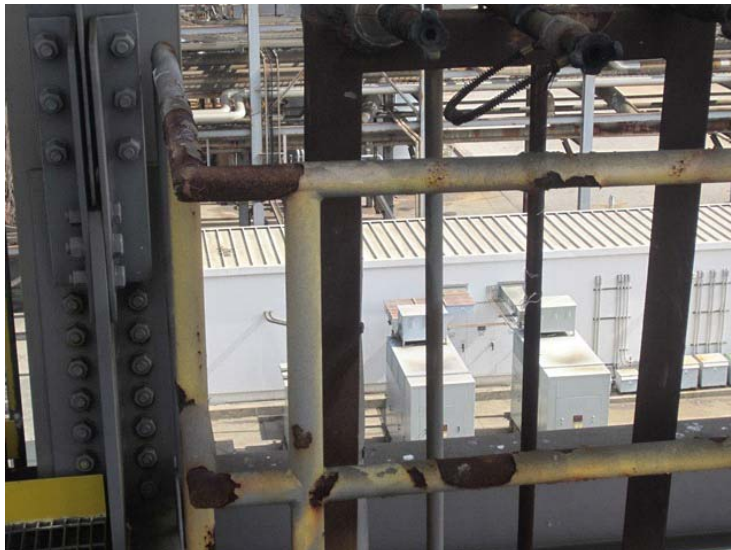
Corrosion on handrails

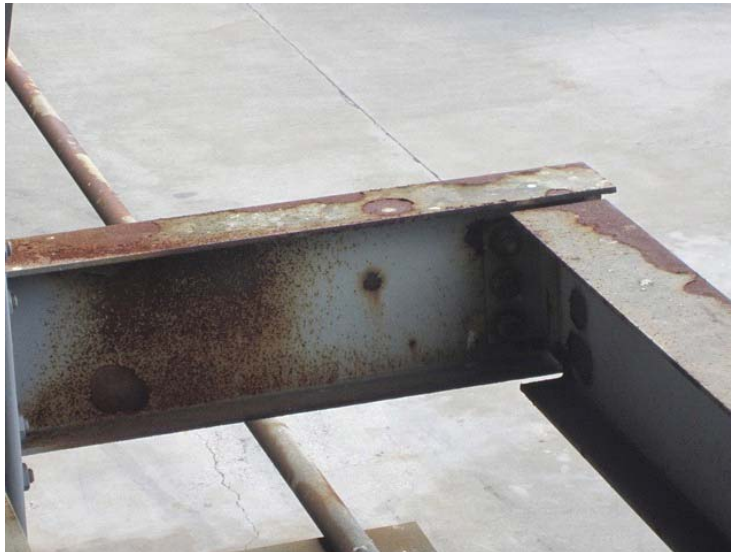
Corrosion Rating: 7.5 - 0.2% rust

Corrosion Type: D - Undercutting or Mill Scale

View of corrosion on structure in section

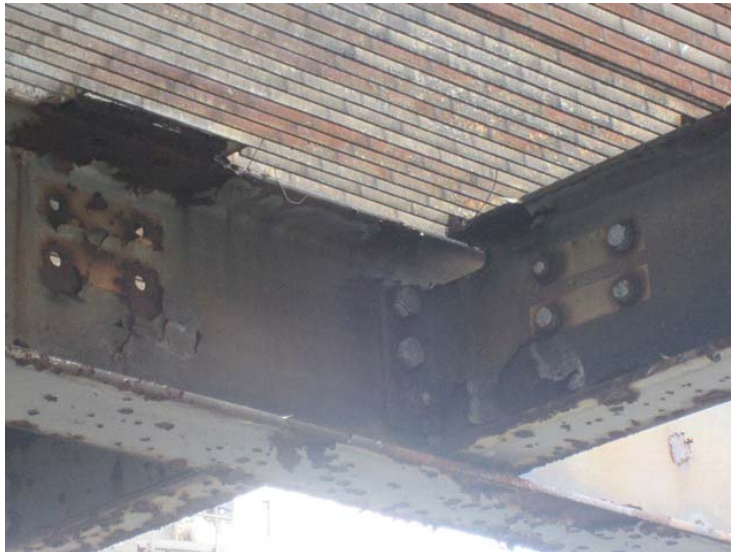
Comments: Localized- Metal Loss on Structure area North side of section above Pipe Rack.

Corrosion on structure in section

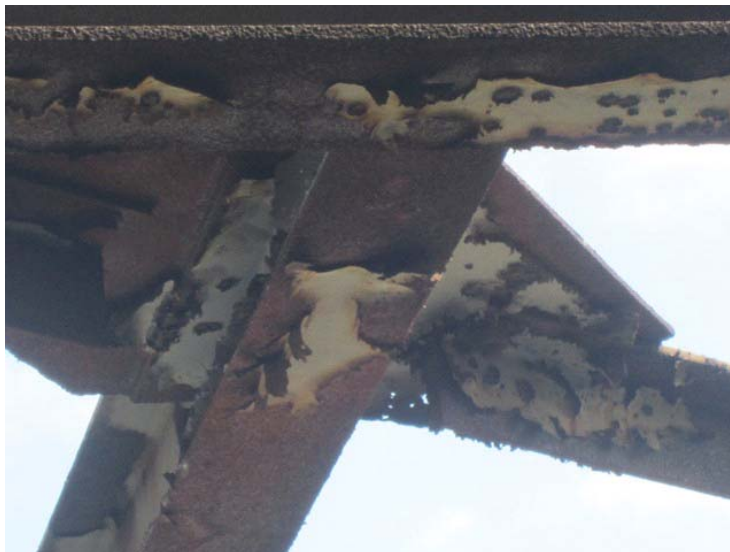
Comments: Localized- Metal Loss on Structure area North side of section above Pipe Rack.

Heavy corrosion on structure

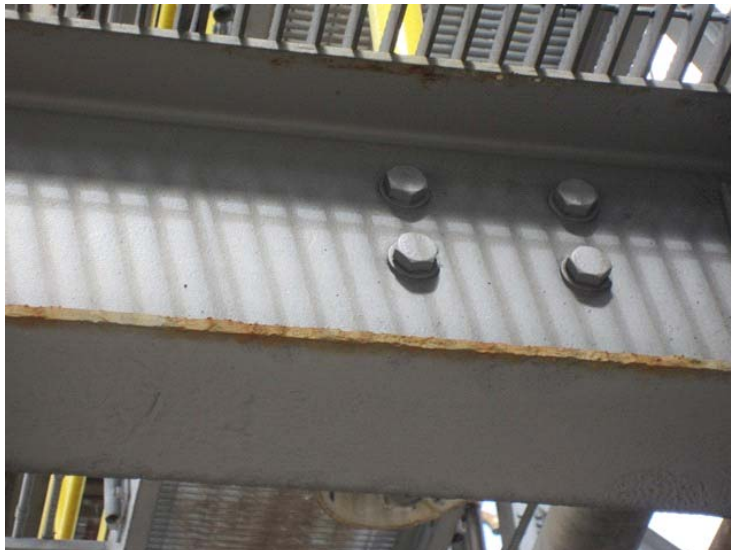
Minor edge corrosion

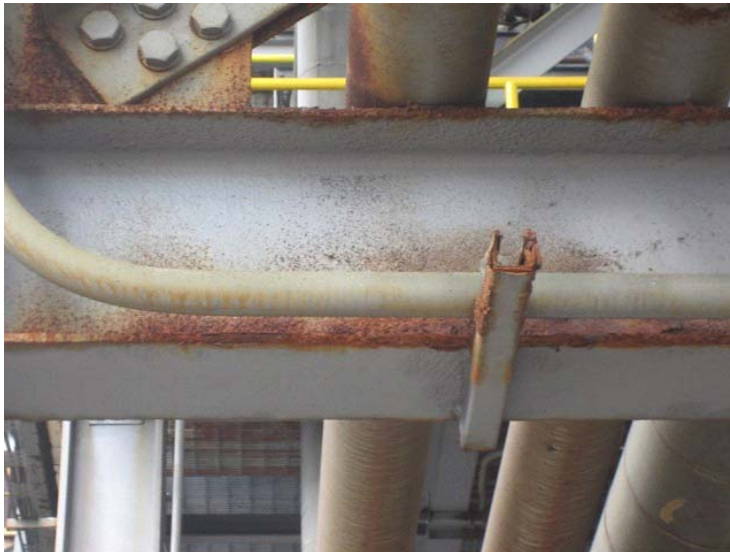
Corrosion Rating: 7.0 - 0.3% rust

Corrosion Type: C - Edge or Pinhole Corrosion

Pin hole and edge corrosion occurring

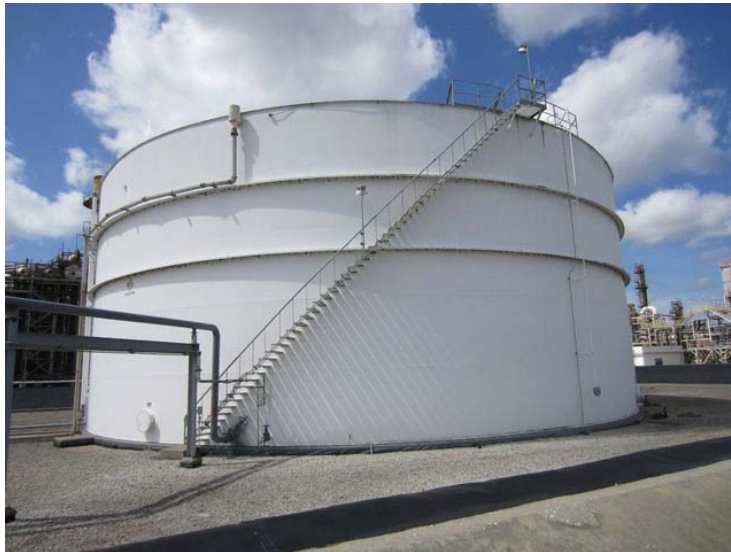
Comments: Mold on Tank Roof. Pressure Wash.

General view of tank

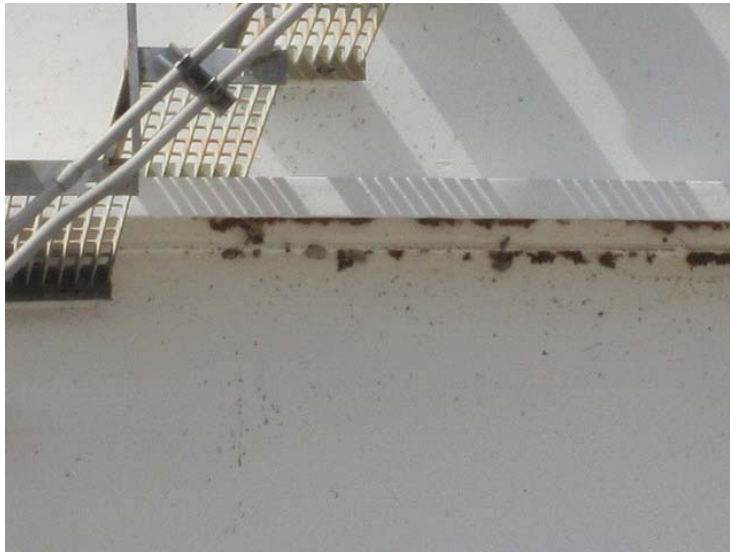
Comments: Mold on Tank Roof. Pressure Wash.

Coating wear visible

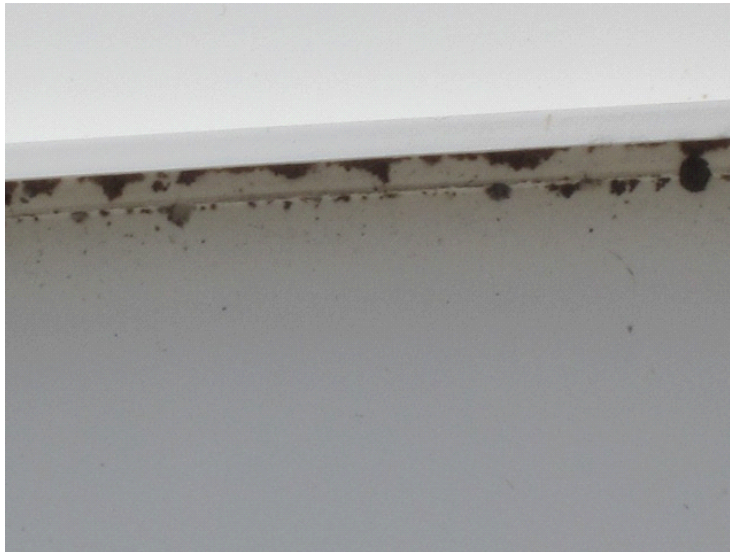
Comments: Mold on Tank Roof. Pressure Wash.

Minor coating wear

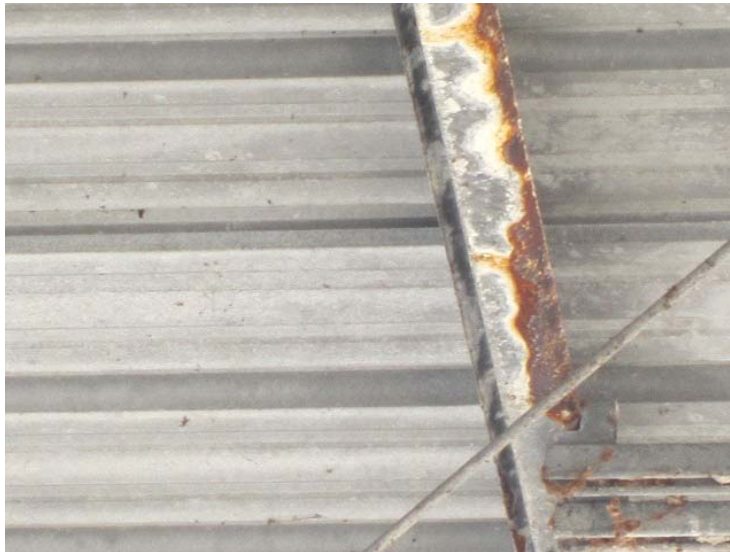
Environment Rating 3 - Moderate
Visibility: 5 - Moderate Traffic or Visibility
Corrosion Rating: 5.5 - 2% rust
Corrosion Type: D - Undercutting or Mill Scale
Priority: 3 - Wearout

Corrosion on structure

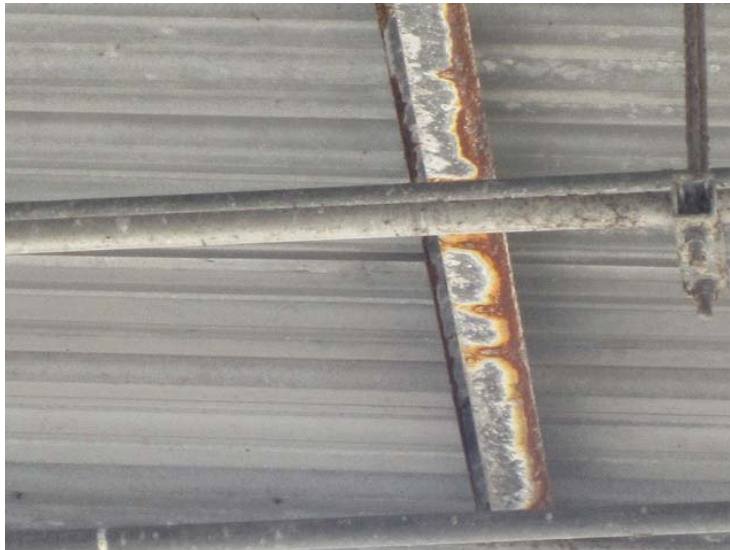
Corrosion Rating: 5.5 - 2% rust

Corrosion on structural steel

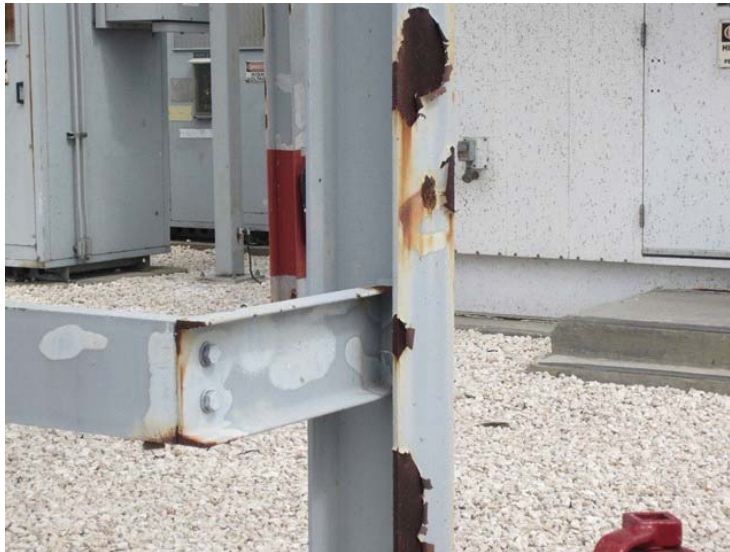
Environment Rating 3 - Moderate
Visibility: 6 - Low Traffic or Visibility
Corrosion Rating: 4.5 - 7% rust
Corrosion Type: E - Pitting or Rust Nodules
Priority: 5 - Localized Corrosion

Comments: Electrical Boxes on West side and South Structure needs paint.

Heavy corrosion on structural steel

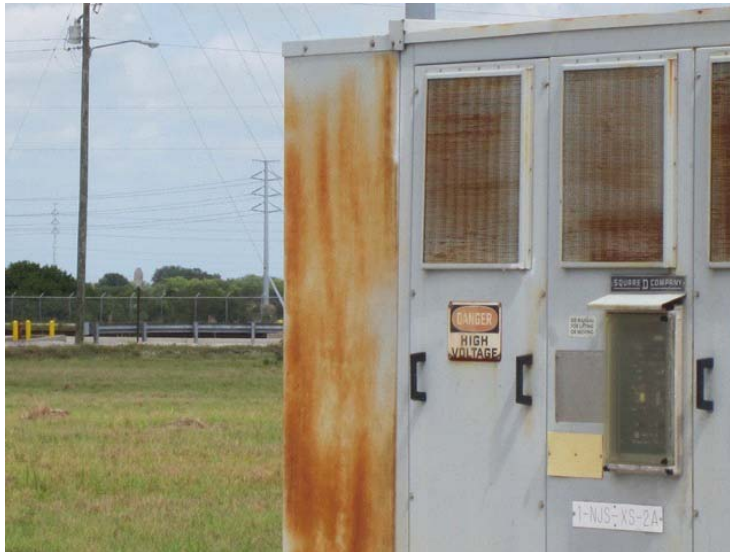
Comments: Electrical Boxes on West side and South Structure needs paint.

Minor surface rust on electrical boxes

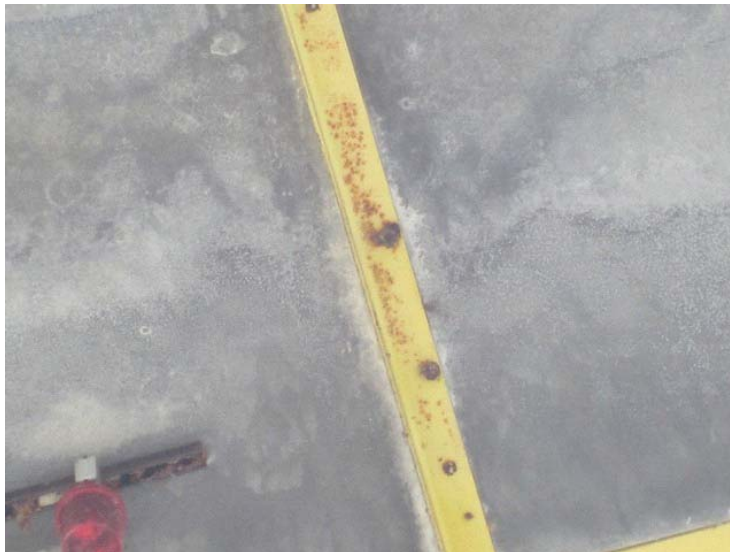
Comments: Needs Pressure Washed.

Pin hole rust on structure

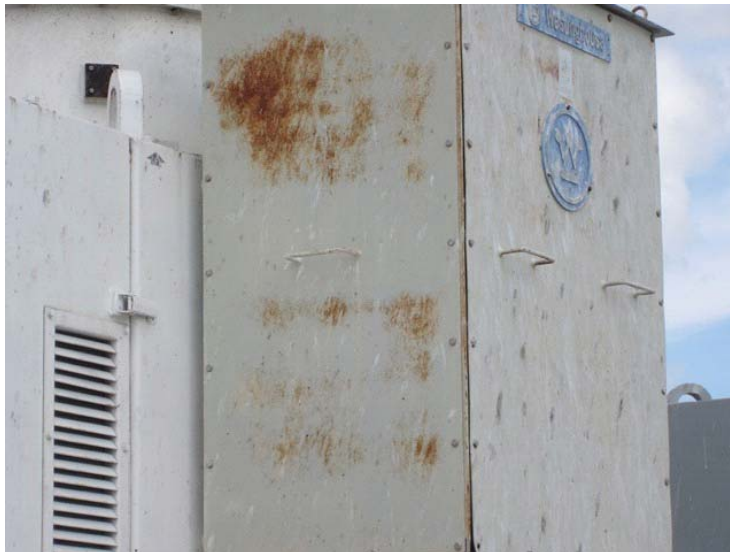
Comments: Needs Pressure Washed.

Minor surface corrosion

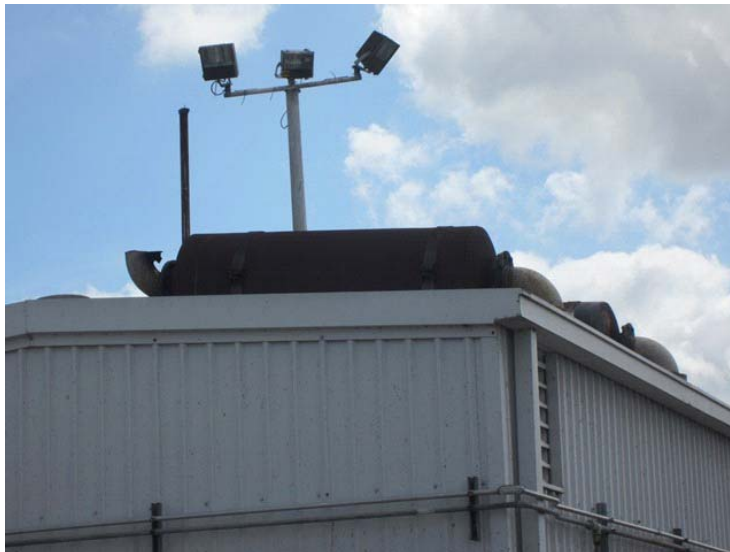
Comments: Needs Pressure Washed.

Corrosion visible on vessels

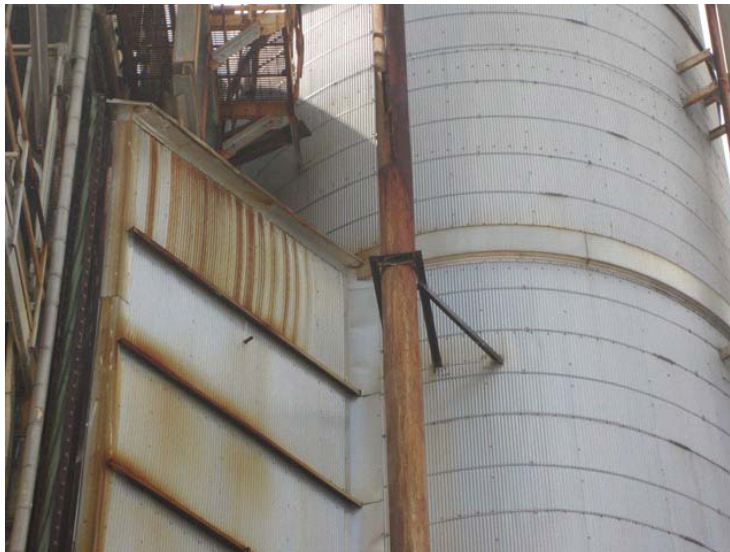
Comments: Stack is Insulated. Supporting Structure Only

Corrosion on stack structural supports

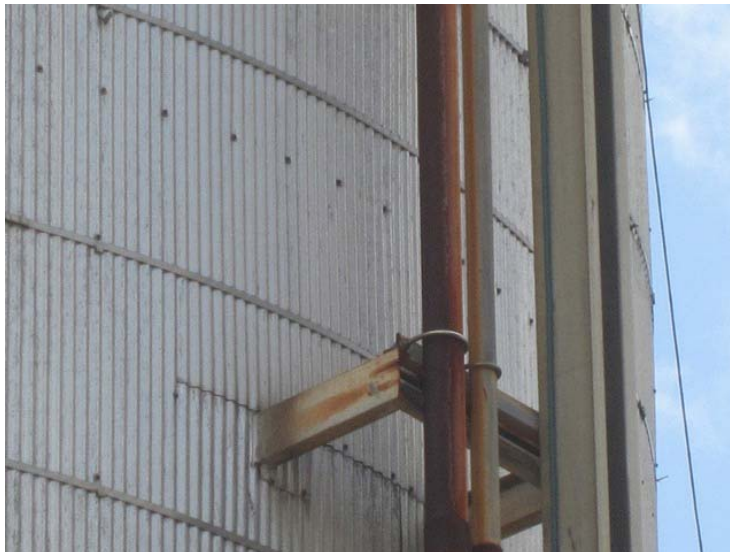
Comments: Stack is Insulated. Supporting Structure Only

Corrosion on structure and pipe

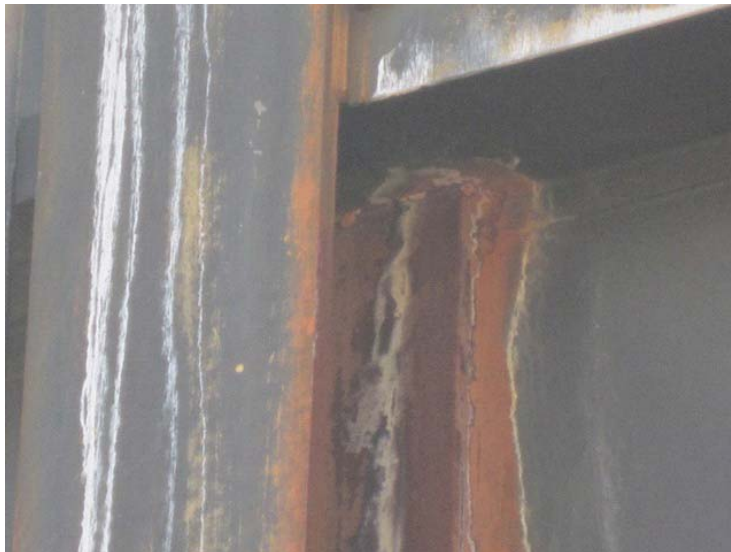
Corrosion Rating: 4.0 - 10% rust

Corrosion on HRSG skin

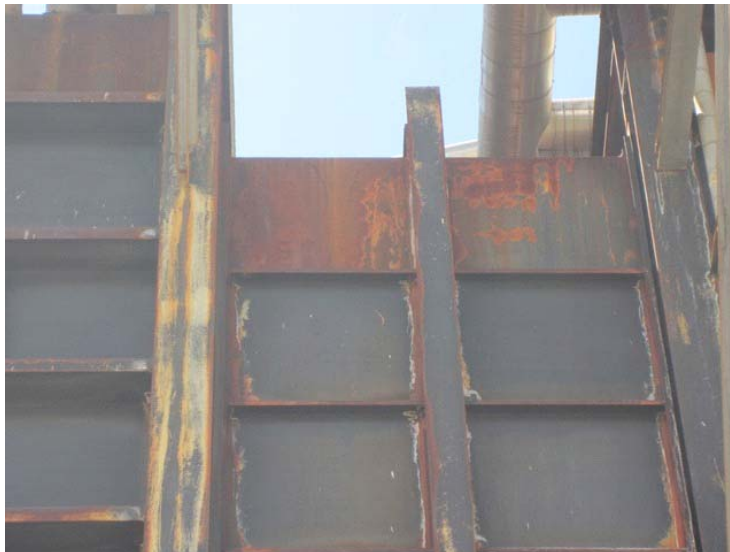
Corrosion Rating: 4.0 - 10% rust

Heavy corrosion on HRSG

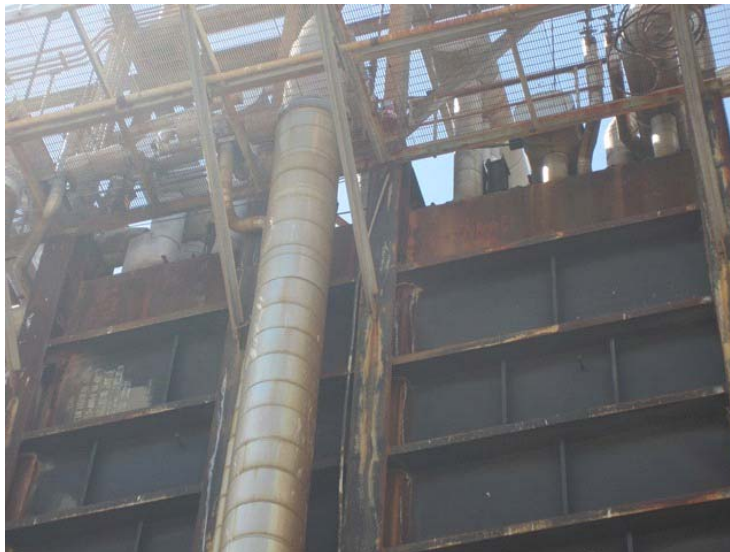
Corrosion Rating: 4.0 - 10% rust

View of corrosion on HRSG skin

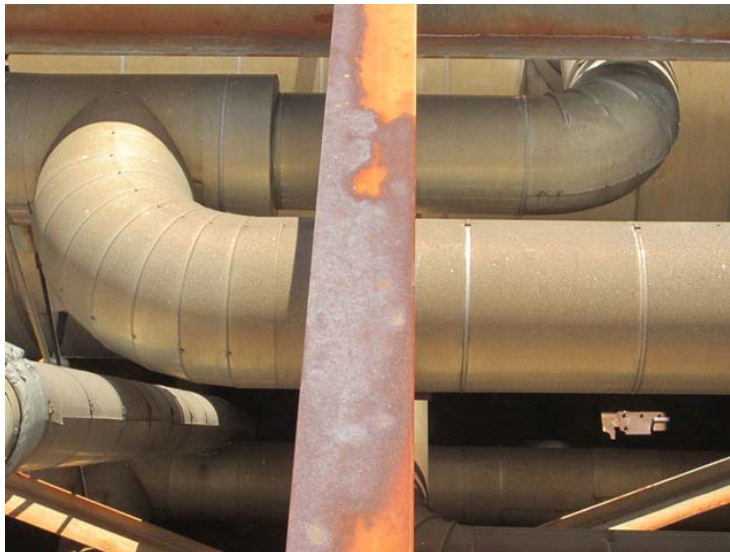
Corrosion Rating: 4.0 - 10% rust

Corrosion on structure in section

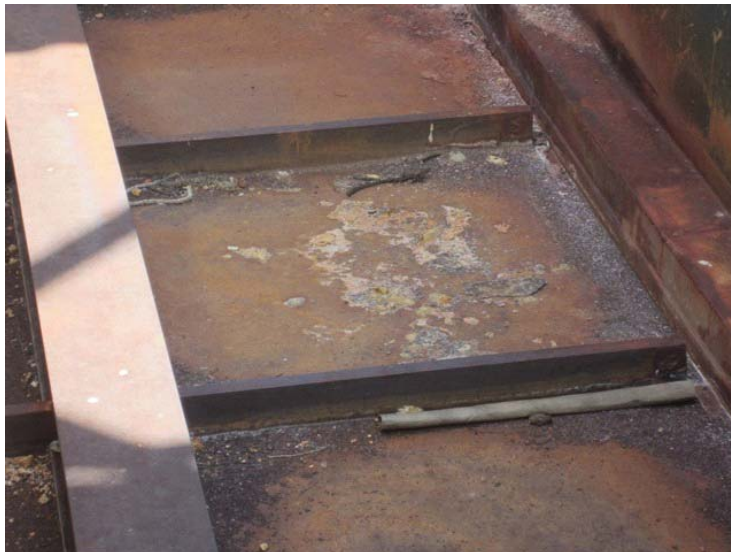
Corrosion on HRSG structure

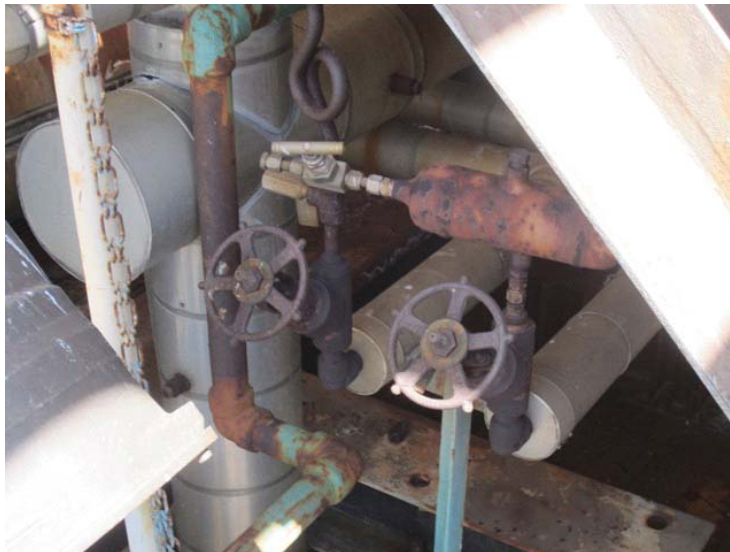
Corrosion on piping

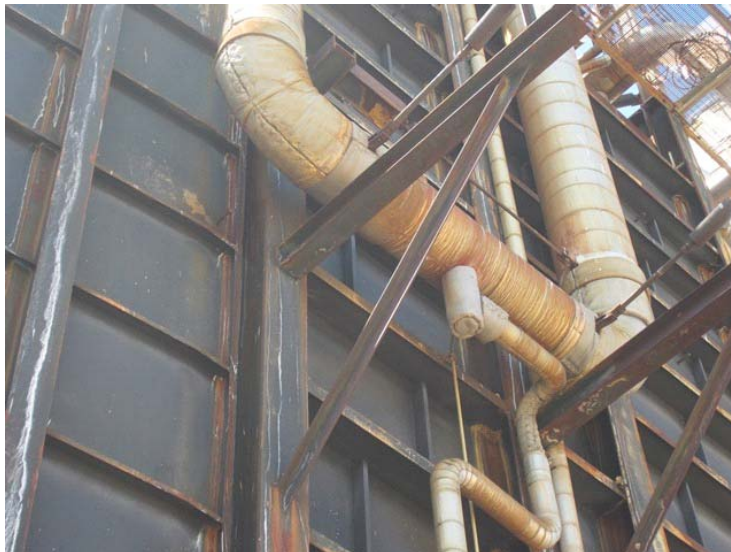
Corrosion Rating: 4.5 - 7% rust

Corrosion Type: B - Surface Rust

View of corrosion on pipe supports

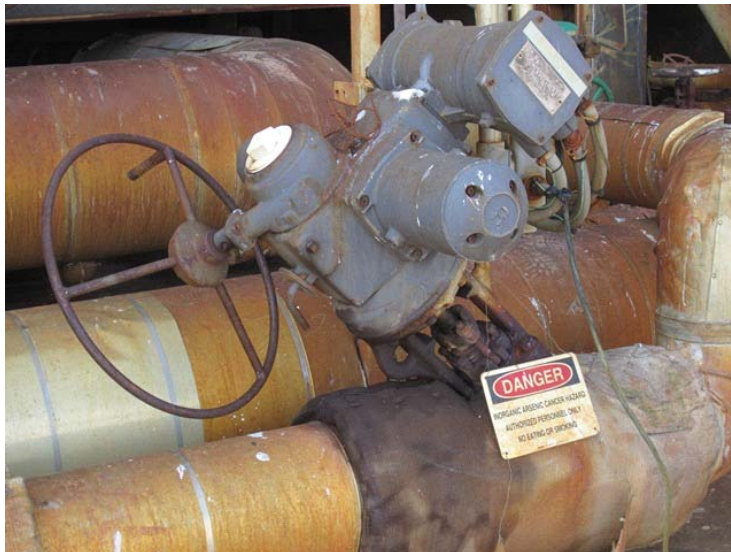
Corrosion Rating: 4.5 - 7% rust

Corrosion Type: B - Surface Rust

View of corrosion on valves

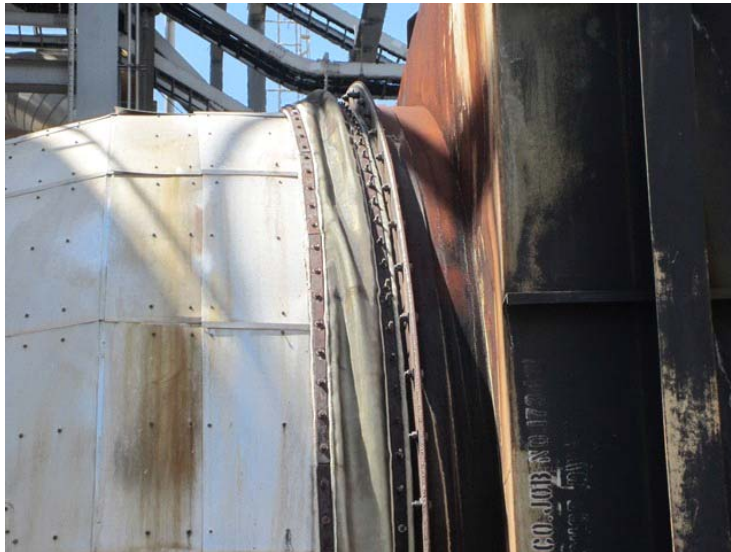
Corrosion Rating: 6.0 - 1% rust

Corrosion Type: B - Surface Rust

Corrosion in section

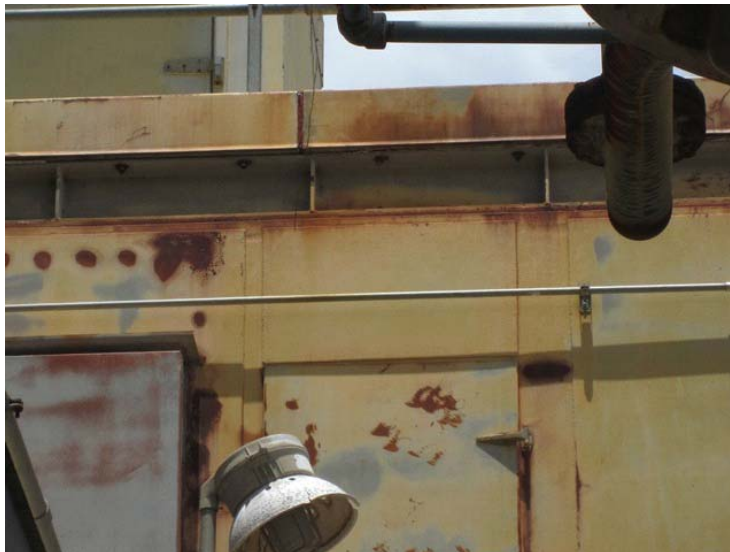
Environment Rating 3 - Moderate
Visibility: 5 - Moderate Traffic or Visibility
Corrosion Rating: 6.0 - 1% rust
Corrosion Type: B - Surface Rust
Priority: 3 - Wearout

View of corrosion on building

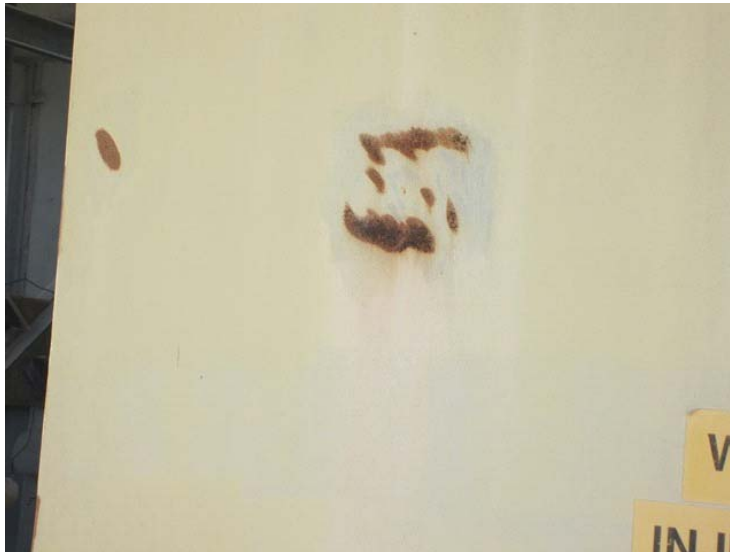
Environment Rating 3 - Moderate
Visibility: 5 - Moderate Traffic or Visibility
Corrosion Rating: 7.0 - 0.3% rust
Corrosion Type: D - Undercutting or Mill Scale
Priority: 2 - Optimum

Minor corrosion on building structure

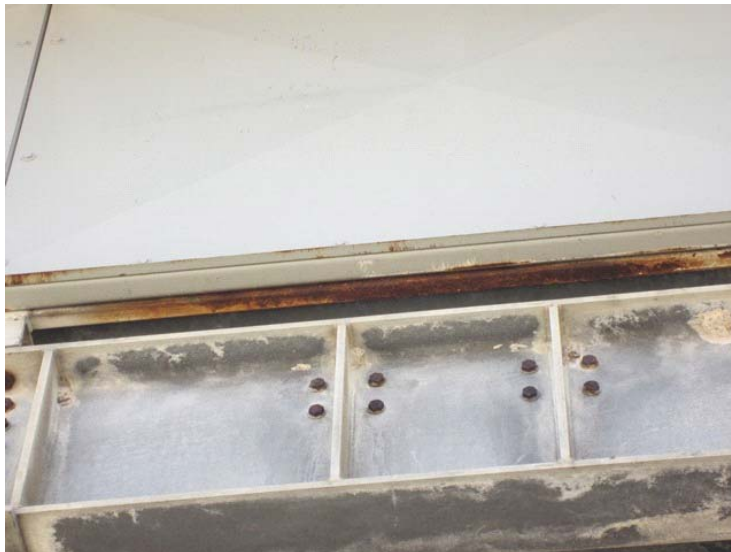
Corrosion Rating: 7.0 - 0.3% rust

Comments: Delamination on back sides of intake.

Corrosion on filter structure

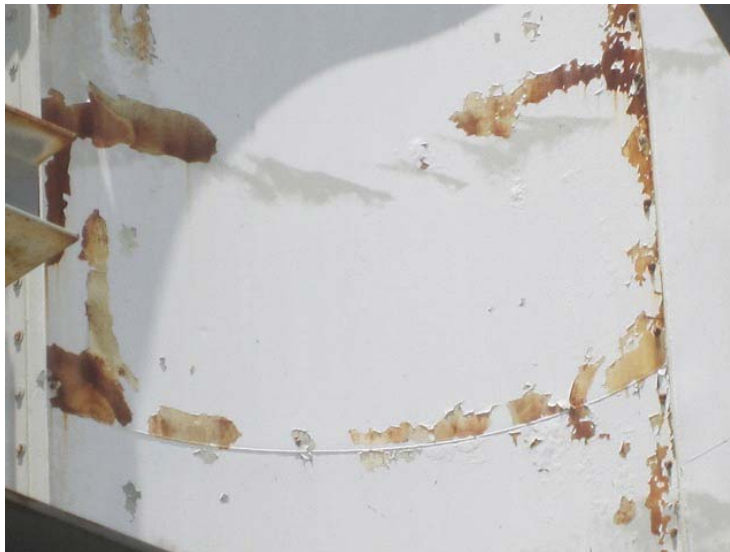
Corrosion Rating: 7.0 - 0.3% rust

Comments: Delamination on back sides of intake.

Delamination of coating with corrosion occurring

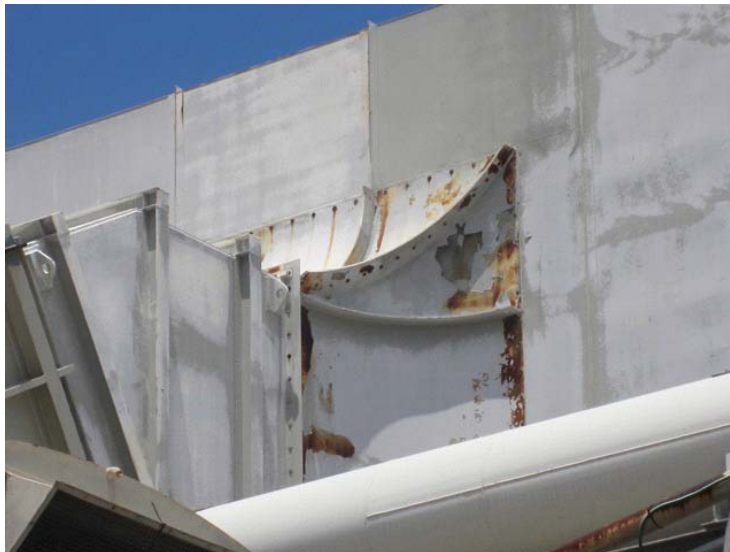
Corrosion Rating: 7.0 - 0.3% rust

Comments: Delamination on back sides of intake.

View of corrosion occurring

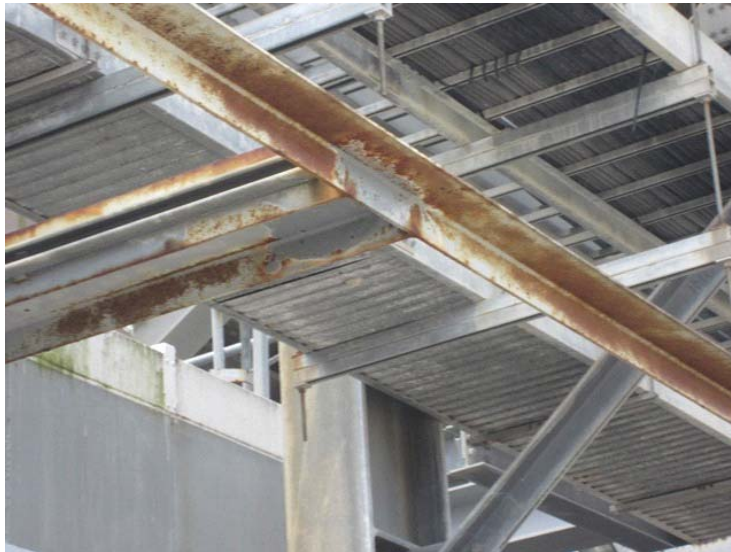
Environment Rating 3 - Moderate
Visibility: 5 - Moderate Traffic or Visibility
Corrosion Rating: 6.5 - 0.7% rust
Corrosion Type: D - Undercutting or Mill Scale
Priority: 7 - Fair

Corrosion on structure

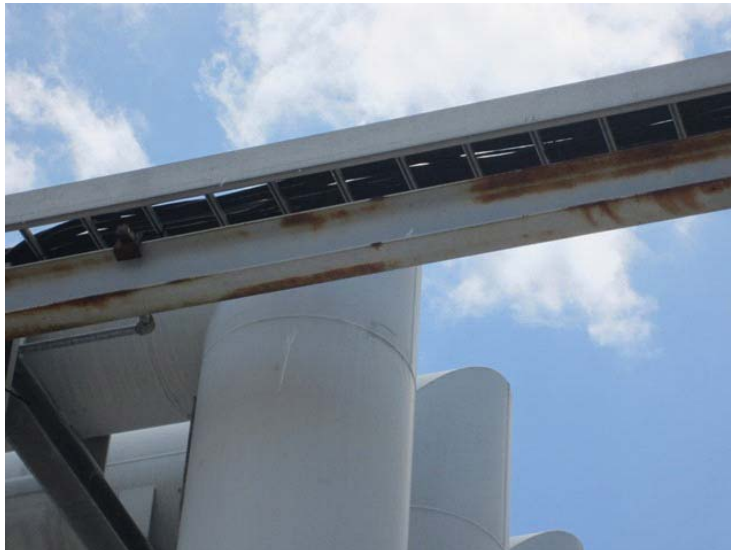
Environment Rating 3 - Moderate
Visibility: 3 - Tank Area
Corrosion Rating: 8.0 - 0.1% rust
Corrosion Type: B - Surface Rust
Priority: 7 - Fair

Corrosion on rack structure

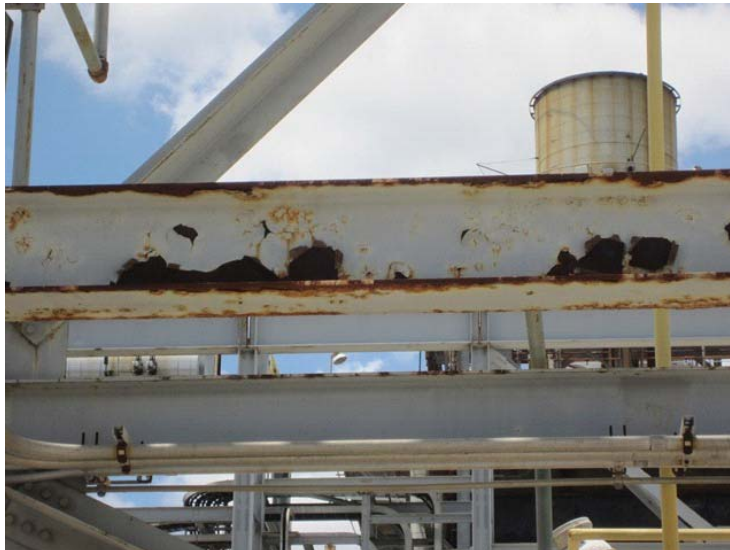
Environment Rating 3 - Moderate
Visibility: 4 - Hi Employee Traffic or Visibility
Corrosion Rating: 5.5 - 2% rust
Corrosion Type: E - Pitting or Rust Nodules
Priority: 3 - Wearout

Corrosion on structure

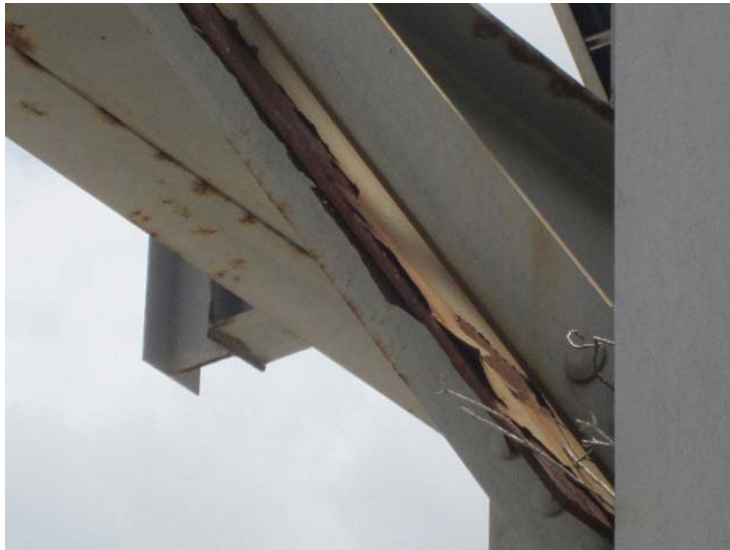
Environment Rating 3 - Moderate
Visibility: 4 - Hi Employee Traffic or Visibility
Corrosion Rating: 5.5 - 2% rust
Corrosion Type: E - Pitting or Rust Nodules
Priority: 3 - Wearout

Corrosion on support structure

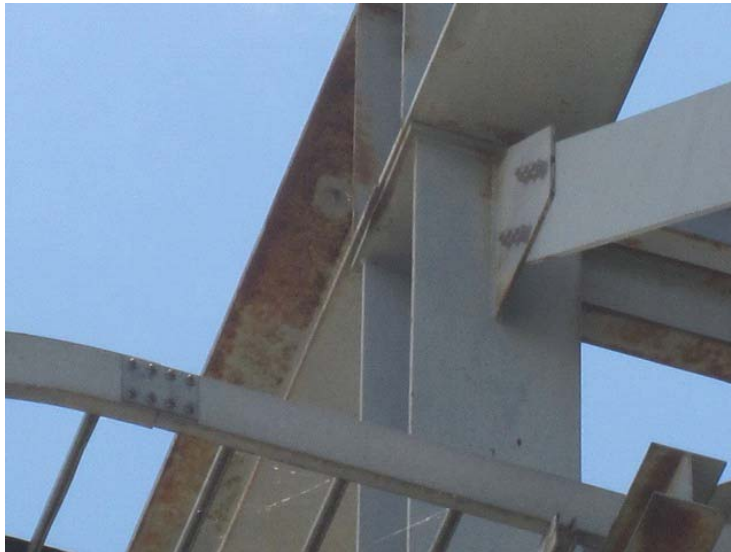
Environment Rating 3 - Moderate
Visibility: 5 - Moderate Traffic or Visibility
Corrosion Rating: 7.0 - 0.3% rust
Corrosion Type: E - Pitting or Rust Nodules
Priority: 3 - Wearout

Corrosion on structure

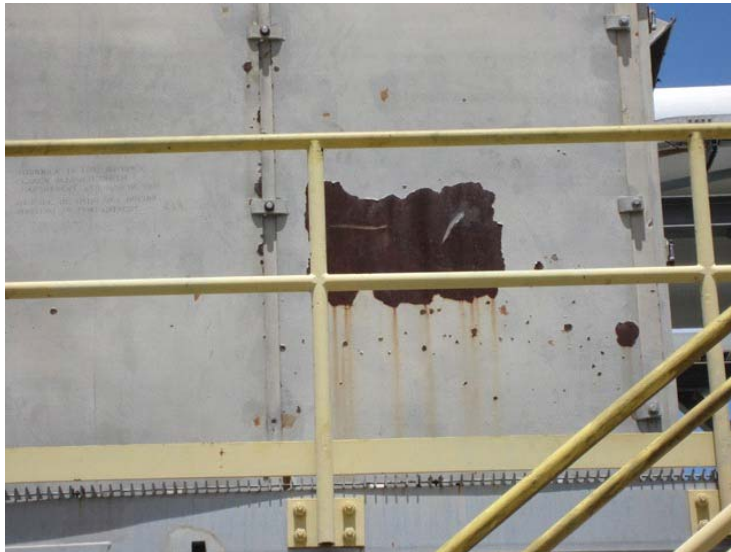
Environment Rating 3 - Moderate
Visibility: 5 - Moderate Traffic or Visibility
Corrosion Rating: 6.0 - 1% rust
Corrosion Type: D - Undercutting or Mill Scale
Priority: 3 - Wearout

Corrosion on equipment structure

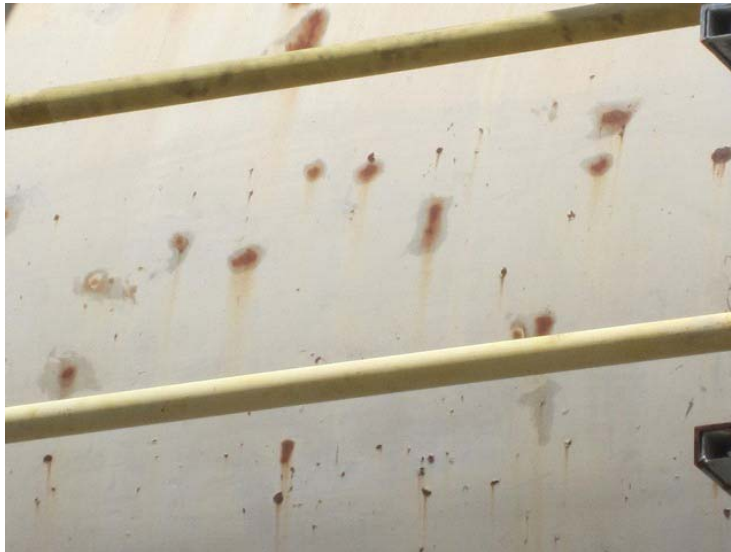
Environment Rating 3 - Moderate
Visibility: 5 - Moderate Traffic or Visibility
Corrosion Rating: 6.0 - 1% rust
Corrosion Type: D - Undercutting or Mill Scale
Priority: 3 - Wearout

View of corrosion

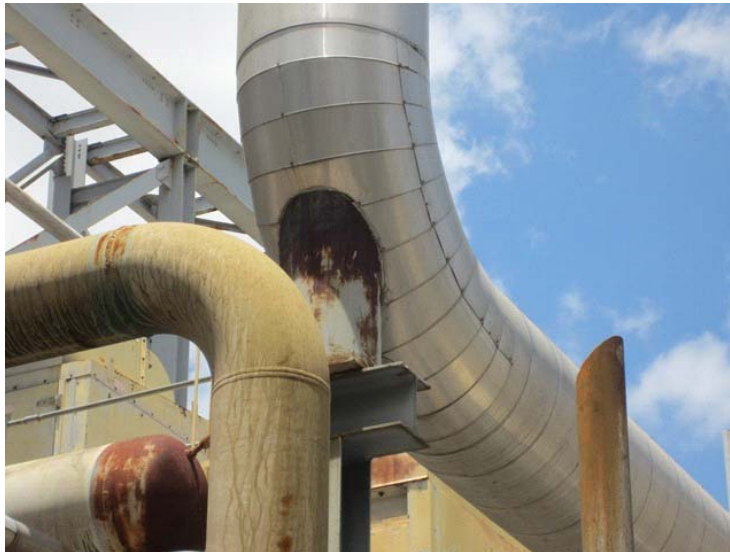
Environment Rating 3 - Moderate
Visibility: 5 - Moderate Traffic or Visibility
Corrosion Rating: 6.0 - 1% rust
Corrosion Type: C - Edge or Pinhole Corrosion
Priority: 3 - Wearout

Corrosion on supports

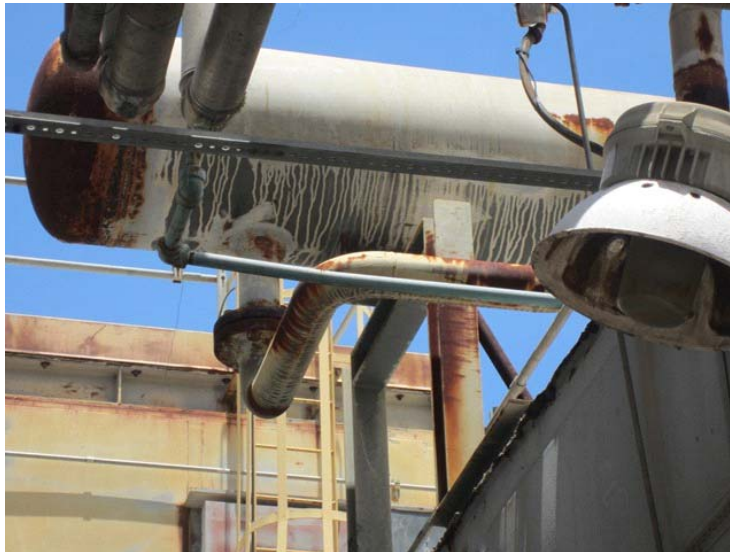
Environment Rating 3 - Moderate
Visibility: 5 - Moderate Traffic or Visibility
Corrosion Rating: 6.0 - 1% rust
Corrosion Type: C - Edge or Pinhole Corrosion
Priority: 3 - Wearout

Corrosion on piping and structure

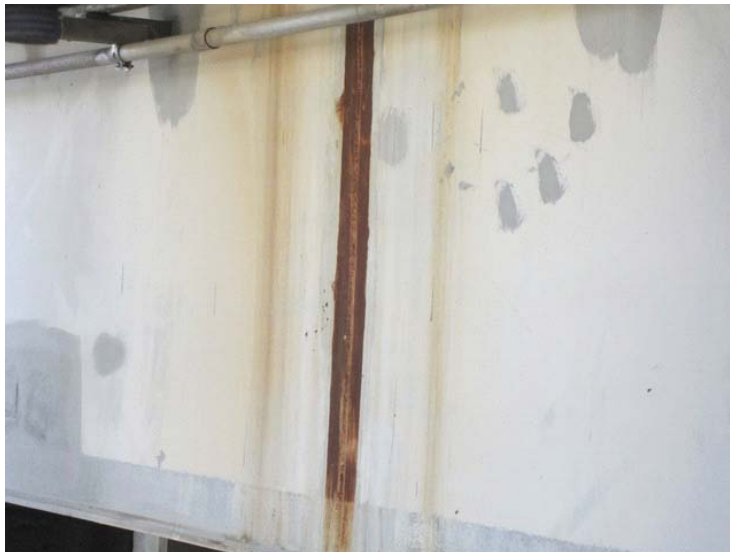
Corrosion Rating: 6.5 - 0.7% rust

Corrosion Type: C - Edge or Pinhole Corrosion

Coating wear and corrosion occurring

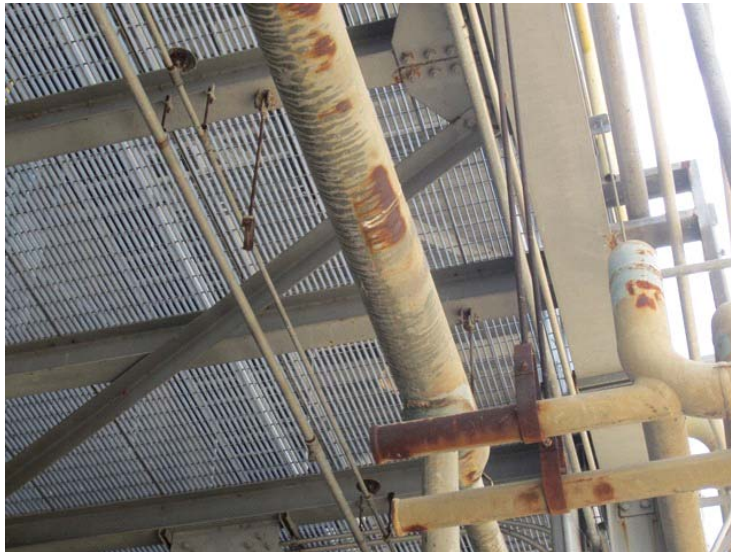
Corrosion Rating: 6.0 - 1% rust

Corrosion Type: D - Undercutting or Mill Scale

Corrosion on piping

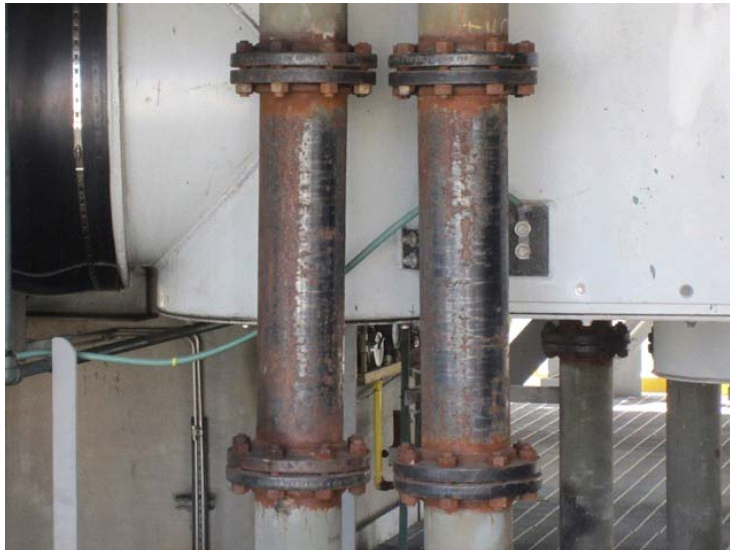
Corrosion on piping
