Condition Analysis

Block: 01 Northwest Unit of the plant. Includes Gasification Unit, Brine Unit, Acid Unit, Coal Slurry Building, and pipe lines to flares.

Subblock: A On West side of Block 1. Contains Flare, pipe racks to flare, and conveyor belt.

Section: 01 Flare and associated structure.

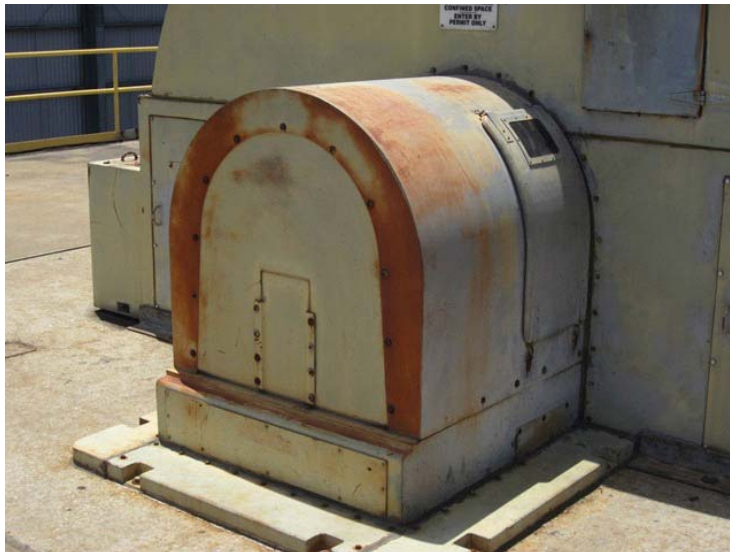
Corrosion on equipment

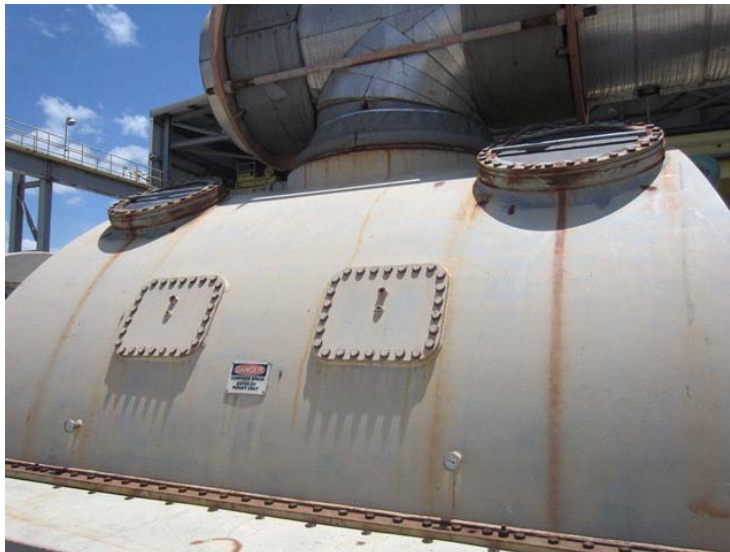
Corrosion on turbine structure

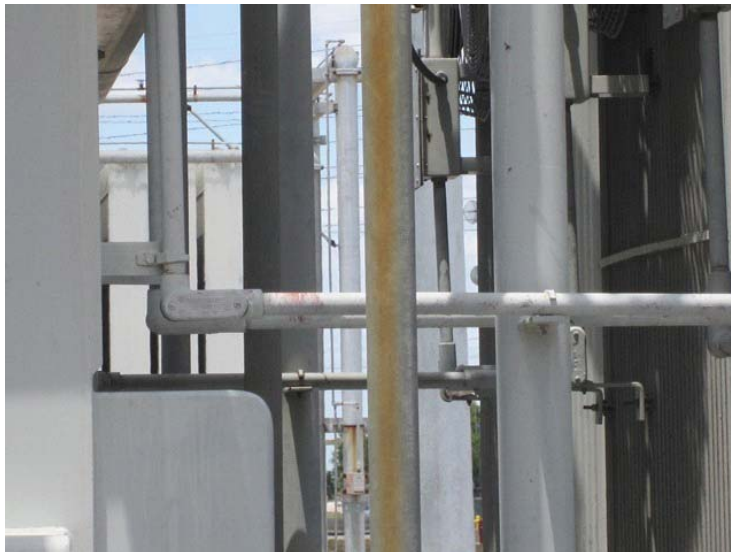
Environment Rating 3 - Moderate
Visibility: 6 - Low Traffic or Visibility
Corrosion Rating: 8.5 - <0.1% rust
Corrosion Type: A - No or Minimal Corrosion
Priority: 7 - Fair

Minor corrosion on structure

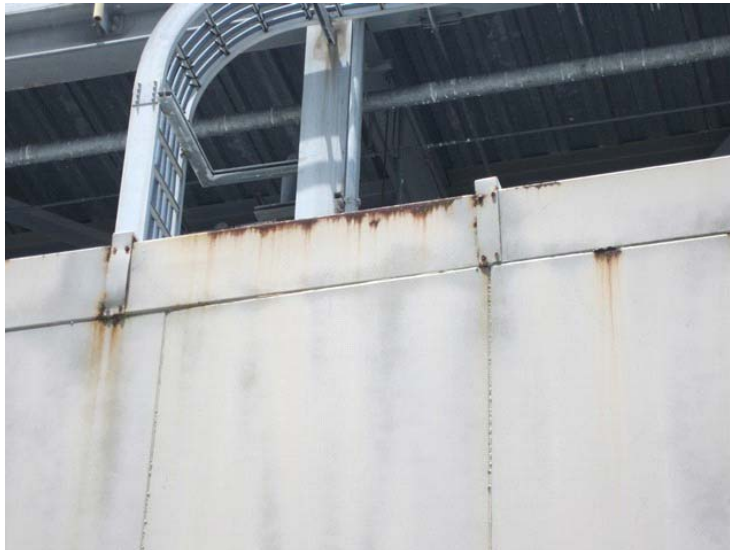
Environment Rating 3 - Moderate
Visibility: 5 - Moderate Traffic or Visibility
Corrosion Rating: 8.0 - 0.1% rust
Corrosion Type: B - Surface Rust
Priority: 7 - Fair

Edge corrosion on building structure

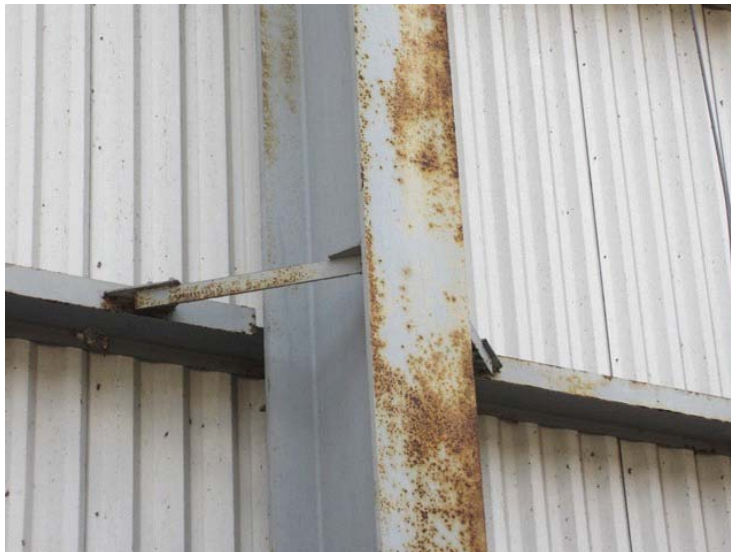
Corrosion Rating: 8.0 - 0.1% rust

Corrosion Type: C - Edge or Pinhole Corrosion

Corrosion on structural steel

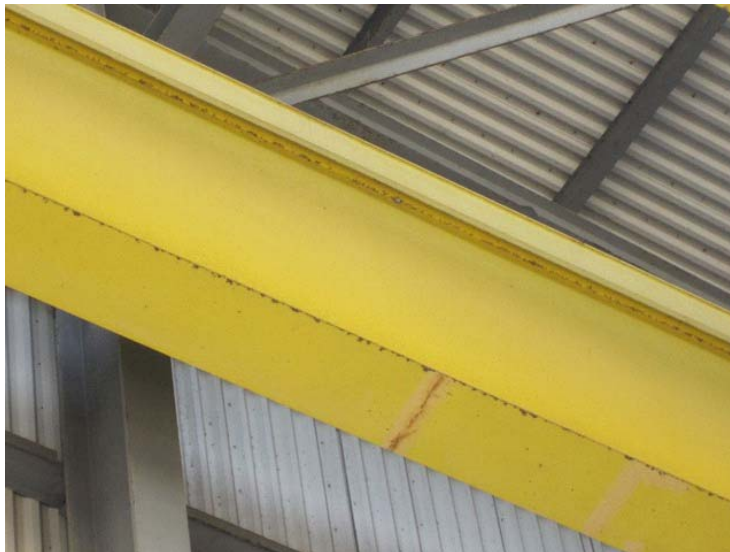
Corrosion Rating: 8.0 - 0.1% rust

Corrosion Type: C - Edge or Pinhole Corrosion

View of minor corrosion on crane rail

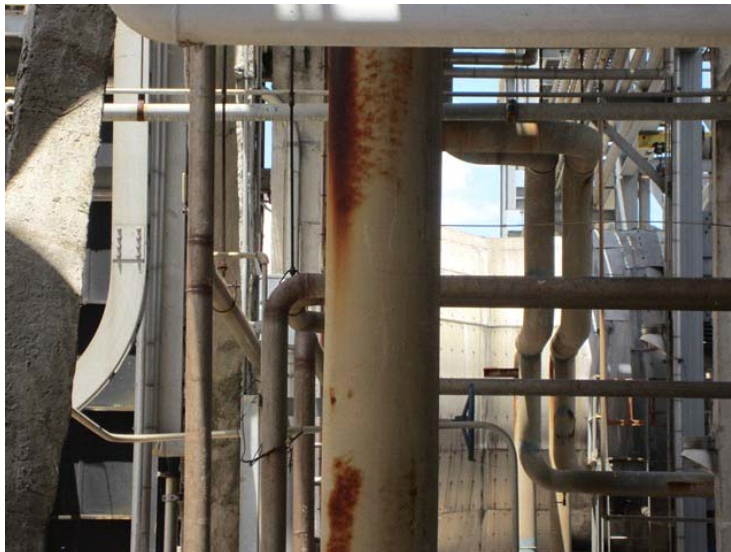
Environment Rating 3 - Moderate
Visibility: 4 - Hi Employee Traffic or Visibility
Corrosion Rating: 6.5 - 0.7% rust
Corrosion Type: E - Pitting or Rust Nodules
Priority: 2 - Optimum

Corrosion on piping in section

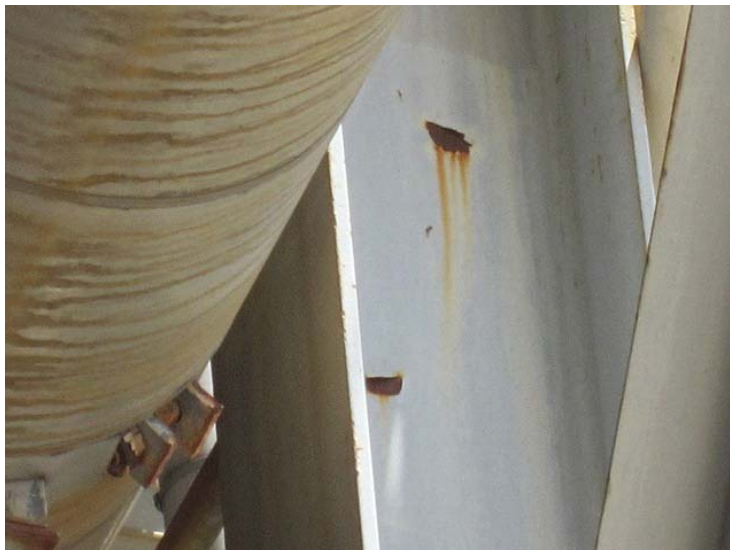
Environment Rating 3 - Moderate
Visibility: 4 - Hi Employee Traffic or Visibility
Corrosion Rating: 6.5 - 0.7% rust
Corrosion Type: E - Pitting or Rust Nodules
Priority: 2 - Optimum

Corrosion on structure

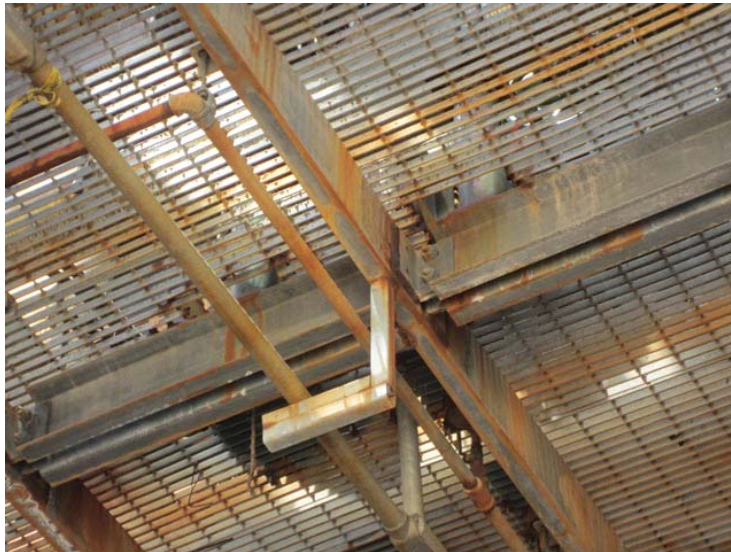
Corrosion Rating: 6.0 - 1% rust

Corrosion Type: B - Surface Rust

Corrosion on structure in section

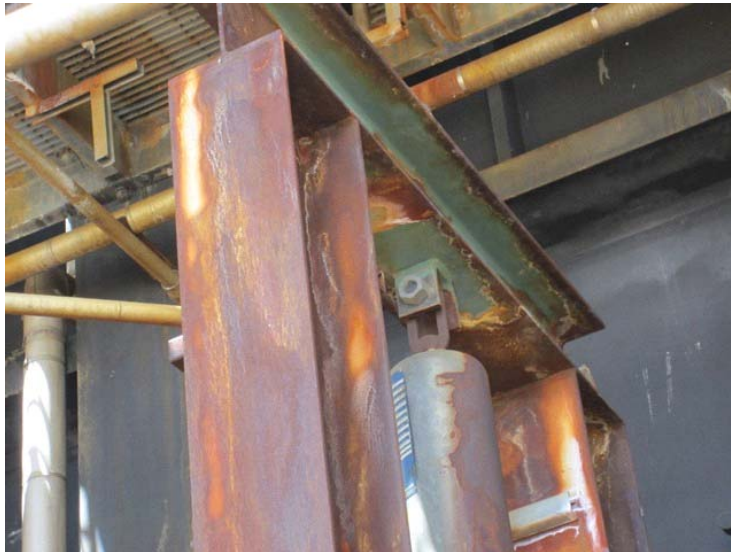
Corrosion Rating: 6.0 - 1% rust

Corrosion Type: B - Surface Rust

Heavy corrosion on supports

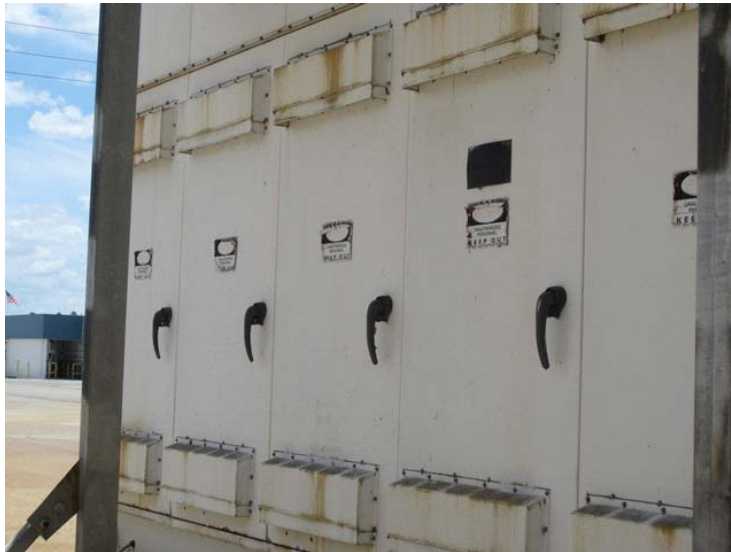
Environment Rating 3 - Moderate
Visibility: 5 - Moderate Traffic or Visibility
Corrosion Rating: 8.5 - <0.1% rust
Corrosion Type: A - No or Minimal Corrosion
Priority: 7 - Fair

View of minor corrosion on electrical boxes

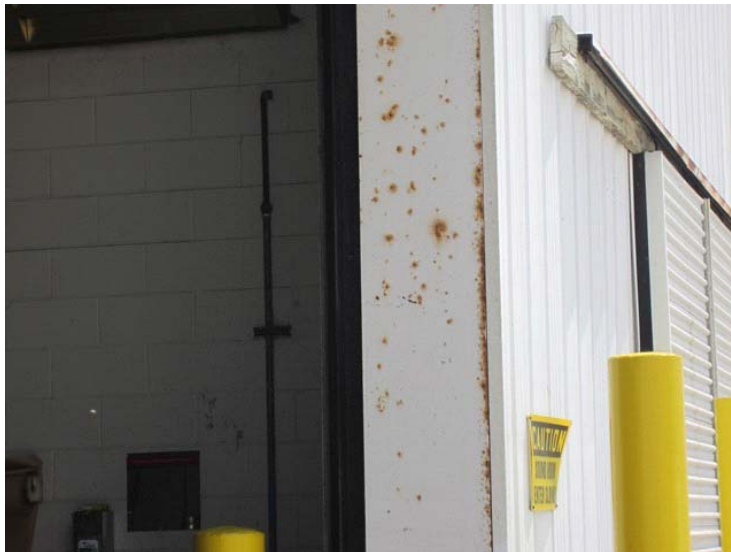
Environment Rating 3 - Moderate
Visibility: 4 - Hi Employee Traffic or Visibility
Corrosion Rating: 8.0 - 0.1% rust
Corrosion Type: B - Surface Rust
Priority: 7 - Fair

Minor corrosion on warehouse structural steel

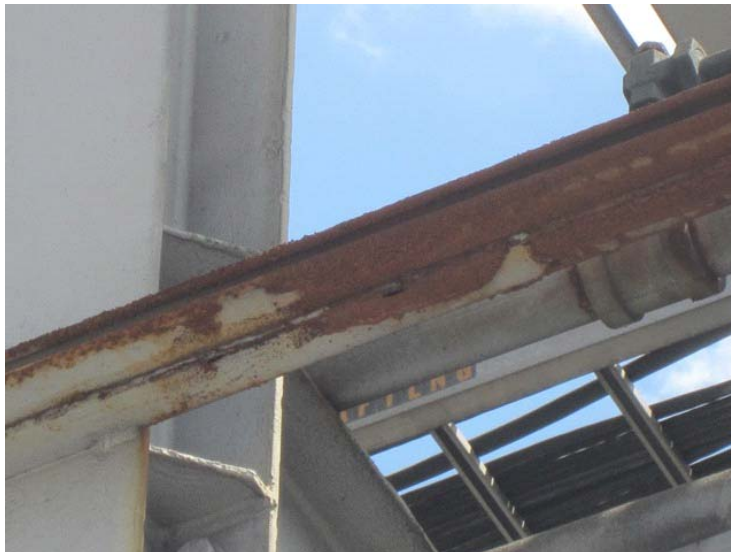
Corrosion Rating: 7.5 - 0.2% rust

Corrosion Type: D - Undercutting or Mill Scale

Corrosion on structure

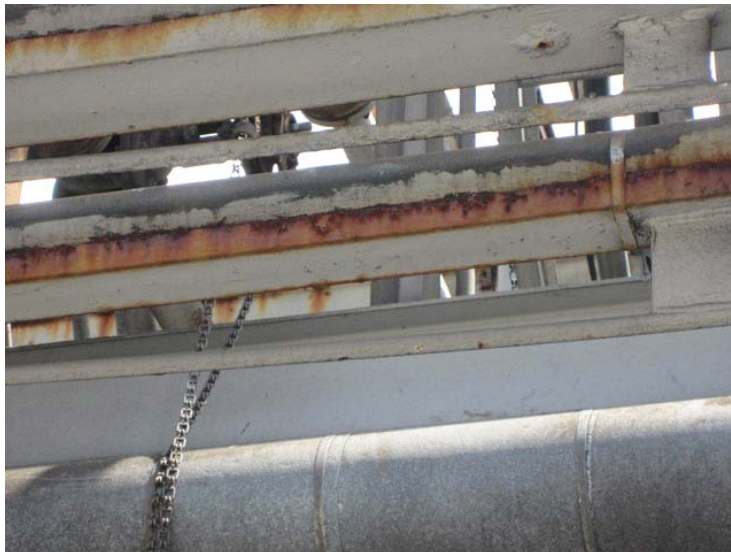
Corrosion Rating: 7.5 - 0.2% rust

Corrosion Type: D - Undercutting or Mill Scale

Corrosion on structure

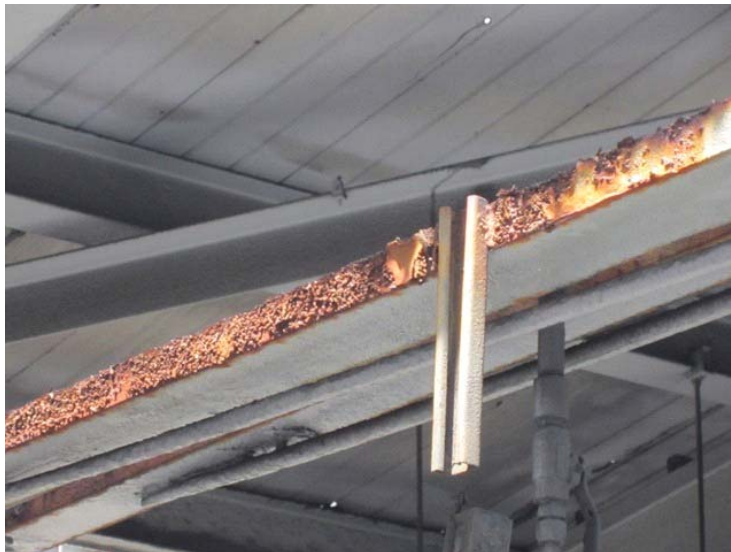
Corrosion Rating: 7.5 - 0.2% rust

Corrosion Type: C - Edge or Pinhole Corrosion

Corrosion on structure

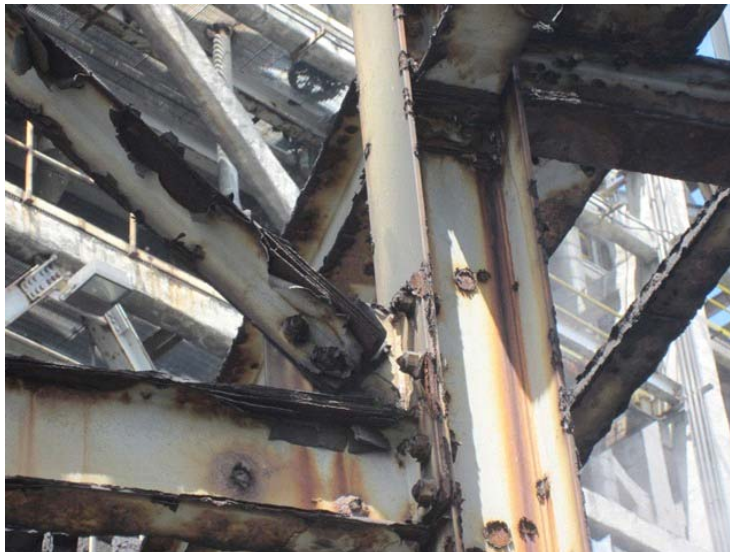
Priority: 1 - Advanced Corrosion

Heavy corrosion on structure

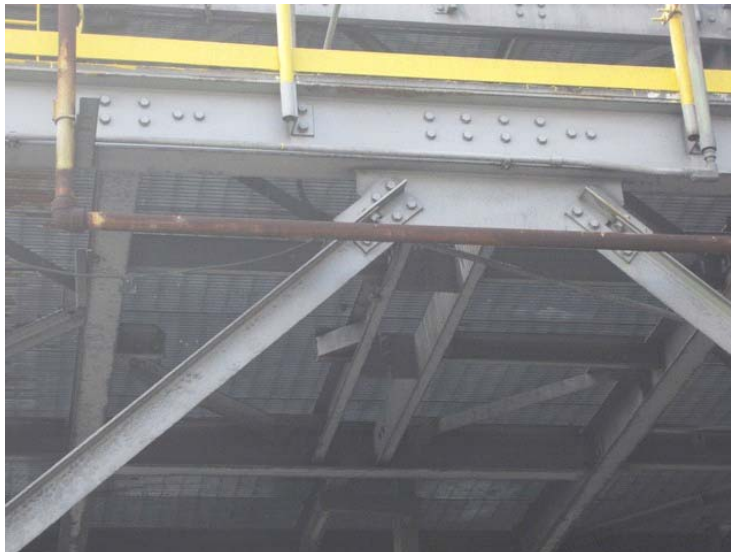
Priority: 7 - Fair

Corrosion on pipe

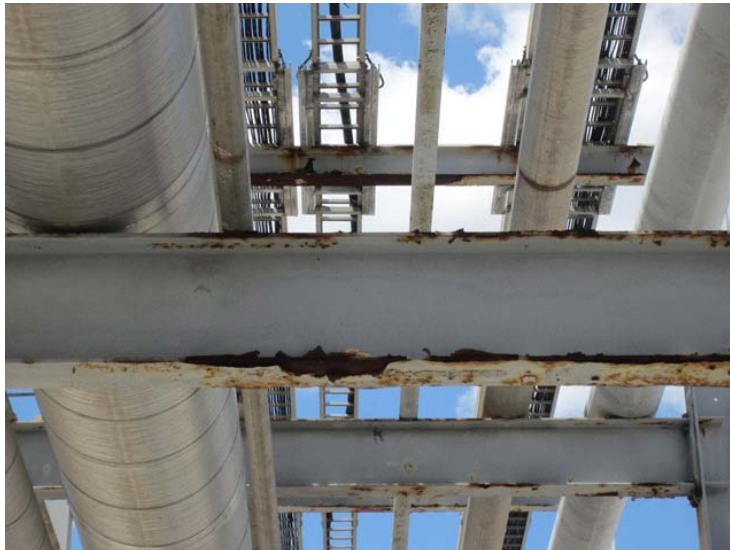
Environment Rating 3 - Moderate
Visibility: 4 - Hi Employee Traffic or Visibility
Corrosion Rating: 5.0 - 3% rust
Corrosion Type: E - Pitting or Rust Nodules
Priority: 4 - Substandard

Corrosion on structure

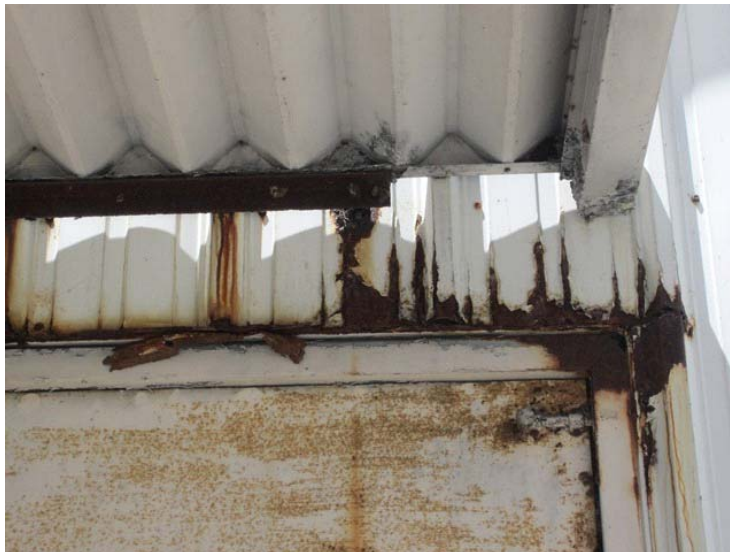
Environment Rating 3 - Moderate
Visibility: 4 - Hi Employee Traffic or Visibility
Corrosion Rating: 8.0 - 0.1% rust
Corrosion Type: C - Edge or Pinhole Corrosion
Priority: 7 - Fair

Corrosion on structure

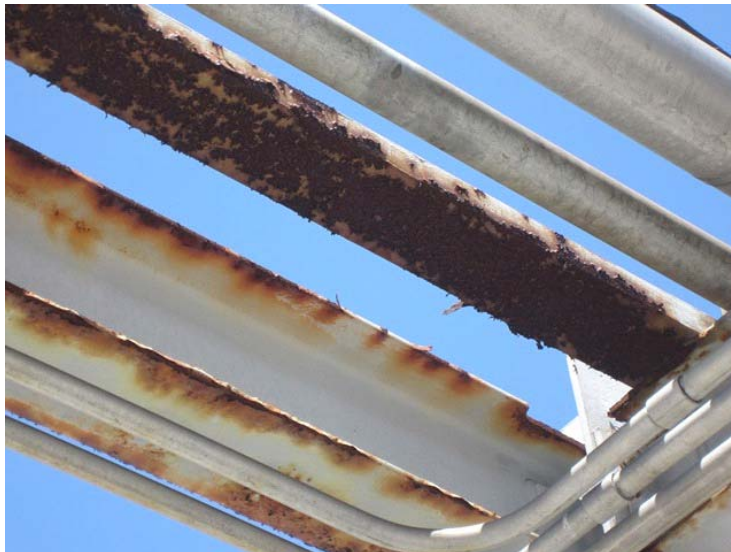
Environment Rating 3 - Moderate
Visibility: 4 - Hi Employee Traffic or Visibility
Corrosion Rating: 4.5 - 7% rust
Corrosion Type: E - Pitting or Rust Nodules
Priority: 4 - Substandard

Heavy corrosion on piping and structure

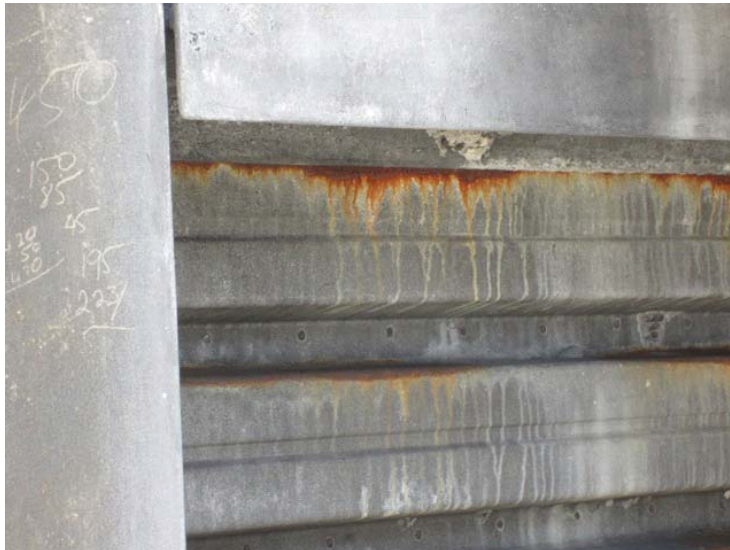
Environment Rating 3 - Moderate
Visibility: 6 - Low Traffic or Visibility
Corrosion Rating: 6.0 - 1% rust
Corrosion Type: E - Pitting or Rust Nodules
Priority: 3 - Wearout

Corrosion on siding

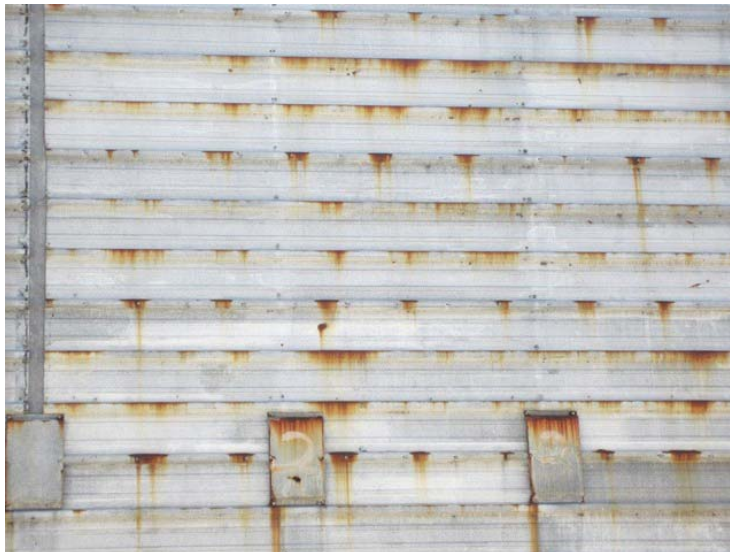
Environment Rating 3 - Moderate
Visibility: 6 - Low Traffic or Visibility
Corrosion Rating: 7.0 - 0.3% rust
Corrosion Type: E - Pitting or Rust Nodules
Priority: 7 - Fair

Uniform corrosion on siding

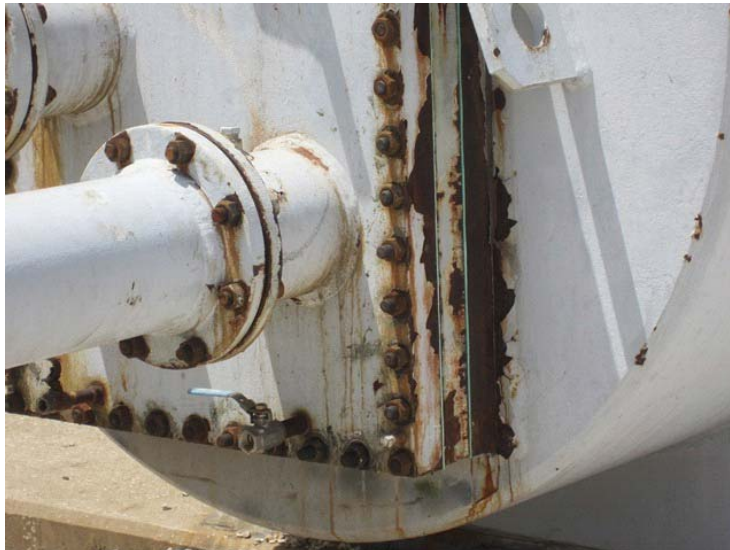
Environment Rating 3 - Moderate
Visibility: 4 - Hi Employee Traffic or Visibility
Corrosion Rating: 6.5 - 0.7% rust
Corrosion Type: D - Undercutting or Mill Scale
Priority: 3 - Wearout

Corrosion on vessel

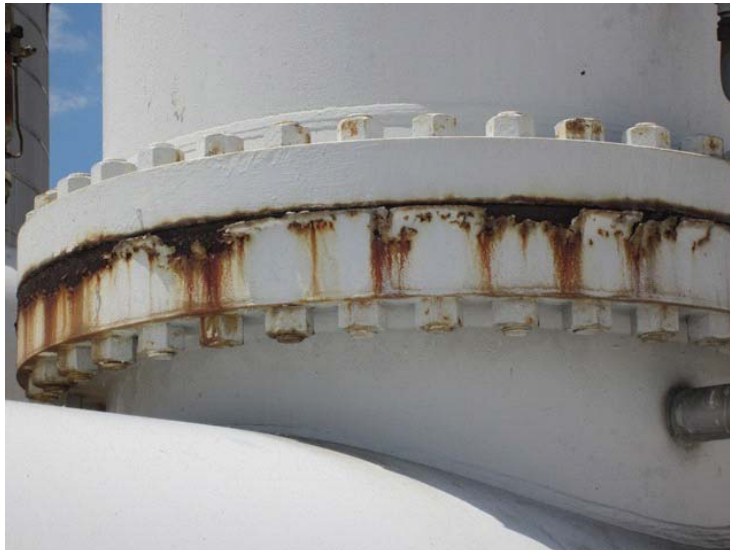
Environment Rating 3 - Moderate
Visibility: 4 - Hi Employee Traffic or Visibility
Corrosion Rating: 6.5 - 0.7% rust
Corrosion Type: D - Undercutting or Mill Scale
Priority: 3 - Wearout

Corrosion on flange

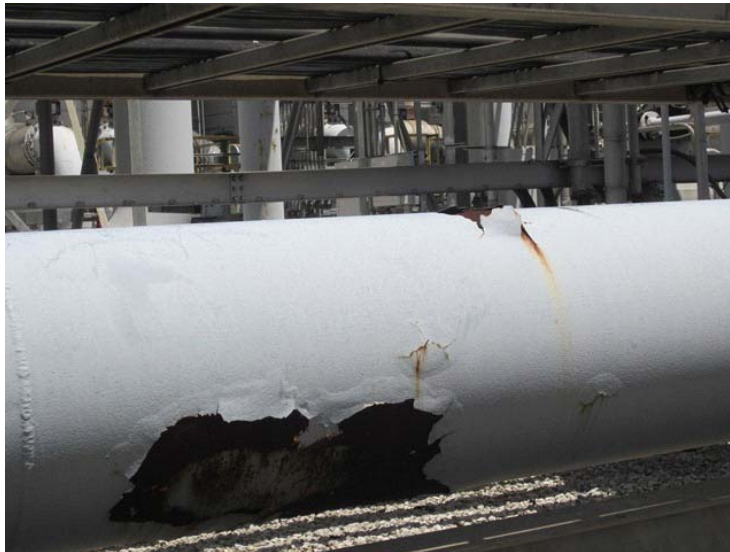
Environment Rating 3 - Moderate
Visibility: 6 - Low Traffic or Visibility
Corrosion Rating: 5.5 - 2% rust
Corrosion Type: D - Undercutting or Mill Scale
Priority: 3 - Wearout

Undercutting on piping

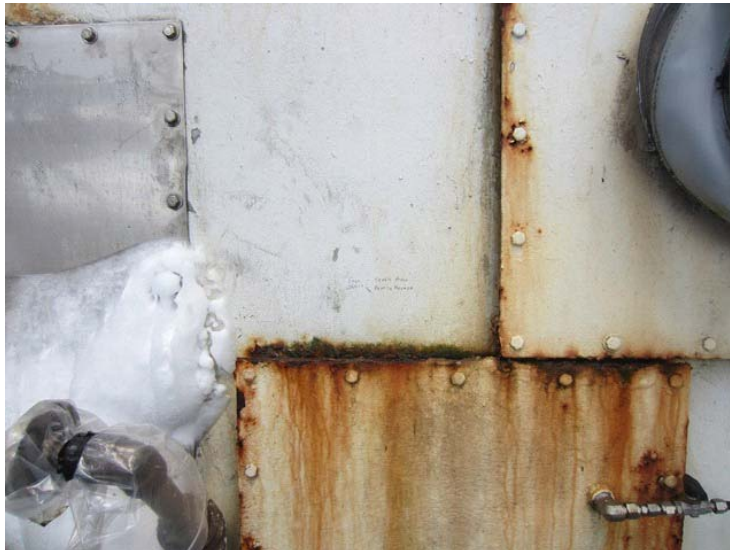
Environment Rating 3 - Moderate
Visibility: 6 - Low Traffic or Visibility
Corrosion Rating: 5.5 - 2% rust
Corrosion Type: D - Undercutting or Mill Scale
Priority: 3 - Wearout

Corrosion on cold box

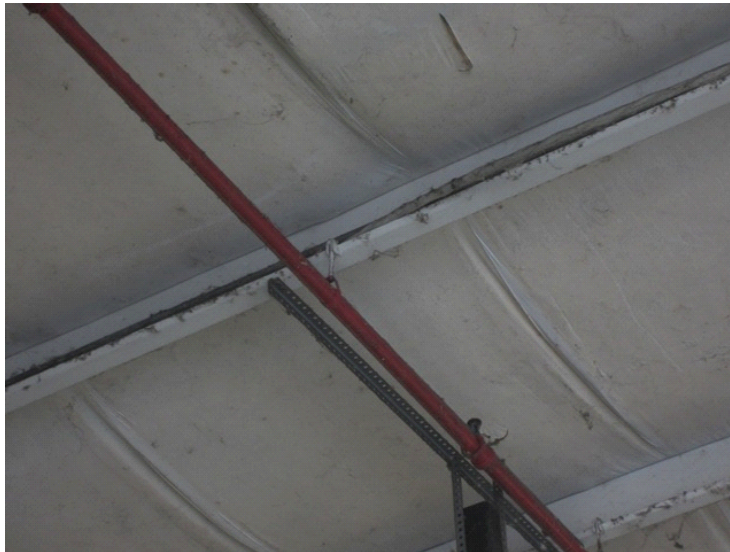
Corrosion Rating: 8.5 - <0.1% rust

Slight corrosion inside warehouse

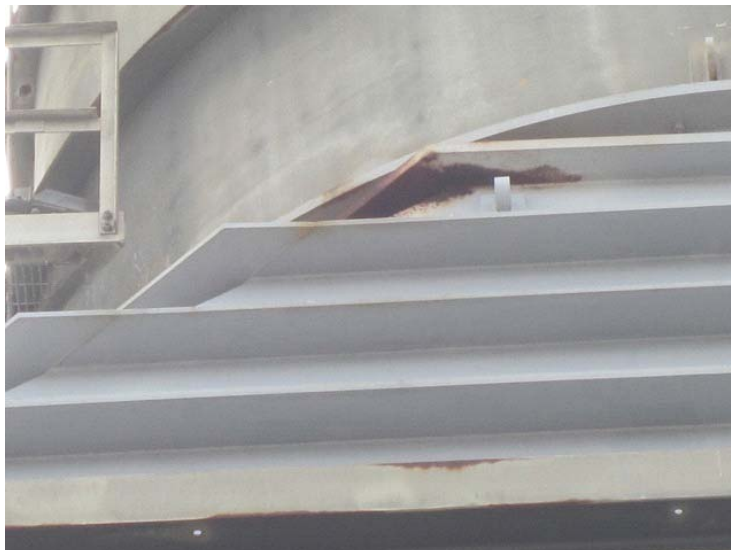
Corrosion on stack

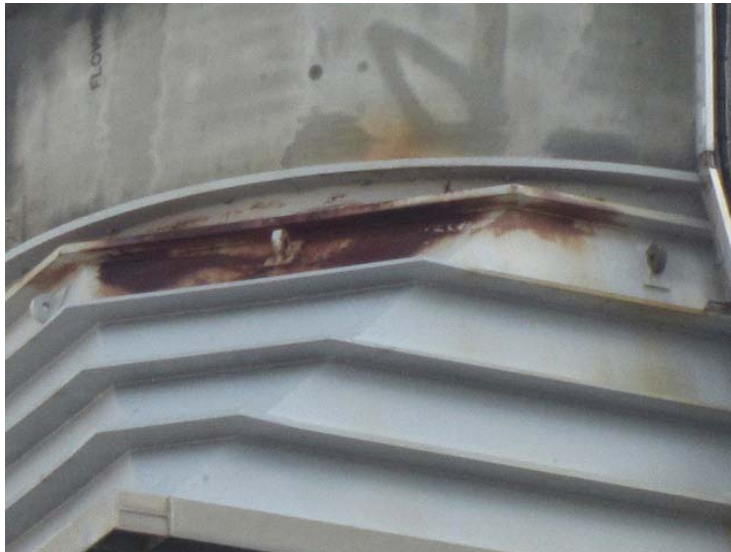
Environment Rating 3 - Moderate
Visibility: 3 - Tank Area
Corrosion Rating: 7.0 - 0.3% rust
Corrosion Type: C - Edge or Pinhole Corrosion
Priority: 2 - Optimum

Corrosion on stack structure

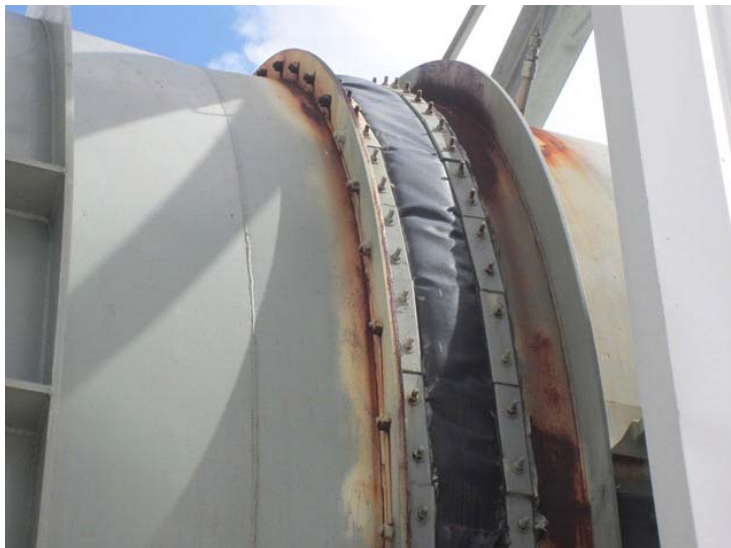
Corrosion at joints

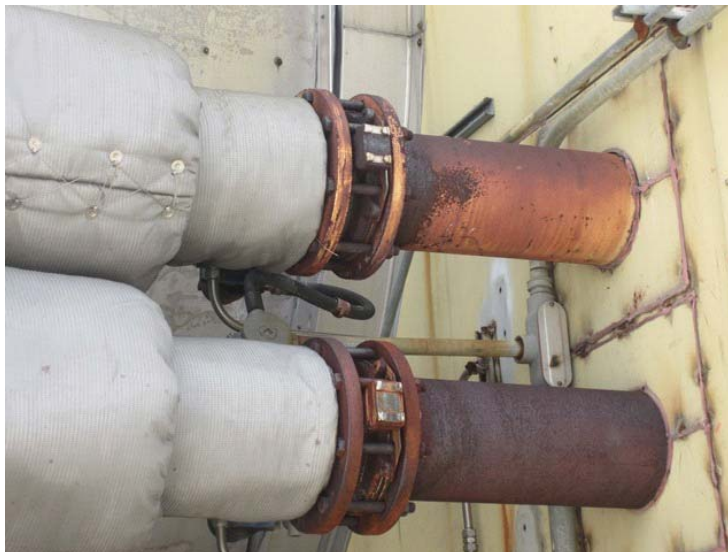
Corrosion Rating: 3.5 - 13% rust

Comments: Corroding pipe on South Side of section.

Corrosion on piping

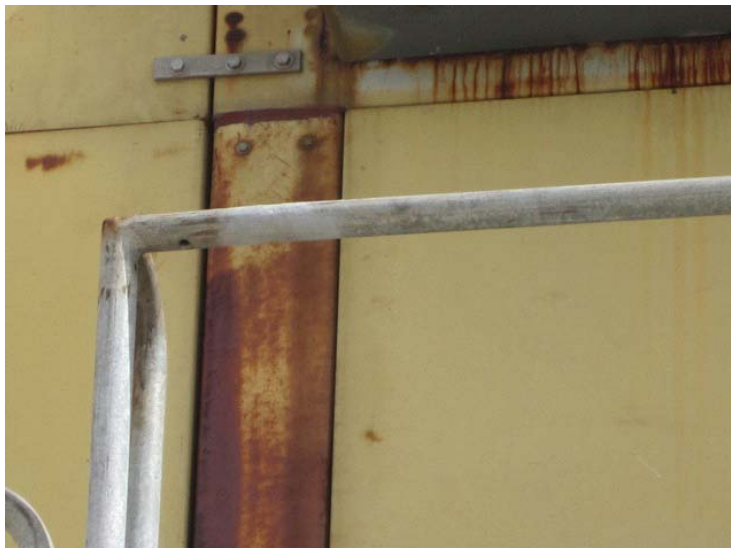
Corrosion on building

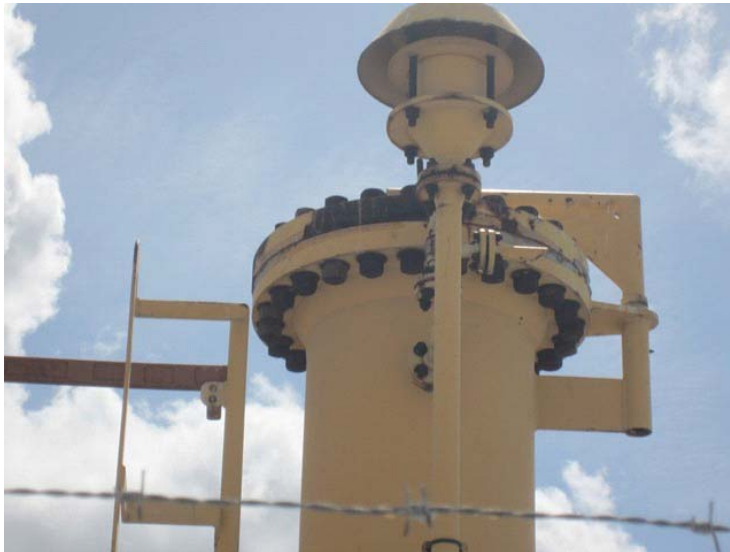
Environment Rating 3 - Moderate
Visibility: 6 - Low Traffic or Visibility
Corrosion Rating: 8.0 - 0.1% rust
Corrosion Type: A - No or Minimal Corrosion
Priority: 7 - Fair

Corrosion on flange

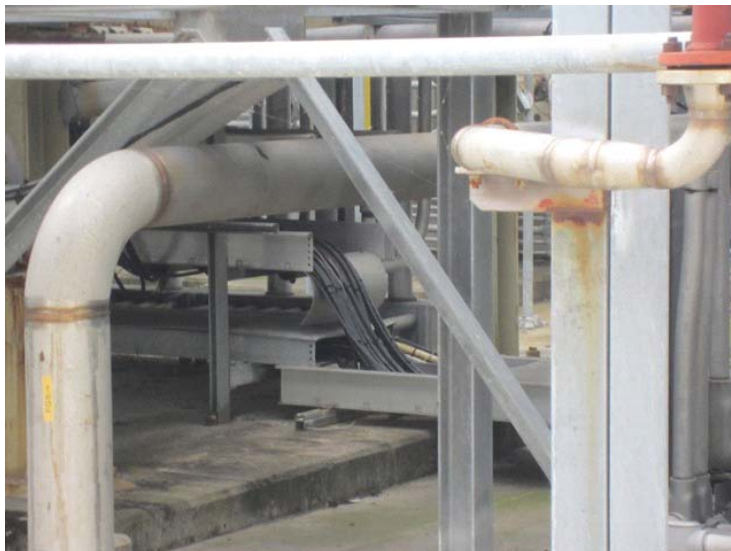
Environment Rating 3 - Moderate
Visibility: 5 - Moderate Traffic or Visibility
Corrosion Rating: 7.5 - 0.2% rust
Corrosion Type: B - Surface Rust
Priority: 7 - Fair

Slight corrosion in section

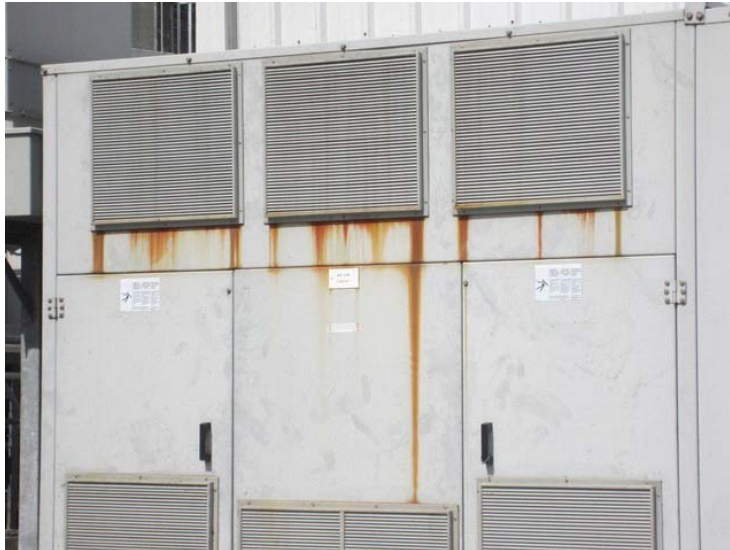
Comments: Building has corrosion on south side.

Corrosion on electrical boxes

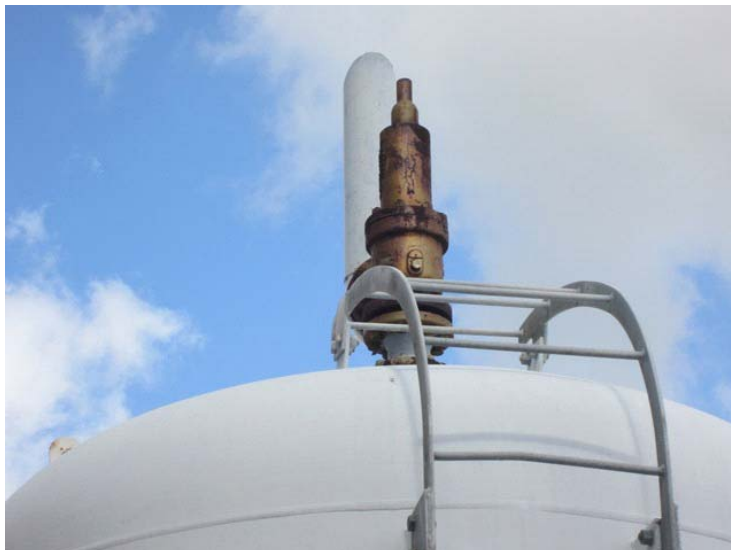
Environment Rating 3 - Moderate
Visibility: 5 - Moderate Traffic or Visibility
Corrosion Rating: 7.0 - 0.3% rust
Corrosion Type: E - Pitting or Rust Nodules
Priority: 7 - Fair

Corrosion on top of tank

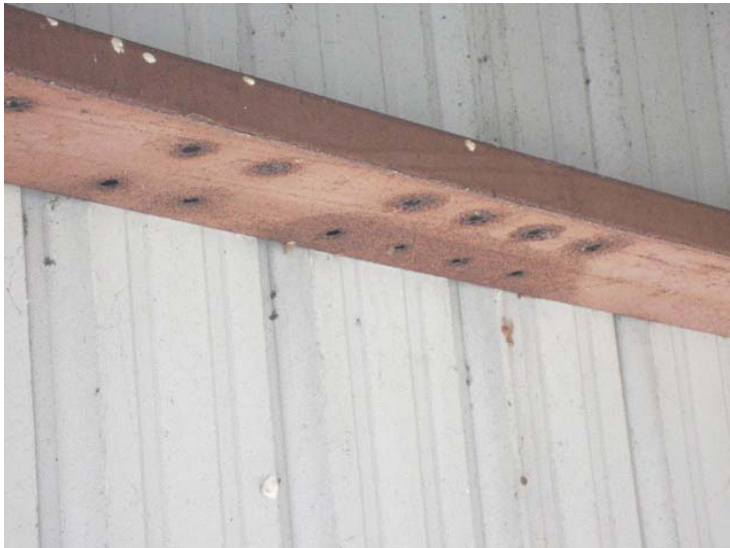
Environment Rating 3 - Moderate
Visibility: 6 - Low Traffic or Visibility
Corrosion Rating: 7.0 - 0.3% rust
Corrosion Type: B - Surface Rust
Priority: 7 - Fair

Corrosion on structure

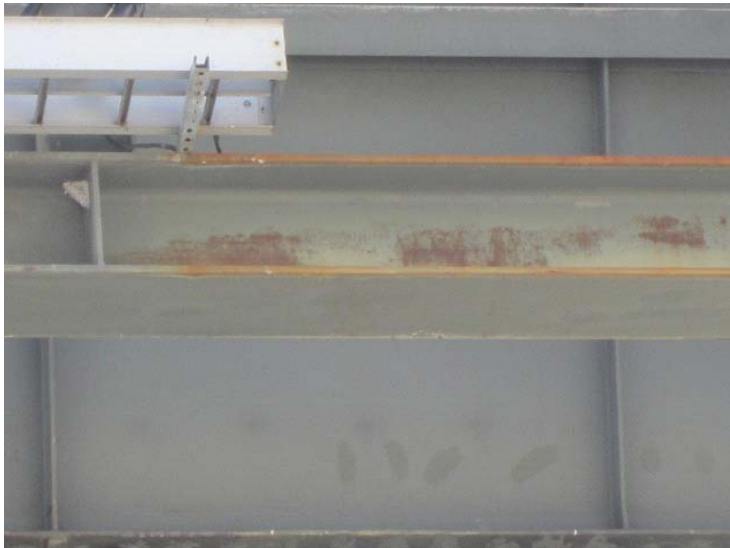
Environment Rating 3 - Moderate
Visibility: 3 - Tank Area
Corrosion Rating: 7.5 - 0.2% rust
Corrosion Type: C - Edge or Pinhole Corrosion
Priority: 7 - Fair

Corrosion on stack structure

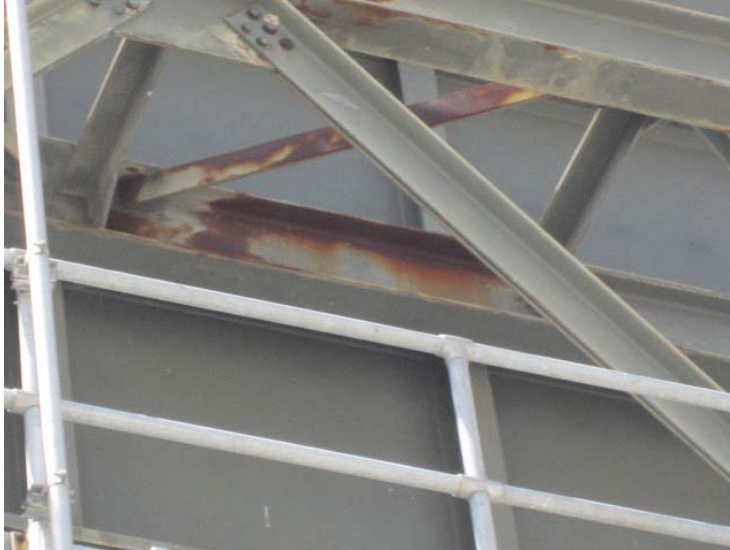
Environment Rating 3 - Moderate
Visibility: 3 - Tank Area
Corrosion Rating: 7.5 - 0.2% rust
Corrosion Type: C - Edge or Pinhole Corrosion
Priority: 7 - Fair

Corrosion on structure

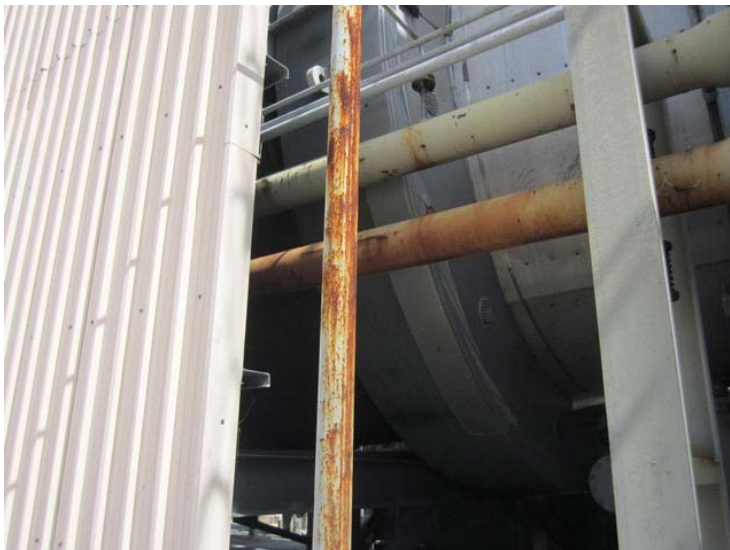
Environment Rating 3 - Moderate
Visibility: 4 - Hi Employee Traffic or Visibility
Corrosion Rating: 3.5 - 13% rust
Corrosion Type: D - Undercutting or Mill Scale
Priority: 5 - Localized Corrosion

Comments: Highly Corroded pipe- Inside Door on South Side

Corrosion on piping

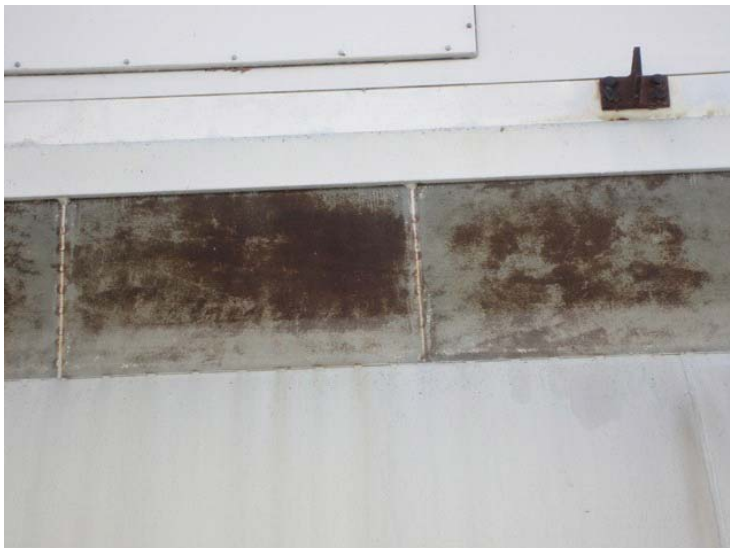
Environment Rating 3 - Moderate
Visibility: 5 - Moderate Traffic or Visibility
Corrosion Rating: 7.0 - 0.3% rust
Corrosion Type: E - Pitting or Rust Nodules
Priority: 7 - Fair

Corrosion on generator

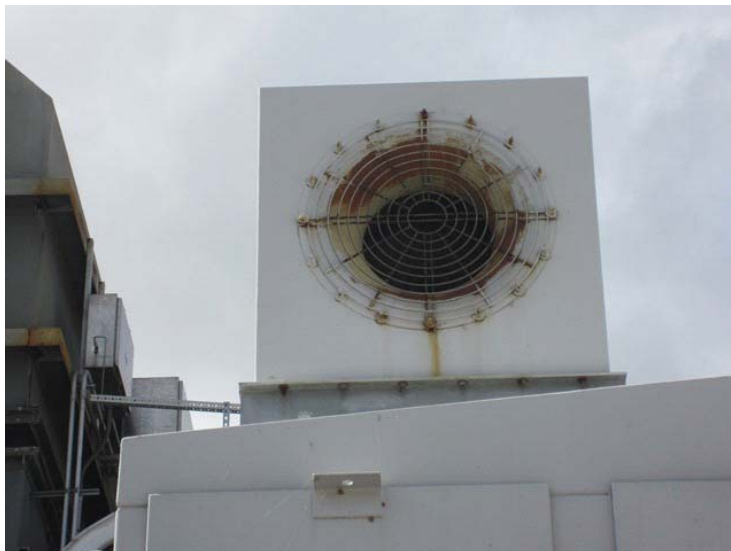
Environment Rating 3 - Moderate
Visibility: 5 - Moderate Traffic or Visibility
Corrosion Rating: 7.5 - 0.2% rust
Corrosion Type: B - Surface Rust
Priority: 7 - Fair

Minor corrosion on fan

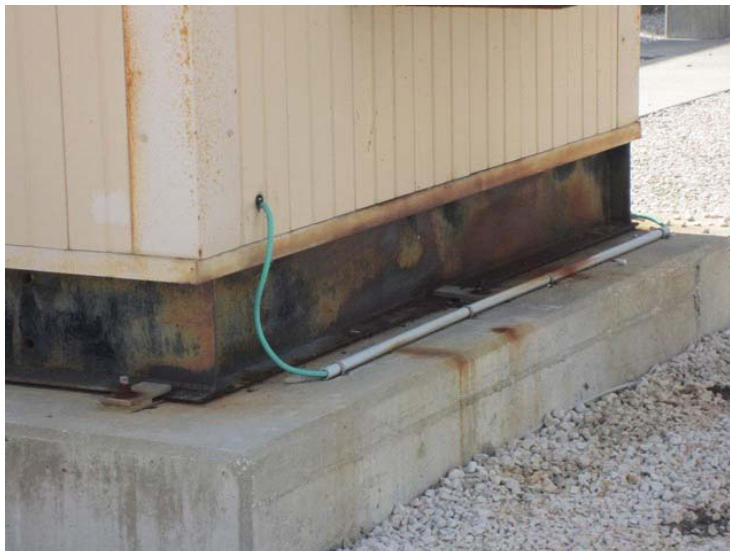
Environment Rating 3 - Moderate
Visibility: 5 - Moderate Traffic or Visibility
Corrosion Rating: 4.0 - 10% rust
Corrosion Type: C - Edge or Pinhole Corrosion
Priority: 5 - Localized Corrosion

Comments: Rust on Building Structure

Heavy corrosion on building structure

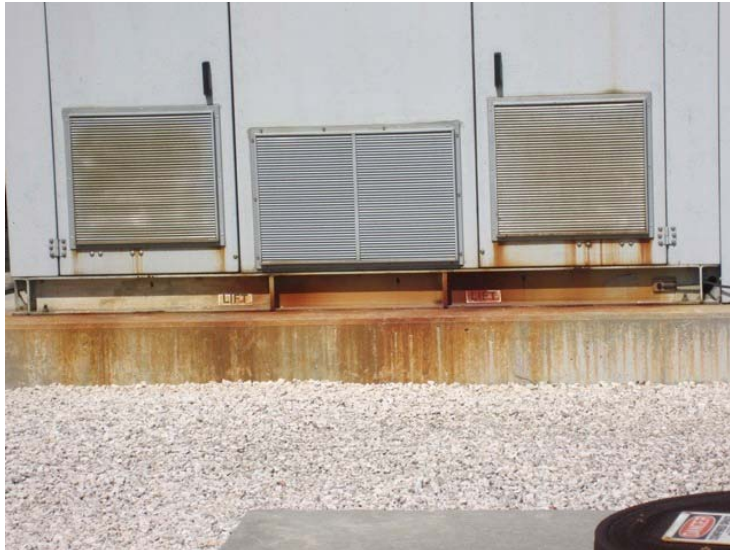
Environment Rating 3 - Moderate
Visibility: 5 - Moderate Traffic or Visibility
Corrosion Rating: 4.0 - 10% rust
Corrosion Type: C - Edge or Pinhole Corrosion
Priority: 5 - Localized Corrosion

Comments: Rust on Building Structure

Corrosion on building structure

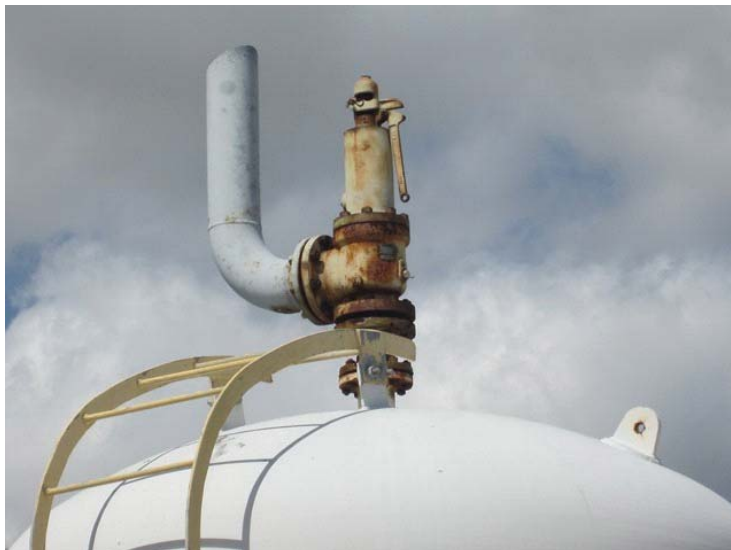
Environment Rating 3 - Moderate
Visibility: 5 - Moderate Traffic or Visibility
Corrosion Rating: 8.0 - 0.1% rust
Corrosion Type: B - Surface Rust
Priority: 7 - Fair

Corrosion on vent

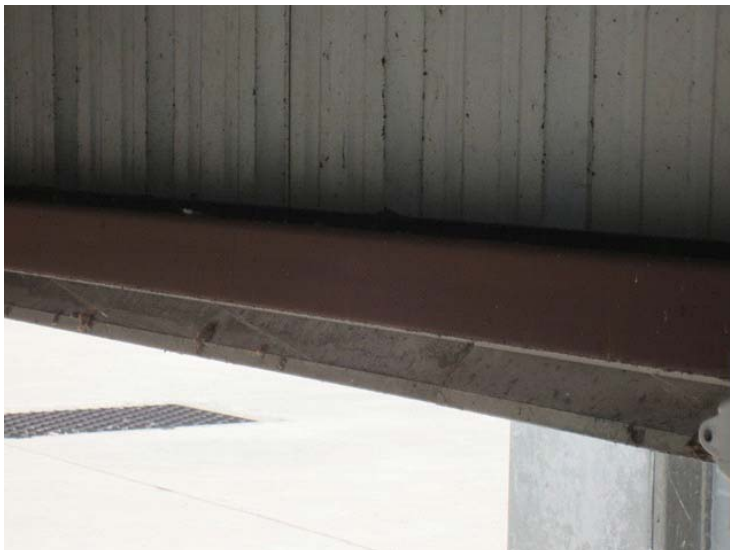
Corrosion Rating: 7.5 - 0.2% rust

Corrosion Type: D - Undercutting or Mill Scale

Comments: Mold on Tank

Corrosion on structure

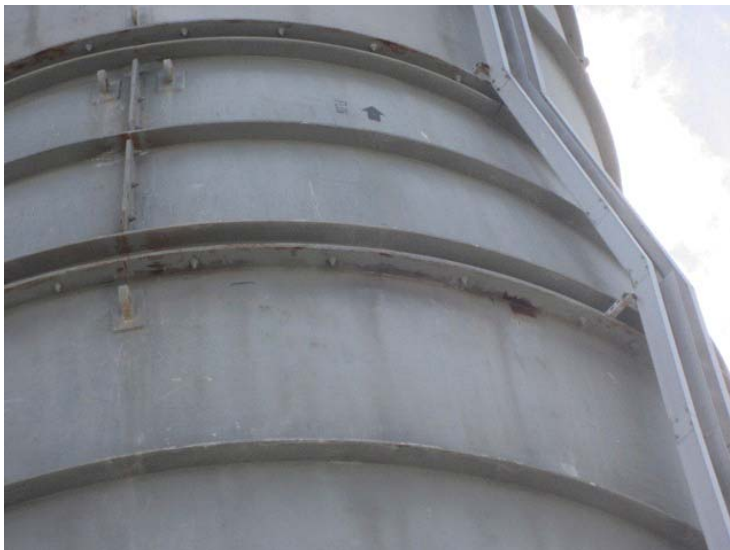
Edge corrosion on stack

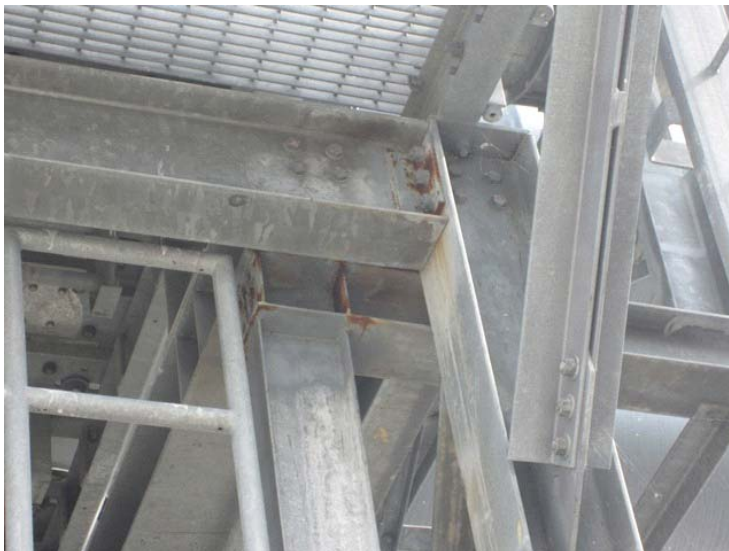
Minor corrosion on structure

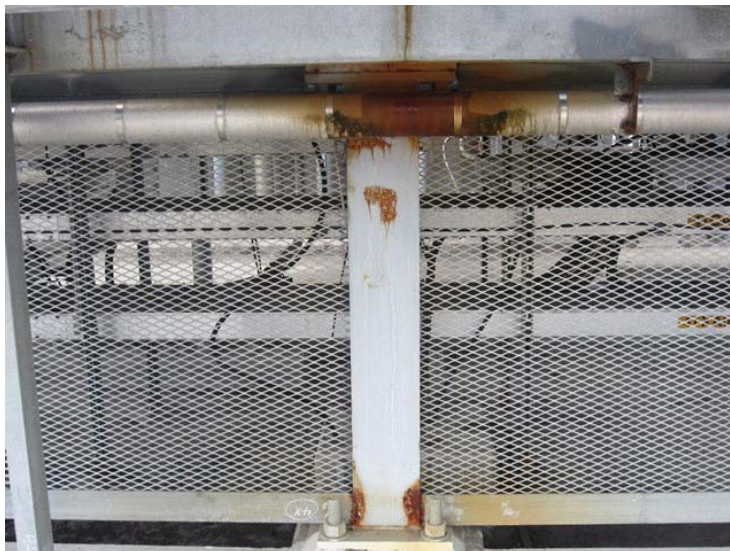
Corrosion on structure

Environment Rating 3 - Moderate
Visibility: 4 - Hi Employee Traffic or Visibility
Corrosion Rating: 7.0 - 0.3% rust
Corrosion Type: E - Pitting or Rust Nodules
Priority: 7 - Fair

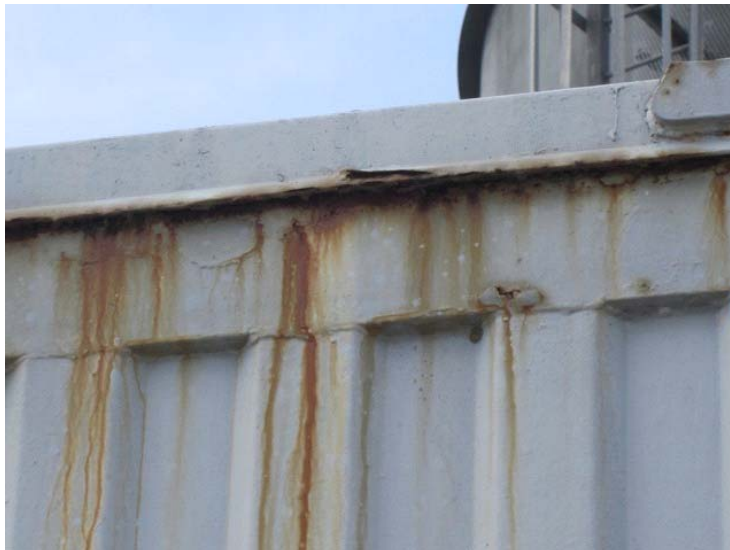
Heavy corrosion on structure

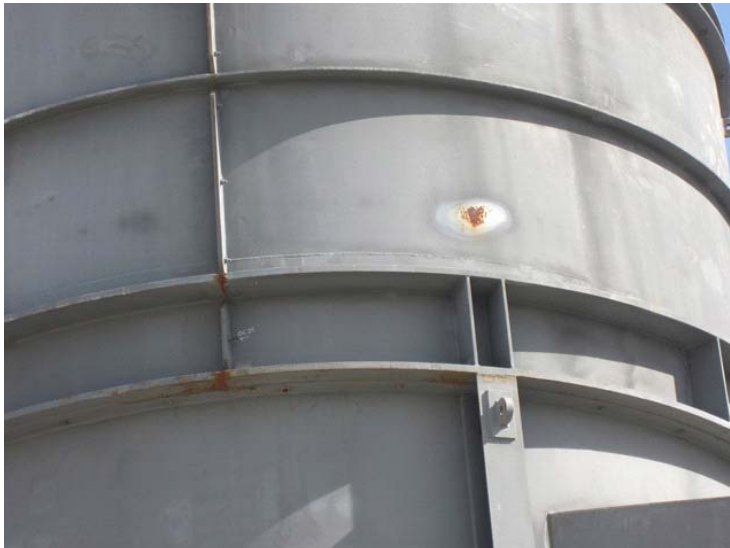
Corrosion on stack

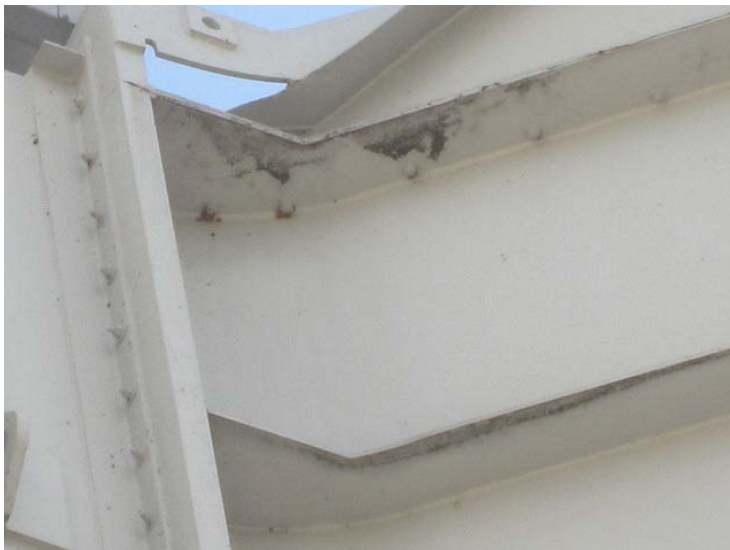
Comments: Coating Blisters

Minor corrosion in section
