Condition Analysis

Block: 01 Northwest Unit of the plant. Includes Gasification Unit, Brine Unit, Acid Unit, Coal Slurry Building, and pipe lines to flares.

Subblock: A On West side of Block 1. Contains Flare, pipe racks to flare, and conveyor belt.

Section: 01 Flare and associated structure.

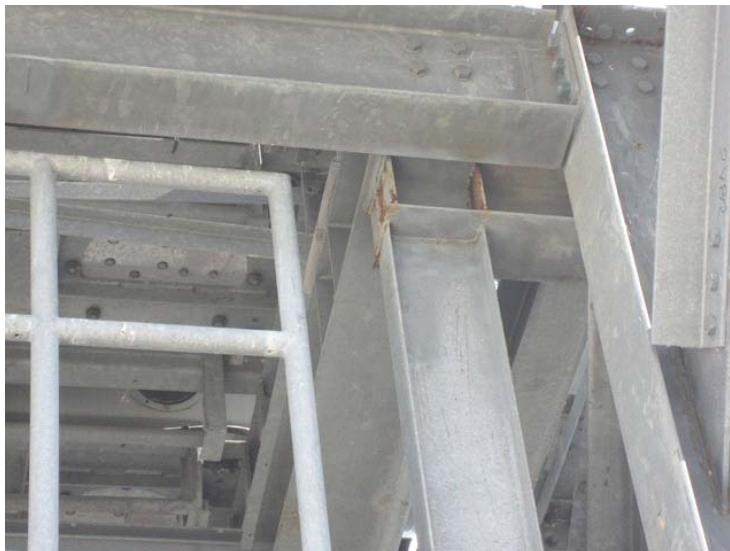
Minor corrosion in section

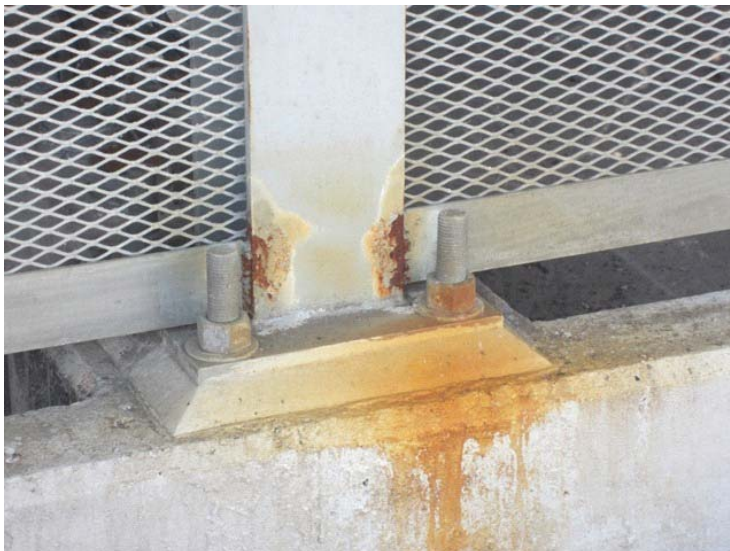
Corrosion on structure

Environment Rating 3 - Moderate
Visibility: 4 - Hi Employee Traffic or Visibility
Corrosion Rating: 7.0 - 0.3% rust
Corrosion Type: E - Pitting or Rust Nodules
Priority: 7 - Fair

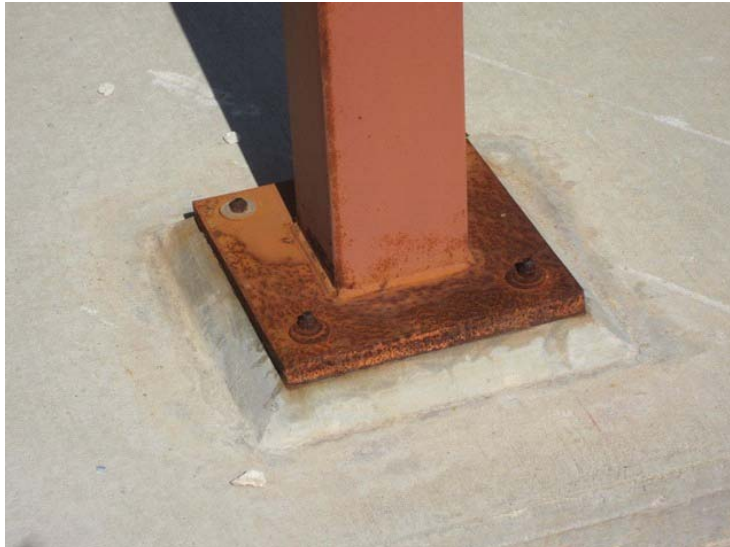
Corrosion on supports
