**Tampa Electric Company  
(TECO)  
Coal Yard Mechanical,  
Electrical and Structural  
Assessment**

Results from field review of the  
coal unloading equipment,  
structures and conveyors.

June 21, 2010

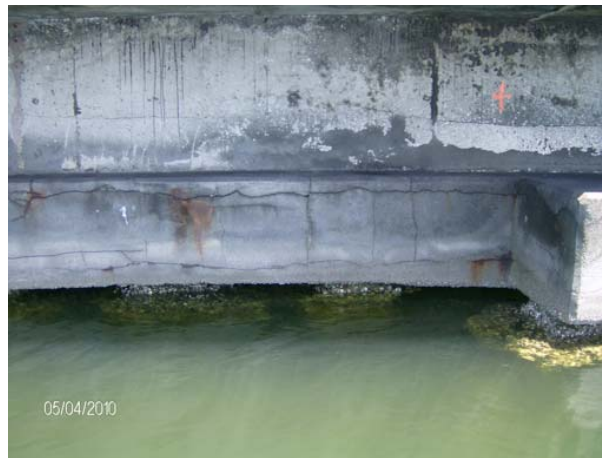
PICTURE DOCK-A

At and near the waterline, the Dock and piles appear to be in good shape. There is some horizontal and spider cracking evident in the pile caps with some corrosion discoloration, as seen in Picture DOCK-A.

This cracking and corrosion does not appear to be severe enough to cause sprawling of the concrete at this time. In general, there is minimal damage near the waterline due to impacts although some damage was observed, as seen in Pictures DOCK-B and DOCK-C that should be repaired.

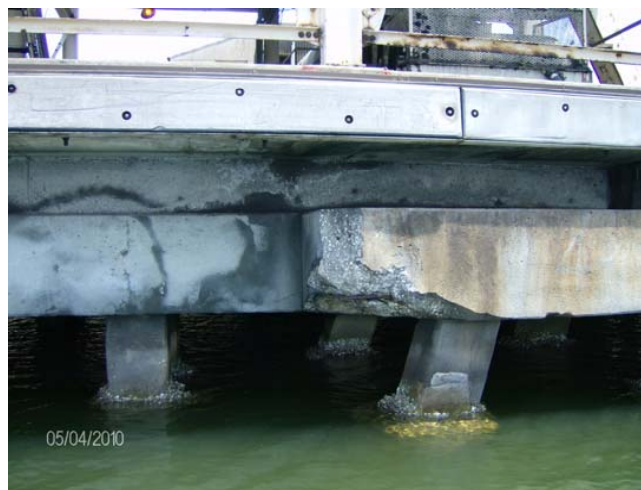
PICTURE DOCK-B

along the face of the Dock where there has been contact with the Coal Barges while docking, as seen in pictures Dock-B and Dock-C.

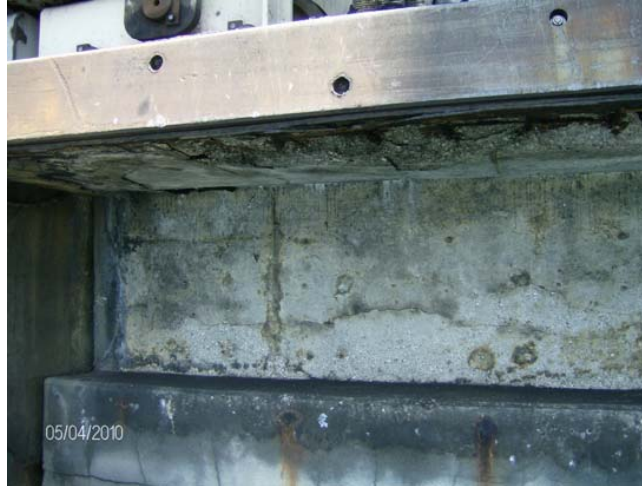
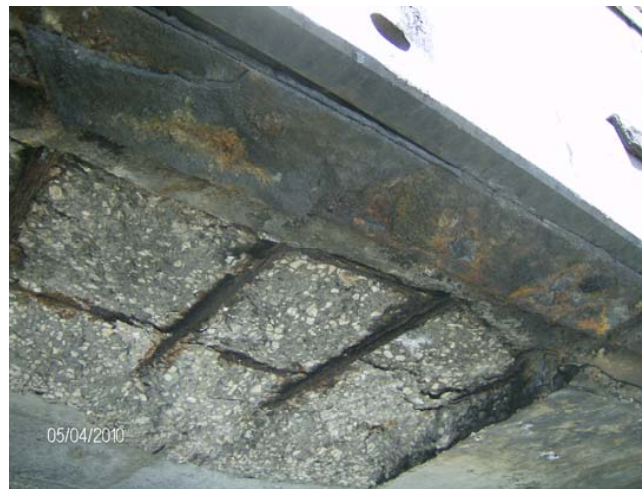
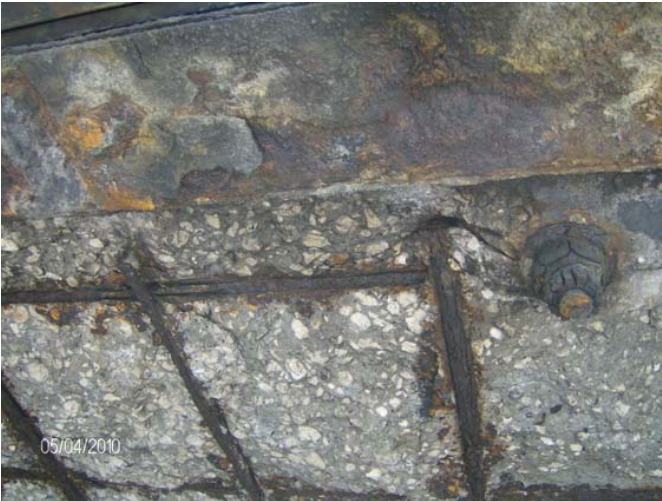
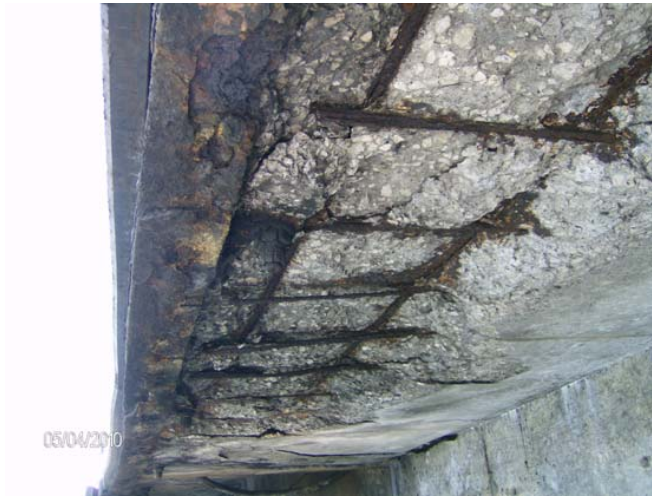
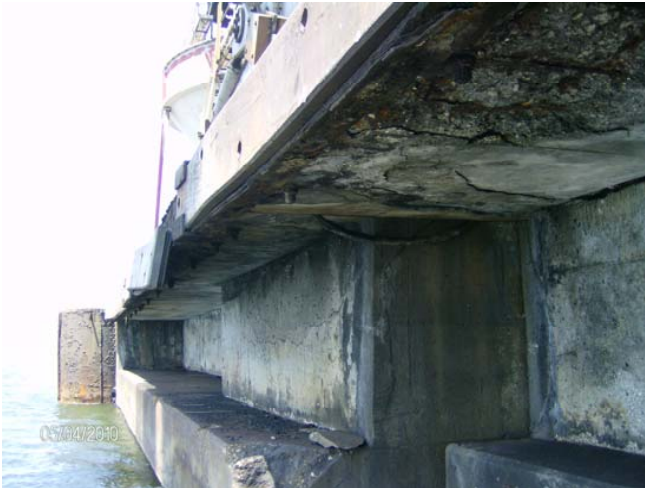
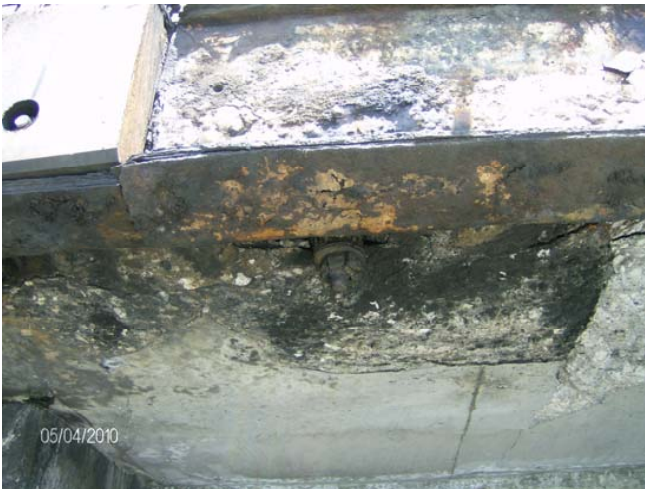
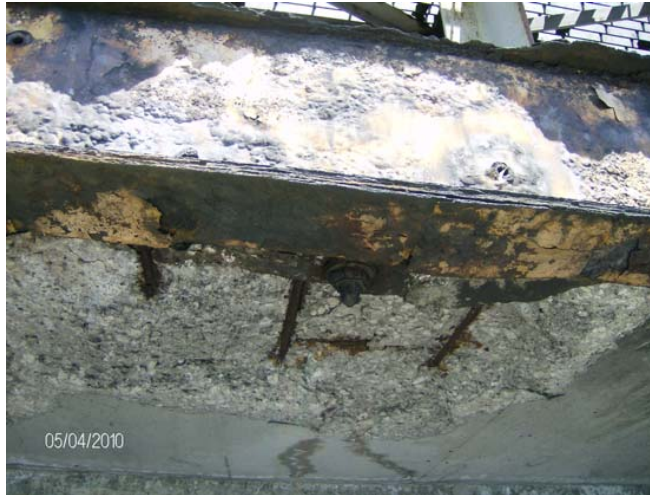
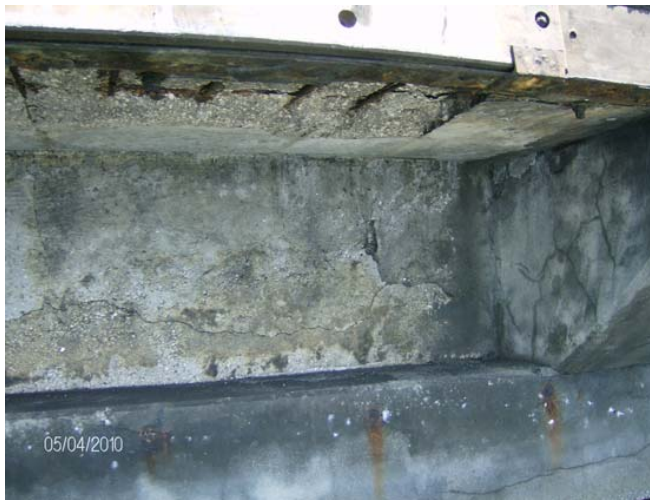
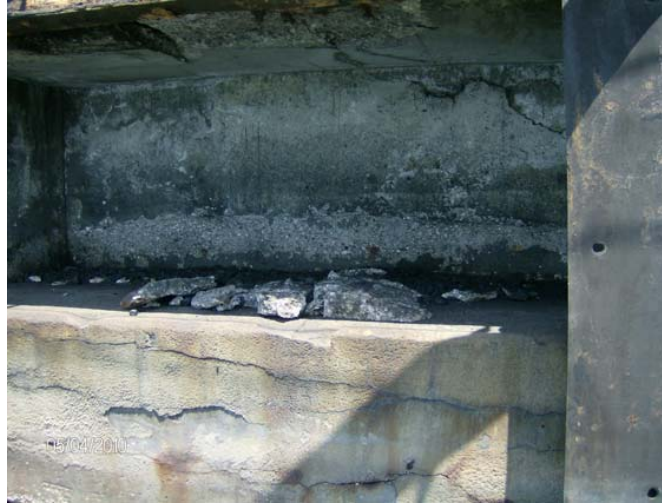
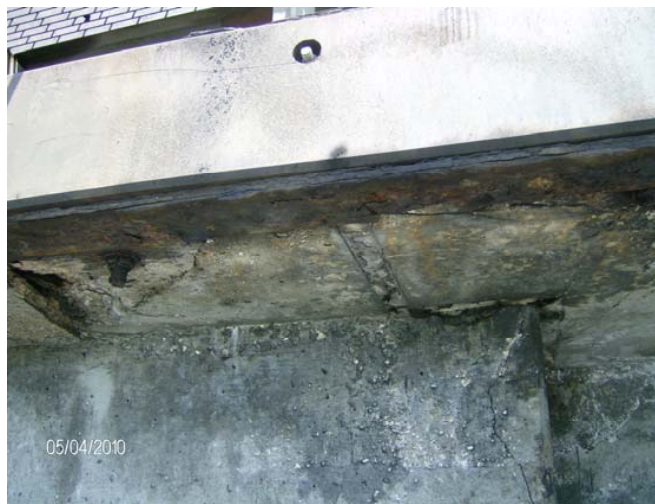
The most damage observed was along the deck edge, as seen in Pictures DOCK-D thru DOCK-N, where bumper strips were installed to protect the edge from impacts from the barges. Over the course of time since the Dock was placed into service, these bumpers have been damaged and repaired/replaced. When the cushioning effect of the bumpers failed, much of the force of the barge bumping against the dock was transmitted into the edge of the deck causing damage to the deck. Additionally, the steel edge channel on the face of the deck has corroded and may not be performing as intended. These bumpers appear to have been added after the dock was constructed. They do not show up on the original construction drawings

The underside of the deck overhang at some of these bumpers has “popped” off causing exposure of the reinforcing and making it subject to corrosion. At these locations, the reinforcing bars need to be cleaned and the underside of the deck repaired to protect the reinforcing steel.

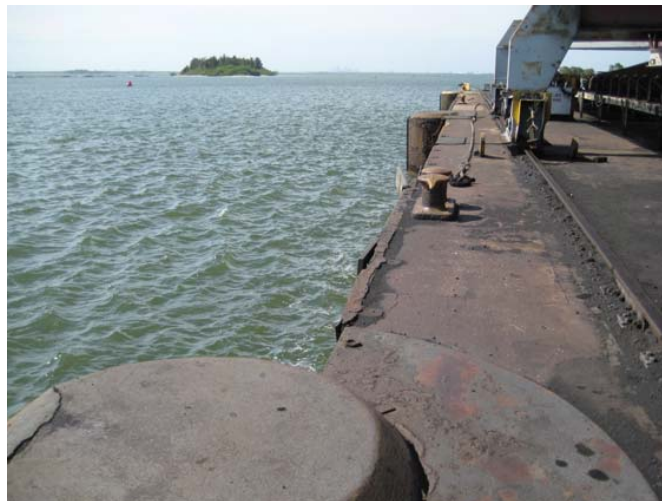
PICTURE DOCK-R

Some of the dock bumpers may not be performing as intended. In some instances, the attachment of the backing steel to the top of the deck has broken free and the bumpers are loose, as in Pictures DOCK-P and DOCK-R. Also, in some cases, the bumper surface has been removed or fallen off into the water below, as in Picture DOCK-S. Additionally, the backing steel is severely corroded in some cases, as seen in the pictures. In these locations, the bumper surface should be removed and the backing steel repaired/replaced. The

underside of the deck should be repaired, if necessary, before new bumper backing steel is installed.

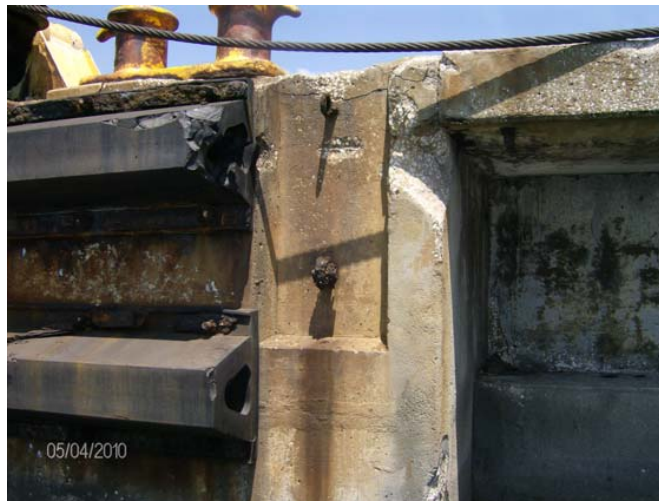
PICTURE DOCK-T

Because of the damage received from impact, an alternate bumper system may be worth considering such as the type used in other locations along the dock, as seen in Picture DOCK-T.

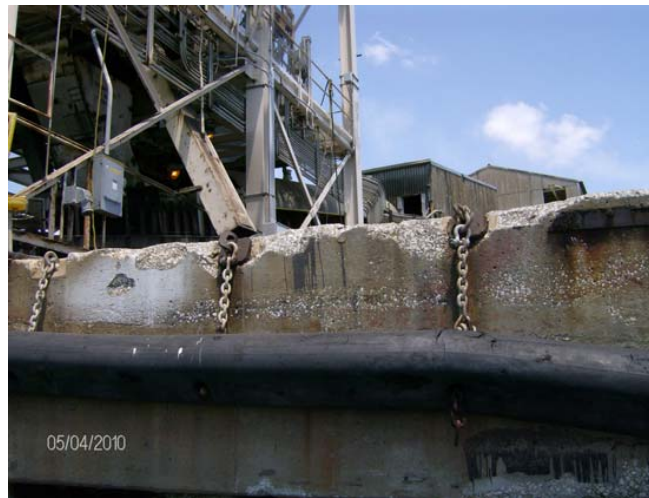
PICTURE DOCK-U

Additionally, there has been some wear over the years along the top edge of the deck due to chains holding bumpers where the Tug ties up. The movement of these chains due to boat movement and wave action has caused the concrete to wear away as seen in Picture DOCK-U

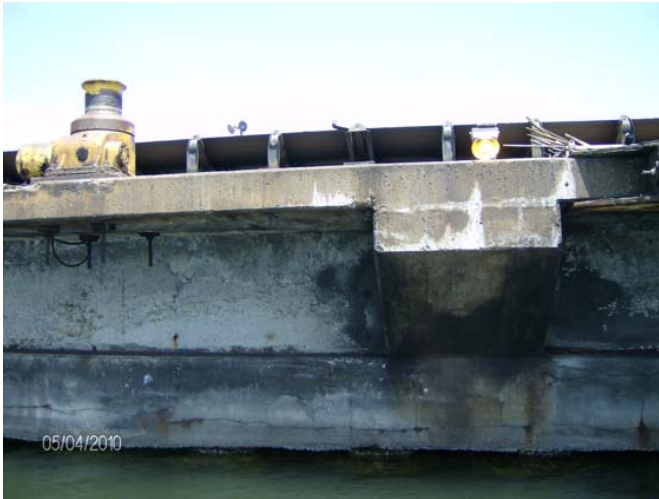
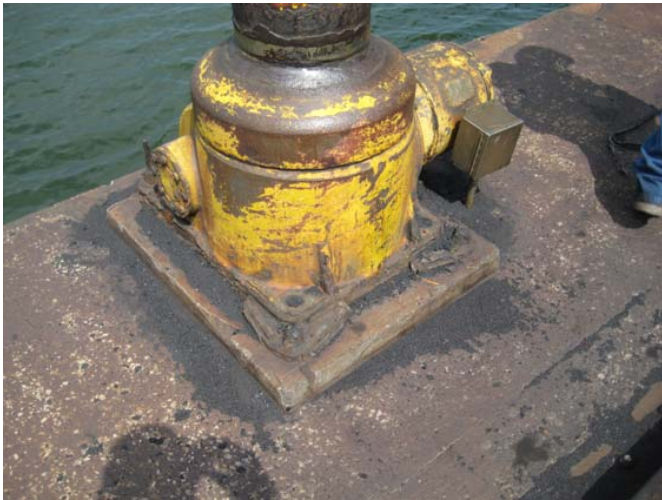
One of the Winches used to pull the Barge in towards the dock has had the nuts on the anchor bolts corroded off, as seen in Pictures DOCK-V and DOCK-W. These nuts should be replaced, which may also include replacement of the through-bolts since there is minimal bolt projection remaining.

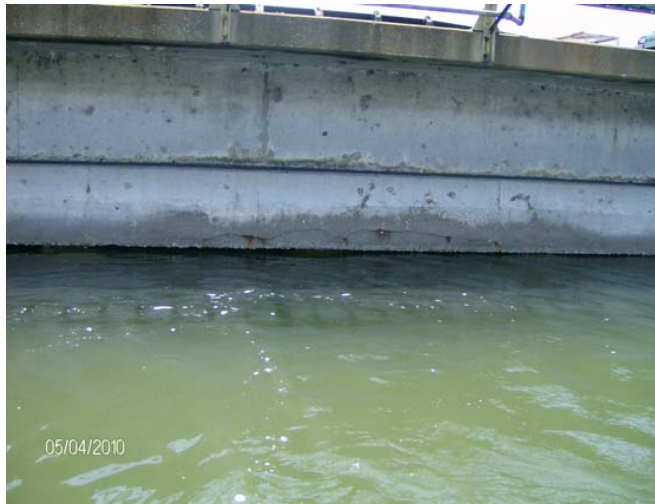
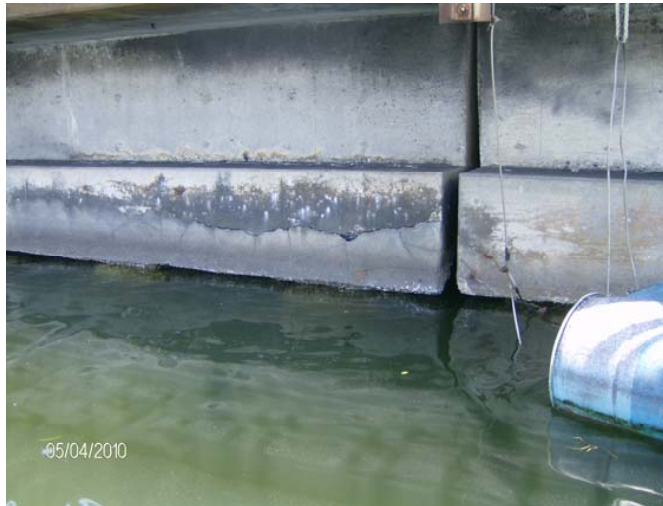
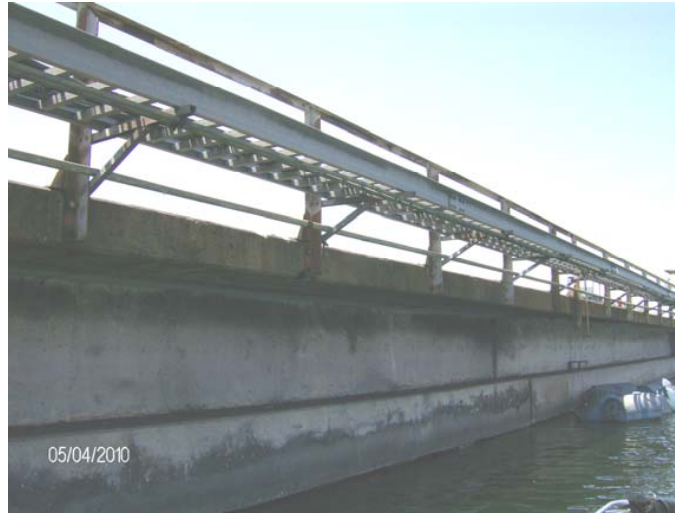
In general, as seen in Pictures DOCK-X thru DOCK-Z, the landside edge of the dock is also in good condition, in part because it does not see impacts from the barge but also because it is the sheltered side. Some minor cracking was observed as would be expected for a concrete structure of this age but is not a structural problem.

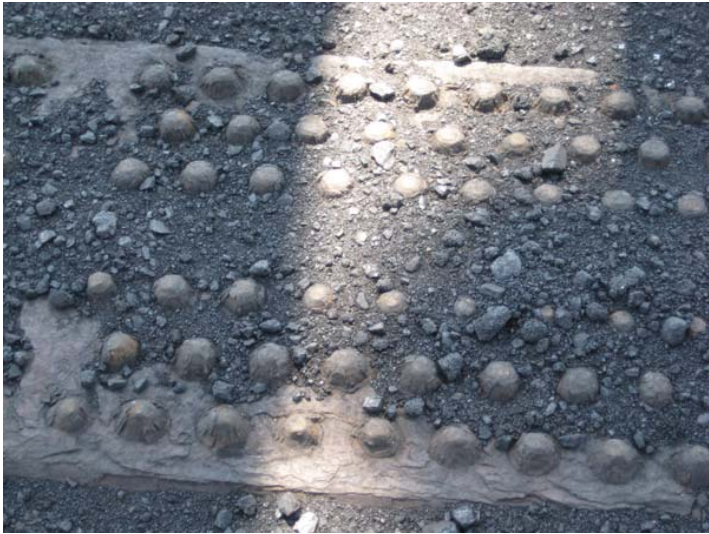
PICTURE DLU-A

At the payloader staging level, approximately 20 feet above the dock, a number of rivet heads were observed to be corroded, as seen in Picture DLU-A. These rivets are critical to the stability of the equipment. Rivets with missing or minimal heads should be removed, one at a time and replace with galvanized high strength A325 bolts of the same diameter. Additionally, this level should be cleaned of all coal accumulation and the metal cleaned and painted to minimize further corrosion. Some corrosion of the toe plate at this level was also observed. This toe plate should be repaired or replaced as required.

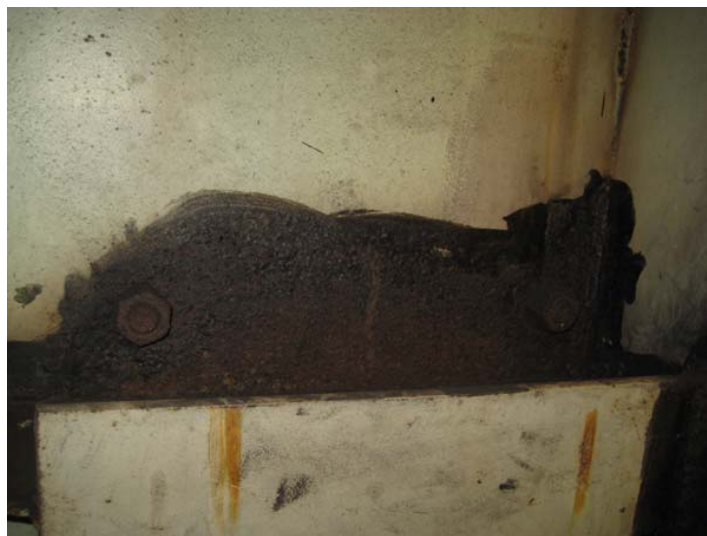
PICTURE DLU-C

Some corrosion within the Unloader Tower was noted on the east side of the tower at the 7<sup>th</sup> Level, as seen in Pictures DLU-B and DLU-C. This appears to be where guides for the counterweight were added and occurs in a number of locations. The new steel added in this area should be cleaned and painted to minimize further corrosion

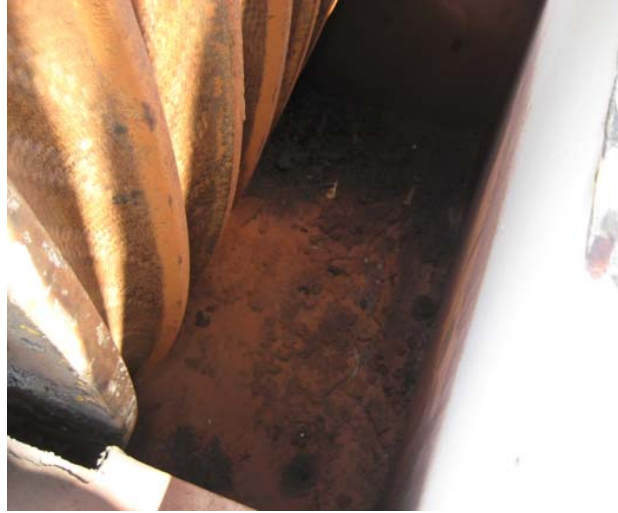
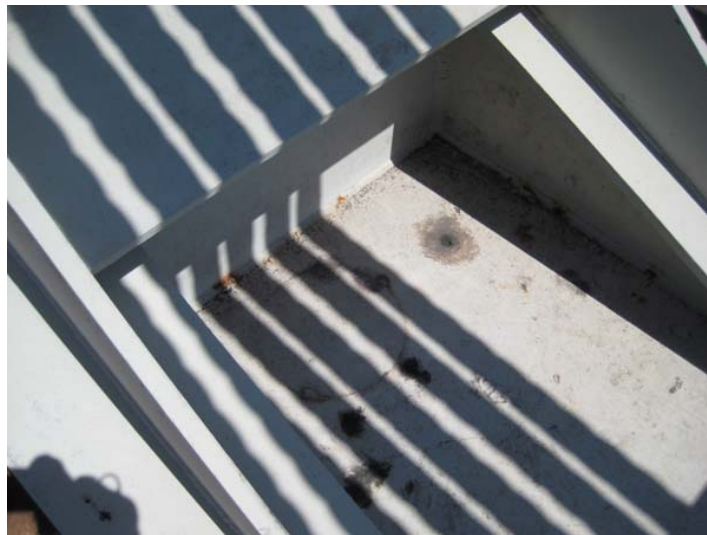
There is a plate under the sheave at the southeast sheave that is not at the northeast sheave. In front of this plate, Picture DLU-K, there is negligible corrosion. Behind the plate, Picture DLU-L, there is corrosion similar to Picture DLU-J. Again, cleaning and painting is recommended.

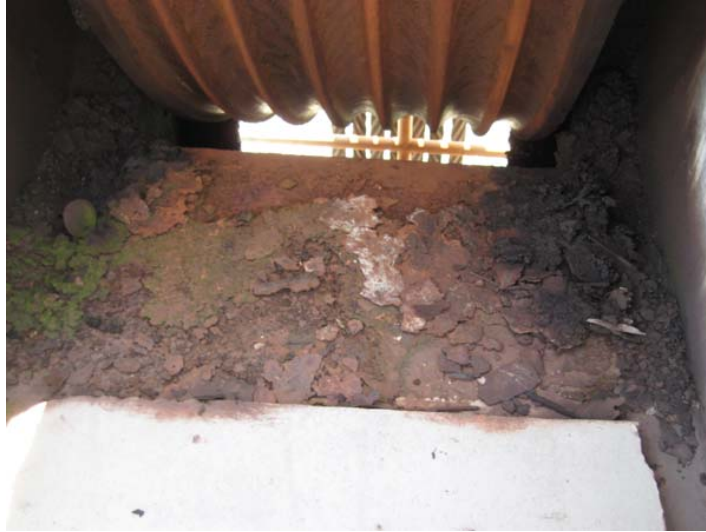
PICTURE DLU-M

Some minor corrosion under the southwest sheave at the Tower Sheave Platform was noted in Picture DLU-M. Cleaning and painting is recommended. The situation at the northwest sheave is similar.

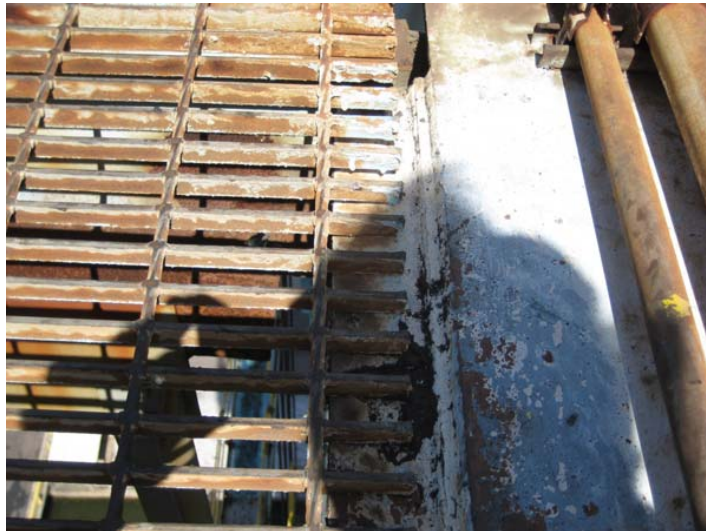
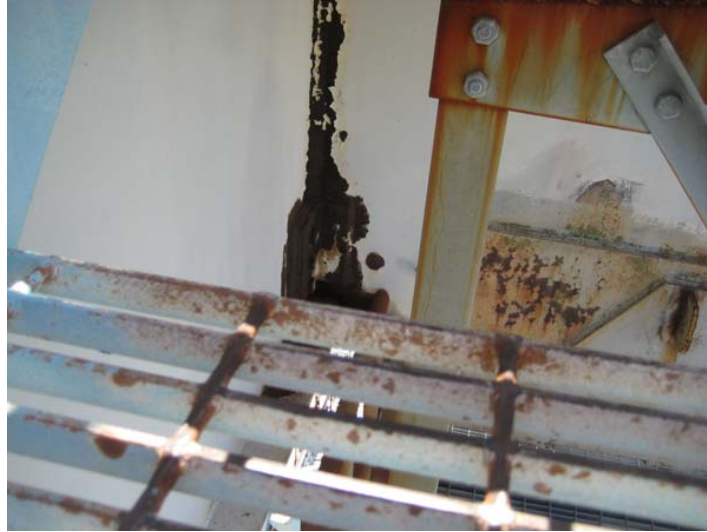
At the top of the stairs at the Tower Sheave Platform, as seen in Pictures DLU-N and DLU-P, the top flange of a beam supporting the stairs and a platform suspended below has corroded through the bottom flange. This is a safety issue and this beam needs repair/replacement as soon as possible.

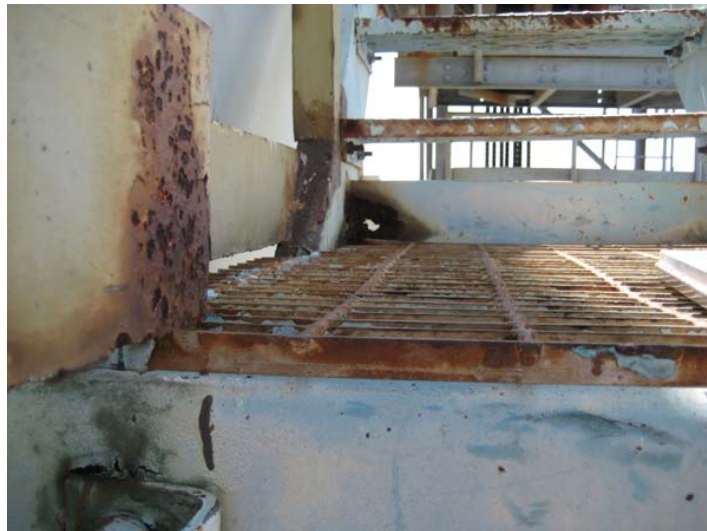
PICTURE DLU-R

At bottom of these same stairs, as seen in Picture DLU-R, there is a hole thru the toe plate and additional corrosion of the stair stringers. The toe plate needs repair and the stringers need a general cleaning and repainting.

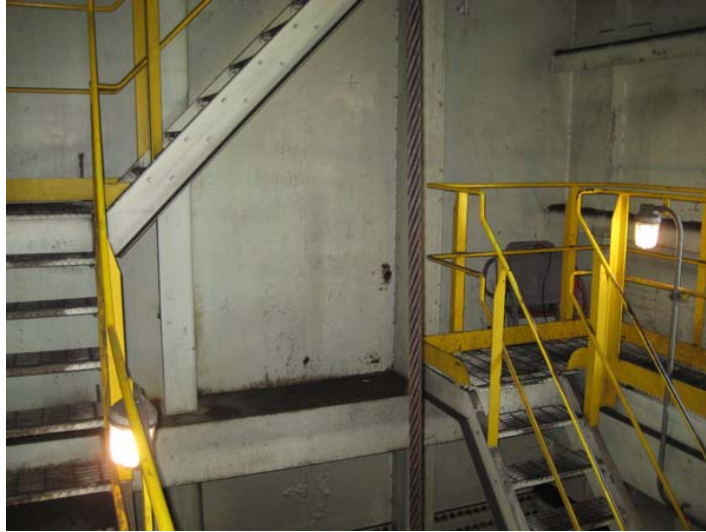
PICTURE DLU-S

Picture DLU-S shows the inside of the Tower with paint still in relatively good condition.

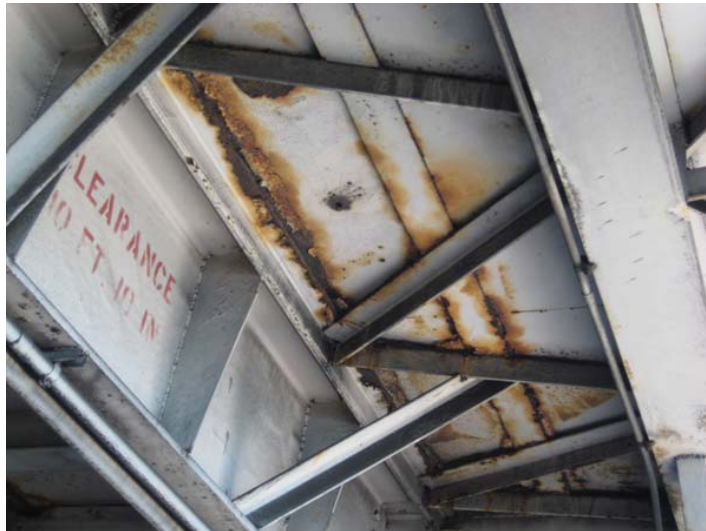
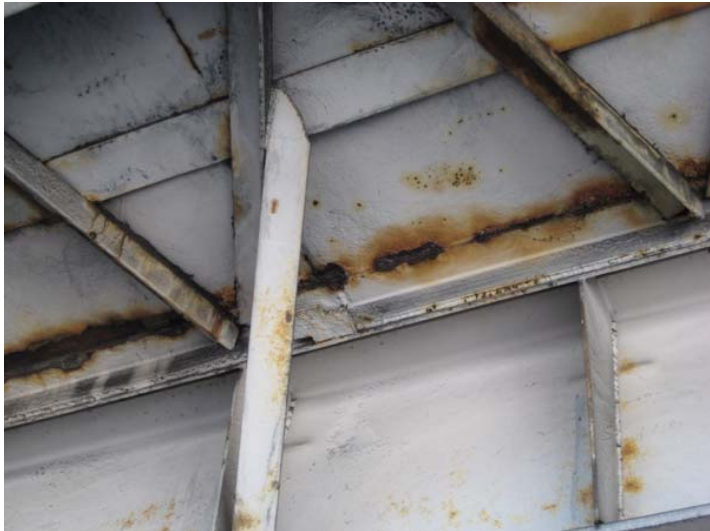
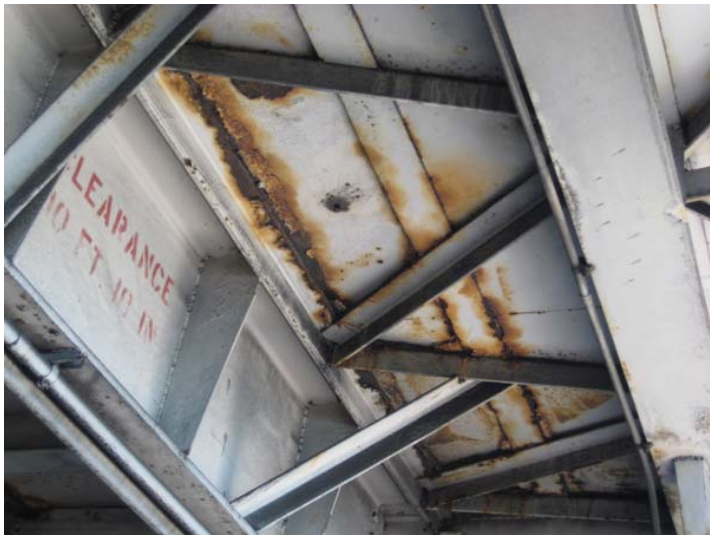
The underside of the horizontal section, seen in Pictures DLU-T, DLU-U and DLU-V, has corrosion of some members. Members need to be cleaned and painted or replaced depending upon condition once all rust and scale have been removed.

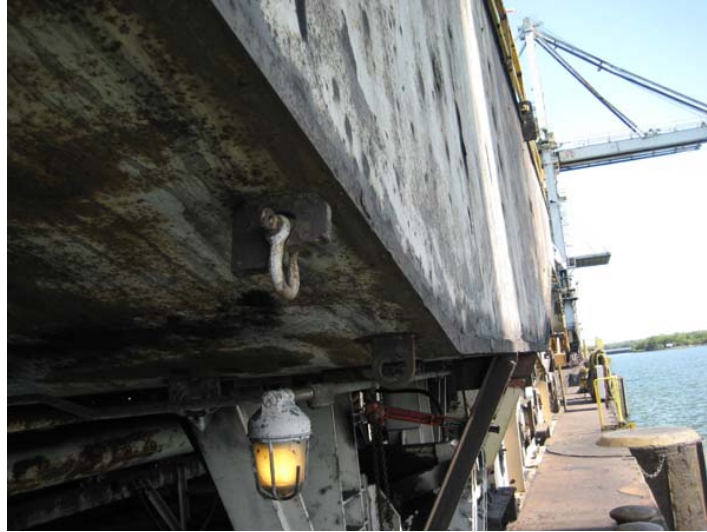
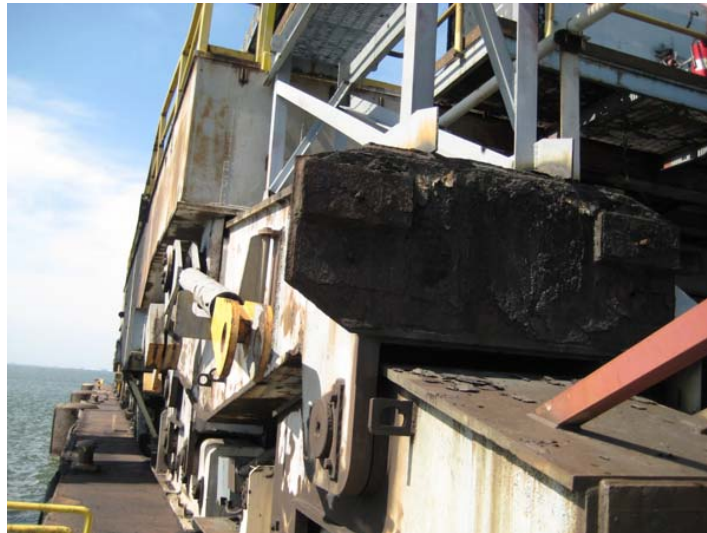
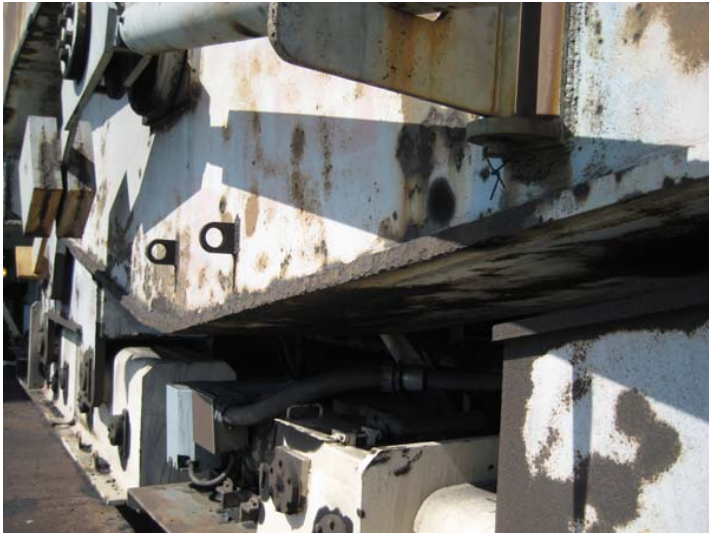
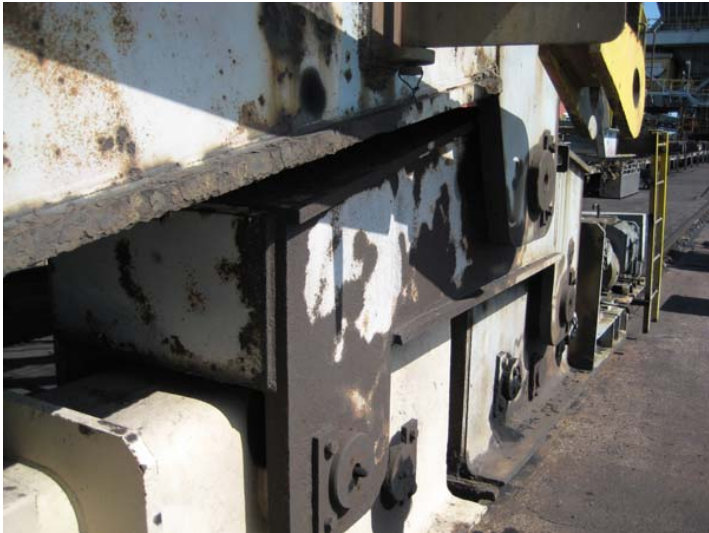
Pictures DLU-W thru DLU-AB are along the waterside of the Outboard Travel Trucks showing corrosion of the framing beams and at the pins. Cleaning and painting is recommended. Again, depending upon condition once all rust and scale have been removed, some reinforcement or replacement of components may be required. Pins should be checked to insure they function as intended.

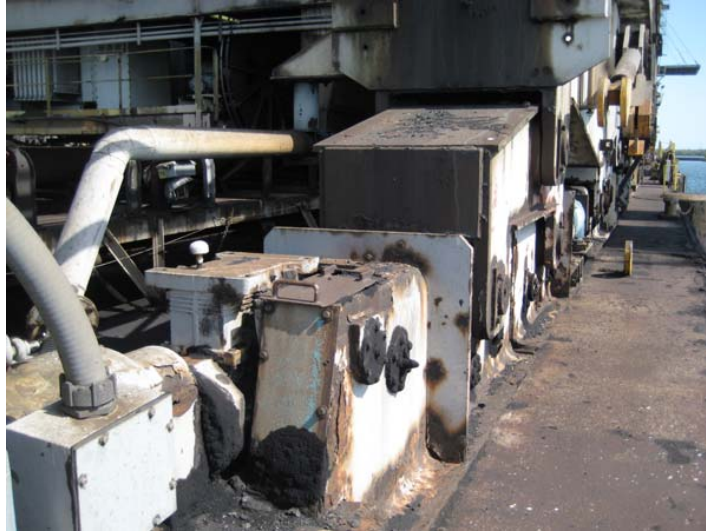
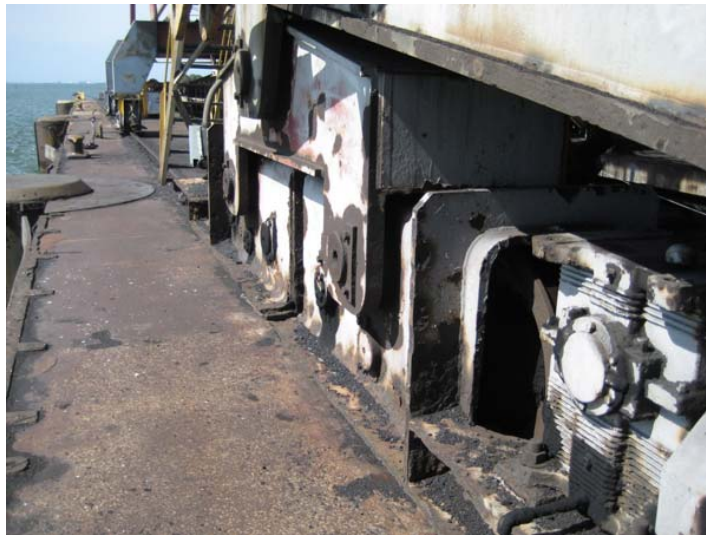
Pictures DLU-AC and DLU-AD are also along the waterside of the Outboard Travel Trucks showing corrosion of the framing beams and at the pins.

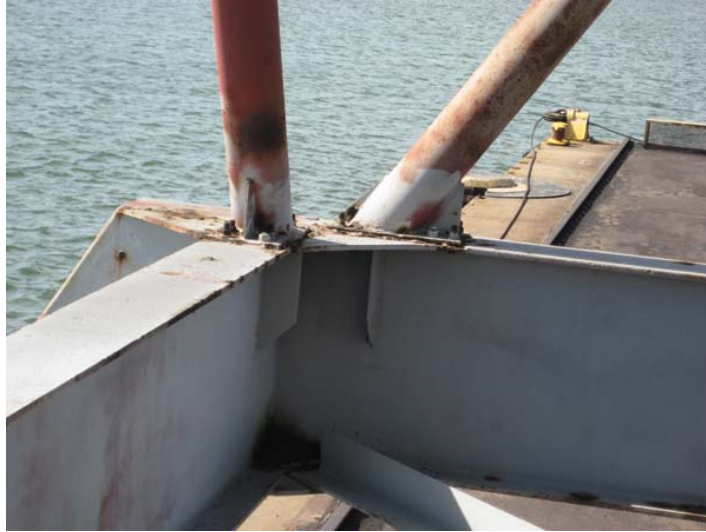
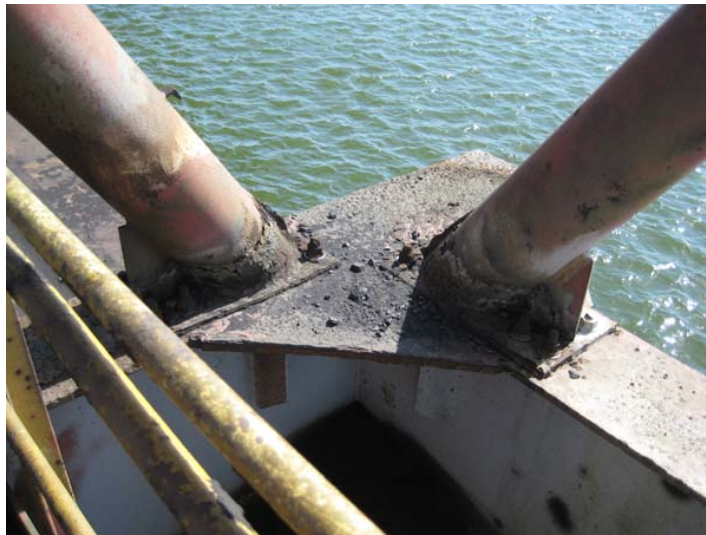
The vertical pipe braces for the Hopper, seen in Pictures DLU-AE and DLU-AF, show significant corrosion of the braces at the southwest corner and some at the northwest corner.

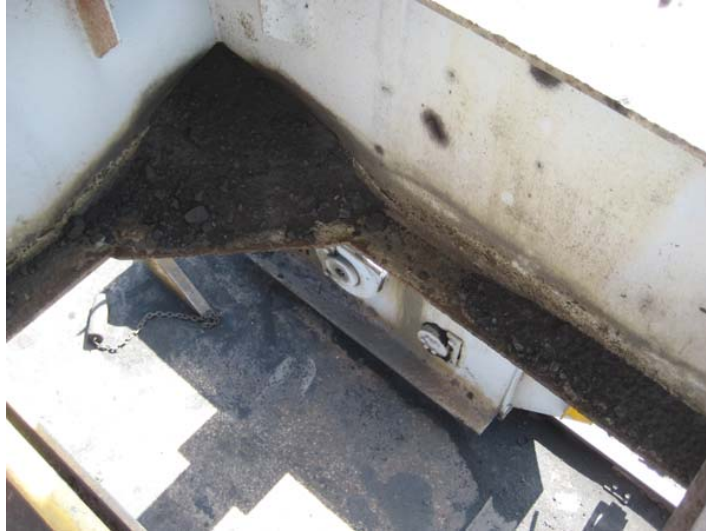
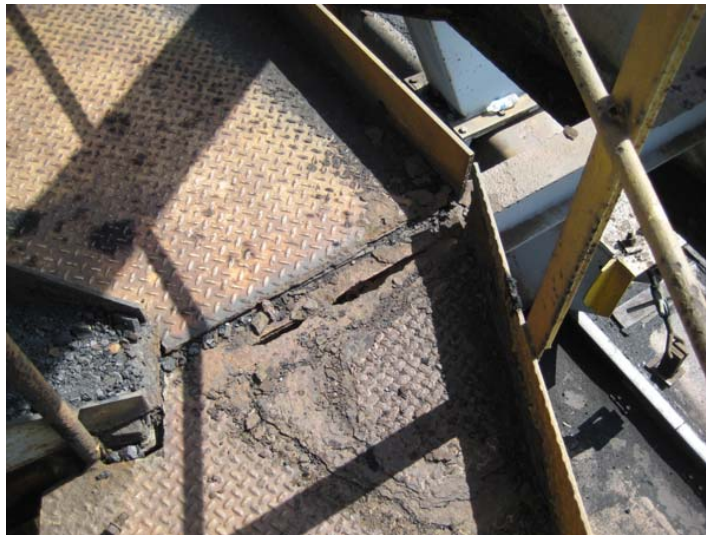
Accumulated coal in corners and on horizontal surfaces, seen in Pictures DLU-AG and DLU-AH, is creating corrosion problems throughout the lower levels of the exterior surfaces of the Unloader.

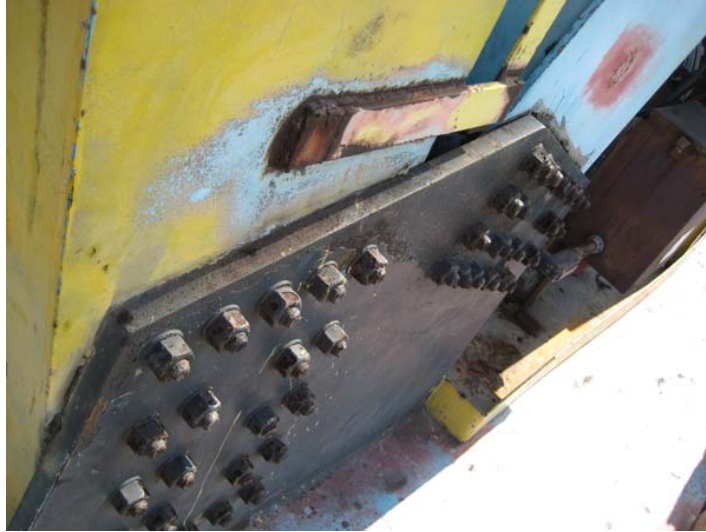
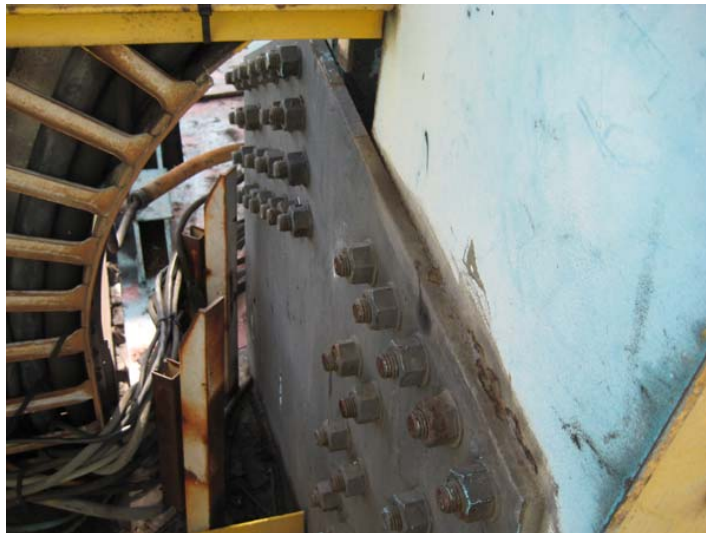
The plates in Pictures DLU-AJ and DLU-AK appear to be replacement plates. They should be cleaned and painted, along with the nuts, to minimize further corrosion.

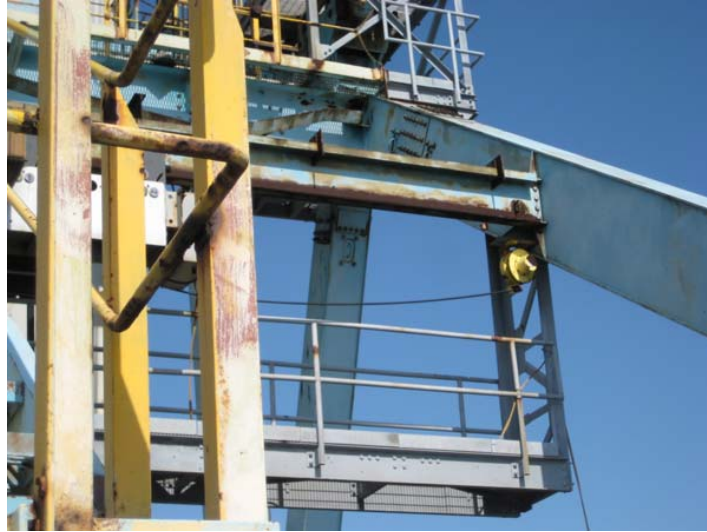
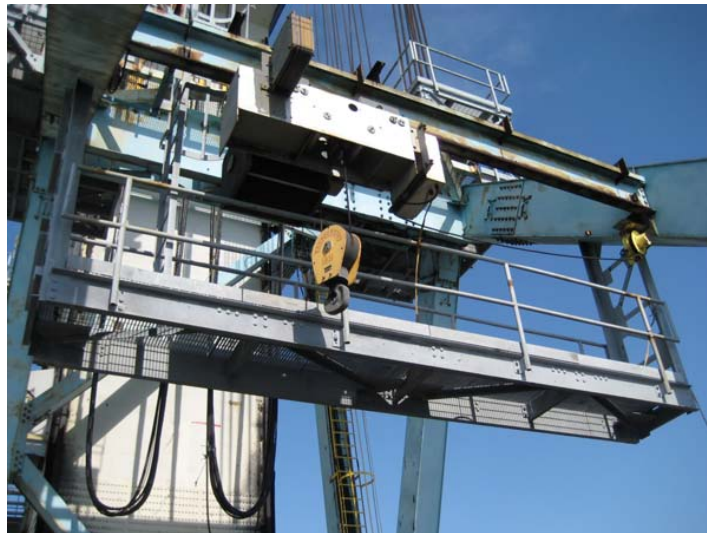
The bottom flange of a monorail between the cantilever arms of the Unloader is severely corroded, as seen in Pictures DLU-AL and DLU-AM. This beam should be repaired and painted or replaced before the monorail is used again.

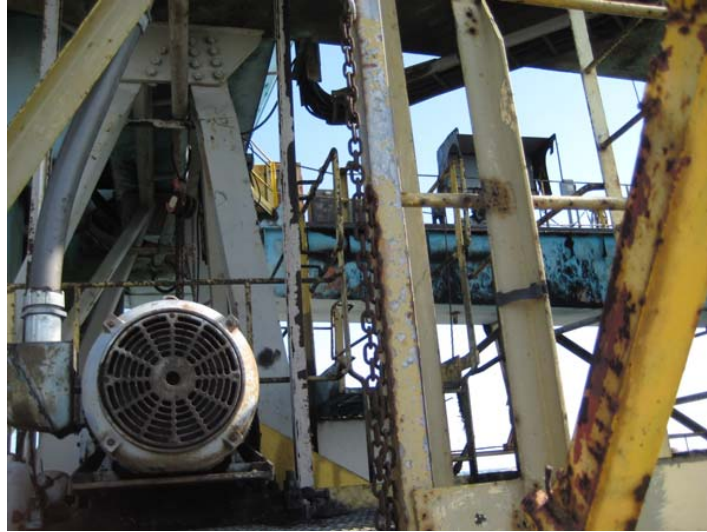
PICTURE DLU-AN

The cantilever arms of the Unloader, Picture DLU-AN, are showing some signs of corrosion. They should be cleaned and inspected up close for the extent of the corrosion and repaired, if required, and repainted.

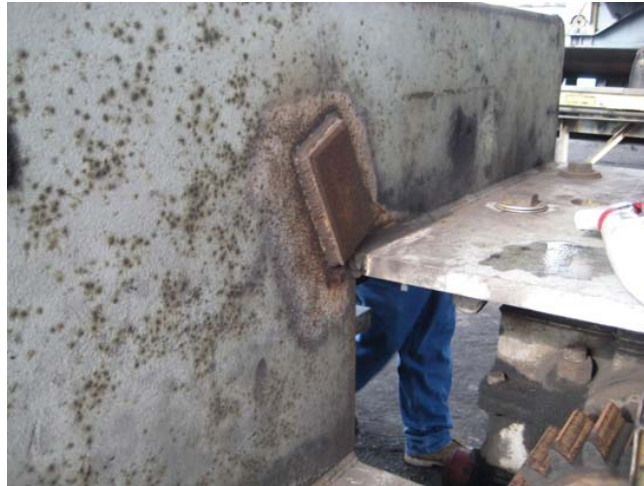
PICTURE PCU-A

Reinforcement/repair plates were added at the corners of the vertical plates which were installed to support the drive motors during a drive train change, as seen in Picture PCU-A.

Based on the observed installation, a square corner was cut in the vertical plate and the horizontal plate was brought in tight and welded. This square cut resulted in localized stress concentrations at the corner causing the crack. Setting the horizontal plate back  $\frac{1}{2}$ " and providing a  $\frac{1}{2}$ " radius corner in the vertical plate should eliminate this from occurring if any drive changes are made in the future.

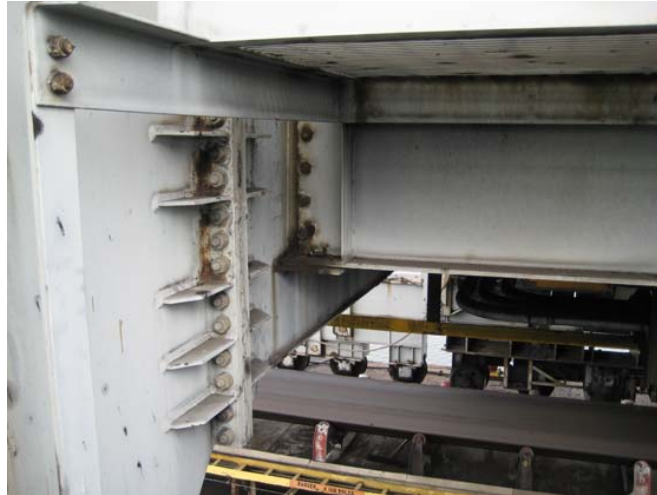
PICTURE PCU-B

Beneath the Transformer Building floor level, the connection of the horizontal members to the vertical members is showing some corrosion, as seen in Picture PCU-B. In this area, cleaning and painting should be adequate. Also, the connections of some of the horizontal floor framing members will need cleaning and repainting. Repair as required if cleaning reveals severe corrosion.

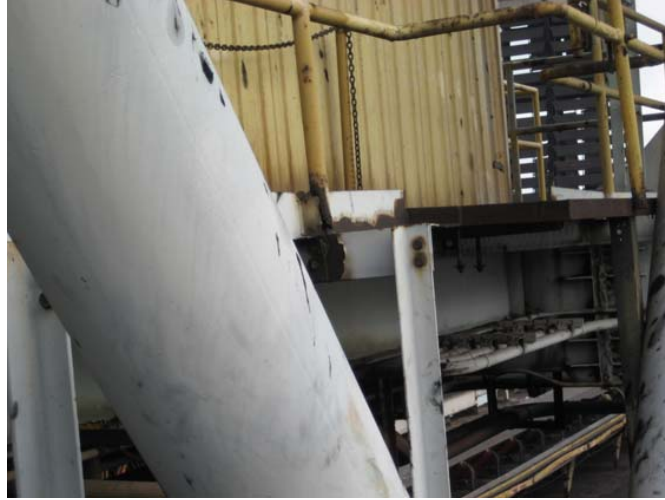
PICTURE PCU-C

Some handrail posts have corroded or nearly corroded completely thru and will need to be repaired in order to comply with OSHA requirements. Also, the toe plate for the platform beyond does not meet the OSHA 4" high minimum requirement. Some corrosion of the toe plate at this level was also observed. This toe plate should be repaired or replaced as required. See Picture PCU-C

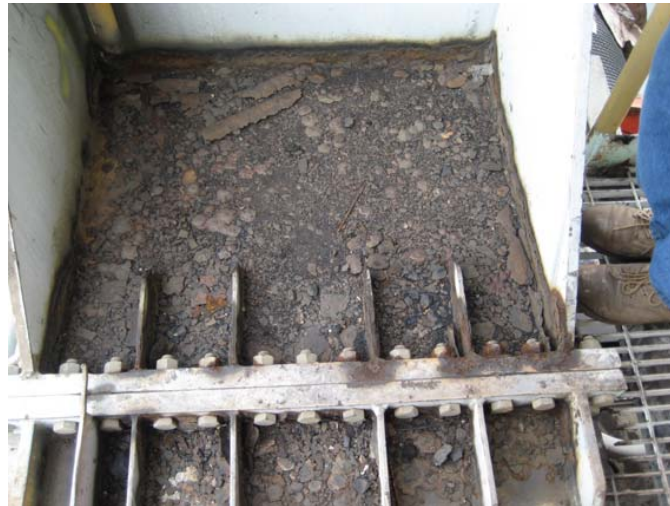
PICTURE PCU-D

On top of the Transformer Building floor level at the northeast corner, the connection of the horizontal member to the vertical member is showing some extensive corrosion, in part because moisture is trapped and coal fines and dust can accumulate and create an acidic environment. Refer to Picture PCU-D.

This is typical for most areas where the horizontal members connect to the vertical members and moisture and coal are trapped. In these areas, the stiffeners will need to be replaced, one at a time, as well as those fasteners that have corroded to the point the bolt head or nut is essentially gone. These

corroded bolts should be replaced, one at a time, with new, hot dip galvanized high strength bolts. Once this is complete, the area needs to be repainted and accumulated coal removed on a regular basis.

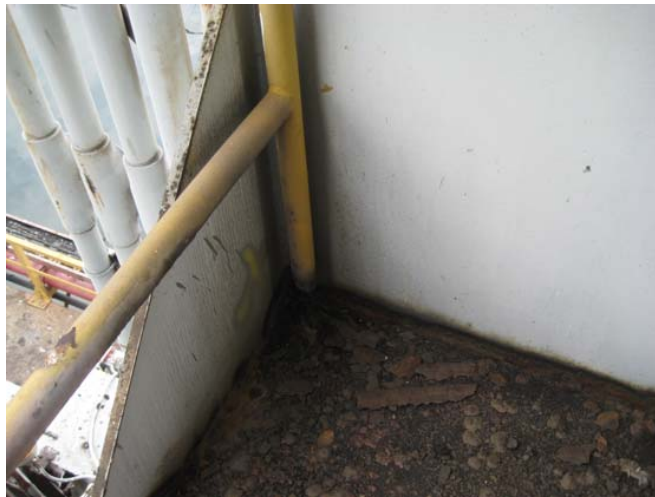
PICTURE PCU-E

In Picture PCU-E, the handrail post has corroded free at the base due to trapped moisture and coal dust.

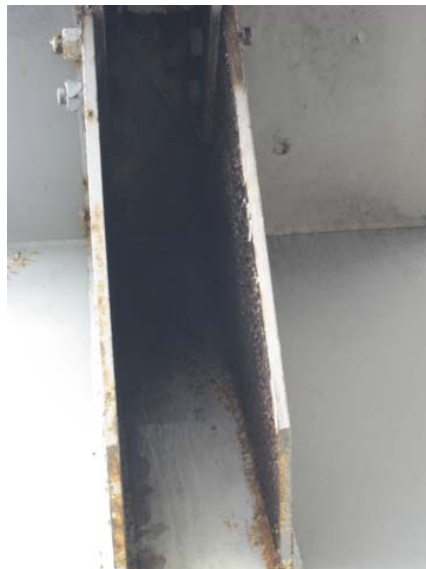
PICTURE PCU-F

Corrosion can be seen between gusset plates of pipe brace connection at northeast corner above Transformer level, as seen in Picture PCU-F. Clean and paint to minimize additional corrosion.

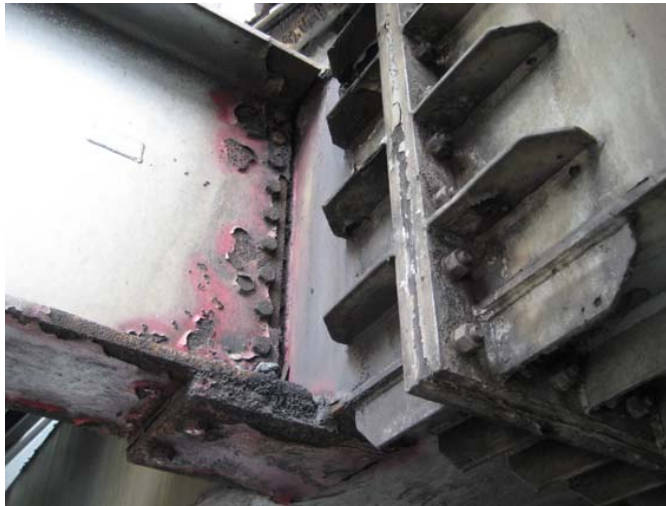
PICTURE PCU-G

Corrosion can be seen in Picture PCU-G at the northwest corner for main members and a Hopper support beam. This connection needs cleaning and painting with repairs, as necessary.

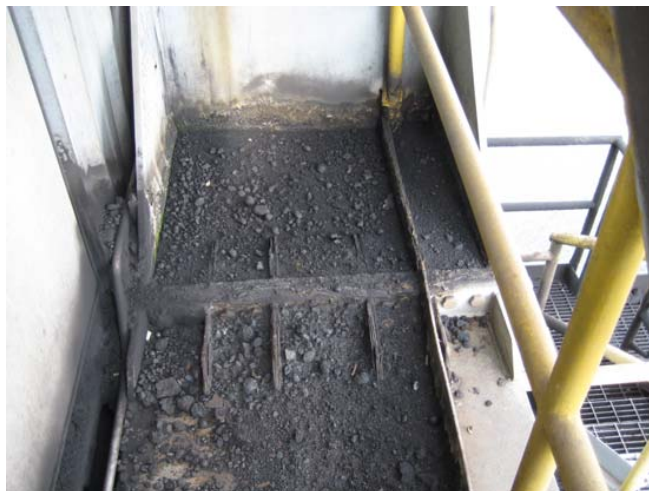
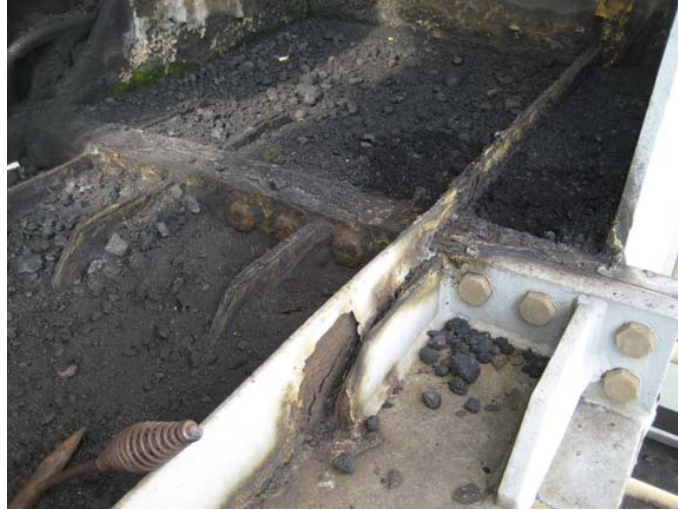
Pictures PCU-H and PCU-J are at the northwest corner at Transformer Building level, similar to Picture PCU-D. Removal of coal and repair of the flanges as well as the stiffeners and fasteners will be required here followed by painting.

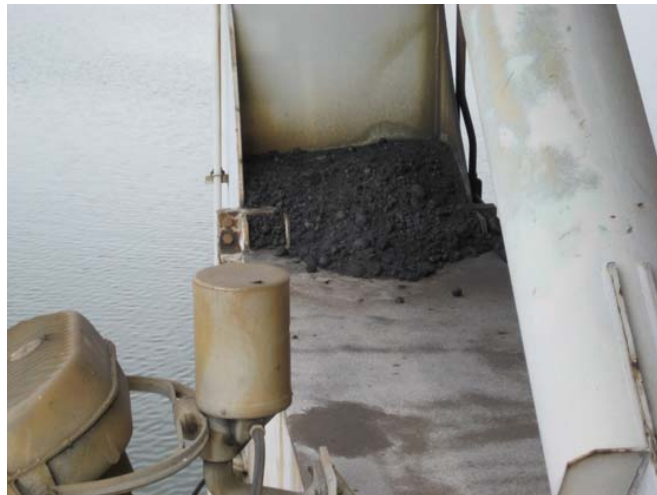
PICTURE PCU-K

Accumulated coal at the southwest corner is seen in Picture PCU-K. Due to lack of access, the condition of the connection is unknown. However, based on other observations, considerable corrosion is expected. Clean, repair and paint as before.
