**Tampa Electric Company  
(TECO)  
Coal Yard Mechanical,  
Electrical and Structural  
Assessment**

Results from field review of the  
coal unloading equipment,  
structures and conveyors.

June 21, 2010

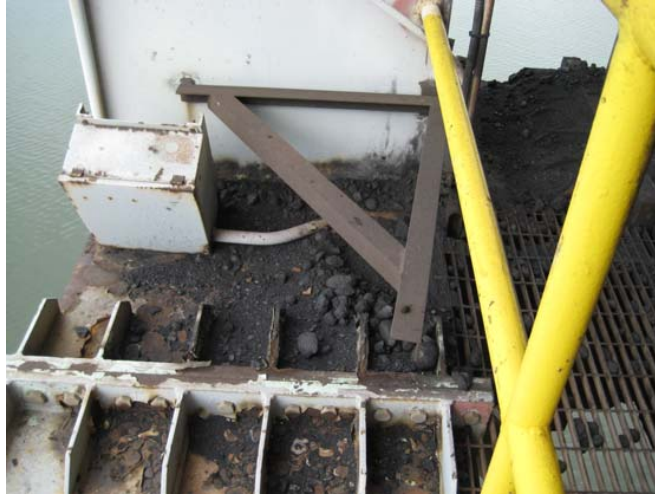
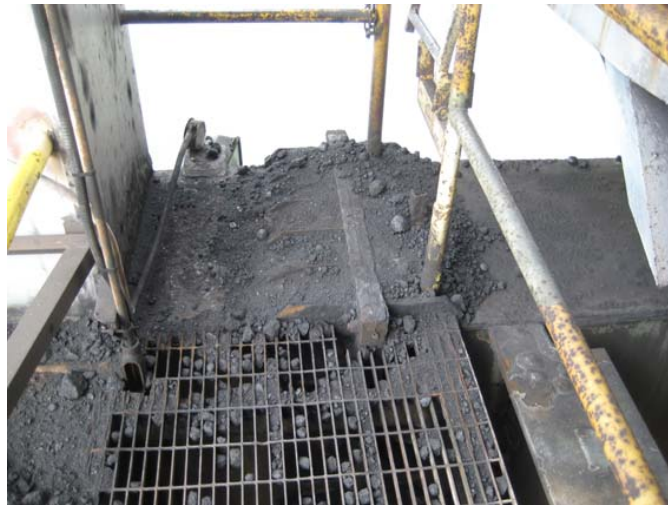
At the southwest corner at the Dribble Deck level, the build-up of coal and extensive corrosion of stiffeners and bolts and grating corrosion can be seen in Pictures PCU-L and PCU-M. Clean, repair and paint as before.

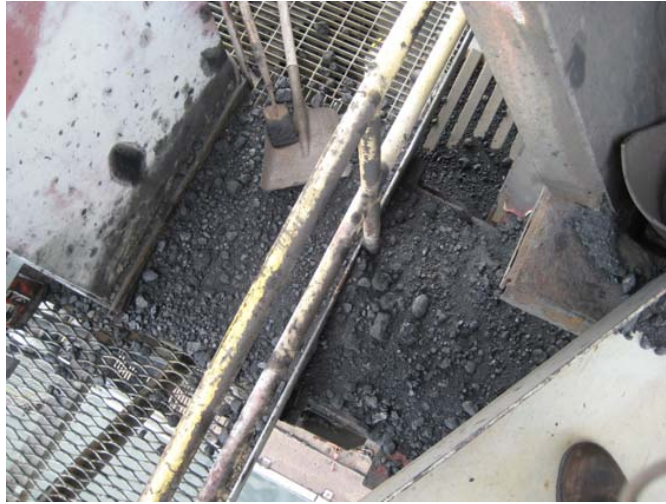
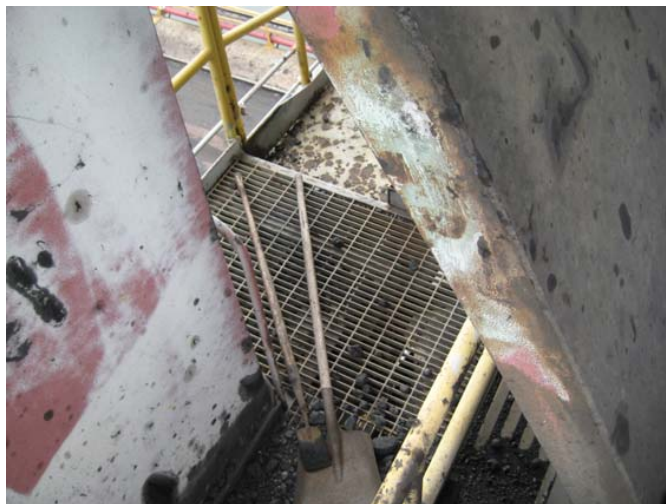
The situation is similar at the northwest corner, as seen in Pictures PCU-N and PCU-P with conditions similar to those at southwest corner.

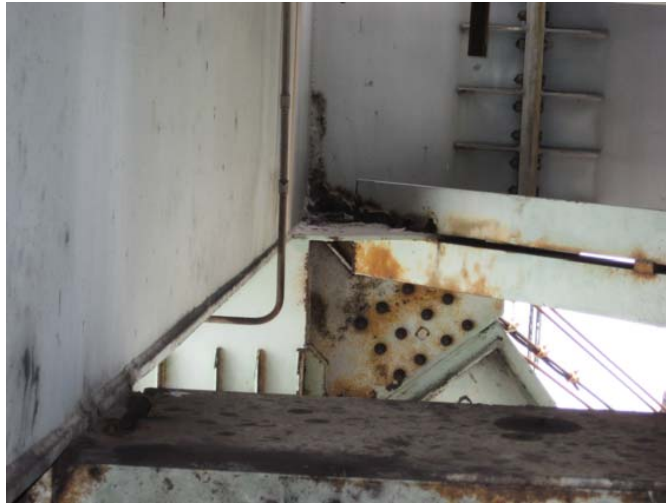
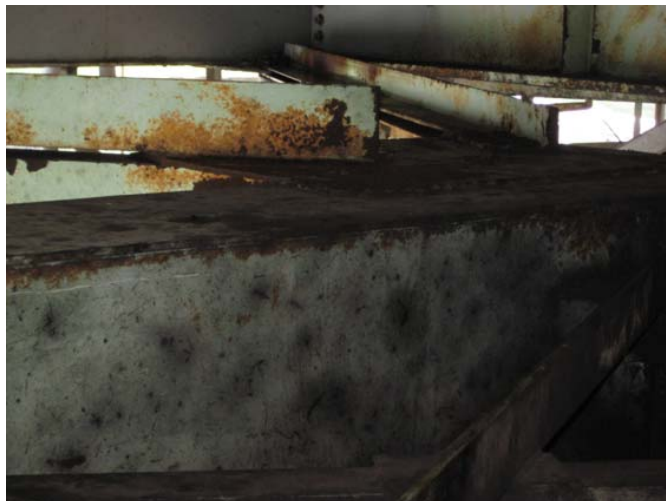
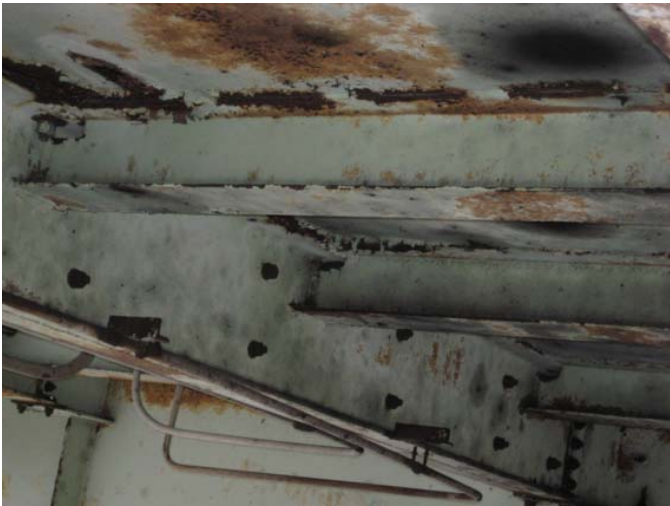
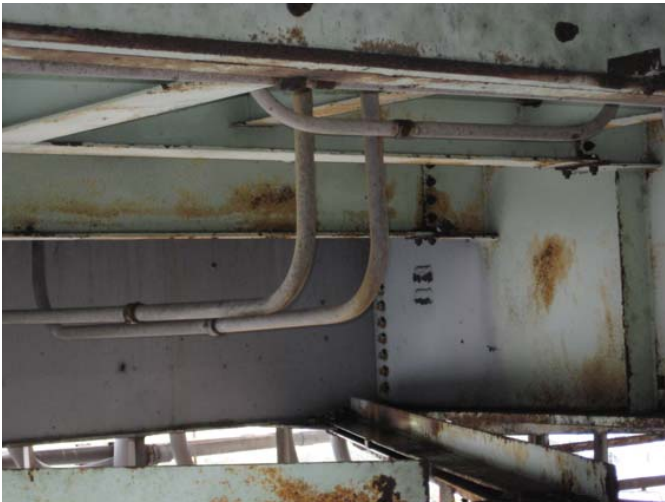
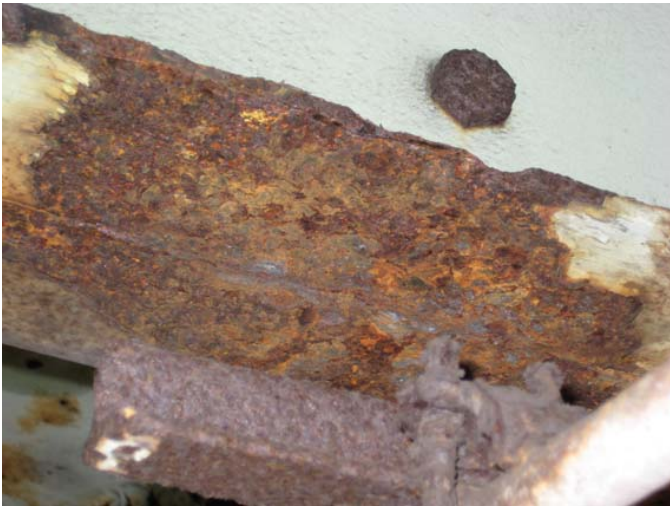
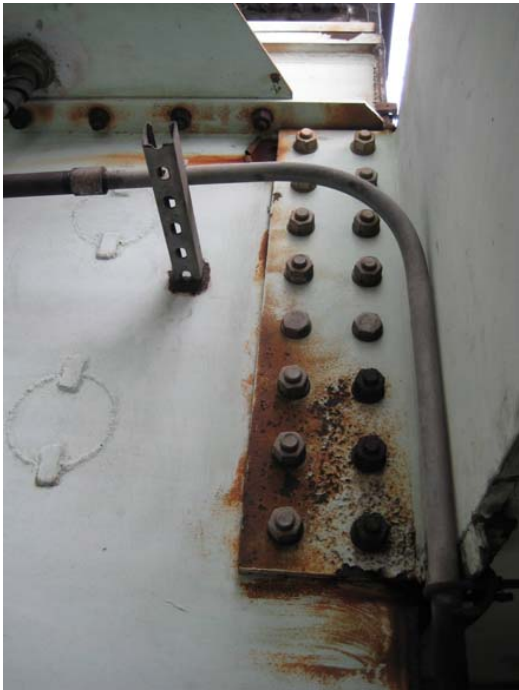
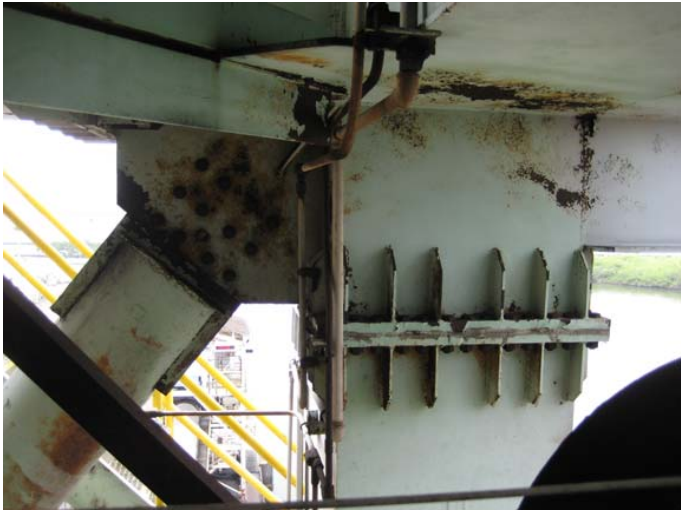
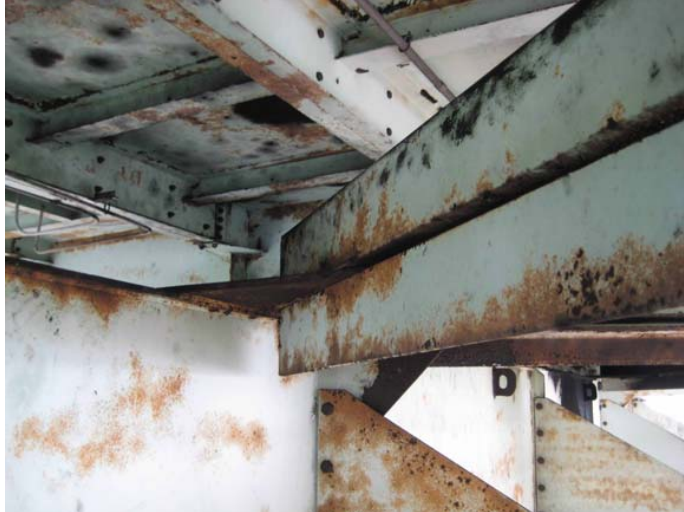
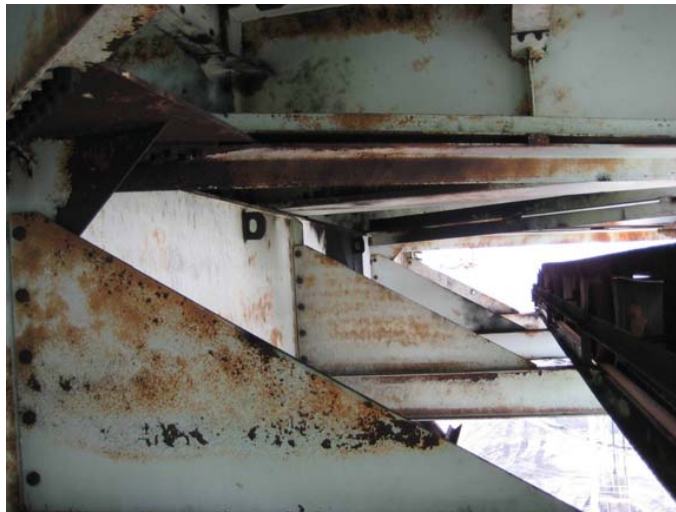
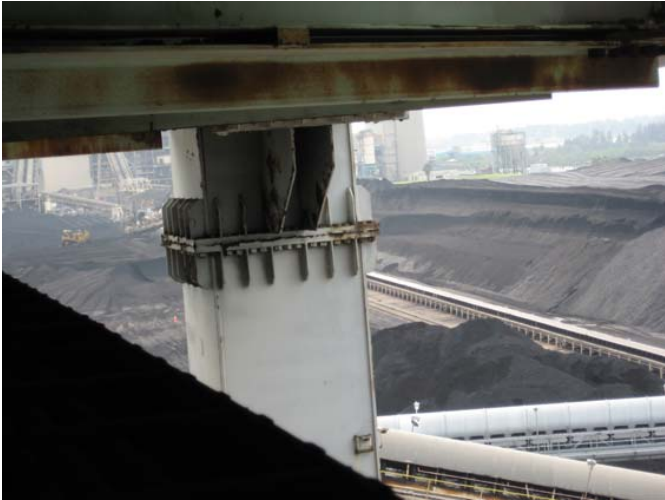
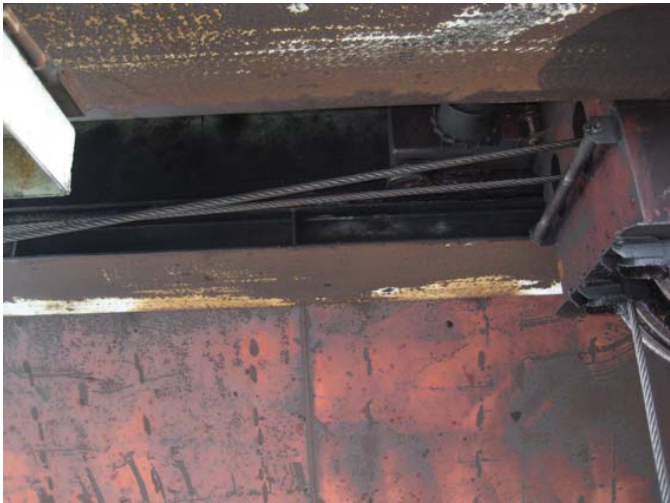
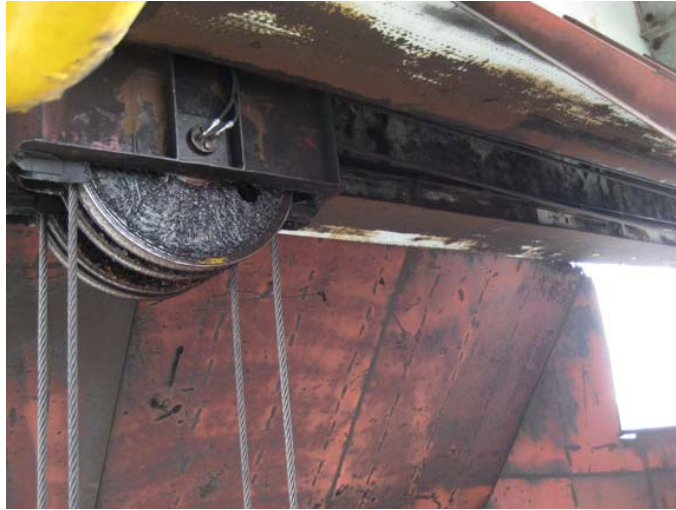
Pictures PCU-R thru PCU-AC show the steel on the underside of the Machine House, as seen from the top of the Operator's Cab, showing varying degrees of corrosion. However, most can be addressed with cleaning and repainting.

Should cleaning reveal a considerable loss of section, repair or replacement will be required.

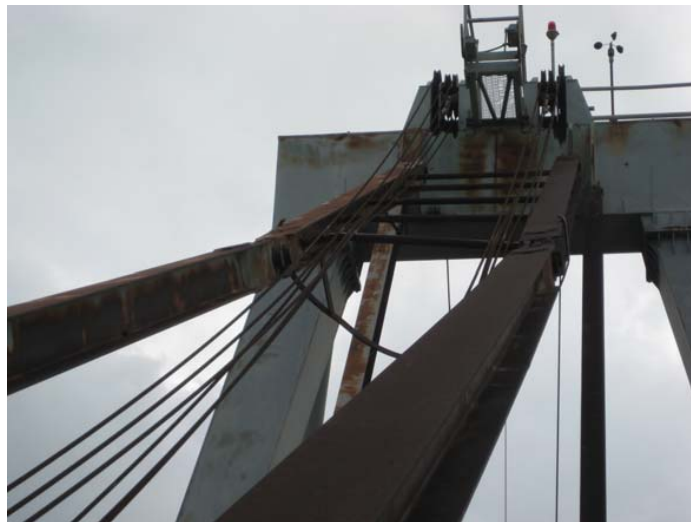
PICTURE PCU-AD

The south upper Boom Hanger assembly sags more than the north upper Boom Hanger resulting from some distress during a high wind event in the past. The booms show some corrosion due to exposure, as seen in Picture PCU-AD.

The condition of the booms at the pins is not known since these were not easily accessible. These hanger assemblies including the pins should be inspected for wear and the hanger assemblies tightened to reduce the sag in the assemblies. The inner hanger assemblies should be addressed similarly.

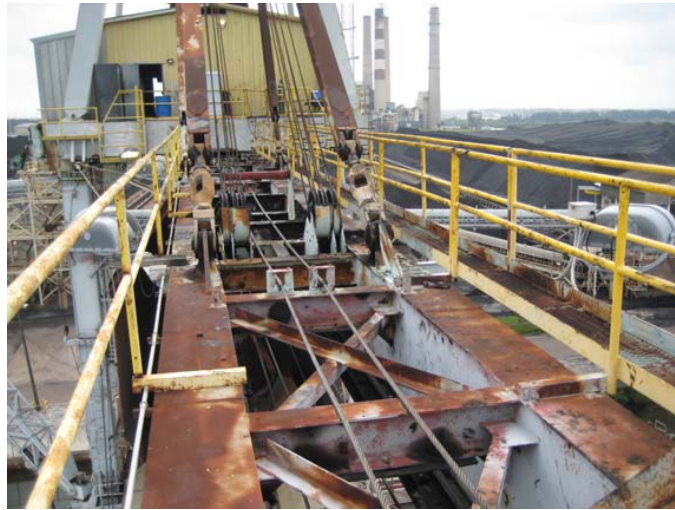
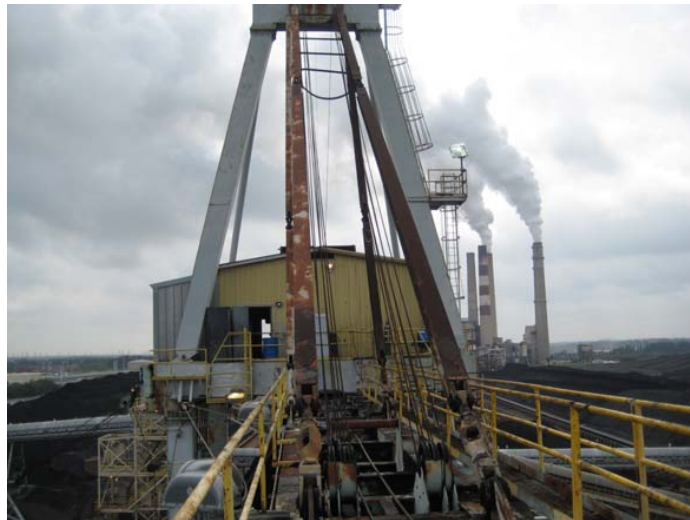
The top surfaces of the Hinged Boom Assembly show varying degrees of corrosion, as seen in Pictures PCU-AE and PCU-AF, but, because this area is well above the levels where coal can accumulate, the corrosion is not severe and only cleaning and painting should be necessary.

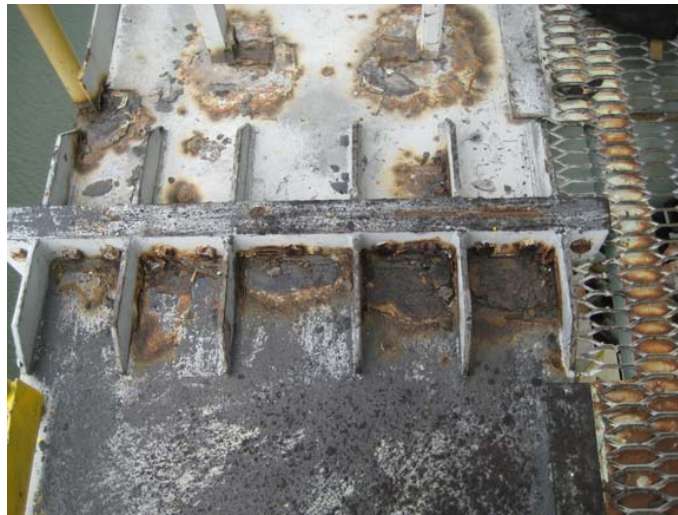
PICTURE PCU-AG

Some corrosion was observed at the Machinery Room level at the connections between the main horizontal and vertical members. Refer to Picture PCU-AG. In general, this did not appear to be too severe and cleaning and painting is recommended. Again, depending upon the condition of the bolts, these fasteners may need to be replaced.

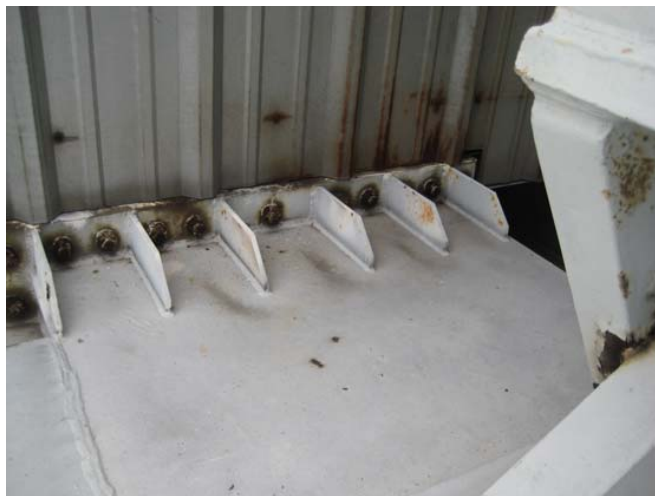
PICTURE PCH-AH

Also, some of the other connections and horizontal surfaces show some signs of corrosion, as seen in Picture PCH-AH. However, unless corrosion is severe, cleaning and painting should be sufficient.

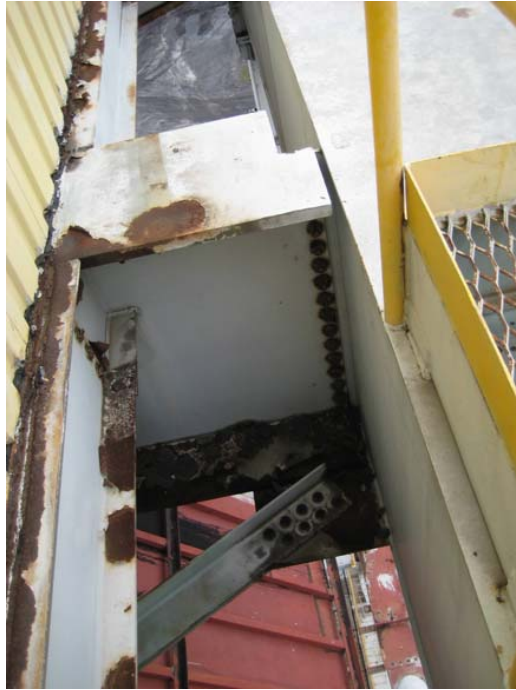
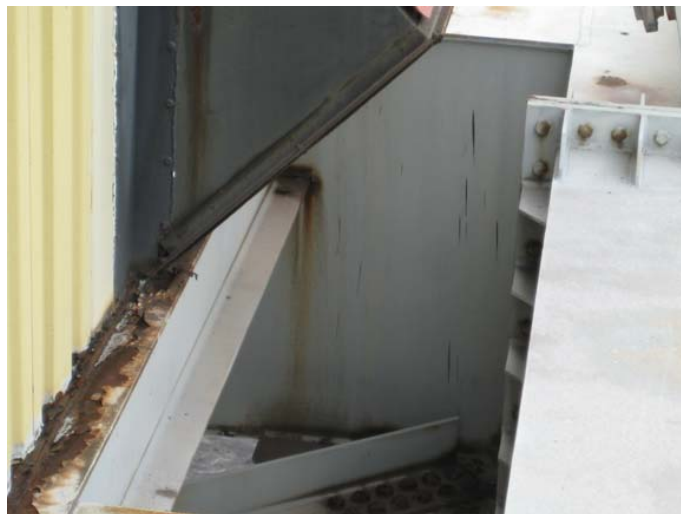
The sill of the Transformer Room shows signs of corrosion, as seen in Picture PCU-AJ and PCU-AK although this does not appear to be severe and cleaning and painting should be adequate.

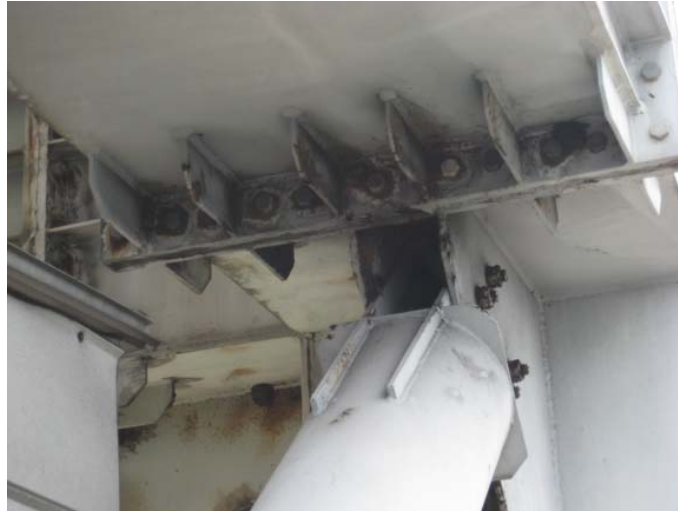
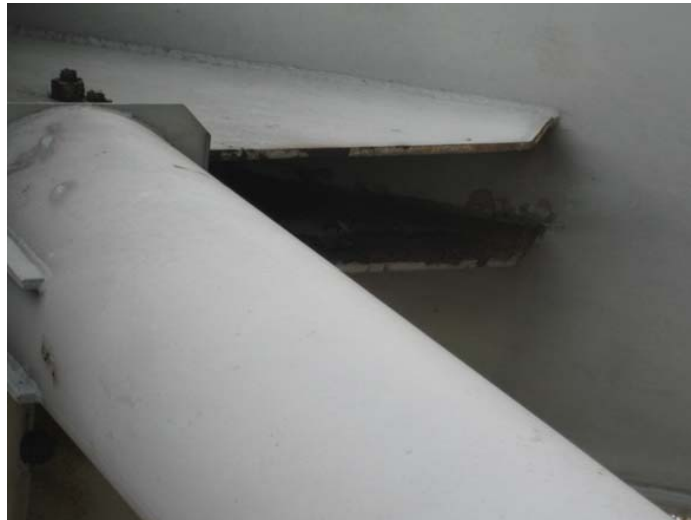
Where the pipe braces connect to the underside of the horizontal framing above the Transformer Room, corrosion is evident, as seen in Pictures PCH-AL and PCU-AM. However, cleaning and painting should be adequate.

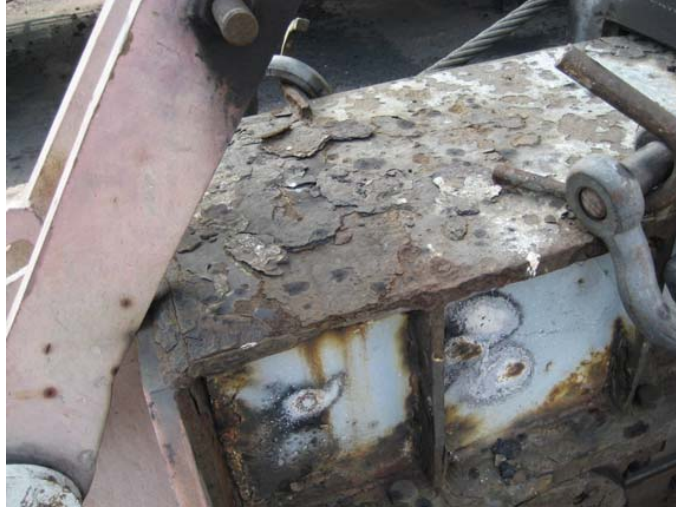
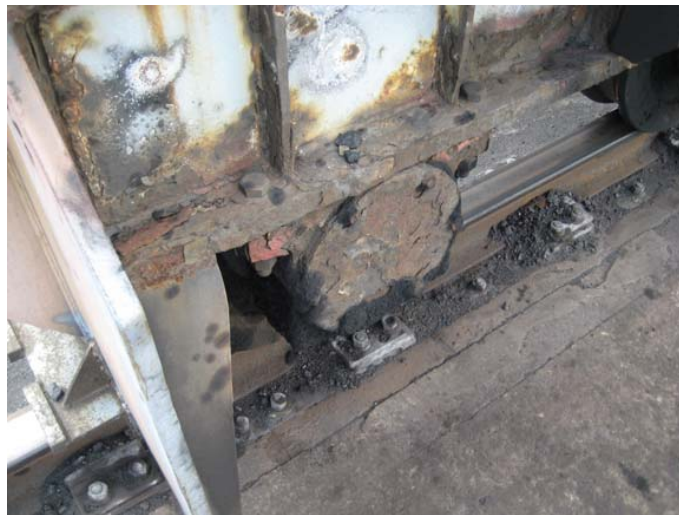
The corrosion of the outboard Travel Trucks is seen in Pictures PCU-AN and PCU-AP. The trucks will need cleaning and painting and possibly repairs should cleaning show significant loss of metal.

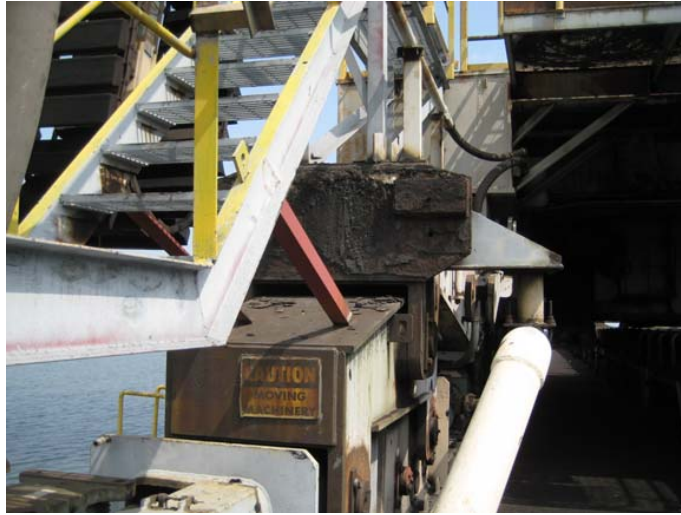
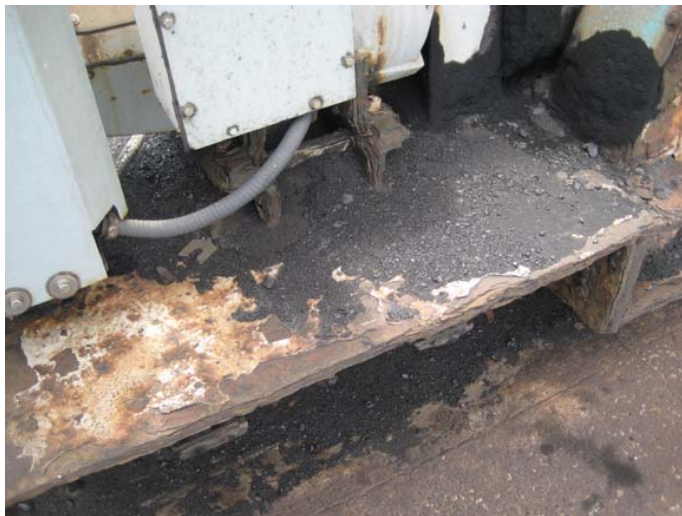
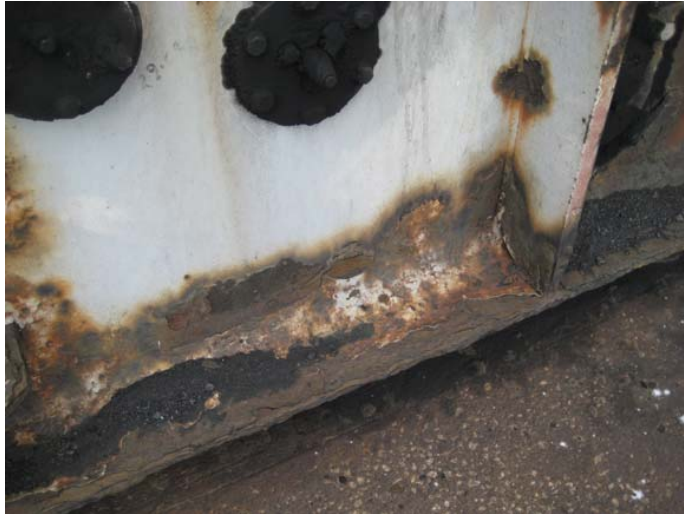
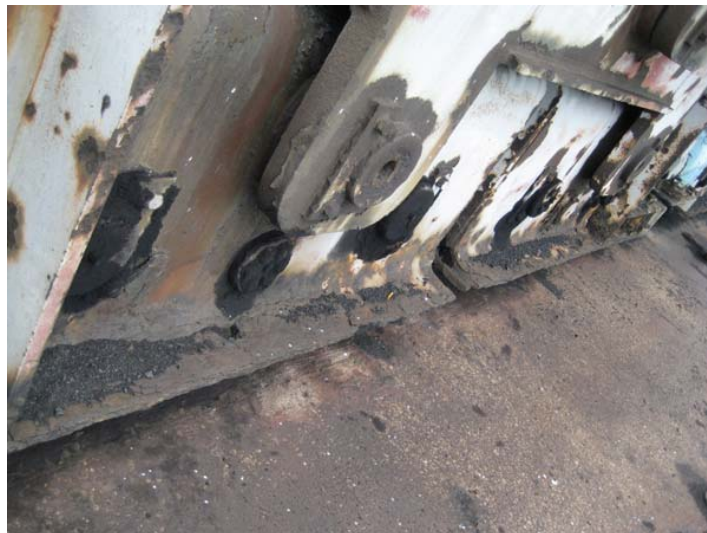
Additional corrosion of the outboard Travel Trucks is seen in Pictures PCU-AR, PCU-AS, PCU-AT and PCU-AU. The trucks will need cleaning and painting and possibly repairs should cleaning show significant loss of metal.

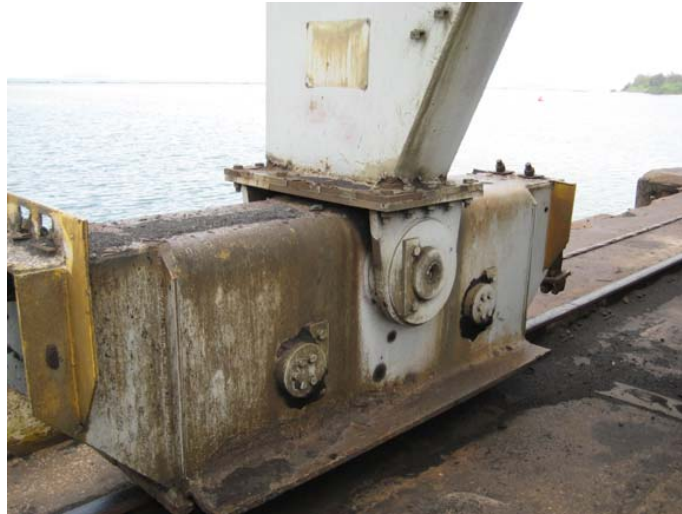
PICTURE PCU-AV

The Travel Trucks on the Hopper are less corroded, as seen in Picture PCU-AV, but will require cleaning and painting to minimize further corrosion.

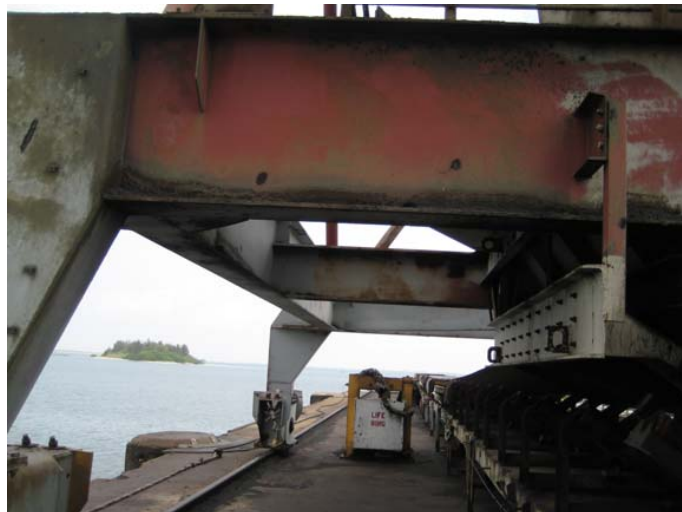
PICTURE PCU-AW

The underside of the Hopper support structure has varying degrees of corrosion. At some locations, cleaning and painting may be all that is required.

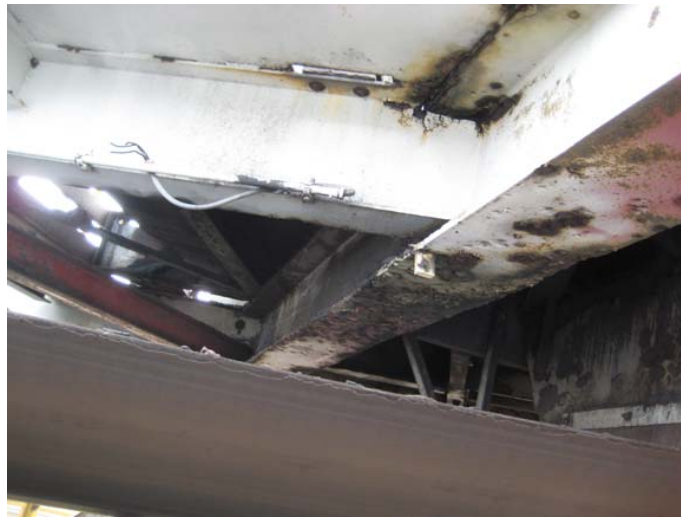
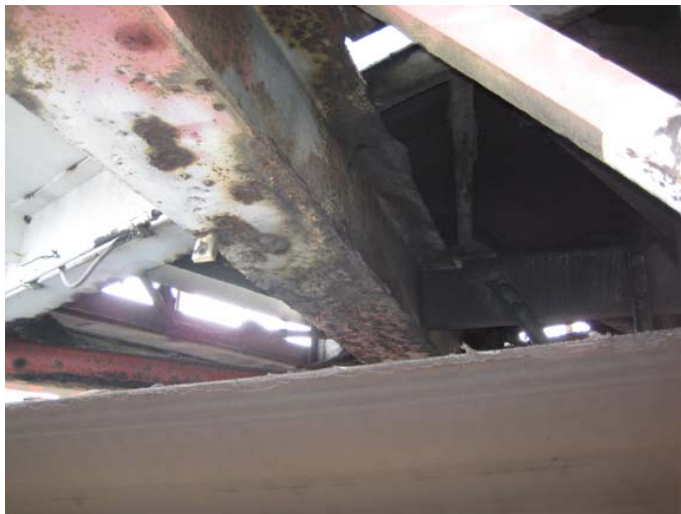
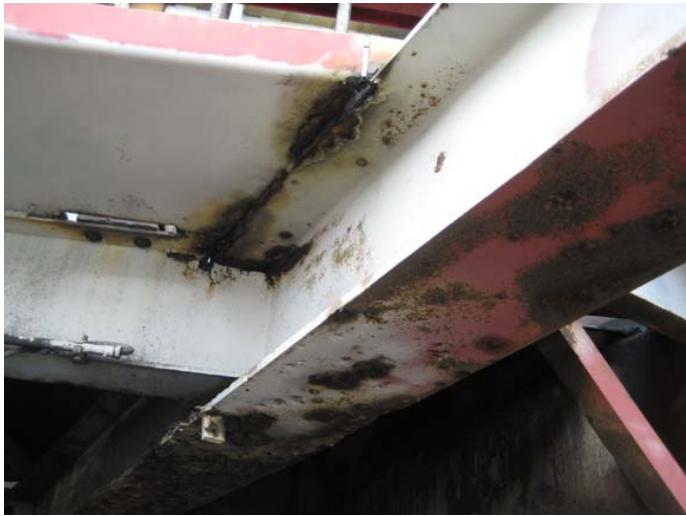
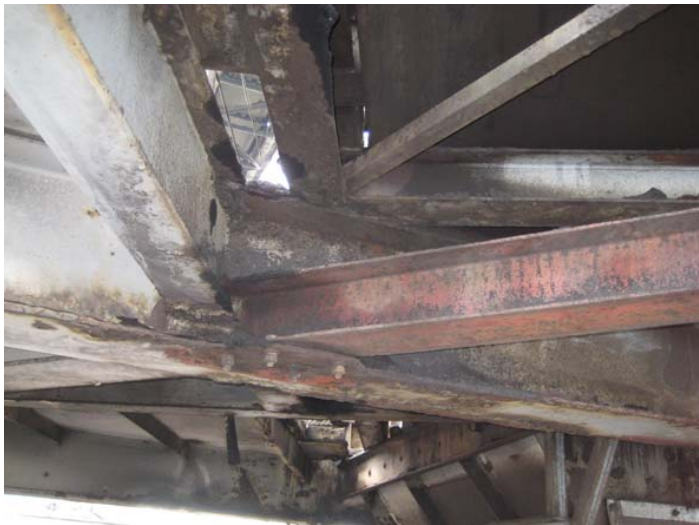
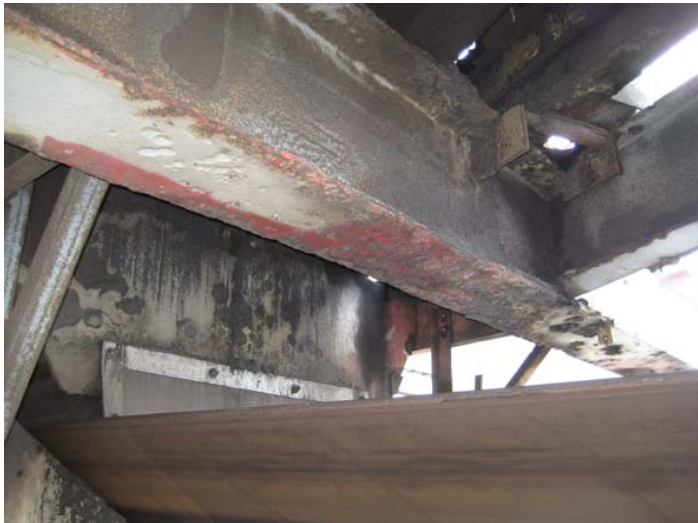
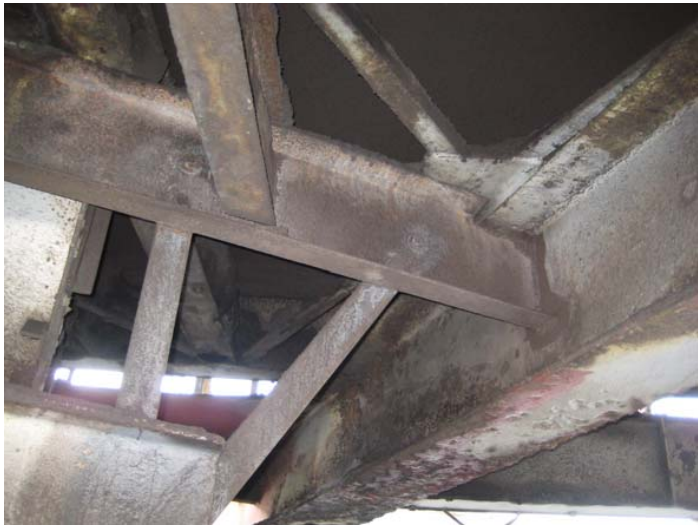
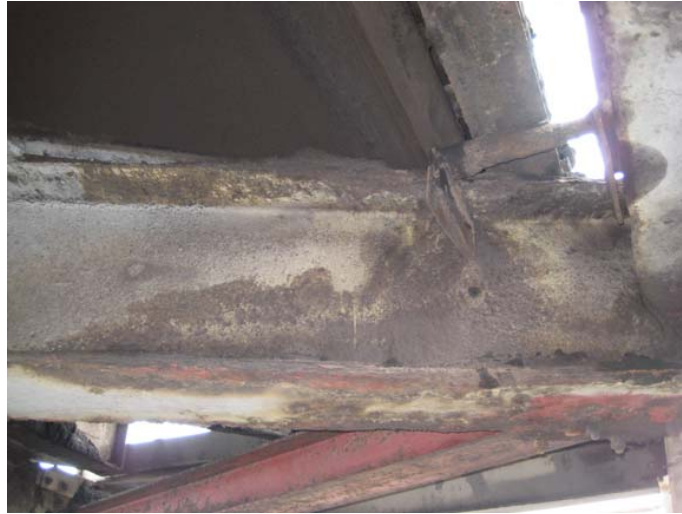
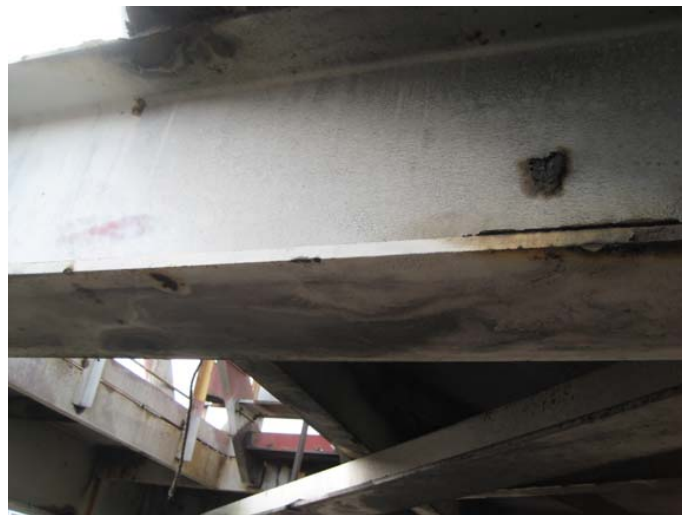
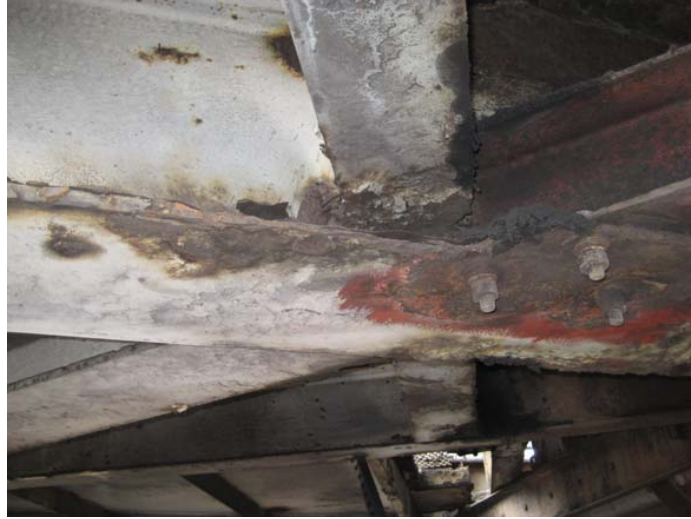
In other areas, as seen in Pictures PCU-AX thru PCU-BF, the underside of the Hopper support structure will require considerable cleaning and painting, and repair of members that have lost significant section due to corrosion will be necessary. This will become more evident once the rust and loose material have been removed back to solid metal.

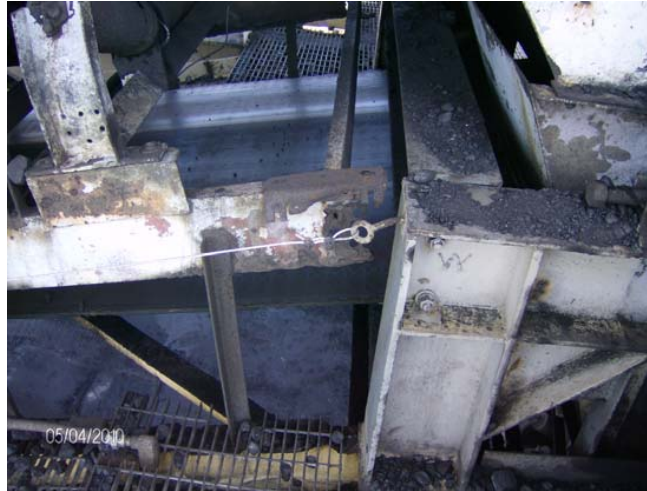
Several of the conveyor deck plates have corroded through allowing coal to spill on the return belt. These should be replaced on the elevated portions of the conveyor as a minimum to prevent coal from falling on personnel and to facilitate cleanup.

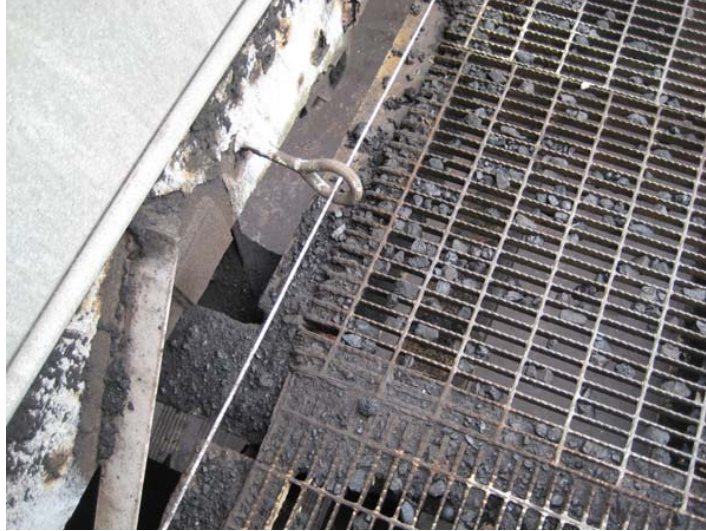
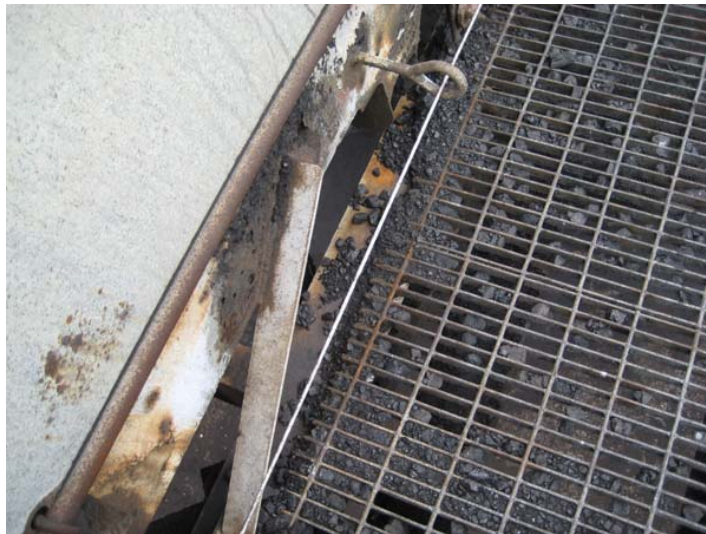
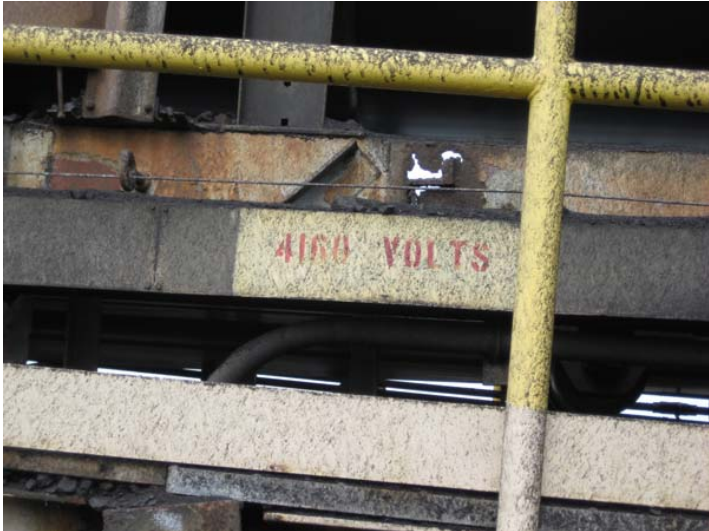
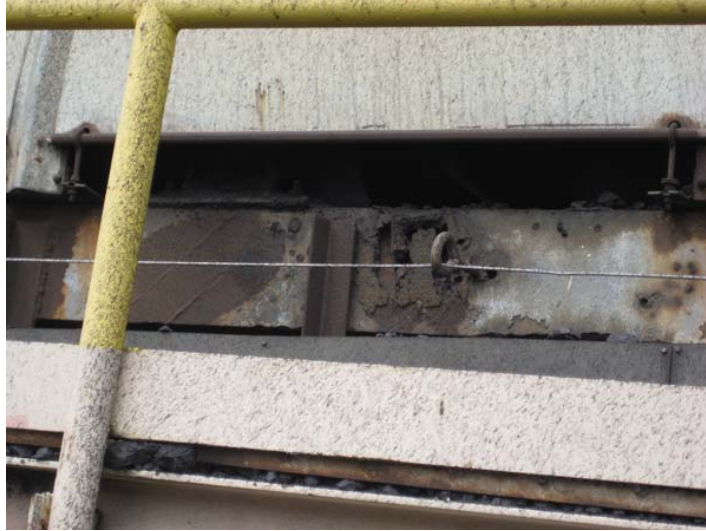
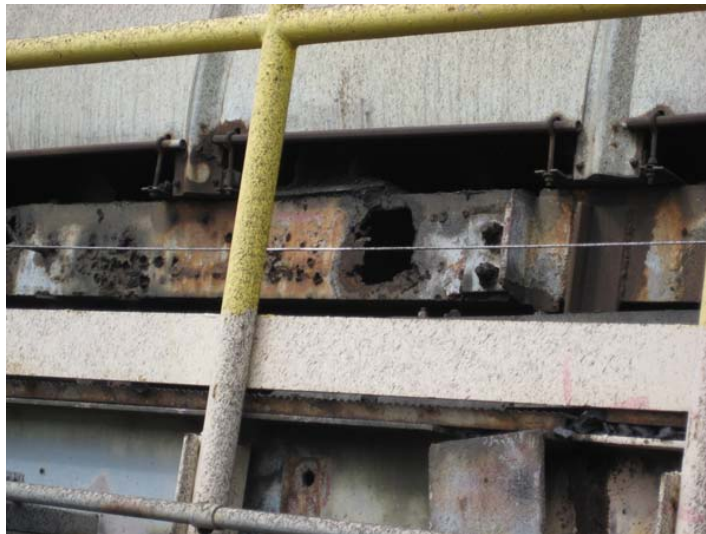
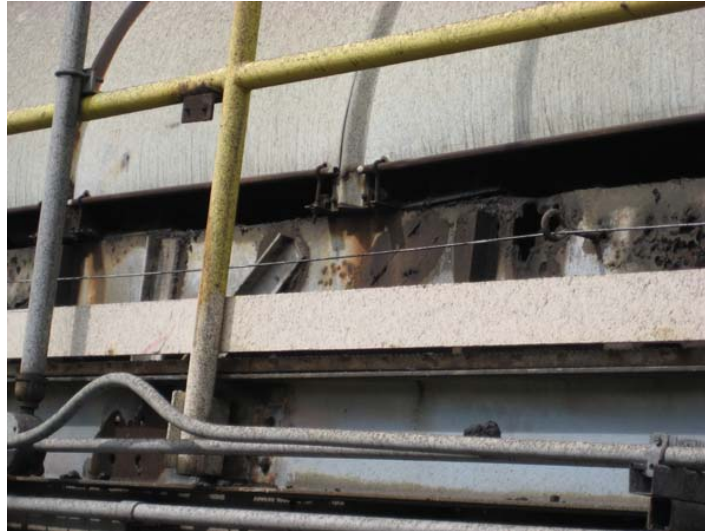
- C-1            Along the inclined portion of the conveyor, there is corrosion through some of the conveyor frame members as seen in Pictures CONV-D1-A thru CONV-D1-G. Additionally some of the grating is corroded to the point that the bearing bars are no longer being supported.

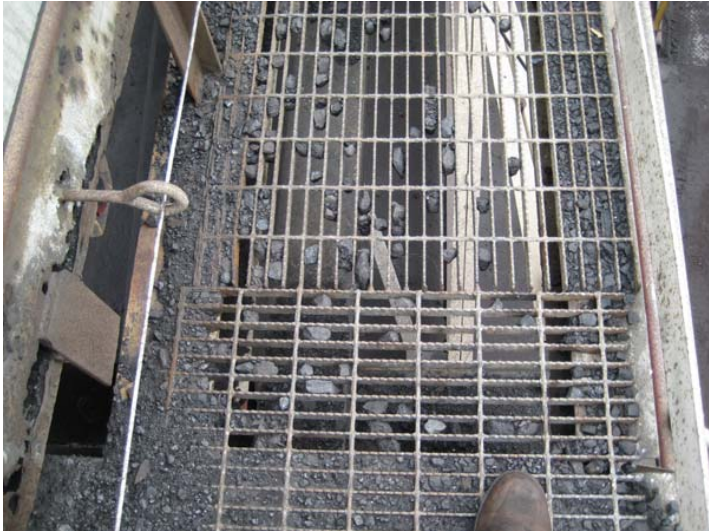
PICTURE CONV-D1-C

- C-2 It was also observed that some sections of the grating are spanning in one direction and others are spanning perpendicular to them as seen previously in Picture CONV-D1-C.
- C-3 The bottoms of the legs at a number of locations are not supported on the deck of the dock structure as can be seen in Pictures CONV-D1-H thru CONV-D1-K or the grout under the base plate has deteriorated. The base plates should be cleaned, painted and re-grouted. Replacement of anchor bolts and/or base plates may be required after cleaning if it is determined that the corrosion is significant.

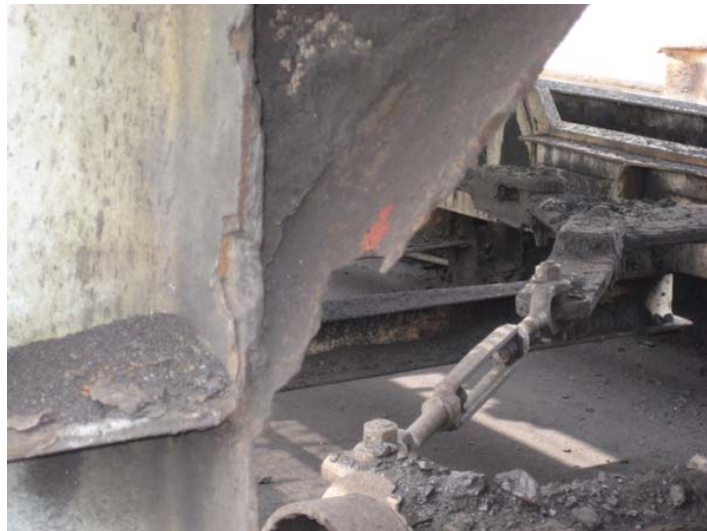
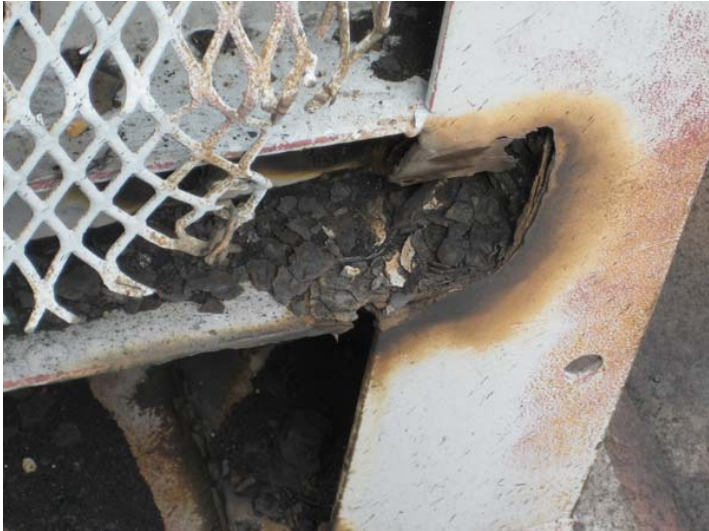
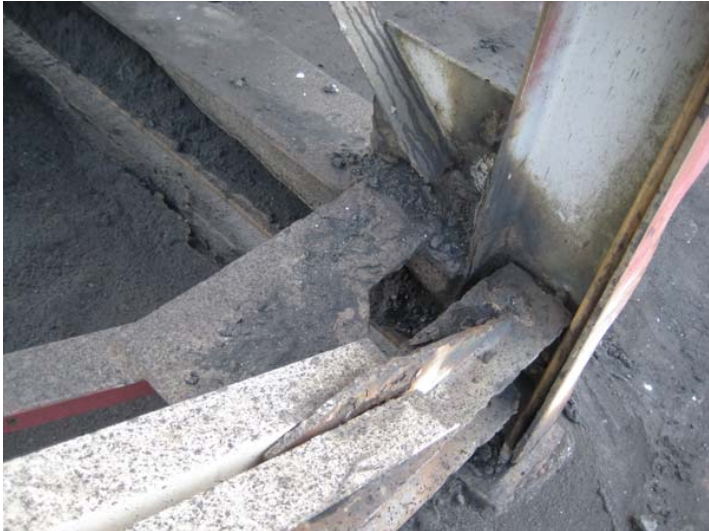
- C-1 Many of the structural members of the Take-up Tower show a lot of corrosion such as deterioration at connections (Pictures CONV-D1-L thru CONV-D1-N),

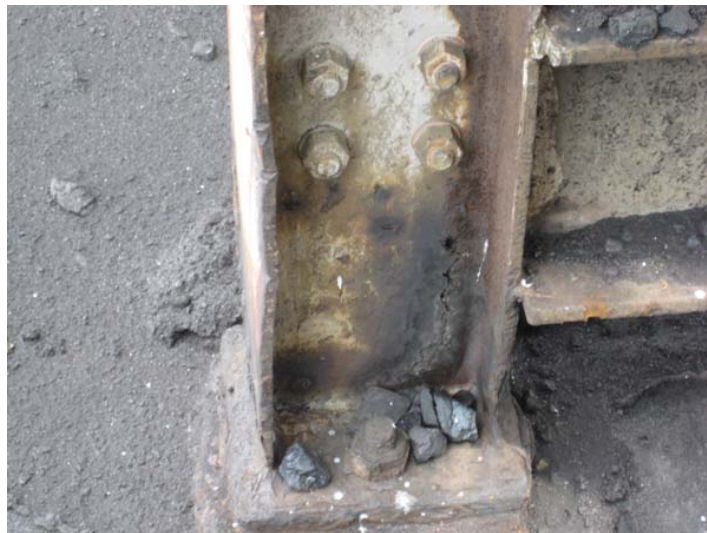
PICTURE CONV-D1-P

Extensive corrosion at the bottoms of the columns and their base plates (Pictures CONV-D1-P thru CONV-D1-T),

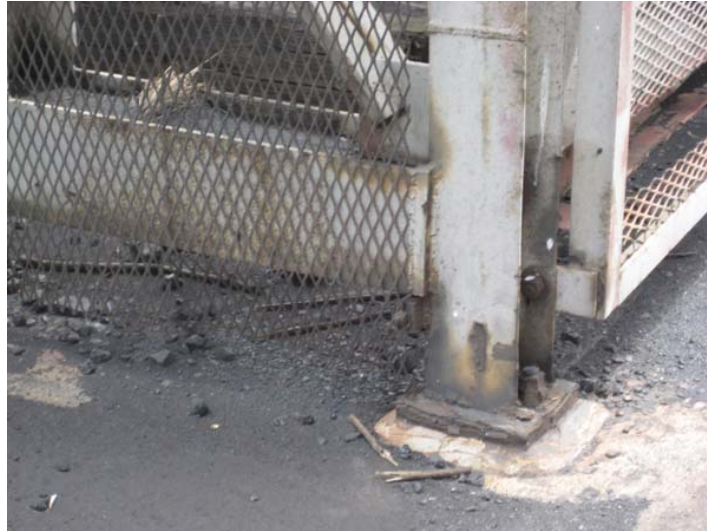
PICTURE CONV-D1-S

holes thru the webs of the columns (Pictures CONV-D1-R, CONV-D1-S, CONV-D1-U, CONV-D1-V and CONV-D1-W),

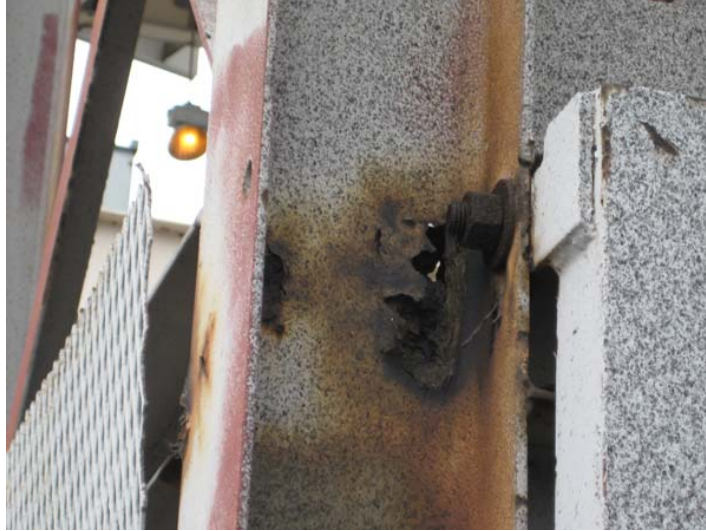
PICTURE CONV-D1-W

and loss of section of members (Pictures CONV-D1-W and CONV-D1-X).

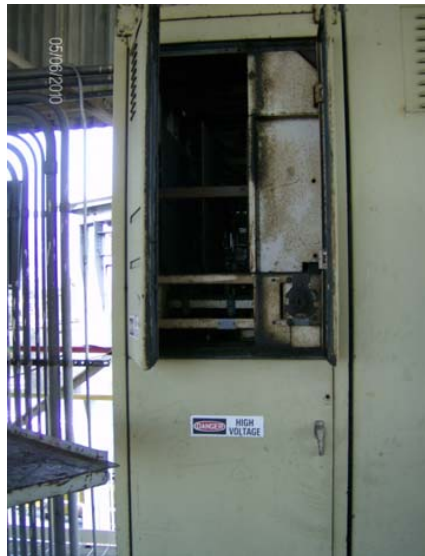
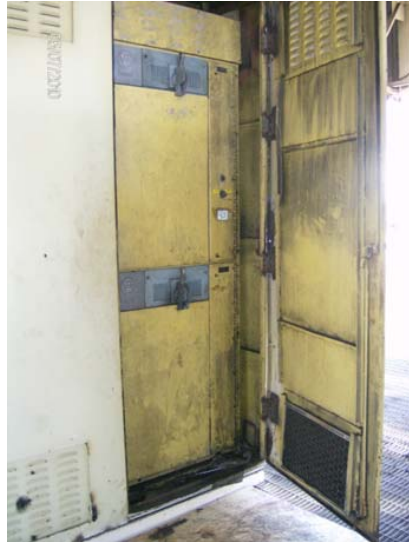
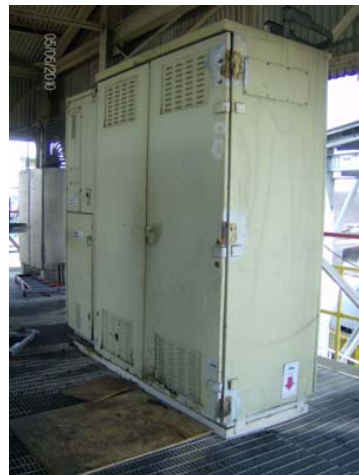
1. E1 Conveyor Motor (200 HP, 1800 RPM, 4000V)
2. 4160V Westinghouse Ampgard™ Switchgear Assembly in an outdoor enclosure containing motor controllers for D1, E1, and Z Conveyors, and a switch for the Dravo Bucket Unloader. This assembly has a large amount of rust evident on the enclosure that has been repaired with sheet metal already. The mechanical interlocks for the door housing the Dravo Bucket Unloader switch has failed so that the live 4160V switch can be accessed while it is energized. This switchgear should be replaced.

5kV Switchgear at T2

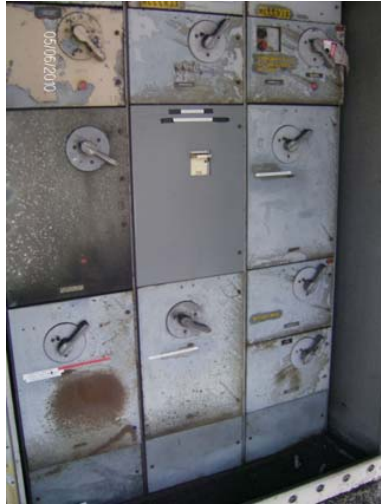
3. 480V Cutler-Hammer Unitrol™ 3-section motor control center in a NEMA 4x stainless steel enclosure. This MCC is over 25 years old and should be replaced because the steel enclosure has rusted through.

480V MCC at T2

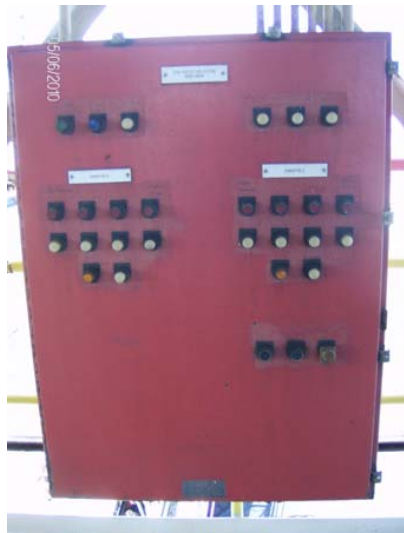
Fire Suppression Cabinet at T2

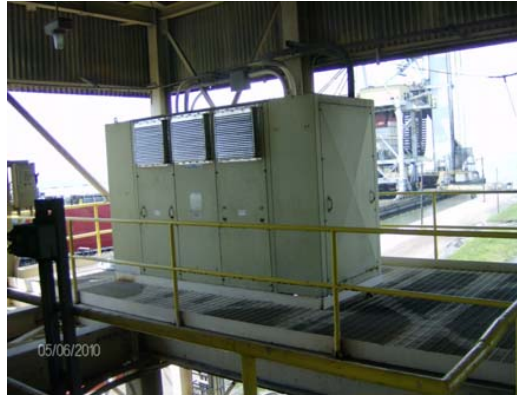
6. 500kVA, 4160V delta – 480V delta Square D dry type transformer in NEMA 3R enclosure. The louvers on this enclosure were modified presumably because rain was dripping on the transformer windings.

500kVA Transformer at T2

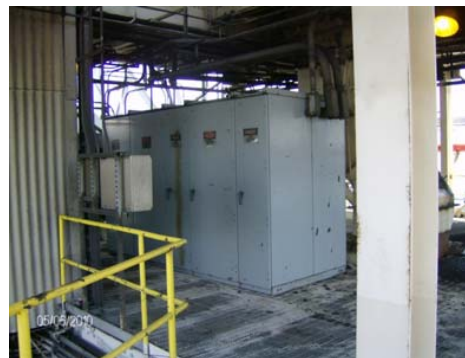
3. 4160V Square D Switchgear Assembly in an outdoor enclosure containing switches for selecting the power source from 111W or 117E. A load-side switch feeds the motor controllers for D1, E1, and Z Conveyors, the Dravo Bucket Unloader, and the 500kVA transformer on the top elevation. This switchgear appears to be in relatively good condition. A third source of power from the new rail unloading conveyor system was added to improve electrical power availability at the dock.

5kV Switchgear at T2 mid-level
