**Tampa Electric Company  
(TECO)  
Coal Yard Mechanical,  
Electrical and Structural  
Assessment**

Results from field review of the  
coal unloading equipment,  
structures and conveyors.

June 21, 2010

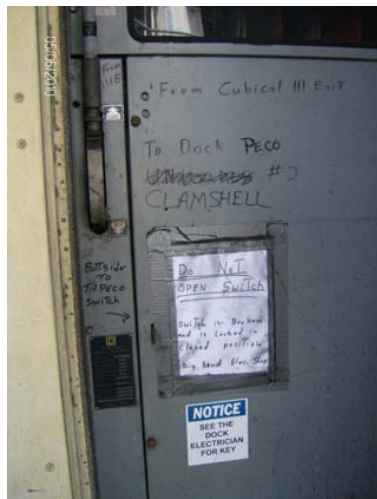
1. 120/240V power panel 1PCH2.
2. Lighting Panel with lighting contactor.
3. Junction box padlocked shut. Could be for fire protection system.
4. Fire Protection system riser flow switches.
5. 4160V Switchgear containing a 600A switch that feeds the Peco Clamshell Unloader. This switch has a note that it is broken and power must be switched back in the powerhouse (circuit 111E) if maintenance is required on the Peco Clamshell Unloader.

PECO Disconnect in T2 (not working)

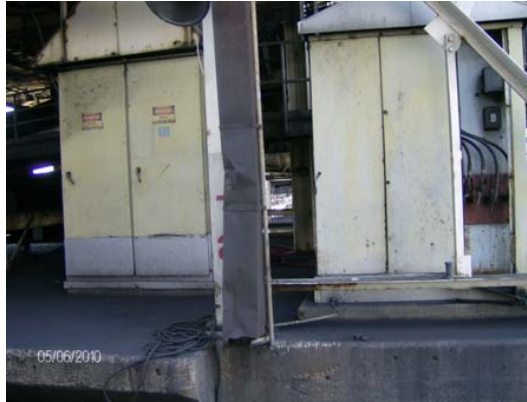
6. 4160V General Electric switchgear that is out of service and abandoned in place.

5kV Switchgear at base of T2 (gear on right is dead)

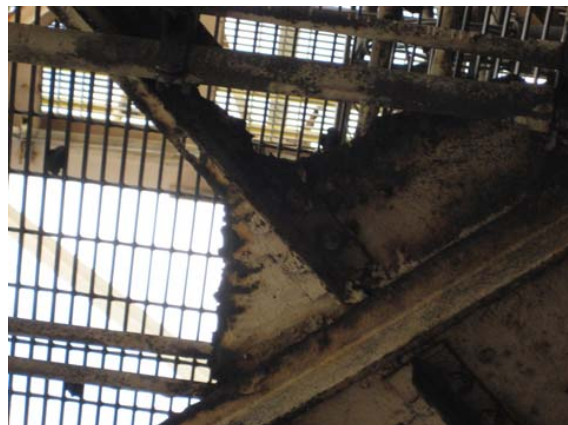
PICTURE TTWR-T2-J

- C-1 Horizontal brace and gusset plate have severe corrosion and metal loss. Recommend replacing brace and gusset plate in kind. See included photo TTWR-T2-J.

- C-2 Horizontal brace and gusset plate have severe corrosion and metal loss. Recommend replacing brace and gusset plate in kind. See included photo TTWR-T2-J.
- C-3 Top flange of floor beam has severe corrosion and metal loss. Recommend cutting out deteriorating section of flange and welding in new plate. Ensure beam is unloaded prior to cutting out damaged section. Alternatively the beam could be replaced in kind. See included photo TTWR-T2-F.

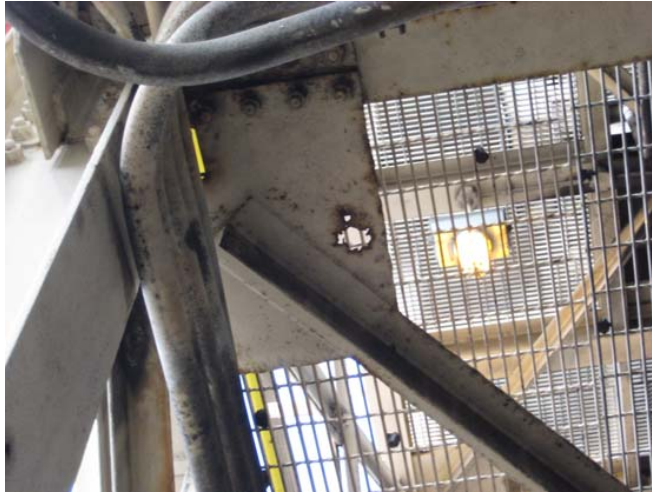
PICTURE TTWR-T2-K

- C-4 Gusset plate has developed holes near horizontal brace connection. Recommend grinding hole back to sound metal and welding a patch over hole. Weld should be at plate and through hole to ensure moisture cannot get between the two. See included photo TTWR-T2-K.

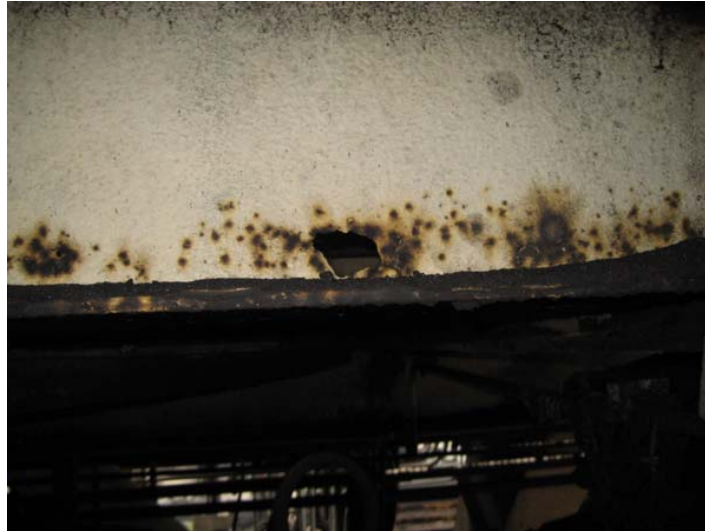
PICTURE TTWR-T2-H

- C-5 Floor beam has developed holes in web and flange. Recommend grinding holes in web back to sound metal and welding a patch over hole. Weld should be at plate and through hole to ensure moisture cannot get between the two. The flange could be cut out back to sound metal and plate welded back in to replace flange. Ensure beam is unloaded prior to cutting out damaged section. See included photos TTWR-T2-G and TTWR-T2\_H.

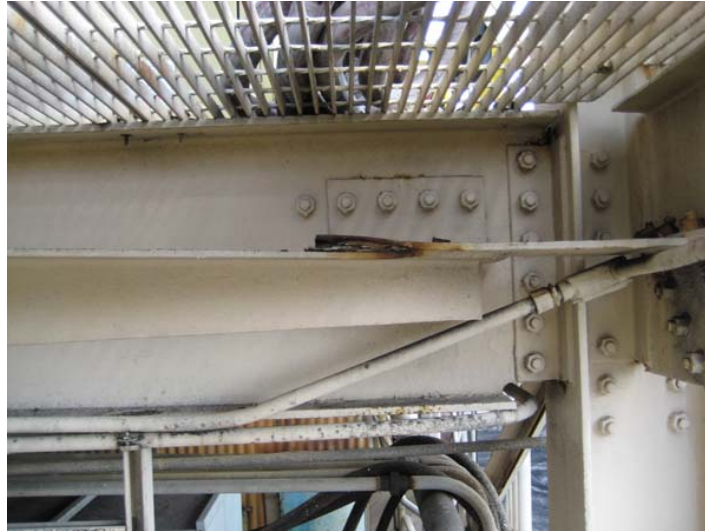
PICTURE TTWR-T2-C

- C-7 There is delamination between the horizontal brace and the gusset plate and the connection has begun to pry apart. Area should be cleaned and seal welded to prevent moisture from getting between the two. See included photo TTWR-T2-C.

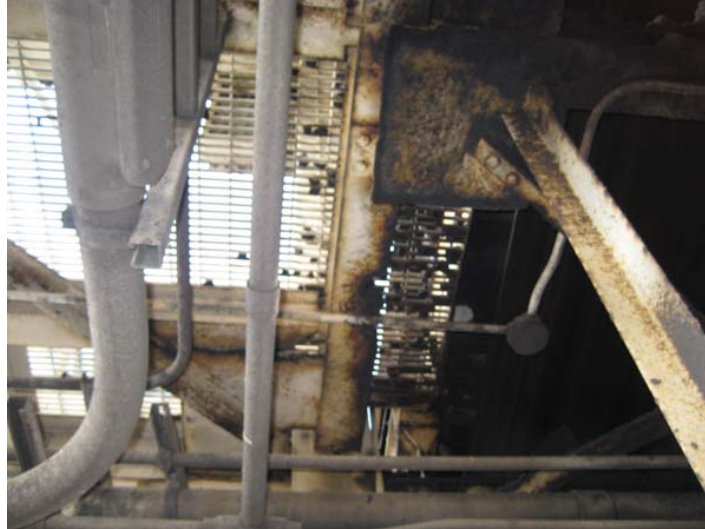
PICTURE TTWR-T2-E

- C-8 Floor beam has delamination of the top flange and should be cleaned and painted to prevent further damage.
- C-9 Floor beam has delamination of the bottom flange and should be cleaned and painted to prevent further damage.
- C-10 Floor beam has severe rot. Recommend placement in kind.
- C-11 Top and bottom flange of the floor beam has moderate delamination and metal loss. Recommend cleaning and inspection prior to painting to prevent further damage.
- C-12 Bottom flange of floor beam has severe corrosion and metal loss. Recommend cutting out deteriorating section of flange and welding in new plate. Ensure beam is unloaded prior to cutting out damaged section. Alternatively the beam could be replaced in kind. See included photo TTWR-T2-E.

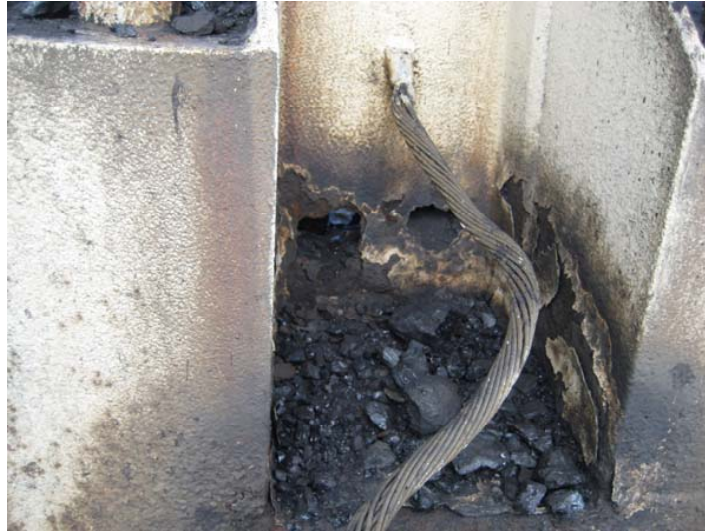
PICTURE TTWR-T2-A

- C-20 Monorail support brace has severe rot. Recommend replacement in kind. See included photo TTWR-T2-B.
- C-21 thru 34 Double angle horizontal braces in bottom chord of roof trusses have pitting and moderate to severe corrosion between the angles. Recommend cleaning and painting or possibly replacing with a new WT with similar properties.
- C-35 Double angle vertical truss brace has delamination at intersection of the braces. Recommend cleaning and seal welding to keep out moisture. Alternatively the beam could be replaced in kind. See included photo TTWR-T2-A.

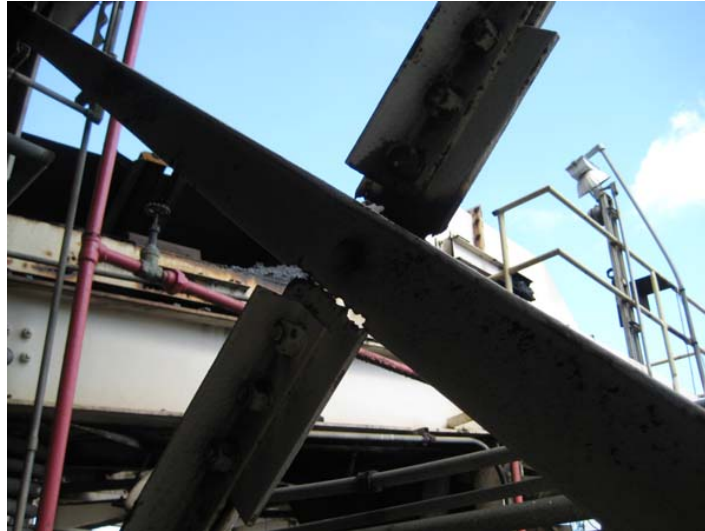
PICTURE TTWR-T2-L

- C-37 Brace has been upgraded to red from the previous assessment done in 2003. Brace has severe rot and metal loss. Recommend replacing damaged section of brace in kind.
- C-38 Section of vertical brace is rotten. Recommend replacing damaged section in kind.
- C-39 Intersection of vertical braces has moderate corrosion. Recommend cleaning and painting to prevent further damage.
- C-40 Vertical brace has moderate corrosion at a previous repair. Recommend cleaning and painting to prevent further damage.
- C-41 Strut between columns has moderate corrosion and a small amount of metal loss. Recommend cleaning and painting to prevent further damage.
- C-42 Connection of vertical brace to gusset plate has rotten free and brace is no longer taking load. Recommend replacing gusset plate and field welding existing braces to new gusset plate. See included photo TTWR-T2-L.

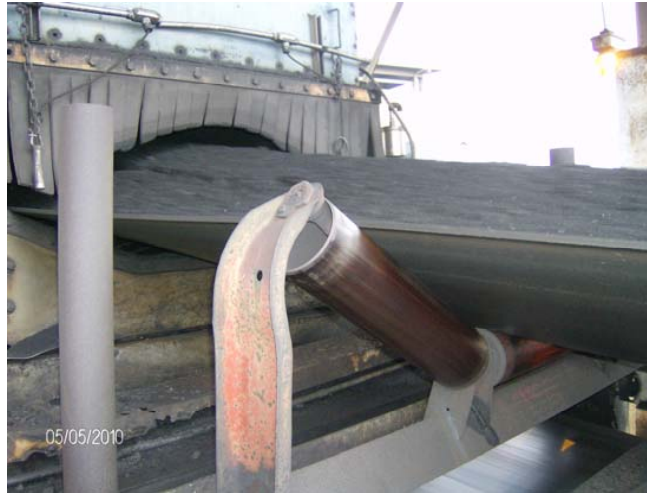
Conveyor F has been replaced within the last five years due to severe corrosion. Mechanically the conveyor is in relatively sound condition. The conveyor was running during the walk down and in general there was only one noisy idler. The bearing is gone in the last idler at the head of conveyor F1. The idler roller is riding on the shaft.

Idler Roller on Shaft

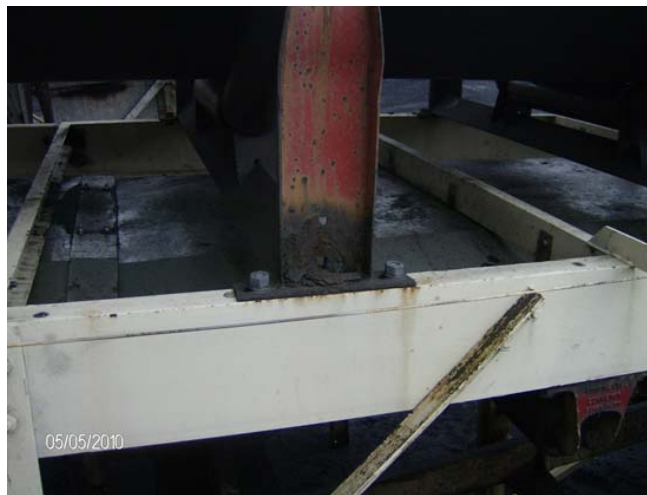
Corroded idler supports are present at the head end. It appears that newer black supports are okay while older red supports show signs of corrosion. The newer black frames also have sealed bearings versus Zerk fitting which will reduce maintenance costs.

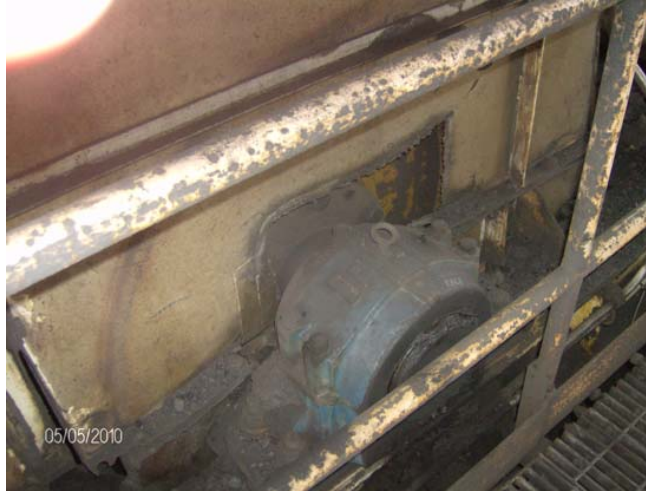
Guarding should be added around the penetration through the head chute between the head pulley and bearing housing opposite the drive side.

Penetration at Head Chute

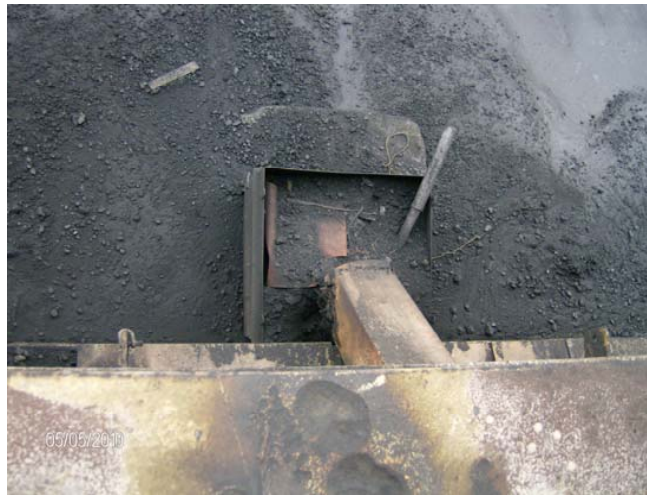
A traveling magnet over the head end of conveyor F1 continuously removes tramp metal from the coal. It drops the metal down a chute into a bin. The bin was full during the walk down. The bin must be kept emptied to prevent plugging the chute and carryover of tramp metal into the fuel.

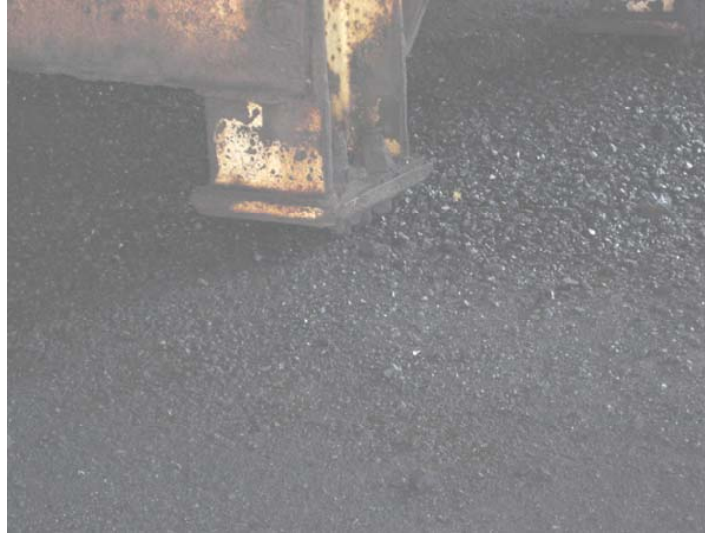
PICTURE CONV-F1-B

- C-1 The grout beneath the base plates of the frame supporting the tail end of Conveyor F1 has disappeared over time as can be seen in Pictures CONV – F1 – A and CONV – F1 – B. Additionally, as can be seen in Picture CONV – F1 – C, the condition of the anchor bolts and nuts is poor. The bottom of the columns and their base plates should be cleaned and painted and repaired, as necessary. The underside of the base plates should be cleaned of any coal and the grout should be replaced. The anchor bolts should be cleaned and painted and the nuts replaced, if possible; otherwise a new means of anchorage will be required.

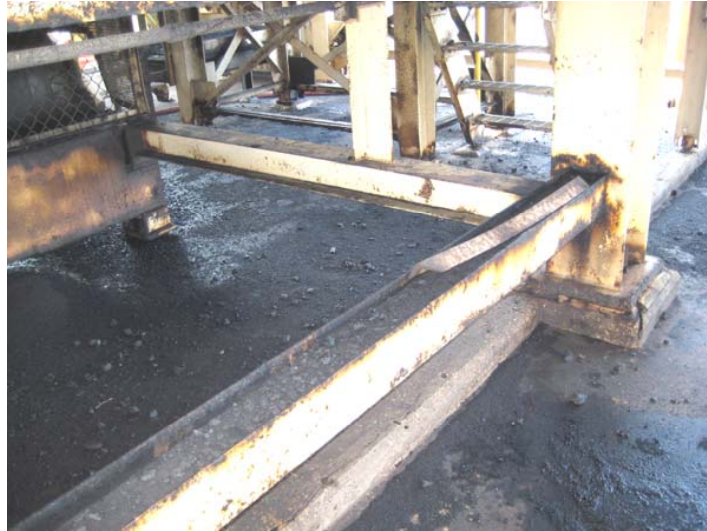
PICTURE CONV-F1-D

- C-2 A beam spanning between Transfer Tower T-2 columns with web horizontal has filled with coal to nearly the tips of the flanges, as can be seen in Pictures CONV-F1-D, CONV-F1-E and CONV-F1-F. This beam supports a walkway at the tail end of Conveyor F1 and also braces Conveyor F1. This beam needs to be cleaned of coal and painted and repaired as necessary. If it is going to be continued to be used, it is recommended that a plate be added to

the top of the beam to eliminate coal accumulation and minimize further corrosion.

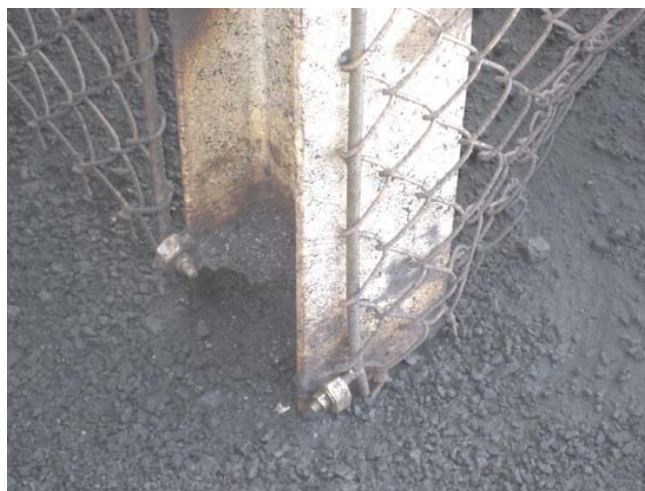
PICTURE CONV-F1-G

- C-1 Much of the bottoms of the columns for the Conveyor F1 Take-up Enclosure are embedded in coal, as seen in Pictures CONV-F1-G AND CONV-F1-H. At other locations this had led to significant corrosion at the bottom of the columns and to the anchor bolts and nuts. The coal should be removed from around the bottoms of the columns and kept clear of the bottoms of the columns. The columns should then be cleaned and painted and repairs made to the columns and anchor bolts as necessary.

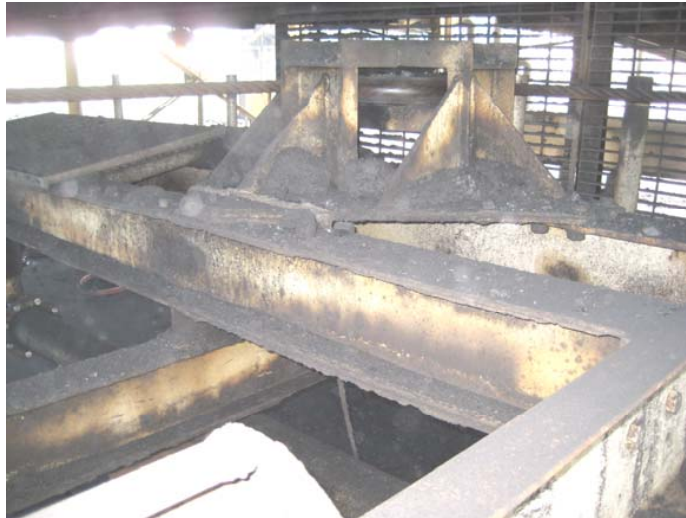
PICTURE CONV-F1-J

- C-2 The framework supporting the horizontal pulley for the Conveyor F1 Take-up is extremely corroded as seen in Pictures CONV-F1-J and CONV-F1-K. This framing will need cleaning and paint, at the least, and possibly repairs if cleaning back to solid metal exposes significant loss of section of the members.

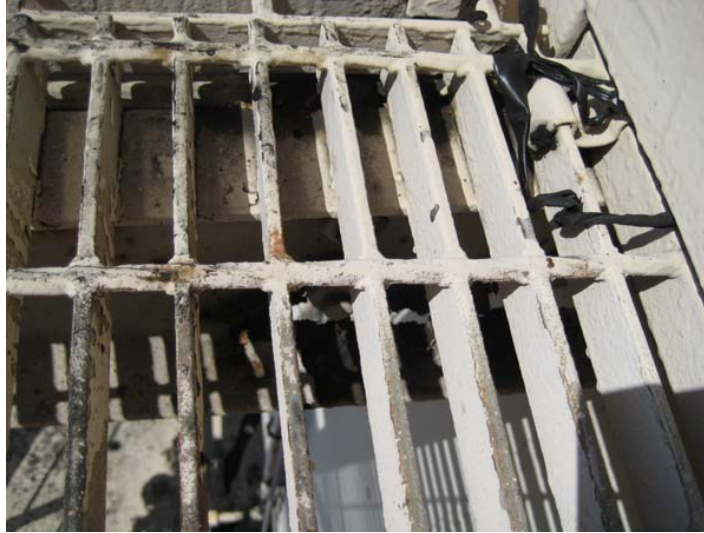
PICTURE DSR-D

- C-13 Members marked in yellow have moderate corrosion and metal loss. Recommend cleaning and painting to prevent further damage.
- C-14 Members marked in red have severe corrosion and metal loss. Much of the metal loss are at the end connections. Recommend replacing braces and gusset plates at all locations.
- C-15 Expanded metal grating is rotting at support. Recommend replacing grating.
- C-15a Braces have considerable metal loss. Recommend replacement in kind.

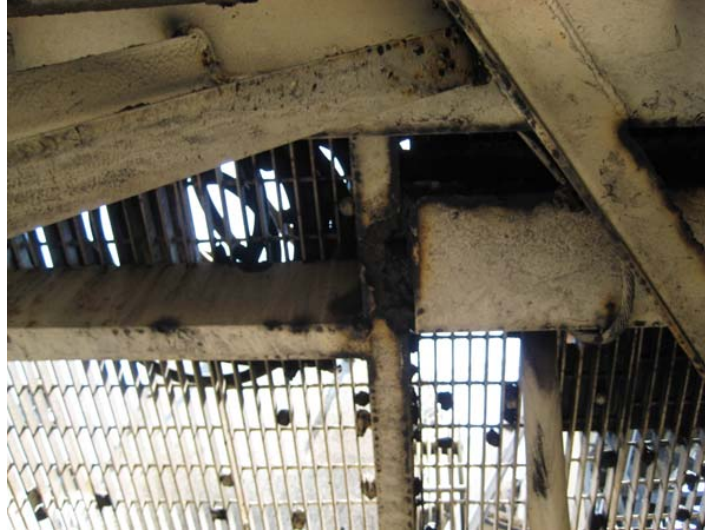
PICTURE DSR-C

- C-16 Beam has holes in the web and delamination of the bottom flange. Recommend grinding holes in web back to sound metal and welding a patch over hole. Weld should be at plate and through hole to ensure moisture cannot get between the two. Also recommend grinding away rotten steel at the bottom flange and cover plating. Beam may require temporary support.
- C-17 Beam has severe metal loss and rot on bottom flange at connection. See included photo DSR-C. Recommend replacement in kind.

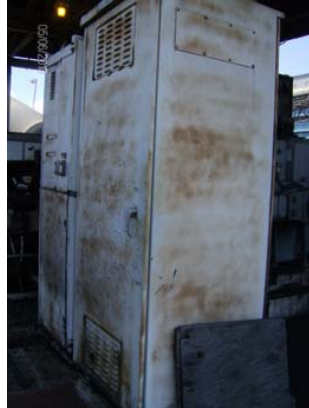
5kV Switchgear at T3

- i. Two unlabelled 480V motor starters (out of service).
- j. Painted steel control cabinet CS3-1 containing terminal strips which was once the original control panel. Since the installation of the Modicon PLC, this control panel is used as a junction box. There is a lot of rust on the door and it will not close all the way.
- k. 4160V Westinghouse Ampgard™ switchgear lineup in an outdoor enclosure for: South Stacker/Reclaimer, F conveyor. This switchgear is old and poor condition.

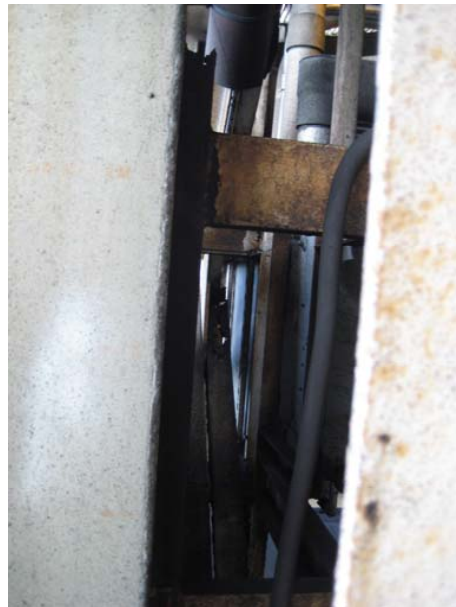
PICTURE TTWR-T3-A

- M-1 Brace previously noted as missing has not been replaced. It should be replaced in kind.
- M-4 This brace has not been repaired/replaced as previously recommended. This brace is between Column Lines 1 and 1.5 on Column Line A, not between 1.5 and 2 as previously noted. This corrosion can be seen in Pictures TTWR-T3-A and is behind some electrical panels.

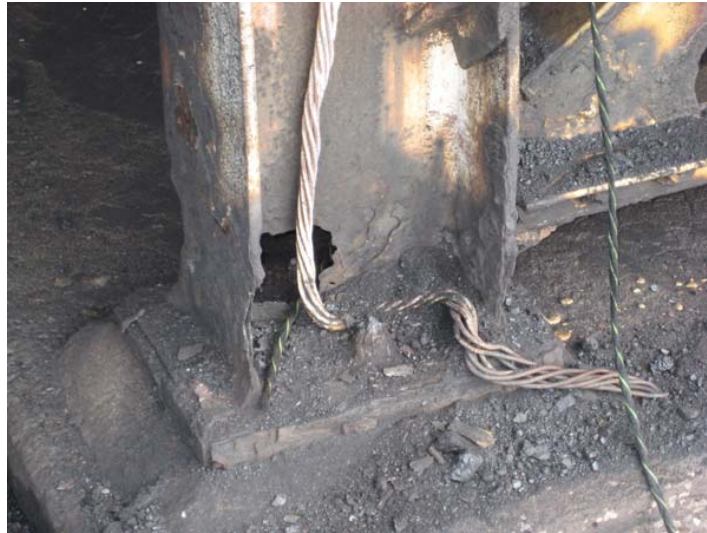
PICTURE TTWR-T3-C

- C-2 The bottom of Column A-1 is severely corroded, as seen in Picture TTWR-T3-C, with a large hole thru the web and significant lose of the flanges. Additionally, the anchor bolt nuts have nearly corroded away. The gusset plate and vertical bracing members framing into this column are also quite corroded. Column needs to be repaired at the bottom and the anchor bolt nuts replaced, if possible. If the nuts cannot be replaced, new anchor bolts will need to be installed or some other means of anchorage will need to be used.

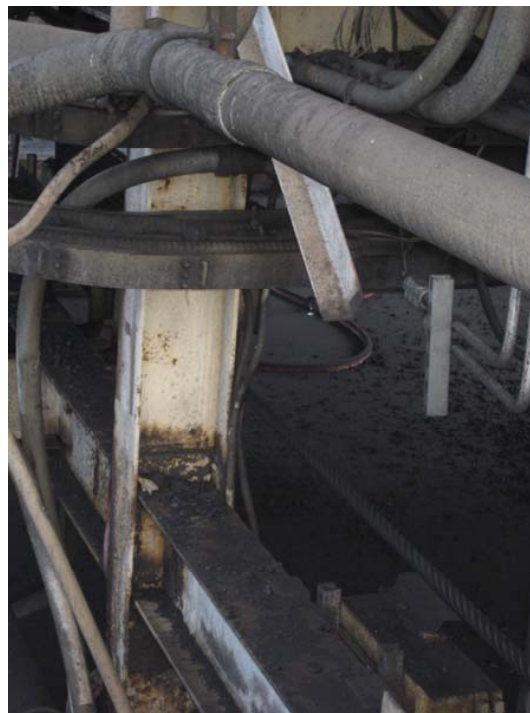
PICTURE TTWR-T3-E

- C-4 The vertical double angle member connecting the horizontal tension tie connecting Columns A-1.5 and A-2 near the bottom of the columns is missing. This member needs to be replaced.
- C-5 At Column B-2, the framing connection at the first level above grade, as seen in Picture TTWR-T3-E, needs cleaning and painting and possibly repairs once the rust has been removed.

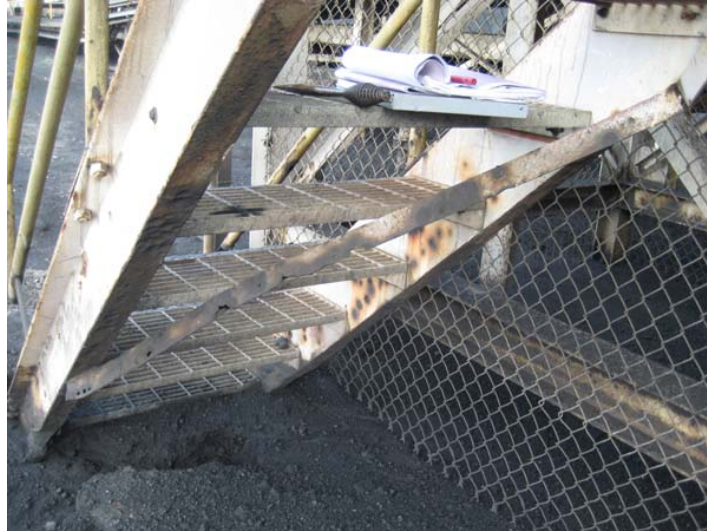
PICTURE TTW3-T3-F

- C-6 Some of the under stair bracing, as seen in Picture TTWR-T3-F, has corroded severely and needs to be replaced.

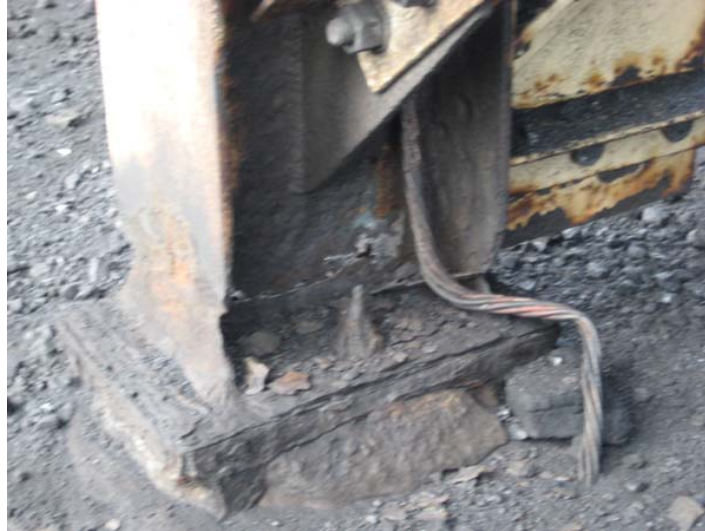
PICTURE TTWR-T3-H

- C-7 The bottom of Column A-2 is severely corroded with holes through the web and loss of flange section, as seen in Pictures TTWR-T3-G and TTWR-T3-H. Additionally, anchor bolt nuts have corroded away. Column bottom needs to be repaired and cleaned and painted and anchor bolts repaired and new nuts installed, if possible. Otherwise a new anchorage system will be required.

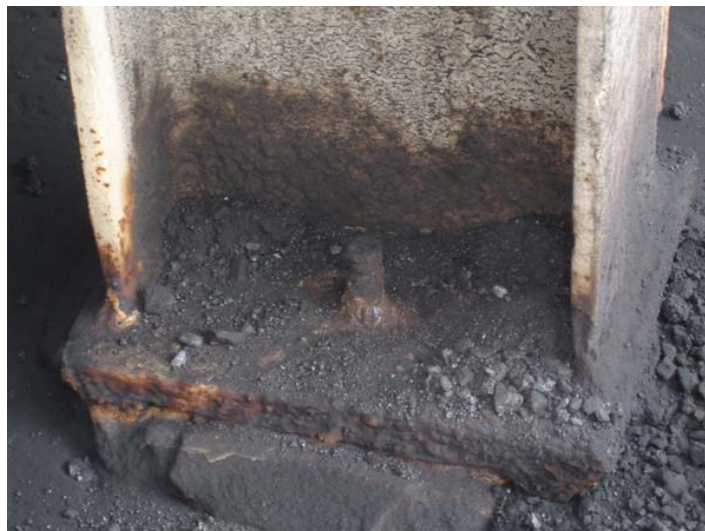
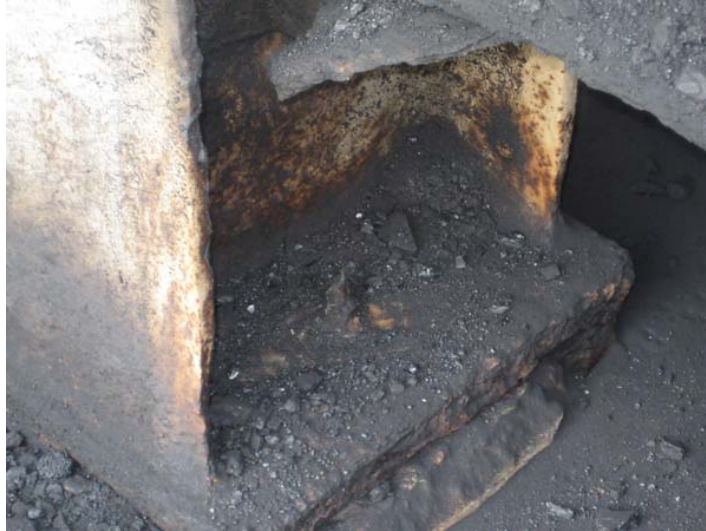
- C-8 The bottom of Column B-2 as seen in Pictures TTWR-T3-J and TTWR-T3-K. Column bottom needs to be repaired and cleaned and painted and anchor bolts repaired and new nuts installed, if possible. Otherwise a new anchorage system will be required.

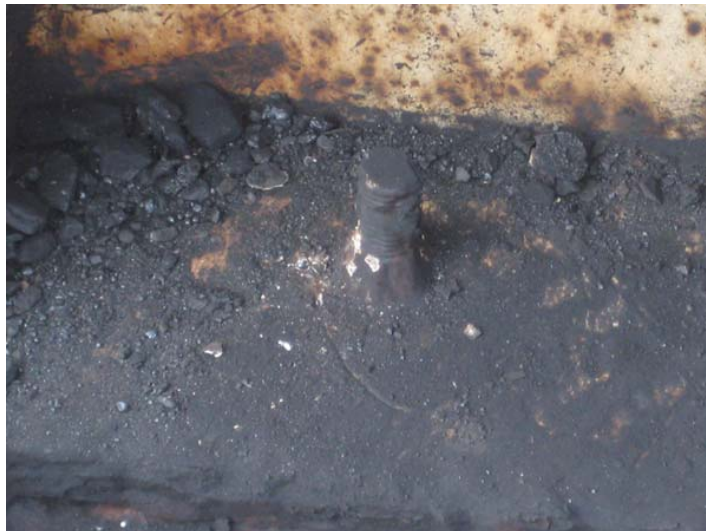
TTWR-T3-L

- C-9 The bottom of Column C-2 as seen in Picture TTWR-T3-L. Column bottom needs to be cleaned and painted and anchor bolts repaired and new nuts installed, if possible. Otherwise a new anchorage system will be required.

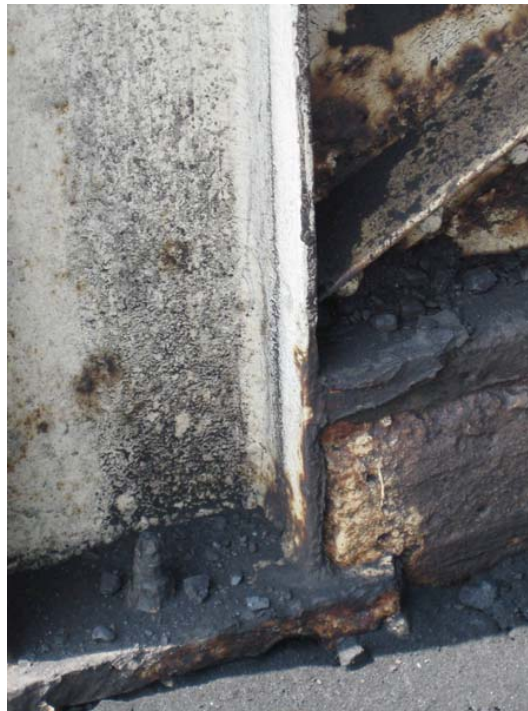
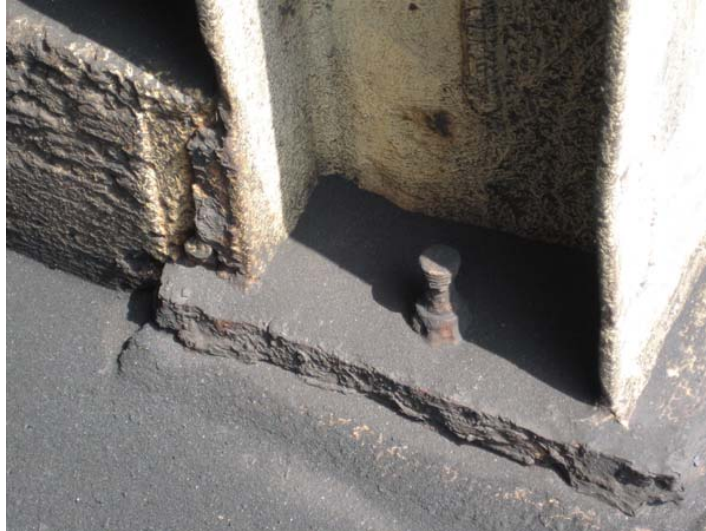
- C-10 The bottom of Column D-2 as seen in Pictures TTWR-T3-M and TTWR-T3-N. Column base needs to be cleaned and painted and anchor bolts repaired and new nuts installed, if possible. Otherwise a new anchorage system will be required. Vertical brace and gusset also need cleaning and painting/repair as applicable.

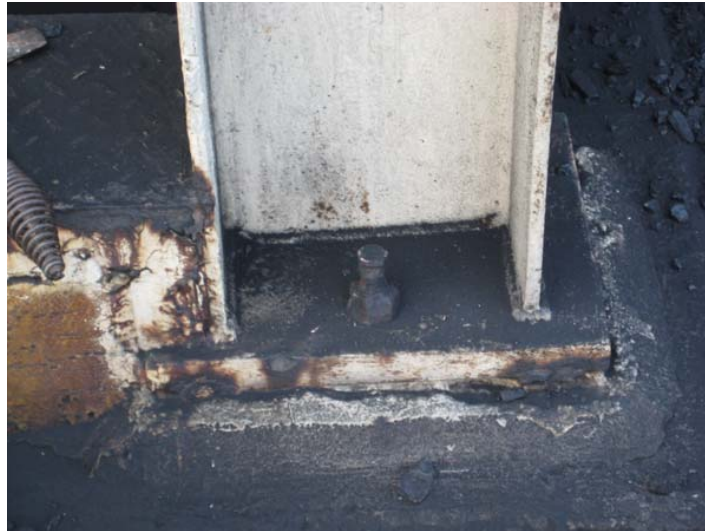
TTWR-T3-R

- C-12 The bottom of Column D-1 is in fair condition, as seen in Picture TTWR-T3-R, although it will need cleaning and painting. The anchor bolts appear to also be in fair condition. Anchor bolt nuts need to be replaced since they are losing their corners.

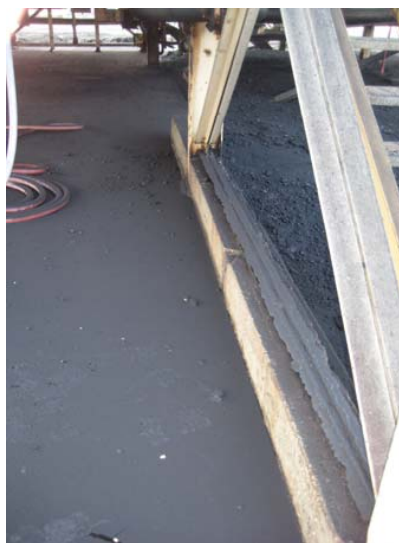
TTWR-T3-S

- C-13 The cross tie at grade between columns C-1 and D-1 is severely corroded as seen in Picture TTWR-T3-S. Tie needs to be repaired or replaced.

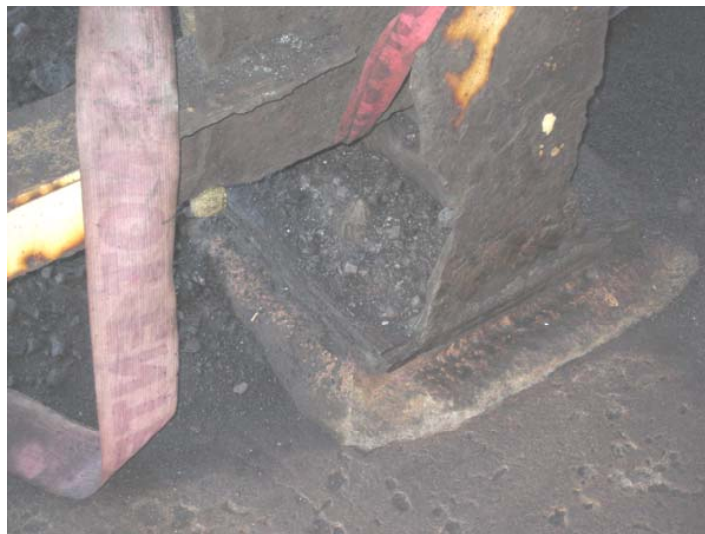
TTWR-T3-U

- C-14 The bottom of Column B-1, as seen in Pictures TTWR-T3-T and TTWR-T3-U, is in poor condition. Corrosion is severe and column bottom needs to be repaired and cleaned and painted and anchor bolts repaired and new nuts installed, if possible. Otherwise a new anchorage system will be required.

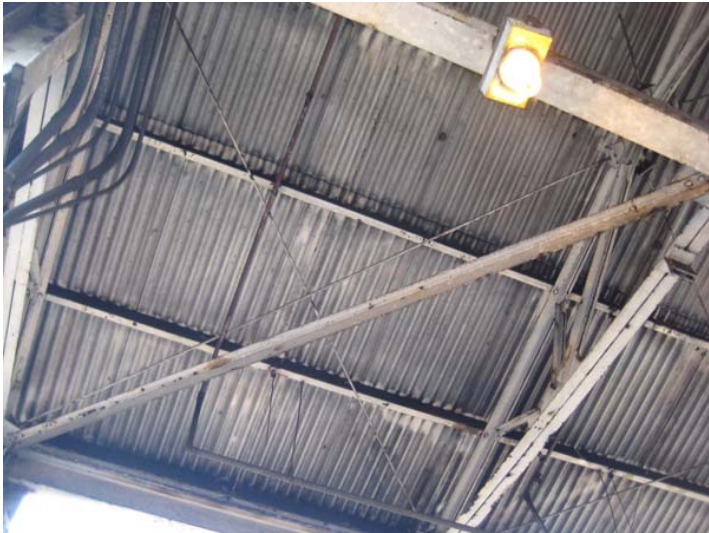
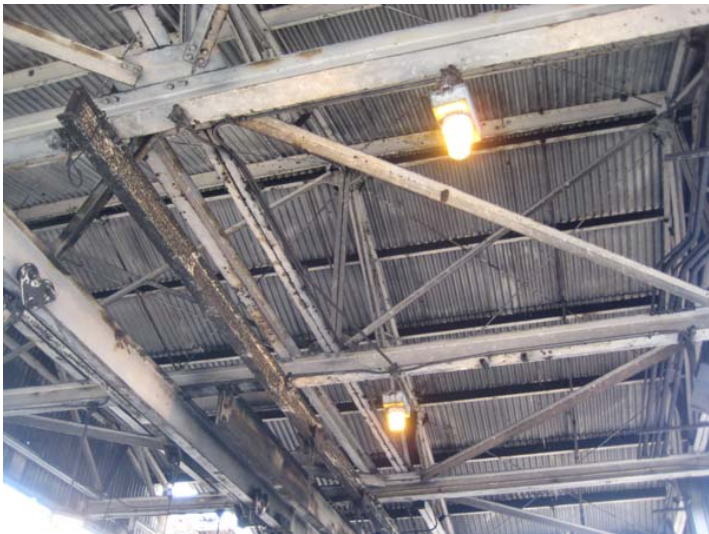
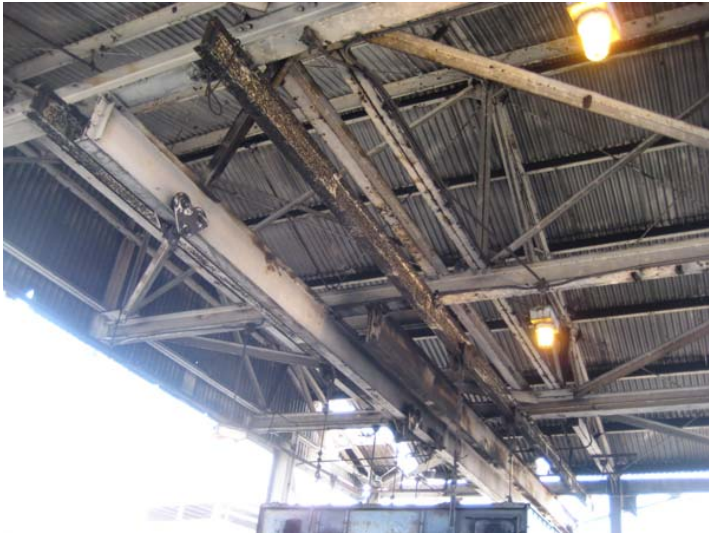
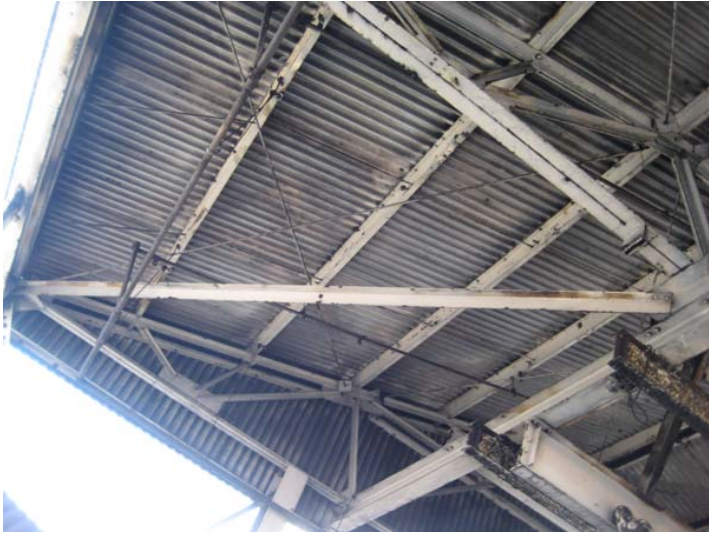
Pictures TTWR-T3-W, TTWR-T3-X, TTWR-T3-Y AND TTWR-T3-Z show the general condition of the roof framing and monorails. In general, the framing looks in fair condition needing only to be cleaned and painted. However, should cleaning back to solid metal indicate significant loss of metal, repairs will be required before painting. 3 of the monorails, as seen in Pictures TTWR-T3-X and TTWR-T3-Y show some more severe corrosion. These should be cleaned back to solid metal and examined closer to determine if they are still in serviceable condition. If it is determined that the corrosion is to severe, replacement is recommended.

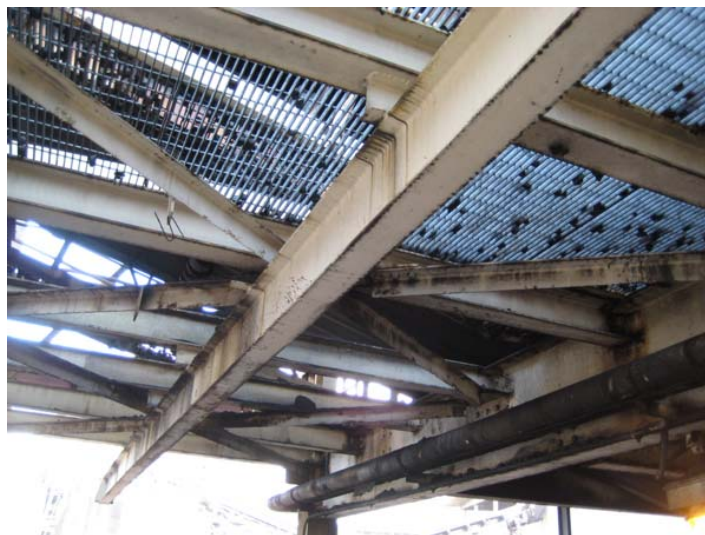
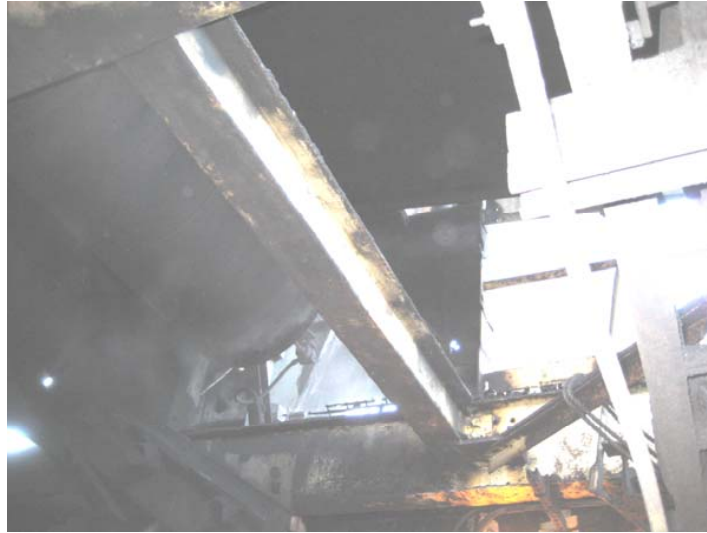
Pictures TTWR-T3-AA, TTWR-T3-AB and TTWR-T3-AC show the general condition of the floor framing systems. Coal accumulation on the grating surfaces and the presence of moisture have lead to corrosion of the grating and the support steel in many areas. The grating surfaces should be kept free of coal and the corroded areas cleaned and painted to minimize further corrosion. Should cleaning of the members back to solid metal expose significant corrosion, repairs or replacement will be required.

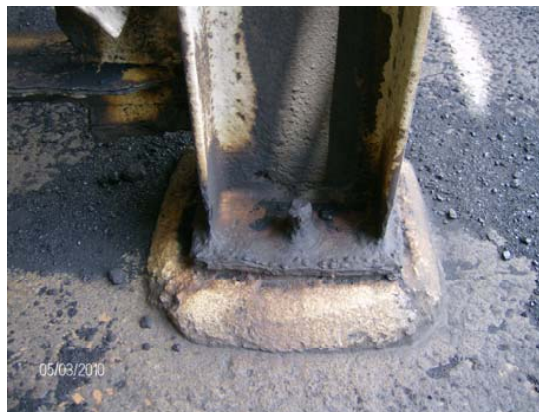
The tail section support legs are corroded through and require repair.

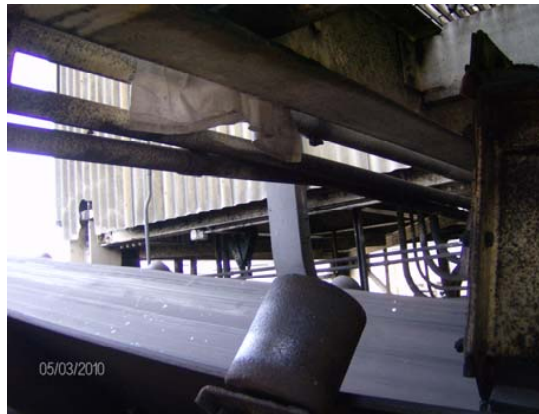
The chute work at the tail end of conveyor Y is severely corroded and should be repaired or replaced to reduce dusting.

A shear gate or lumpbreaker roll should be installed to protect the conduits downstream of the loading area on Y conveyor. These conduits have been bent.

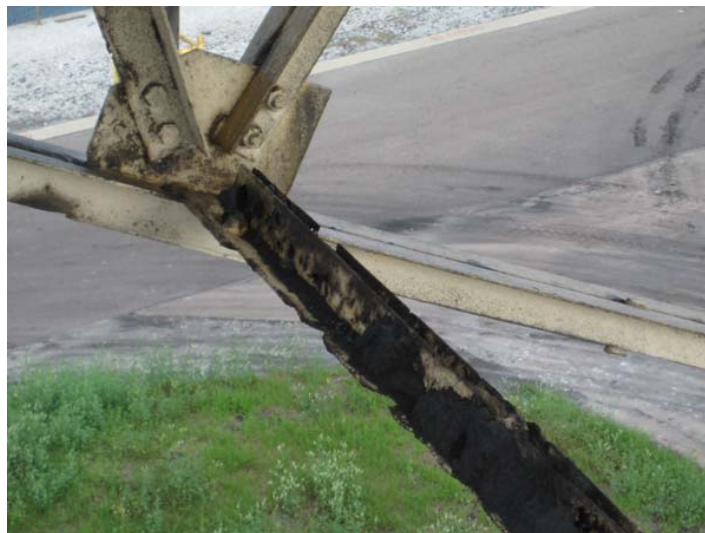
PICTURE CONV-Z-A

C-1 At the Drive Platform, there is some loss of section of some horizontal members, as seen in Picture CONV-Z-A.

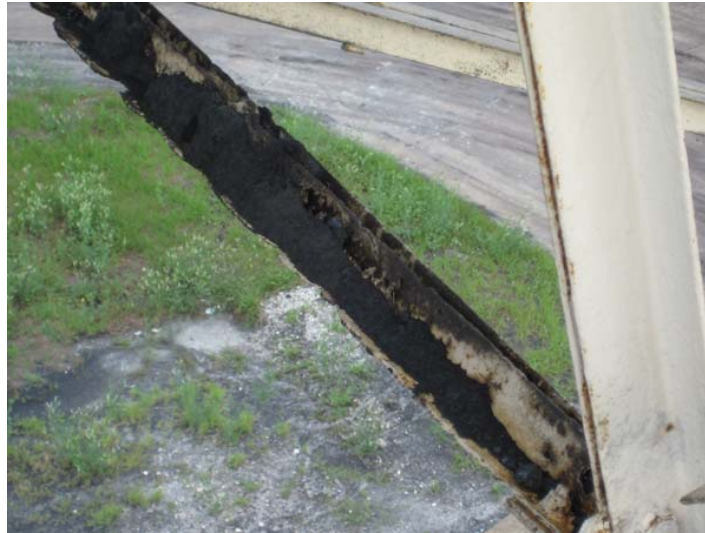
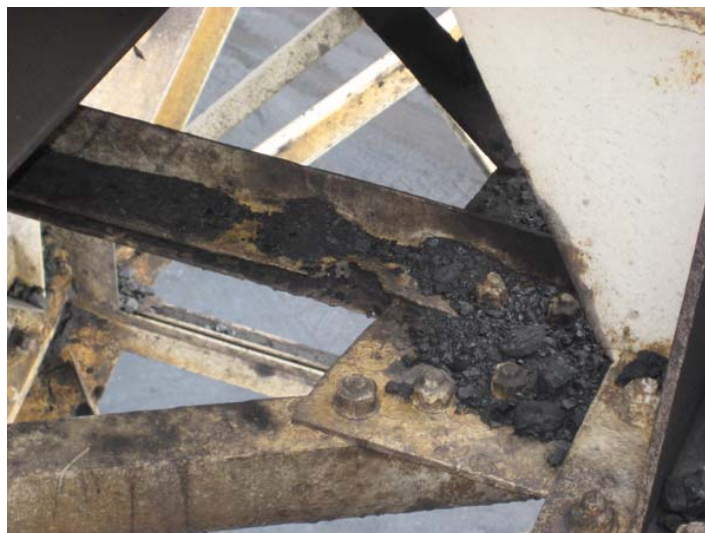
- C-2 At the Drive Platform, there is some loss of section of some horizontal members, as seen in Pictures CONV-Z-B and CONV-Z-C.

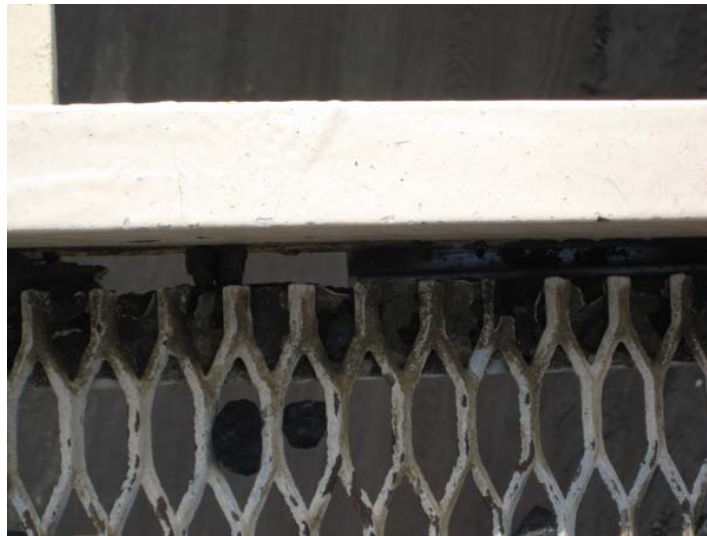
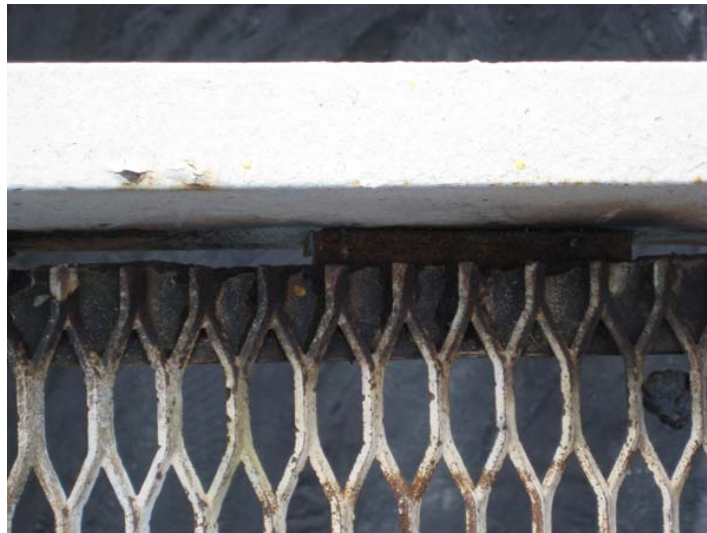
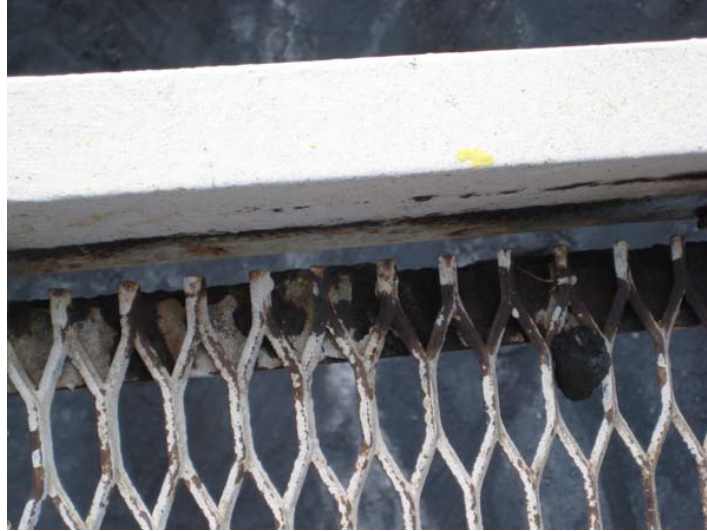
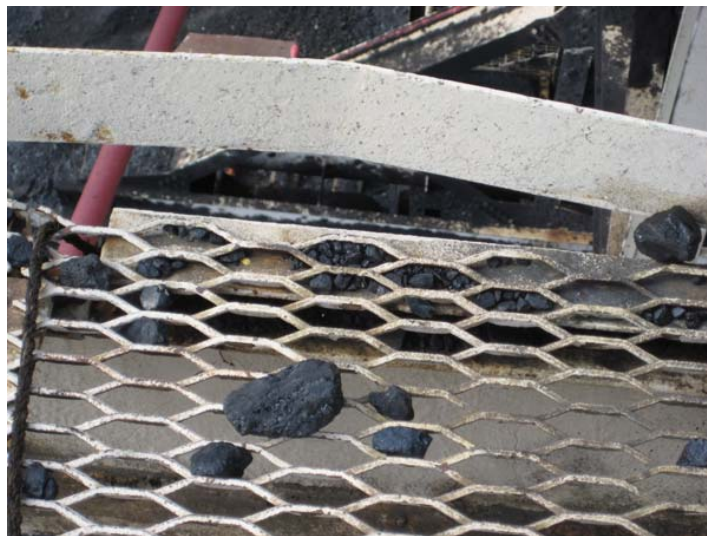
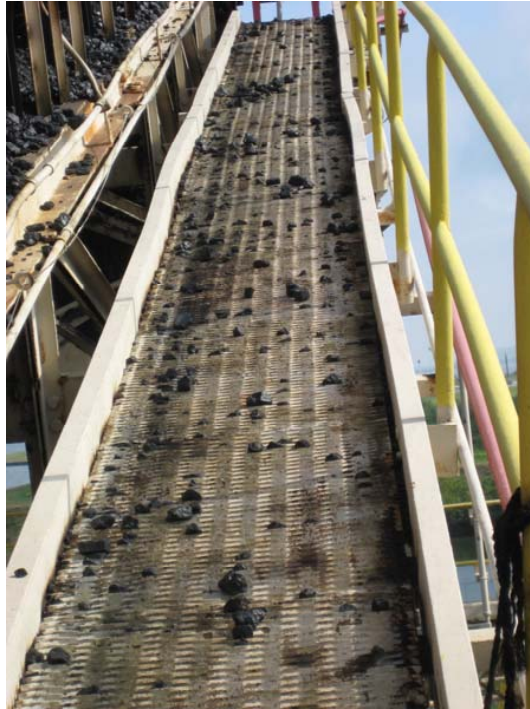
- C-3 The grating support is separating from the walkway stringers, as seen in Pictures CONV-Z-D thru CONV-Z-H. The presence of coal on the inclined walkway also makes walking up the incline difficult. At times the coal tends to roll under foot. Even though you try not to step on it, at some locations it can't be avoided.

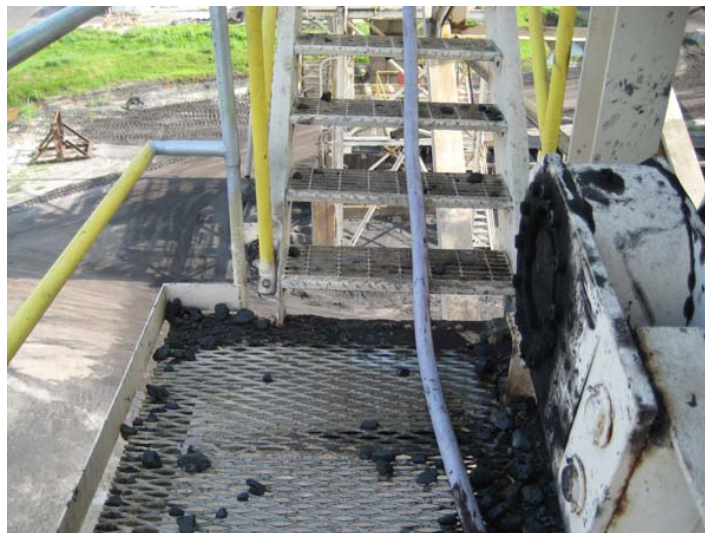
PICTURE CONV-Z-J

C-4 There is no toe plate under the first tread, as seen in Picture CONV-Z-J.

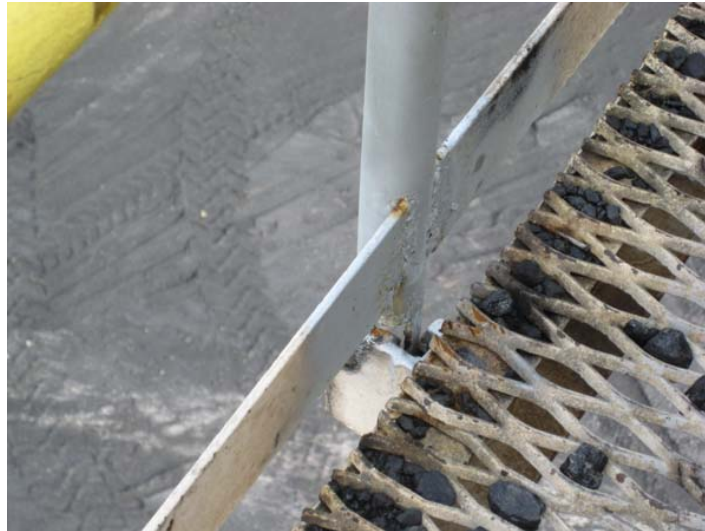
PICTURE CONV-Z-K

- C-5 In Picture CONV-Z-K, it can be seen that the handrail has corroded free of the walkway.

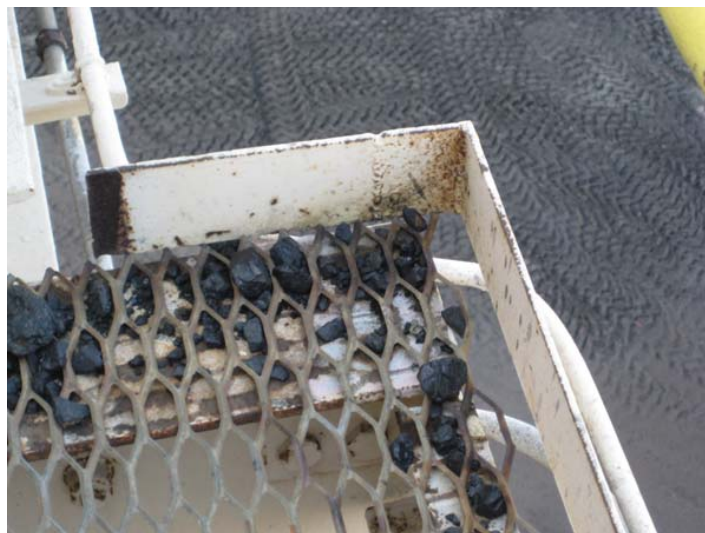
PICTURE CONV-Z-L

- C-6 Toe plate is not secured and has pulled away from the walkway, as seen in Picture CONV-Z-L. The gap between the toe plate and the grating exceeds OSHA requirements at many locations.
