**Tampa Electric Company  
(TECO)  
Coal Yard Mechanical,  
Electrical and Structural  
Assessment**

Results from field review of the  
coal unloading equipment,  
structures and conveyors.

June 21, 2010

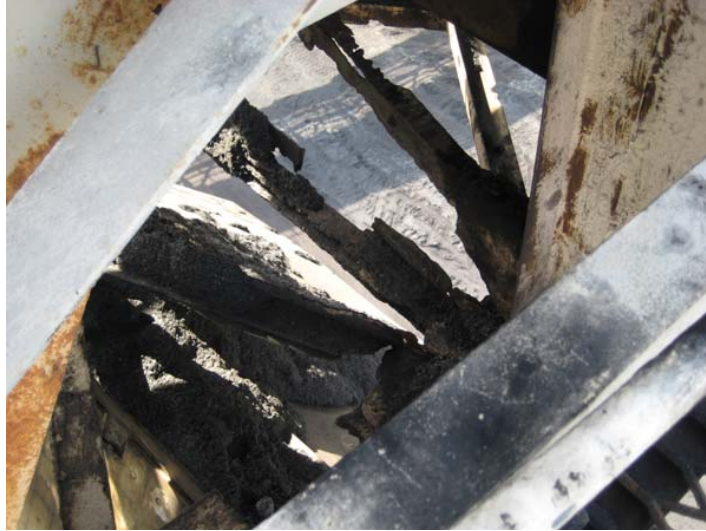
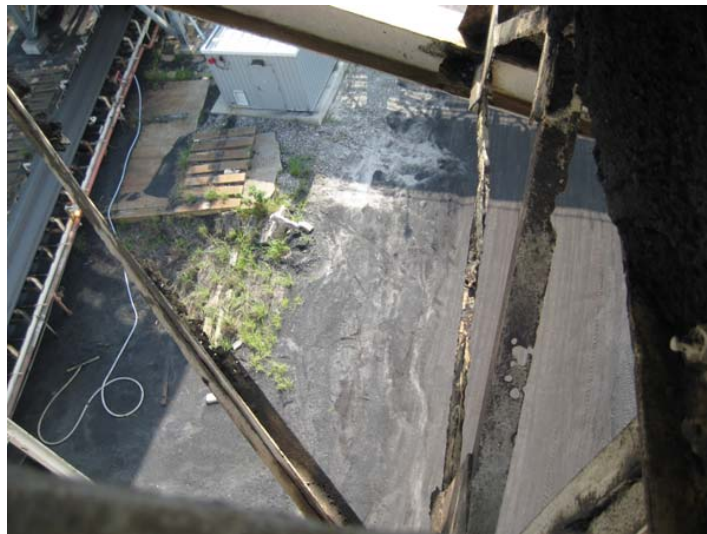
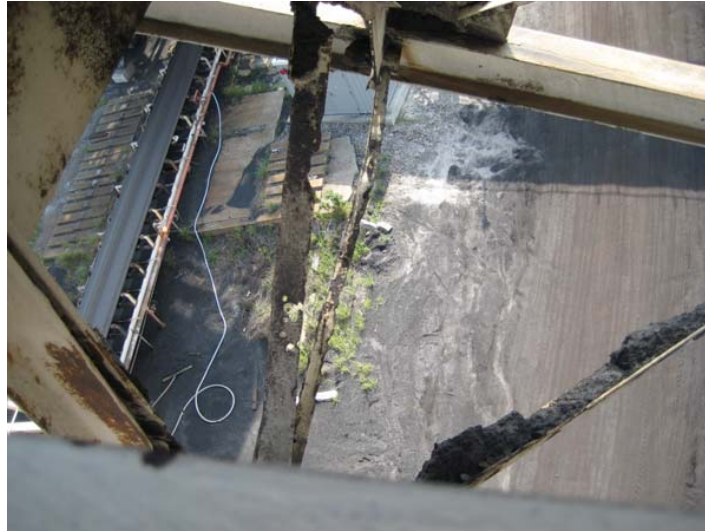
- C-2 Considerable loss of section in the bottom chord brace members and the vertical sway frames between the trusses can be seen in Pictures CONV-Z-R thru CONV-Z-T.

These members should be replaced in order to maintain the stability of the conveyor.

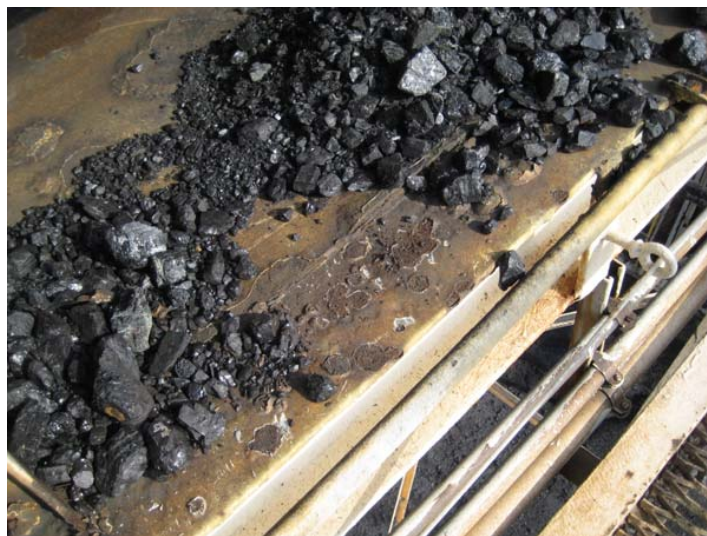
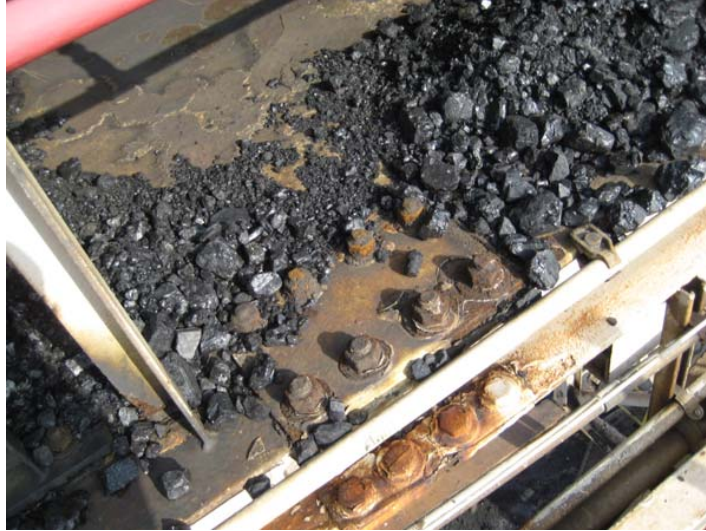
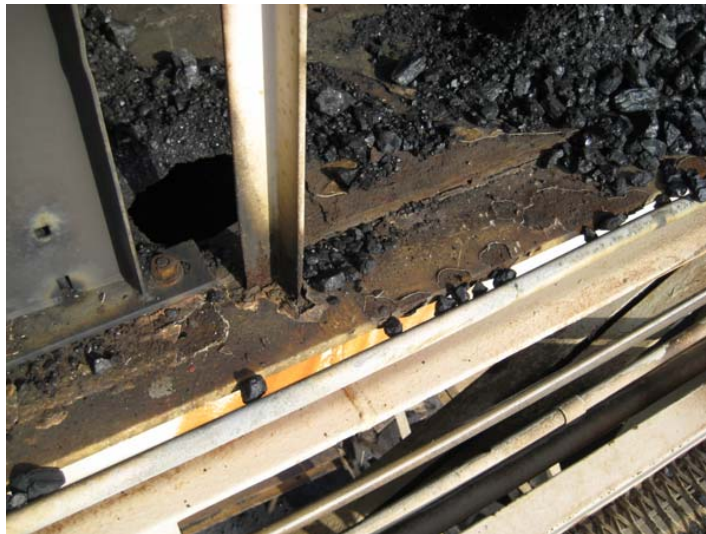
- C-4 Accumulation of coal subjected to moisture is corroding the top flange of the truss and also the bolts in the splice connection. In some instances the nuts are no longer hexagonal but are becoming more rounded. Refer to Pictures CONV-Z-V thru CONV-Z-Y.

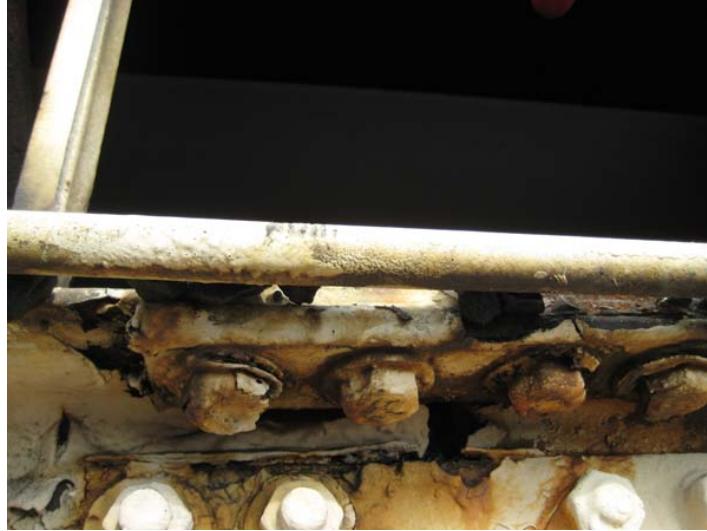
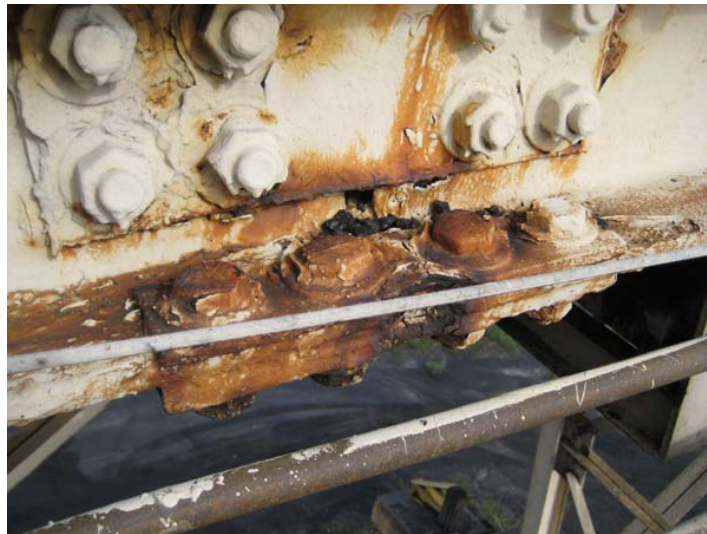
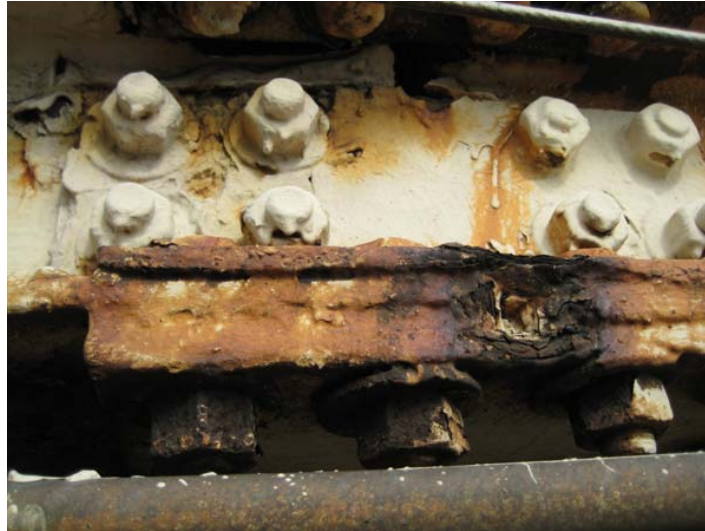
- C-8 Typical truss top chord splice showing corrosion of plates and fasteners at both the top and bottom flanges of the top chord, Pictures CONV-Z-AC thru CONV-Z-AF.

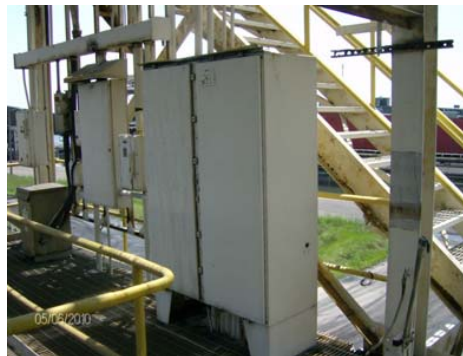
PLC Cabinet 1CYH-PCT4

1. A proximity switch to detect when someone climbs up/down the ladder at the top elevation.
2. Electrodes for lightning protection (presumably because this is one of the highest structures in the area).
3. Lighting fixtures with photocell control (note: photocell not working because all the lights were on).
4. Chute plug detector.
5. 1000W flood lighting fixtures.
6. Modicon PLC cabinet. This painted steel enclosure has lots of corrosion.

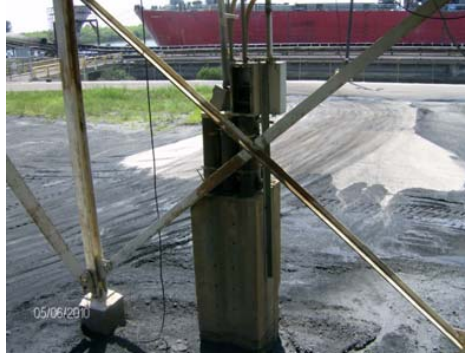
Ductbank at T4 with broken conduits

11. The most important issue noted at the T4 tower is the obsolete PLC system in operation and a number of corroded/broken conduits and ductbanks.

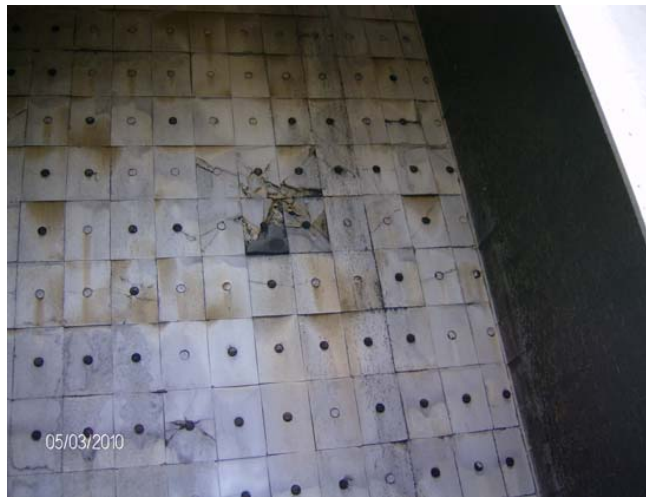
The discharge chute at the head end of Z conveyor is a new stainless steel chute with tile lining. There has been some damage to the tiles.

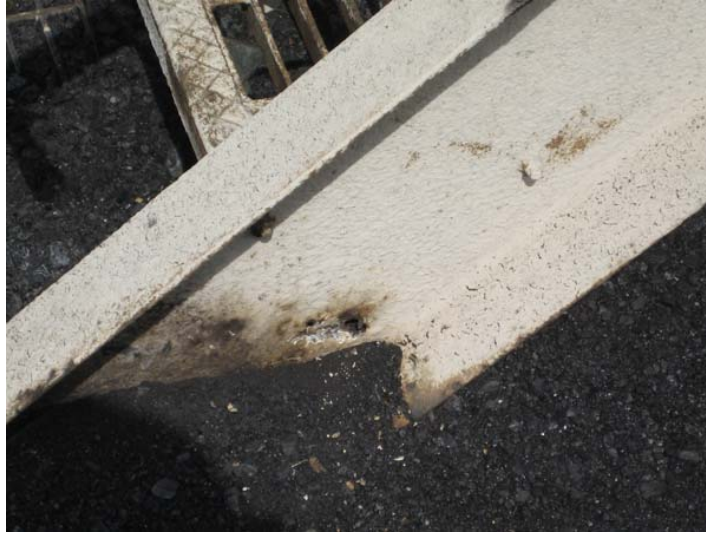
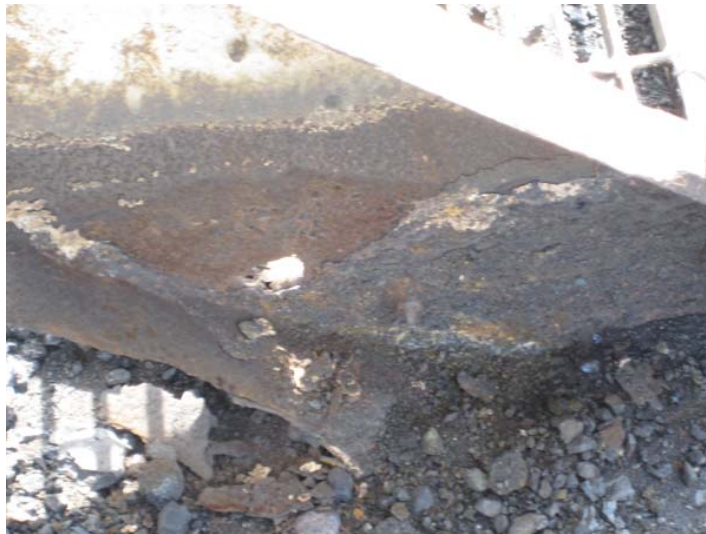
- C-2 The stairs at the bottom of the tower are embedded in a pile of coal. The bottom of the stair stringers is corroded completely through, as seen in Pictures TTWR-T4-B and TTWR-T4-C. The coal needs to be cleared away from the stair to provide a safe walking surface and the stringers repaired and cleaned and painted or replaced.

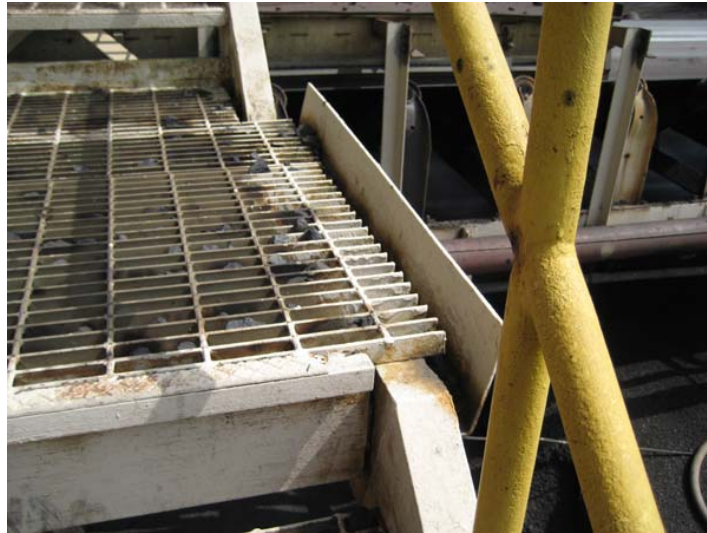
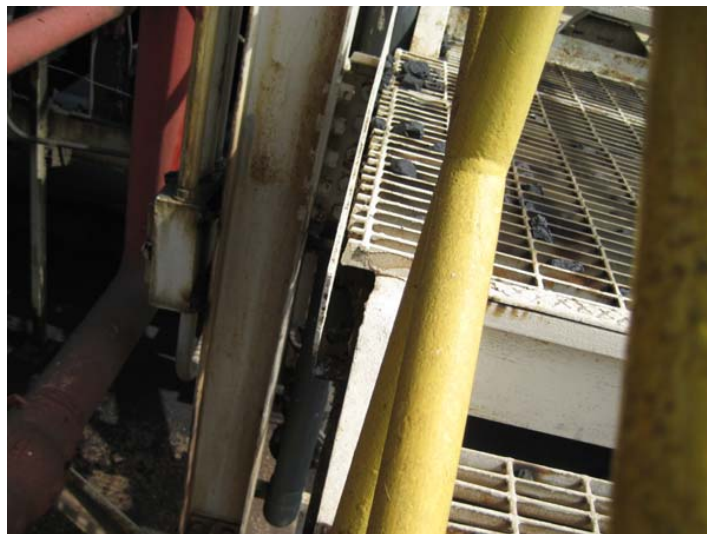
- C-3 The toe plate has corroded free at the first landing level on both sides of the landing, as seen in Pictures TTWR-T4-D and TTWR-T4-E. The toe plates need to be reattached to the platform and cleaned and painted as necessary.

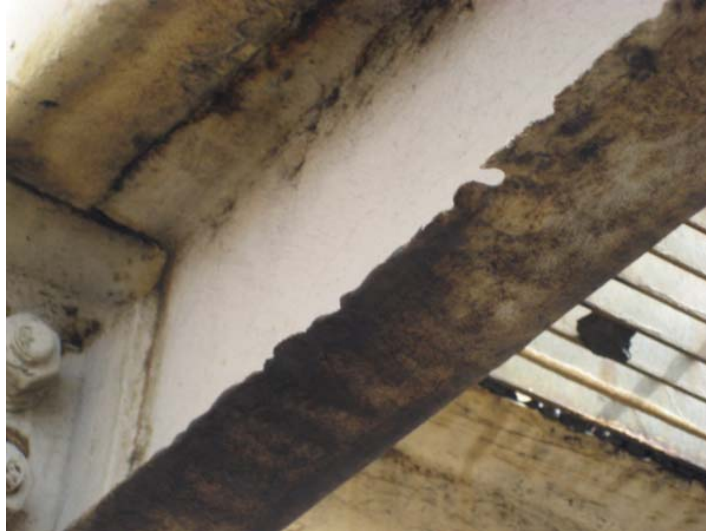
PICTURE TTWR-T4-F

- C-4 The bottom flange of the beam on the west side of the landing has severe corrosion, as seen in Picture TTWR-T4-F. This needs to be repaired or the member replaced if, after cleaning, it is determined that the corrosion is too severe and the member is not salvageable.

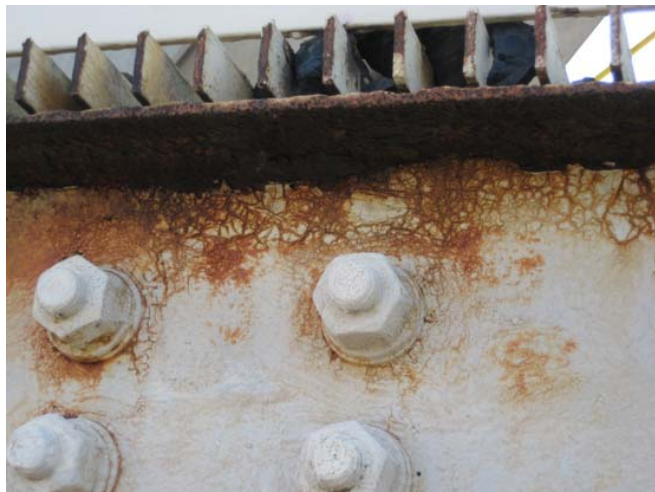
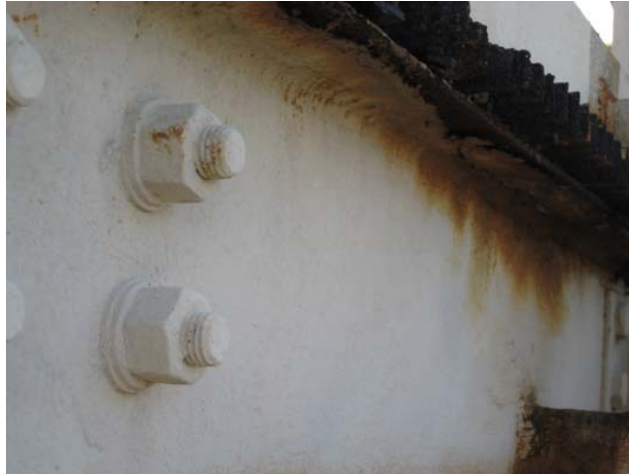
- C-1 At a number of locations where coal is allowed to accumulate at the edges of the platforms, the top flange of the support steel has corroded significant. In some instances the corrosion has wrapped around and started corrosion of the underside of the top flange, as seen in Pictures TTWR-T4-G and TTWR-T4-H. The coal should be removed and not allowed to accumulate. Also, the beam flange should be cleaned and repaired as necessary and then painted.

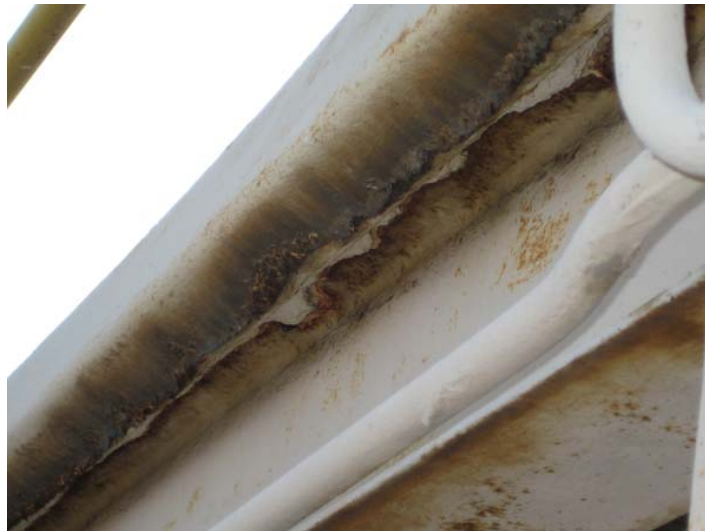
PICTURE TTWR-T4-J

- C-2 Where the toe plate is a bent plate welded to the underside of the top flange, moisture has seeped between the plate and the top flange causing corrosion. In some instances, such as at the stair landing seen in Picture TTWR-T4-J, the toe plate has corroded free or almost free. The plate should be reattached and painted and coal should not be allowed to accumulate.

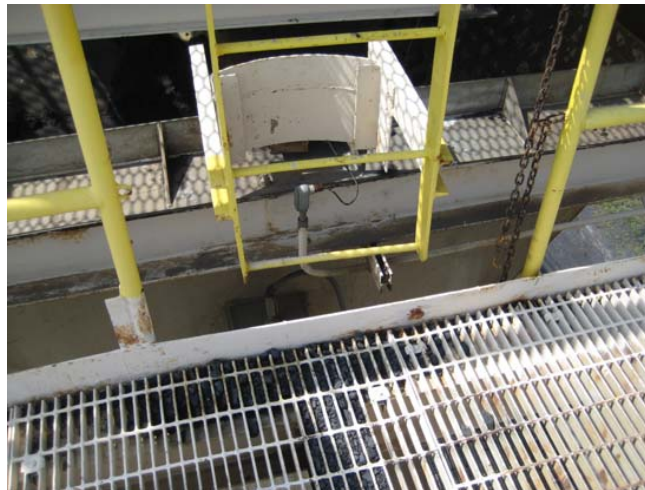
PICTURE TTWR-T4-K

- C-1 The ladder from the top of Conveyor Z to the top of Transfer Tower T-4 does not appear to comply with OSHA requirements. The toe plate directly below the ladder, as seen in Picture TTWR-T4-K provides a tripping hazard for anyone using the ladder. Also, the ladder itself should be over the grating of the lower platform, not beyond it. The ladder should be extended out over the lower platform or the toe plate removed and a landing behind the ladder added that complies with OSHA regulations.

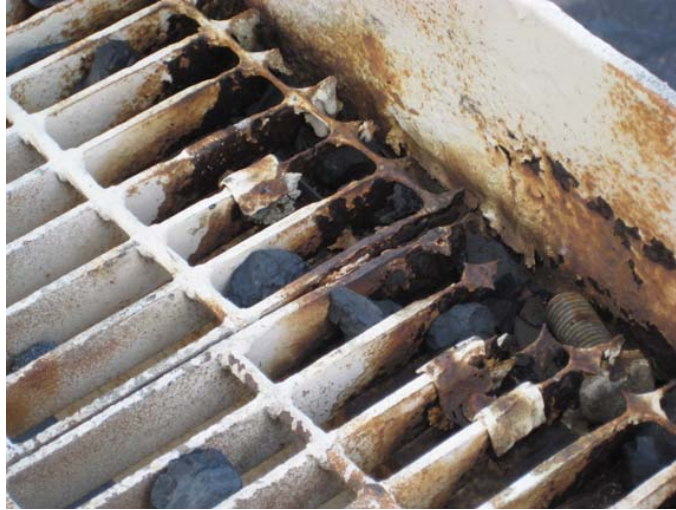
PICTURE TTWR-T4-L

At some locations, the bearing bars of the grating have corroded to the point that they are no longer providing end support for the grating, as seen in Picture TTWR-T4-L. In these instances, the grating needs to be replaced, preferably with galvanized grating.

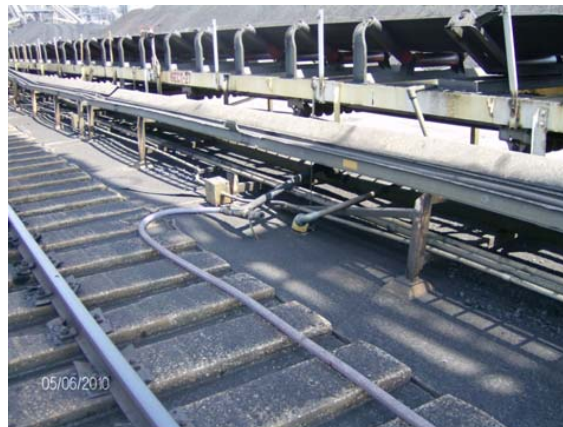
Conduits on north of P conveyor

1. There is a 480V mining cable for feeding a portable reclaim conveyor. This cable is routed in a cable tray on the north side of the P conveyor and is fed from MCC MCH-1.
2. Some of the lighting fixtures mounted to the base of the conveyor are falling down.
3. The pullcord safety switch housings are rusty.
4. Some of the conduit running along the P conveyor is unsupported and broken.

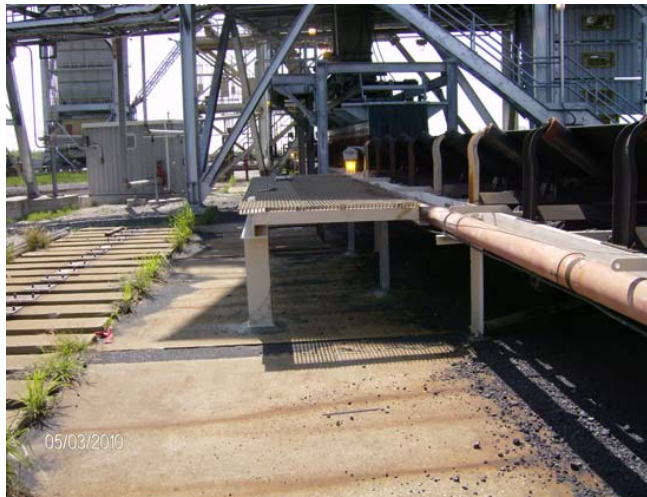
Platforms along P conveyor should be fitted with handrails and toe plates to comply with OSHA requirements.

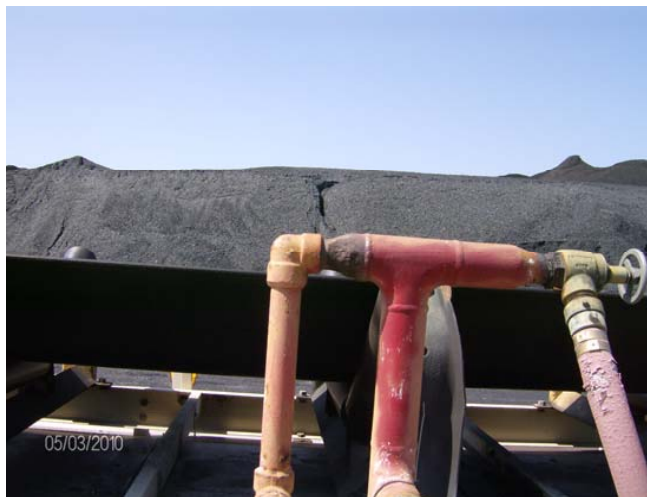
A fire protection line alongside the conveyor is severely pitted and should be painted to slow down the corrosion.

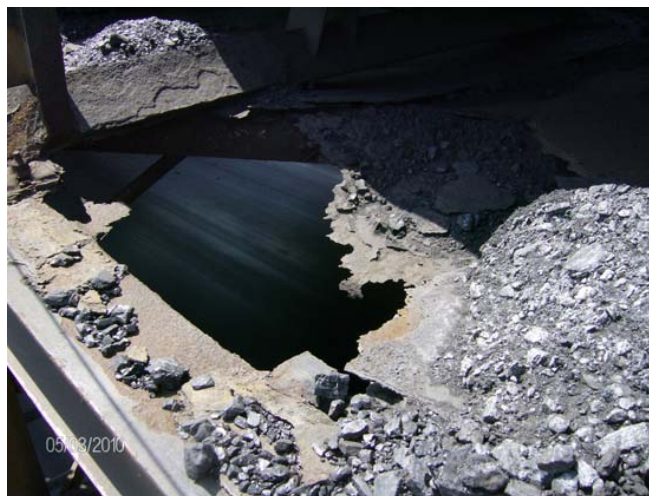
The stacker conveyor deck plates are rotted away and should be replaced to prevent coal from dropping out and possibly hitting someone.

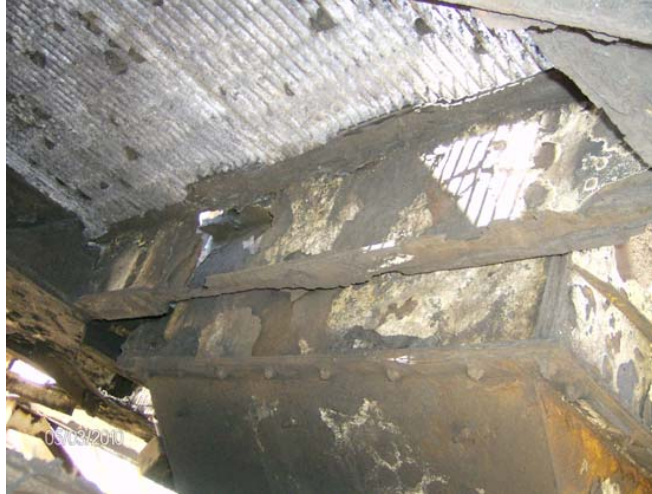
The reclaim chute is severely corroded as is the support steel and will need to be replaced.

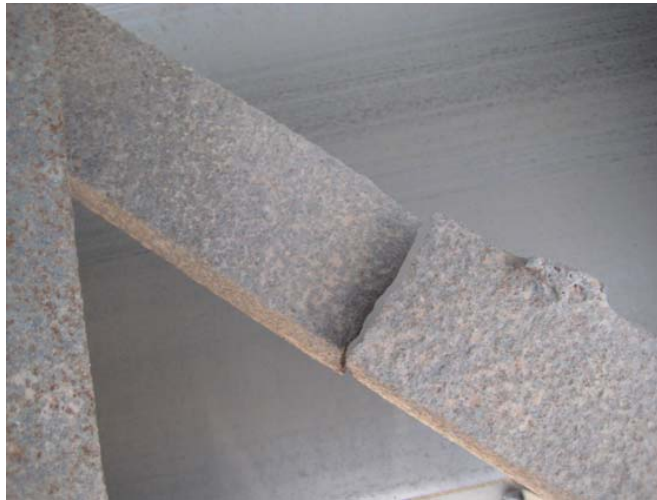
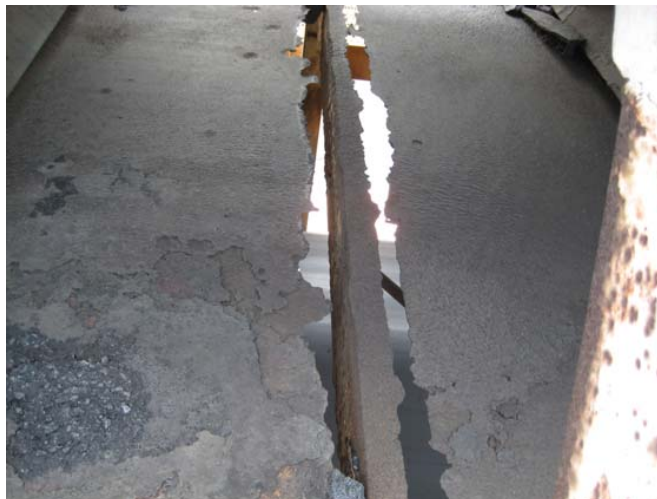
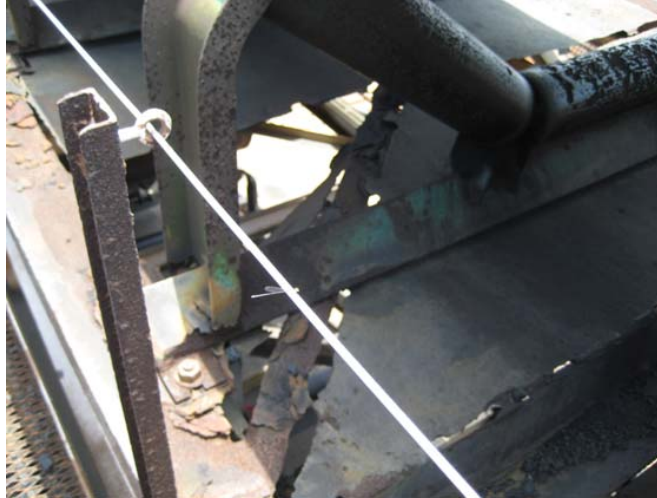
C-3 & 4 Horizontal brace C-3 has broken free from connection and C-4 has broken at mid-span. See included photo MSR-AA, MSR-E and MSR-G. Recommend replacement in kind. In general all other horizontal braces in the top chord have moderate metal loss and should be cleaned and inspected prior to painting to prevent further damage.

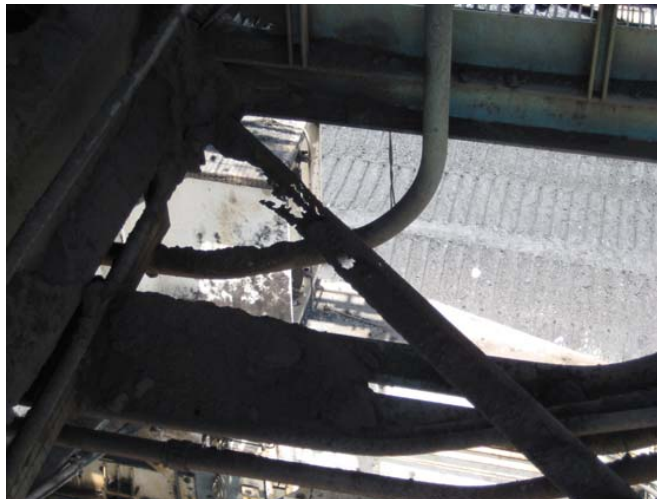
PICTURE MSR-AB

- C-5 Horizontal brace is rotten. See included photo MSR-AB. Recommend replacement in kind.

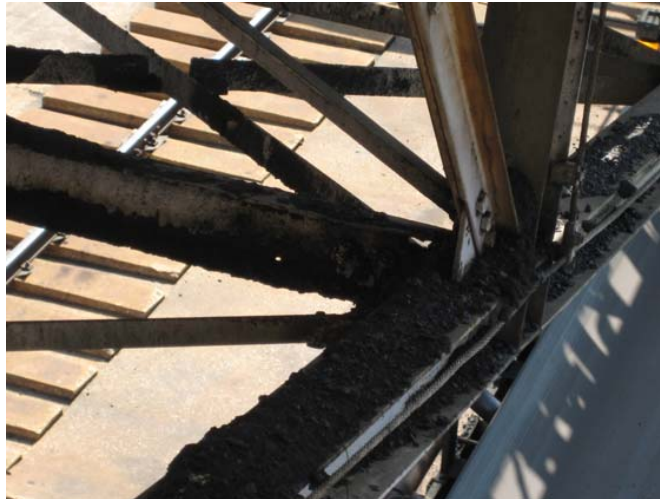
PICTURE MSR-Z

- C-6 Vertical brace has been bent out of plane. Recommend replacement in kind.
- C-7 Brace has broken free from connection and is bent out of plane. Recommend replacement in kind.
- C-8 Horizontal cross member has several holes in web. See included photo MSR-Z. Recommend replacement in kind.

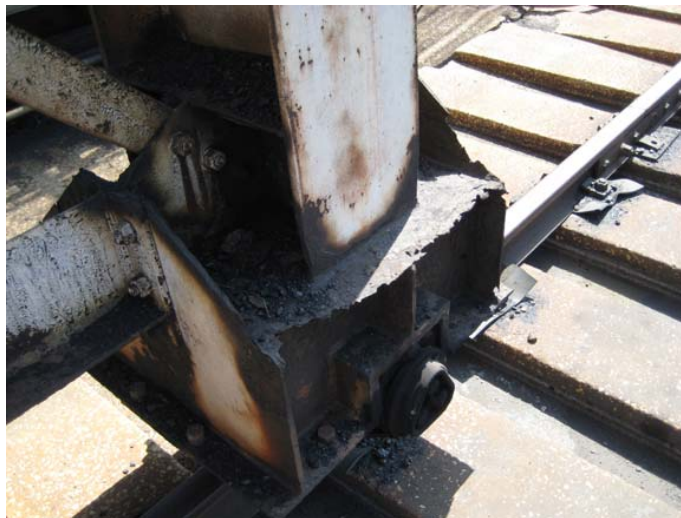
PICTURE MSR-U

- C-11 Members that make up the wheel frame have severe corrosion and metal loss. See included photos MSR-U and MSR-V. Recommend replacing all rotted members and painting to prevent further damage.

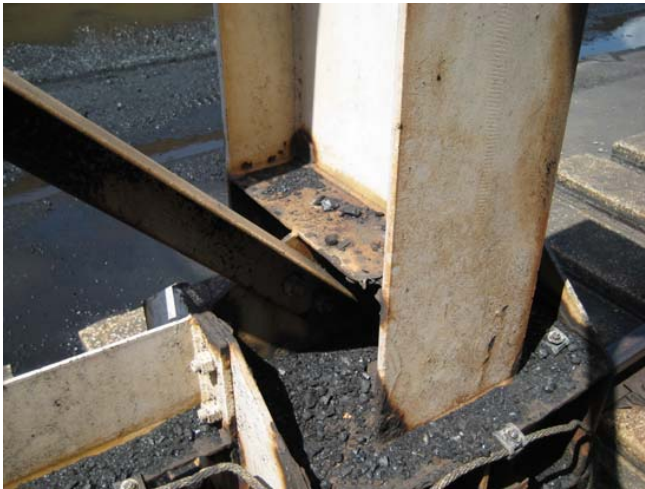
PICTURE MSR-S

C-12 Members that make up the wheel frame have severe corrosion and metal loss. See included photos MSR-S and MSR-T. Recommend replacing all rotted members and painting to prevent further damage.

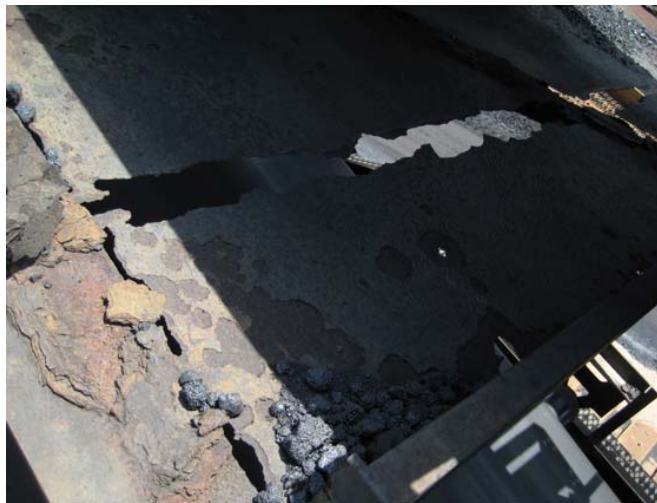
PICTURE MSR-F

C-13 & 14 Tops chords of conveyor support truss have uneven metal loss of the top flange. The flanges inboard towards the conveyor have lost approximately half their thickness. Recommend cover plating the top flange. There will be difficulties getting good contact between cover plate and top flange, as well as, solid metal to weld to due to the unevenness of the top flange. See included photo MSR-F.

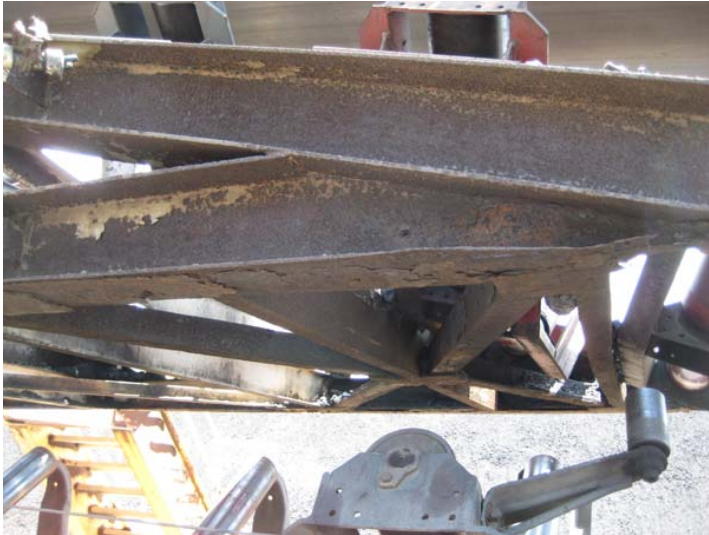
PICTURE MSR-A

C-15 All the members in the tail section of the trailer have severe corrosion and moderate metal loss. See included photo MSR-A, MSR-B and MSR-C.

Recommend replacing and repairing all members. Paint after repair to prevent further damage.

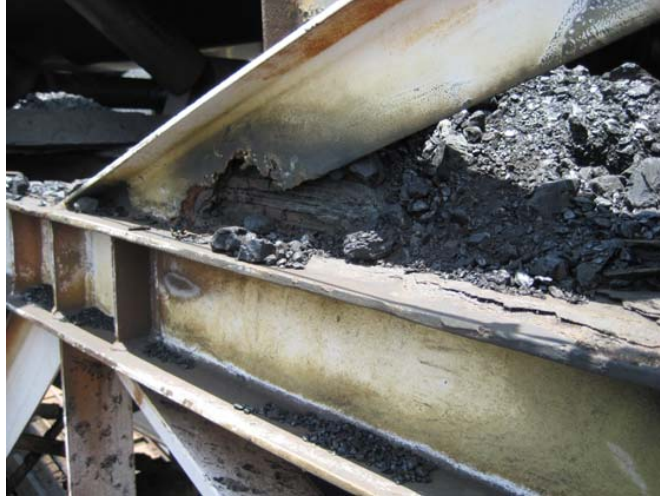
PICTURE MSR-J

- C-17 Vertical brace has large portion of stem rotten. See included photo MSR-J. Recommend replacement in kind.

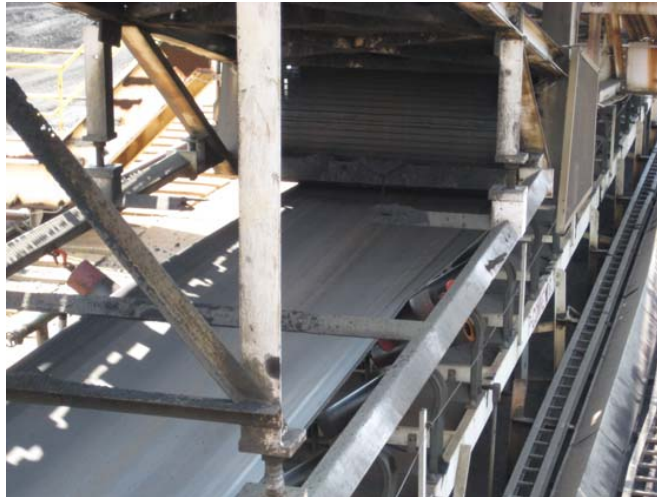
PICTURE MSR-N

Vertical braces and cross member have severe corrosion and are rotten. See thru 20 included photos MSR-M and MSR-N. Recommend replacement in kind.

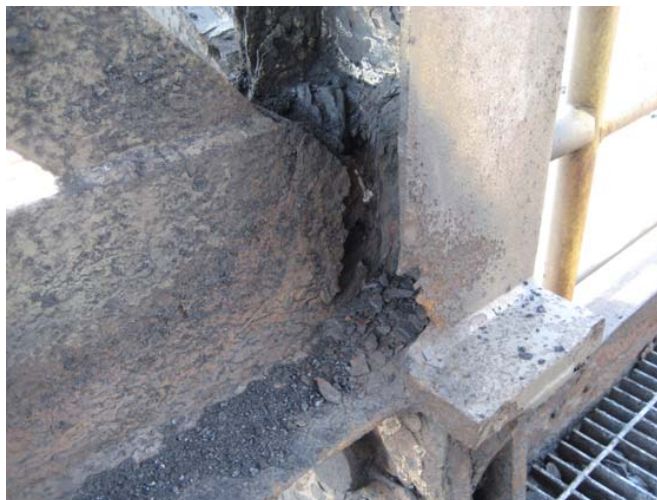
PICTURE MSR-P

Vertical brace and plates that make up pin connection have severe corrosion and are rotten. See included photos MSR-P and MSR-Q. Recommend replacing vertical brace in kind and cleaning, inspection of plate prior to painting.

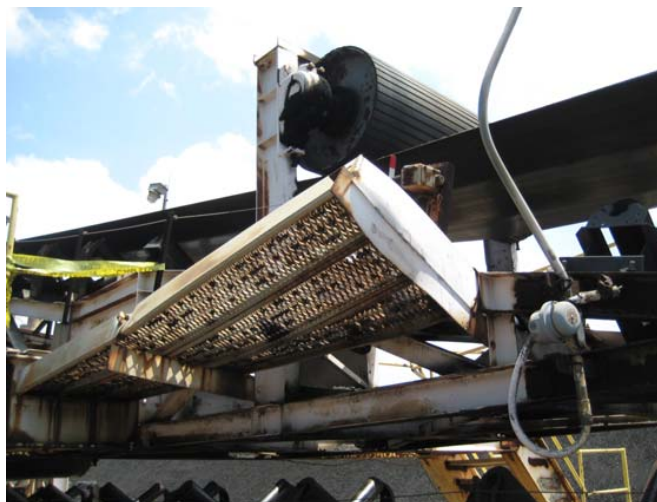
PICTURE MSR-D

Platforms have been damaged and bent. See included photo MSR-D.  
Recommend replacing bent section of platform in kind.

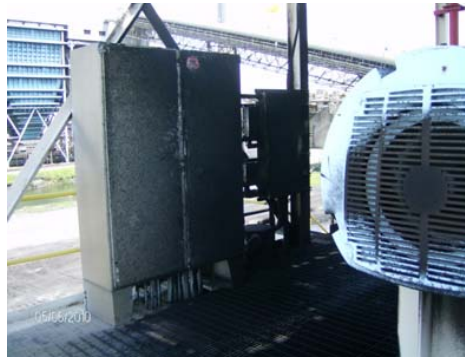
PLC Cabinet 1CYH-PCT5

2. Modicon PLC cabinet 1CYH-PCT5. The P conveyor gearbox is leaking oil and slinging it onto the front of the PLC cabinet. Conveyor gearbox should be repaired.

The leaking oil from the P conveyor gearbox should be cleaned up.

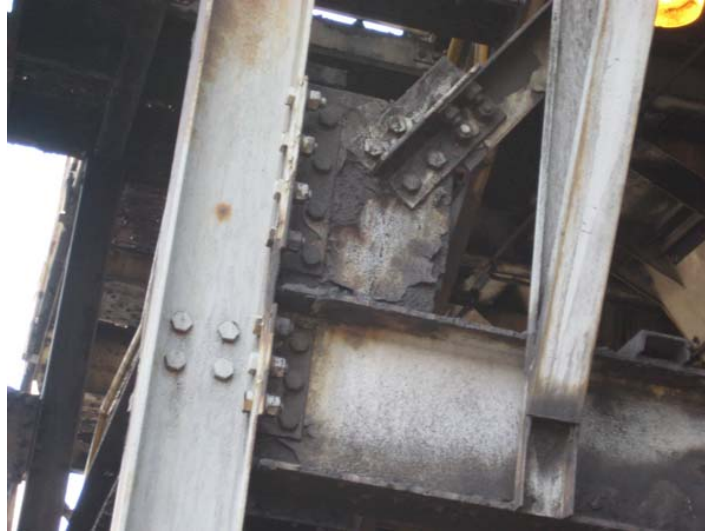
PICTURE TTWR-T6-B

- C-2 At Column E-6, at El 22' – 0", the W10 framing in from the north is corroded as is the gusset plate and brace above, as seen in Picture TTWR-T6-B. These members need to be cleaned of all loose material back to solid metal to determine if they need only painting or if repairs are required before painting.

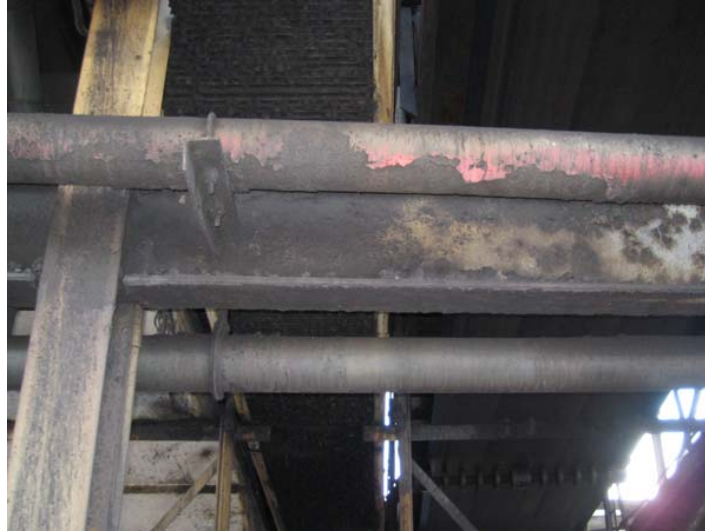
PICTURE TTWR-T6-D

- C-1 At Column G-8, at El 22' – 0", the W10's framing in from the south and the north are extremely corroded, as seen in Pictures TTWR-T6-C and TTWR-T6-D. These members need to be cleaned of all loose material back to solid metal to determine if they can be painted or if repairs are required before painting.

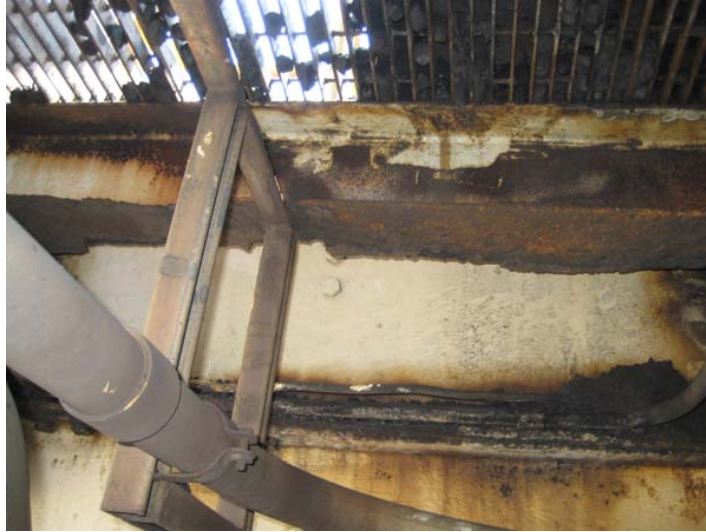
PICTURE TTWR-T6-F

Additionally, Pictures TTWR-T6-F and TTWR-T6-G are examples of the condition that the floor framing is in below the grating floor, in part due to the accumulation of coal on the grating mixing with moisture due to rain or humidity.

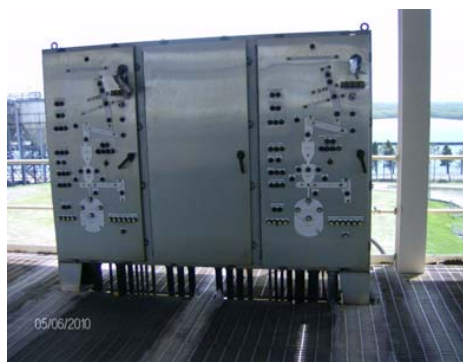
Sampling System Controls

1. On the top floor elevation, the steel and equipment was relatively clean and without signs of corrosion. This is because the coal dust tends to accumulate at the lower elevations. Equipment on the top floor includes:
  - a. T1 Conveyor motor (300 HP, 1800 RPM, 4000V, 509LL Frame)
  - b. T1 conveyor start/stop pushbutton station
  - c. T1 tilt switch
  - d. T2 Conveyor motor (300 HP, 1800 RPM, 4000V, 509LL Frame)
  - e. T2 conveyor start/stop pushbutton station
  - f. T2 tilt switch
  - g. Crusher Dust Collector Fan, Motor, and start/stop station.
  - h. Crusher Dust Collector Rotary Airlock and start/stop station.
  - i. T1 & T2 conveyor (Zone 11 & 12) Fire Suppression System.
  - j. T1 and T2 Conveyor Sampling System Control Cabinet (out of service).

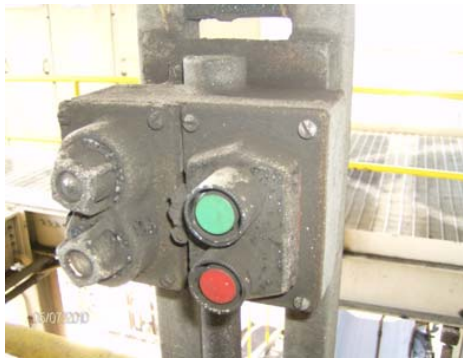
Pushbutton Station (typical)

- c. Manual flop gate to select either W1 conveyor or U conveyor to dump onto ground (this flop gate was help in place with a come-along.
  - d. Rexa Electraulic Actuator controls flop gate to bypass the crusher (east).
  - e. Manual flop gate to select either W2 conveyor or U conveyor to dump onto the ground.
  - f. There is a large accumulation of coal dust and resulting conveyor corrosion at this level.
4. Conditions observed on the 1st floor elevation (crusher level) includes:
- a. Abandoned J-Box in the northeast corner.
  - b. East Crusher Motor (800 HP, 600 RPM, 4000V).
  - c. East Crusher Lube Oil Unit (Auto Lube #2).
  - d. East Crusher start/stop pushbutton station. This pushbutton station is similar to all of the others in that legends or nameplates are either illegible or not existing.

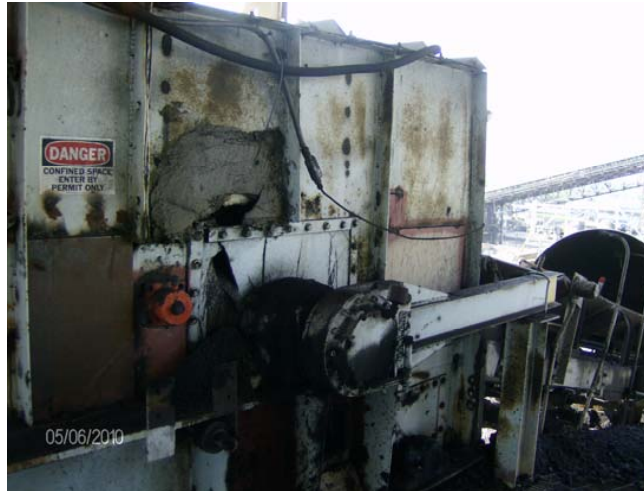
The Rotoclone on the T1 head chute is corroded and should be replaced.

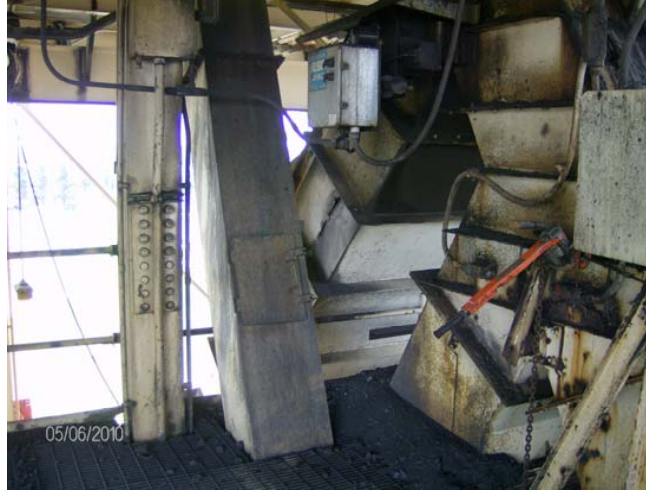
The chute work below the second floor that feeds the crushers is corroded and is in need of repair and painting.

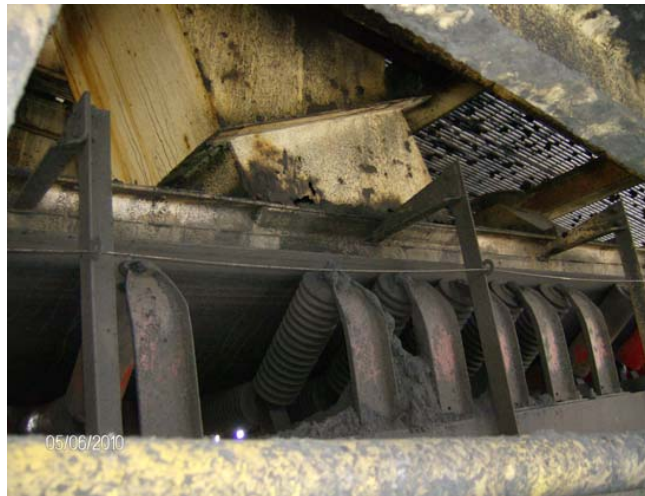
The coal chutes from the third floor passing through the second floor to the W conveyors are in average condition. Painting is recommended.

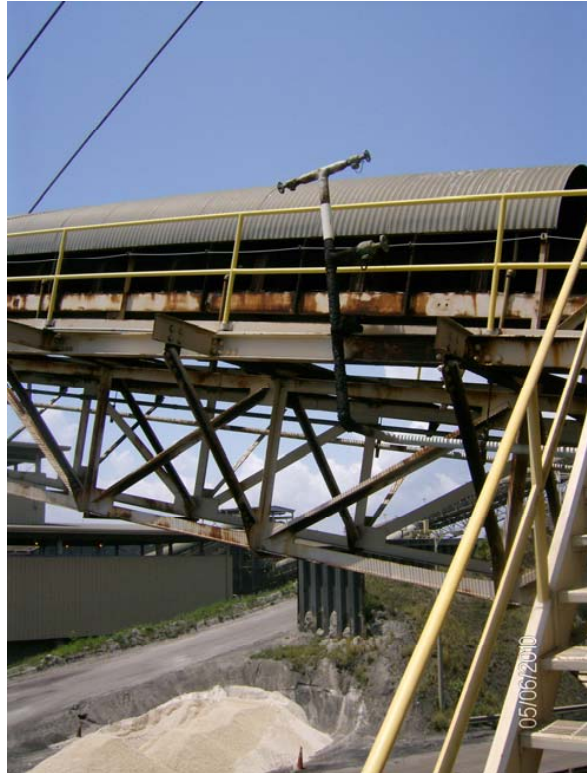
The belt scraper on the belt return near the tail pulley should be adjusted or replaced.

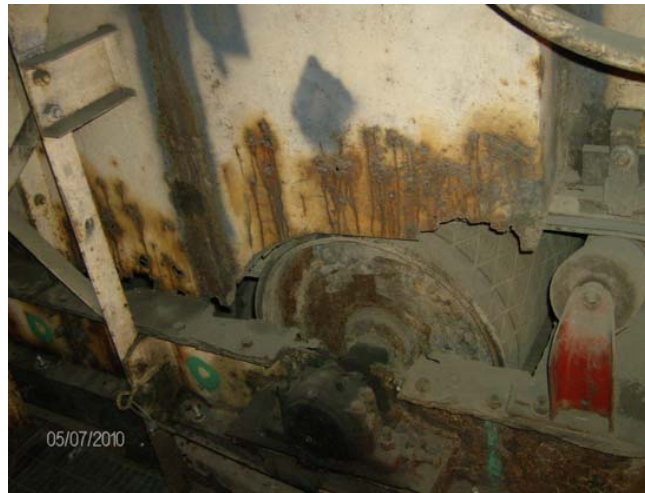
K-Feeder Discharge Chute

High humidity levels have caused corrosion of the carbon steel equipment. The steel at the mating flanges of the feeders is delaminating. Much of the chute work needs patching and the conveyor frames need to be cleaned and painted.

TECO may want to consider purchasing one new feeder and swapping out one at a time to rebuild them.

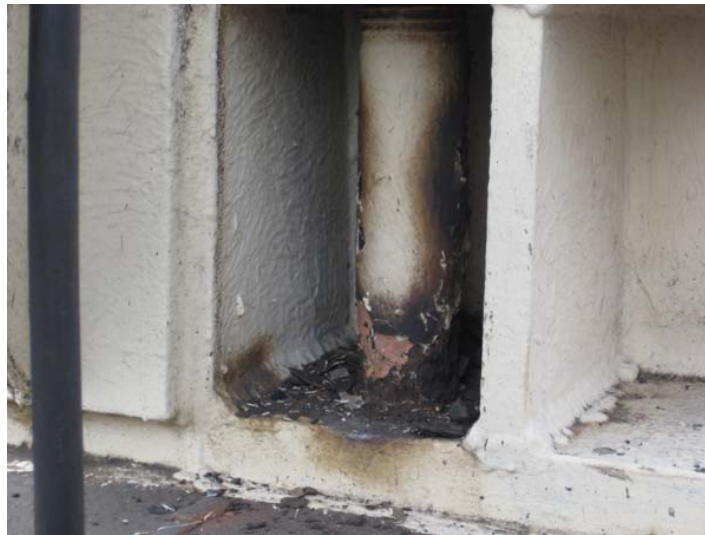
PICTURE CONV-L1-D

Pictures CONV-L1-M thru CONV-L1-T and CONV-L1-Y refer to the southeast leg and Pictures CONV-L1-U thru CONV-L1-X refer to the southwest leg. A number of the anchor bolts seem to have “necked-down” near the top of the base plate, as seen in Pictures CONV-L1—D, CONV-L1-E, CONV-L1-J, CONV-L1-K, CONV-L1-M and CONV-L1-U. The anchor bolts should be cleaned back to solid metal to determine how much of the anchor bolt is left in order to determine if repairs are necessary. At the northeast leg, as seen in Picture CONV-L1-K, there has been some significant corrosion of the nuts for the anchor bolts. This appears to be due to a pipe from above dumping on top of the nuts and causing corrosion. The discharge from this pipe should be redirected away from these anchor bolts as was done at the southeast leg. However, at the southeast leg as seen in Picture CONV-L1-Y, the pipe is damaged and may still be dumping on the anchor bolts. Although these column bottoms have been repainted, there is still considerable coal dust accumulation around these bases and anchor bolts. This dust needs to be cleared away from the column bottoms regularly so as to minimize further corrosion. In Picture CONV-L1-X, the ground lead has been broken. It should be repaired and reconnected to the grounding grid.

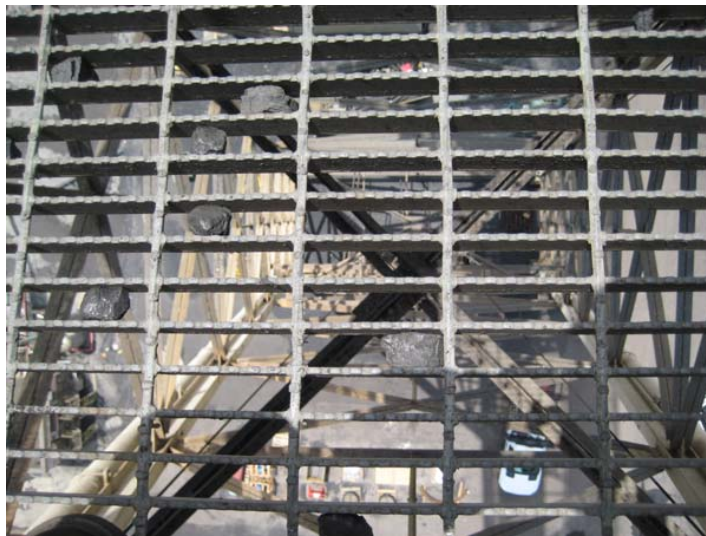
PICTURE CONV-L1-Z

M-11 The double angle horizontal X-bracing near the top of Tower No. 2 seen in Pictures CONV-L1-Z and CONV-L1-AA is separating and corroded to the point that there is little section left of these members. These members are critical to the stability of the Tower and will need to be replaced, preferably with WT-sections in place of the existing double angle sections. WT's will not separate the way double angles do.

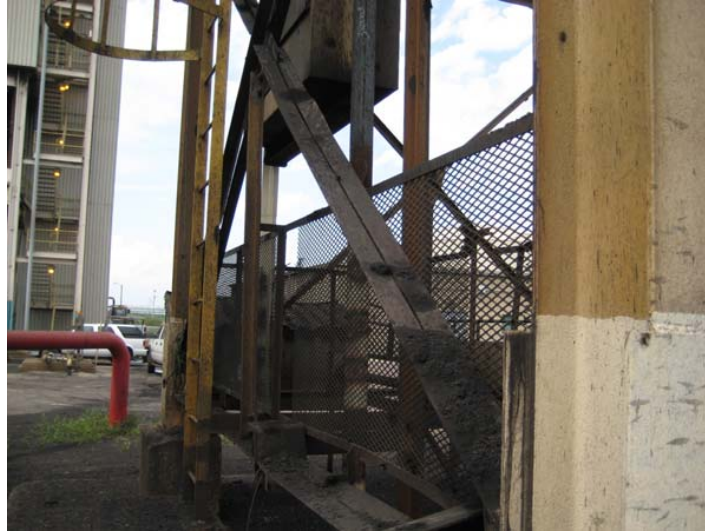
PICTURE CONV-L1-AB

M-14 As seen in Picture CONV-L1-AB, it appears that the ladder has been repaired/replaced.

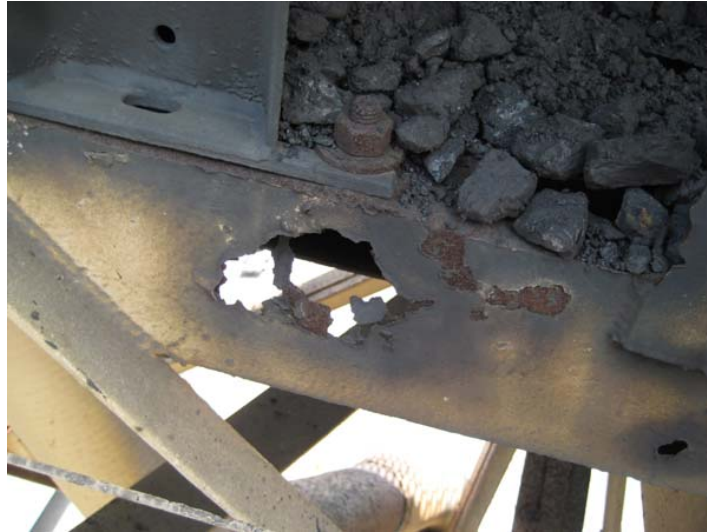
PICTURE CONV-L1-AE

C-2 In Pictures CONV-L1-AC thru CONV-L1-AE, it can be seen that some of the conveyor frames have corroded thru and the spill pans have also corroded and separated from the frames. In general, the frames should be able to be repaired by cover plating over the holes and the spill pans reattached to the frames. Cleaning and painting will also be necessary

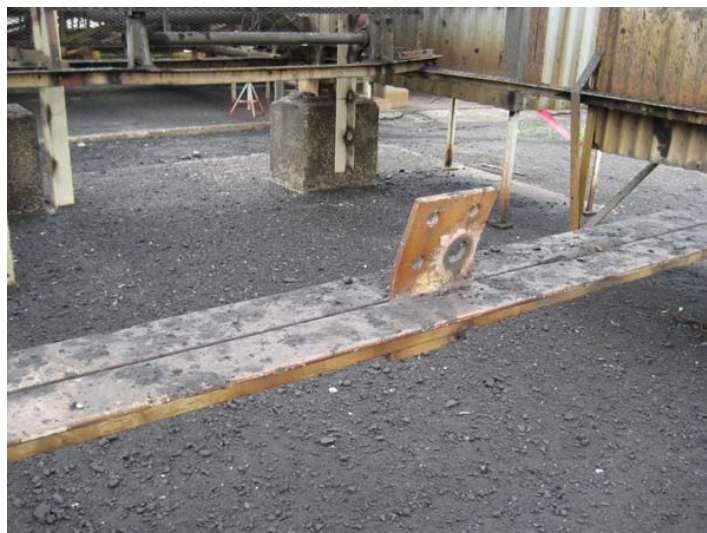
PICTURE CONV-L1-AF

- C-3 In Pictures CONV-L1-AF and CONV-L1-AG, it can be seen that a vertical double angle member is missing at grade on the east side of Tower No 1. This member should be replaced, preferably using a WT section.
